THE ALLIANCE AND LION SALT WORKS, MARSTON, NORTHWICH

SCHEDULED MONUMENT NO 34985-002

VOLUME III: THE ARCHAEOLOGICAL EXCAVATIONS, 1992-2015

REPORT NO 2015-01

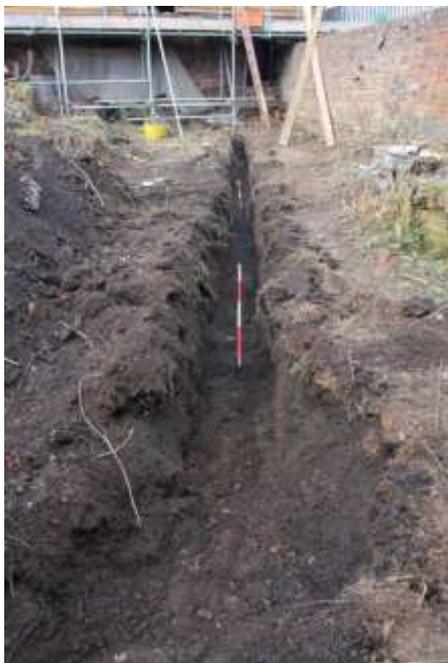
The area north of Pan 2, was covered with loose black clinker silt (2262) that varied in depth between 0.60m and 0.80m (10.3).

10.3: External Works, Area C, Surface Water Trench, North of Pan 2, North-West Facing

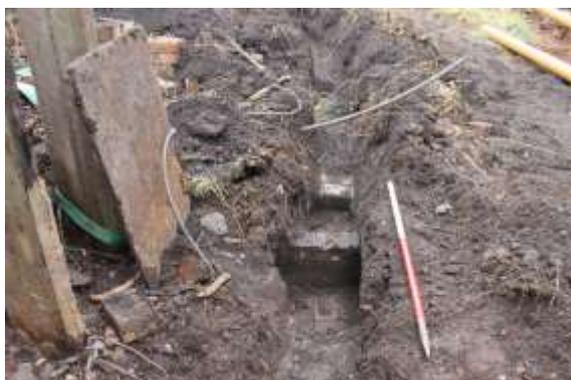
The front of the pan had a series of sumps and drains (10.4). A yellow brick sump (2265), 1.20m (east-west) by 0.90m (north-south), with a brick base at a depth of 0.60m, was located at the eastern end of the north ditch of Pan 2. A ceramic pipe (2266), 9" diameter, entered from the ditch on its western side. Another ceramic pipe (2267), 9" diameter, exited to the south. The sump was covered with a ferrous metal plate (2264).

10.4: External Works, Area C, Surface Water Trench, East of Pan 2, North Facing

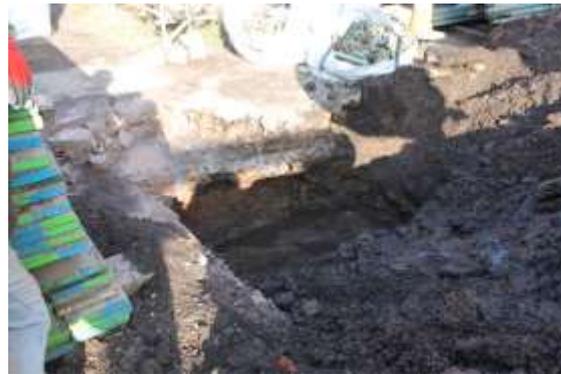
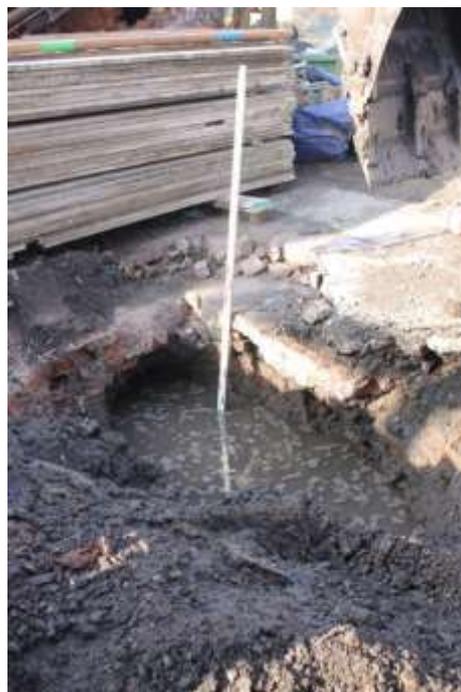
The area of soft ground was covered by the remains of a machine-pressed, red brick, floor surface (2268), designed as work area in front of Pan 2 (10.5, 10.6). It was later replaced by a series of two skimmed concrete surfaces, with rough lain brick underneath. The lower layer of concrete slab (2277) was 7.5m (north-south) x 3.5m (east-west) x 0.40m deep. The upper layer of concrete slab (2276) was 7.5m (north-south) x 3.5m (east-west) x 0.25m deep. An east-west aligned wooden timber (2269) between Pan 2 and the Brine Tank, c. 3.50m long, retained concrete 2277 at its northern side. An east-west, machine pressed, red brick, wall foundation (2263) between the Pan 2 ditch and the Brine Tank may have been part of Pan 2 or an earlier pan in this location. As a whole

10.5: External Works, Area C, Test Sondage, East of Pan 2, North-East Facing

10.6: External Works, Area C, Test Sondage, East of Pan 2, North-East Facing

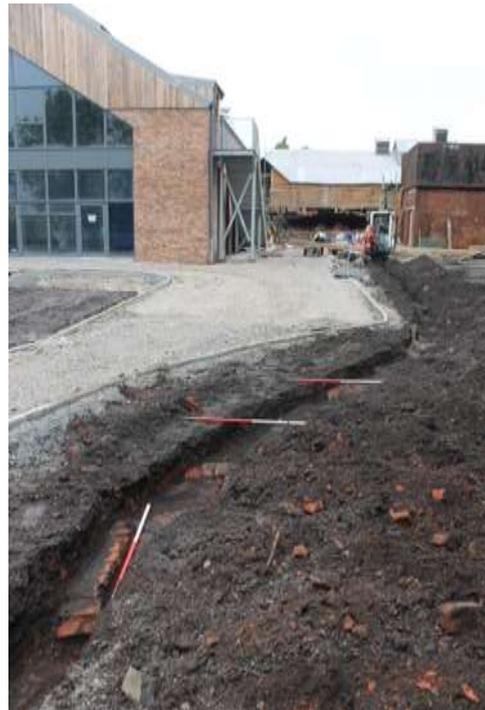
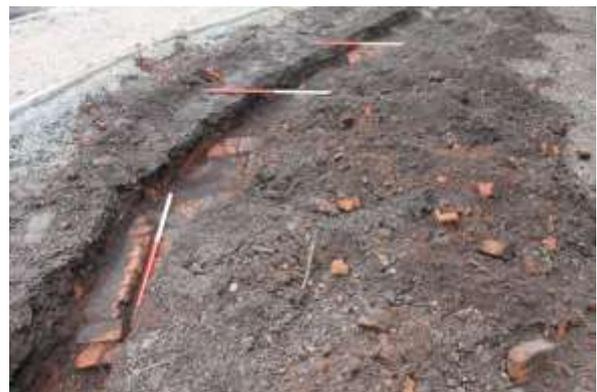
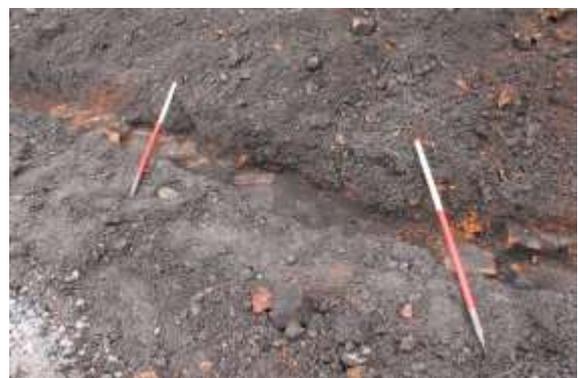
The earliest deposit related to a series of brick structures visible in plan during the watching brief. Located 15.0m east and 2.0m north of Stove House 5, north-east corner was a series of three north-south flue wall foundations (2373, 2374, 2375; AS087, 10.7, 10.8, 10.9). These were hand-made, red brick, flue walls with brick laid in header form, aligned north-south. The western two 2373 and 2374, appears to form a dead draught along the side of a furnace. A single small hand-made, brick pier, wall foundation (2372), 0.70m x 0.70m in size, abutted flue wall/ dead draught (2373).

10.7: External Works, Area E1, Electricity Cable Trench, West Facing

10.8: External Works, Area E1, Remains of Fine Pan, Alliance Works, West Facing

10.9: External Works, Area E1, Remains of Fine Pan, Alliance Works, North Facing

Further to the east the structure took a different form (10.7, 10.8, 10.10). A curved flue wall (2376) initially ran east-west and turned to run north-south. It was again made of hand-made, red brick. A second flue wall (2377) ran over curved wall 2376. It appeared to be bonded to it and part of the same structure. A further flue wall (2388) was located between 2375 and 2376. It was a single skin of hand-made, red brick, that formed a possible corner wall of the stove house or the flue system as it passes into the stove house.

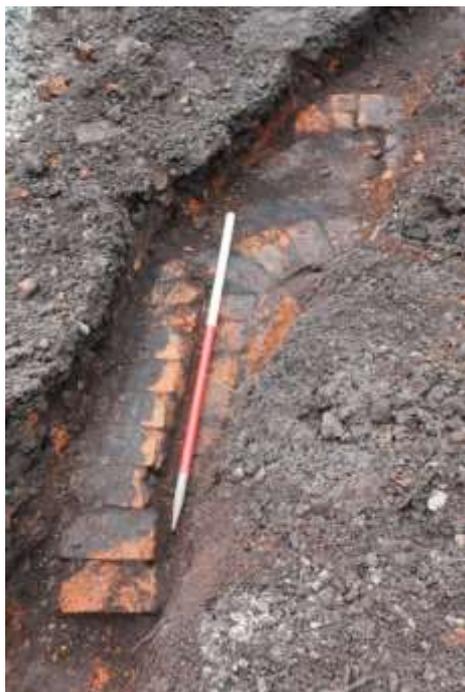
10.10: External Works, Area E1, Remains of Fine Pan, Alliance Works, West Facing

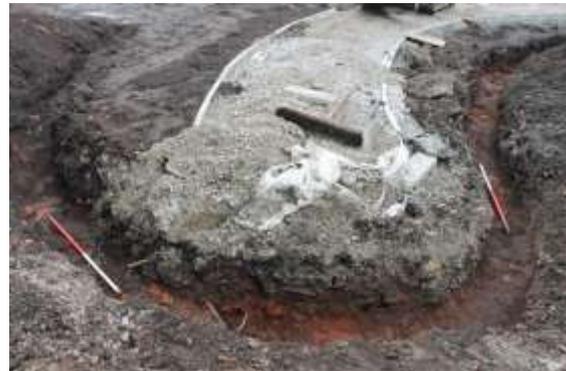
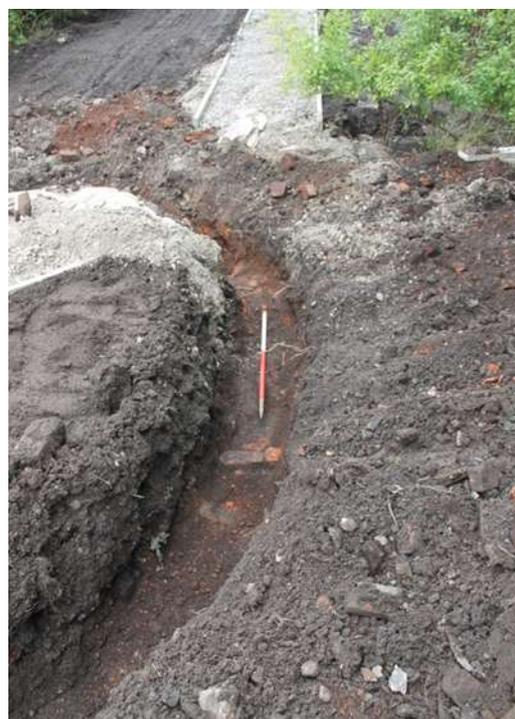
of dismantled pan or stove house (10.11, 10.12). The whole area was overlain by loose black clinker silt (2384).

10.11: External Works, Area E1, Electricity Cable Trench, East End, South-West Facing

10.12: External Works, Area E1, Flue Remains, North Facing

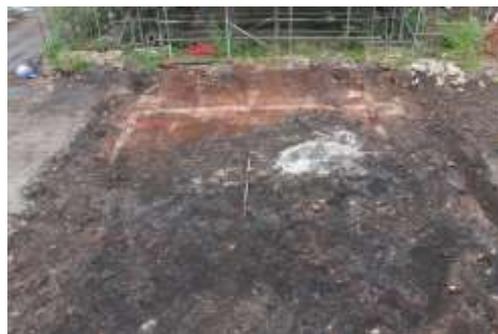
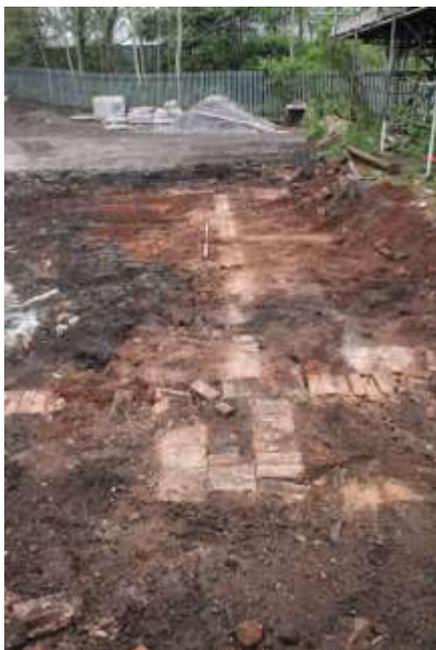
The furnace of Pan 5 was built directly onto this layer. It was built exclusively of machine-pressed, yellow brick, with wedge shaped frogs, marked 'SNEYD', two skins thick, and 0.22m wide. The construction consisted of two east-west walls; the north wall foundation (2354) and south wall foundation (2356) survived for length of c. 9m, separated by a distance of 6.6m. On the southern side was an area of brickwork forming footing of pier (2360), 0.70m x 0.80m (10.13, 10.14).

10.13: External Works, Area E2, West Side, East Facing

10.14: External Works, Area E2, Remains of Pan 5 Furnace, North Facing

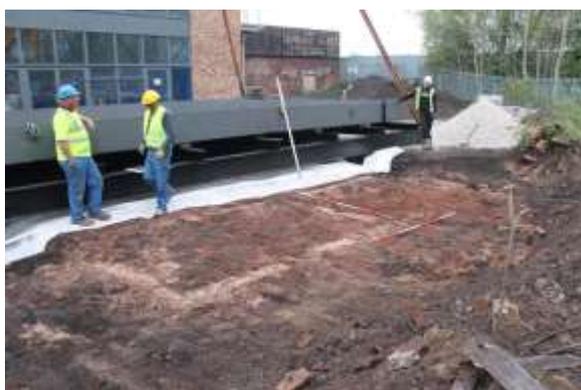
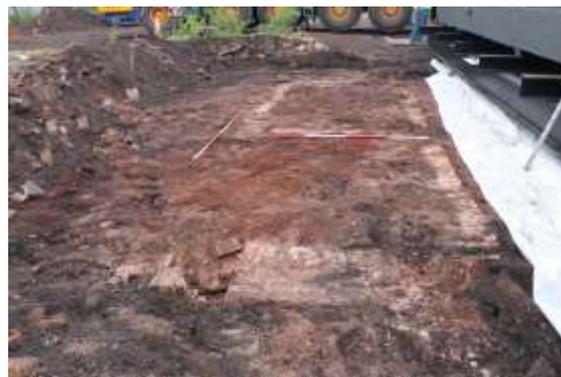
At the eastern end were two wall foundations (2355) and (2368), orientated north-south, which survived for length of c. 6.6m (10.15, 10.16). Between them was a cross-wall (2358) extending east-west, 1.50m long. These wall foundations formed two chambers. Within these chambers were two small brick pier bases or floor areas of yellow brick, at the north (2357) and at the south (2359).

10.15: External Works, Area E2, East Side, North-West Facing

10.16: External Works, Area E2, Remains of Pan 5 Furnace

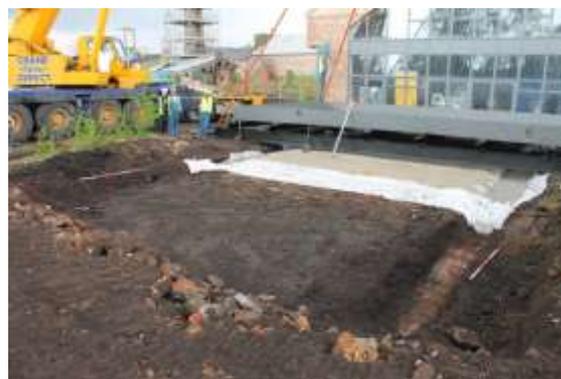
steels (10.17), at eastern end of the area outside of the footprint of the original Pan 5 furnace (see below). This was the top of demolition layer associated with the collapse and demolition of the Alliance Salt Works. A layer of red sand and rubble (2366), formed the layer for building of the furnace of Pan 5. The material was not dissimilar to other instances where it appears to have formed a 'caulk' for the stoves.

10.17: External Works, Area E2, East Side, South-West Facing

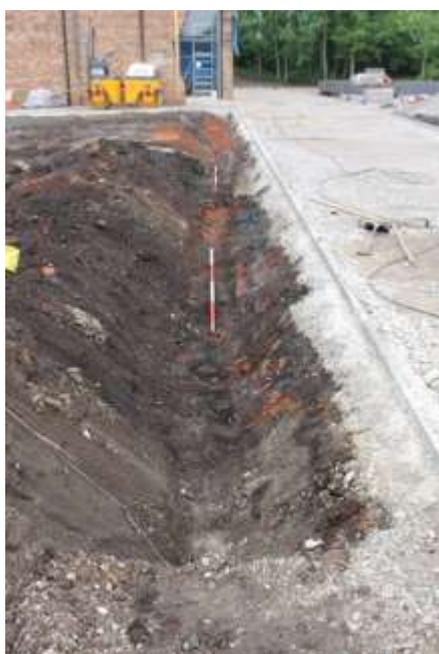
A shallow low voltage electricity service trench was laid in the area South of Stove House 5. It followed the western line of the new access road in a direction north-south from the south-east corner of Stove House 5. It was c. 21m long, 1.0m wide and 0.4m deep (see AS006 above, AS007; 10.18).

10.18: External Works, Area E3, North Facing

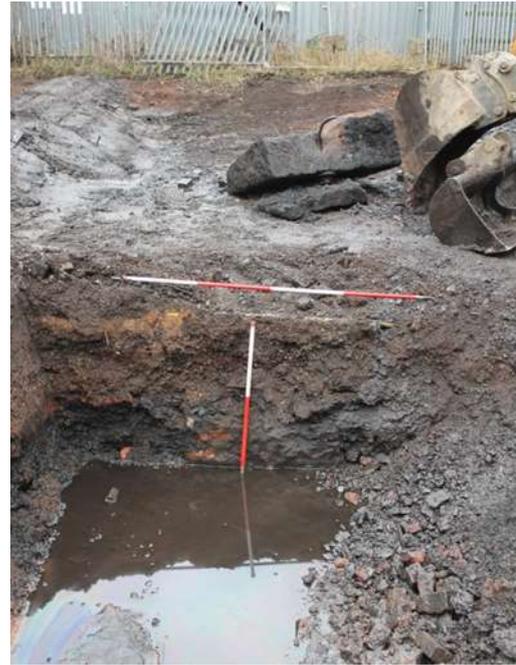
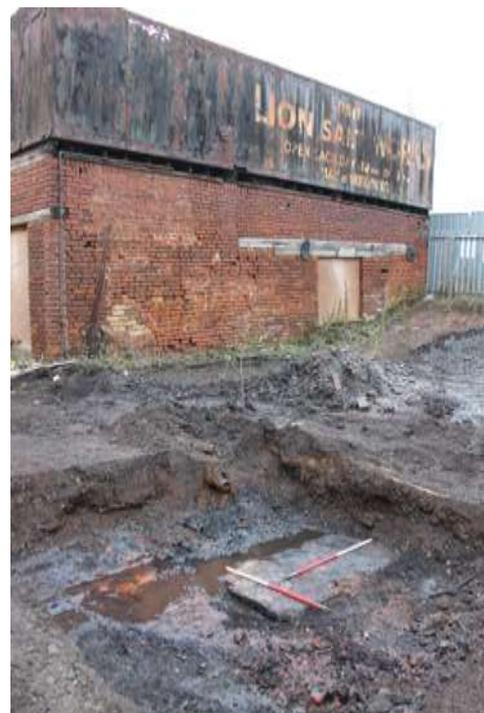
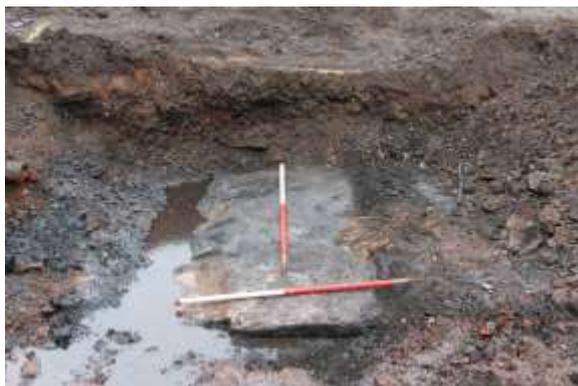
10.20: External Works, Area G1, Sandstone Base in section, 2306, note sandstone base removed above

10.21: External Works, Area G1, Sandstone Machine Base, 2305; North-West Facing

10.22: External Works, Area G1, Sandstone Machine Base, 2305; North Facing

Phase 3/4: Machine bases 2305/ 2306/ 2307 appeared to have been used for tying down late-19th century machinery, such as a large steam engine, a crushing machine, or a beam engine or pump. It is not clear precisely what they relate to. The adjacent and related wall foundation (2304) was substantial and sufficiently large to be associated with a large warehouse, from the Alliance Works. However, the features appear to relate to two enigmatic buildings on the 1898, 2nd edition and 1910, 3rd edition Ordnance Survey Maps.⁵⁶ They would appear to be associated with machinery in these two small buildings such as a steam engine.

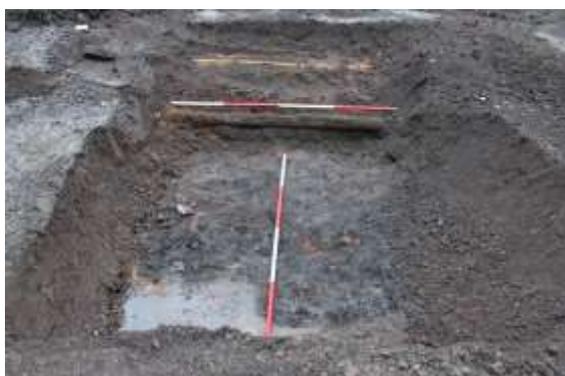
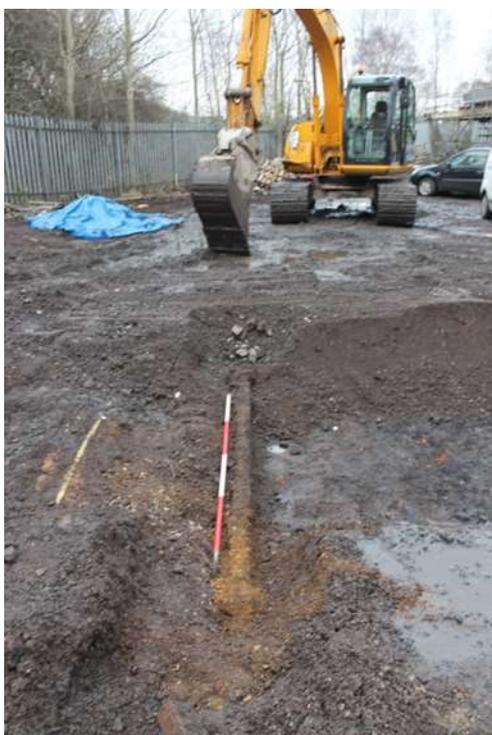
This was covered by compact, black, silt and clinker layer (2302) with rubble, spread across the area 0.65m deep, under loose, black, clinker silt and rubble layer (2301), 0.70m deep, spread across area north of Stove House 5. In one location there was a cast-iron brine pipe (2300; 1023, 1024), orientated east-west, 7" diameter and 2.80m long, with collars at either end. It continued to the east and west outside area. It related to the brine pipe that exited the brine tank to the east, (1001), and a short section uncovered to the east and displaced during soft-stripping around Pan 5.

10.23: External Works, Area G1, Brine Pipe, north facing

10.24: External Works, Area G1, Brine Pipe, east facing

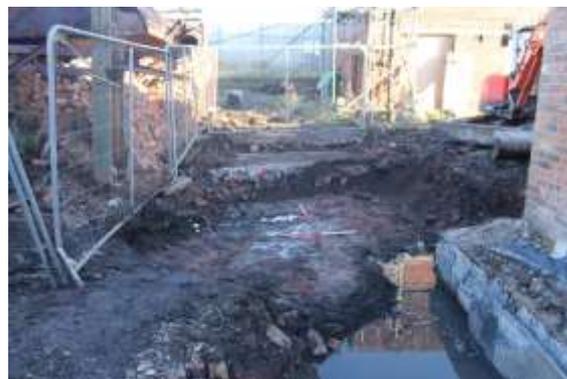
At the very north of the trench were slabs 2276 and 2277, a lower layer of concrete slab (2277), 7.5m (north-south) x 3.5m (east-west) x 0.40m deep, and an upper layer of concrete slab (2276), 7.5m (north-south) x 3.5m (east-west) x 0.25m deep (10.27). These are described in greater detail above in Area C.

10.27: External Works, Area C/ G2, concrete slabs, north facing

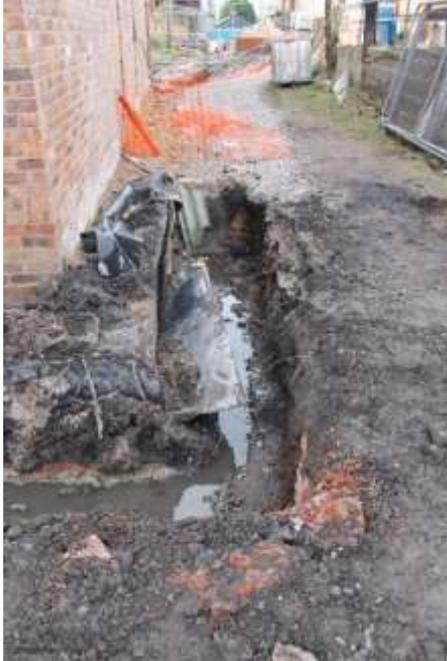
10.29: External Works, Area G2, Foul Water Trench, North-West corner SH5, south facing

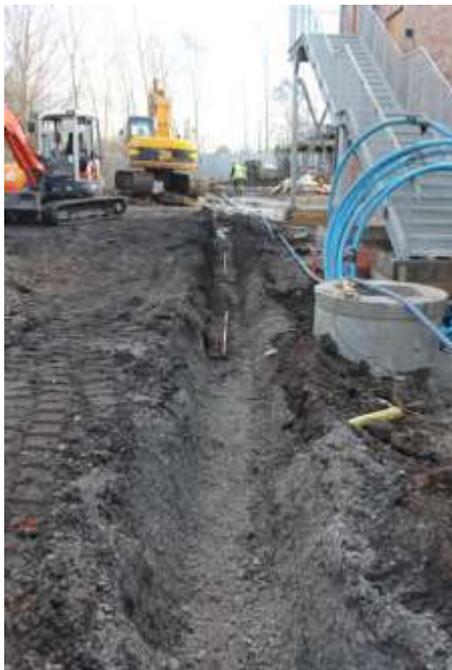
10.30: External Works, Area G2, Surface Water Drainage, east facing

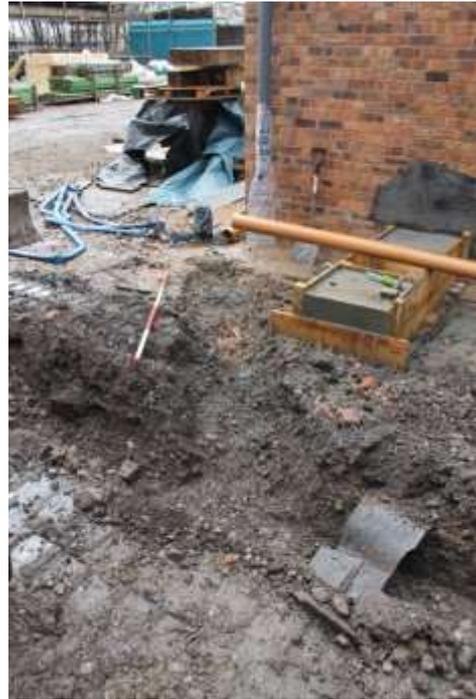
10.31: External Works, Area G2, Surface Water Drainage, south-east facing

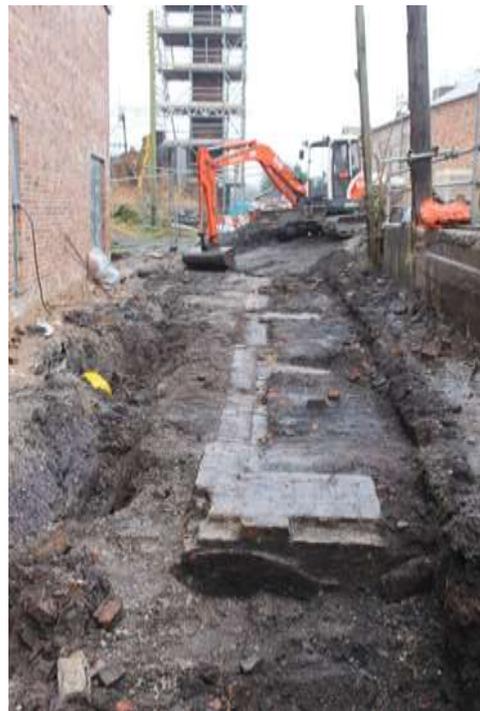
10.32: External Works, Area G2, North-East Fishery Pan, south facing

At the southern end of the trench, the foundations of the North-East Fishery Pan Furnace had been constructed (see AS085, AS090; 10.32, 10.33). This was one of four fishery pans that existed on site. It was previously excavated during the 2013

The North-East Fishery Pan furnace consisted of four walls, three of which were located in the current area (2287, 2288, 2289; 10.32, 10.33, 10.34, 10.35, 10.36). The wall foundations were of machine-pressed yellow brick in Stretcher bond,

two skins thick, surviving to 7 courses high, with a corbelled foundations at the base. The southern wall (2289) was orientated ESE-WNW and equivalent to 2022 (see Section 9). It was not bonded with wall 2287 but appeared to be inserted between east and west walls of the furnace. The western wall (2287) was 15.70m in length and orientated NNE-SSW, supported by buttresses 2281, 2282, and 2283. The northern wall (2288) was orientated ESE-WNW, equivalent to 2024 (see Section 9). Against the western wall were a series of three piers/ buttresses (2281), (2282) and (2283). These were 70m x 0.50m in size and constructed of machine-pressed yellow brick.

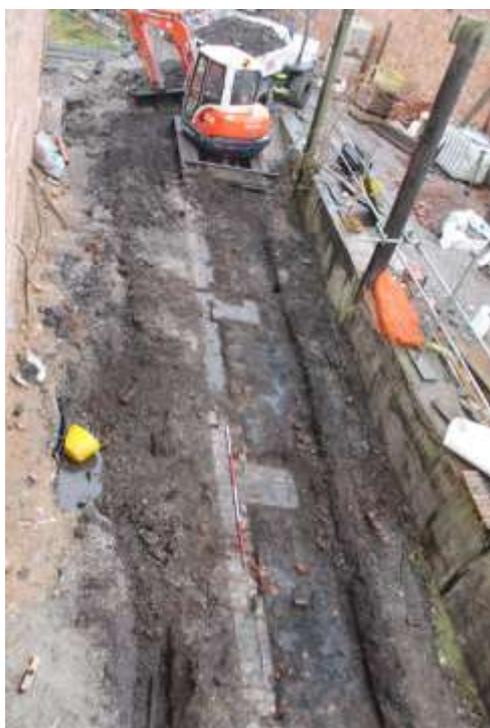
10.33: External Works, Area G2, North-East Fishery Pan, south-west facing

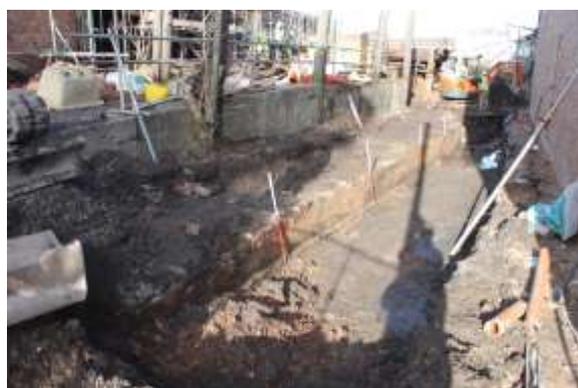
10.34: External Works, Area G2, North-East Fishery Pan, north-west facing

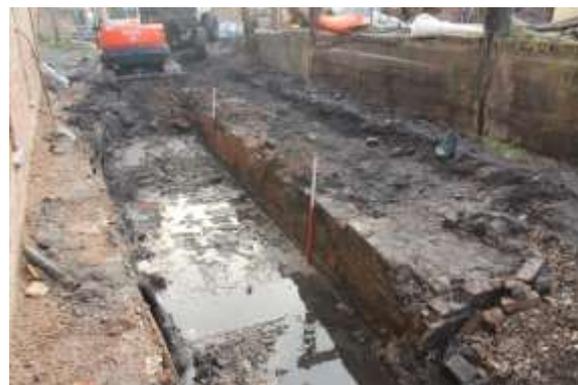
10.35: External Works, Area G2, North-East Fishery Pan, south-west facing

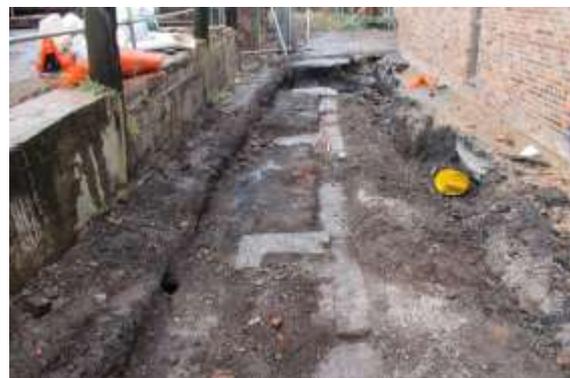
10.36: External Works, Area G2, North-East Fishery Pan, north facing

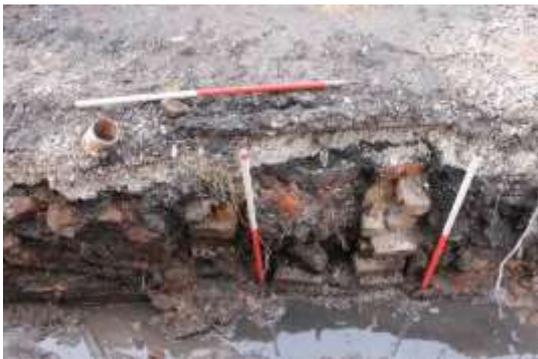
10.37: External Works, Area G2, Flues 2284 and 2285

To the north of the furnace was a series of wall foundations. A narrow, single skin thick, machine-pressed, yellow brick wall foundation (2286) may have been associated with the furnace. It was seen in section only. To the north of this were two flue walls (2284 and 2285; AS090; 10.37), running east-west, 2 skins thick, orange-red machine pressed brick, surviving to a height of 8 courses that ran towards Chimney 4, and were designed to vent the North-West Fishery Pan. Chimney 4 was located just north of the furnace and was recorded during the excavation of Stove House 5 footprint (see section 9). There was no clear relationship with Chimney 4 and the furnace and this suggests the flue entered at a higher level. The flues were set within a layer of mixed black clinker silt (2294) and (2295) to the north and south. The flues 2284/2285 of Chimney 4 were backfilled with brick rubble and black clinker silt (2296) when they became redundant.

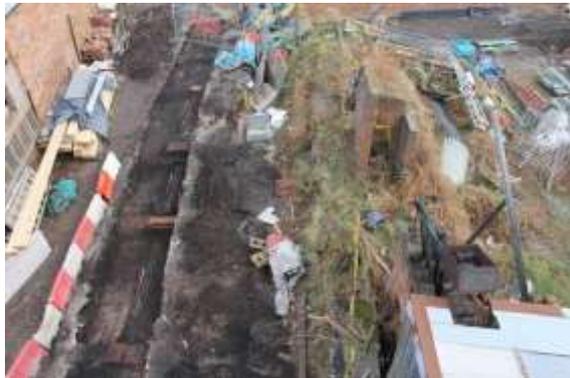
10.38: External Works, Area G3, overhead, north facing

west of The Nodding Donkey complex and Pump House. This was a continuation of the trunk route in Area G2. It ran for c. 25m north-south and was 2.5m wide and 1.10m deep below finished ground level (see AS006 above, AS091, AS092, AS093; 10.38).

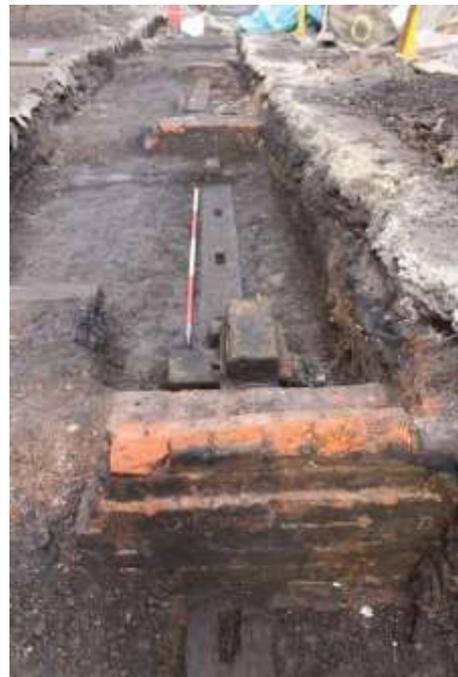
10.39: External Works, Area G3, brick piers/ buttresses (2215, 2216, 2219, 2220) and wooden sill beams (2214, 2223, 2238), north facing

Running the length of the eastern side of the trench, was the remains of the South-East Butter Pan (10.39, 10.40, 10.41, 10.42). The western wall of the furnace of the South-East Butter Pan (2213; 10.43), survived to a height of 6 to 7 courses in eastern section of trench, for a length when finally exposed of c. 14.0m. It was constructed of machine-pressed, red brick in English Garden Wall bond, four stretchers to one header. It was orientated NNE-SSW, and ran parallel to the eastern wall of the furnace (1017; for details see

Volume IV: The Nodding Donkey Complex). This was supported on the western side by a series of four brick piers/ buttresses (2215, 2216, 2219, 2220). They were built of machine-pressed, red brick, 5 courses wide, 6 courses high, with a brick corbel at the base. They were roughly 0.60m x 1.00m in size.

Between each pier was wooden sill beams (2214, 2223, 2238; AS091, AS092; 10.39, 10.40) orientated NNE-SSW, running parallel to wall 2213, 0.60m to the west. The sill-beams underlay buttress 2215, 2216, 2219 and 2220. Sill beam 2214 and 2215 were c. 7.5m in length and 0.25m

wide. They had a series of nine tenons for studs, 0.75m apart and 0.25m wide. To the north was a further sill-beam 2223, 3.05m long, 0.25m wide plain with a plain upper with no tenons. On top of the beam were a series of pads, designed to act as supports for the hurdle structure above (see 2221; 2224, 2225, 2226, 2227, 2228; 10.42). These were made of bricks, or wood or a combination of the two, and 0.2-0.35m square in size. The wood re-used elements of sill-beams.

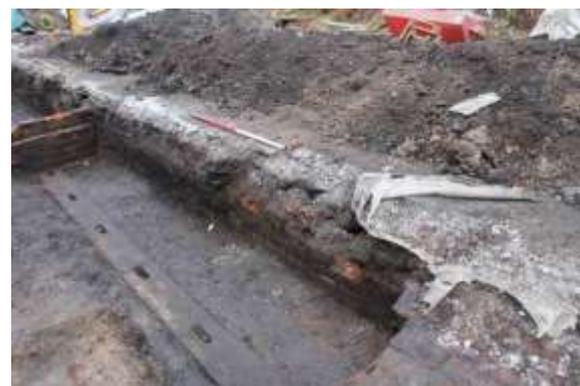
10.40: External Works, Area G3, wooden sill beam (2223), north-east facing

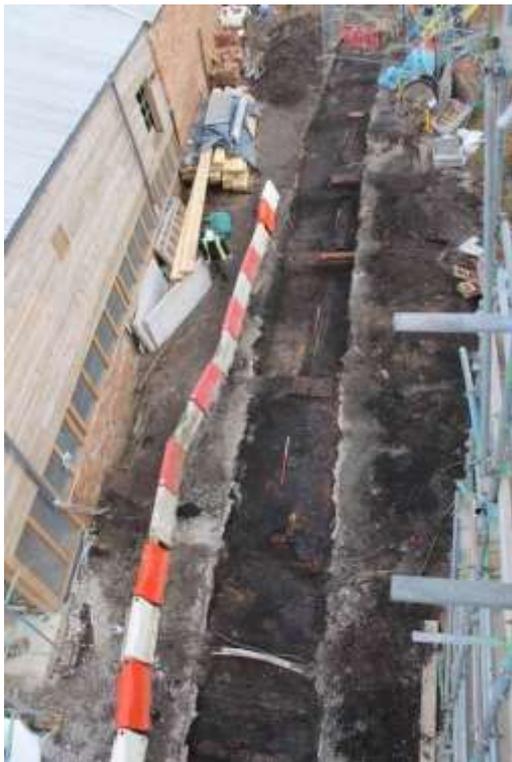
10.41: External Works, Area G3, overhead, showing butresses of the south-east butter pan, north facing

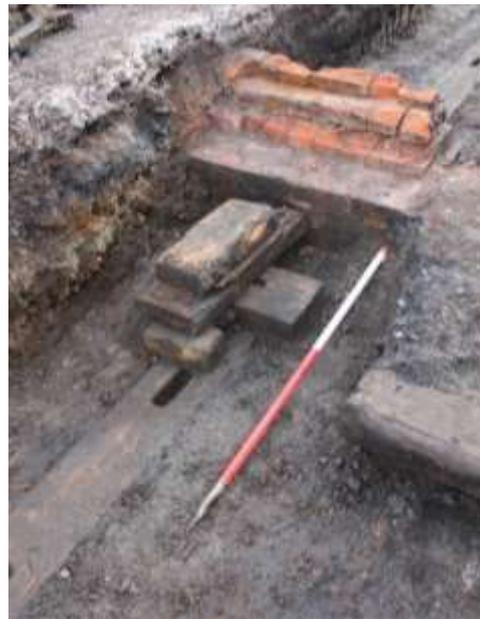
10.42: External Works, Area G3, Buttress and pad detail of hurdles supports, south-east facing

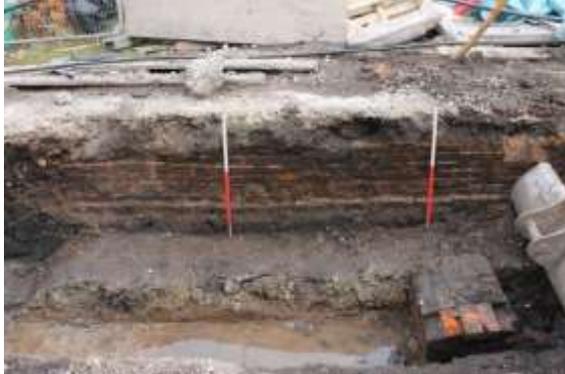
10.43: External Works, Area G3, western wall of the furnace of the South-East Butter Pan (2213), east facing

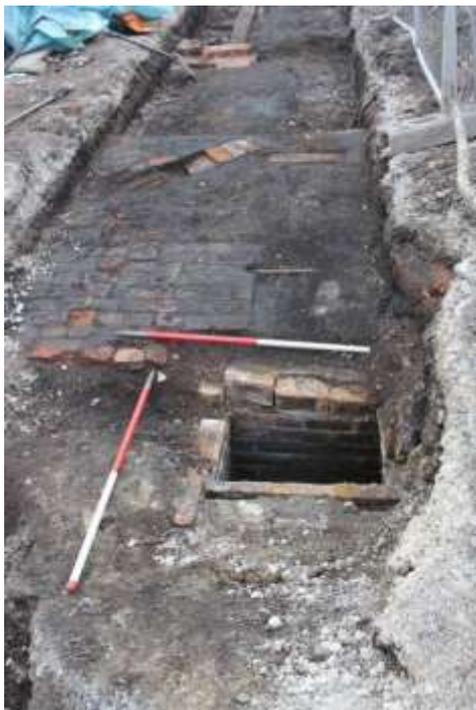
10.44: External Works, Area G3, brick floor surface (2235) and brick drain (2234) at north end, south facing

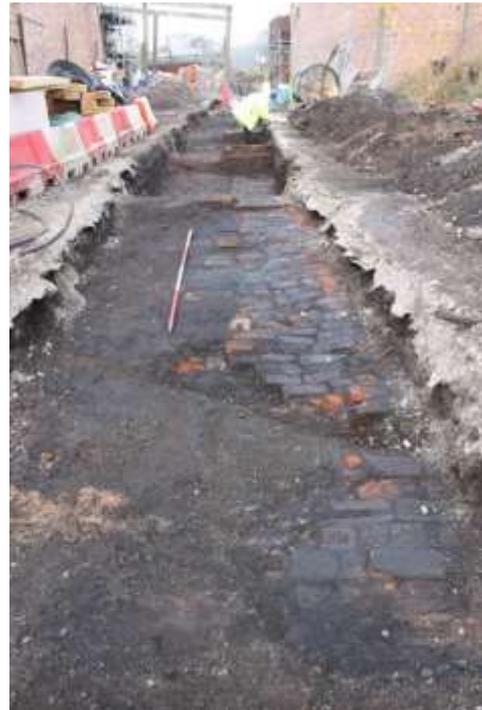
10.45: External Works, Area G3, brick paviour floor surface (2235), north facing

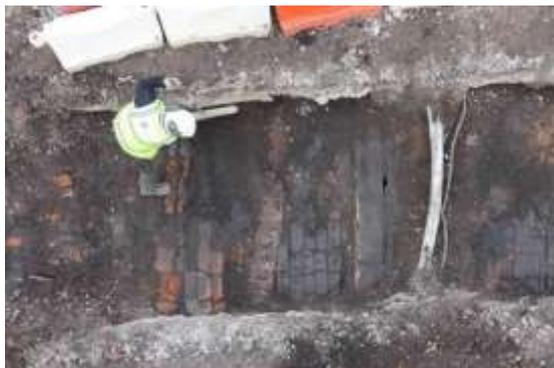
10.46: External Works, Area G3, wood casing (2204/ 2338) for brine pipe (2205), wall foundations (2200/ 2342, 2201/ 2337), overhead

Located south of this floor surface were the remains of the wood casing (2204/ 2338; 10.46) for an east-west orientated brine pipe (2205). The wood casing had two parts, a lid and box casing below. The cast-iron brine pipe was not excavated

and was left within the wooden box. A fragment of salt pan (2206) had been used to cover the brine pipe. It was constructed of three ferrous metal riveted plates, 1.12m x 0.91m in size, and was probably a remnant of the South-East Fishery Pan.

Two brick wall foundations, which appeared to represent the base of a flue, ran at a slight angle to the brine pipe above (10.46). The northern of these walls foundations (2200/ 2342), was of machine-pressed red brick, 2 skins wide, orientated ESE-WNW. Parallel to the south was wall foundation (2201/ 2337), 2 skins wide, orientated ESE-WNW. Between the two walls was a brick paviour floor surface (2202) and (2203), of red brick, laid on-side in Stretcher bond. In places this was skimmed with concrete (2343). Their orientation corresponded with the earlier 'Rhomboid-shaped building', a large salt warehouse.

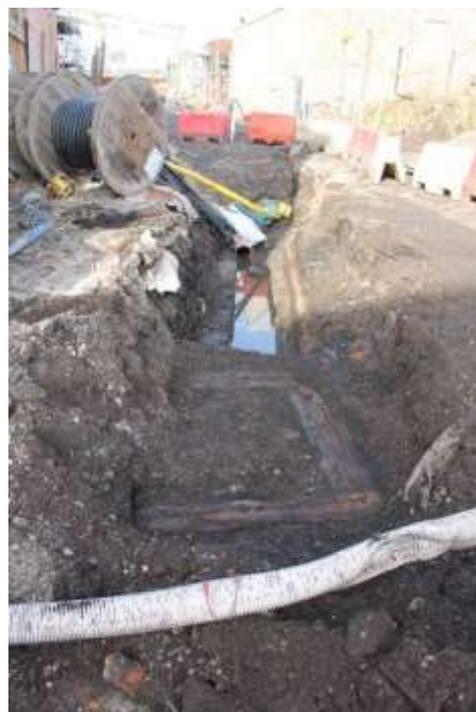
10.47: External Works, Area G3, brick chamber for sump (2341), north facing

Running along the western side, and draining the ditches of the South-East Butter Pan was the remains of two brick sumps (2237, 2341) and connecting pipework (2236). This appears to be dated by clay tobacco pipe to the earliest two decades of the 20th century. It strongly suggests the drainage was associated with the laying out of the Butter Pans.

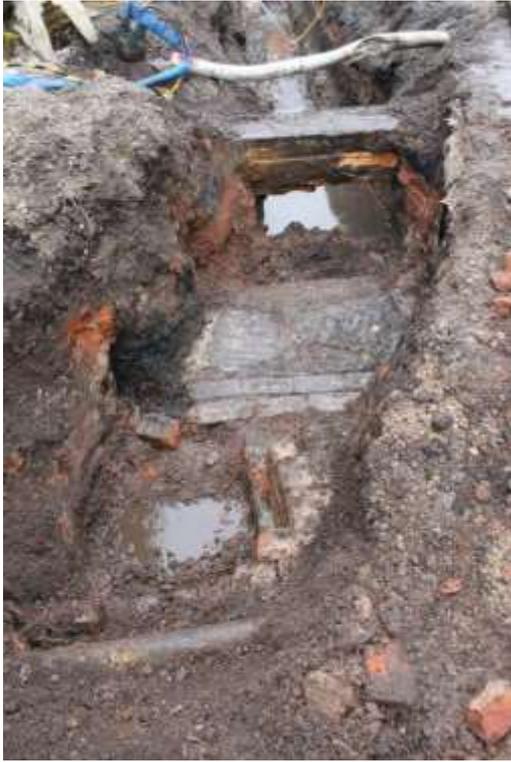
10.48: External Works, Area G3, External Works, Area G3, wood casing (2204/ 2338) for brine pipe (2205), wall foundations (2200/ 2342, 2201/ 2337), north facing

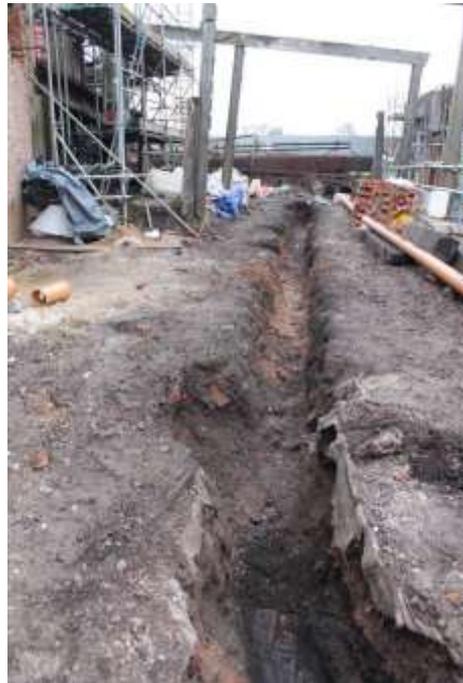
10.49: External Works, Area G4, north end in Loading Bay, north facing

A total of six surface water drainage runs were excavated. From the down-spouts of Pan House 4, Stove House 4 and the Loading Bay into the main surface water drainage channel in G3. This included an additional run extending from Area G3 to the north and into the Loading Bay (see AS006 above, AS091; 10.49). These trenches were each 1.0m wide and sloped from the surface to a depth of 0.85m deep from finished ground level.

The area was covered by a mixed black clinker and silt deposit (2347), 0.6m deep. Within this were the remains of a ferrous metal plate (2353), 0.5m x 0.2m in size and 5mm thick, with a series of rivet holes. It appeared to be a discarded plate from one of the pans. The remainder of the trench, north of this area through the Loading Bay, was overlain by ceramic building material, clinker and silt deposit (2346), 0.7m deep at maximum. The area was covered by grey gravel (2345) during the restoration (10.49).

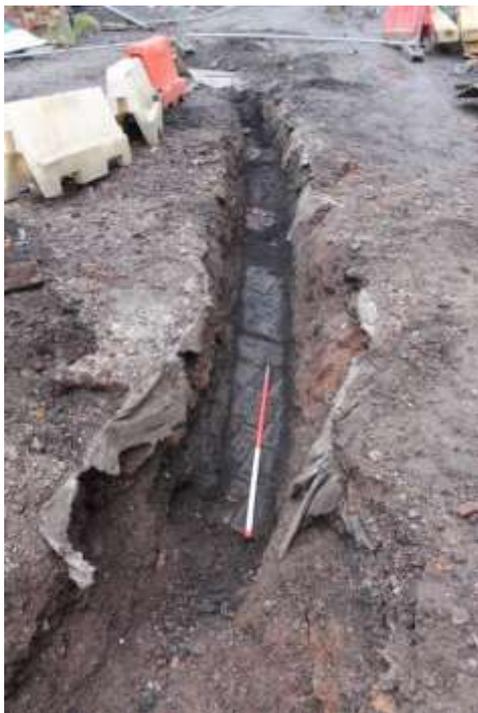
10.50: External Works, Area G4, brick floor surface (2349, 2351, 2352), south facing

At the north end of the area, as the trench entered the Loading Bay, the remains of a mixed black clinker and ash deposit (2348), 0.2m deep, acted as bedding for a discontinuous brick floor surface (2349, 2351, 2352; 10.50, 10.51). The floor surface was made of machine-pressed, red brick, laid on-side in the Stretcher bond, stretchers laid north-south. It was dissected a wooden board (2350), 200m wide, between brick surfaces 3249 and 3251, aligned NW-SE.

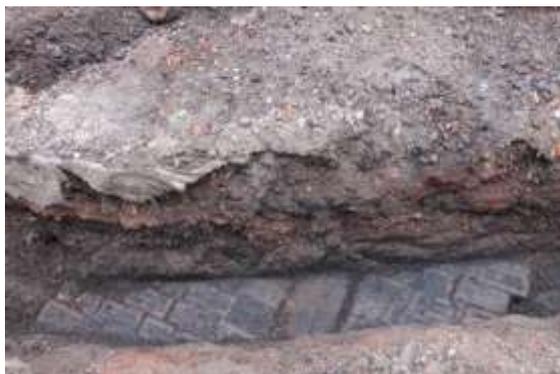
10.51: External Works, Area G4, brick floor surface (2349, 2351, 2352), overhead

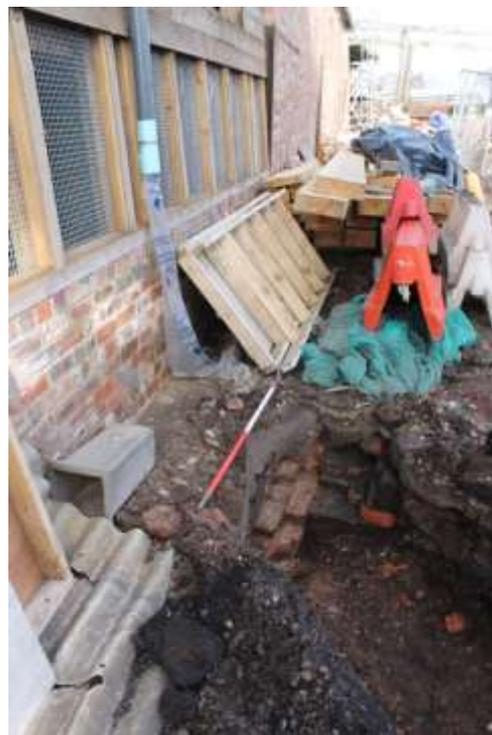
10.52: External Works, Area G4, butter pan wall foundation (2254) and brick pier (2255), north facing

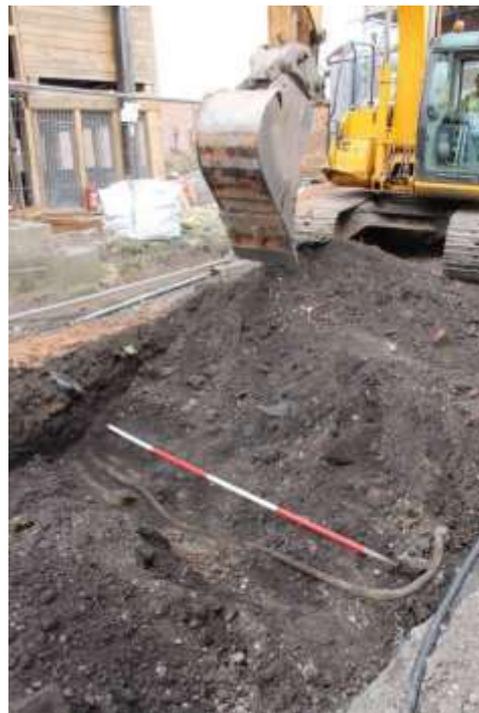
10.53: External Works, Area G5, wooden sleeper (2392) and metal pin (2393), north-east facing

At the western end were the remains of a wooden sleeper, aligned north-south and c. 0.4m in width (2392). On top of this was a metal pin (2393), c. 150mm in diameter, and extending c. 2.4m +, north-south continuing to the north towards the railway tracks. It had a central pivot connected to the sleeper below. A clip allowed it to be kept in place (10.53, 10.54).

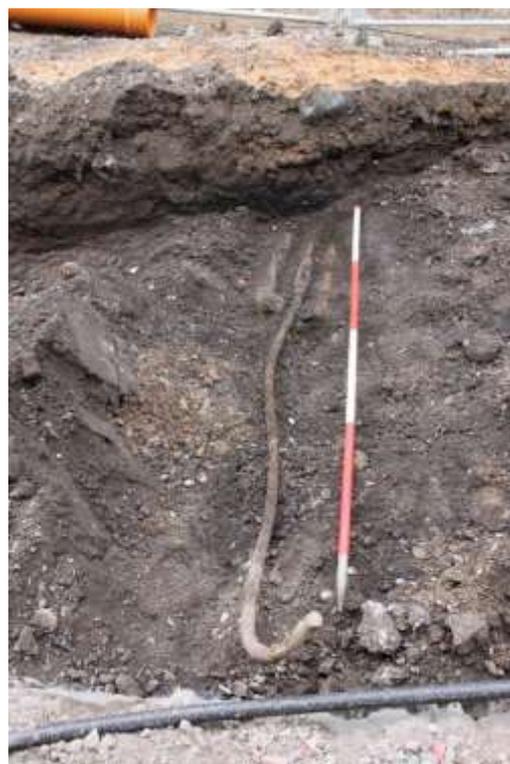
10.54: External Works, Area G5, metal pin (2393), north facing

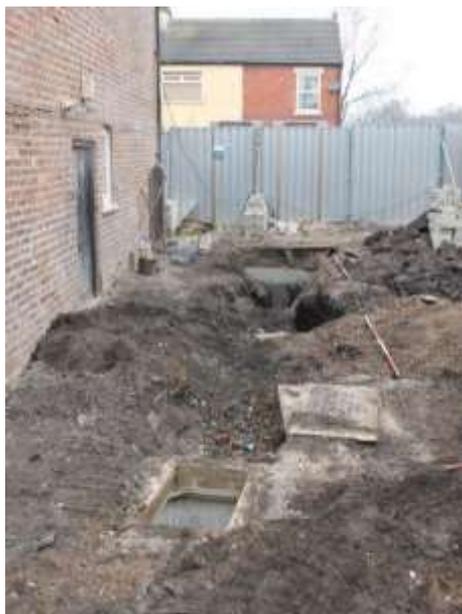
10.55: External Works, Area G5, remains of later services, west facing

Excavated through the layers of clinker were the remains of a series of later services (10.55, 10.56). These included a foul drain from the toilets located in the Red Lion Inn (2394), aligned broadly east-

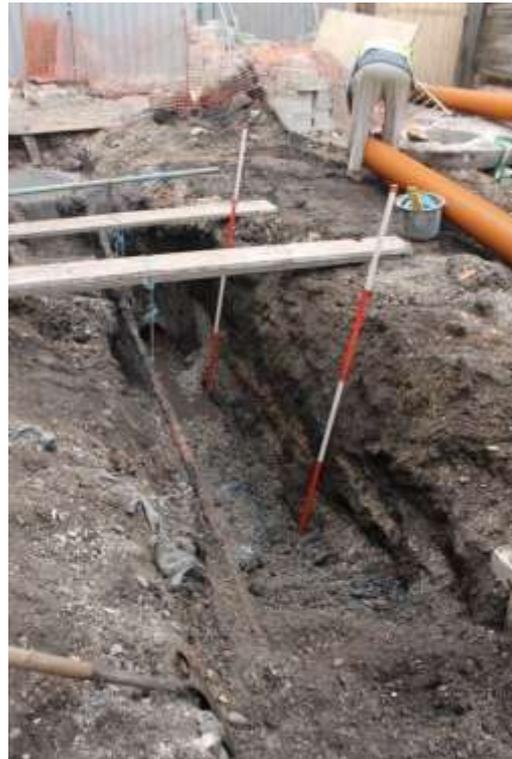
10.56: External Works, Area G5, section through services, west facing

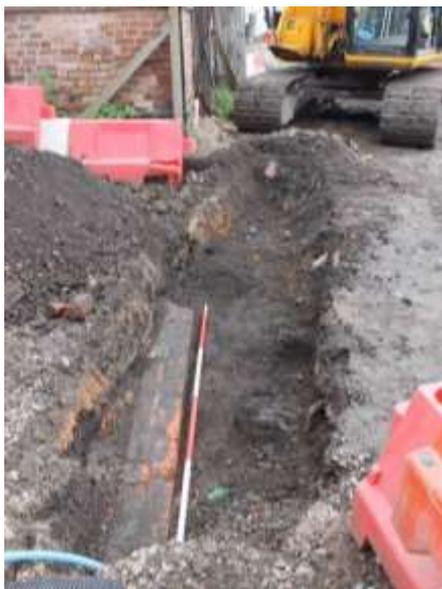
10.57: External Works, Area G6, wall foundation, (2406), east facing

At the northern side of the trench, running approximately east-west was a machine-pressed, red brick, wall foundation, two courses wide and five courses deep (2406; AS094; 10.57). This appeared to be the remains of the boundary wall of the Lion Salt Works, excavated in Area G7 (see below).

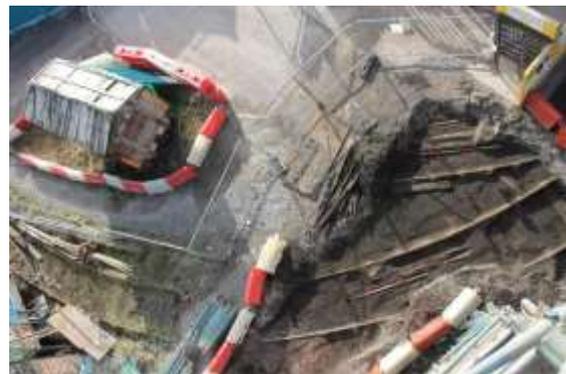
10.58: External Works, Area G6, railway tracks, overhead

A compact layer of clinker silt and slag residues (2324) formed a base for a series of two railway tracks and points (AS094; 10.58, 10.56, 10.57, 10.58, 10.59, 10.60, 10.61, 10.62, 10.63, 10.64). The rails were supported on a series of wooden sleepers, roughly perpendicular to the rails. These were of a standard cross-section, 0.16m deep and 0.30m wide but varied in length up to 4.20m where they supported the points (see below, sleepers 2344, 2405, 2406, 2407, 2408, 2409, 2410, 2411). Where the tracks split into two the sleepers were shorter c. 1.8m in length (e.g. 2243, 2244). Not all the sleepers were fully exposed. A single wooden sleeper (2249) was located between the northern and southern set of rails. Their positions were betrayed by the presence of chairs that connected the rails to the sleepers below.

Two sets of rails existed. The northern pairs were ferrous metal rail, orientated WNW curving to south-east, (2239, 2240). They were 60mm wide, 140mm deep. Pairs of shoes (cleats) attached to the sleepers 2243, 2244 below. The southern pair

were represented by ferrous metal rails (2241, 2242/ 2330), orientated north-west curving to south-east, 60mm wide, 140mm deep, with pairs of shoes (cleats) attached to sleepers below (sleepers not exposed). The rails continued to the east. Points (2332, 2335, 2242/ 2331, 2248/ 2339) allowed the salt vans and coal carriages to transit between the two lines.

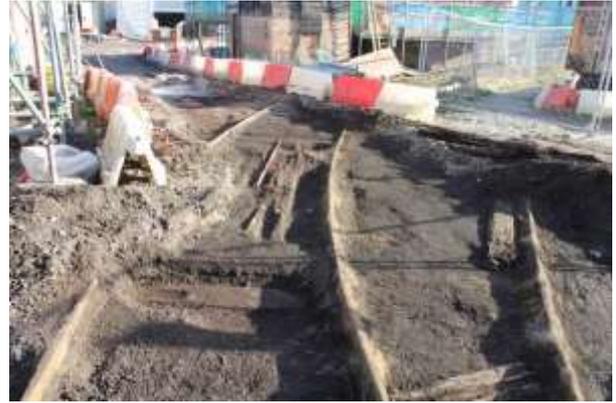
10.62: External Works, Area G6, northern set of rail tracks (2239, 2240), south-east facing

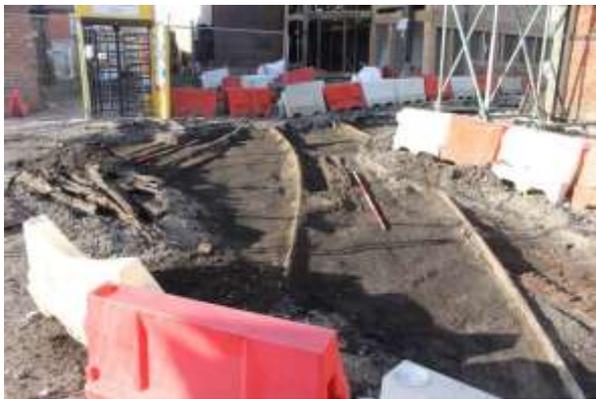
10.60: External Works, Area G6, northern set of rail tracks (2239, 2240), north-west facing

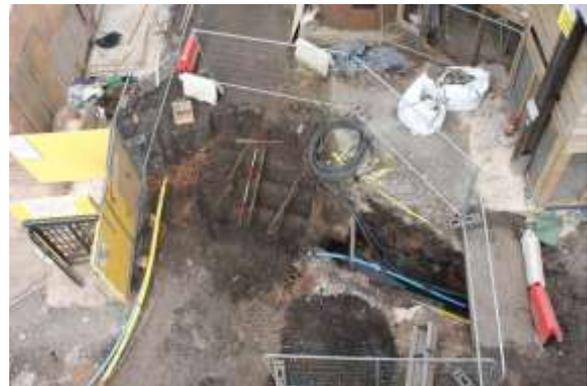
10.63: External Works, Area G6, rail tracks during excavation underneath, overhead

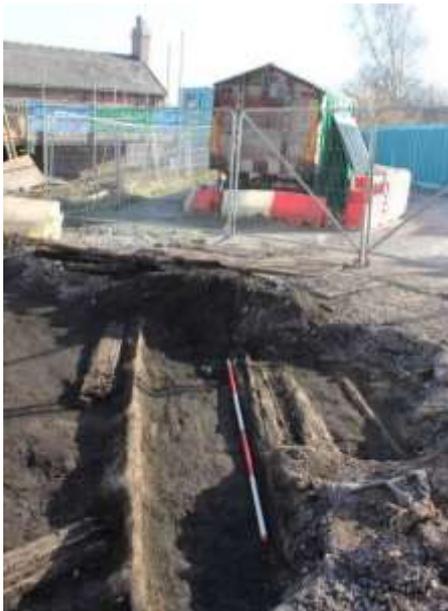
10.61: External Works, Area G6, southern set of rail tracks (2241, 2242/ 2330), south-east facing

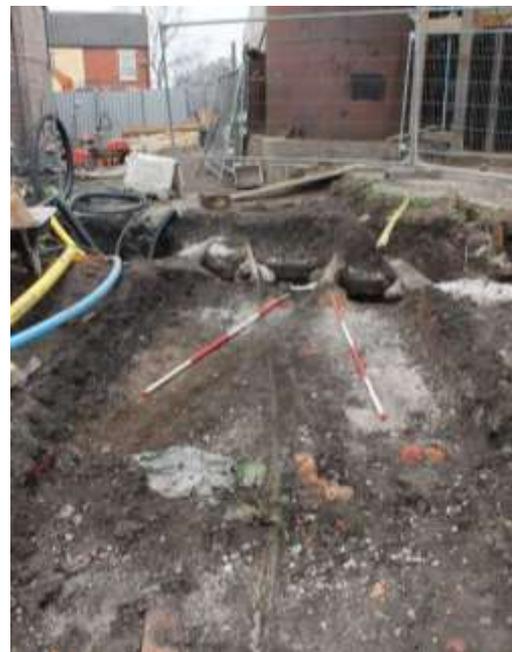
10.64: External Works, Area G6, rail tracks during excavation underneath, west facing

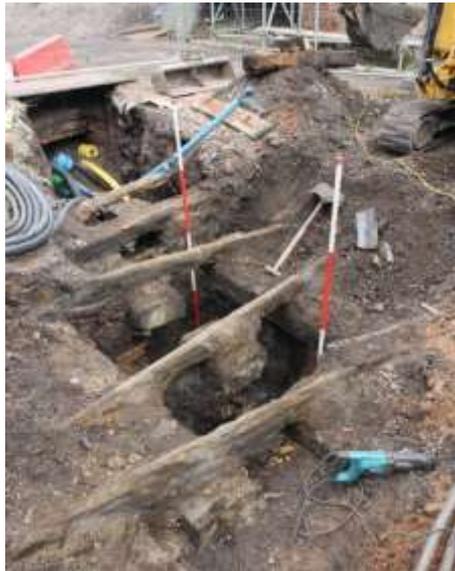
10.65: External Works, Area G6, rail tracks during excavation underneath, north facing

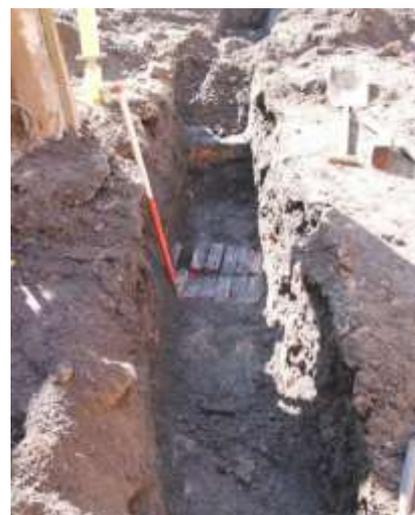
10.66: External Works, Area G7, wall foundation (2327), south facing

At this level was wall foundation (2327; 10.66), a single layer of brickwork located beneath floor 2315/ 2316, two courses deep and laid on edge to form a corbel course. It was constructed of machine-pressed, red brick, and orientated WNW-ESE. The wall had been subsequently robbed. The robber cut (2329) went through floor surface 2315/ 2316. It was filled with a loose mortar and clinker fill (2328).

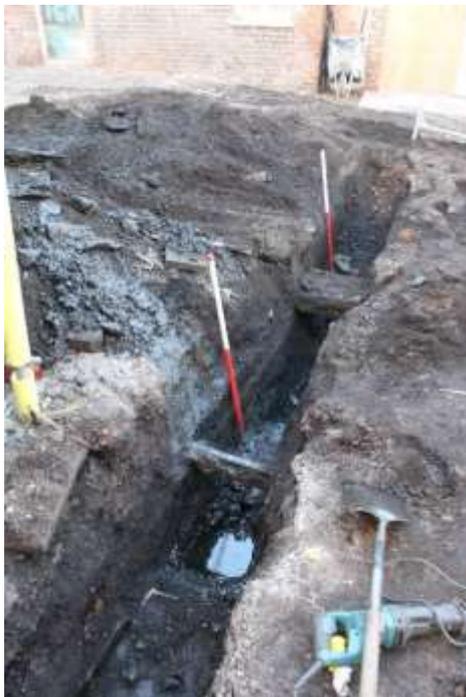
10.67: External Works, Area G7, under the rail tracks, south facing

Black clinker and silt layer (2323), was the build-up for floor surfaces 2309, 2311, 2315, 2316 (10.67). A sloping brick surface, 2309, 2311, 2315, ran north-south and abutted wall 2327. It was built up of machine-pressed, red brick, laid on-side in Stretcher bond, and orientated ENE-WSW, at a slight angle to the later buildings of Pan House 3 and 4 (10.68). In total it covered an area of c. 4.5m (north-south). The floor formed part of an exterior floor surface outside pan houses, contemporary with the Phase 4, rhomboid-shaped building. Within the floor surface were a series of wood timbers (2310, 2314), 0.30m wide, aligned east-west, with no clear function. The remains of the wooden casing for the brine pipe (2312) were also set within this floor. It was made of a large timber trough with ferrous metal brine pipe inside, 0.35m wide. It was uncovered previously (see Area G3 above; Section 5.8, 3081, HC16, 3157, HC20) and appears to be contemporary with Fishery Pans (SW and SE) and later reused for PH3 and PH4.
