THE ALLIANCE AND LION SALT WORKS, MARSTON, NORTHWICH

SCHEDULED MONUMENT NO 34985-002

VOLUME III: THE ARCHAEOLOGICAL EXCAVATIONS, 1992-2015

REPORT NO 2015-01

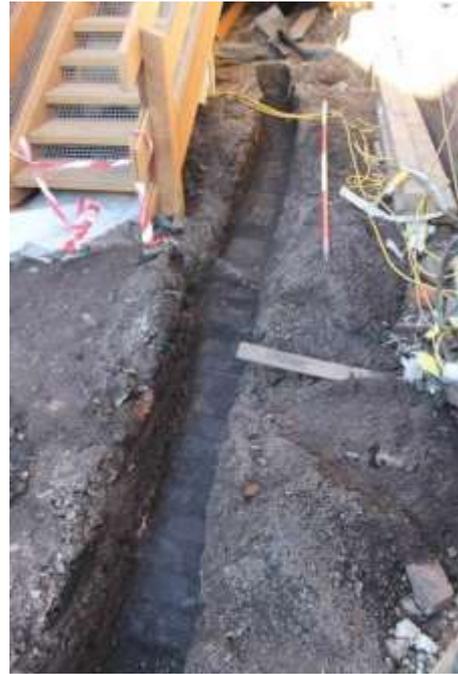
10.68: External Works, Area G7, brick surface, 2309, 2311, 2315, north facing

Black clinker and silt layer (2323), was the build-up for floor surfaces 2309, 2311, 2315, 2316 (10.67). A sloping brick surface, 2309, 2311, 2315, ran north-south and abutted wall 2327. It was built up of machine-pressed, red brick, laid on-side in Stretcher bond, and orientated ENE-WSW, at a slight angle to the later buildings of Pan House 3 and 4 (10.68). In total it covered an area of c. 4.5m (north-south). The floor formed part of an exterior floor surface outside pan houses, contemporary with the Phase 4, rhomboid-shaped building. Within the floor surface were a series of wood timbers (2310, 2314), 0.30m wide, aligned east-west, with no clear function. The remains of the wooden casing for the brine pipe (2312) were also set within this floor. It was made of a large timber trough with ferrous metal brine pipe inside, 0.35m wide. It was uncovered previously (see Area G3 above; Section 5.8, 3081, HC16, 3157, HC20) and appears to be contemporary with Fishery Pans (SW and SE) and later reused for PH3 and PH4.

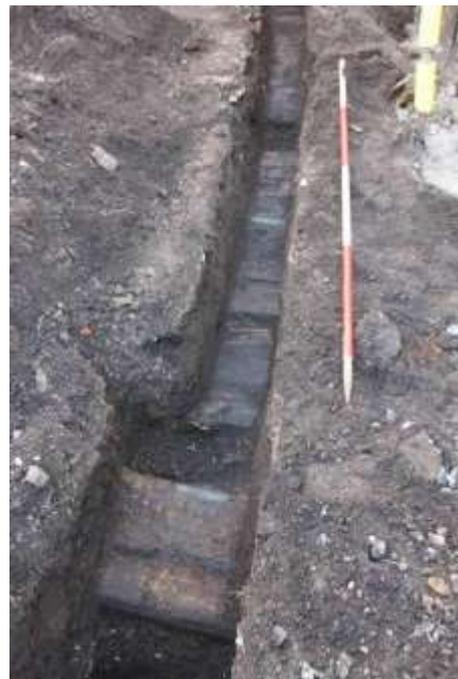
10.69: External Works, Area G7, rail tracks (2317, 2318), north facing

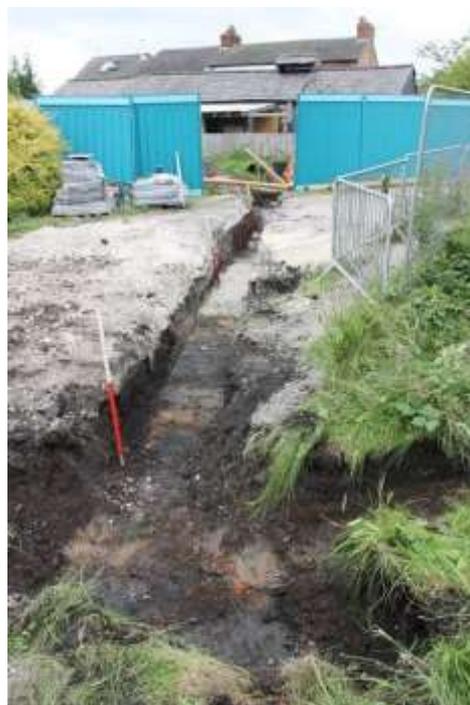
10.70: External Works, Area H1, services south of the Manager’s House, south-west facing

The natural subsoil at the south end of the site was yellow-brown silt-clay (2419), 900mm below the surface. Above this was an interface layer of mixed grey-black clay (2418), 250mm deep. This was generally overlain by mixed black clinker-silt layer with some rubble (2413), derived from the furnaces and spread across the eastern and southern part of the site (AS098; 10.70).

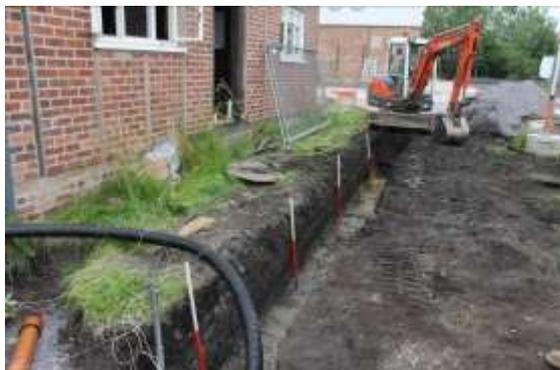
10.71: External Works, Area H1, services east of the Manager's House, north facing

This was used as a yard or working surface as it kept dry during rain. It was overlain by black clinker silt layer (2416) similar to deposit 2413. A further dump of waste material, a layer of clinker and slag (2420), c. 250mm thick, was located east of the Manager's House (10.71, 10.72).

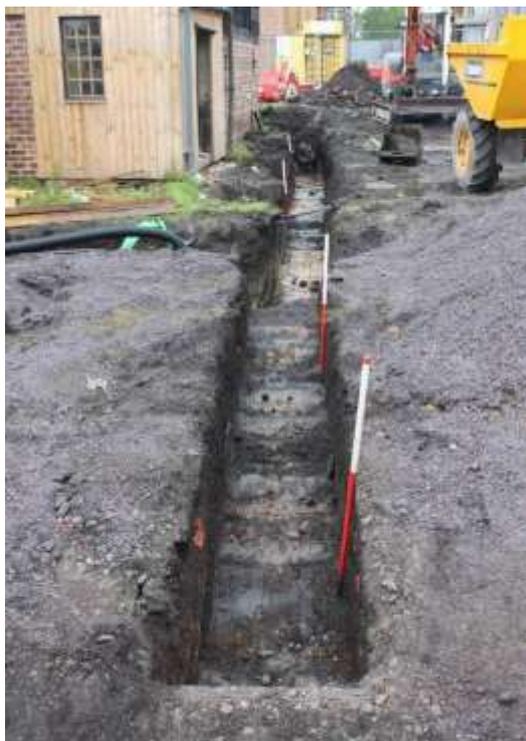
10.72: External Works, Area H1, services north of the Manager's House, west facing

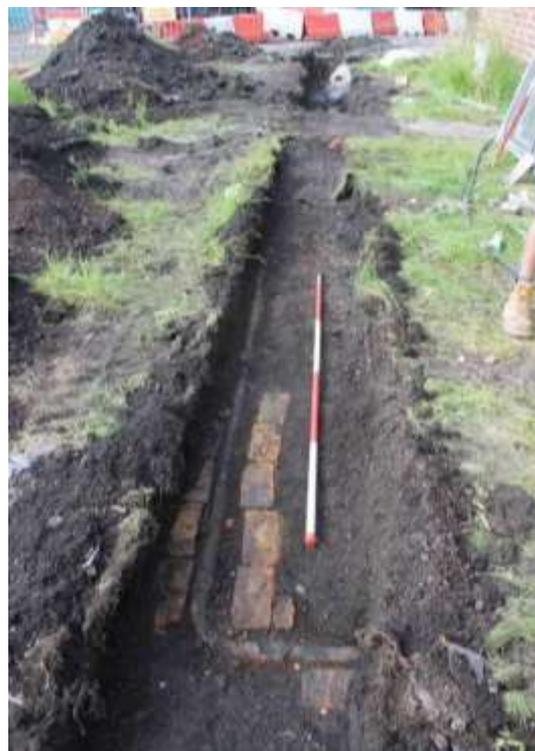
10.73: External Works, Area H1, metal out-pipe (2421) from the boiler, south facing

Within these layers were a series of features. A ceramic land drain (2414) orientated NW-SE, extended from the southern end of the Manager's House. A 2½" diameter, ferrous metal out-pipe (2421; AS098; 10.73) extended from the base of the boiler, c. 4m to the east from the coal shed. It turned sharp at a right angle to the south and

extended for a further 11m. The pipe was designed to take waste water away from the boiler. The sharp angle of the pipe was surrounded by brick (2422), designed to protect the pipe.

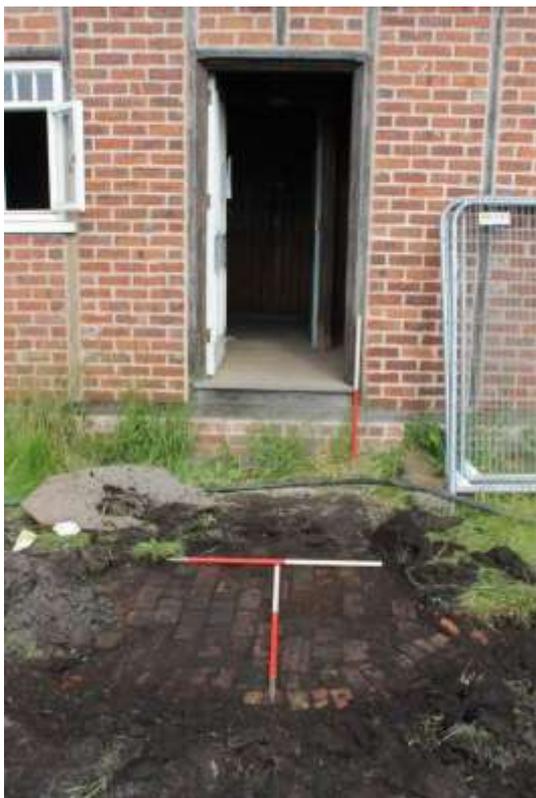
10.74: External Works, Area H1, brick floor surface (2423), west facing

A brick paviour floor surface, of very eroded, hand-made red brick (2423; AS098; 10.74), was laid in stretcher bond with a semi-circular surround directly east of the door as an entrance path for the Manager's House. The path continued around the side of the Manager's House to the Pump House and main works as a brick path (2425, 2427; 10.75, 10.76), 0.70-0.90m wide, initially orientated north-south and curving to run east-west. It continued to the east as 2250/2253 in Area G6.

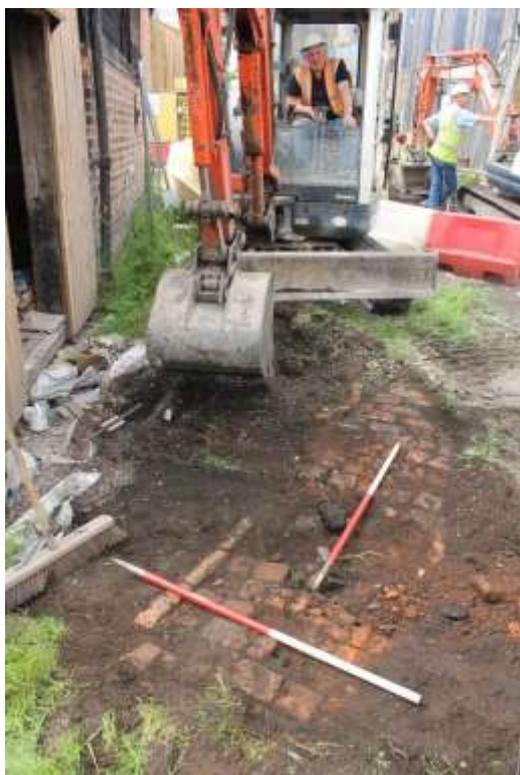
10.75: External Works, Area H1, brick floor surface (2425), west facing

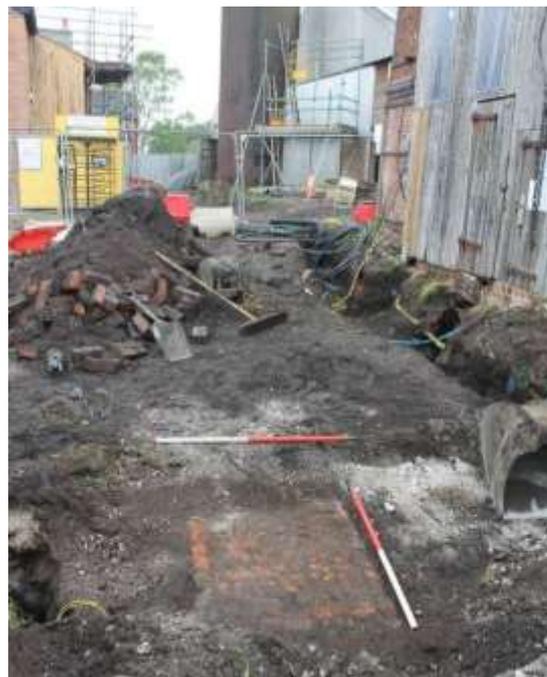
10.76: External Works, Area H1, brick floor surface (2427), west facing

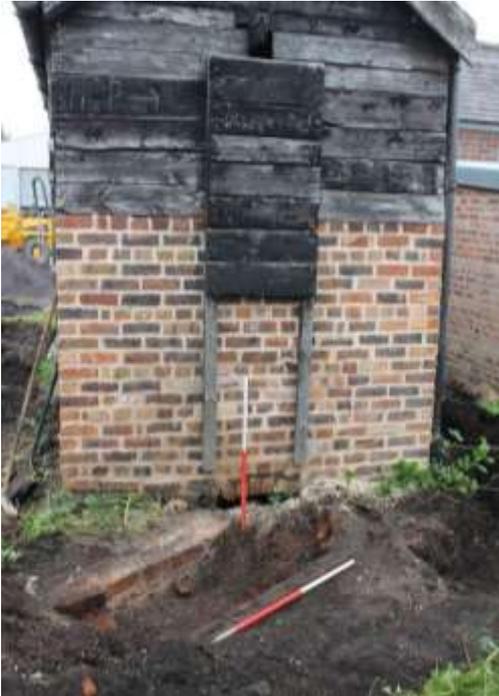
10.77: External Works, Area H1, Flue from the western side of the Boiler House (2428, 2429), south-east facing

The remains of the flue from the western side of the Boiler House continued under the occupation road (AS098; 10.77). It was represented by two flue walls (2428, 2429) of machine-pressed red-brick, two skins wide. The total width of the flue was 0.90m, and it extended for c. 9.5m. Initially it exited the Boiler House running east-west, turned sharply and ran SE-NW, and then turned again to run east-west into the base of Chimney 3 in the Pump House (10.78).

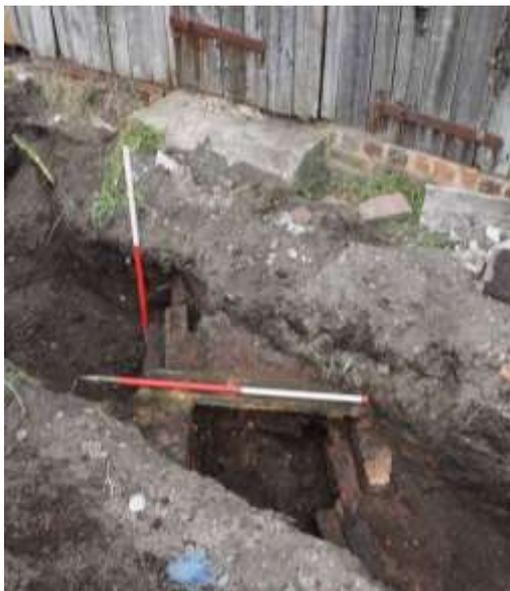
10.78: External Works, Area H1, Flue from the western side of the Boiler House (2428, 2429), north-west facing

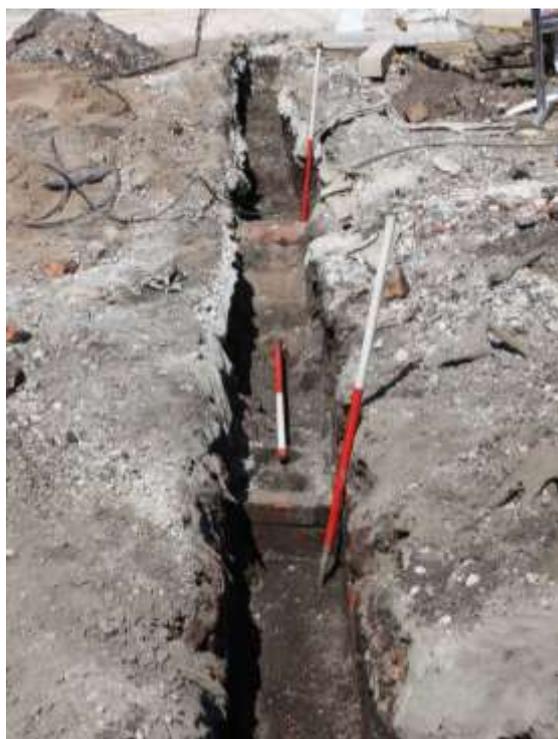
10.79: External Works, Area H2, pan house, Building 13, walls (2433, 2434, 2435), north facing

The remains of pan house, Building 13 were represented by three hand-made red brick wall foundations, running parallel to each other and orientated east-west (10.79). The first and northernmost was three skins thick (2433), and was probably surviving foundation of the kiln wall. Just to the south was a further wall two skins thick (2434) and a further wall, a single skin thick (2435), 2.3m to the south. Brick rubble and clinker ash (2436) between walls 2434 and 2435 was part of the original rubble infill. Overall these represented the remains of the hurdle ditches within Building 13.

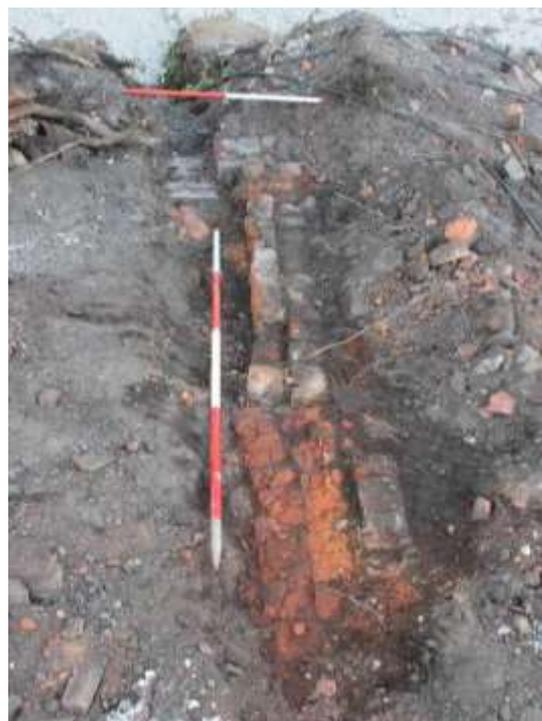
10.81: External Works, Area H2, stove house, Building 12, wall foundation (2442), east facing

The stove house, Building 12, to the east of Building 13 was represented by a series of walls located during the watching brief. The south-east corner was excavated as a substantial hand-made red brick wall foundation, five skins thick, aligned east-west and corbelled at the base (2442; 10.80, 10.81). It continued to the north as hand-made red brick wall foundation (2443; 10.82), four skins thick, aligned north-south and forming the eastern side of Building 12. The southern side was only visible for short length in section as a hand-made red brick wall foundation, orientated east-west (2438). Extending from this was a narrow hand-made, red-brick, wall foundation (2437), aligned north-south. It was two skins wide, and may have been a buttress. Otherwise the southern side of the building was represented by mixed red brick and red sand layer (2432), c. 0.40-0.50m deep extends for a total of c. 18m (10.83). This was the collapse of material from the adjacent Building 12.

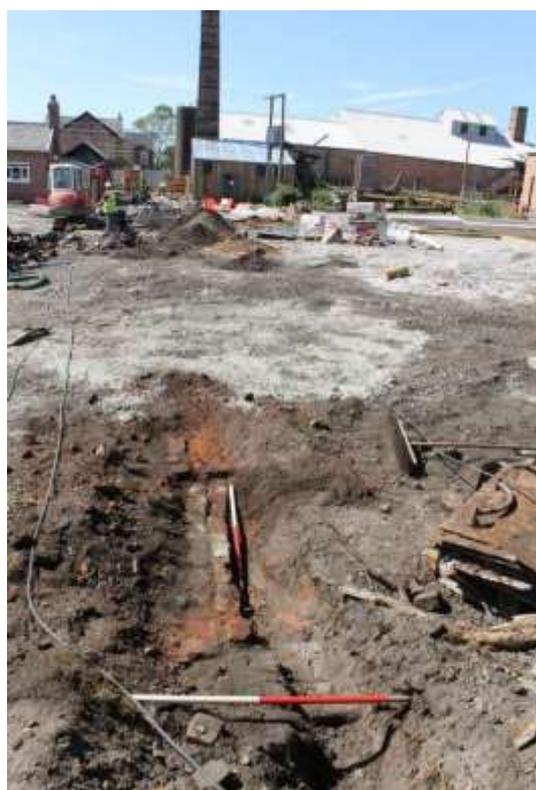
10.80: External Works, Area H2, stove house, Building 12, wall foundation (2442), west facing

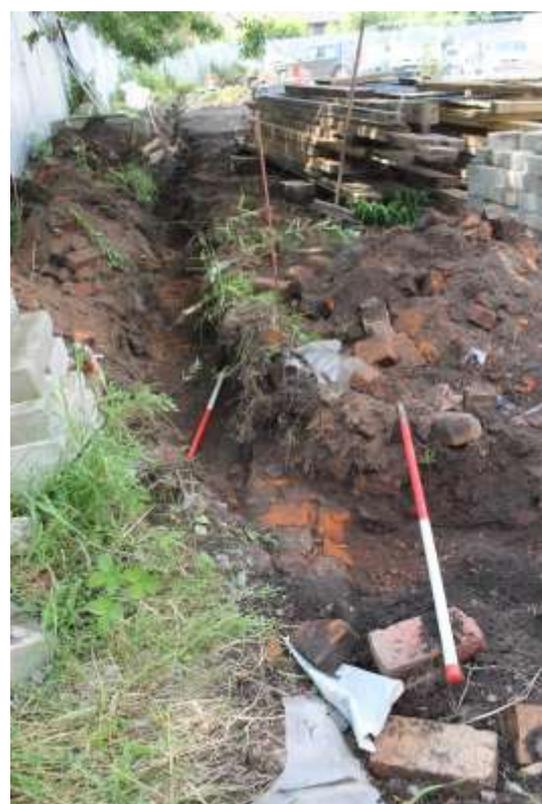
10.82: External Works, Area H2, stove house, Building 12, wall foundation (2443), south facing

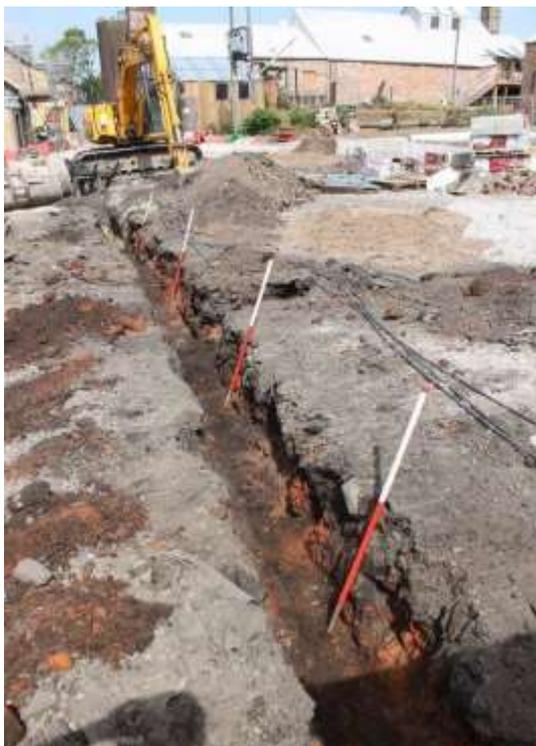
10.83: External Works, Area H2, brick and red sand collapse (2432) from Building 12, west facing

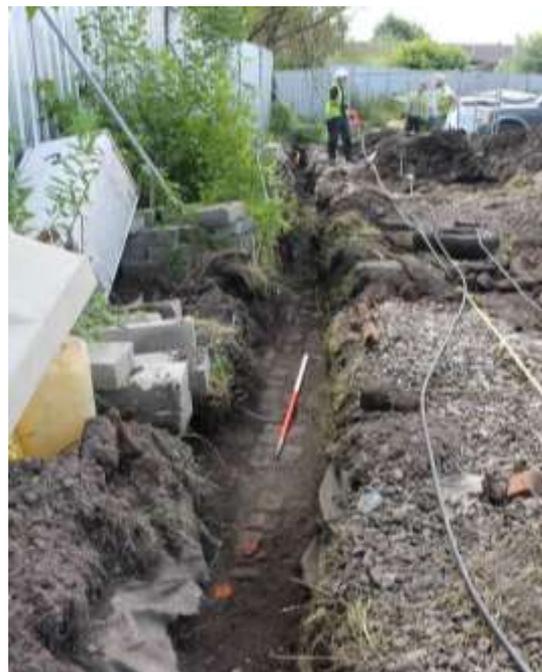
10.84: External Works, Area H2, brick paviour surface (2444), south facing

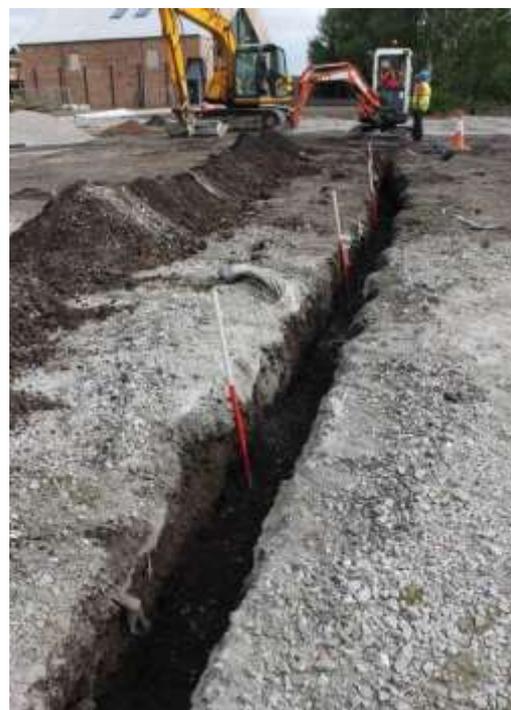
10.85: External Works, Area H2, extensions across the car park, north facing

The whole area of the car park was covered with black clinker silt (2431) derived from furnaces and

dumped across the eastern and southern side of the site (10.85, 10.86).

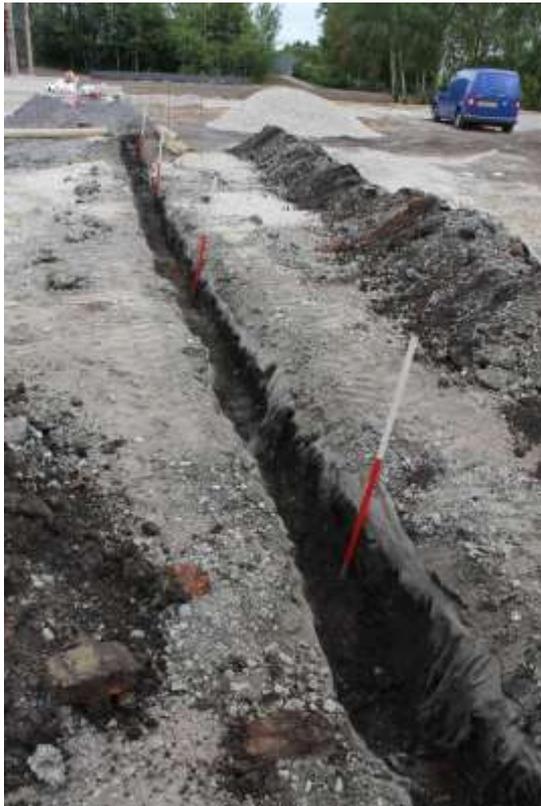
10.86: External Works, Area H2, extensions across the car park, north facing

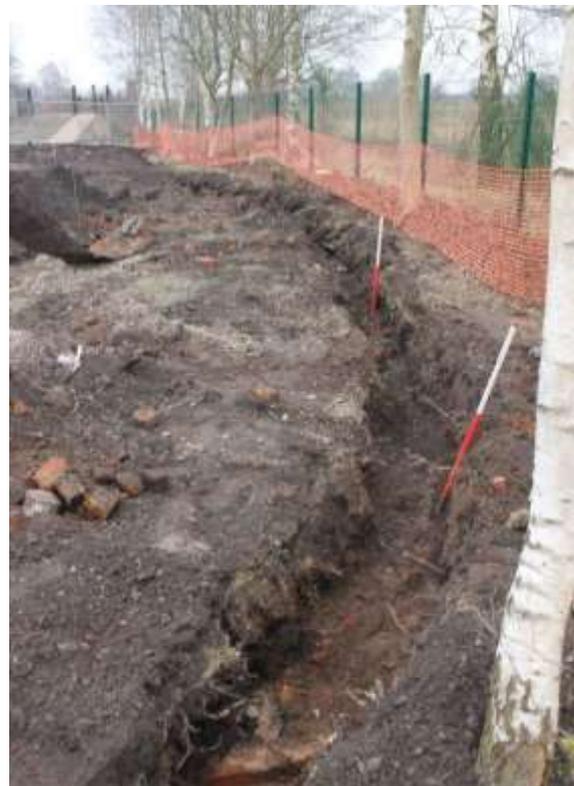
10.87: Area H3, Play Area, Excavation for borders, north facing

The borders of the play area were curvilinear and covered an area of 33.5m (north-south) by 17.5m (east-west). The excavations were generally 0.6m wide and between 0.4m to 0.8m deep at a maximum depth of 23.44m AOD (10.87).

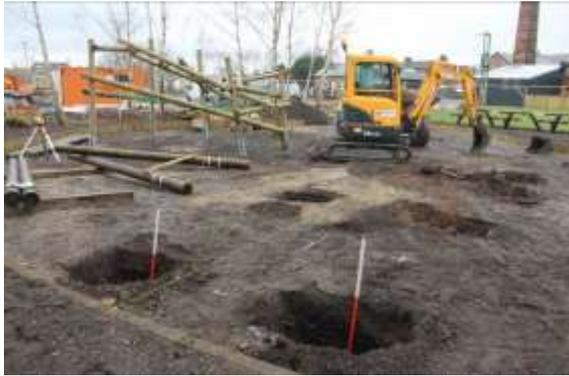
10.88: Area H3, Play Area, excavation for central concrete bases, south-west facing

Seven concrete bases were excavated on the southern side of the complex (A1-A7) for a climbing frame. These were generally 0.5m x 0.8m and 0.8m deep. At the northern end were four six concrete bases (B1-B6) for a slide and tower. These were generally 1.0m x 0.8m in size and 0.5m deep. Two larger trenches (B3, B4) were 3.50m x 0.9m and 0.5m deep. Centrally were six concrete bases (C1-C6) for a number of pieces of

equipment. These were generally 0.8m x 1.0m and 0.6m deep (10.88).

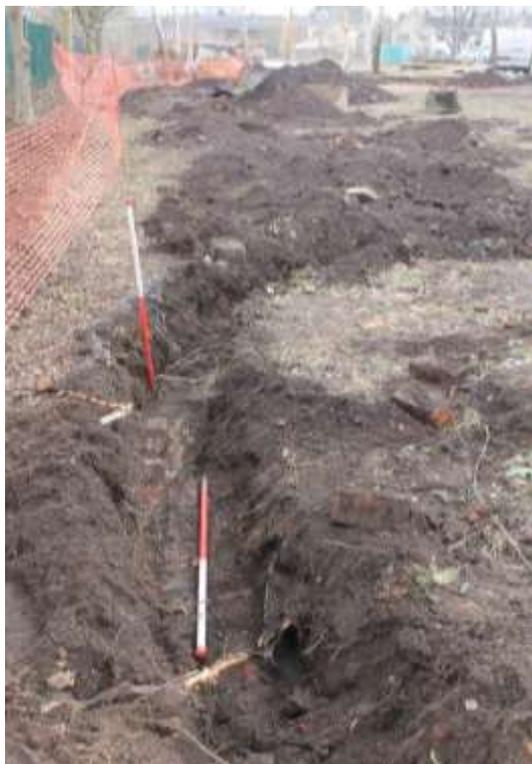
10.89: Area H3, Play Area, Wall foundation 2452, 2453, east side of Building 3, south facing

The earliest deposit in the area is a mixed red clay silt layer (2451) associated with the interface of the overburden with the natural grey clays. In the north-east border of the area a hand-made, red-brick, wall foundation (2452) was aligned north-south before turning at right angles to the west (2453). It was two brick courses wide (brick size 9" x 4¼" x 2¾") (10.89). This related to the remains of Building 4 of the Alliance Salt Works.

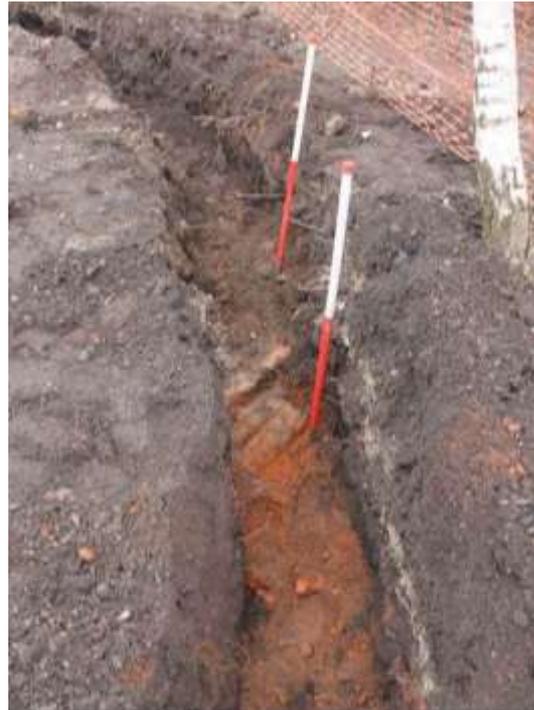
10.90: Area H3, Play Area, Wall foundation 2454, north side of Building 12, east facing

At the south of the area located at the base of the borders and concrete foundation A4 were the remains of the northern wall of Building 12 of the Alliance Salt Works. It consisted of a hand-made, red-brick, wall foundation aligned east-west (2454, 2455, 2456; 10.90, 10.91). At the eastern end

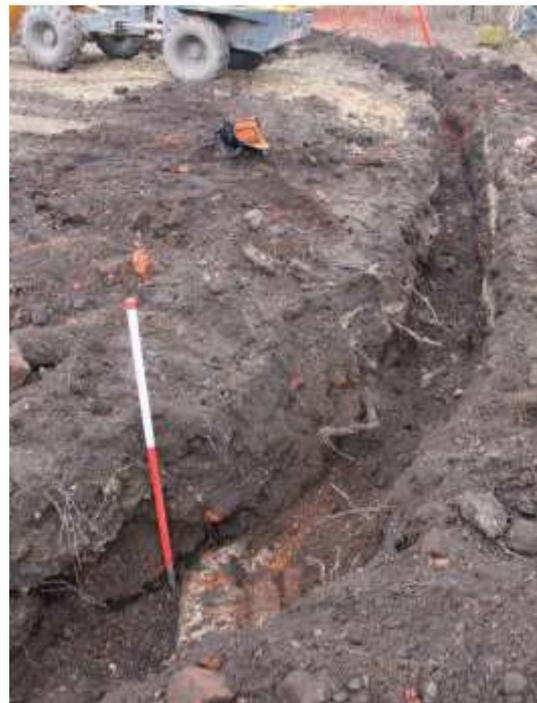
10.91: Area H3, Play Area, Wall foundation 2456, north side of Building 12, east facing

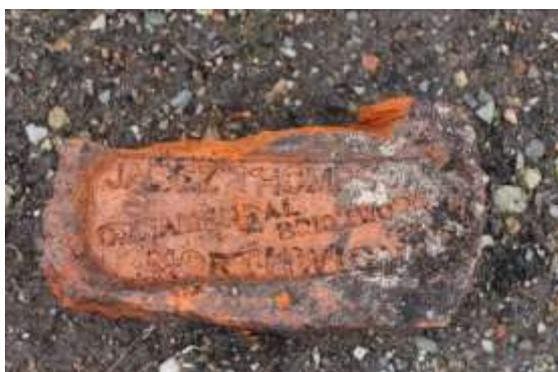
10.92: Area H3, Play Area, brick from wall foundation 2456, north side of Building 12

there was slight evidence of a wall perpendicular and turning to the north (2457). It was two brick courses wide (brick size 9" x 4¼" x 2¾"). A single brick marked 'Jabez Thompson, Ornamental Brickworks, Northwich' was recovered from the brick rubble dislodged during excavation of the trench (10.92).

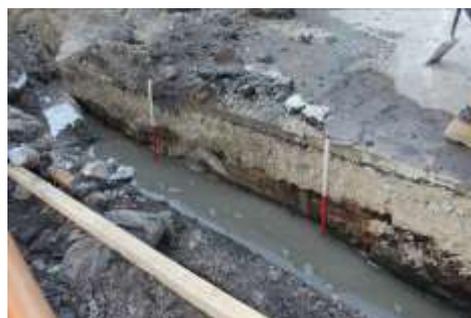
10.93: Area I, Wall foundation 2449 visible in section, north-west facing

The earliest deposit was mixed grey black clay and clinker (2446, 2450), build-up of material above the natural clays that also supported the rail tracks. Built into this was the remains of brick wall foundation (2449), visible in the south facing section, machine pressed red brick in the Stretcher bond (10.93). This appears to have been remnants of an outhouse formerly located in the garden of cottages on Ollershaw Lane. Over this was grey gravel formation layers (2445, 2448) c. 400mm deep, under the tarmac roadway (2447) (10.94).

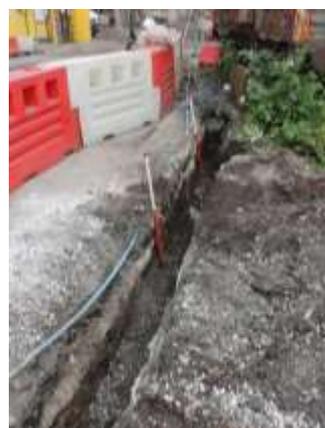
10.94: Area I, excavations under the roadway, north facing

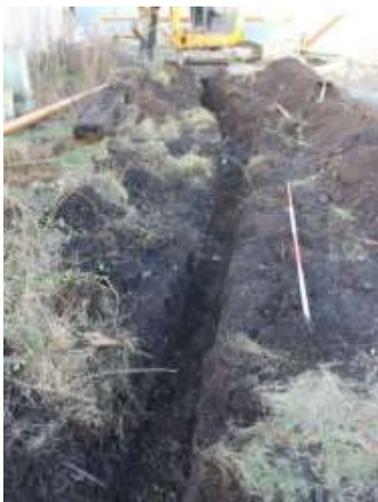
10.95: External Works, Area J, mixed clinker ash and rubble (2258) east of Smithy, north facing

This area was located in the vicinity of the Smithy. It was designed to accommodate a series of surface water drainage channels for the downspouts of the roof drainage of the Smithy. The drainage channels ran from the southern side, then curved around the eastern side, before turning along the northern side of the Smithy. The channels were 0.4-0.5m wide and 0.5-0.9m deep below current ground level. They ran for c. 22.0m (see AS006, AS102; 10.95).

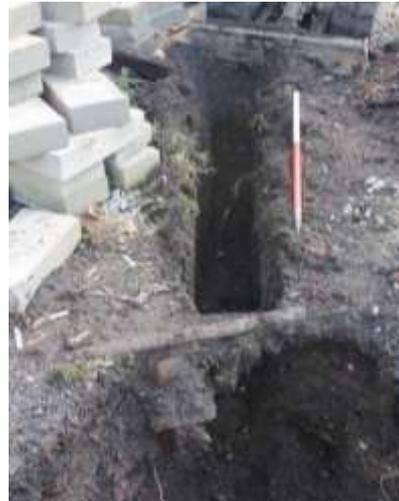
10.96: External Works, Area J, metal rail track (2261), east facing

The earliest deposit in the Smithy garden was a red clay subsoil layer (2257), located 0.90m below the current ground level. This was overlain by a deep layer of mixed clinker ash and rubble (2258), 0.70m deep. This layer formed the basis for the continuation of the railway lines (10.96) visible in Areas G5 and G6 (see above). The tracks were supported by wooden sleepers of which (2256) and (2260), c. 2.0m long, cross-section 0.40m x 0.20m, was an example. A metal bracket or chair attached the sleepers to the rails above. A single ferrous metal rail track survived on the western

side (2261). This was originally the western of two sets and the eastern set had been removed. It continued from the north in a NNW-SSE orientation curving to the south. It had a cross-section 80mm x 180mm. The whole area in the Smithy garden was covered by a humus-silt topsoil layer (2259).
