Historic Building Recording

Rosewell Mains Steading

29/01/2015

- 1.1 Rosewell Development Trust Community Company Ltd commissioned Neo Environmental Ltd to undertake a Level 1 Historic Building Survey at Rosewell Mains Steading, Gorton Loan, Rosewell (NGR 328877 662571) prior to the development of the site. The survey was required to fulfil a condition set by East Lothian Council to “record the upstanding remains and determine whether the development will disturb any buried archaeological deposits.”
- 1.2 The farmhouse steading is situated within the village of Rosewell, 1.7km to the east of Roslin and 11km to the south of the city centre of Edinburgh. The site is located in the south of the village, bounded by Gorton Road to the northeast and by a mix of modern buildings and disused brownfield sites.

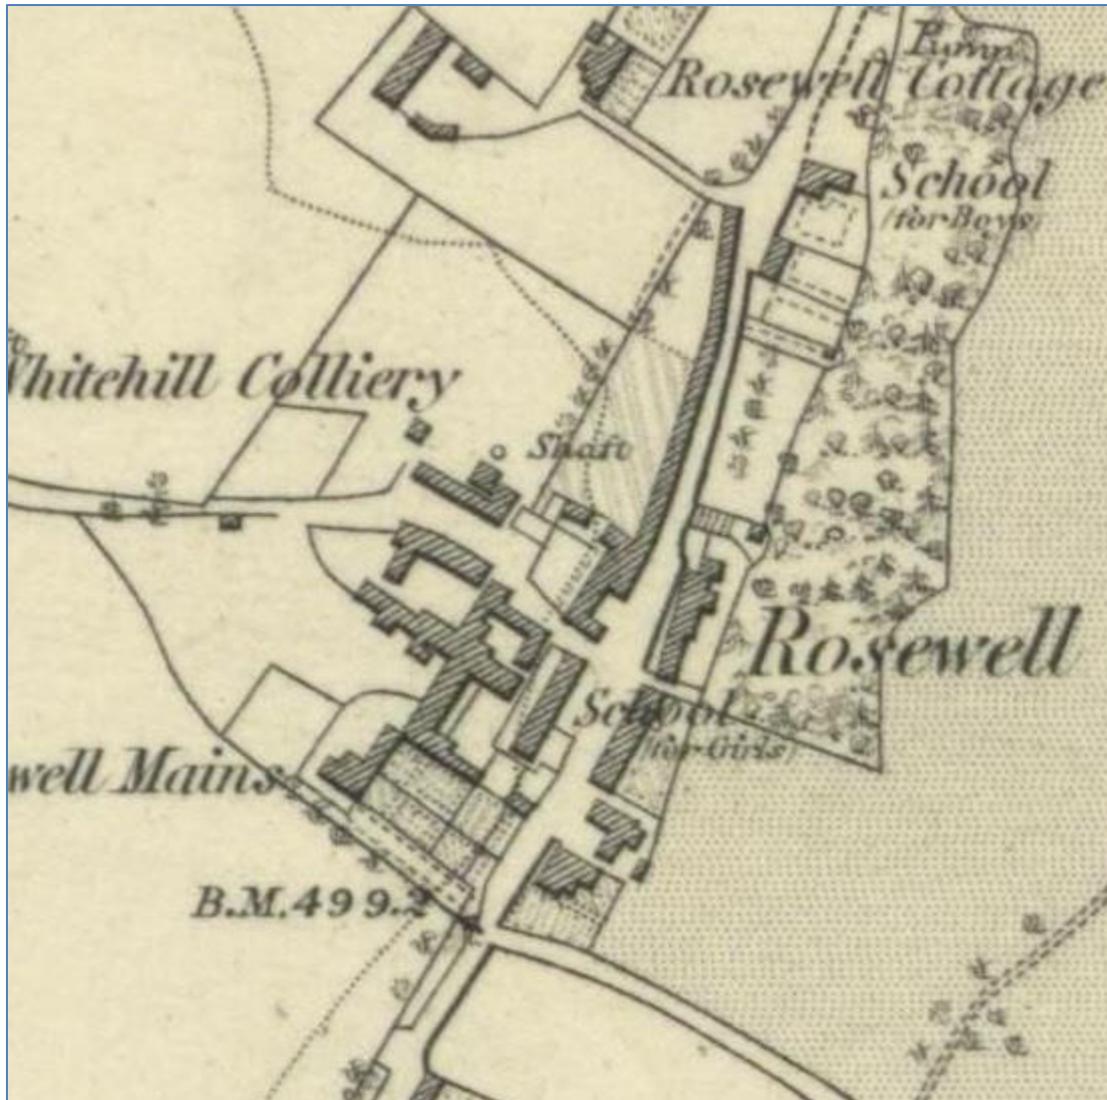
FIGURE 1: EXTRACT FROM ORDNANCE SURVEY (1ST EDITION) 1854

3.1 Rosewell Mains Steading dates from the mid-19th century. Its presence is first evident on the 1st edition OS map from 1854 (Figure 1), and is part of only a handful of buildings visible in Rosewell at the time.

- 4.1 The Rosewell Mains Steading dates back to the mid-19th century and is first visible on the 1854 Ordnance Survey map (Figure 1). Although slightly schematic, the buildings are represented clearly enough to make out the form that it had at the time. Many of the buildings still currently standing are recognisable on this map, but differ somewhat in their layout and surroundings.

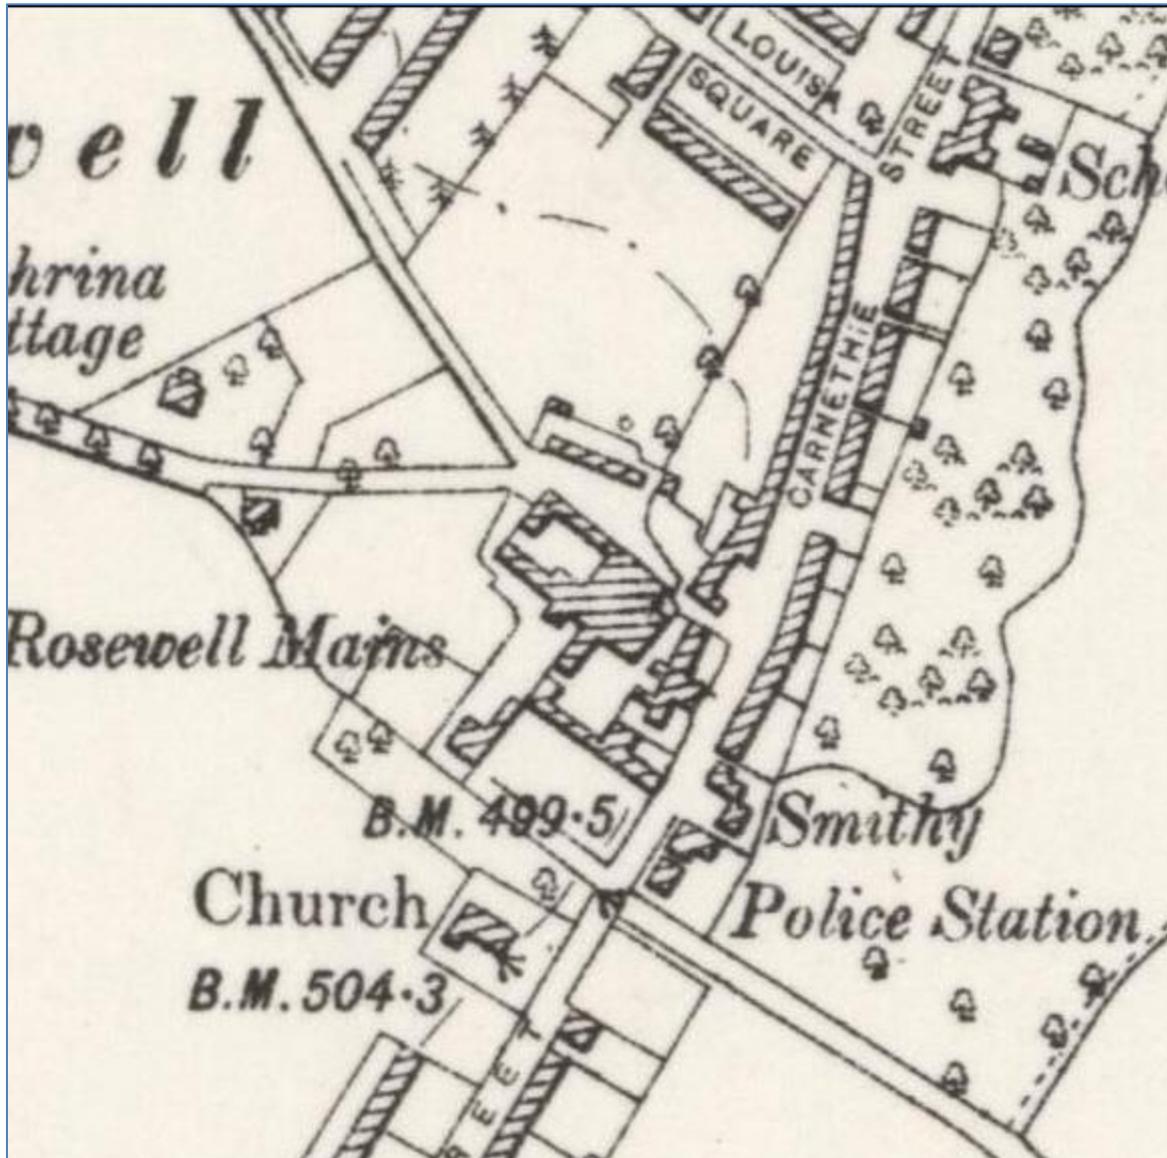
FIGURE 2: EXTRACT FROM ORDNANCE SURVEY 1892

- 4.2 The 1892 Ordnance Survey map (Figure 2) shows notable changes to these buildings since 1854, including consolidating some of the buildings on the east side and north side, as well as splitting from the building to the southwest. These changes define the steading more clearly than before, and the resulting layout still forms the core of the modern site.

- 4.3 The period between 1854 and 1892 represents significant changes to the farmstead itself, which coincides with the period of change that the surrounding town also undergoes. This is due to the mining boom that occurred at this time, as discussed previously. There are many developments visible on the 1892 map as a result, such as the Penicuik to Dalkeith railway and the miners' housing to the north of the farmstead, while Whitehills Collieries is established approximately 600m to the south and is connected to the railway. This mining industry leads to notable population growth and defines the identity of the town at this time. The former girls' school and boys' schools are no longer visible, and appear to be merged into a larger primary school on the site of the former boys' school. The former girls' school, on the other side of Carnethie Street to the east of the steading, appears to be converted to housing to support the population growth. Additionally, some of the field boundaries to the west of the farmstead have been removed to increase the size of the fields, with Cochrina Cottage being constructed here, close to the farmstead. Rosewell Parish Church is also now established to the south of the farmstead.

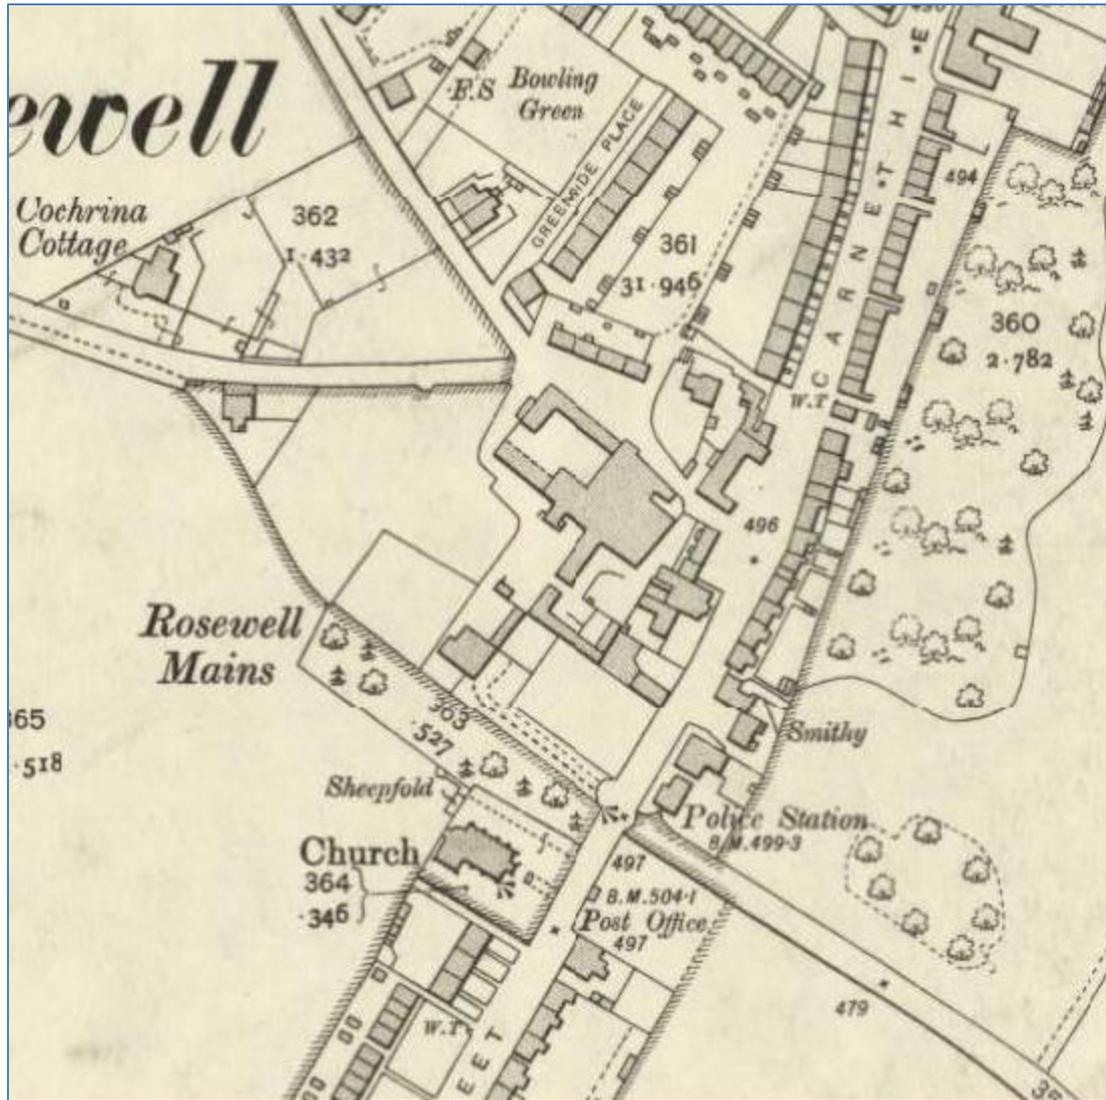
FIGURE 3: EXTRACT FROM ORDNANCE SURVEY 1905

- 4.4 There are no significant changes to the layout of the farmstead after 1892. Most small changes in its appearance can be attributed to the increase in detail on the maps themselves, with the exception of buildings H, J and K, which appear to have been extended between 1905 and 1957. Therefore any physical changes that occurred during this time must have been primarily cosmetic or repair work. The wider area of Rosewell continues to see residential development after 1905, and there are many new areas of housing visible, including Cochrina Place, a new housing development built directly to the north of Cochrina Cottage.

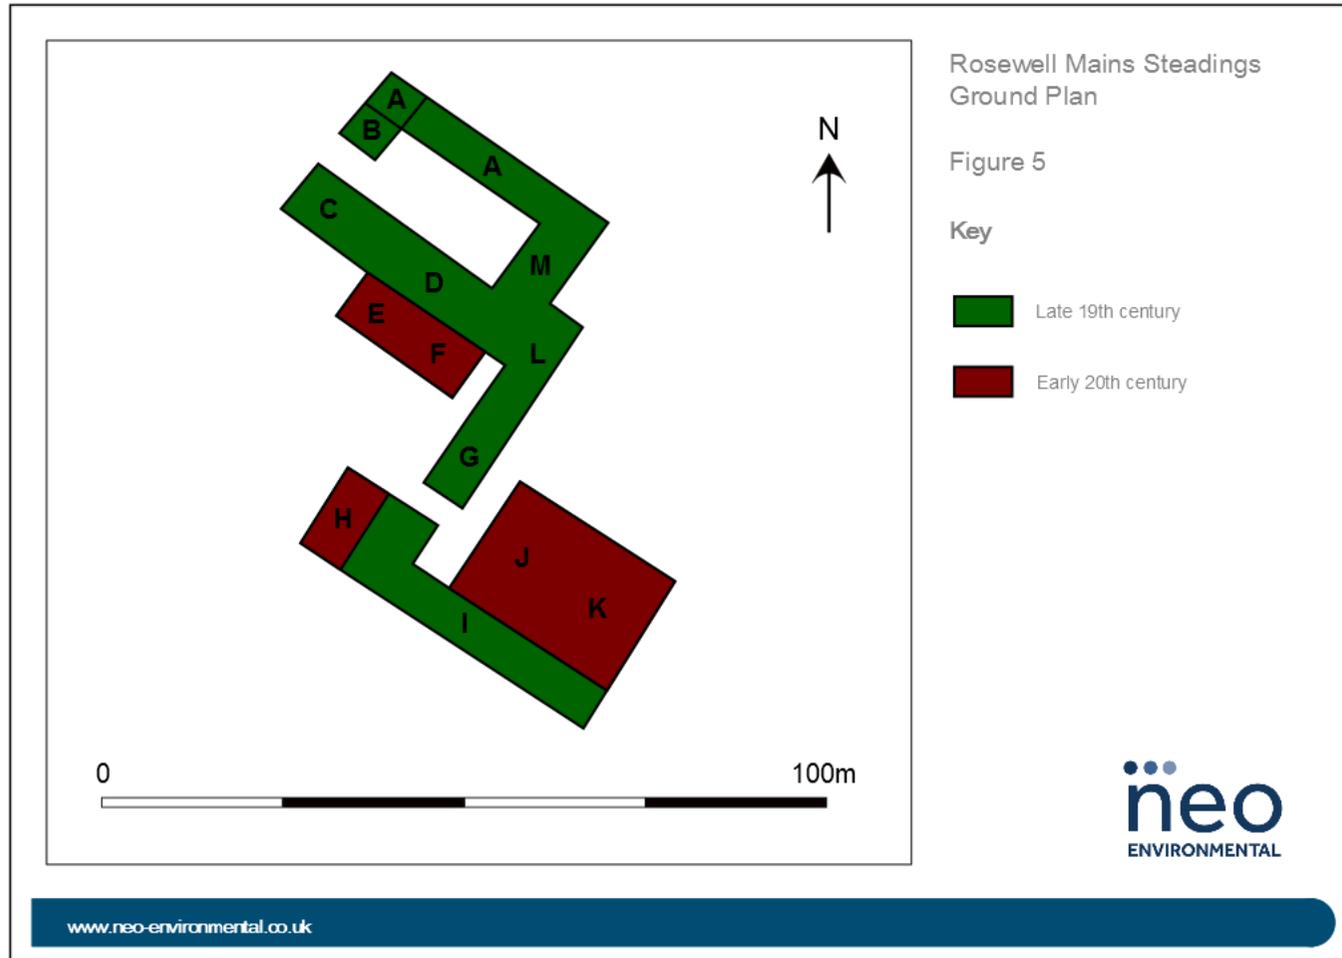
FIGURE 5: GROUND PLAN OF ROSEWELL MAINS STEADINGS

- 4.5 The map regression analysis has shown that there are three distinct phases to the layout of the Rosewell Main Steading. The first phase is the original farmstead visible on the 1854 OS map, the second phase is illustrated by the 1892 OS map after the period of significant change within Rosewell and the third phase is illustrated by modern OS maps, which show the additions or extensions of buildings H, J and K. Figure 5 illustrates the differences in second and third phases

(late 19th century and early 20th century), specifically the modern alterations to buildings E, F, H, J and K. The differences between the first and second phases, while significant, are not as clear on a ground plan, as they involve many instances of joining or separating buildings on the north, south and east sides of the complex in order to better define the group of buildings.

5.1 The Rosewell Main Steading currently consists of thirteen buildings². For the purposes of this report, these buildings are labelled (A-M), which can be seen in Figure 5.

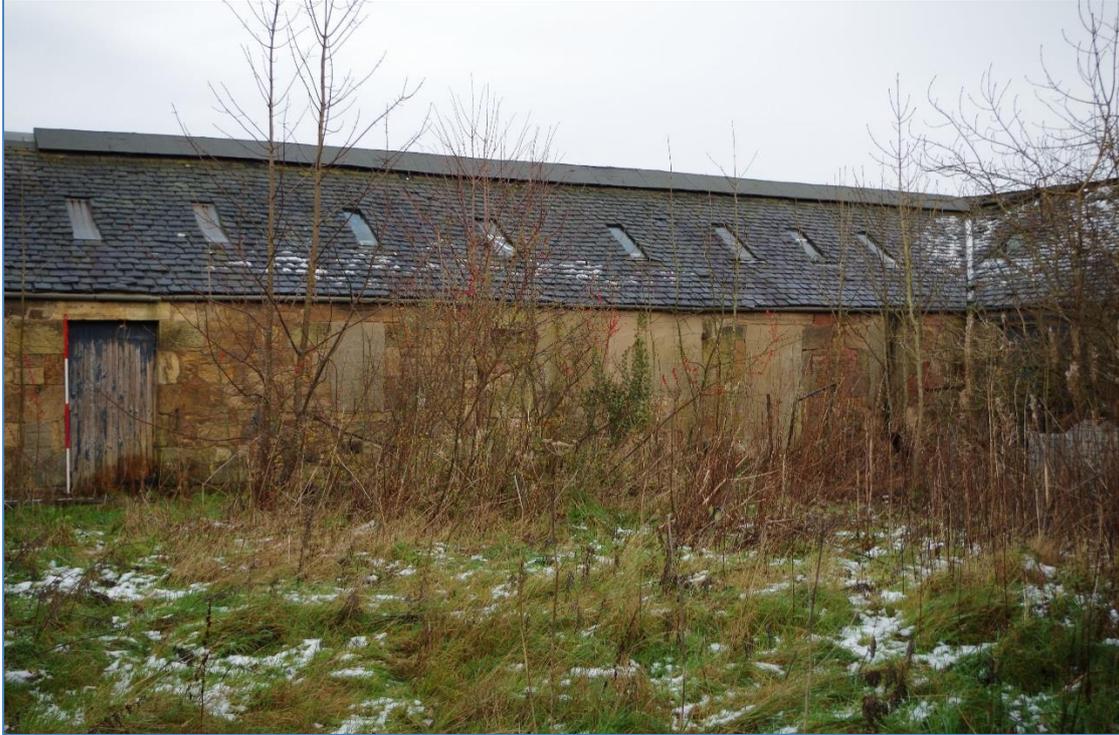
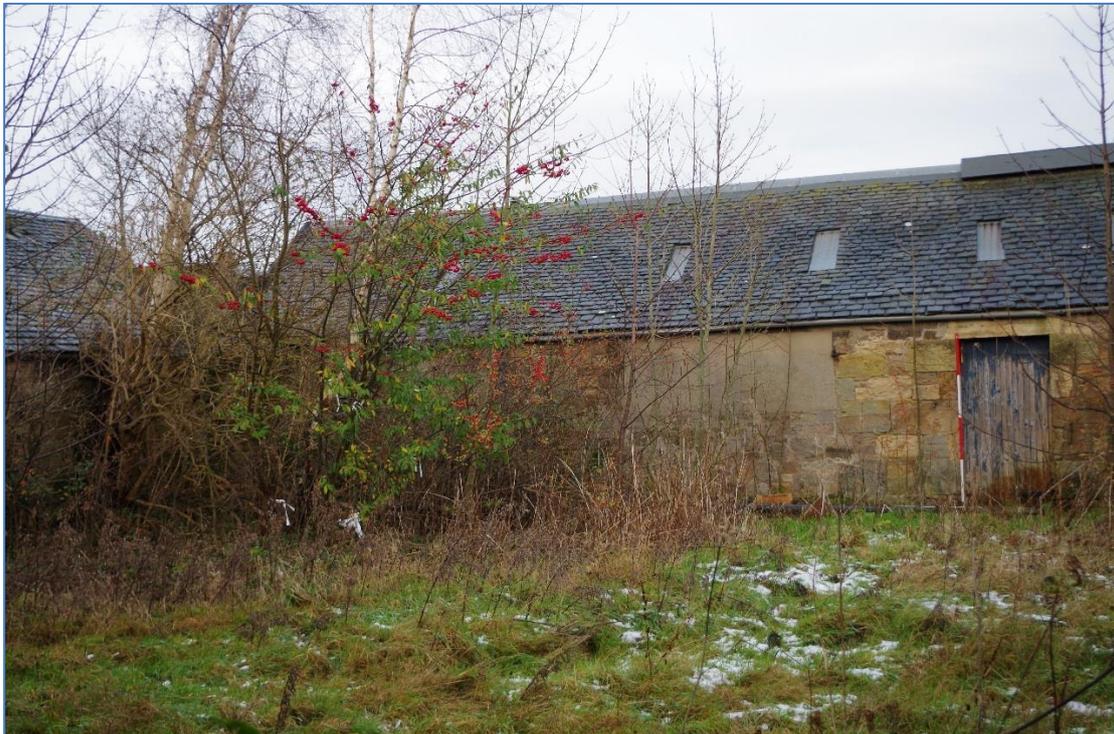
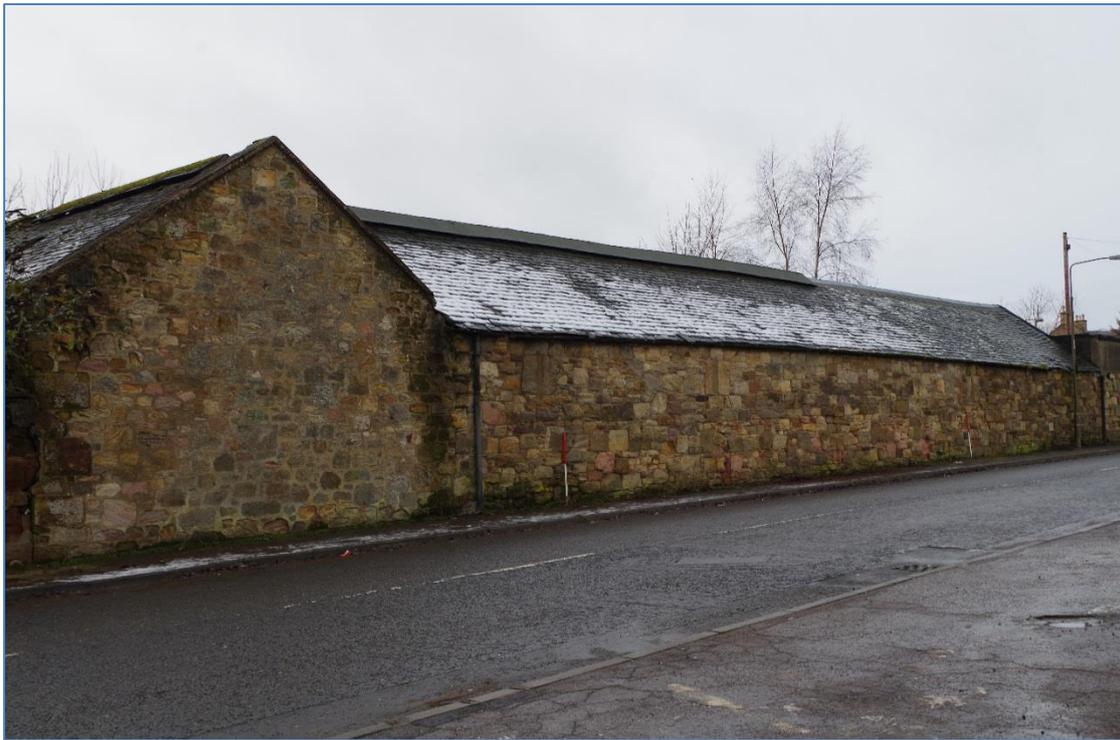
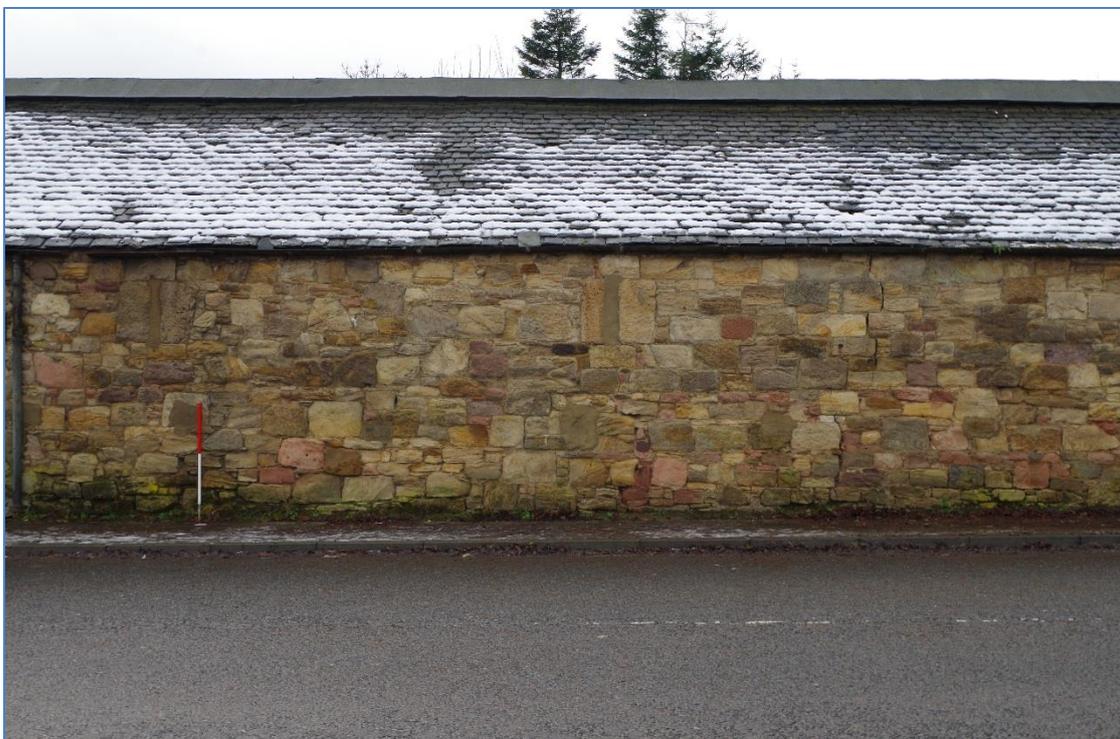
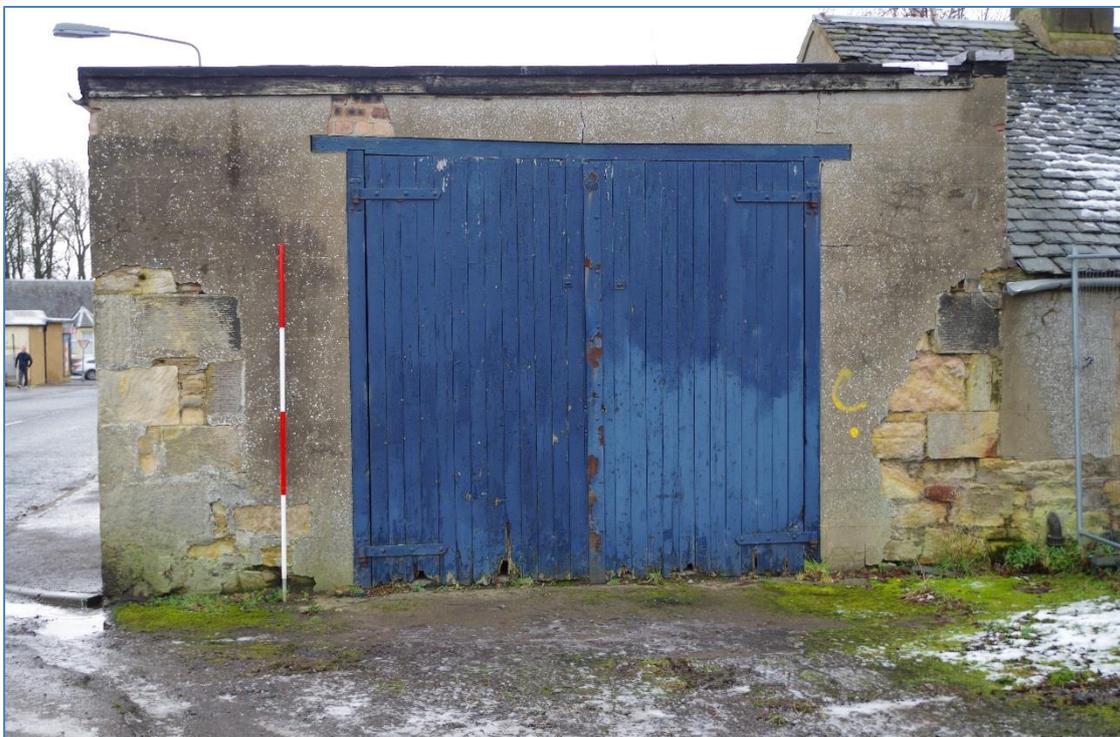
5.2 Located adjacent to Gorton Road, the single-storey building is constructed from sandstone rubble with a slate roof. The southwest elevation contains a centrally located entrance with a blue timber plank door. Four blocked-up windows are discernible, two located either side of the entrance. The rear elevation (northeast facing) contains three slots, presumably to facilitate ventilation, which have been blocked with mortar. A blocked-up window is located near the gable end to the north of the elevation, above which a modern red brick addition has been constructed to accommodate a gently sloping, felt covered roof. A benchmark has been chiselled into the foundation quoin at the northern extent of the rear elevation. The northwest facing gable has a modern blue timber plank garage door installed. The gable end has been rendered with a modern facing beneath which the sandstone rubble wall is observed. This building makes up the core of the steading's first phase, along with buildings D and L/M, which enclose the central courtyard.

Plate 1: Building A, general view of southwest facing elevation

Plate 2: Building A, general view of southwest facing elevation

Plate 3: Building A, general view of northeast elevation

Plate 4: Building A, general view of northeast elevation

Plate 6: Building A, general view of northwest facing elevation

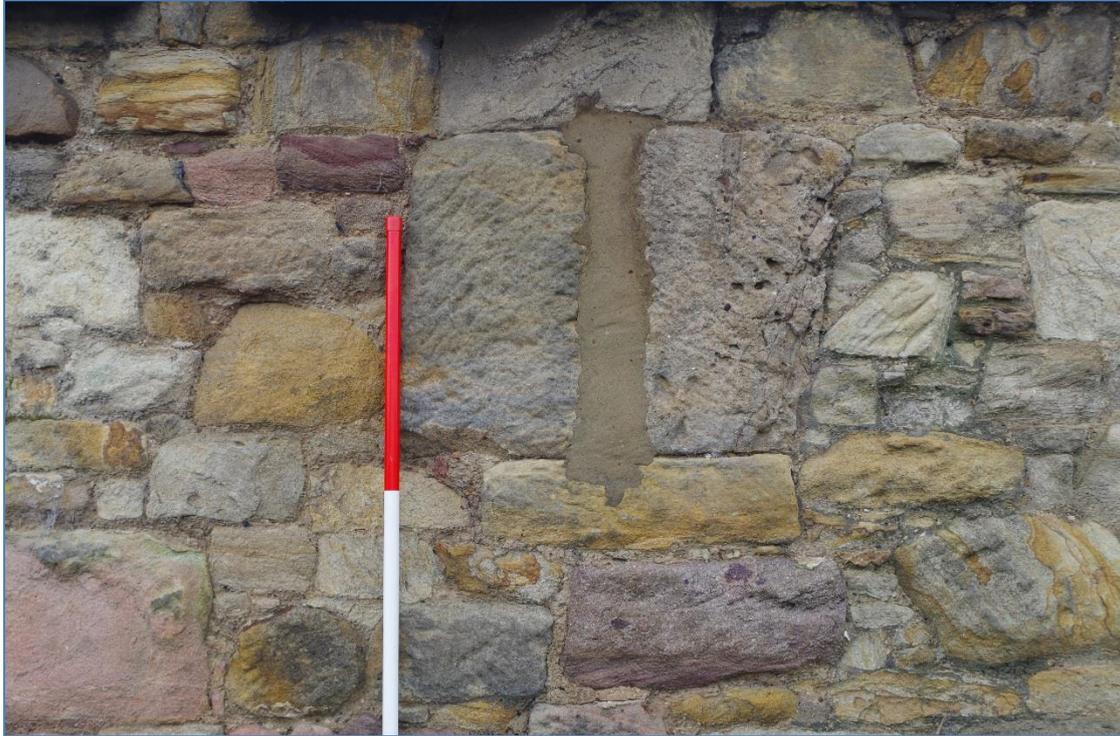
Plate 5: Building A, detail of blocked-up 'air vent'. Northeast elevation.

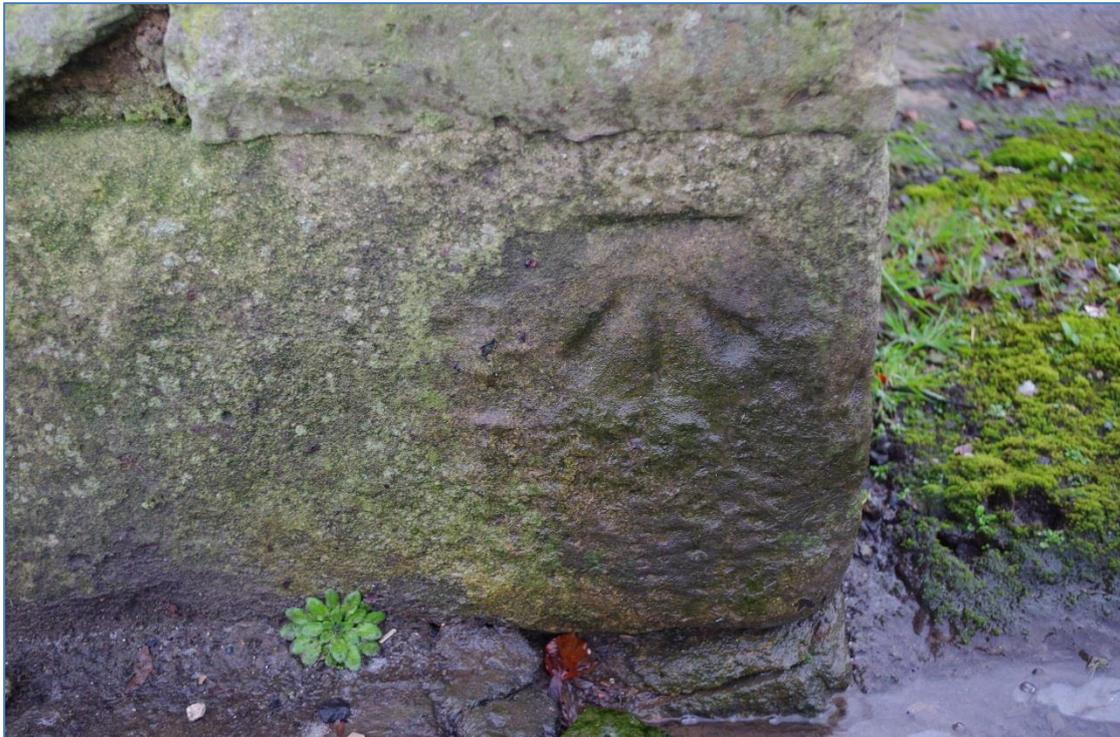
Plate 7: Building A, detail of benchmark on north end of northeast elevation

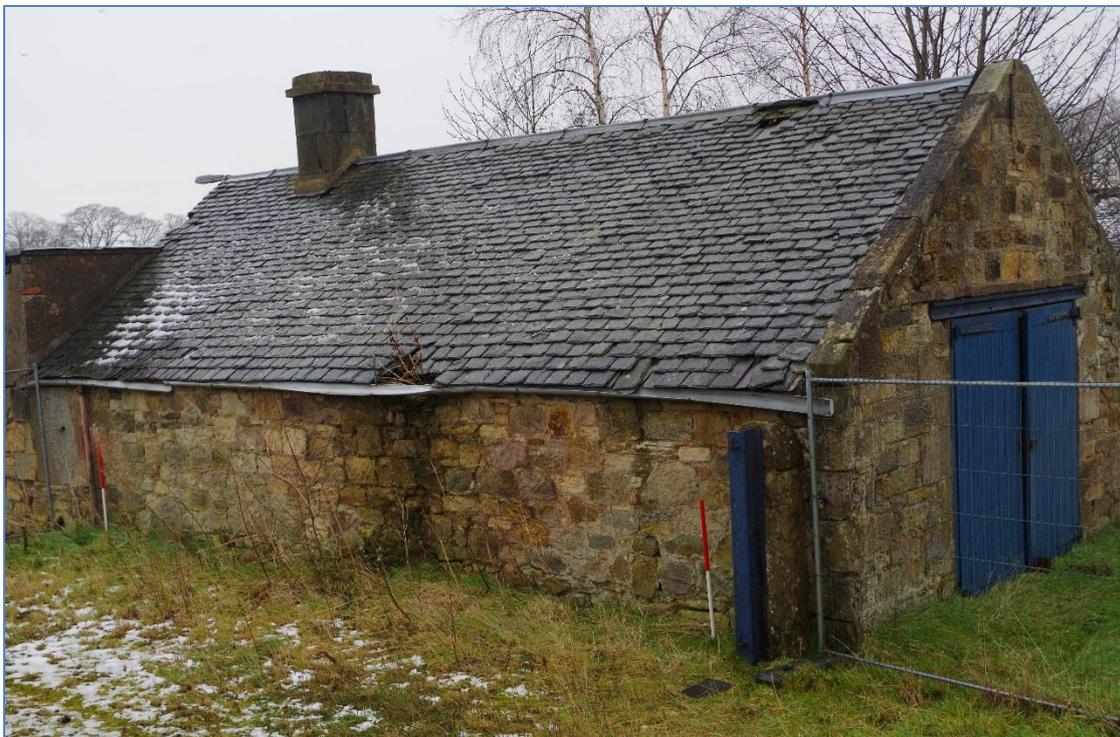
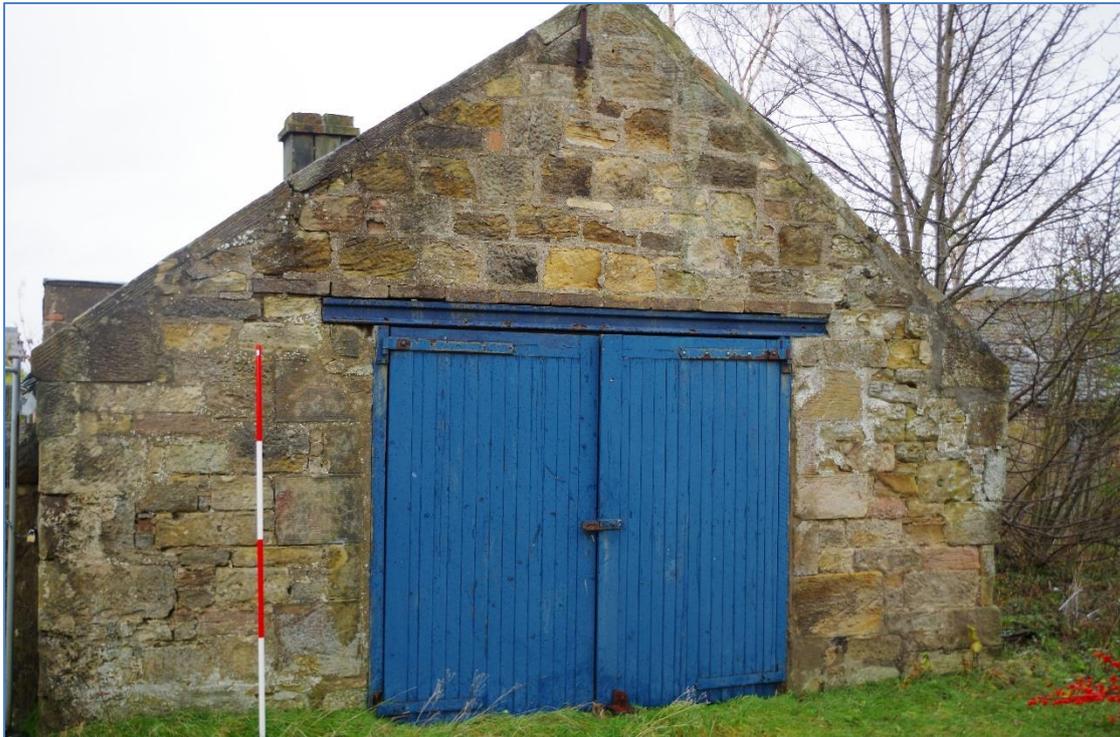
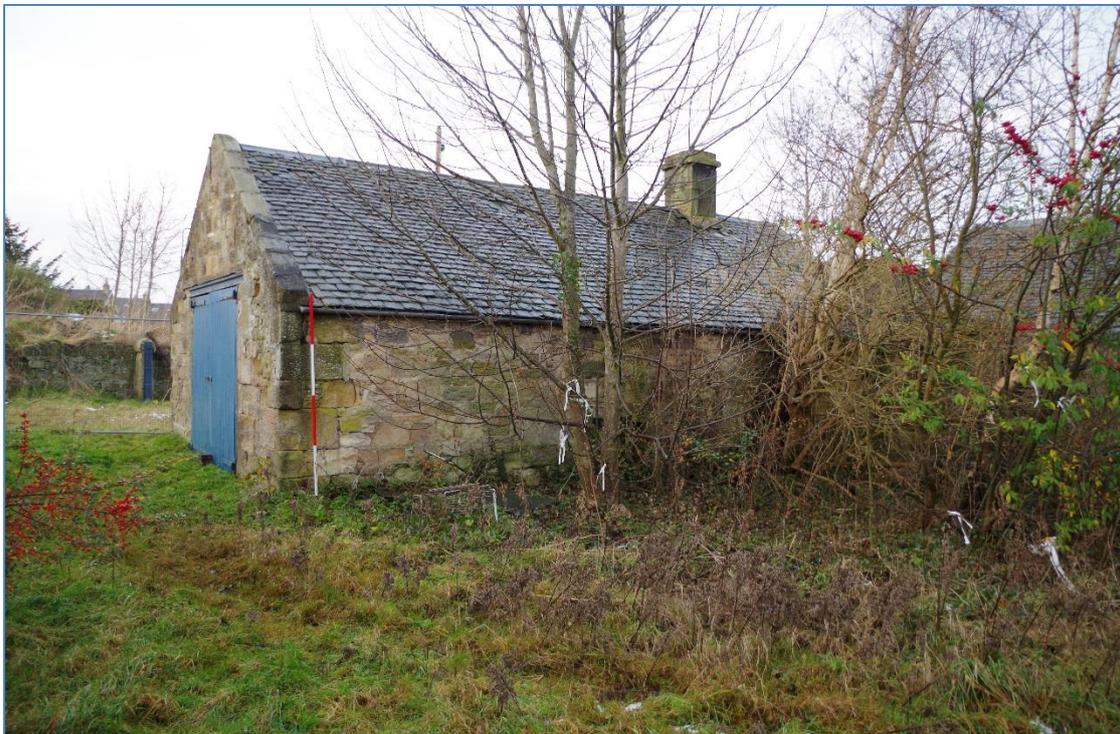
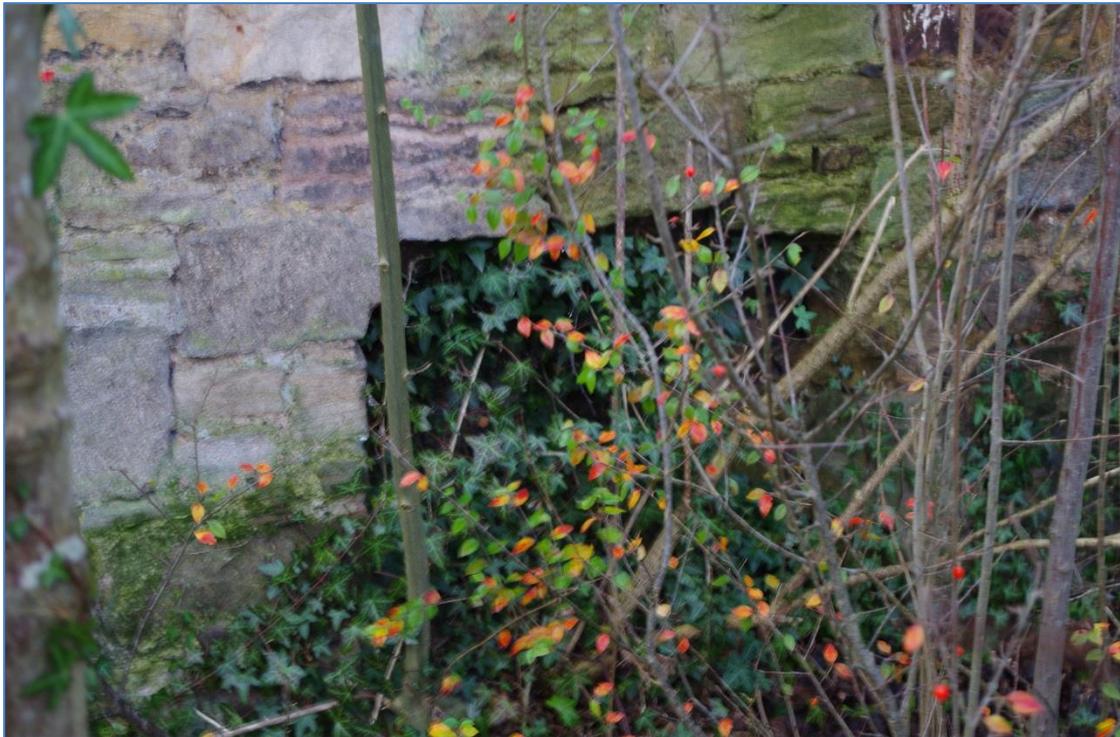
5.3 Located adjacent to the northwest facing gable end of Building A, the single-storey rubble stone building appears to be a continuation of the gable end of Building A. The building has a slate roof with a later square ashlar chimney located upon the ridgeline. The northwest facing elevation contains a blocked-up window. Abutting the western extent is a chiselled stone gate pier. The southwest elevation contains an entrance with blue timber plank twin doors and iron lintel cut into the rubble stone wall. This appears to be a modification of the historic entrance. The southeast elevation is plain but contained a square opening at the base of the structure of unknown function but may possibly have been used for storage space or accommodated farm machinery.

Plate 8: Building B, general view northwest facing elevation

Plate 9: Building B, general view southwest facing elevation

Plate 10: Building B, general view of southeast facing elevation

Plate 11: Building B, detail of opening in southeast facing elevation

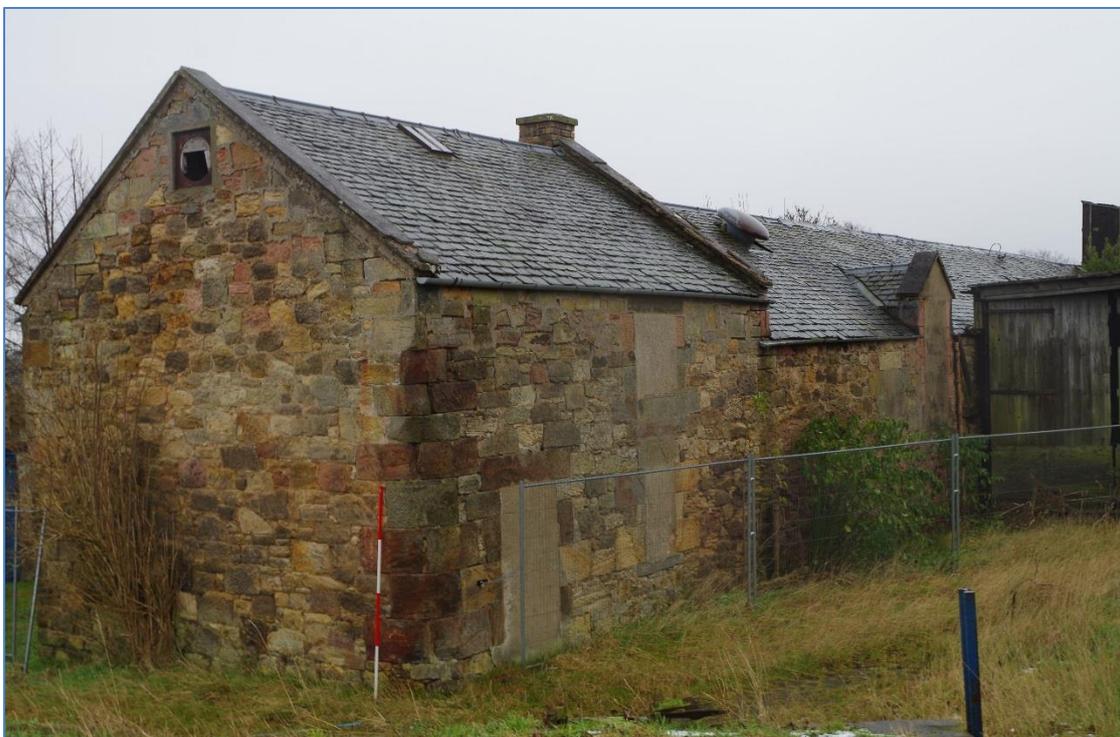
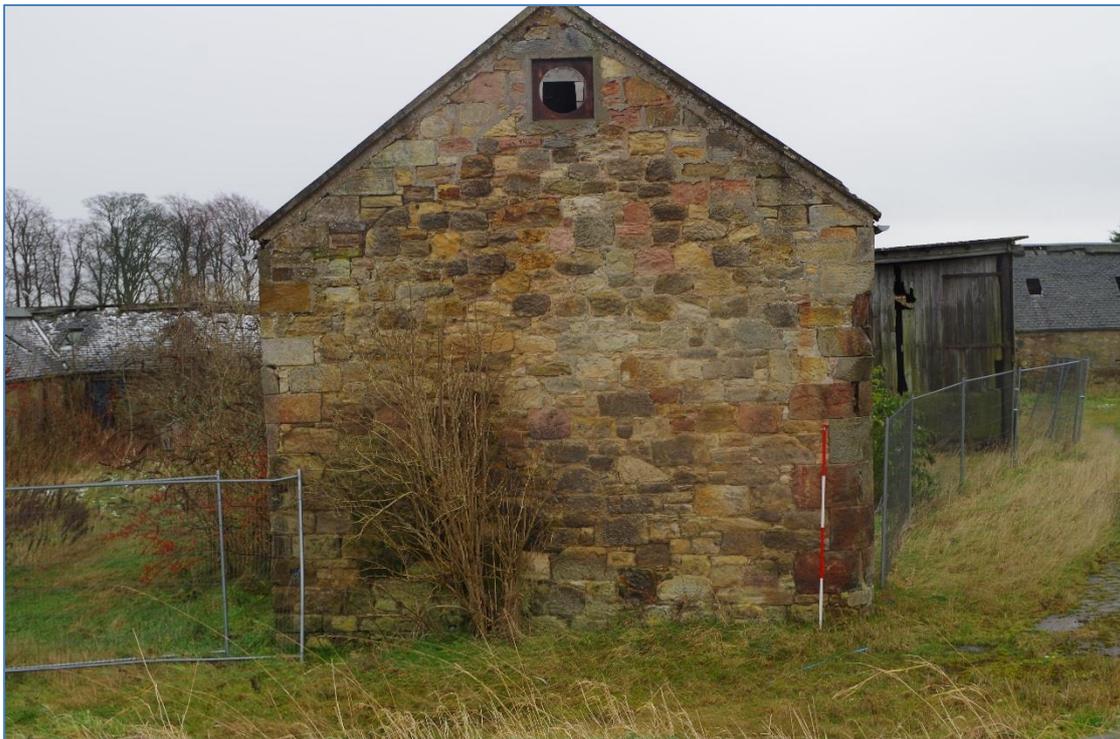
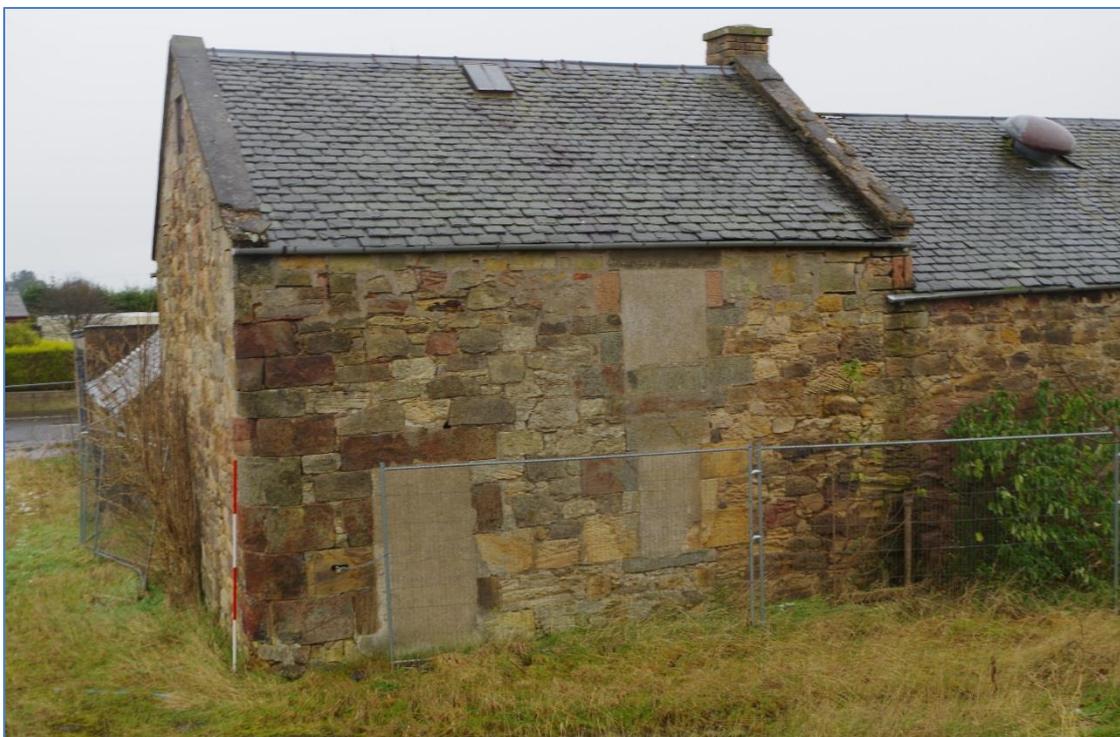
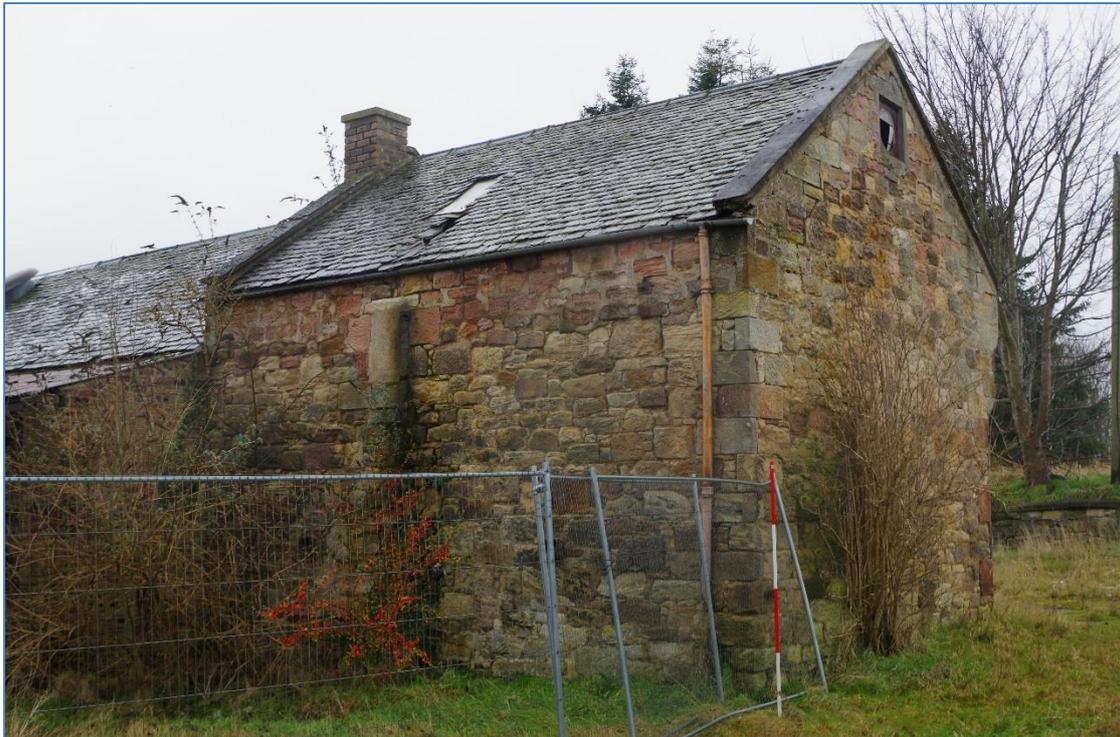
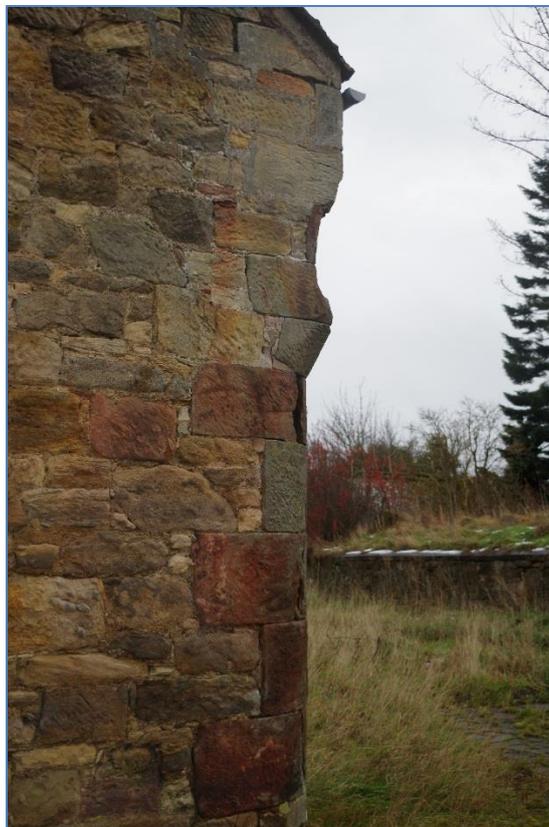
5.4 Building C is a two storey rubble stone building with a loft and later slate roof. The main entrance is located on the southwest facing elevation with a window on each storey. The entrance and windows are presently blocked-up. The northwest elevation is plain excepting a round aperture in the centre of the elevation near the ridgeline of the roof. Obviously, a later addition its function is unknown but may have provided ventilation of the loft space and possibly indicates a change of use of the building from a dwelling to a functional element of the farm complex. The quoin stones between the two elevations are interesting as they have been purposely rounded; possibly to facilitate agricultural traffic manoeuvring along the adjacent farm track. The northeast facing elevation contains a small blocked-up central window located just below the roofline. This appears to be an adaptation of a larger window and the stone work below the roofline has undergone some remedial work, possibly to accommodate the later roof. Approximately 1m from the base of the elevation two pipes are seen to extrude from the wall and are later additions indicating a change of function. Only a portion of the southeast facing elevation is visible, as Building C abuts Building D, but beneath the roofline modern brickwork is observed with a brick chimney clearly illustrating that the roof is a later addition.

Plate 12: Building C, general view showing northwest and southwest elevations

Plate 13: Building C, general view of northwest elevation

Plate 14: Building C, general view of southwest facing elevation

Plate 15: Building C, general view of northeast elevation

Plate 16: Building C, detail showing curved quoins between northwest and southwest elevations
