Historic Building Recording

Rosewell Mains Steading

29/01/2015

- 1.1 Rosewell Development Trust Community Company Ltd commissioned Neo Environmental Ltd to undertake a Level 1 Historic Building Survey at Rosewell Mains Steading, Gorton Loan, Rosewell (NGR 328877 662571) prior to the development of the site. The survey was required to fulfil a condition set by East Lothian Council to “record the upstanding remains and determine whether the development will disturb any buried archaeological deposits.”
- 1.2 The farmhouse steading is situated within the village of Rosewell, 1.7km to the east of Roslin and 11km to the south of the city centre of Edinburgh. The site is located in the south of the village, bounded by Gorton Road to the northeast and by a mix of modern buildings and disused brownfield sites.

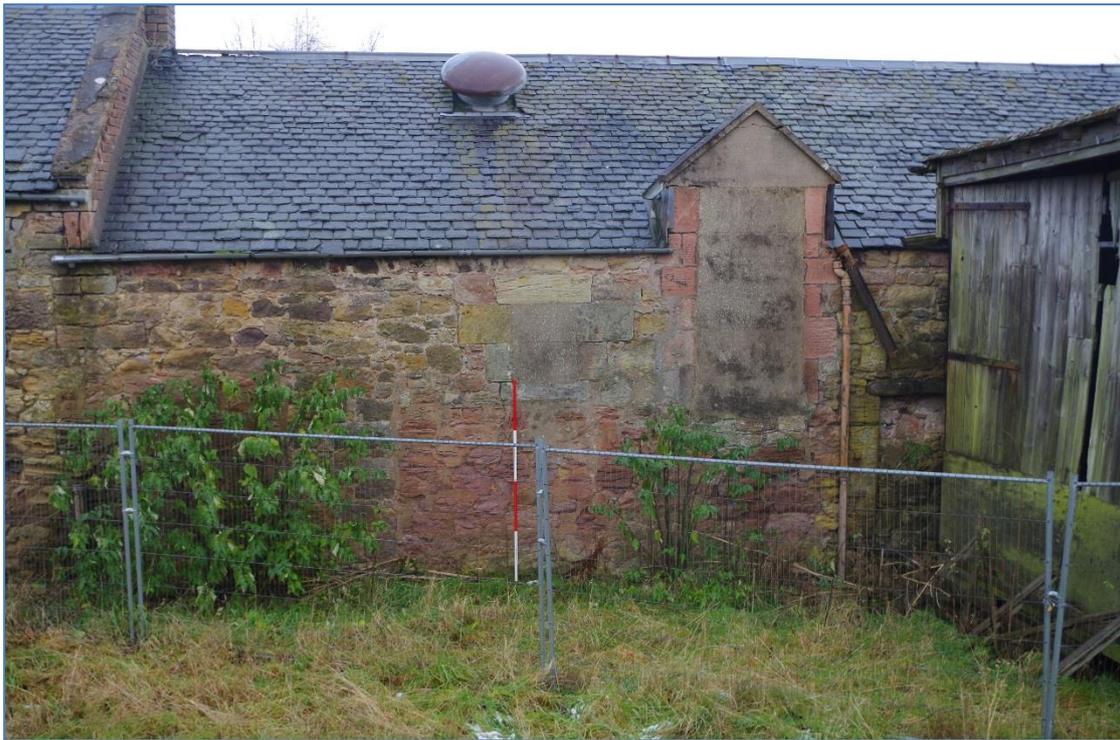
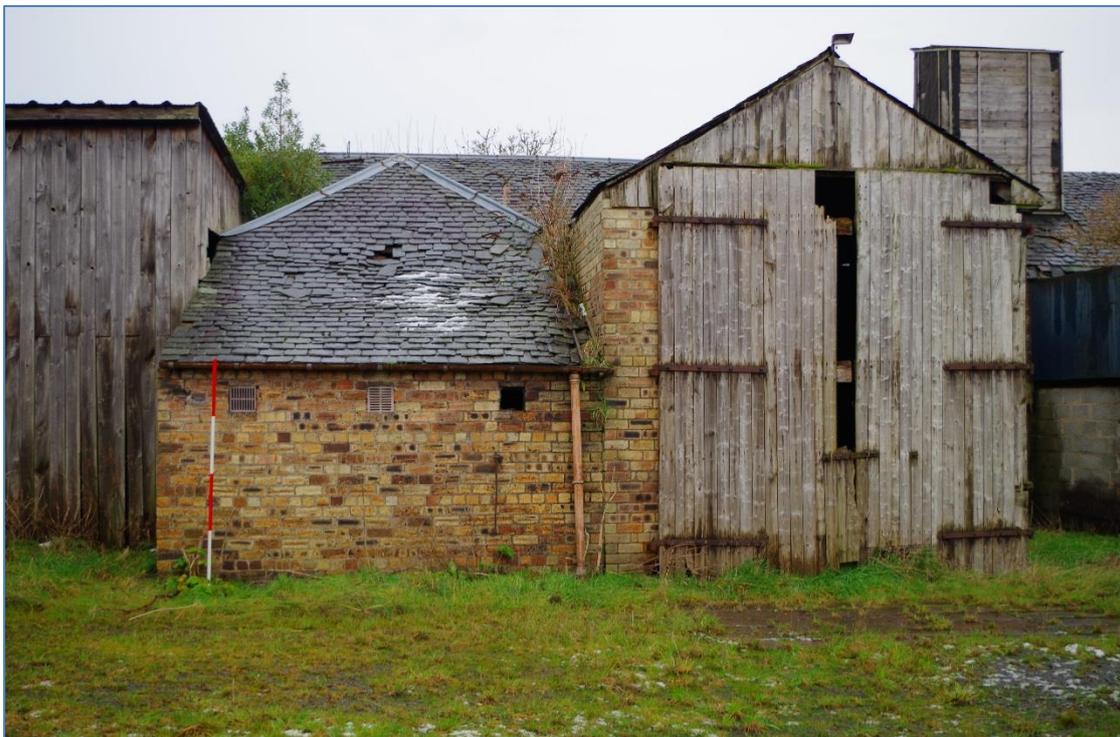
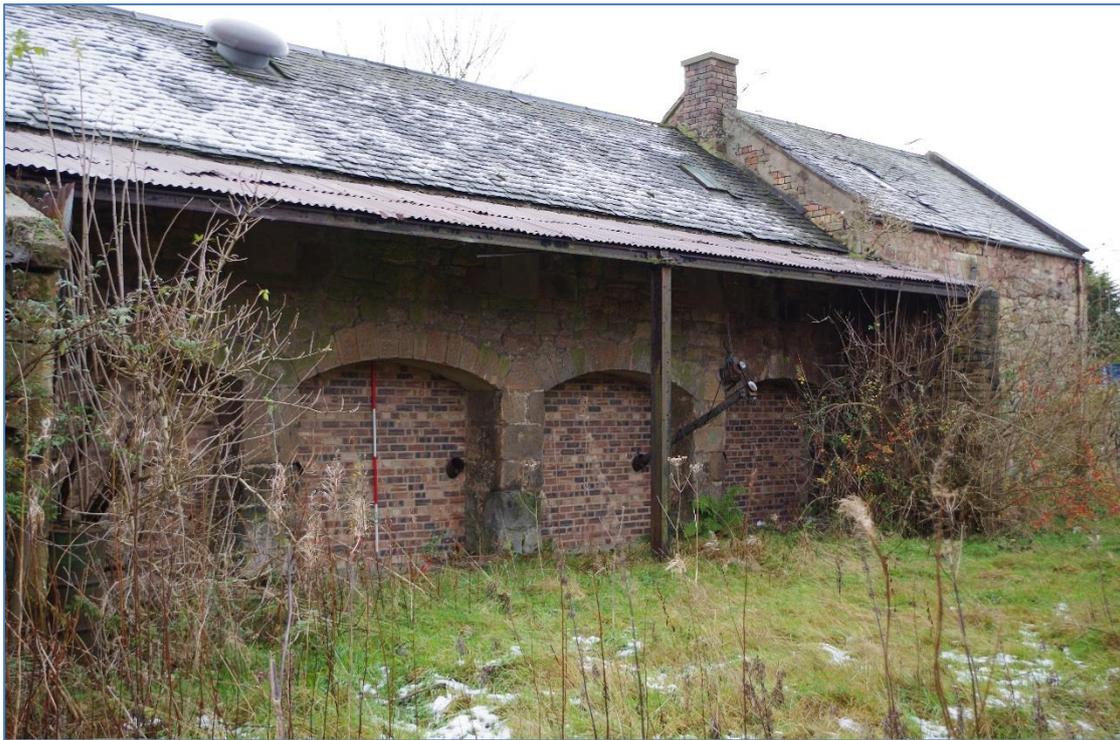
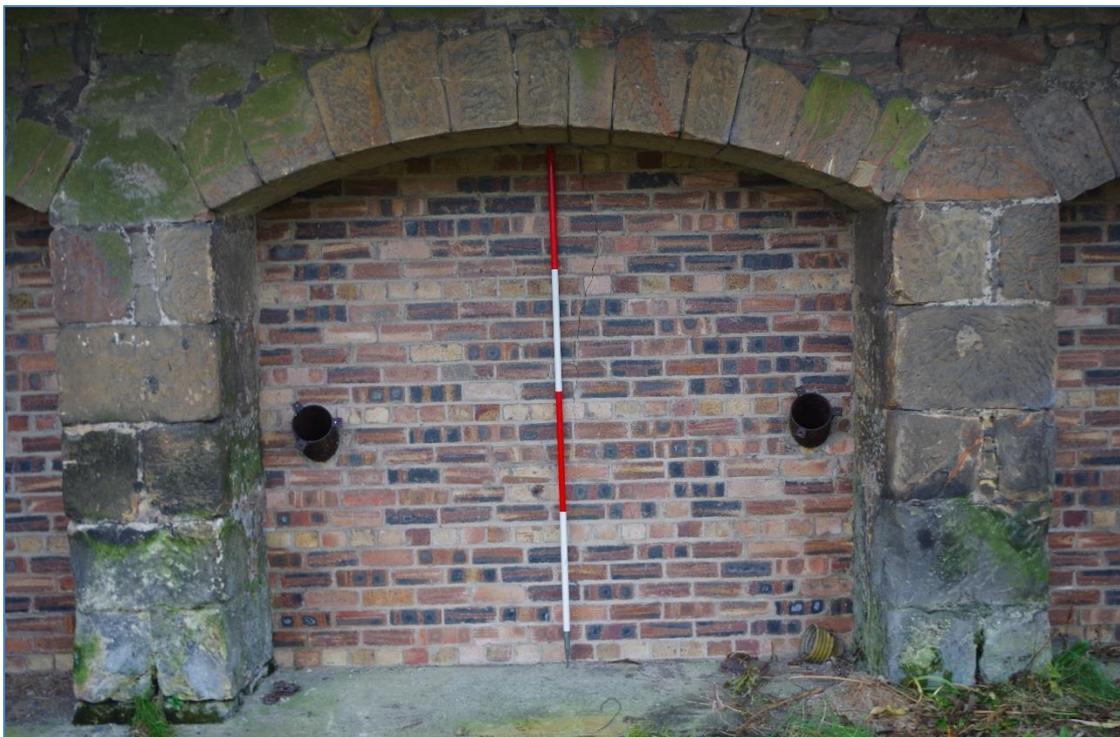
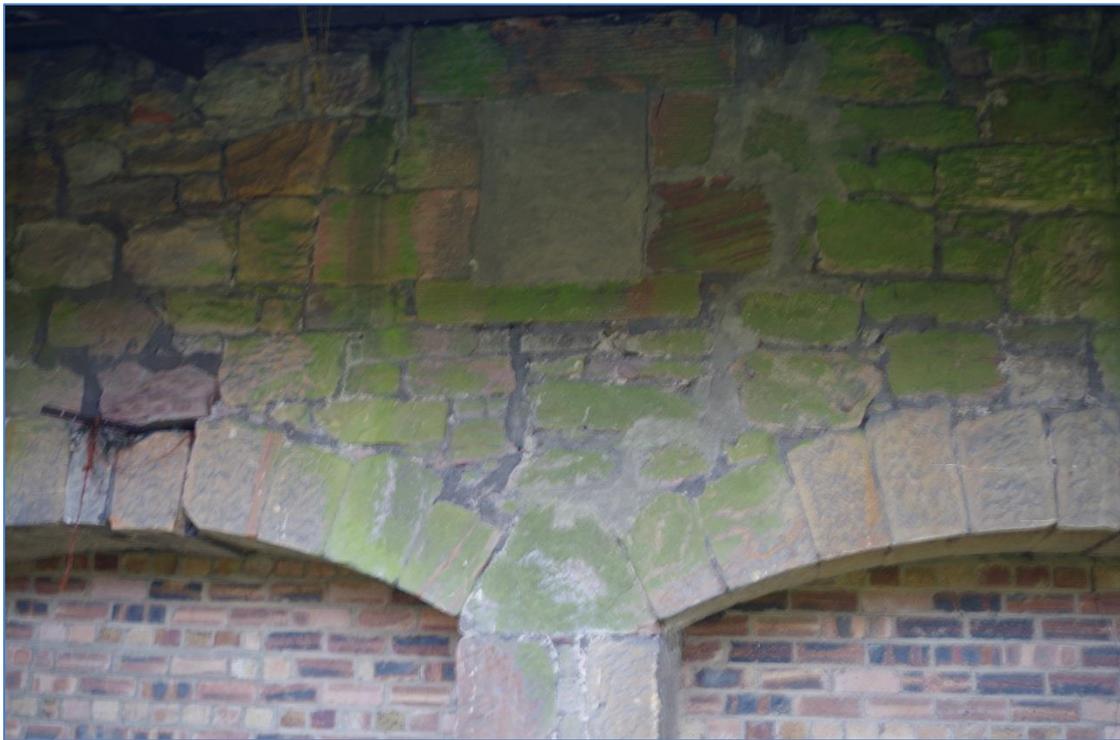
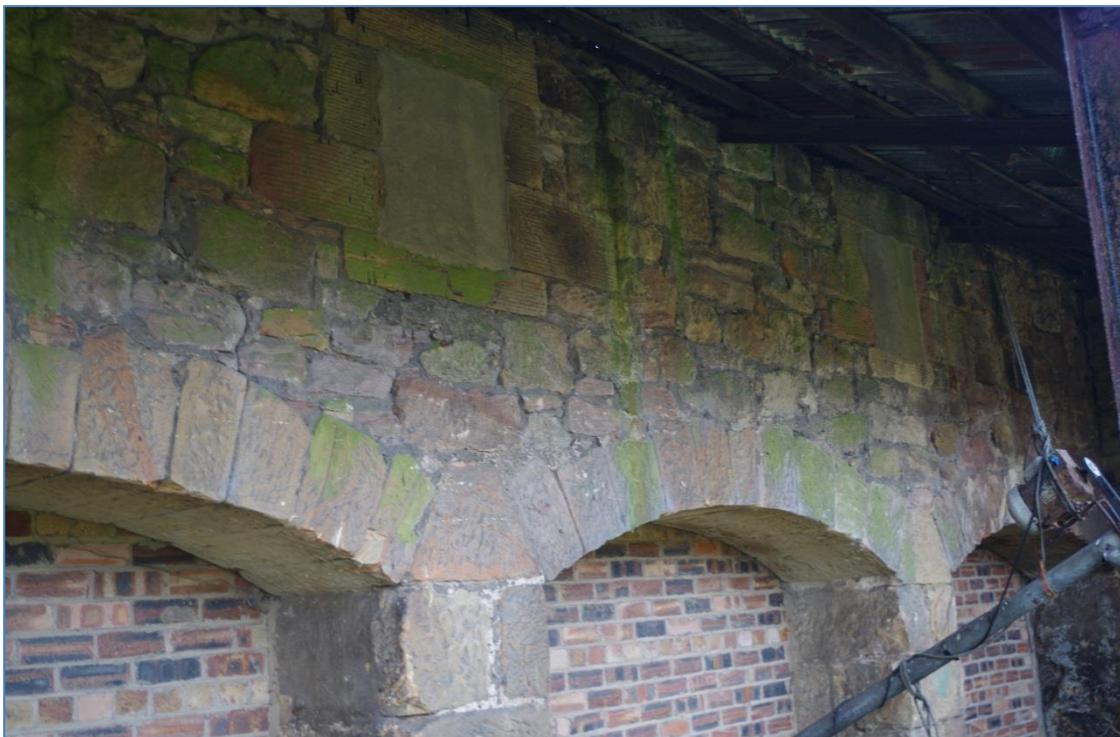
5.5 Building D is a one storey rubble sandstone building with a slate roof. The southwest facing elevation is largely obscured by modern wood and brick structures. However, a large window inscribed “Rosewell 1935” is observed. The stonework (red sandstone blocks) appear to be later additions. Adjacent to this window a smaller original window is located to the north. To the south of the main window a possible entrance is discerned, however, this has been blocked-up with rubble sandstone. The rear elevation, northeast facing, contain four archways located side-by-side that have been bricked-up, probably in the not too distant past. Each arch is approximately 2m in height by 2m width. Columns consist of large chiselled sandstone blocks. The masonry appears to be a rubble sandstone, however, there is a discernible higher quality to the buildmanship which contrasts with the stonework found elsewhere within the steading. Three small square windows are located below the roofline above each of the supporting columns of the archways below. Modern adaptations to the elevation include an iron frame roofing extending beyond the archways into the courtyard supported by a brick wall and circular apertures cut into the modern brick work accommodating metal pipes; possibly functioning as air vents.

Plate 17: Building D, general view of southwest facing elevation

Plate 18: Building D, southwest facing elevation showing Building E and F

Plate 19: Building D, general view of northeast facing elevation

Plate 20: Building D, detail of archway in northeast facing elevation

Plate 21: Building D, detail of window in northeast facing elevation

Plate 22: Building D, detail of windows in northeast facing elevation

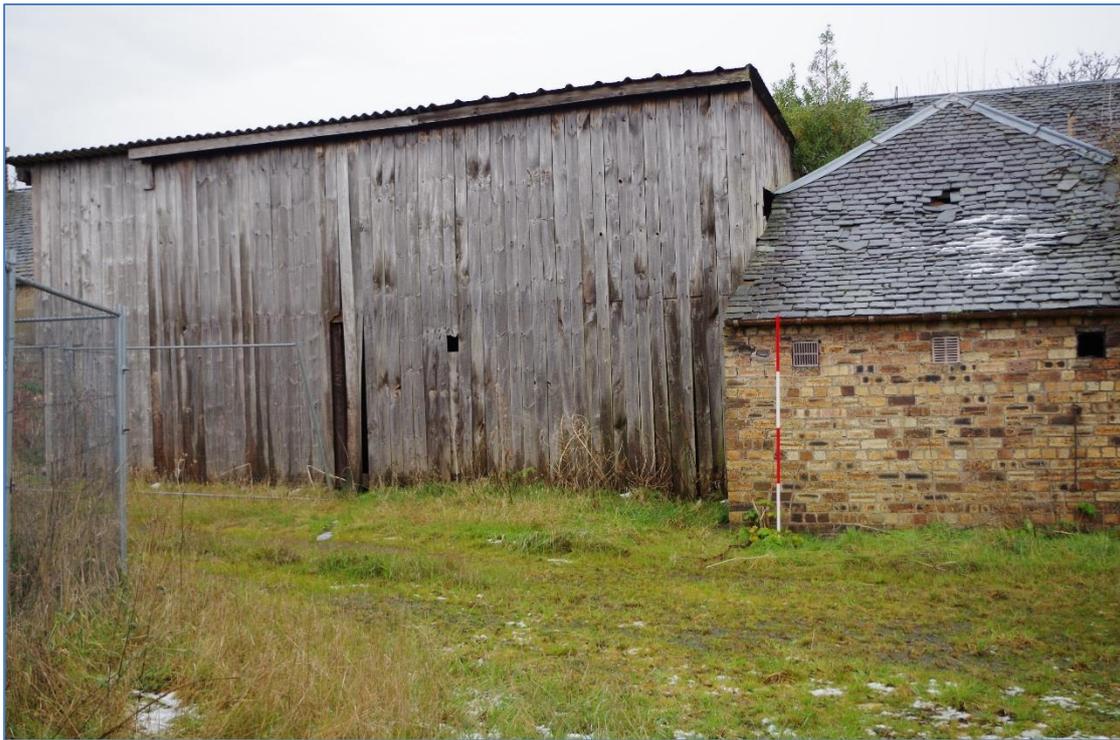
Plate 23: Building E and F, general view of southwest facing elevations

5.6 Building E is a modern timber planked shed abutting the southwest facing elevation of Building D.

5.7 This building is a modern brick extension to Building D, and has a slate roof and large wooden barn door on the southeast part of the southwest facing elevation. There are three small square vents on the southwest facing elevation, next to the barn door.

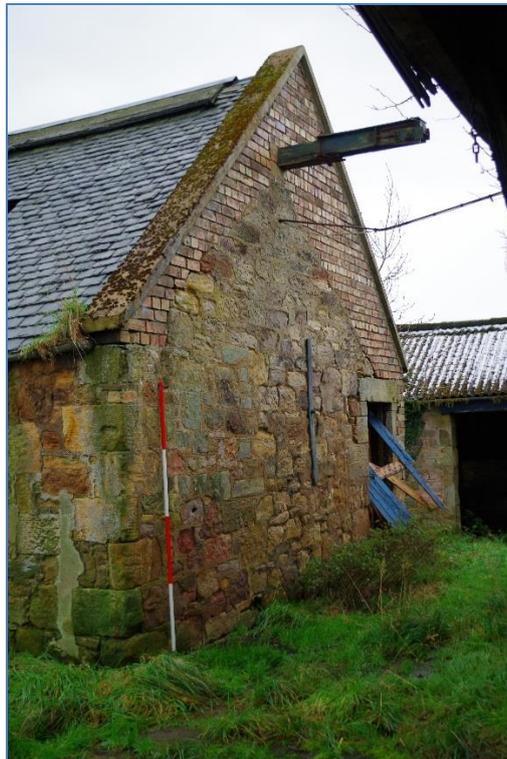
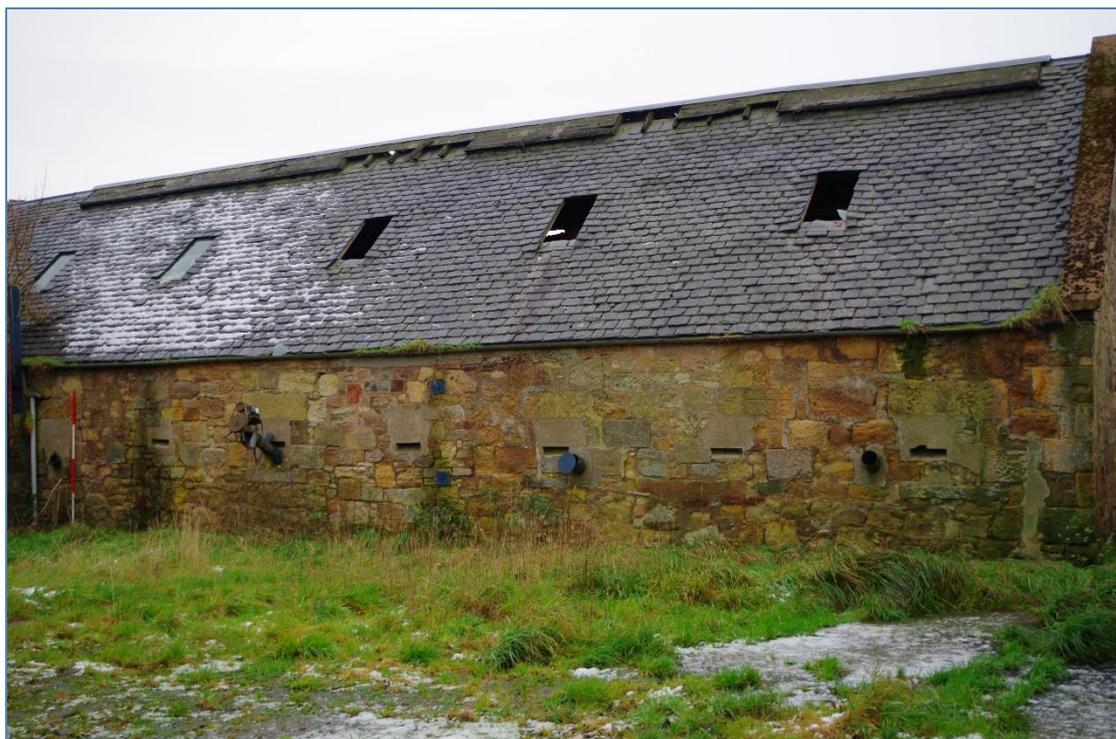
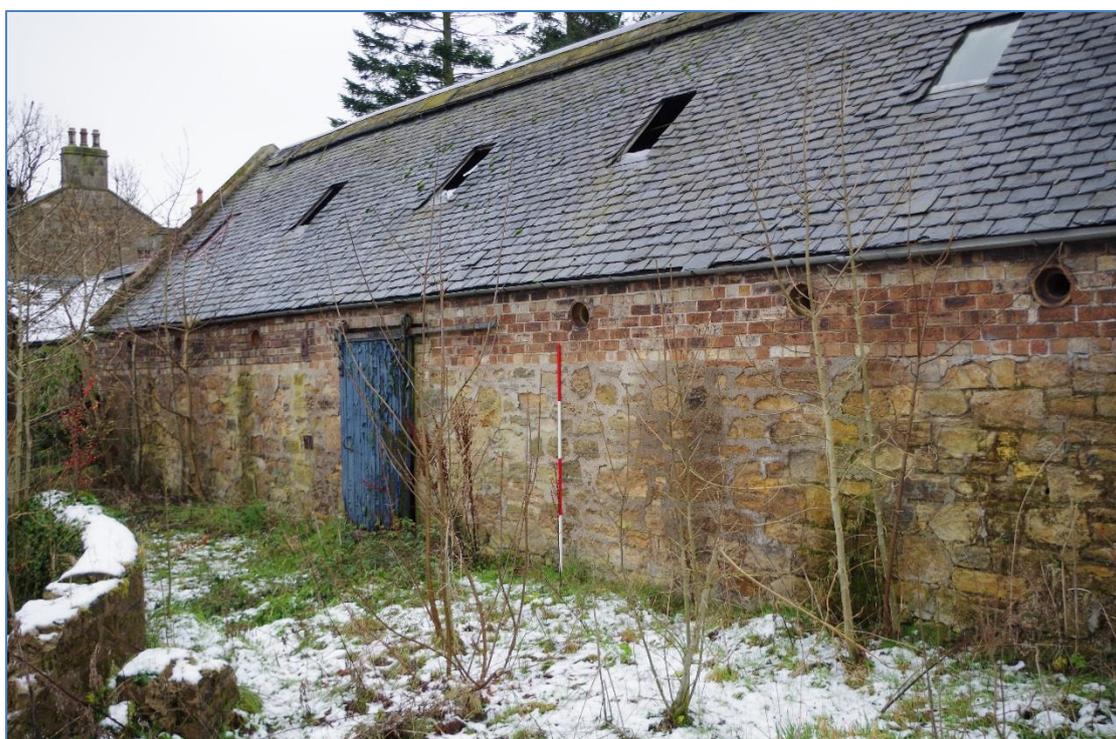
5.8 Building G is a rubble sandstone one-storey building with a slate roof. An entrance is located in the southwest facing elevation, although it is not clear if this is a later addition to enlarge the building as phasing in this elevation suggests that it may have formed a plain gable end. Later brick work is clearly visible below the roofline contrasting starkly with the original rubble sandstone below, indicative of an enlargement of the roof space. The original pitch of the roof is possibly implied in this elevation although this interpretation should be treated with caution. A blue iron extension (possibly a crane) is embedded into the modern brick work. The southeast facing elevation is primarily of rubble sandstone construction with modern brick above to accommodate the later roof. It is not clear if the rubble sandstone is contemporary with similar elevations within the steading as it appears to be of a different hue. This fact may lend credence to the interpretation that the building was enlarged. An entrance with a blue timber plank doorway is observed within a central location and circular apertures possibly for ventilation are located in the modern brick work beneath the roofline. Four windows were identified in the northwest facing elevation which have been blocked-up, although some examples accommodate small rectangular slots presumably for ventilation. Pipes are observed protruding from the elevation and deposits of grain (possibly barley) were found within the pipes.

Plate 24: Building G, general view of southwest facing elevation

Plate 25: Building G, general view of northwest facing elevation

Plate 26: Building G, general view of southwest facing elevation

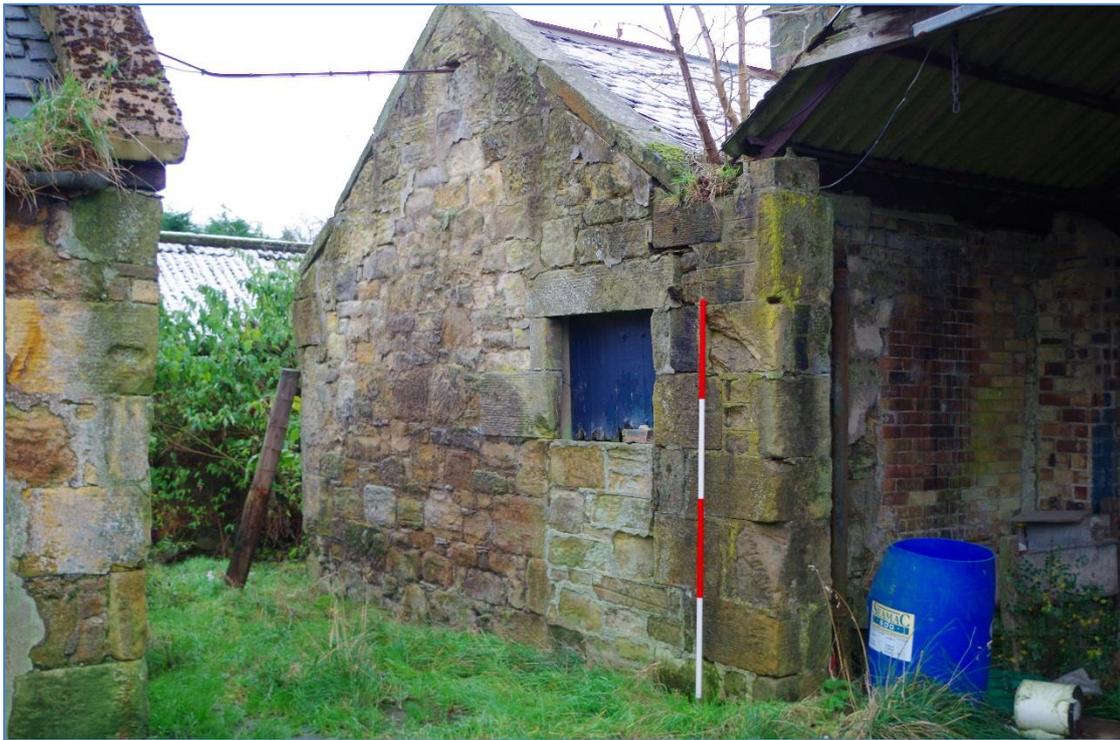
Plate 27: Building I, general view of northeast facing elevation

5.10 Building I adjoins Building H but is clearly earlier in date. This is another sandstone and slate construction, and has a doorway in the northeast facing elevation, which has been partially blocked by sandstone, while part of the wooden door is still present which has been used to block the remainder.

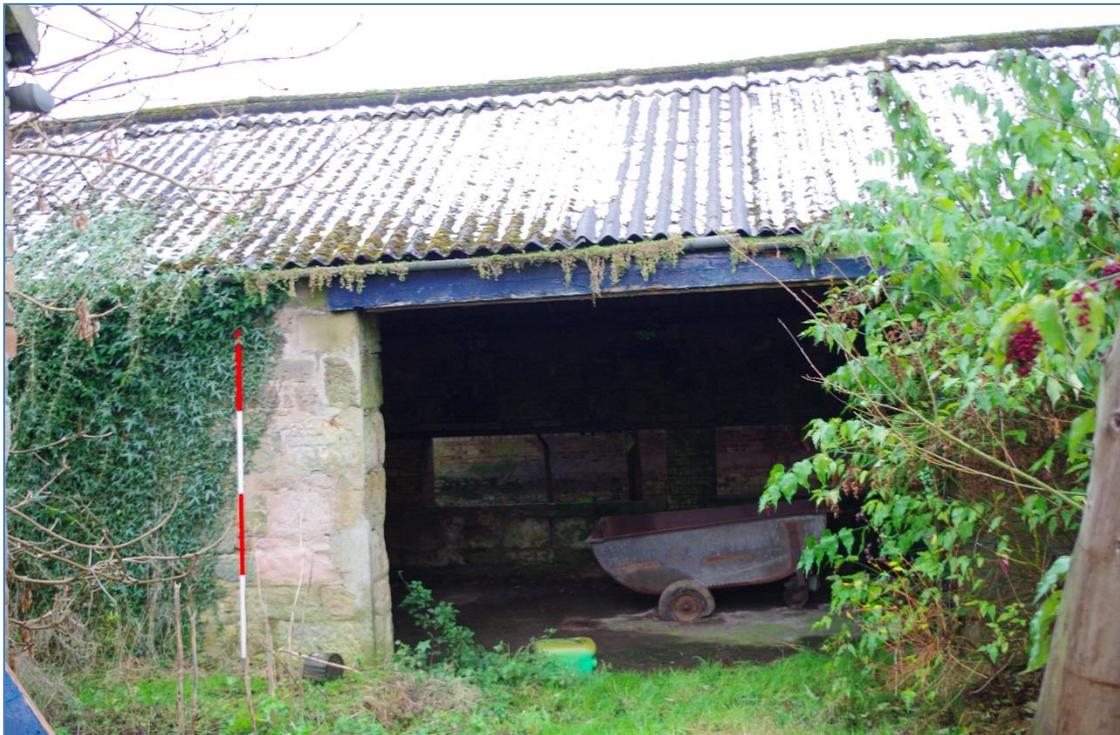
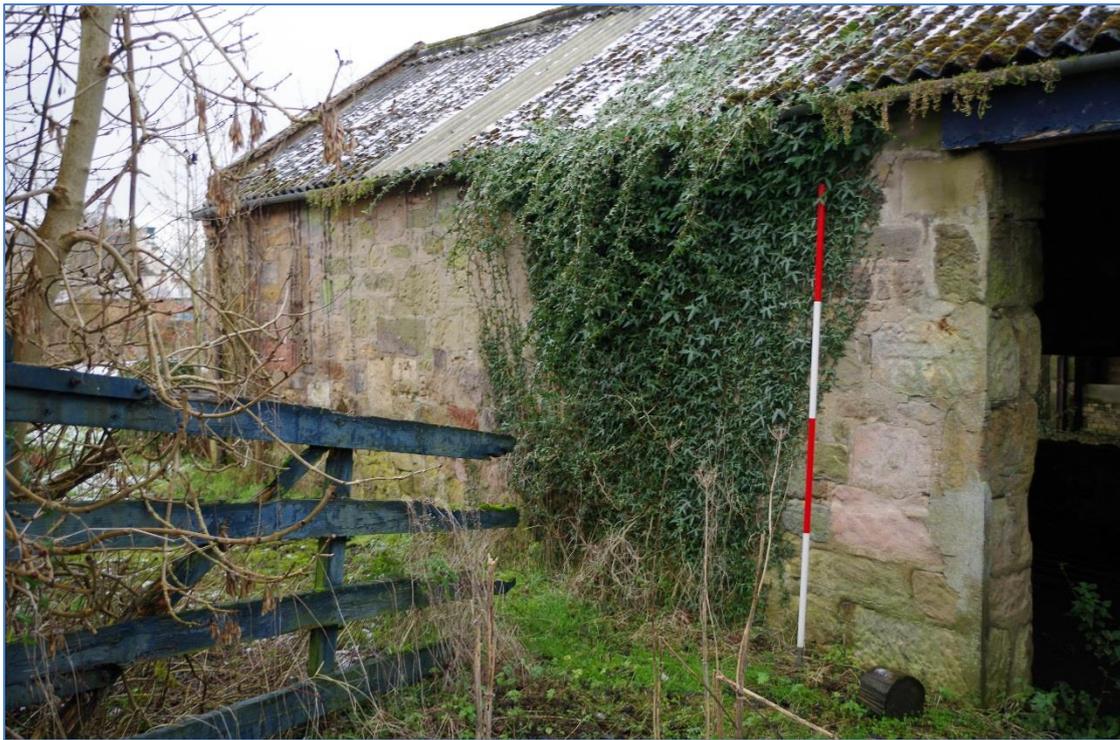
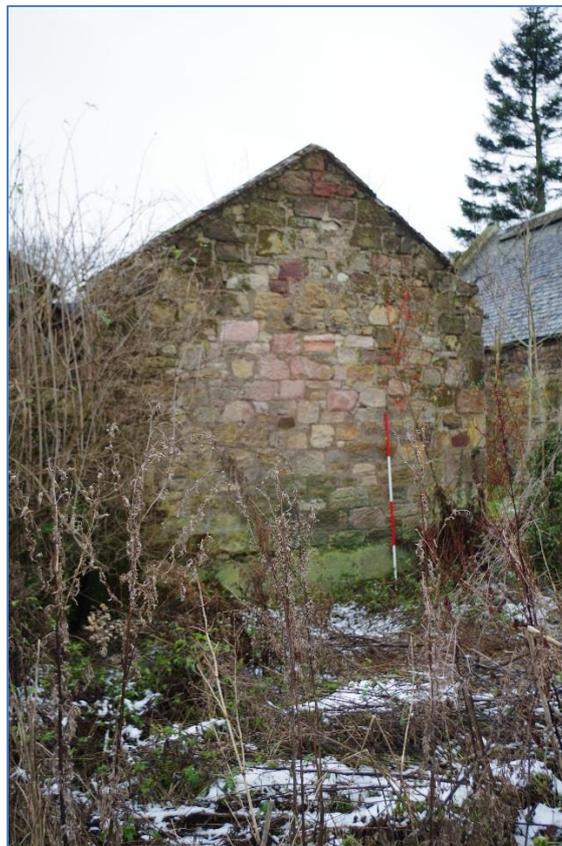
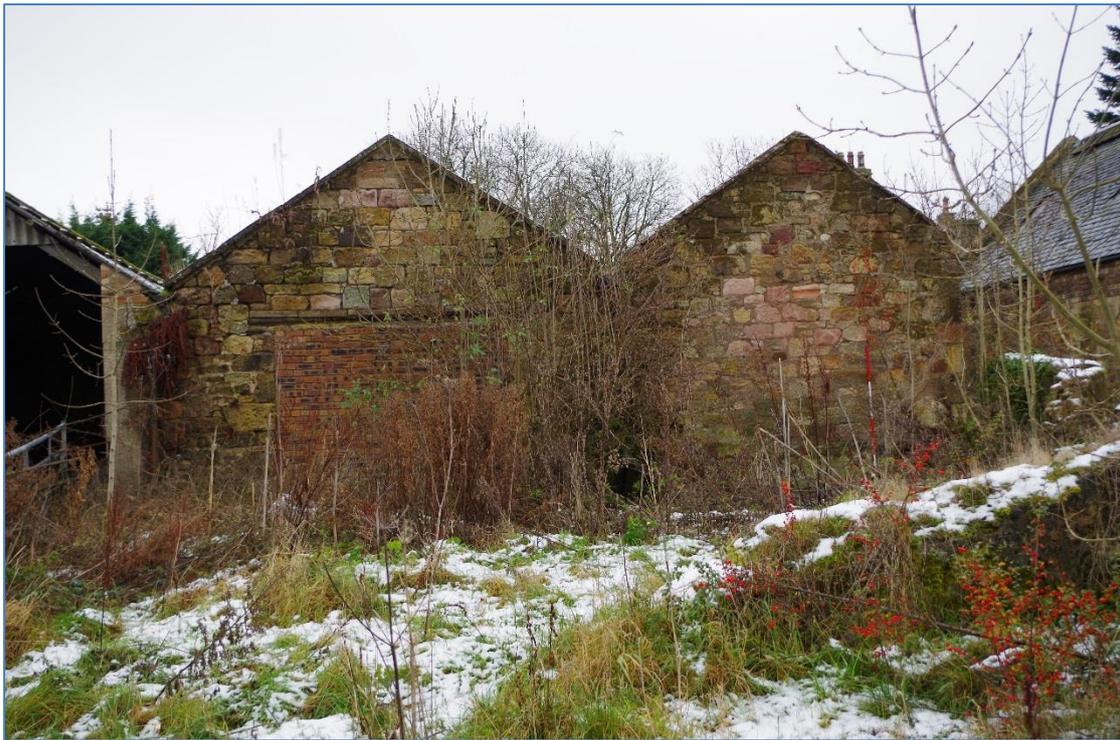
5.11 This appears to have been a large storage building constructed in the early 20th century from sandstone blocks with a corrugated metal roof. There is a large entrance in the northwest facing elevation and it adjoins Building I at the south end, while leaving a gap of approximately 2m between Buildings G and J.

5.12 The northeast gable end is plainly constructed from sandstone blocks, and has been more recently patched with different sandstone within the centre of the elevation, possibly as part of repair work done here.

5.13 Building K is immediately adjacent and adjoining Building J at its southeast, the construction of which is contemporary. These buildings are very similar, but Building K has a large blocked entrance with large horizontal sandstone slabs forming a lintel. It has been blocked using bricks but no concrete facing. There is also a recent shed adjoining this building to the southeast, constructed largely from corrugated metal and in poor condition.

Plate 28: Building J, general view of northwest facing elevation

Plate 29: Building J, general view of northwest facing elevation

Plate 30: Building J, general view of northeast facing elevation

Plate 31: Buildings J and K, general view of northeast facing elevation

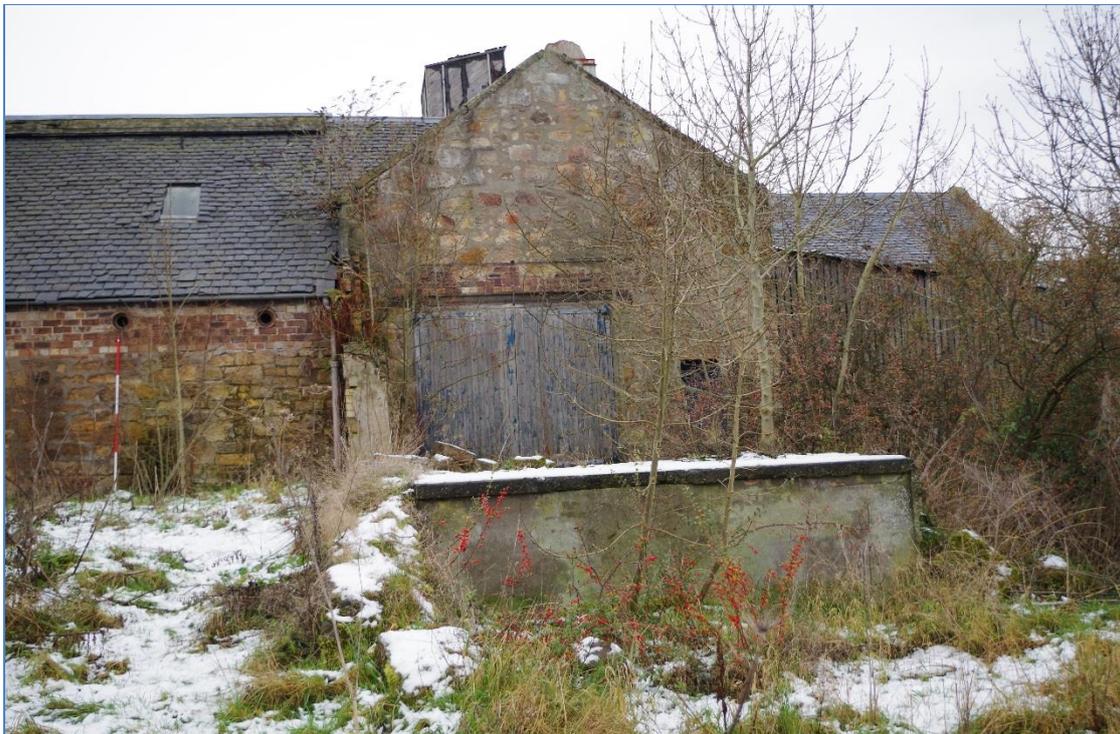
Plate 32: Building L, general view of southeast facing elevation

5.14 This is another substantial sandstone building, which together with Buildings A, D and M, makes up the main early phase steading, enclosing the courtyard area inside. The southeast facing elevation cannot be seen clearly due to the heavy vegetation present in front of it. There is another wooden shed extension built onto this elevation where it meets Building E.

5.15 The northwest facing elevation contains several windows blocked with brick and concrete facing, one of which is very large, as well as another wooden door, also painted blue.

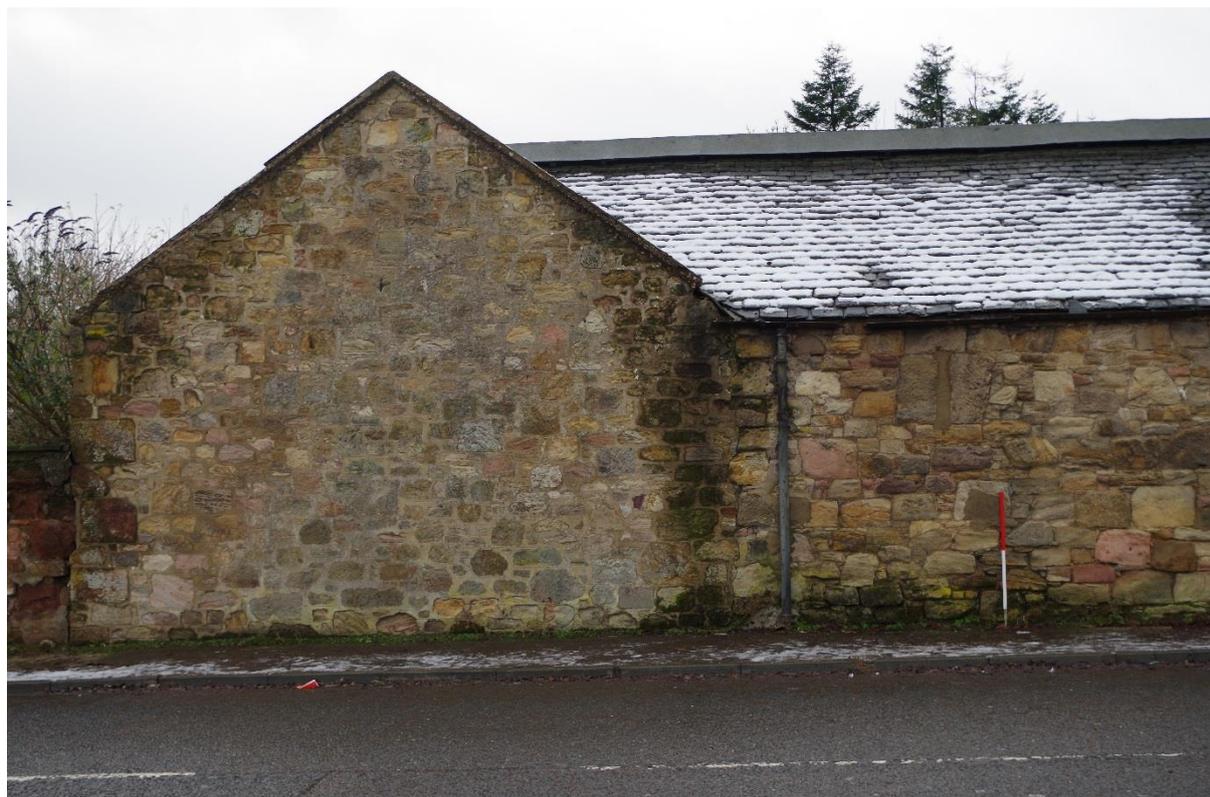
Plate 33: Building M, general view of northeast facing gable end

5.16 The elevations of Building M were largely obscured by thick vegetation. However, the northeast facing gable end was visible. It was constructed from a rubble sandstone and was largely featureless. The slate roof appeared to be a later addition. Due to difficulty of access it was not clear if the building was part of Building L or a later component of Building A.
