Archaeological Watching Brief

Rose & Hill Cottages,
The Hill,
Burford
(SP25047 12027)

Polyolbion Site Ref. BURA 14

Planning Application:
14/1090/P/FP

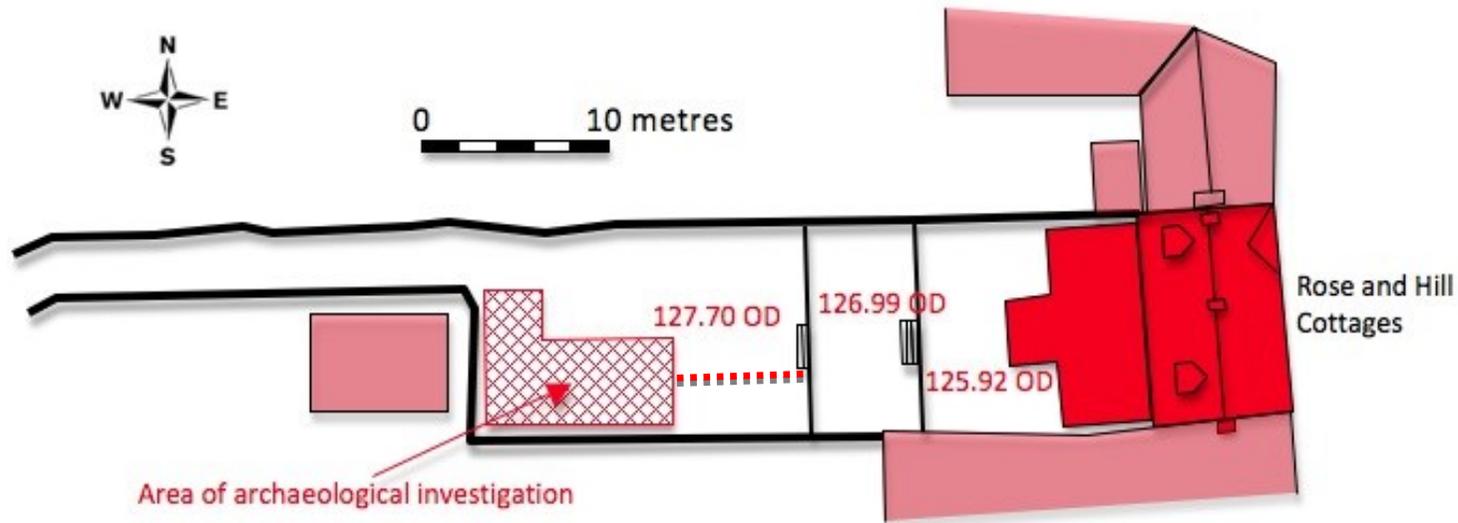
Fig.2 Rose and Hill Cottages, area for monitoring

2.2 The study area was a plot of land at SP25047 12027 of approximately 60 square metres against the southern boundary of the property about 20 metres to the west of the house (Fig.2).

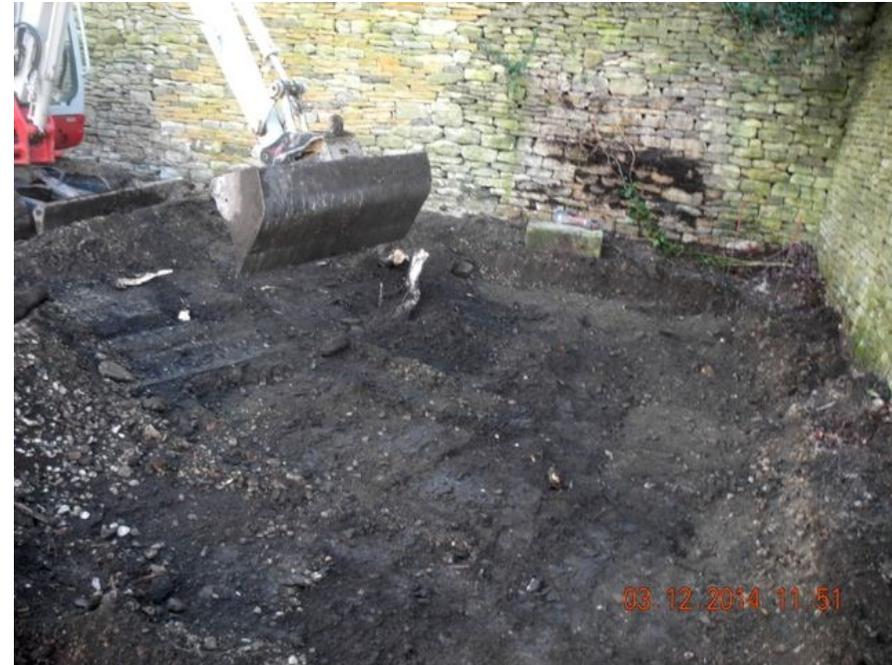
Fig. 4 Grading underway, west end of site looking south east

3.1 the machining was carried out under direct archaeological control, using a mechanical excavator equipped with a toothless grading bucket (Fig. 4). Work commenced at the west end of the site furthest away from the house and soil was removed to a depth of a maximum of 30 cm, however, because of the fall of the land the amount dug out diminished so by the time the east end of the area was reached no more was done than smooth out the existing surface.

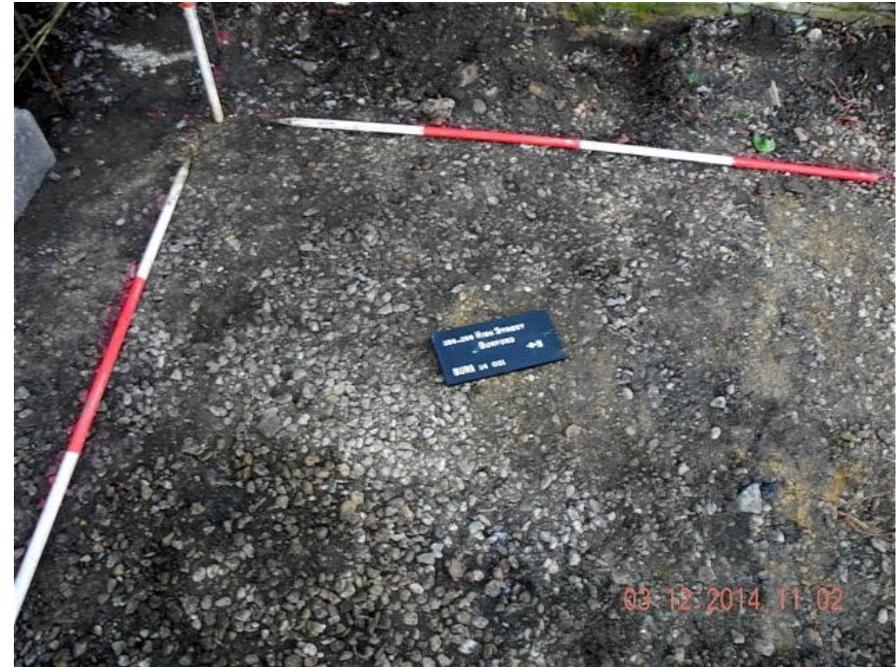
Fig.5 Surface of 001 south west corner looking west

4.1 the exposed uppermost deposit (001) was a series of spreads of stone chippings with some broken concrete and sand and was primarily the product of construction activities that had been going on in and around the house in previous months (Fig. 5).

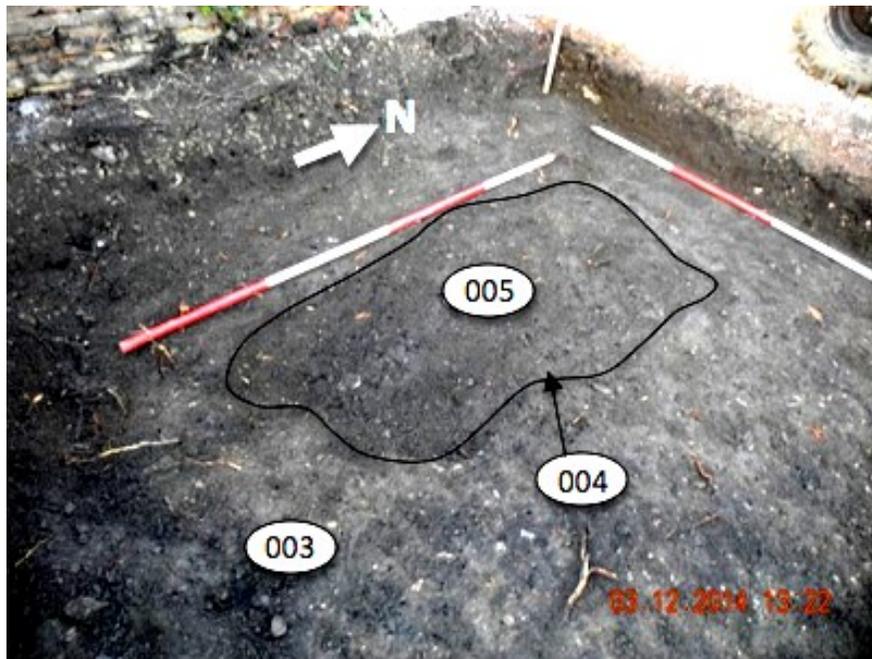
Fig. 6 Pit 004/005 Oblique view looking north east

4.4 Cut into the sub soil were two features. Towards the north west corner was an irregular but roughly oblong pit (004) around 160 cm (N-S) by 100 cm (E-W). The loose dark brown sandy loam fill contained large quantities of charcoal (around 10%) and some lenses of ash (Fig.6). The upper 5cm of this fill was examined and some further fragments of clay pipe stems and 19th. century pottery were recovered.

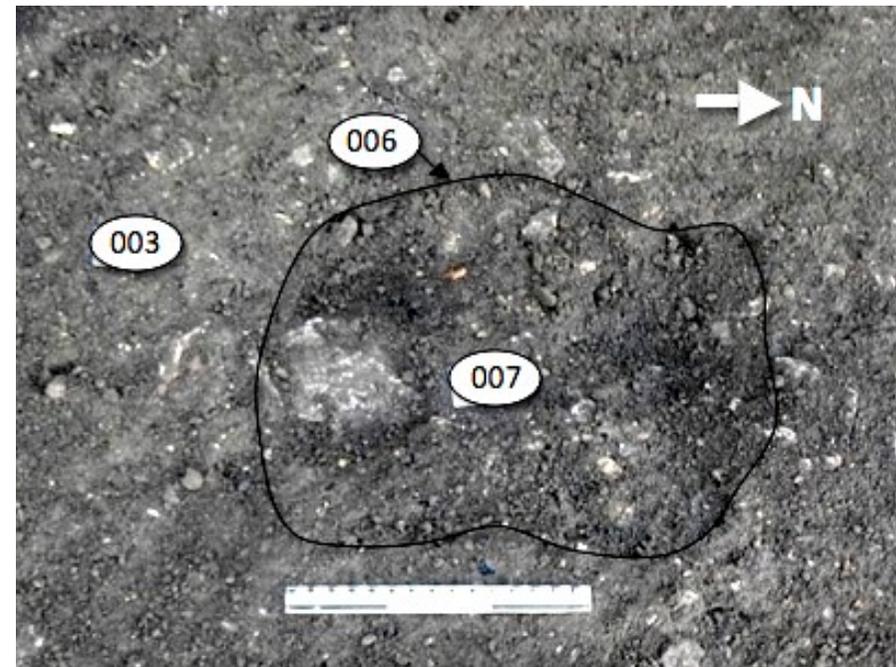
Fig. 7 Pit 006/007 Vertical view

Close to the south west corner was a cut for a small oval pit (006) roughly 50 cm in diameter and with a loose fill of loam and lias fragments (Fig. 7). Again the upper portion of this fill was examined and further 19th. century pottery identified.

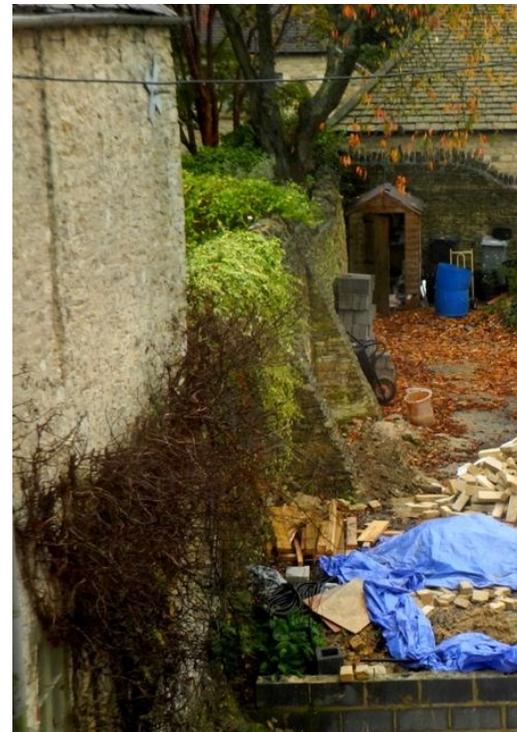
Fig. 8 View from upstairs window looking west. Something of the difference in height between adjacent plots can be seen.

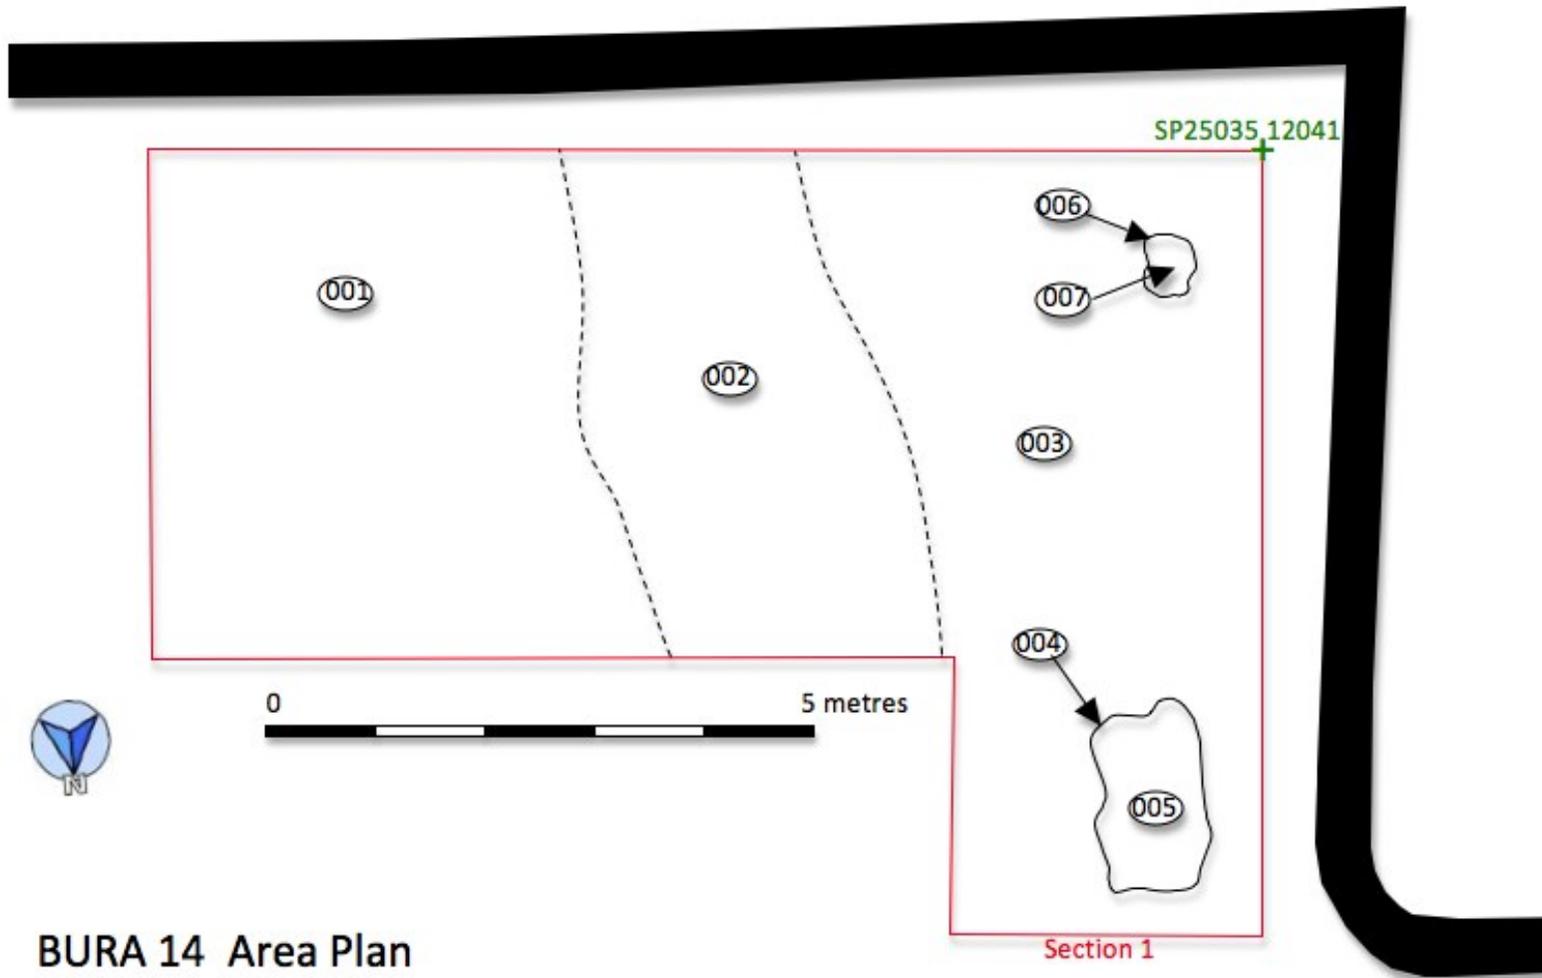
Fig. 9 Plan showing contexts in area investigated

4.0 Results (Figs. 9 and 10)

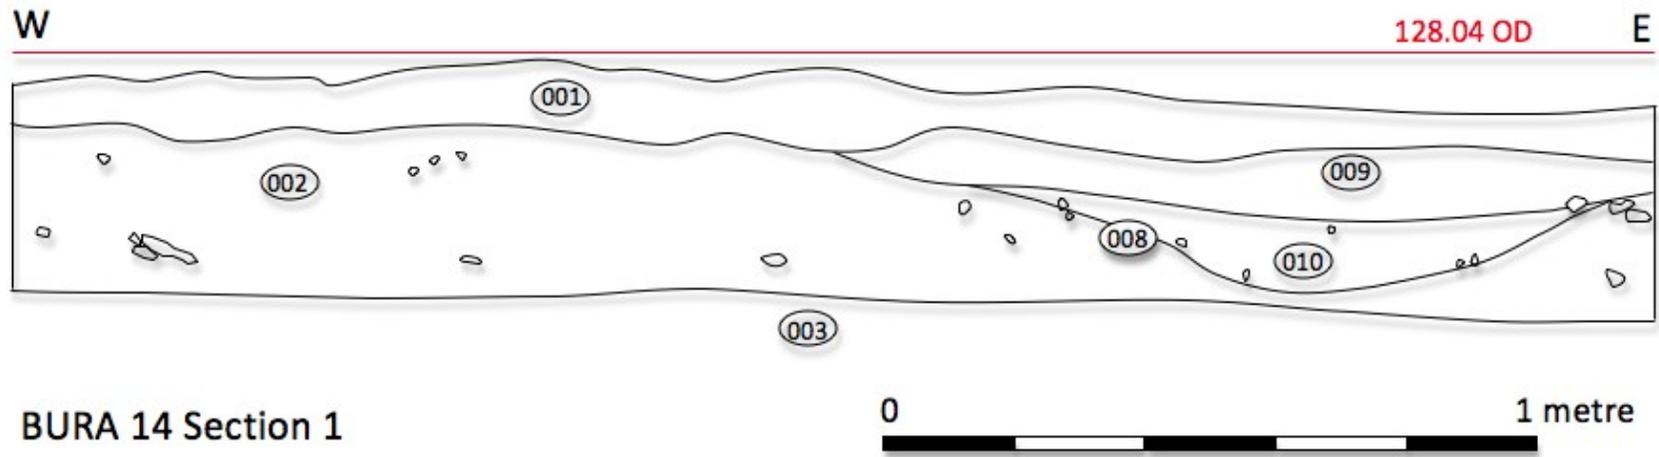
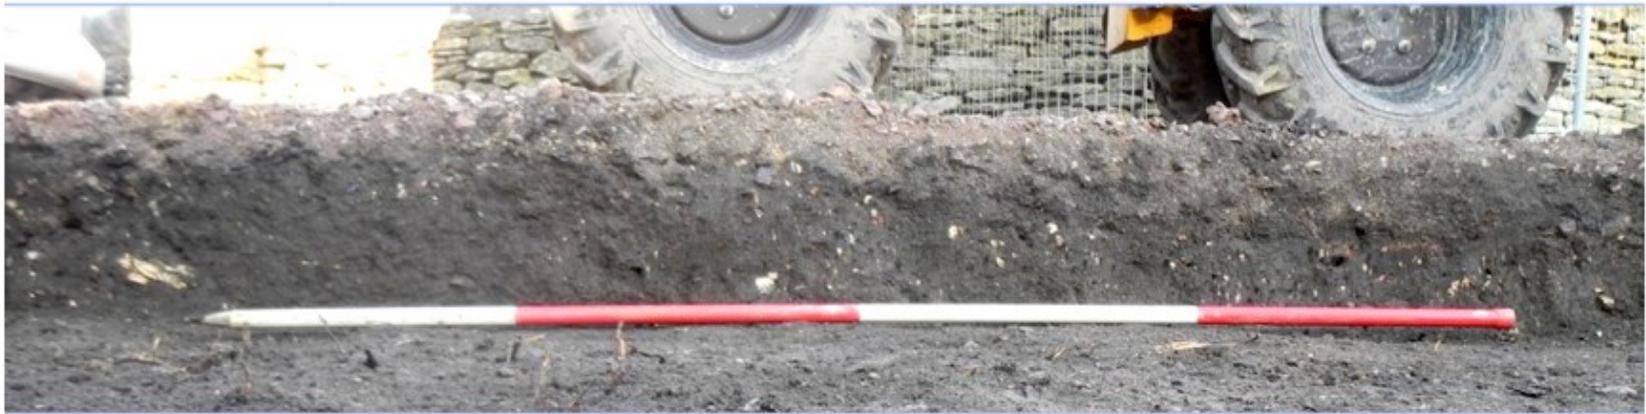
Fig. 10 Section 1, north side of east end: drawing and photograph

3.4 Two features were identified in the western area (004/005 and 006/007) and these were further cleaned and recorded. The upper 5 cm of the fill of these features was investigated but as they were not going to be subject to further disturbance full excavation was not attempted. The only section selected for detailed recording was along the south side and this was cleaned and drawn (Fig. 10).

4.6 Examination of section 1 revealed a further cut within the topsoil 002. This took the form of a shallow scoop (008) roughly 120 cm across and 30 cm deep. The fill was differentiated into a lower slightly gravelly portion (009) and an upper cleaner layer (010), both essentially similar to 002. This feature probably reflects recent cultivation of the garden.
