HCP 156 Little Banqueting House WiFi Cable Installation, Hampton Court Palace

An Archaeological Watching Brief

November 2016 – revised July 2017

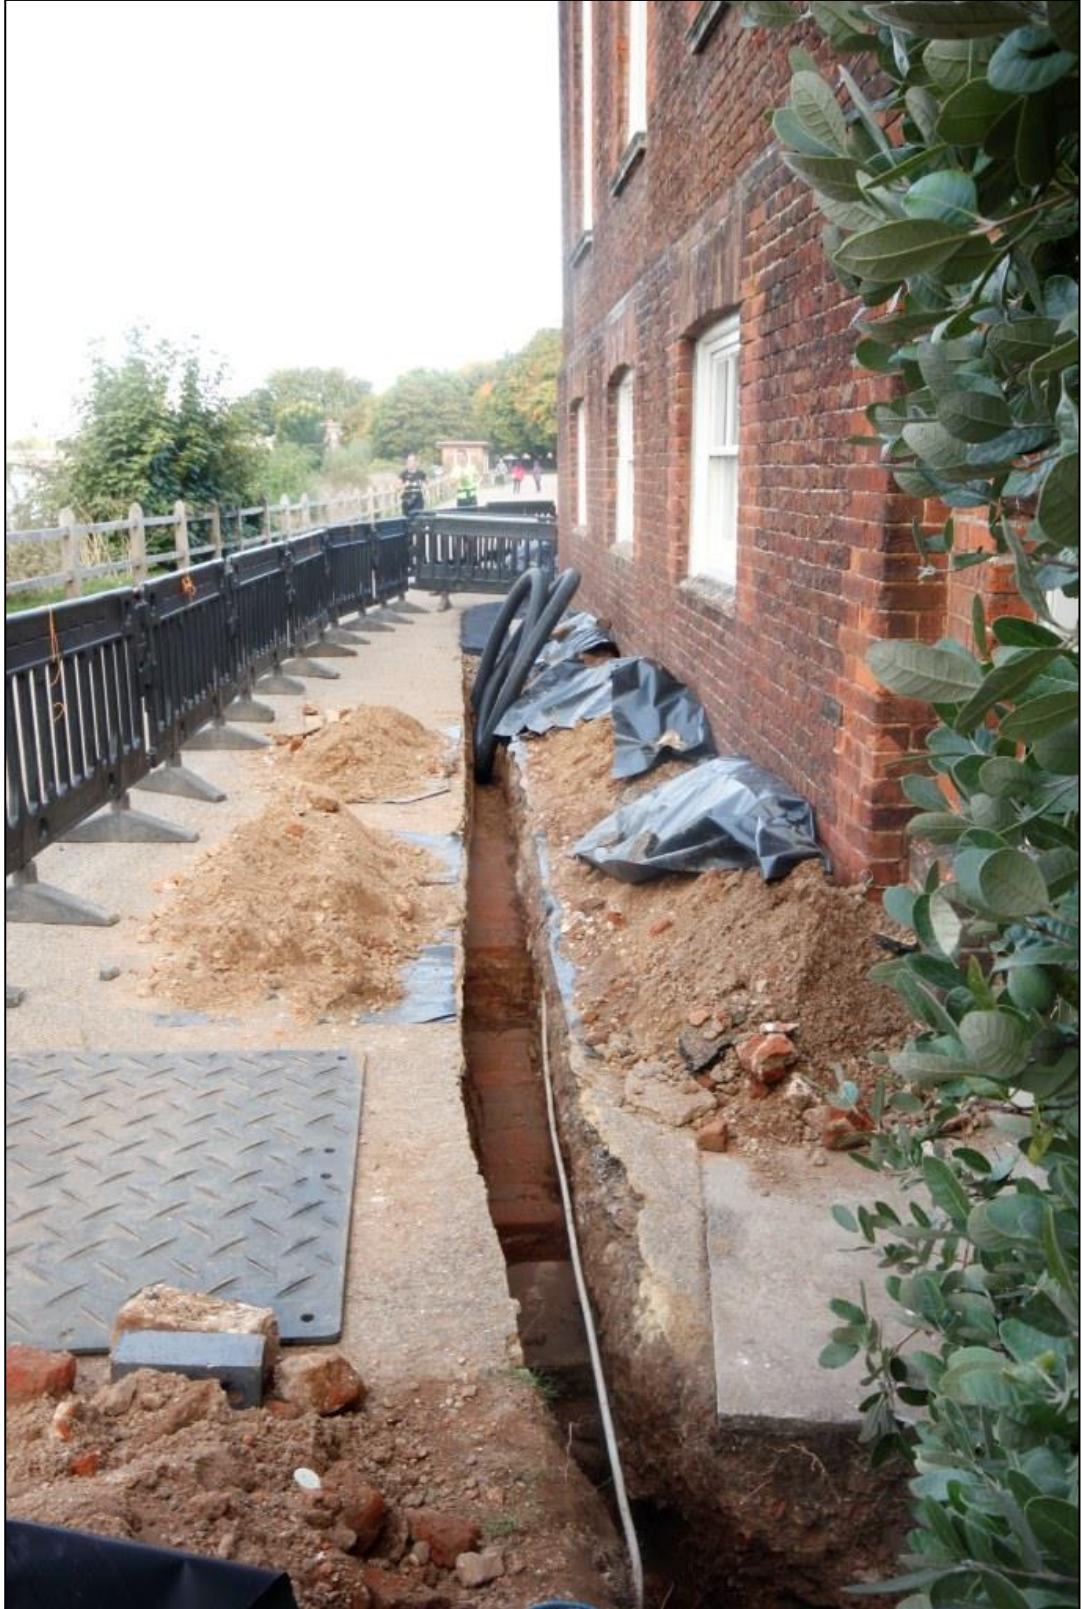
Figure 4: General view of the trench looking towards the west

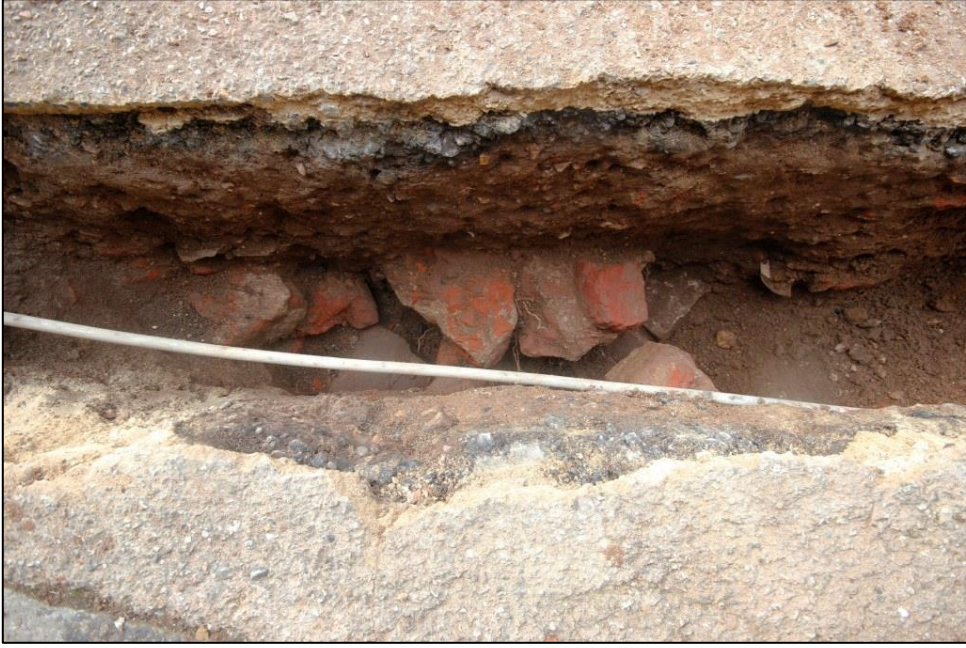
Figure 5: Rubble dump towards the eastern end of the trench, context 9

- 4.12 These archaeological features were overlain by several rubble and levelling deposits including **deposits 13 and 14**, a very loose light orangey brown silty sand material containing a high frequency of coarse gravels and small fragments of CBM and occasional fragments of chalk. **Deposit 14** contained a higher frequency of brick and rubble but was fundamentally the same the deposit. The separate numbering was allocated because the layer was truncated and separated by **cut 21**, which presented a rounded profile and was filled by **deposit 9**, a loose silty soil containing large quantities

of modern frogged bricks, some still bonded together with thick cementitious mortar. This feature measured 0.5 m depth with a width of 1.2 m and appeared to be a modern rubble dump.

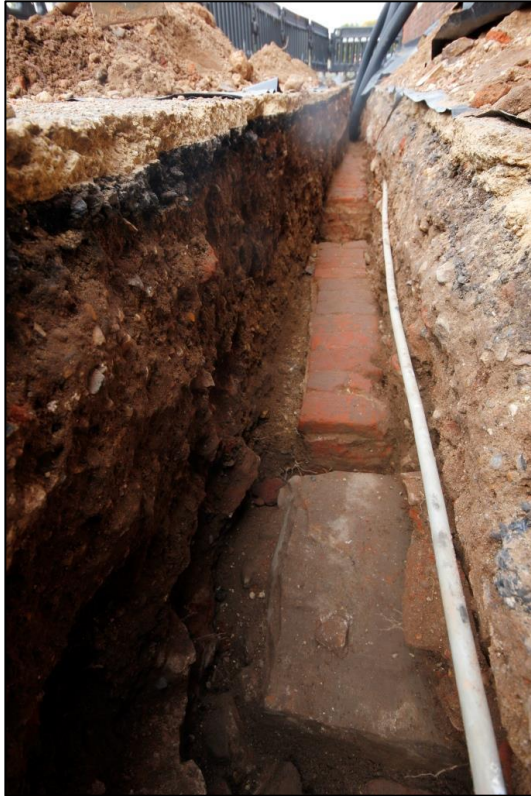
Figure 6: Looking towards the west, contexts 10, 11 and 12

- 5.6 A later possible drainage feature was observed at the eastern end of the trench between the drain (context 18) and the eastern portion of the Tudor wall (context 11) and appeared to be capped by a Yorkstone slab (context 10). However, it was not possible to fully excavate the feature due to the confined nature of the excavation and therefore impossible to come to any decisive conclusions.

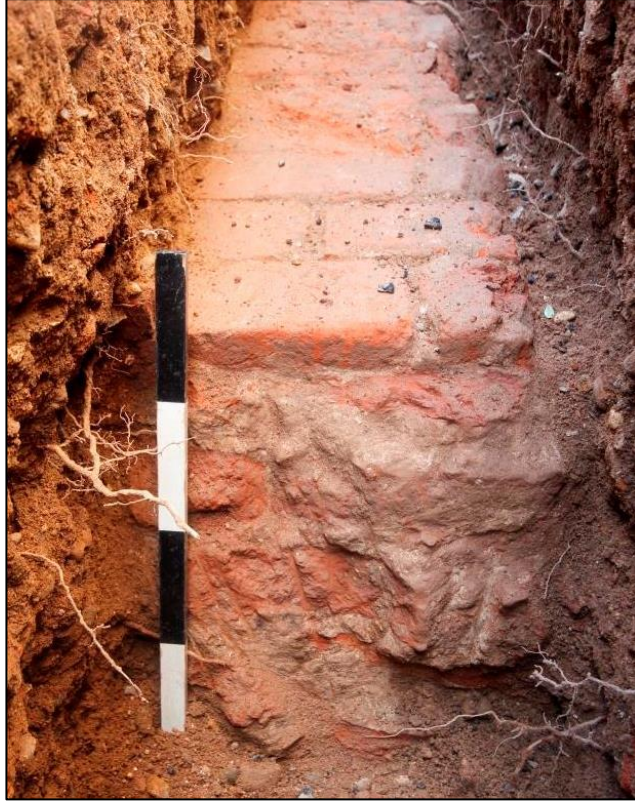
Figure 8: Wall 12 seen in profile, east-facing section

- 4.3 **Walls 11 and 12** were two east-west aligned brick structures separated by a 0.9 m gap. **Wall 12** was the western-most structure, and was preserved over a length of 1.40 m with a width of 0.21 m. The wall was visibly truncated to the north along its whole length. The base was not reached due to the confined space of the trench, but it was nevertheless excavated to a depth of 0.35 m at the eastern end revealing its profile and 5 courses of brick. The top of the wall appeared at a depth of 7.45 m OD. It was composed of soft orange/red bricks with rounded or weathered arrises, some of the bricks were under-fired to the extent they were still very soft and clayey. Individual bricks measured 210 mm x 100 mm x 40 - 50 mm and were laid on bed on the upper-most course with the header face exposed. The eastern profile suggests that the arrangement of the bricks alternated between header and stretcher bond. The bonding material was composed of a creamy white lime mortar with inclusions of

- lime granules. These bricks were comparable to Type C Henrician Stock Brick (1529-1566) in terms of size, colour and the mortar type.
- 4.4 The overall state of conservation of the bricks was good, though the wall has obviously been truncated longitudinally to the north where the bricks were broken as well as to the east where the break in the wall could be seen in profile (see Figs. 7 and 8). The exact nature of this truncation remains unknown due to the confined nature of the excavation.

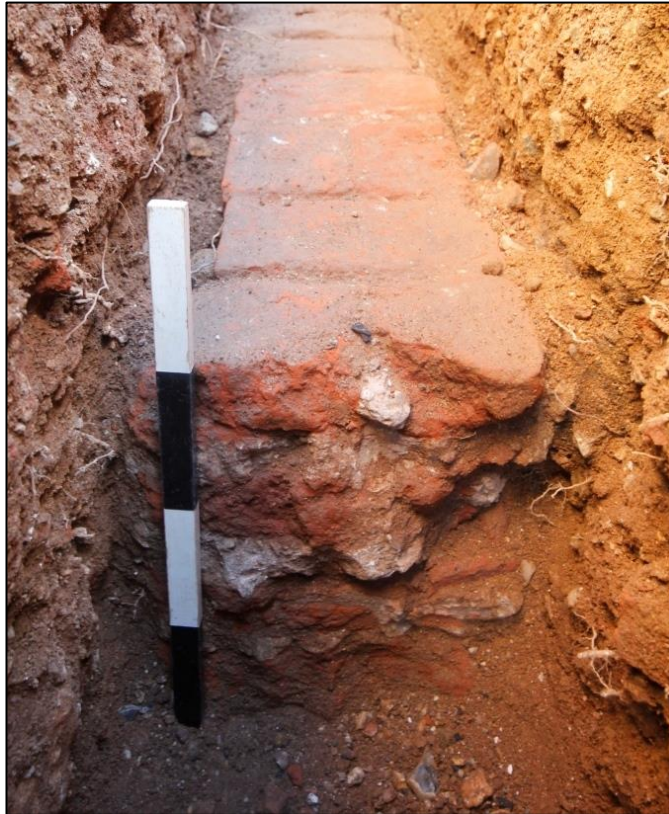
Figure 9: Wall 11 seen in profile, west-facing section

- 4.5 **Wall 11** was a similar structure lying 0.9 m to the east of **wall 12** and was composed of the same orangey red Henrician Stock bricks as seen in the wall described in sections 4.3 and 4.4. This wall was conserved over a length of 1.4 m and was one brick wide with a width of 0.21 m. Although the signs were not as obvious as they were in **wall 12**, it was probably also truncated on the north side as well on the western and eastern ends. The southern face had a thick layer of hard greyish white gritty lime mortar with fragments of lime, indicative of wall render, whilst the northern face had no such element. A number of bricks on the eastern end were crumbling on the northern side, further highlighting the existence of a truncation.

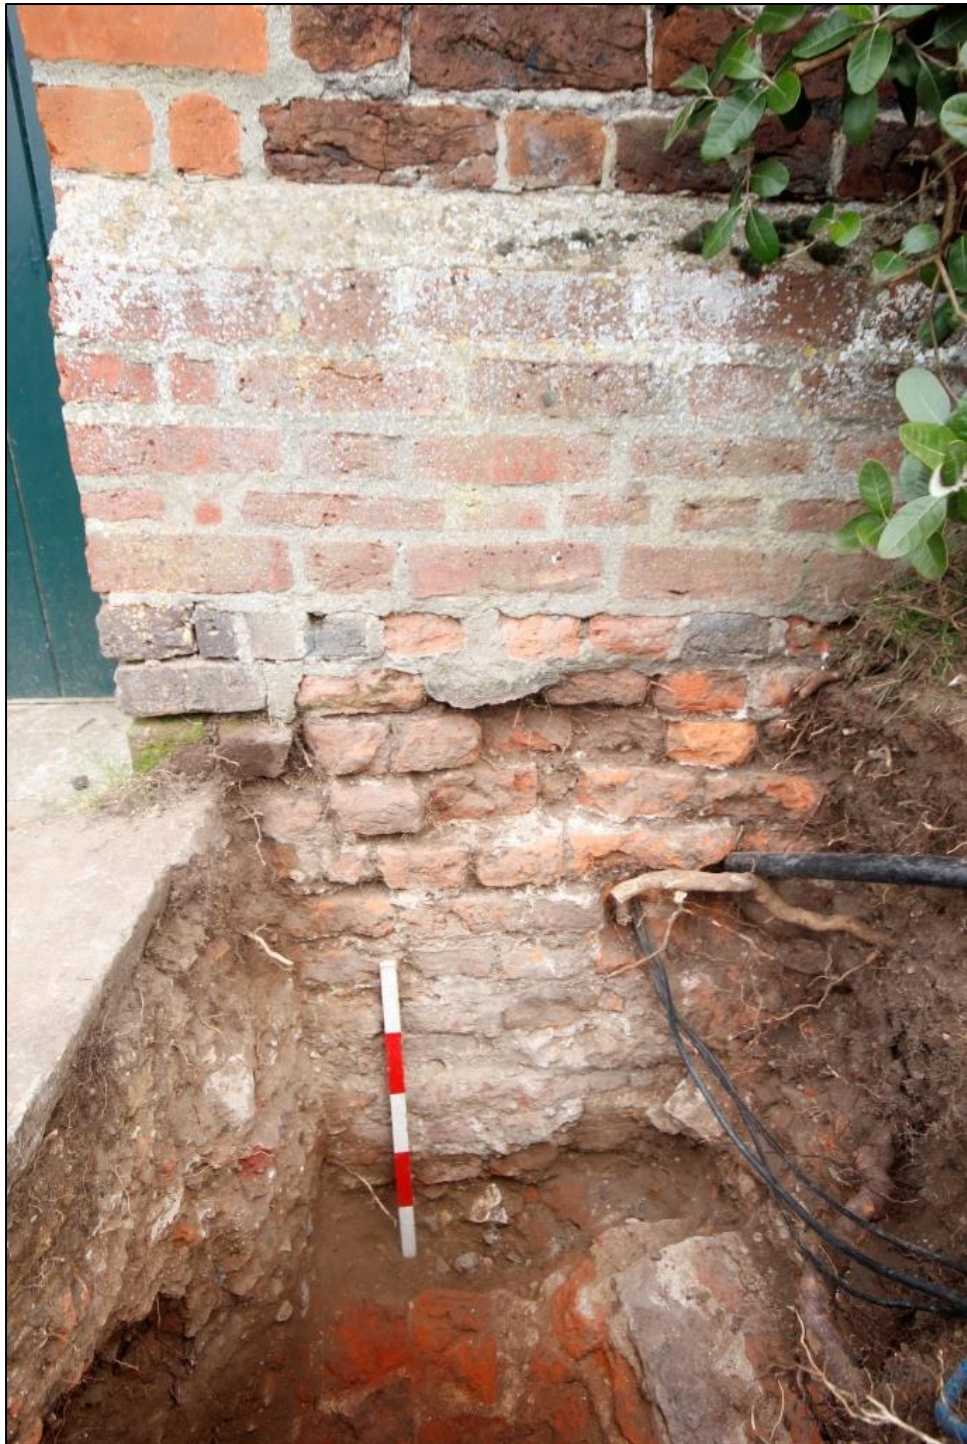
Figure 10: The boundary wall and its Tudor foundation, context 17

- 4.10 The foundation of the **boundary wall 17** was observed over 0.67 m in height; however the base of the structure was not reached. This foundation was comprised of orange/red bricks measuring 200 mm x 10 mm x 50 mm, and observed over ten courses. The bricks were in a poor state of conservation with signs of heavy weathering and damage caused by the growth of tree roots as well as modern disturbance caused by the installation of cables. The surface of the bricks was uneven. The bonding material was composed of a hard gritty greyish white lime mortar. There was no pointing evident especially at the lowest level; whilst the joints on the upper portion of the structure have weathered away almost entirely in certain places, especially where plant growth was more substantial.

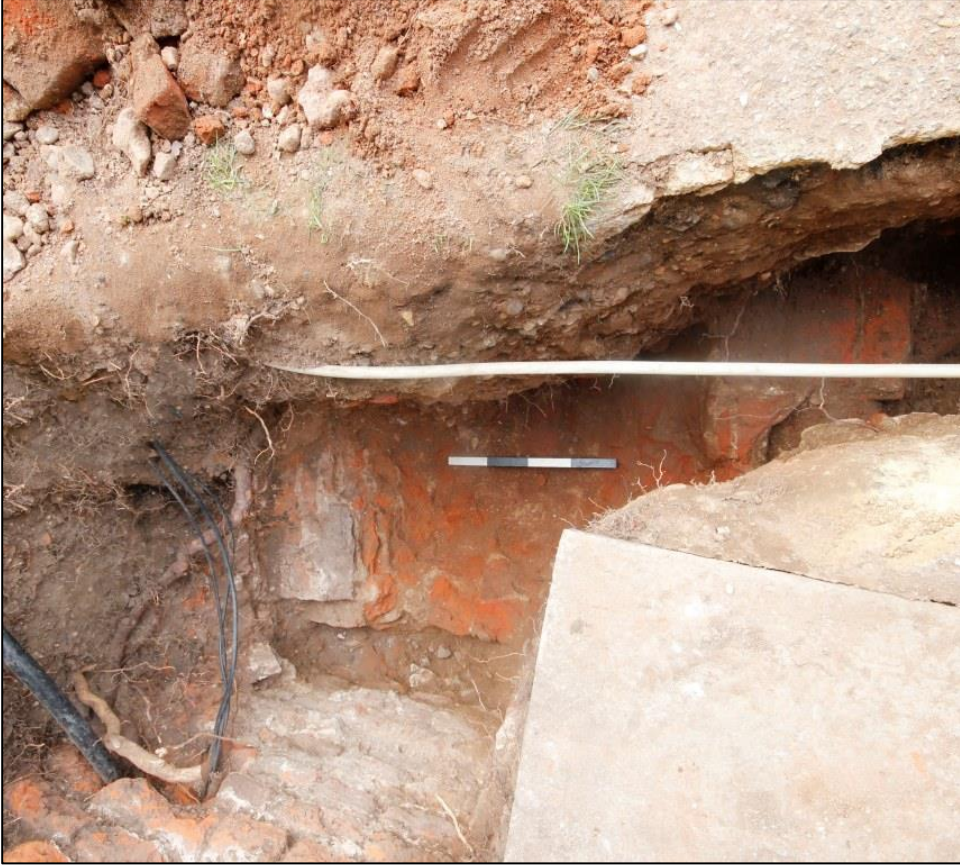
Figure 11: Tudor brick tubular drain seen from above truncated by context 17

- 4.7 Located at the far eastern end of the trench, 0.94 m to the east of **wall 11**, was a brick drain feature (**context 18**), which appeared at its uppermost point at a height of 7.42 m OD, which was in line with the appearance of the walls described in sections 4.3 and 4.4. It measured a width of over 1.20+ m, (the full extent extended just beyond the eastern limits of the trench) and had a depth of 0.38 m. It was composed of red Henrician Stock bricks similar to those seen in **walls 11 and 12**, which were arranged to create a tubular structure with the brickwork on the sides designed to increase depth, presenting a width of 0.3 m. The bricks were heavily worn, particularly at the base of the structure. The bonding material was comprised of a coarse-grained creamy white sandy lime mortar.

- 4.8 The tubular drain feature was clearly truncated at the northern end by a construction cut (**context 19**) for the **boundary wall foundation 17**, which delimits the former Aviary Garden.

- 5.5 This Henrician drainage structure was clearly truncated by the narrow construction cut associated with the boundary wall that delimits the former Aviary Garden to the east of the Banqueting House (wall 17). Though the elevation of this wall is composed of several modern construction phases having been repaired a number of times, the foundations exposed were composed of what appear to be consistent with **Type H**, Wren Stock bricks used between the late 17th century and the early 18th century. As well as having been observed in the main palace building, they have also been recorded in the Broad walk Boundary Wall and the Banqueting House. This wall was constructed as part of the re-development of the palace's riverfront in 1700-01, enclosing the Aviary Garden to the south.

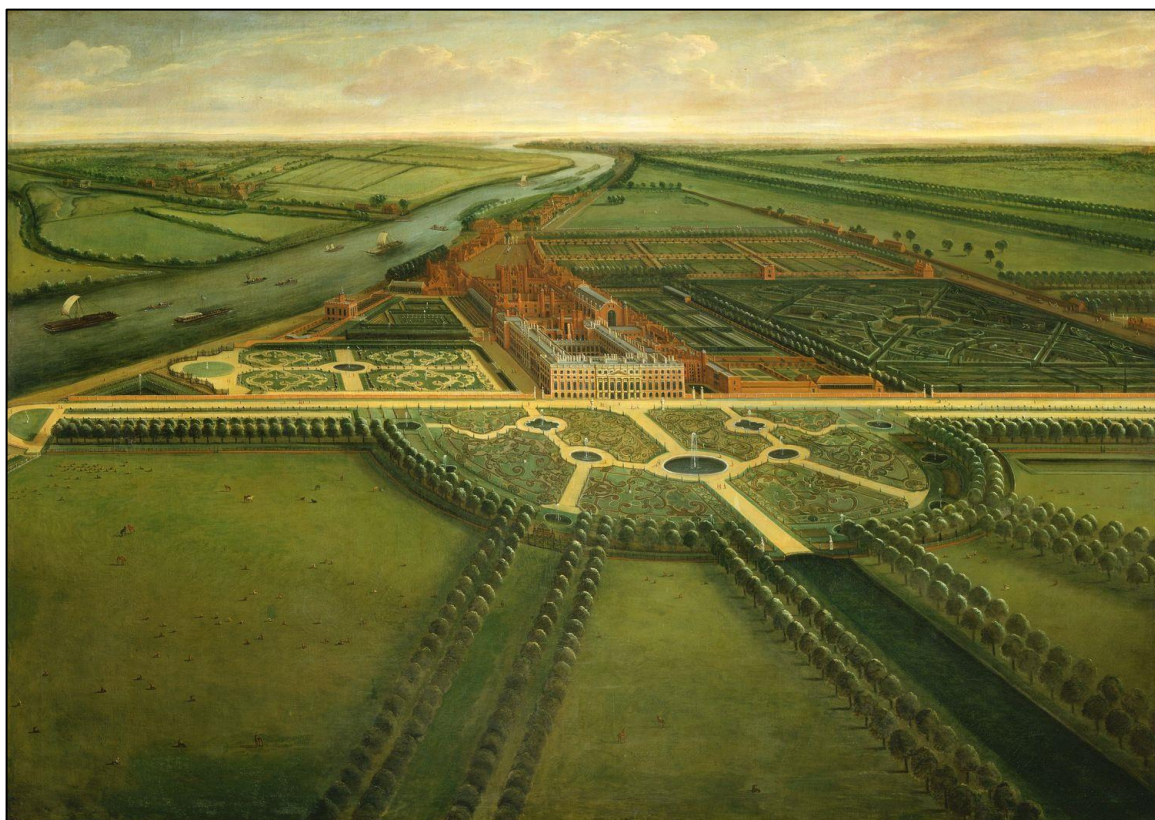
Figure 13: Knyff view of Hampton Court from the East in 1703, the Water Gallery and other buildings along Barge Walk have been demolished, replaced by the Little Banqueting House and Aviary Garden
