THE APPLICATION OF PHOTOGRAMMETRIC SURVEY WITHIN THE CONSERVATION OF THE GREAT CEILING AT PETERBOROUGH CATHEDRAL

Paul G. Bryan BSc
Survey Team Leader
English Heritage
United Kingdom
paul.bryan@english-heritage.org.uk

KEY WORDS: Conservation, Painted ceiling, Digital photogrammetry, Orthophotograph, Colour balance

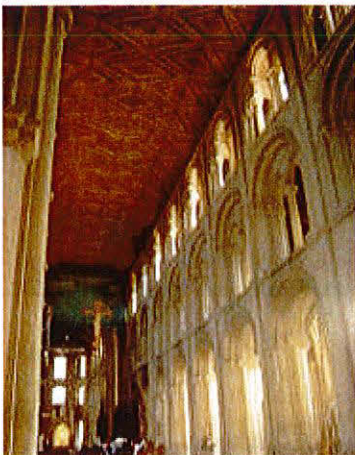
Figure 1 General view of the nave.

The magnificent wooden ceiling of the nave in Peterborough Cathedral and the intricate painted details covering its entire length, are not easily missed (Fig.1). Dating from around 1210-1230 this extraordinary feature, 62m long, 11m wide and canted on either side, appears as one continuous structure upon which the many images of kings, saints, angels, archbishops and other icons are delicately painted. Only on closer examination does the complexity of the true construction become obvious and the underlying conservation problems start to become apparent. Row after row of overlapping oak boards, were originally held in place by nails driven into the overlying trusses from below (Fig. 2).

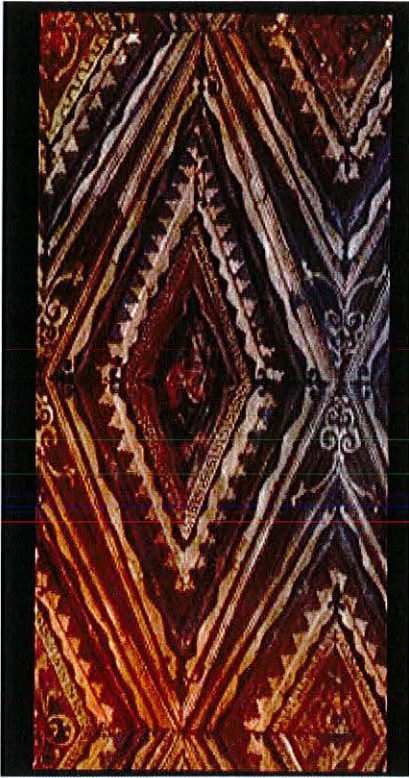
Figure 2 Extract from orthophoto showing construction of ceiling.

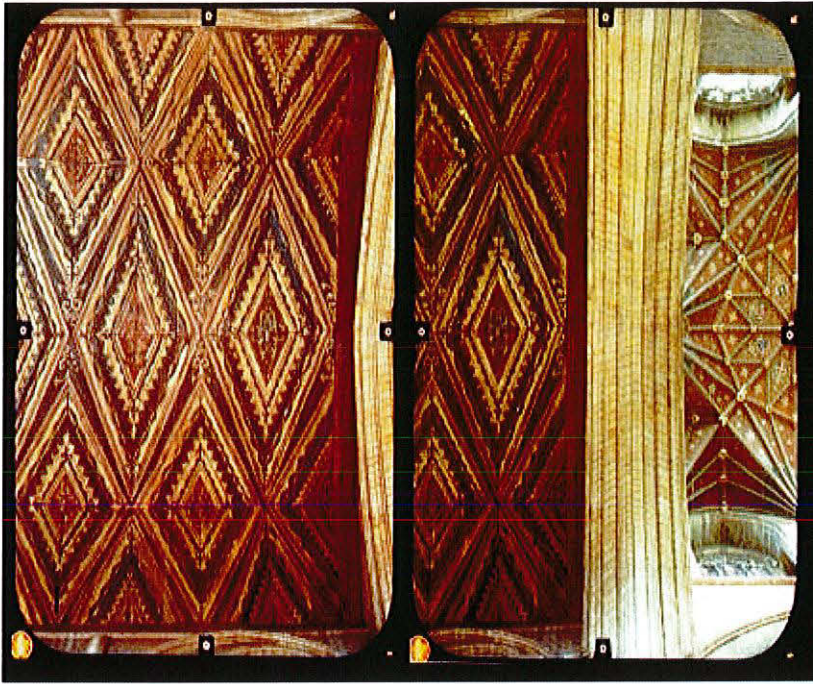
Figure 4. Stereo pair taken with Zeiss UMK 30/1318 metric camera of eastern most bay

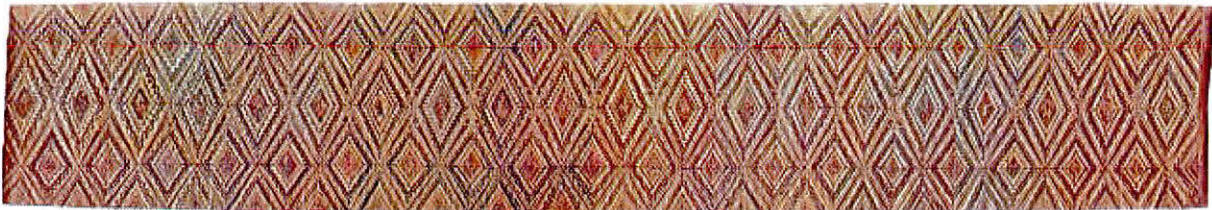
Figure 6 Unformatted version of the complete orthophotographic survey processed at 5mm resolution

The Photogrammetric Unit already had experience of digital photogrammetry through the survey of the standing stones at Stonehenge in Wiltshire. As with this survey, the original colour negatives were scanned at 22.5 micron resolution, using a Zeiss PSI photogrammetric scanner, yielding files of around 120MB each. These were imported into a Helava DPW770 digital workstation, running SO CET Set software, and processed to form a complete digital orthophotograph (Fig. 6) of the entire ceiling at 5mm resolution and a file size of 90MB.

Considering the use of detail points only for the survey control, and the observation and photography over a 25m range, the errors achieved during the orientation of each of these models were deemed perfectly acceptable for the production of an orthophotograph - mean RMS errors of the X, Y and Z co-ordinates of the 87 control points were 3.4mm, 6.0mm and 11.6mm respectively.

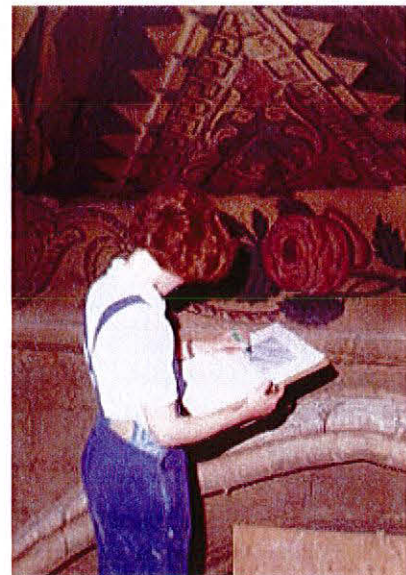
Figure 8 - Conservator using base survey on site

Extracts from this complete orthophotograph have since been provided, in digital form, to the conservators working directly on the ceiling (Fig.8).

Using CorelDRAW these images have been imported into their own site based computers located on the scaffold platform above the nave, to provide a full colour backdrop to the outline line drawings, previously supplied and imported via DXF format.
