PETERBOROUGH CATHEDRAL, NAVE CEILING

INVESTIGATION OF PAINTING MATERIALS AND TECHNIQUES, CONSERVATION PHASE 4, BAYS 9-17

May 2002

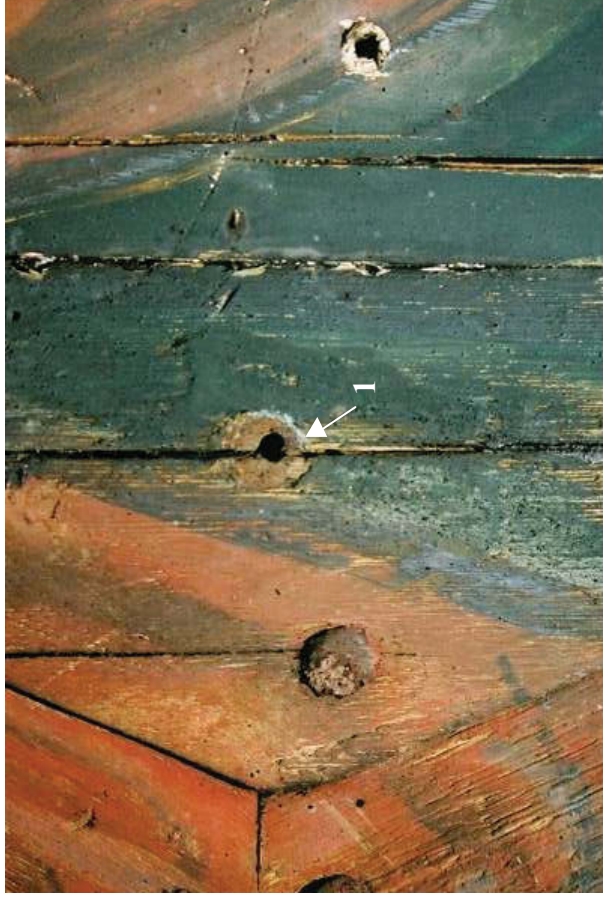
Sample 1 (3070) was taken from location 12 II a, lozenge, blue paint from under an original nail head, which is now missing. Analysis required to confirm whether the blue paint is original.

The sample contains large particles of Prussian blue so cannot be original paint, but rather must represent later paint which was drawn

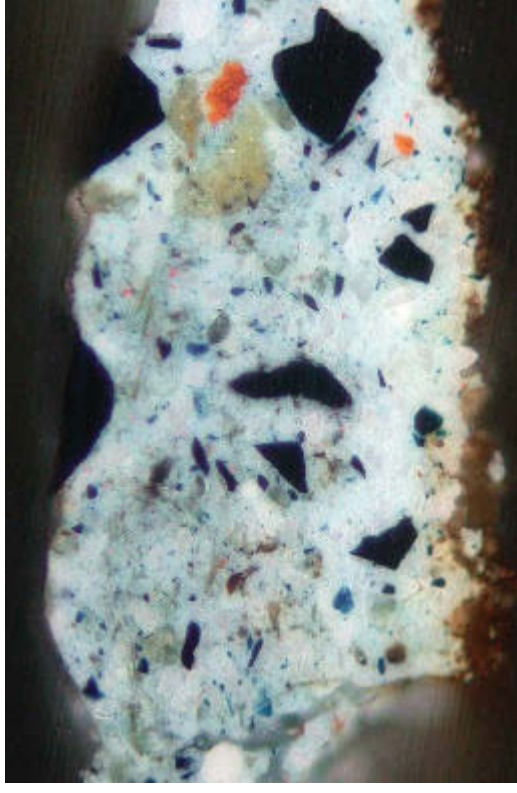
under the nail head whilst wet. The particle characteristics (varying size up to very large and angular) suggest the paint probably dates from the eighteenth century restoration.⁸ Interestingly SEM.EDX identified the presence of potassium associated with the blue, this might possibly originate from the saltpeter or alum used in manufacture of the pigment.⁹ Lead white and red iron oxide are also present.

Sample 1 (3070) photographed in cross-section under reflected light at 200 x magnification. (Printed magnification not calculated).

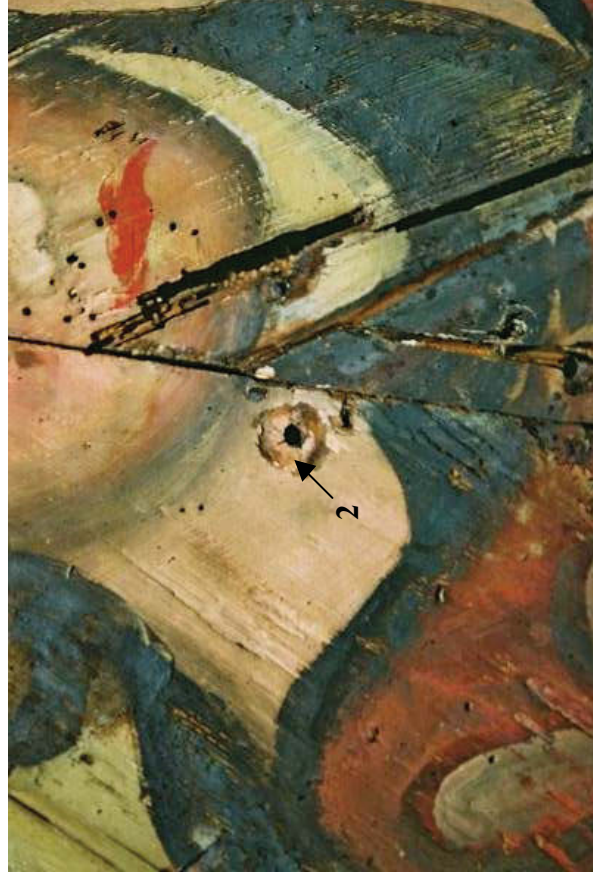
Sample 2 (3071) was taken from location 12 II a, lozenge, flesh tone from neck of King (4), below original nail head, which is now missing. Analysis required to confirm whether paint is original.

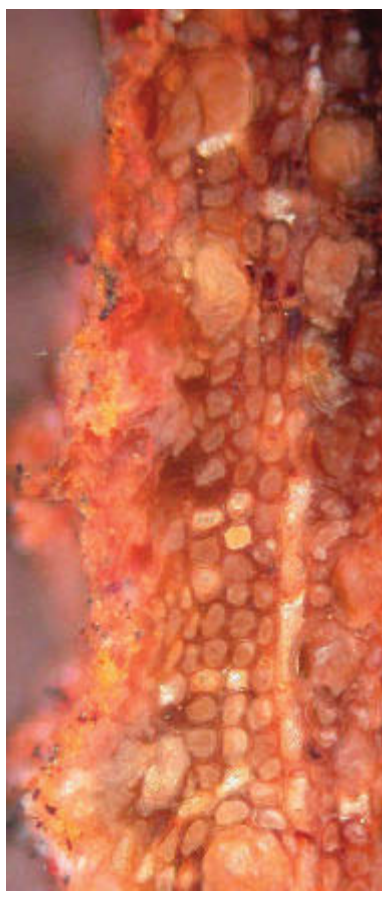
The paint is a single layer of red lead with a little carbon black and possible some calcium carbonate. The paint appearance is consistent with it being original.

Sample 3 (3072) photographed in cross-section under reflected light at 200x magnification. (Printed magnification not calculated).

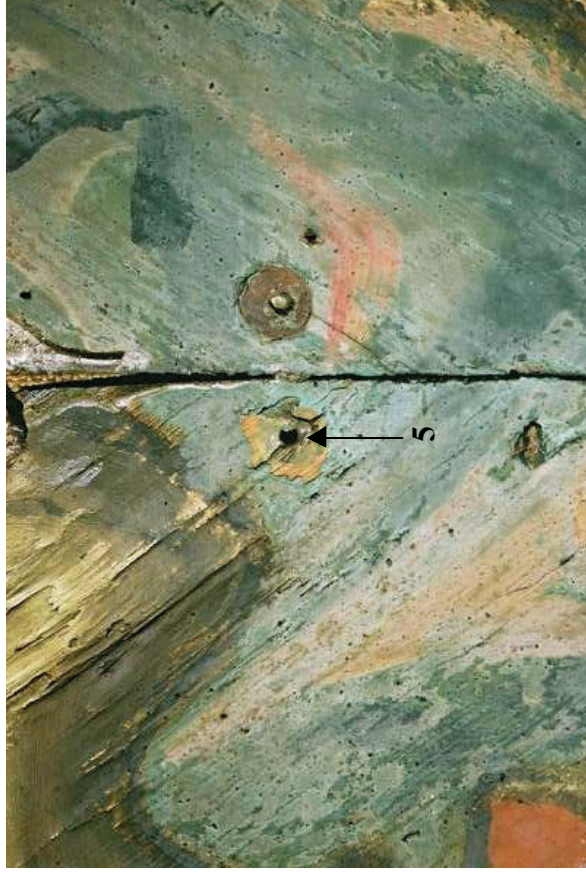
Sample 5 (3074) was taken from location 13 I c, lozenge, green paint on drapery of organistrum, paint from below original nail head, which is now missing.

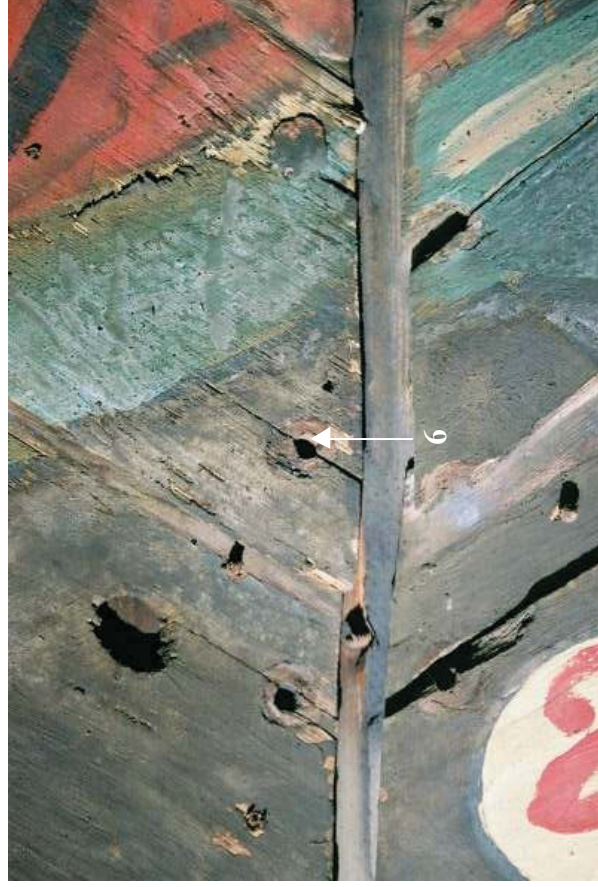
Sample 6 (3075) was taken from location 14 III aa, lozenge, brown paint from background of logic, from below an original nail head, which is now missing.

The sample shows a single layer of red paint applied thinly to the timber substrate. The paint is a mixture of red lead with a little carbon black. Some red iron oxide also appears to be present, although this could result from contamination from the missing nail. The appearance of the paint is consistent with a thirteenth century date.

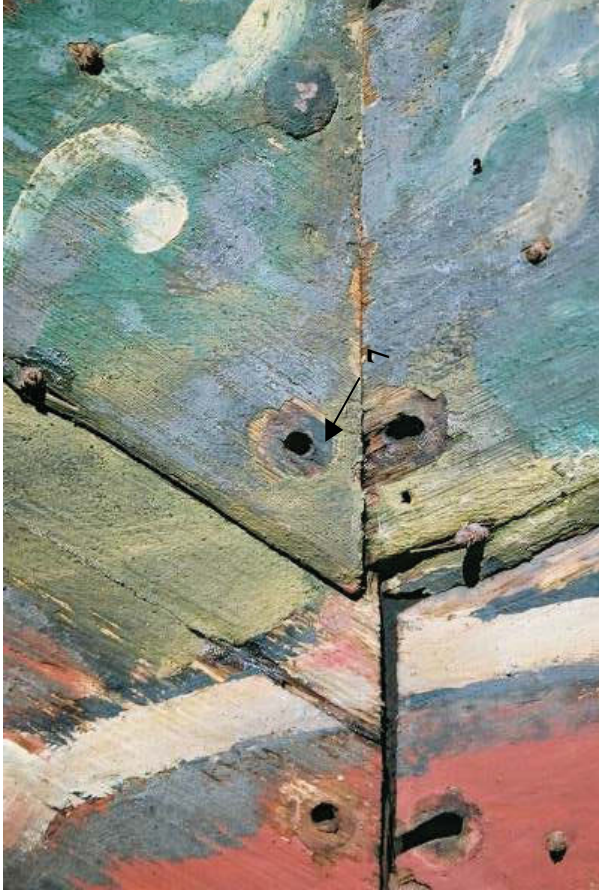
Sample 7 (3076) was taken from location 17 II b, green paint from background of Grammar, paint from below original nail head, which is now missing.

The blue-green paint contains a similar pigment mixture to that found on sample 5 above, with the absence of any arsenic pigment. There appears to be a trace of metal from the absent nail head on the

sample surface. Carbon black is also present. Barium sulphate was present: see discussion on following page.

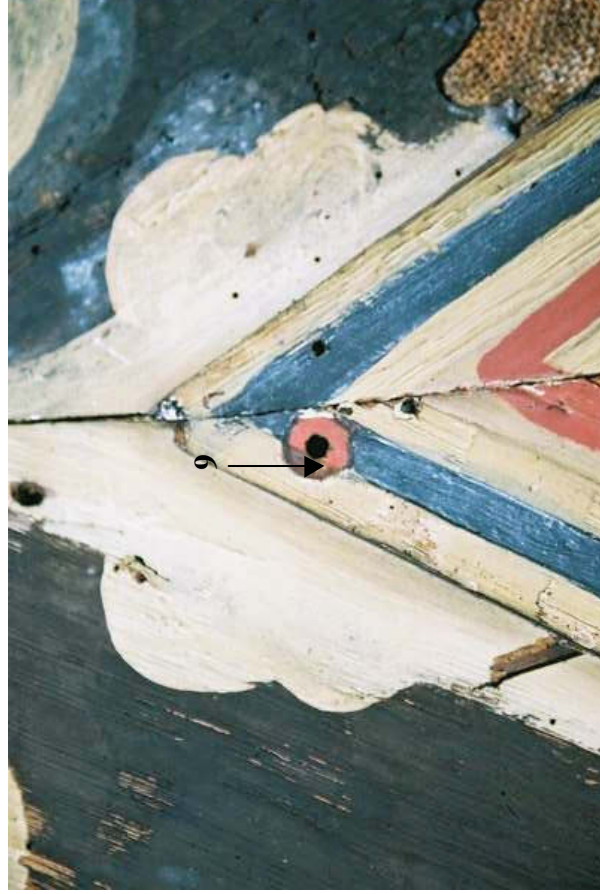
Sample 9 (3078) was taken from location 17 IV b, lozenge, red paint from outer groove, from below original nail head, which is now missing. Control sample for comparison with samples 10 and 11.

Appearance consistent with the sample being from original paint. Single layer of red lead. Some of the red lead appears to have altered to lead white.

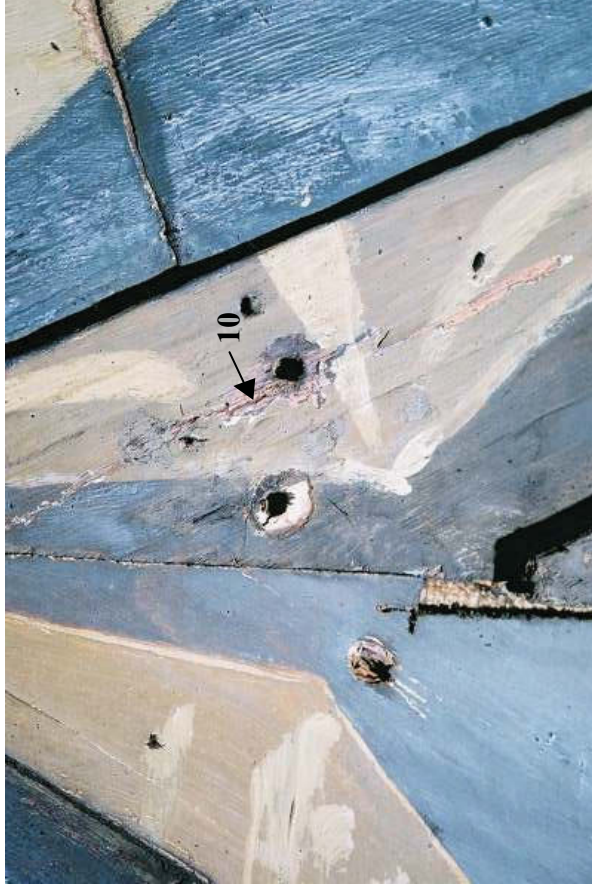
Sample 10 (3079) was taken from location 11 I s, grey chevron, red paint from middle groove, from below original nail head which is now missing. Very few instances of red paint have been found in middle grooves, so analysis of paint and comparison with other samples is required to establish the date of the red paint here.

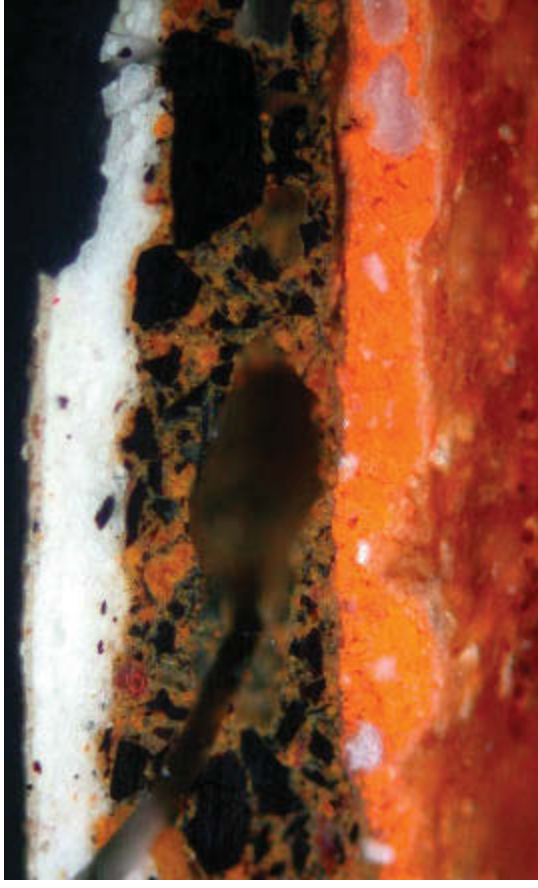
The surface grey paint layer comprises lead white with calcium carbonate, the colouring pigments appear to be iron oxide, carbon black and an organic brown. The second white layer is also lead white with calcium carbonate, pigmented with a little iron oxide and carbon black. The orange-brown layer appears to consist of iron oxide, some red lead and carbon black in particles ranging from medium to very large. The carbon particles have a smooth even surface. The primary paint layer is red lead, with some white lead inclusions. The red lead paint appears to be consistent with a thirteenth century date.

Sample 10 (3079) photographed in cross-section under reflected light at 200x magnification. (Printed magnification not calculated).

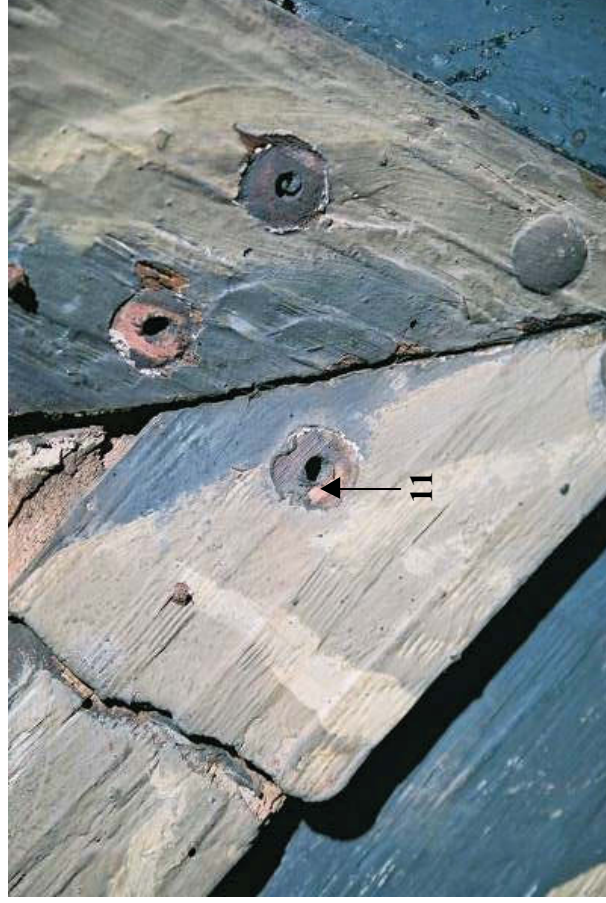
Sample 11 (3080) was taken from location 11 f, grey chevron, red paint from middle groove, from below original nail head which is now missing. Very few instances of red paint has been found in middle grooves, so analysis of paint and comparison with other samples is required to establish the date of the red paint here.

Appearance consistent with it being original paint, single layer of red lead applied directly to the timber surface.

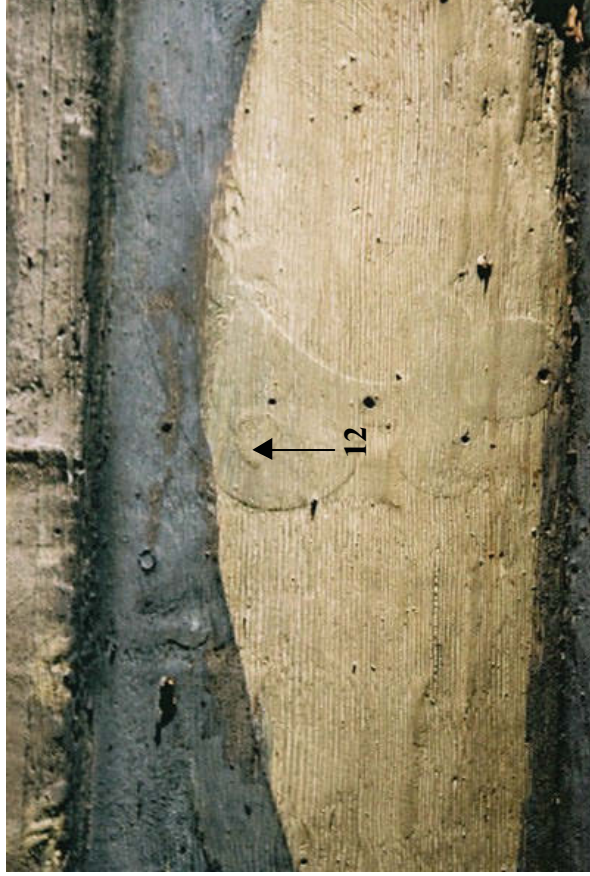
Sample 12 (3081) was taken from location 14 III k, extended chevron, paint from small *impasto* dot on 'body' of original trefoil. Similar embellishments found previously on some trefoil heads in Bays 2 and 3. Analysis required to identify *impasto* and examine stratigraphy of paint layers and their dates.

The sample shows lead white with a little calcium carbonate, over a thin carbon black layer, possibly representative of underdrawing. Identical layers have been observed in similar locations without a raised dot.¹⁶

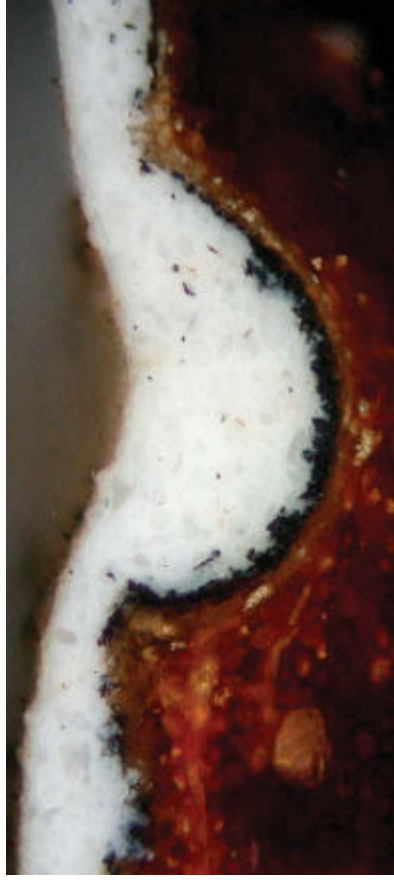
Sample 12 (3081) photographed in cross-section under reflected light at 200x magnification. (Printed magnification not calculated).

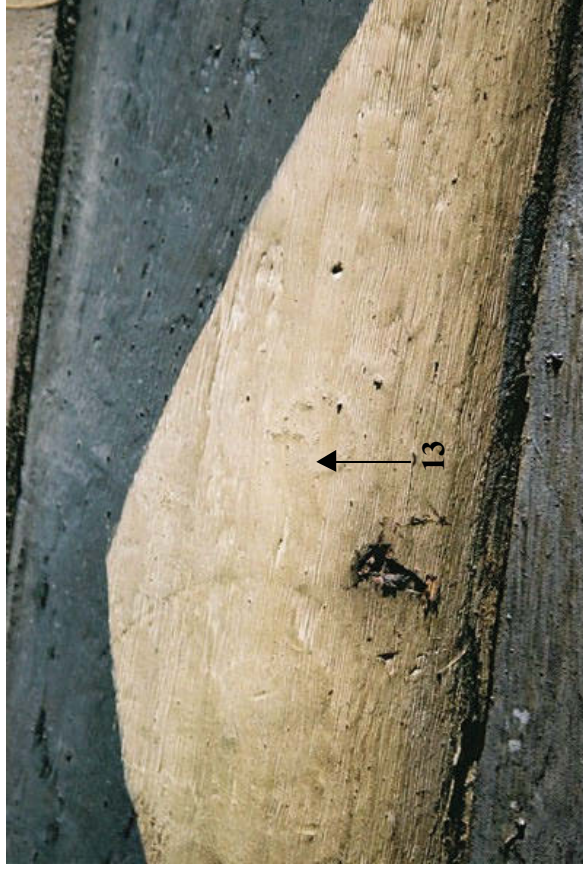
Sample 13 (3082) was taken from location 15 I q, extended chevron, paint from small *impasto* dot on 'body' of original trefoil. Similar embellishments found previously on some trefoil heads in Bays 2 and 3. Analysis required to identify *impasto* and examine stratigraphy of paint layers and their dates.

The sample reveals two layers of lead white with a little calcium carbonate, over a thin carbon black layer, mixed with a thick translucent layer. The translucent layer contains no pigmentation, it stains weakly for protein and is probably an animal glue, which may arise from later intervention. The presence of two white layers is clearly revealed in the SEM.EDX backscattered shown on the following page. Similar layers have been observed in similar locations without a raised dot. Further sampling may elucidate this query.

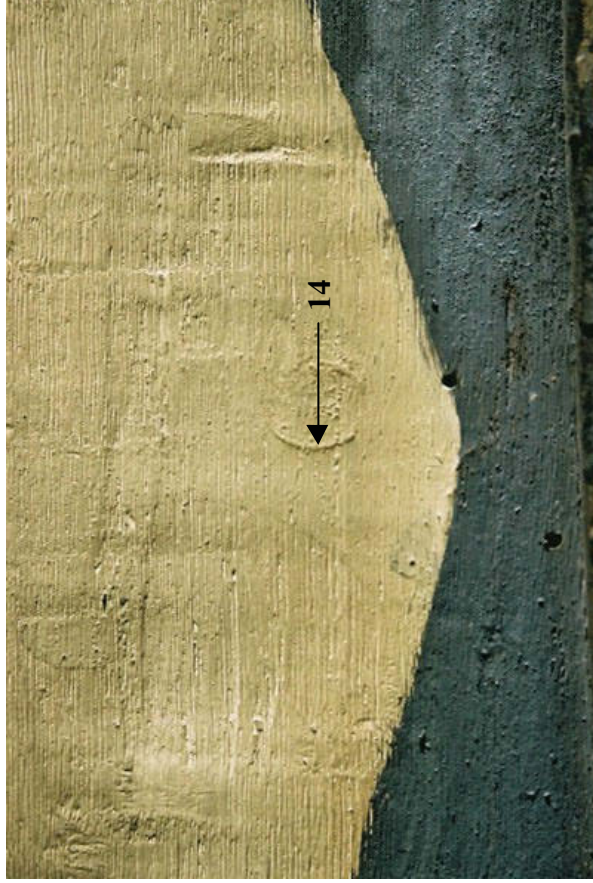
Sample 14 (3083) was taken from location 14 III t, extended chevron, paint from small *impasto* dot on 'body' of original trefoil. Similar embellishments found previously on some trefoil heads in Bays 2 and 3. Analysis required to identify *impasto* and examine stratigraphy of paint layers and their dates.

The sample shows lead white with a little calcium carbonate, over a thin carbon black layer. Similar layers have been observed in similar locations without a raised dot. Further sampling may elucidate this query.

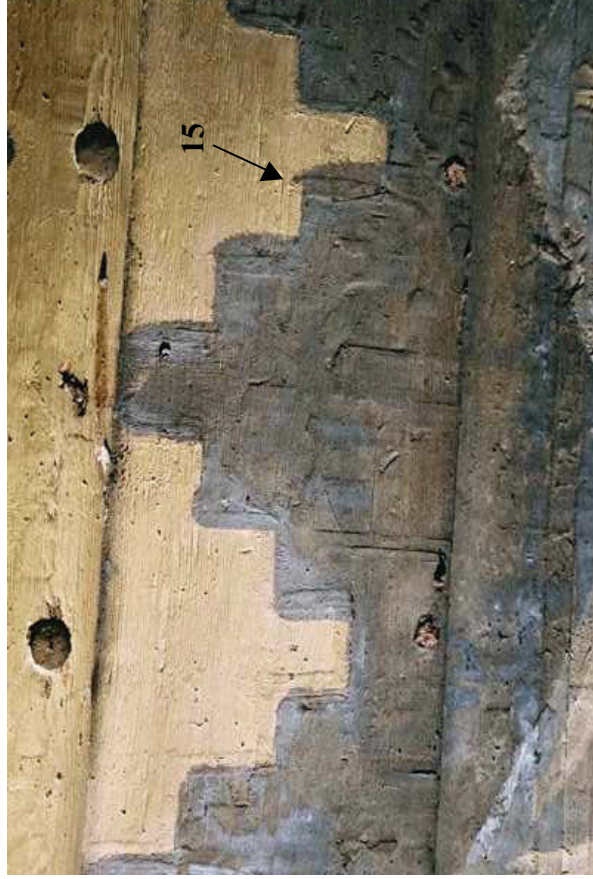
Sample 15 (3084) was taken from location 9 I f, stepped chevron, original linear stepped chevron decoration visible in relief under 18th /19th century overpaint. Sample through white. Analysis required to identify original paint if present on sample.

The sample appears to show two layers of lead white. The upper layer being fairly thinly applied. The lower, thicker white contains a very few coloured particles, probably vermilion and carbon black. A translucent organic substance appears to be present at the paint timber interface.

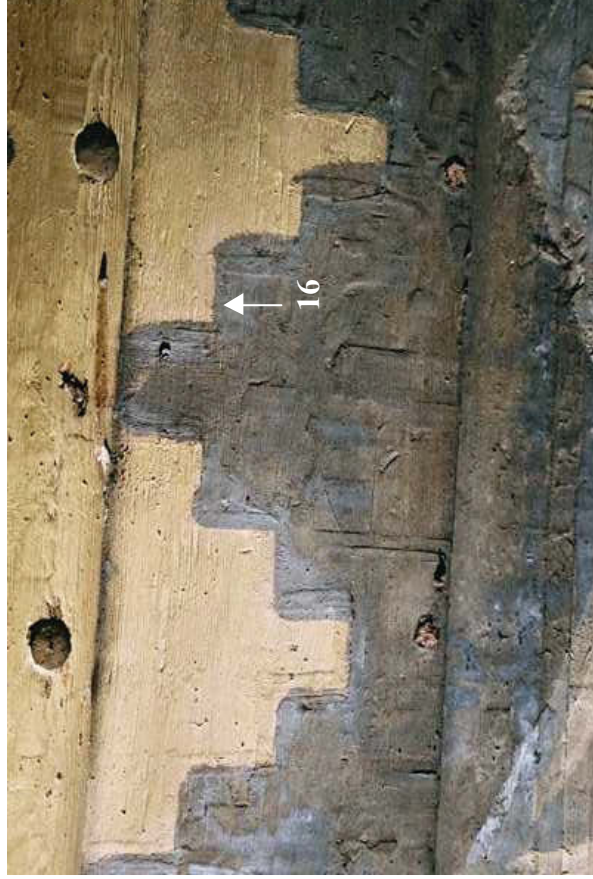
Sample 16 (3085) was taken from location 9 I f, stepped chevron, original linear stepped chevron decoration visible in relief under 18th /19th century overpaint. Sample through black. Analysis required to identify original paint if present on sample.

The sample shows brown on white on coarse orange-brown paint directly on the timber substrate. Microscopy suggests the paint dates from the eighteenth and nineteenth centuries, with any earlier paint absent from this specific location. The characteristic chunky orange-brown paint is present overlying apparently thirteenth century paint on sample 10 and it has therefore been tentatively assigned to the 1740s phase.

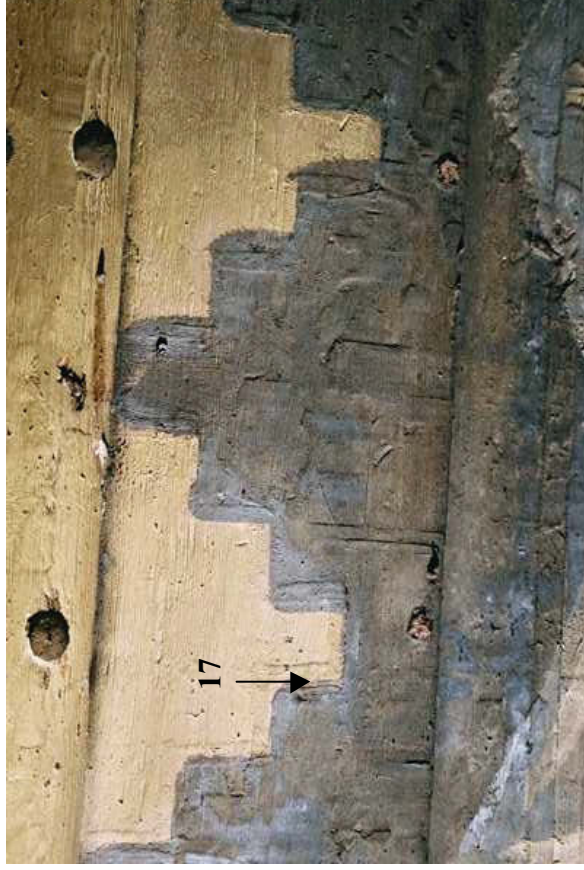
Sample 17 (3086) was taken from location 9 I f, stepped chevron, original linear stepped chevron decoration visible in relief under 18th /19th century overpaint. Sample through black. Analysis required to identify original paint if present on sample.

The sample appears to show only off-white paint. Under reflected light it is just possible to discern two off-white paint layers, the upper one being thinly applied. Noticeable at the base of the sample is a beige layer, probably with an animal glue medium.¹⁷

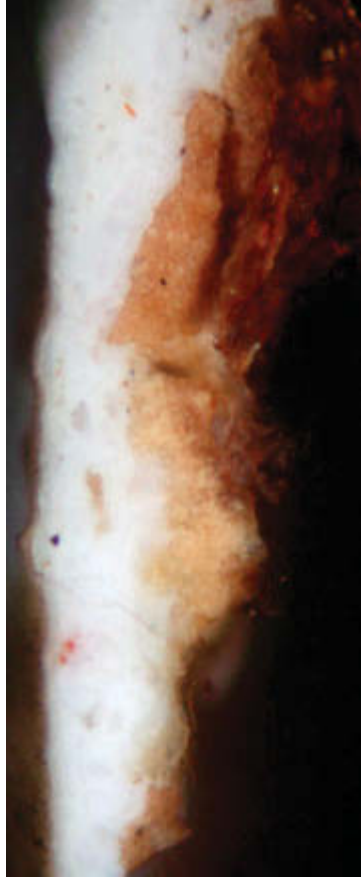
Sample 17 (3086) photographed in cross-section under reflected light at 200x magnification. (Printed magnification not calculated).

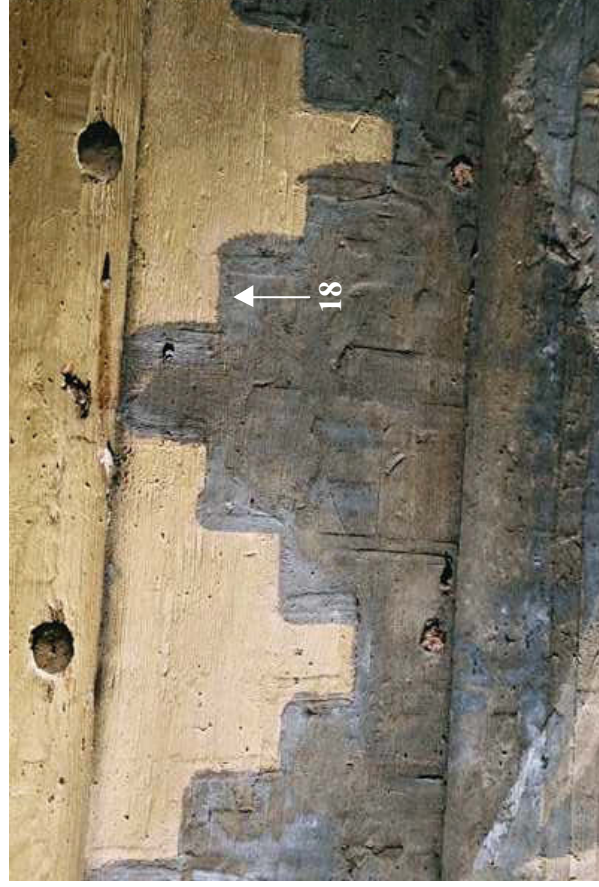
Sample 18 (3087) was taken from location 9 I f, stepped chevron, original linear stepped chevron decoration visible in relief under 18th /19th century overpaint. Sample through black. Analysis required to identify original paint if present on sample.

The upper layers of the sample appear to date from the 1830s. The brown is comprised of umber, natural iron oxide, calcium and barium sulphate. The upper white layer is lead white and calcium carbonate. The lower again lead white and calcium carbonate. The characteristic coarse orange-brown is identical to that observed on previous samples. The lowest white layer is basic lead carbonate and may date from the thirteenth century. The beige layer visible at the base of the sample appears to be calcium sulphate in an animal glue binder.

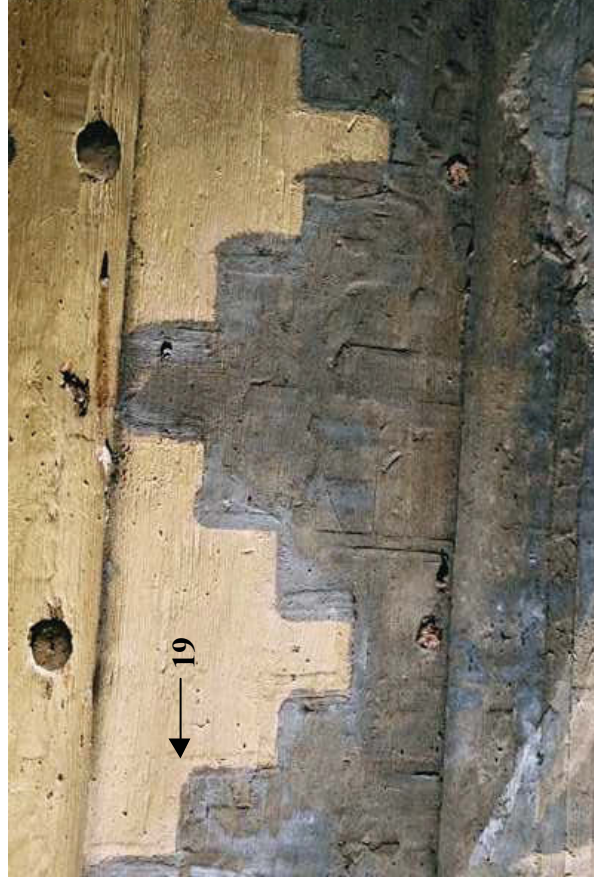
Sample 19 (3088) was taken from location 9 I f, stepped chevron, original linear stepped chevron decoration visible in relief under 18th /19th century overpaint. Sample through white. Analysis required to identify original paint if present on sample.

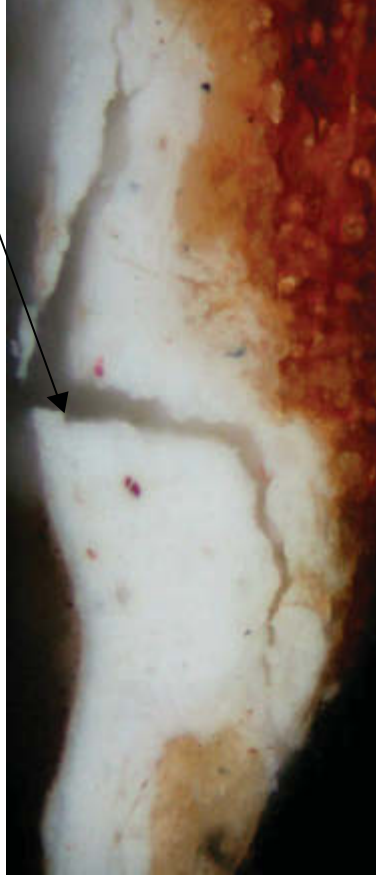
The sample appears to show two layers of lead white. The upper layer being fairly thinly applied. The lower, thicker white contains a few coloured particles, probably vermilion and carbon black. The beige layer visible at the base of the sample appears to be calcium sulphate in a glue binder.

Boundary of white layers suggested by break in sample

Sample 19 (3088) photographed in cross-section under reflected light at 200x magnification. (Printed magnification not calculated).

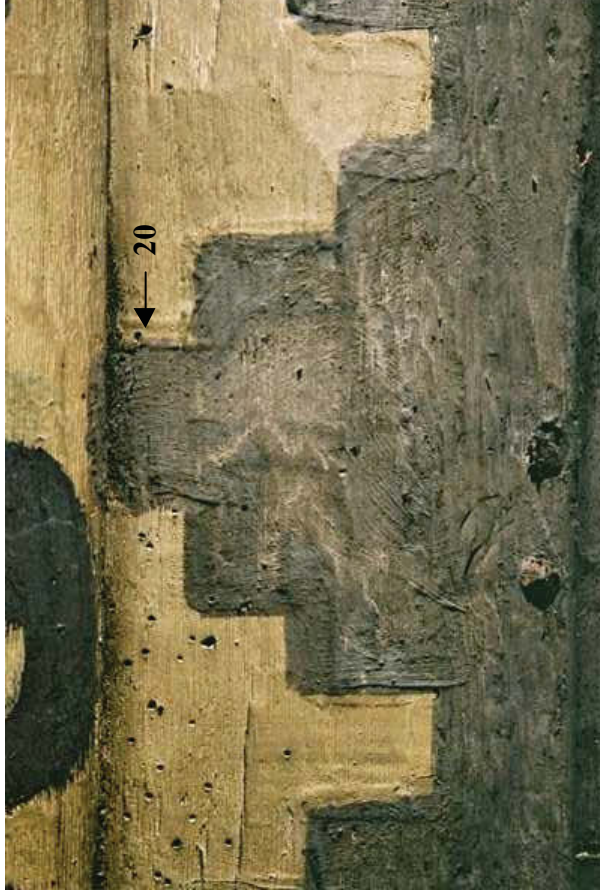
Sample 20 (3089) was taken from location 12 III e, stepped chevron, original linear stepped chevron decoration visible in relief under 18th /19th century overpaint. Sample through white. Analysis required to identify original paint if present on sample.

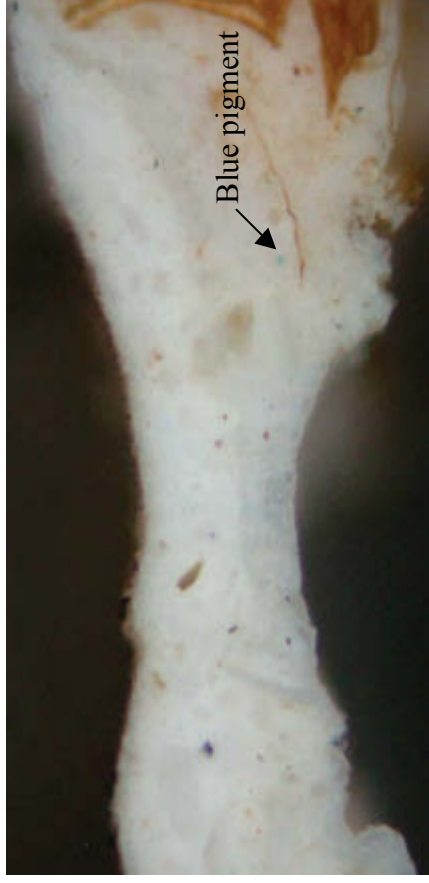
The presence of two distinct white layers can be seen on this sample under dark and bright field reflected light and even more clearly on a EDX backscattered image. Both layers consist primarily of basic lead carbonate with small amounts of extender and coloured pigments. Interestingly the lower layer contains a small copper blue particle, possibly natural azurite, which would seem to associate that paint layer with the thirteenth century paintwork.

Sample 20 (3089) photographed in cross-section under reflected light at 200x magnification. (Printed magnification not calculated).

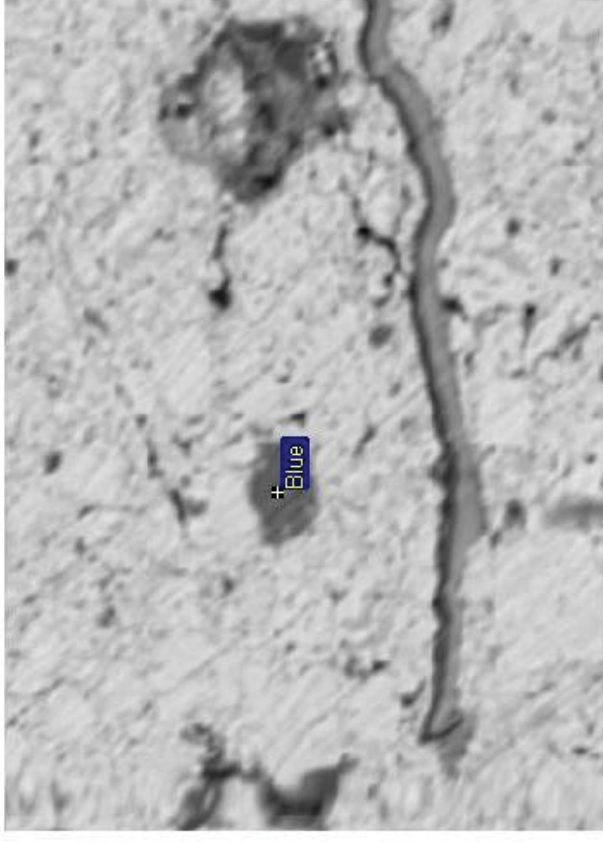
SEM-EDX backscattered image of sample 20, area 2 showing points at which EDX spectra were made. Spectra from the blue particle detects the presence of copper, lead, carbon and oxygen. This copper blue could be azurite, thereby associating the layer with the original paint containing azurite, which was being applied elsewhere.

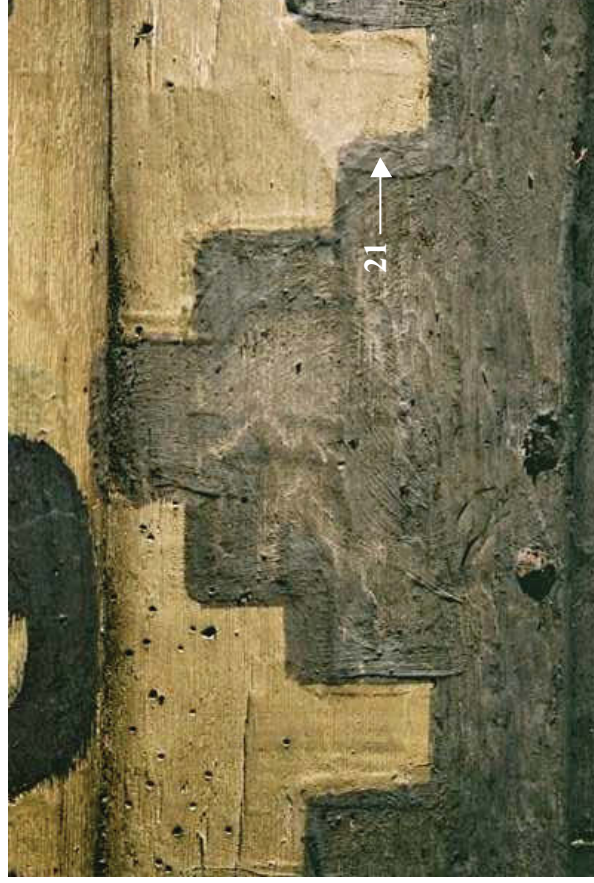
Sample 21 (3090) was taken from location 12 III e, 12 III e, stepped chevron, original linear stepped chevron decoration visible in relief under 18th /19th century overpaint. Sample through black. Analysis required to identify original paint if present on sample.

This sample has a very similar appearance to sample 18 discussed above. The brown is comprised of umber, natural iron oxide, calcium and barium sulphate. The characteristic coarse orange-brown is identical to that observed on previous samples. The lowest white layer is basic lead carbonate and may date from the thirteenth century. The beige layer visible at the base of the sample appears to be calcium sulphate in an animal glue binder.

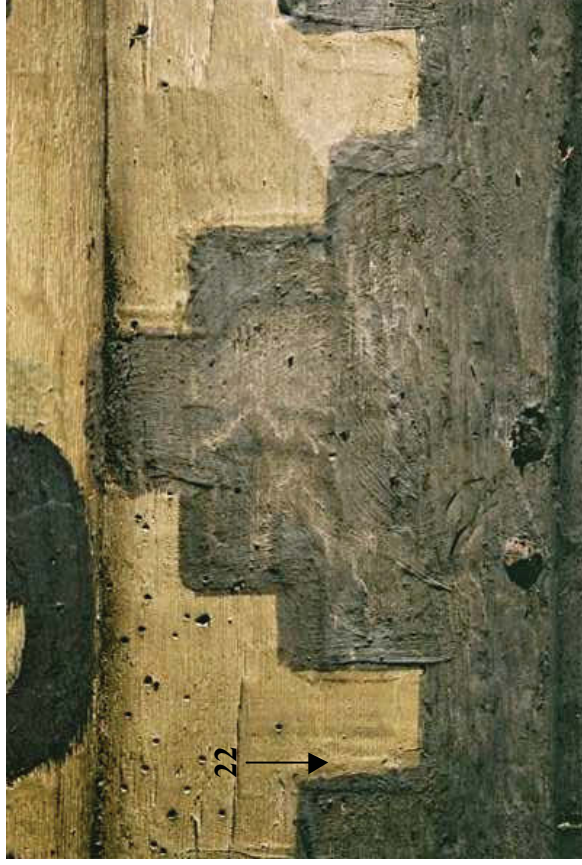
Sample 22 (3091) was taken from location 12 III e, stepped chevron, original linear stepped chevron decoration visible in relief under 18th /19th century overpaint. Sample through white. Analysis required to identify original paint if present on sample.

The sample shows a lead white paint applied over the characteristic orange-brown discussed above. The lower white lead layer may be dated to the thirteenth century.

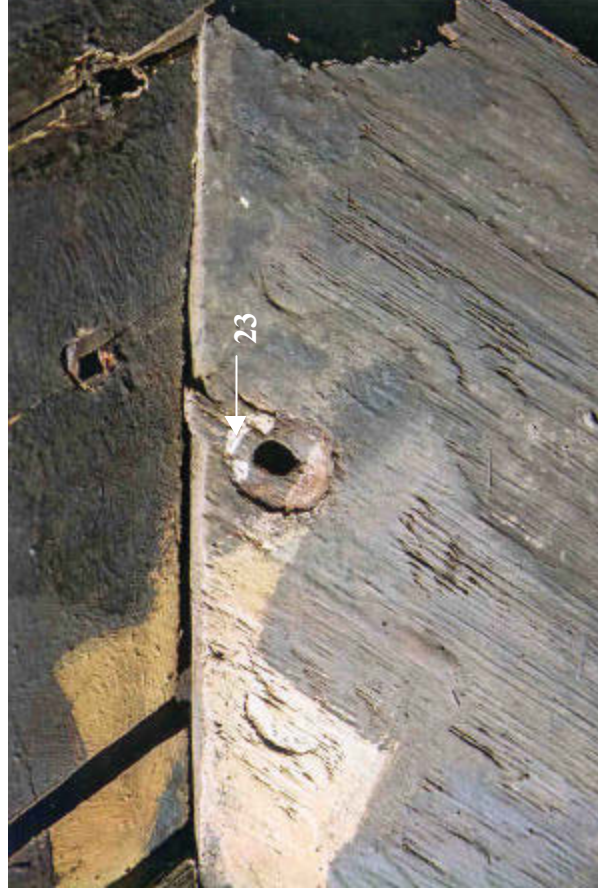
Sample 23 (3092) was taken from location 17 IV g, stepped chevron, white paint from raised linear stepped chevron pattern, below original nail head, which is now missing. Analysis required to confirm whether this is the original paint and if so, it's material composition.

The sample shows a very thinly applied white lead layer directly on the timber substrate. It has not been overpainted. Its microscopic appearance is consistent with it being of thirteenth century date.

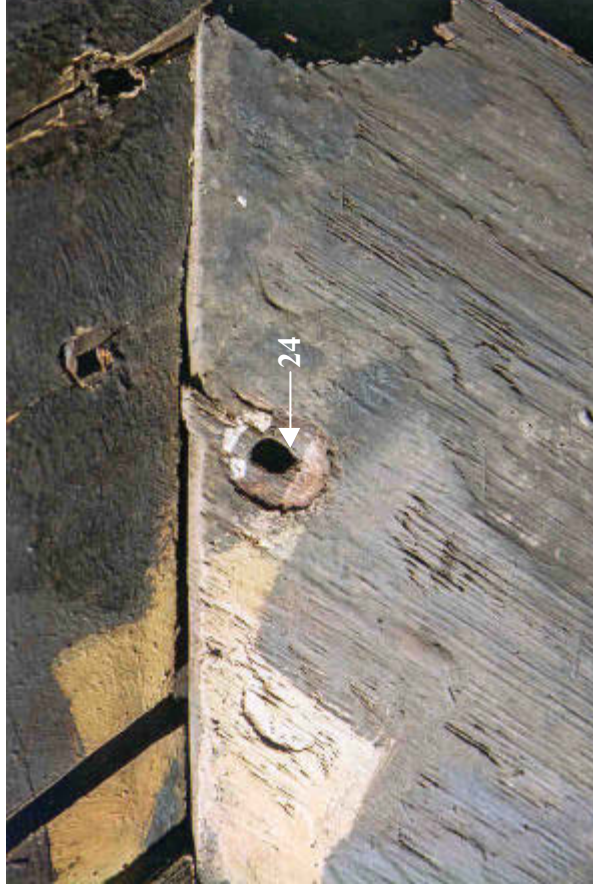
Sample 24 (3093) was taken from location 17 IV g, stepped chevron, black paint from background area adjacent to raised linear stepped chevron pattern, below original nail head, which is now missing. Analysis required to confirm whether this is the original paint and if so, its material composition.

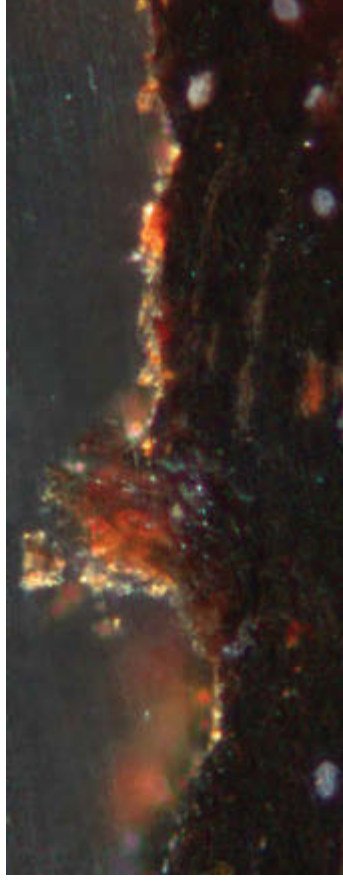
The sample appears to show unpainted timber. Surface deposits appear to be accretions of dust and debris, rather than a deliberately applied paint finish.

Sample 24 (3093) photographed in cross-section under reflected light at 200x magnification. (Printed magnification not calculated).

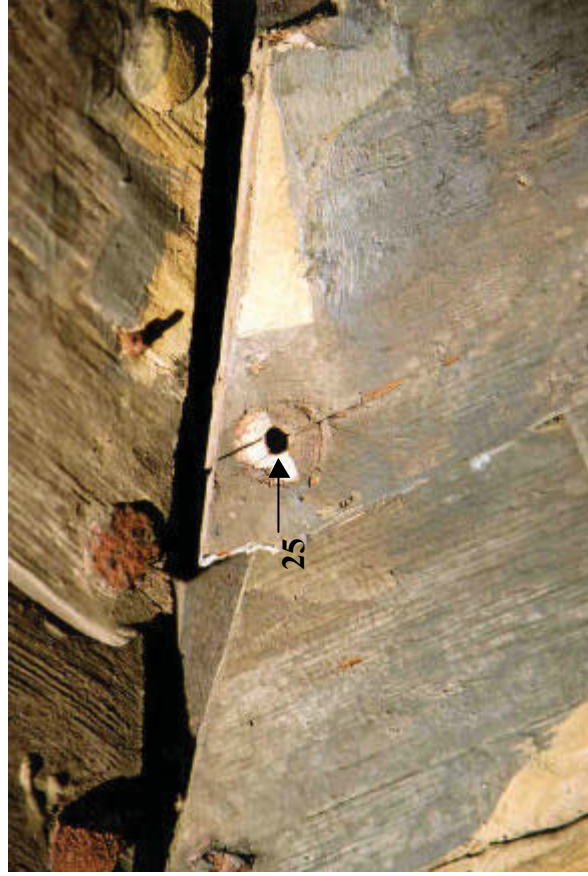
Sample 25 (3094) was taken from location 15 I f, stepped chevron, white paint from raised linear stepped chevron pattern, below original nail head, which is now missing. Analysis required to confirm whether this is the original paint and if so, its material composition.

The sample shows a thinly applied white lead layer directly on the timber substrate. It has not been overpainted. Its appearance may be consistent with a thirteenth century date.

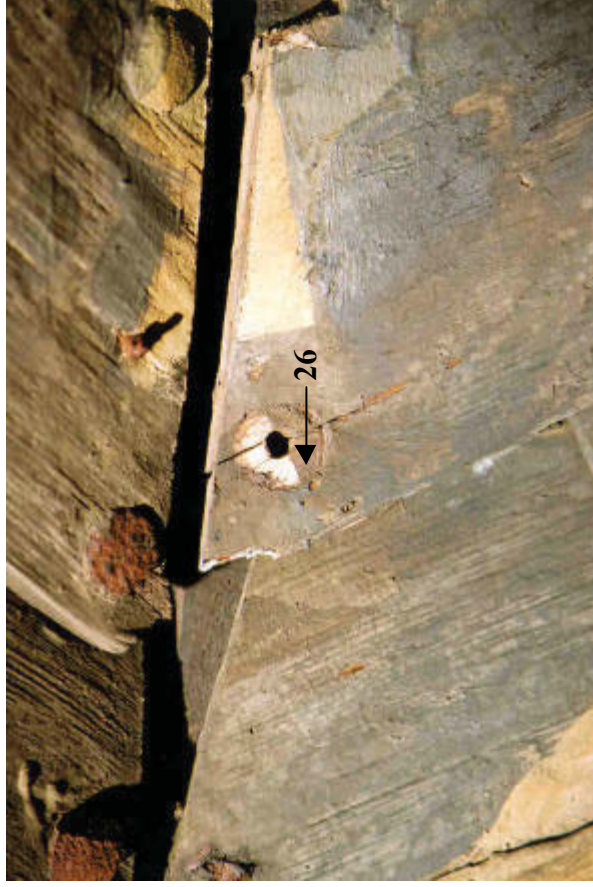
Sample 26 (3095) was taken from location 15 I f, 17 IV g, stepped chevron, black paint from background adjacent to raised linear stepped chevron pattern, below original nail head, which is now missing. Analysis required to confirm whether this is the original paint and if so, its material composition.

The sample appears to show unpainted timber. Surface deposits appear to be accretions of dust and debris, rather than a deliberately applied paint finish. It has not been overpainted. However, iron corrosion products, probably from the now absent nail head are present on its surface.

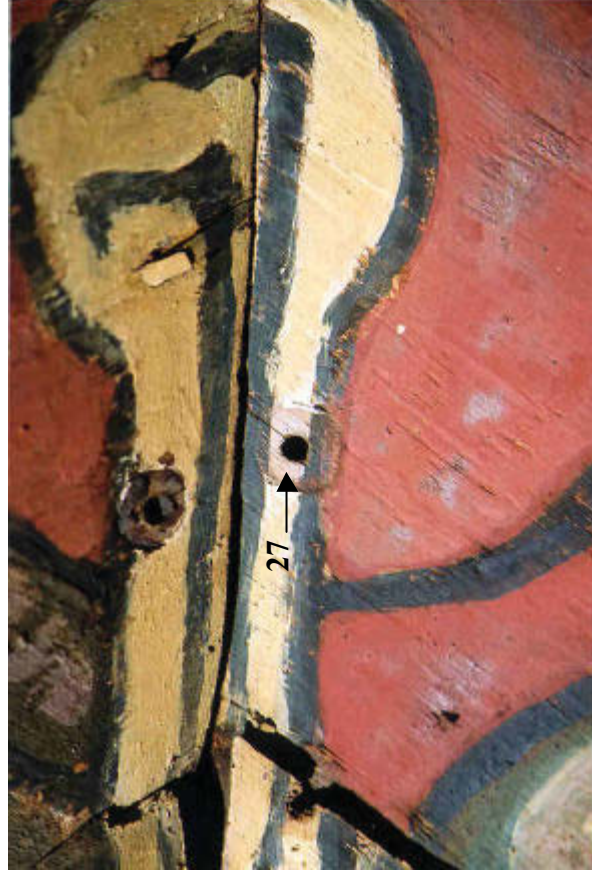
Sample 27 (3096) was taken from location 14 I w, lozenge board, off-white paint from neck of organistrum, from below original nail head, which is now missing.

The paint appears to be a single application of lead white, vermilion, carbon black with a little iron oxide yellow. Its appearance is consistent with it being of thirteenth century date. A similar paint mixture has been identified in previous research and attributed to the original decoration (Howard 1997).

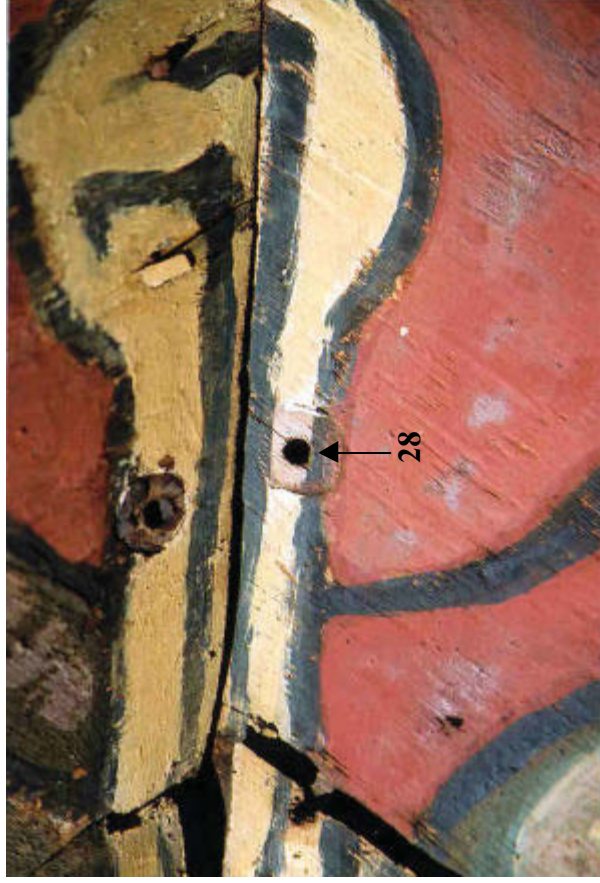
Sample 28 (3097) was taken from location 14 I w, lozenge board, black paint from neck of organistrum, from below original nail head, which is now missing.

The sample reveals a dark paint containing carbon black and a little iron oxide. The paint layer is intermingled at its lower boundary with a white lead paint, which appears to contain a particle of azurite. The appearance of the paint is consistent with a thirteenth century date.

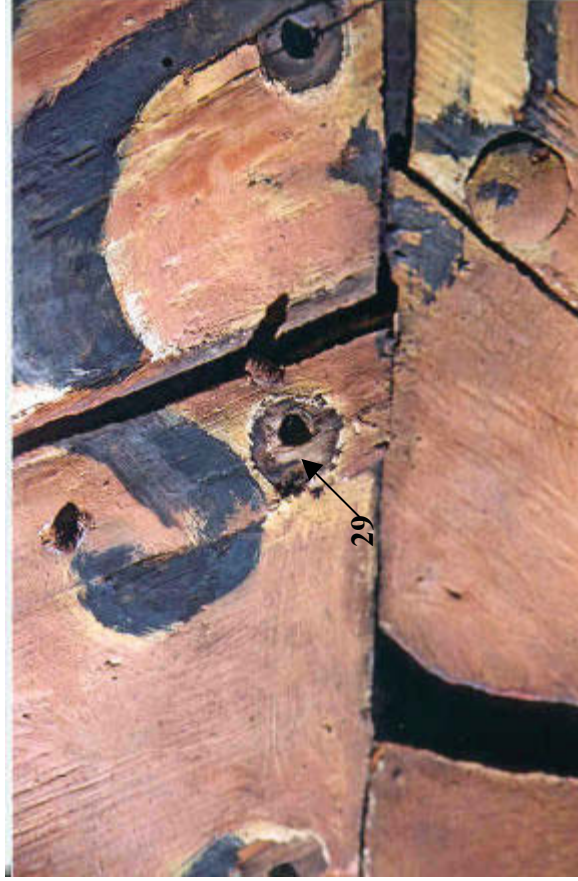
Sample 29 (3098) was taken from location 14 II bb, pink paint from body of organistrum, from below an original nail head, which is now missing.

The paint appears to be a single application of lead white, vermilion, carbon black with a little iron oxide yellow. Its appearance is consistent with it being of thirteenth century date. A similar paint mixture has been identified in previous research and attributed to the original decoration (Howard 1997).

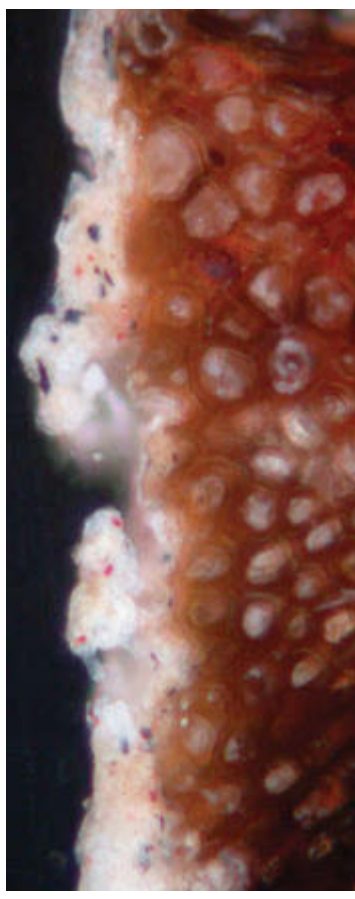
Sample 29 (3098) photographed in cross-section under reflected light at 200x magnification. (Printed magnification not calculated).

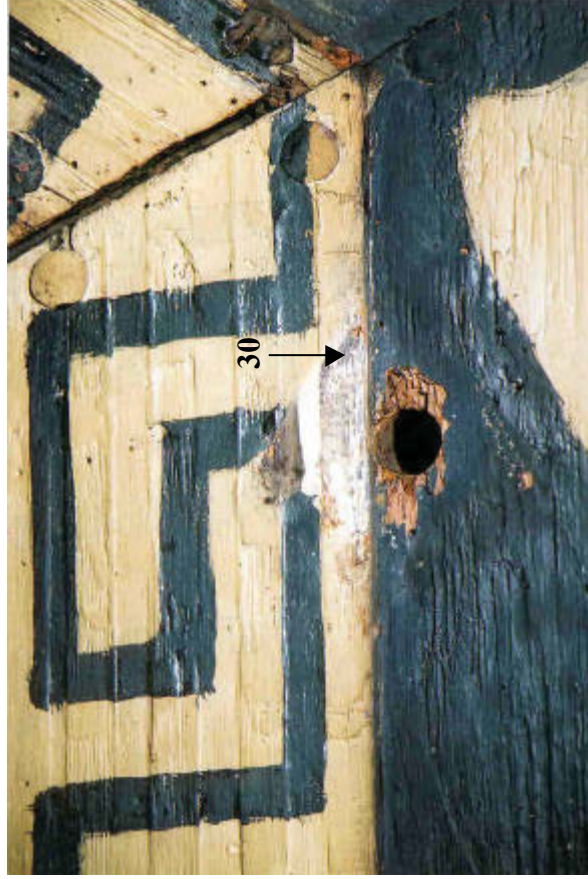
Sample location photograph (below):

Sample 30 (3099) was taken from location 8 III c, key. Paint below 1830s hanging bolt (temporarily removed during treatment). Black paint on raised area between outer groove and outer edge of board. Current theory is that these raised areas were originally unpainted.

Sample shows a thinly applied carbon black layer over white lead paint directly on the board. No evidence useful for specifically dating the paint layers has been noted on the sample.

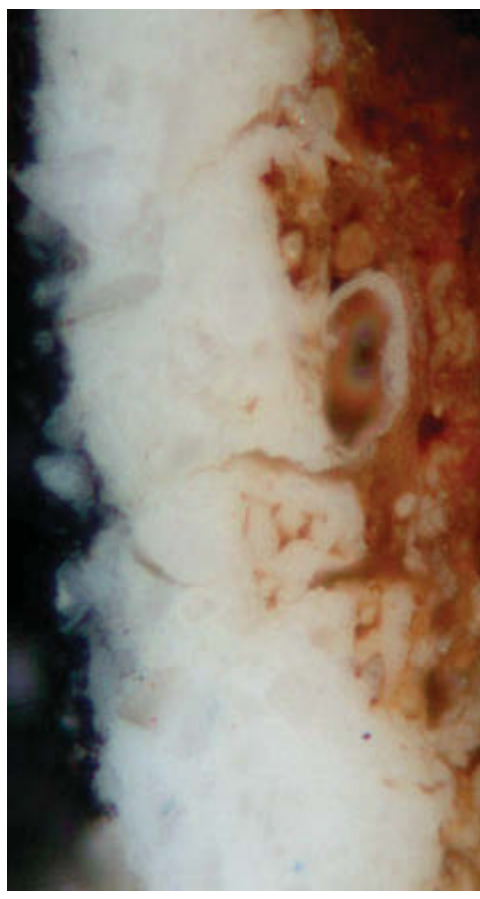
Sample 30 (3099) photographed in cross-section under reflected light at 200x magnification. (Printed magnification not calculated).
