PETERBOROUGH CATHEDRAL, NAVE CEILING

INVESTIGATION OF PAINTING MATERIALS AND TECHNIQUES, CONSERVATION PHASE 4, BAYS 9-17

May 2002

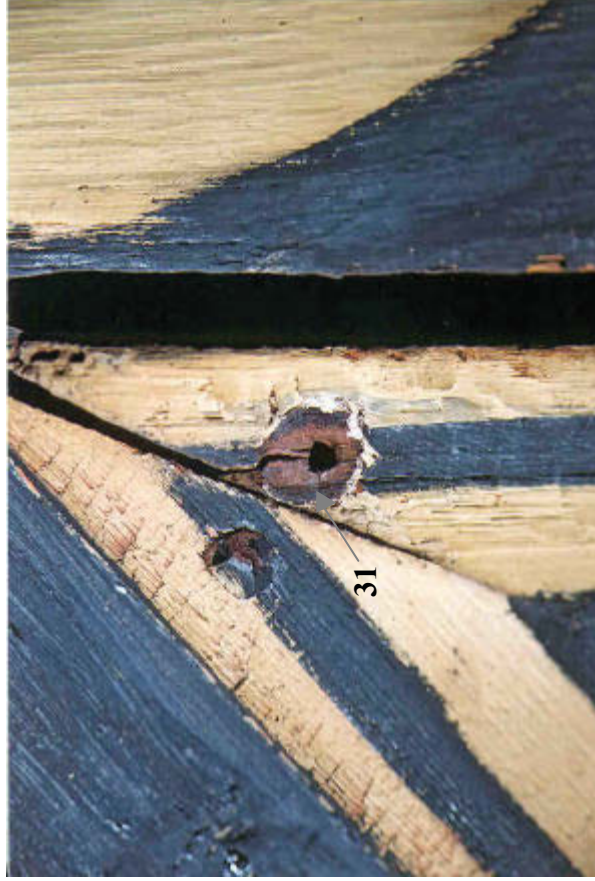
Sample location photograph (below):

Sample 31 (3100) was taken from location 12 II d, black paint from raised area between outer and middle groove from below an original nail head, which is now missing. Current theory is that these areas were originally unpainted.

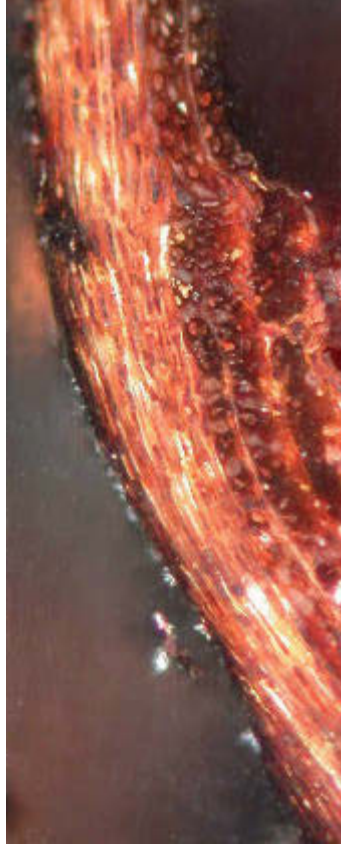
The sample appears to show unpainted timber. Surface deposits appear to be accretions of dust and debris, rather than a deliberately applied paint finish.

Sample 31 photographed in cross-section under reflected light at 200x magnification (on slide). (Printed magnification not calculated).
