### PETERBOROUGH CATHEDRAL, NAVE CEILING

INVESTIGATION OF PAINTING MATERIALS AND TECHNIQUES, CONSERVATION PHASE 5

March 2004

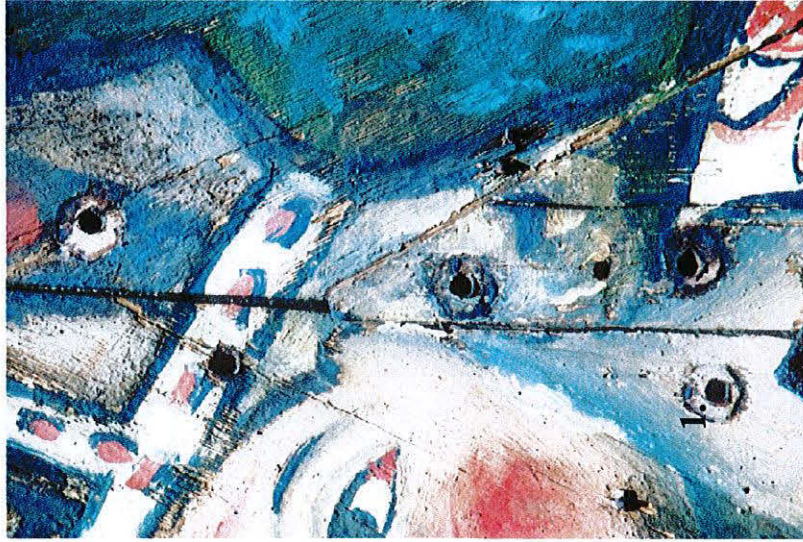
## 2.2 Sample 1 (3105)

Paint under original nail head (now missing). Flesh tone on neck of Archbishop 22 III a, lozenge.

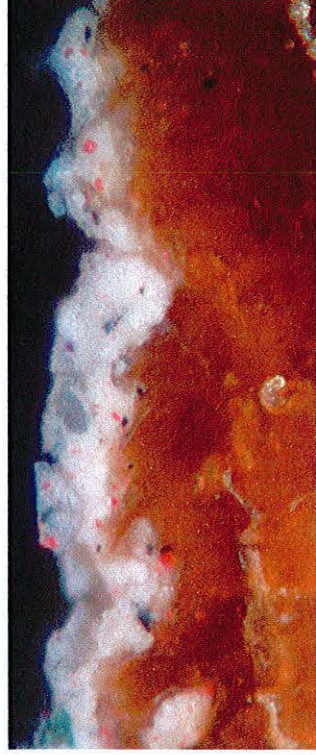
The sample shows a single layer of flesh coloured paint, comprised mainly of lead white with some vermilion and carbon black particles. Its appearance is consistent with it being of thirteenth century date.

Sample 1 photographed in cross-section under reflected light at 200x magnification. (Printed magnification not calculated).

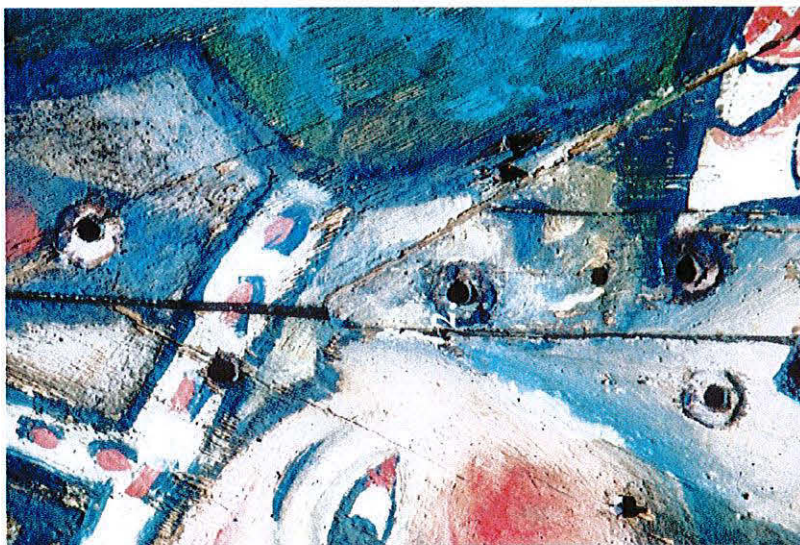
**Sample 2 (3106)**

Paint under original nail head (now missing). Green with red stripe within hair of Archbishop 23 II cc, lozenge.

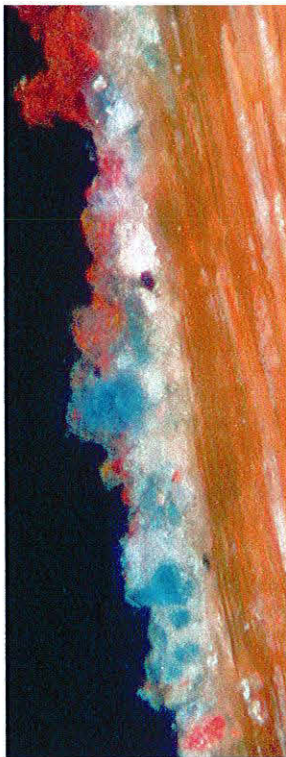
The sample clearly shows the blue-green paint superimposed by a layer of deep red pigment. The blue-green layer containing a mixture of natural azurite with lead white and a red pigment, possibly Vermilion. This paint appears very similar to the bright blue-green seen in previous research.<sup>3</sup> The upper red layer has a microscopic appearance consistent with iron oxide.

Sample 2 photographed in cross-section under reflected light at 200x magnification. (Printed magnification not calculated).

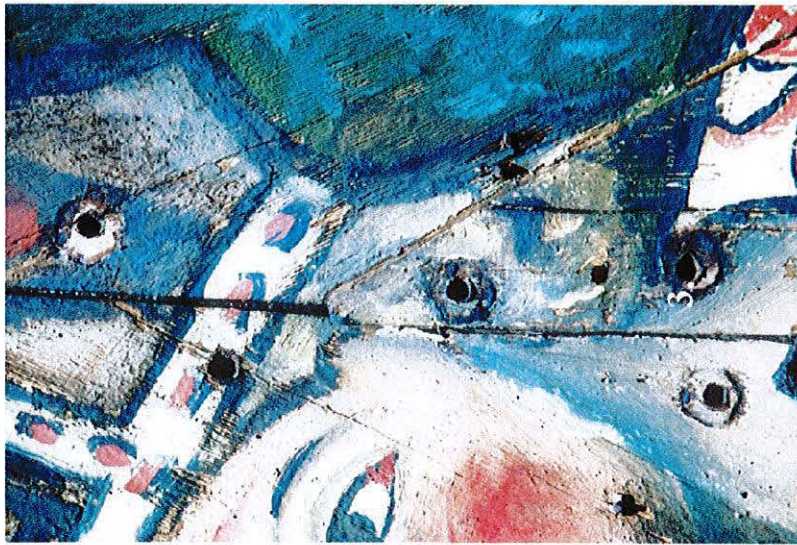
**Sample 3 (3107)**

Paint under original nail head (now missing). Flesh tone with red edge on neck of Archbishop 23 II cc, lozenge.

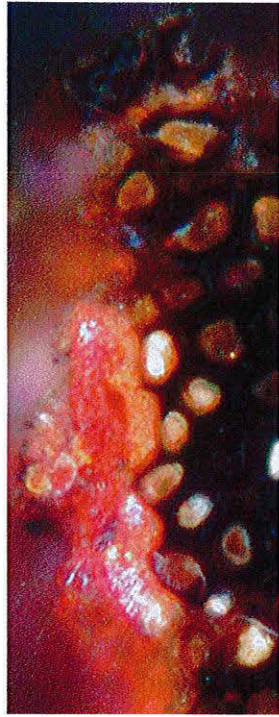
The paint comprises two layers, the lower appears to be red lead (minium) and the upper iron oxide. No flesh tone paint is visible on the sample as polished. The paint appearance is consistent with it being of thirteenth century date.

Sample 3 photographed in cross-section under reflected light at 200x magnification. (Printed magnification not calculated).

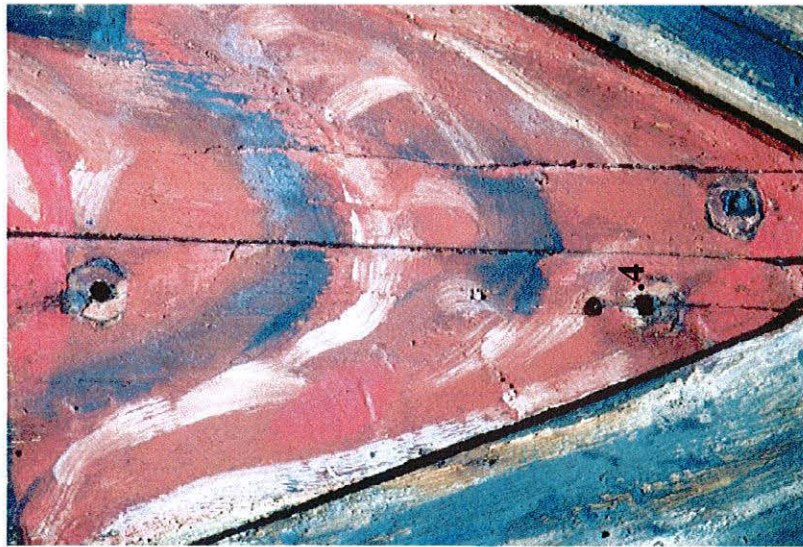
**Sample 4 (3108)**

Paint under original nail head (now missing). Light red from within lower robe drapery of Archbishop 22 III a, lozenge.

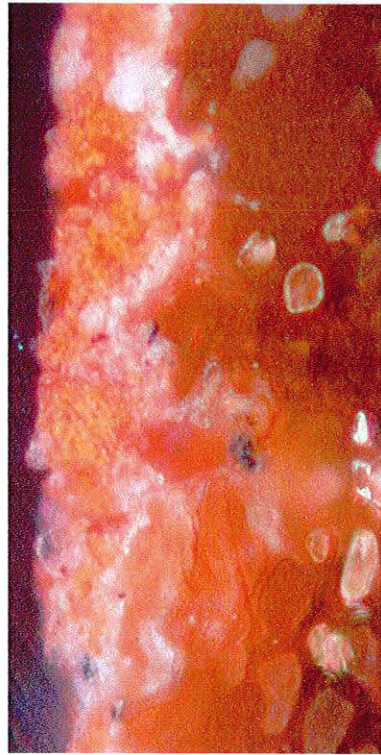
The paint is a single layer of red lead with a little carbon black and possibly some calcium carbonate. The white could be cerussite arising from the conversion of minium.<sup>4</sup> The paint appearance is consistent with it being of thirteenth century date.

Sample 4 photographed in cross-section under reflected light at 200x magnification. (Printed magnification not calculated).

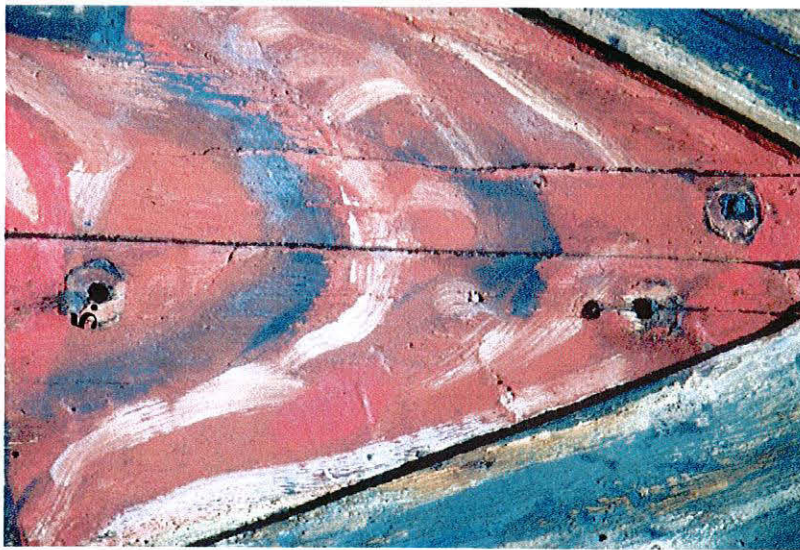
**Sample 5 (3109)**

Paint under original nail head (now missing). Light red from within lower robe drapery of Archbishop 22 III a, lozenge.

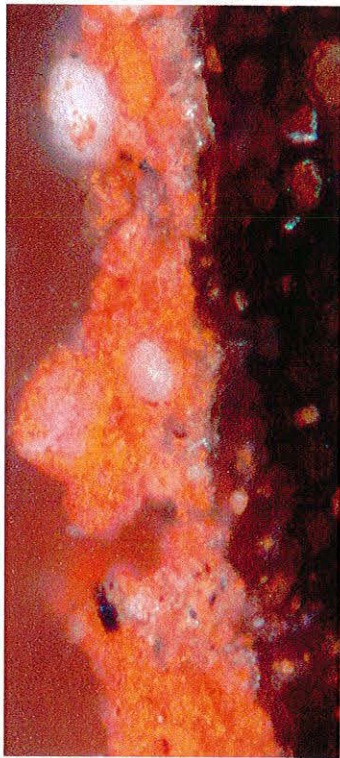
The paint is a single layer of red lead with a little carbon black and possibly some calcium carbonate. The white could be cerussite arising from the conversion of minium.<sup>5</sup> The paint appearance is consistent with it being original.

Sample 5 photographed in cross-section under reflected light at 200x magnification. (Printed magnification not calculated).

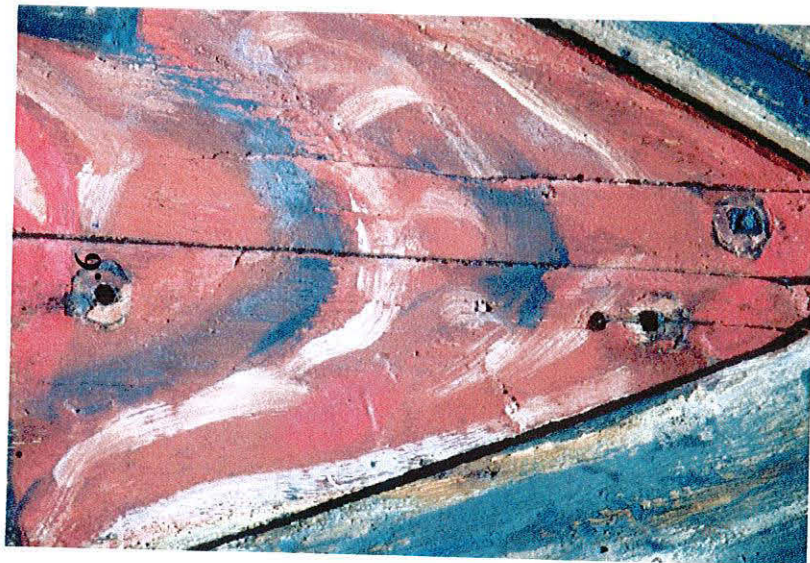
**Sample 6 (3110)**

Paint under original nail head (now missing). Dark red from within lower robe drapery of Archbishop 22 III a, lozenge.

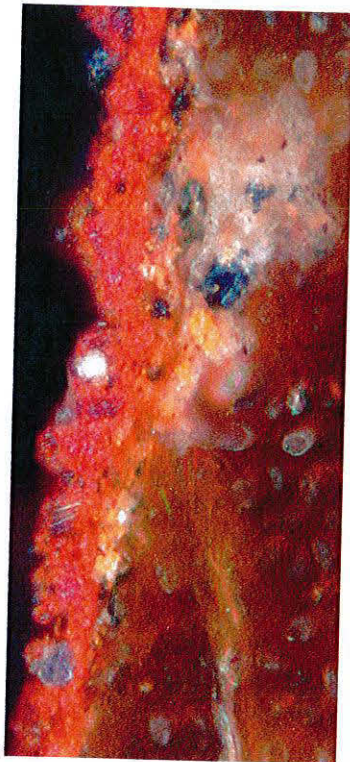
The lower paint layer appears to consist of red lead with some carbon black particles. The upper paint layer has a microscopic appearance consistent with iron oxide. Some white and black particles are present within the iron oxide matrix.

Sample 6 photographed in cross-section under reflected light at 200x magnification. (Printed magnification not calculated).

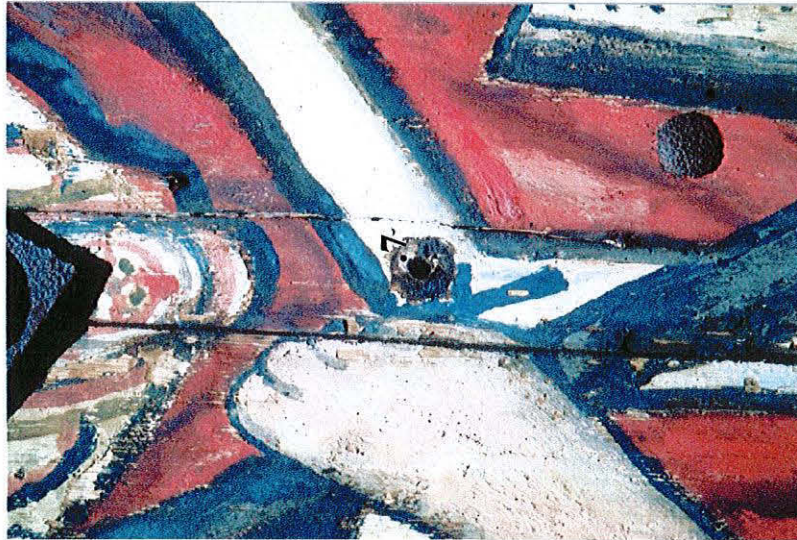
**Sample 7 (3111)**

Paint under original nail head (now missing). Off-white from white edging of drapery of Archbishop 23 II cc, lozenge.

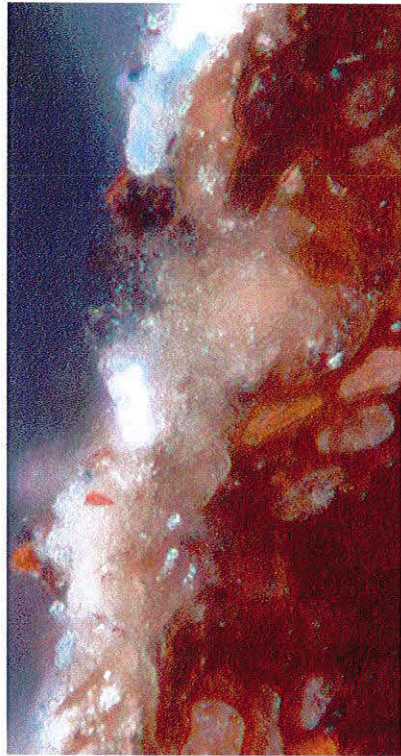
Sample shows a single layer of off-white paint over a translucent substance directly on the timber surface. The translucent material may be the calcium sulphate combined with a proteinaceous material (probably animal glue) which was identified at the timber/paint interface during previous research.<sup>6</sup>

Sample 7 photographed in cross-section under reflected light at 200x magnification. (Printed magnification not calculated).

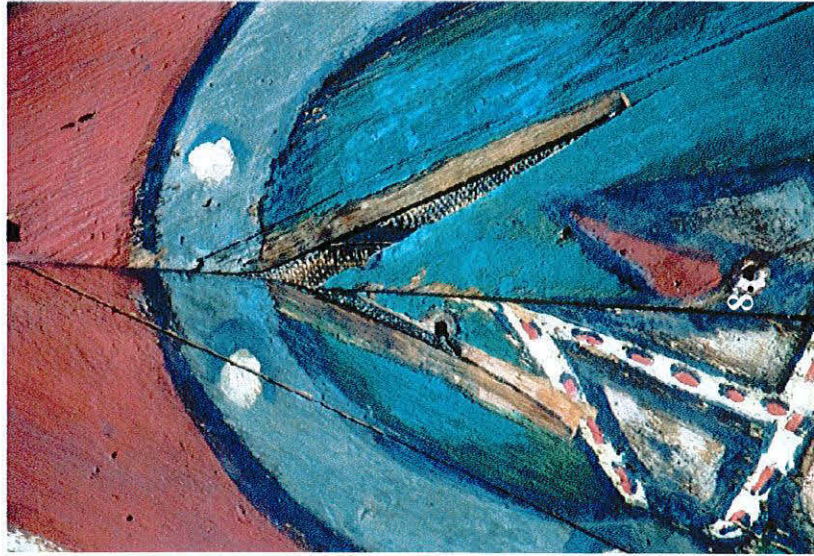
**Sample 8 (3112)**

Paint under original nail head (now missing). White paint from mitre of Archbishop 23 II aa, lozenge.

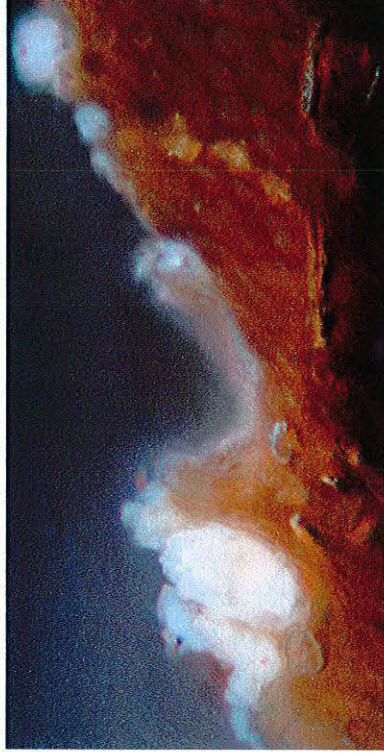
Single thin layer of white paint, shows no evidence of design. Possibly a significant sample in aiding our understanding of the original production of the ceiling, as it suggests the basic colours were blocked out prior to the ceiling being fixed in place, but the design details added after the nails were inserted. However, it maybe that during later interventions the design details were considerably altered and the sample is simply from an area that was originally plainly painted.

Sample 8 photographed in cross-section under reflected light at 200x magnification. (Printed magnification not calculated).

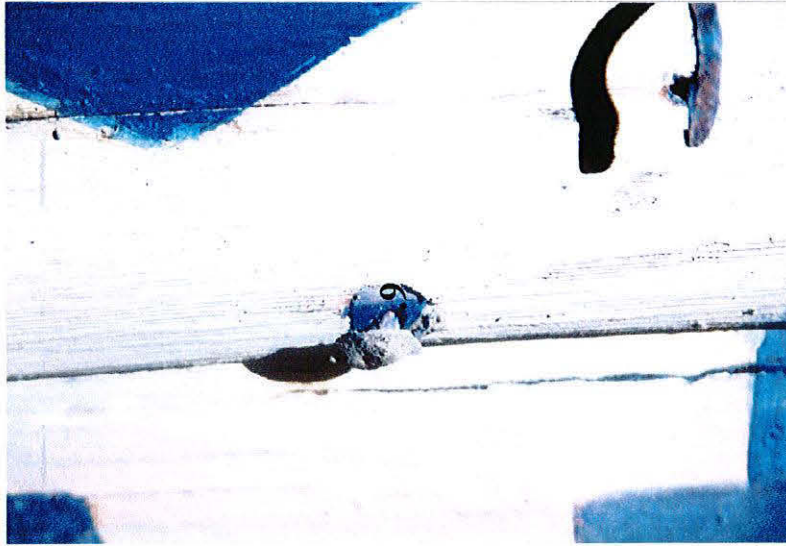
**Sample 9 (3113)**

Paint under original protruding nail head. Black from apparent black line on outer curved edge of board 21 III e wave.

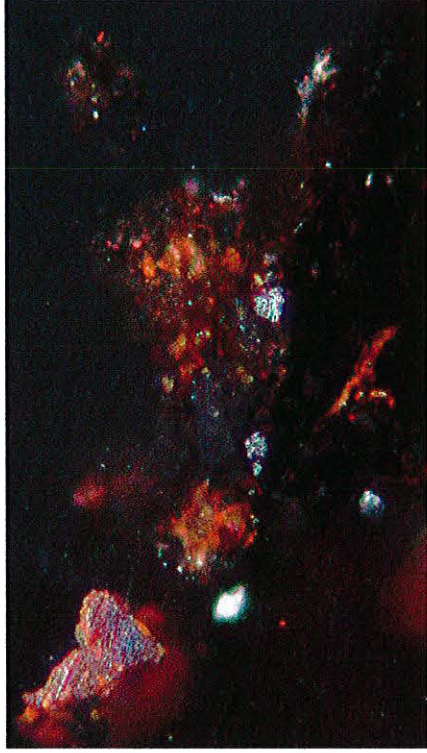
Very limited evidence on sample of carbon black paint.

Sample 9 photographed in cross-section under reflected light at 200x magnification. (Printed magnification not calculated).

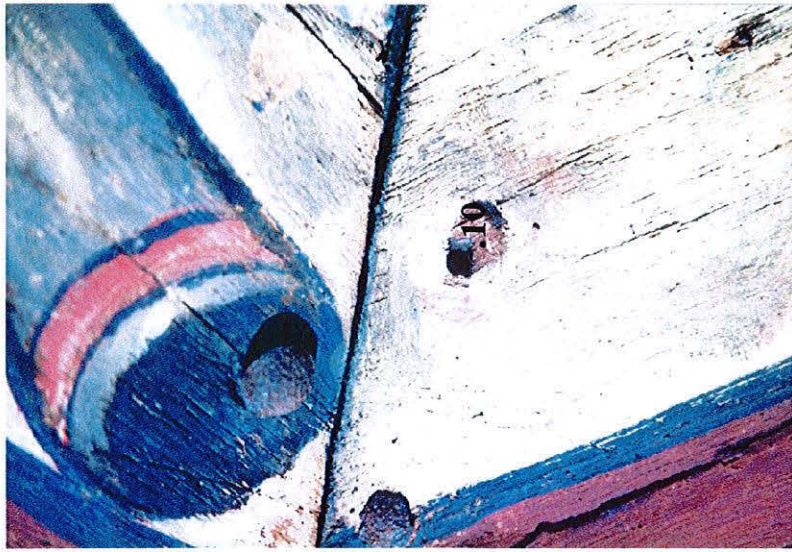
**Sample 10 (3114)**

Paint under original nail head (now missing). Red paint from within white background of angel with cornetto lozenge 21 I c, lozenge.

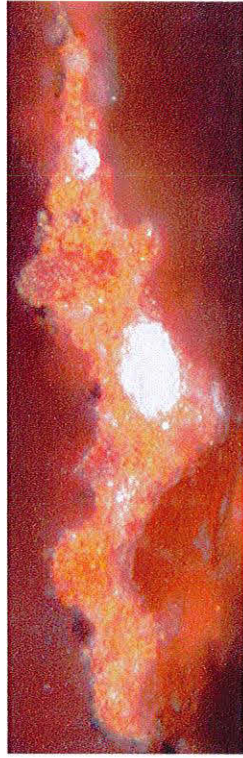
The paint is a single layer of red lead with a little carbon black and possibly some calcium carbonate. The white could be cerussite arising from the conversion of minium.<sup>7</sup> The paint appearance is consistent with it being original.

Sample 10 photographed in cross-section under reflected light at 200x magnification. (Printed magnification not calculated).

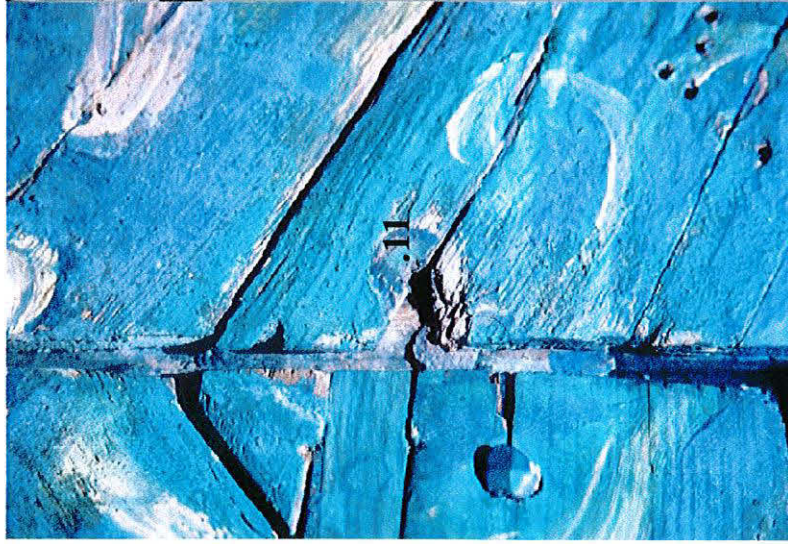
**Sample 11 (3115)**

Paint under original nail head (now missing). Green paint from within drapery (?) of Grammar lozenge 18 I ee, lozenge.

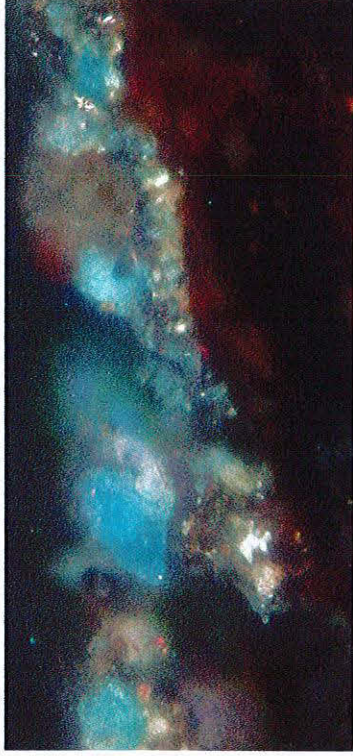
The blue-green layer containing a mixture of natural azurite with lead white and an red/orange pigment, possibly iron oxide. This paint is similar to the bright blue-green seen in previous research.<sup>8</sup>

Sample 11 photographed in cross-section under reflected light at 200x magnification. (Printed magnification not calculated).
