Nails from the wood panelled nave ceiling of Peterborough Cathedral:
Technological investigation of nails
 from Bays 5 and 6

By Brian Gilmour

Nails from the wood panelled nave ceiling of Peterborough Cathedral: Technological investigation of nails from bay three (Phase three) of the restoration programme.

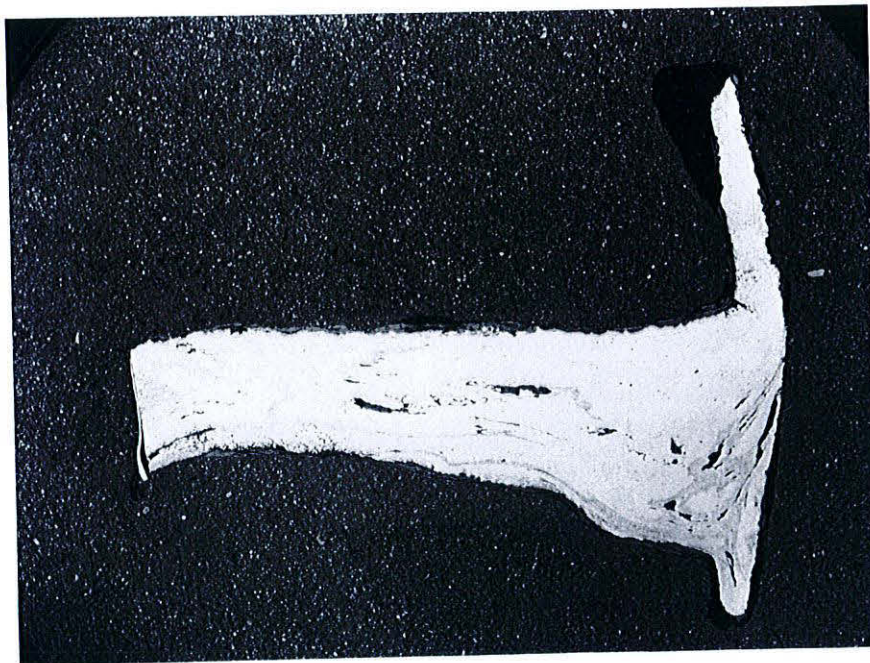
Fig 7. Flat-headed panel-fixing nail (HM109) in longitudinal section at low magnification.
Magnification x6: etched with 2% nital.

In longitudinal section after etching this nail was found to be similar in structure to the previous example (HM106) with an uneven patchy appearance, but with a less streaky or banded appearance indicating a lesser degree of forging along one direction than for the other, this being particularly apparent a low magnification (Fig 7). As before this differential appearance was due mainly to a very variable iron (ferrite) grain size plus the presence of an irregular distribution of, mainly dark grey, non-metallic slag inclusions (Fig 8). Three different phases were again visible in the slag although the proportion of the paler grey iron oxide (wüstite) was lower for this nail (Fig 9).

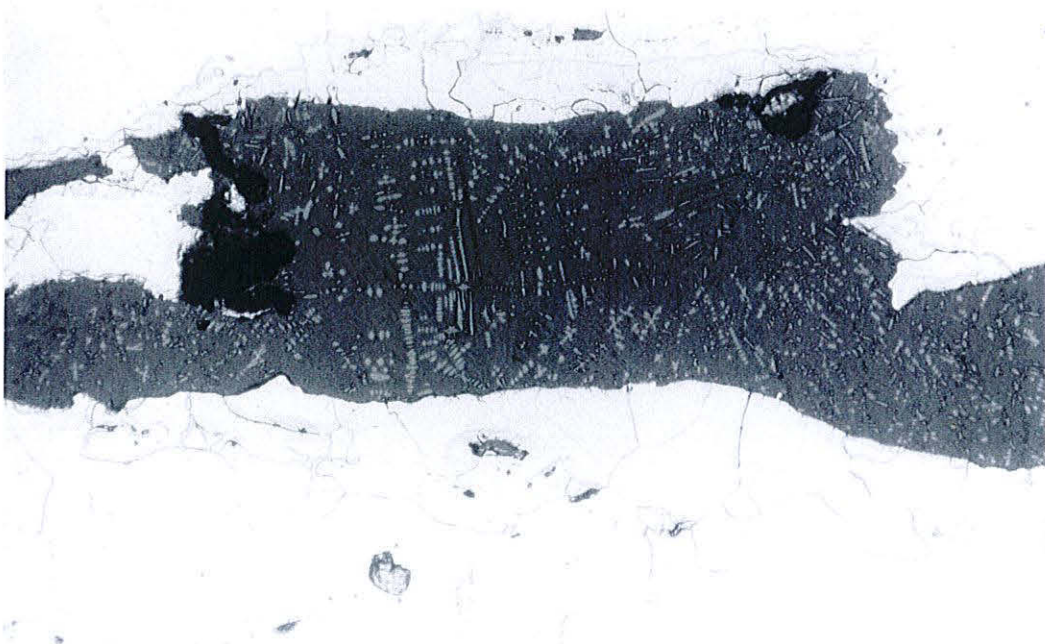
Fig 9. Detail of one of the larger non-metallic slag inclusions shown in Fig 8 with three phases again visible as different shades of grey. Magnification x200: etched 2% nital.

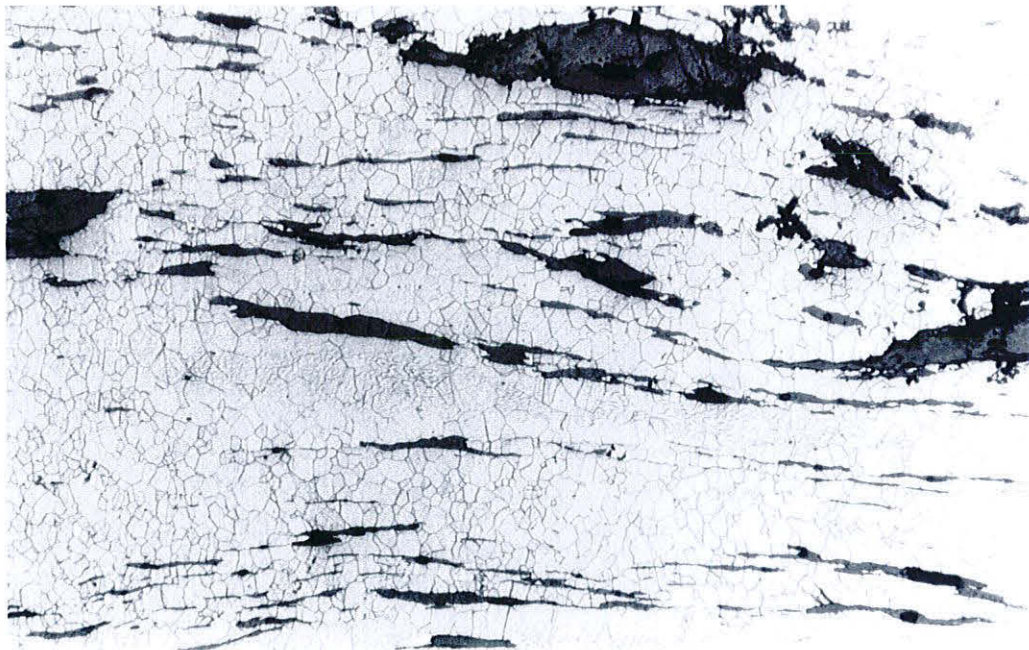
Fig 11. The structure of part of the shank of the same nail (HM111), showing the rather more even ferrite grain structure of the iron (compared to HM106 and HM109) plus the greater volume of elongated darker non-metallic slag inclusions. Magnification x50: etched 2% nital.

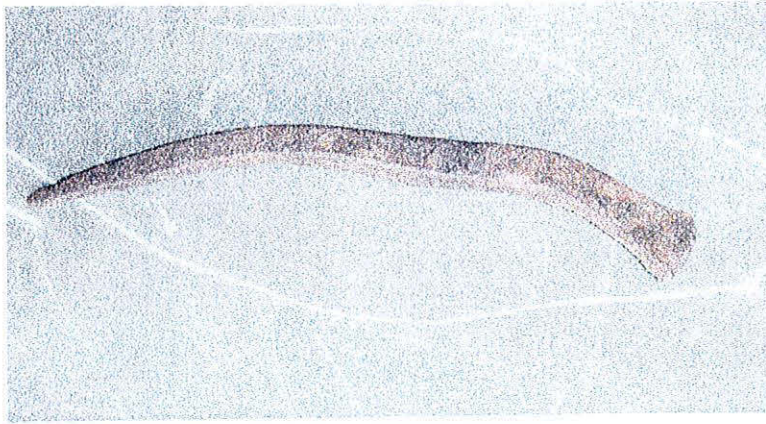
Fig 19. Medium sized brad type nail from Joist 22, south end.

6. Phase III, Joist 22, south end: In both size and form this very well preserved and complete nail is completely unlike any of the nails so far encountered in this project. It is 110 mm in length and has a square cross-section to the shank which tapers evenly on all sides down to the tip, while at the other end the shank is only slightly splayed out to form a square head measuring 10 mm across (Fig 19).

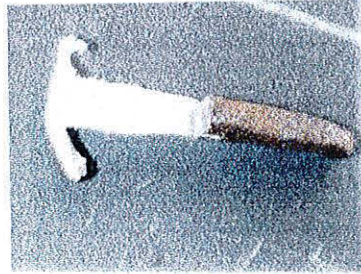
Fig 26 Very similar panel fixing nail (HM110) again of uncertain date but most likely associated with the 1740's restoration, this example being incomplete but very similar to HM107.

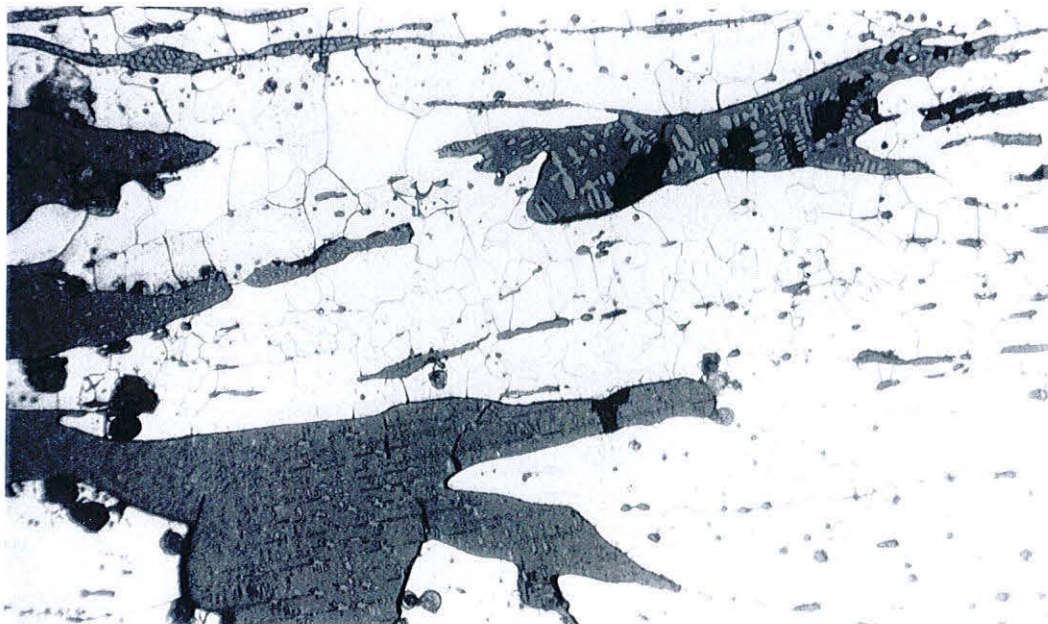
Fig 38. Detail (of Fig 37) showing a cluster of, in shape, more irregular, larger non-metallic slag inclusions, with the different internal appearance of these visible, in particular the varying presence of the pale grey, iron oxide phase (wüstite). Magnification x200; etched 2% nital.
