Nails from the wood panelled nave ceiling of Peterborough Cathedral:

Technological investigation of nails from bay three (Phase Four) of the restoration programme.

by Brian Gilmour

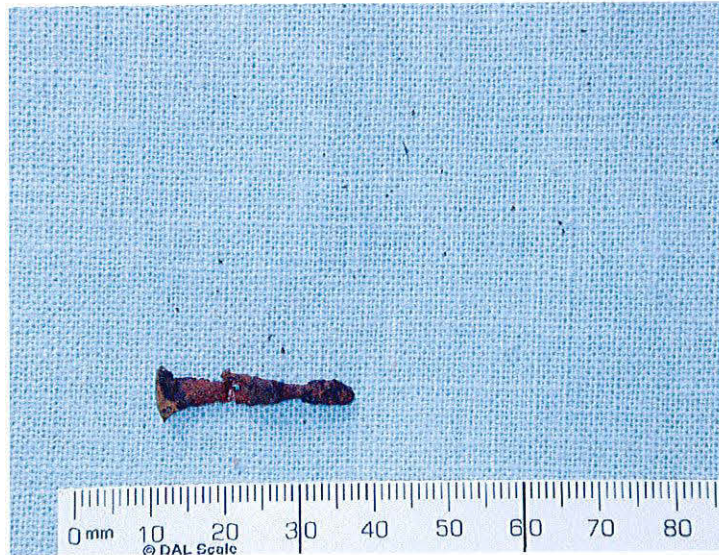
Fig 1. Surviving upper part of a flat-headed panel fixing nail (HM163) identified as belonging to the original nave ceiling construction of *c*1220; length of nail fragment 27 mm.

1. **Phase IV, 17 I, Board N:** This nail (HM163) was typical of the smaller, 'flat-headed original' type of panel fixing nail first encountered in Bays 5 and 6. Only the head and part of the shank (measuring 27 mm in length) survived, the shank being approximately 4 mm square at the head, tapering to a rectangular profile of 3x2 mm at a point 15 mm down from the head (Fig 1). What remained of the nail was quite heavily corroded but despite this its overall form and original shape was quite clear. The head was irregular but roughly circular in plan and measured 11x13 mm across. The overall proportions of the nail are very similar to those of the smaller, 'flat-headed original' type already reported and an original length of approximately 50 mm would therefore be expected.

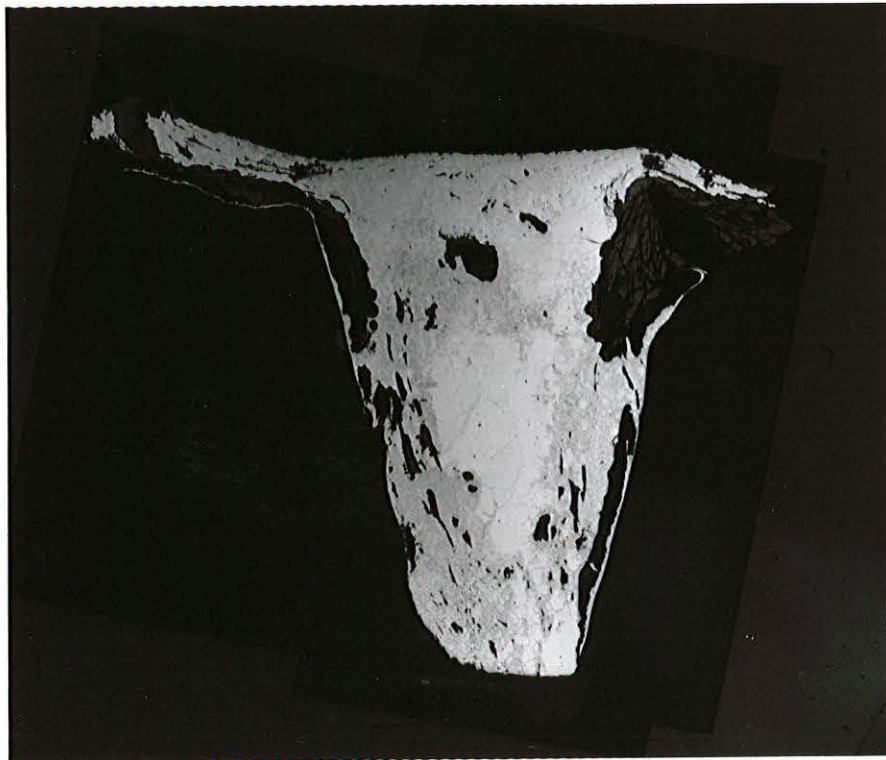
Fig 2. Longitudinal section through the upper part of this 'flat-headed original' nail (HM163) showing an uneven, blotchy looking structure typical of an inhomogeneous phosphoritic bloomery iron. Magnification x9; etched with 2% nital.

At low magnification in section the overall structure of the nail gave a rather blotchy or irregular patchy appearance typical of a very inhomogeneous, phosphoritic bloomery iron (Fig 2). In this case the larger dark areas visible in section represent corrosion voids in the metal, voids which filled with corrosion products as soon as they were formed. Much of this corrosion has focussed on non-metallic slag inclusions trapped in the metal either left over from the time it was smelted and consolidated, or from subsequent smithing/forging cycles. If one thinks away the dark corrosion voids on this view the overall content of non-metallic slag is fairly typical for a bloomery iron, although perhaps relatively low in this case.

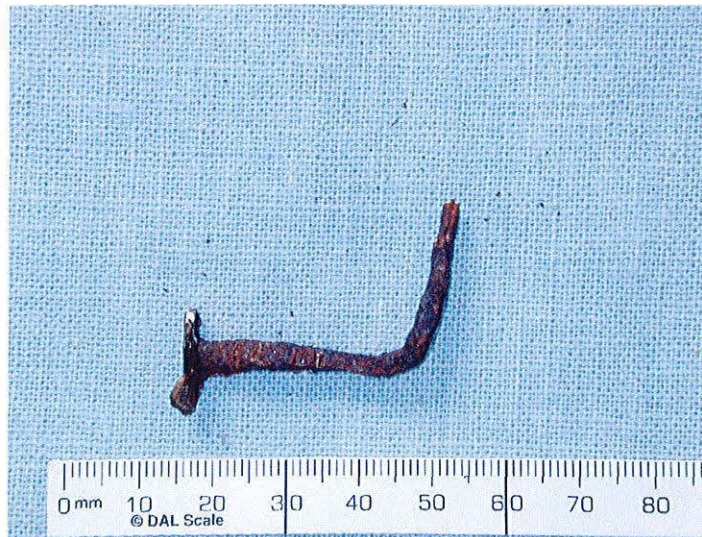
Fig 3. A complete flat-headed panel fixing nail (HM164) identified as belonging to the original nave ceiling construction of c1220; length of nail 57 mm.

2. **Phase IV, 15 III, Board N:** Again a 'flat headed original' type the head of this slightly larger nail (HM164) was similarly irregular in its shaped in plan, this time measuring 14x16 mm across (Fig 3). This complete nail was 57 mm in length, and had a rectangular shank with an unusual shape. The upper part of this was 7x4 mm and only tapered slightly down to a point a little over one third of the way down the shank where it dipped in sharply on either side so the profile became much more nearly square from this point, from where it tapered down evenly to the tip.

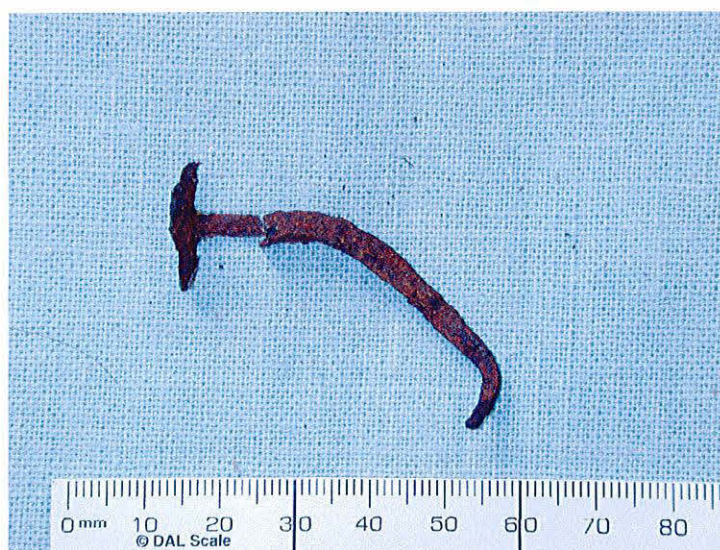
Fig 6. Another complete flat-headed panel fixing nail (HM167) identified as belonging to the original nave ceiling construction of c1220; length of nail 60 mm.

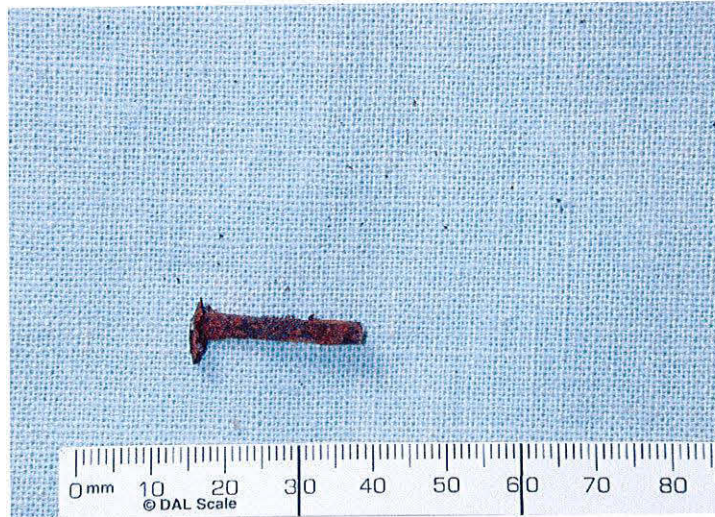
Fig 9. The surviving upper part of a smaller 'flat-headed original' panel fixing nail (HM168) identified as belonging to the nave ceiling construction of *c*1220; fragment 28 mm long.

4. Phase IV, 14 III, Board N: Although the two previous examples were about the same size, this nail (HM168) was the surviving upper part of a smaller 'flat-headed original' type (similar in scale to HM163 here, and HM124 in the previous group examined). The head also was much the same in size and shape to (HM163) the first of this group although this time it was damaged (Fig 10). The shank was slightly rectangular in section, measuring approximately 3x4 mm across near the head, and this again tapered gently on all four sides towards the tip the end of which was missing. A total length of 27 mm survived although the overall proportions suggested it would not have been much more than 40-45 mm long originally.

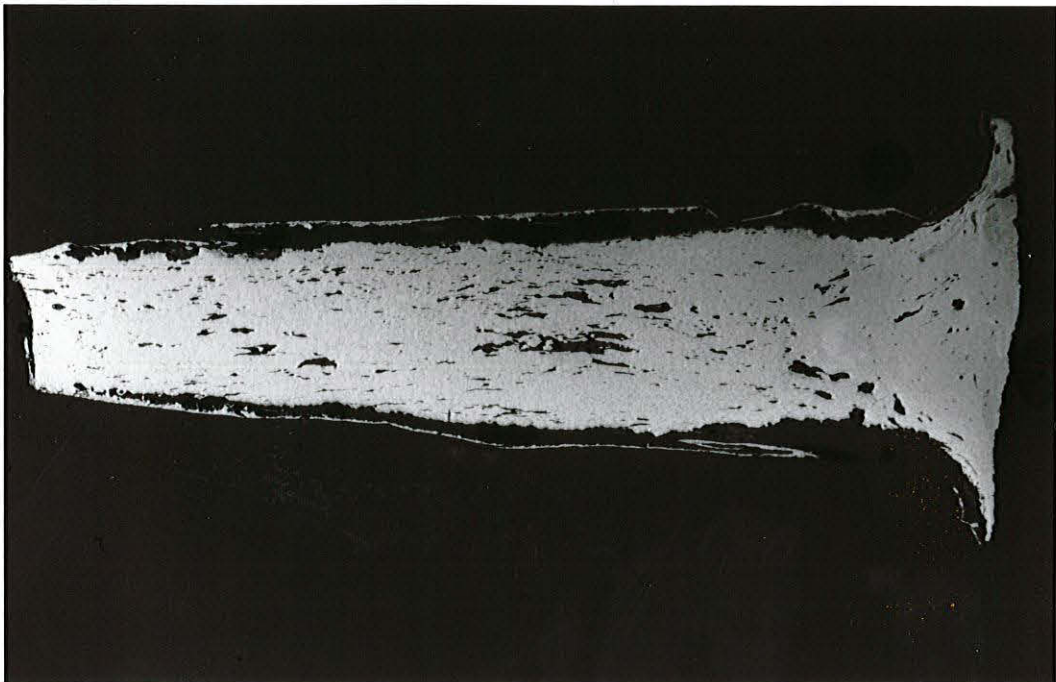
Fig10. Longitudinal section through the upper part of this 'flat-headed original' nail (HM168) with its much more even generally fine to medium grain iron structure along much of the section. Towards the head it becomes a more blotchy looking structure typical of an inhomogeneous phosphoritic bloomery iron. The overall content of non-metallic slag inclusions is high but irregular in its distribution. Magnification x9; etched with 2% nital.

In section this nail (Fig 10) was found to consist mostly of medium grain plain iron with very little pearlite (iron carbide) showing indicating the carbon content to be mostly very low. This structure also indicates the phosphorus content to be fairly low, possibly below about 0.1-0.2%, although one or two larger grain patches, particularly one towards the head, suggest that the phosphorus content may be slightly higher in places. The overall content of non-metallic slag inclusions is relatively high although the distribution and size of these is very uneven across the section. At higher magnification the relatively even, medium grain structure of the iron, and the lack of phosphorus ghost structure, is clearly visible (Fig 11), and at higher magnification again the two phase structure of much of the non-metallic slag, with its very high iron oxide content (the pale constituent) can also be seen (Fig 12). Micro-analysis confirmed the phosphorus content of the metal to be relatively low with a mean phosphorus content of 0.1%.

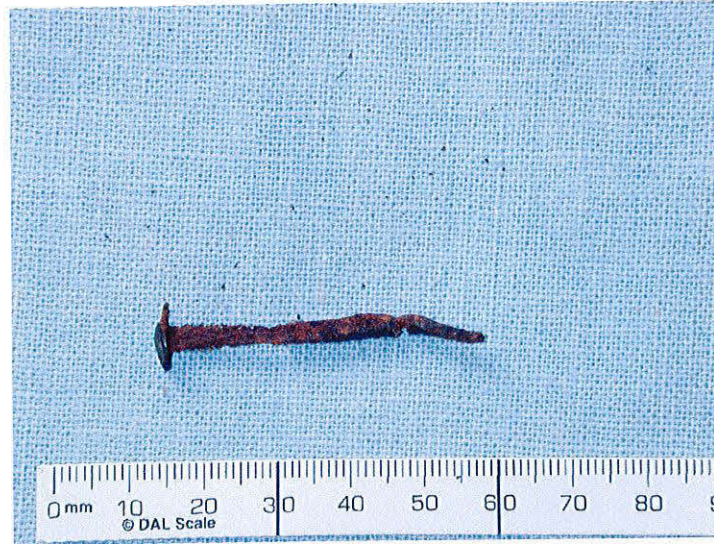
Fig17. A complete but corroded 'lost head, square shank' nail (HM165) with a small pyramidal head with four facets and (despite the name) a slightly rectangular shank. Identified as belonging to the restoration of the 1740's. Length of nail 45 mm.

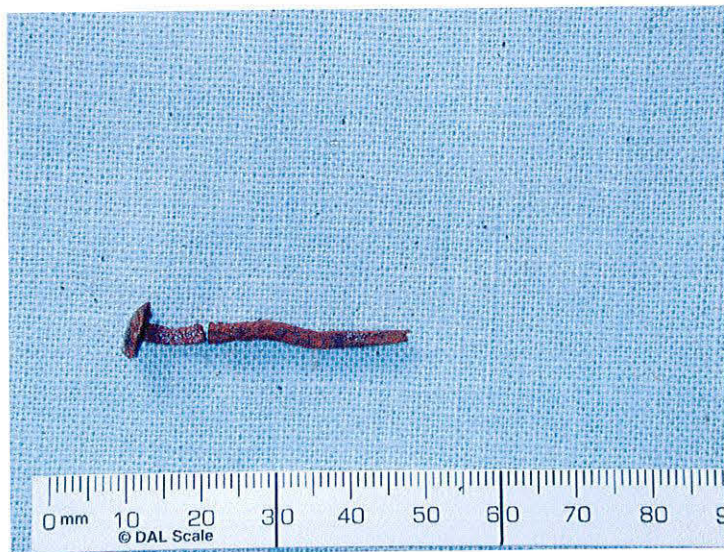
Fig20. A nearly complete although damaged 'lost head, square shank' nail (HM166) again with a small pyramidal head with four facets and a slightly rectangular shank. Identified as belonging to the restoration of the 1740's. Length of surviving nail 39 mm.

7. Phase IV, 10 IV, Board I: This nail (HM166) was clearly much the same as the previous example of small 'lost head, square shank' nail. The shank was more or less exactly the same in size and shape although about 5 or 6 mm of the tip had broken off, the surviving nail measuring 39 mm in length (Fig 20). Its four-sided faceted head was again very irregular in plan and also measured 9x12 mm across.

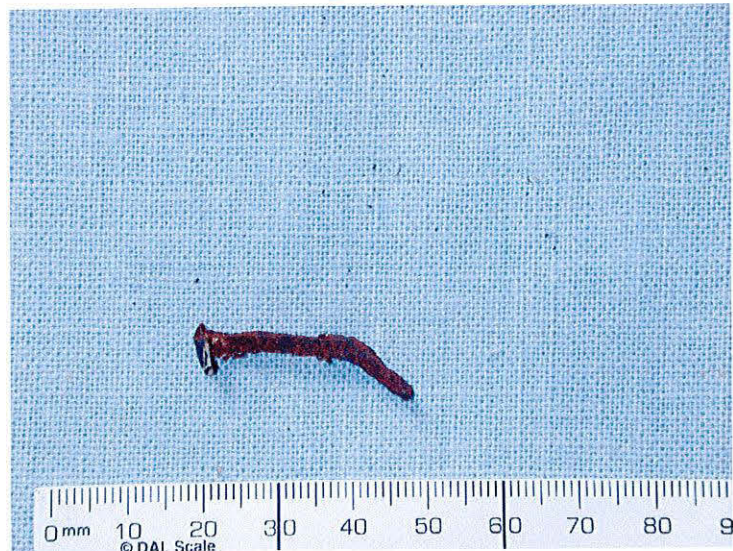
Fig23. The surviving upper part of a 'lost head, square shank' nail (HM236) again with a small pyramidal head with four facets and a slightly rectangular shank. Identified as belonging to the restoration of the 1740's. Length of surviving nail 32 mm.

3.5x2.5 mm across near the head) although one variation in this case was that the shank tapered down more evenly towards the tip on all four sides. The main part of this nail survived although the tip end had broken off (Fig 23). What was left measured 32 mm in length, and like the previous example its overall proportions indicated its original length to be within the range 40-45 mm, or perhaps slightly less.

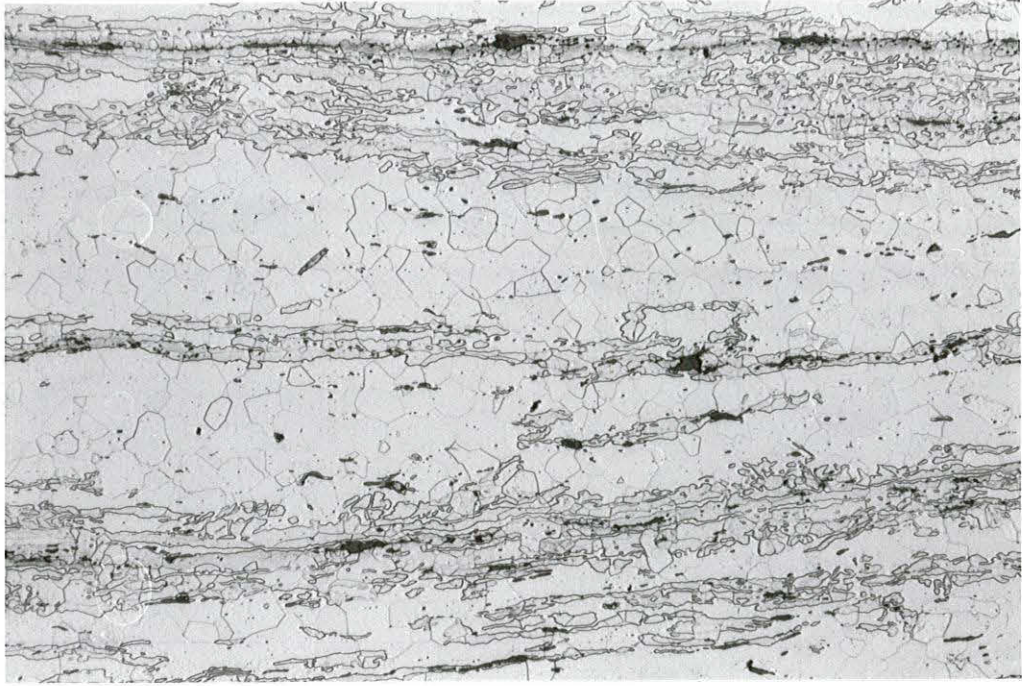
Fig25. Detailed view of the banded structure seen in section above (HM236), showing the large grain phosphoritic pale bands which occupy much of the section, these contrasting with the intermediate bands where the grain size is smaller and which also show phosphorus ghosting (where the phosphorus content is less). Magnification x50; etched 2% nital.

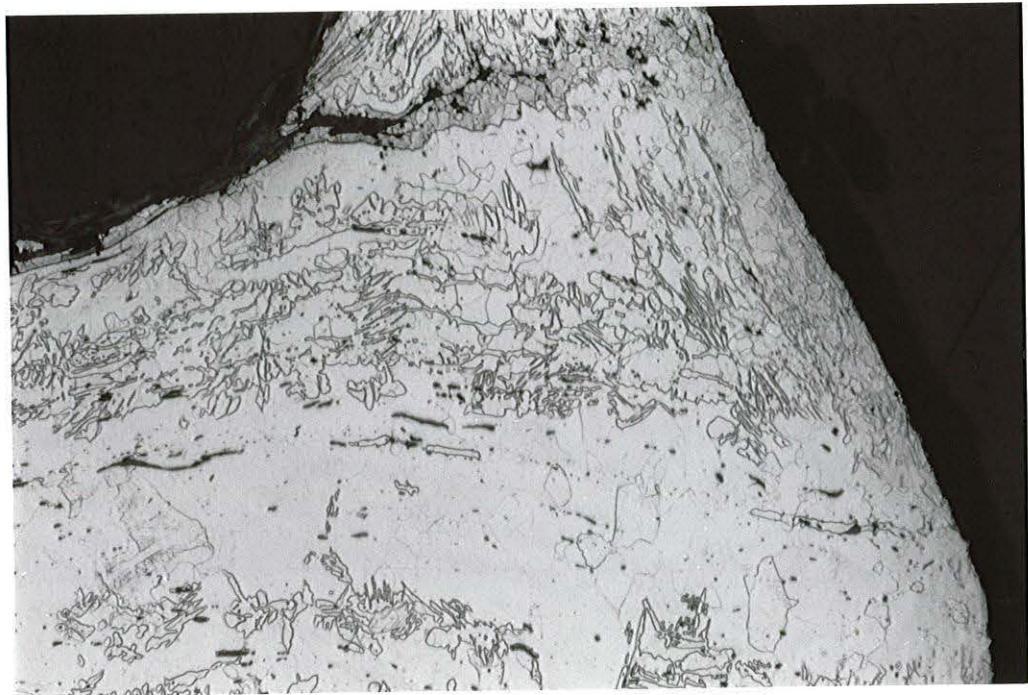
Fig26. Further along the section (of HM236) the same banded structure visible in the previous view (Fig 26), is seen here to continue little changed through the head of the nail. Magnification x50; etched 2% nital.

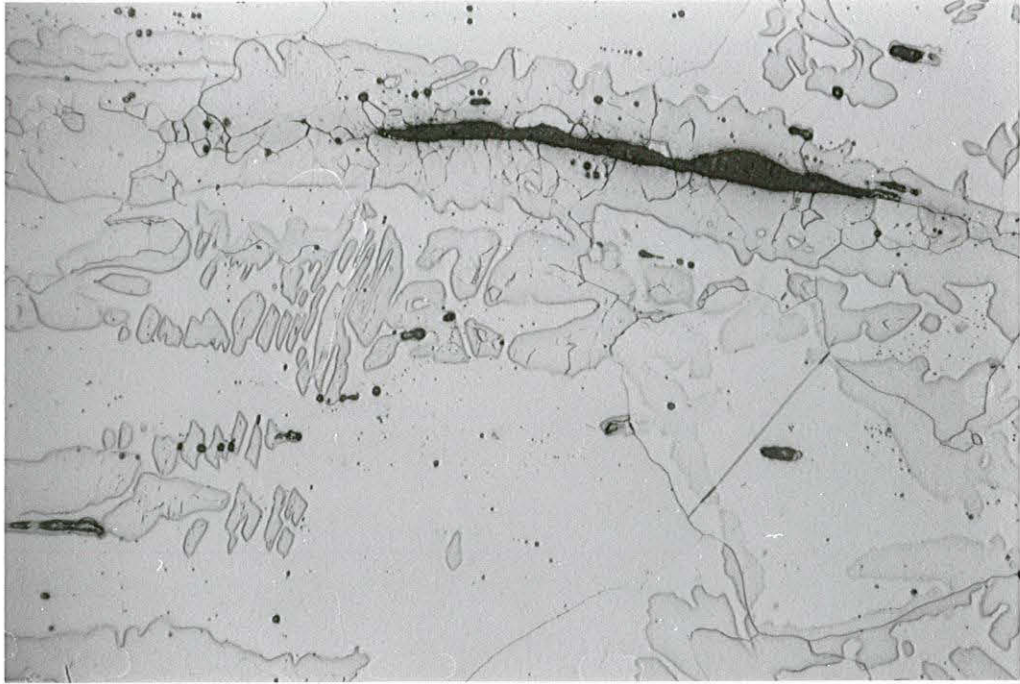
Fig27. Detailed view of the structure in part of the shank of the same nail (HM236) showing part of one of the pale, large grain phosphoric iron bands (over much of the lower part of this view) and a finer grain area lower in phosphorus surrounding a larger ribbon-like slag inclusion near the top of this view. In the in-between areas of intermediate phosphorus content the grain structure of the metal is obscured by a watery looking structure characteristic of phosphorus ghosting. Magnification x200; etched 2% nital.

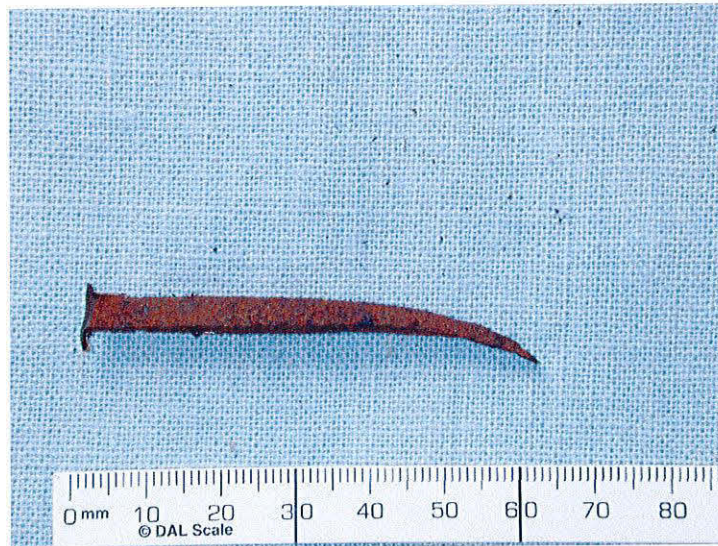
Fig33. A complete nail (HM239) which is well preserved except for damage to the smallish pyramidal head which has four facets. Unlike others of this date the shank is more or less square in cross-section. It belongs to the restoration of *c*1830 and its length is 64 mm.

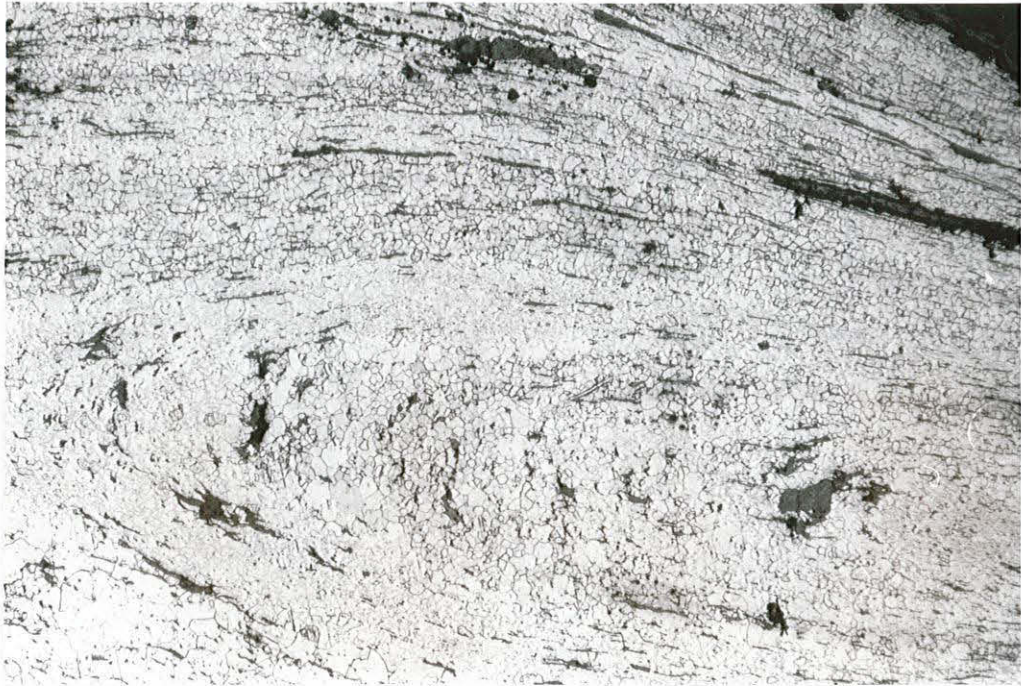
Fig35. Detail showing the convoluted forged structure visible in the head of the nail. Magnification x50; etched 2% nital.

In section the structure was found not to be a simple rolled, puddled iron structure as was found for other nails of this 19th century phase of restoration. Instead a more complex structure dividing into three areas (or parts of the nail) was found although in each of these the structure was almost certainly one of puddled wrought iron demonstrating that this nail does indeed belong to this phase of restoration. This nail has almost certainly been made from at least three pieces of recycled puddled wrought iron (Fig 34). The head and very short length of shank (approximately 1 mm) is made of banded wrought iron reused so that the bands now run across the head, and in one place are actually folded, rather than running straight through it along the main axis of the shank as we would (now) expect for fresh rolled bar iron (Fig 35).

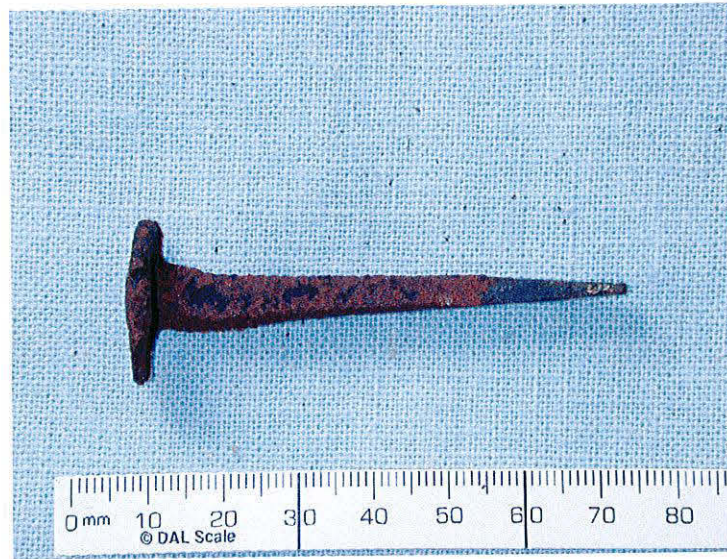
Fig37. A heavy duty nail, one of a group of six found protruding from a part of the ceiling support framework inserted during the restoration of c1830. Length of nail 67 mm.

11. Phase IV, Tie beam of c1830: This was one of a group of six similar nails of a very distinctive type found, not forming any structural function, sprouting like a group of (horizontal) mushrooms sprouting from a tie beam of the c1830 phase of restoration. What they are doing there is something of a puzzle as no nails of this type have so far been noted in any part of the ceiling structure. It is too bulky a nail to have been used for fixing panels in position but nails of this type may have been intended for use part of the restored or reconstructed sub-structure to the ceiling but perhaps not used. Unlike any other nails examined from this ceiling this example had been made from a piece of iron bar circular in section and approximately 9mm in diameter. The head was roughly circular, quite thick and measured approximately 22 mm across. The nail was 67 mm long and most of the shank had been forged down from the original circular section to give four sides tapering down to a relative blunt tip (Fig 37).
