**PETERBOROUGH
CATHEDRAL
NAVE CEILING
PHOTOGRAPHS**

PART II

APPENDIX B: PAINT ANALYSIS / PHOTOMICROGRAPHS

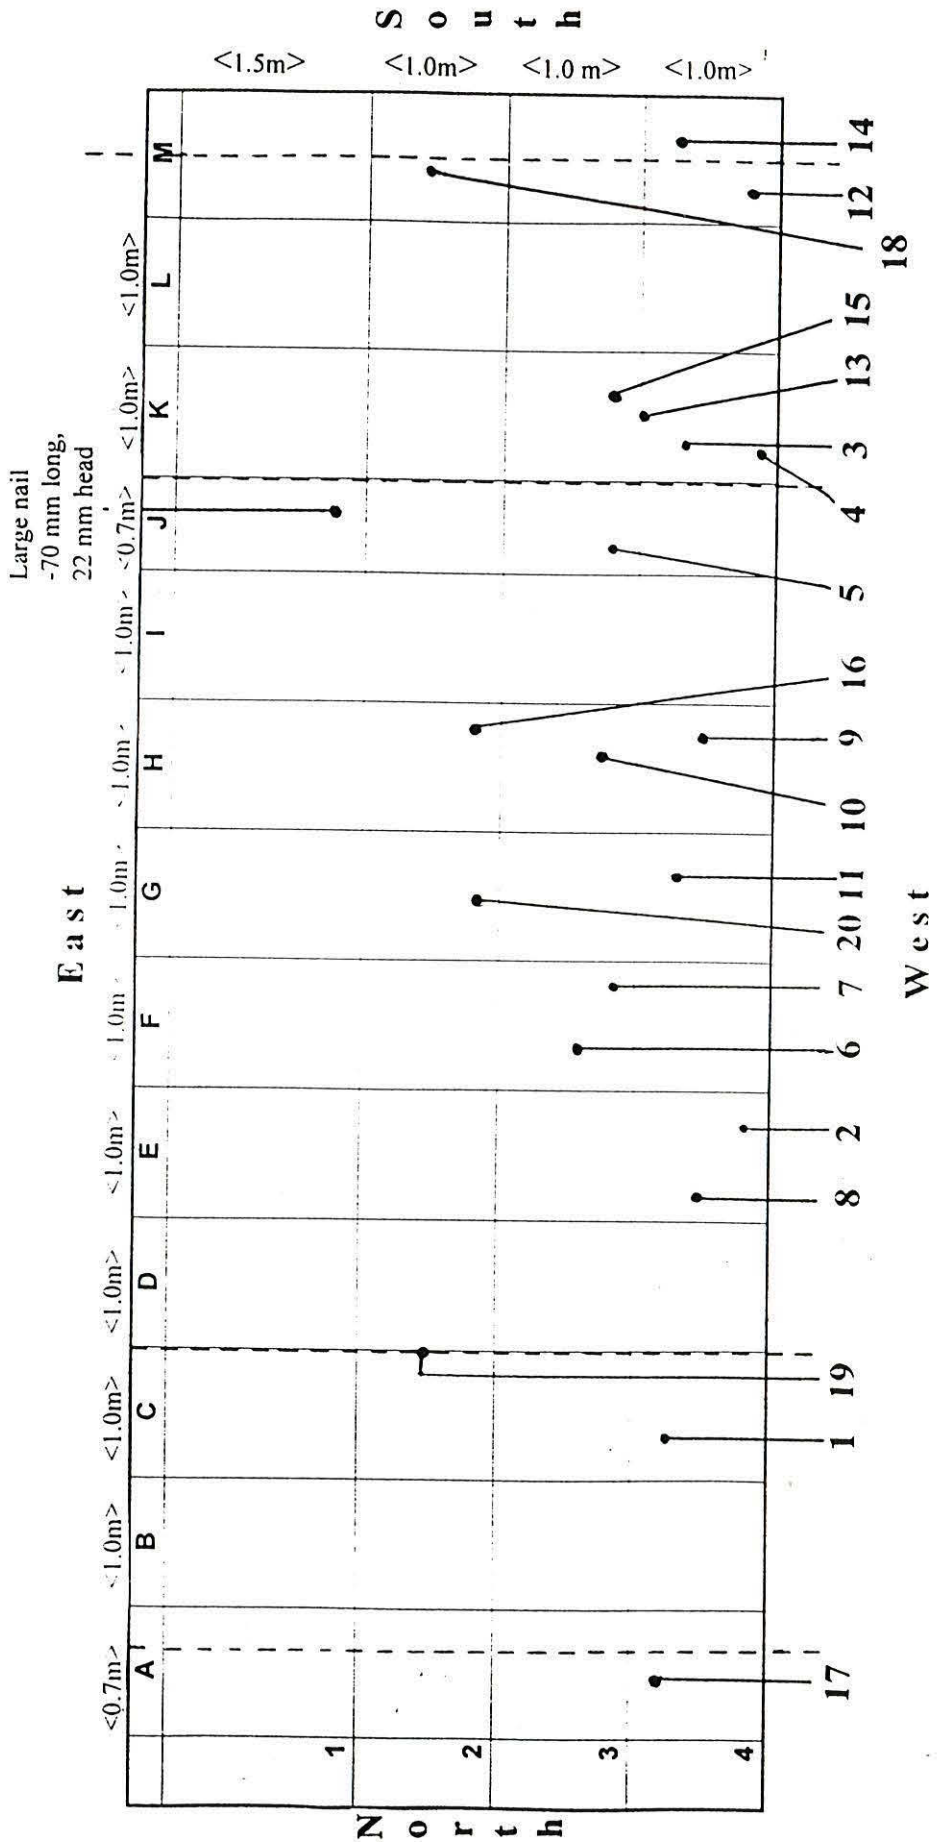
PLAN SHOWING LOCATION OF PAINT SAMPLES

A number of paint samples were taken for microchemical and cross-sectional analysis to help determine the layer structure, pigments, date, medial and sequence of previous restorations. The results are tabulated below.

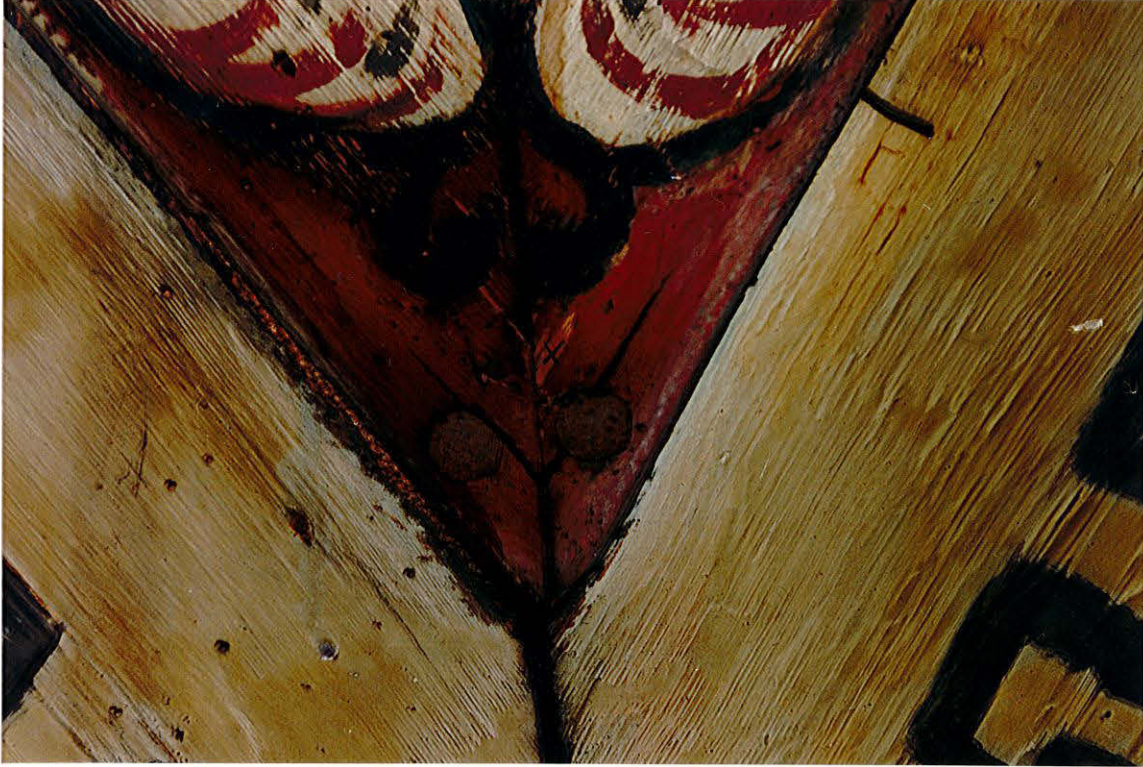
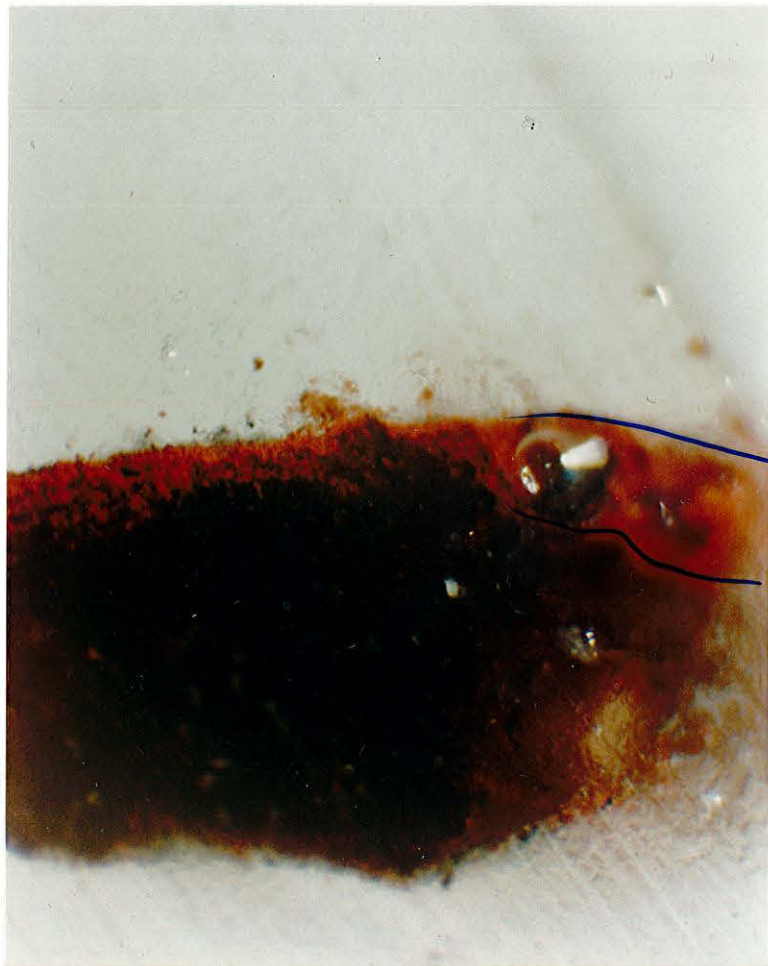
Sample no.	Location	Colouration/pigments/media/layers
1	C4	Red ochre paint (old layer on black) from red lozenge surround to face. Note: White ground layer appears to be absent from earlier painted decoration.

red ochre

wood

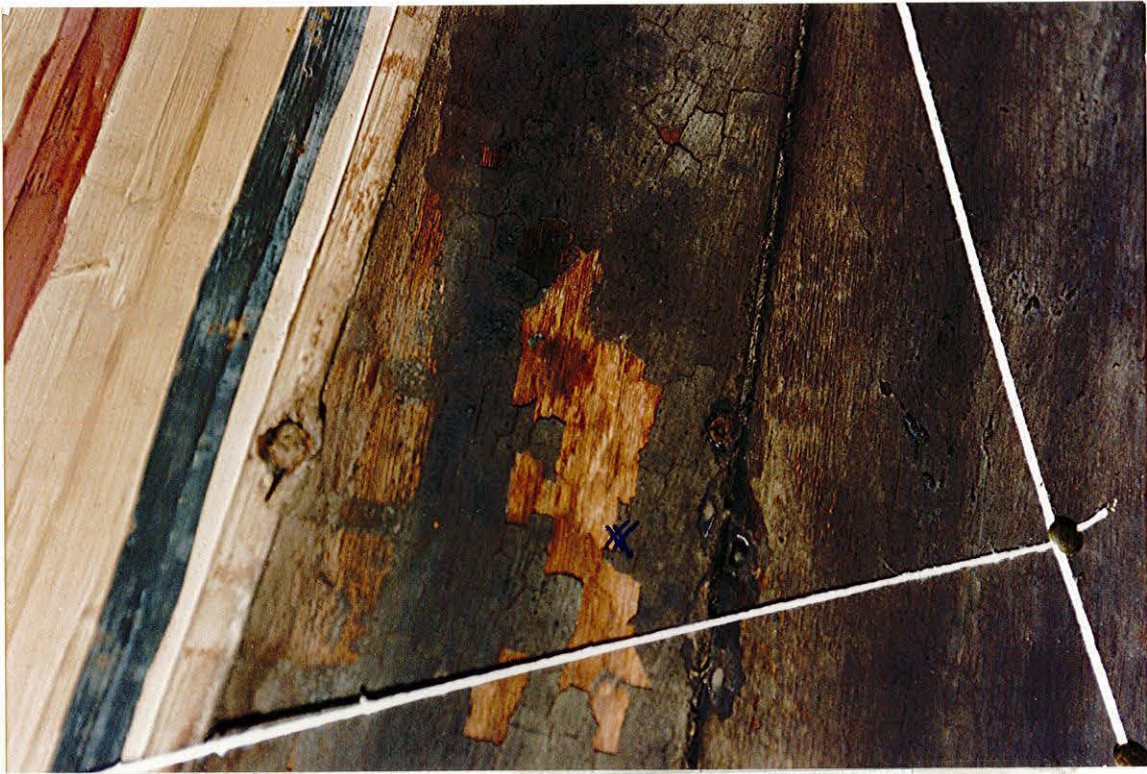
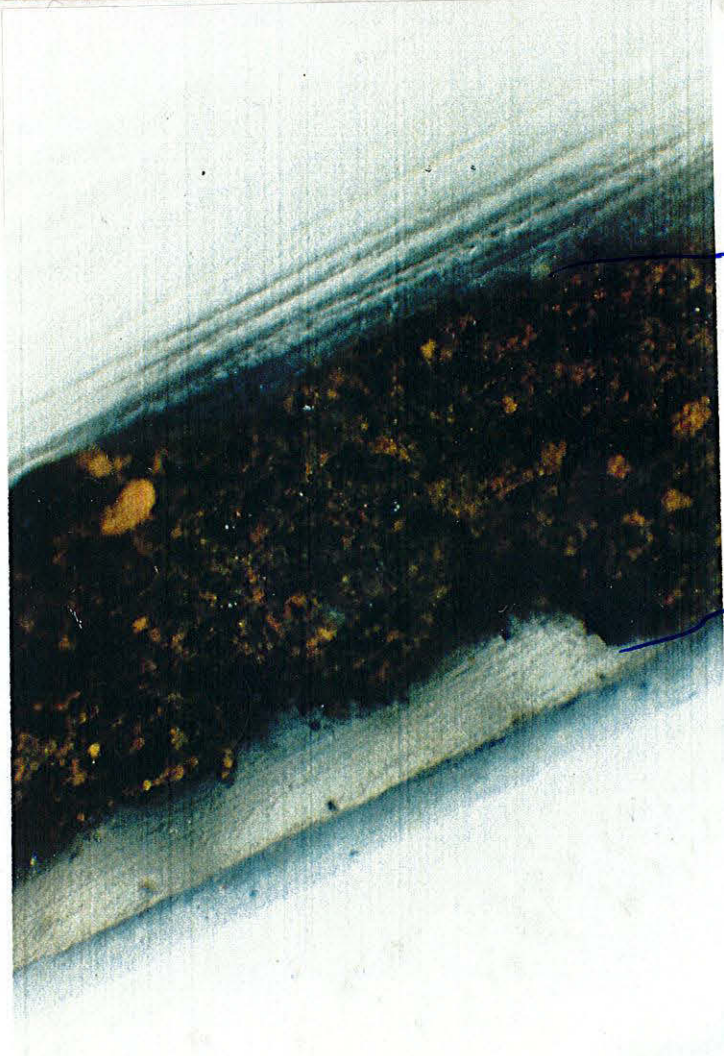
2

One layer - a mixture of black and brown earth particles, no apparent ground layer. NB - flaking apparent.

One layer -
black & brown
(earth) particles
No Ground

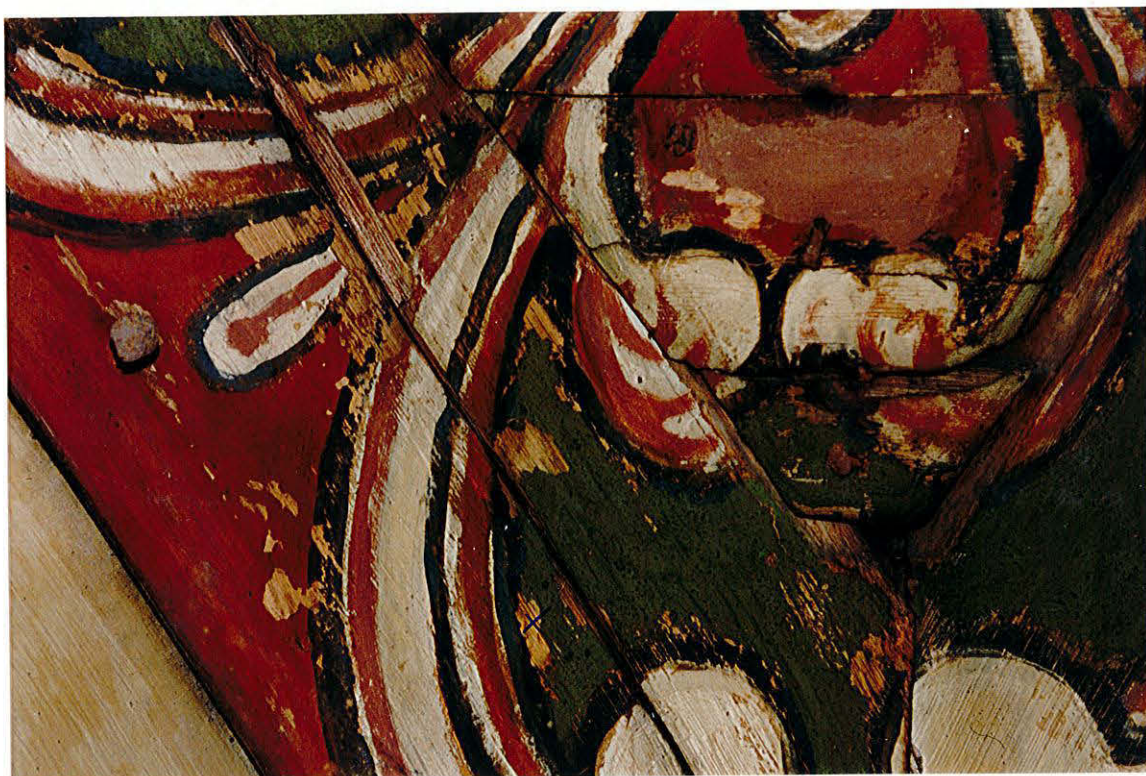
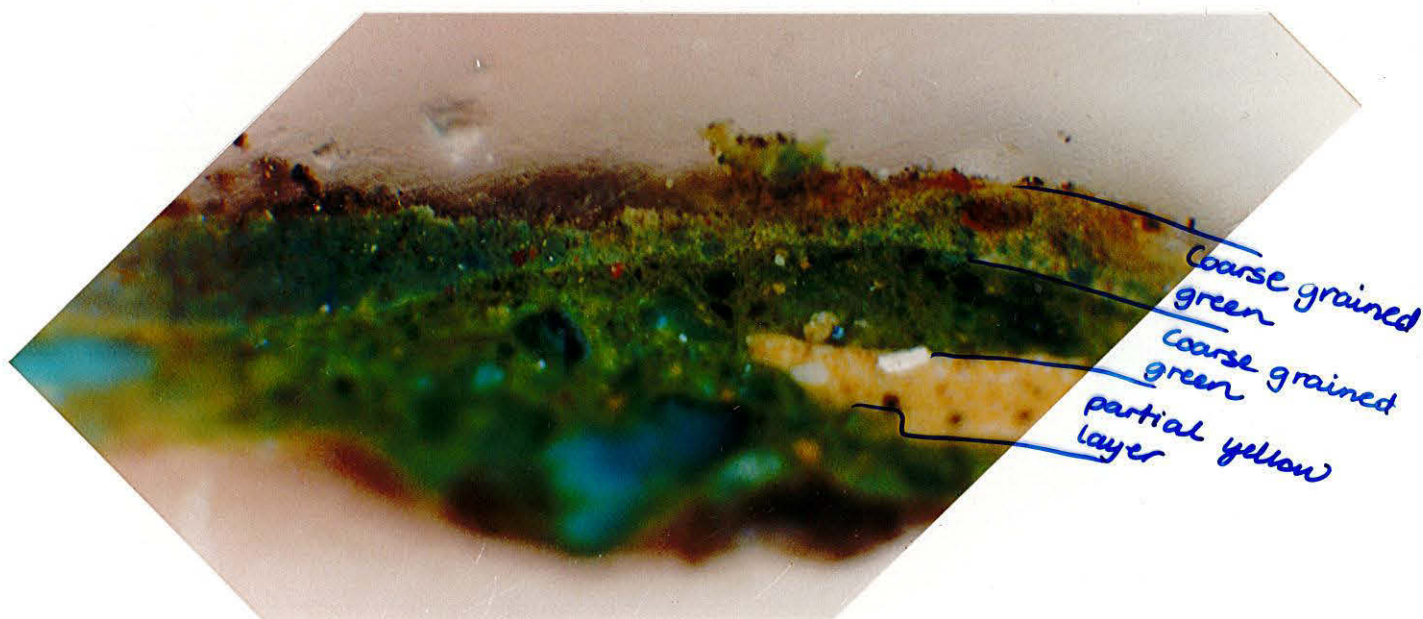
Coarse grained Verdigris (copper acetate) are visible as the blue/green clear particles in x-section. No ground layer evident. From corner section of face to green man, most likely to be original paint. On the second x-section a partial yellow layer lies beneath the green layers. From corner section of face to green man, most likely to be original paint. NB - flaking of the coarse grained layer is evident.

- 1 A golden ground layer was evident, possibly composed of chalk in a size medium. Small, clear particles were evident.
- 2 A thinner, whitish layer was noted.
- 3 A partial thin layer of black (charcoal?) and red particles was also evident. This may be underdrawing.
- 4 Large, irregular particles of a copper blue were interspersed with yellow ochre.
- 5 Nothing of note was observed under U.V. examination.

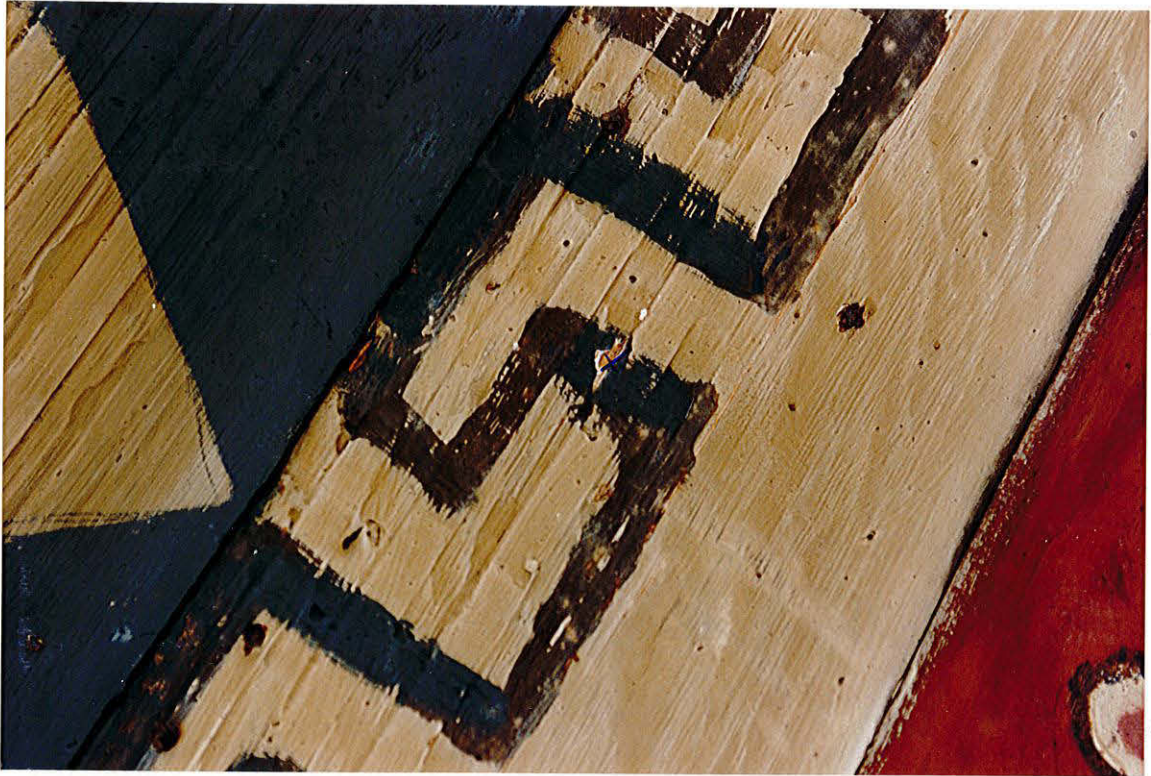
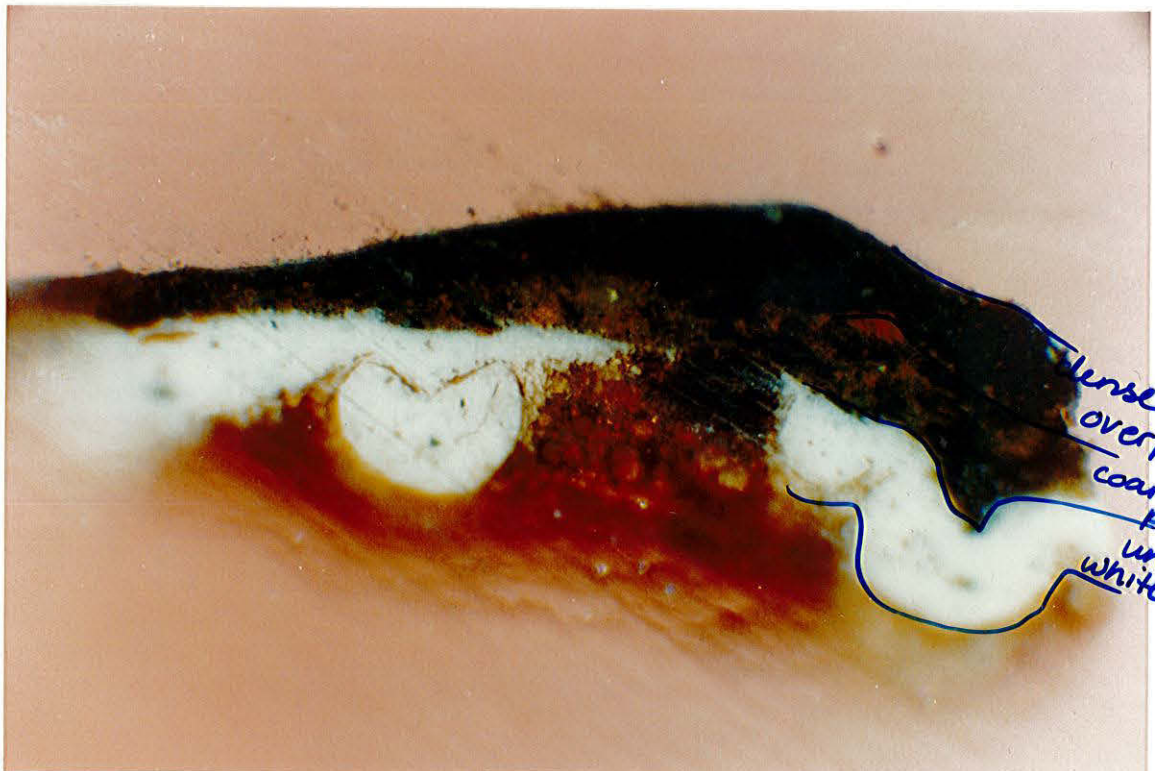
4

Black layer with earth coloured particles evident, on white ground or gesso. From grooved area of older board. See x-section.

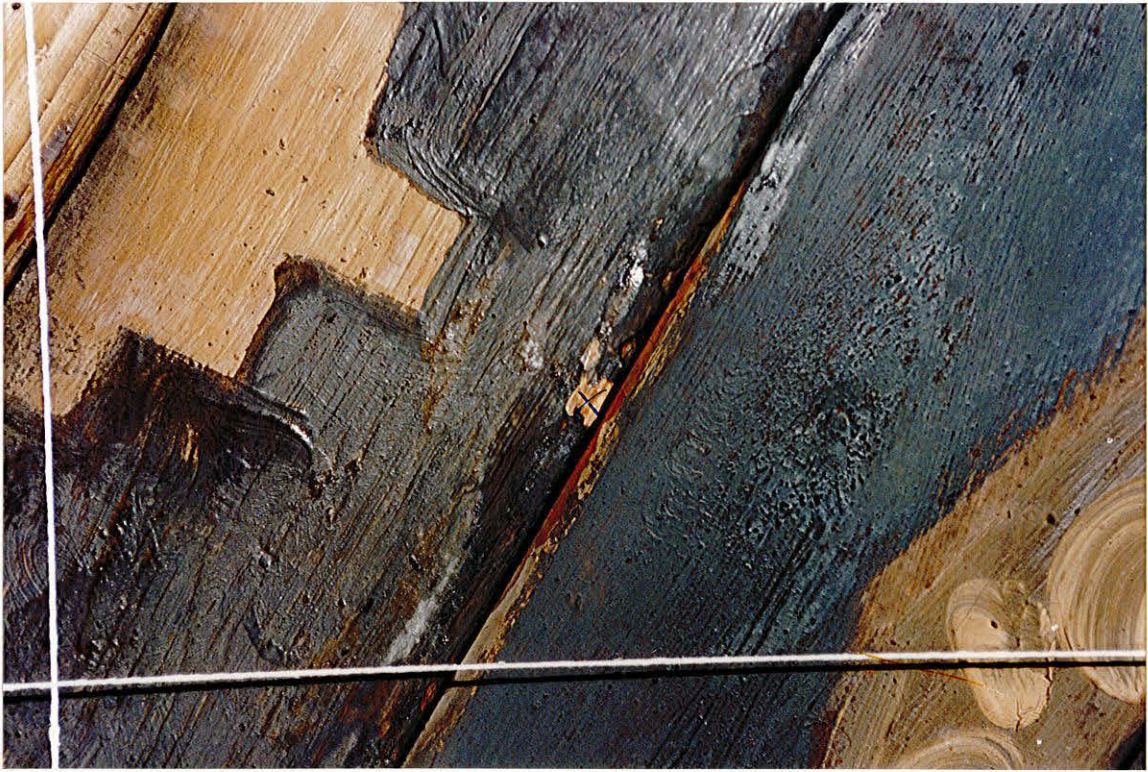
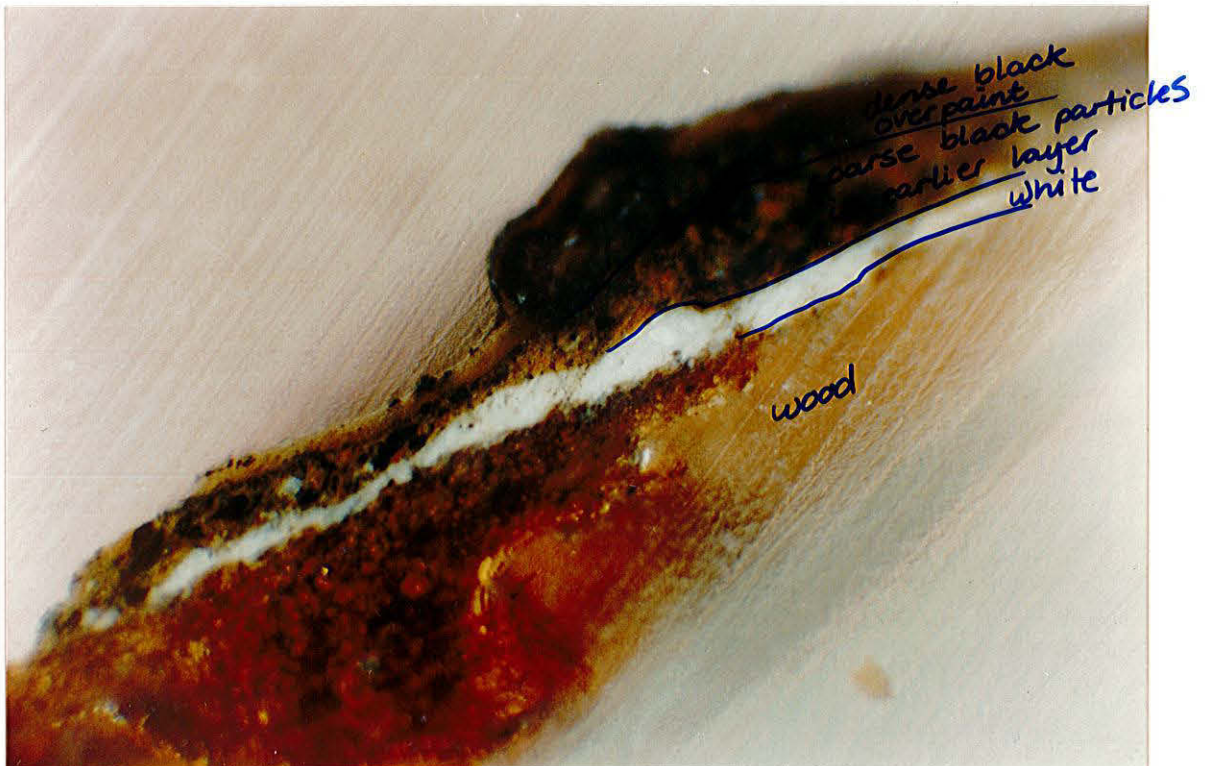
5

Black layer on white ground. Appears glossy but thin in situ, from an older board. Contains earth coloured particles and a discontinuous transparent layer on top (possibly glue-drips from hessian application). See x-section.

- 1 A golden layer was noted on the top of the sample. This appeared to be glue size (probably from the hessian application).
- 2 In U.V. this layer fluoresced slightly and was confirmed as glue. The fluorescence could result from an anti-bacterial additive to the glue size.
- 3 A very mixed coarse layer, at first thought to be black, contained brown particles.

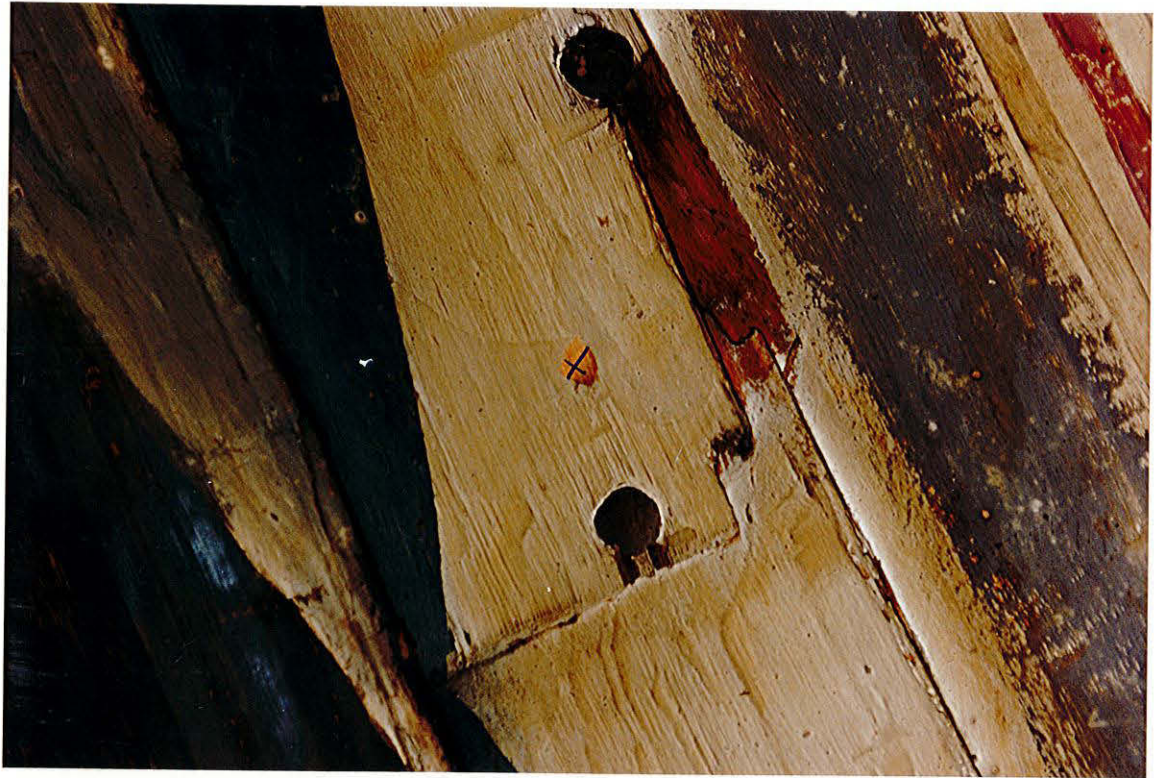
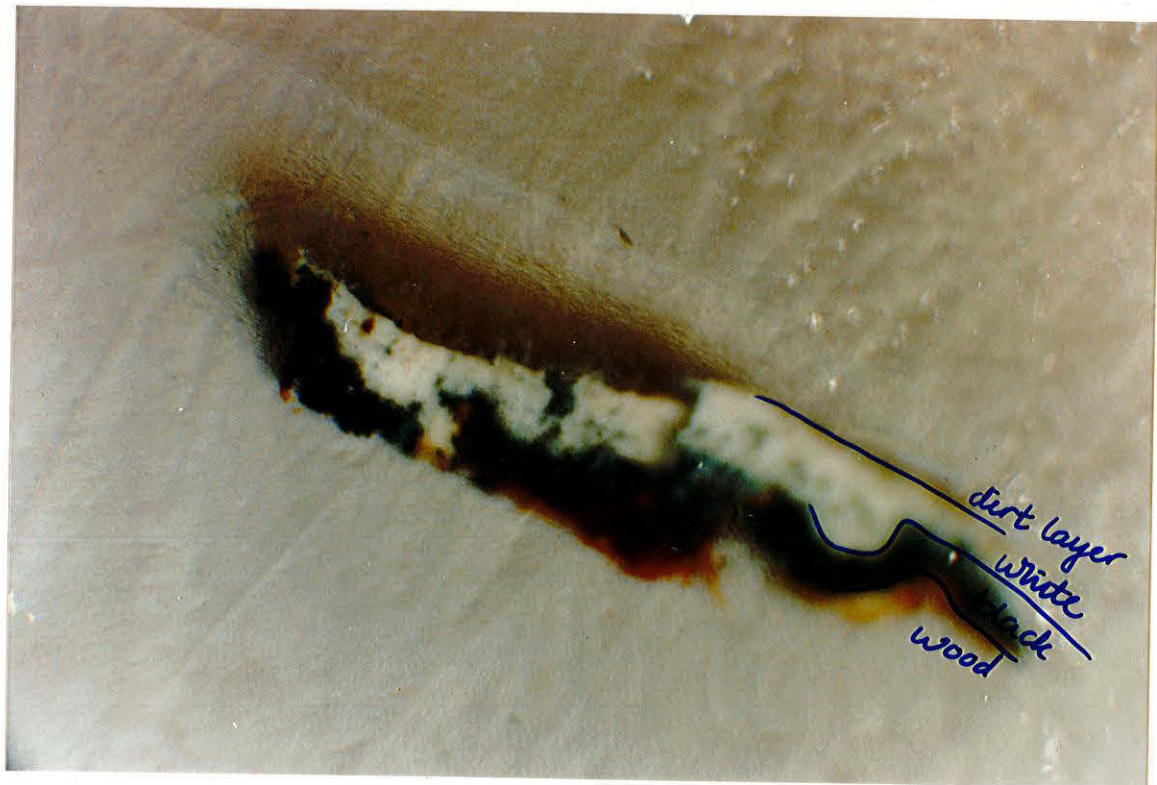
6

Buff/white paint with dirt layer taken from area where underpaint could be seen. No obvious ground layer. Relief pattern seen in raking light in situ. See x-section.

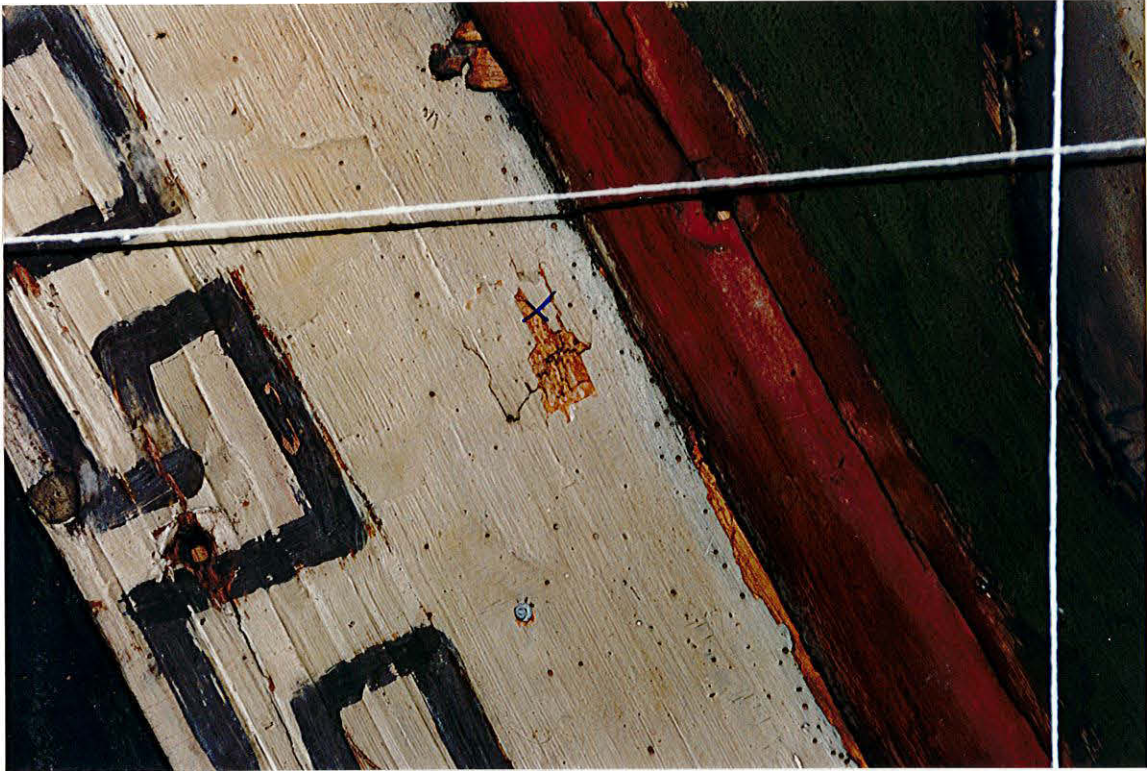
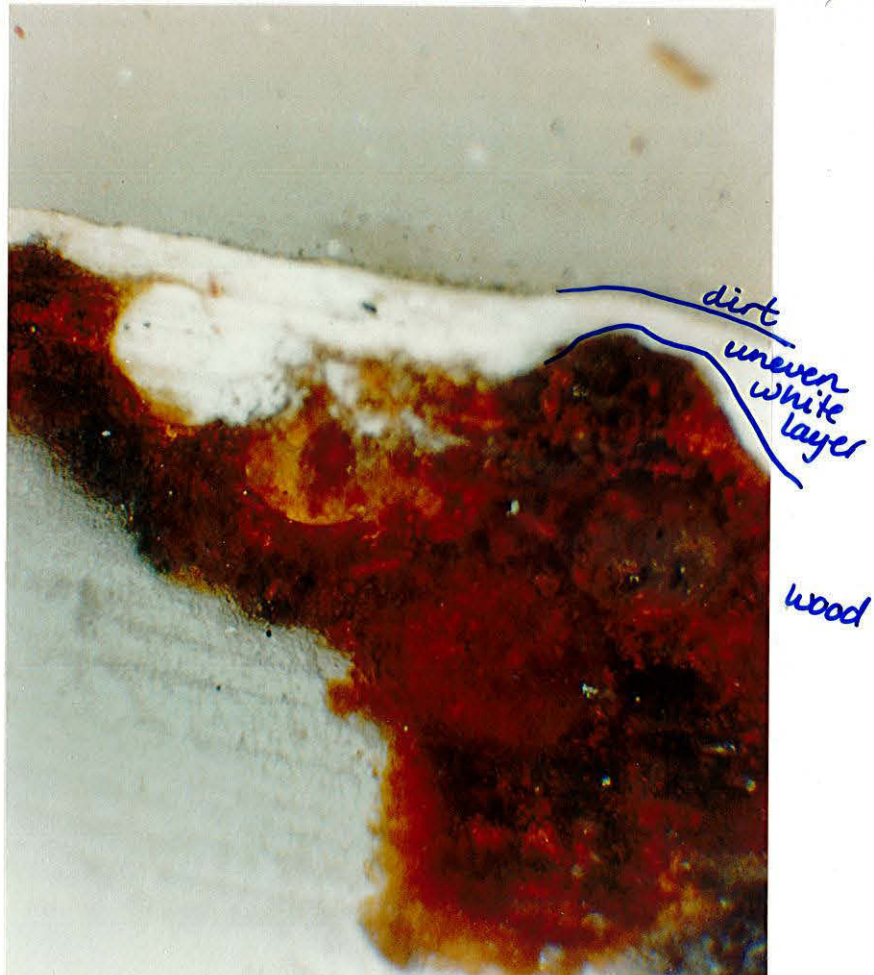
7

Buff/white paintlayer on wood.

- 1 The sample has only one layer of white, where it was suspected there could be two.

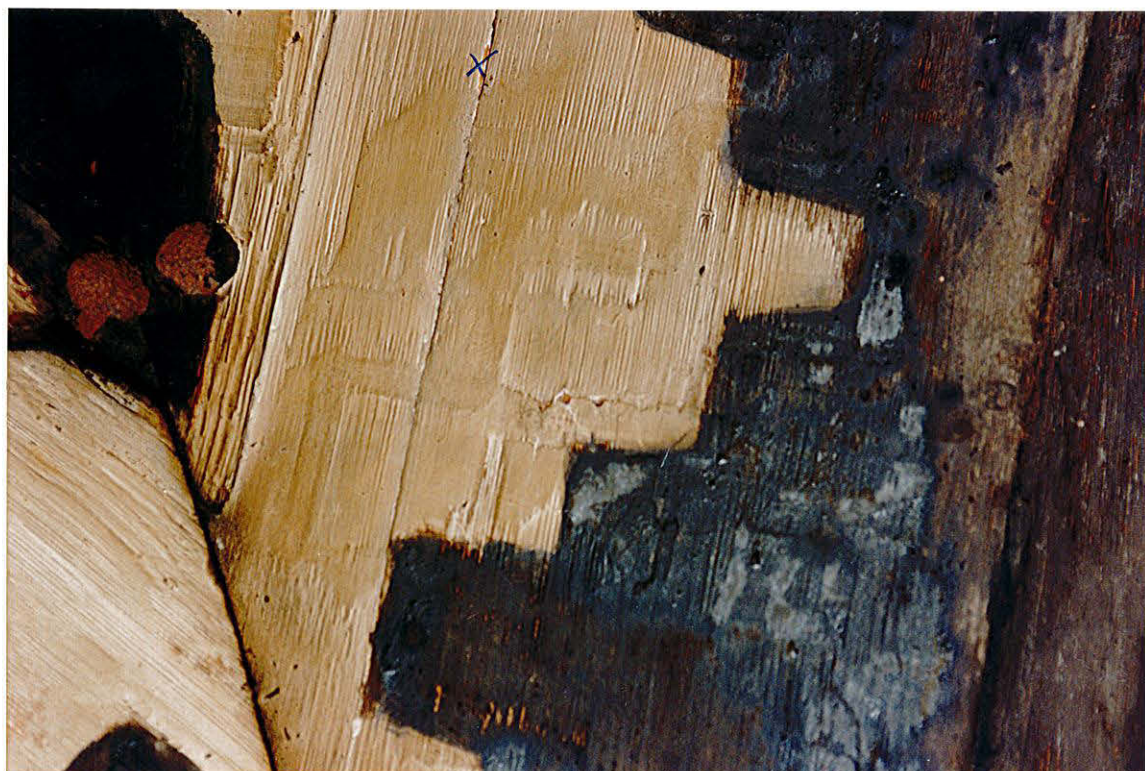
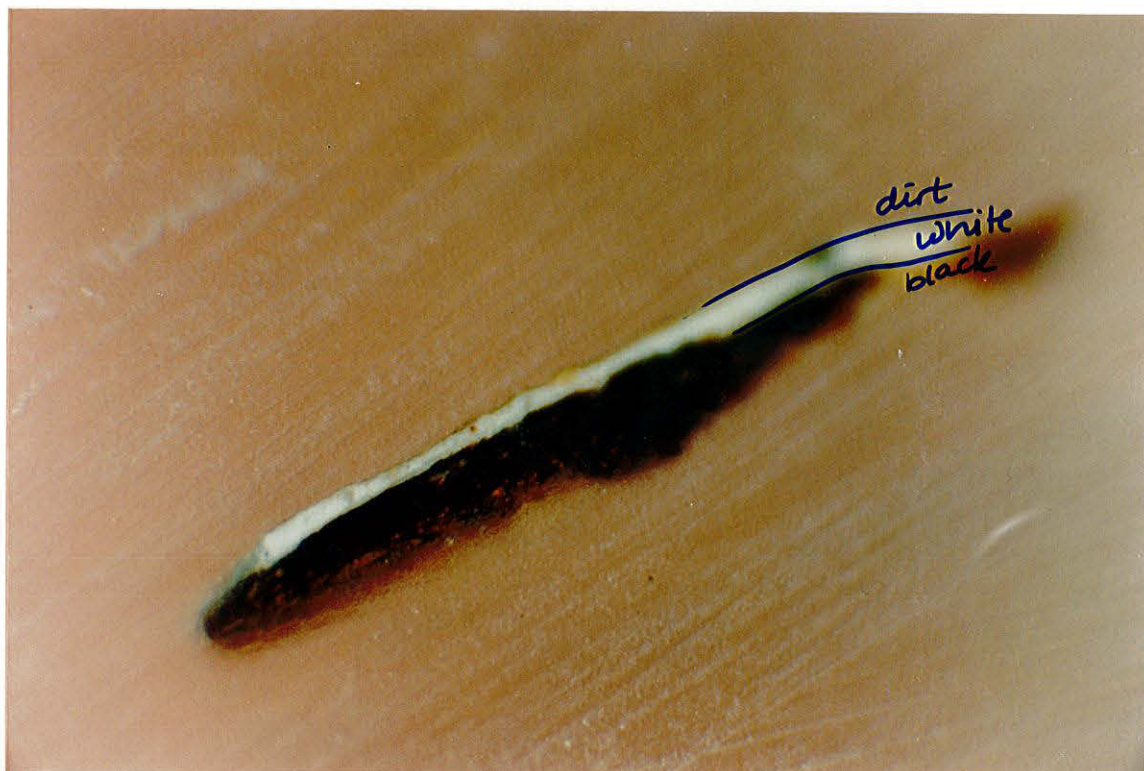
8

White paint layer on black thin underpaint. In situ underpainted design seen in raking light. The board was presumably re-located at some time. See x-section.

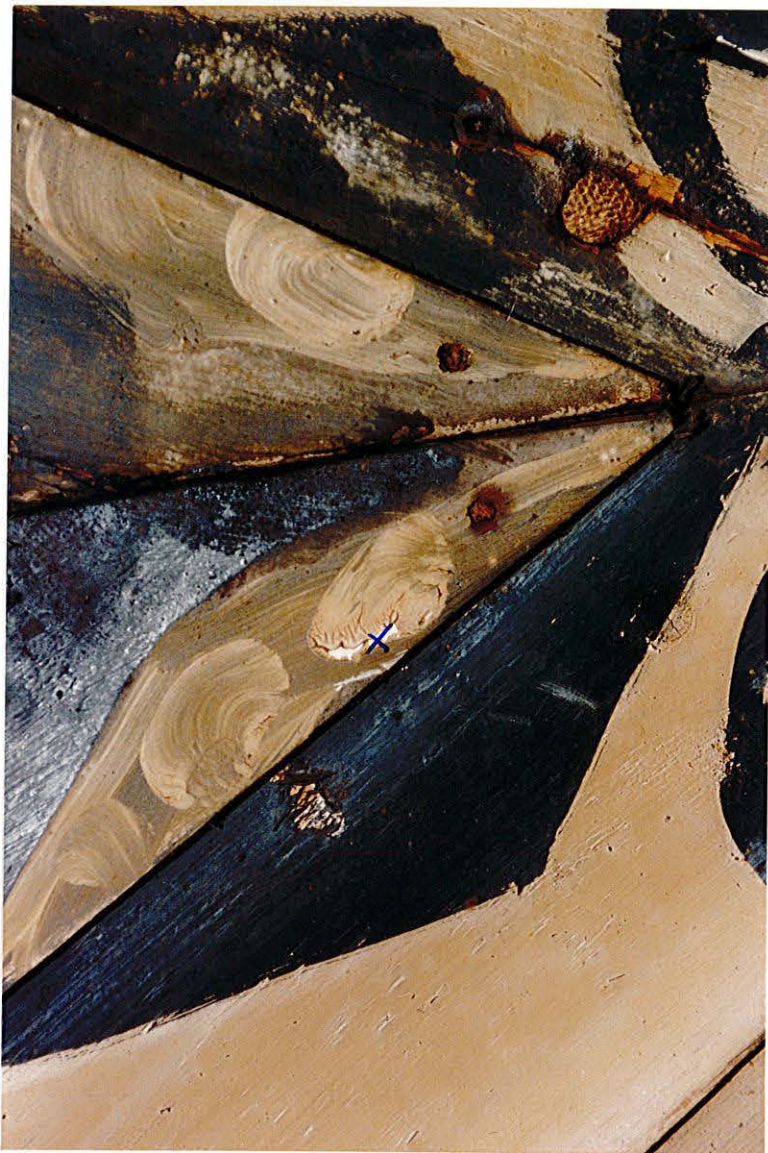
9

H4 Thick layer on white ground. High impasto overpaint seen in raking light. (Cross-section inconclusive - photomicrograph hence not included.)

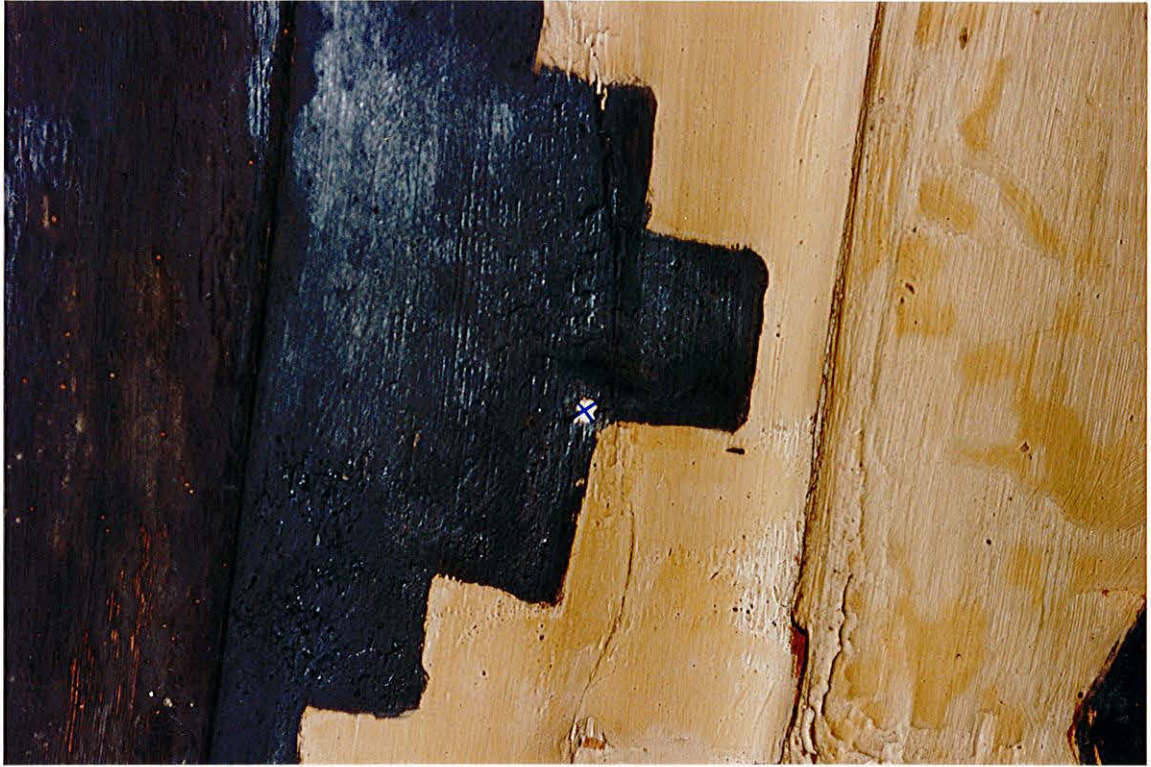
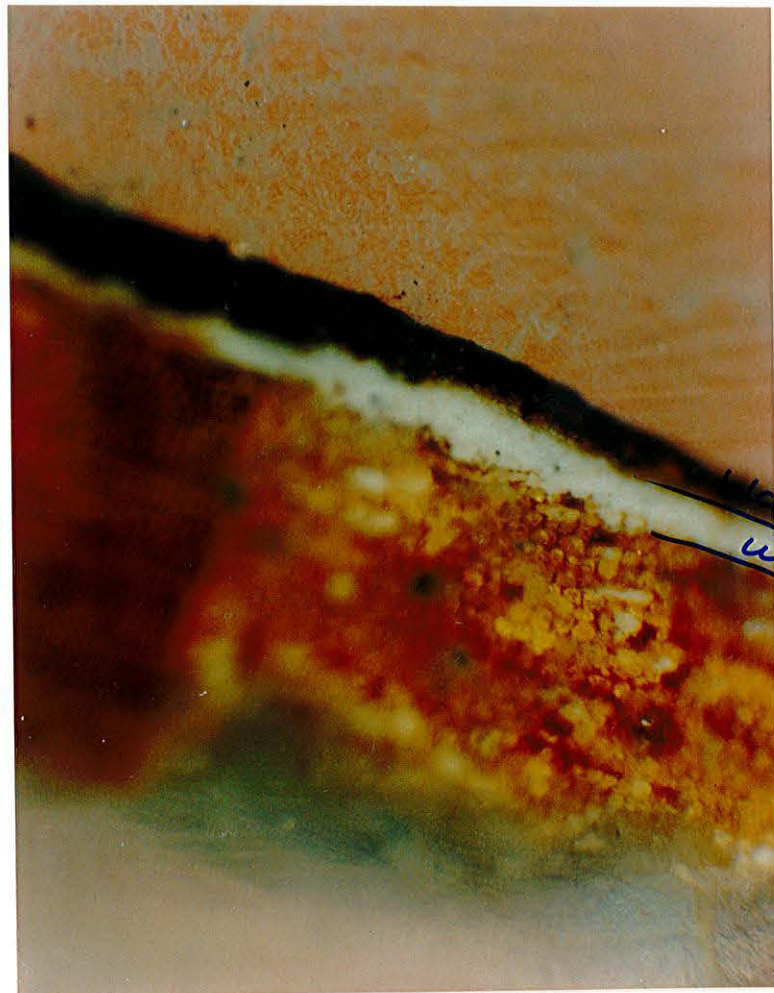
10

Black layer on white ground. From new board. See x-section.

Black
White
Wood

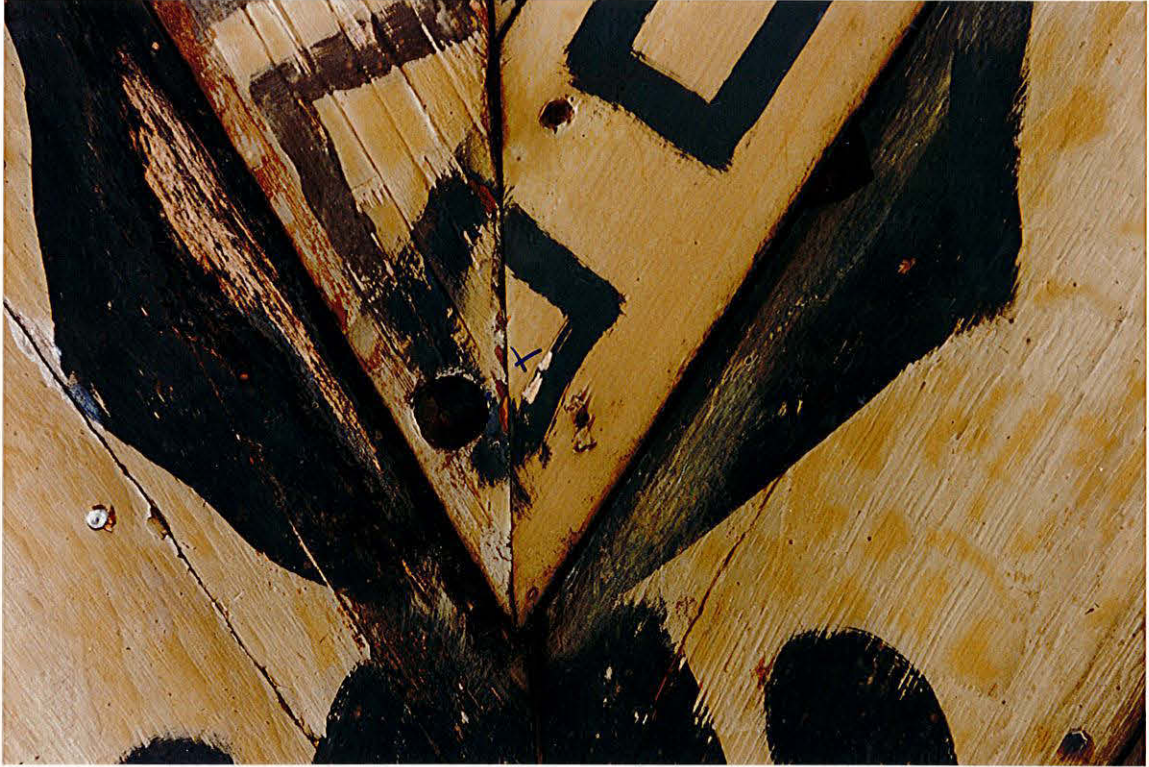
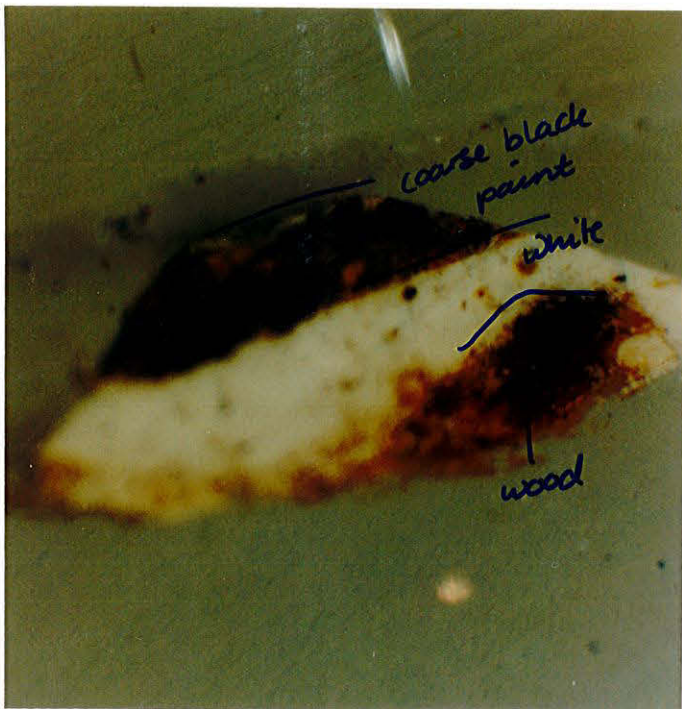
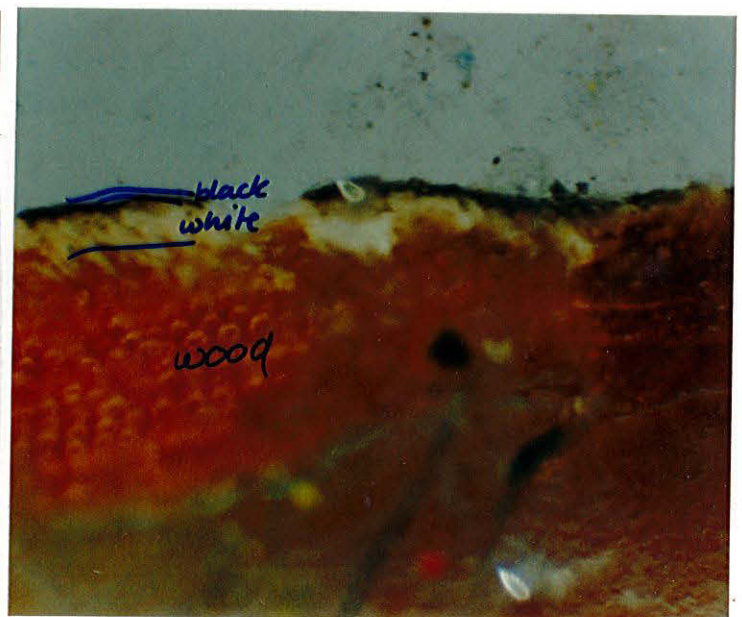
11

Two samples were taken - one from old board and one from new board. See cross-sections for comparison of paint layers.

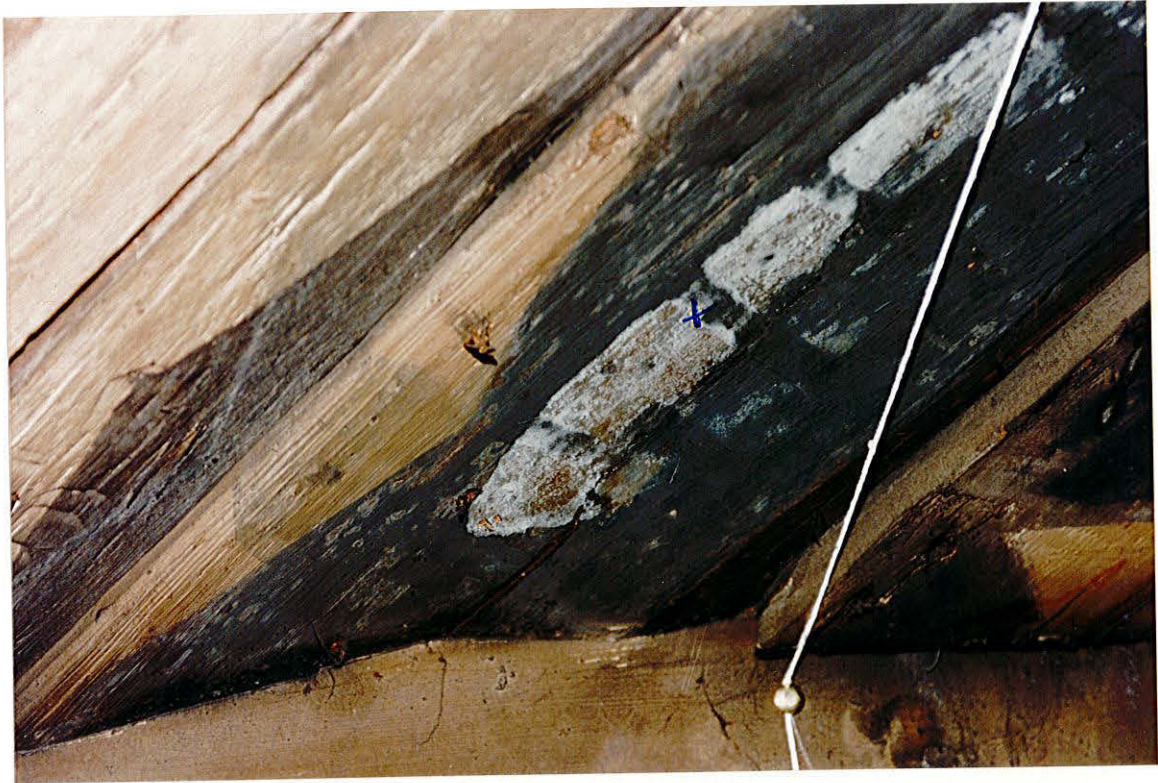
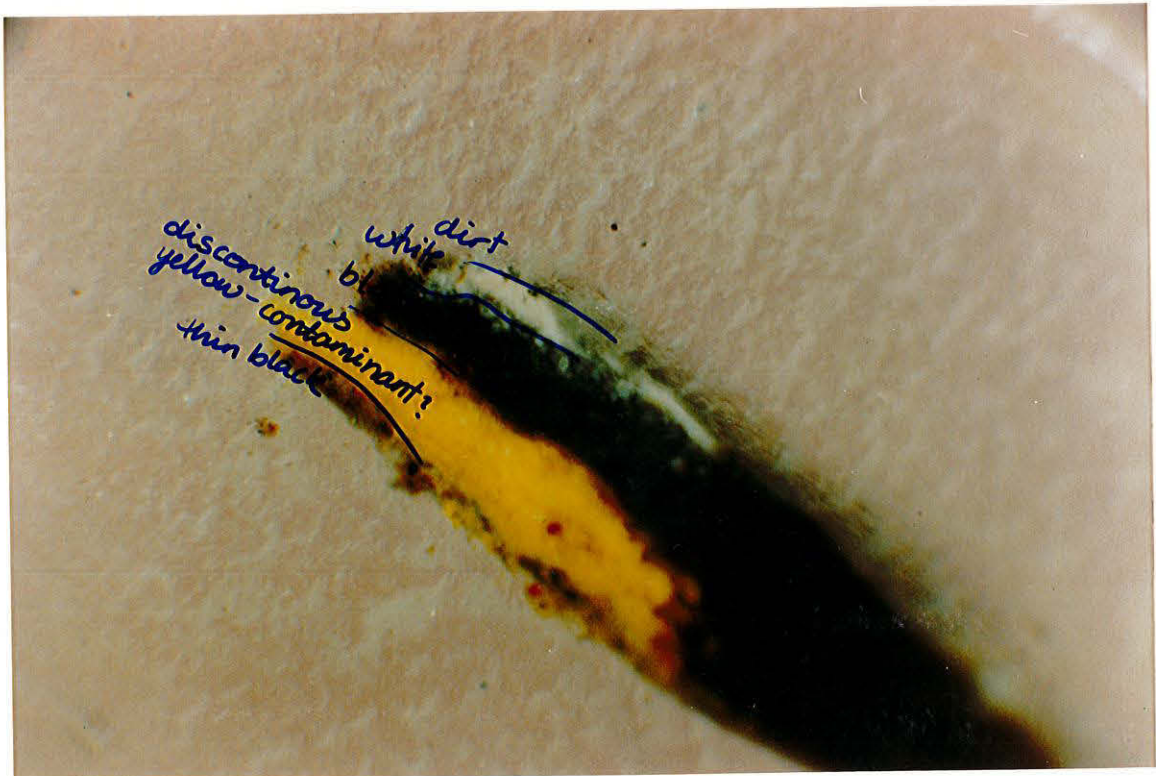
12

Black layer on white ground with a discontinuous yellow layer. In situ, surface is greyish and discontinuous. See x-section.
