**PETERBOROUGH
CATHEDRAL
NAVE CEILING
PHOTOGRAPHS**

PART II

APPENDIX B: PAINT ANALYSIS / PHOTOMICROGRAPHS

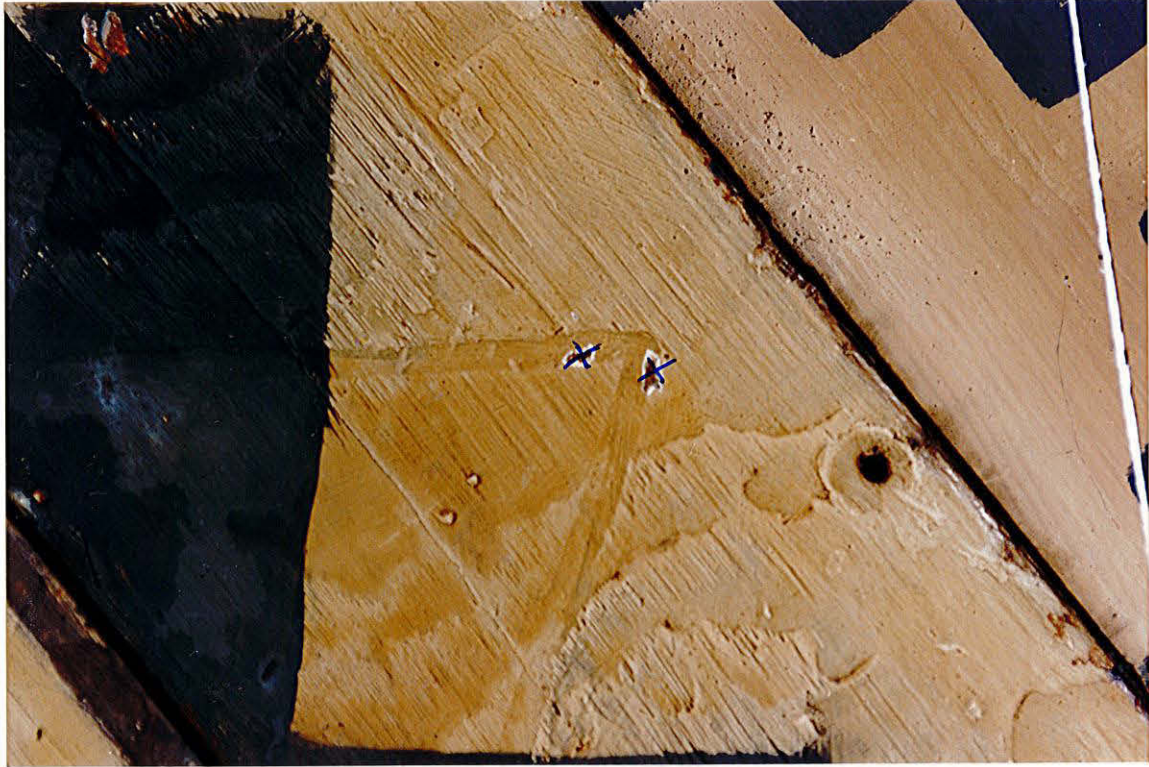
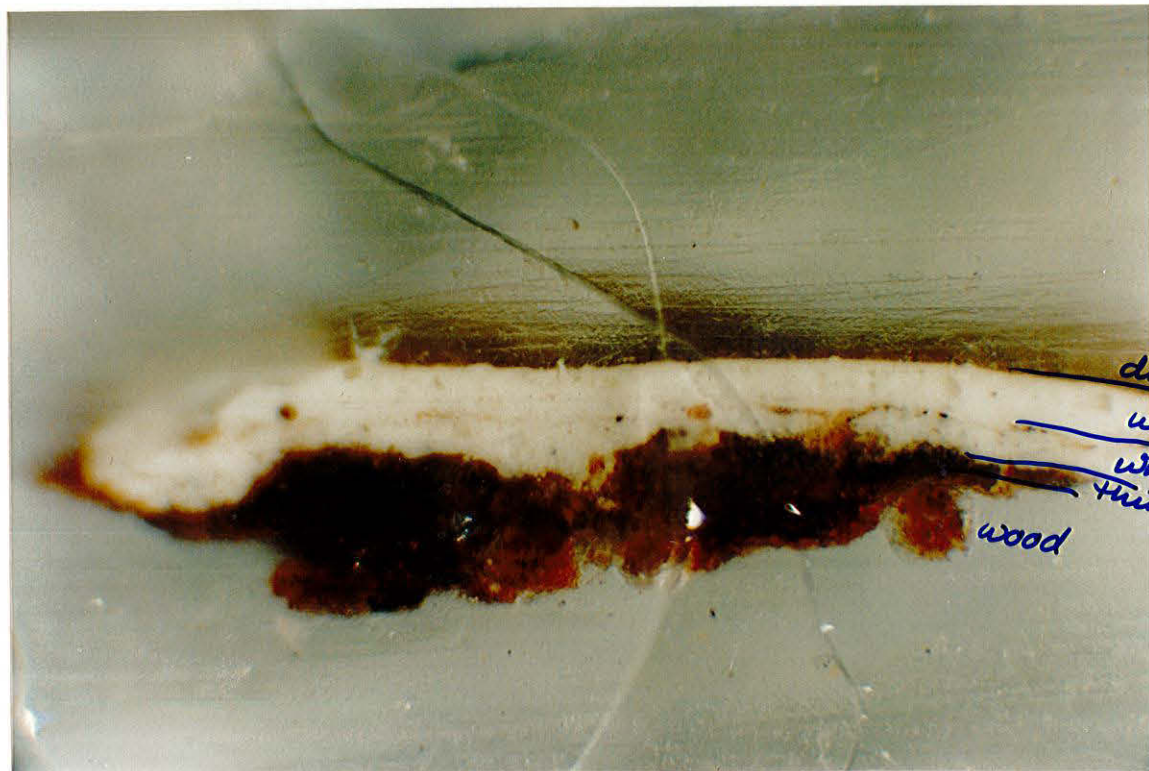
13

White paint layers on black. Cream surface with white ground, clearly an altered design on old board. See x-section.

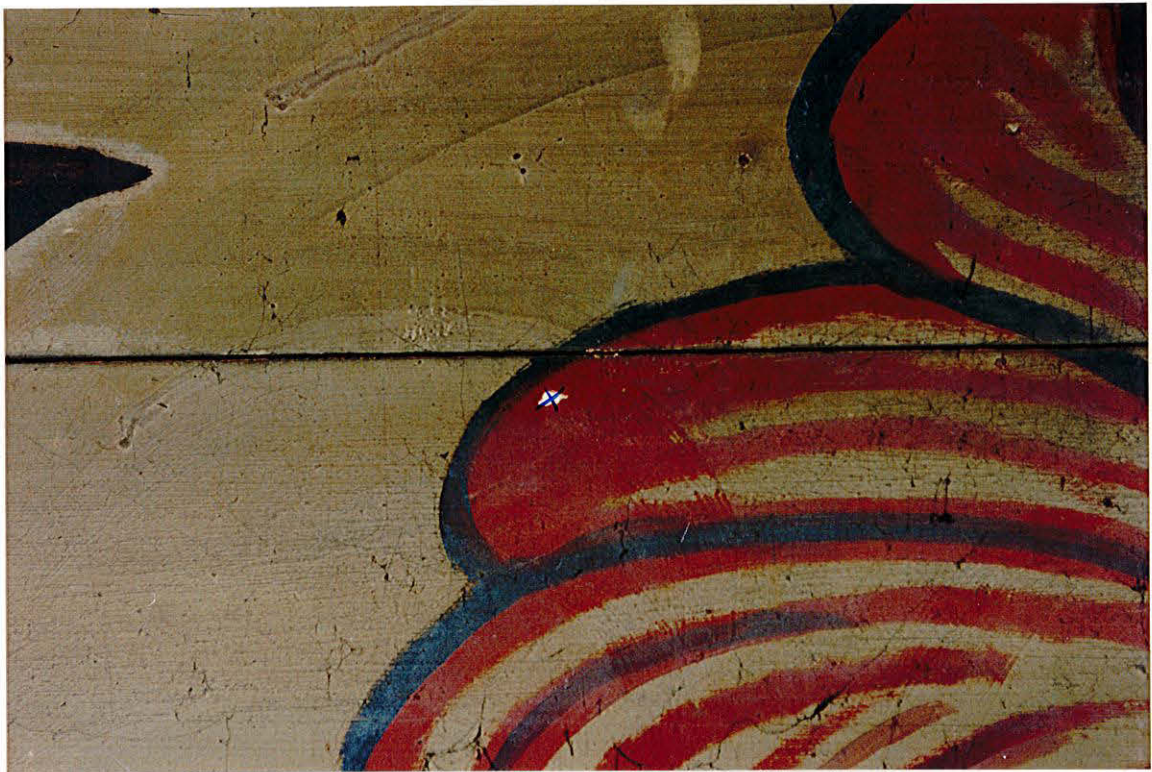
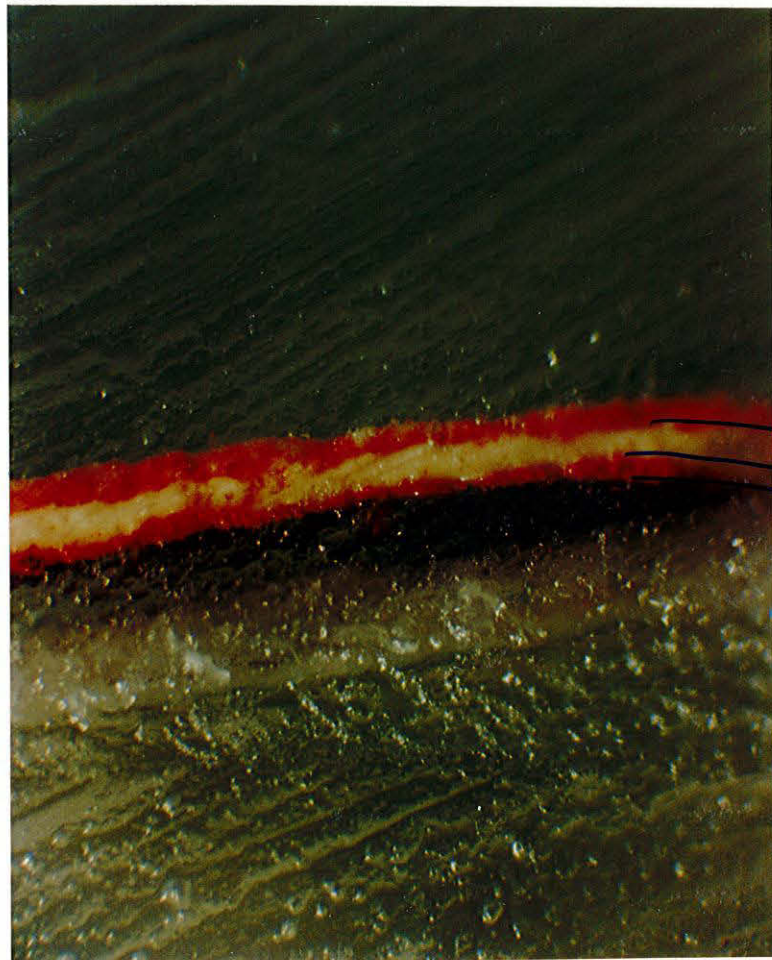
14

Red from flower petal, North-side. Cross-section showing red on white on red.

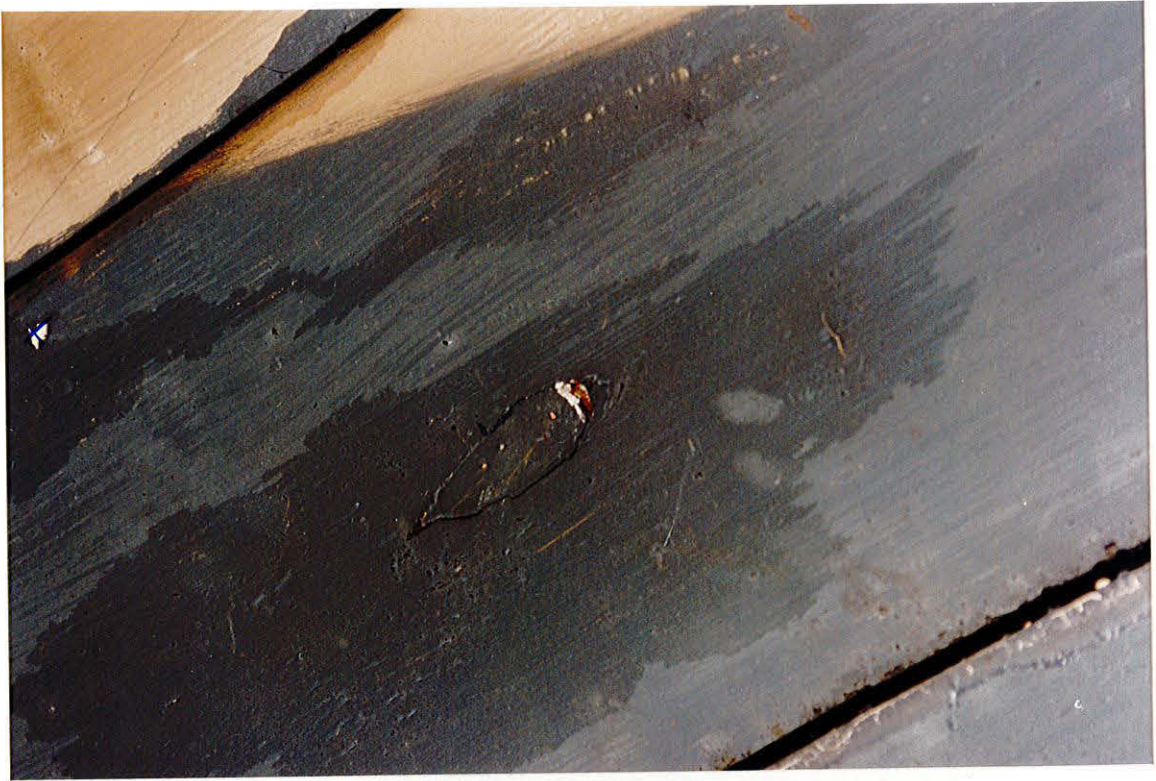
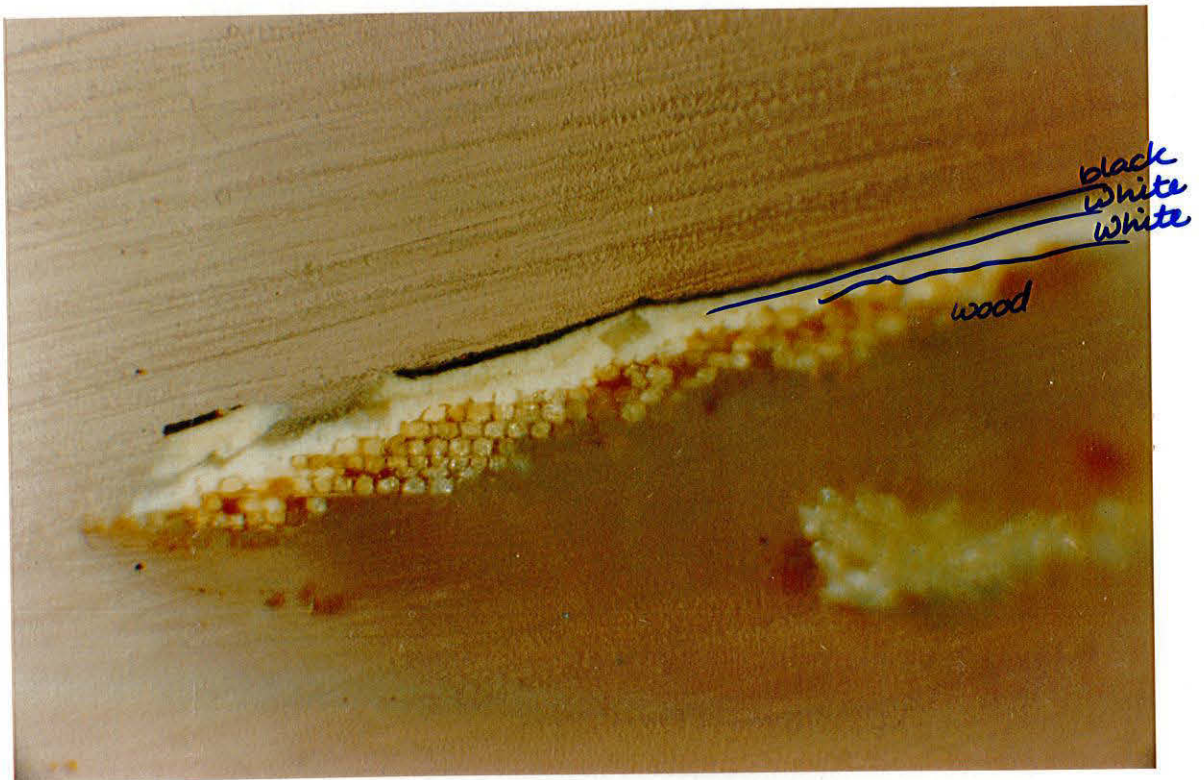
15

Black layer on white ground layers. Appears greyish in situ on newer board.

- 1 Softwood.
- 2 Chalk ground with inclusions. Possibly two ground layers.
- 3 Single black layer.

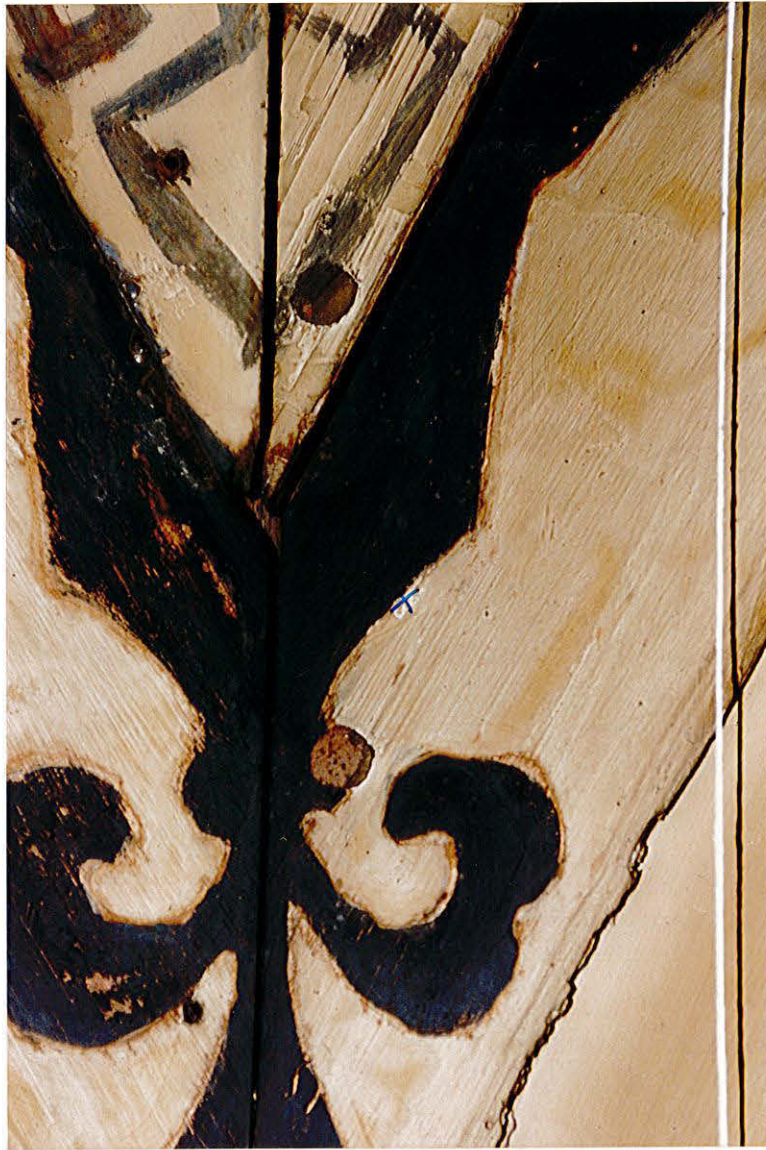
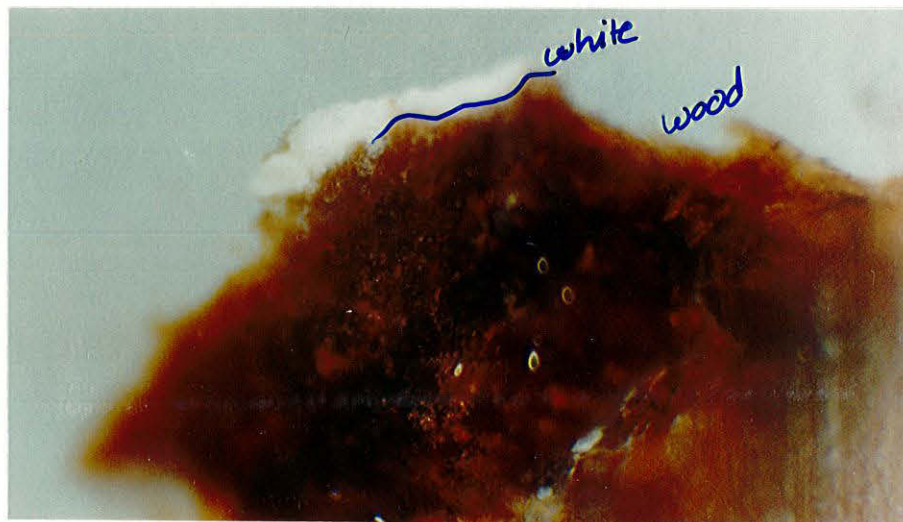
16

Cream/white paintlayer on wood. From edge of black design on old board.

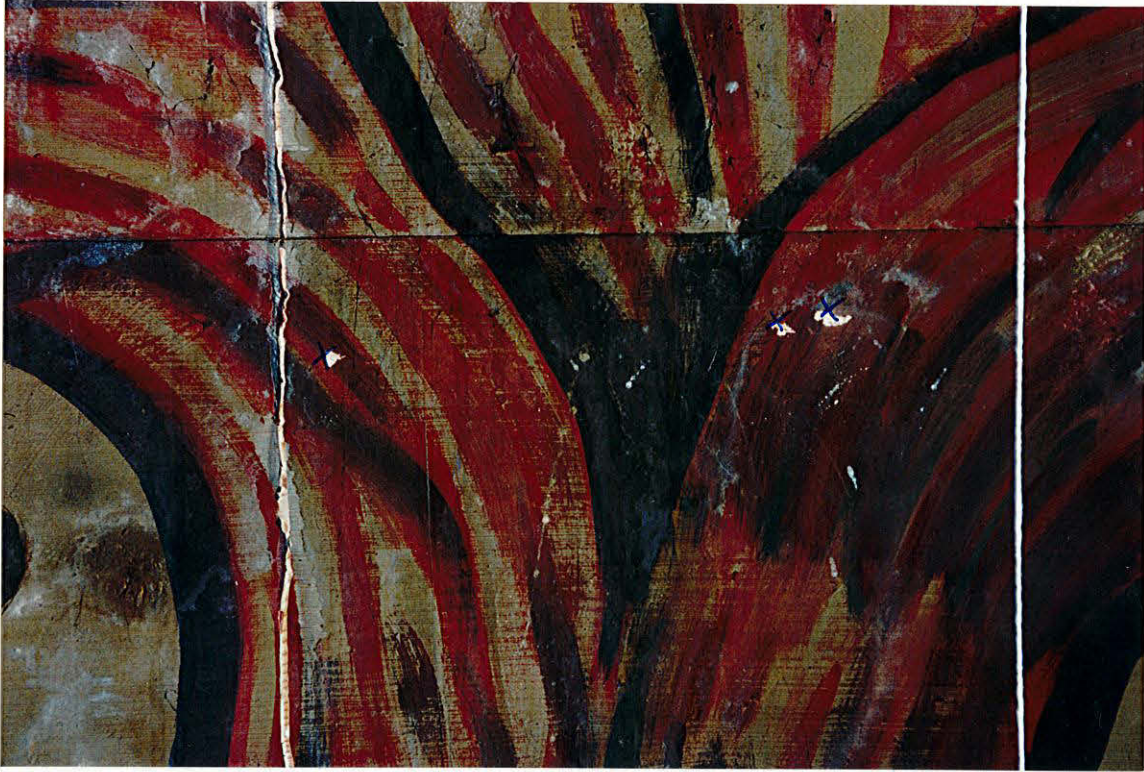
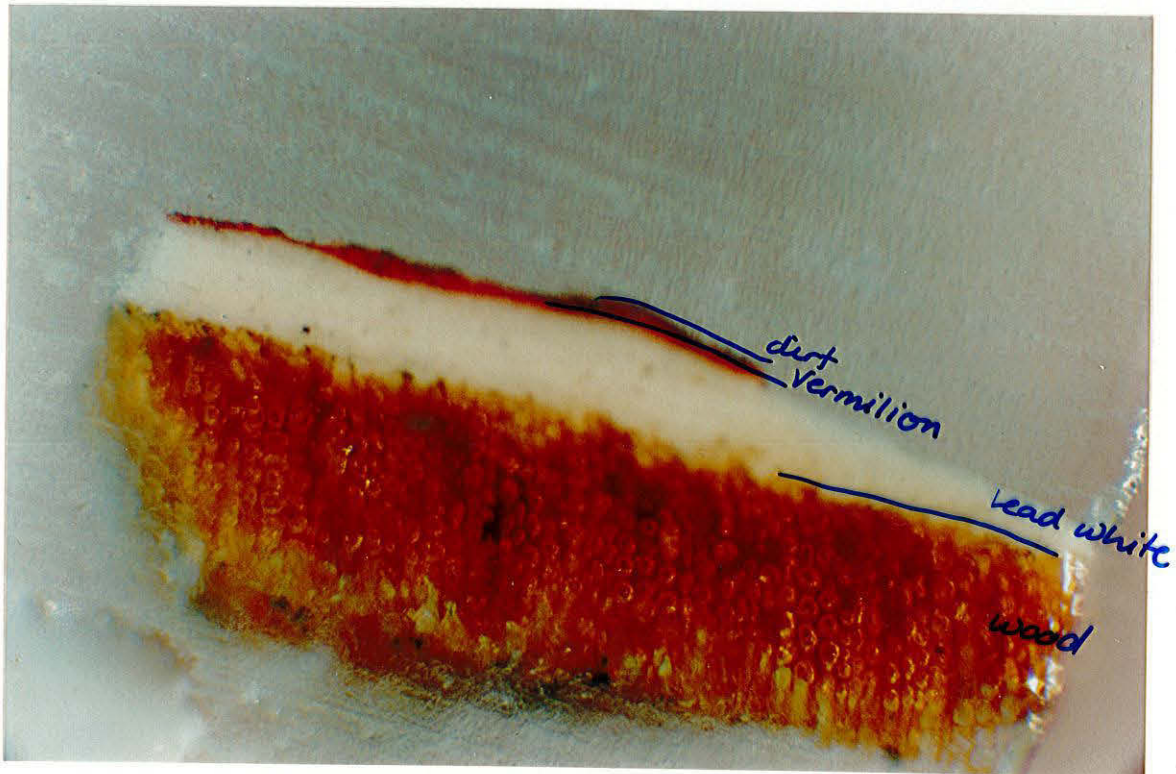
From red flower. Dirt layer on thin red paint on white on wood no ground layer evident. Sample 17 tested positive for Vermilion, the white ground was lead white. Medium stains tested positive for protein (tempera?). Raking light suggests alterations, if not overpaint - in which case the earliest layer visible is white.

- 1 Softwood.
- 2 Thick white ground.
- 3 The Tudor flower is clearly painted in Vermilion.

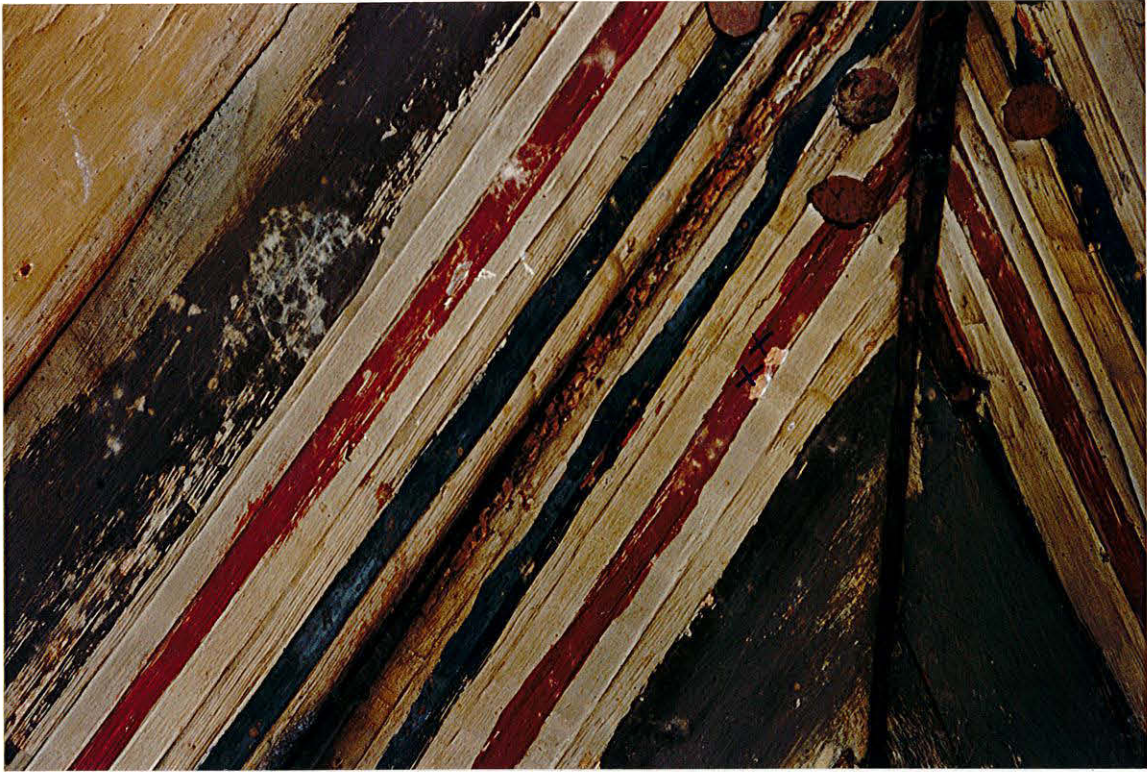
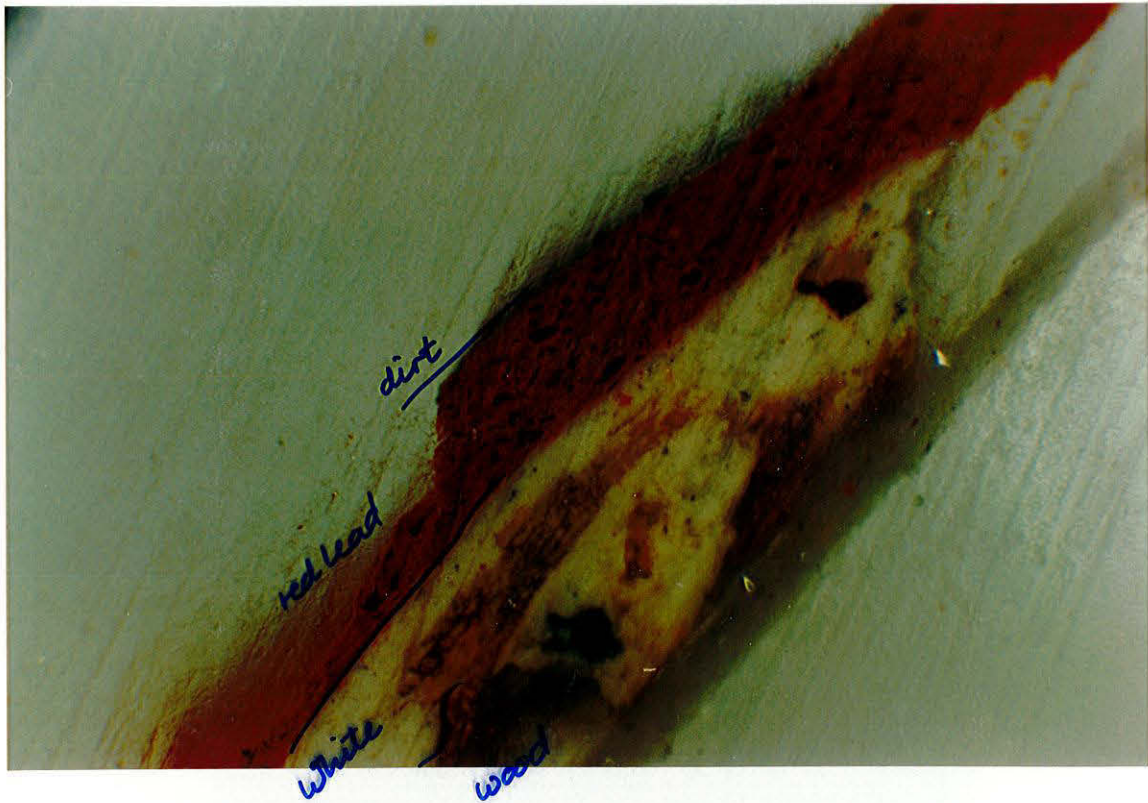
18

Sample taken from older, grooved panel. Cross-section showing dirt-layer, red (lead) layer, white layer on wood.

- 1 Seems to have a Vermilion layer with a red lake layer on top. Common painting technique of the period.

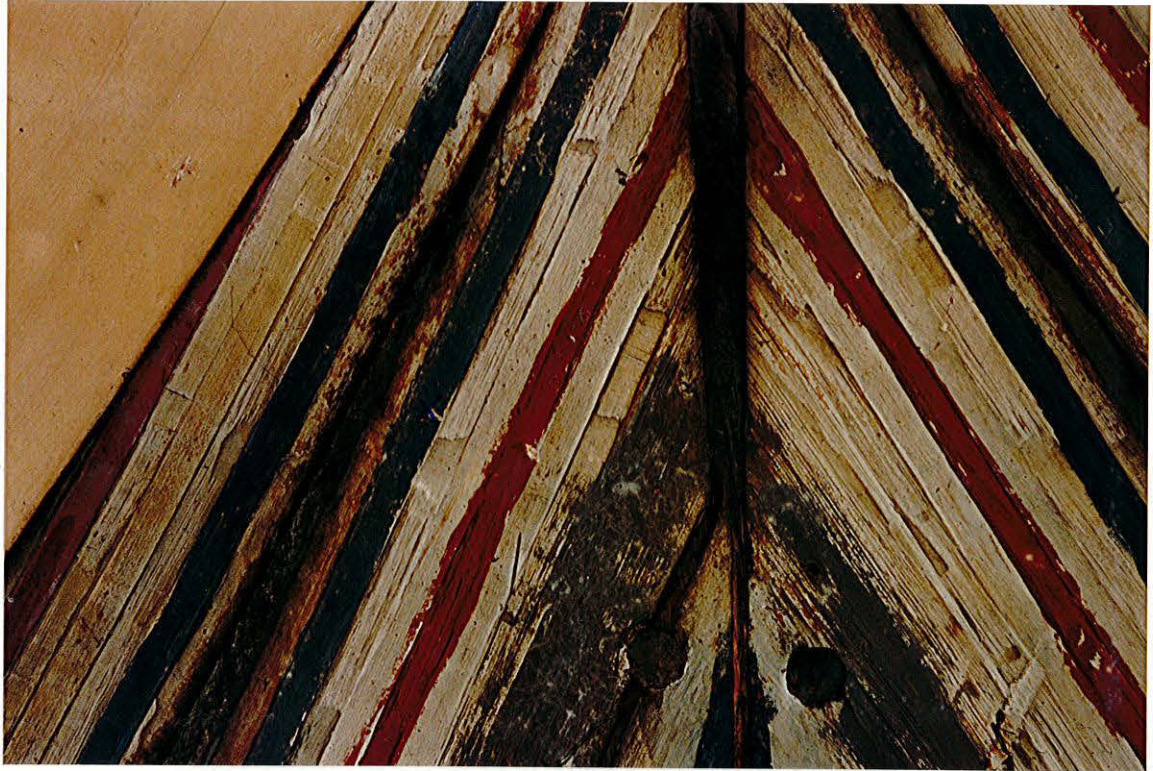
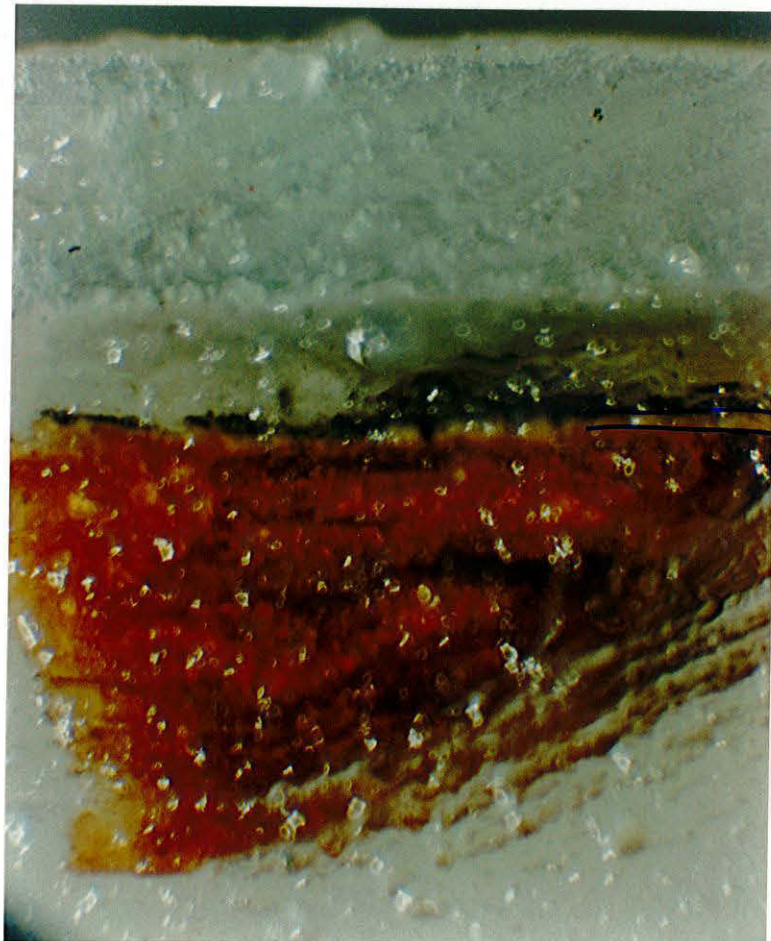
19

Sample from older, grooved panel. Cross-section is showing thin blue layer, thin white layer on wooden ground.

Thin black layer
Thin white layer
wood
