CONSERVATION OF WALL PAINTING DEPARTMENT
COURTAULD INSTITUTE OF ART

**Peterborough Cathedral, nave ceiling:
Scientific examination of the original
decoration**

❧ *Volume II Plates*

HELEN HOWARD
September 1997

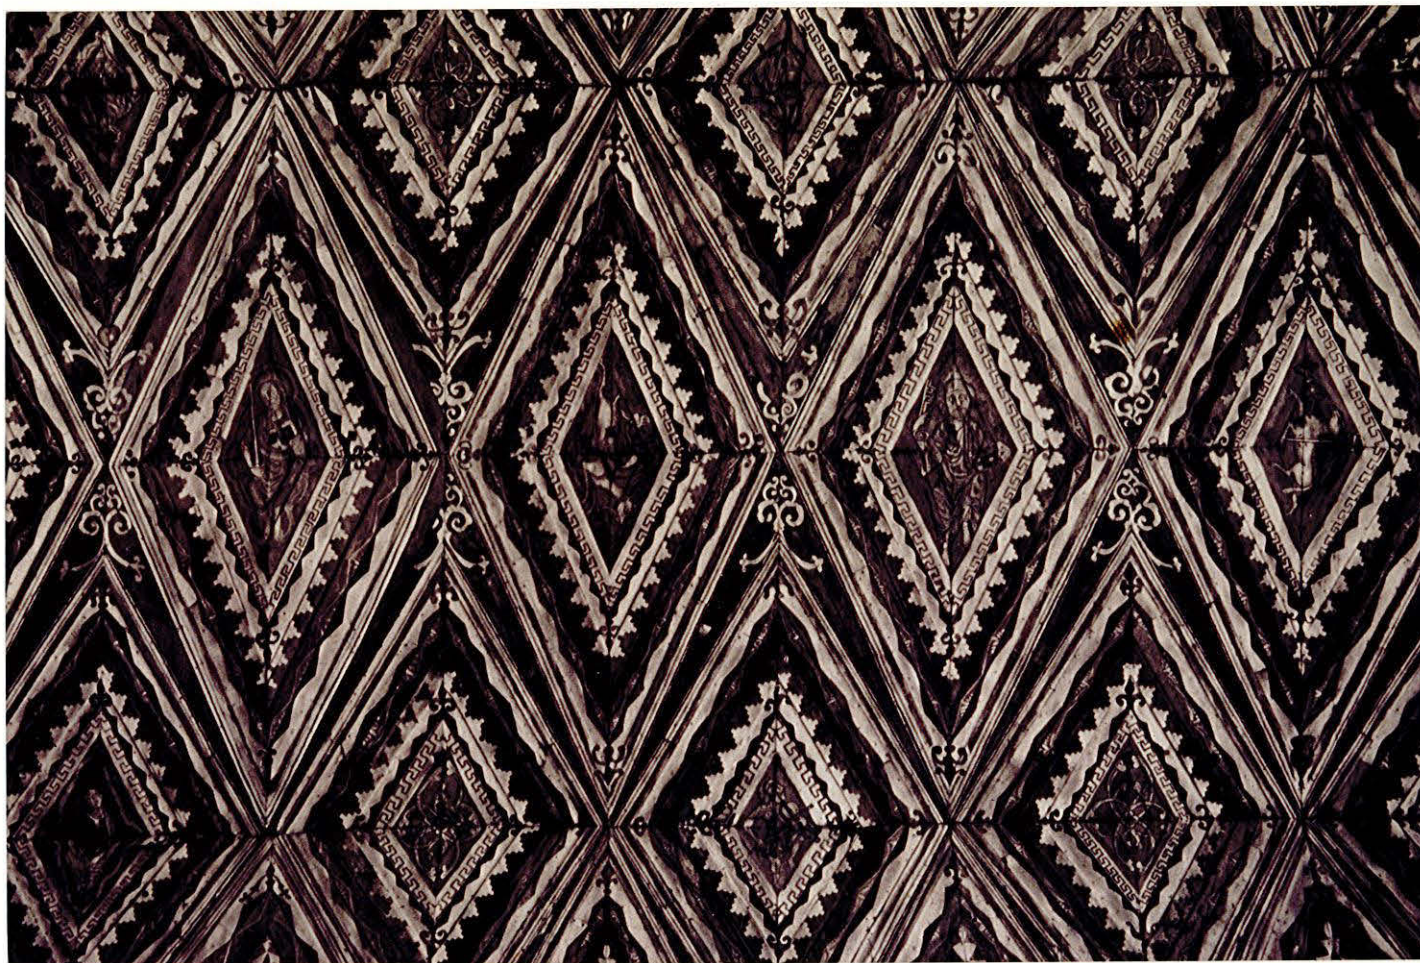
Plate 1. Peterborough Cathedral, nave ceiling: detail showing the figures of *St. Peter* (centre right), *St. Paul* (left) and the *Psaltery Player* (lower left).

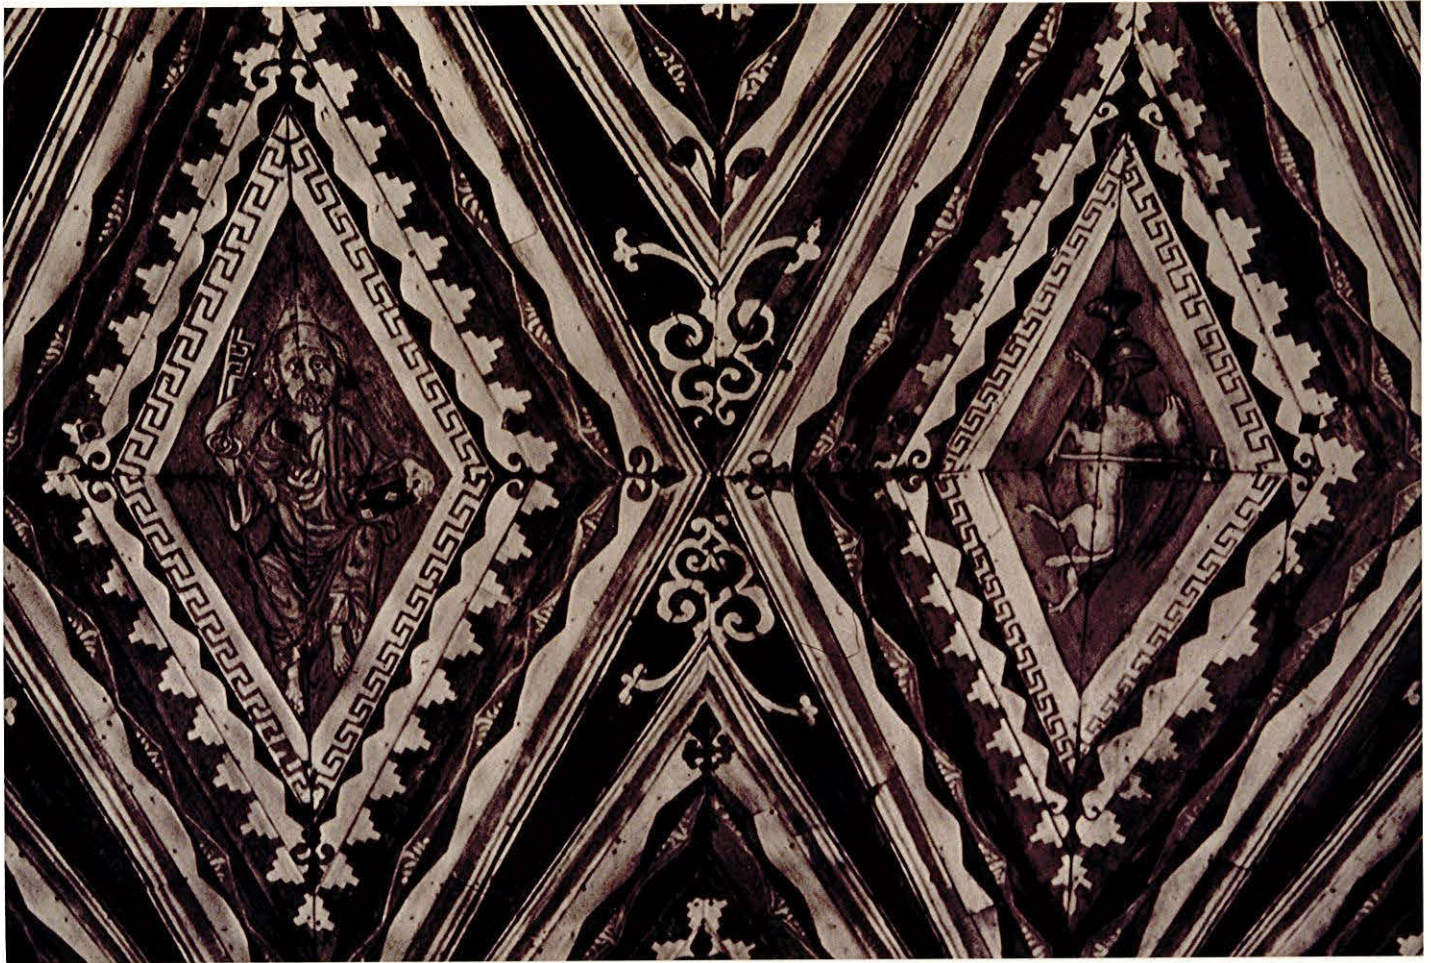
Plate 2. Detail of ceiling showing *St. Peter* and the *Agnus Dei*.

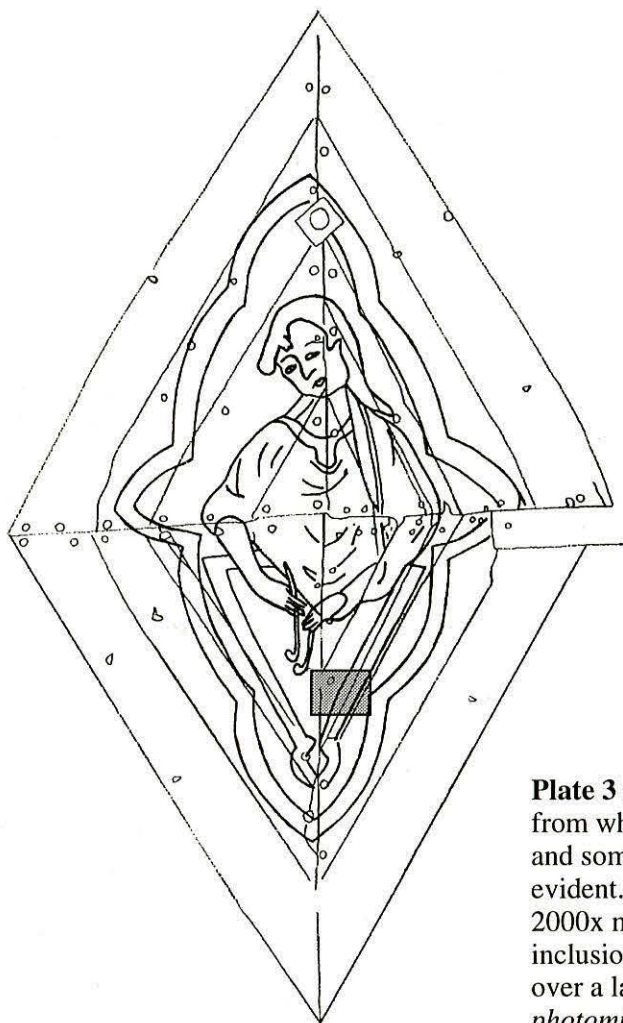
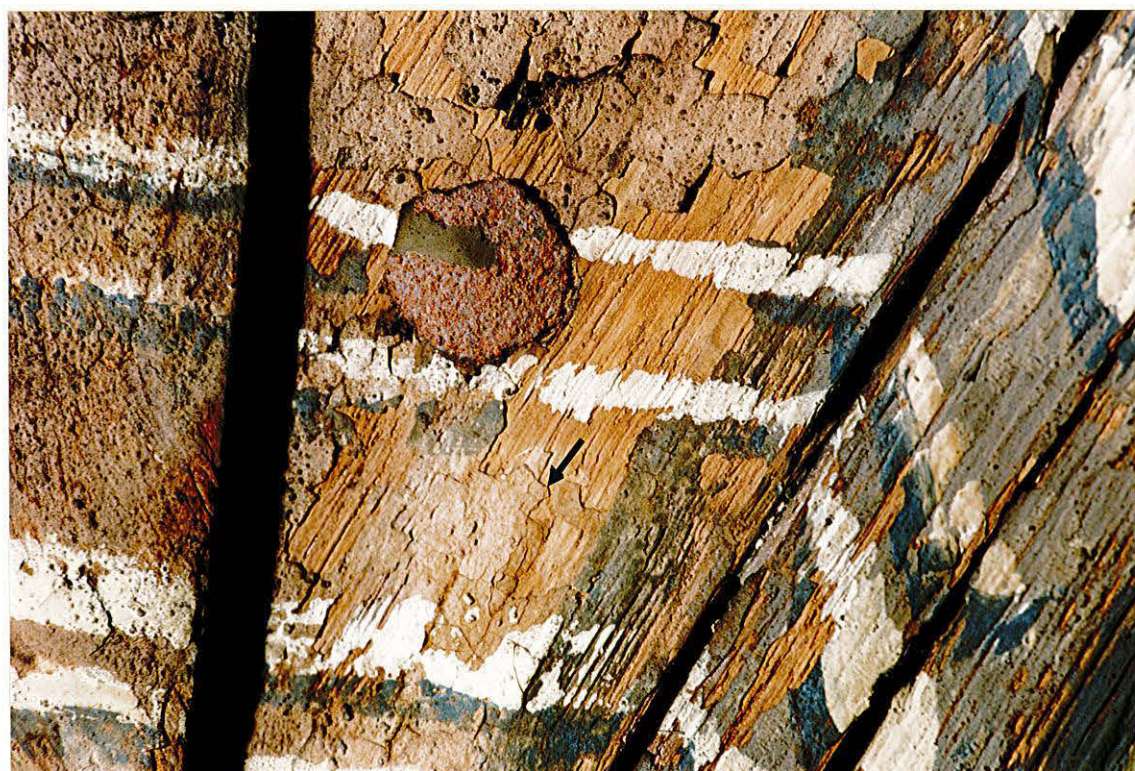
Plate 3 (below). Detail of the *Psaltery Player* showing the pinky/grey area from which Sample 1/2093 was taken. The extent of paint loss in this area, and some crudely retouched linear details in white and brown are also evident. **Plate 4 (above).** Cross-section of Sample 1/2093 shown here at 2000x magnification. The rough texture of the paint is due to the siliceous inclusions in the yellow iron oxide-rich paint layer, which has been applied over a layer of red iron oxide. (*Macrophotograph Heritage/Howard 1997, photomicrograph Howard 1997*).

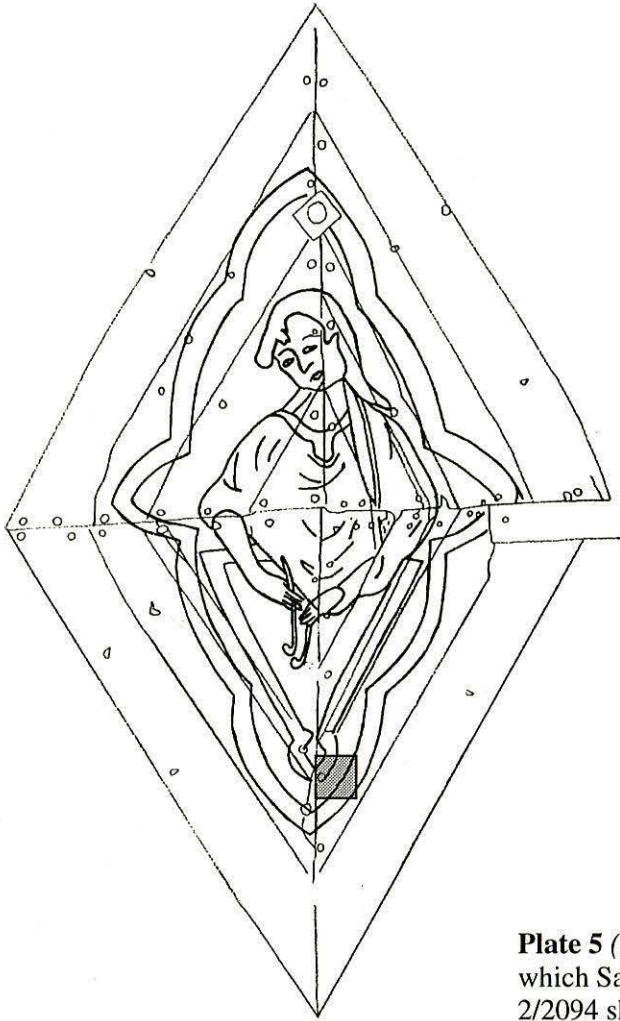
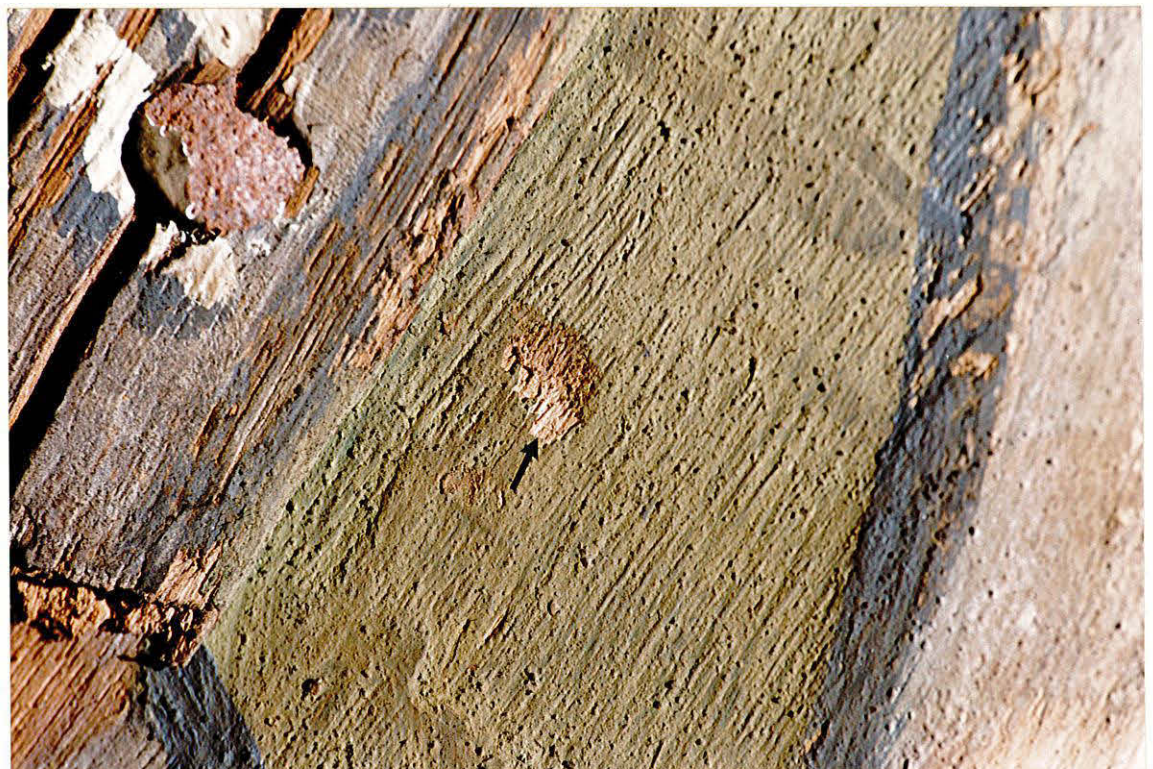
Plate 5 (*below*). Detail of the *Psalter* *Player* showing the green area from which Sample 2/2094 was taken. **Plate 6** (*top*). Cross-section of Sample 2/2094 shown at 2000x magnification. Particles of basic verdigris have been combined with yellow iron oxide to produce the yellow/green paint layer. One of the particles of verdigris, photographed in plane polarised transmitted light, is shown at 3320x magnification in **Plate 7** (*above*). (*Macrophotograph Heritage/Howard 1997, photomicrographs Howard 1997*).

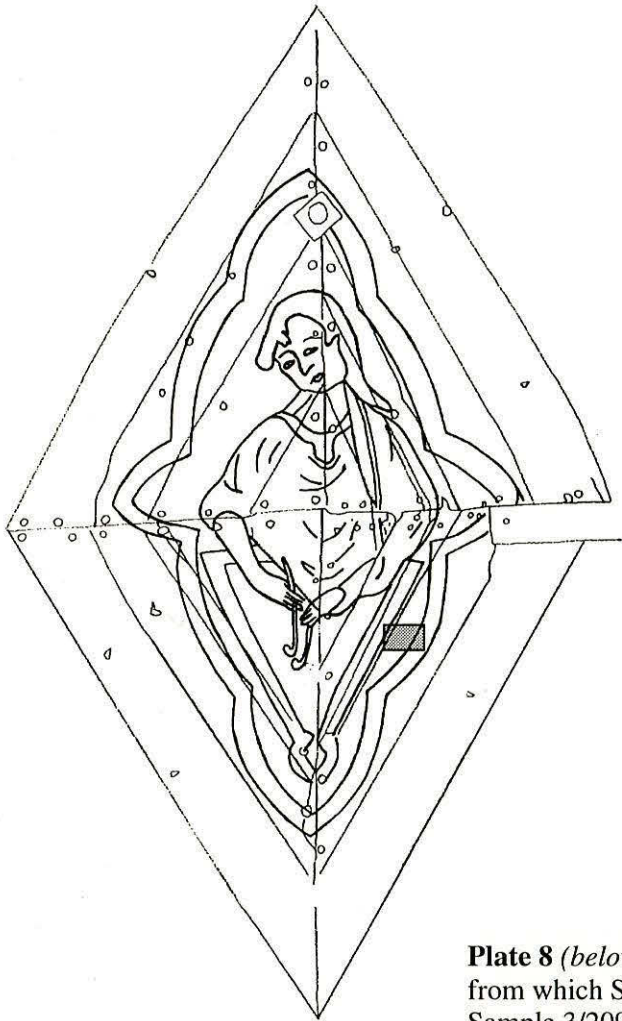
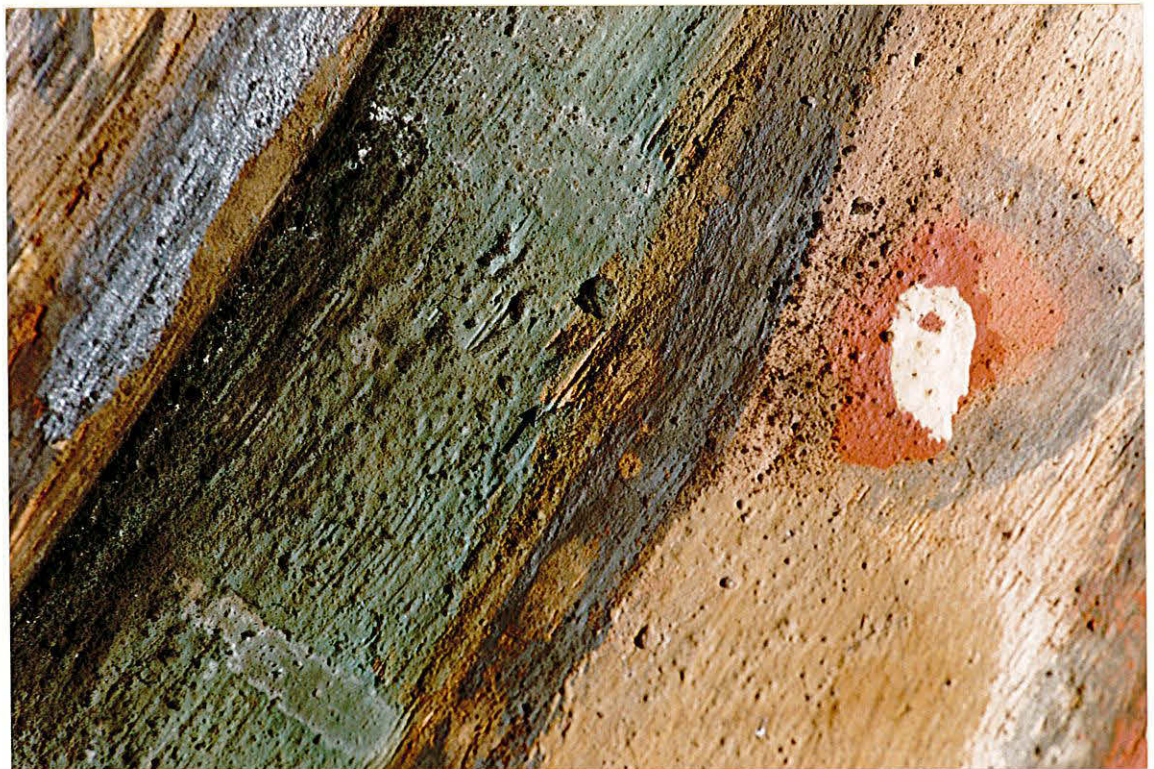
Plate 8 (below). Detail of the *Psaltery Player* showing the blue/green area from which Sample 3/2095 was taken. **Plate 9** (above). Cross-section of Sample 3/2095 shown at 672x magnification. Prussian blue combined with lead white has been applied over the verdigris and yellow iron oxide (mid-green paint layer) below. (*Macrophotograph Heritage/Howard 1997, photomicrograph Howard 1997*).

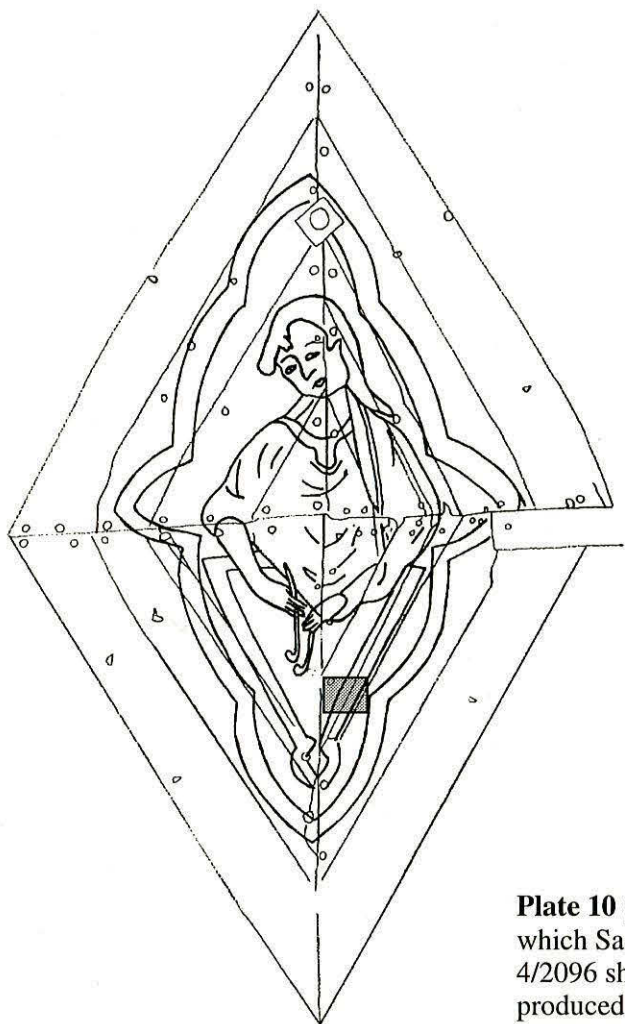
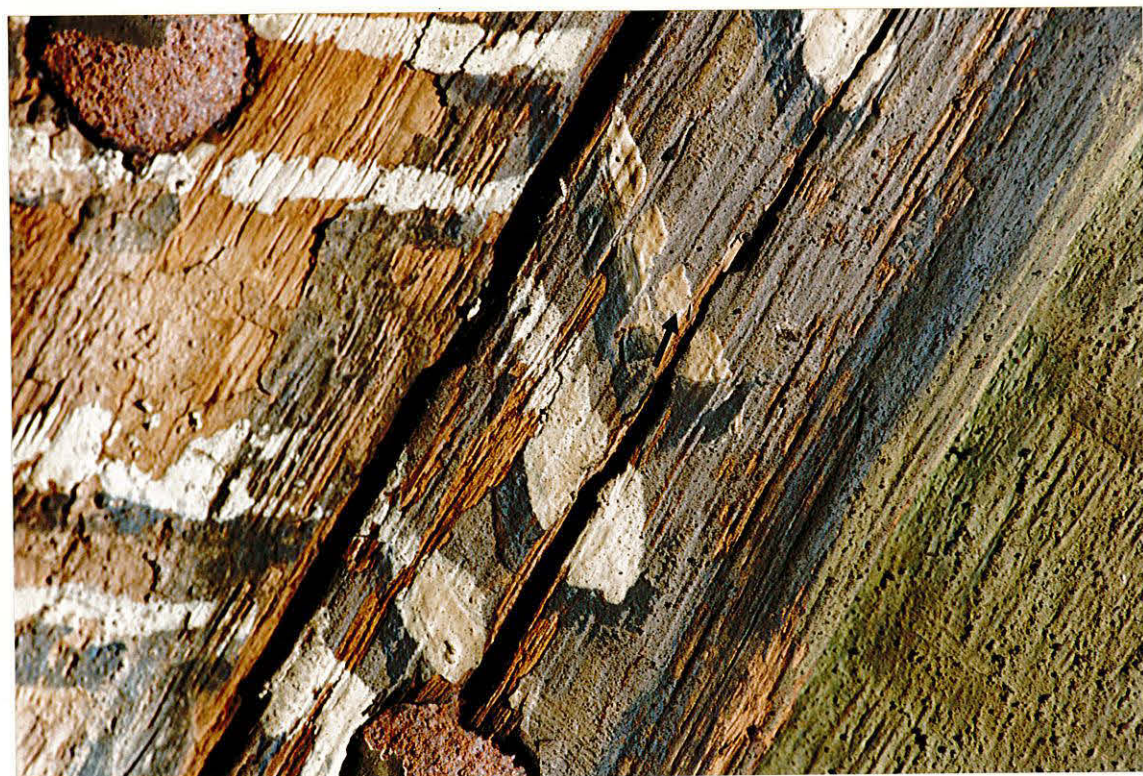
Plate 10 (*below*). Detail of the psalter, showing the pale purple area from which Sample 4/2096 was taken. **Plate 11** (*above*). Cross-section of Sample 4/2096 shown at 1752x magnification. The purple appearance has been produced by combining red and yellow iron oxide pigments with carbon black and lead white. A large inclusion of verdigris is also evident in this paint layer. A linear detail in lead white has been applied in impasto over the purple area. Crude retouchings white are also visible. (*Macrophotograph Heritage/Howard 1997, photomicrograph Howard 1997*).

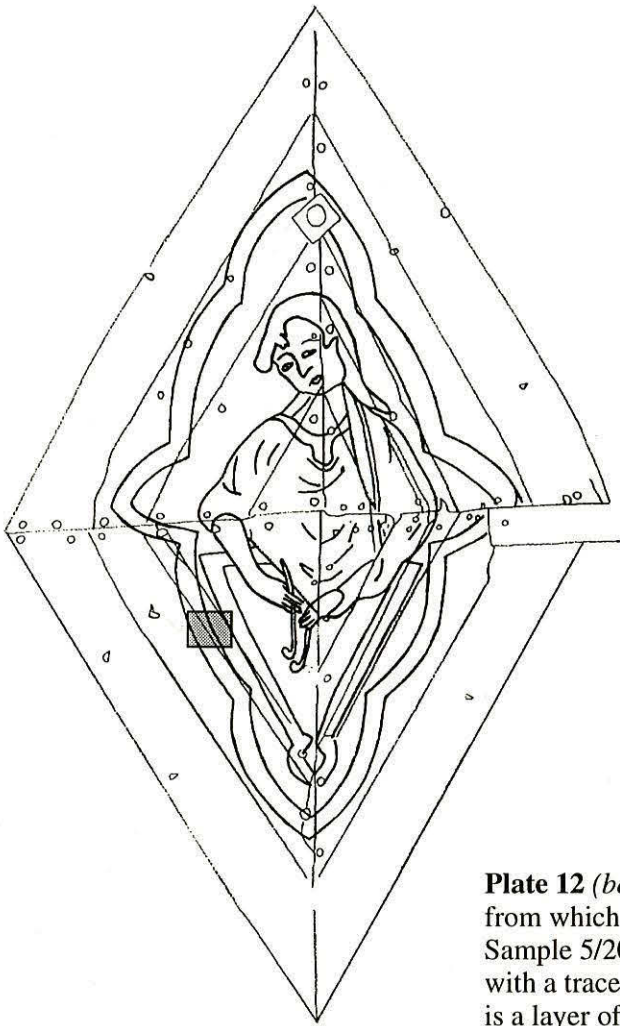
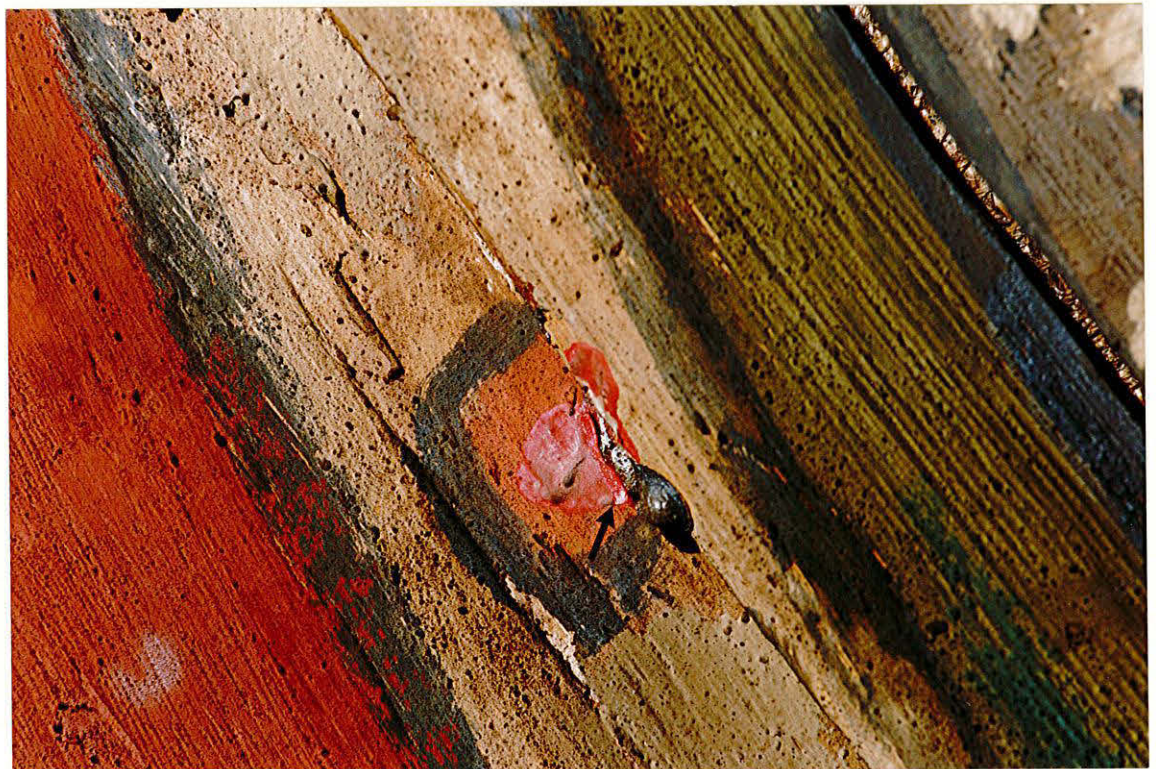
Plate 12 (below). Detail of the *Psaltery Player* showing the brilliant red detail from which Sample 5/2097 was taken. **Plate 13** (above). Cross-section of Sample 5/2097 at 724x magnification, showing a layer of pure vermilion with a trace of a creamy white preparation below. On top of the red pigment is a layer of glue 330 μm thick. This layer of animal glue, and the accretion of dirt which has accumulated on its surface, is clearly visible in UV light, as shown in **Plate 14** (top). (*Macrophotograph Heritage/Howard 1997, photomicrographs Howard 1997*).

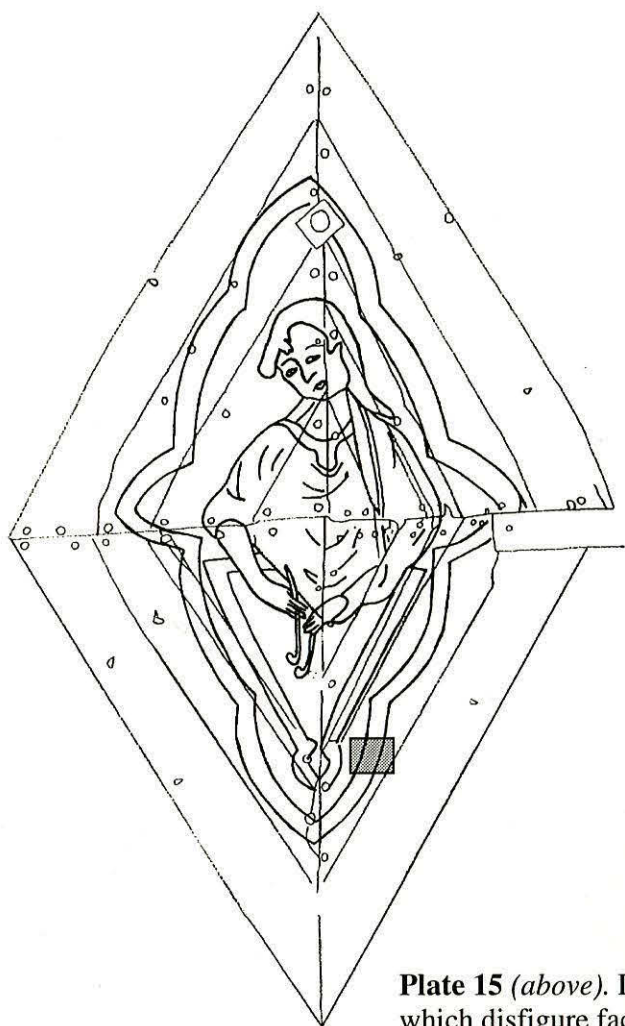
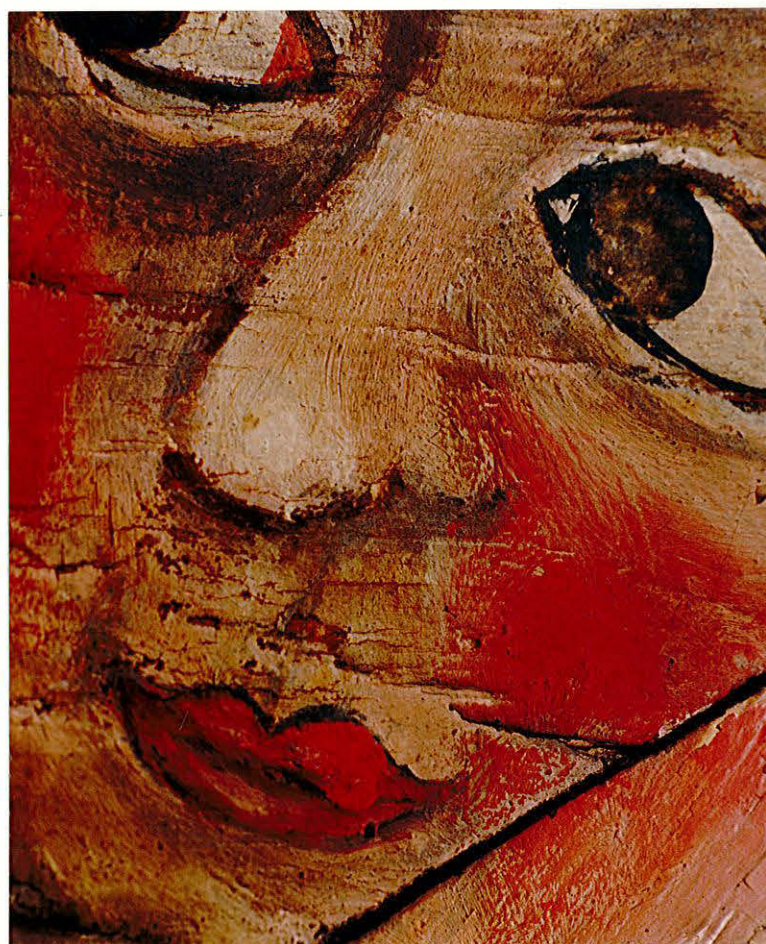
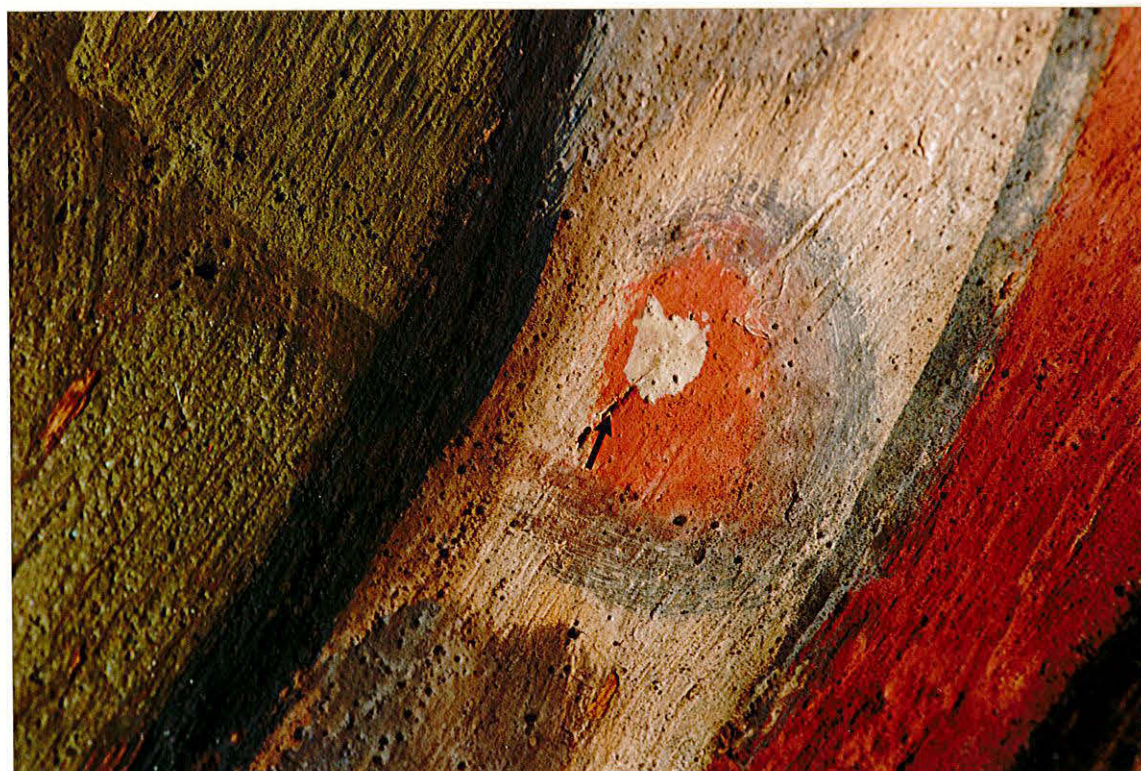
Plate 15 (above). Detail of the *Psaltery Player* showing some of the crude retouchings which disfigure facial detail such as the eyes, mouth and cheeks. **Plate 16** (below). Detail of the *Psaltery Player* showing the brilliant red detail from which Sample 6/2098 was taken. Examination of a dispersion of Sample 6/2098 confirmed the presence of vermilion. (*Macrophotographs Heritage/Howard 1997*).

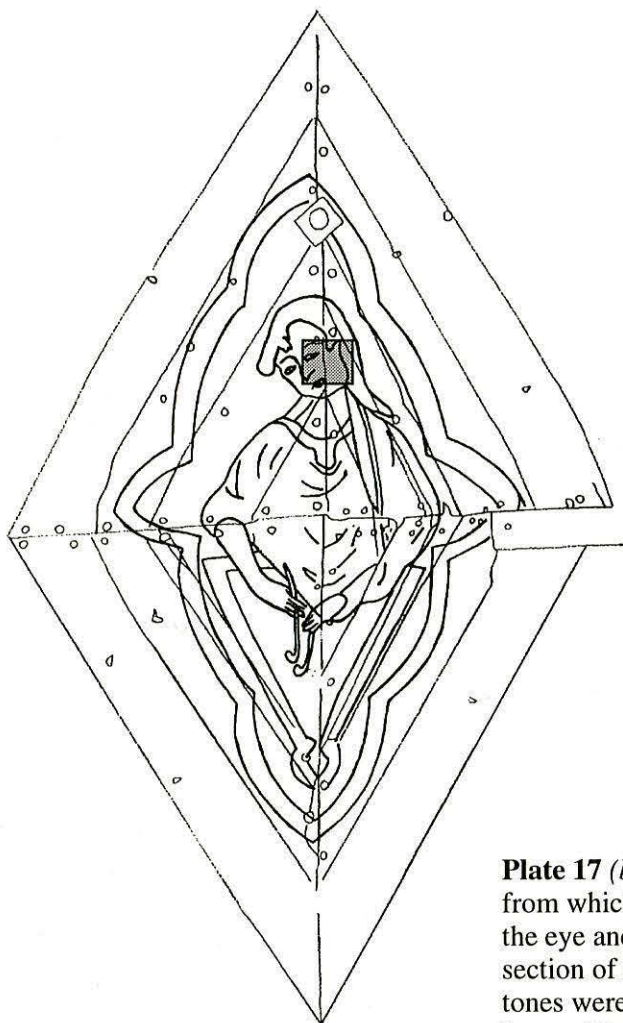
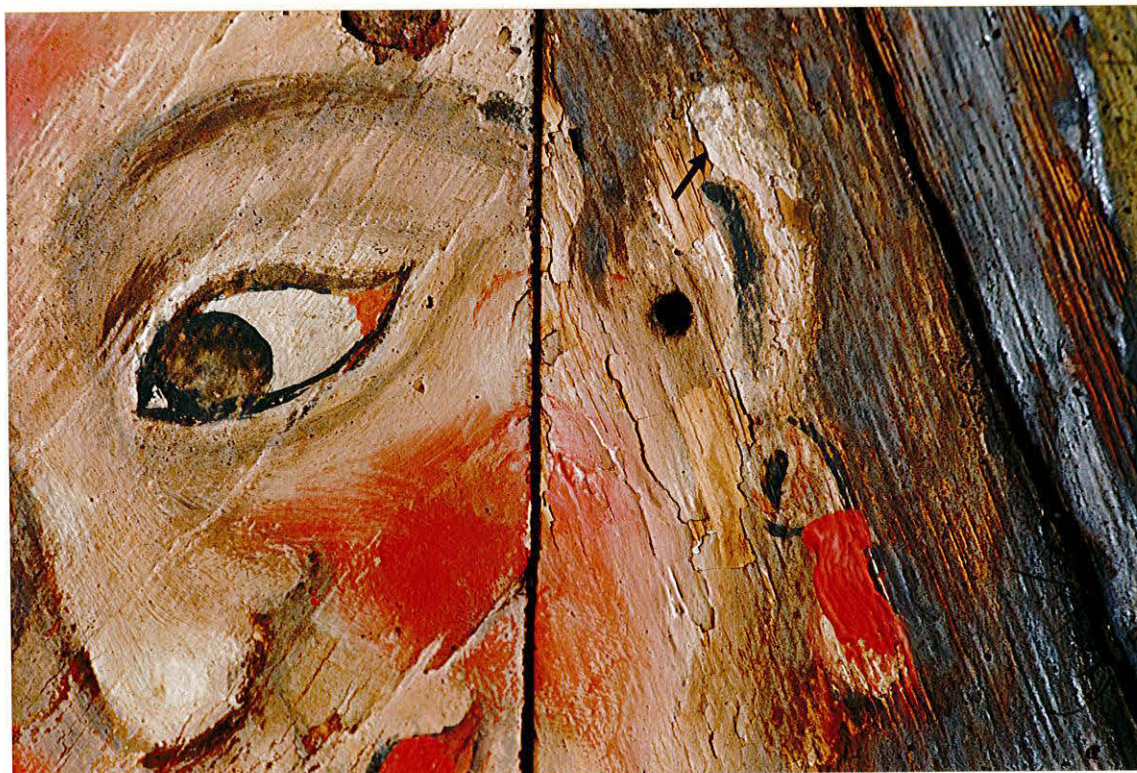
Plate 17 (below). Detail of the *Psaltery Player* showing the area of flesh from which Sample 7/2099 was taken. The crude linear reinforcement of the eye and other details is also clearly visible. **Plate 18** (above). Cross-section of Sample 7/2099 at 2000x magnification, showing how the flesh tones were built up by the application of vermilion combined with yellow iron oxide and carbon black over a grey ground. An accretion of surface dirt is clearly visible over the highlight of the flesh which consists of lead white combined with a little vermilion. (*Macrophotograph Heritage/Howard 1997, photomicrograph Howard 1997*).

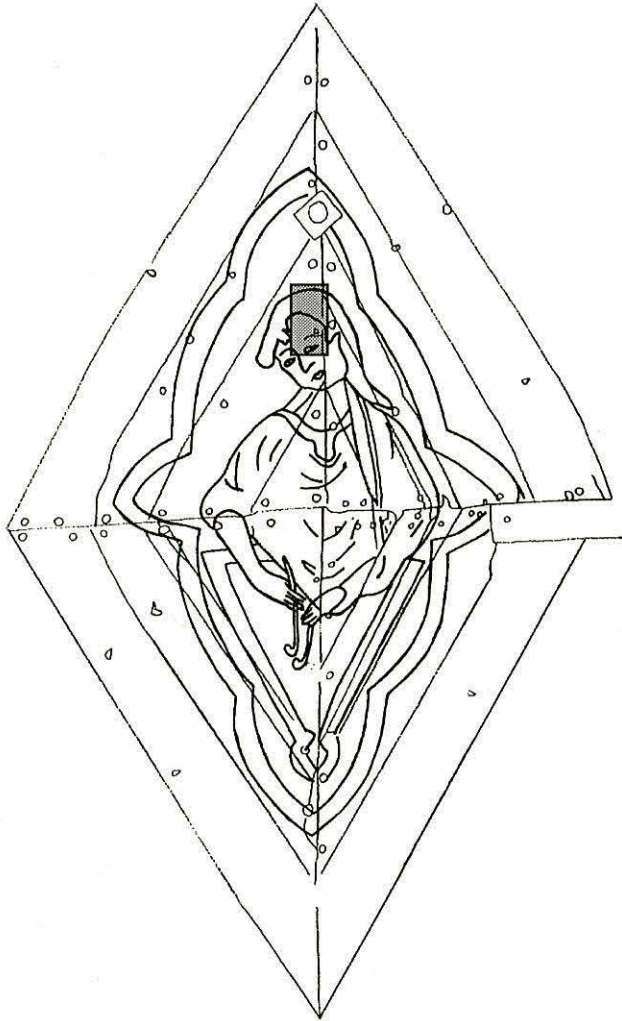
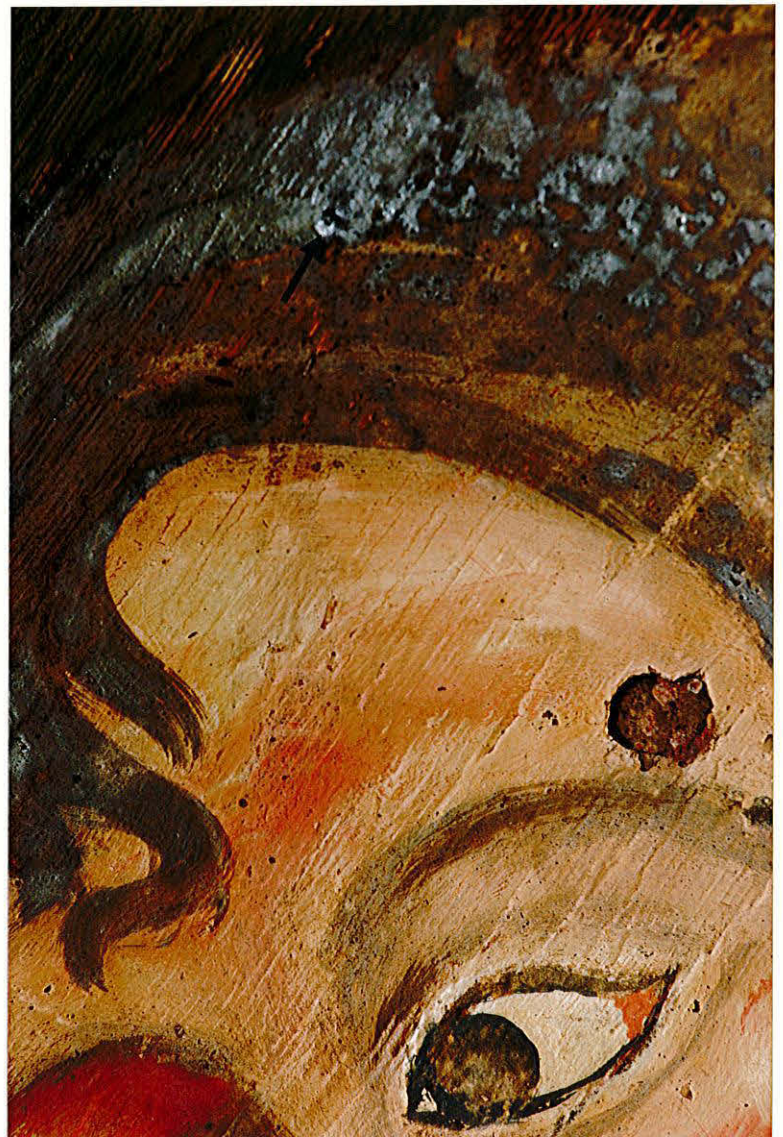
Plate 19 (below). Detail of the *Psaltery Player* showing the 'metallic sheen' which is evident on areas of the hair and the adjacent green background from which Sample 8/2100 was taken. **Plate 20** (above). Cross-section of Sample 8/2100 at 1952x magnification, showing the dense dark layer incorporating black and red particles which has been applied over the green background of verdigris and yellow iron oxide. (*Macrophotograph Heritage/Howard 1997, photomicrograph Howard 1997*).

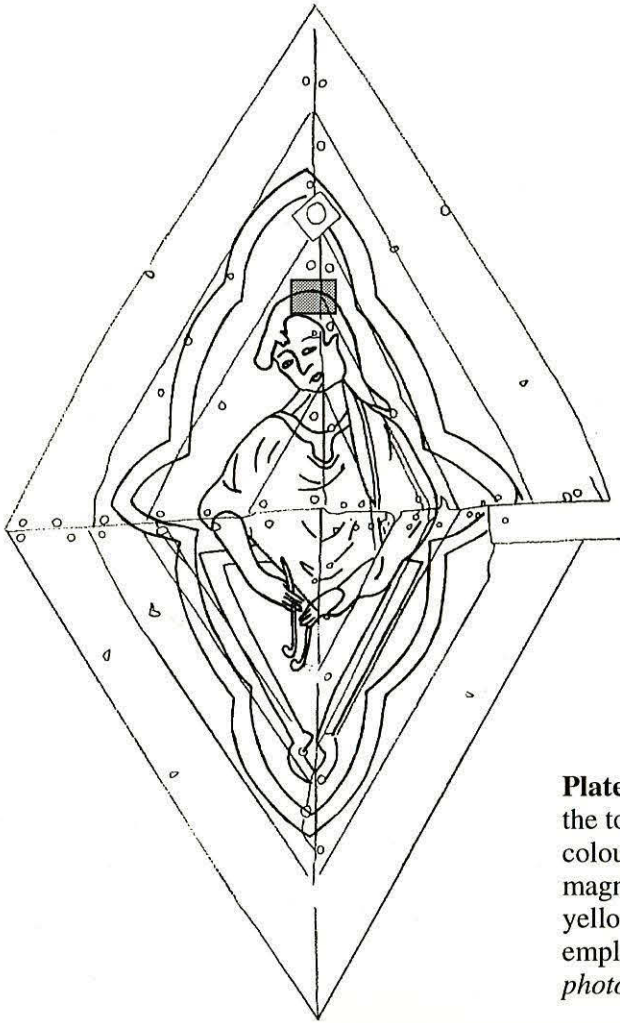
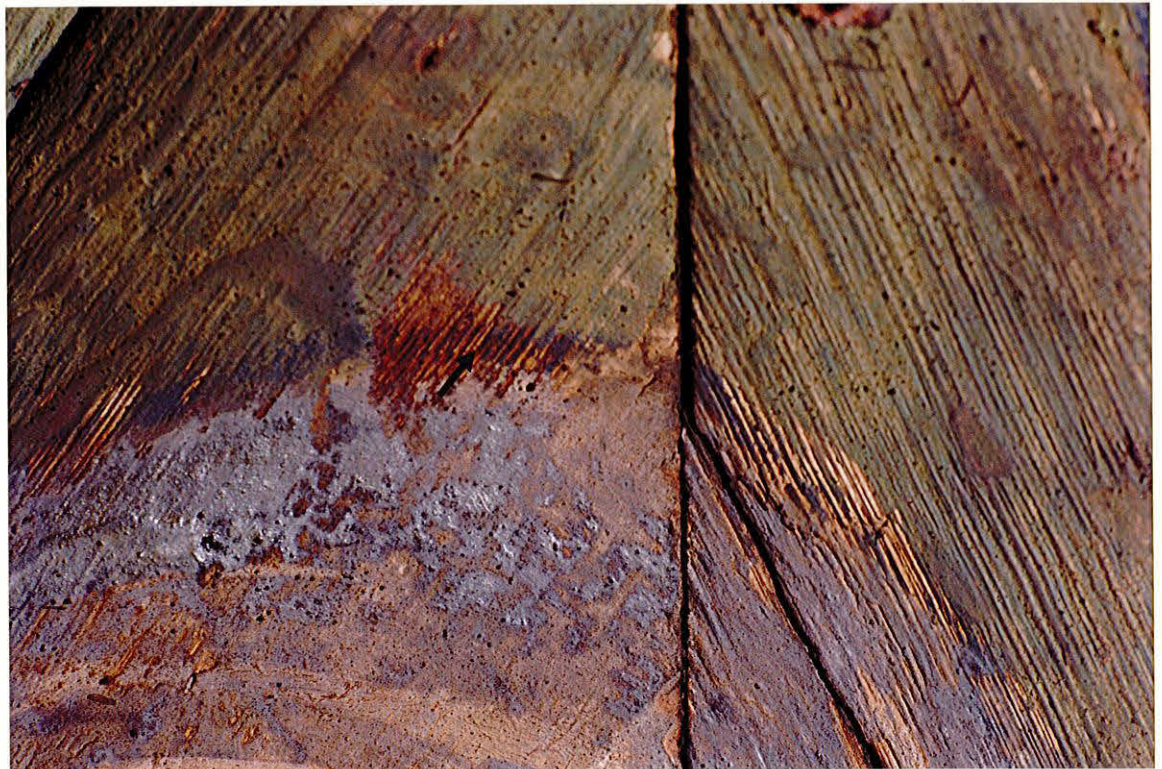
Plate 21 (below). Detail of the *Psaltery Player* showing the line indicating the top of the figure's head which is clearly beneath the green background colour. **Plate 22** (above). Cross-section of Sample 9/2101 at 2000x magnification which indicates that a mixture of carbon black, brown and yellow iron oxide pigments, together with a single particle of massicot, were employed for this dark line. (*Macrophotograph Heritage/Howard 1997, photomicrograph Howard 1997*).

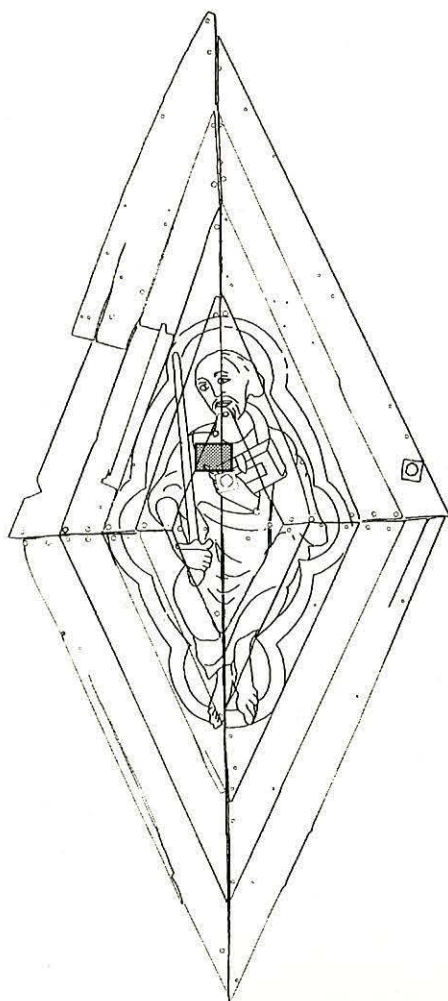
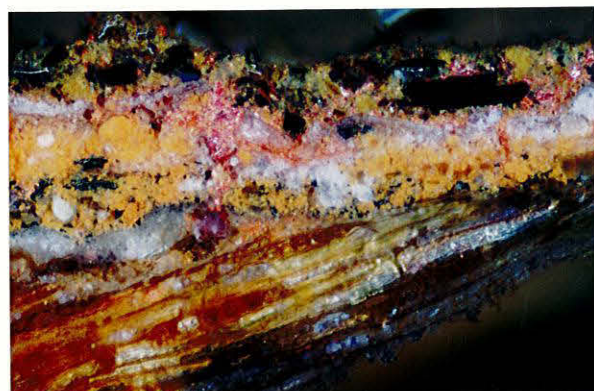
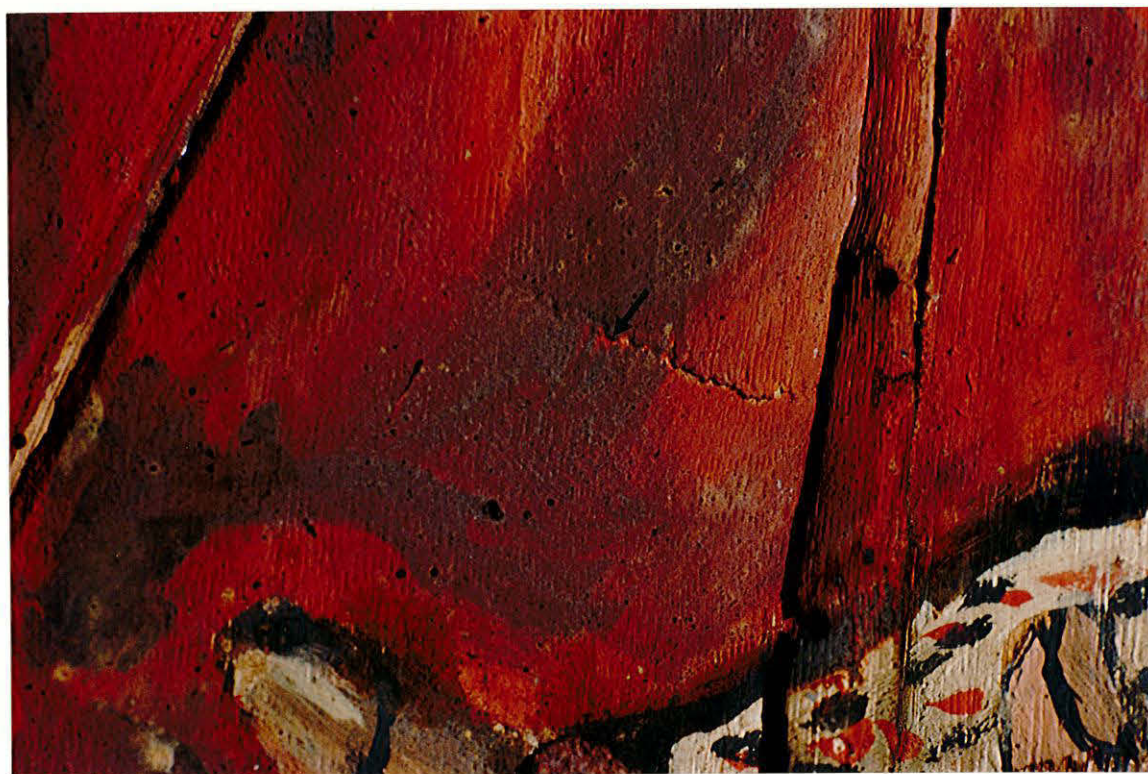
Plate 23 (*below*). Detail of the St. Paul's red drapery showing the grey linear detail which was found to bloom readily in contact with water. **Plate 24** (*above*). Cross-section of Sample 10/2102 at 1480x magnification, and with a few particles in the uppermost layer stained pink to show the presence of the sulphate ion (SO_4^{2-}). It seems likely that the layer of red lead combined with a carbon black pigment, together with the red lead and vermillion layers which overlay it, are original. The rather crude, thick, and now grey-coloured line which is made up of yellow iron oxide combined with carbon black, lead white, calcium sulphate and clay-rich particles is likely to have been added later. (*Macrophotograph Heritage/Howard 1997, photomicrograph Howard 1997*).

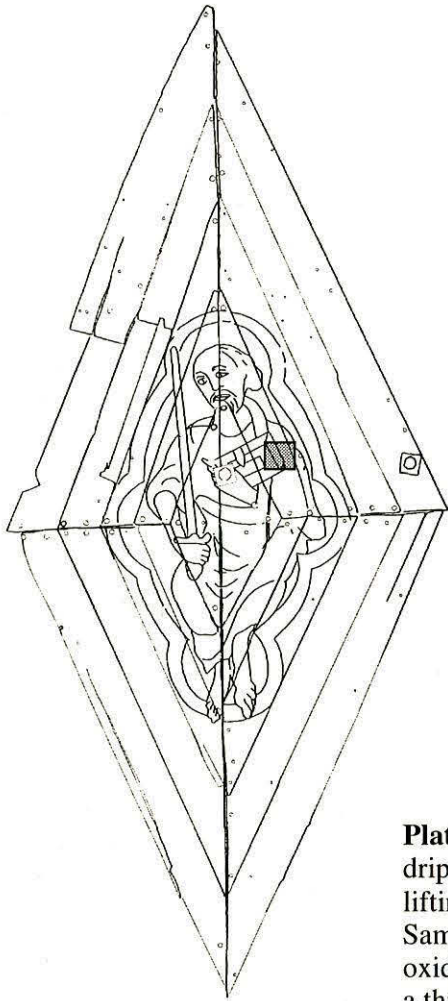
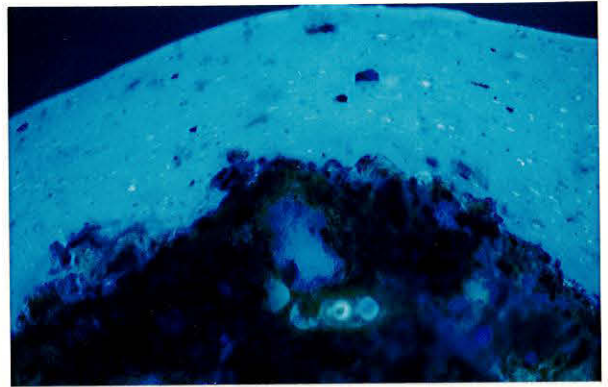
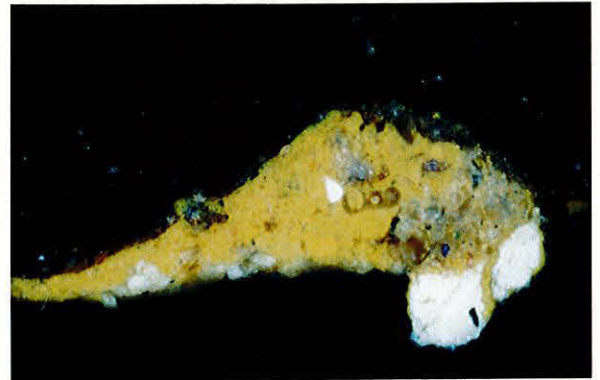
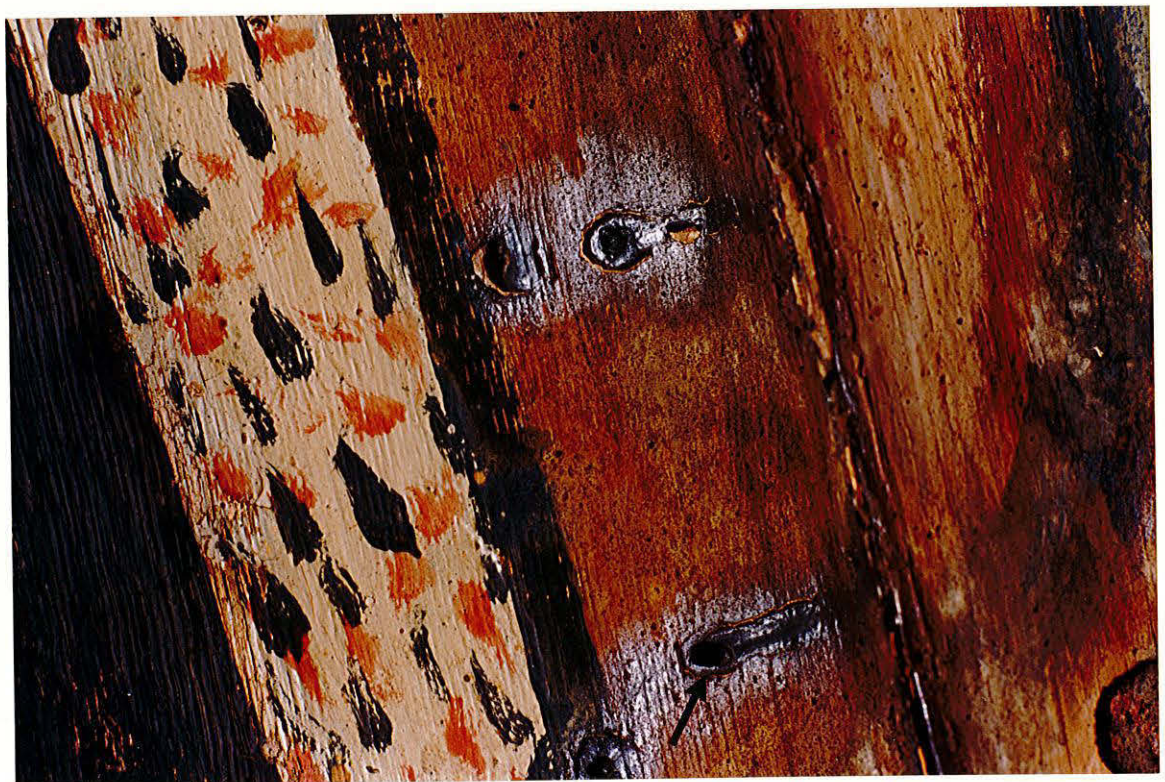
Plate 25 (*below*). Detail taken from the area adjacent to St. Paul's bible where drips of a material which is clearly causing considerable contraction and lifting of the paint layer are evident. **Plate 26** (*above*). Cross-section of Sample 11/2103 at 1160x magnification, showing a layer of a yellow iron oxide pigment with a trace of a lead white ground beneath. On the surface is a thick layer of animal glue which is more clearly visible when the sample is viewed in UV light, as in **Plate 27** (*top*), since the material fluoresces a pale blue colour under these conditions. (*Macrophotograph Heritage/Howard 1997, photomicrograph Howard 1997*).
