CONSERVATION OF WALL PAINTING DEPARTMENT
COURTAULD INSTITUTE OF ART

**Peterborough Cathedral, nave ceiling:
Scientific examination of the original
decoration**

❧ *Volume II Plates*

HELEN HOWARD
September 1997

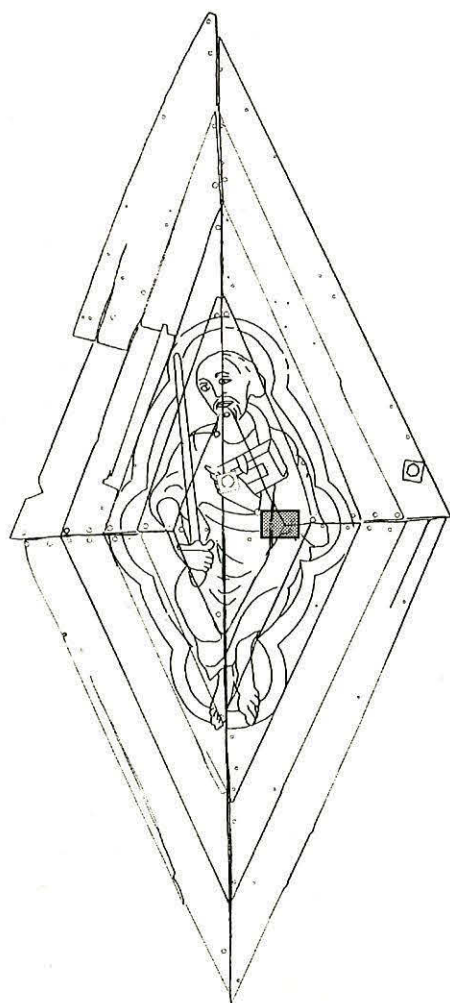
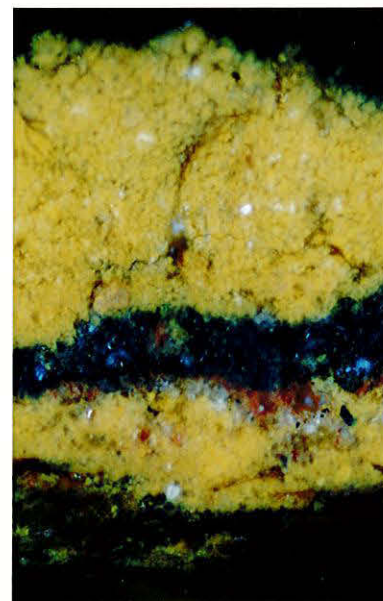
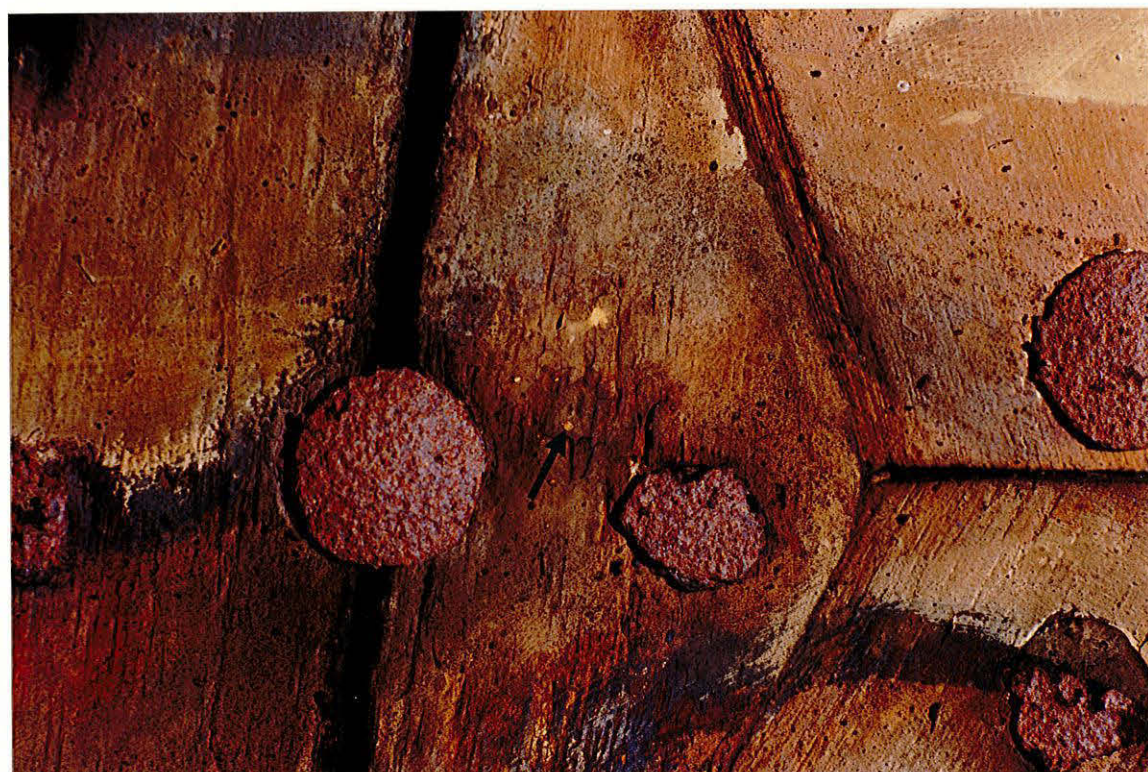
Plate 28 (*below*). Detail taken from St. Paul's left proper sleeve showing the intense yellow colour which is evident when the surface dirt is removed from raised particles in the paint layer. **Plate 29** (*above*). Cross-section of Sample 12/2104 at 1328 x magnification, showing two layers of yellow iron oxide pigment divided by a layer of carbon black. Though the uppermost layer of yellow clearly represents a level of repainting, it is not clear whether the lower yellow paint layer is original or not. (*Macrophotograph Heritage/Howard 1997, photomicrograph Howard 1997*).

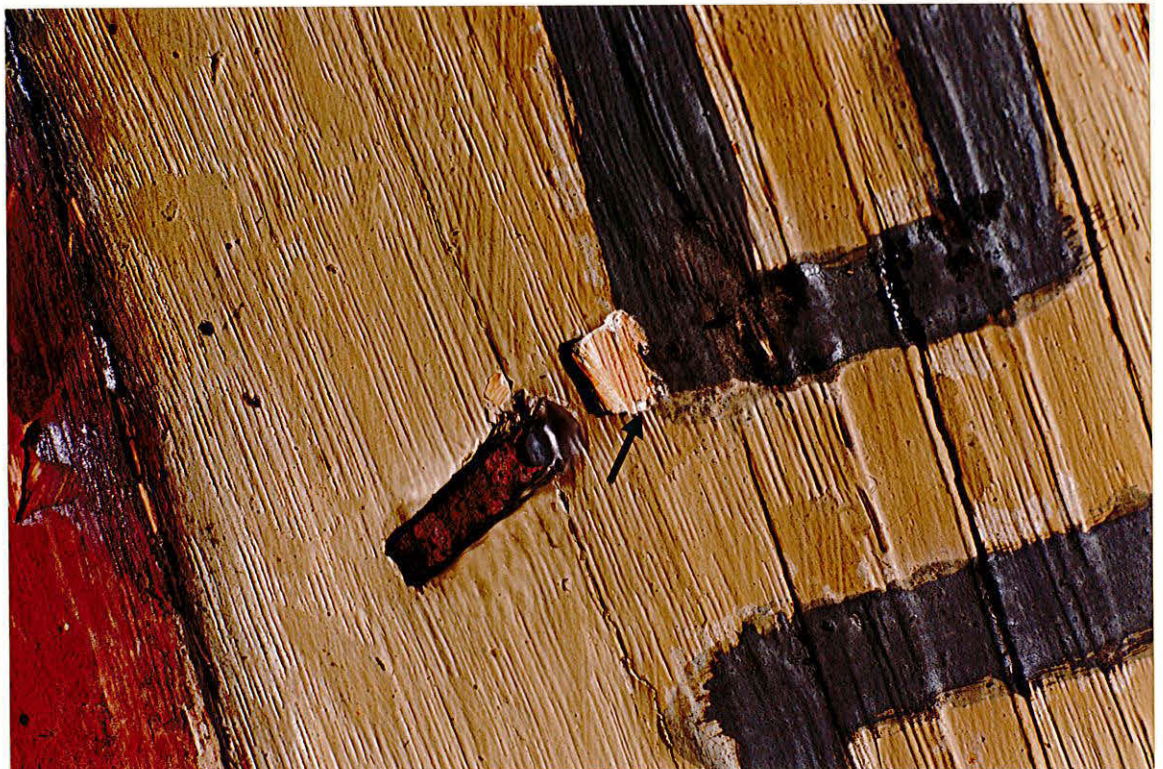
Plate 30 (*below*). Detail taken from the key pattern around *St. Paul*. Sample 13/2105 was taken from the edge of the area of loss shown in the centre of the plate, at the edge of the black key pattern. **Plate 31** (*above*). Cross-section of Sample 13/2105 at 1728 x magnification, showing the lead white ground layer penetrating into the wood support, over which is a layer of carbon black combined with yellow iron oxide particles. Another lead white ground covers this black paint layer but the uppermost layer of black repainting is not present in the sample. (*Macrophotograph Heritage/Howard 1997, photomicrograph Howard 1997*).

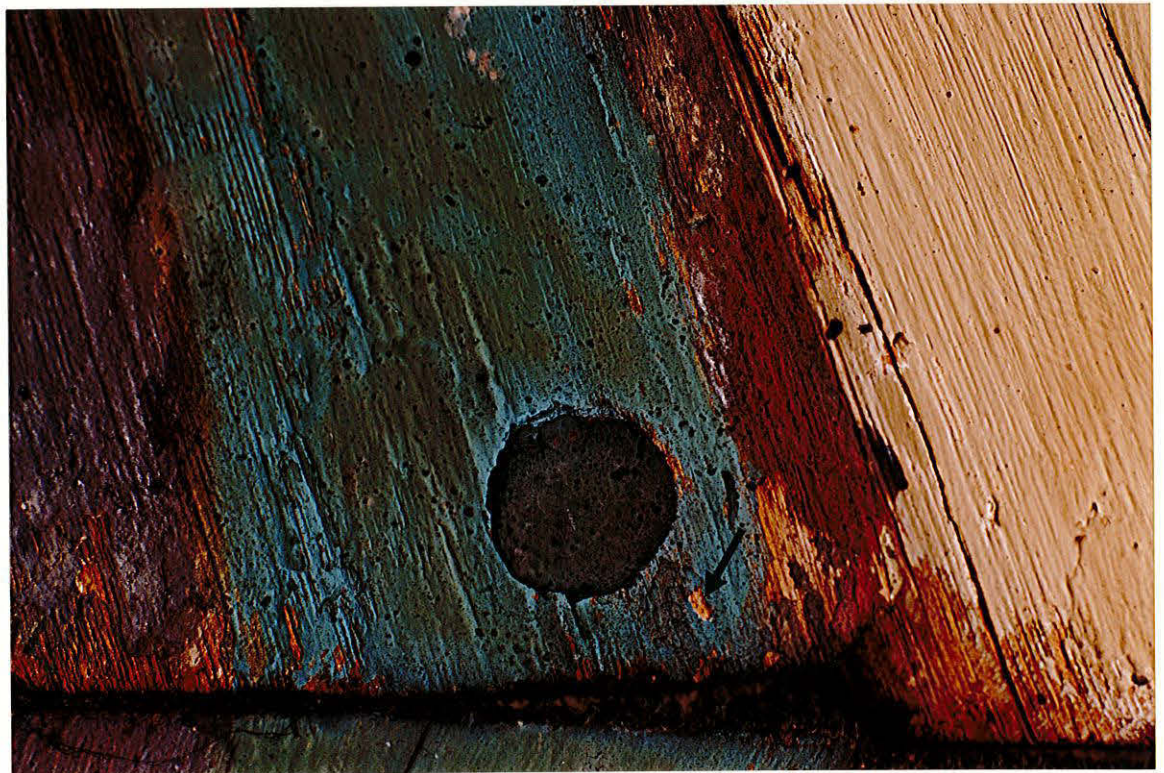
Plate 32 (*below*). Detail taken from the cusped mandorla around *St. Paul*, showing the thick 'petrol' blue paint layer. **Plate 33** (*above*). Cross-section of Sample 14/2106 at 1856 x magnification, showing two layers of Prussian blue combined with lead white - the lower containing a higher proportion of lead white. Both of these layers are clearly part of the 19th-century retouching of the scheme. (*Macrophotograph Heritage/Howard 1997, photomicrograph Howard 1997*).

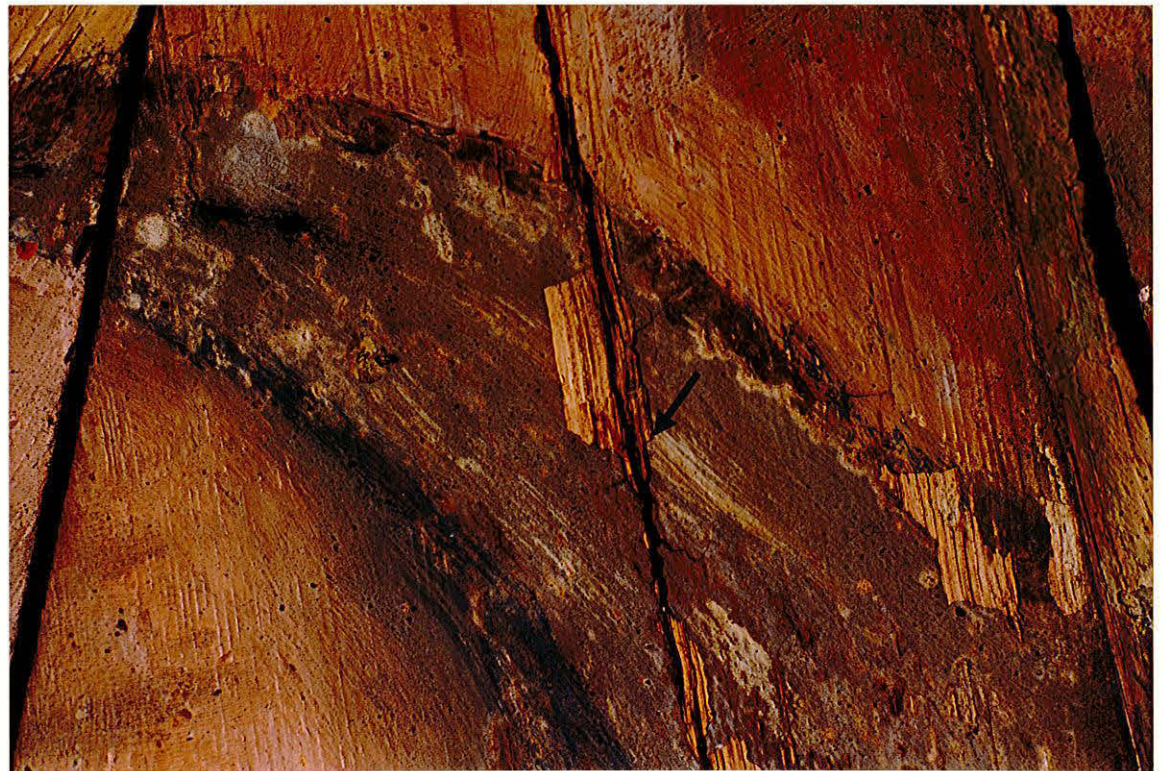
Plate 34 (*below*). Detail of St. Paul's, hair. **Plate 35** (*above*). Cross-section of Sample 15/2107 at 1056 x magnification, showing large particles of carbon black combined with red and yellow iron oxide pigments applied in a layer 300 microns thick. Over this a lead white ground has been applied, and a layer consisting of lead white combined with carbon black and yellow iron oxide on top. It seems likely that the lead white ground and overlying paint layer represent a phase of repainting. (*Macrophotograph Heritage/Howard 1997, photomicrograph Howard 1997*).

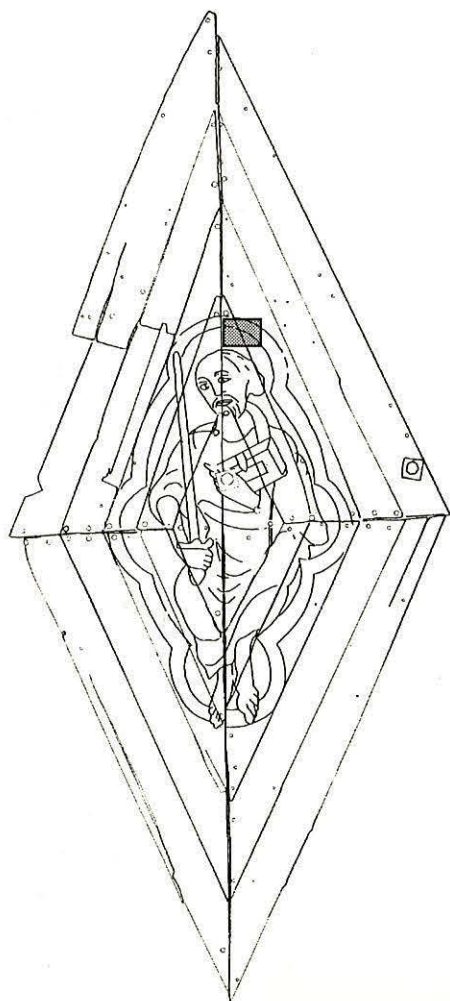
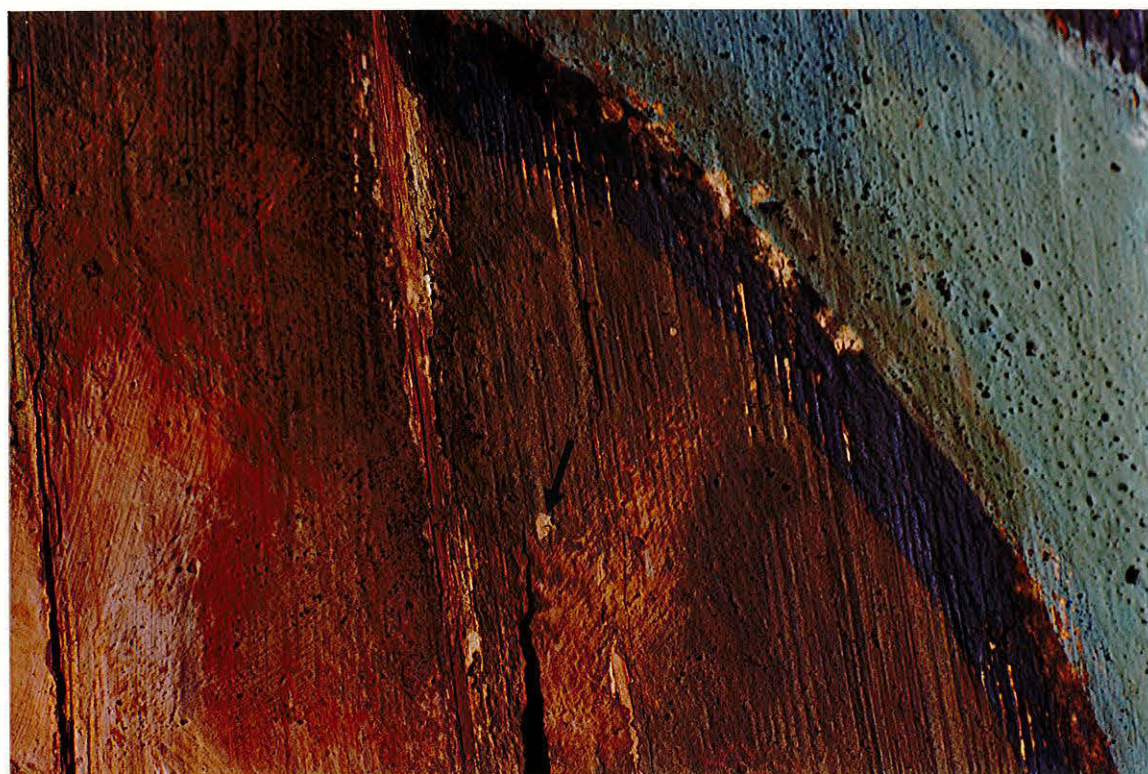
Plate 36 (below). Detail of the inner zone of the cusped mandorla around *St. Paul*. **Plate 37** (above). Cross-section of Sample 16/2108 at 1088 x magnification, taken from the dark green zone shown in the left portion of plate 36. A layer of natural azurite combined with a little yellow iron oxide, which almost certainly represents the original layer, is evident at the base of the sample with a layer of verdigris and yellow iron oxide on top. A thin layer of lead white mixed with vermilion and yellow iron oxide lies on the surface of the green layers. (*Macrophotograph Heritage/Howard 1997, photomicrograph Howard 1997*).

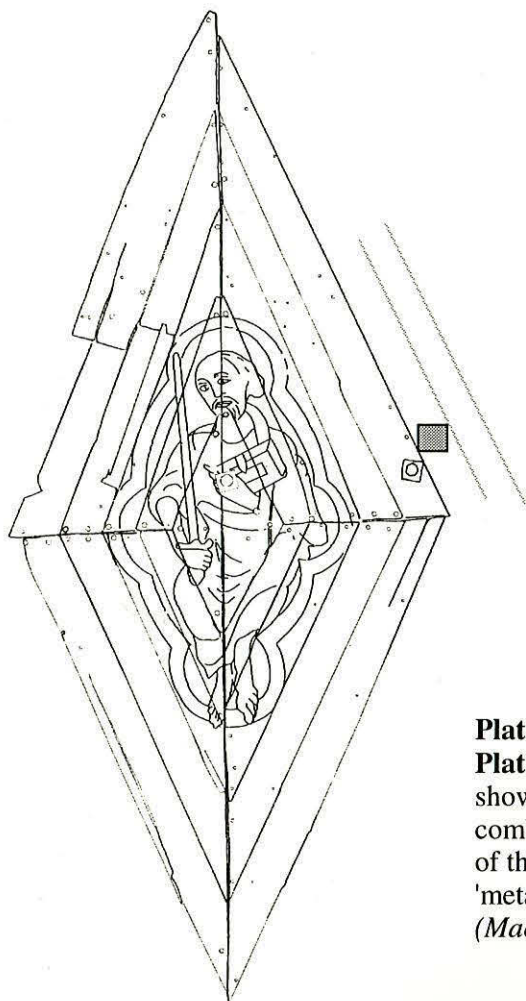
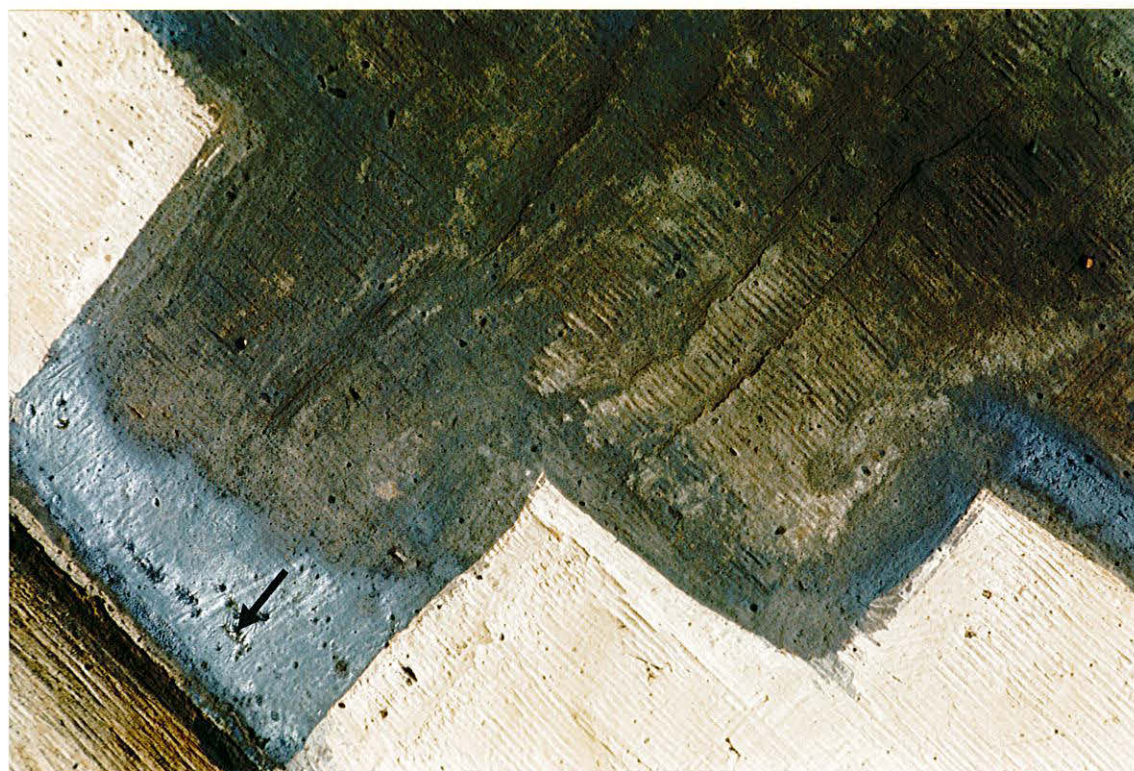
Plate 38 (*below*). Detail of the stepped border which surrounds *St. Paul*.
Plate 39 (*above*). Cross-section of Sample 17/2109 at 1808 x magnification, showing a thick layer of dark repainting and, beneath, a layer of carbon black combined with yellow iron oxides and lead white. On the uppermost surface of the sample is a thin coating (or layer of consolidant) which produces a 'metallic sheen', as seen in the lower left corner of Plate 38.
(*Macrophotograph Heritage/Howard 1997, photomicrograph Howard 1997*).

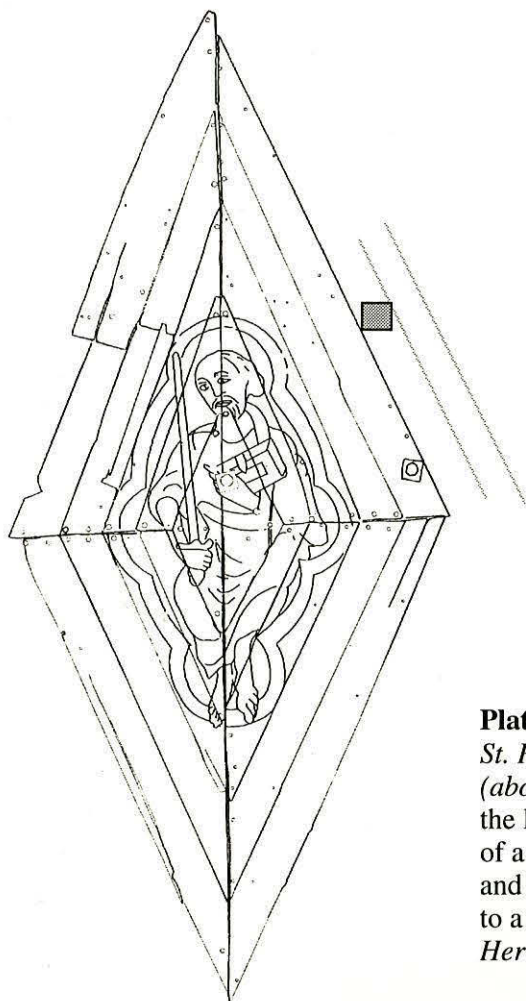
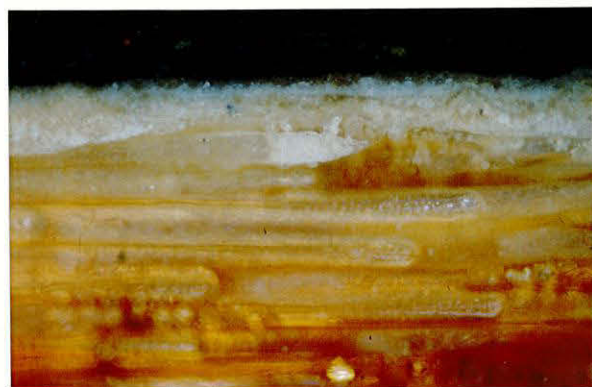
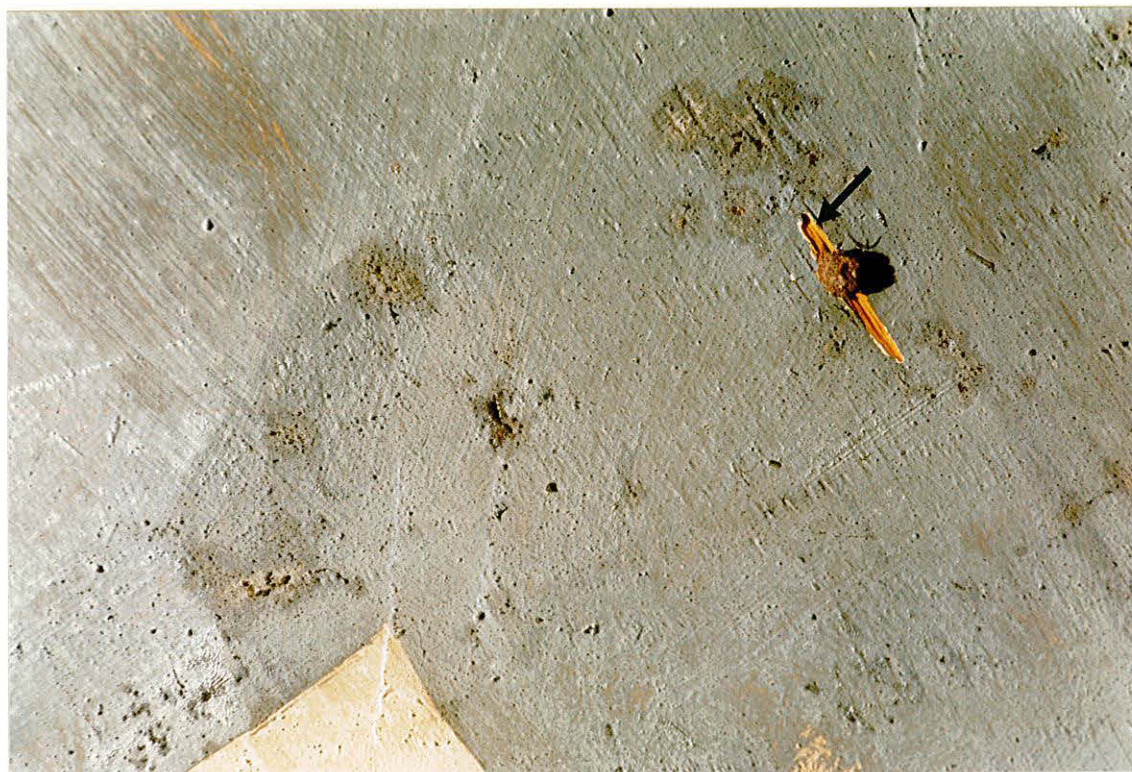
Plate 40 (*below*). Detail of a portion of the stepped border surrounding *St. Paul*, which has been painted on a replacement pine board. **Plate 41** (*above*). Cross-section of Sample 18/2110 at 1256 x magnification, showing the lead white preparatory layer, and dark brown paint layer which consists of a mixture of brown and yellow iron oxide pigments combined with barytes and carbon black. The silvery sheen on the surface of the paint layer is due to a pale coating which has not yet been identified. (*Macrophotograph Heritage/Howard 1997, photomicrograph Howard 1997*).

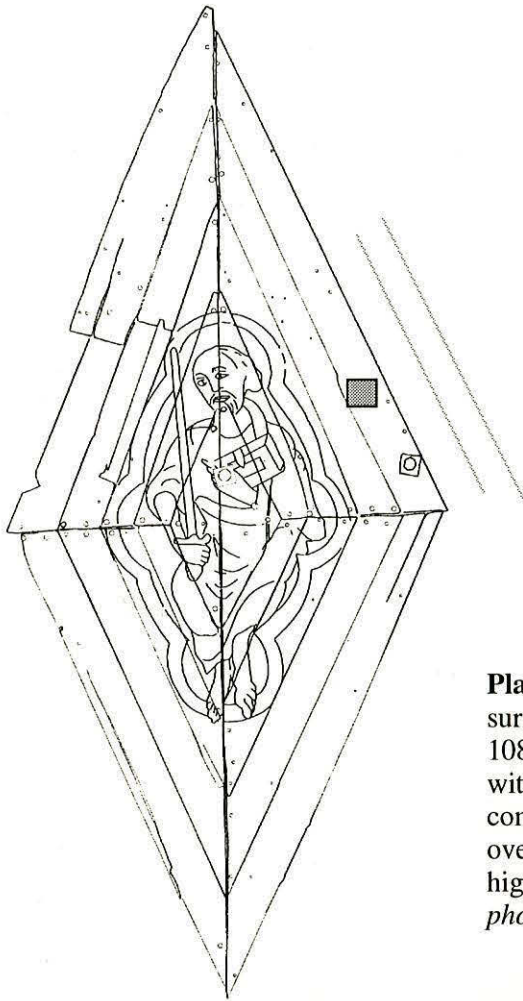
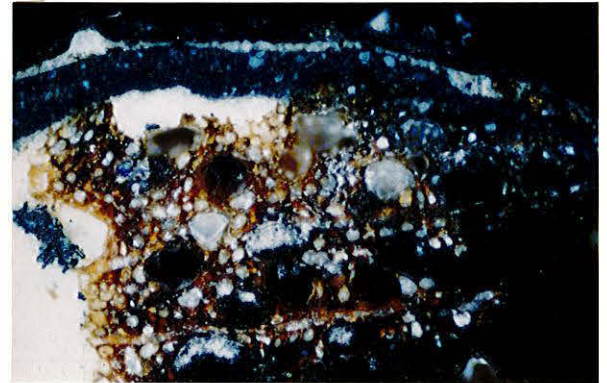
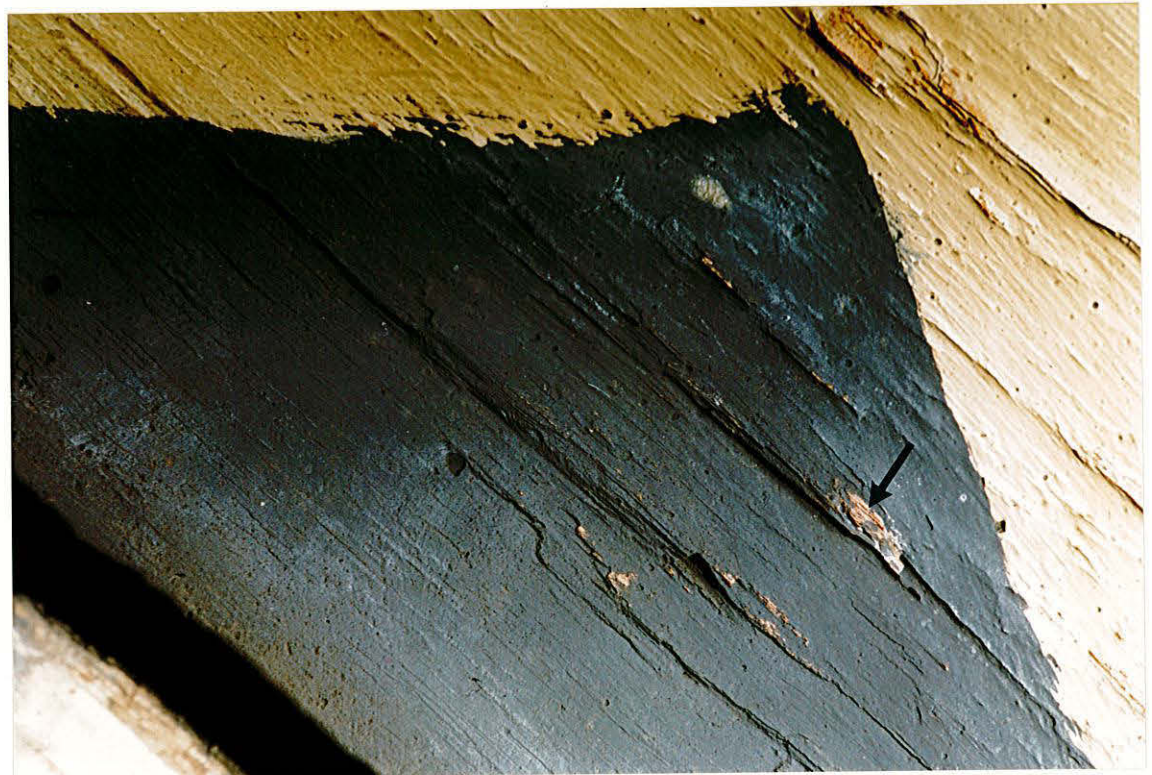
Plate 42 (*below*). Detail of a portion of the wave-pattern border which surrounds *St. Paul*. **Plate 43** (*above*). Cross-section of Sample 19/2111 at 1080 x magnification, showing the wood support which has been prepared with a lead white ground and, over this, a dense layer of carbon black combined with lead white. A second lead white ground has been applied over the lower black layer. The uppermost layer of the sample consists of highly reflective black particles. (*Macrophotograph Heritage/Howard 1997, photomicrograph Howard 1997*).

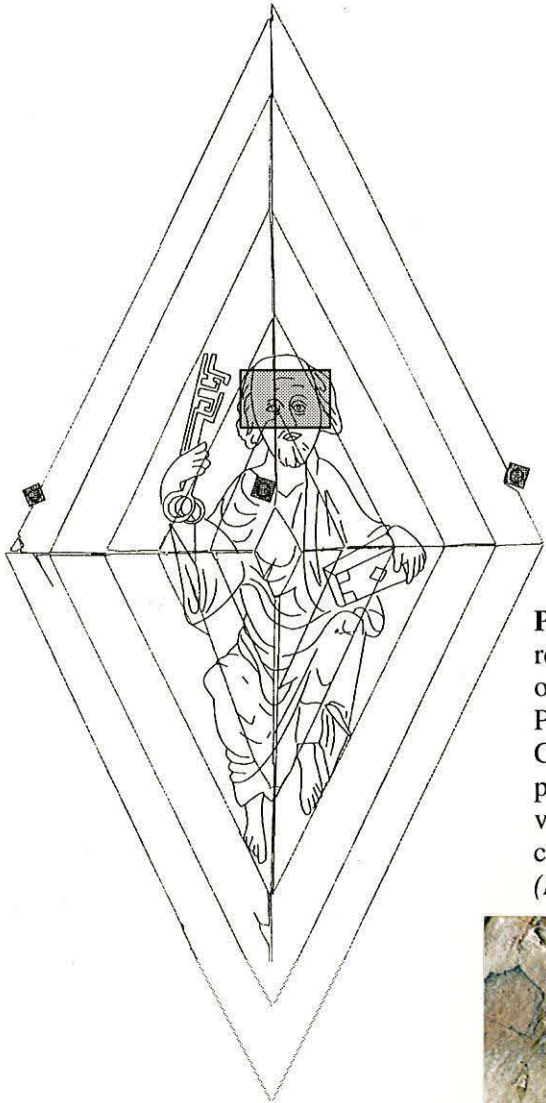
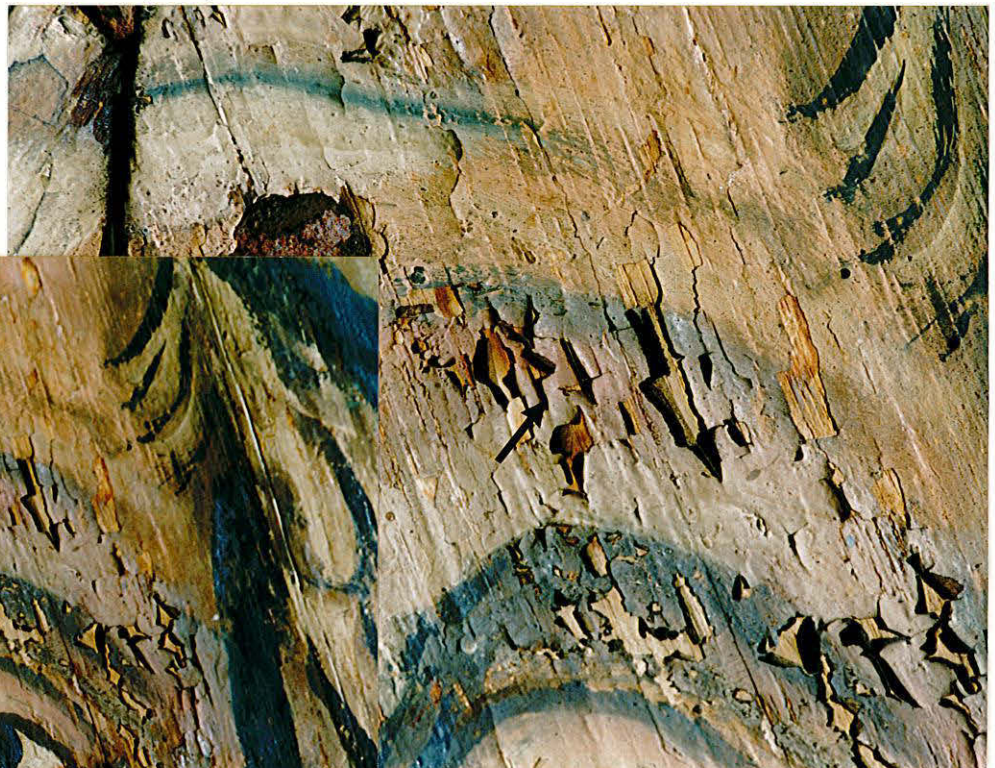
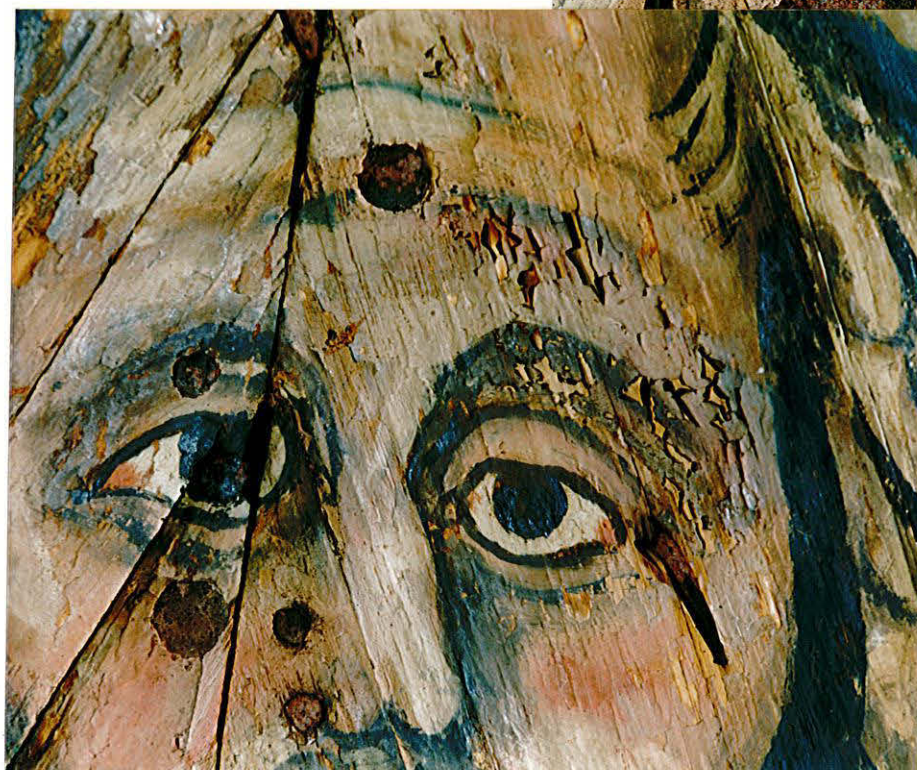
Plates 44 & 45 (below). Detail of St. Peter's head, showing the crude repainting and the severe cupping and lifting of the paint layers. The area of paint shown at the left of the plate has been re-laid by the Perry Lithgow Partnership in their recent phase of conservation. **Plate 46** (above). Cross-section of Sample 20/2112 at 2000 x magnification, showing the grey preparation applied to the wood support, over which the flesh tone of vermilion combined with lead white in an oil medium was applied. The crude repainting has been undertaken in red lead combined with lead white. (Macrophotographs Heritage/Howard 1997, photomicrograph Howard 1997).

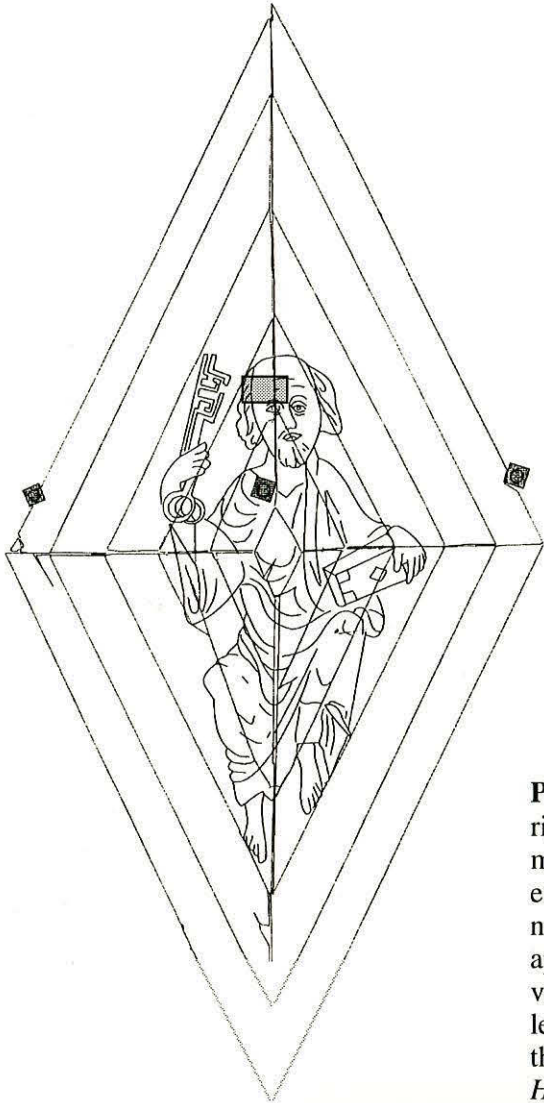
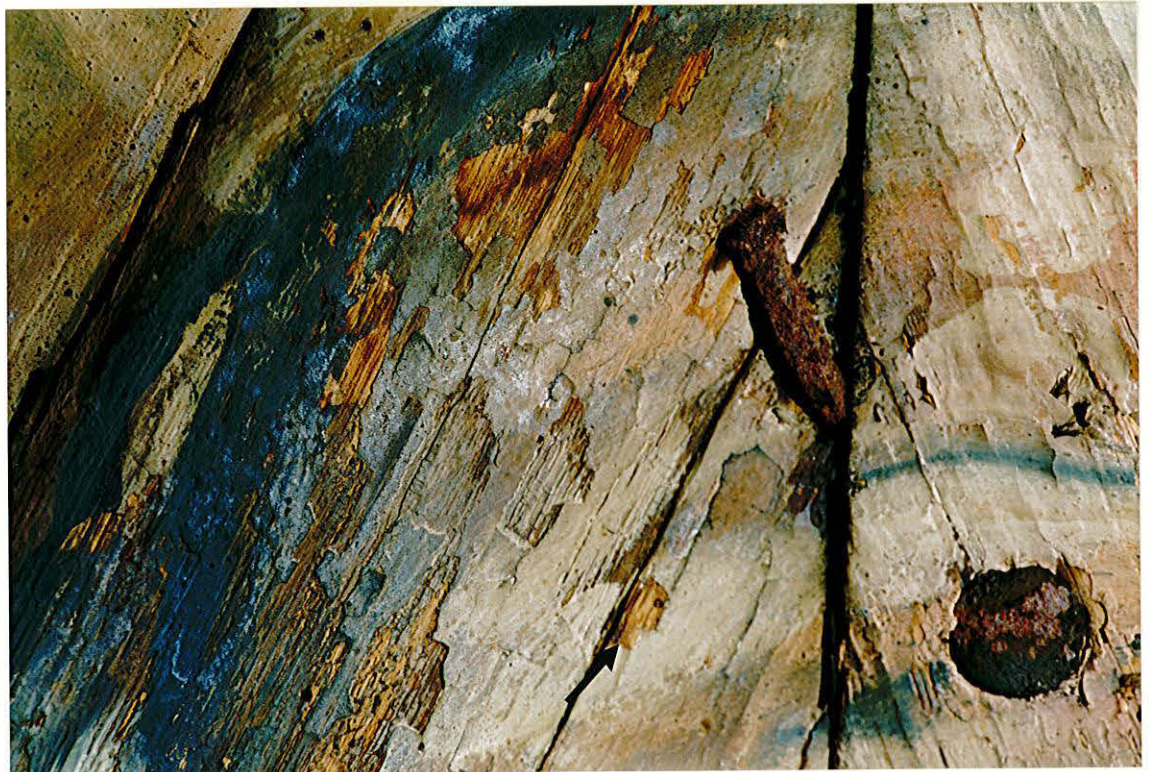
Plates 47 (below). Detail of St. Peter's head, showing the region above his right eye. **Plate 48** (above). Cross-section of Sample 21/2113 at 2000 x magnification, showing that an underpainting in pale green was originally employed to model the flesh tones. This underpaint consists of a layer of natural azurite combined with yellow iron oxide and lead white, and was applied in a layer 60 microns thick. Over this was applied the flesh tone of vermilion combined with lead white. A layer of repainting, consisting of lead white combined with a little carbon black, is evident on the surface of the sample. (*Macrophotograph Heritage/Howard 1997, photomicrograph Howard 1997*).

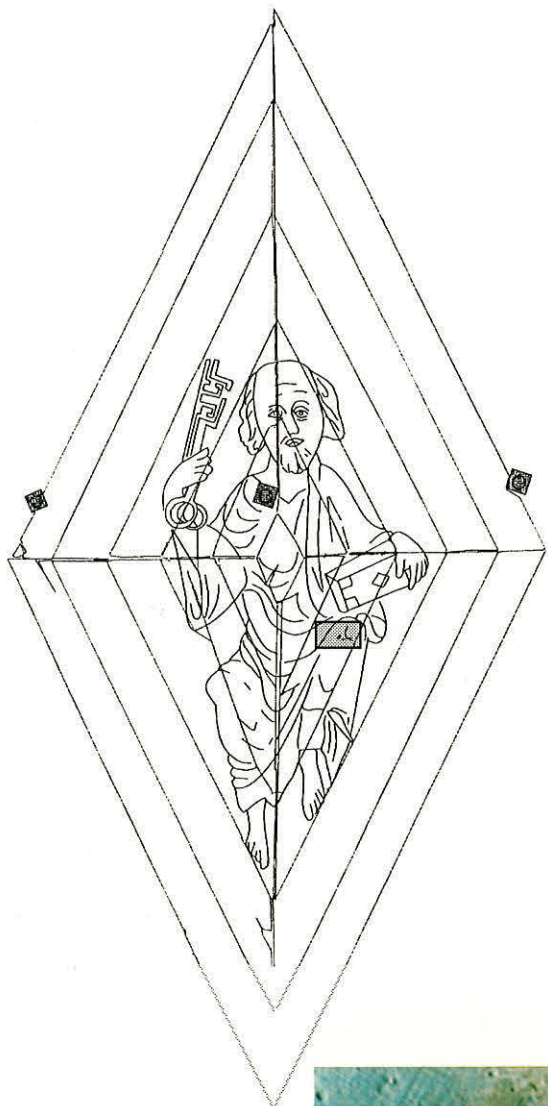
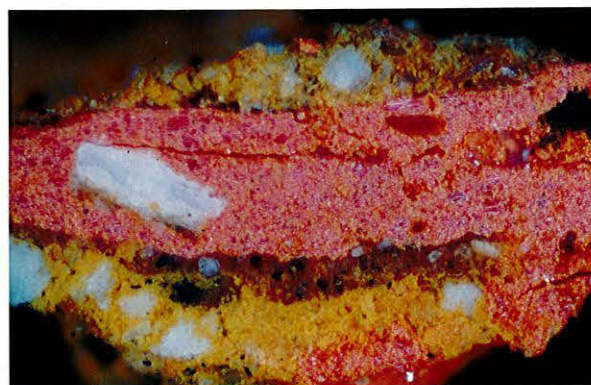
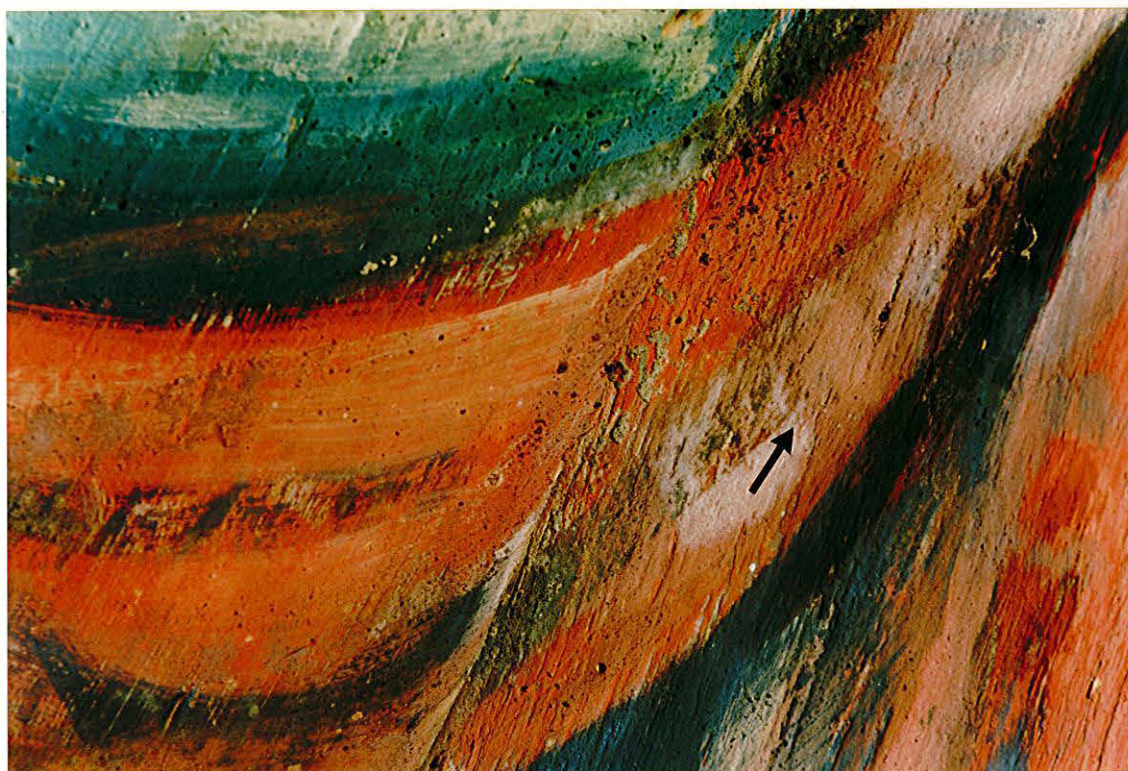
Plates 49 (below). Detail of the red drapery over St. Peter's left knee. The pale greyish highlight of the drapery was found to bloom readily in contact with water. **Plate 50** (above). Cross-section of Sample 22/2114 at 1712 x magnification, showing a layer of red lead combined with a little carbon black and lead white which was applied in preparation for the thick vermilion paint layer. The uppermost layer contains red lead, lead white, and a sulphate-rich component. (*Macrophotograph Heritage/Howard 1997, photomicrograph Howard 1997*).

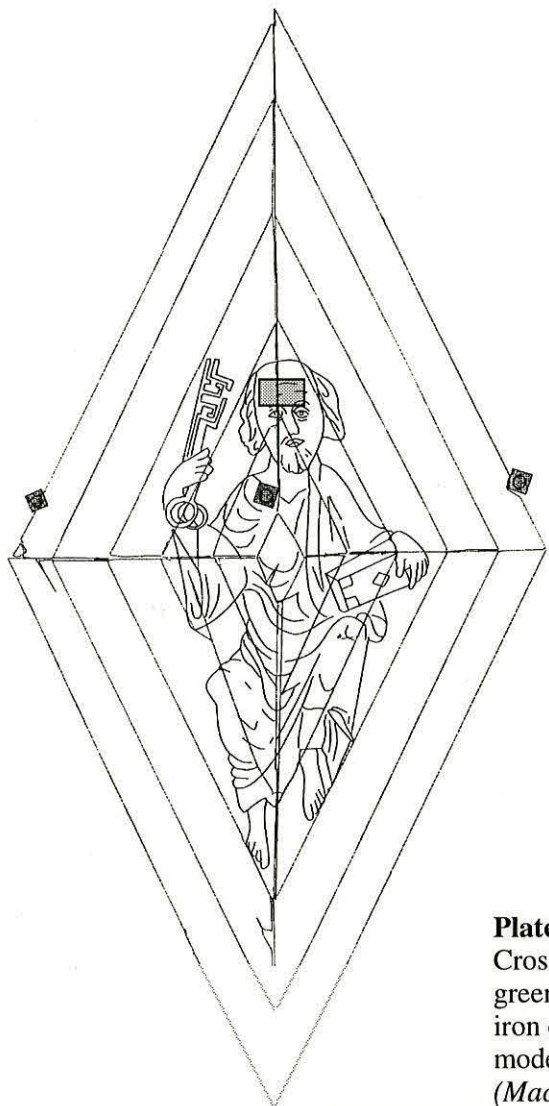
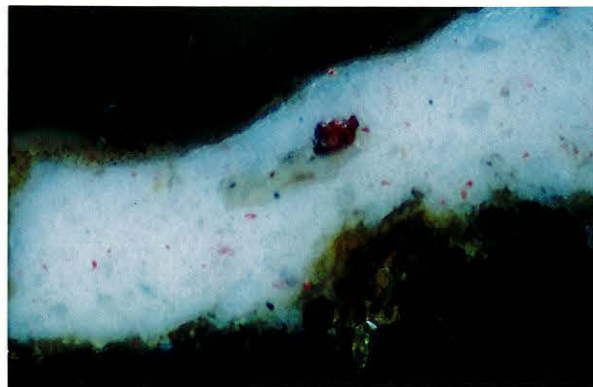
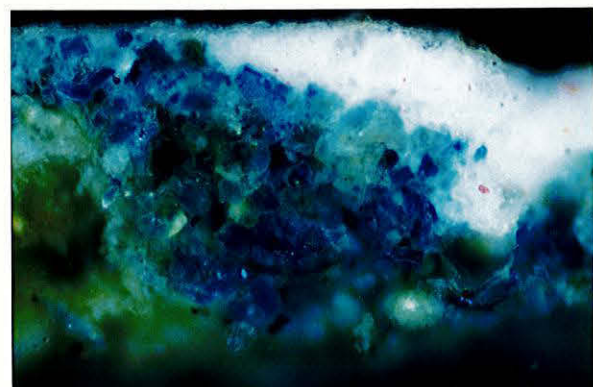
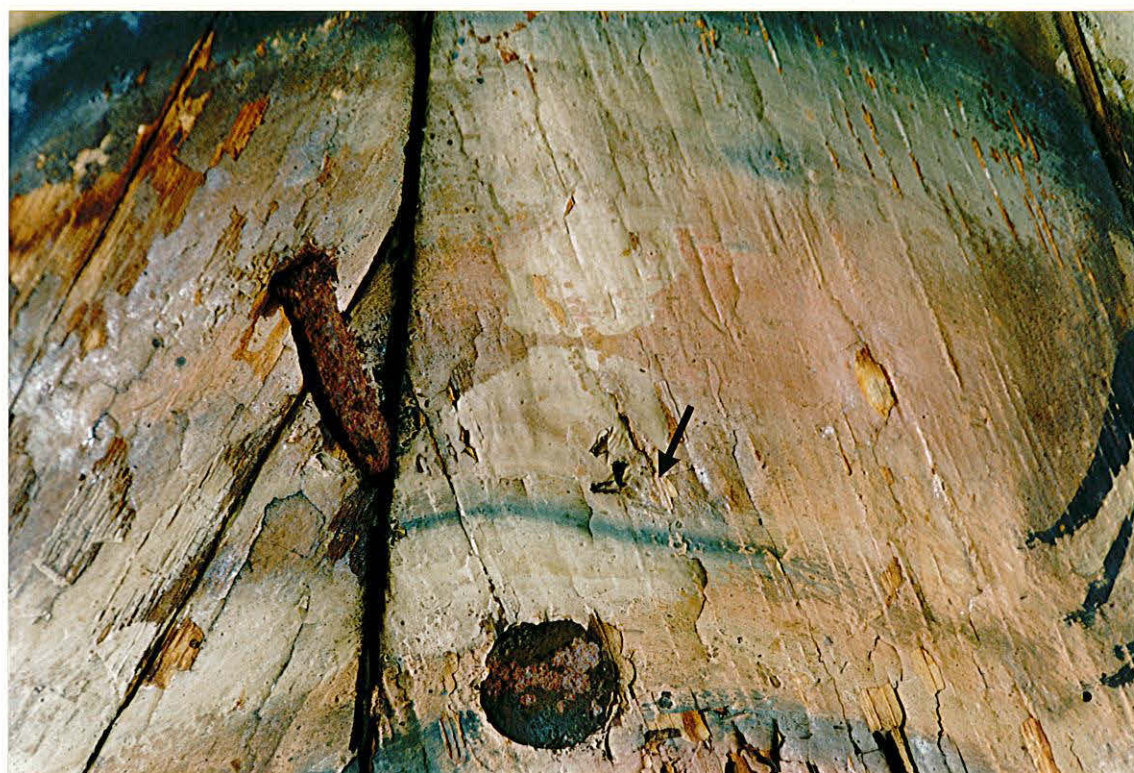
Plates 51 (*below*). Detail of St. Peter's left temple. **Plates 52 & 53.** Cross-section of Sample 23/2115 at 2000 x magnification. A layer of dark green underpainting produced by mixing natural azurite and some yellow iron oxide in a lead white matrix (*above*) was employed to produce the tonal modelling for the flesh tones of vermilion combined with lead white (*top*). (*Macrophotograph Heritage/Howard 1997, photomicrographs Howard 1997*).

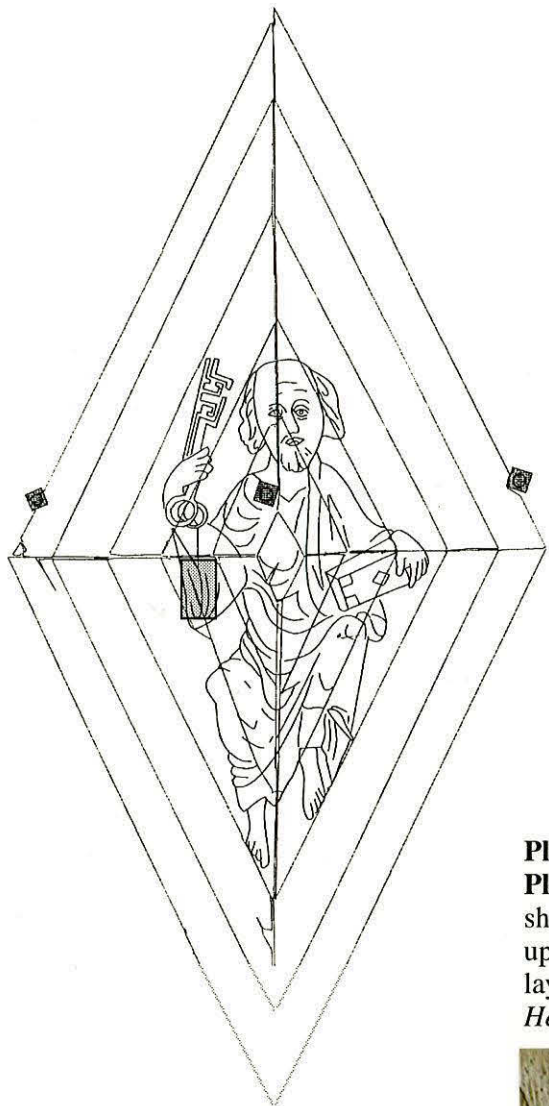
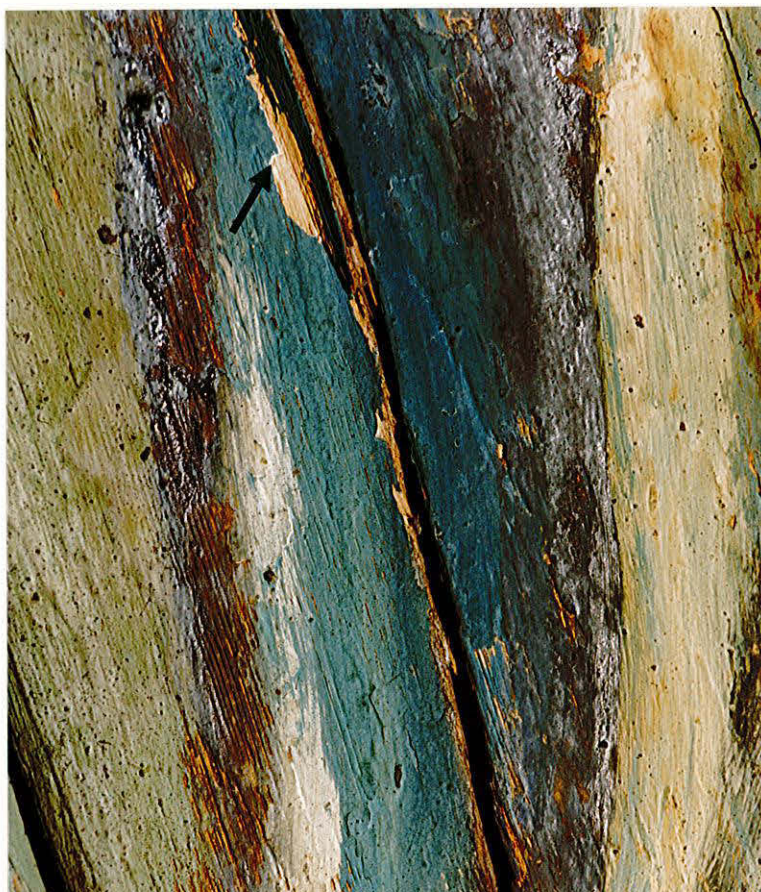
Plates 54 (*below*). Detail of the blue drapery of St. Peter's right sleeve.
Plate 55 (*above*). Cross-section of Sample 24/2116 at 800 x magnification, showing two layers of Prussian blue combined with lead white. The uppermost layer contains a higher proportion of Prussian blue, and both layers are part of a 19th-century phase of repainting. (*Macrophotograph Heritage/Howard 1997, photomicrograph Howard 1997*).

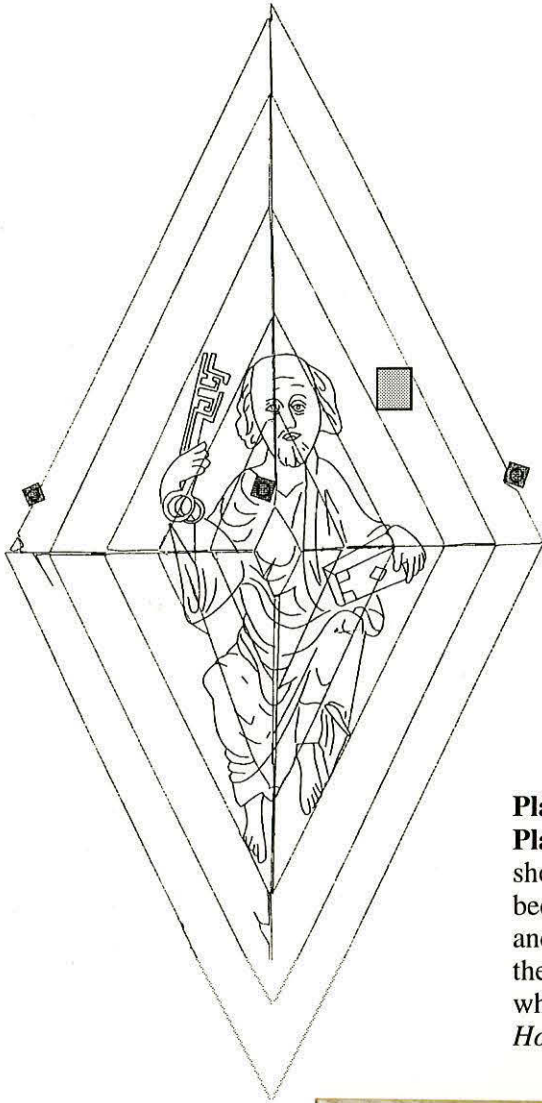
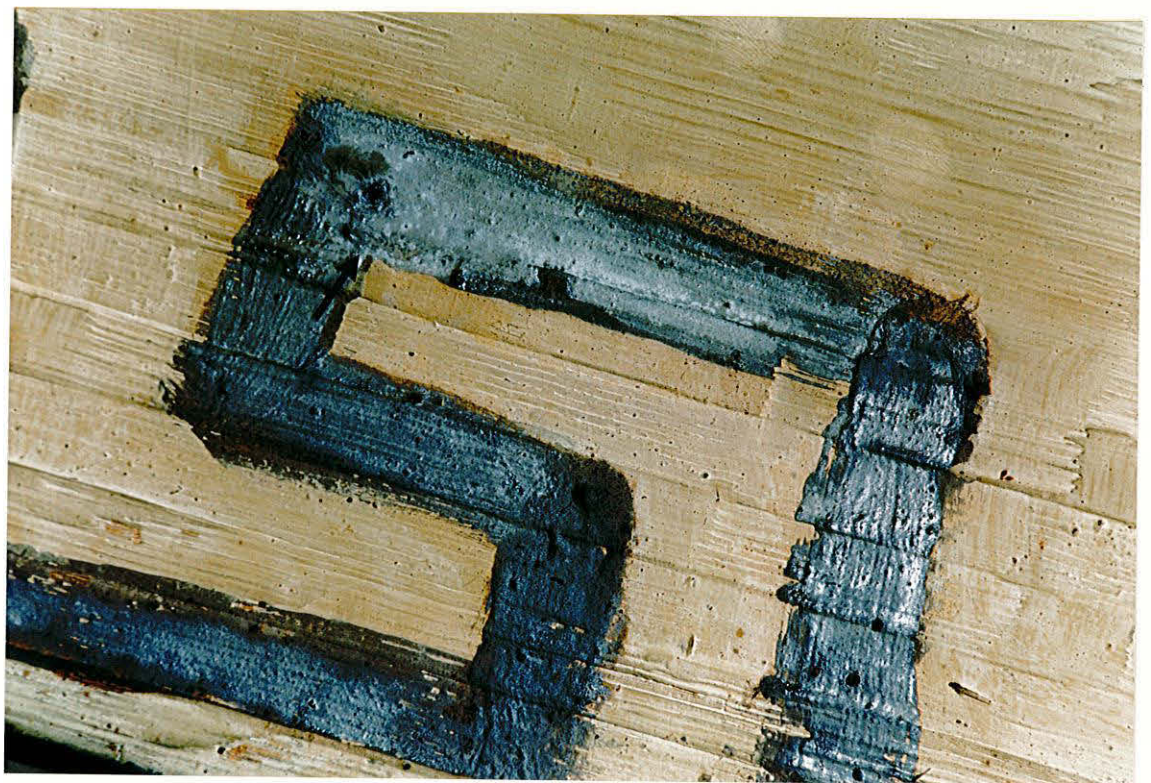
Plates 56 (below). Detail of the key pattern border around St. Peter.

Plate 57 (above). Cross-section of Sample 25/2117 at 552 x magnification, showing a thick dark layer of black, brown and yellow inclusions which has been applied directly over a layer containing yellow iron oxide, carbon black and lead white on a lead white ground. The metallic sheen on the surface of the paint layer, evident in plate 56, is due to the unidentified surface coating, which remains on the surface of the sample. (*Macrophotograph Heritage/Howard 1997, photomicrograph Howard 1997*).
