CONSERVATION OF WALL PAINTING DEPARTMENT
COURTAULD INSTITUTE OF ART

**Peterborough Cathedral, nave ceiling:
Scientific examination of the original
decoration**

❧ *Volume II Plates*

HELEN HOWARD
September 1997

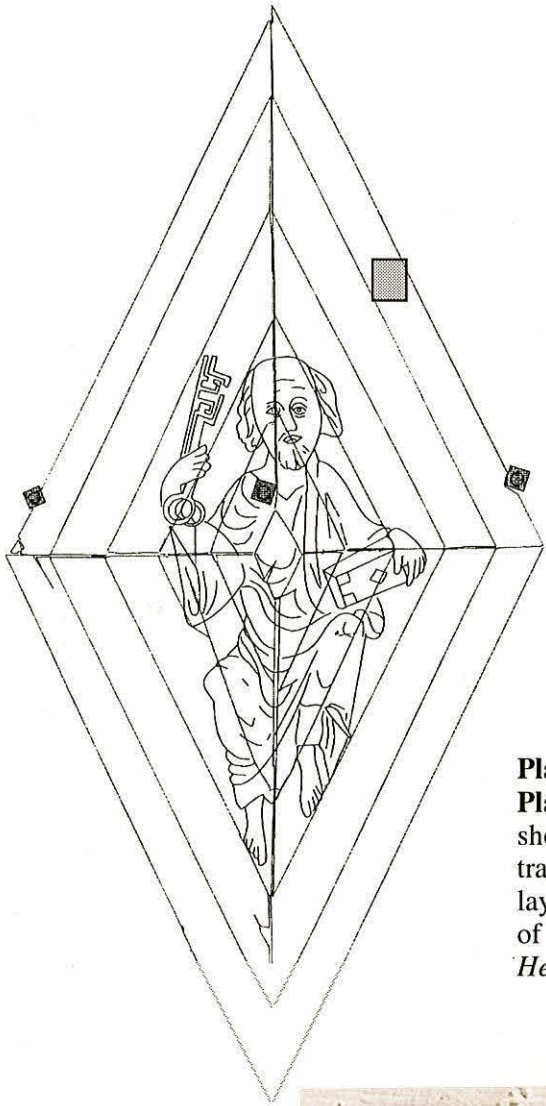
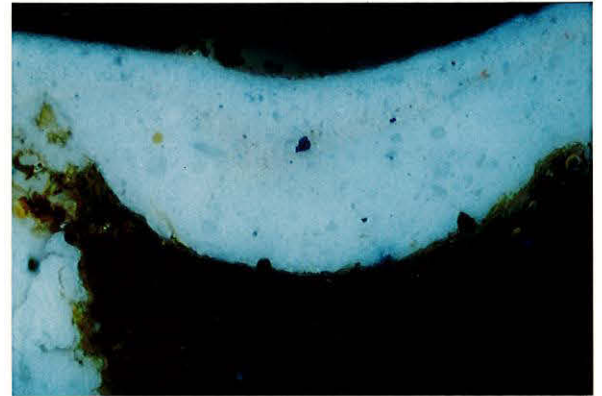
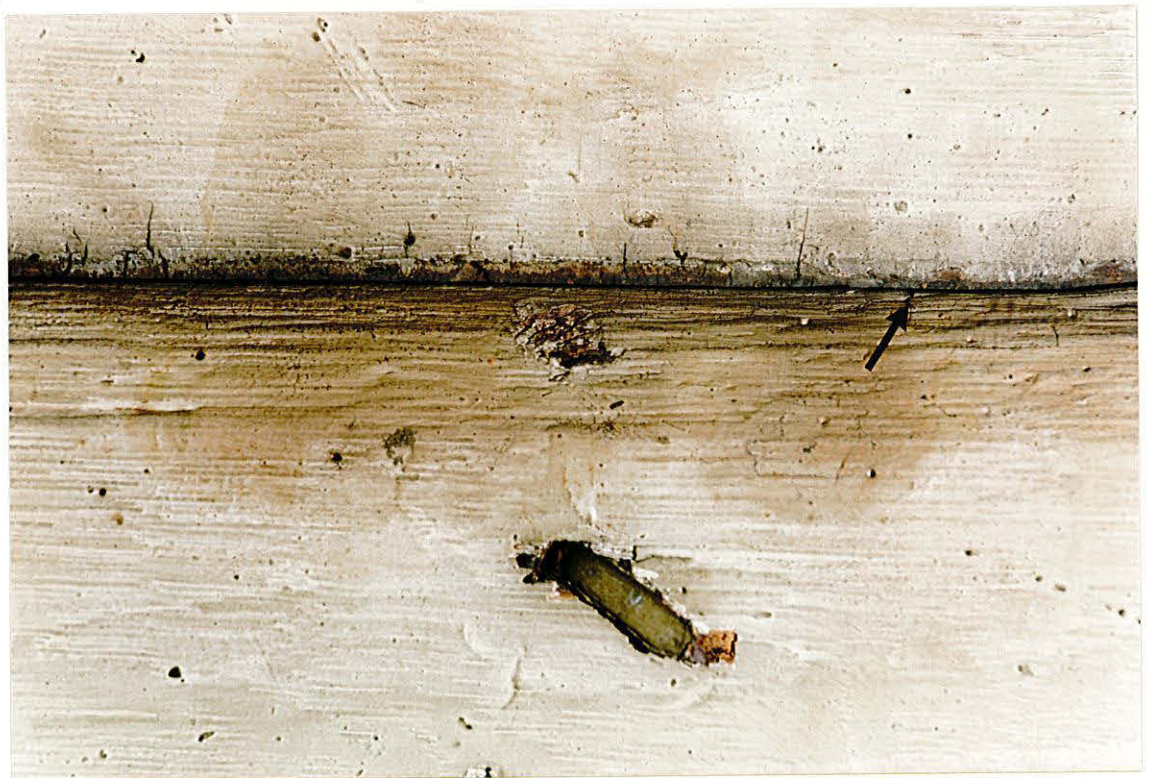
Plates 58 (*below*). Detail of wave-pattern border surrounding St. Peter.
Plate 59 (*above*). Cross-section of Sample 26/2118 at 1208 x magnification, showing the wood support over which a layer of lead white is evident. A trace of vermilion is apparent towards the upper part of this thick white layer which compares closely to that found in Sample 27. A thick accretion of surface dirt is visible at the top of the sample. (*Macrophotograph Heritage/Howard 1997, photomicrograph Howard 1997*).

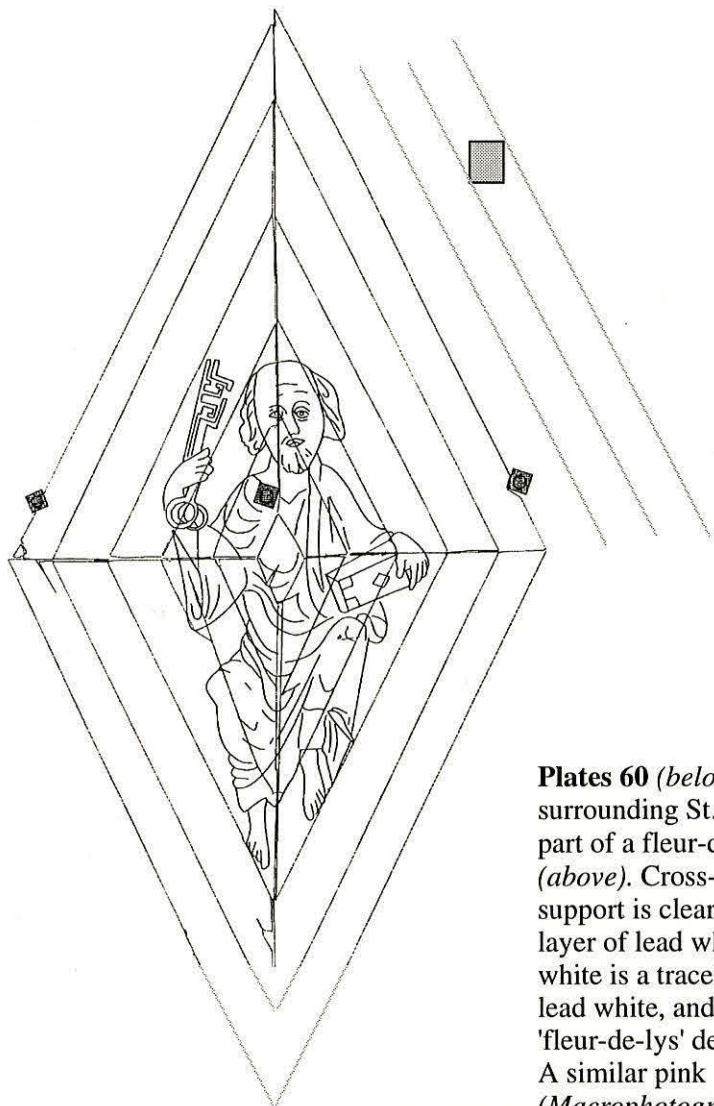
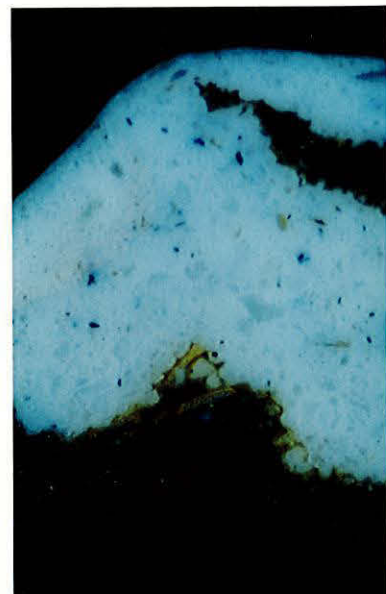
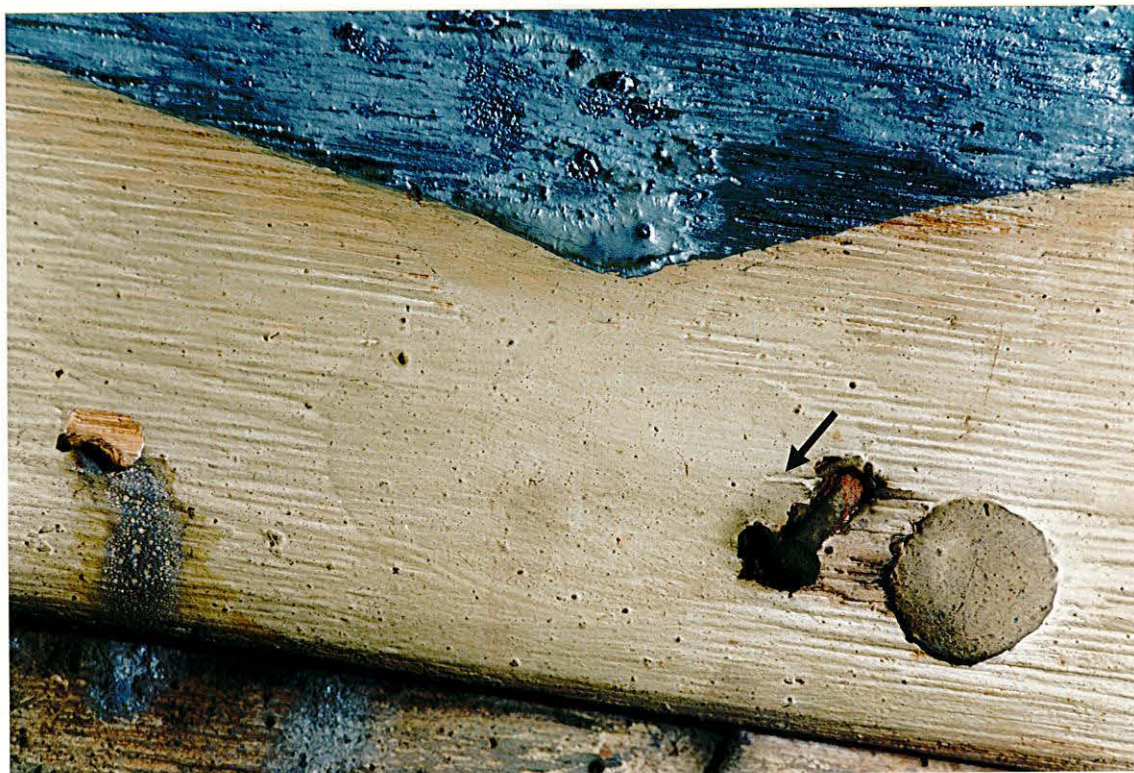
Plates 60 (*below*). Detail of centre of extended chevron pattern border surrounding St. Peter. In the centre of the plate the ghost of an image perhaps part of a fleur-de lysis visible beneath the lead white repainting. **Plate 61** (*above*). Cross-section of Sample 27/2119 at 1160 x magnification. The wood support is clearly visible at the bottom of the cross-section, and over this a layer of lead white has been applied. Approximately 3/5 up this layer of lead white is a tracebarely visible in the photograph of vermilion combined with lead white, and it seems likely that this combination was employed for the 'fleur-de-lys' decoration. A second layer of lead white covers the pink motif. A similar pink layer is visible in Sample 26/2118 (Plate 59). (*Macrophotograph Heritage/Howard 1997, photomicrograph Howard 1997*).

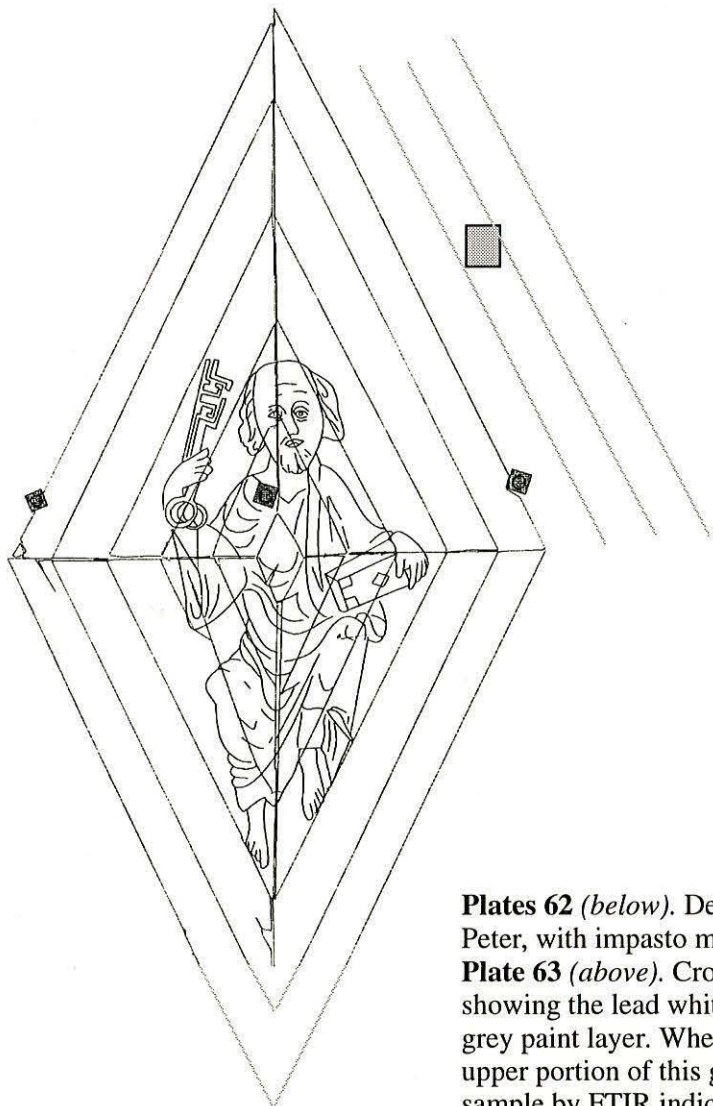
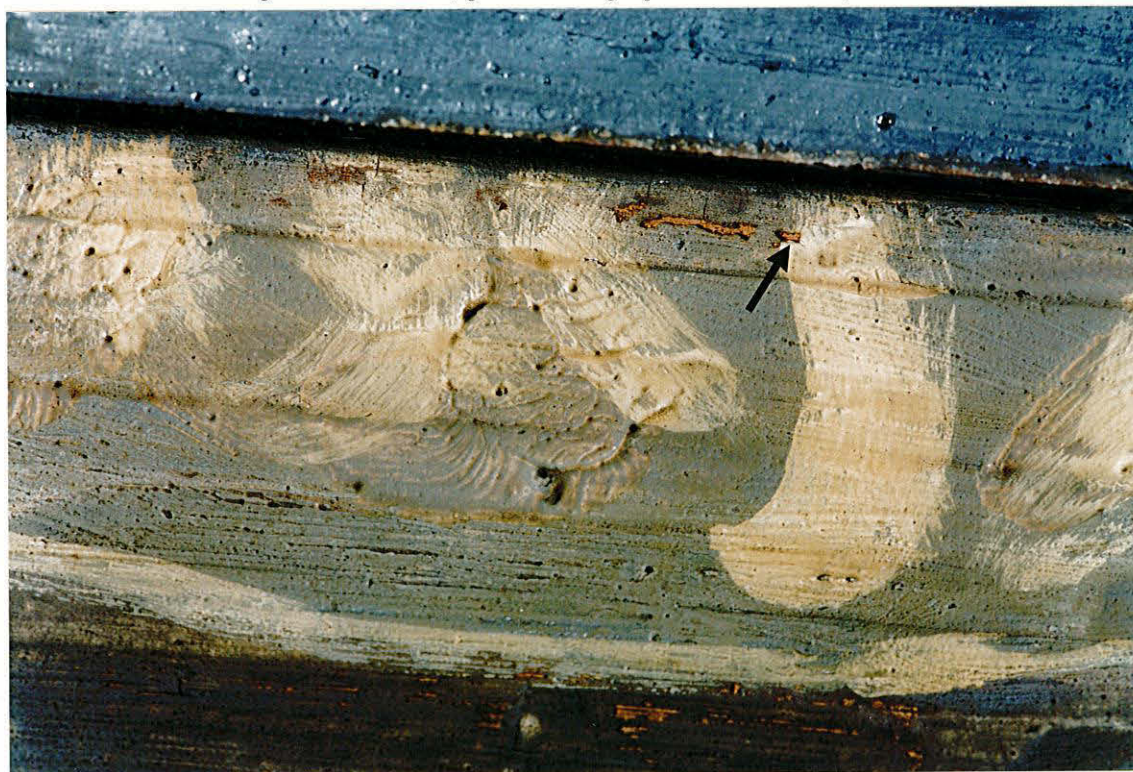
Plates 62 (below). Detail of grey chevron-pattern border surrounding St. Peter, with impasto motifs clearly visible below the grey and white repainting. **Plate 63 (above).** Cross-section of Sample 28/2120 at 720 x magnification showing the lead white layer which was applied in impasto, and the overlying grey paint layer. When viewed in UV light, as shown in **Plate 64 (top)** the upper portion of this grey layer fluoresces. Analysis of this portion of the sample by FTIR indicated that shellac may be present. (*Macrophotograph Heritage/Howard 1997, photomicrograph Howard 1997*).

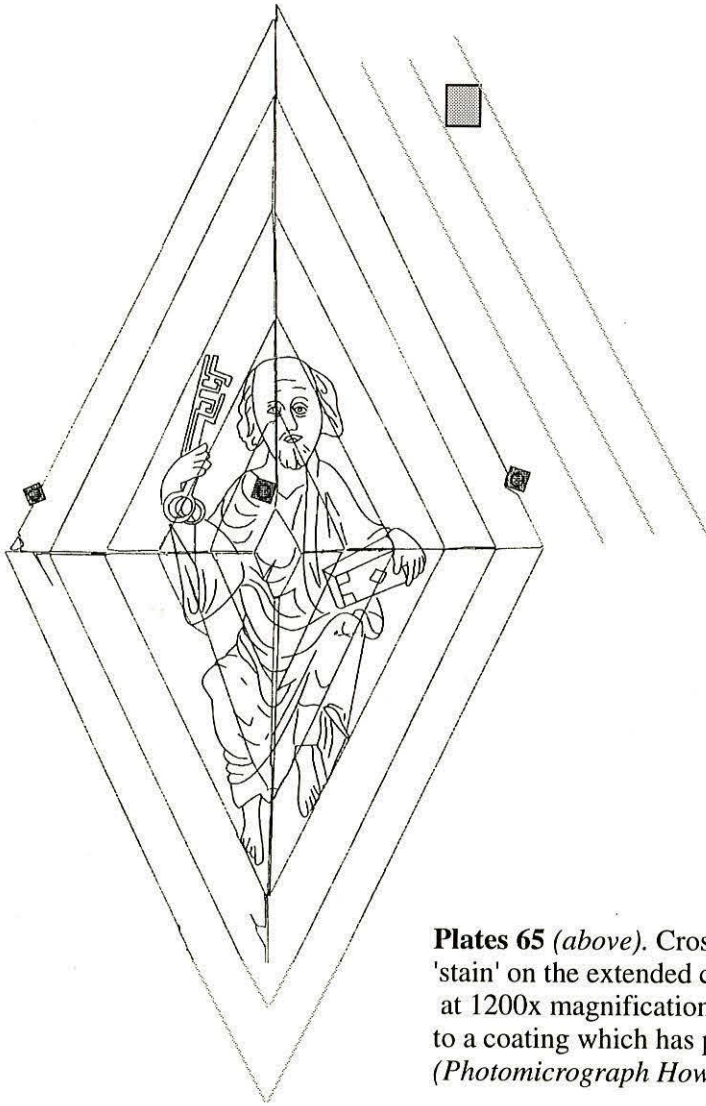
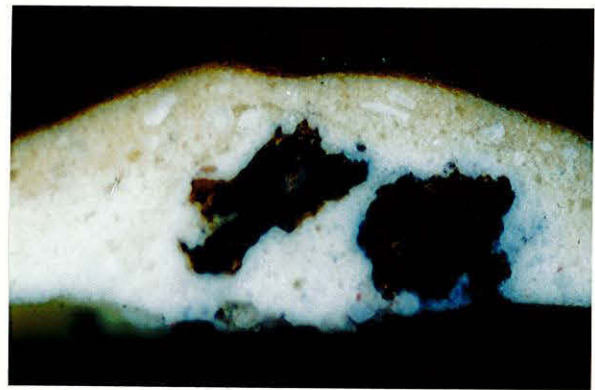
Plates 65 (*above*). Cross-section of Sample 29/2121 taken from a brown 'stain' on the extended chevron pattern border surrounding St. Peter, shown at 1200x magnification. The brown appearance of the surface is clearly due to a coating which has penetrated into the lead white paint layer. (*Photomicrograph Howard 1997*).
