**Peterborough Cathedral, nave ceiling:
Scientific examination of the original decoration
of bays 36-39**

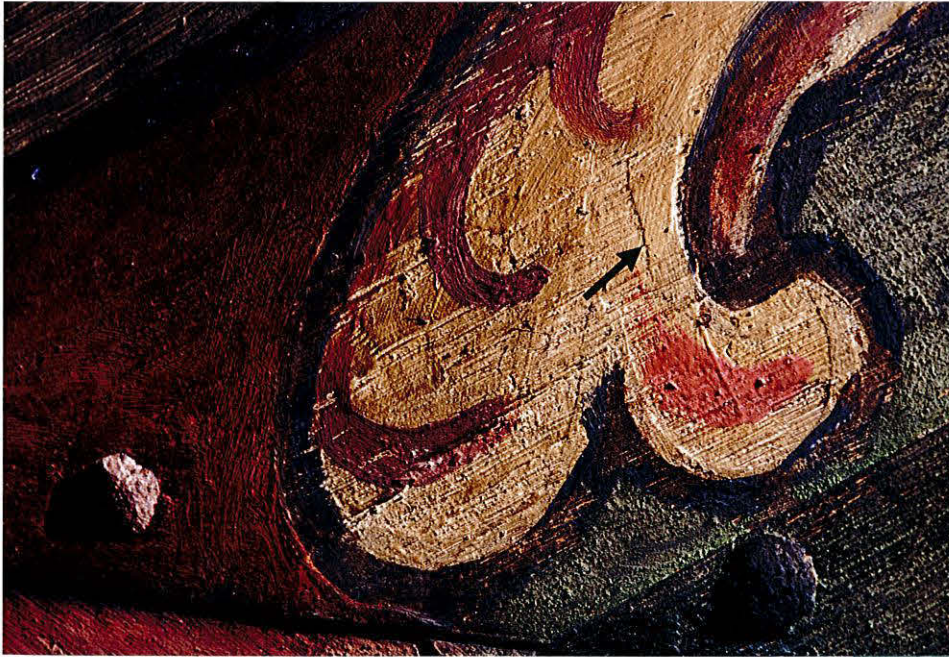
Plate 5 (above): Detail of foliate scroll on ceiling board 36 IV dd. Close examination of the raised foliate motif in this area indicated that it may have been carved in shallow relief into the oak board. **Plate 6 (above right):**

In addition, examination of the surface indicated that the raised motifs which are visible in a few discrete areas are likely to be the result of shallow carving into the original oak boards, and may have been employed to assist in setting out the design. This is evident for example in the foliate motifs on boards 37 IV b and 36 IV dd (Plate 14, lower right, and Plate 5, right side) where a distinct raised edge is clearly visible.

The results which are perhaps of greatest interest in this phase of investigation concern the raised motifs which are visible in raking light beneath the present paint surface. In some places the slightly raised areas appear to be the result of shallow carving into the original oak boards, and may have been employed to assist in setting out the design. This is evident for example in the foliate motifs on boards 37 IV b and 36 IV dd (Plate 14, lower right, and Plate 5, right side) where a distinct raised edge is clearly visible. In each case the shallow carving of the scroll motif is followed—though not absolutely—by the crude line of the repaint. Elsewhere, as in the chevron motif on board 38 IV t (Plate 12), the crude later repainting is completely offset from the earlier raised pattern. Similar shallow relief carving employed to produce lozenge and contiguous circle patterns has been identified on the contemporary reredos now at Adisham, Kent.¹⁴

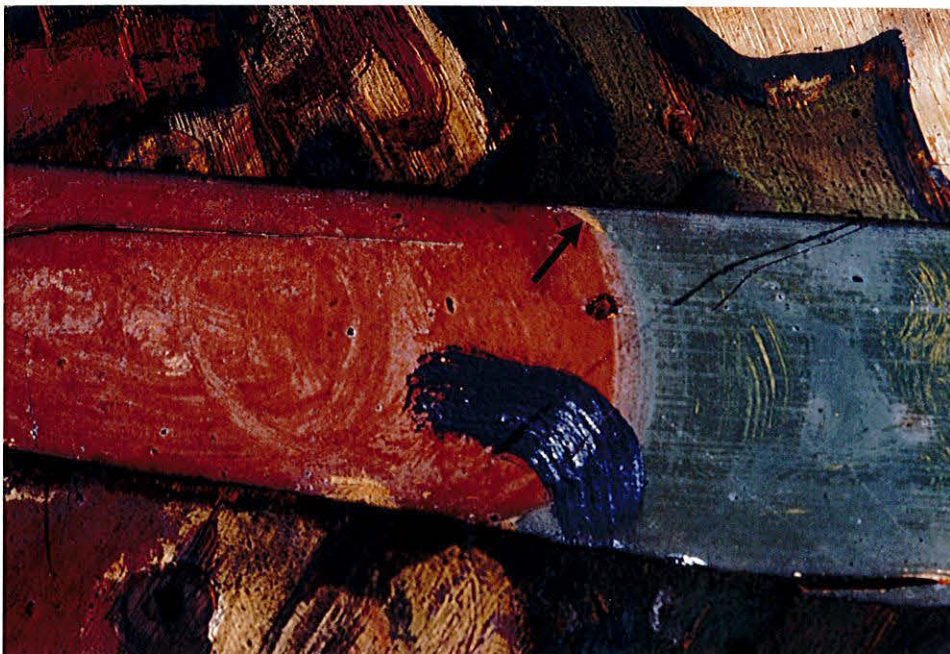
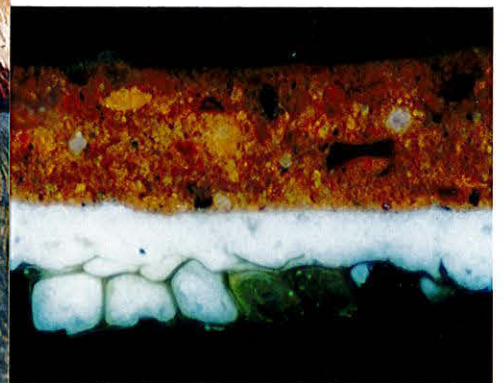
Plate 9 (below right): Cross-section of Sample 4/2350 taken from the crude red repainting shown in Plate 8, shown at 2000x magnification. A thick layer of red earth combined with carbon black was applied over a lead white ground on the new support. (*Macrophotographs, Heritage & Howard 1998; photomicrographs, Howard 1998*).

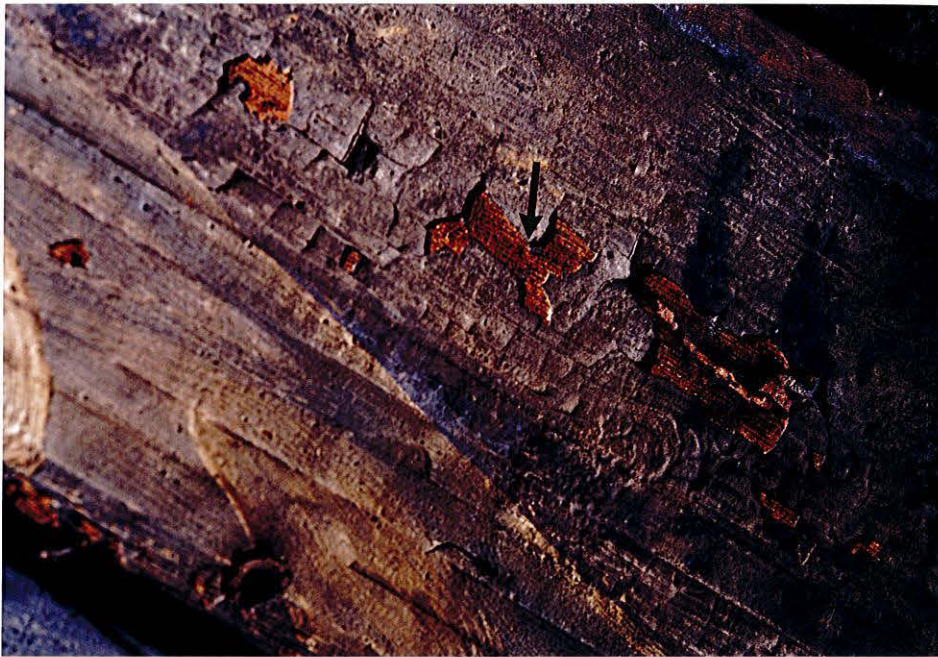
Plate 10 (*above*): Detail showing black paint with blooming and extensive craquelure on board 36 III w. **Plate 11** (*above right*): Cross-section taken from the black paint shown in Plate 10, shown at 800x magnification. A thick layer of charcoal black combined with yellow earth and lead white was applied directly to the wood support. **Plate 12** (*below*): Detail of the chevron pattern painted in grey on ceiling board 38 IV t. Beneath the grey chevron pattern there are traces of a similar motif which appears to have been carved in shallow relief into the ceiling board. **Plate 13** (*below right*): Cross-section of a sample taken from the grey chevron pattern, shown at 472x magnification. Here a layer of carbon black combined with lead white and red, yellow and brown earth particles was applied over a lead white ground. (*Macrophotographs, Heritage & Howard 1998; photomicrographs, Howard 1998*).

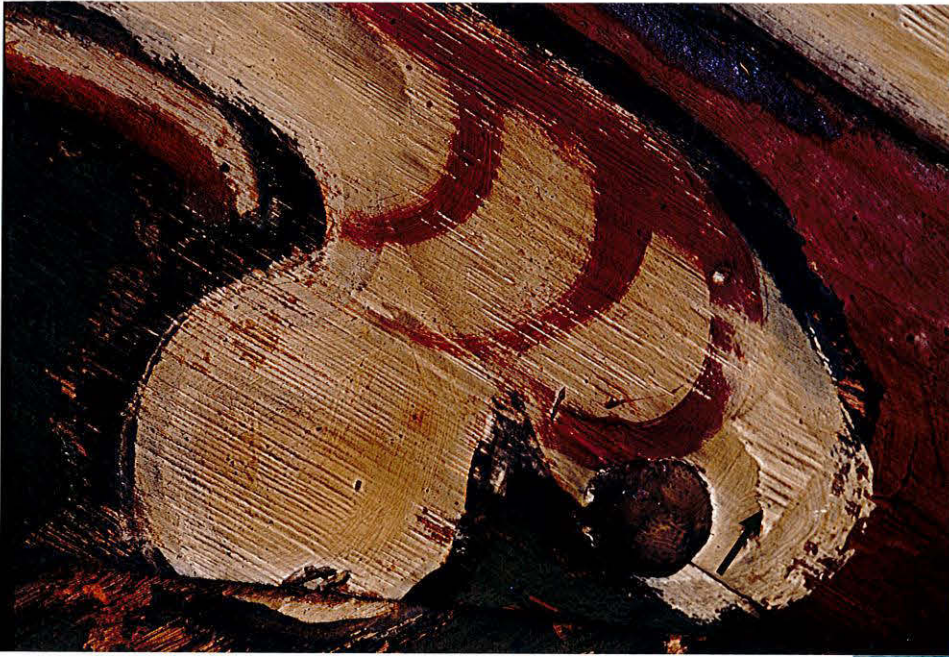
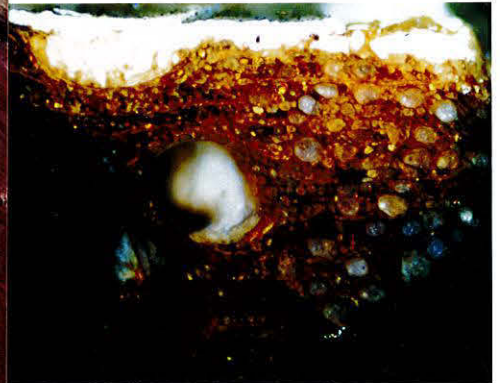
Plate 14 (*above*): Detail of foliate motif near the mouth of the *Green Man* on ceiling board 37 IV b. In raking light it is apparent that the curvilinear detail was carved in shallow relief in the oak board. **Plate 15** (*top right*): Cross-section of Sample 7/2353 taken from the creamy-white paint over the raised line, shown at 584x magnification. In normal incident light a single layer of lead white is visible on the wood support, however, when viewed in bright-field illumination at 1760x mag.

(**Plate 16**, *right*) two distinct layers of lead white are visible. **Plate 17** (*below*): Detail of the *Green Man*. **Plate 18** (*below right*): Cross-section of Sample 8/2354 taken from the flesh tone below the *Green Man's* left eye, shown at 2000x magnification. At the base of the sample the original green shading of the flesh tone—in azurite, yellow earth and lead white—is evident, over which lead white with some charcoal black was applied. (*Macrophotographs, Heritage & Howard 1998; photomicrographs, Howard 1998*).

Initial examination of paint samples taken from the areas carved in shallow relief indicated the presence of a single paint layer of lead white with no distinct stratigraphy— i.e. no early paint layer with a dirt layer on top followed by layers of repaint. However, further examination of the paint cross-sections in bright field illumination indicated the presence of two distinct paint layers, both consisting principally of lead white (Plates 7 & 16).

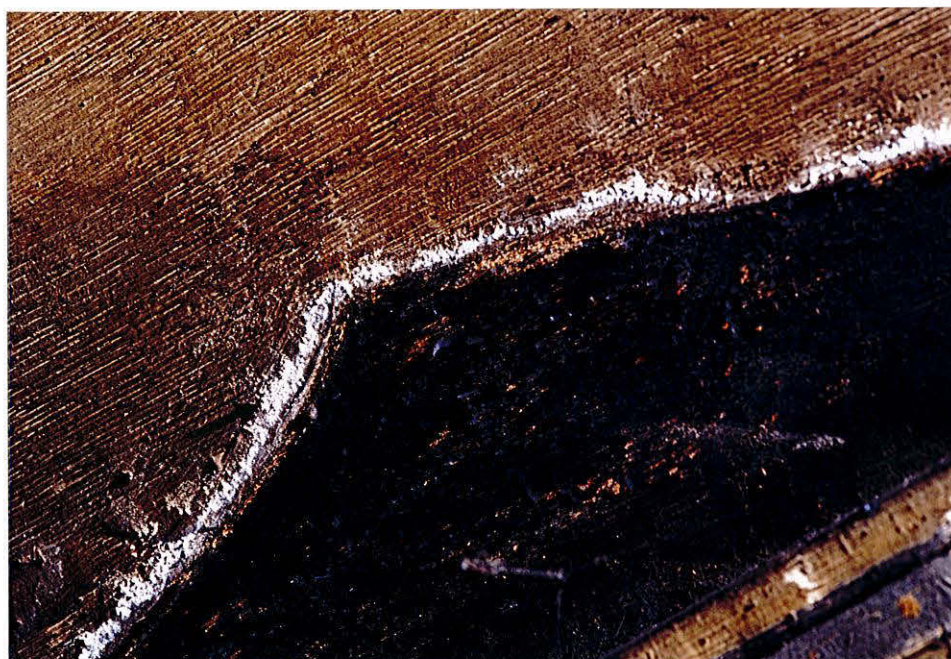
Plate 19 (*above*): Detail of the salt efflorescence which follows the edge of the black chevron pattern on ceiling board 37 I d. Instrumental analysis of the salts in a sample taken from this area confirmed the presence of ammonium lead sulphate and sodium sulphate. **Plate 20** (*below*): Detail of the vertical board below the ceiling on the north side of bays 38-39. **Plate 21** (*below right*): Cross-section of Sample 10/2356 taken from the flower bud shown in Plate 20, shown at 1720x magnification. The secondary lead white ground and thick uppermost red layer of vermilion combined with red lead and lead white clearly indicates that this zone has undergone comprehensive repainting. (*Macrophotographs, Heritage & Howard 1998; photomicrograph, Howard 1998*).

In a few areas a distinct line of white salts was evident adjacent to designs in black paint, as is clearly visible along the edge of the chevron pattern on board 37 I d (Plate 19). Preliminary analysis of these salts by optical microscopy suggested the presence of two species. Both displayed pleochroism and birefringence in transmitted light, but though the refractive indices of one were greater than 1.58, the refractive indices of the other appeared to be less than 1.58. Subsequently instrumental analysis was undertaken by SEM/EDX and by XRD and this confirmed with presence of ammonium lead sulphate $\{(NH_4)_2.PbSO_4\}_2$ and sodium sulphate {thenardite, Na_2SO_4 }. Although a high degree of sulphation was noted in the ground and paint layers in the preliminary phase of analysis, the mechanism for the production of these salts in such distinct zones requires further investigation. However, it is evident that the presence of these salts is associated only with the later paint layers.
