**CLUN CASTLE
SHROPSHIRE**

**RECORDING & EXCAVATION
WORKS
1990**

AN INTERIM REPORT

**November 1990
Hereford Archaeology Series 89**

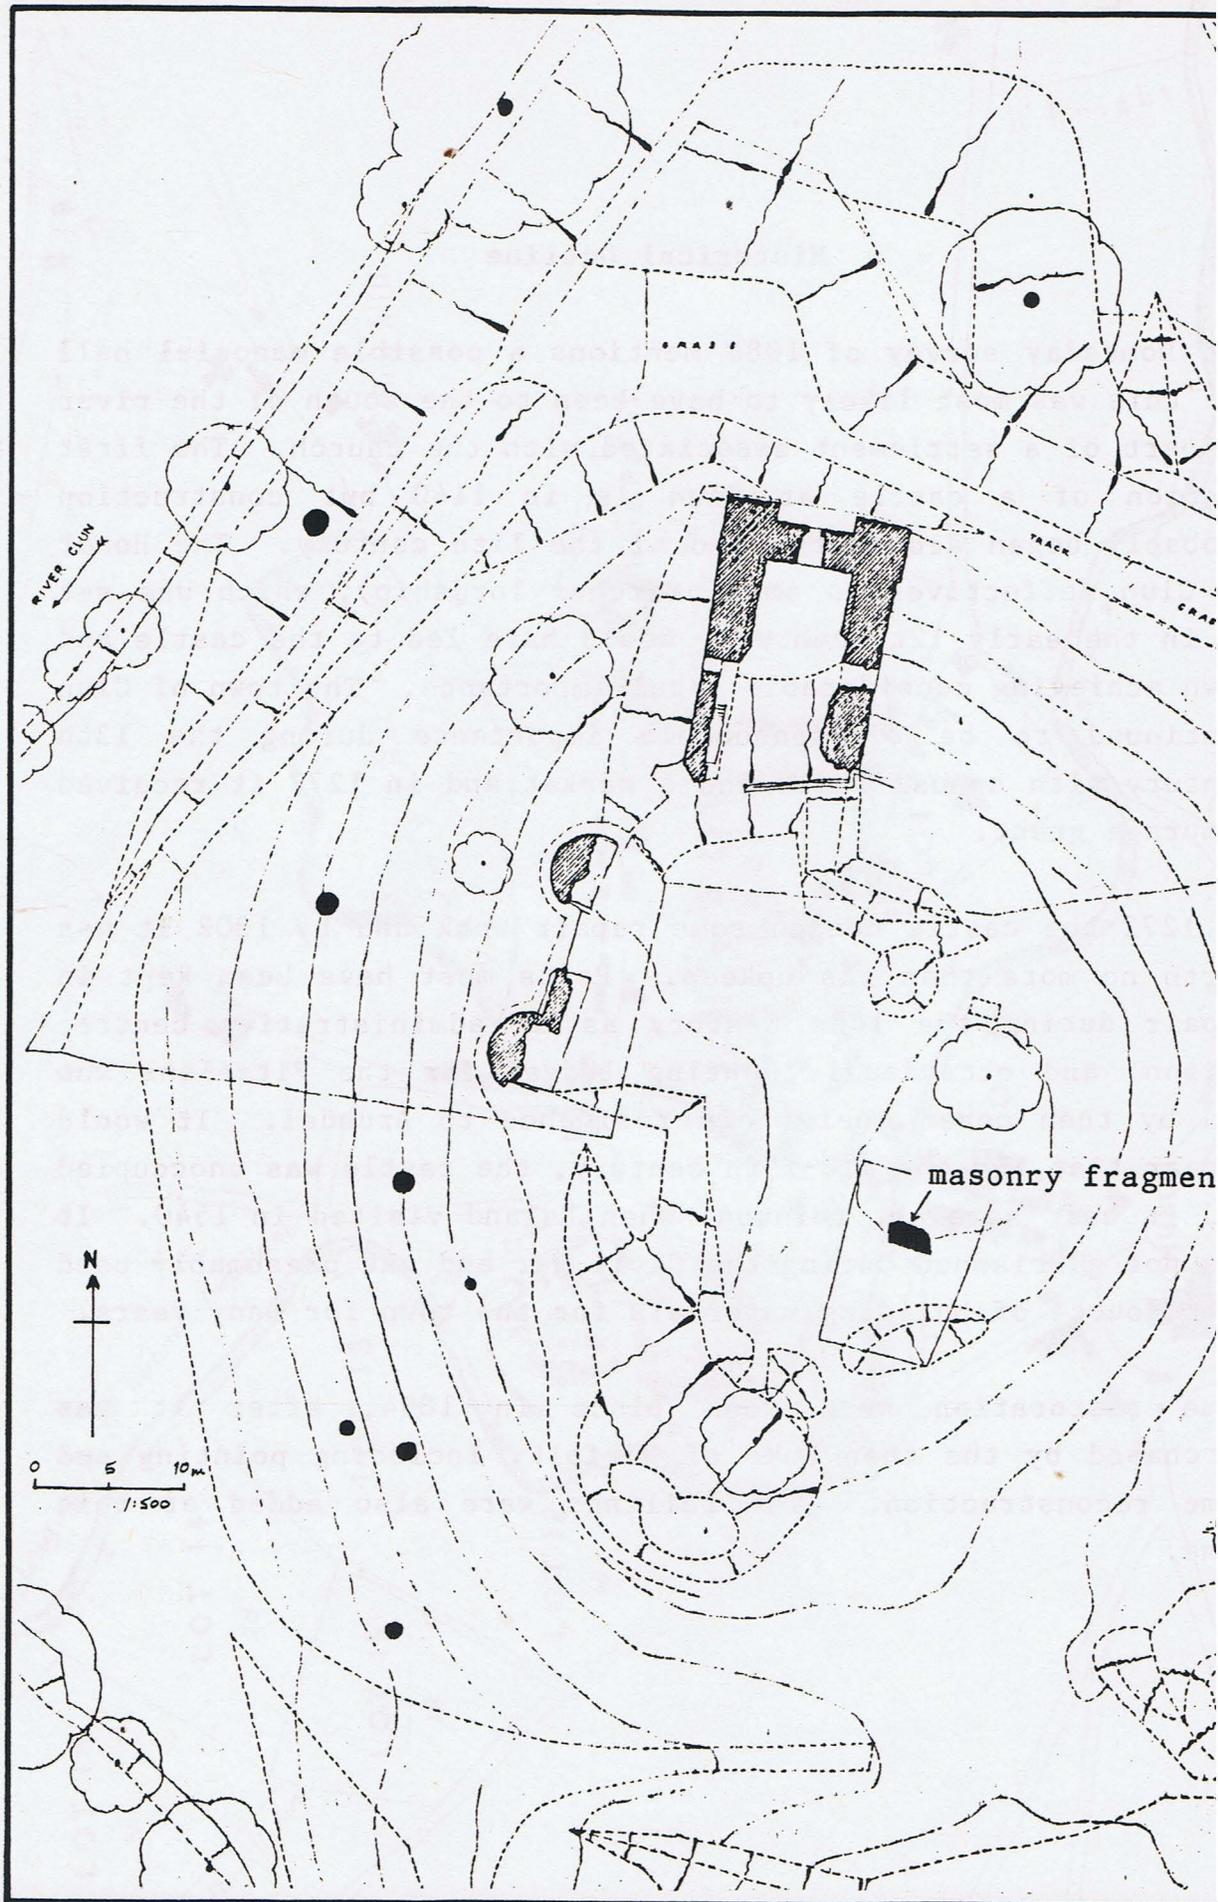
The location of the masonry fragment

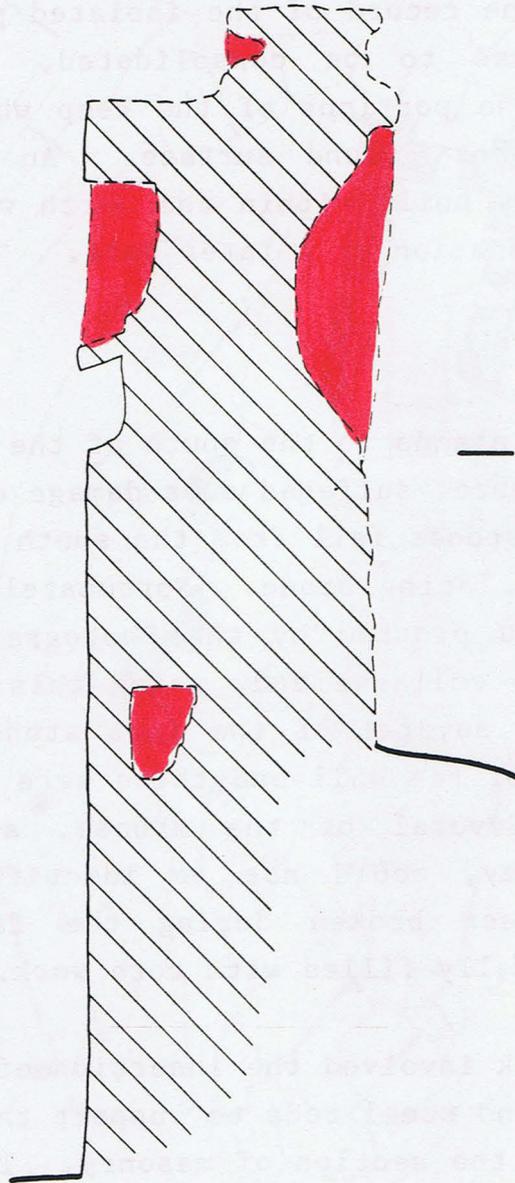
Section A-A of the masonry fragment

The fragment of masonry is aligned with the north wall of the keep. It is approximately 3m long and has a face 6m high on southern side. The north side consists entirely of core material and, due to a slope in the ground, is only 4m high.

The fragment varies in thickness up to a maximum of 1.5m.

On the face side, at a height of 3.8m above the present ground surface there is a set-back on the face approximately 0.3m high and averaging 0.2m deep. This was apparently designed to take a joist or beam of some description and would suggest that this face was internal to a building.

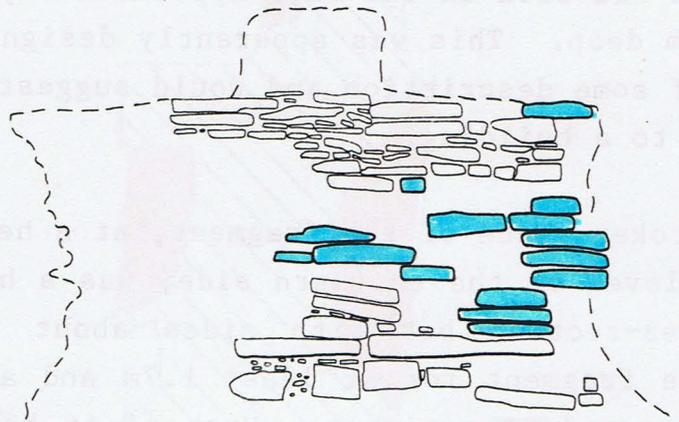
The upper part of the south face before consolidation showing recommended positions of the stones to be replaced

This fragment, which stands to the south of the keep surrounded by a post and wire fence, suffered some damage during the earth tremor when several stones fell from the south side - the only side which still has facing stone. Fortunately this face had been photographed and plotted by the Photogrammetric Unit at York previous to the collapse and, using this record, it was possible to identify several of the face stones from amongst the rubble in front of the wall and these were put on one side for replacement. Several of the stones, apparent in the photogrammetric survey, could not be identified, presumably they had been broken during the fall, and their positions were eventually filled with core work.

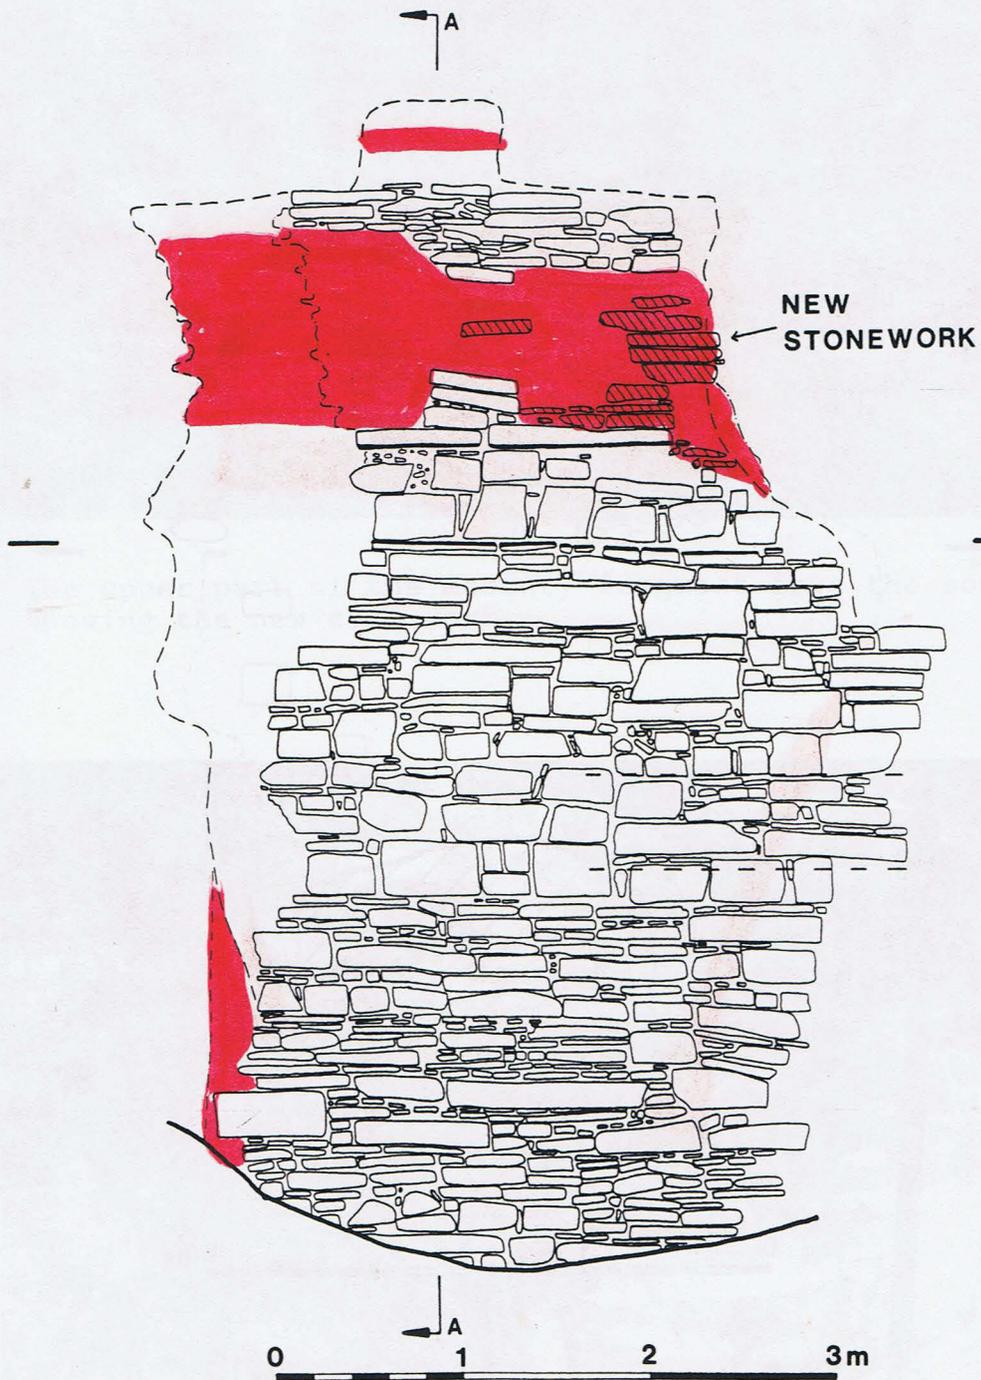
The south face of the masonry after consolidation

The consolidation work involved the insertion of a considerable core work and steel rods to support the fragile areas of the upper part of the section of masonry. The fragment was re-surveyed on completion of the consolidation work to identify the new work.

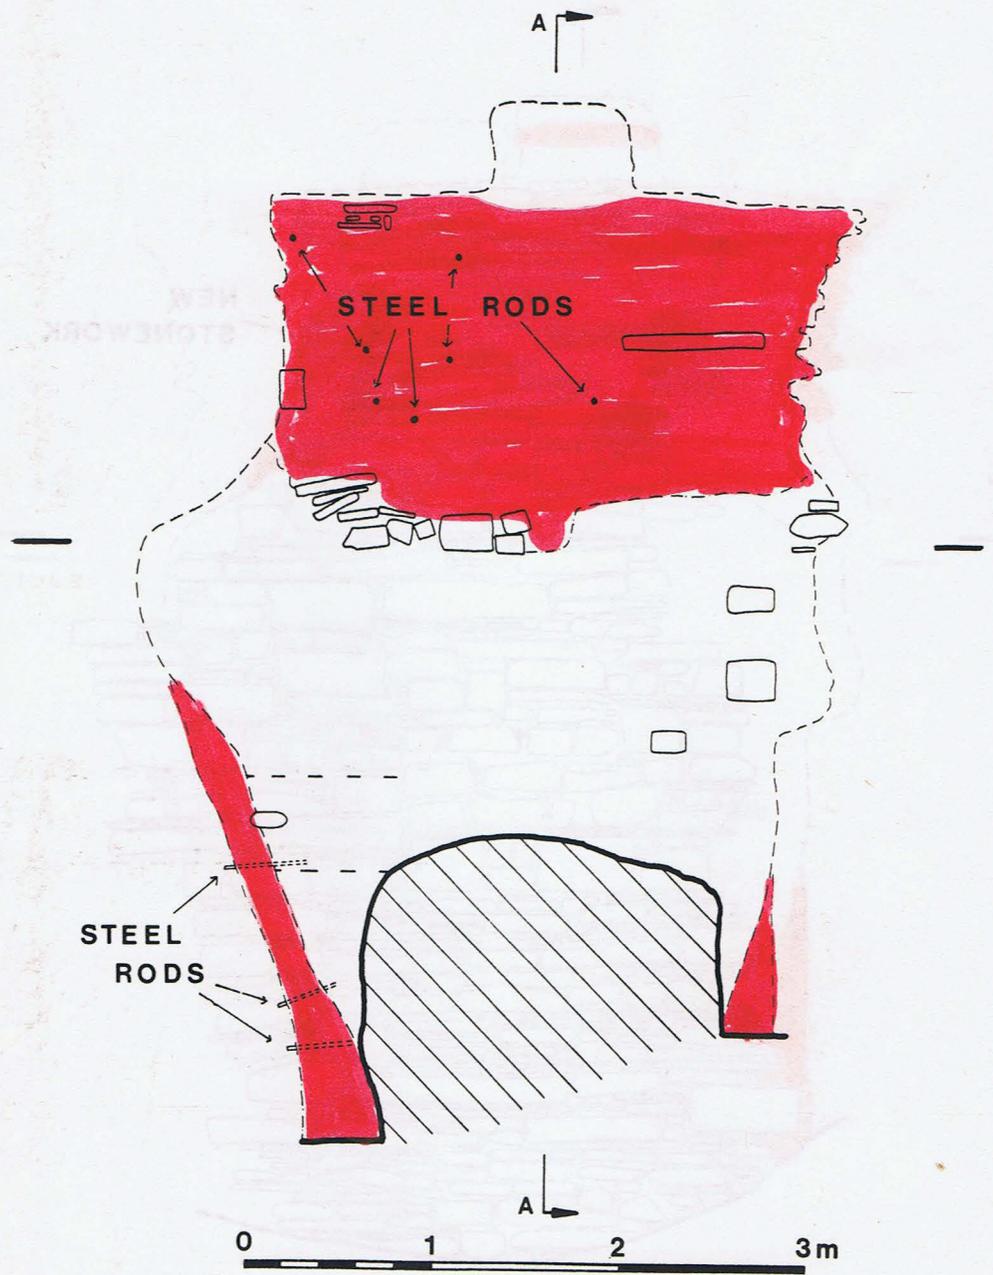
The north face of the masonry fragment after consolidation

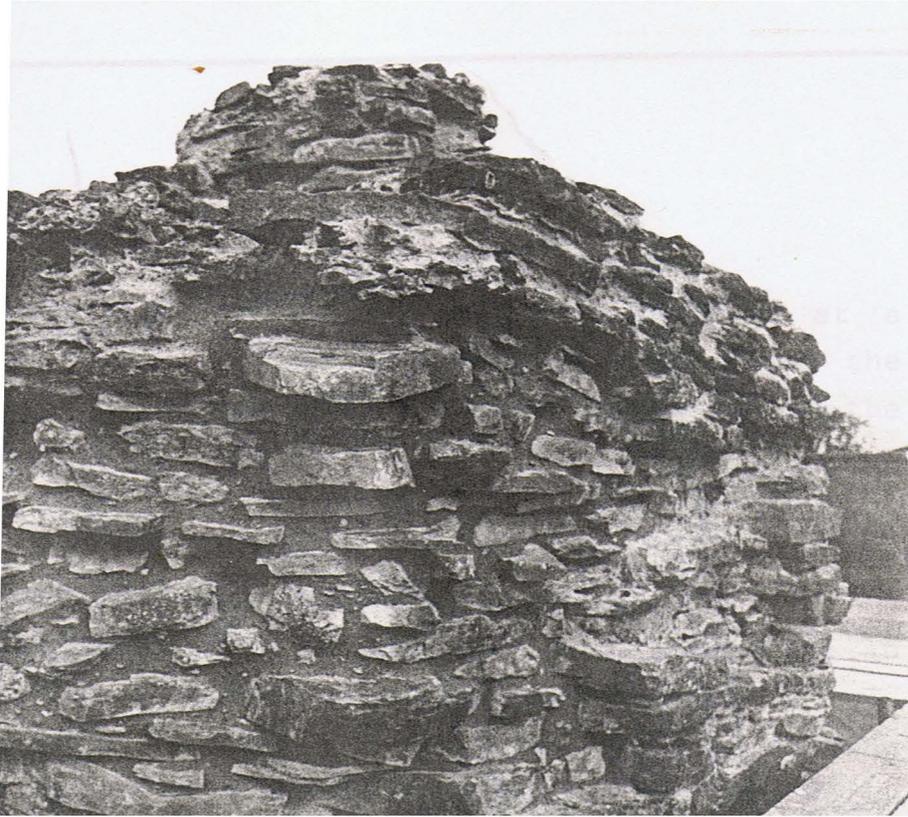
The upper part of the masonry fragment from the south-west showing the new core-work

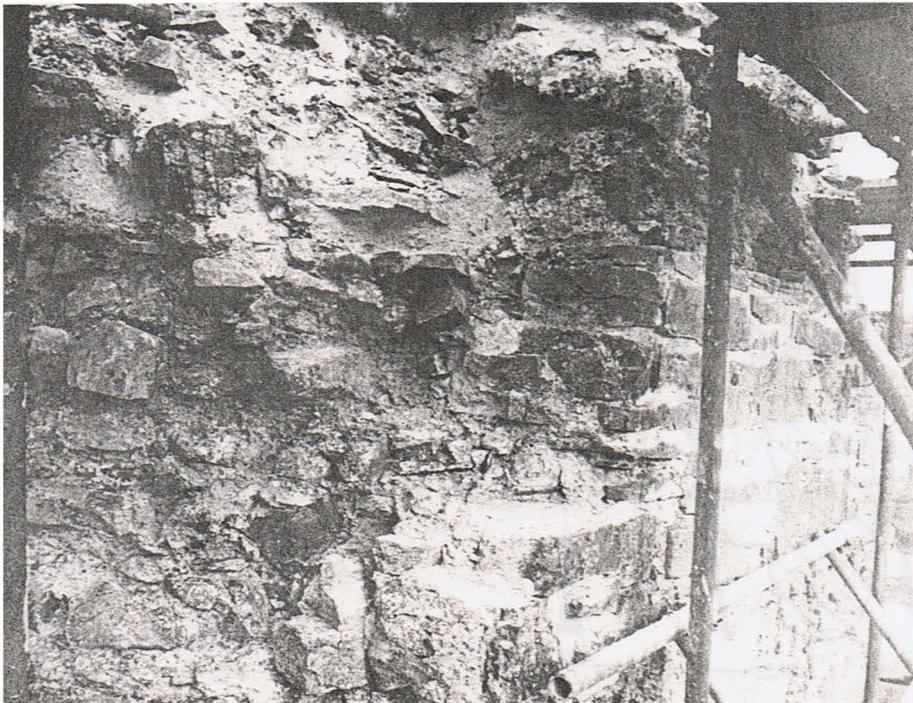
The lower part of the masonry fragment from the south-west

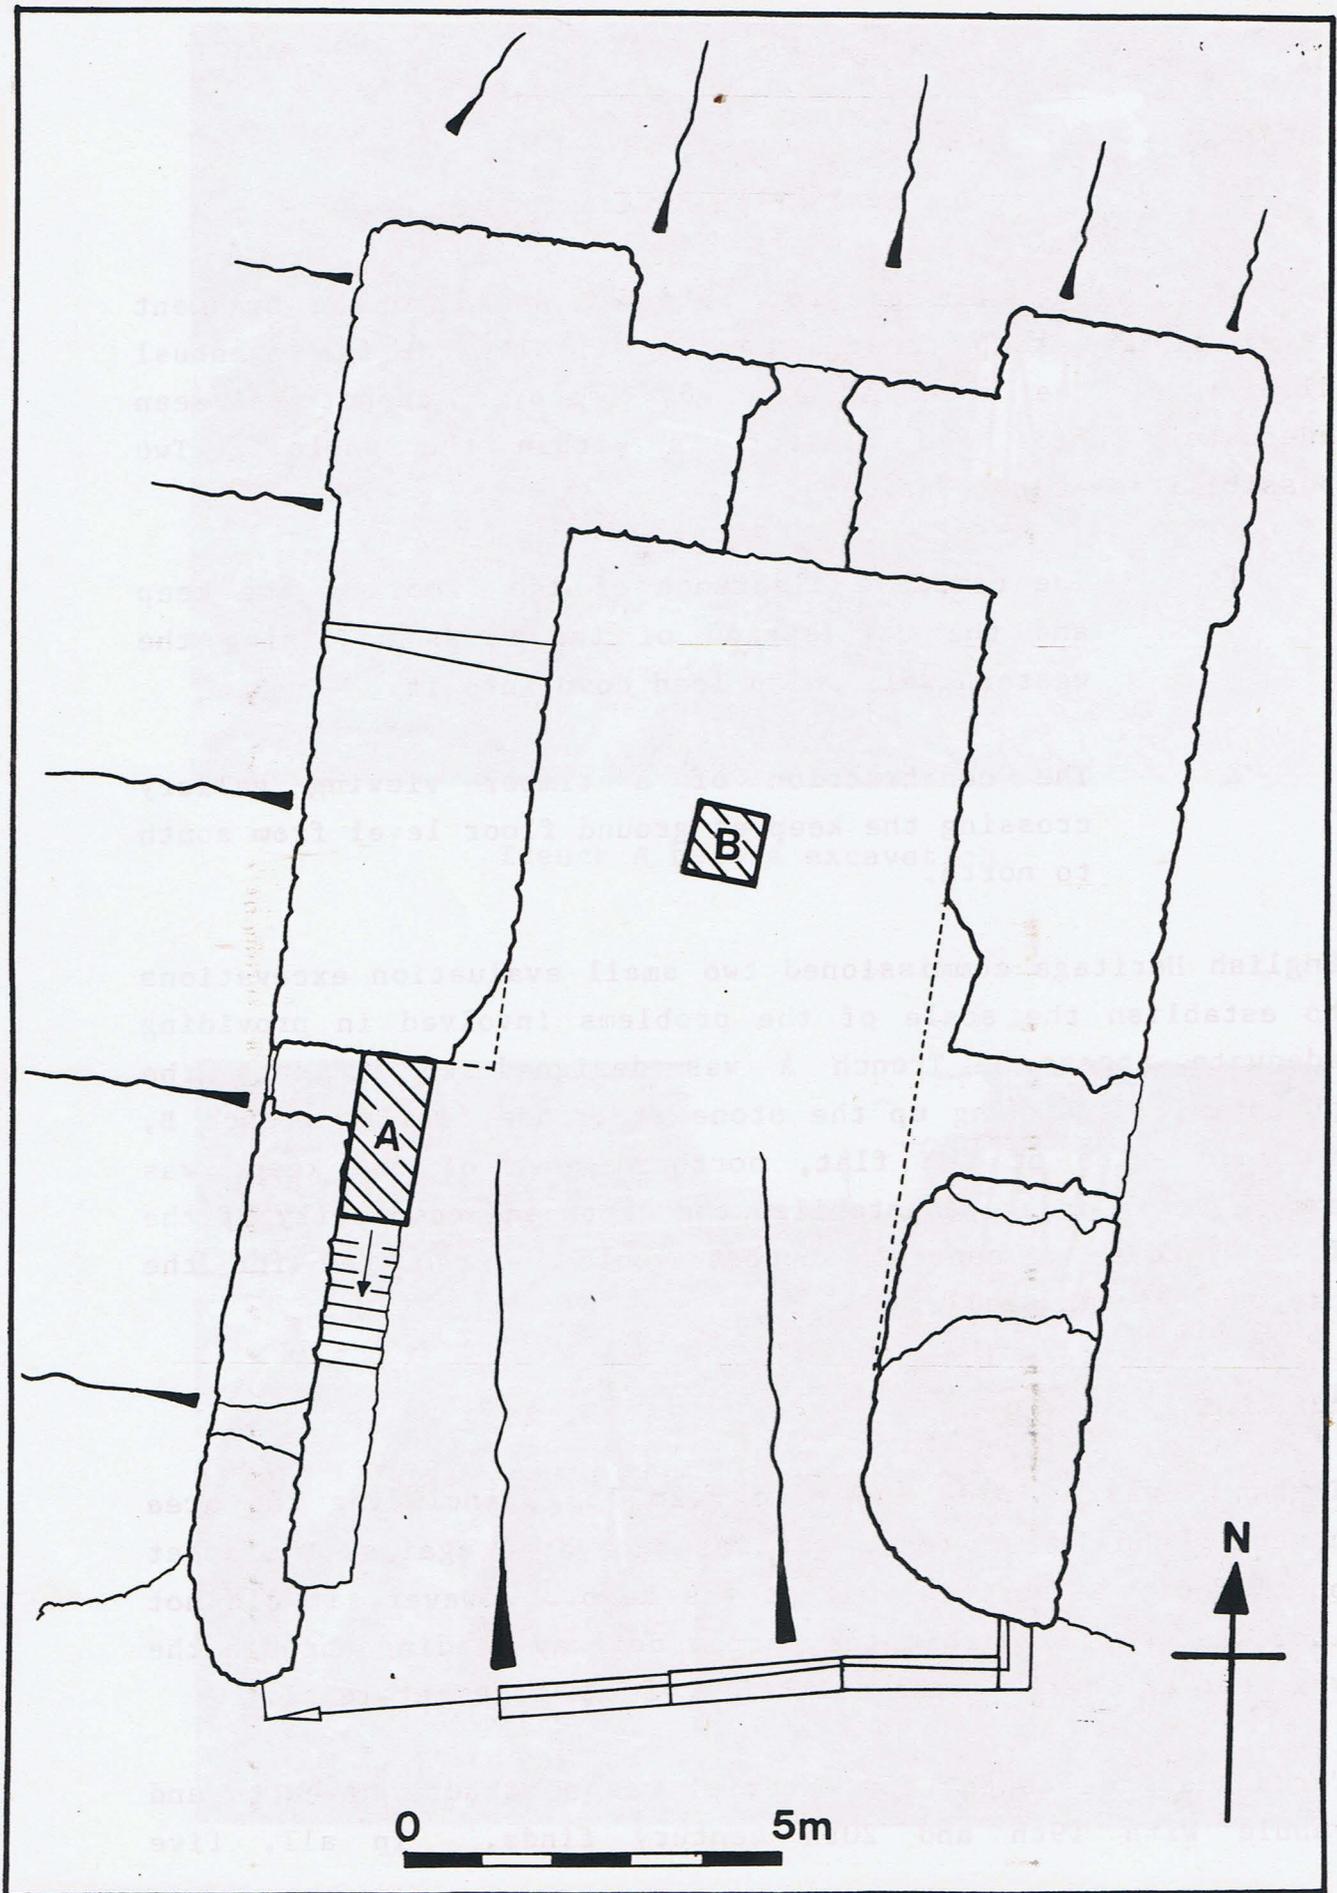
The keep showing the location of the two evaluation trenches

English Heritage commissioned two small evaluation excavations to establish the scale of the problems involved in providing adequate access. Trench A was designed to indicate the potential of opening up the stone staircase, whilst trench B, in the centre of the flat, northern area of the keep, was excavated in order to establish the depth and complexity of the fill in case a central support would be required for the proposed viewing gallery.

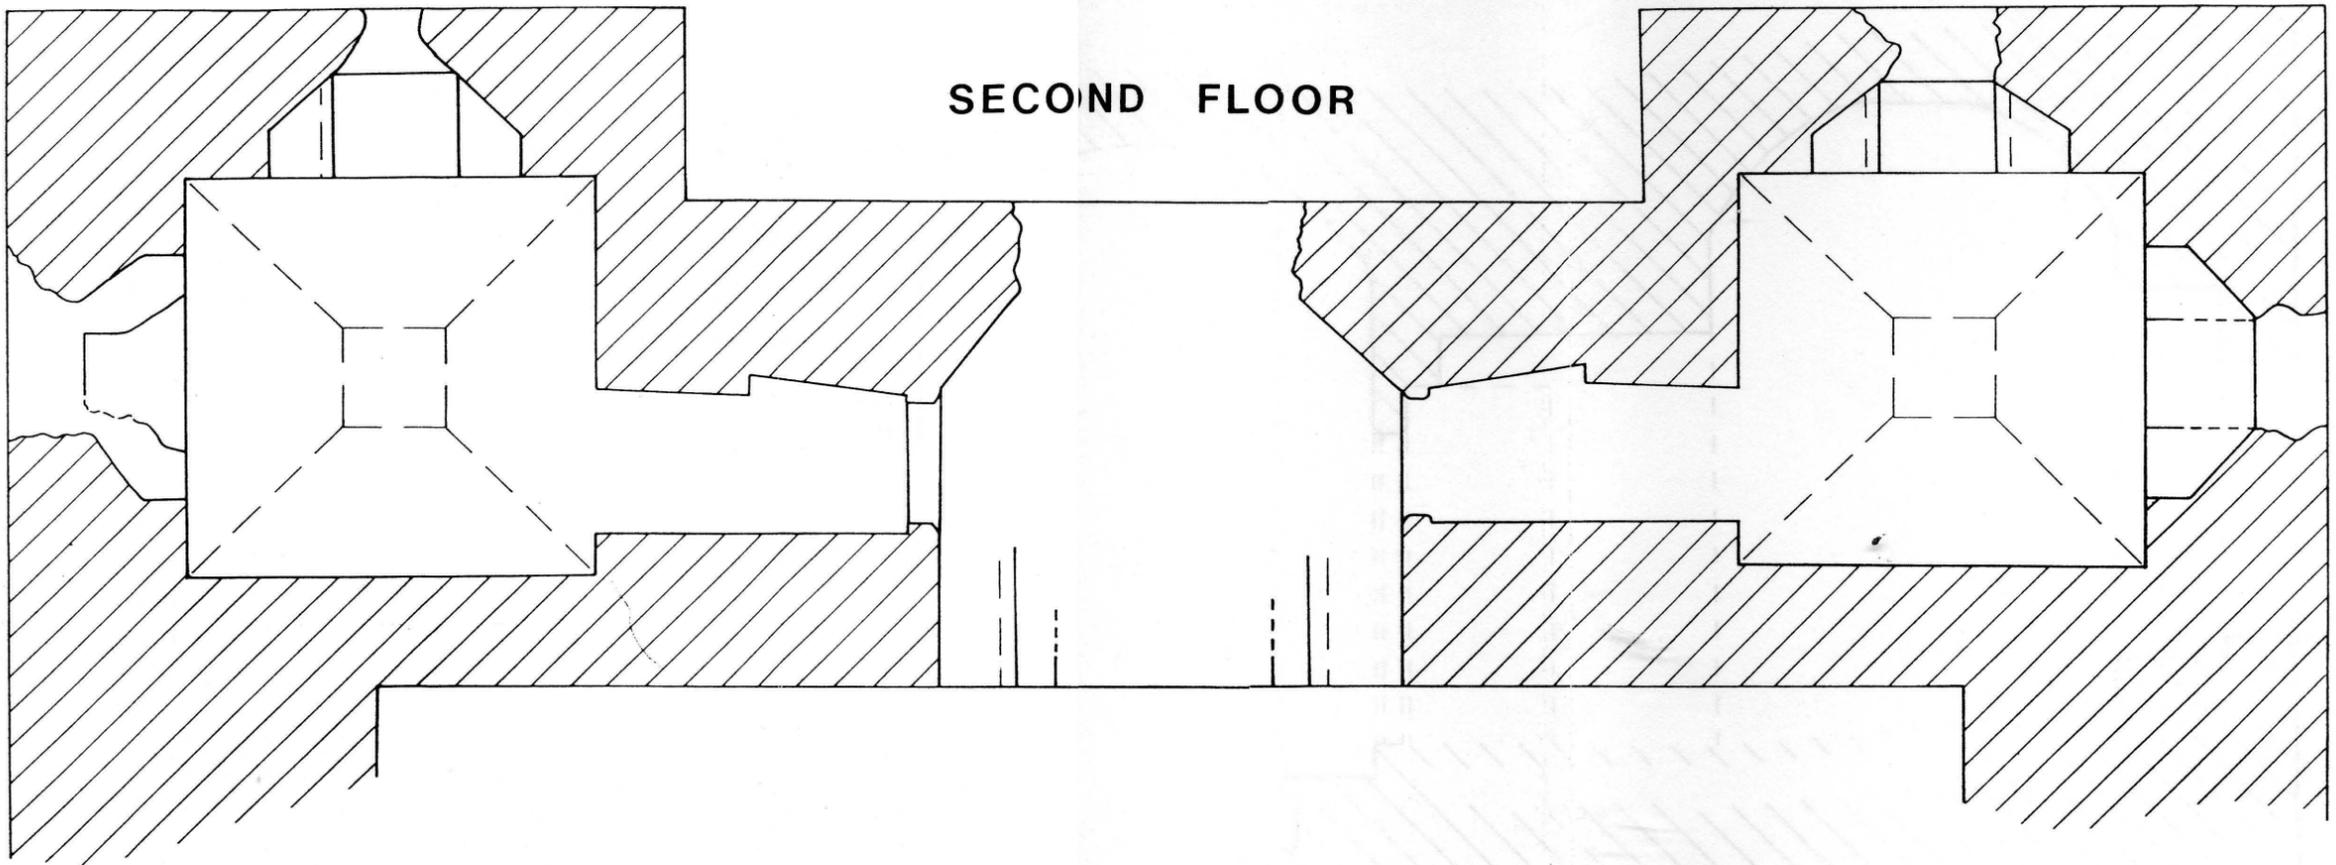
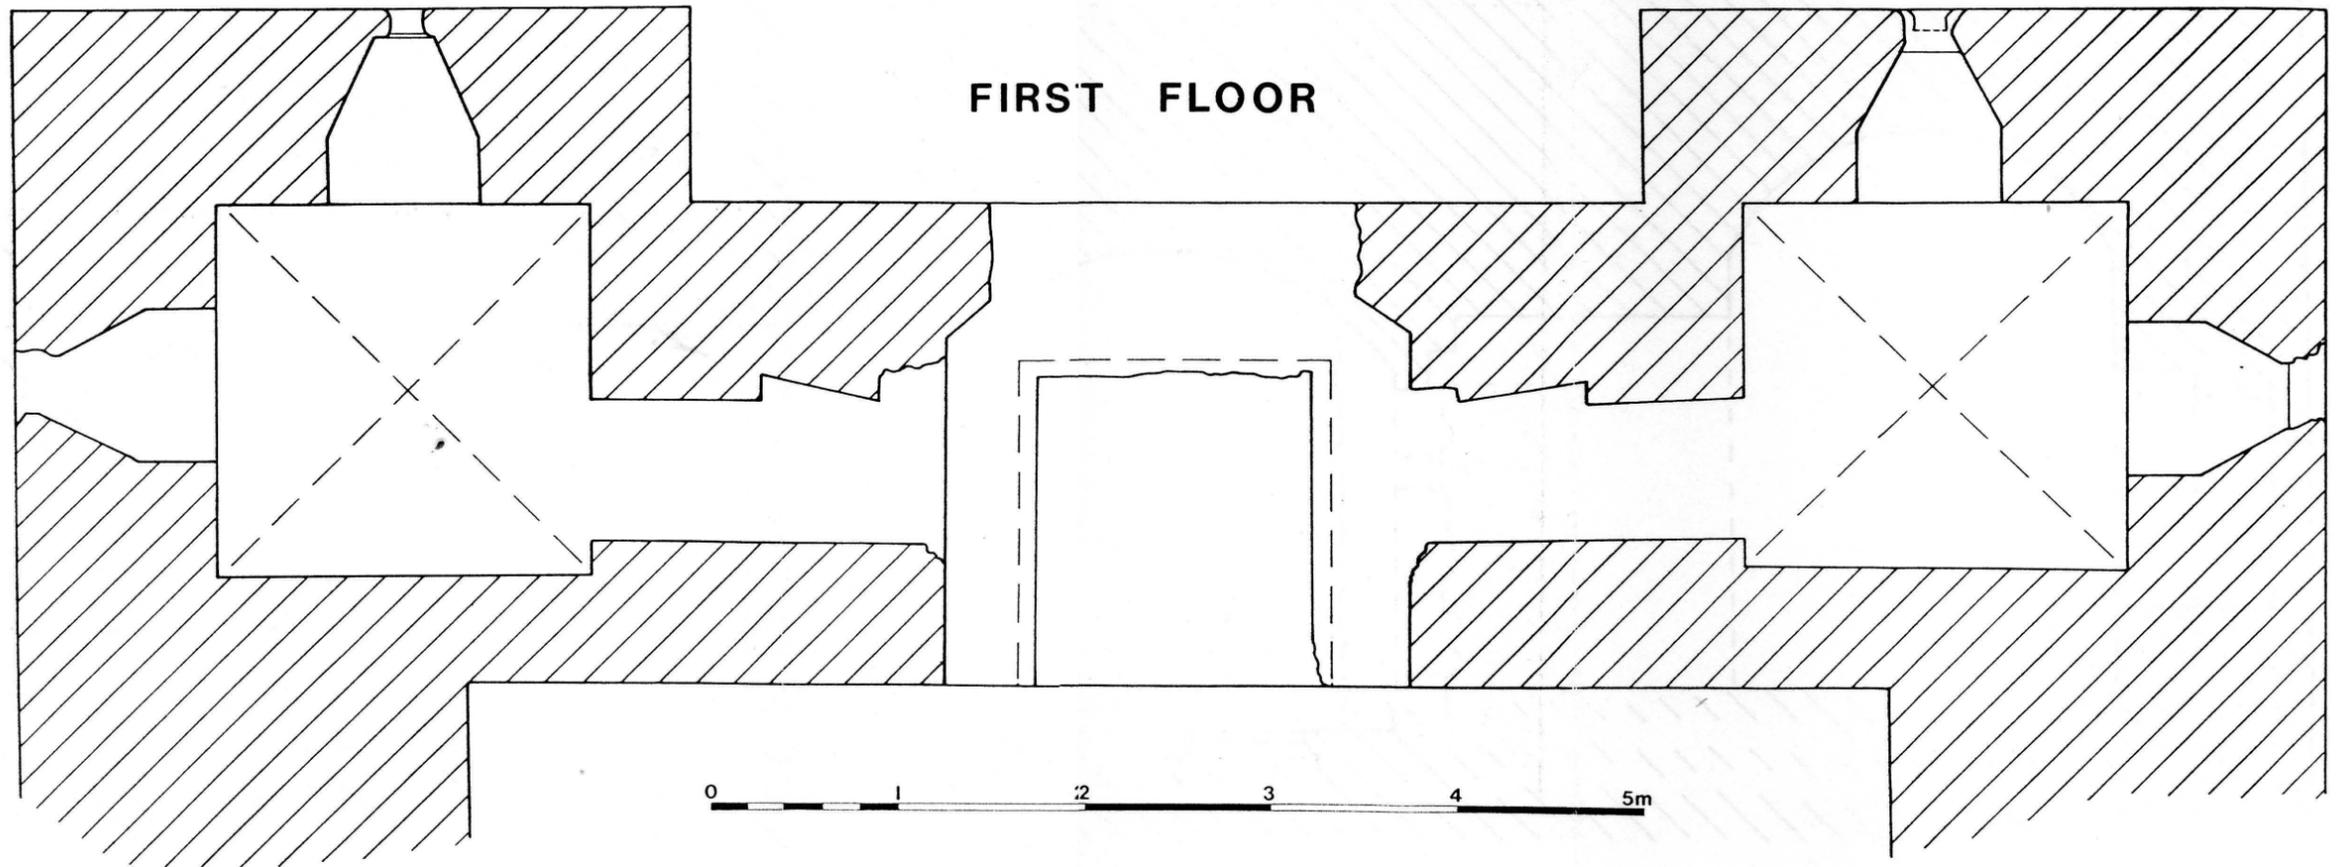
The rooms built in the thickness of the north wall

A scaffold tower was erected within the keep for a short period of time to allow access to the rooms at first and second floor levels which had been built within the thickness of the north wall of the keep.

As an addition to the original commission, the Unit produced a set of plans at each level and a composite east-west cross-section through all four rooms. These were drawn at a scale of 1:20 and reduced copies are included in this report.

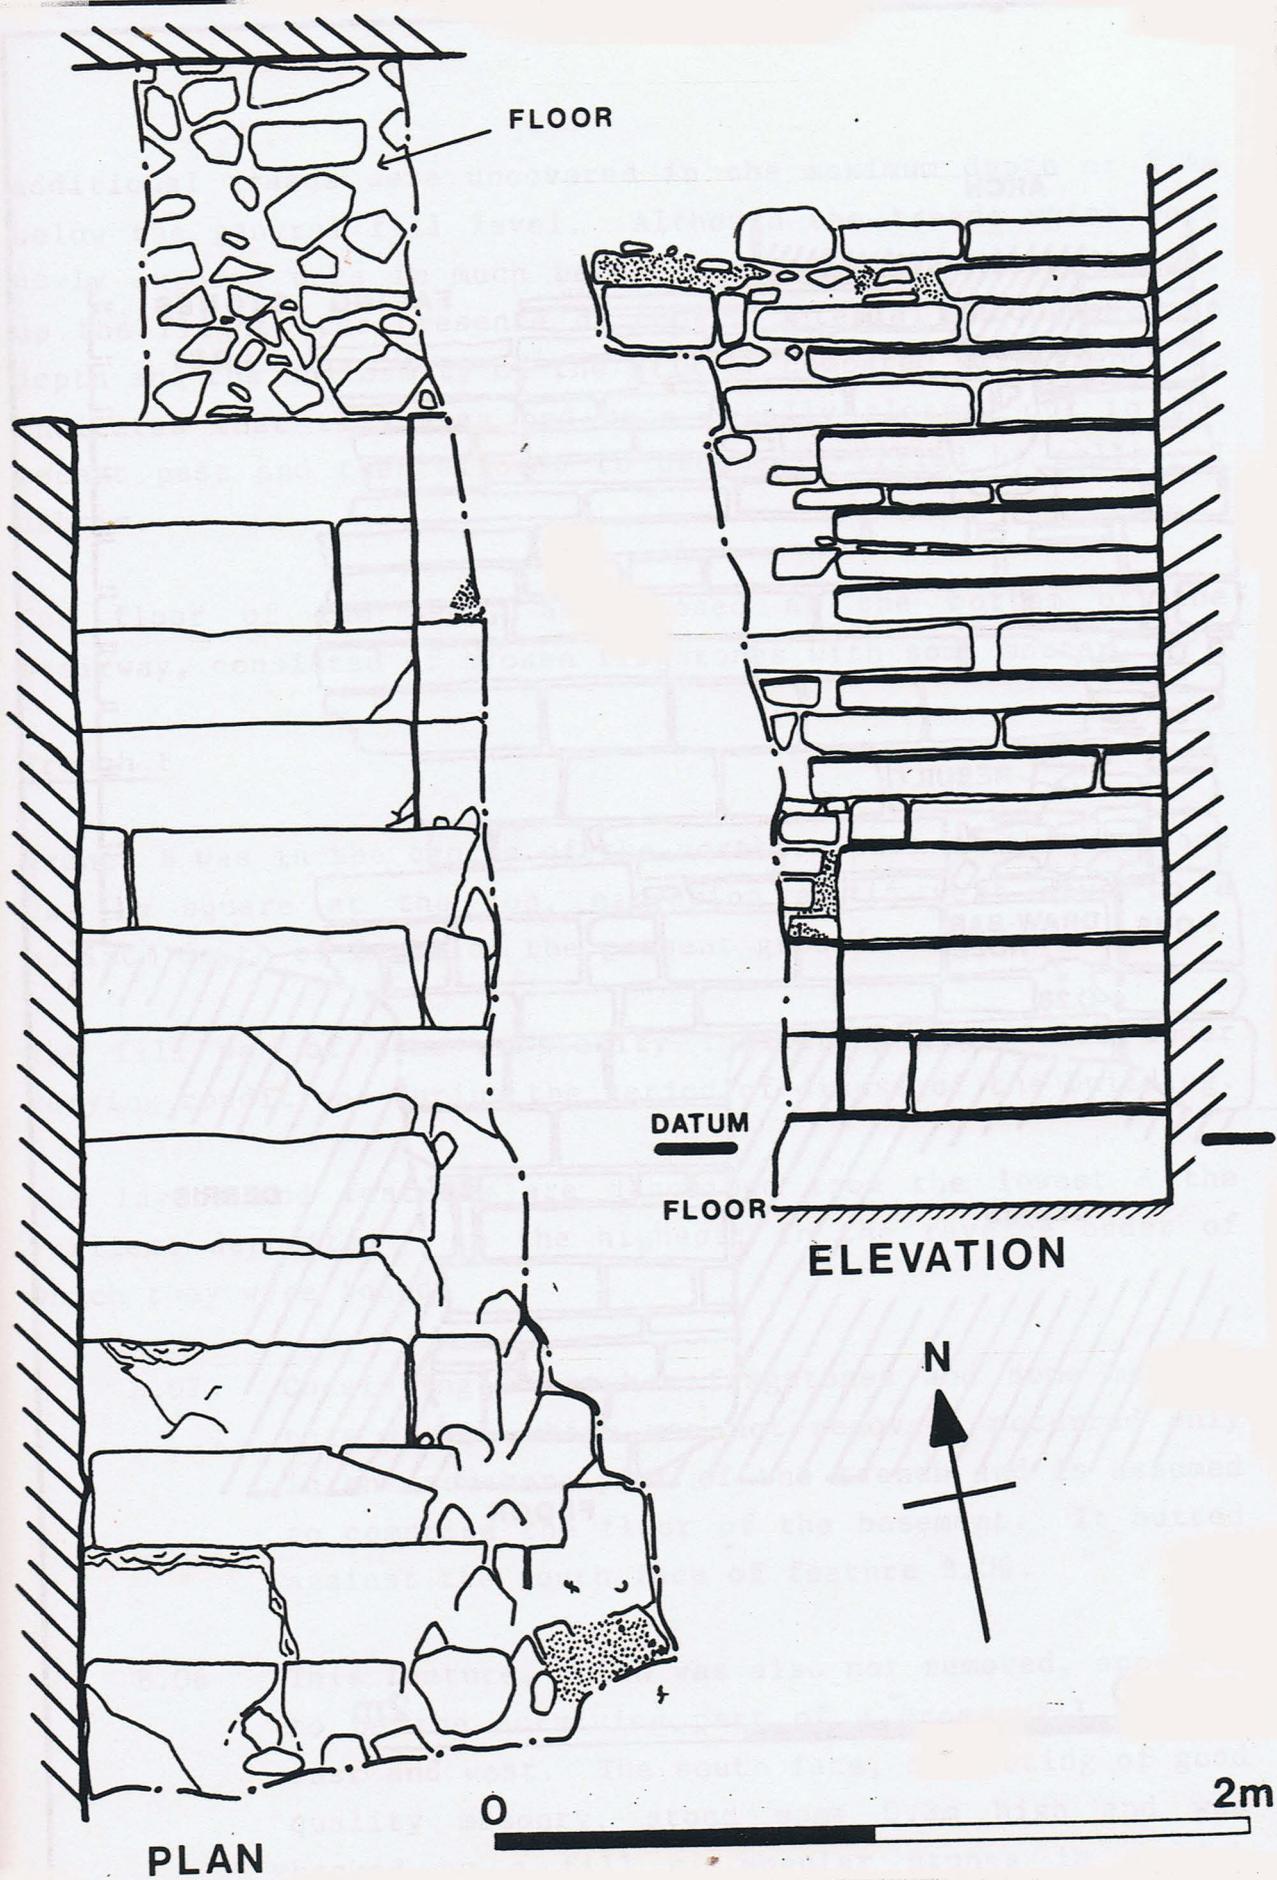
Plan & elevations of steps
 Trench A - Plan & elevation of steps

Trench A was 1m wide and some 2.2m long, including the area covering the lower steps. It was excavated against the inset portion of the western wall of the keep. However, it did not include the fill within the narrow doorway leading through the wall nor any part of the main fill of the basement level.

Throughout the depth, the material was a mixture of earth and rubble with 19th and 20th century finds. In all, five

additional treads were uncovered in the maximum depth of 1.4m below the general fill level. Although the treads which were newly exposed were in much better condition than those higher up the flight, the presence of modern material throughout the depth and the uniformity of the fill as compared with trench B, indicates that this area had been totally cleared out in the recent past and then allowed to become re-filled by collapsed debris.

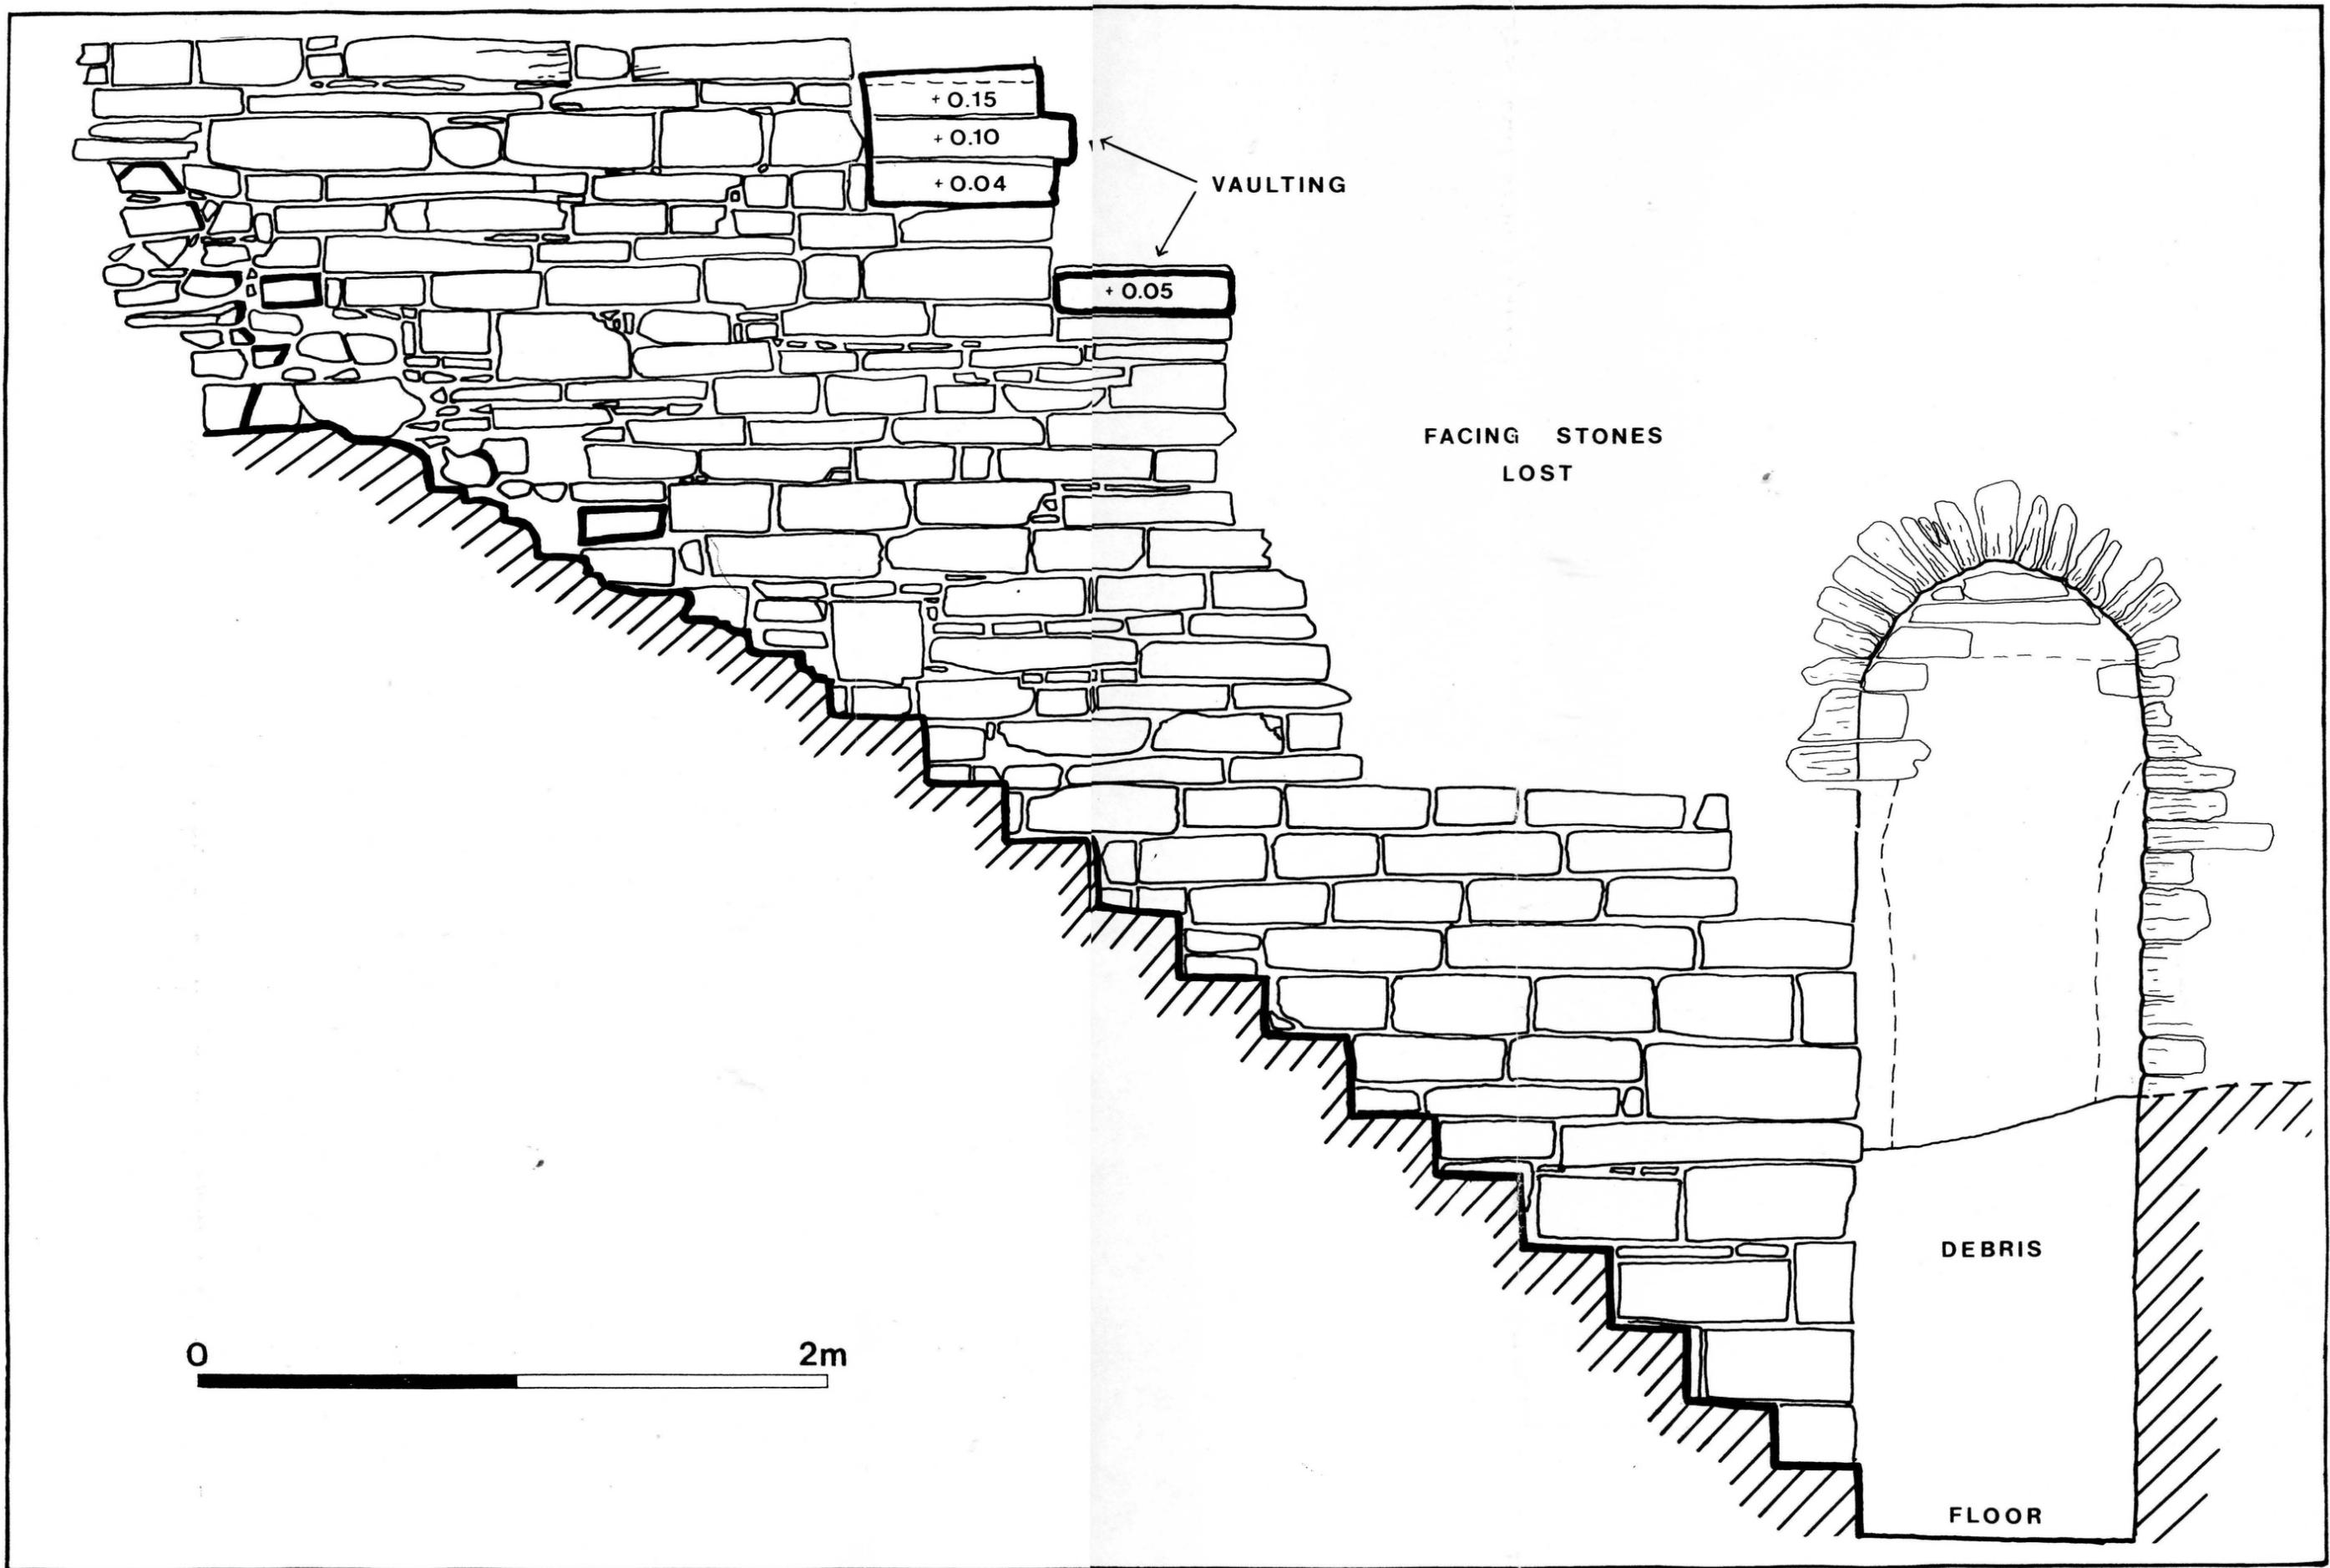
Trench A - West face & steps above

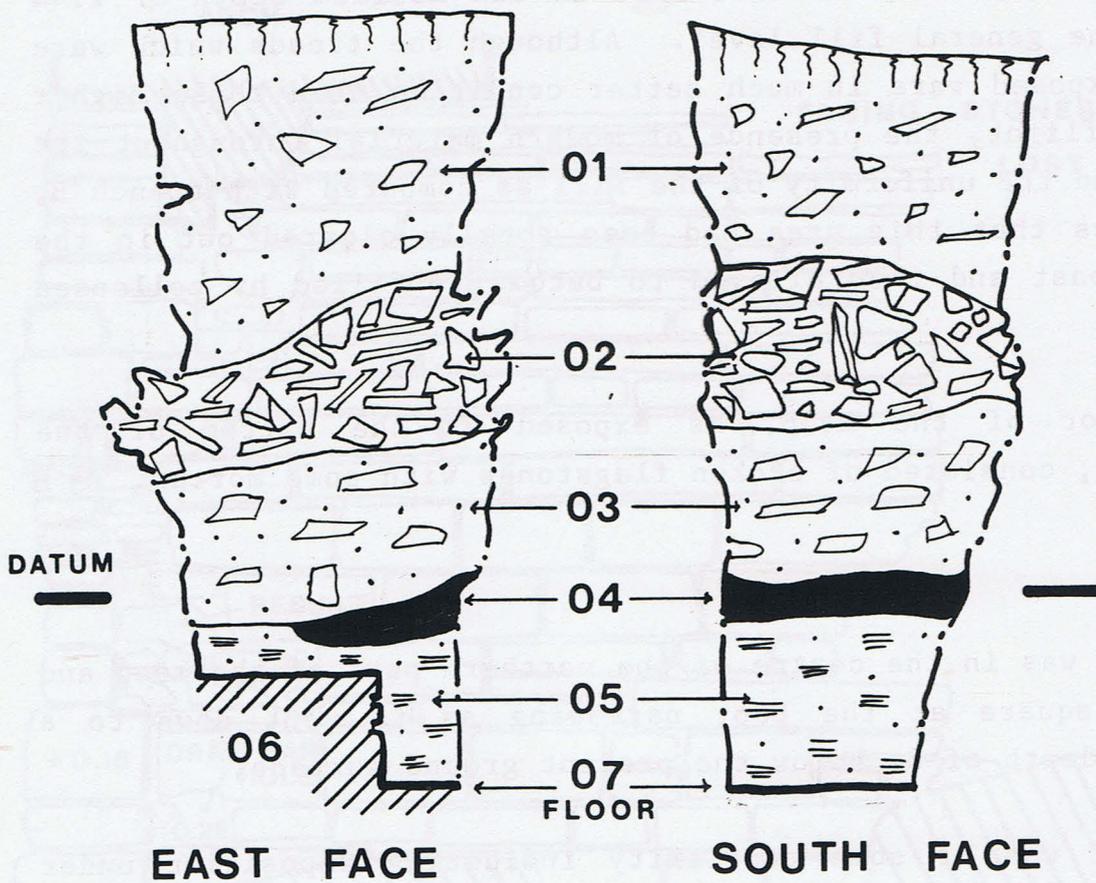
Trench B plan & section

Trench B was in the centre of the northern part of the keep and was 1m square at the top, narrowing as it went down to a maximum depth of 2m below the present ground surface.

The fill was of some complexity indicating deposition under varying conditions during the period of disuse of the building.

Consisting of broken flagstones and some mortar, this layer, which was not removed, occurred only in the southern part of the trench and is assumed to comprise the floor of the basement. It butted against the south face of feature B.06. This feature, which was also not removed, appeared to be the surviving part of a cross-wall running east and west. The south face, consisting of good quality masonry, stood some 0.3m high and was backed by a fill of angular stones in a rich

B.05 Filling the area between the face of B.06 and the southern edge of the trench and sealing the top of the presumed wall, layer B.05 was a compact light orange clay loam which included some pea-sized gravel.

B.04 The southern part of the flat surface of B.05 was covered with a layer of burnt material with a maximum thickness of 0.1m. Apart from the charcoal, this layer contained several animal bones which did not exhibit signs of being burnt. There were few stones within this layer.

B.03 This was a thick (0.4m), approximately level layer of earth and large angular rubble.

B.02 Above B.03 was a layer of very loose angular rubble with no earth and consequently liable to collapse. The surface sloped downwards to the north and east and the layer varied in thickness from 0.45m to 0.3m.

B.01 The uppermost layer excavated within the trench consisted of relatively small fragments of stone in an earth matrix and varied in thickness from 0.6m to 0.8m.
