**CLUN CASTLE
SHROPSHIRE**

**RECORDING & EXCAVATION
WORKS
1990**

AN INTERIM REPORT

**November 1990
Hereford Archaeology Series 89**

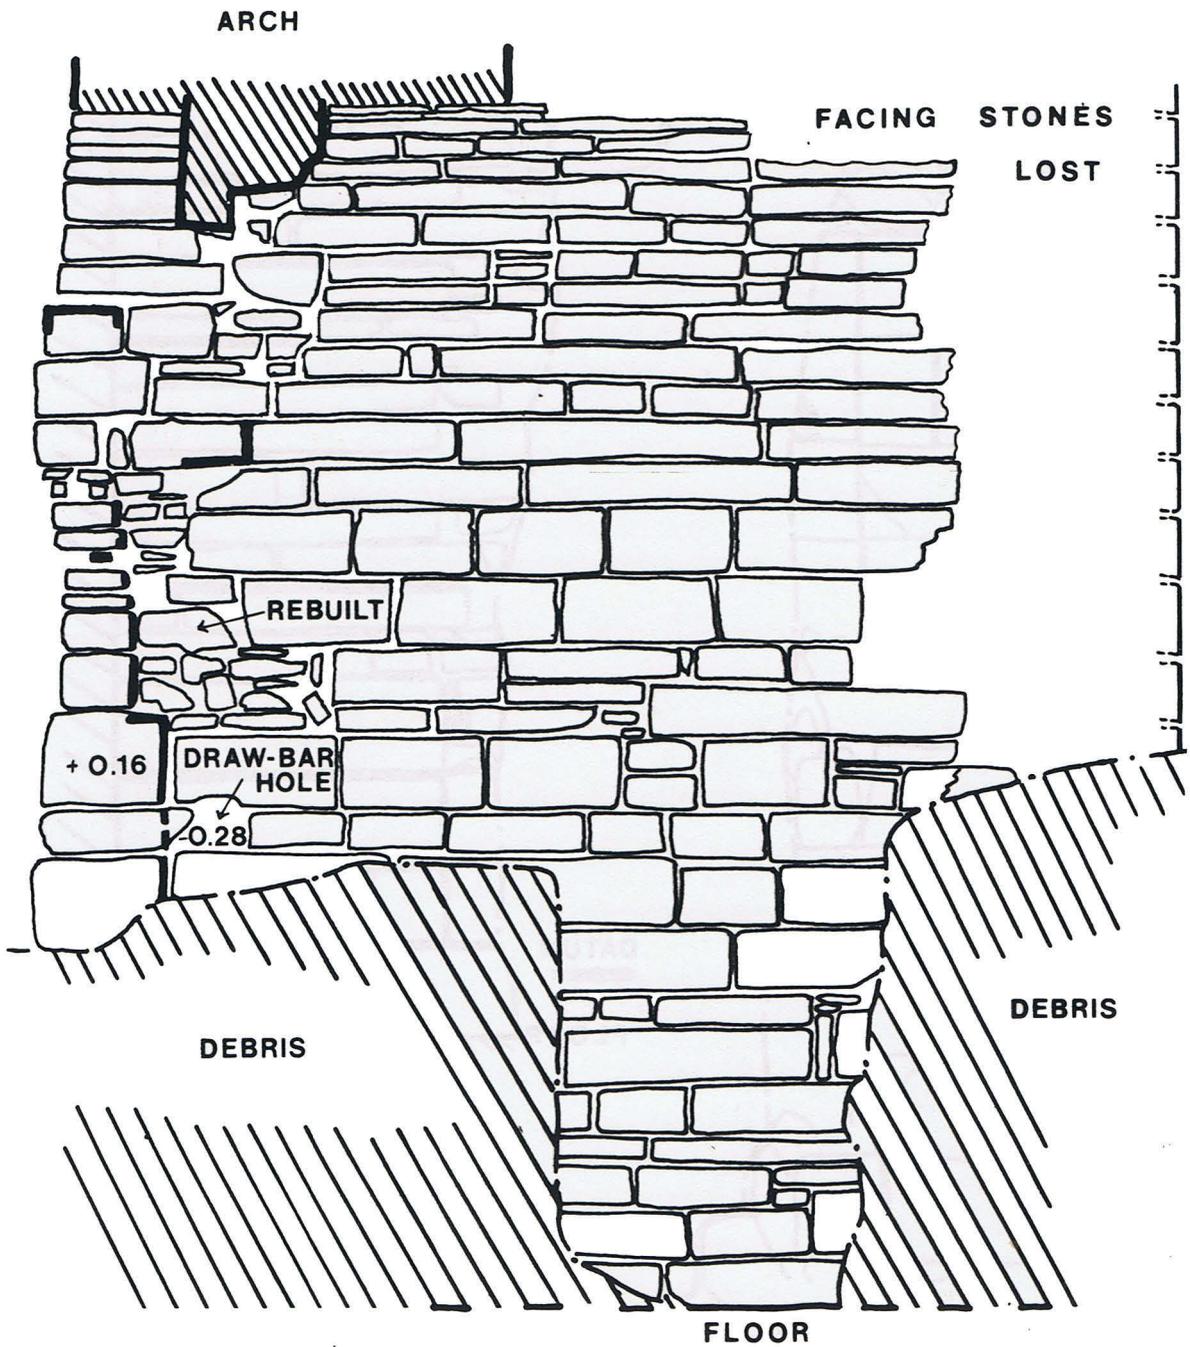
Trench A - North face & doorway above
