Lowestoft South Beach Coastal Protection Works Phase 2

Final Report

Client: Waveney District Council

Date: 14 September 2016

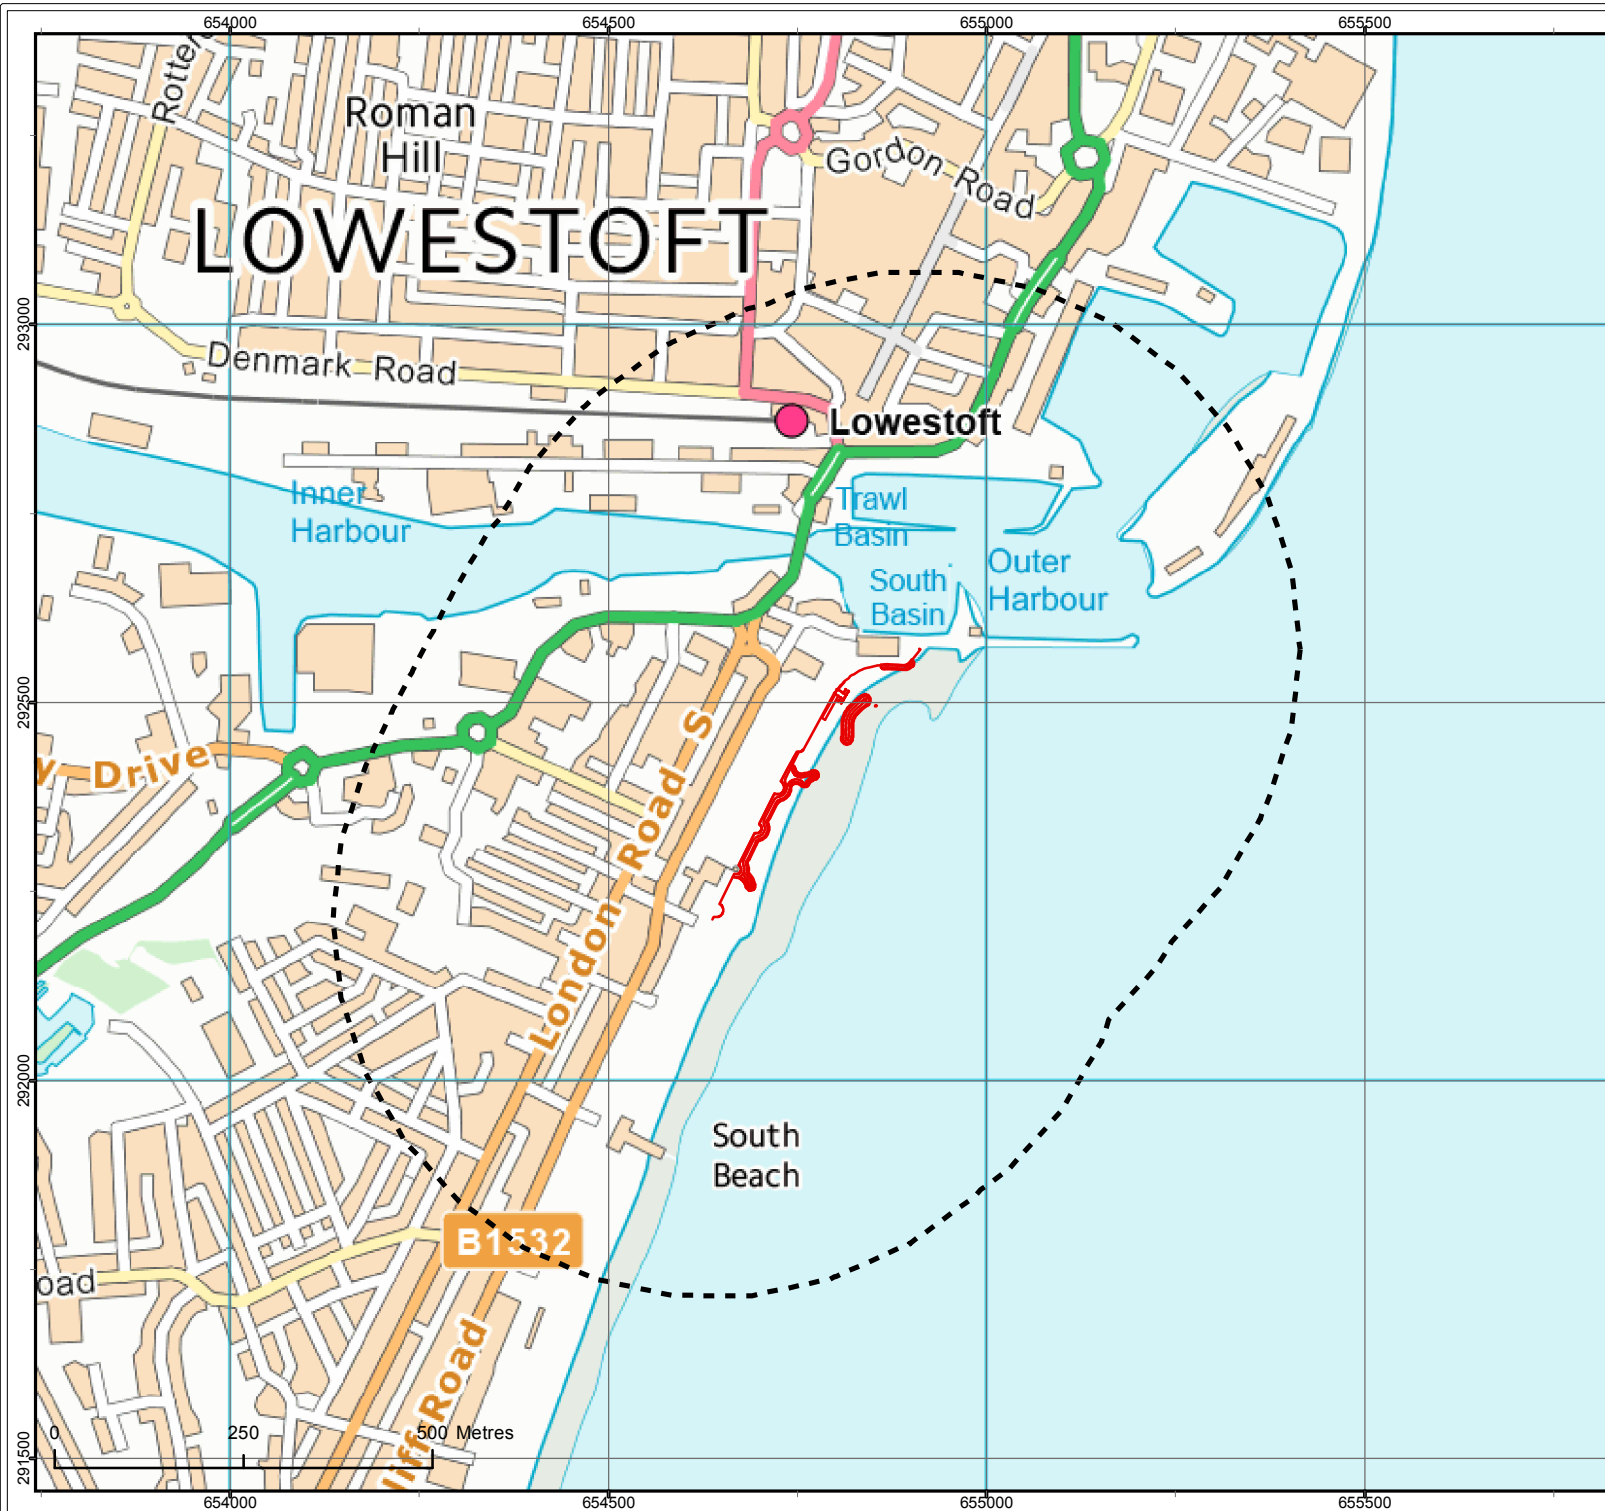
Site Location Plan

The area of proposed coastal protection works is located along the northern stretch of South Beach (known as Children's Corner) towards South Pier in South Lowestoft, East Suffolk, and centred on National Grid Reference 654930 292520. The coastal town of Lowestoft is 19km from Great Yarmouth and 35km from Norwich (**Figure 1**).

- Location of Proposed Coastal Protection Works
- - - 500m Study Area

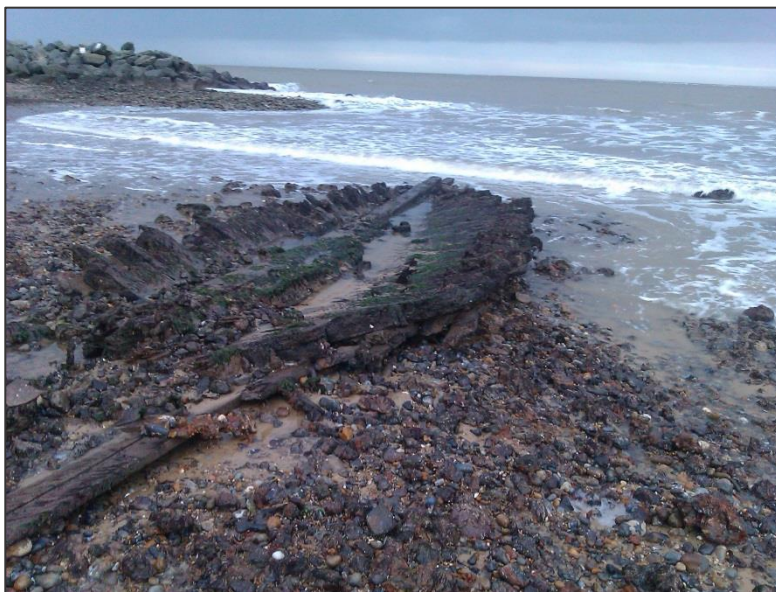
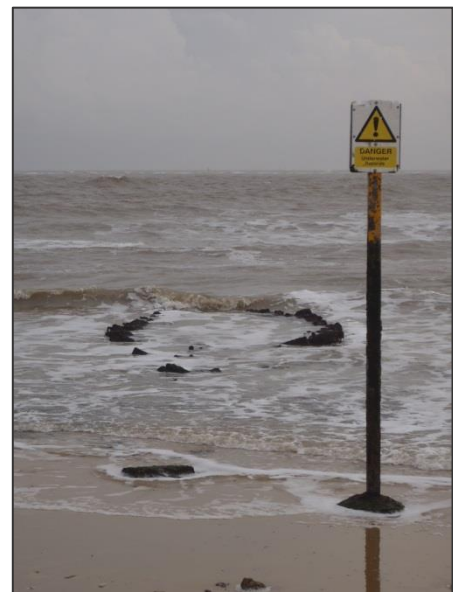
Plate 1: Wreck of the *Lily of Devon*

The position of the prow of the *Lily of Devon* was marked by a previously installed marker post (**Plate 1**). In advance of the works commencing, Mackley marked out the extent of the exclusion zone on site using posts encased in precast concrete manhole rings (**Plate 2**). This technique allowed for the markers to be visible at all states of the tide without the need to attach anything to the wreck.

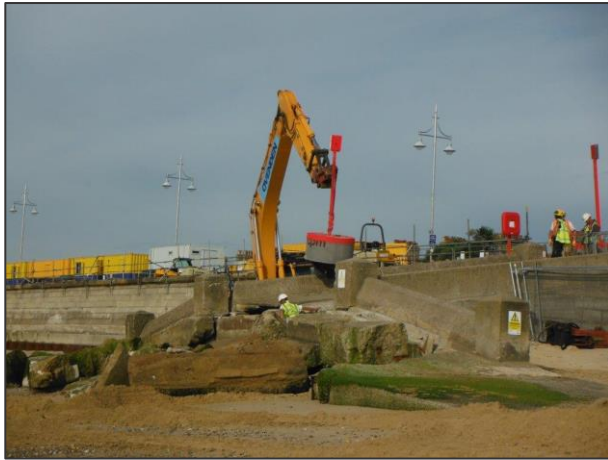
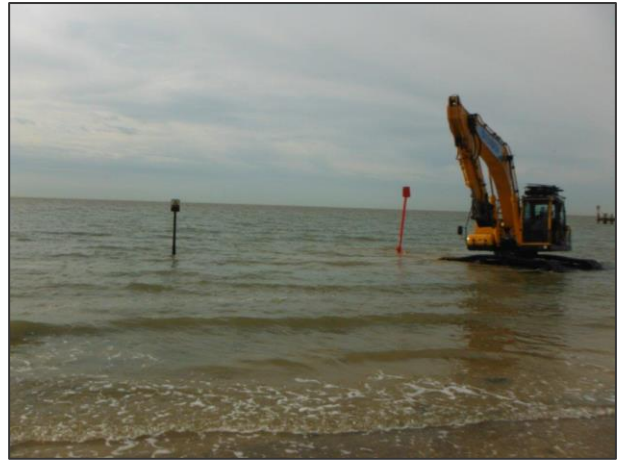
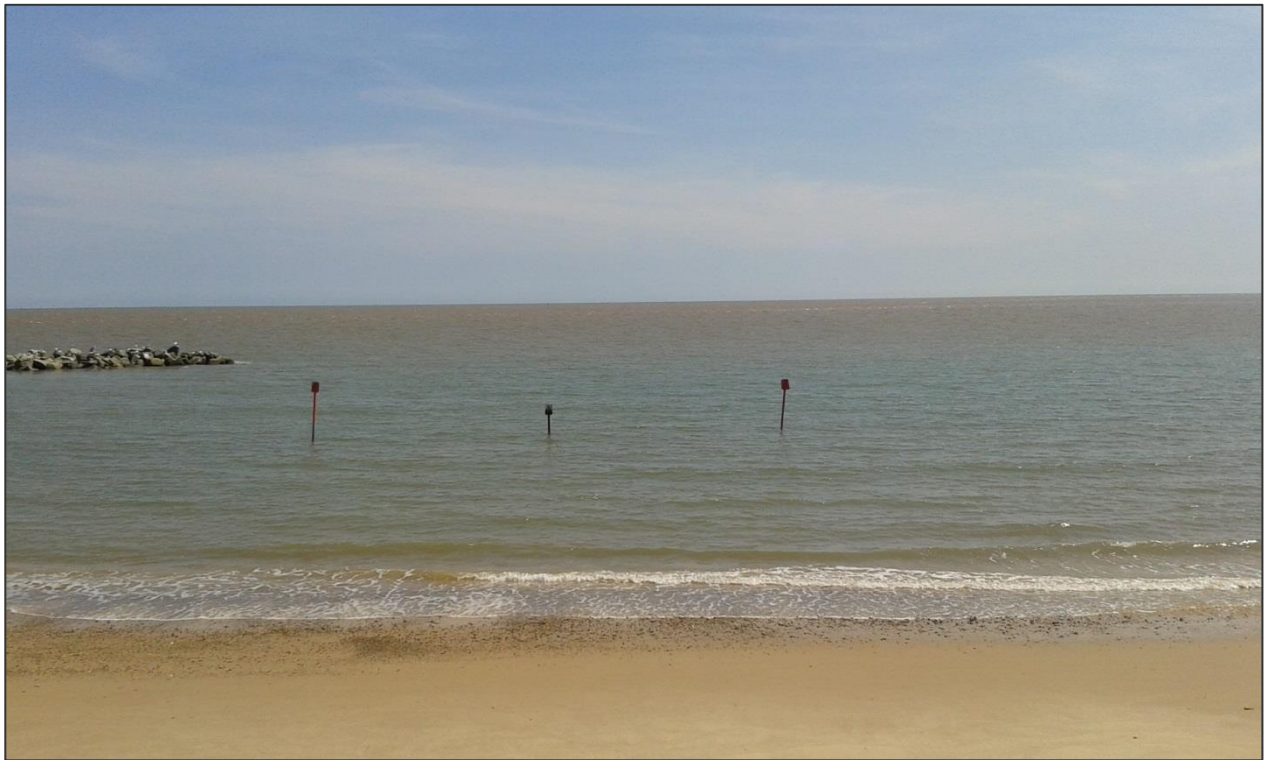
Plate 2: Installation of exclusion zone markers

Due to this increased visibility and commitment by the contractor to observe the exclusion zone there were no reported transgressions of the boundary and no reported damage to the *Lily of Devon* during works.

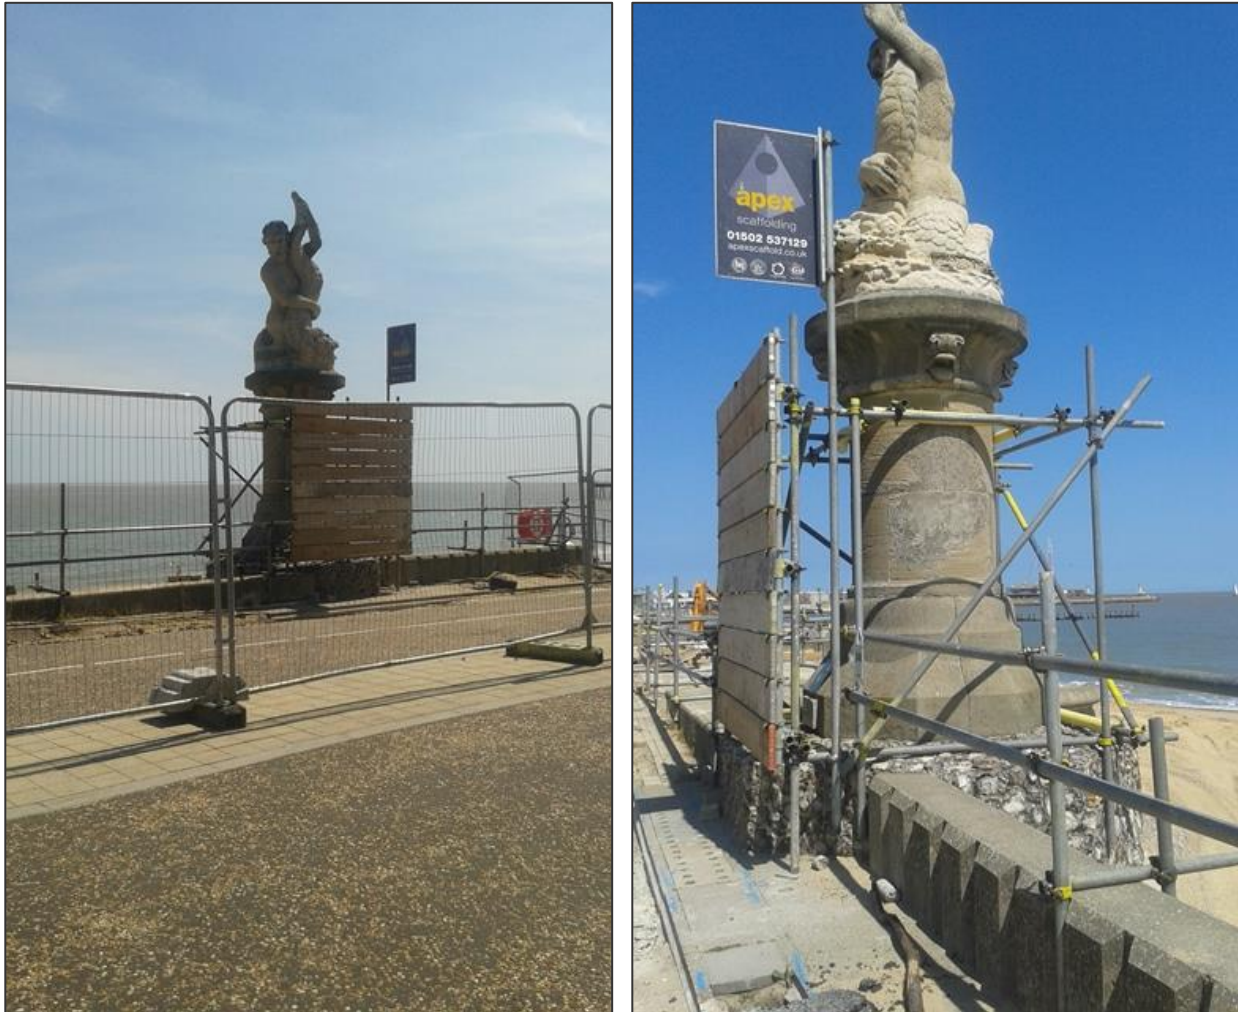
Plate 3: Protection installed around Grade II Listed Statue of Triton (3)

Although the statue was located on the sea wall and not in the footprint of the works, in order to increase visibility and to protect the statue from accidental damage during works scaffolding was placed around the statue with boarding on the landward side (Plate 3). In addition, the statue was located within the heras fenced boundary of the site.

No damage was reported to either statue during the programme of works.

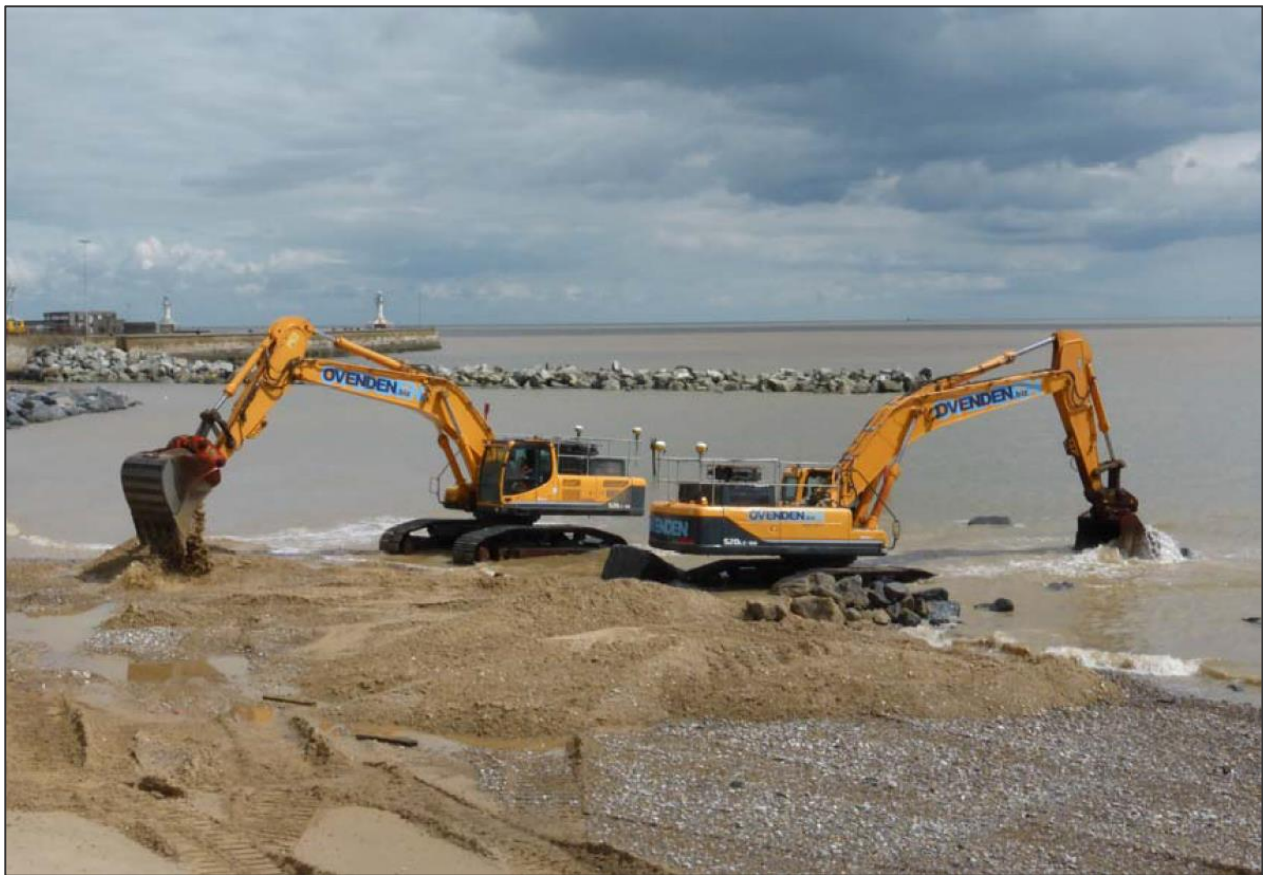
Plate 4: Work Underway on Rock Structure 3 (SASCIC, 2015: Plate 6)

During site visits, work relating to the construction of the Rock Structures (**Plate 4**) and works relating to the piling operations for the new beach access ramp (**Plate 5**) were observed. Where activities were undertaken below the high water, spoil was observed as it was tipped from the machine bucket.

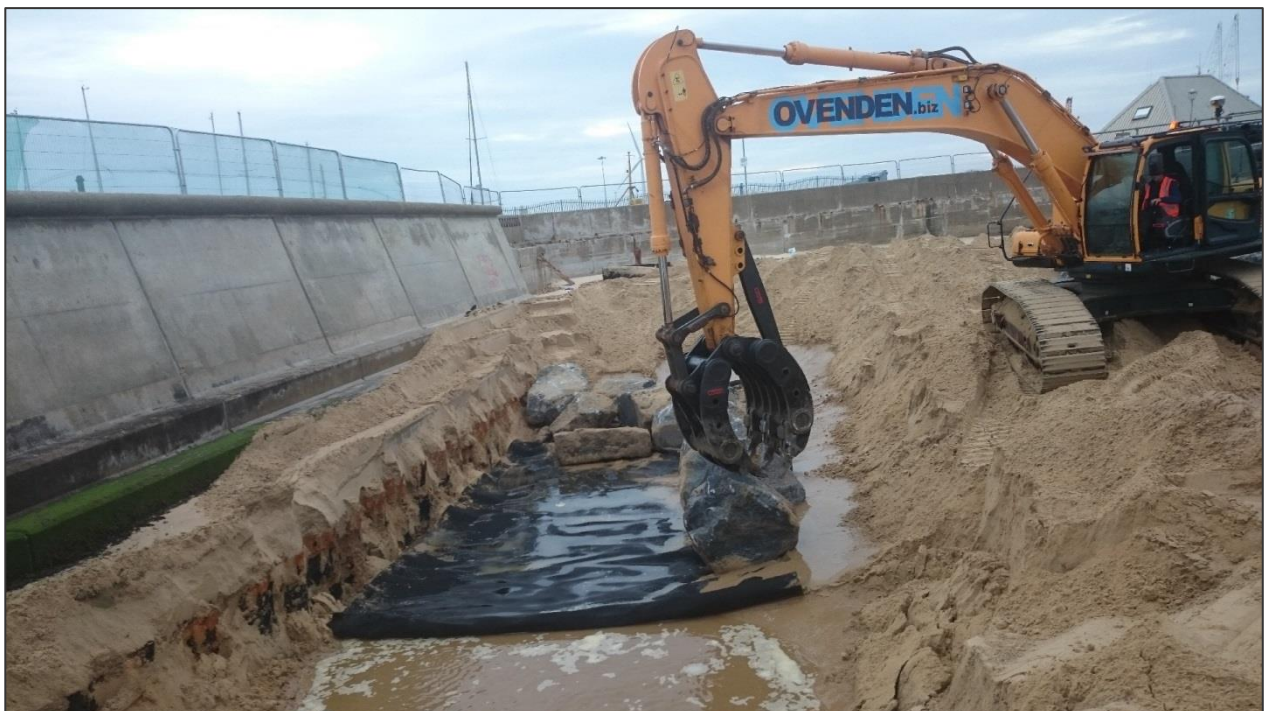
Plate 6: Shallow excavations in advance of Knuckle rock placement

During monitoring visits, only reworked beach sands and shingle deposits were observed (e.g. **Plate 6**) and no archaeological remains were identified. No artefacts were discovered and no features or deposits of archaeological potential were identified. It was noted that had any substantial archaeological evidence been present, such as a wreck site, it would have been readily apparent.

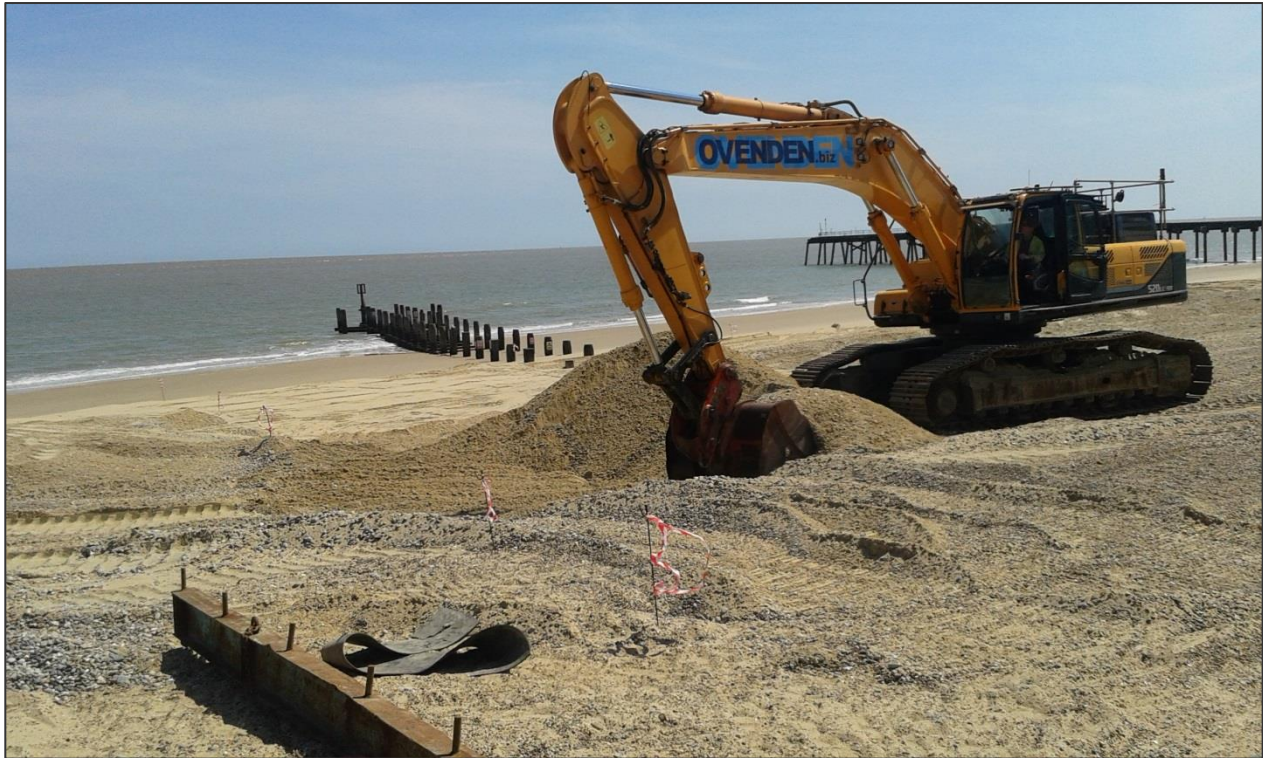
Plate 7: Borrowing of beach material from the causeway donor area, on the north side of Claremont Pier

On 16th July 2015, works to borrow sand for causeway construction were also observed by Royal HaskoningDHV (**Plate 7**). The Heritage Statement (Royal HaskoningDHV, 2015a) had previously concluded that these works were unlikely to impact buried archaeological deposits. In accordance with this conclusion, only reworked sand deposits were seen and no artefacts or features of archaeological interest were identified.

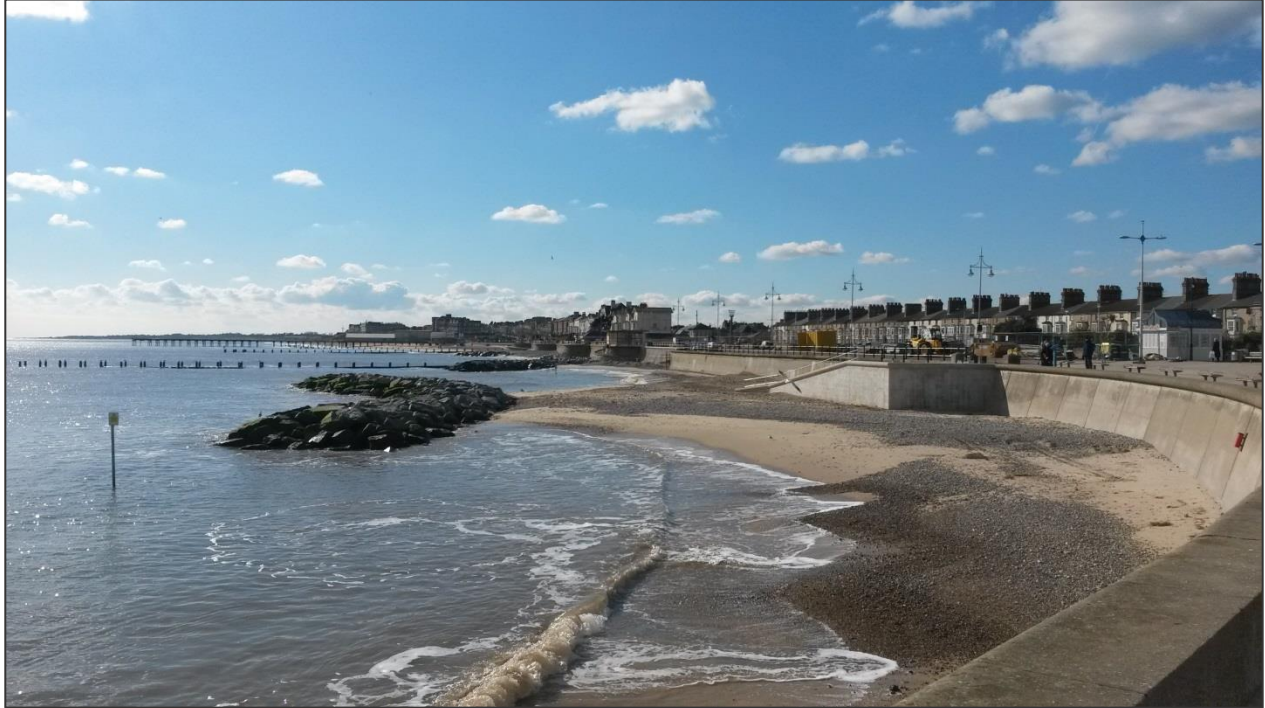
Plate 8: Completed works and location of new public warning sign

In addition to the above activities, works were also undertaken to replace the permanent public warning marker for the *Lily of Devon* (Activity 3.11 of the Marine Licence). The methodology comprised the selection of an accessible siting location for the sign off the northern end of the new rock 'reef' where the seabed is exposed on spring low tide and well clear of the actual wreck remains. A pit was excavated using a mechanical excavator, the sign (set on a post within a concrete filled barrel base) was set in the pit, which was then backfilled and beach levels reinstated.

The location of the new sign is shown in **Plate 8**.
