Upper Holton Airfield Halesworth, Suffolk

Geophysical Survey and Field Evaluation

Date: **March 2013**

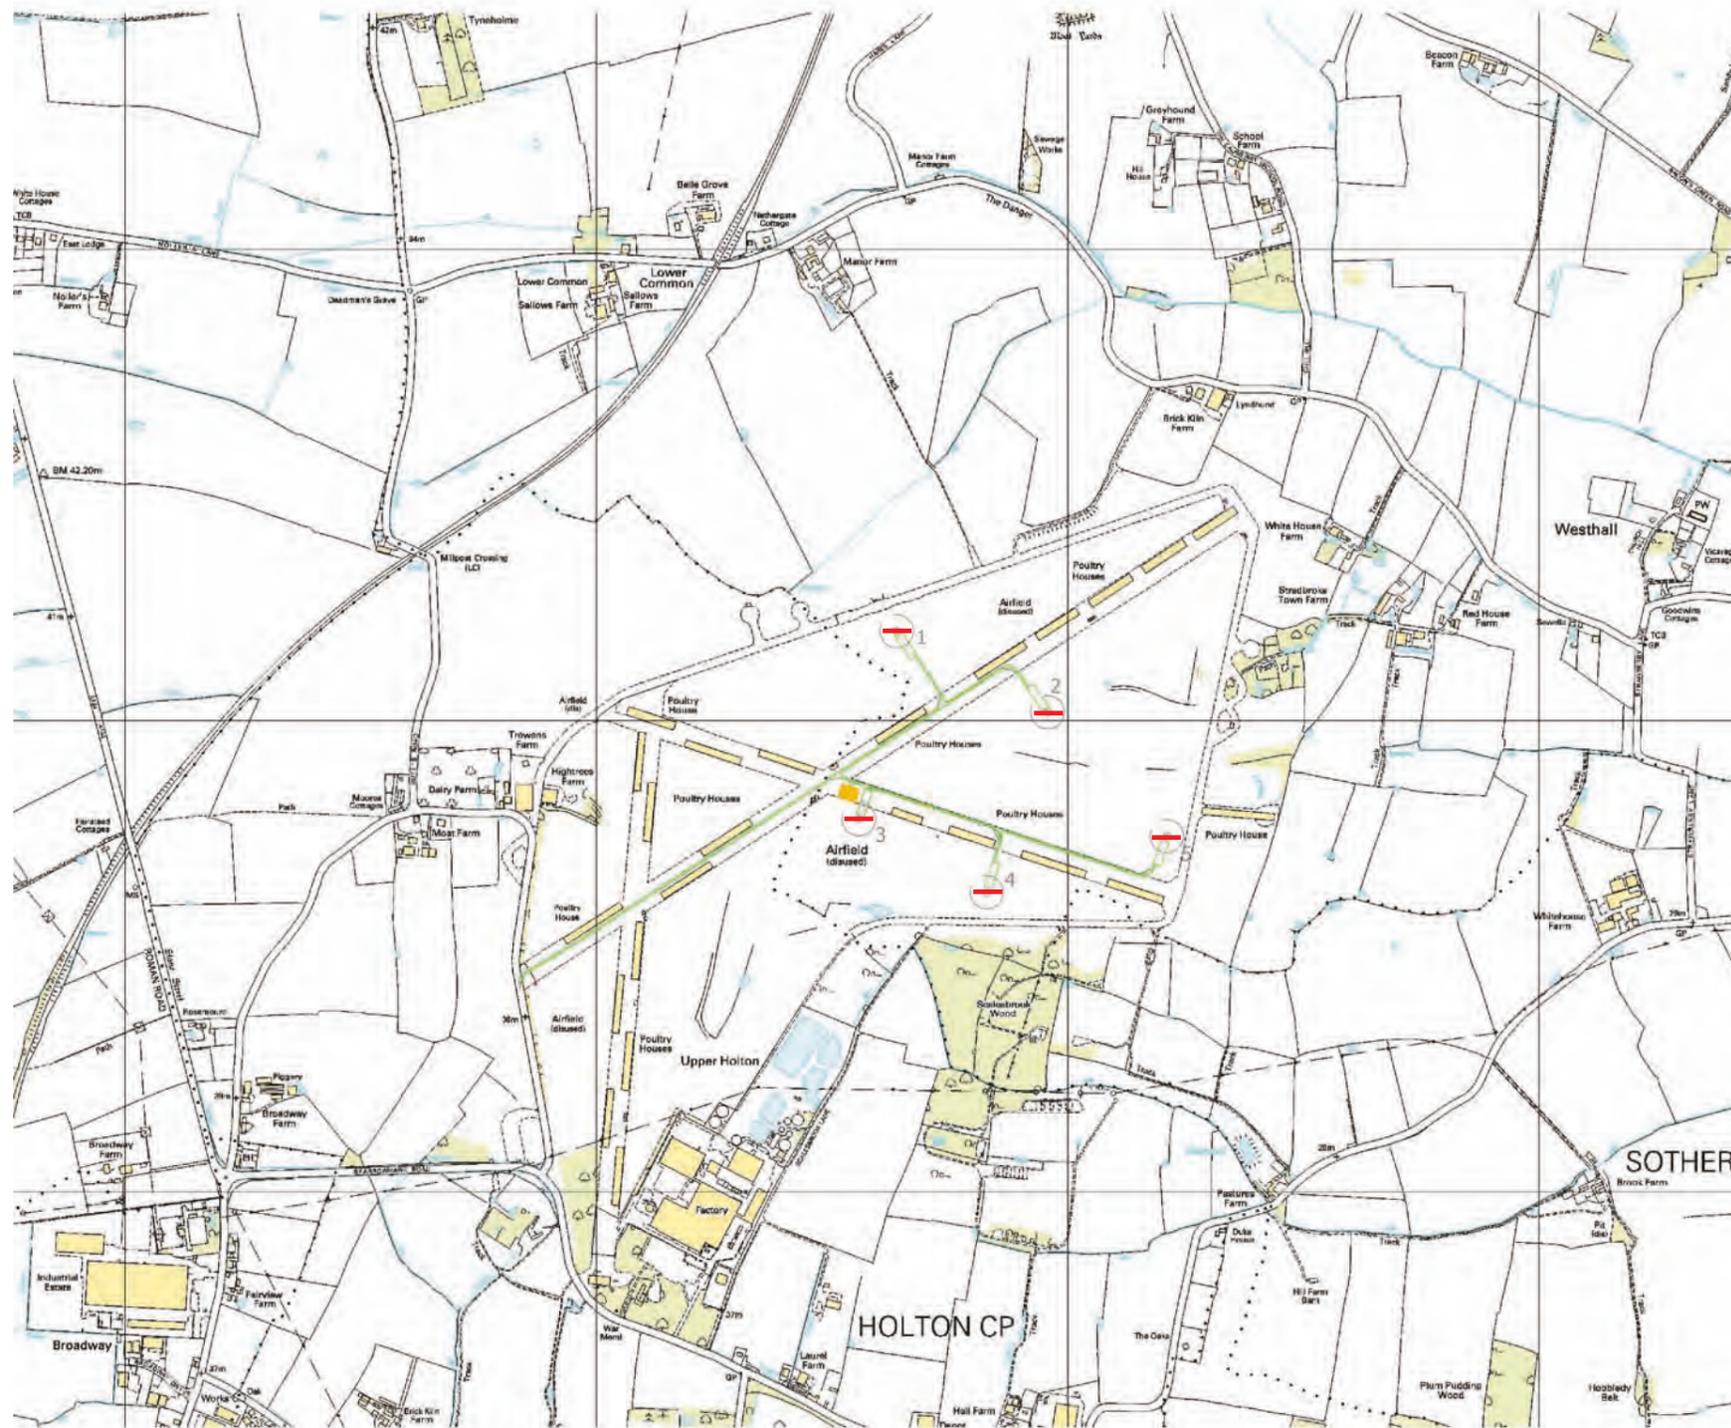
Figure 2
Trench Layout
Scale 1:15 000

Proposed turbine location and hardstanding

Site track (showing turning pull-ins)

Temporary construction compound

11kV substation

Permanent meteorological mast location

- 5.1.1 The soil sequences in each trench appeared composed of topsoil up to 0.45m deep overlying thick natural clay.
- 5.1.2 Trenches positions were informed by the results of the geophysical surveys. Figures 3 to 7 show the locations of the trenches in relation to the survey areas.
- 5.1.3 Ground conditions were very wet with severe flooding hampering excavation proceedings in places.
- 5.1.4 Owing to the severe flooding and its impediment to accurate archaeological observations, where linear ditches were identified in trenches 1-3, an additional length of trench was positioned immediately adjacent to the main trench so as to include the ditch. This area, rather than the severely flooded main trench, was subsequently excavated.

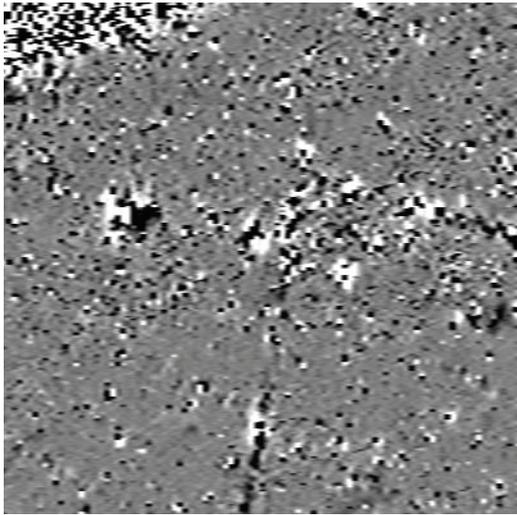
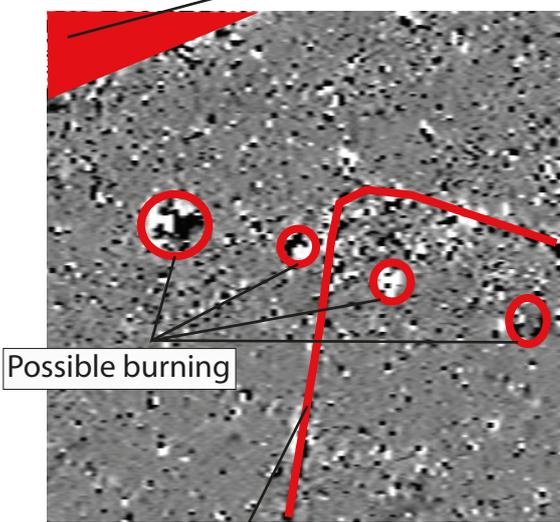
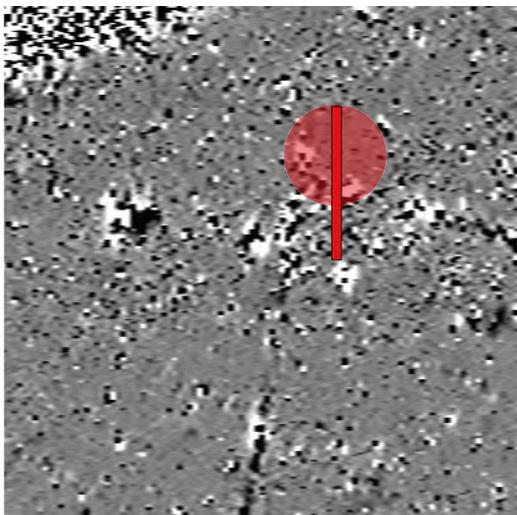
Fig 3

Survey of turbine 1 area

Disturbance from Road

Survey of turbine 1 area showing features

Field boundary on 1st-4th Ed OS Maps

Survey of turbine 1 area showing location of turbine base and location of 30m evaluation trench

4.3.1 Turbine 1 (Fig 3). The survey of the turbine 1 area showed only one feature of archaeological interest. A ditch running north – south including a 90° return to the east is clearly identifiable on the plot. There are four small areas of possible burning or large metallic concentrations also visible as well as an area of interference from the line of the nearby road.

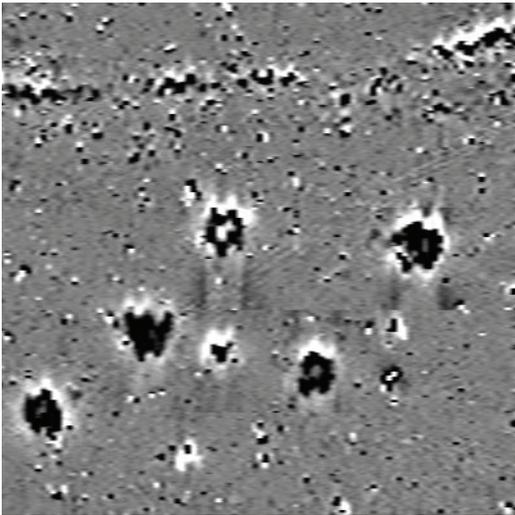
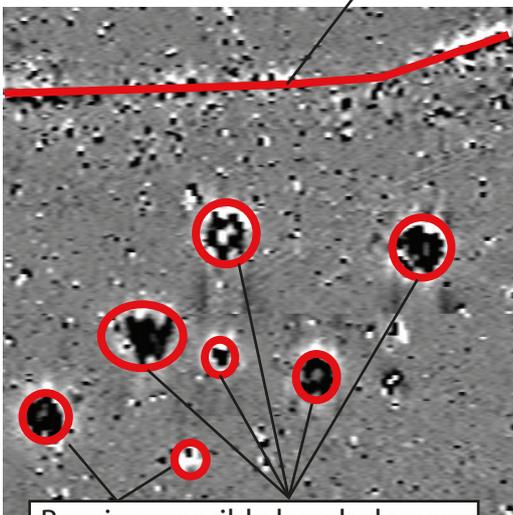
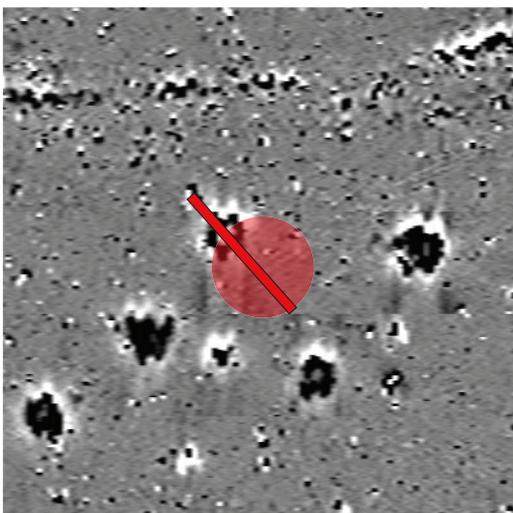
Fig 4

Survey of turbine 2 area

Field boundary marked on historic mapping

Burning, possible bomb damage

Survey of turbine 2 area showing features

Survey of turbine 2 area showing location of turbine base and location of 30m evaluation trench

4.3.2 Turbine 2 (Fig 4). The survey of the turbine 2 area again showed only one features of archaeological interest. A ditch running roughly east – west is clearly identifiable on the plot. There are seven areas of possible burning, similar to those seen on the survey of turbine 1.

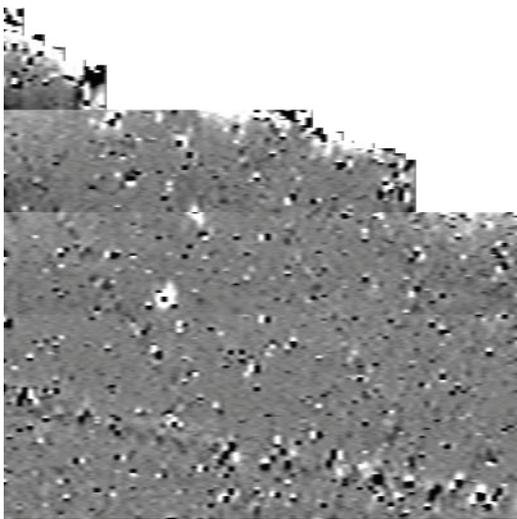
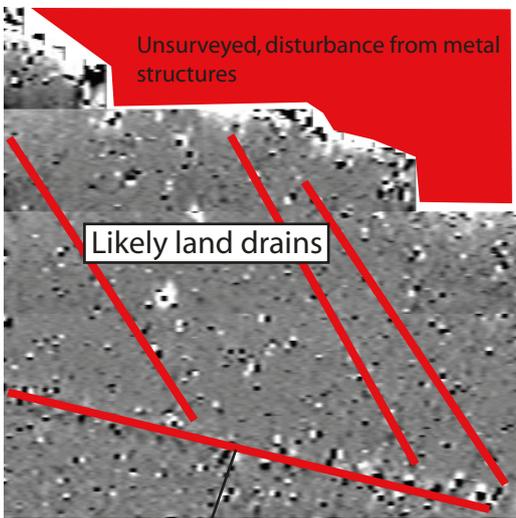
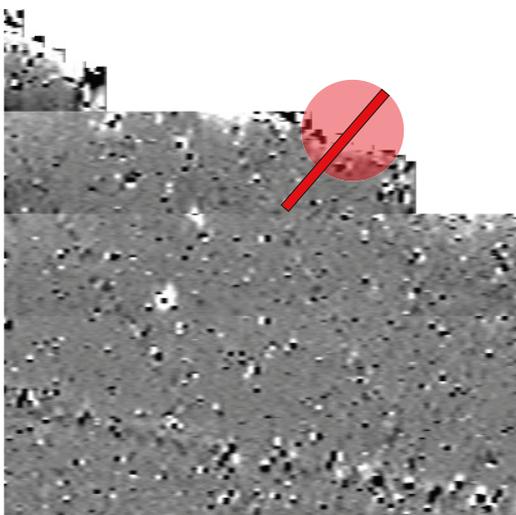
Survey of turbine 3 area

Survey of turbine 3 area showing features

Field Boundary shown on historic mapping

Survey of turbine 3 area showing location of turbine base and location of 30m evaluation trench

4.3.3 Turbine 3 (Fig 5). The survey of the turbine 3 area again showed only one feature of archaeological interest. A ditch running roughly east – west is clearly visible on the plot. Three land drains, each running north west to south east and seemingly terminating at the ditch feature, were also noted. 5 grids on the northern edge of the plot were un-surveyed due to the proximity of metal structures interfering with the machines.

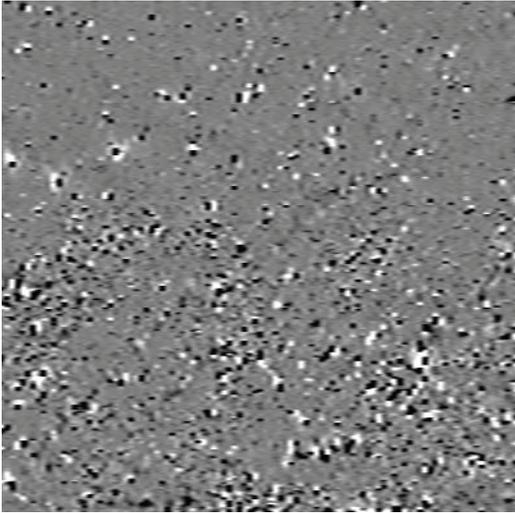
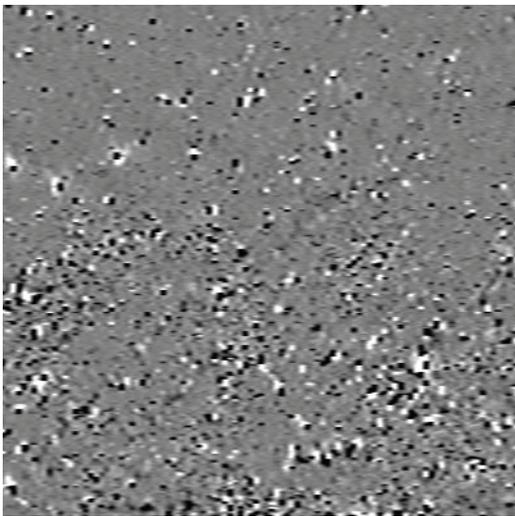
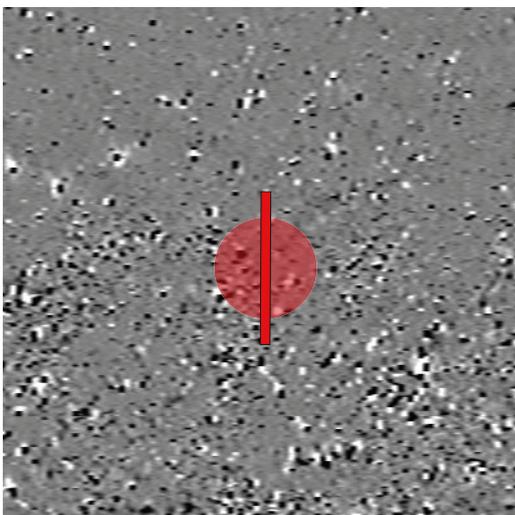
Fig 6

Survey of turbine 4 area

Survey of turbine 4 area showing features

Survey of turbine 4 area showing location of turbine base and location of 30m evaluation trench

4.3.4 Turbine 4 (Fig 6). The survey of the turbine 4 area showed no features, of archaeological interest or otherwise.

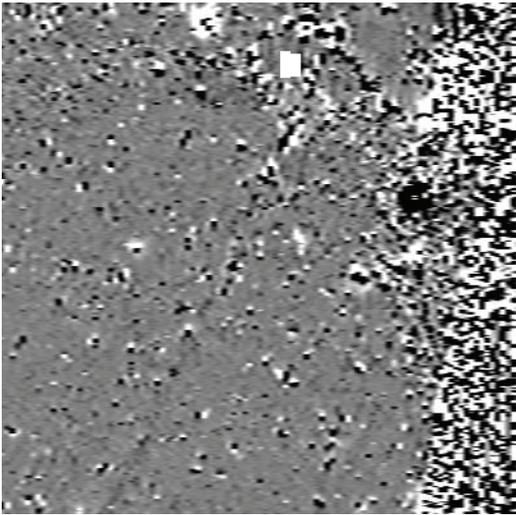
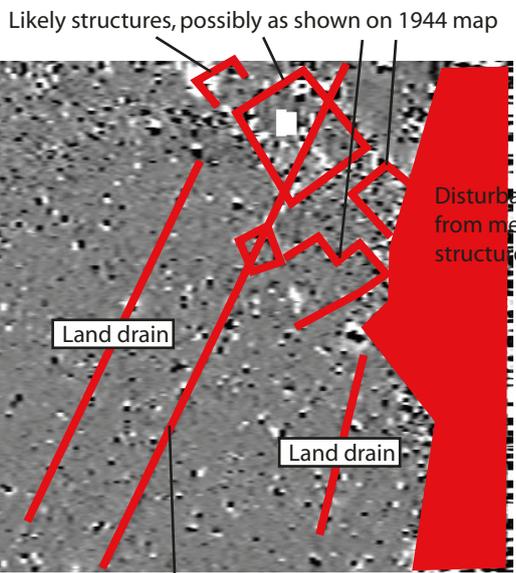
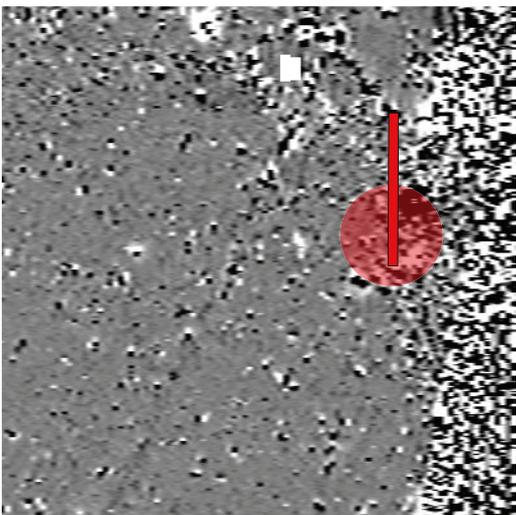
Fig 7

Survey of turbine 5 area

Survey of turbine 5 area showing features

Field boundary on historic mapping

Survey of turbine 5 area showing location of turbine base and location of 30m evaluation trench

4.3.5 Turbine 5 (Fig 7). The survey of the turbine 5 area showed four seemingly rectilinear structures as well as large amounts of associated disturbance. A large amount of disturbance from metal structures was noted on the eastern edge of the survey. A linear ditch running north east to south west, through the area of the rectilinear structures, is clearly visible. Two land drains, running north east to south west, were also noted.

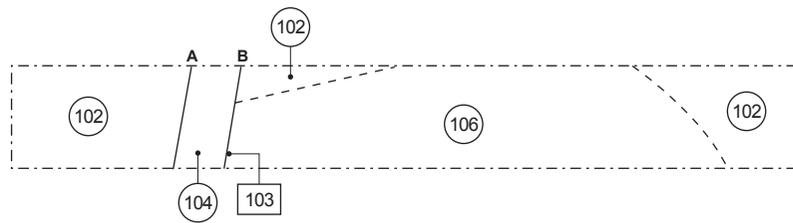
Figure 08:

Drawing Title: Trench 1 plan

- 5.2.1 Trench 1 measured 32m by 1.8m, and was aligned North to South. The soil sequence consisted of topsoil (101), some 18-45cm thick, overlying natural clay (102).

- 5.2.2 A layer (106) was encountered below the topsoil in the southern half of the trench - this extended some 9m north-south and circa 0.8m below surface. This deposit was recorded as a soft to firm dark brown clay with inclusions of fine chalk gravel. This layer has been interpreted as redeposited natural, resulting from the modern disturbance.

- 5.2.3 A ditch [103] was identified towards the centre of the trench. It was not possible to define and excavate this feature as adverse weather subsequently resulted in severe flooding of Trench 1. Ditch [103] was subsequently exposed within an additional 14m long excavation positioned 3m to the east of Trench 1.

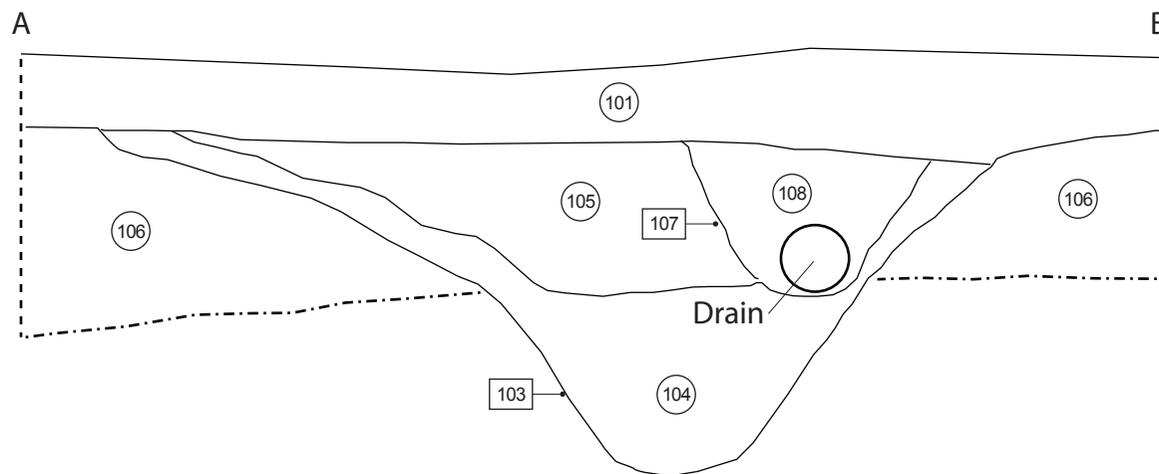
Figure 09:

Drawing Title: EFS T1

- 5.2.4 Ditch 103 was recorded as 2.36m wide and 0.92m deep, aligned West-North-West to East-South-East. The ditch contained a basal fill (104) of very soft dark brown humic clay silt, with patches of dark grey clay. The upper fill (105) comprised a stiff orange brown clay, with occasional medium and coarse flint and fine chalk gravel. A one metre wide slot was hand-excavated across the lower fill (104); modern roof tile was retrieved from this deposit. This indicates that the ditch appears to have been buried in

- 5.2.5 Ditch 103 appears to have been re-cut [107] to lay a land-drain (200mm diameter) along the line of the former drainage channel. The ditch cut [107] measured as 0.64m wide and 0.42m deep. Ditch 107 contained an homogenous fill (108) of dark grey brown humic clay with much coarse gravel and flint cobbles. This most probably represents flint bedding material surrounding the ceramic drain, with further backfill of redeposited topsoil.

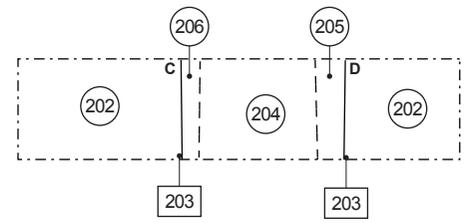
Job Title:	Upper Holton
Drawing Title:	Trench 2 Plan
Date:	14/02/2013
Drawn By:	JFH
Scale:	1:75@A4
Figure 10:

- 5.3.1 Trench 2 measured 31m by 1.8m, and was aligned North to South. The soil sequence consisted of topsoil (201), some 22-36cm thick, overlying natural clay (202).

- 5.3.2 A ditch [203] was identified towards the northern end of the trench. It was not possible to define and excavate this feature as adverse weather subsequently resulted in severe flooding of the trial trench. Ditch 203 was subsequently exposed within an additional 8m long excavation positioned 3m to the west of Trench 2.

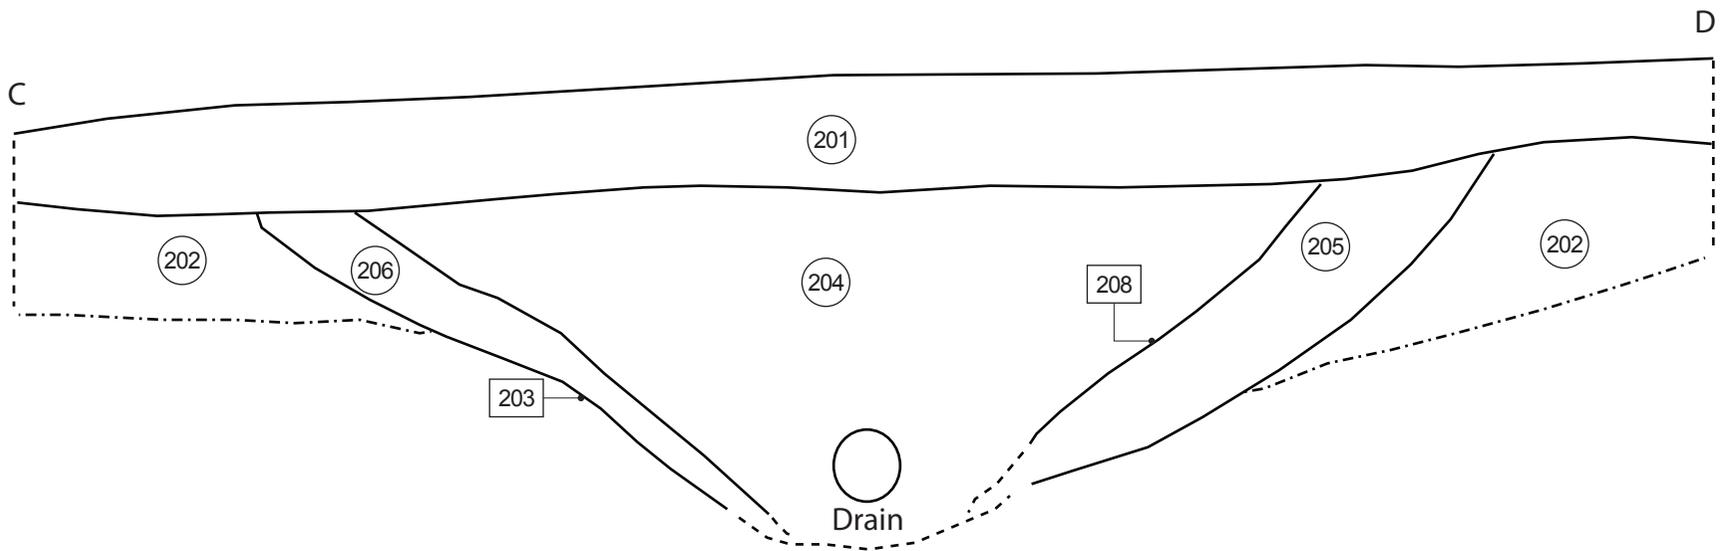
Job Title:	Upper Holton
Drawing Title:	Trench 2 Sec
Date:	14/02/2013
Drawn By:	JFH
Scale:	See Bar
Figure 11:

- 5.3.3 Ditch 203 was recorded as 3.65m wide and 1.06m deep, aligned East to West. The ditch contained a basal fill (205) (206) of a *stiff orange-brown slightly silty clay*.

- 5.3.4 Ditch 203 appears to have been re-cut [208] to lay a land-drain (200mm diameter) along the line of the former drainage ditch. The ditch cut [208] measured 2.84m wide and about a metre deep. Ditch 208 contained flint cobbles and brick rubble surrounding the ceramic drain. The bricks were noted to comprise 'soft reds' dating from the late 1900's or early 20th century. The drain backfill (204) comprised a *firm dark grey-brown silty clay mixed with a stiff mottled orange-grey clay*. Tip-lines were also evident within this fill. The ditch fill (204) contained frequent inclusion of brick rubble as well as some occasional modern ferrous items. The latter deposit appears to derive from the topsoil (201) and natural clay (202). The backfill of this feature is comparable with the ditch found in Trench 1; it is probable that Ditches 107 and 208 are contemporary.

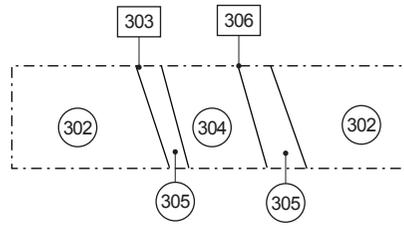
Job Title:	Upper Holton
Drawing Title:	Trench 3 plan
Date:	14/02/2013
Drawn By:	JFH
Scale:	1:75@A4
Figure 12:

- 5.4.1 Trench 3 measured 31m by 1.8m, and was aligned North-East to South-West. The soil sequence consisted of topsoil (301), some 24-36cm thick, overlying natural clay (302).

- 5.4.2 A ditch [303] was identified towards the south-west end of the trench. It was not possible to define and excavate this feature as adverse weather subsequently resulted in severe flooding of the trial trench. Ditch 303 was subsequently exposed within an additional 7m long excavation positioned 3m to the north-west of Trench 3.

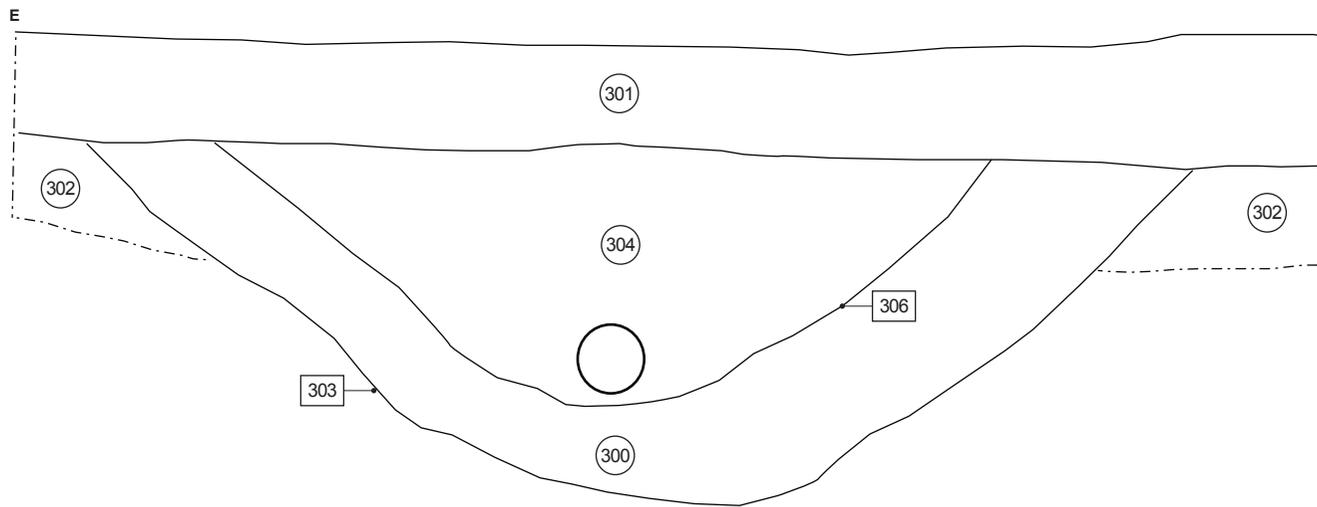
Job Title:	Upper Holton
Drawing Title:	Trench 3 sec
Date:	15/02/2013
Drawn By:	JFH
Scale:	1:20@A4
Figure 13:

- 5.4.3 Ditch 303 was recorded as 2.96m wide and 0.93m deep, aligned West-North-West to East-South-East. The ditch contained a basal fill (305) of a soft orange-brown slightly silty clay.

- 5.4.4 Ditch 303 appears to have been re-cut [306] to lay a land-drain (200mm diameter) along the line of the former drainage ditch. The ditch cut [306] measured 2.05m wide and 0.66m deep. Ditch 306 contained flint cobbles surrounding the ceramic drain. The drain backfill (304) comprised a stiff mottled orange-grey clay, with a few modern ferrous items present. The latter deposit appears to derive from the natural clay (302). The backfill of Ditch 306 is similar to the features found in Trenches 1&2 (Ditches 107 and 208).

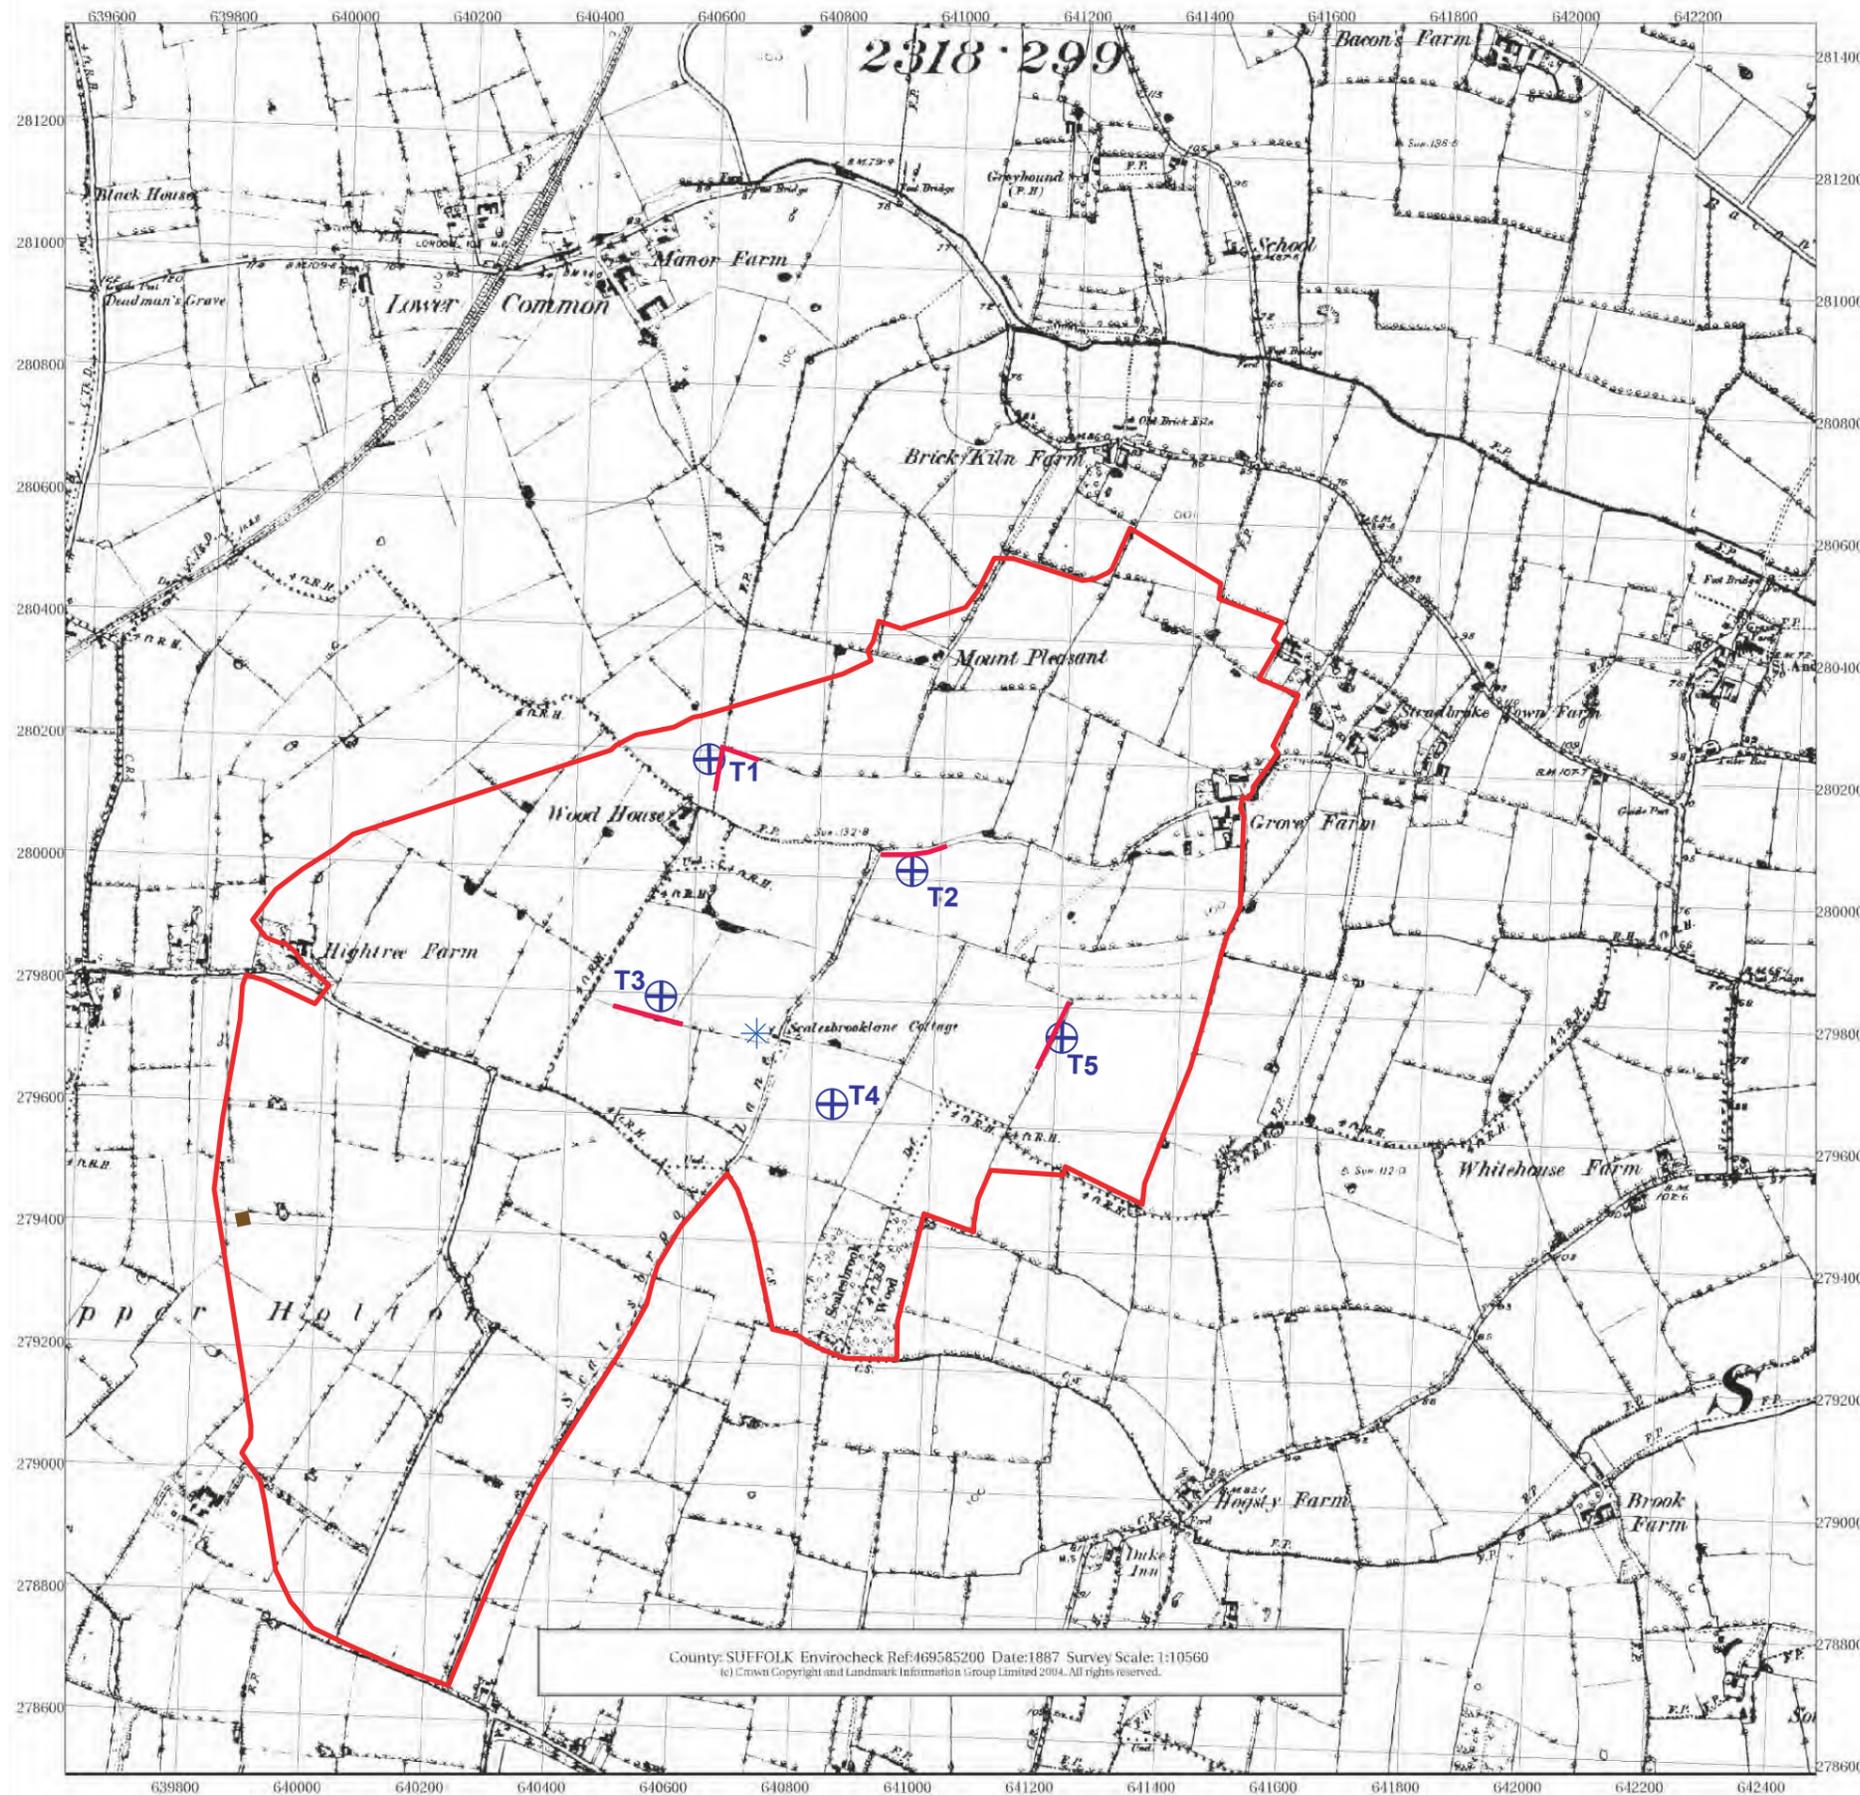
Figure 16

Field Boundaries in red show those ditches identified during geophysical surveys

OS First Edition Map 1886/7

- 4.4.1 The geophysical surveys show very little in terms of significant archaeological features. The linear ditch features visible on the turbine 1-3 & 5 surveys all represent defunct field boundaries and are visible on the historic mapping (Fig 16).
- 4.4.2 The rectilinear structures on the turbine 5 survey appear to be associated with the sites former use an airfield. An aerial photograph from 1946 shows airfield structures in this area (Fig 17).

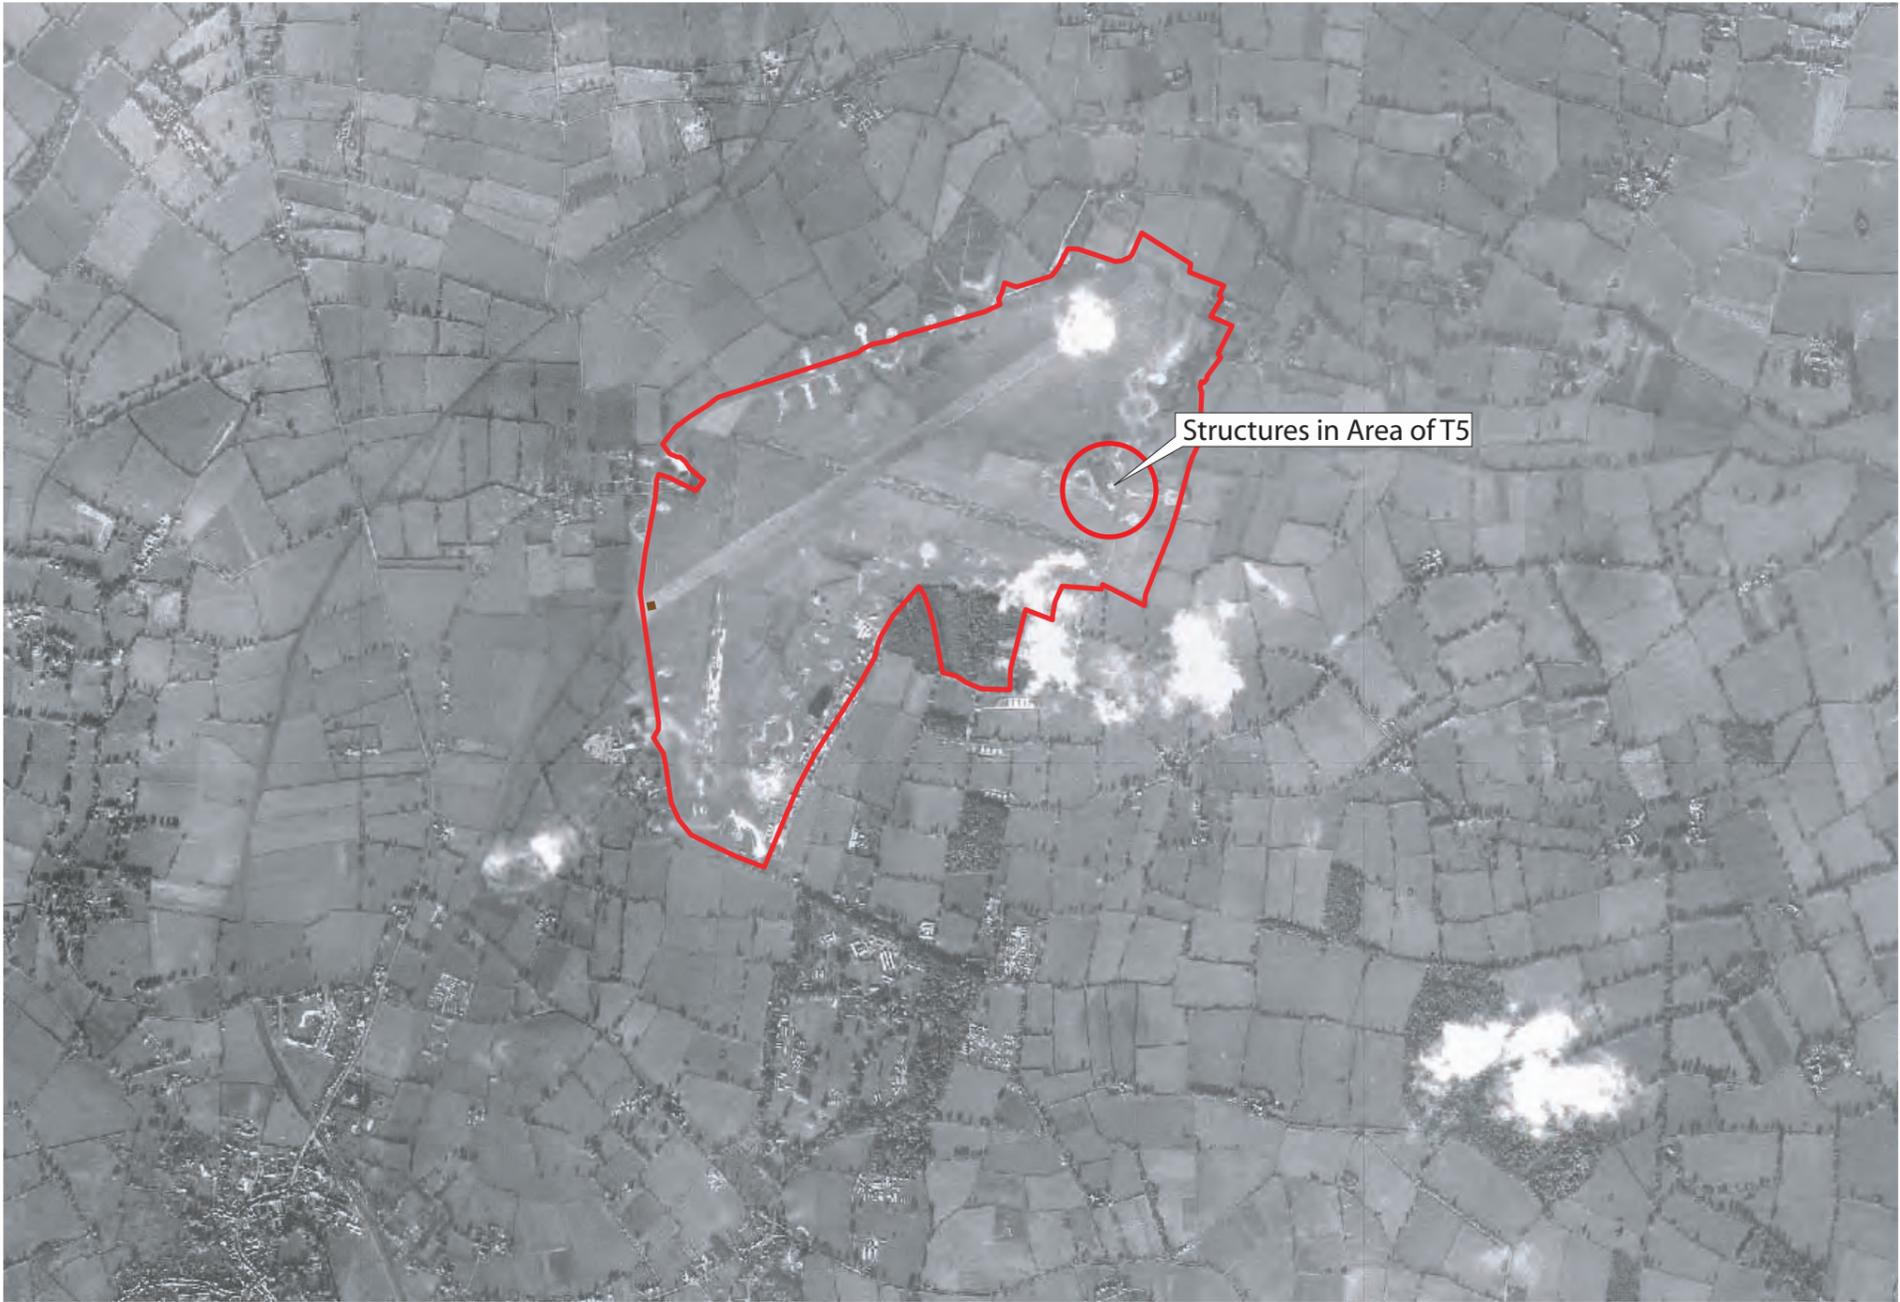
Figure 17

1946 RAF Aerial Photo

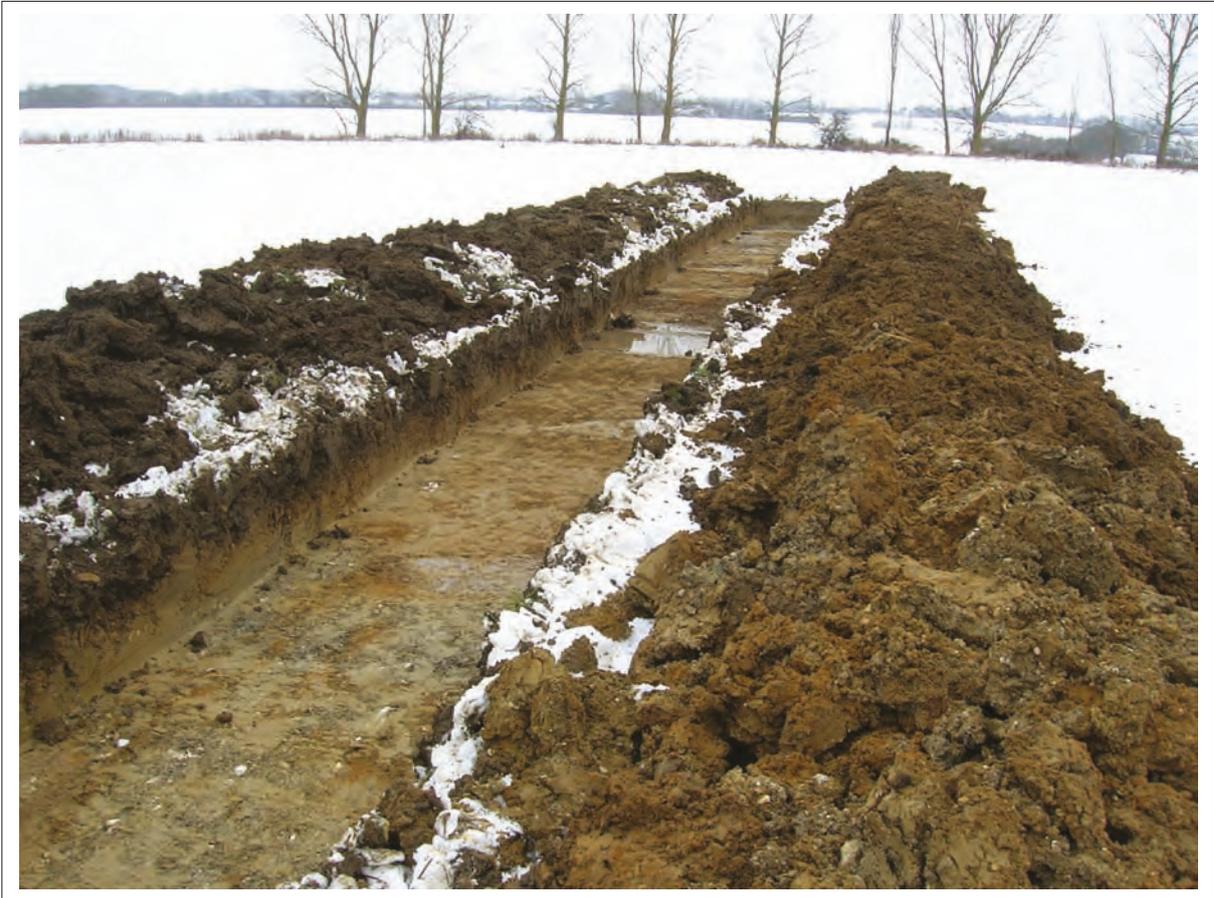
Plate 1:Trench 1, Looking north west

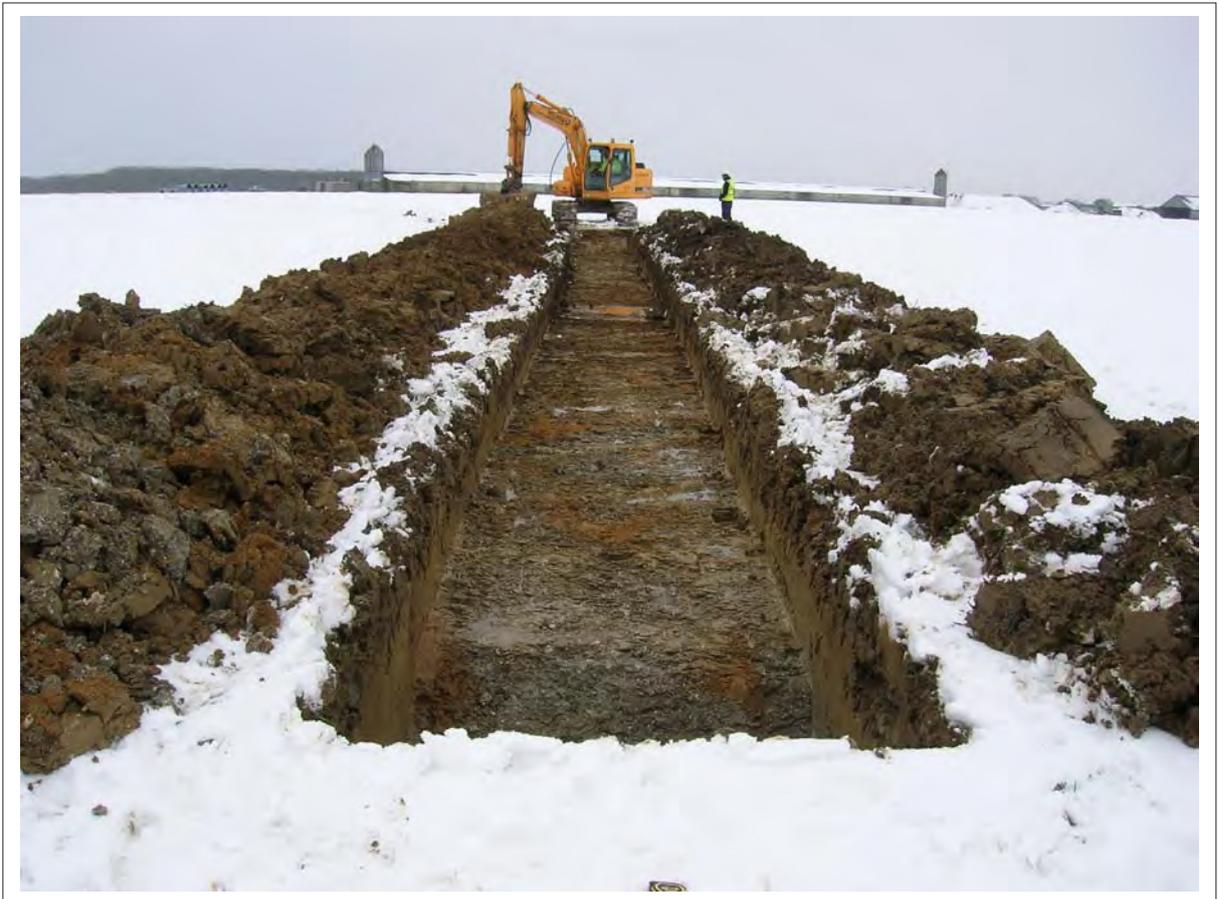
Plate 2:Trench 1, Looking south

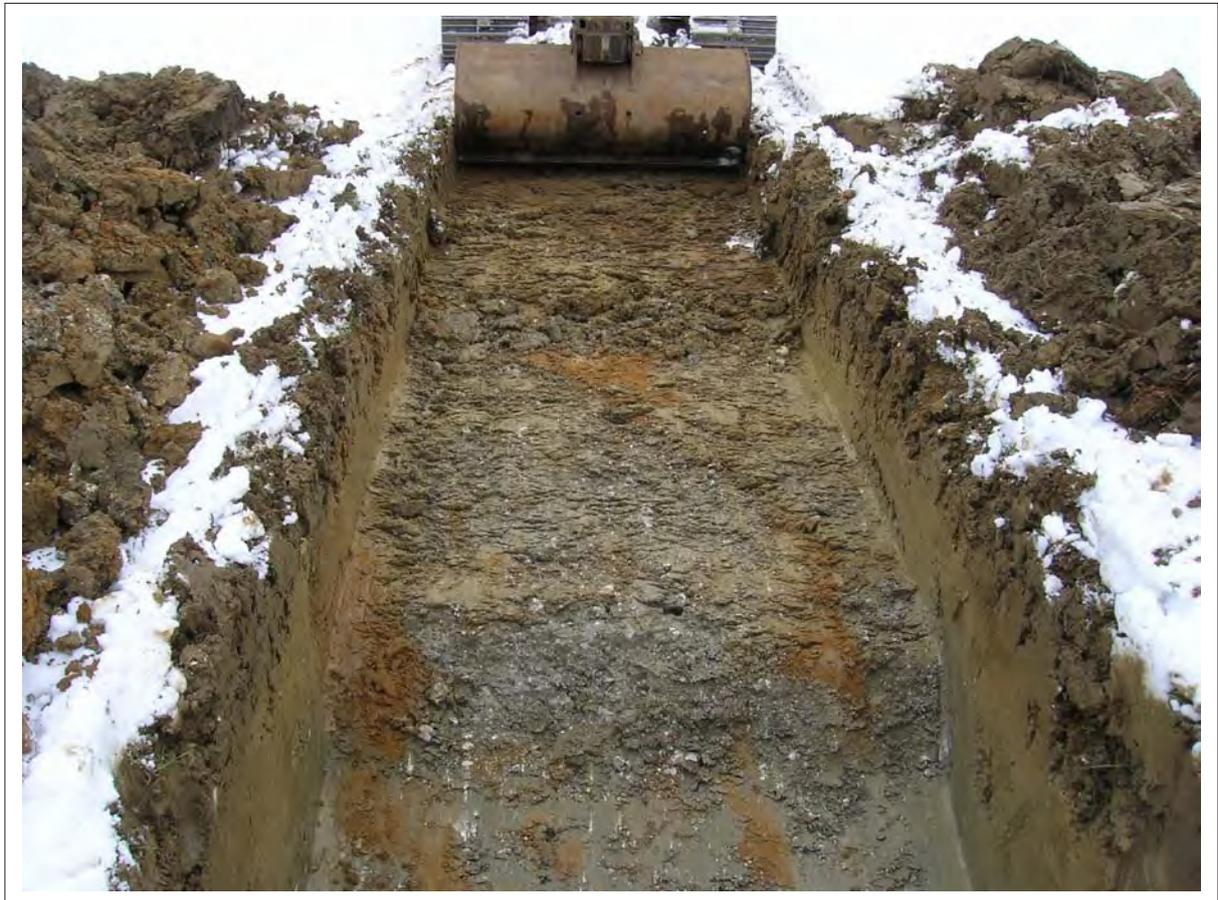
Plate 3: Northern end of trench 1, looking south

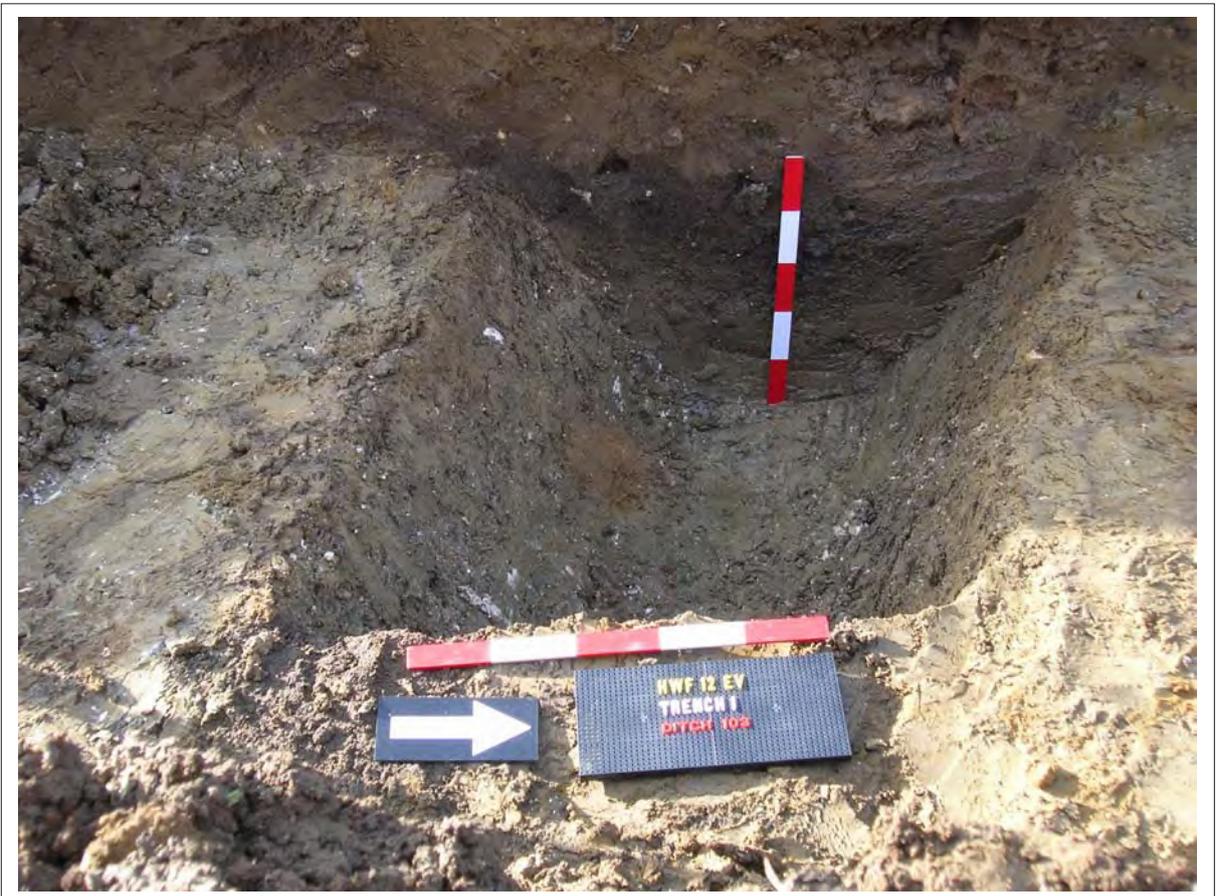
Plate 4: Ditch 103, east facing section, looking west. Scale 1x0.5m

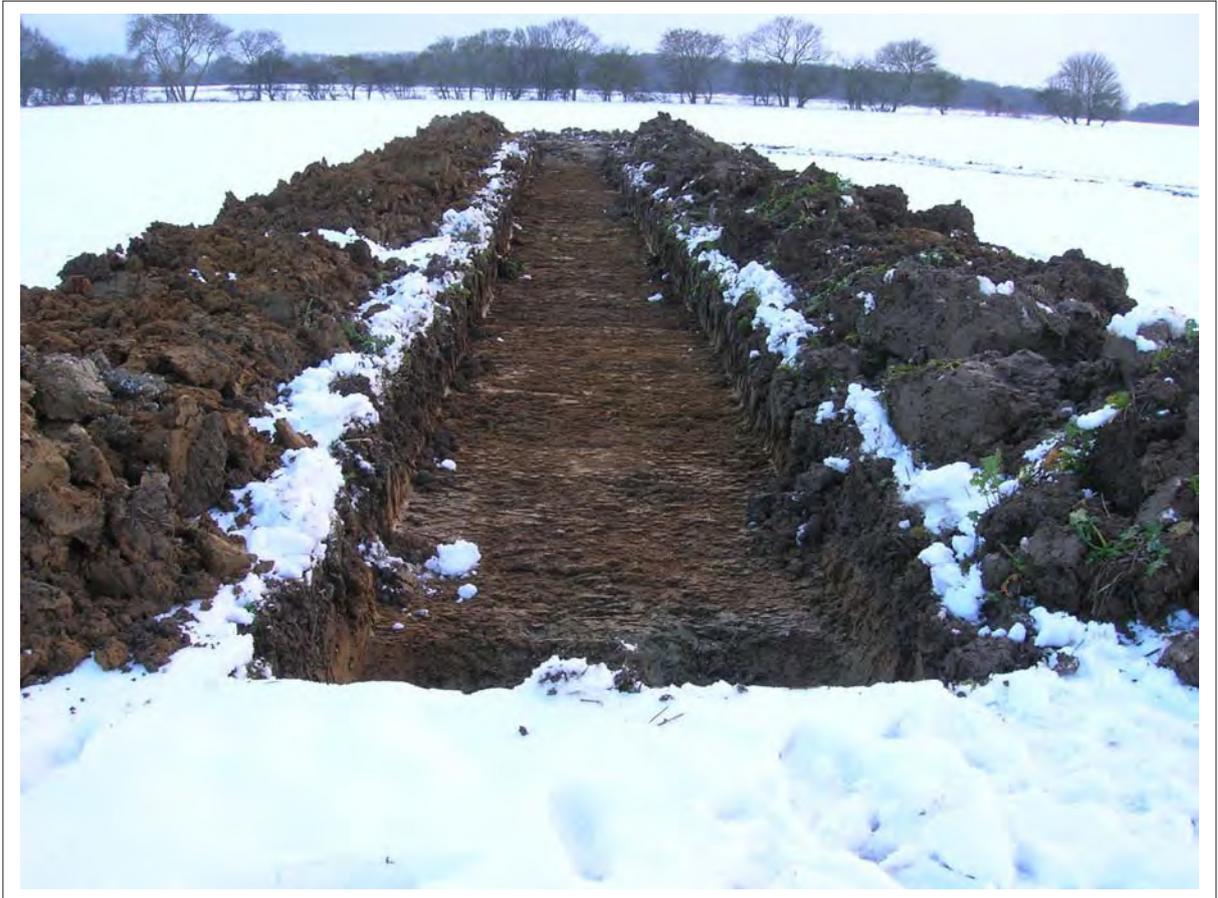
Plate 5: Trench 2, Looking south
