Upper Holton Airfield Halesworth, Suffolk

Geophysical Survey and Field Evaluation

Date: **March 2013**

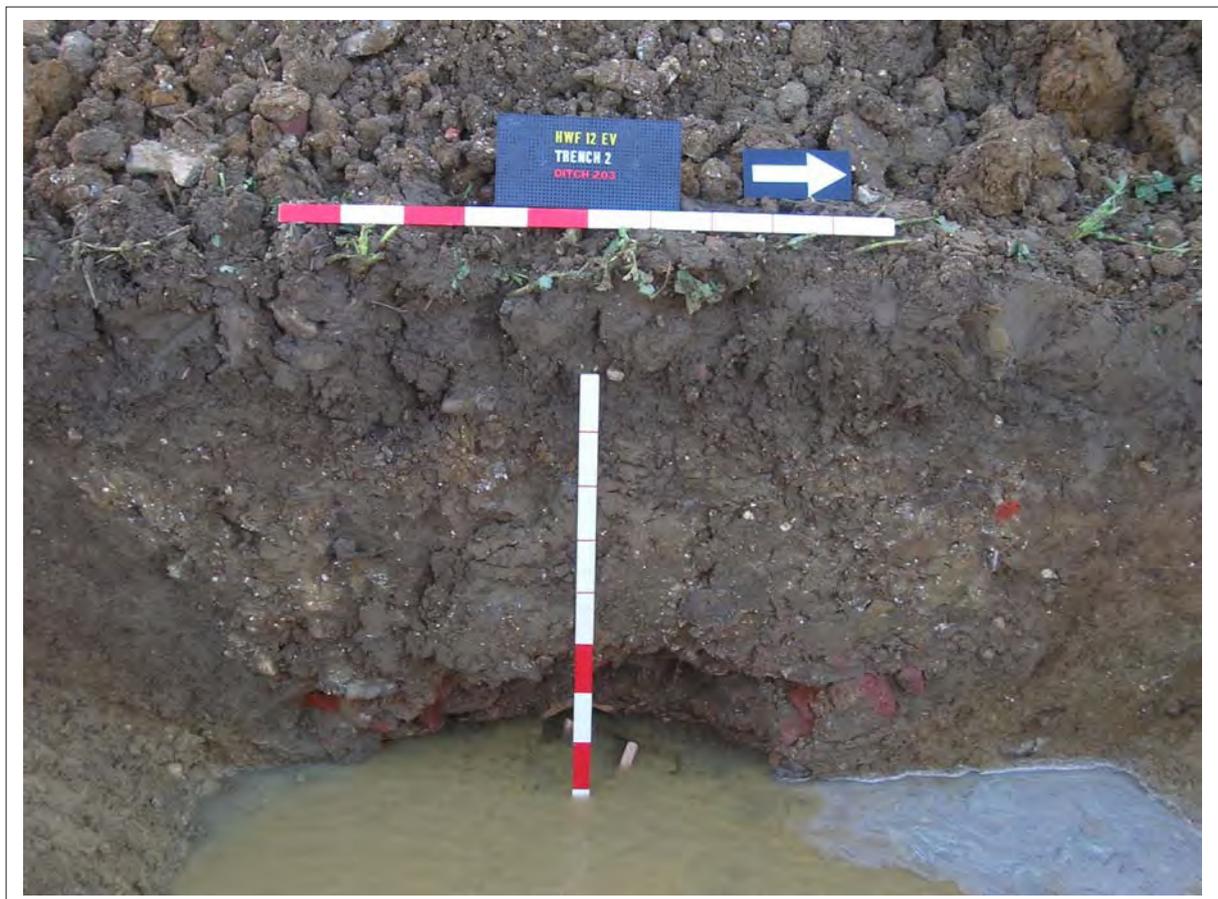
- 5.3.3 Ditch 203 was recorded as 3.65m wide and 1.06m deep, aligned East to West. The ditch contained a basal fill (205) (206) of a *stiff orange-brown slightly silty clay*.

Plate 6: Ditch 203, east facing section, looking west

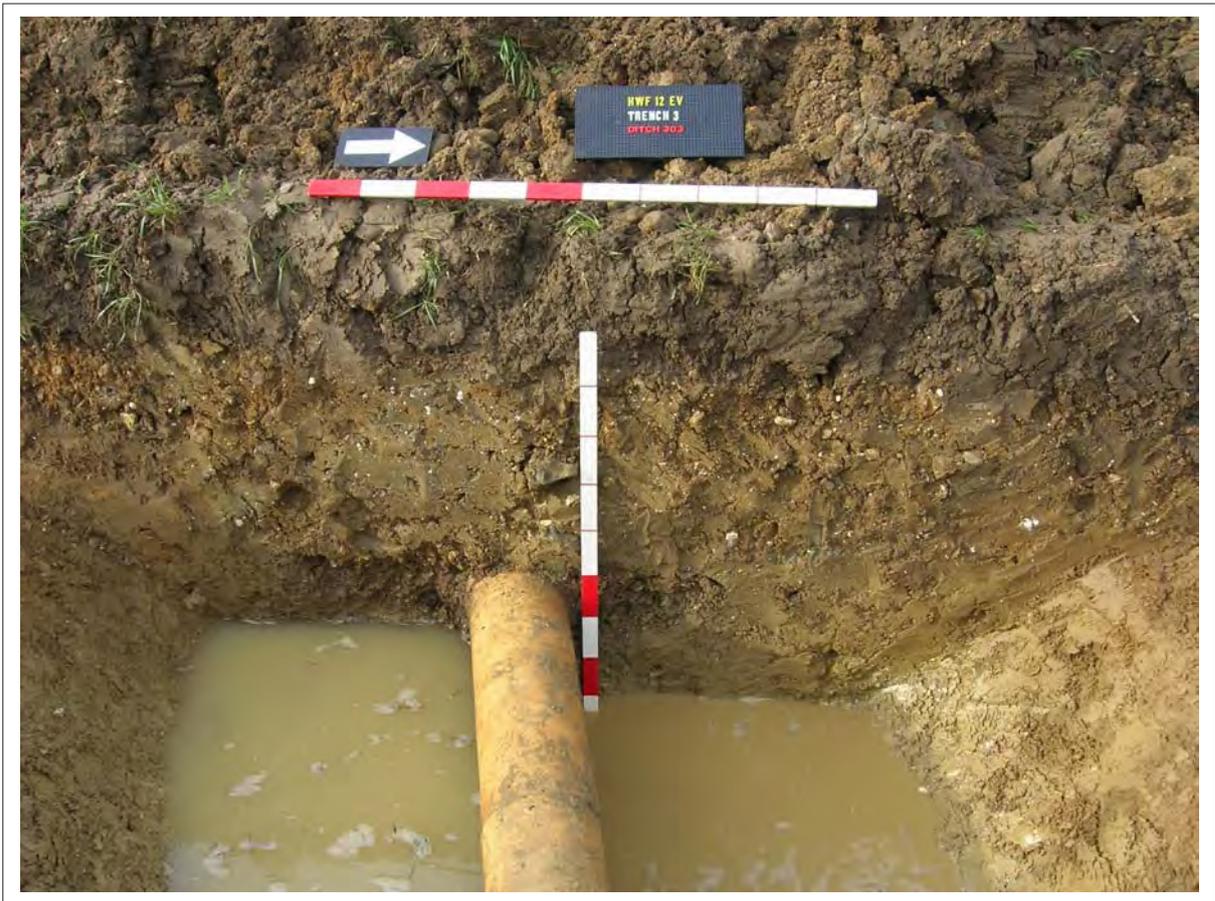
- 5.4.3 Ditch 303 was recorded as 2.96m wide and 0.93m deep, aligned West-North-West to East-South-East. The ditch contained a basal fill (305) of a soft orange-brown slightly silty clay.

Plate 7: Ditch 303, east-south-east facing section, looking west north west
