SCHEME OF ARCHAEOLOGICAL BUILDING RECORDING

THE OLD RECTORY
MAIN ROAD
THIMBLEBY
HORNCastle

SITE CODE: TORT 12
GRID REF: TF 2410 7004
ACCESSION NO: LCNCC 2012.147
PLANNING: S/181/01127/12,
S/181/01128/12

NOVEMBER 2012

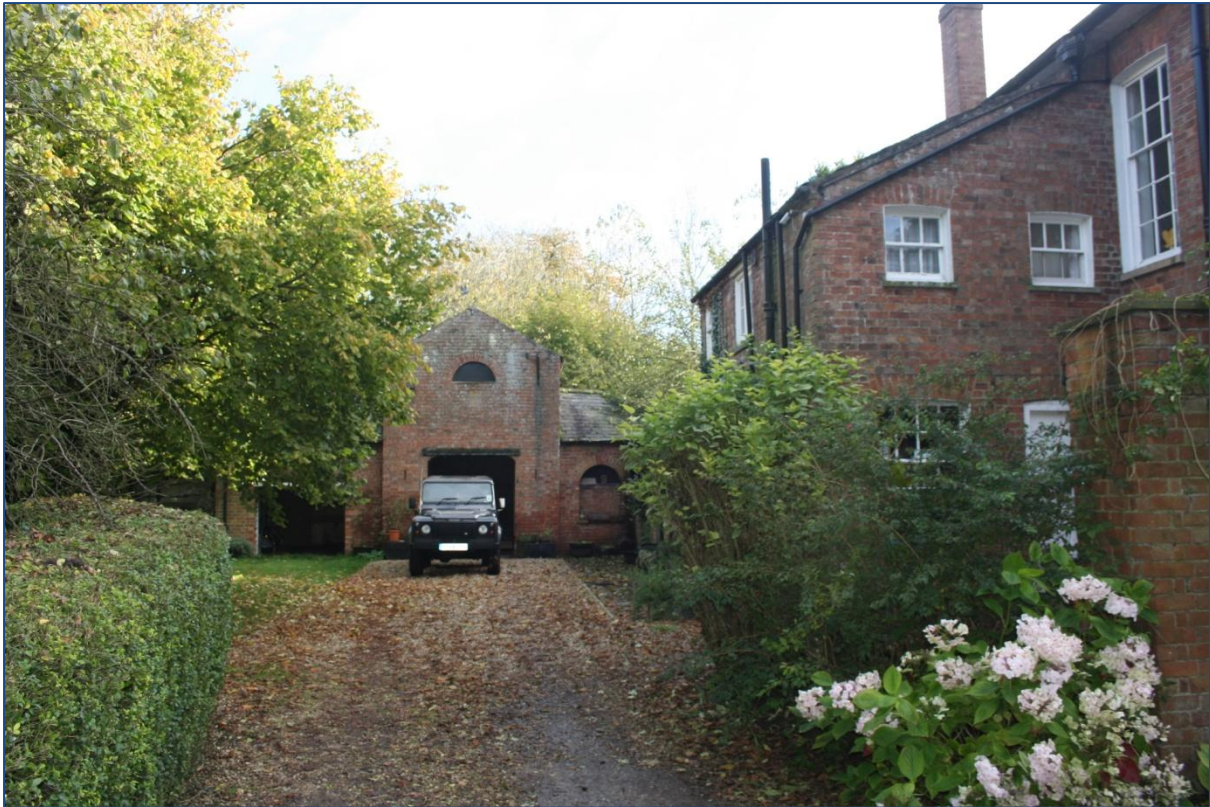
Plate 1: Site looking east.

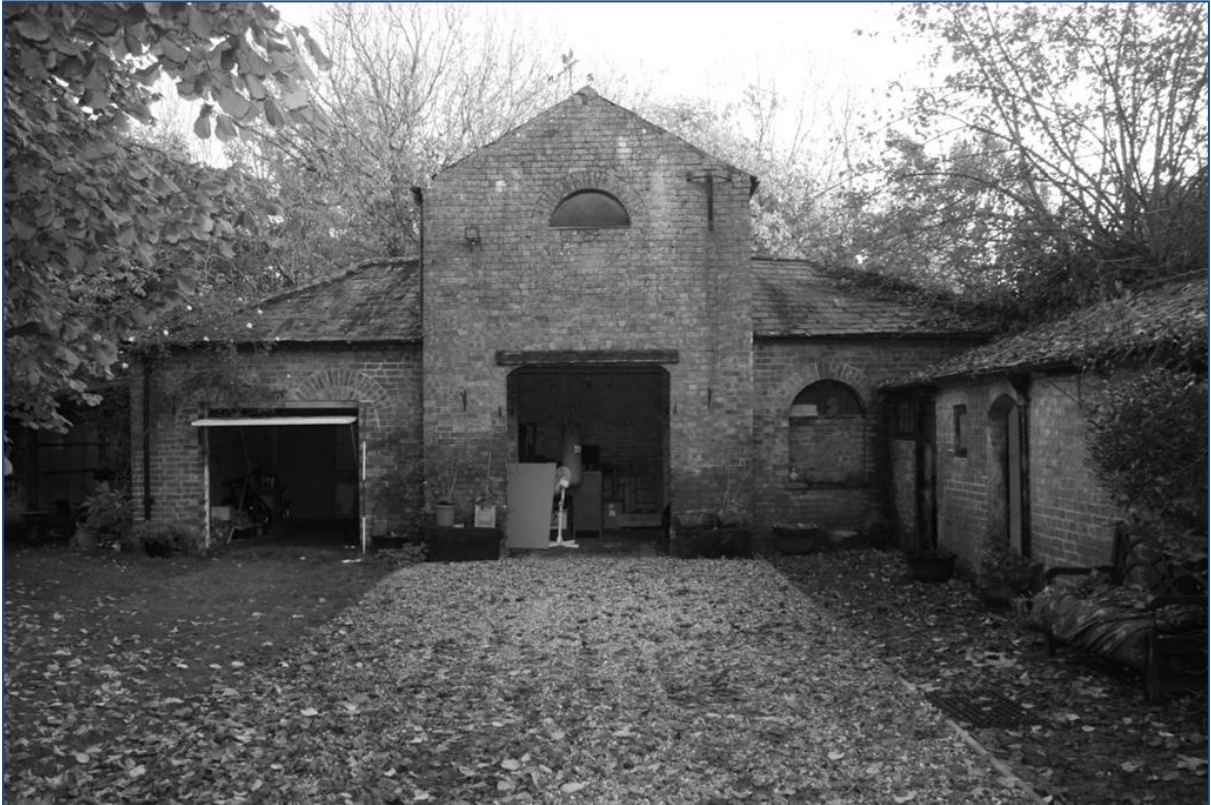
The building is in a late Georgian style built from (23.00cm x 11.00cm x 7.00cm) red brick in a variety of English and random bonding patterns with lime mortar.

Rectangular in plan the building lies on a north-south alignment and comprises of a central two storey coachhouse with over loft and an accompanying single storey wing at each end which served as stabling, Stable area 1 and Stable Area 2.

The exterior of the building is relatively plain in design albeit with a dentilation stringer course of red brick at eaves level and Lunette windows dispersed throughout the west and east elevations, the ones in the second storey acting as pitch-holes, whilst small rectangular ventilators are present in each of the stables east elevations. The central opening to the building is of double span with a small rectangular porch area in front facilitating access to each stable internally. The roof of the central element of this building is of the gabled type, whilst both Stable area 1 and 2 are hipped, both roofs are under slate.

Plate 2: West elevation of the coachhouse building range looking east.

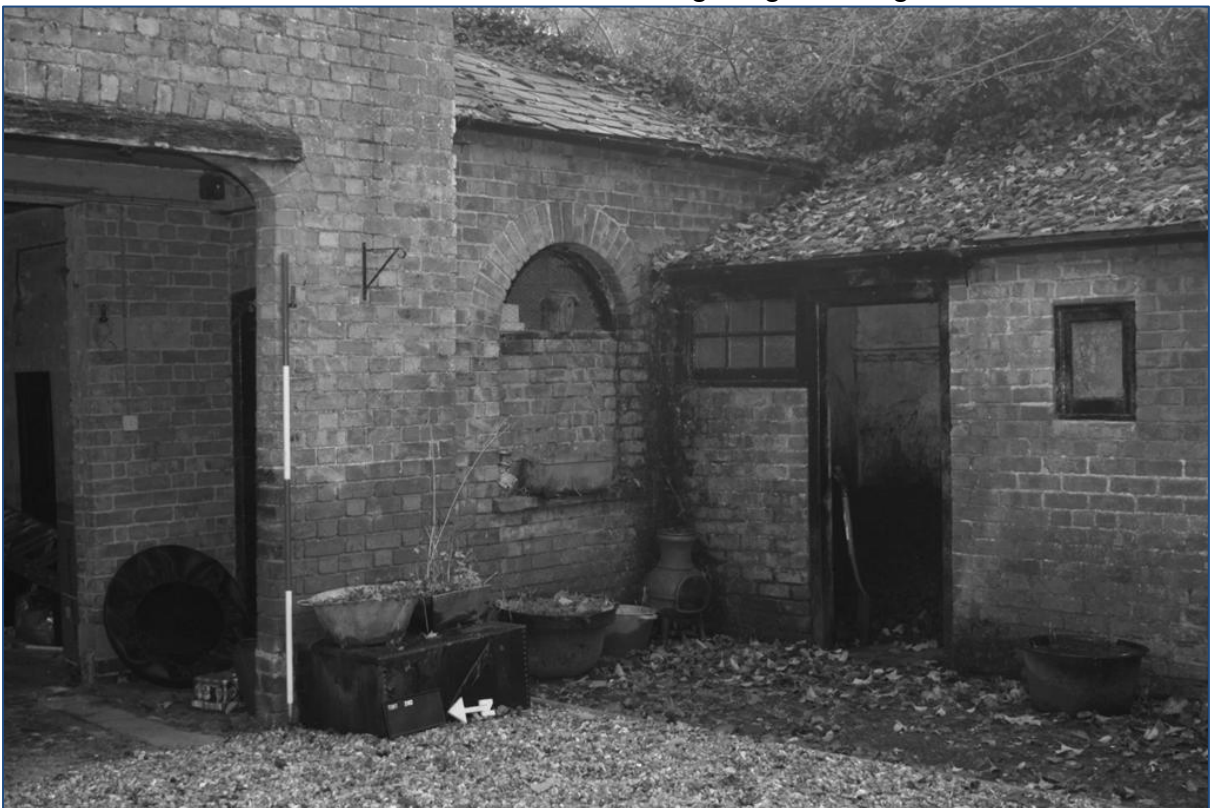
Some later alteration has taken place over the preceding years, most noticeably the interruption of the south-west corner of Stable Area 2 with the addition of a later range of buildings east-west, this has obscured one of the Lunette windows, the remaining window being partially blocked, whilst Stable Area 1 has undergone much alteration, noticeably that of a modern garage opening to the west elevation and a lean-to structure to its north. Across the top of the segmented brick arch of the central double-span entrance a heavy timber lintel has been let in, probably to strengthen this area for the addition of a pair of exterior double doors which once hung here, although all that remains now are the remains of their iron hinge pins located in the jambs of this opening (figs. 2, 9, plates 1, 2, 3, 4, 5, 6, 7, 8, 9).

Plate 3: West elevation of the coachhouse building range adjoining east-west building range looking south-east.

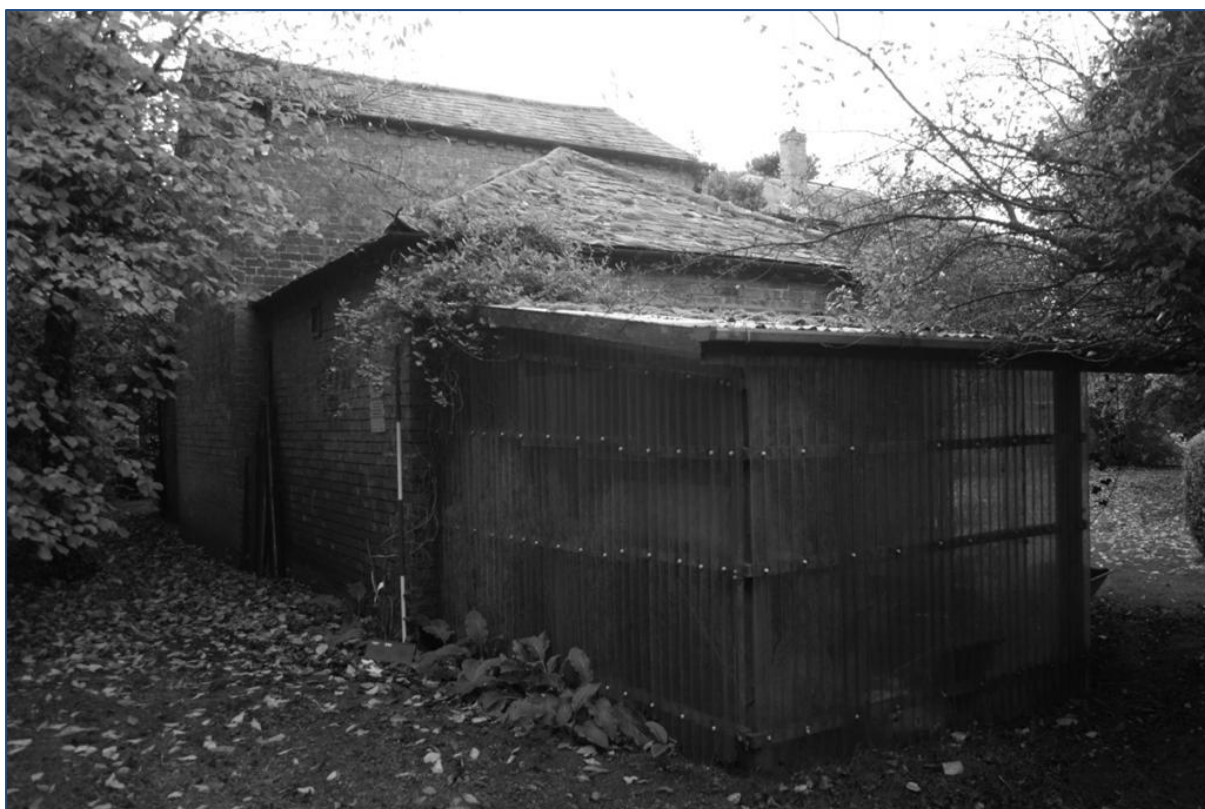
Plate 4: North elevation of the coachhouse building range looking south-west.

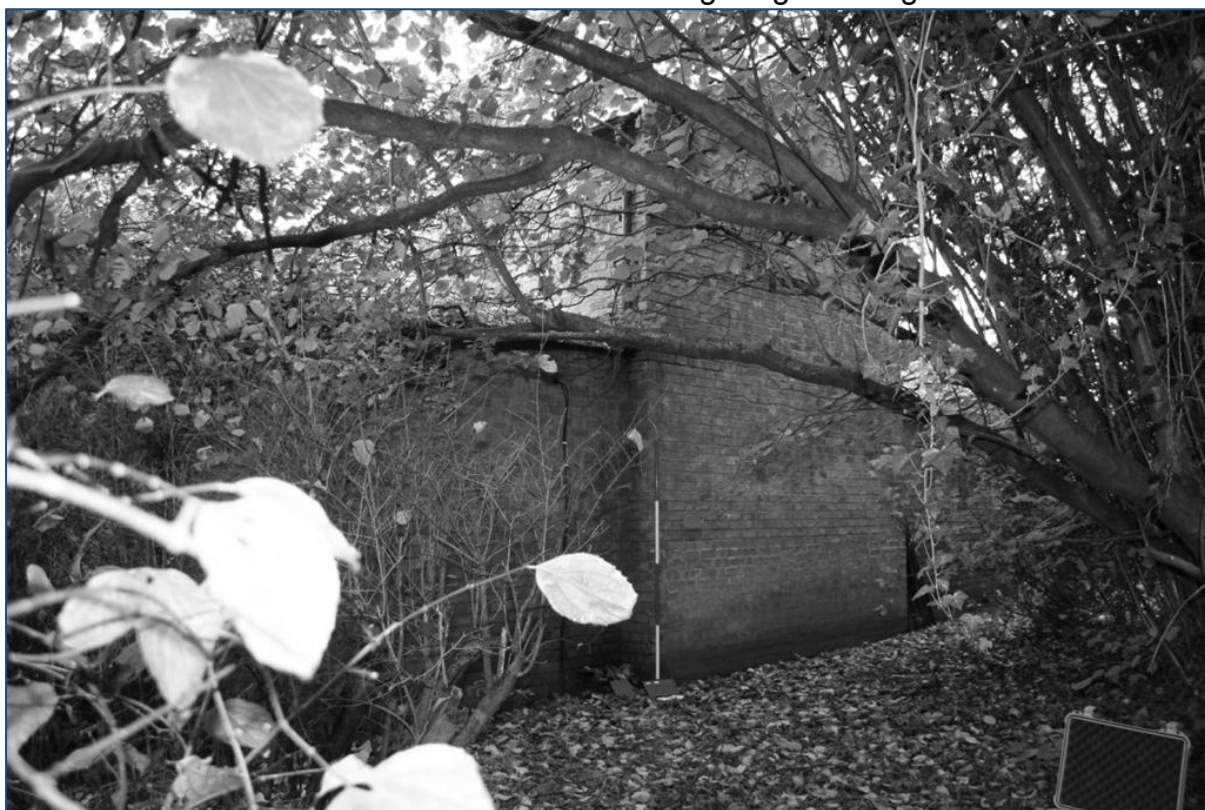
Plate 5: East elevation of the coachhouse building range looking north-west.

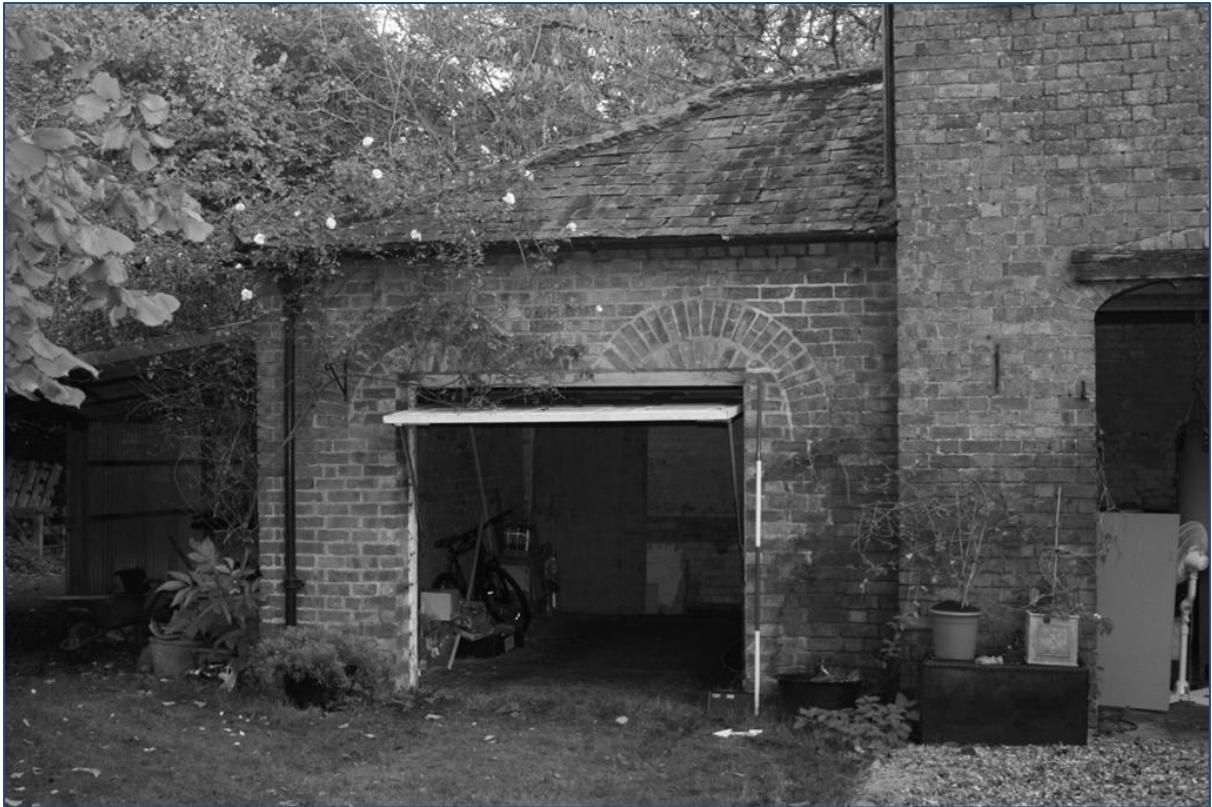
Plate 6: West elevation of Stable Area1 looking north-east.

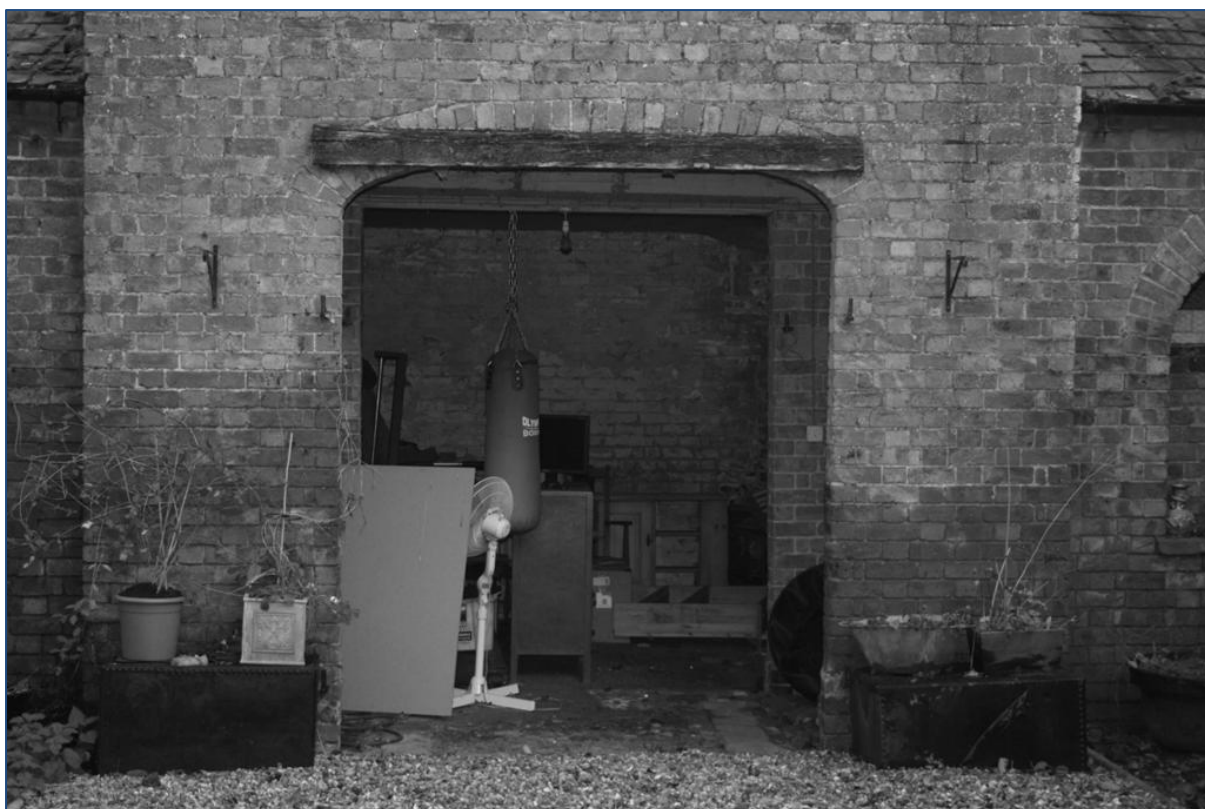
Plate 8: Entrance to coachhouse looking east.

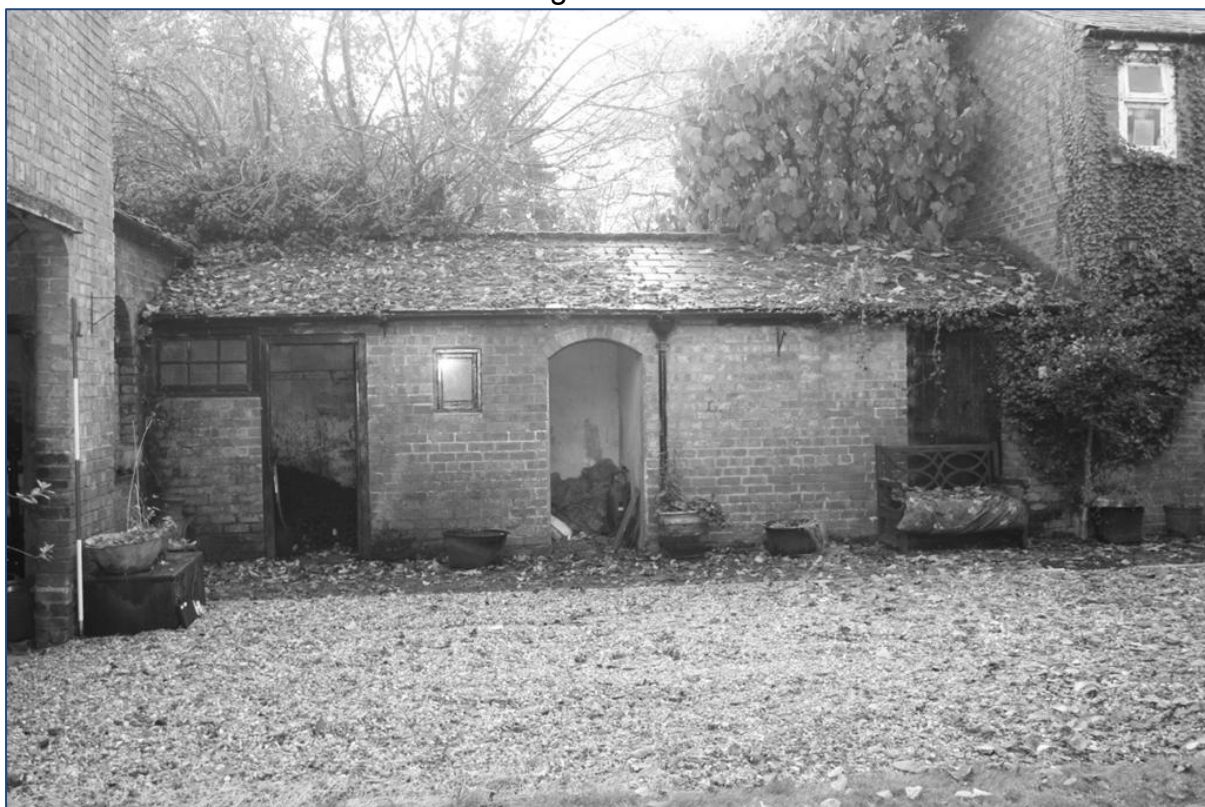
Plate 9: Store building connecting coachhouse building range to the Old Rectory looking south.

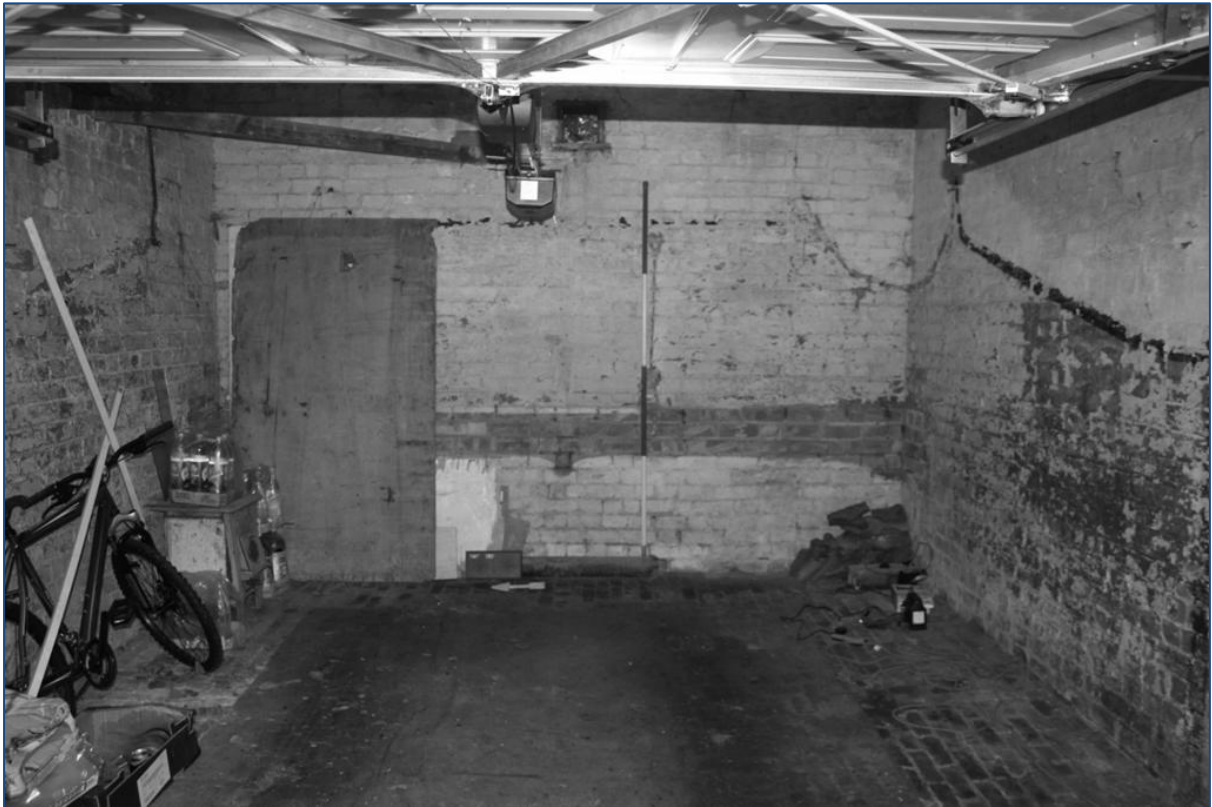
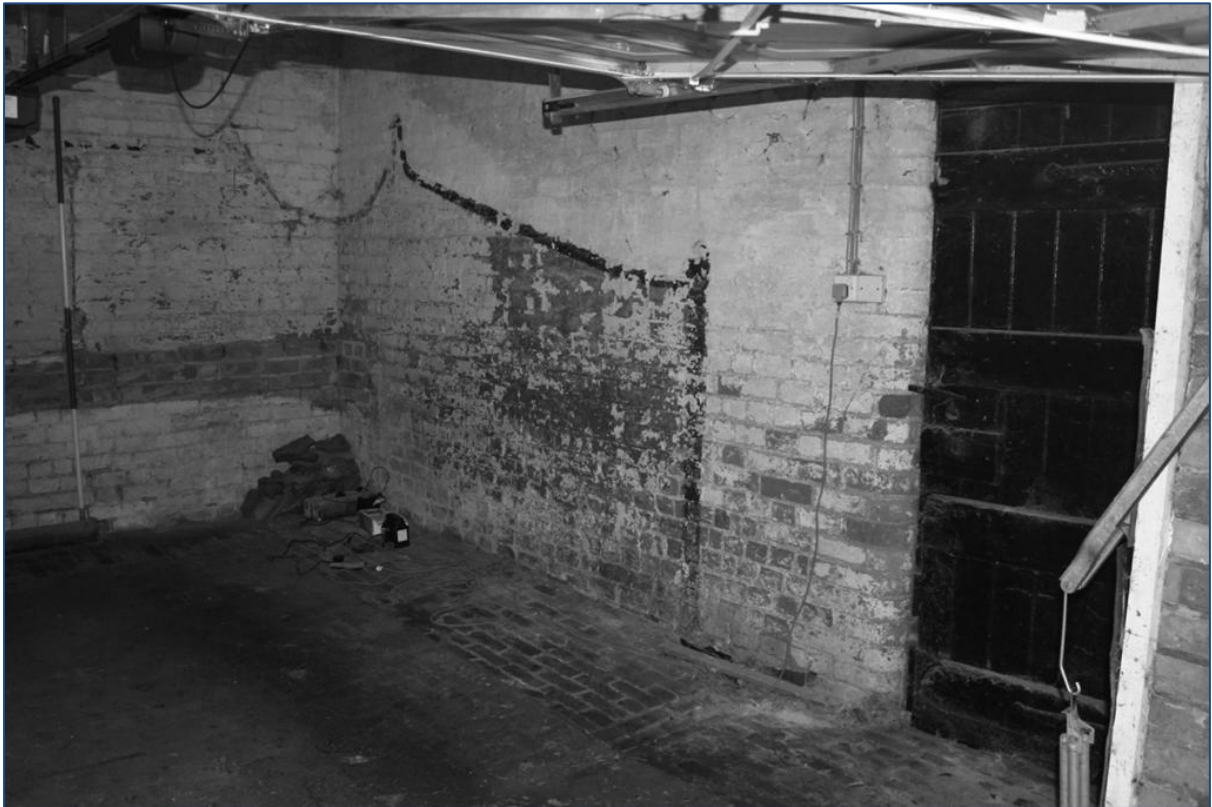
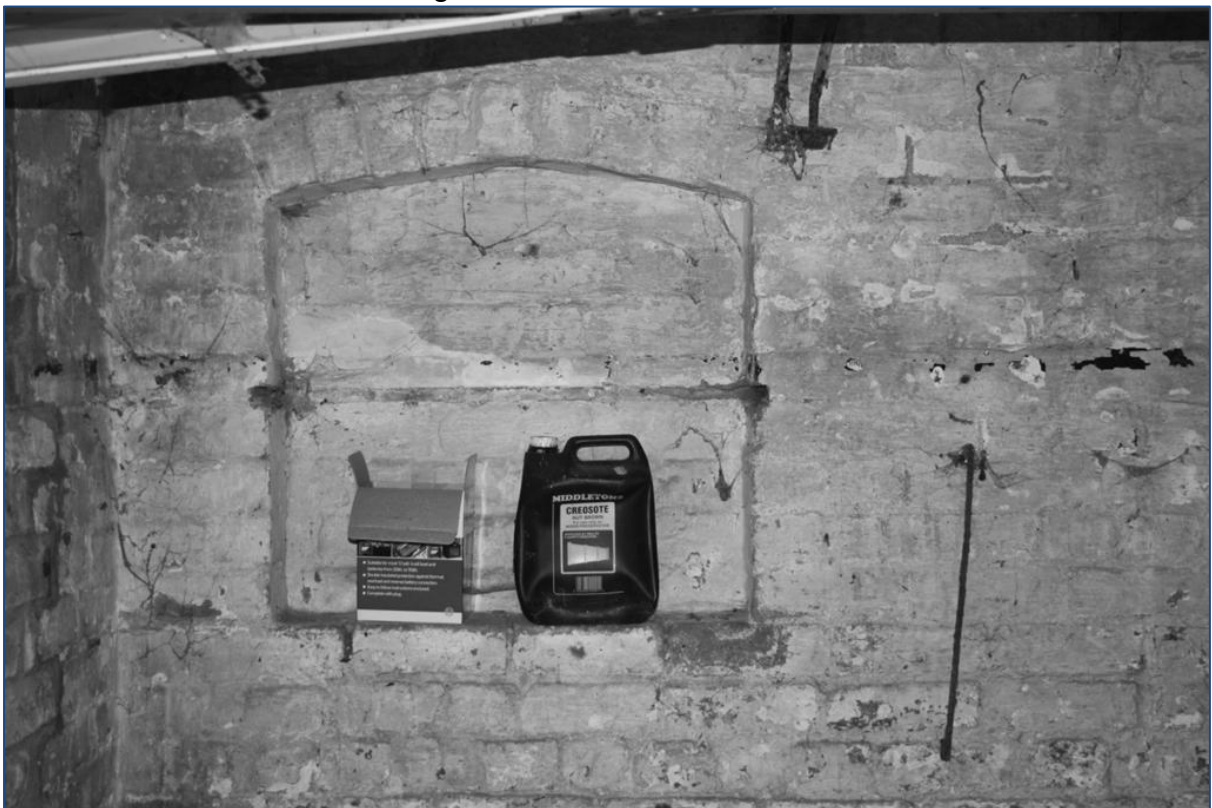
The stable is rectangular in plan with a floor of (22cm x 6.5cm) red brick incorporating drainage channels. The walls are in the same brick and bonding pattern as the coachouse and are also painted white, while there is evidence in the paint of the former timber stalling of this room. The ceiling is of modern plasterboard. Recessed into the north wall of the room is a shallow recess or 'keep-hole', this is opposite the entrance leading to the porch area and which is of 'Bullnose' brick jambs set with a heavy timber frame and segmented brick arch above and hung with a wooden planked and ledged door with traditional style iron strap hinges and large mortise type lock. To the west is a modern double-span opening facilitating an up and over style metal garage door (figs. 2, 9, plates 10, 11, 12, 13).

Plate 10: Stable Area1 looking east.

Plate 11: Stable Area1 looking north-east.

Plate 12: Stable Area 1 looking south-east.

Plate 13: Niche-hole in Stable Area1 looking north.

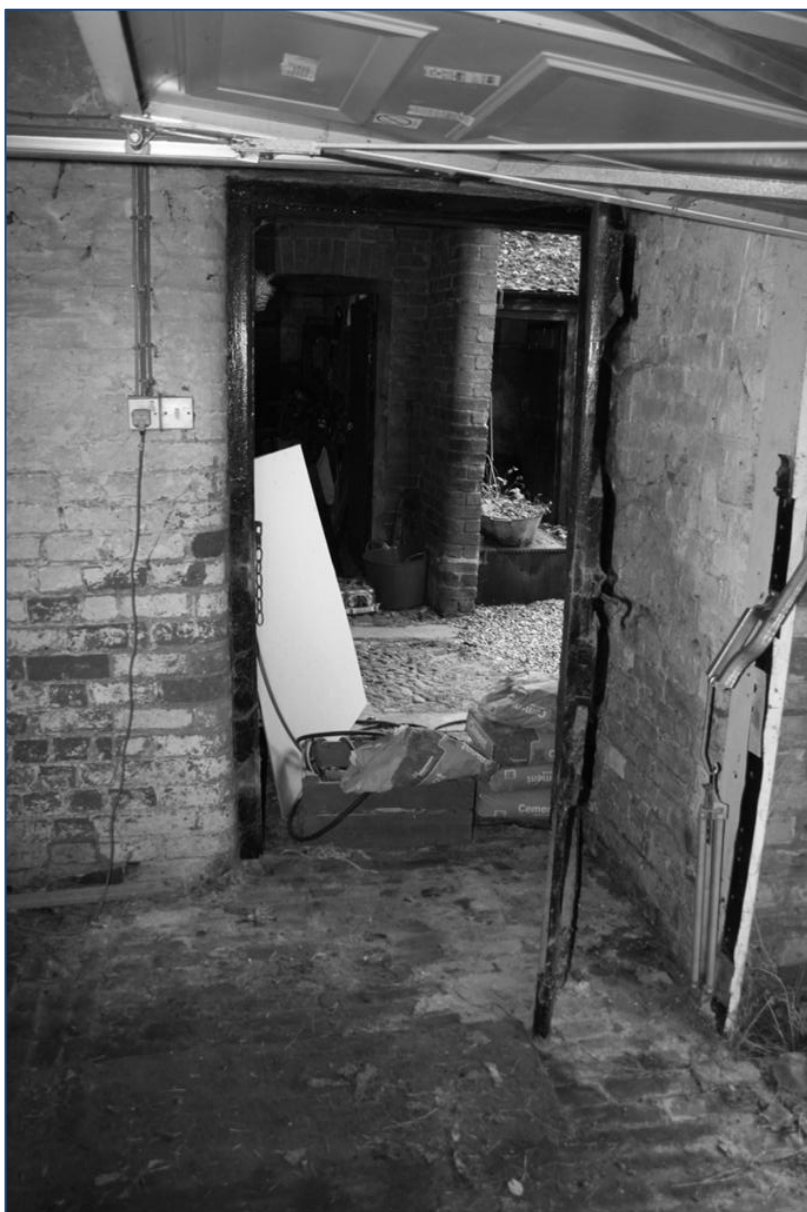
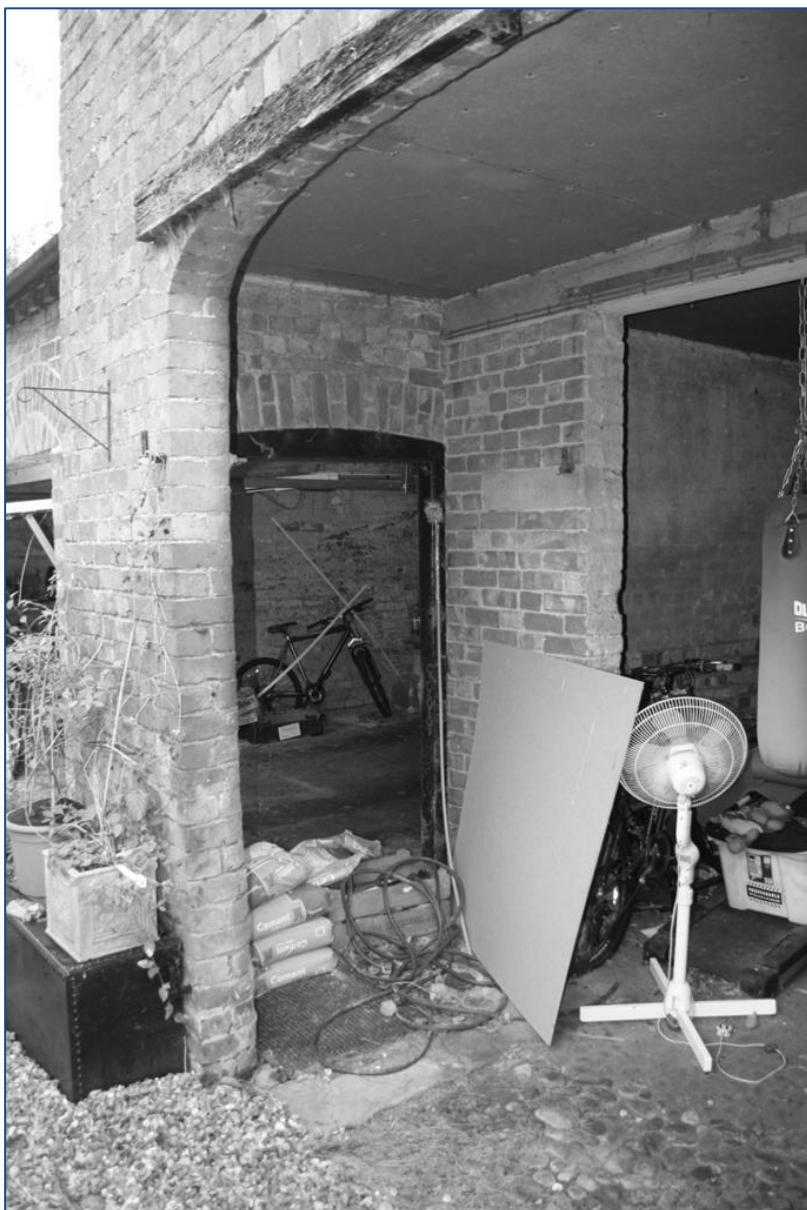
The porch area is rectangular in plan and accessed from the outside by a double-span entrance which also leads to each of the stable areas. The floor is of random cobbles, while there is evidence of the former cart track runs which run east-west; the ceiling is of modern plasterboard whilst the walls are unpainted. The jambs of the opening have Bullnose detailing to them (figs. 2, 9, plates 15, 16, 19).

Plate 14: Stable Area 1 leading to porch looking south.

Plate 15: Porch leading to Stable Area1 looking north-east.

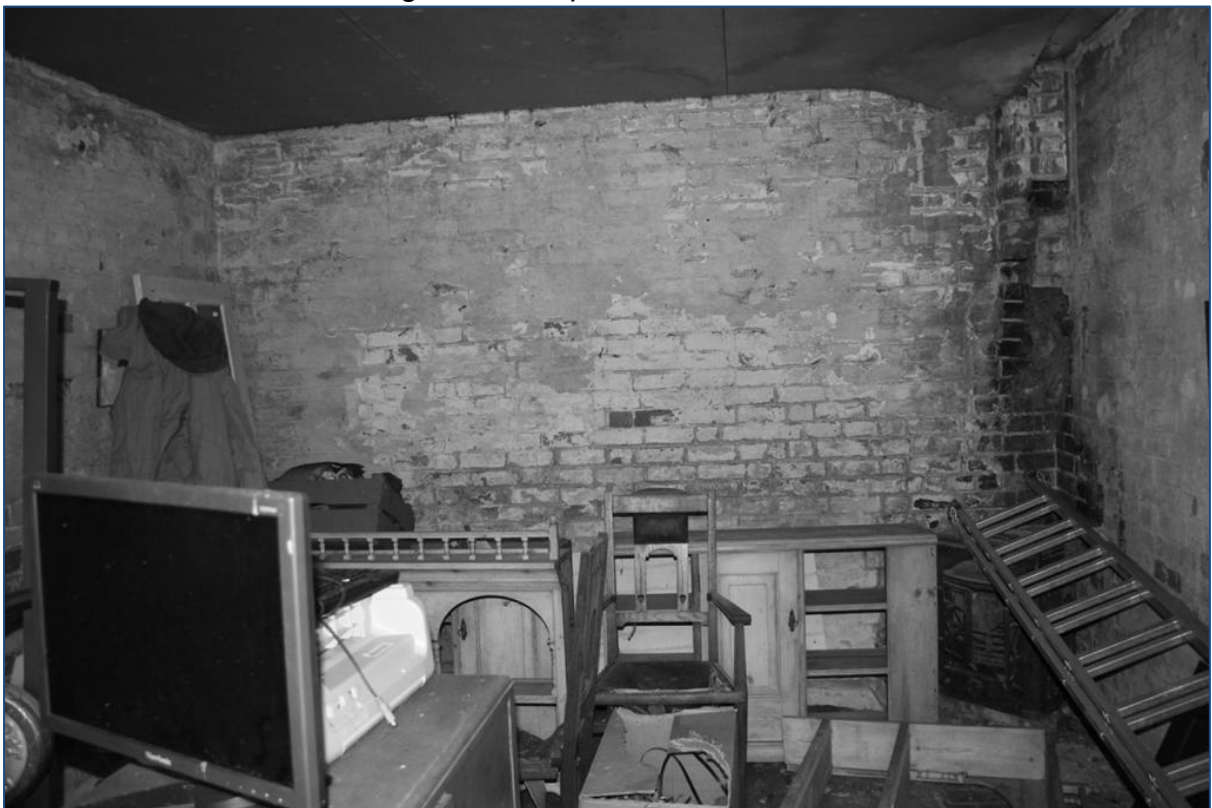
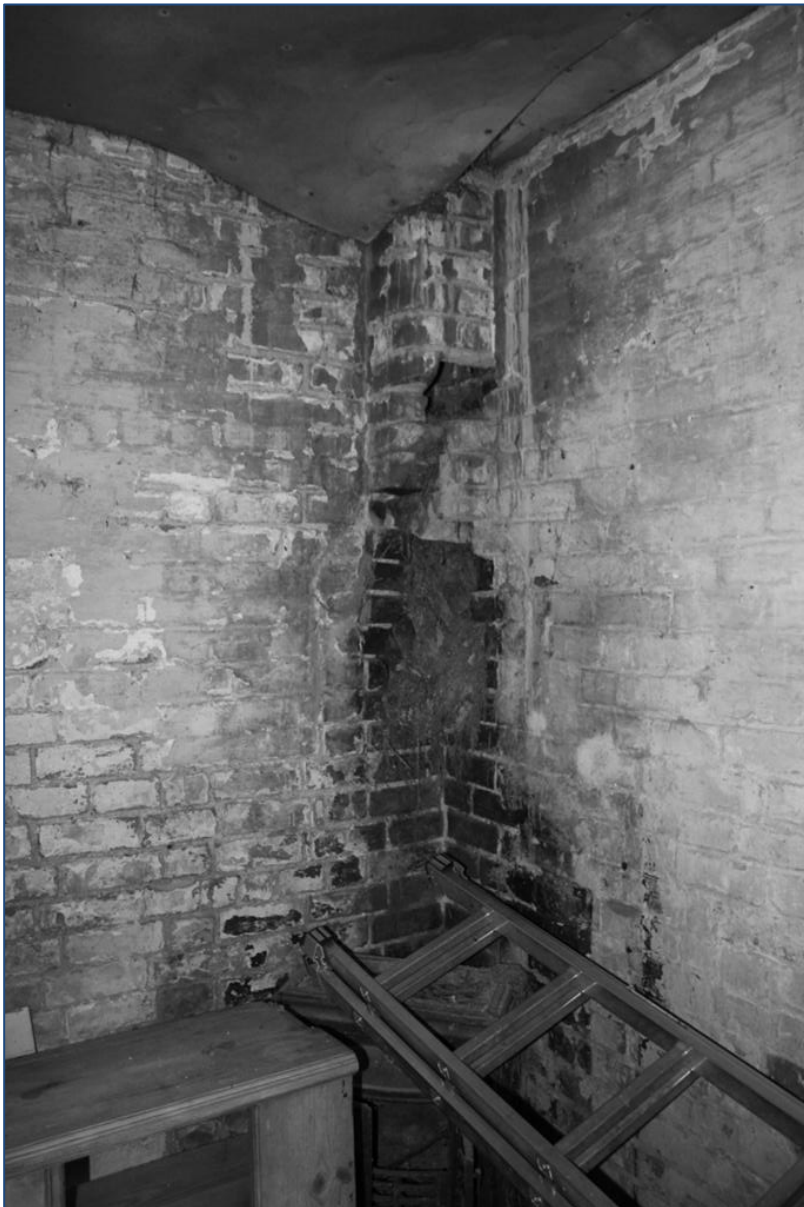
This room is square in plan with a floor of (22cm x 6.5cm) red brick and accessed from the porch area via a double-span opening supported by a heavy timber beam. This opening has the remains of iron pivots for attachment of a pair of doors and which are fixed into stone blocks set within the brick jambs. The ceiling is of modern plasterboard, whilst the walls are (23.00cm x 11.00cm x 7.00cm) brick in English Bond and painted white. Located within the south-east corner is a small flue, partially collapsed and presumably once heating a copper. Access to the over loft is gained via a narrow rectangular opening within the south-west corner of the ceiling (figs. 2, 9, plates 16, 17, 18, 19).

Plate 16: Coachhouse looking east from porch.

Plate 17: Coachhouse looking east.

Plate 18: Flue in coachhouse looking south-east.

Plate 19: Coachhouse porch leading to Stable Area 2 looking south-east.

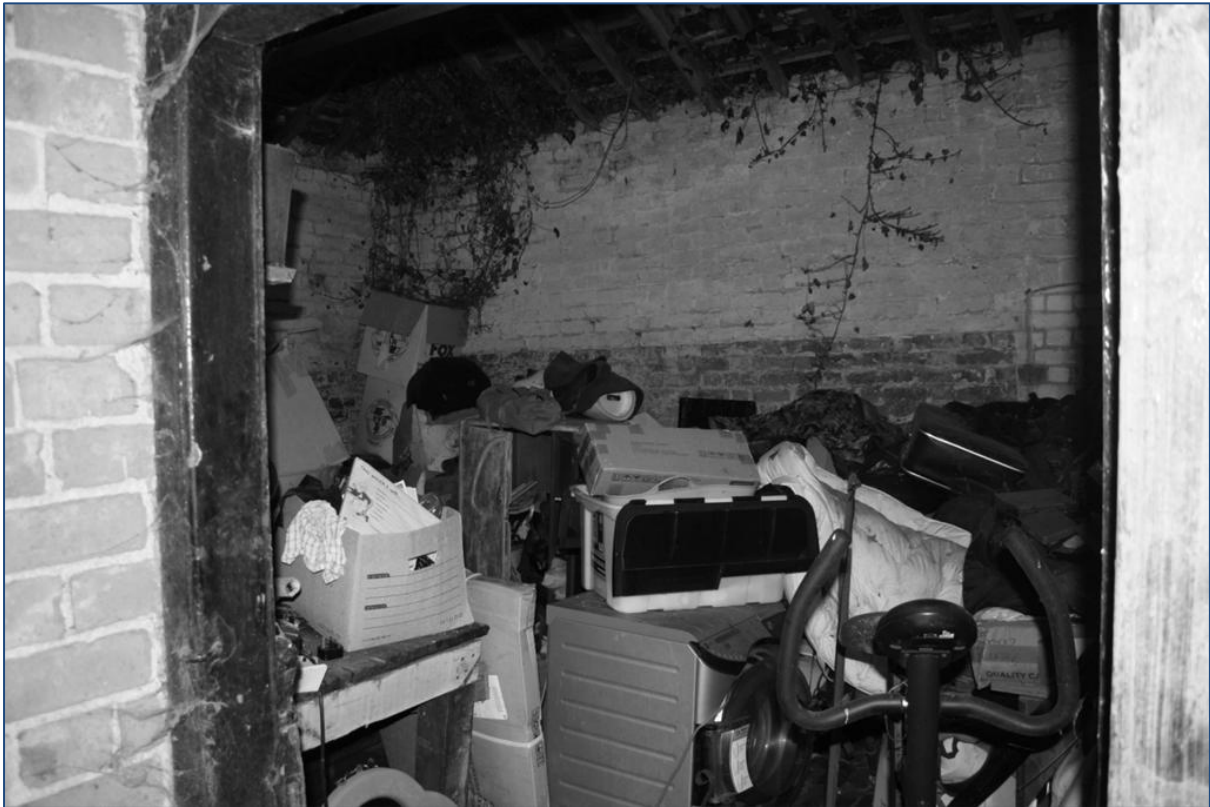
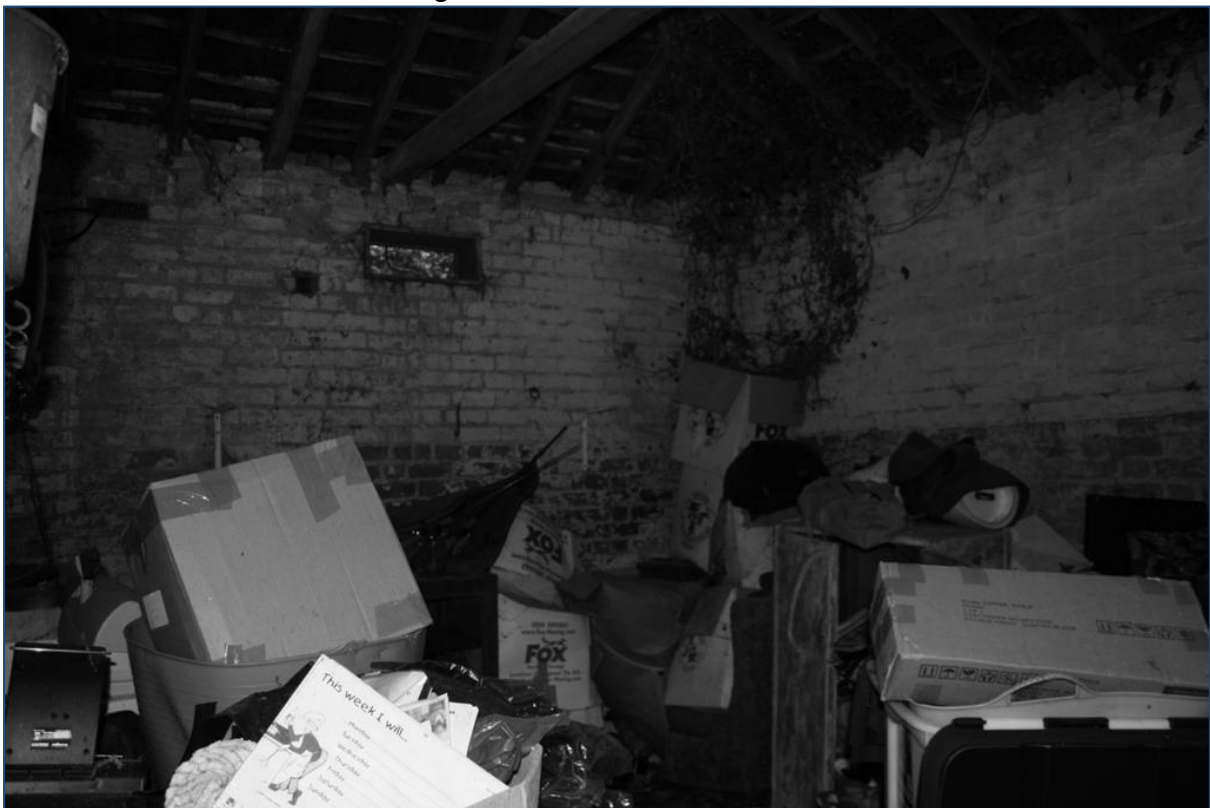
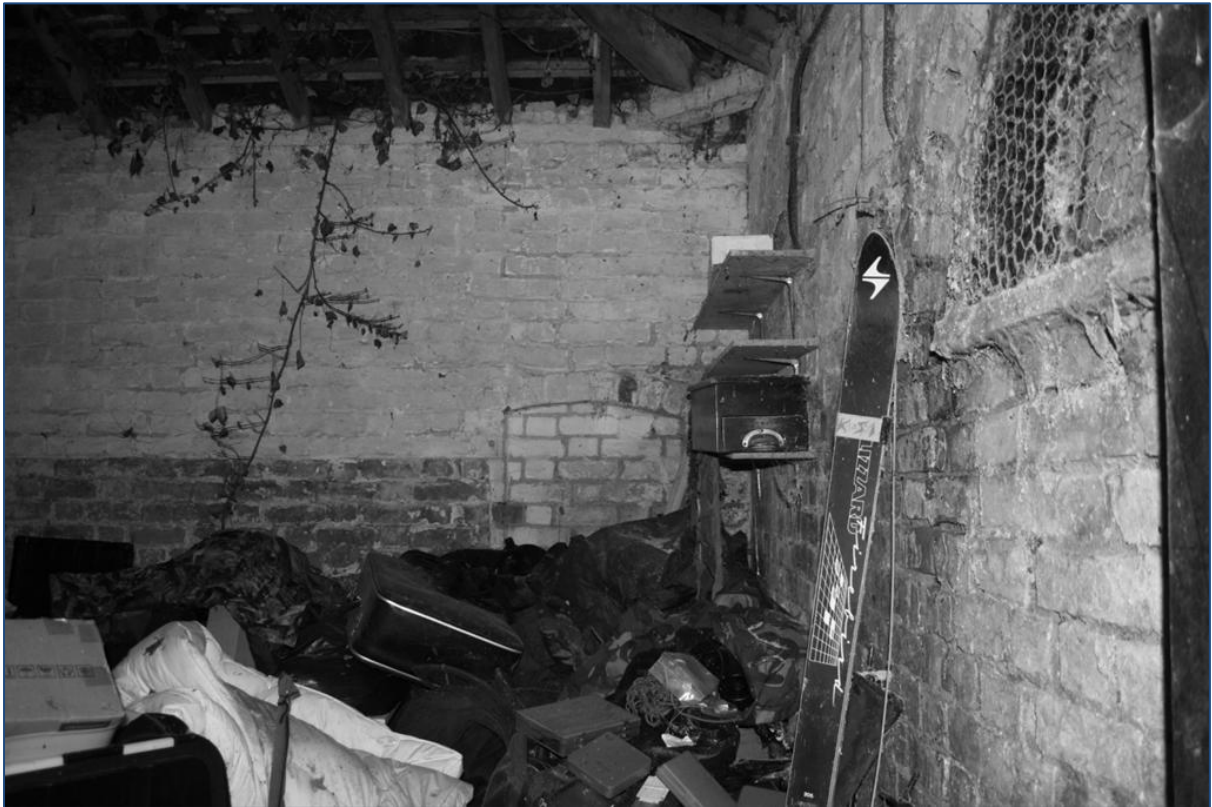
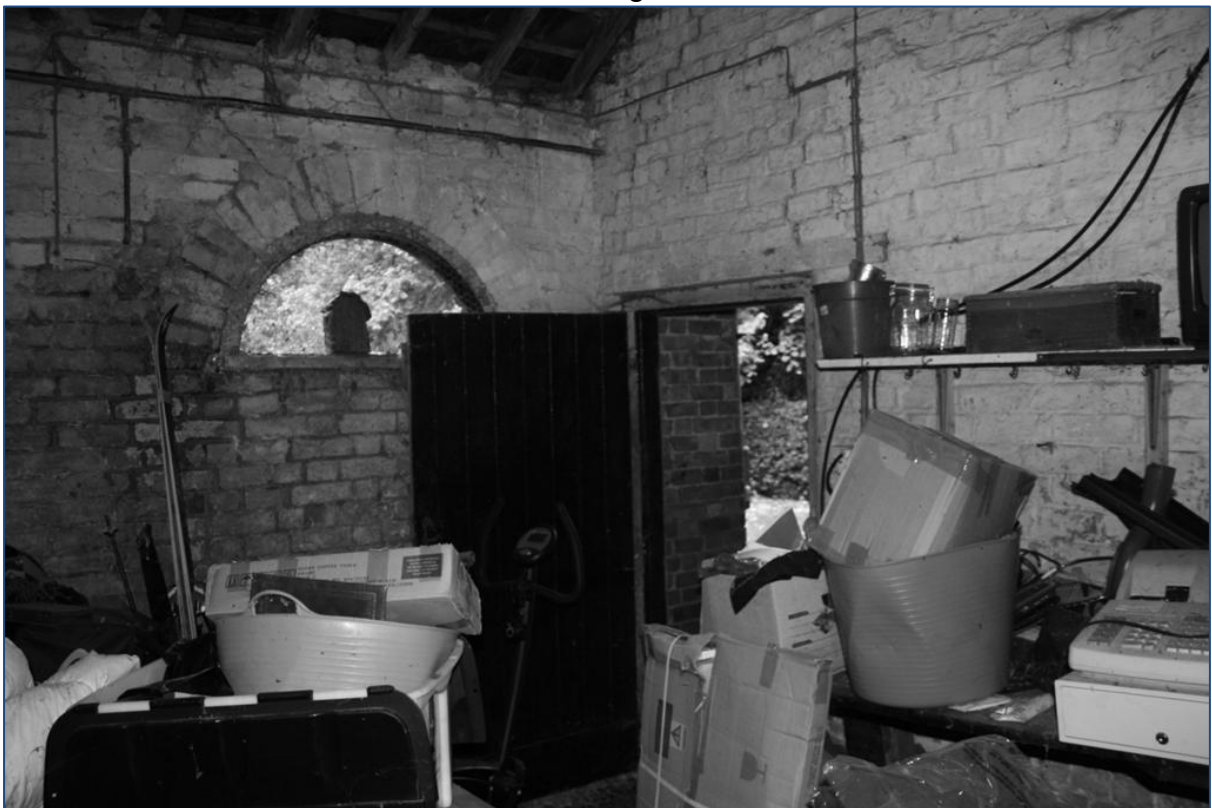
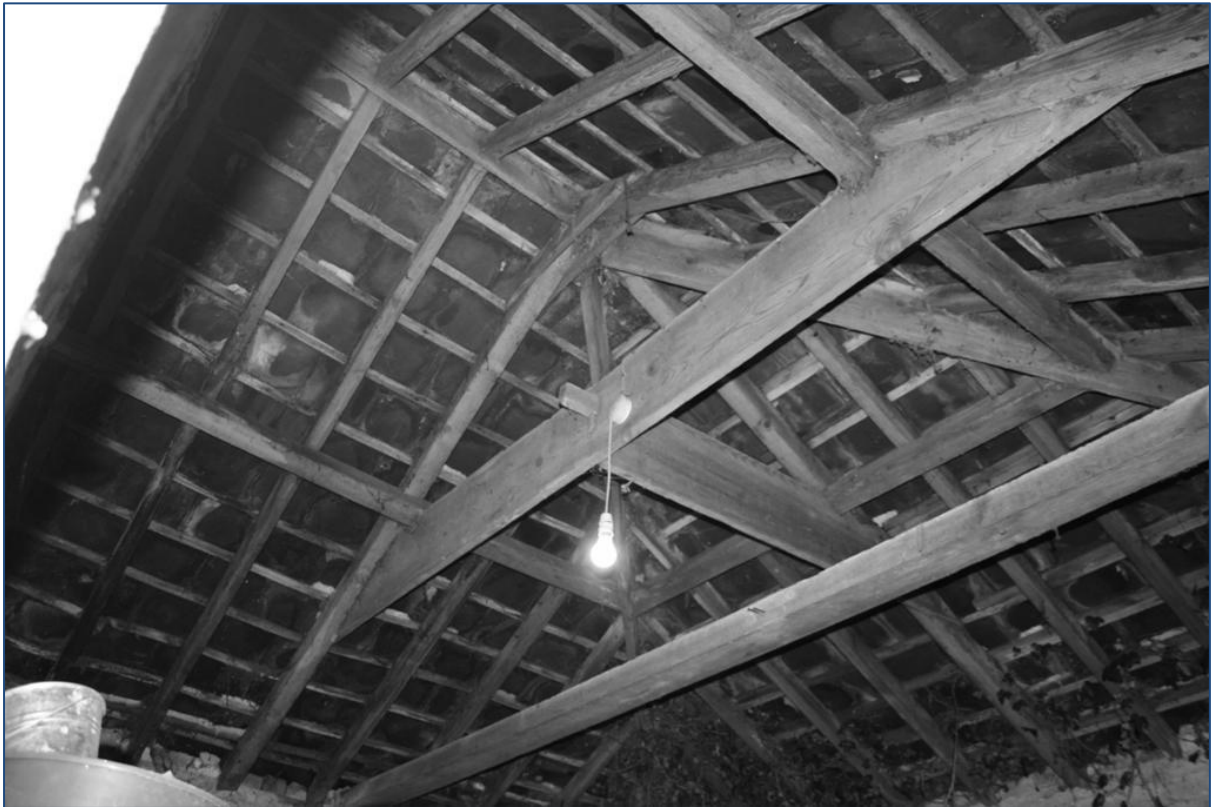
This room mirrors that of Stable Area 1, except for that the floor comprises of random cobbles with some brick patching and also that the ceiling is of exposed

rafters showing a clasped purlin type roof construction (figs. 2, 9, plates 20, 21, 22, 23, 24).

Plate 20: Stable Area 2 looking south-east.

Plate 21: Stable Area 2 looking south-east.

Plate 22: Niche-hole in Stable Area 2 looking south.

Plate 23: Stable Area 2 looking north-west.

Plate 24: Roof timbers in Stable Area 2 looking south-east.
