SCHEME OF ARCHAEOLOGICAL BUILDING RECORDING

THE OLD RECTORY
MAIN ROAD
THIMBLEBY
HORNCastle

SITE CODE: TORT 12
GRID REF: TF 2410 7004
ACCESSION NO: LCNCC 2012.147
PLANNING: S/181/01127/12,
S/181/01128/12

NOVEMBER 2012

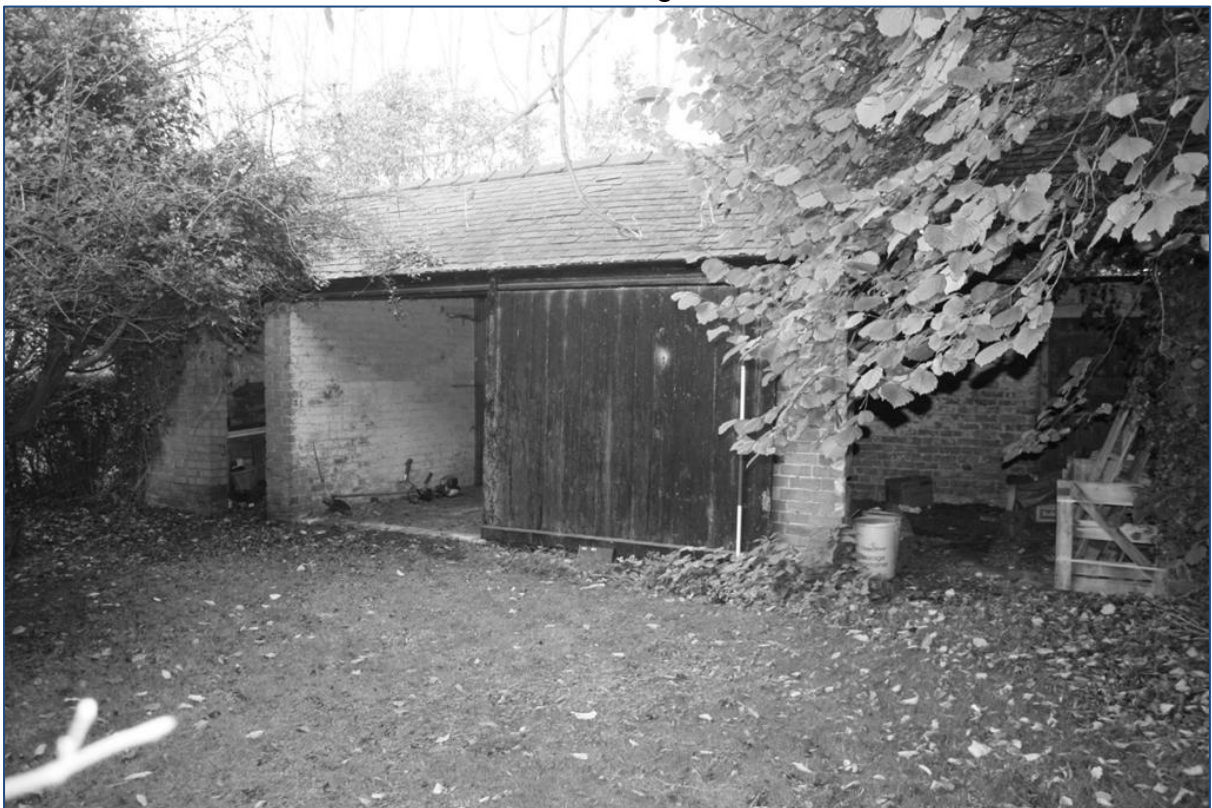
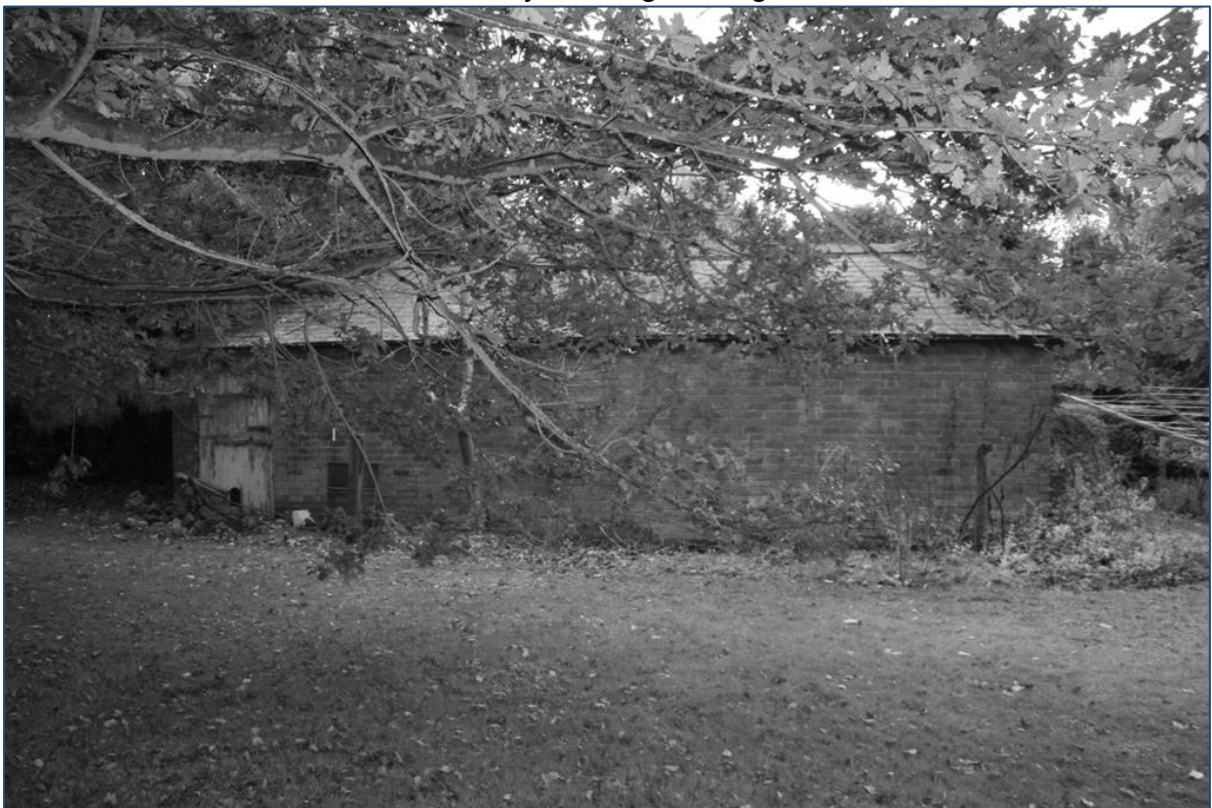
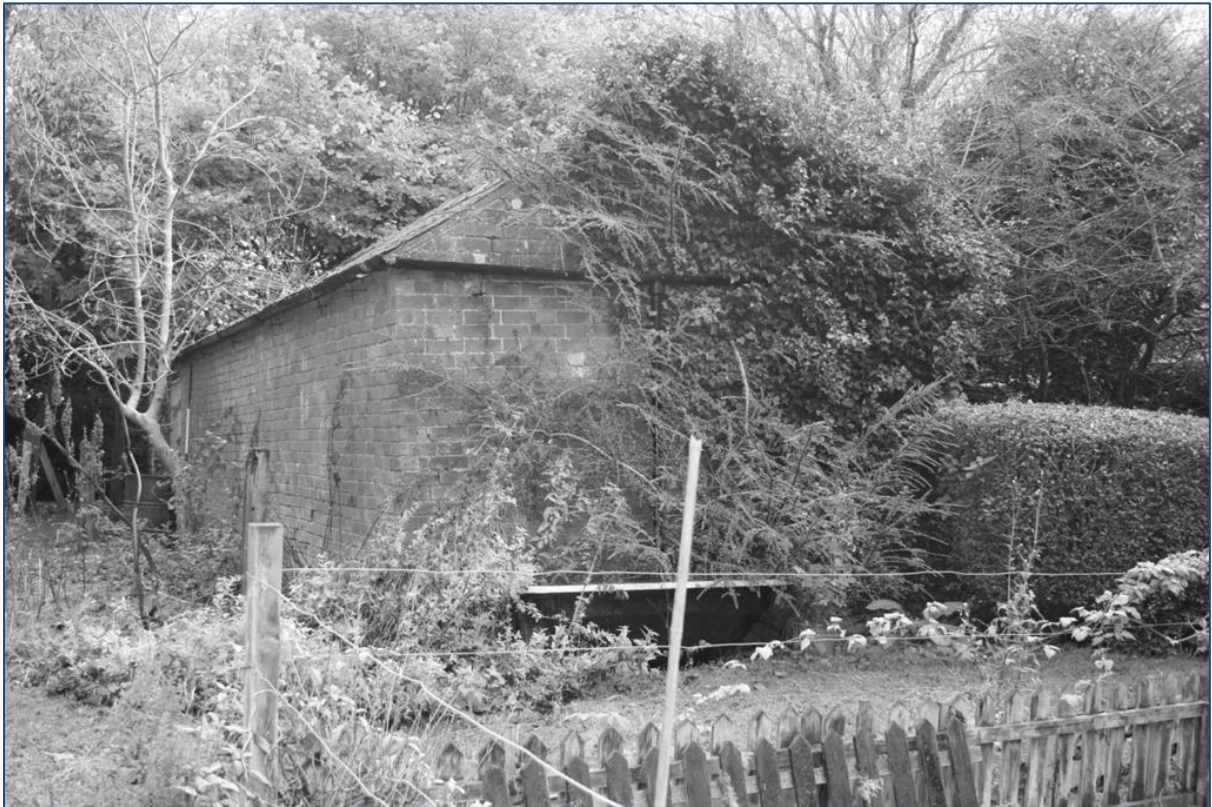
The building is plain in style and built from (23.00cm x 11.00cm x 7.00cm) red brick in a variety of English and Flemish bonding patterns with lime mortar, is rectangular in plan with a gabled roof under slate and lies on an east-west alignment (fig. 2, plate 25).

Plate 25: South elevation of secondary stabling looking north-west.

Plate 26: East elevation of secondary stabling looking west.

Plate 27: North elevation of secondary stabling looking south.

Plate 28: West elevation of secondary stabling looking east.

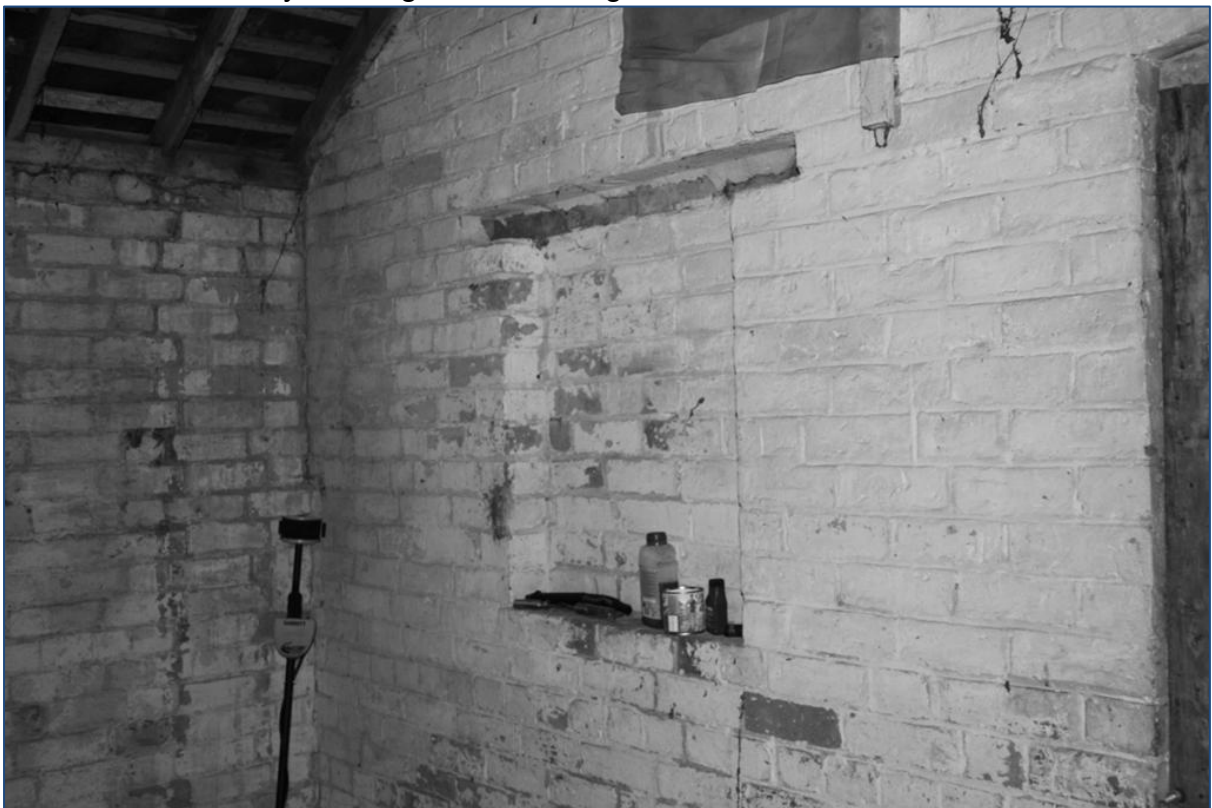
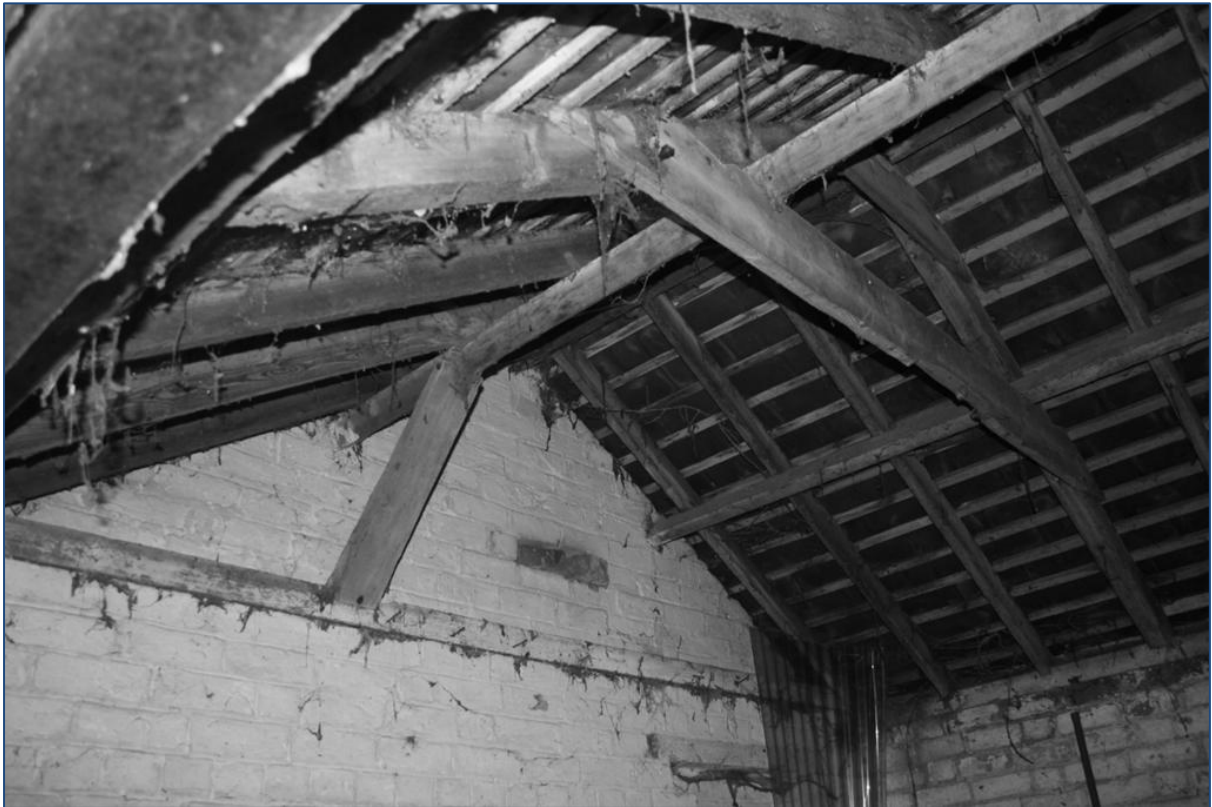
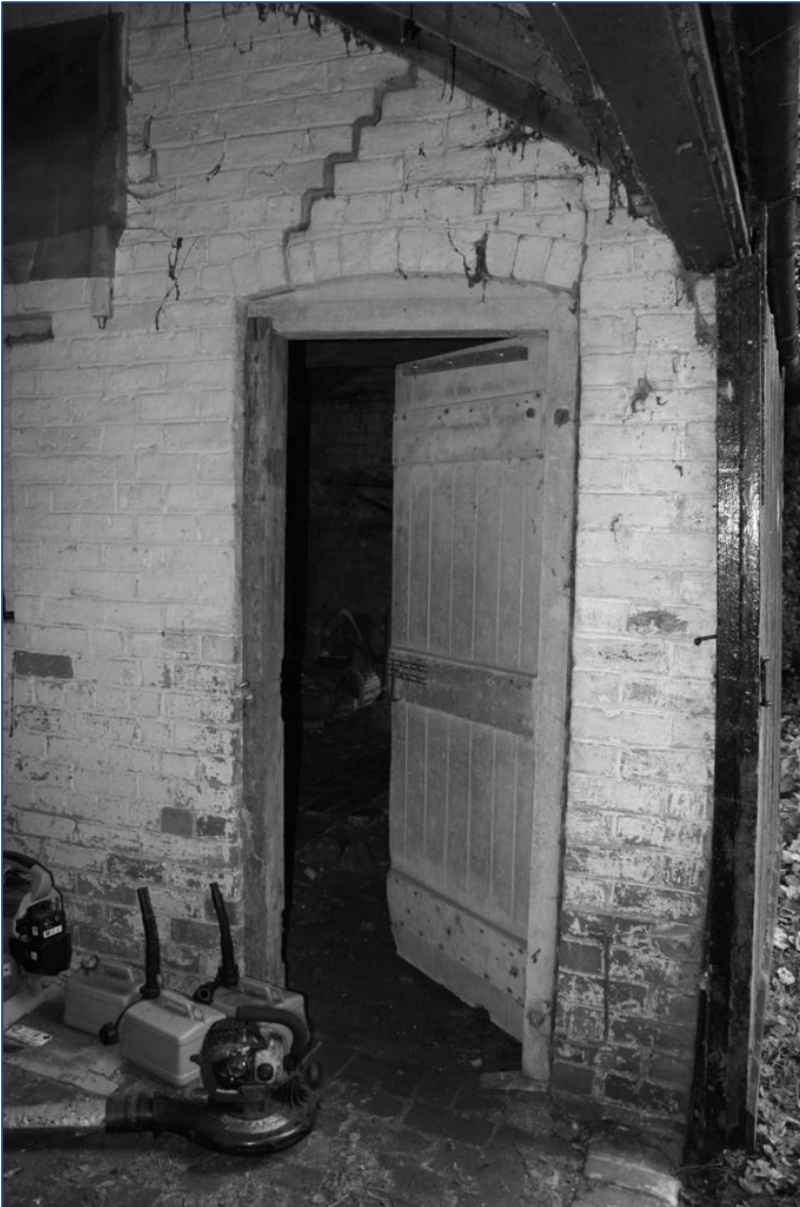
This room is rectangular in plan with the same type brick floor as the previous room. Set within the east wall is a doorway which leads into the adjacent cart store, this is fitted with a heavy wooden frame and segmented brick arch above and is hung with a wooden planked and ledged door on iron strap hinges. Just to the left of the doorway there is a small keep-hole and above this a small rectangular ventilation opening, the exposed roof timbers form a clasped purlin type roof (figs. 2, 10, plates 30, 31, 32, 33).

Plate 30: Secondary stabling stable looking north.

Plate 31: Secondary stabling stable looking north-east.

Plate 32: Secondary stabling stable roof construction looking north-west.

Plate 33: Secondary stabling connecting door to adjacent cart store looking north-east.

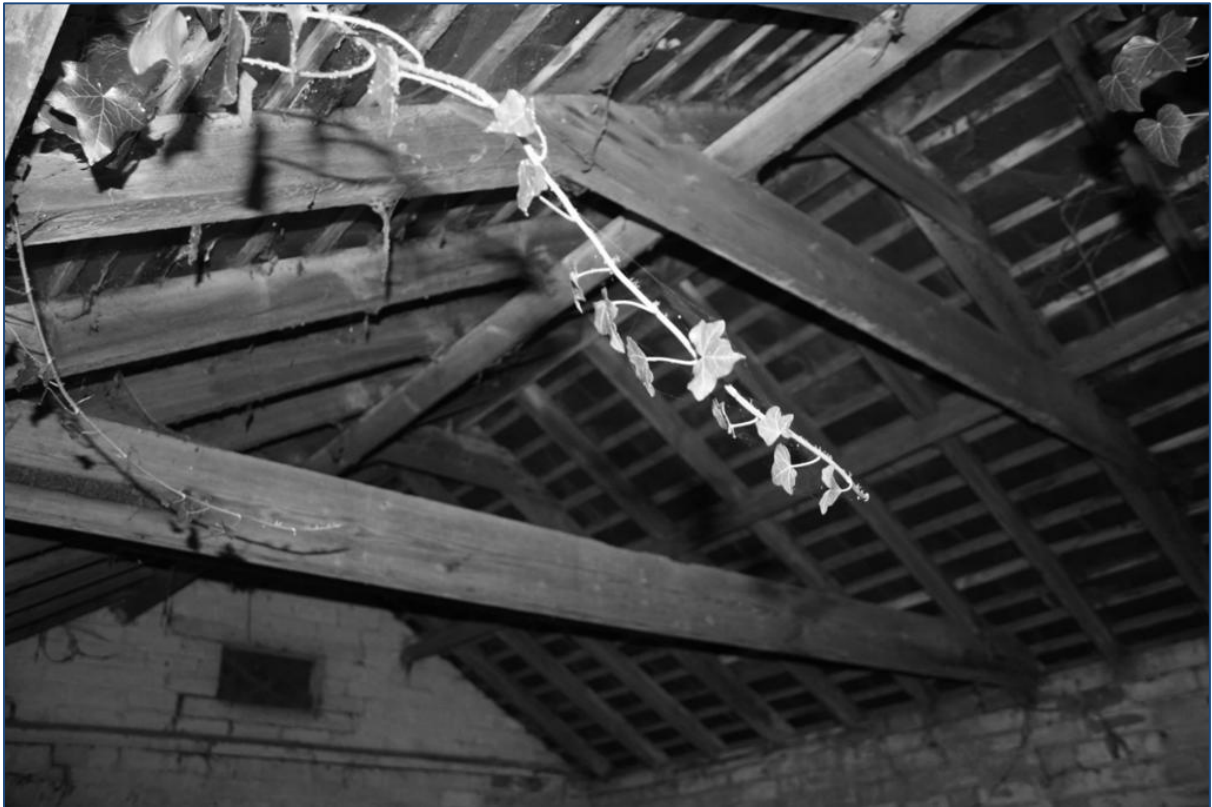
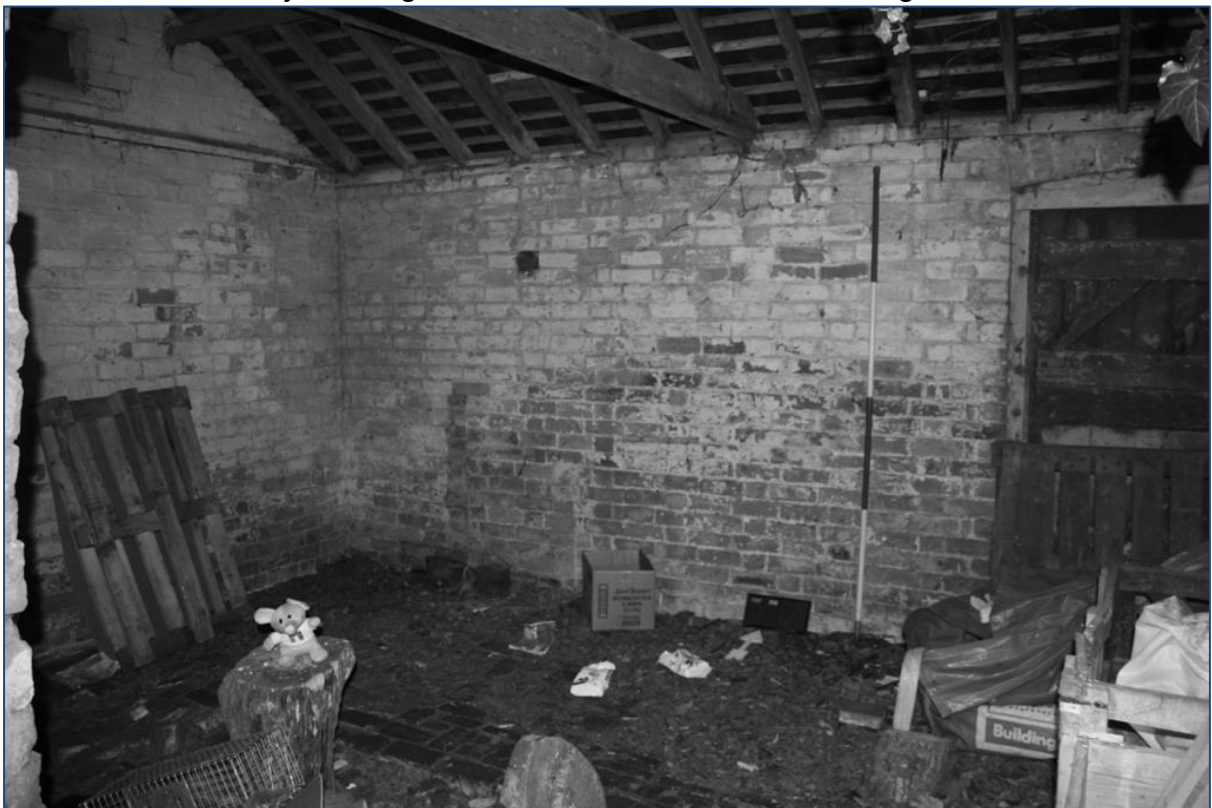
This room is rectangular in plan with a brick floor and clasped purlin type roof. As well the main access to the south there is also a single access doorway located within the north wall of the room and set with a heavy timber frame; segmented brick arch and hung with a wooden stable style planked and ledged door with iron strap hinges (figs. 2, 10, plates 34, 35, 36).

Plate 34: Secondary stabling cart store roof construction looking north-west.

Plate 35: Secondary stabling cart store looking north-west.
