# Archaeological Watching Brief

**Corner Farm  
Sherburn  
North Yorkshire**

**Site:** Corner Farm, Main Street, Sherburn, North Yorkshire

**Development:** Change of use, alteration and extension of former agricultural buildings to form a 6-bedroom holiday let with leisure facilities and formation of car park for visitor use

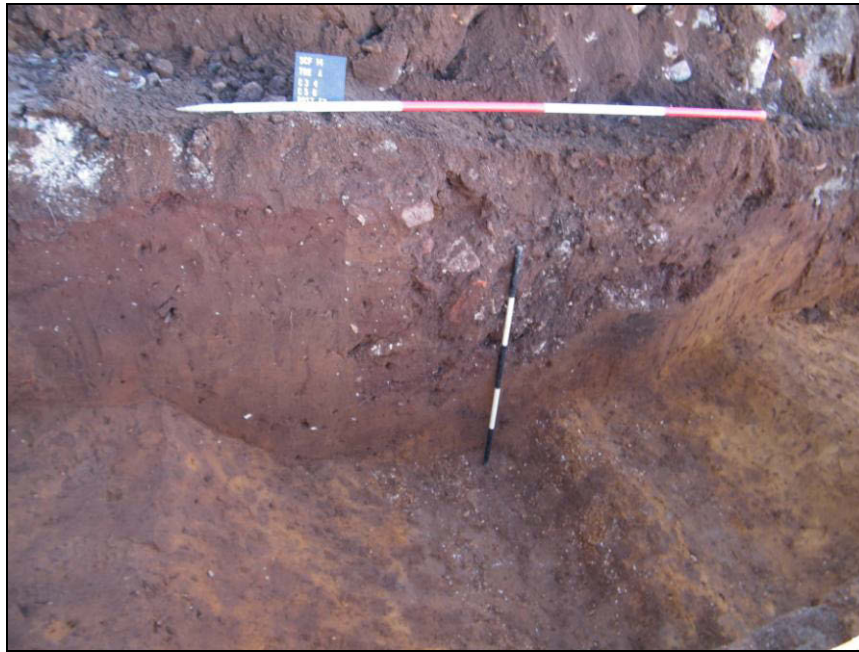
Located towards the northeast side of the west court yard, this feature measuring 1.0m in depth and 1.70m in width, was recognized and recorded from section, having vertical edges, and uneven base. The fill consisting of a brown sandy silty clay deposit, contained sporadic fragments of modern rubble and stones (Figure 4 Figure 5).

This pit (context 2) appeared to cut through all the deposits, modern topsoil, windblown sand and partially impacted on feature 4.

Feature 4 with both edges cutting the natural at about 50° degree angle and a concaved base, appears to be a north to south aligned ditch measuring 1.90m in width and 0.60m in depth, filled by a single deposit (context 3) which consists of an orange brown sandy silt material mixed with small angular and rounded small limestone gravel (Figure 4 Figure 5).

Figure 4: Section showing modern pit (context 2) cutting through feature 4

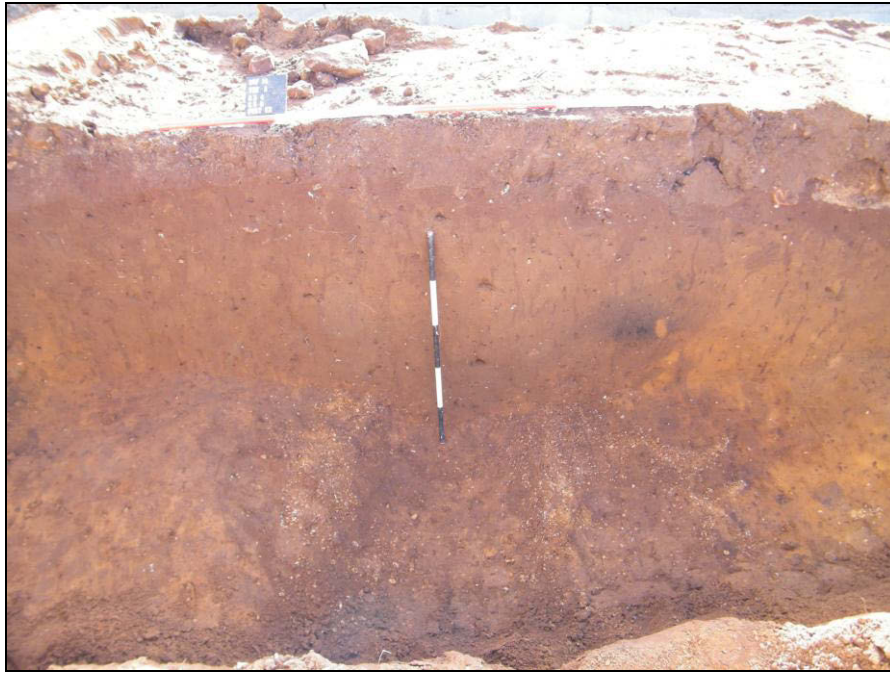
Although in plan Feature 4 was thought to be a single linear structure running on a north to south direction between both the foundation trenches, in section it clearly appeared of a later phase, cutting an earlier linear feature (context 6) set on a similar alignment.

Feature 6, filled by a single brown sandy silt deposit mixed with rounded and angular chalk gravel, measures approximately 1.30m in width and 0.50m in depth. Although the eastern edge of this feature has been truncated by ditch 4, the western edge cuts the natural at about 45° degree angles towards an uneven base.

**Figure 6: Section showing feature 4 and 6**
