48-50 St. Hilda's Street,
Sherburn, North Yorkshire

Archaeological Watching Brief Report

January 2016

Development: A new link building joining two existing structures, to
extend the current surgery facilities.

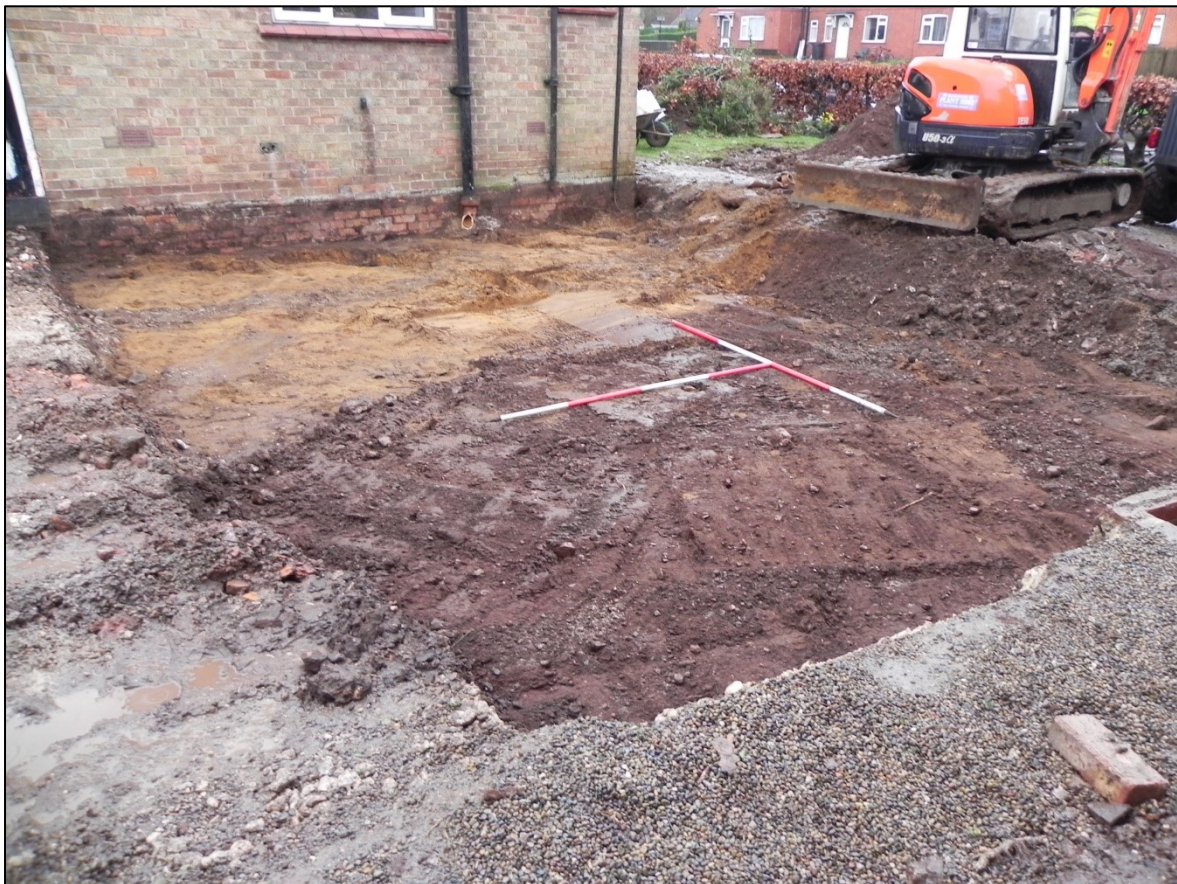
- 5.1 Prior to machine stripping, the area between the two existing buildings (the doctor's surgery and 48 St. Hilda's Street) was characterized by made-up ground. The whole area was initially stripped down to a foundation level, which was on average some 45cm below the current ground surface. This was done in three stages due to the size of the machine, with a back-acting ditching bucket being used. Natural comprised a yellow sand, and was only reached in the southern half of the site. In the north, the foundation level did not go beneath the made-up ground (see Figure 5).

Figure 5: the site after the initial strip down to foundation level

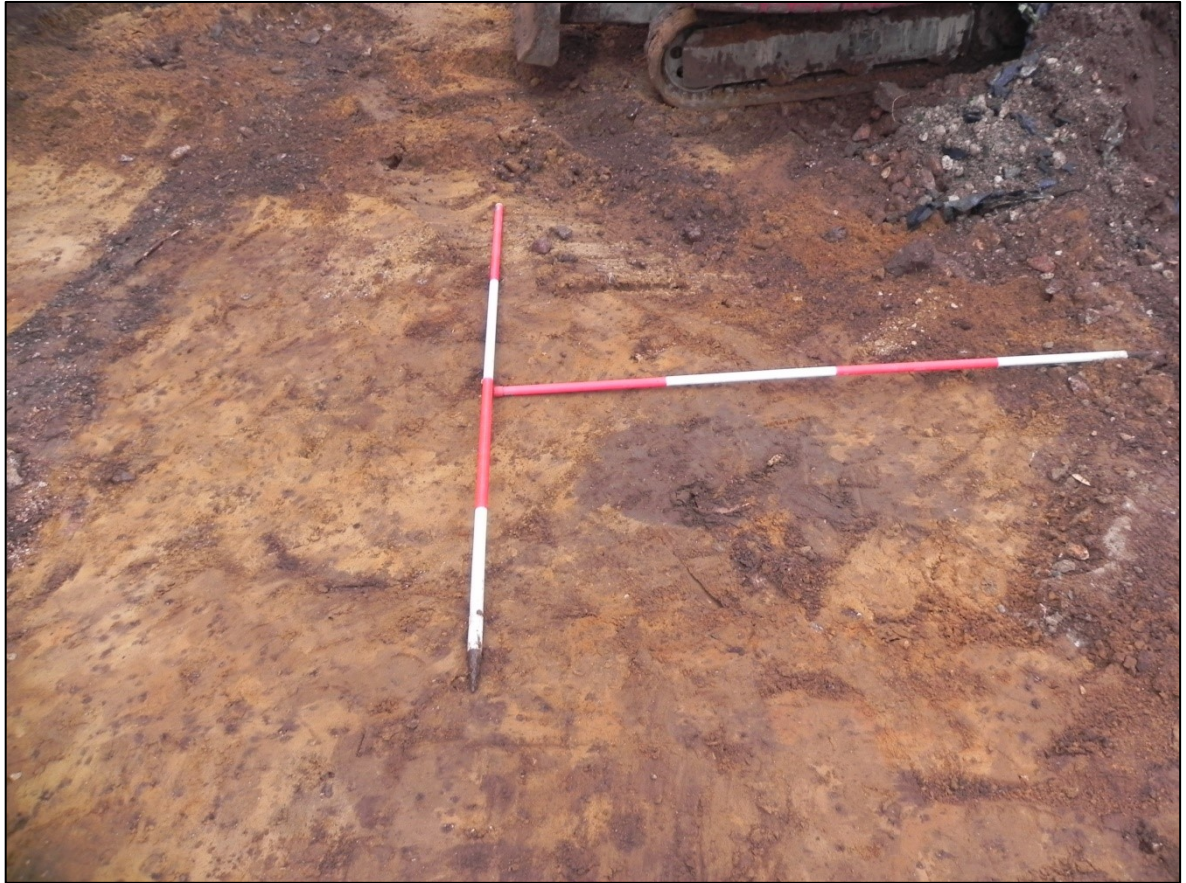
6.0.1 The only feature of an archaeological origin was initially seen during the stripping of the topsoil down to the foundation level. It was a small pit, the upper part of which had been destroyed when one of the services pipes had been laid (see Figure 7, which also shows another services trench to the south).

Figure 7: pre-excavation view of the pit looking west

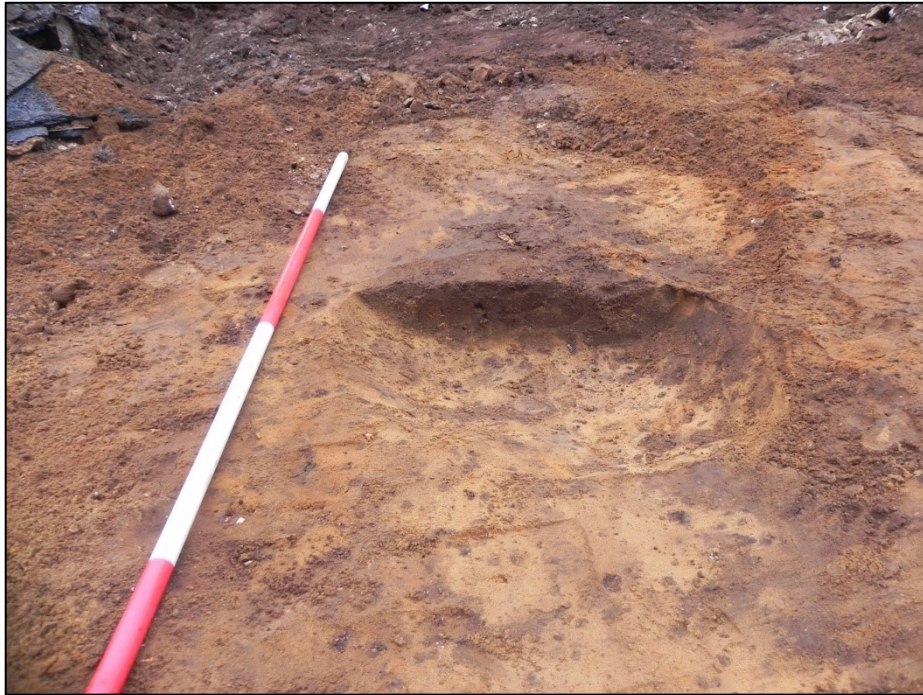
6.1.1 It soon became clear that all that remained of the pit was the truncated remains of the base (see Figure 10 for photograph and Figure 9 for section drawing), as the upper part of the feature had been completely destroyed when the drainage pipes from 48 St. Hilda's Street were installed.

Figure 10: half-section of pit context 4 taken from the south

| Context | Area | Type | Shape | Profile | Length | Width | Depth | Notes |
|---|---|---|---|---|---|---|---|--|
| 4 | A | Pit cut | Ovate | Bowl-shaped | 89 | 58 | 11 | Truncated remains of a small pit. Cut into natural yellow sand with a regular profile. |

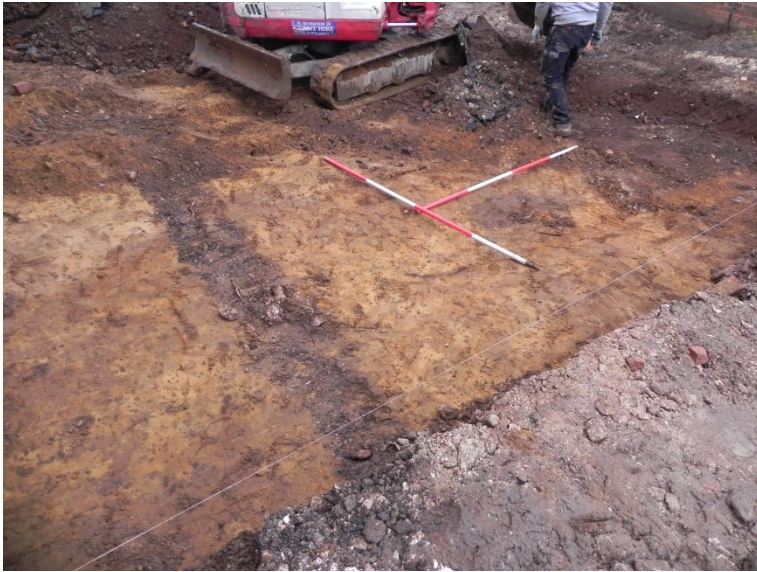
Photo 1: showing service trench from the south-west

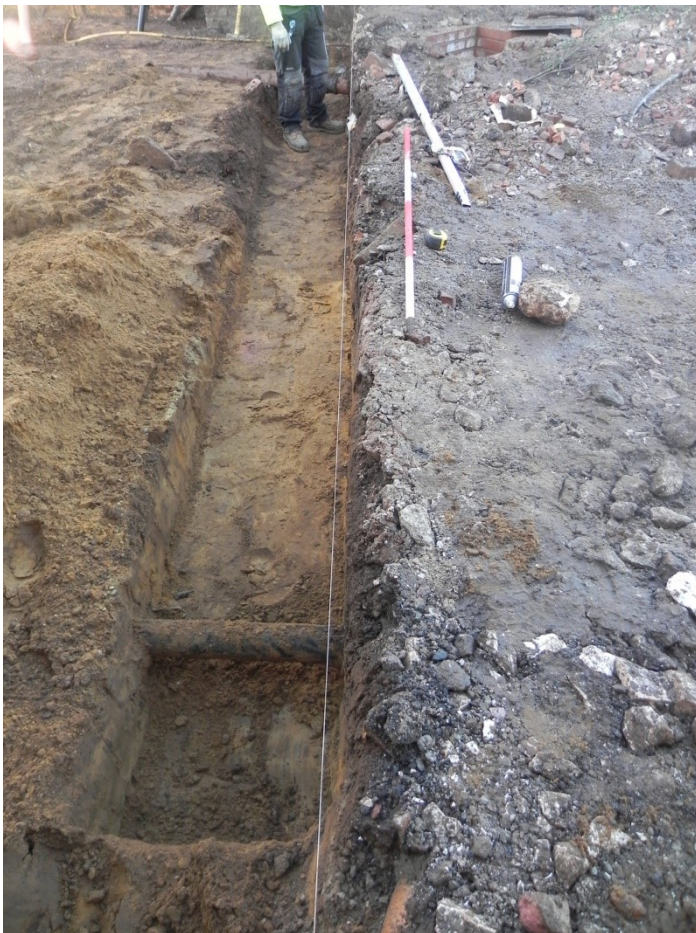
Photo 2: more services- view from south-east

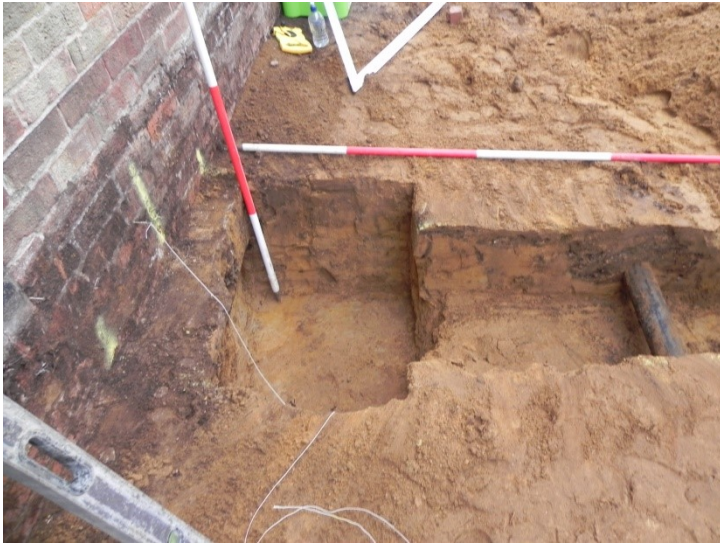
Photo 3: south-western corner of foundation trenches

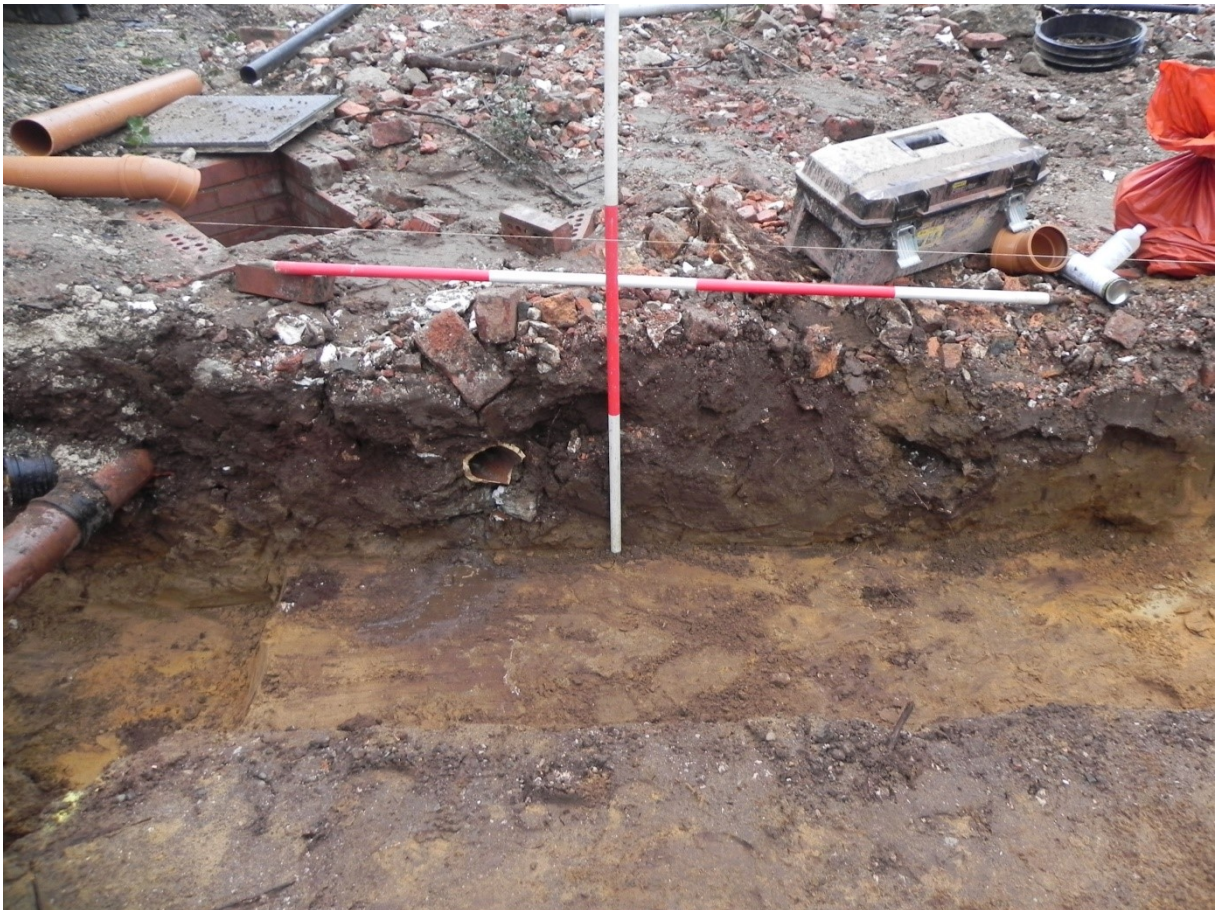
| Context | Area | Type | Shape | Profile | Length | Width | Depth | Notes |
|---|---|---|---|---|---|---|---|--|
| 1 | A | Topsoil | Rectangular | Flat | 1000 | 850 | 45 | The topsoil consisted of made up ground, with soil mixed in with bricks and other materials. It was much disturbed, with seven services trenches cut through the area. |

Photo 4: showing made up ground and services
