Report of an Archaeological Evaluation, at;
Yearsley Moor Wood, Yearsley, North Yorkshire

Site: Yearsley Moor Wood, Park Wood, Yearsley, North Yorkshire

Site Codes: YMAP 12

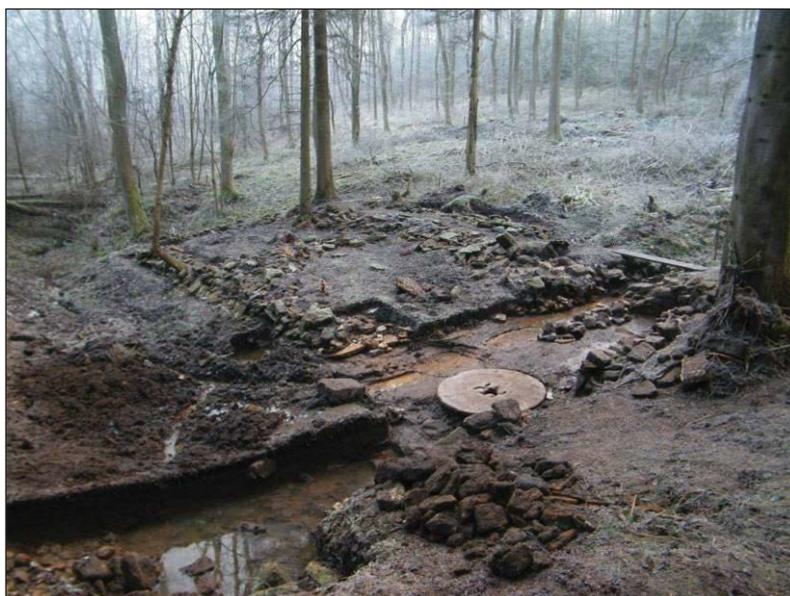
Figure 5: Site 3, view of the mill house, looking southeast

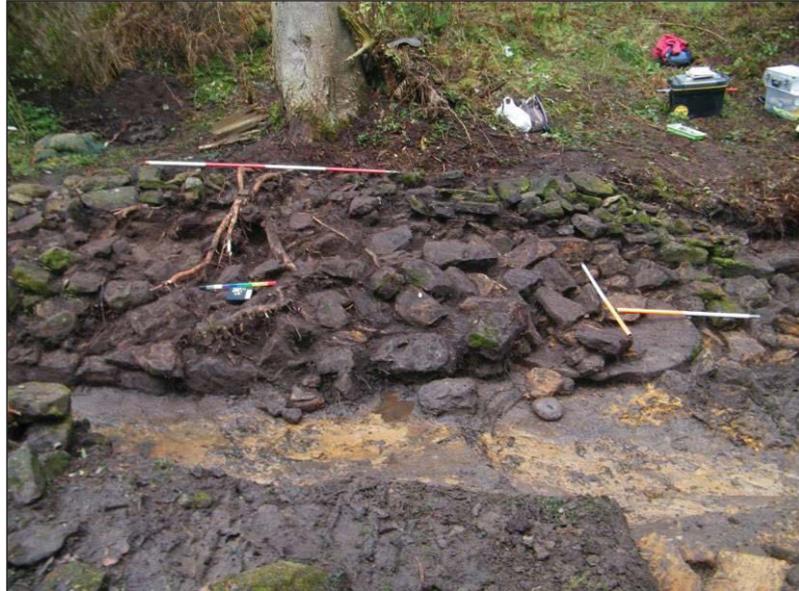
The removal of top soil (context 1), a mixture of organic material and dark brown clay, revealed an accumulation of rubble material (context 16) extending over an area of approximately 200m² (Figure 8).

Figure 6: Rubble context 16, looking southwest

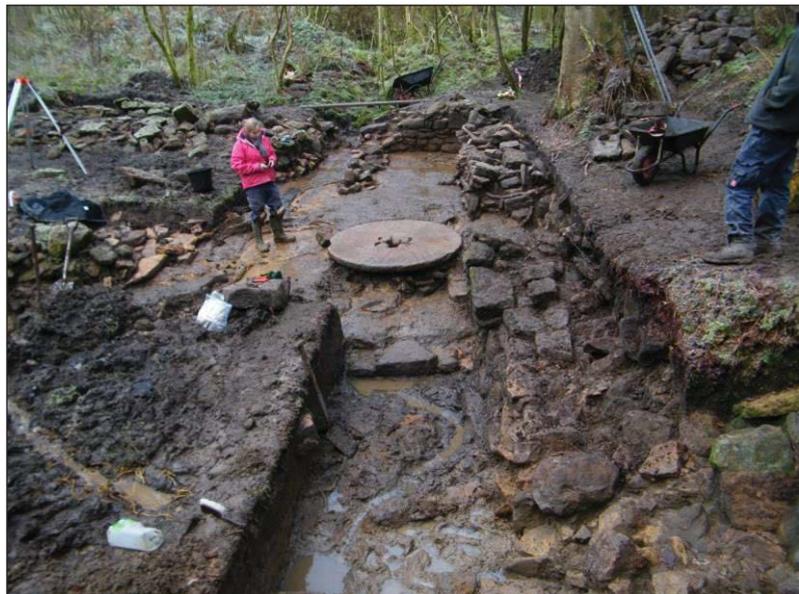
Figure 7: Site 3, view of the mill-stone (context 17), looking southwest

At some point during the life of the mill a nearly intact mill stone (context 17) measuring 1.5m in diameter and 0.10m in thickness was laid adjacent to the doorway face up (not in its original position) on the bedrock surface. In order to position it on the level, a cut was made in the bedrock the same size as the wheel. To the east of wheel 17 the bed rock showed sign of another circular cut, possibly made in order to host another wheel (Figure 15).

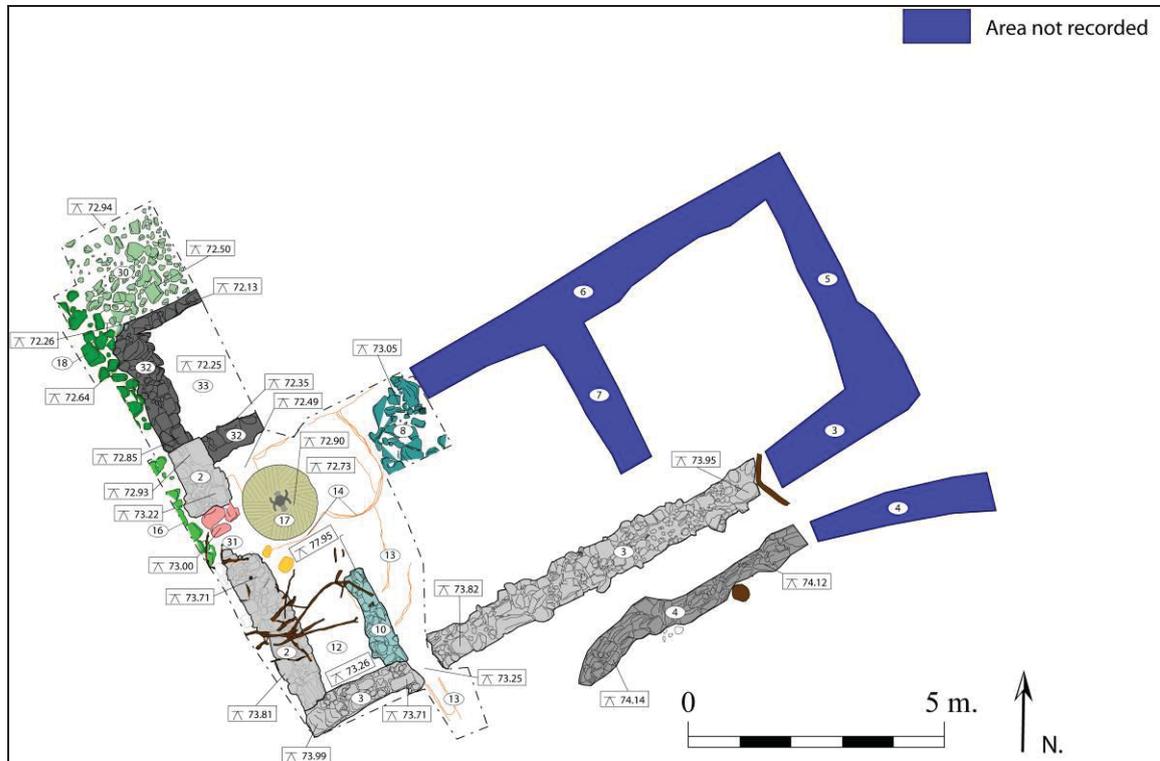
While cleaning the area, the remains of four wall structures came to light, revealing the presence of a former rectangular building orientated on a southeast to northwest alignment, with the internal space divided by two small partition walls. A stream crossed the building in a northeast to southwest direction. Although part of the walls were only recorded in plan, a trench measuring 11.00m by 3.00m was positioned to the west of the building, with the intent of establishing the date and use of this dwelling.

Figure 8: Site 3, plan of the structures

The archaeological investigation on Site 3 revealed the presence of a rectangular building erected directly on the natural bed rock, measuring 13.50m in length and 5.70m in width, aligned in a north east to south west direction, and a boundary wall running parallel, at a meter distance, to the south east wall of the main building (Figure 8).

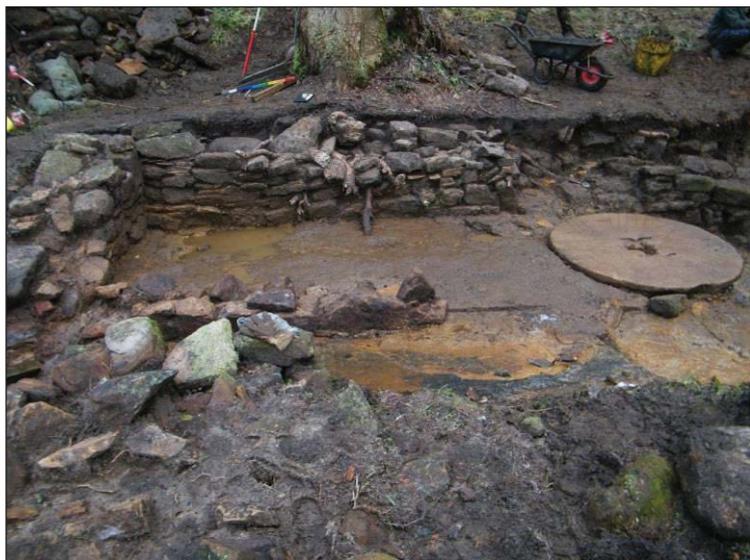
Forming the southwest side of the building, wall 2, orientated on a northwest to southeast alignment and made of large sandstone blocks, was recorded as measuring 5.75m in length and 0.75m in width. At the southwest corner of the building, where it bonds with wall 3, it survives to a height of 0.60m. After the removal of rubble 16, a gap within wall 2 measuring 1.10m in width was found which appeared to be the location of the entrance to the building (context 31). This is located at 3.30m northwest along wall 2 and adjacent to the mill stone (context 17) (Figure 8).

Figure 9: Site 3, showing wall 2 abutting wall 3, looking southwest

Measuring 1.10m in width and located along wall 2 with some flat sandstone slabs surviving at the base, structure 31 was recorded, after the removal of rubble 16, as the doorway leading to the mill engine room (Figure 8, Figure 9).

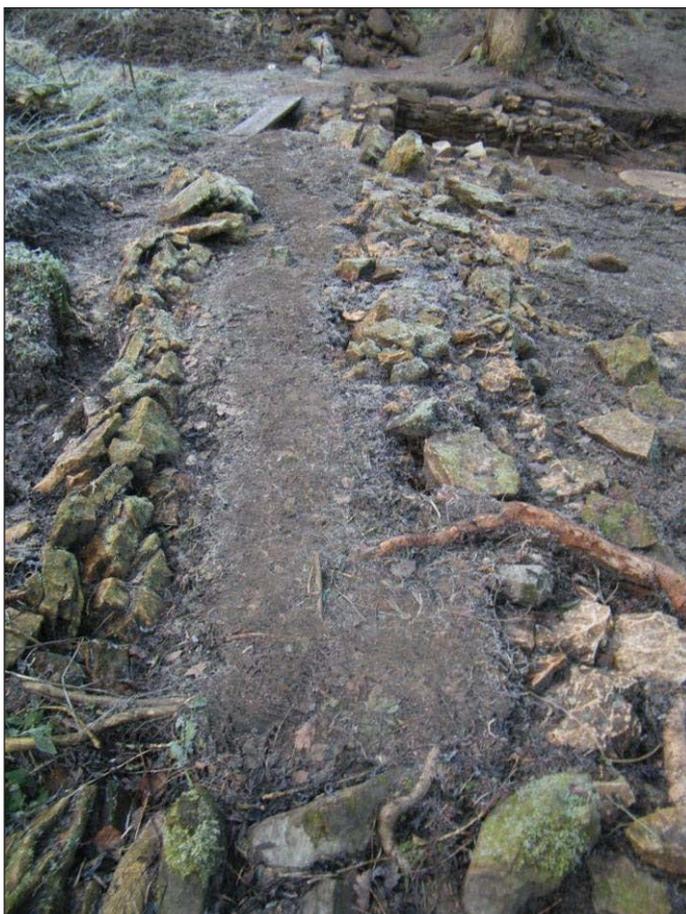
Orientated on a northeast to southwest alignment, measuring 13.70m in length, 0.60m in width and 0.60m in depth (only recorded in plan for 10.0m of the length), wall 3 forms the south side of the mill. It was recorded as bonding with wall 2 and it appeared to have been constructed with the same technique and similar material (Figure 8). This feature has also been cut through by a small stream (context 13, wall 10) which runs in a northwest to southeast direction.

Figure 10: Site 3, showing wall 3 and wall 4, from the northeast corner. Looking southwest

Measuring 9.0m in length and 0.50m in width, (only recorded in plan for a length of 5.20m) wall 4 is orientated in a northeast to southwest direction, running parallel to wall 3. A gap of approximately 1.0m separates the two walls and towards the north end wall 4 appears to gently curve toward east (Figure 8, Figure 10).

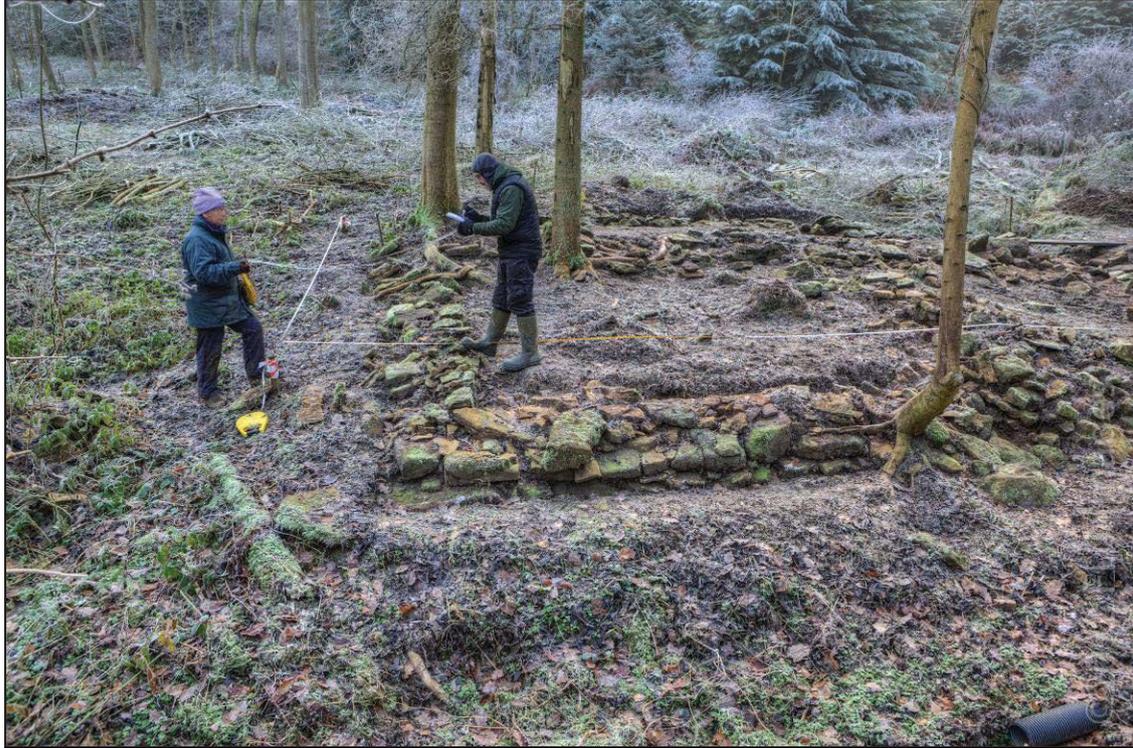
Due to restricted resources only the outlines of these walls were recorded in plan. Wall 5, forming the west outer wall of the mill, measured approximately 4.6m in length. Wall 6, running in a northeast to southwest direction and forming the north side of the mill, measured 7.2m in length. Wall 7, an internal partition wall running from wall 6 in a southeast direction, measured 3.0m in length (Figure 8).

Figure 11; archaeologists planning the outline of walls 5, 6 and 7, looking southwest

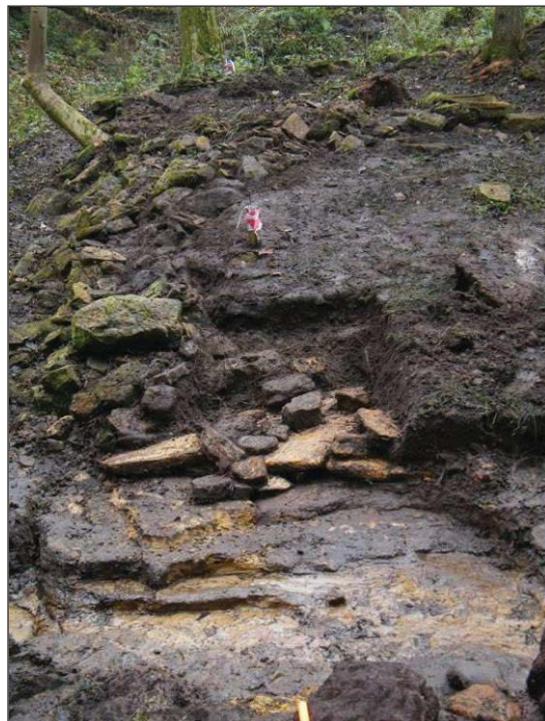
This context number was allocated to the southwest end area of wall 6, where it was thought the wall might turn at a right angle forming another internal partition wall (Figure 8). Both these features extended beyond the 2012 excavation limits; therefore there was neither time nor resources to investigate any further.

Figure 12; southwest end of wall 6, and possible wall 8

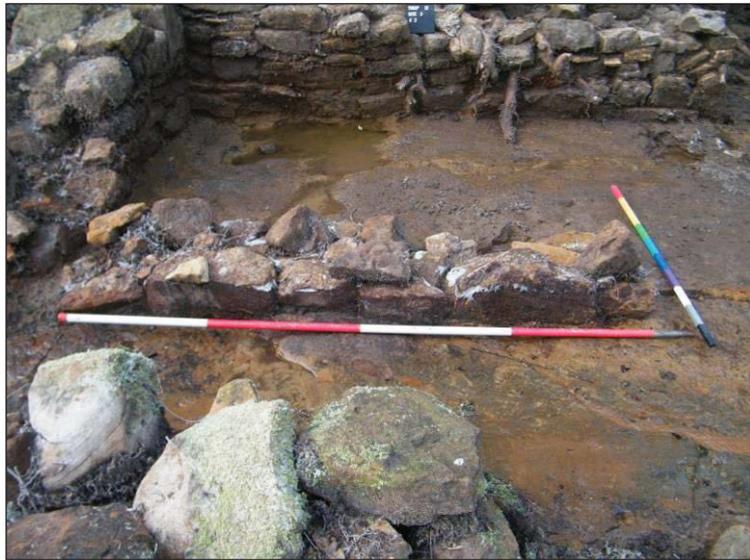
This structure, running parallel to wall 2 in a northwest to southeast direction, survives for a length of 2.0m, and to a height of 0.10m, measuring an average of 0.50m in width. It has been built with large cobbles and sandstone blocks, bonded with what appears to be clay material.

Figure 13; the remains of wall 10, looking southwest

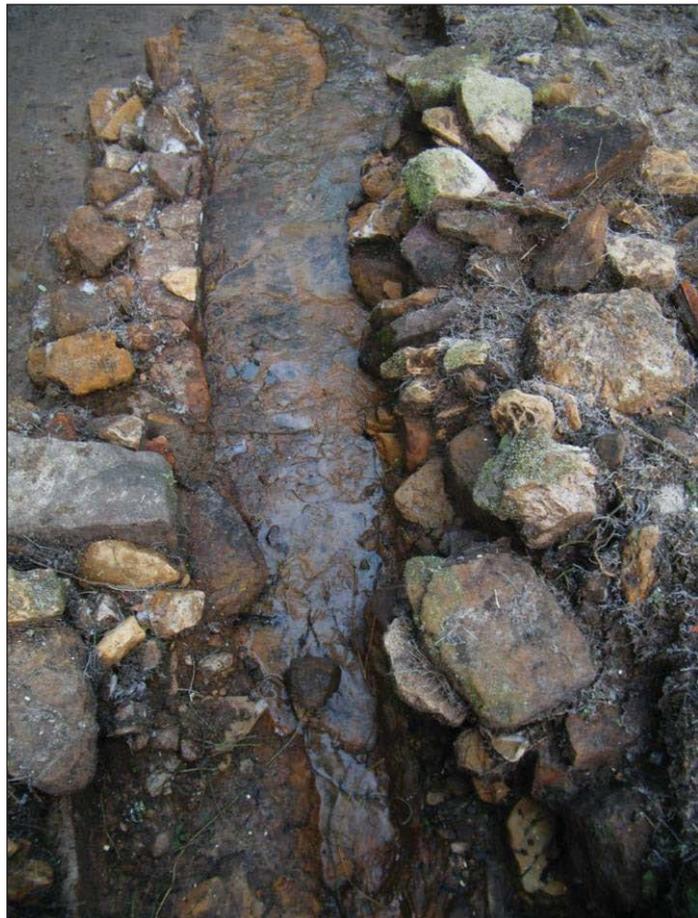
Wall 10 was built as part of the stream channel (west side), which crosses the mill on a northwest to southeast alignment. The stream also runs alongside the evaluation trench but due to lack of resources it was not possible to extend this trench in order to verify the presence or absence of the opposite stream wall. Further excavation is required in order to establish the function of this stream channel.

Figure 14; the stream channel with wall 10 to the left, looking northwest

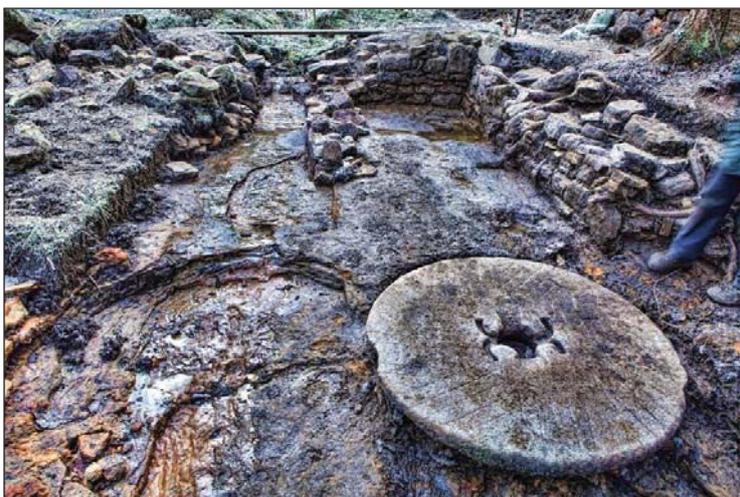
Figure 15; wheel 17 and, to the left, the circular cuts into the bedrock, looking southeast

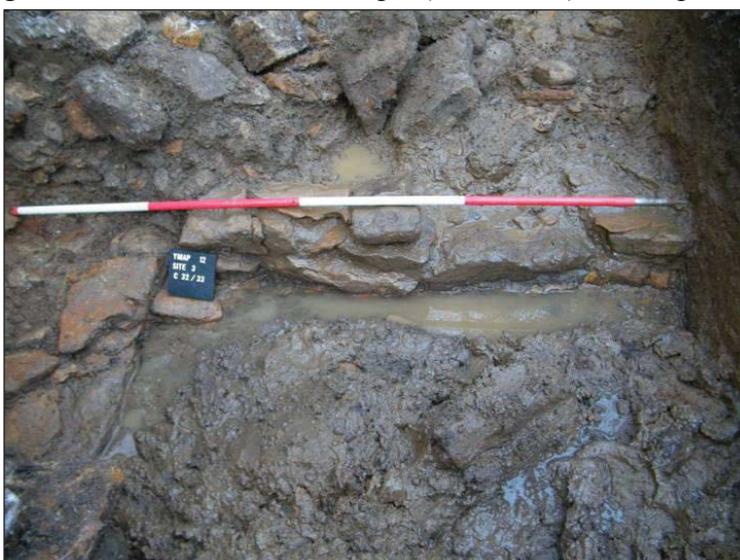
This feature was only partially investigated, due to limited resources and adverse weather conditions. Measuring 2.30m in width, the wheel pit (context 33) was exposed for a length of 1.20m. Due to the high water table level, pit 33 was only excavated to a depth of 0.50m. Three of the four walls of this feature were exposed, all measuring on average 0.50m in width. The southern wall appeared to have been built directly on top of the bedrock. A large quantity of pottery and fragments of glass was recovered during the excavation of this pit.

Figure 16; wheel pit 33 and structure 32, looking northwest

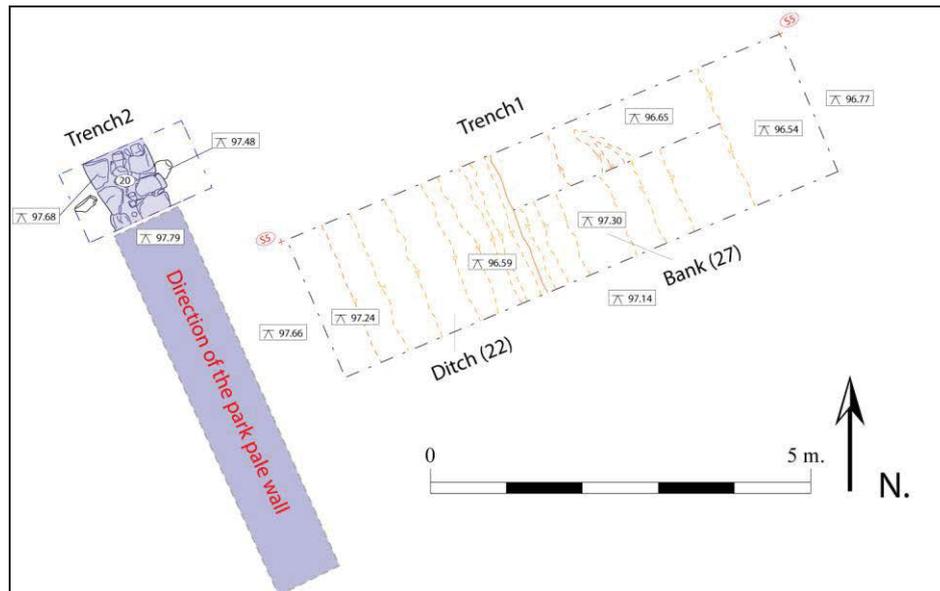
The site lies at approximately 97m above Ordnance Datum. Two trenches were positioned perpendicular to a ditch and bank, on a north east to south west alignment, in order to evaluate the presence and character of the park-pale boundary. The trenches measured respectively; 7.10m in length and 2.00m in width (trench 1), and, 1.80m by 1.00m (trench 2) (Figure 19).

Figure 19; Site 4, plan of trenches 1 and 2

Due to the dense wood plantation, it was not possible to extend the limits of trench 1 further to the west in order to assess the presence or absence of a park pale wall related to the ditch and bank. Therefore a small trench (trench 2) was excavated a few meters north west of trench 1, measuring 1.80m in width and 1.00m in length (Figure 19).

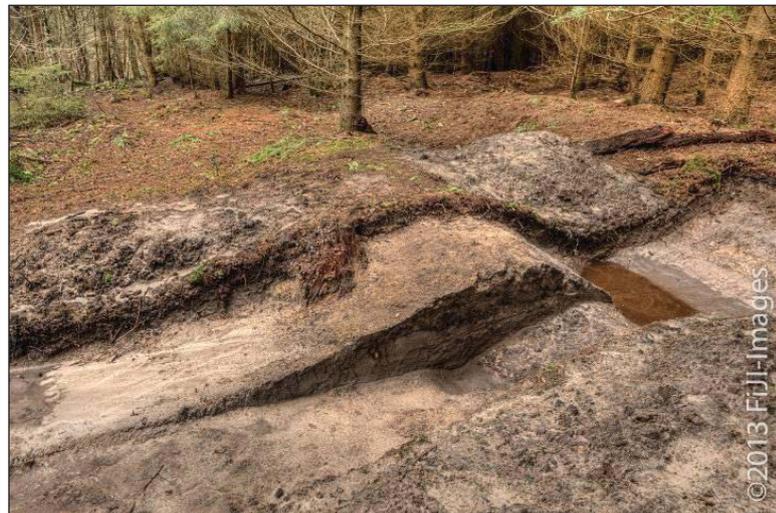
Ditch 22, a linear feature measuring 2.40m in width and 0.50m in depth, was recorded as having a shallow concave base, with the western edge cutting the natural at an angle of less than 30°. In contrast, the opposite edge was set at a steeper angle and was formed by the bank (context 27), (Figure 18).

The bank (context 27), a linear feature associated with ditch 22, measured 2.75m in width. It was exposed for a length of 2.00m. In order to determine the sequence of its construction, a 0.80m wide section was placed through it, revealing that a total of three distinct layers of material were used to create this feature.

Figure 20; Trench 1, showing the bank 27 and ditch 22, looking south

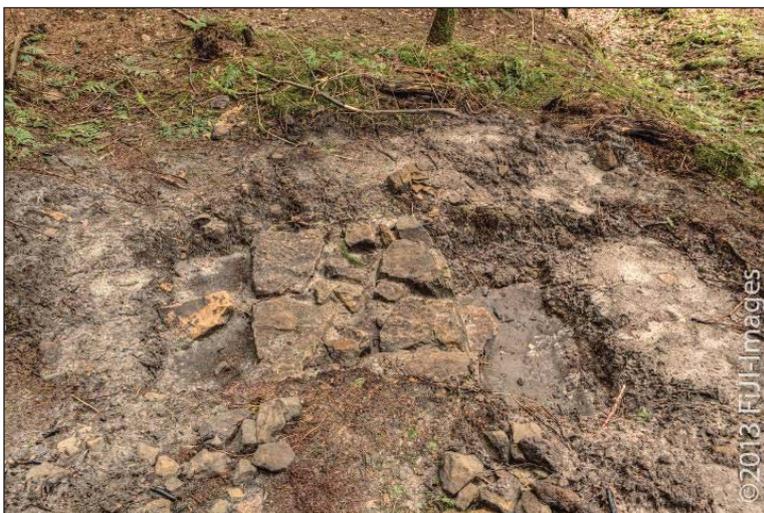
The removal of topsoil within trench 2 revealed the remains of a stone wall foundation (context 20) measuring 0.90m in width and 0.20m deep. This wall was made of two skins of sandstone and limestone blocks measuring on average 0.35m by 0.30 by 0.15m. In between the two skins of stones a rubble deposit (hearting) was laid. Due to restricted time and resources this wall was only exposed for a length of 1.00m.

Figure 21; Trench 2, the foundation wall 20, looking north-west
