**Archaeological building recording at
65 Sartoris Road, Rushden
Northamptonshire
June 2014**

**on behalf of
Bassetform Ltd**

**Archaeological building recording at
65 Sartoris Road, Rushden, Northamptonshire**

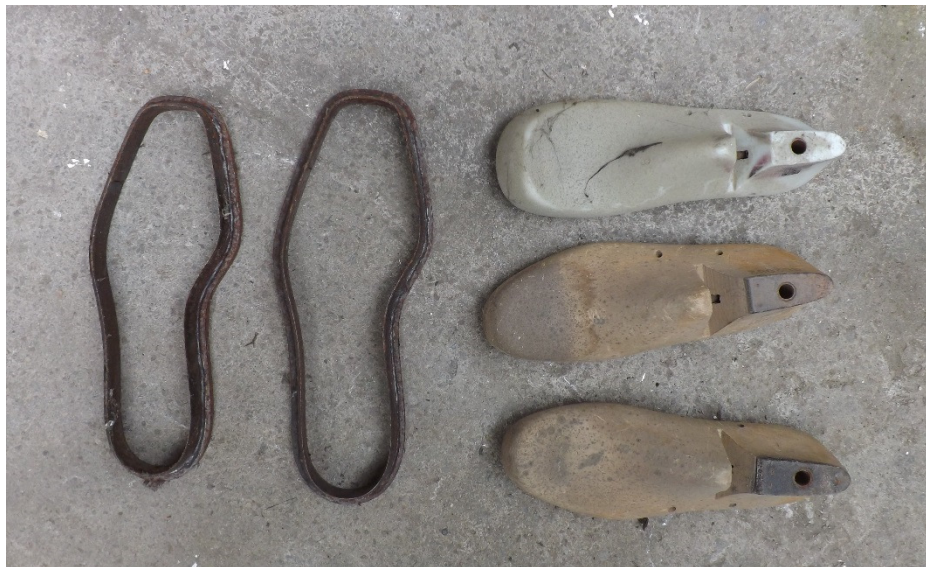
A variety of abandoned objects reflecting the building's recent past were recorded. These included wooden and plastic shoe lasts and steel dies for cutting shoe soles. A number of box labels were also present; these were largely for riding boots.

Fig 5: Shoe lasts and steel dies

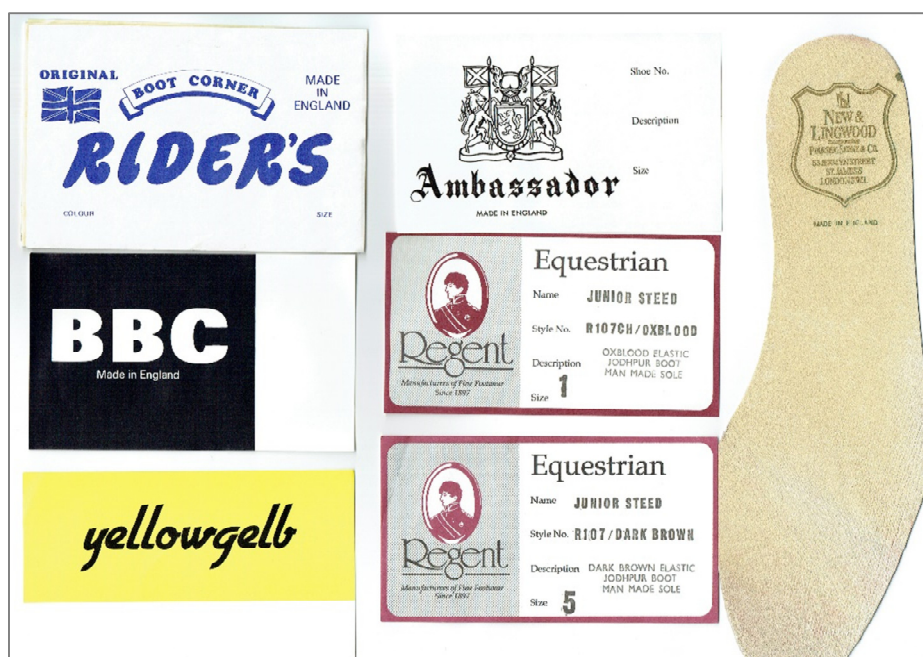
Fig 6: A selection of labels and an insole found at the property

Little information was available concerning most of the labels. The Regent brand, which produces riding boots and associated items, is still a going concern. In 2002 it was acquired by Sanders and Sanders of Rushden. Ambassador Footwear appear to have been another Rushden company. New & Lingwood are a Jermyn Street based company, founded in the 19th century at Eton to serve the pupils of the eponymous school. They are now known for bespoke shirts and tailoring. In 1972, Poulsen Skone, a renowned boot and shoe company was acquired by the firm.

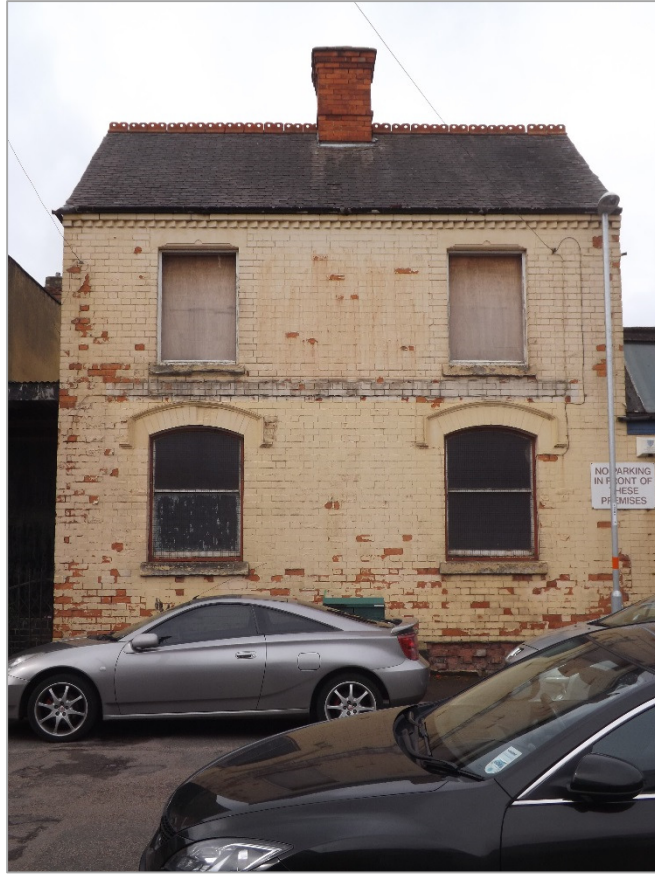
The house is constructed of cream/white-painted red brick laid in Flemish bond with courses of alternate stretchers and headers and queen closers at each corner, with a coggled eaves course (Fig 7). A rectangular area of white paint between the ground and first floor windows probably indicates the position of a former sign. The roof covering is Welsh slate with ornate clay ridge tiles. There is a central chimney stack.

There are arch-headed windows beneath a segmental brick arch with drip mouldings above on the ground floor. The windows are wooden sash with single large panes of glass above and below. Both are screened by thick wire mesh. The first floor lintels have ogee mouldings with stopped chamfers. The windows themselves have been removed and are boarded up. The window sills are all stone.

Fig 7: Front elevation of the house

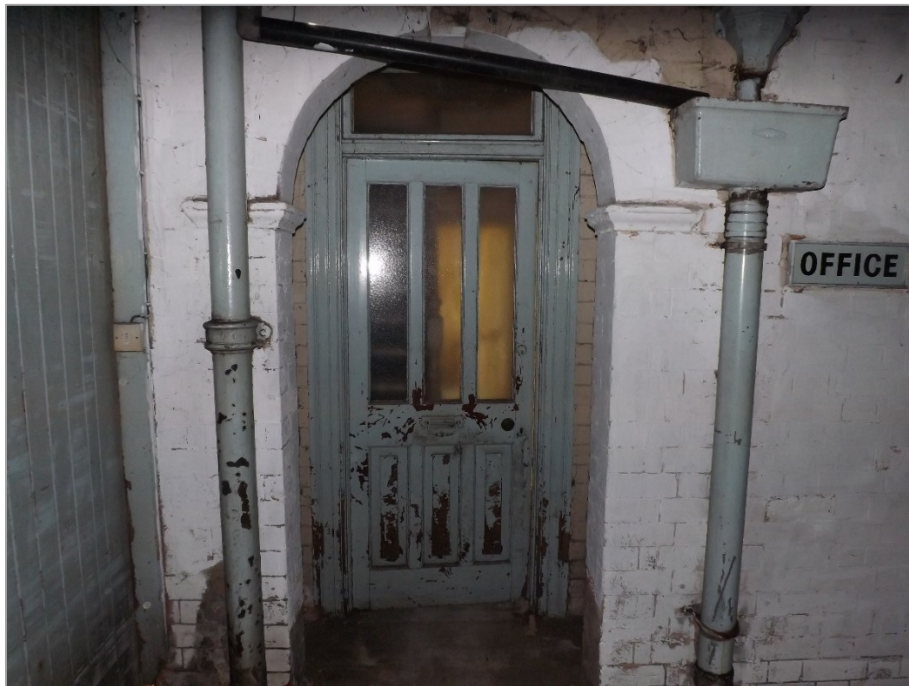
The two-bay south-eastern elevation is only partially visible above the porch. It contains square headed windows under shallow brick segmental arches and stone springers. In the first bay of the ground floor is the original entrance. The entrance is set into a recessed porch which has a semi-circular brick arch (Fig 8). The six-panelled door has three glazed upper panels with a simple rectangular fanlight above. The door has a centrally-placed letter box with integral doorknocker, both overpainted. Either side of the porch are downpipes, with a simple hopper on the right. Just beyond is a sign saying *office*.

Fig 8: Original side entrance with recessed porch

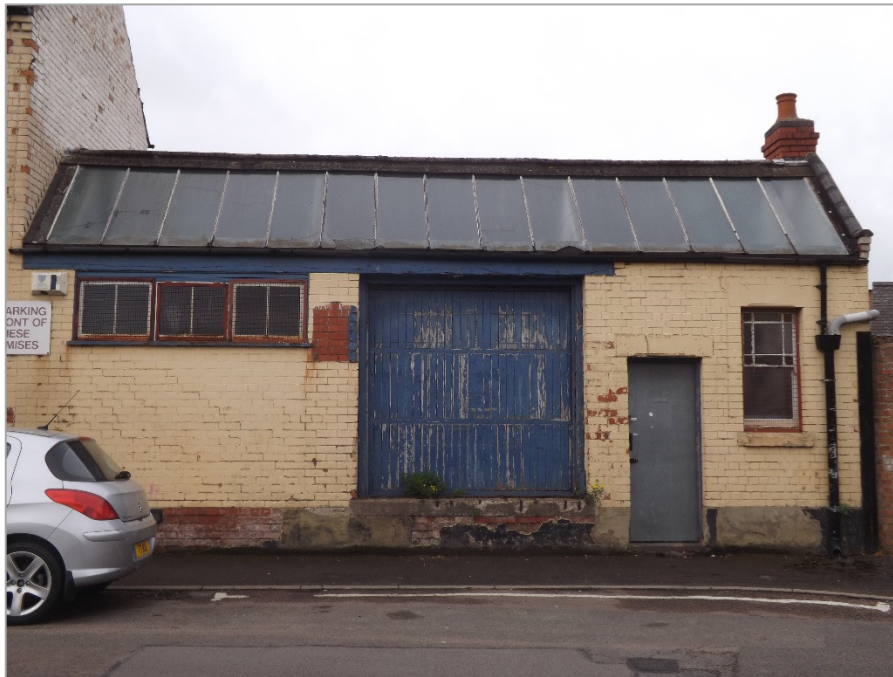
The adjacent single-storey, north-light brick-built factory buildings, which were constructed in the period 1919-1920, are abutted, with a butt joint in the brickwork. A single brick key from the factory to the house was visible.

Fig 9: Adjoining single storey, north-light factory sheds

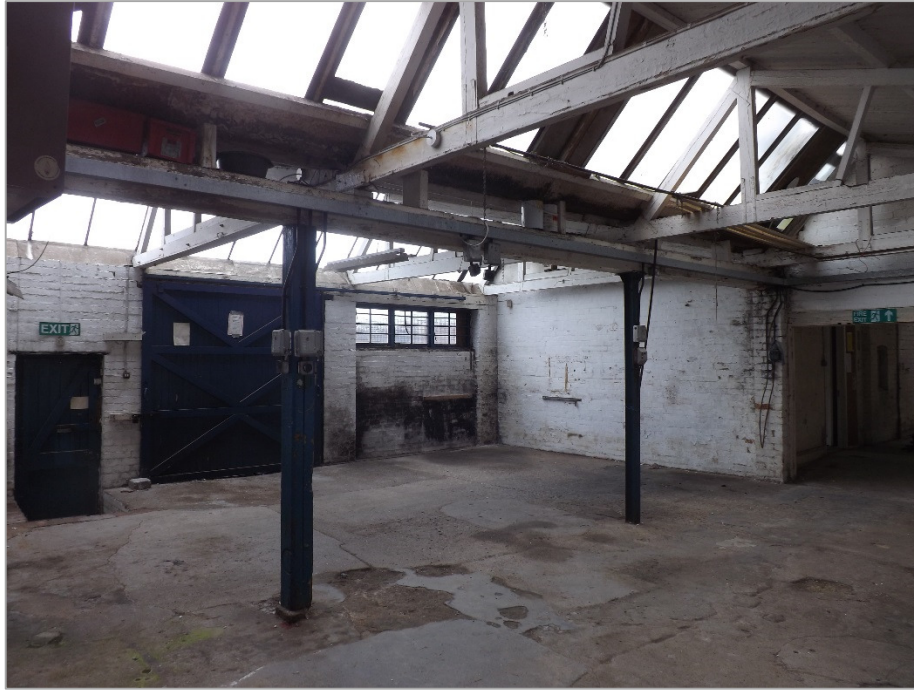
All four ranges of the factory were brick-built with concrete floors and north-light roofs. Intermediate timber columns support the iron and timber roof structure (Fig 11). The roof is glazed on the north side with probably Trafford tile on the south. Internally the south side is clad in tongue and groove timber. All fixtures and fittings have been removed.

Fig 11: The interior of the front range

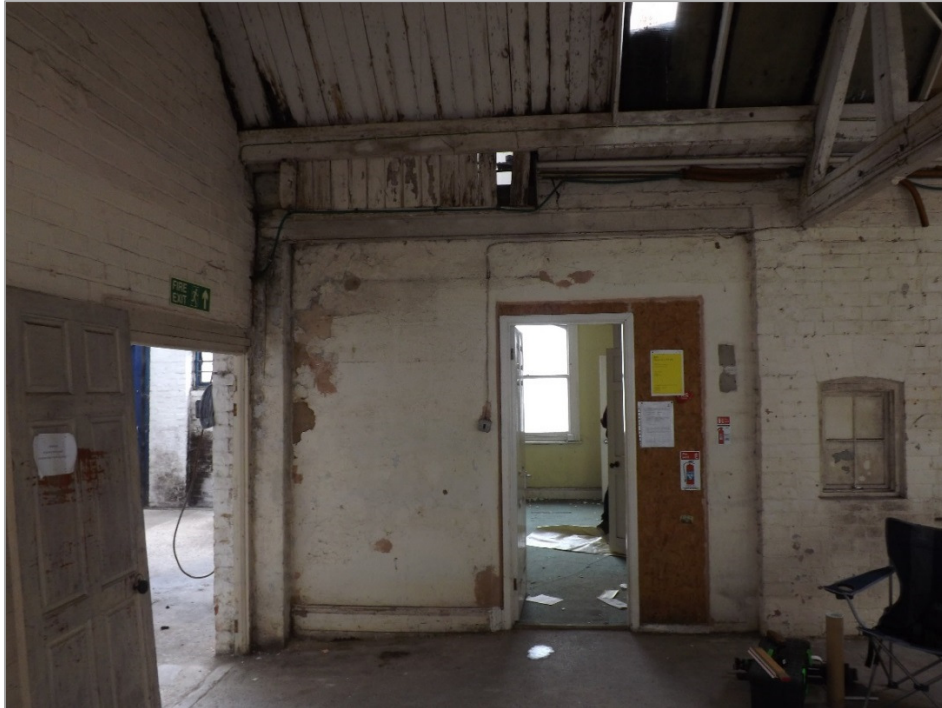
Fig 12: Entrance from factory into G1; note the RSJ above and small painted-up window on right.

A chimney-breast was present in the centre of the south-eastern wall; the former fireplace had been entirely blocked (Fig 10). There was a door into room G2 on the northern side of the chimney-breast and to the south a set of floor-to-ceiling cupboards, a door into the hallway and a door into an under stairs cupboard (Fig 14). The cupboard had no internal features other than a small four-light window beneath a brick segmental arch which looked out into the factory floor behind. The glass had been painted-over (Fig 12).

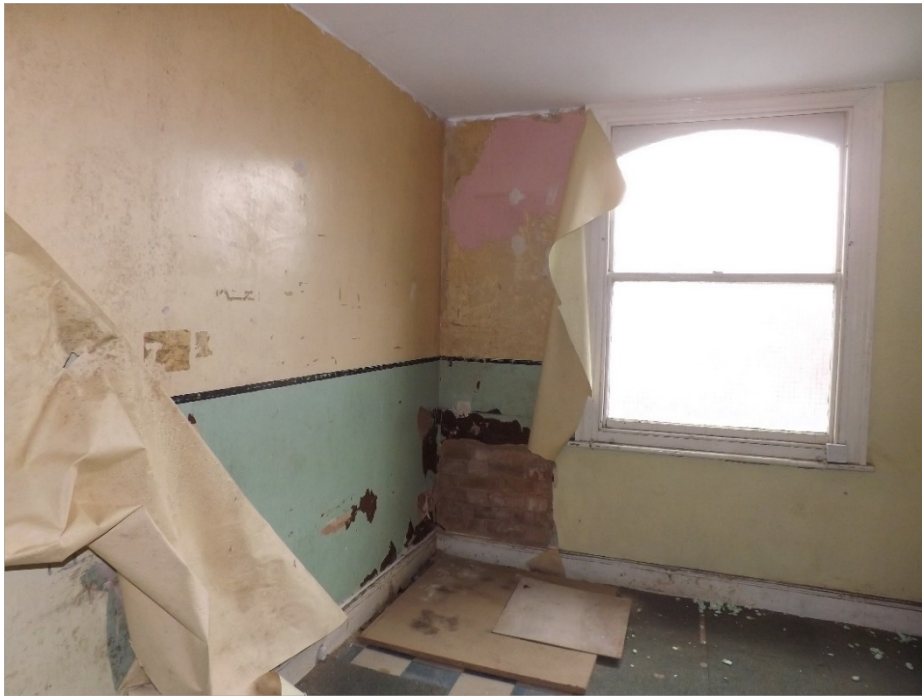
Fig 13: Former paint schemes in G1

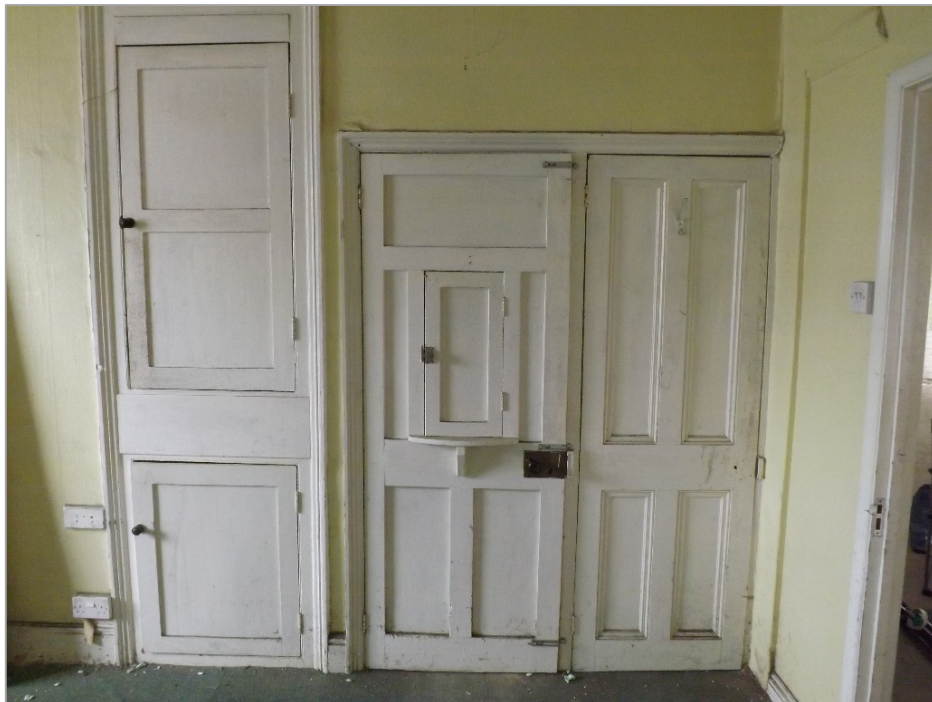
The two floor-to-ceiling cupboards had plain doors; the lower had a single panel, the upper had two. Both had simple round Bakelite knobs from the period c1925-50. The door into the hallway (G3) and door into the under-stairs cupboard were surrounded by the same architrave, and were divided by the end of the panelling associated with the staircase beyond. The door into the hallway (G3) had a central hatch opening to the right, fastened with a catch.

Fig 14: Full-height cupboards (left), door into hallway (centre) with central hatch and under-stairs cupboard in G1 (right)

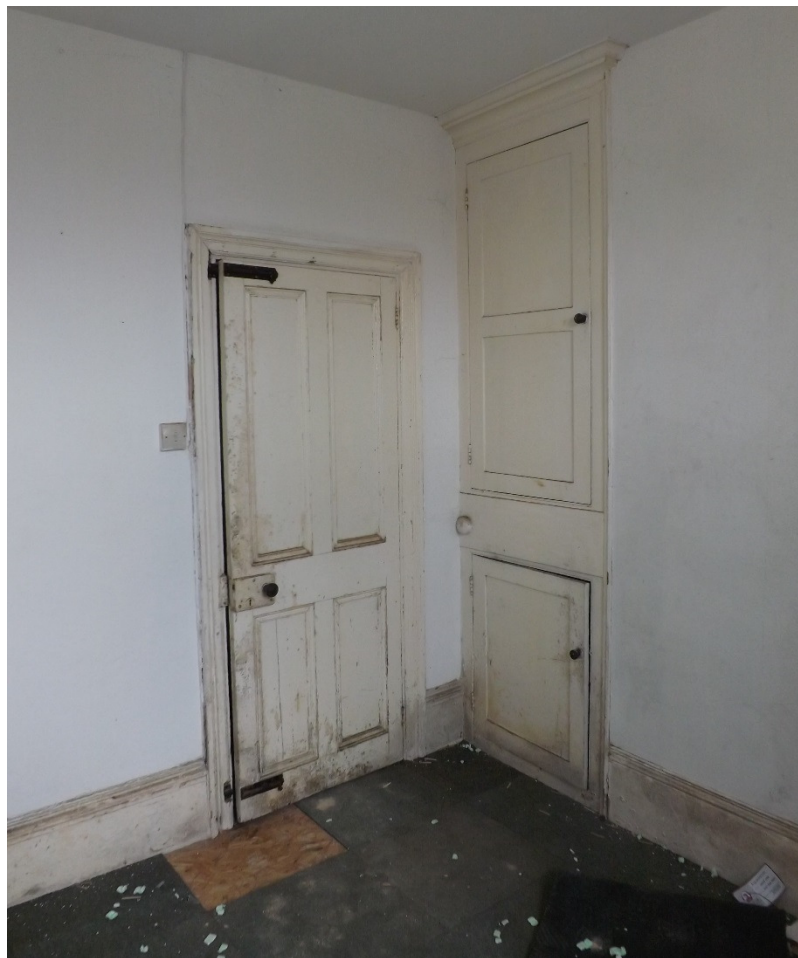
The floor was largely carpeted as G1. The walls are painted white. The skirting boards are 0.28m high, significantly taller than those in G1, and possibly original. The door into hallway G3 is a typical four-panelled internal door with a 'mouse-moulded' panel bead within the house. There are bolts to the top and bottom of the door. There were significant areas of damage in the floor and ceiling. The floorboards had been partially removed beneath the window in the south-eastern side of the room and replaced by chipboard. This too had rotted.

Fig 15: Room G2, typical four-panelled door and floor-to-ceiling cupboards

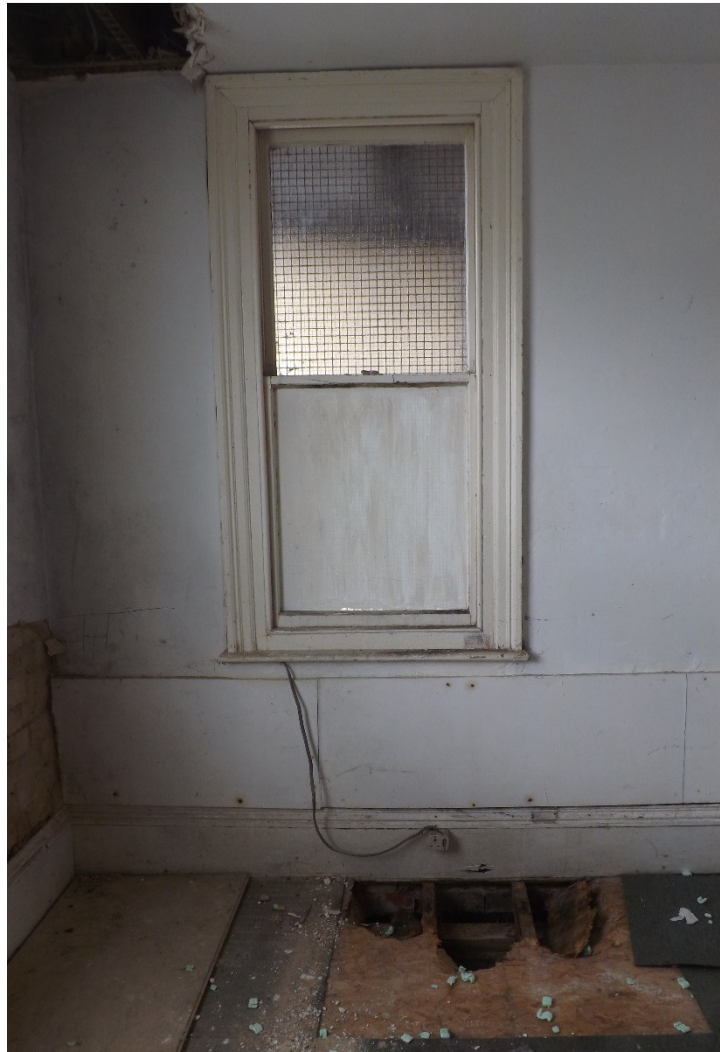
A simple room, with blocked fireplace and floor-to-ceiling cupboards in positions backing onto those in room G1 (Fig 10). Windows to the south-east and north-west aspects. The glass of the lower part of the sash window in the south-east had been painted white for privacy. The upper pane is patterned, rolled glass, again probably for privacy.

Fig 16: Window in south-east elevation, room G2

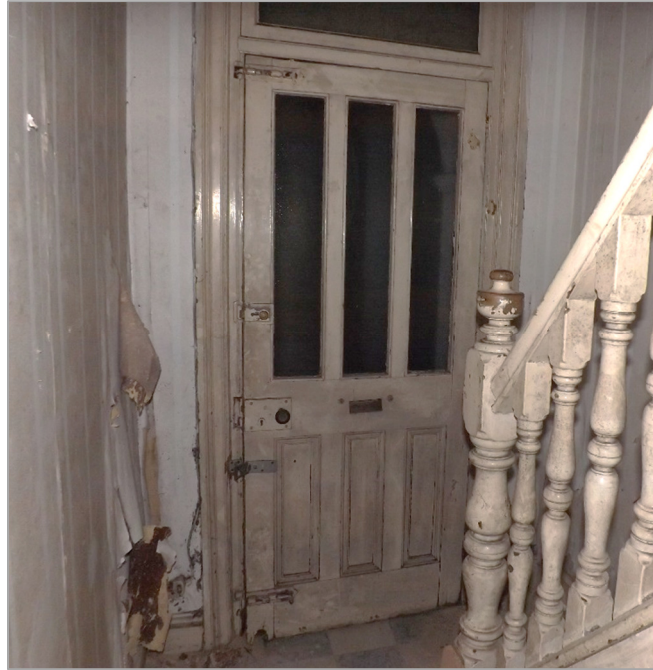
The hallway was aligned along the rear of the house, the stairs rising just in from the front door (Fig 10). Access to room G1 was at the far end and access to room G2 opened halfway along. The floor was covered with black and white linoleum tiles and the walls were papered with beige/cream and white striped wallpaper. The newel posts and balusters of the staircase are typical examples of a modest late Victorian house (Calloway 1991; Fig 17).

Fig 17: Front door, hallway and staircase, G3

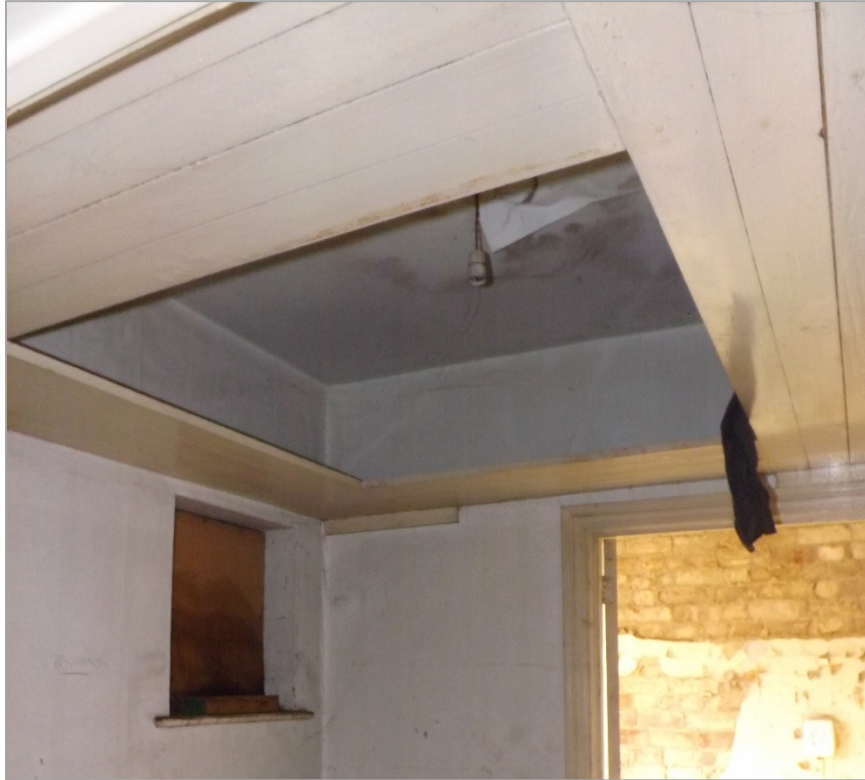
A wide wooden shelf is situated just below ceiling height above the stairwell extending around all four sides (Fig 18).

Fig 18: Wide shelf above stairwell in room F1

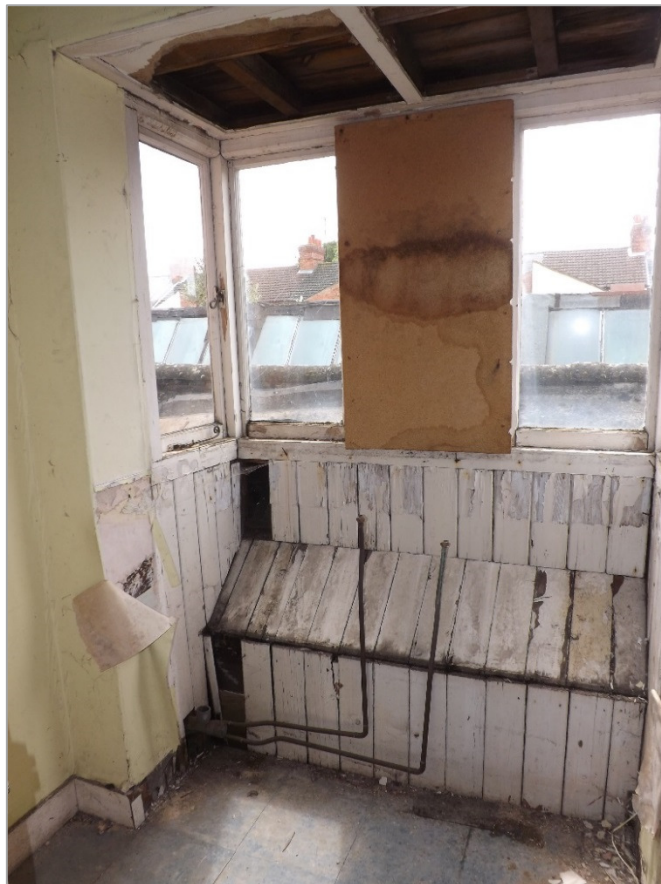
Fig 19: South-west facing oriel-type window in room F2

In this small room just off the stairs the walls are covered with pale yellow wallpaper, although both paper and underlying plaster had been removed in places down to the underlying brickwork, and the floors are covered with grey marbled linoleum. There is low-level rounded profile skirting. A pair of copper pipes against the window suggest it may have had a basin/sink. The south-west facing window in this room is an oriel-type window which projects out from the external wall of the house (Fig 19). The main body of the window is constructed from tongue and grooved timber similar to the ceilings of the single storey factory units. The base of the window partially protrudes into the factory ceiling below (Fig 12).

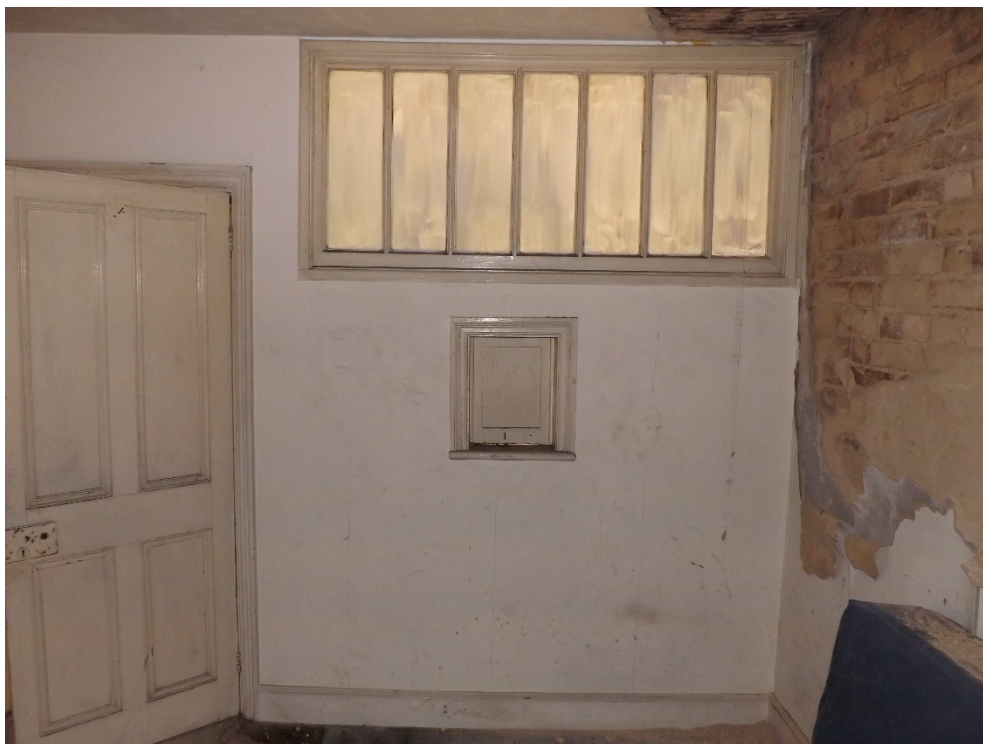
In the rear wall of the room is a centrally placed hatch, which slides upwards to open. Above is a high level window of seven lights to borrow light for room F3. They had been painted over for privacy.

The room is painted white, although significant areas of plaster had been removed to the underlying brickwork. The bricks are 9"x 4 ½"x 3 ½" in size, with a rise over four courses of 13 ¼". The floor covering is grey marbled linoleum tiles, which extends without a break into adjacent room F4, indicating it had been laid after the two rooms had been knocked into one. The door into hallway F1 is the same as in G2 downstairs (Fig 20).

Fig 20: Borrowed light window and hatch, room F3; room F2 beyond

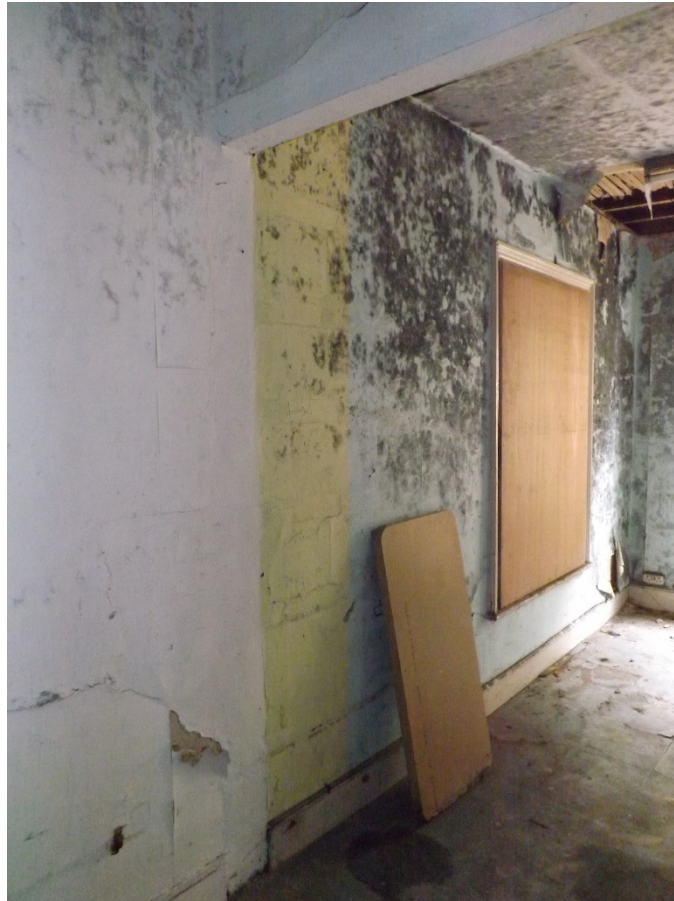
There was a floor-to-ceiling cupboard set into the recess adjacent to the chimneybreast in the same arrangement as the ground floor. The original partition wall between rooms F3 and F4 had been removed (Fig 21). Scars on the wall either side of the former partition wall indicate that there had been sets of equally-spaced shelves set against it.

Fig 21: Room F3 looking into room F4

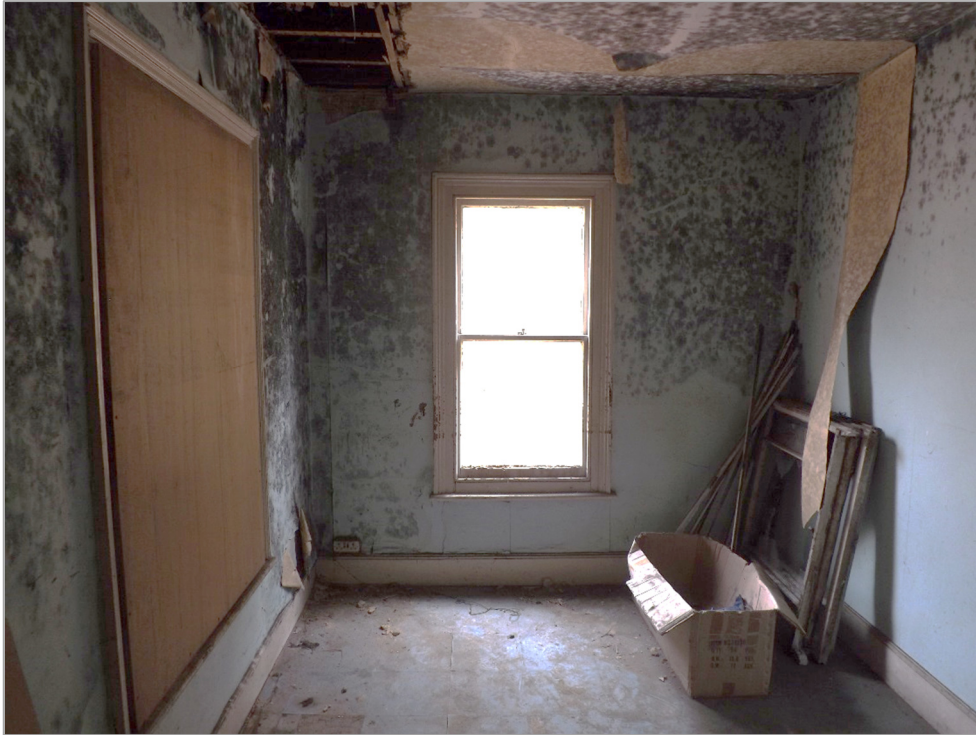
Room F4 is papered in light green/blue wallpaper and the same grey marbled linoleum as the rest of this floor. The walls and ceilings have been much affected by damp, particularly towards the front of the room. As in room F3 the front window has been removed and the opening blocked with a plywood board (Fig 21). The south-east facing window is a narrow sash with a single pane above and below (Fig 22).

Fig 22: Room F4, looking south-east

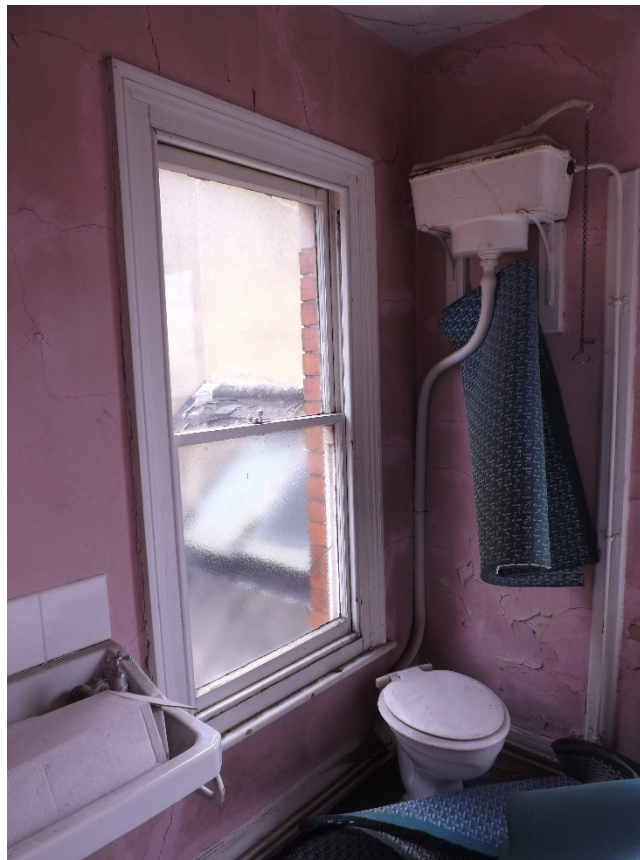
Room F5 is the bathroom, retaining a suite of sink, toilet and enamel bath. The walls are painted pink and the floors are covered with grey marbled linoleum. There are two windows, one facing south-east and the other on the rear elevation. The rear window comprises a sash with a single pane above and below both with patterned, rolled glass. The south-east facing window is similar, but with only the lower part in rolled glass. The toilet comprises a wall-mounted cistern. The toilet bowl itself has been placed in the corner of the room, presumably to save space.

Fig 23: Room F5, the bathroom
