**Archaeological building record of a
Listed former barn at Knuston Home Farm,
Knuston, Northamptonshire**

Knuston Home Farm Barn

Iain Soden BA MifA

September 2012

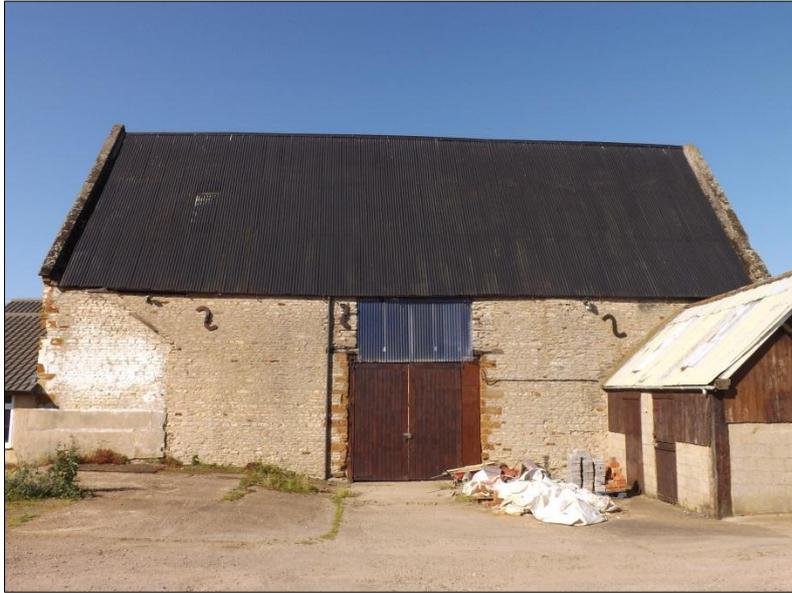
Fig 1: The barn north-east/north wall and addition to right. Limewash on the left denotes a former adjoining building

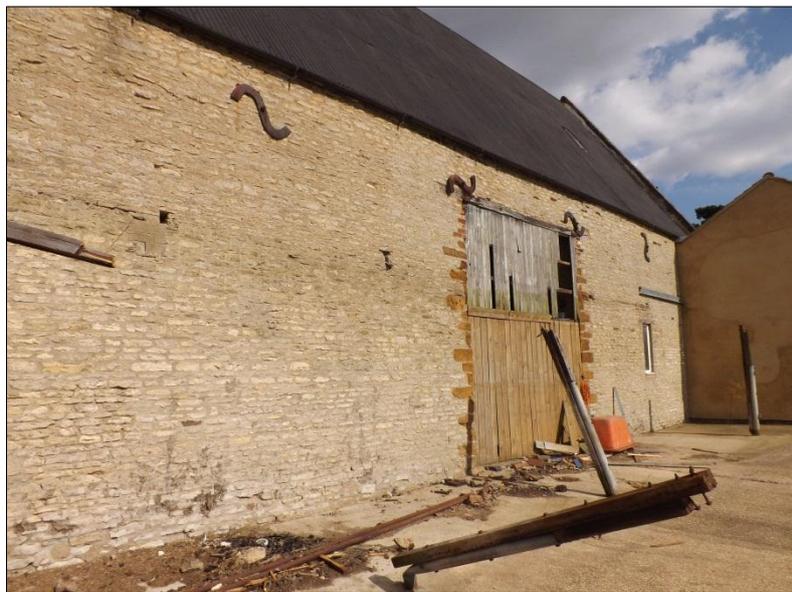
Fig 2: The barn south-west/west wall, a modern lean-to removed, enabling a clearer view

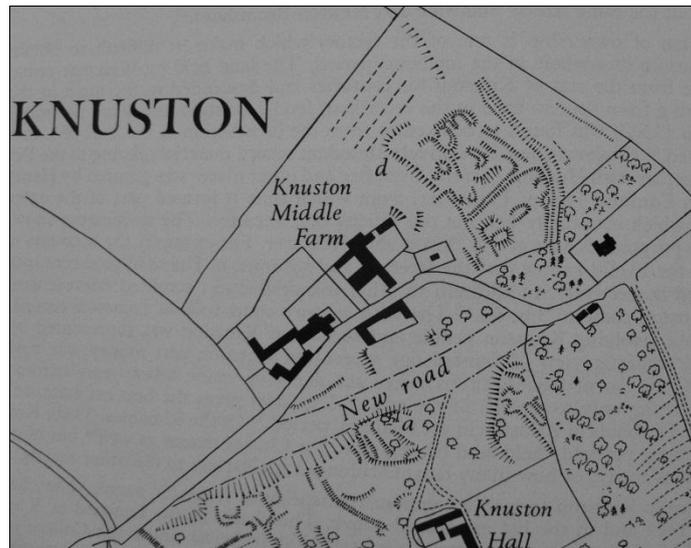
Fig 3. Home (Middle) farm and DMV earthworks surveyed in 1970. The listed barn lies at the centre of the central group

In 1970 the earthworks of the former Knuston hamlet were surveyed and the results published (Brown and Taylor 1975, 178-98; RCHME 1979, 96-7, figs 92, 93, pl 22). The earthworks lie north-east of the present barn at SP 938 662 at about 60m above Ordnance Datum (Fig 3, after Brown and Taylor). Some to the south were lost when the present main road was put in at about that date.

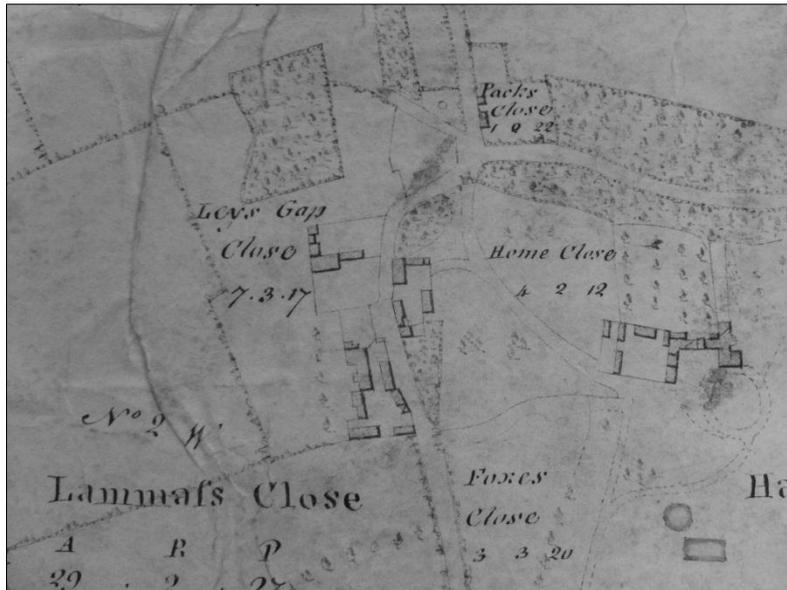
Fig 4: Map of 1791. The barn is the largest building just to the right of the number '17'

Unchanged for a while thereafter, the best early map which shows the barn very clearly is that of 1791, drawn to depict a variety of nearby land transactions on an adjacent estate (NRO Map YZ 8056). Neither the barn nor the farm is named but the barn is very clearly the biggest building of its group (Fig 4).

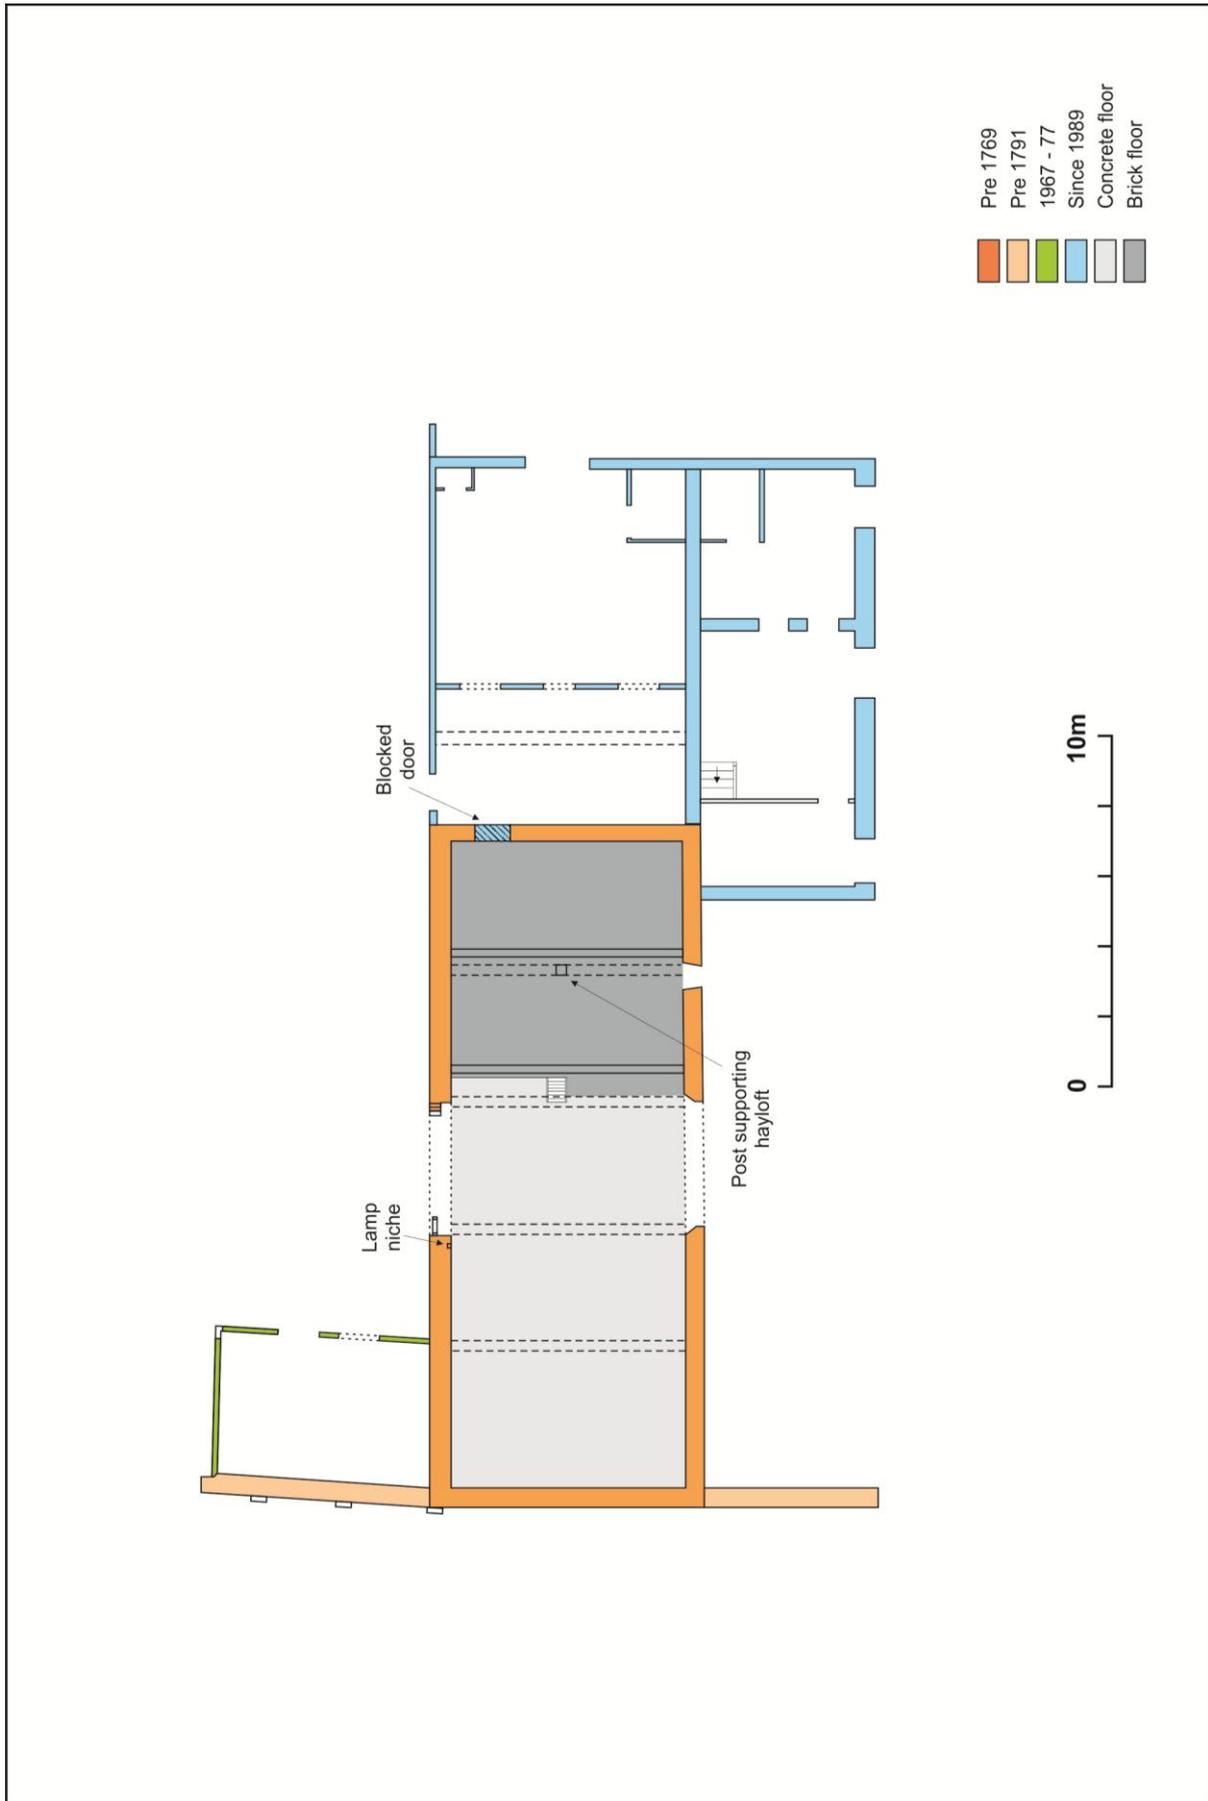
Fig 5 shows the remaining accretions which survived to 2012 with their approximate dates.

Fig 5: Plan of the barn with accretions in 2012

The barn is a simple rectangle, roughly aligned east-west onto which have been added modern buildings at the south and south west, with an older accretion on the north and an added but truncated wall on the west.

The barn interior measures 18.255m long (59.89 feet). In width its long axes have bowed very slightly so that in the northern half it measures 6.399m across (20.99 feet) and in the southern half it measures 6.449m across (21.15 feet). It thus seems to have been conceived on a simple plan of proportions 3:1 (60 x 20 feet). It contains very little architectural or structural detailing.

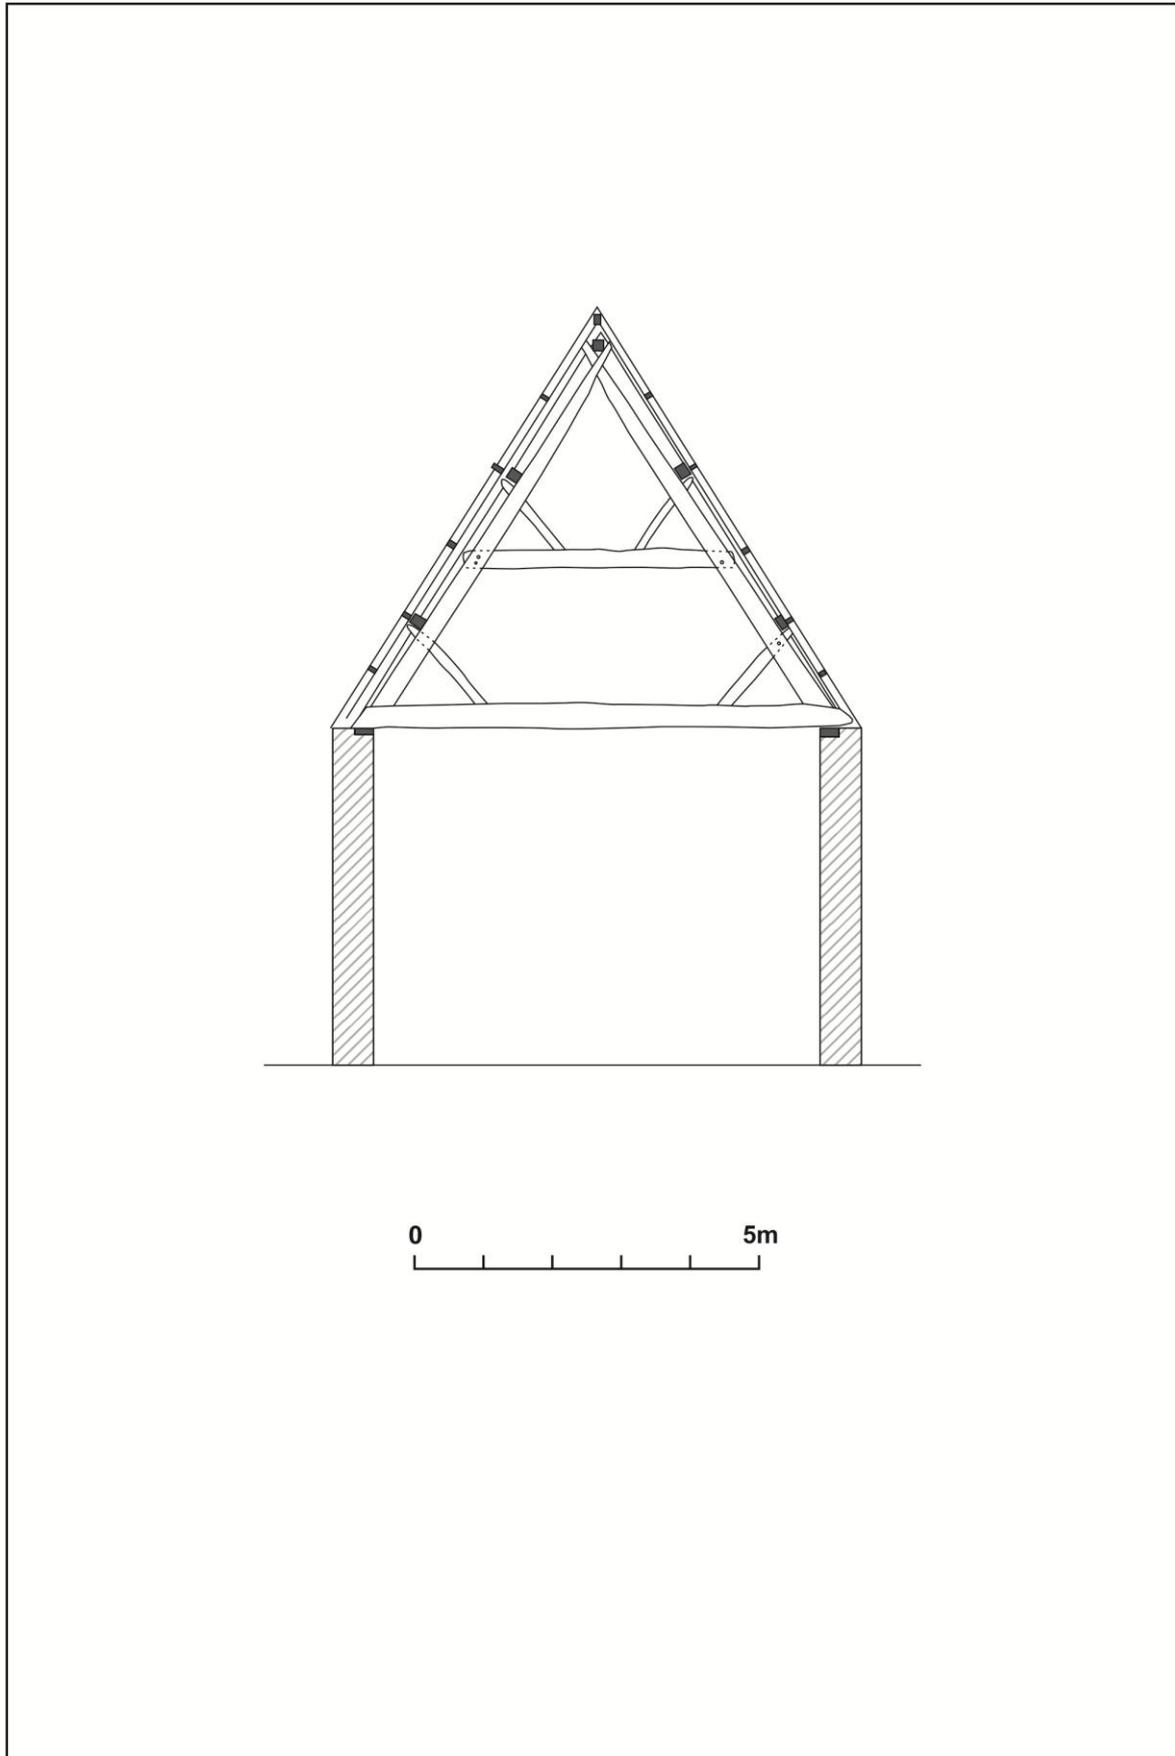
Fig 6: Measured section through the barn

The roof comprises five bays of oak trusses with tie beam and collar at the mid-point, both with raking struts angled to the principal rafters (Figs 6-8). Two sets of back purlins rest on the upper side of the principals, wedged on the ends of the threaded raking struts. At the apex there is a ridge purlin lying where the ends of the principals cross over each-other.

The height at the underside of the oak tie beams is c5.0m (16.4 feet), while the apex is c11.2m (36.75 feet) from the final floor, which is partly of concrete (about 60% of the area) and, under a hayloft, mainly of brick (about 40% of the total area).

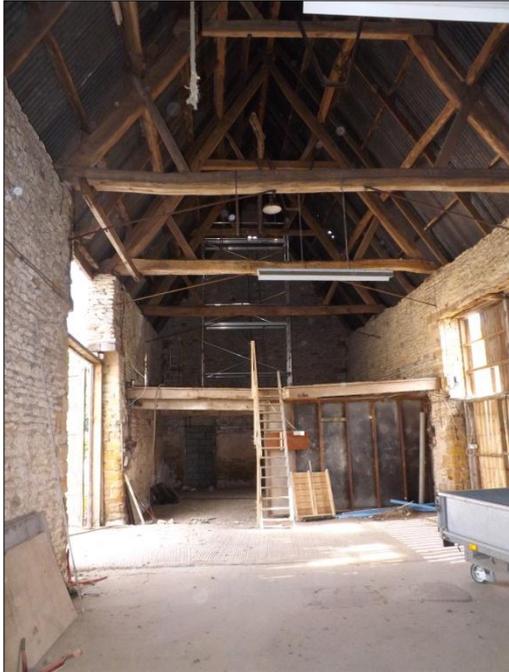
Fig 7: Interior view towards hayloft

At the south-east end is the 20th-century, inserted hay-loft (Fig 7). This was supported upon a single central post (Fig 9). Just inside the north-easterly main door there is a lamp niche in the body of the wall (Fig 10).

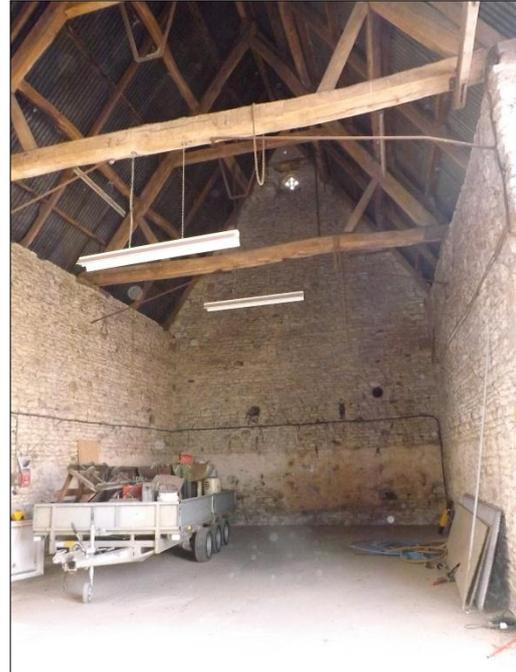
Fig 8: Interior view from hayloft

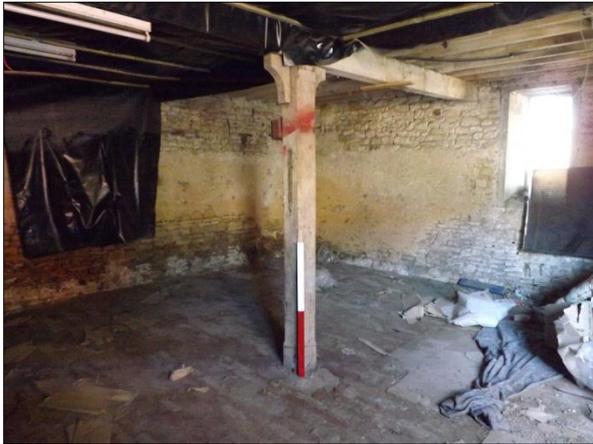
Fig 9: Post supporting the hayloft (Scale 1m)

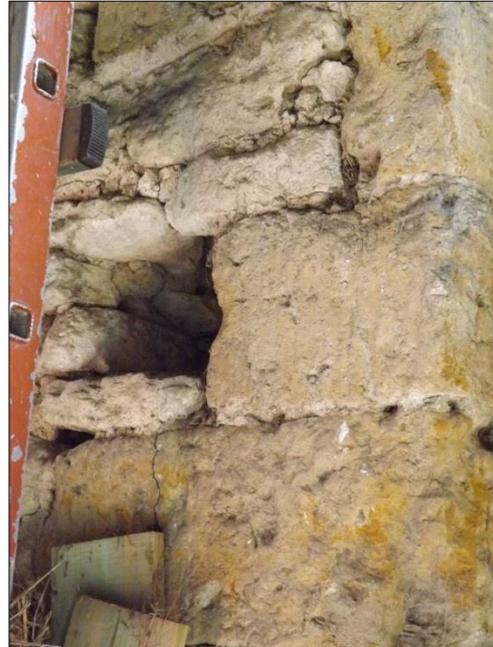
Fig 10: Lamp niche by doorway

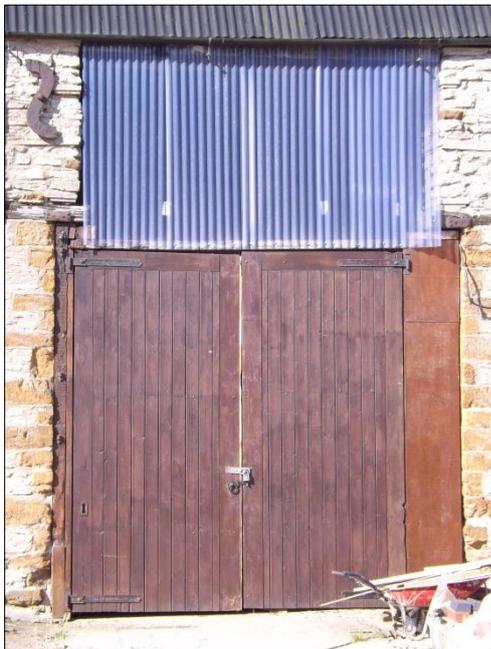
The two main doorways, central in the opposed long walls of the barn, contain no original or early timberwork. Indeed all timber at ground level had been replaced. However, in the uppermost portion of the superstructure is evidence for agricultural change which began in the later 19th century. Above both original doorways the openings had been extended right up to the eaves (Fig 11). Although later filled in with perspex (one side) or timber boarding (the other side), these spaces are probably related to the change from backing in wagons loaded with crops for hand-threshing, to the higher space needed to back in a steam-driven threshing machine, which was generally loaded from on top. On both sides the extended opening was given corners in brick, marking them out from

Fig 11: Extended door reveal

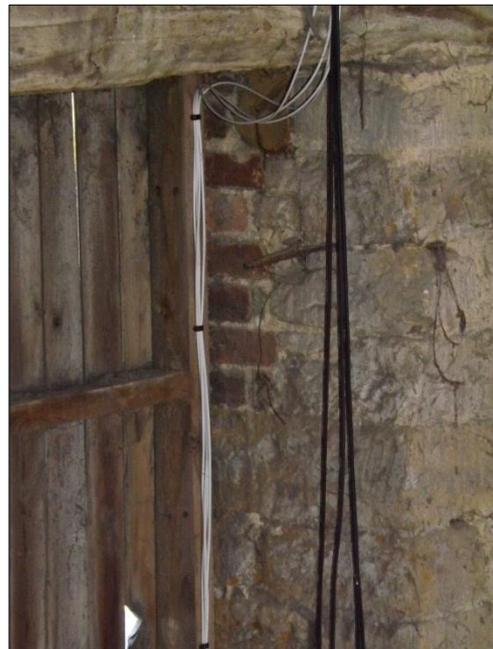
the original stone quoins (Fig 12). Taking out these large portions of stonework at the midpoints of the building seems to have had a deleterious effect on the stability of the walls of the long axes. There is very slight bowing observed, which may have been arrested by the attachment of iron straps through the walls, fixing the outer surfaces to the tie-beams of the roof structure (Fig 15).

Fig.12: Brick quoins on extended reveal

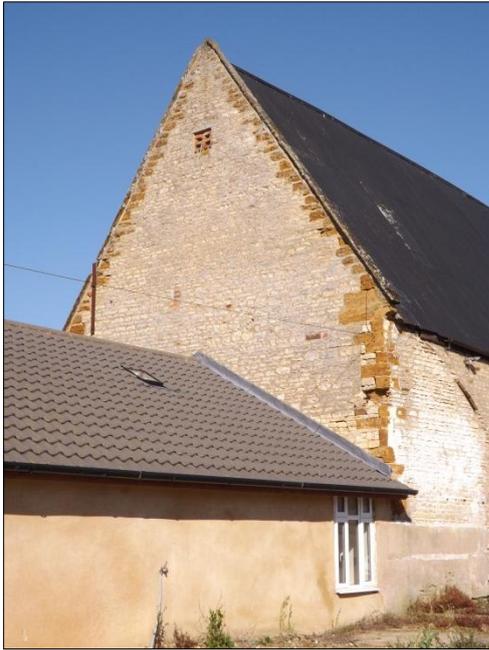
High in both gables are owl holes (Figs 13 and 14). At the south-east the hole is a simple opening, while that on the opposite gable comprises a bull's eye in brick with an insert of stone.

Fig 13: Owl hole in brick

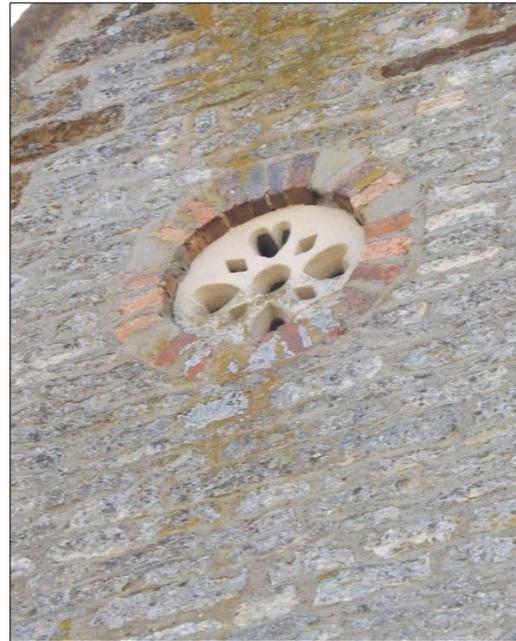
Fig 14: Owl hole in stone

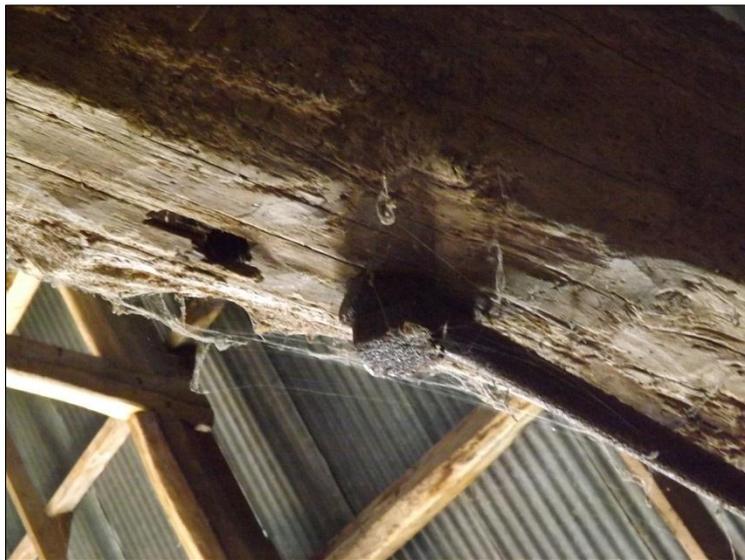
Fig 15: One of the iron bolts and straps fixing the wall to the tie beams

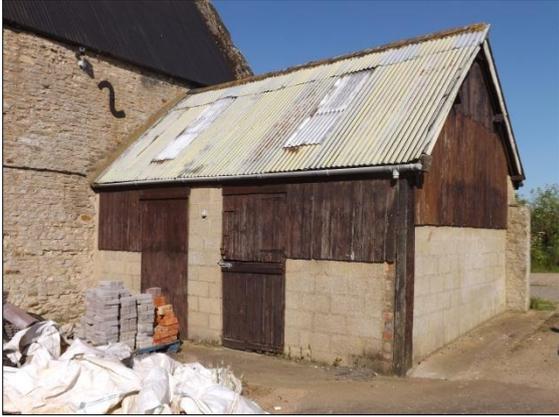
Onto the north-eastern corner of the main barn has been attached a stone wall off which lies a timber and block-work stable/store building of two bays (Figs 5, 16 and 17). While the stone rear wall is of indeterminate age, it probably was there as early as 1791. It has subsequently been buttressed in brick, the block-work and timber, which includes reused railway sleepers, is probably dated to the period between 1967 and 1977, on the basis of its first depiction on OS maps of those dates.

Fig 16: The added stable/store

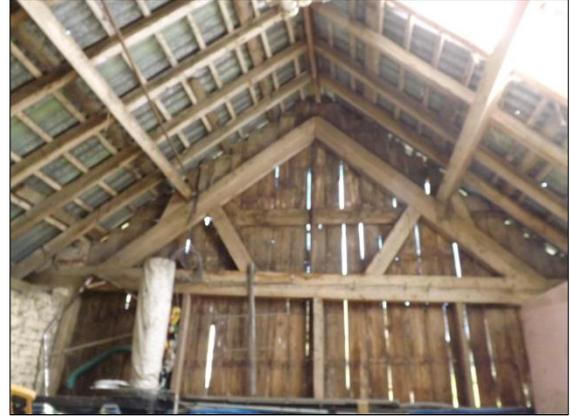
Fig.17: The stable/store interior roof truss
