**Building Analysis and Recording adjacent to
the former kitchen gardens of
Ecton Hall, Northamptonshire**

3 January 2014

Building Analysis and Recording adjacent to the former Kitchen Gardens of Ecton Hall, Northamptonshire

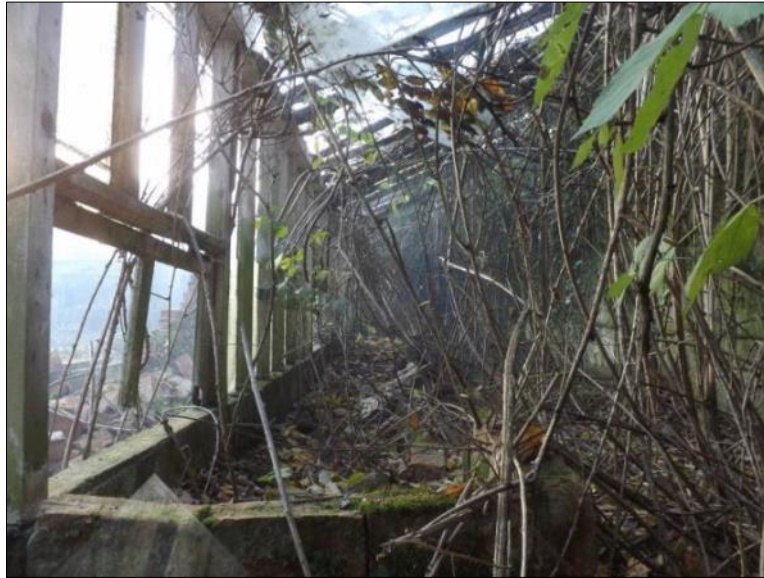
Fig 2: Building 9 (Greenhouse) with typical dense undergrowth; note the teetering glass panes above

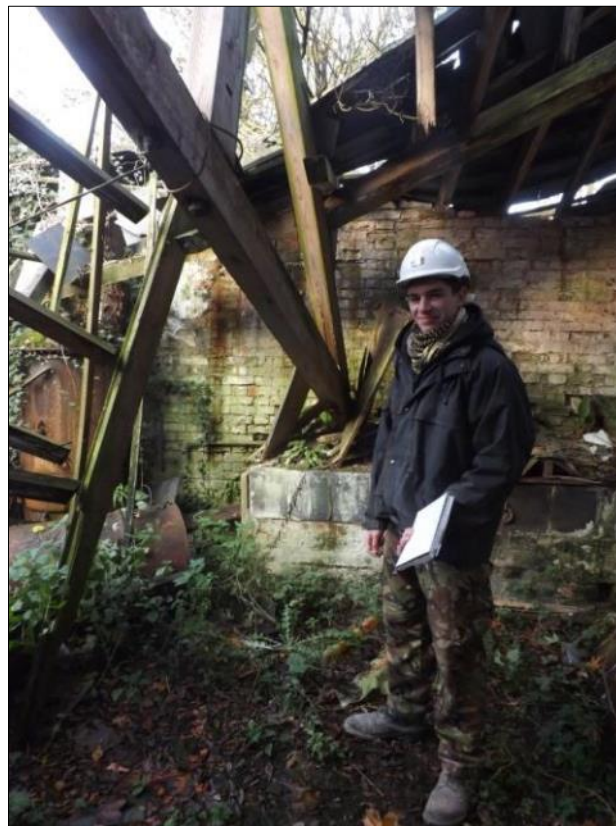
Fig 3: Recording within the collapsing roof of the eastern half of Building 1 (Stables)

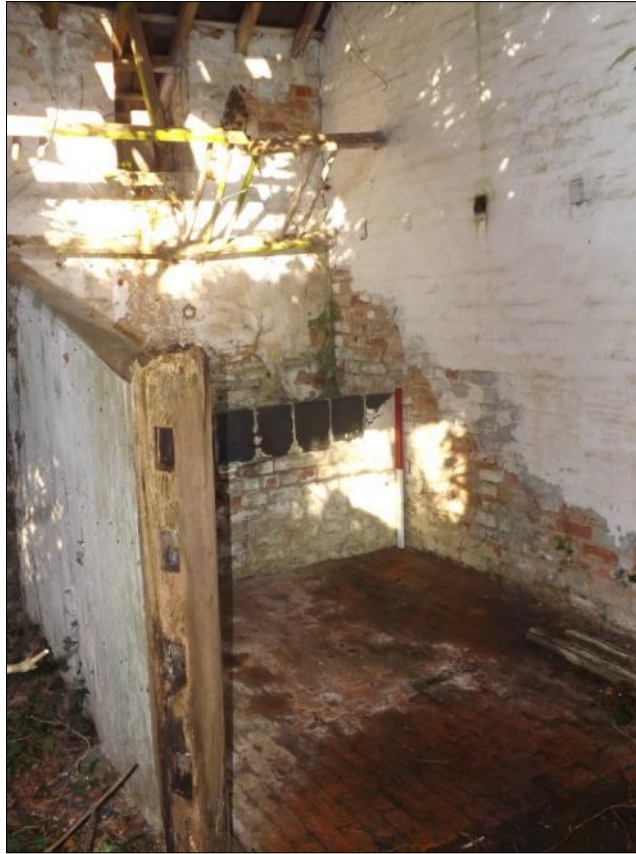
This building measures 26.5m east-west x 4.9m north-south, and is brick-built against the south side of the ironstone wall which forms the southern side of the kitchen garden. There are two surviving stalls, one for two horses, and the other for a single animal. The stall division is probably elm, lime-washed. There is a continuous brick trough, wooden hayrack and ventilation openings still retaining wooden shutters (Fig 10). There are iron tethering rings throughout. There is a drainage gully just south of the heelpost.

Fig 10: Building 1, surviving stall with trough and hayrack; ventilator above

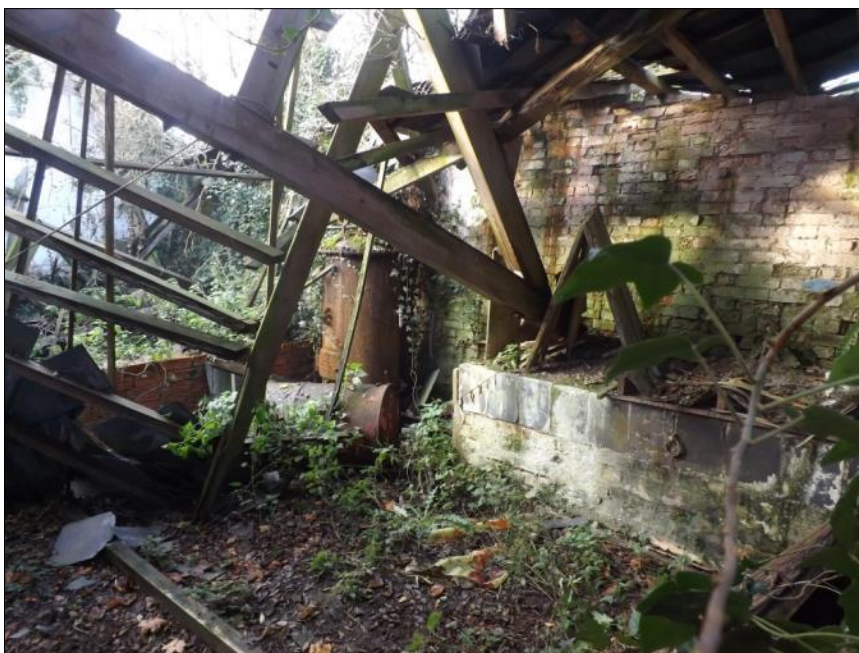
To the east, another double doorway at the midpoint of range created a cart-access to the kitchen garden. The eastern half started as an inexact repetition of the west but for the stable being of three bays divided by two king-strut trusses; this has been later (post-1935) converted to a potting-shed with staging and the introduction of a dated heating boiler where the line of brick feed troughs had been interrupted. There was a cobbled floor with a secondary, redundant chimney in the north-east corner of the east-end room. This end room may have been another tack store (but heated, unlike the first). An OS Map (Fig 8) shows a pump (well) once stood just south of the easternmost room, but there was no visible evidence of this at the time of recording.

Fig 12: The eastern half of Building 1 in a state of collapse; the boiler in the background is named 'Perkins Jubilee 1935 Derby England', and is Jubilee no 04944/2.

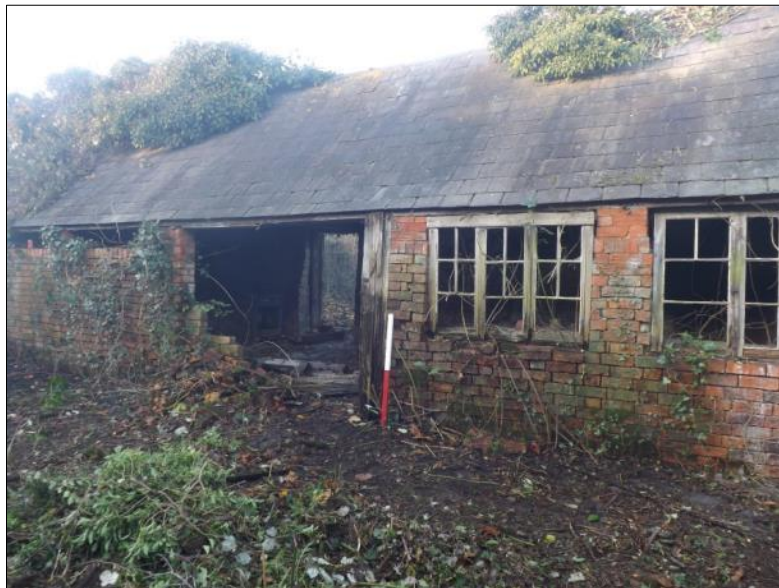
Originally open on the south side, probably as an animal shelter, the structure was subsequently infilled in brick with a high-level ventilation-slot, typical of pig-keeping, and with a single door. In the angles of the south wall against the two gable ends were formerly two cast-iron troughs, only one of which remained. The low level at which they were set is also in keeping with use by pigs.

Fig 14: Building 2, south wall. Left half brick in-filled for pigs, leaving a ventilation slot; right half re-adapted for potting; scale 1m

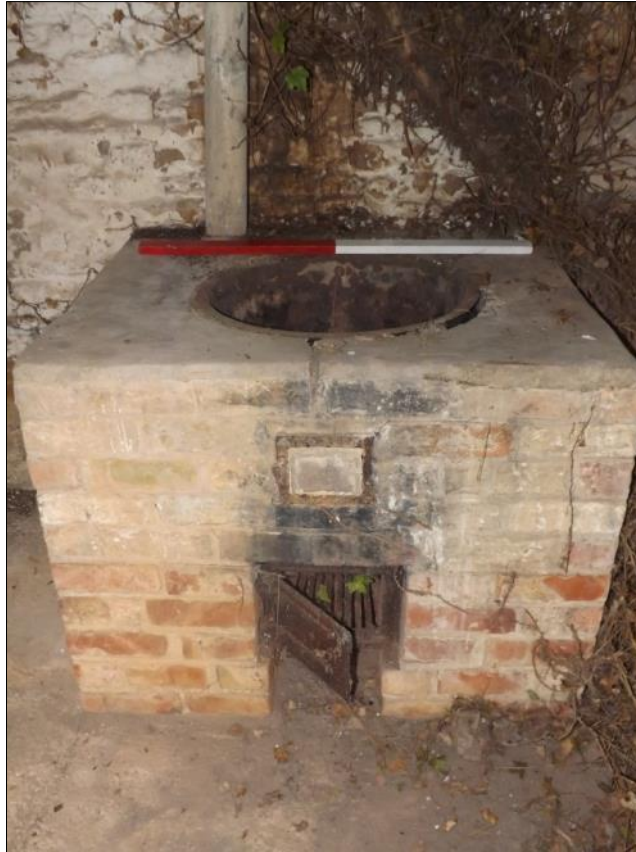
Over half of the south-facing front was again re-built, with the insertion of three windows to create a potting shed. During this last phase and iron 'copper' was inserted. The fire box door has Johnson & Wright, Northampton in the casting.

Fig 15: Building 2, the inserted copper; scale 1m

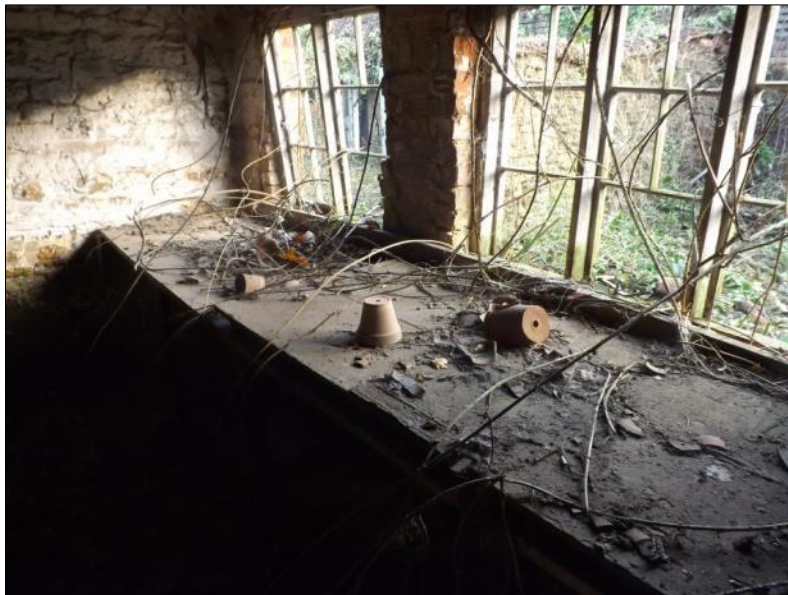
Fig 16: Building 2 interior, as abandoned potting shed; old doors formed the staging

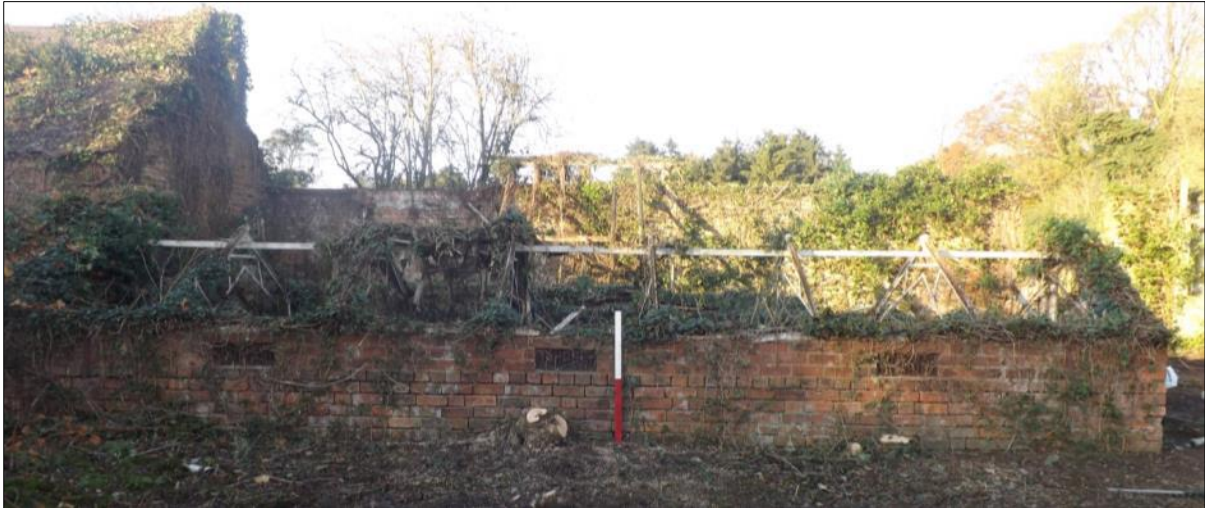
Its low brick walls supported a formerly glazed roof on six cast-iron trusses, each of which had an opening mechanism for whole-side opening, with a separate, moveable ridge-louver. The frames had all rotted away. From there are fixed a trellis framework assembly for the training guides and longitudinal wires for cucumbers at a nominal 9 inches from the glass. The main growing area comprises long, low growing beds which were formed merely of raised hillocks of open compost on slate tables either side of a central walkway (Watson 1933, 85). Both the under-table and glazed parts of the house were heated directly from separate sets of pipes, fed from a small boiler house at the end of the building. The cast iron boiler still survived, stamped “Kinnel house, Foster and Pearson, Beeston, Notts.”

Fig 18: Building 3, Cucumber House, south side. Note the cast-iron trusses and steady iron ridge-pole; scale 1m

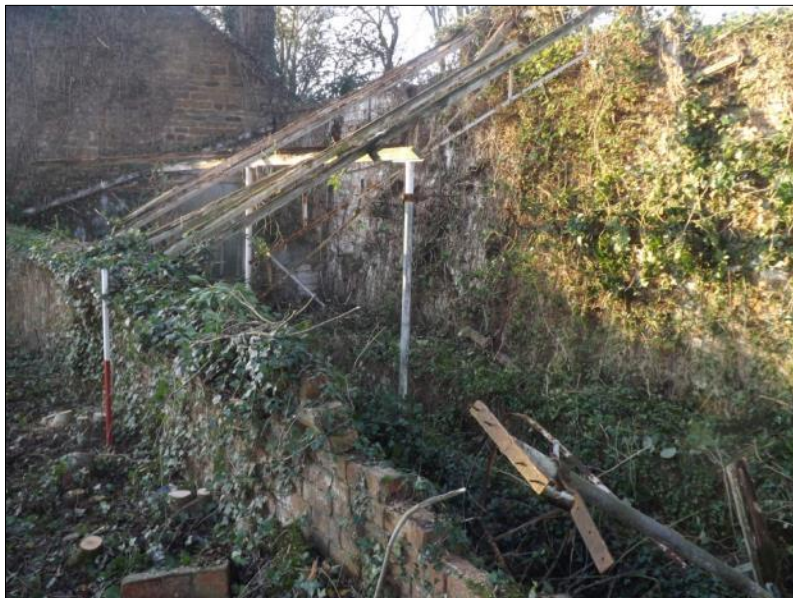
This former building measured 12.4m x 3.7m in plan, laid out in brick to waist-height, but almost no timber superstructure survived, where it once stood against the north wall of the garden, above which it was built to protrude. There had been sunken beds either side of a central pathway. There were training wires on the south-facing wall and heating pipes to a broken-down boiler house at west end which had barely survived.

Fig 19: Building 4, Greenhouse. The least-well preserved fragment of the broken-down greenhouses; scale 1m

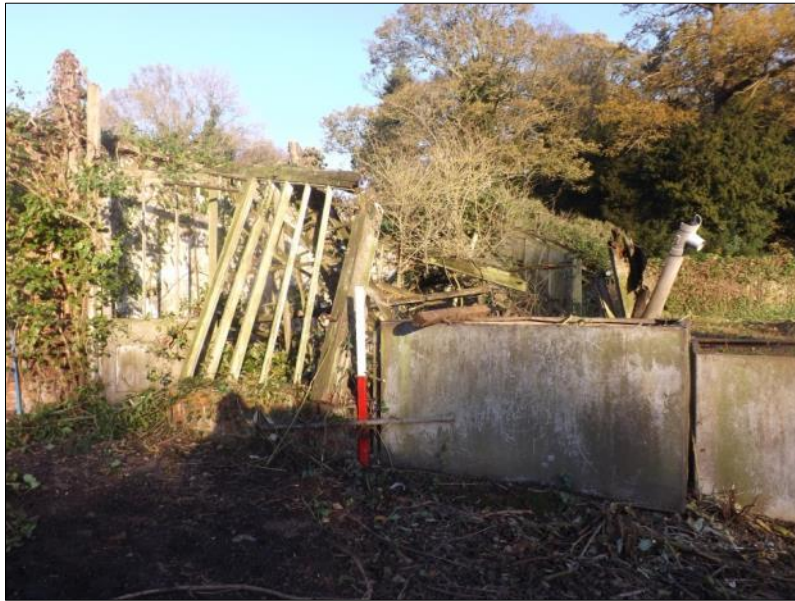
This desperately-collapsing greenhouse, known in its most recent use as The Peach House (Colin Sotheby, *pers comm*), once measured 24.7m long x 3m wide. However, only the western half had survived, with the eastern half taken down completely some time ago.

The superstructure had been apparently identical to building 4 greenhouse, but had been constructed on low brick foundations. Some were spanned on arches, suggestive perhaps of a vine-house design originally, for which this characteristic is often reserved, to enable the vines to have their roots outside, but their fruiting boughs enclosed. The south-facing rear wall was limewashed.

Fig 20: Behind galvanised water-tanks, greenhouse (building 5, viewed from the west) was in an advanced state of collapse; scale 1m

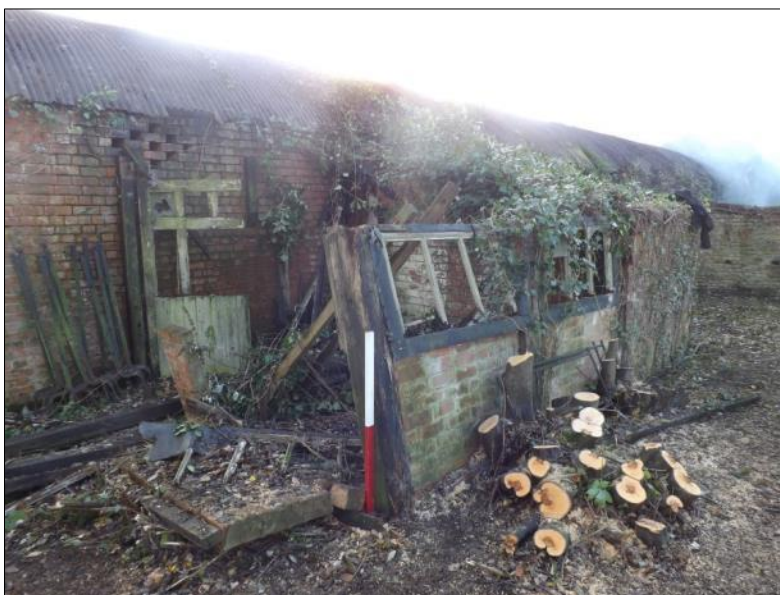
These crudely-assembled outbuildings measured 3.17m x 5m in total and comprised a roofless and collapsing, two-cubicle outside brick toilet with a timber shed built onto the back of it, which had brick-nogged panels between uprights. The whole was in an advanced state of decay and had been built onto the back of the corrugated tin barn (8).

Fig 21: The collapsed WC and brick and timber shed, viewed from the north-east; scale 1m. It was constructed against the north wall of Building 8, of which a brick-diaper ventilator can be seen.

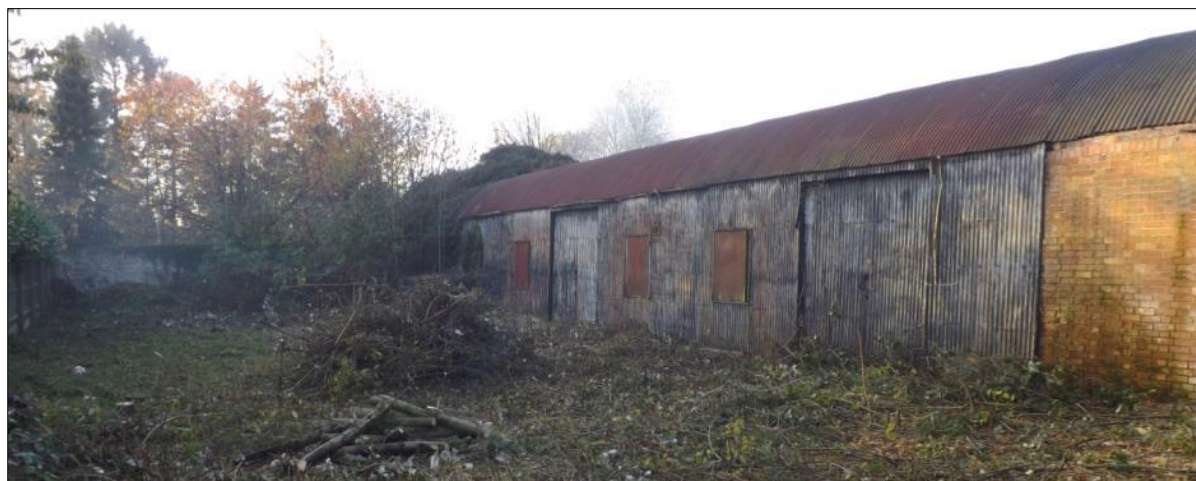
This building was by far the largest on the site, measuring 33.2m x 6m. It employed north and west walls of ironstone with brick on the inner face. The north wall began as a simple garden division and had been lengthened to the east by one bay and increased in height to establish the barn eaves level. Louvers and a diaper pattern of open brickwork alternated to form ventilators at just below eaves all along the north wall. Brick was used to create gables over which was laid a corrugated tin roof in an arc with simple scissor-frame braces. The south wall was of corrugated tin but for one bay at the east (which was part of the eastwards extension). Two pairs of sliding double doors opened onto the south side and alongside there were four casement-windows, all blocked. There was a concrete floor.

Fig 22: The southern, corrugated tin wall of Building 8; the brick bay on the right (east) is an extension.

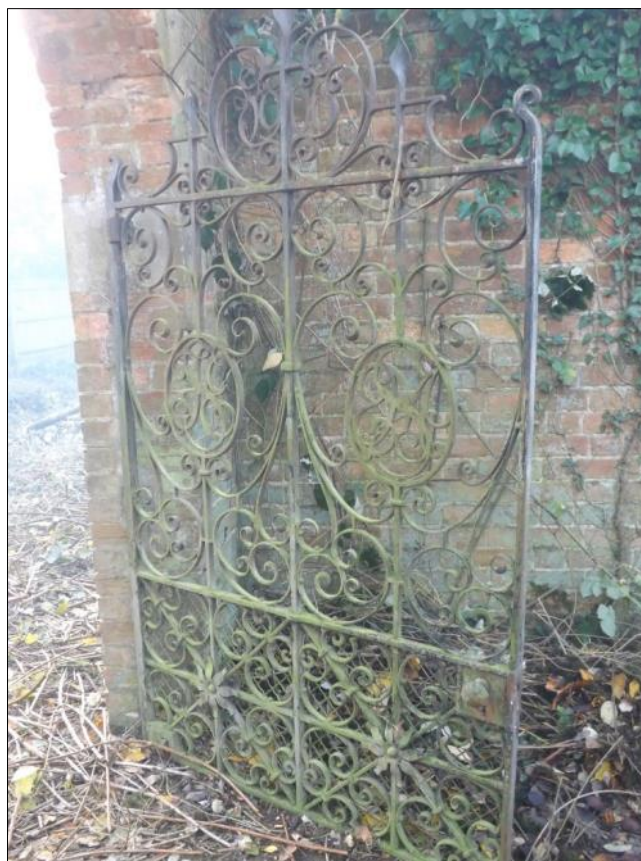
Between Building 8 and Building 9 stood a gateway with a wrought-iron pedestrian garden gate bearing the initials FES and EMS and the date 1906. The initials are those of Major General Frederick Edward Sotheby and his wife Edith May Sotheby. They inherited the estate in 1889 and Frederick dies in 1909. It is perhaps reasonable to consider that of the Sotheby's, Frederick was the most proud of the gardens as they were approaching their zenith, and works after 1889 are attributable to him.

Fig 23: The focal wrought-iron gate across the axial path, monogrammed and dated 1906.

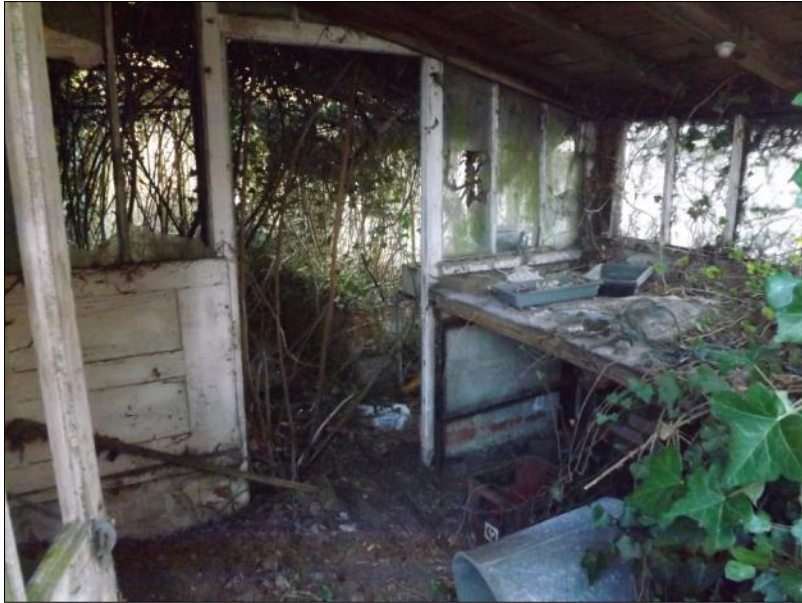
This greenhouse comprised the most extensive surviving remains of this type, measuring in plan 24.8m x 3.6m. The entire superstructure was severely dilapidated and collapsing. It had been a heated greenhouse on the same construction principles as Buildings 4 and 5. A potting bay lay at the west end and a sunken boiler house at the east end. The surviving boiler was an oil-fired 'Robin Hood Junior'. Unlike the glass-construction of the rest, the boiler-house bay was of corrugated asbestos, and therefore probably dating to the 1950s. This probably replaced an earlier boiler-house, since there was a near-complete collapsed brick chimney with chimney-pot still attached, lying in the north-east quadrant of the garden amongst undergrowth (See Fig 4 for location). Too large for transportation on a barrow or cart, this structural feature can only have fallen from the boiler house position.

Fig 24: The potting bay at the west end of Building 9 (Greenhouse)

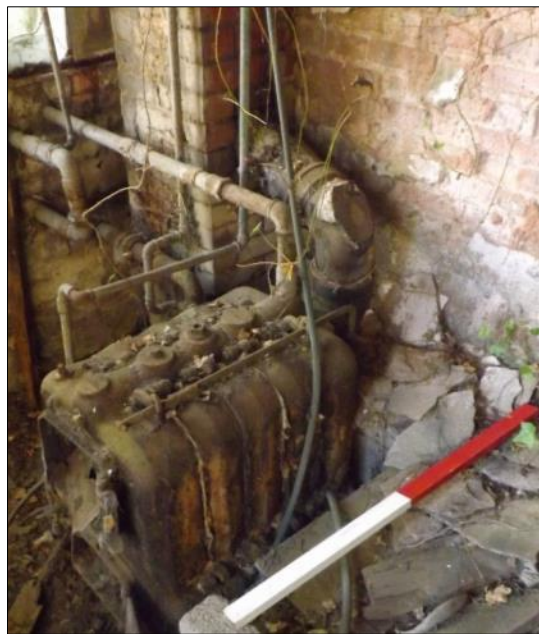
Fig 25: The Robin Hood boiler serving Building 9 (Greenhouse); scale 1m

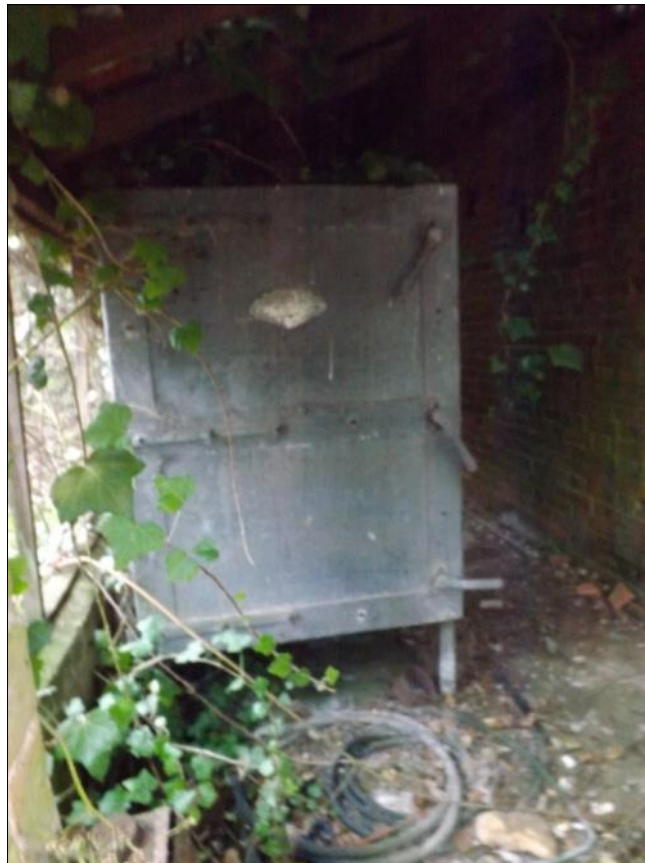
- 2) In the middle, brick piers supporting a pan-tiled roof and which contained a large galvanised steel safe, possibly for storing seed originally, but given the storage of flammable fuels, may have been used to store corrosive or poisonous substances, such as weed-killers and sterilising fluids beloved of 1950s gardeners.
- 3) The southern end, a timber frame under which was parked an Allen-scythe and fuel bottles/drums.

Fig 26: A galvanised steel seed-safe taking up most of Building 10's centre bay

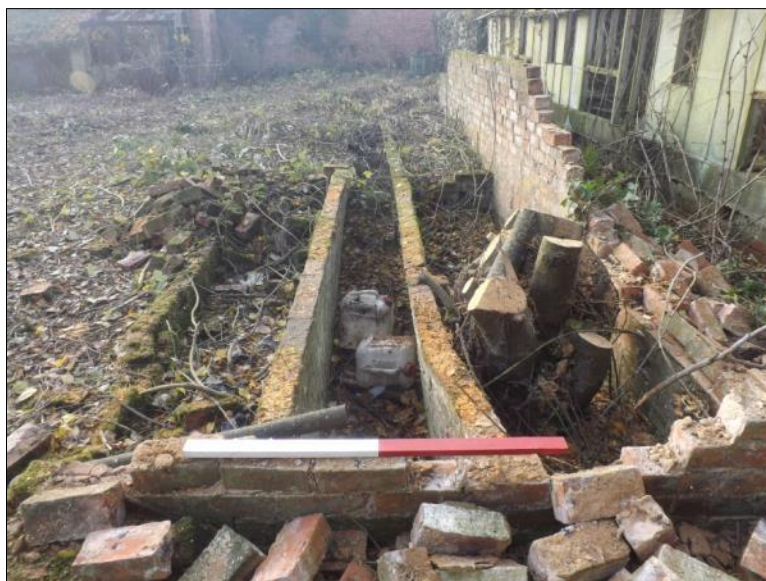
These denuded brick structures lacked any covering but are thought to have been stand-alone deep beds or cold-frames which could be heated by a jury-rigged pipe system on a spur from Building 9 (Greenhouse) and its boiler close to which they stood. They had been prised apart and collapsed when a tree had been allowed to grow inside. One side had collapsed completely, while the other survived only in part. There was a narrow access passage between the two.

Fig 27: The former cold frames (Building 11); scale 1m. To the right Building 9 (Greenhouse)
