**Archaeological Building Recording at the former
Stromag factory, Wellingborough Road,
Rushden, Northamptonshire**

Archaeological building recording at the former Stromag factory, Wellingborough Road, Rushden, Northamptonshire

(Fieldwork by Joe Prentice, Charlotte Walker and Iain Soden)

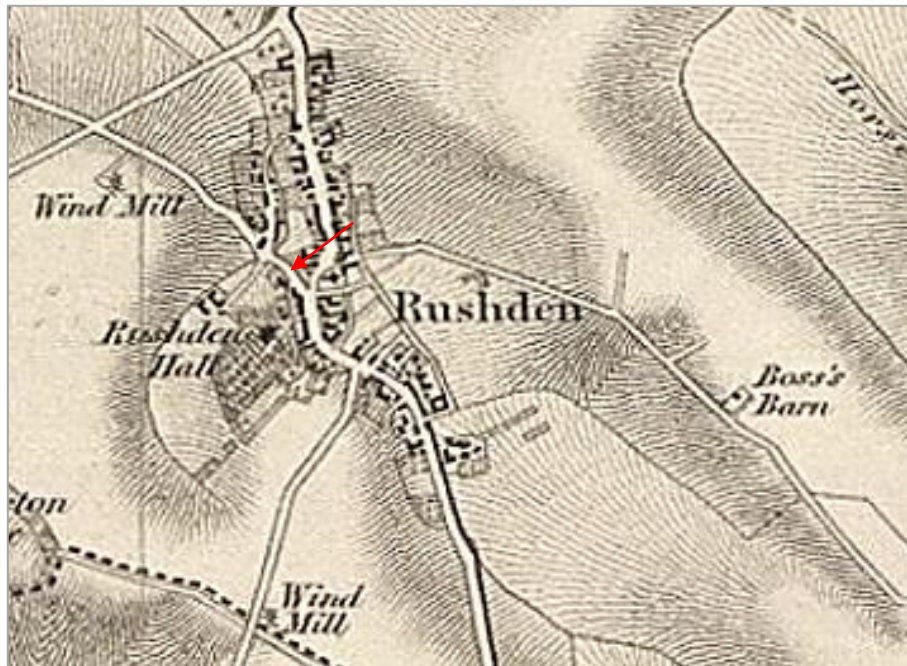
Fig 2: Ordnance Survey First Series, 1834

The earliest map of Rushden, the Ordnance Survey First Series of 1834, though not particularly detailed, shows a long building along the Wellingborough Road frontage. This is likely to be the house from which the frontage property known as 'Brookfied' evolved (see Fig 15 for its layout). There is no building on the frontage of the road to the west of the plot, and it is therefore most likely that this is the building referred to in the will and other documents.

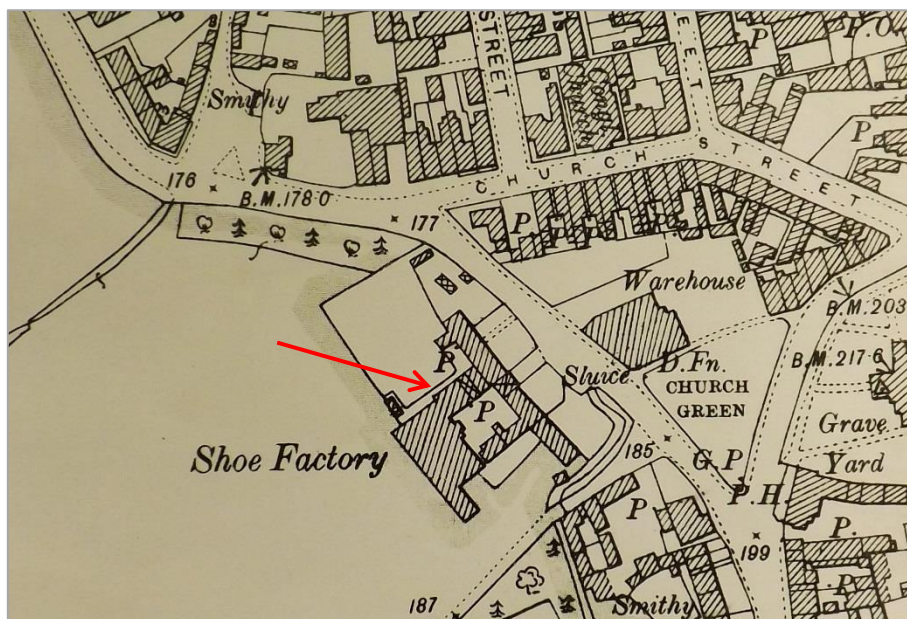
Fig 4: Ordnance Survey map, 1900

This range appears to have survived later modifications to the factory. In 1889 the factory was 'rebuilt', as recorded on the gable of the frontage range *Rebuilt 1889 WC* (for William Claridge). Some early fabric, similar in form to the older parts of Brookfield, appears to have survived this rebuilding, but it was raised to three storeys. To the rear, the narrow range observed on the 1884 map was replaced by a ten-bay brick building with a carriageway passing through the central part (Fig 4).

Of a later phase, but present by the 1900 Ordnance Survey map, was the gatehouse range, which partially wraps around the 1889 building (Fig 4). The gatehouse also adjoined a thatched cottage which was present to the south-east until the 1920s (Fig 5). Census records indicate that this property was inhabited by John Scott in the later 19th and early 20th centuries. Also present by 1900 were the ranges to the south including the north-light sheds and the further three-storey brick built range extending to the south-east. Further buildings also appear to have been erected behind the thatched cottage, although it is not clear whether these are associated with the main factory at this date.

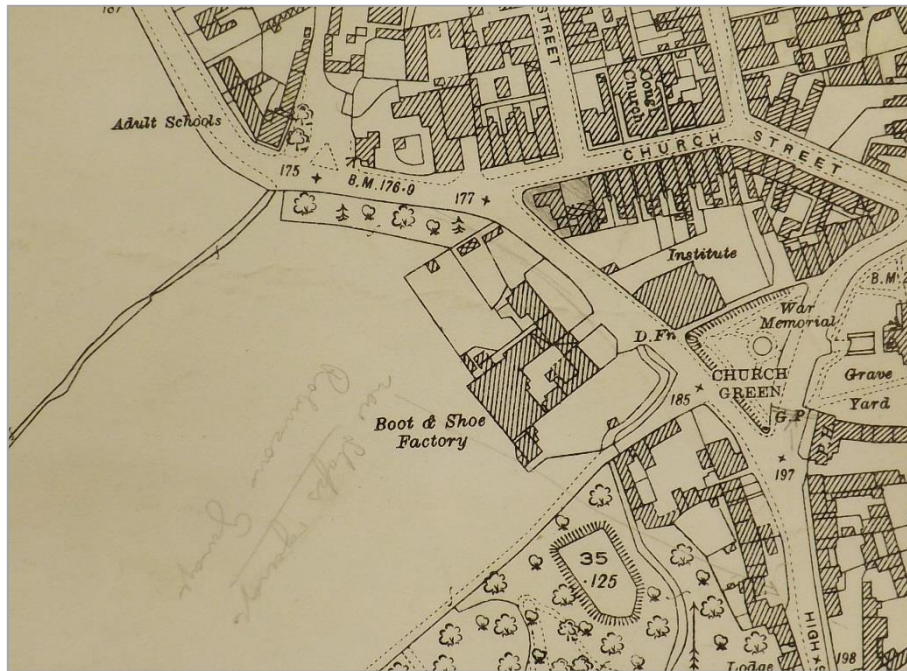
Fig 7: Ordnance Survey map, 1926

A plan of the land in ownership of the Claridge's in 1922 shows that they held all the land and buildings on this plot on the Wellingborough Road (Fig 6). The buildings to the rear of Scott's cottage had been further extended by this date; the 1926 Ordnance Survey map indicates that one of the buildings was partially open to the north-west (Fig 7). This suggests that it was connected with the factory, since it opened into what was a yard at that date. There were few other alterations in the period between 1900 and 1926, other than the probable addition of the toilet block and the apparent relocation of the carriage-arch through the rear part of the 1889 block. In the 1900 edition, this feature is shown at a slight remove from the rear of Brookfield, in the 1926 edition it is shown directly behind the house. No evidence of the original carriage-arch was observed in the fabric of this range, although much of it was obscured by the modern addition.

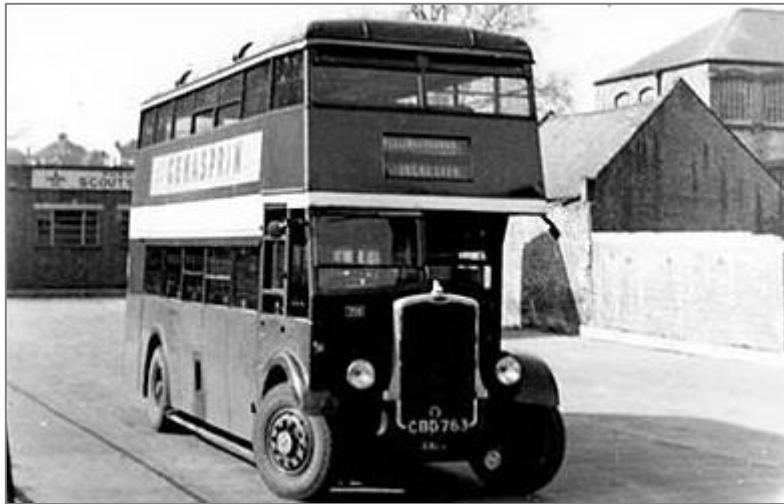
By 1927, the thatched cottage seems to have been demolished (according to a pencil note on the legal documents). Certainly, by the 1960s, the cottage had gone, although the ranges to the rear remained; a photograph of around 1948 indicates that these may have been of single storey brick construction (Fig 8). It is possible that some of these buildings were incorporated into the buildings now associated with Orbit Tyres, although the thatched cottage frontage itself stood forward of the tyre premises, where its customer car park now lies.

Fig 8: The area to the south-east of the factory, looking west, c 1948. One of the lost buildings associated with Claridge's is visible behind the bus to the right (Rushdenheritage.co.uk)

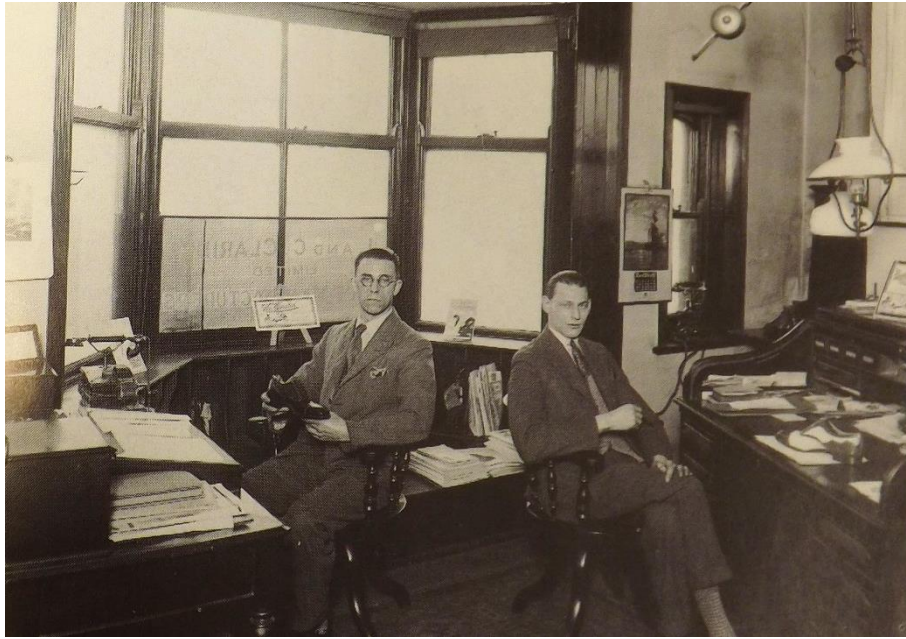
Fig 10: The office at Claridge's, with the oriel window of Room F3, c 1922

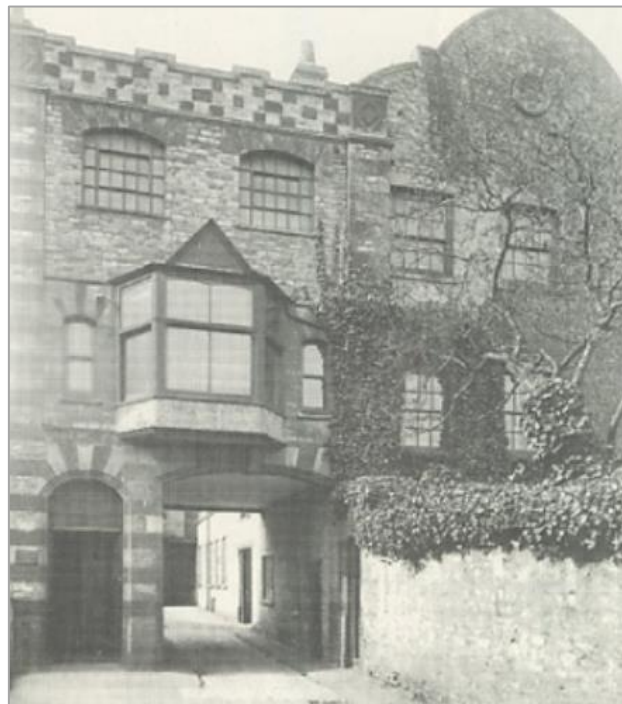
Fig 11: The exterior of the factory c1922

In early 20th century photographs of the factory, the windows on the second floor of the gatehouse range are of Critall type, similar to those still in place elsewhere in the factory (ie room S8). A chimney can also be seen between the 1889 range and the gatehouse range; this has subsequently been removed, possibly when the gatehouse was re-roofed. A further chimney on the south-eastern elevation of the gatehouse has also been removed, although some of the fabric has survived. A wall divided the 1889 factory range and the gatehouse range. Since there does not appear to have been

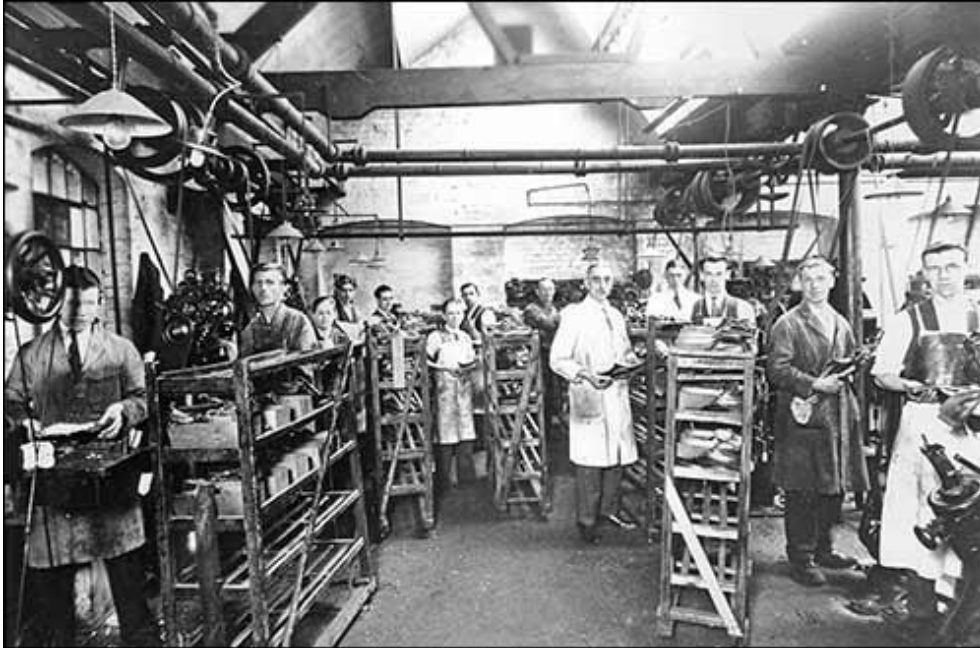
Fig 12: Interior of the north-light sheds (G3),
with overhead belt drives (rushdenheritage.co.uk)

The glazed roofs face south-west, the north-western side is tiled in slate. All three ranges were brick-built with concrete floors. Intermediate cast iron columns support the roof structure. The roof is of queen post truss construction. The roof is glazed on the north side with probably Trafford tile on the south. Blocked segmental arched windows are visible in the south-east, north-east and south-west elevations, to provide extra light to the factory floor (Fig 38). The overhead belt drives, as shown in historic photos of the shoe factory, have been entirely stripped out.

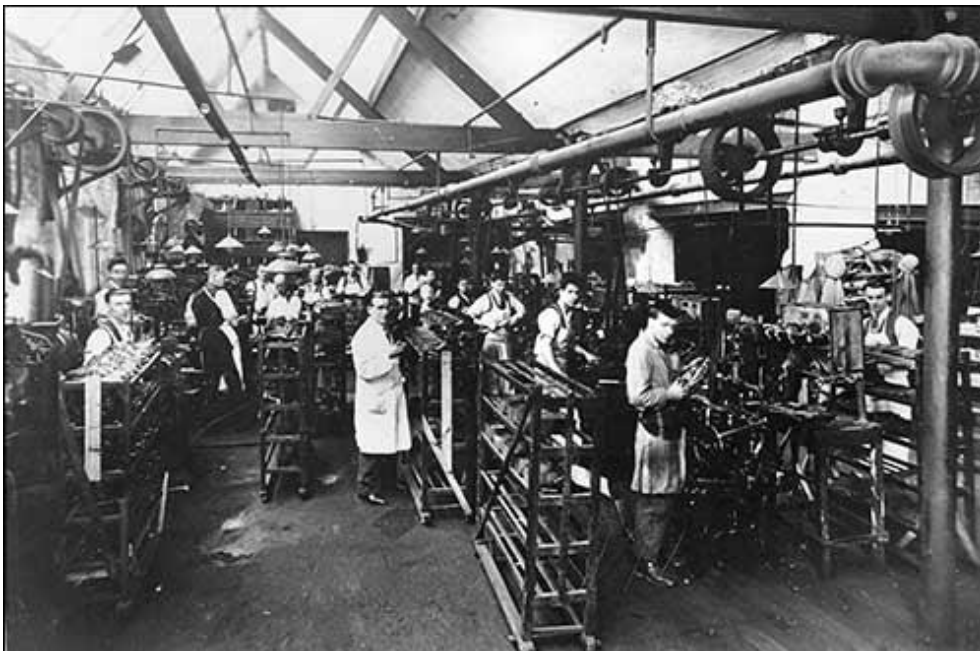
Fig 13: The north-light sheds (G3),
with brick columns of the possible 1870s range to rear right (rushdeheritage.co.uk)

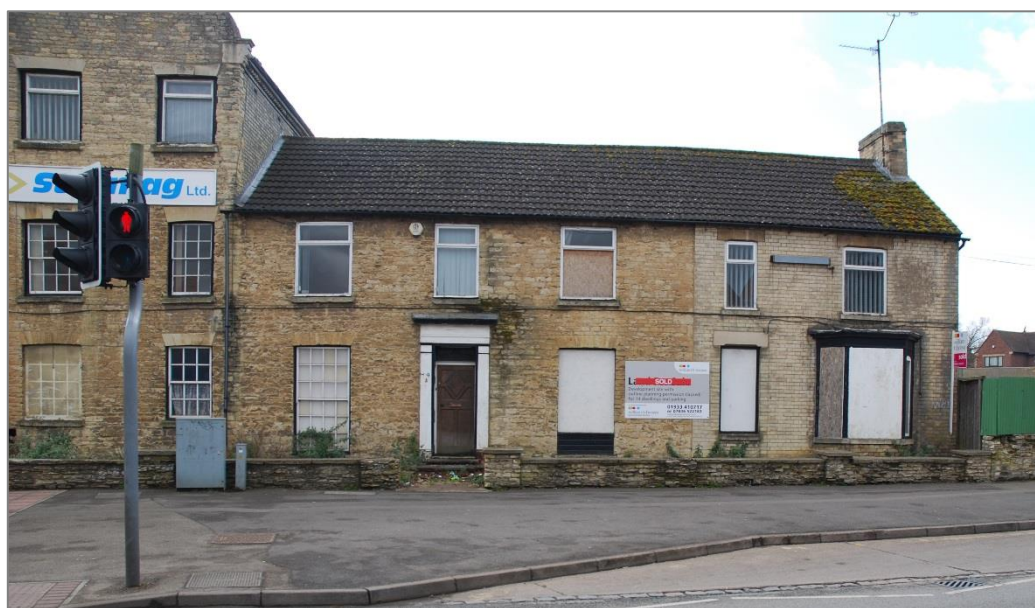
The original house is of two storeys with three-bays of coursed limestone rubble (Fig 18). The ground floor windows have flat stone arches and stone sills; the window to the left of the central doorway retains its long sash window of 24 lights, which almost extends to floor level. To the right the window, which is boarded up, has been partially blocked at the base by horizontal wooden panelling. The central entrance has two steps up to a shallow porch with a simple wooden surround. The simple rectangular fanlight is glazed with a decorative leaded light bearing the name *Brookfield*. The door itself is unpainted panelled oak with a diamond in the upper half. The windows on the first floor, also with flat arches over, have all been replaced with 2-light casements. To the rear much of the ground floor has been obscured by a later red-brick extension. Two former openings immediately to the right of the brick extension have been blocked with brick. Two windows survive in the south-eastern bay; a 2-light casement window with a stone sill and wooden lintel and a small 6-light casement window also with a stone sill and wooden lintel. The latter is likely a former pantry window. On the first floor the three windows are all replacement 2-light casements, with stone sills and timber lintels that are almost at eaves height. The roof is modern concrete tile.

Fig 18: Frontage of Brookfield, looking south-west

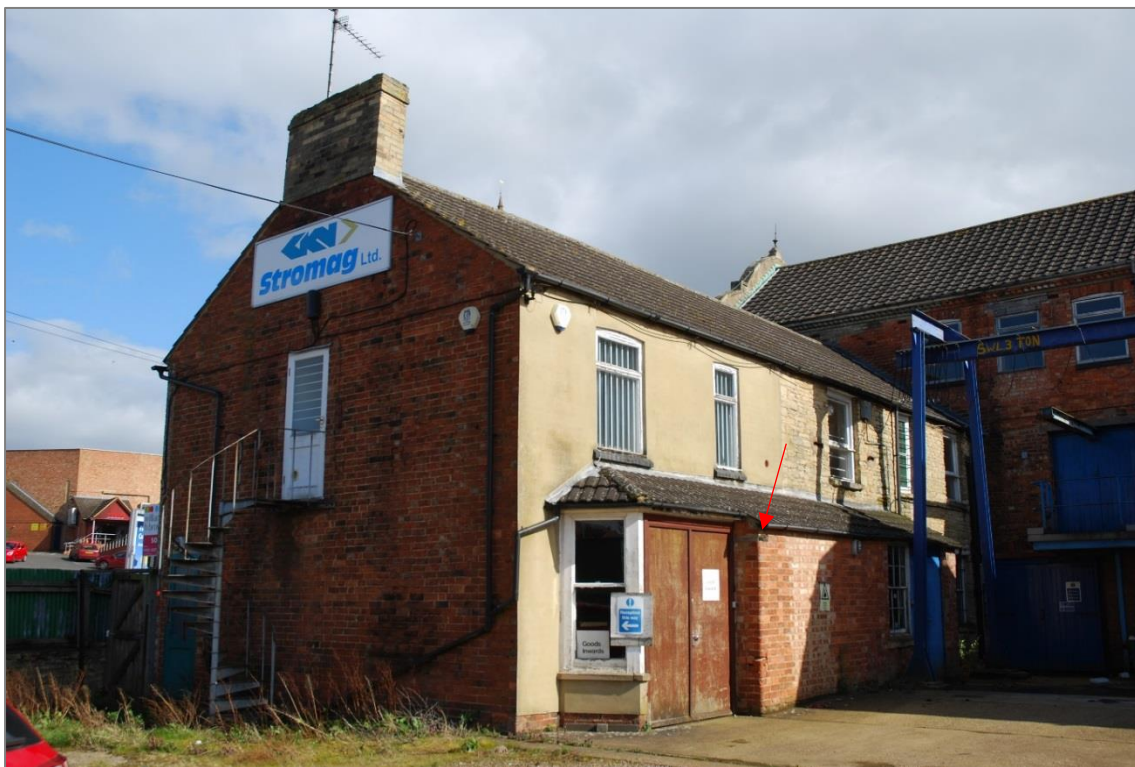
The later narrow red-brick extension, which was probably built when John Claridge united the two dwellings in c1922, runs along the rear of the two properties and provides access between the rear rooms (Fig 19). It has a pitched concrete tiled roof against the rear wall of Brookfield. A pair of plywood doors have been inserted into the front of the former bay. To the right of the doors the brick wall extends outwards slightly with bull nose bricks on the corner. A former wooden lintel is present in the short length of wall extending outwards from the double doors, indicating the presence of a former entrance; modern brick infill is also identifiable (lintel indicated by arrow on Fig 16). A further blocked doorway is also present on the extension. A 16-light, unhorned sash window on the rear wall is likely to have been moved from another location prior to its insertion, as it is stylistically too early. It may have been located in the original rear wall of the house. A pair of braced and ledged doors are located to the right of the window.

Fig 19: Rear of Brookfield and 1889 factory range, looking north-east

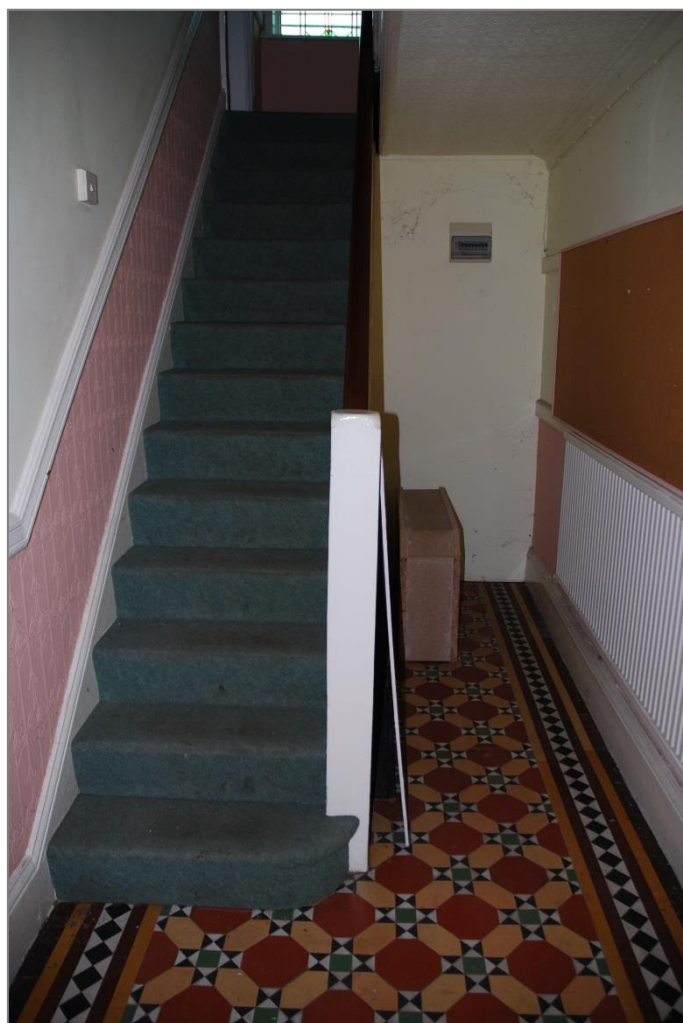
The main entrance allows access to the first floor only via a staircase rising just inside the front door (Fig 20). The hall has blocked doors either side and is tiled with patterned encaustic tiles. Skirting boards, dado rail and cornicing extend up the staircase. The wooden newel post of the staircase is plain, the handrail is of mahogany, and the remainder had been boxed in.

Fig 20: Brookfield hallway with Minton-type tiles

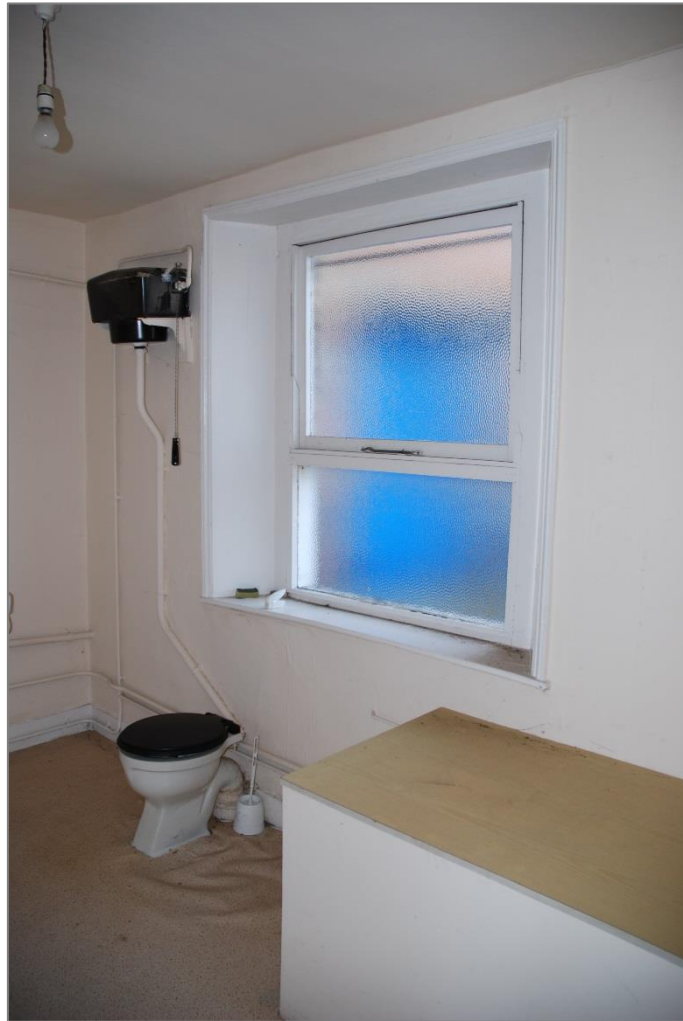
Fittings included a toilet with overhead cistern, hand basin and cupboard. An enclosed shelf to the right of the window may have been a boxed in bath (?).

Fig 21: Room F10, bathroom, looking south

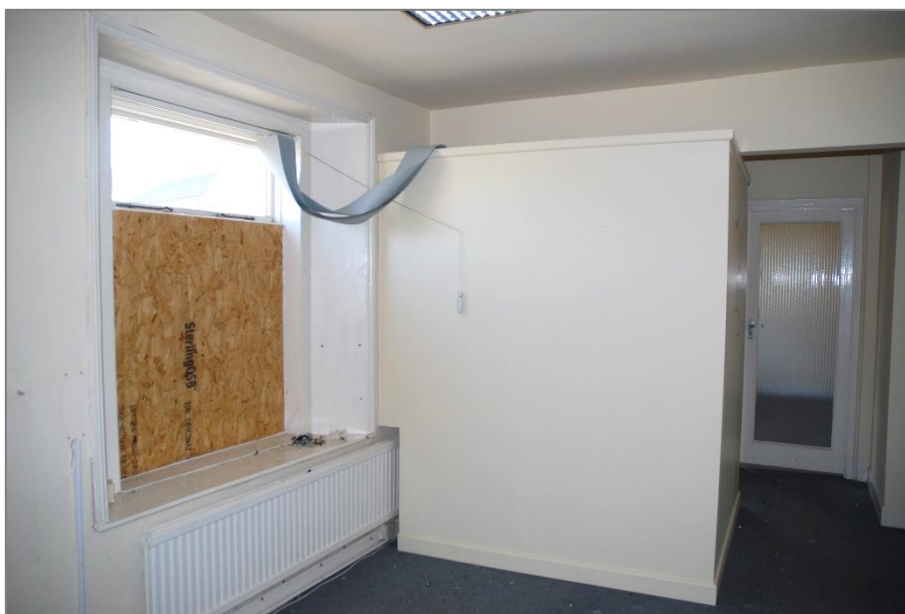
Accessed from the hall via a glass panelled door. Former office area that has been sub-divided with partitions (Fig 22). Two 2-light casement windows with splayed reveals facing onto Wellingborough Road. A former room division is apparent from front to back, located midway between the two casement windows.

Fig 22: Office F12, with modern partition and evidence of former room division above

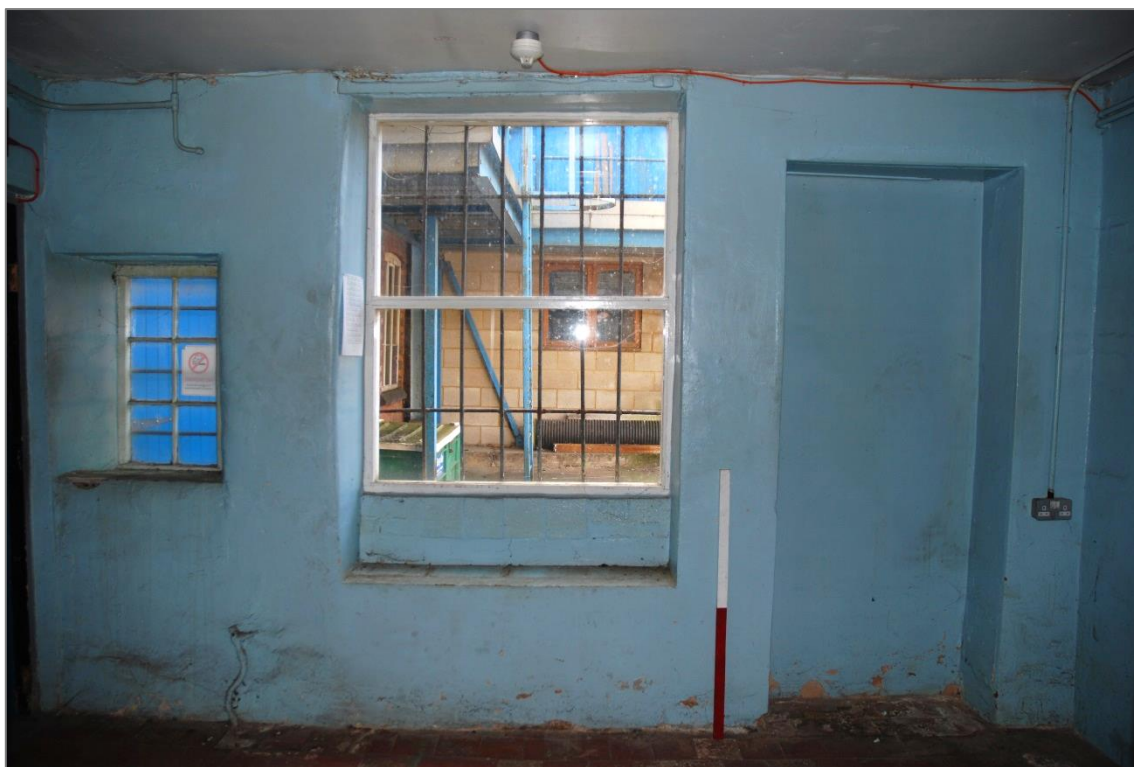
Access to this room is from the corridor to G8 from the main factory. Situated to the rear of the house, this room has red scullery tiles which have been painted red (Fig 23). There are two windows and a blocked doorway to the rear of the room. The central window is a non-opening 2-light casement with a ledge below for a sink. The small 6-light casement window to the left has a splayed reveal on the southern side and a tiled sill. In the north-western corner of the room is a built-in pantry cupboard (Fig 24).

Fig 23: Room G10, looking south-west into factory yard; scale 1m

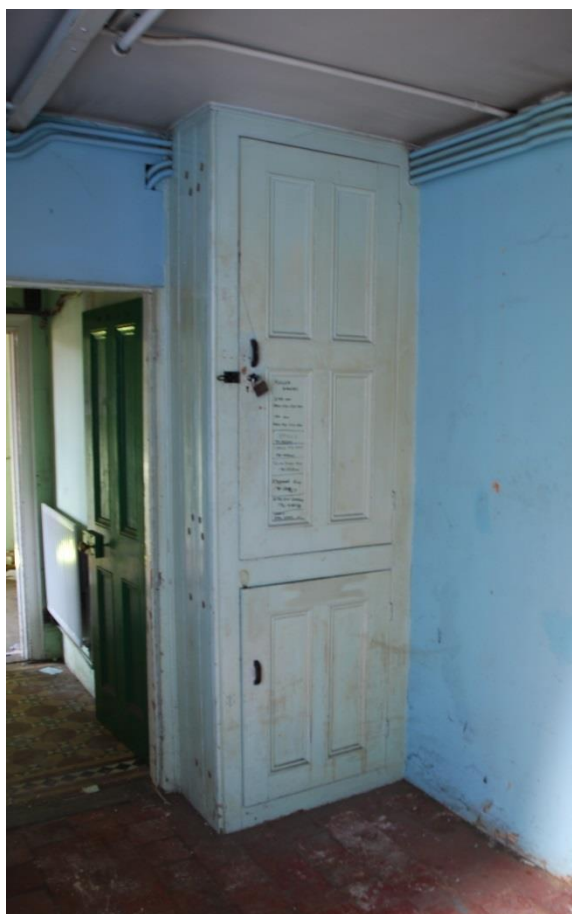
Fig 24: Room G10, built-in pantry cupboard

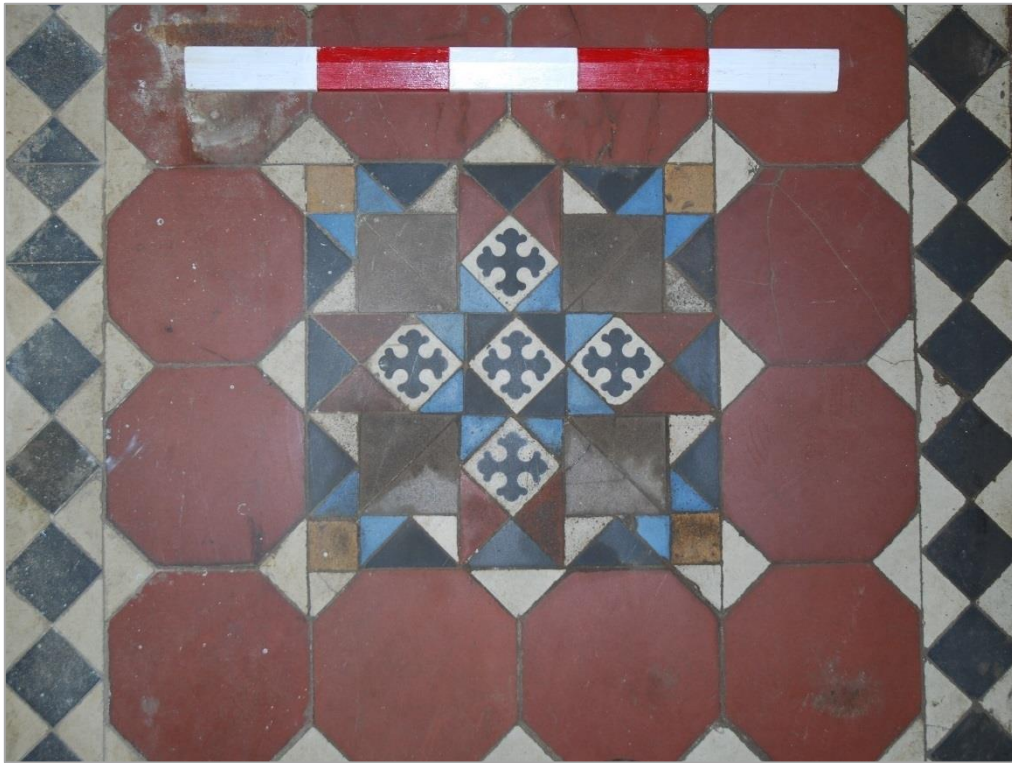
A short length of hallway between rooms G11 and G13 is tiled with an elaborate pattern of encaustic tiles (Fig 25).

Fig 25: Minton-type tiled hallway floor, G11 into G13; scale 50cm

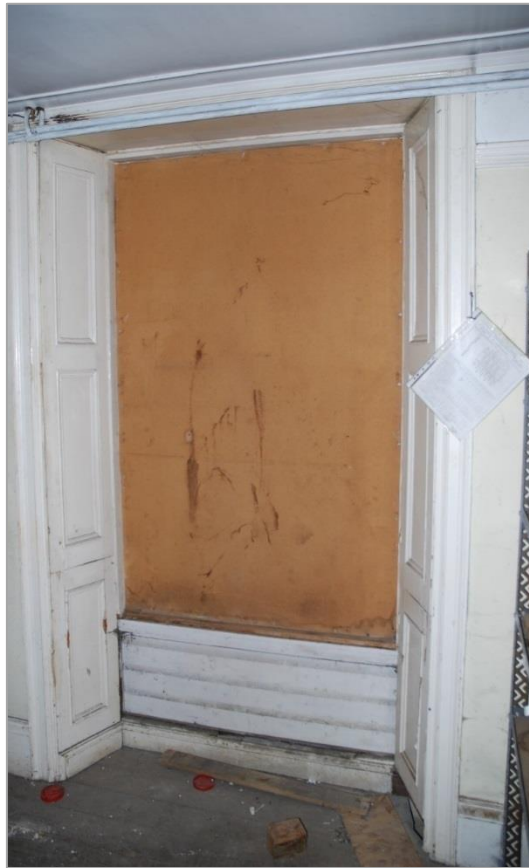
A large splayed window looking out onto Wellingborough Road, with boarded up shutter boxes surviving to either side (Fig 26). The floor is of untreated knotty pine floorboards, suggesting that an overlying floor covering had been stripped out. There is an off-centre brick fireplace with a gauged brick arch on the north-western wall. The fireplace may have inserted during the 19th century. In the south-east wall there is a boarded up door which would have led into the entrance hall. There is a picture rail around much of the room. The rear wall has been largely knocked through into G11. Much of the room was taken up by metal storage shelves.

Fig 26: Splayed window with nailed-up shutter boxes, room G12

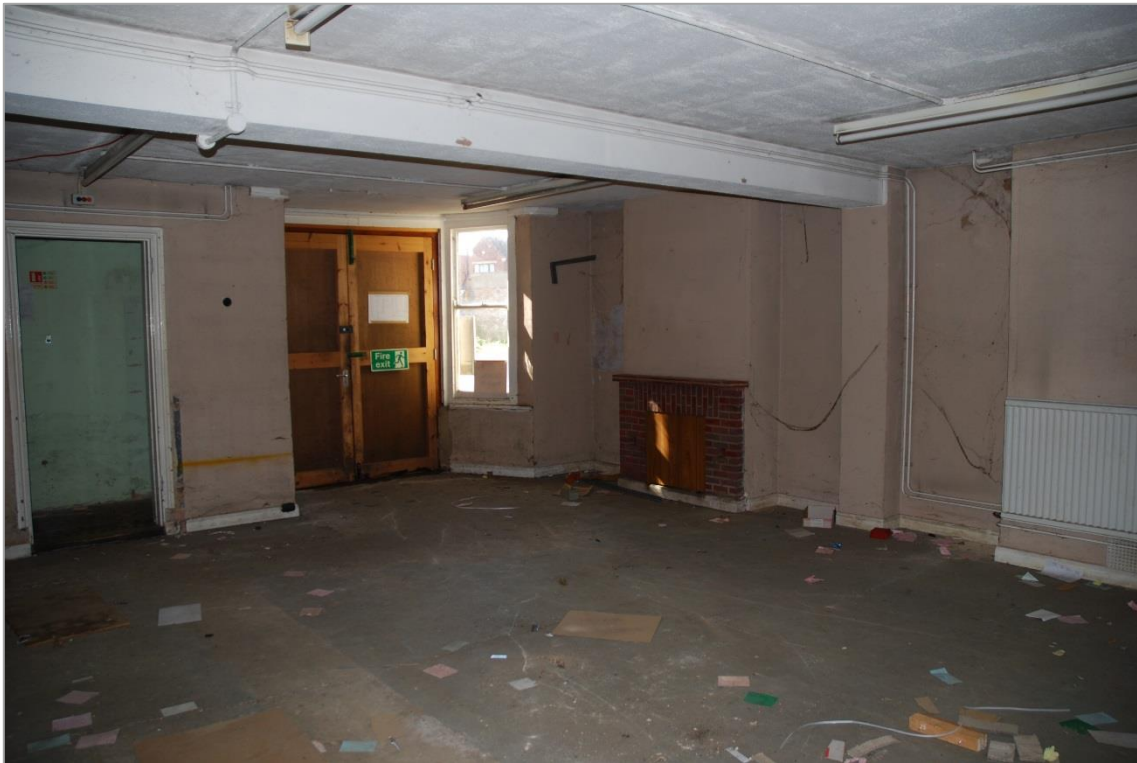
This is the 20th century extension on the north-western end of Brookfield. It was formerly two rooms of equal size, one to the front and one to the rear, but has been knocked into one (Fig 27). It has a concrete floor. There are bay windows to the front and rear elevations, although the rear window has been largely removed by the later brick extension to the rear; there is a set of double doors through into the yard. A further window to the front is a former door opening, with brickwork blocking the lower portion. This suggests that this was a separate house, likely a two-up, two-down property. There are two chimney breasts on the north-western wall; the one in the former rear room comprises a modern brick surround that has subsequently been blocked up. There are no remains of the second fireplace, other than an air vent in the skirting. There is a doorway knocked through into G12 at the front of the room and a further entrance via the hallway to the rear.

Fig 27: Room G13, looking west

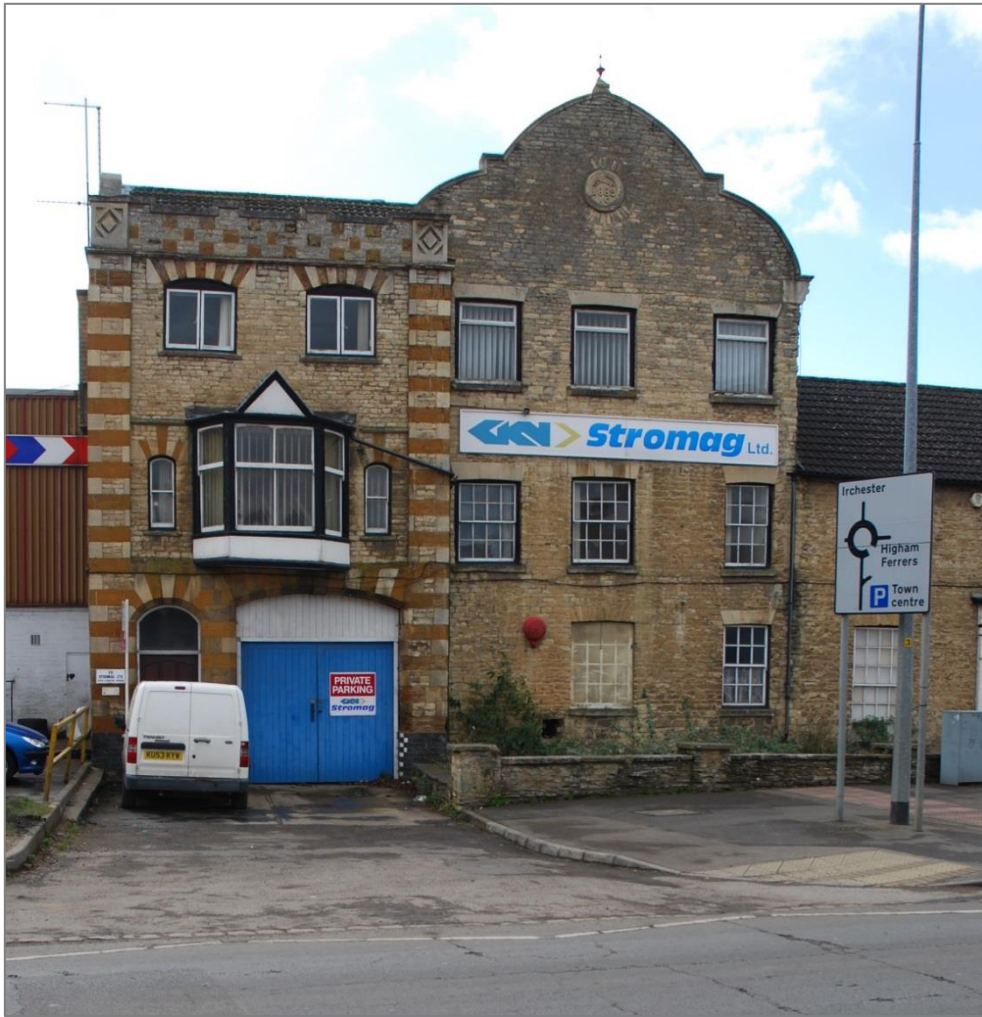
The gable end of the earliest factory range forms the centre of the main frontage (Fig 28). The frontage is of three-bays and three storeys. It is constructed of coursed limestone rubble; there does not appear to be any distinct break with the stonework of Brookfield suggesting the first two storeys are part of the original linear arrangement depicted on the 1884 map (Fig 3). The gable is shaped and has ashlar terminal kneelers and copings and a finial. A roundel above the second storey windows contains the inscription: *Rebuilt/1889/WC*.

Fig 28: The 1889 range and later gatehouse block

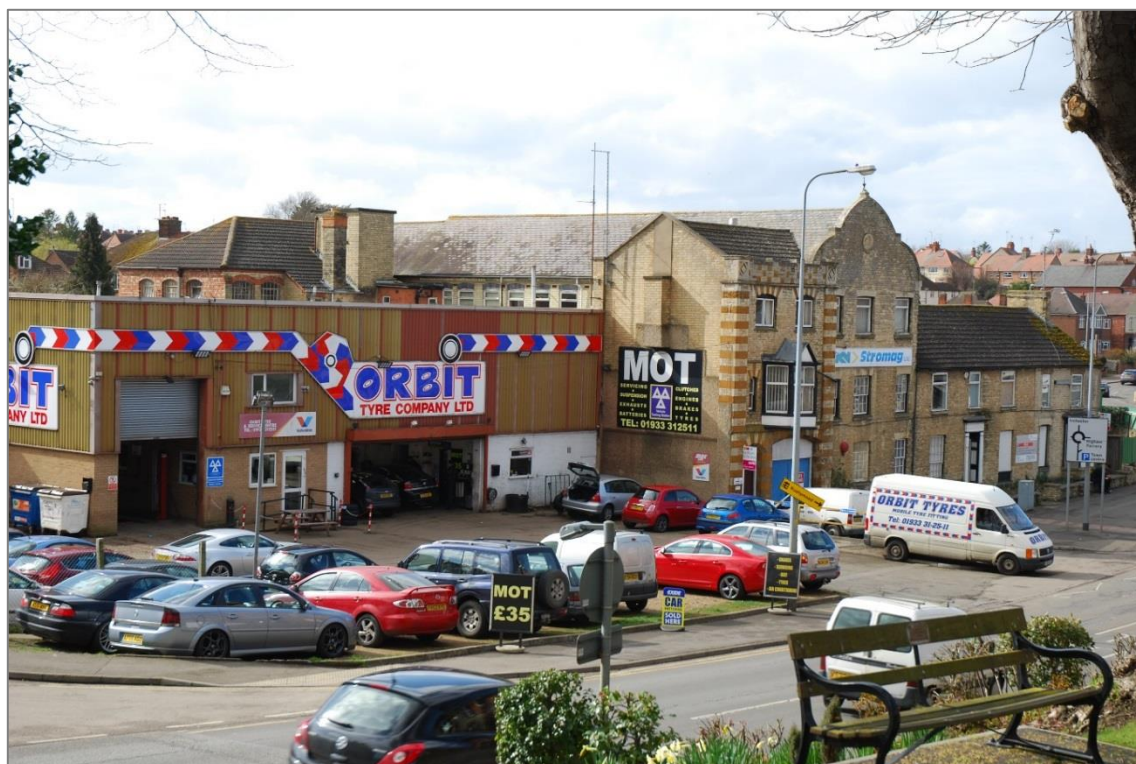
Fig 29: The factory complex, looking north-west

There are two window openings in the ground floor, the left hand bay is blank and there is no evidence of a blocked opening. The window in the central bay has been blocked some time previously and window lights painted on. This window retains a flat stone arch lintel as those surviving on Brookfield. Just below the window opening, to the left, is a square niche. The window in the right, in common with the remainder of windows on this block, has been replaced with an ashlar stone lintel. The window itself is a horned sash of 12-lights. The first floor windows are the same, but are all un-horned sashes, the two left-hand bays are 16-lights, while the right hand bay is 12-lights. The second floor windows are all 2-light casement, with the upper portion opening outwards. Historic photographs indicate that these were 16-light sash windows until at least 1950.

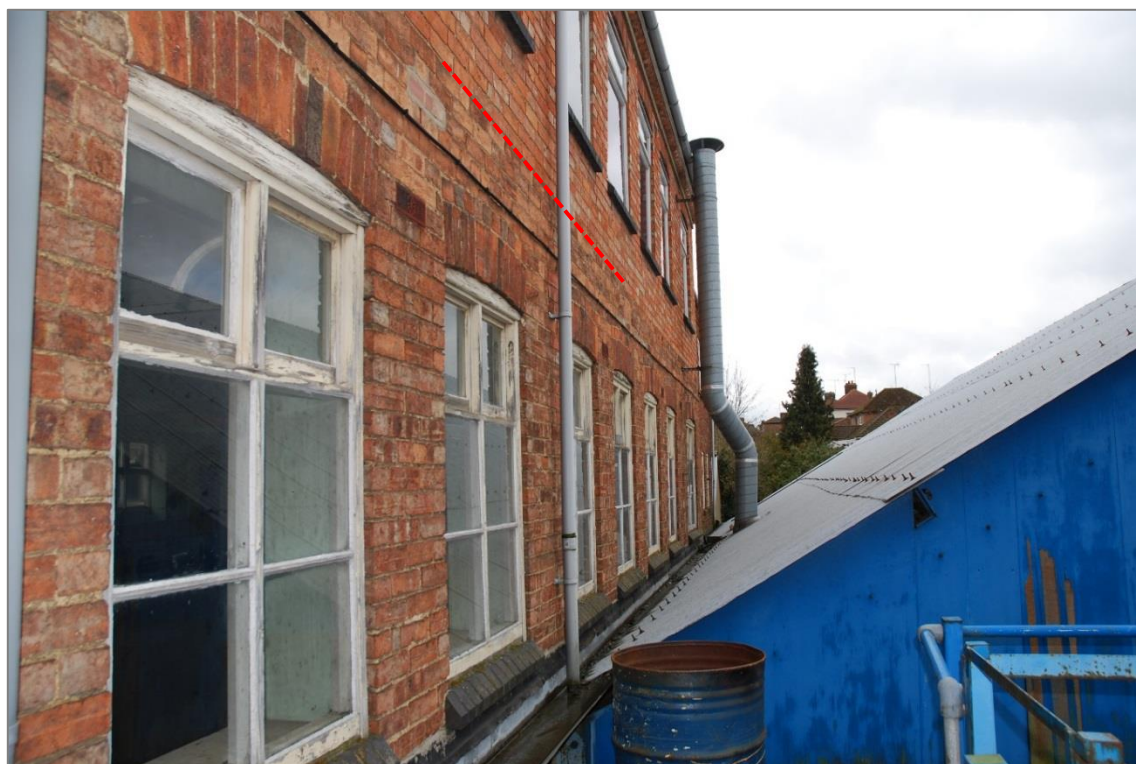
Fig 30: The north-western elevation of the 1889 range, showing change in brickwork from first to second storeys, looking south-west

There is a change in brick colour to the second floor on this elevation, suggesting this storey was added at a different date (Fig 30). However, this change was not observed in other elevations. The window openings of the second storey have flat brick arches with blue engineering brick sills with chamfered edges; the windows are all 2-light casements. The upper light on each opens outwards on a restricted hinge. The window of the second bay from the frontage has been modified with a timber lintel and sill.

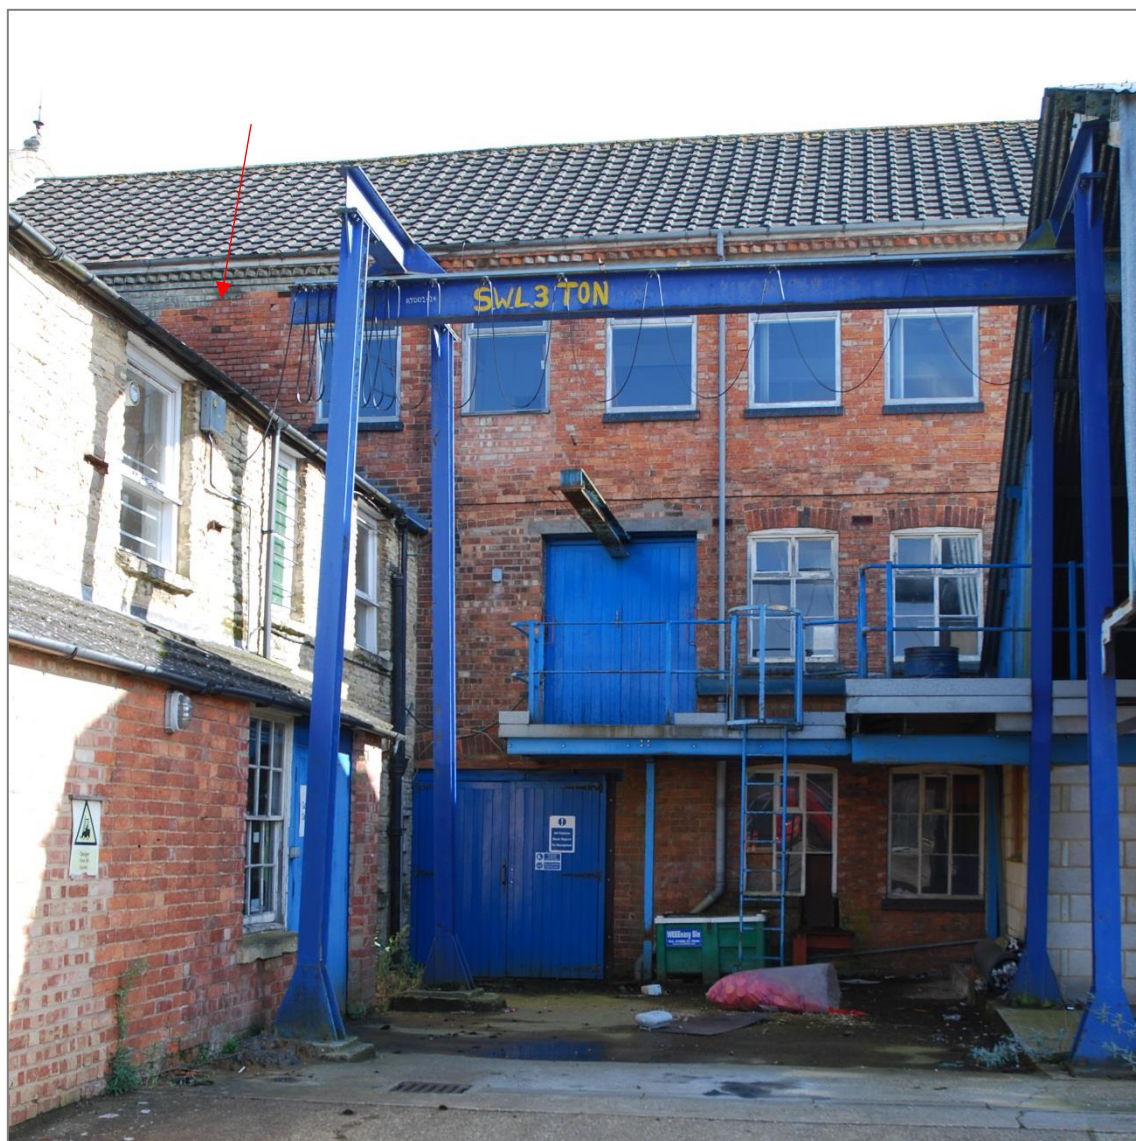
The range extending back from the frontage is of ten bays. The north-western and south-eastern elevations of the building are distinct from each other and will be described separately. The north-western elevation is primarily of red brick laid in English bond with a cogged eaves course. However, where this side of the factory is visible over the roof of Brookfield from the street, the brickwork is buff-coloured, including the cogged eaves (Fig 31). The roof on this side is of concrete tile.

Fig 31: North-western elevation of factory, looking south-east, showing change in brick colour

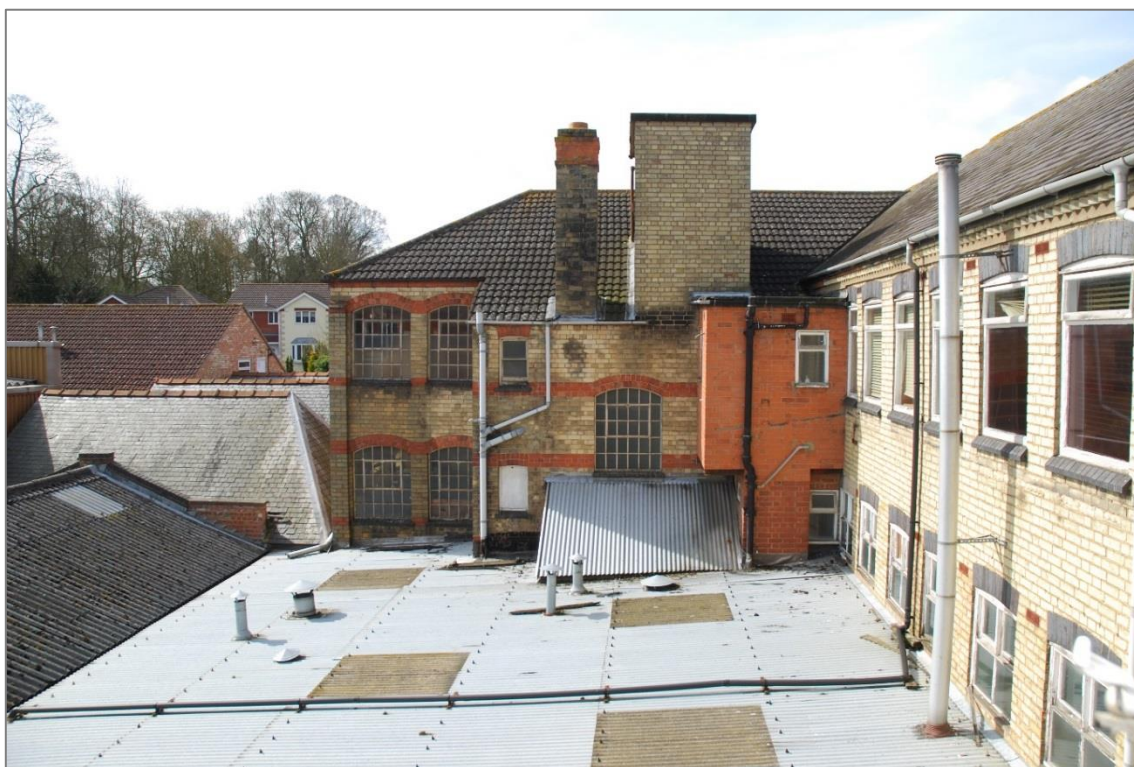
On the first floor the flat brick arches of the windows are of blue engineering brick (Fig 32, range to right of photograph). The windows have been shortened, being partially blocked at the base, probably when the warehouse was constructed. The original sills are still visible just below the roofline of the warehouse roof. These sills were replaced with timber ones. The remaining windows are 4-light casements with the upper two lights opening outwards on restricted hinges. Rectangular cast iron air bricks are present between many of the windows. The second storey windows have the

Fig 32: Rear of factory, looking south-west from gatehouse block

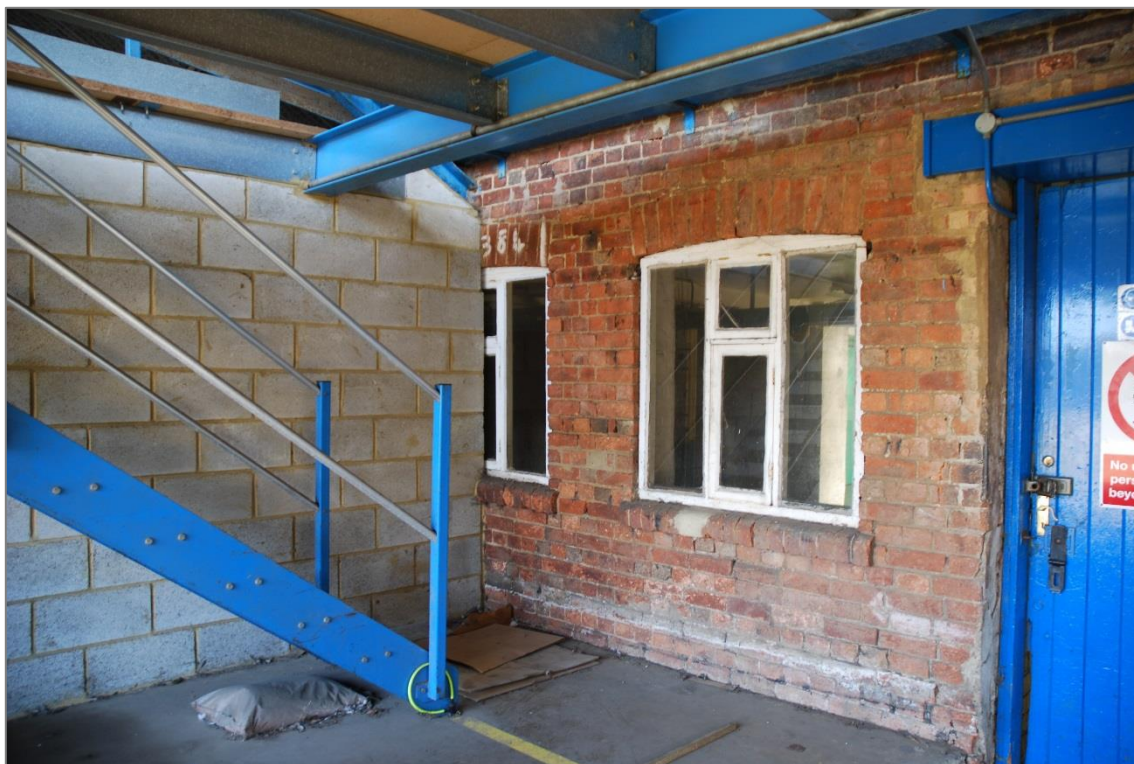
A three-by-seven bay range to the rear of the 1889 range and on the same alignment. Red brick to the north-west and south-west elevations, buff brick to the south-east elevation. Windows with blue brick segmental heads and sills to the south-west and south-east, red-brick segmental heads and sills to the north-west elevation and a coggled eaves course. Hipped roof to rear, concrete tiles with a slightly lower ridge than the adjoining range. There were no clear exterior views of this range due to the modern steel and breezeblock extension abutting the yard elevation. An entrance into the factory has been inserted at the rear of the range via a pair of ledged and braced loading bay doors (Fig 33). The doorway is supported by an RSJ.

Fig 33: The possible 1879 range, with inserted loading bay doors and modern steel and breezeblock extension adjoining

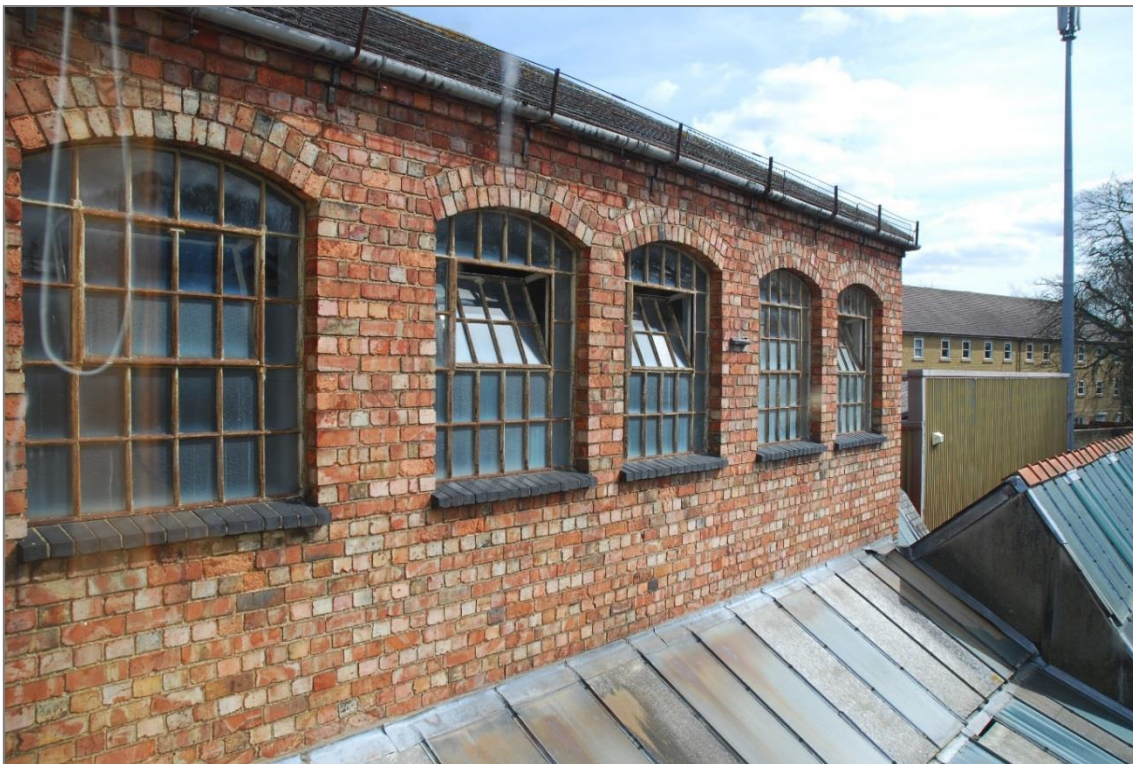
Fig 34: South-west elevation of added wing (S8 rear)
