**Archaeological Building Recording at the former
Stromag factory, Wellingborough Road,
Rushden, Northamptonshire**

Archaeological building recording at the former Stromag factory, Wellingborough Road, Rushden, Northamptonshire

(Fieldwork by Joe Prentice, Charlotte Walker and Iain Soden)

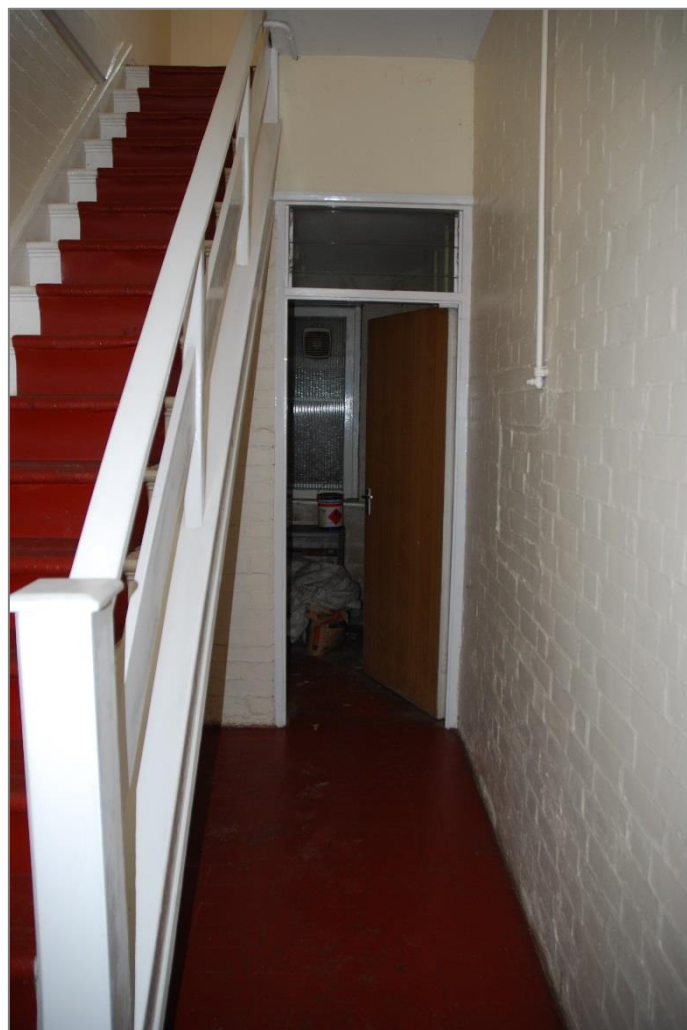
The main entrance into the office areas of the factory, although the décor is very plain, with painted brick walls and red painted quarry-tiled floor (Fig 35). The door is a six-panelled modern replacement with a curved headed fanlight above. The glass in the fanlight is plain. On the western wall is a small blocked window with flat arched head. At the rear of the hallway is a small utility cupboard which has a 4-light horned sash window that has been blocked from the other, factory side. The wooden newel post of the staircase is plain, as are the balusters and handrail. The red-painted stairs emulate a stair-carpet. There is no access to any other ground floor area from here.

Fig 35: Gatehouse hallway, G1

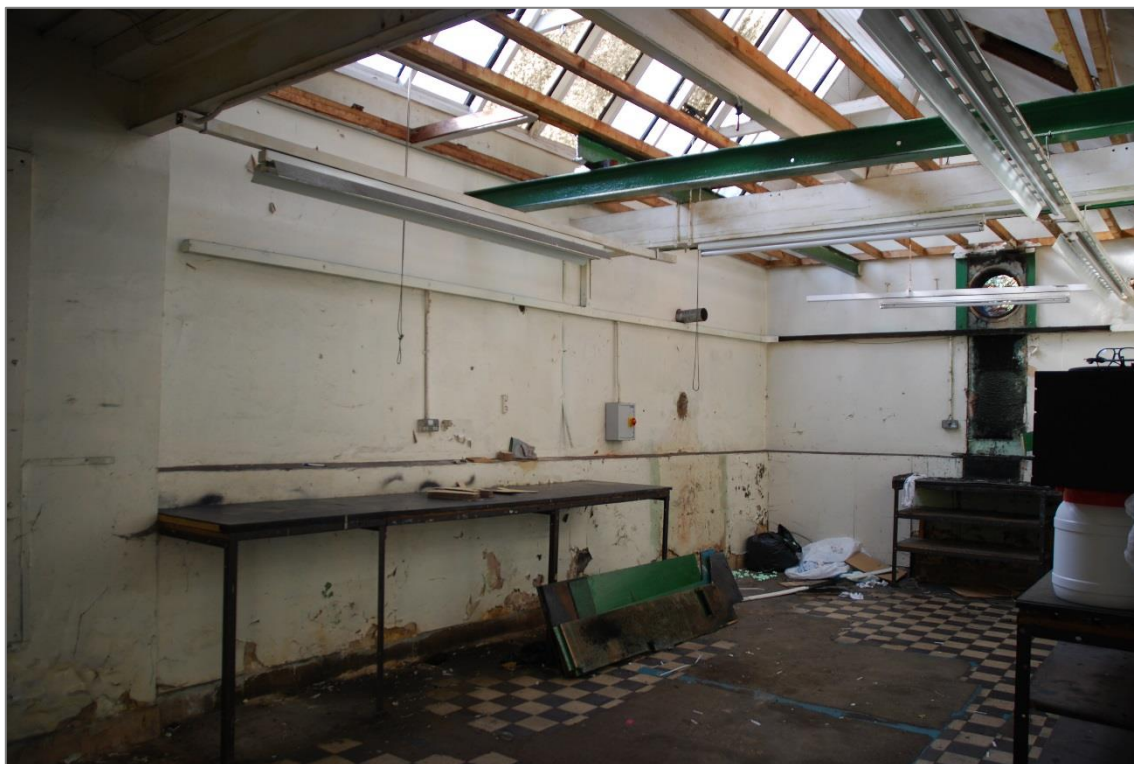
This room is partitioned off from the remainder of the factory working area, but occupies part of one of the north-light sheds (Fig 36). It has black and white chequerboard tiled floor, with concreted areas that are probably where machines once stood.

Fig 36: G2, workshop, looking east

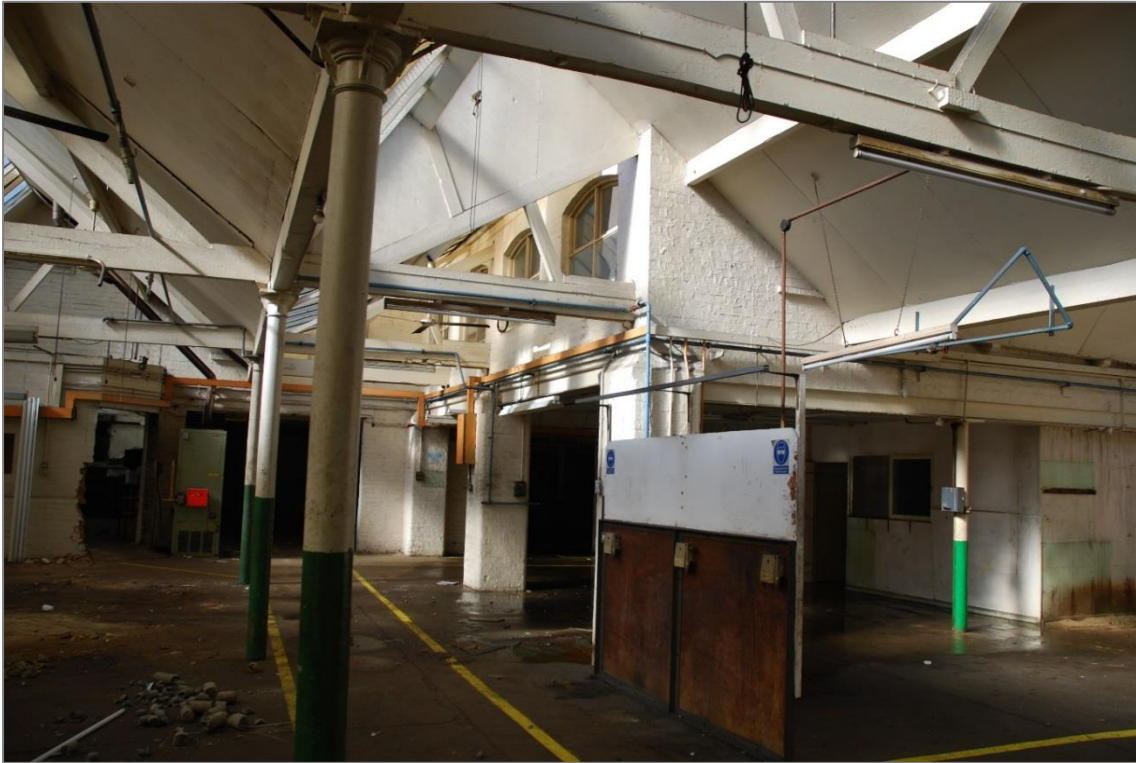
Fig 37: G3, looking north-west to 1870s range

This area comprises the three bay north-light sheds, which are aligned north-west to south-east, and the ground floor of much of the possible 1870s block, which is open to the north-light sheds and supported by brick columns (Fig 37). That half of the 1870s block facing onto the yard area was inaccessible during the survey, but formed a separate room.

The glazed roofs face south-west, the north-western side is tiled in slate. All three ranges were brick-built with concrete floors. Intermediate cast iron columns support the roof structure. The roof is of queen post truss construction. The roof is glazed on the north side with probably Trafford tile on the south. Blocked segmental arched windows are visible in the south-east, north-east and south-west elevations, to provide extra light to the factory floor (Fig 38). The overhead belt drives, as shown in historic photos of the shoe factory, have been entirely stripped out.

The main entrance to this part of the factory is via a pair of ledged and braced loading bay doors from the yard area.

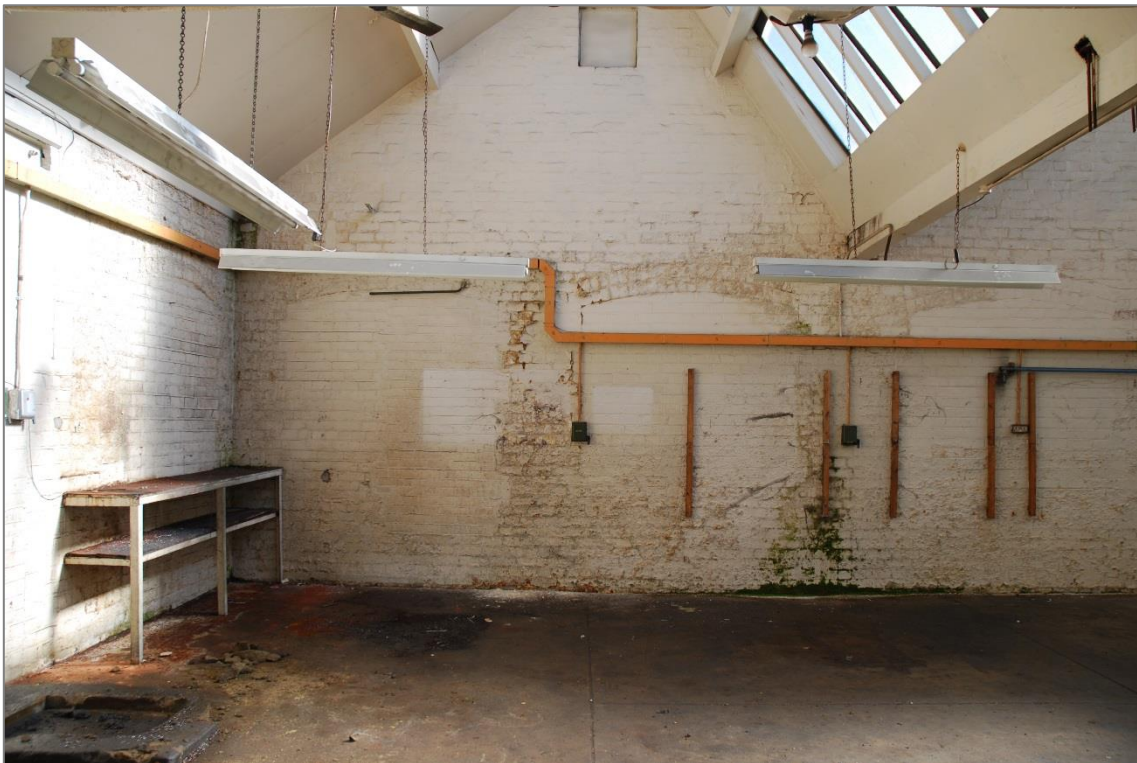
Fig 38: Blocked windows in the south-eastern elevation of north-light sheds

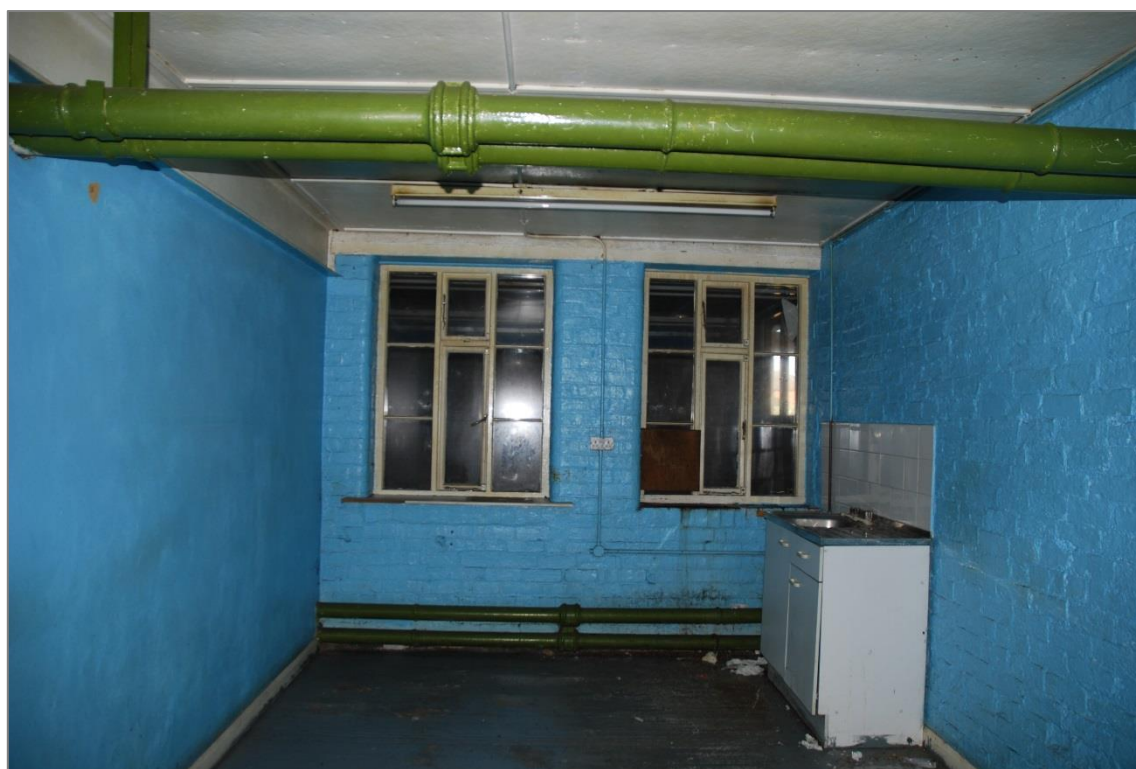
Blue-painted brick walls on the western and northern sides, with a modern partition, also painted blue on the south side (Fig 39). An RSJ supports the roof above the modern partition. Two 8-light Critall-type windows on the yard frontage, the two central lights opening outwards individually. Heating-duct pipes along the yard frontage wall and at ceiling height. Concrete floor and suspended ceiling. A modern sink unit is present on the northern wall.

Fig 39: G4, looking west

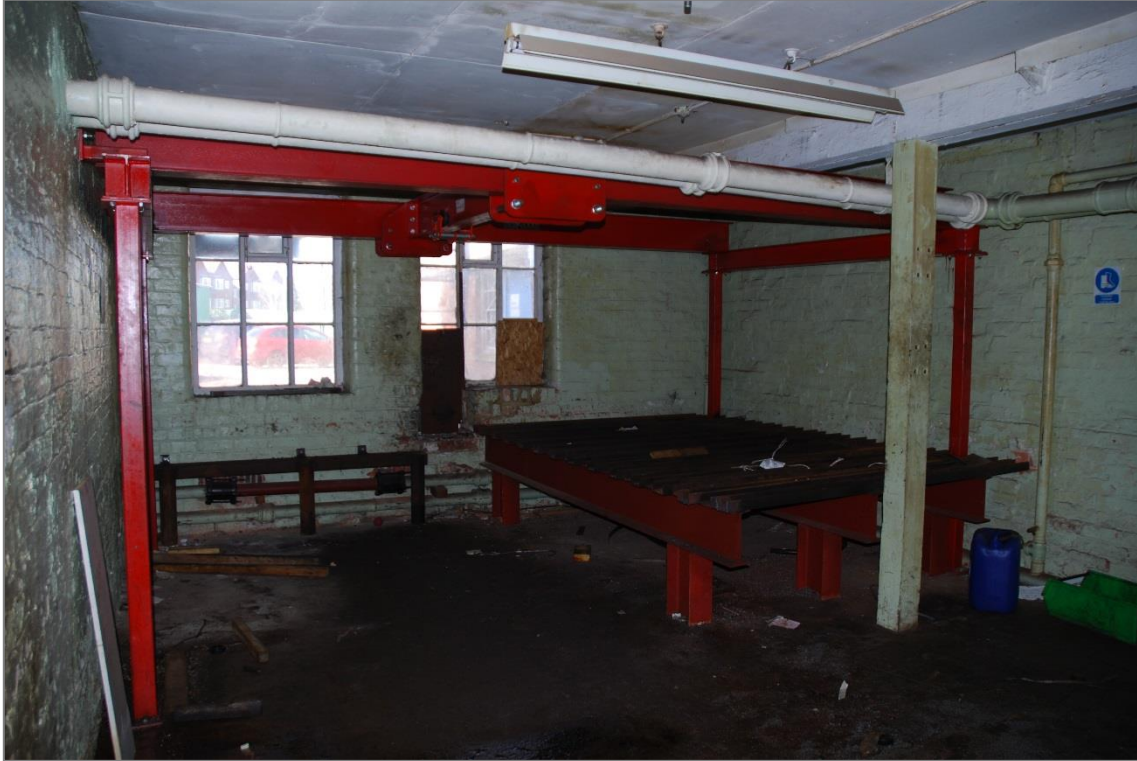
Fig 40: G5, looking north-west

The walls of this room are entirely of painted brick and it appears to be an original space within the 1889 factory (Fig 40). The floor is of concrete. A single timber joist, aligned east to west across the room, is supported by a single timber upright. There are two 9-light casement windows overlooking the yard area, the northern window has been modified, with brickwork removed beneath the lower left-hand light, probably to allow access for a belt-drive or similar. Two further window openings survive in the south-eastern side of the room, much of the timber framed window had been removed in one and the other had been lowered, so that the bull-nose engineering brick sill to the

outside had been lost. There is a ledged and braced door, beneath a timber lintel, in the north-eastern corner of the room, leading into the loading bay area to the north. Heating-duct pipes are present below the windows and just below ceiling height. A modern steel framework has been inserted at the western end of the room, along with a steel base for machinery.

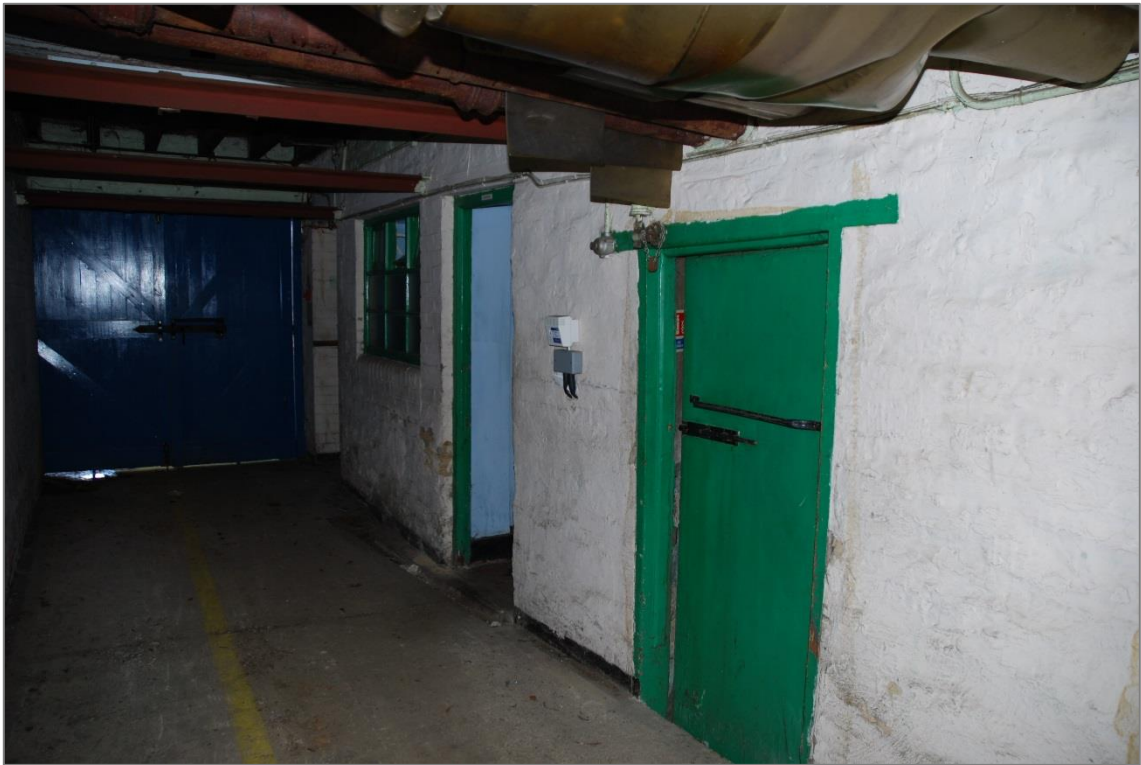
Fig 41: Gateway through the 1889 range, with surviving elements of the earlier building

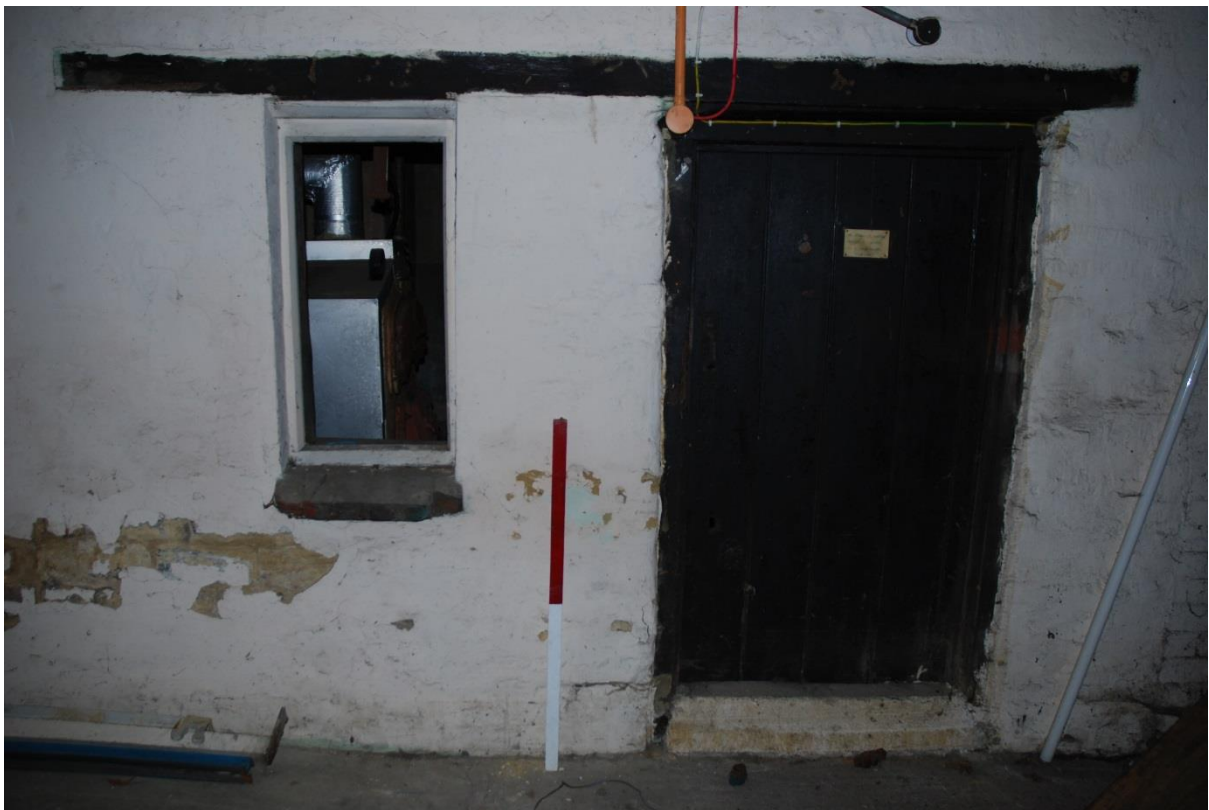
Fig 42: Entrance into G7 from gateway; scale 1m

These rooms occupy the frontage of the 1889 factory block, but appear to preserve the rear and eastern walls of the earlier building and are in places similar in build to the early parts of Brookfield to the east (Fig 41). The walls, where visible beneath the paint and plaster, were a mixture of stone rubble and brick, the brick likely to be part of the 1889 rebuild.

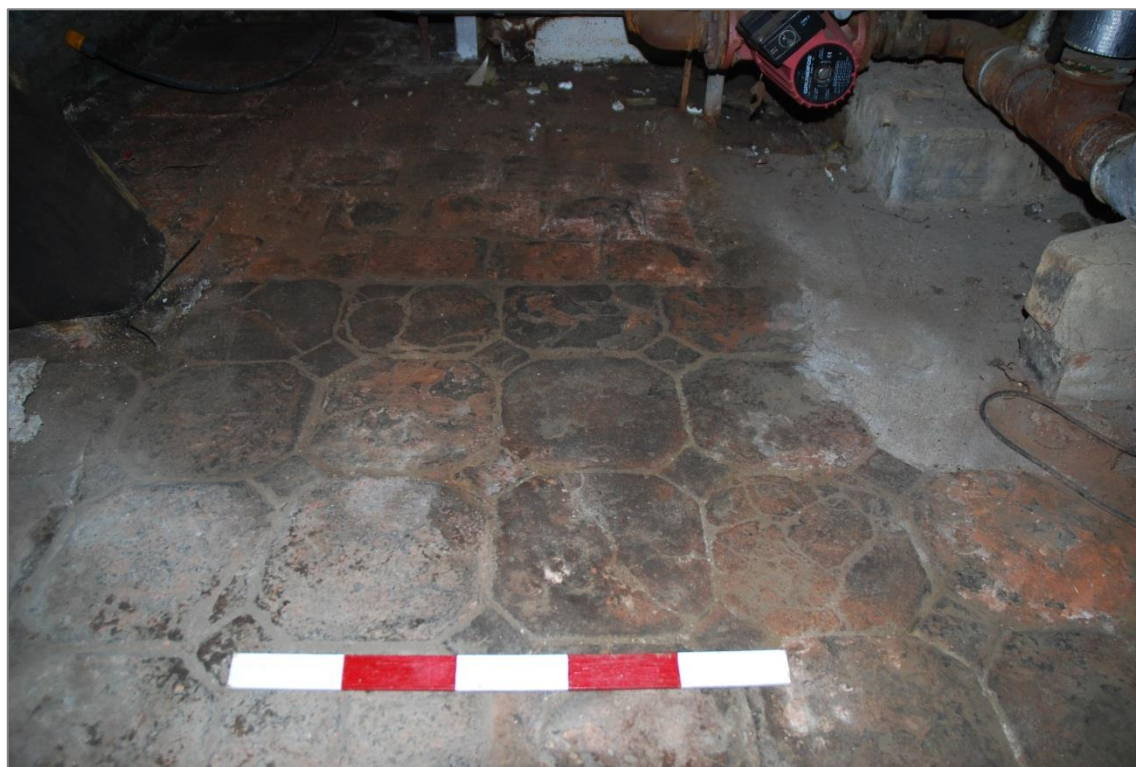
The floor is of octagonal tiles at the southern end, which change to plain 9" tiles after c 2m (Fig 43). Subsequently there is a drop in floor level and the flooring changes to brick. The underside of a former staircase is present in the western corner of the room (Fig 44); the base of the staircase would have been in G6, but there was no surviving evidence for its continuation. A doorway, blocked with brick, was evident halfway along the western wall of the room (Fig 44). There was an exposed timber joist crossing the room from east to west. The joist was not sawn and probably dates to the earlier building.

Fig 43: G7, octagonal floor tiles; scale 50cm

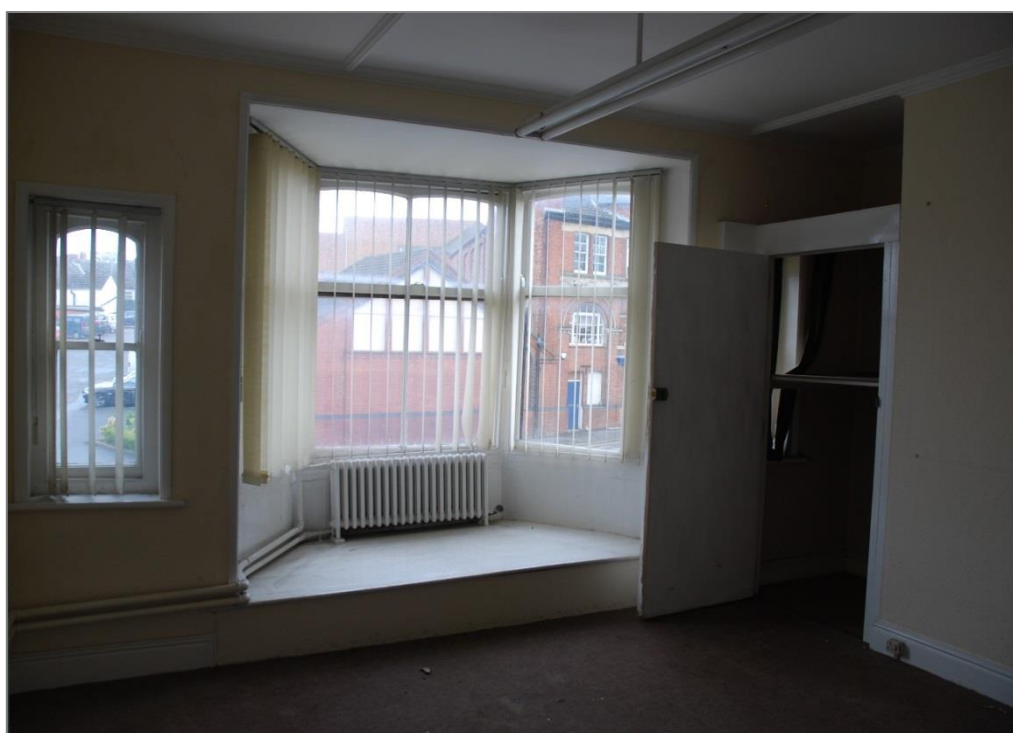
Fig 45: Office, F3, with canted oriel window

This office lies on the first floor of the gatehouse block. The windows are the canted oriel window, which has a 4-light sash window in the centre and 2-light windows either side; all are horned (Fig 45). There is a raised timber dais in within the bay, and a small cast iron radiator under the main window. Either side of the bay is a small 2-light sash window, also horned; the window on the south side is hidden by an inserted cupboard.

There is a decorated cast iron radiator on the rear wall of the room, adjacent to the doorway, which is a modern door. The ceiling is decorated with simple raised plaster mouldings on a grid pattern.

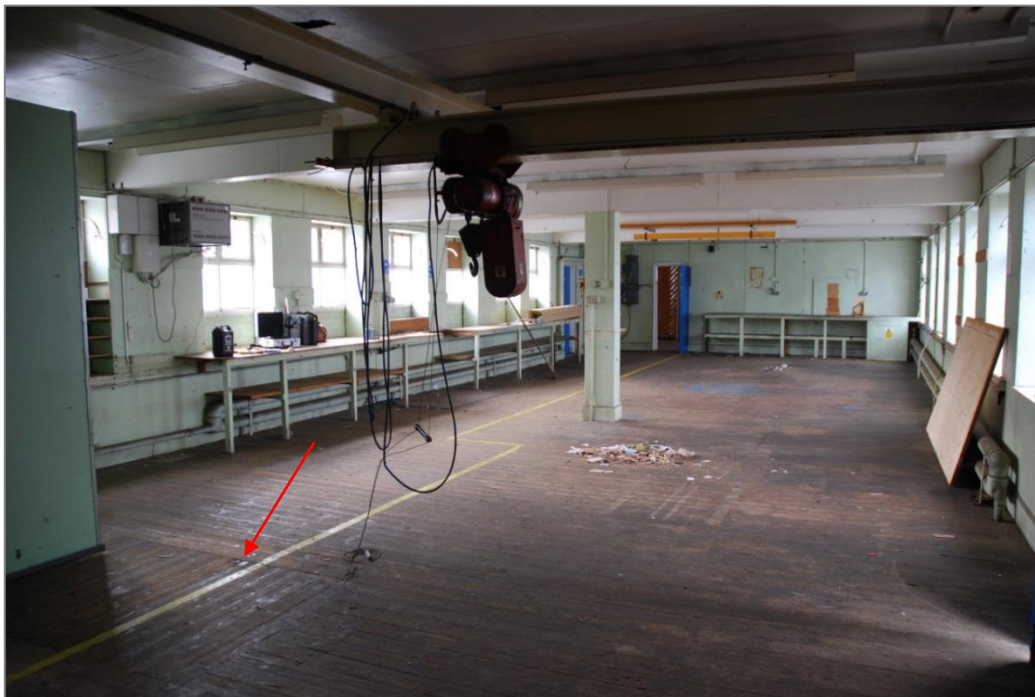
A gantry and pulley at the north-western end of the room, at one end is an RSJ which is marked 'Appleby-Frodingham England 8x8'. The company was formed in 1912 when the Appleby Ironworks was taken over by the Frodingham Ironworks. They joined with various Rotherham based steelworks in 1918 to form the United Steel Companies Ltd, indicating that this was fitted at some point during the period 1912-18, and may indicate factory growth or specific orders to meet national needs during World War I. The gantry exits the building through secondary double doors which have replaced an eighth window, as described from the exterior. There are a number of work benches around the walls and heating pipes along the yard-side wall, as well as modern partitions.

Fig 46: Room F6, looking south-west, 1912-18 gantry above. Arrow marks blocked hoist hatch

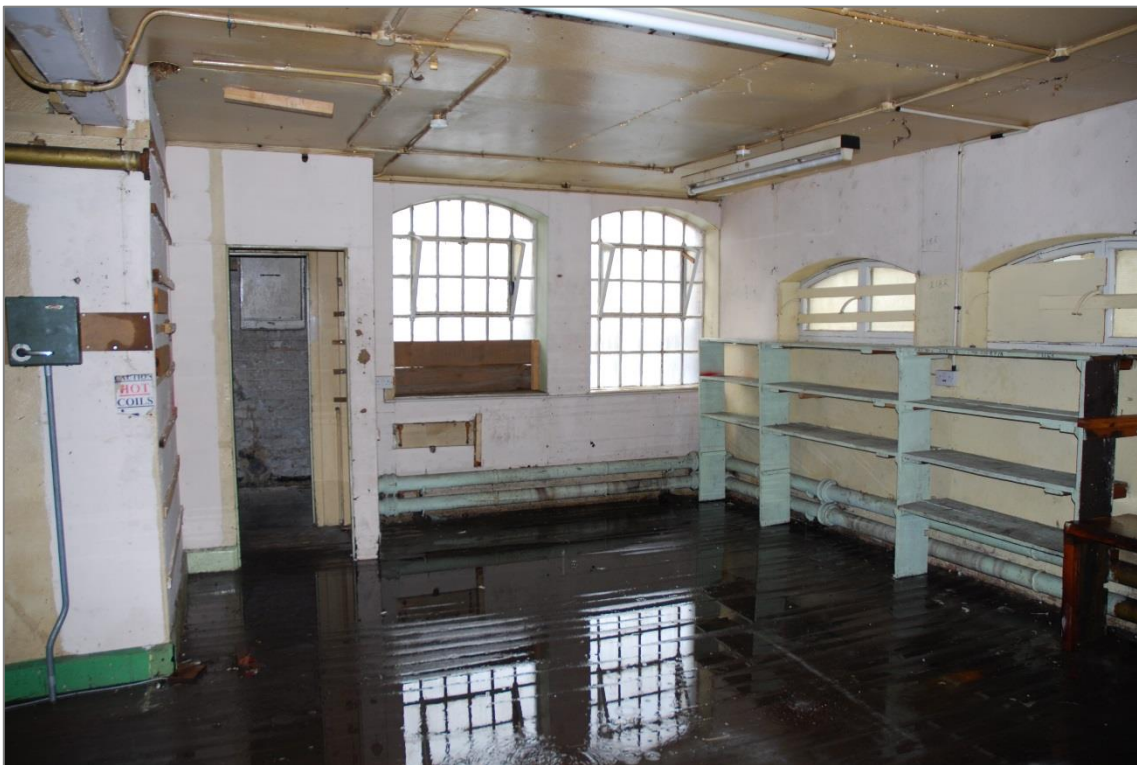
Fig 47: Room F8, looking north-east

This room occupies the post 1889 range. The wall between F7 and F8 has been substantially removed and is supported by an RSJ. A further blocked in RSJ supports the ceiling of F8. There are four casement windows of 4-lights overlooking the interior of G3 to the south. A further three look out to the south-east; these are short arched headed casements of 2-lights. They are hidden from the exterior as they are obscured by the hipped roof of the north-light shed, but appear to have been partially blocked at the base. To the north there are two casements of 30-lights, with an 8-light panel in the centre opening inwards (Fig 47). The floor is of knotty pine floorboards. There are various work-benches and shelves around the perimeter of the room. In the northern part of the room is a WC and to the west a further exit to the lift shaft.

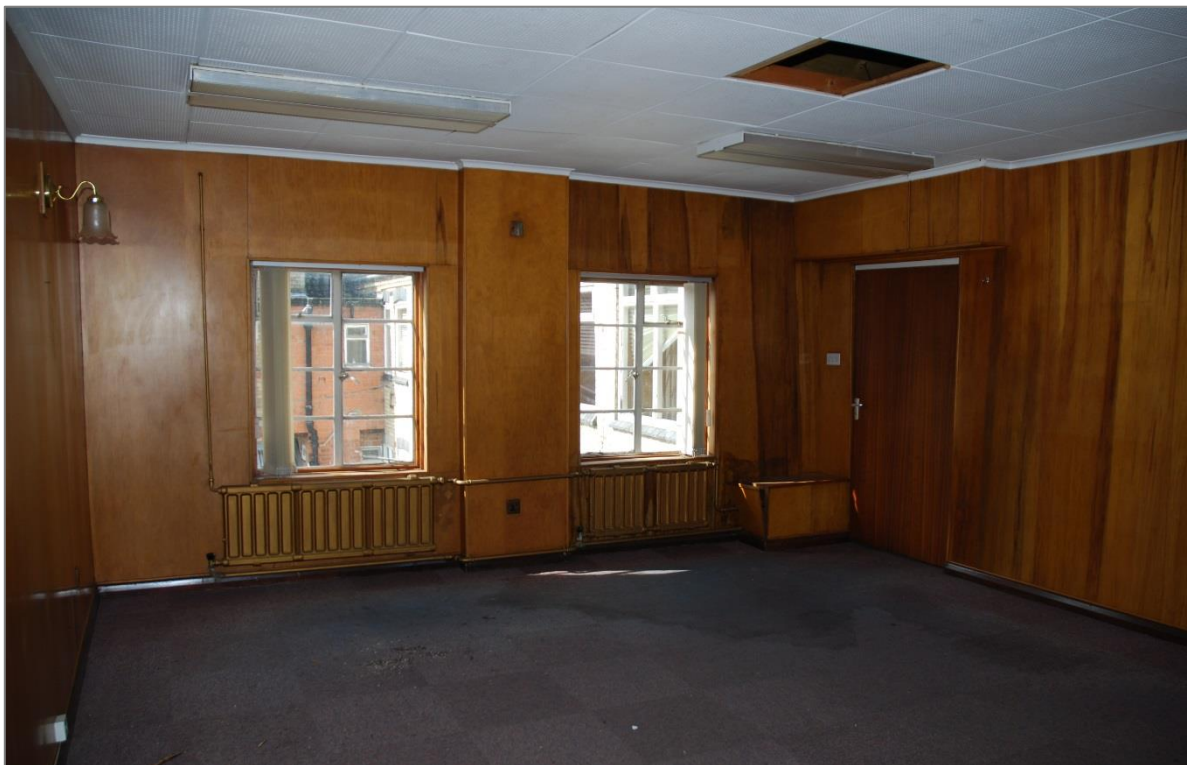
A single large room comprising the entire upper floor of the gatehouse block (Fig 48). Three sides of wall panelled with fake veneer panels and there is a suspended ceiling. A further suspended ceiling had been inserted above, although elements of the roof were visible suggesting it was of king-post truss construction. The two windows looking out over the Wellingborough Road are both 2-light casements, each side opening, with monkey tail catches. Two further windows at the rear of the room were 8-light casements, half opening sideways and a single upper light on the opposite side opening outwards. Beneath each window was a cast iron radiator, painted gold.

Fig 48: Former boardroom, S3, looking west

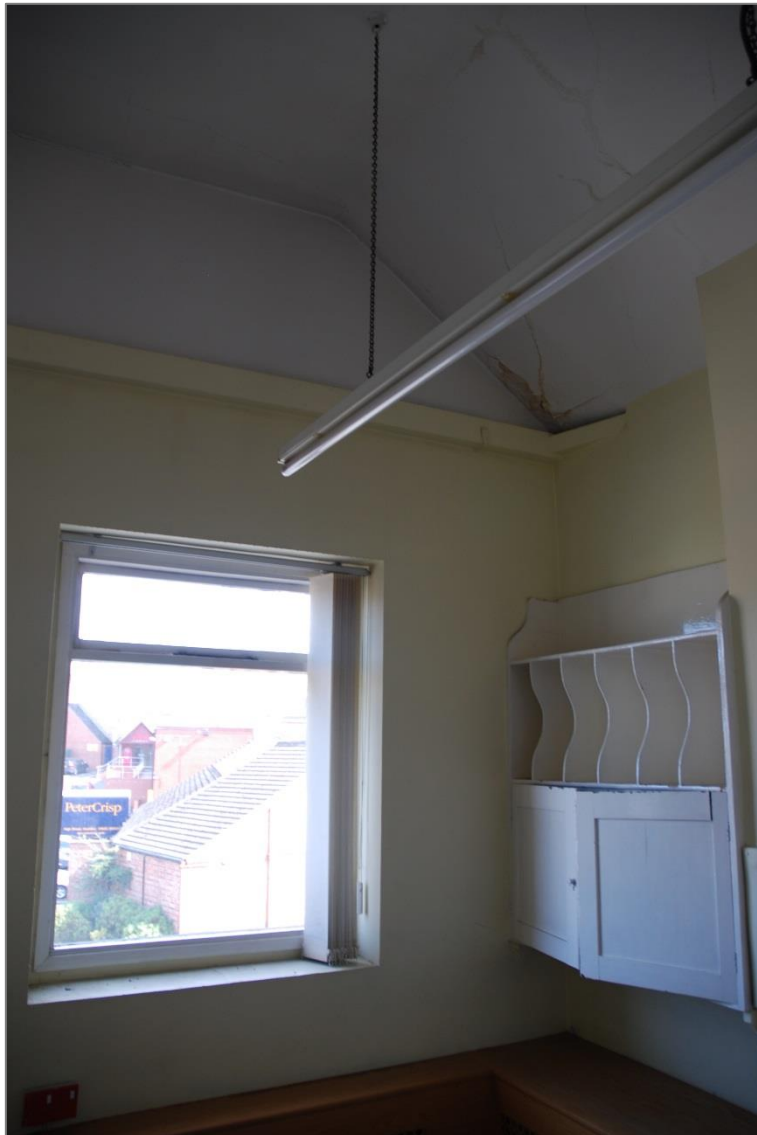
Fig 49: Room S4, post-room, looking north-east

A small room in the 1889 factory block, with a single 2-light casement window looking out onto the Wellingborough Road (Fig 49). There are enclosed heating ducts below the window and along the eastern side of the room. Entry is via a door, with four-lights of patterned, rolled glass in the upper half, from the second floor hallway. The remainder of the rear partition wall between the hallway and the room has a 6-light panel of the same glass in the upper half. The north-western partition wall, with room S5, has a 10-light glass panel in the upper half of rolled, patterned glass and a sliding door. The ceiling is partly gabled on the eastern side.

In the rear, south-eastern corner of the room is a double door cupboard, probably for stationary. Adjacent is a chimney breast, although there is no evidence of a former fireplace. In the north-eastern corner of the room is a small wooden cupboard with vertical trays hung on the wall; this may be a survivor of the earlier shoe factory.

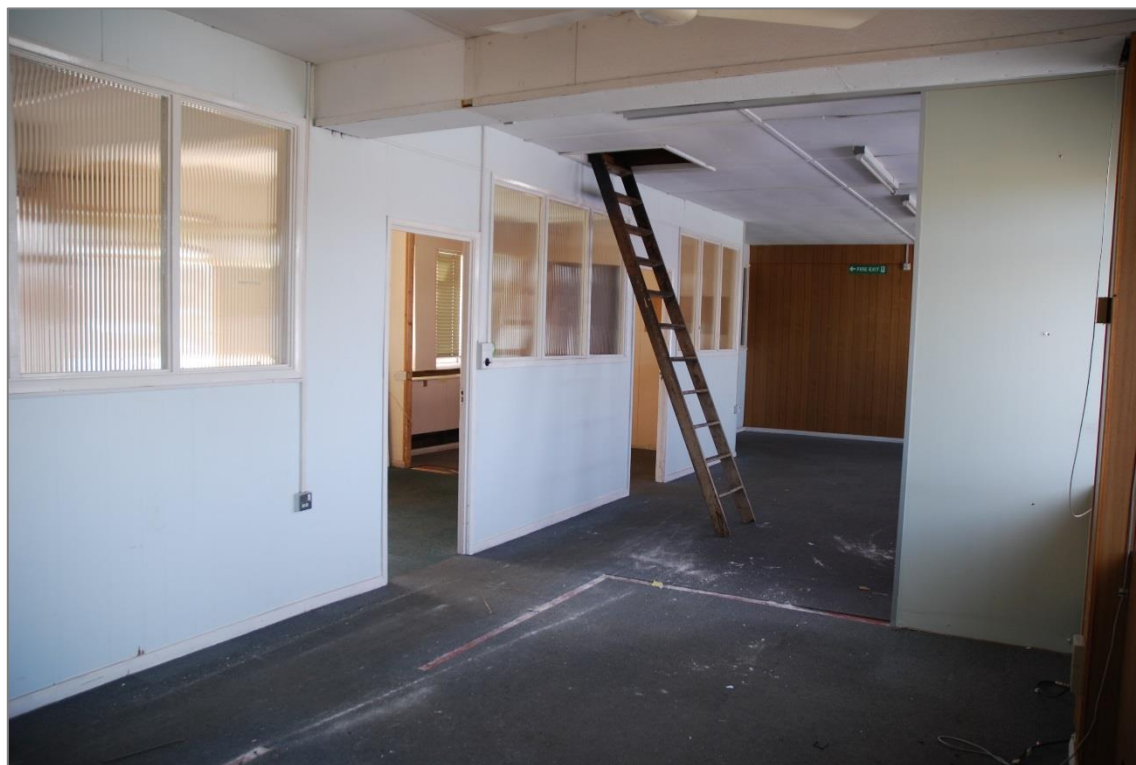
Fig 50: Room S6, looking south-east

This former factory area has been sub-divided into a number of smaller office areas with modern partitions (Fig 50). There is a modern suspended ceiling and the RSJs are boxed in. Much of the lower

half of the walling has been boxed in and the windows have been shortened. There is, in short, very little, if anything, of the original factory fixtures and fittings remaining in this area.

The roof of this part of the factory was of queen-post truss construction.

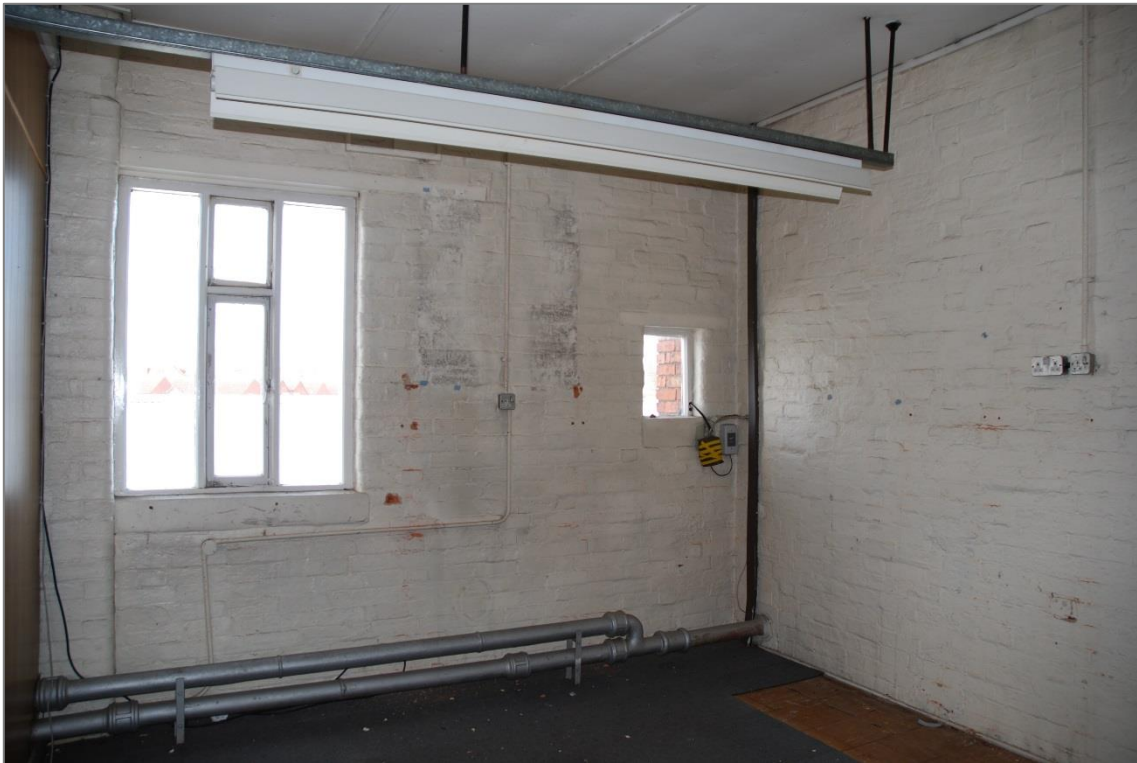
The wall between S6 and S7 was painted brick on S7 side. The first bay on the north-western side of the building was occupied by a small single light window that appeared to be original to the build. The adjacent window, of four lights was typical of those on this side of the range, although a lintel wider than the window indicated past modification. There is a brick pier, with bullnose brick quoins adjacent to the window. The access between S6 and S7 had been partially blocked by modern partitions, but changes in brickwork visible in S7 indicated partial closure of the original wider access.

Fig 51: Northern sub-division of S7; showing small window and brick pier

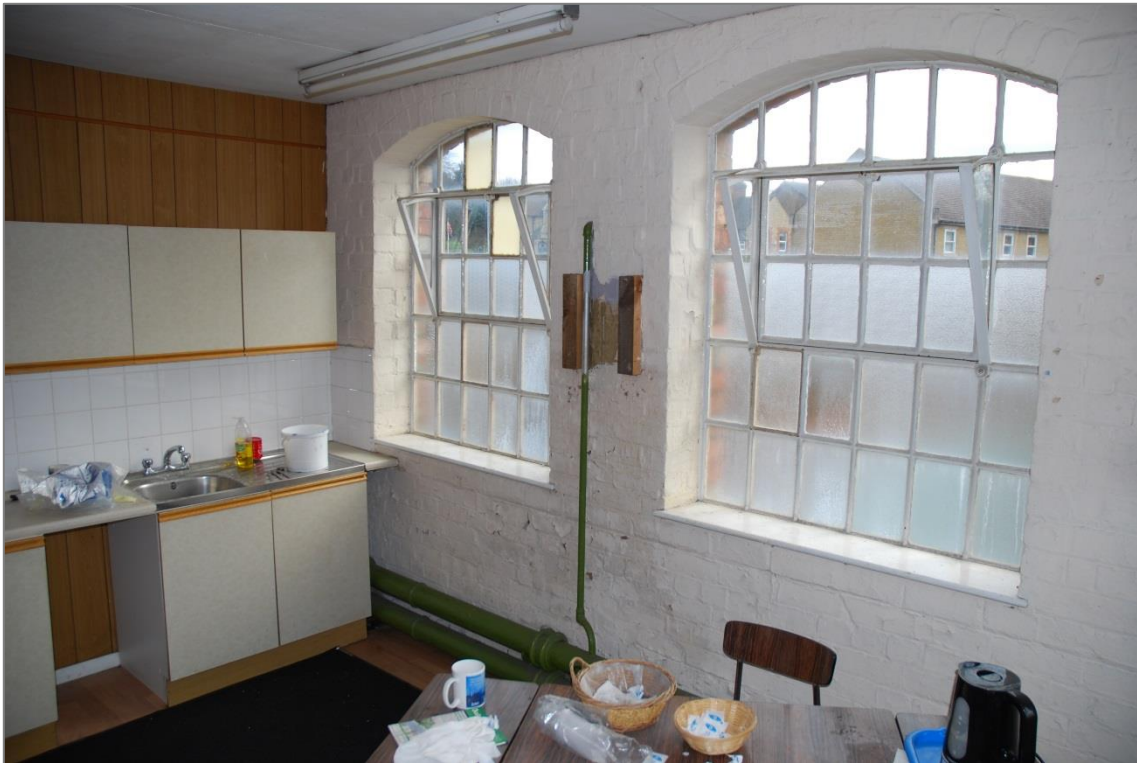
Fig 52: Canteen area in range S8, looking north-east

The second storey of this range had been used as storage and had had a small canteen added (Fig 52). It, too, had been subject to modern partition and suspended ceilings had been fitted.

All the original windows, Critall-type with curved heads and 30-lights, had been retained. The storage area is the only part of the range where the knotty pine floorboards were visible, elsewhere the flooring is linoleum. A lavatory, with a ledged and braced door and smaller 2-light window with rolled and patterned glass, may be an original space, although the fittings were modern. Heating ducts are present around the southern, eastern and part of the northern walls, ending at the entrance to the lavatory.
