**A Heritage Asset Survey of an outbuilding at
Baker's Cottage, 32 Church Street, Quanton,
Buckinghamshire**

A Heritage Asset Survey of an outbuilding at Baker's Cottage, 32 Church St, Quainton, Buckinghamshire

Summary

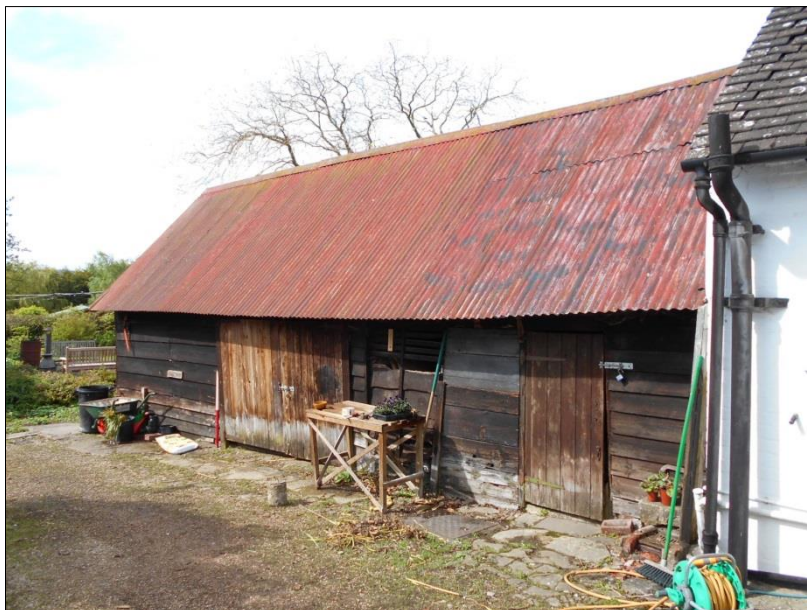
Fig 2: The outbuilding from the north-east; scale 1m

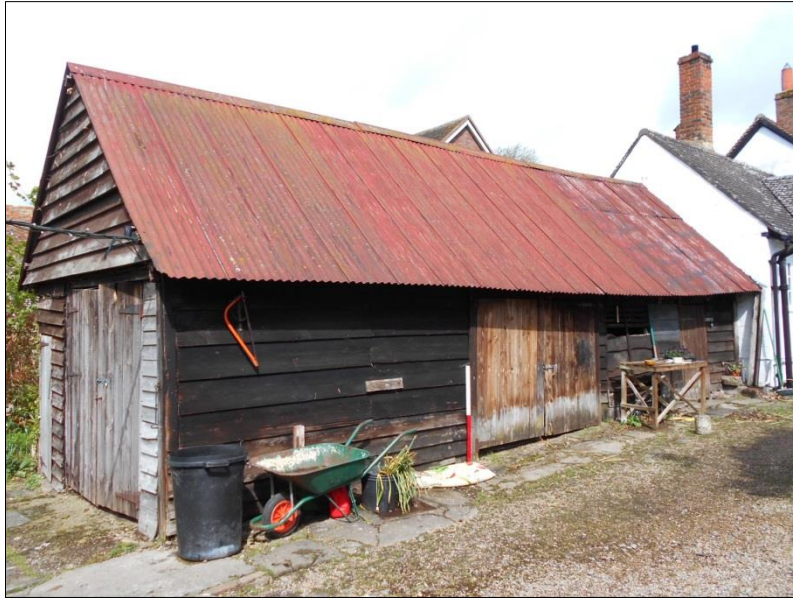
Fig 3: The outbuilding from the south-east; scale 1m

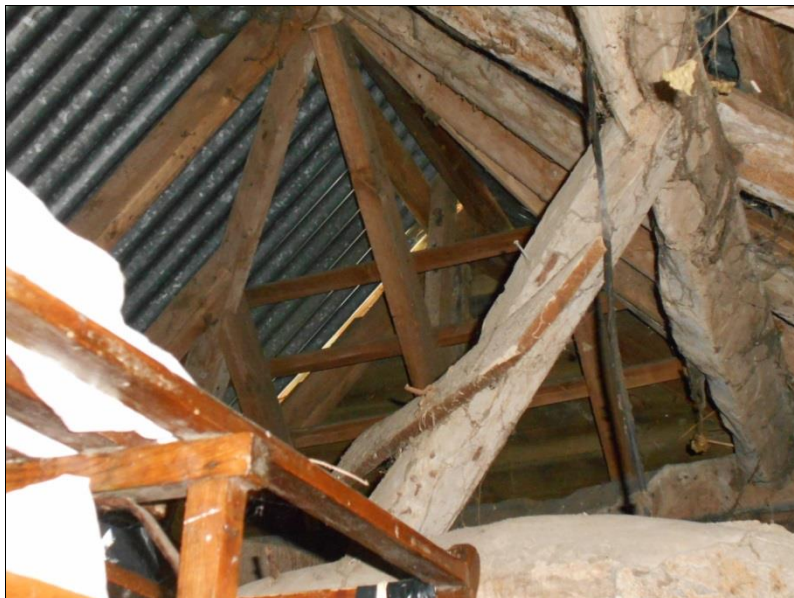
The roof is corrugated tin and is a modern covering over the denuded remains of a former thatched frame, with empty mortises suggesting an even earlier superstructure in part, but which may not have existed on the current site. In height the building measures 3.67m from the ground to the underside of the ridge-plank. While the current south end gable is vertical, the timbers of a hip for its thatched predecessor survive behind it.

Fig 4: The angled frame which once supported the thatched hip of the south gable

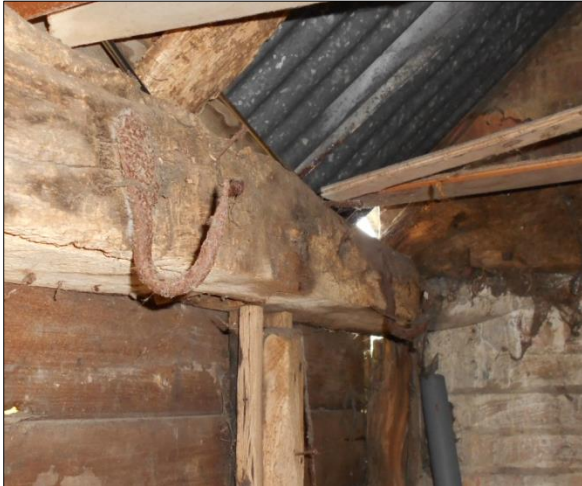
This bay sports a number of butcher's hooks on the wall plates, suggesting it may have been used to hang meat or game. In addition a rustic cleat is nailed to an intermediate upright on the west side which probably used to tie a rope for a pulley/hoist (now gone) mounted in the roof.

Fig 6: Bay 1 West side, butcher's hooks on wall-plate

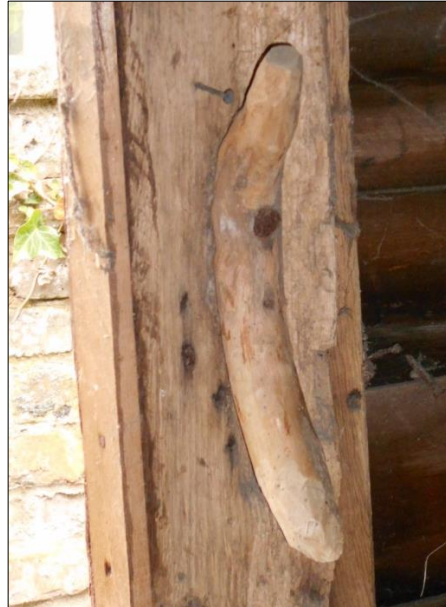
Fig 7: Bay 1 West side, rustic cleat for fixing a hoisted weight

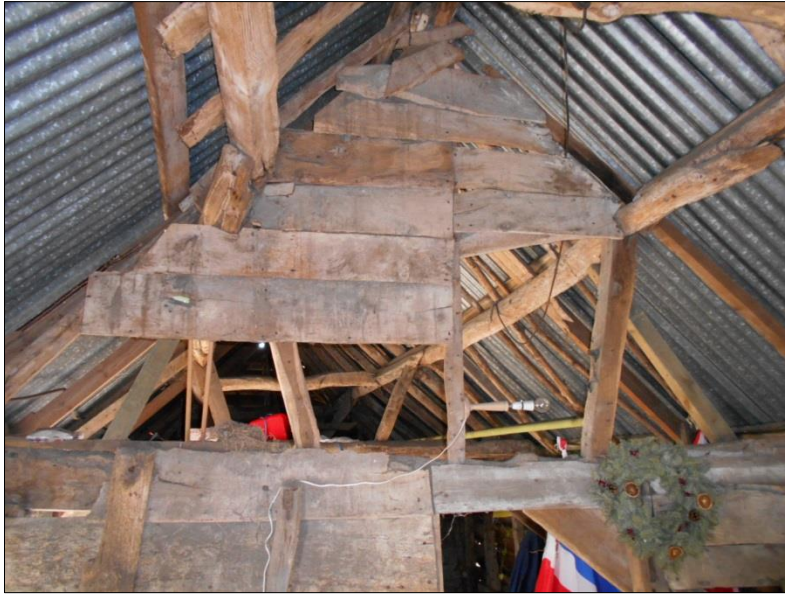
There is exterior weatherboarding applied to the pair of uprights which mark the division between Bays 1 and 2. This extends all the way to the former roof ridge, indicating a division of use which required total separation. A liberal use of lime-wash on the far side suggests that Bay 2 was used to house animals, probably stabling for a horse. This weatherboarding is far from expert, and between the bays includes a re-used oak floorboard!

Fig 8: the weatherboarding right up to the ridge, dividing Bay 1 from Bay 2; looking south

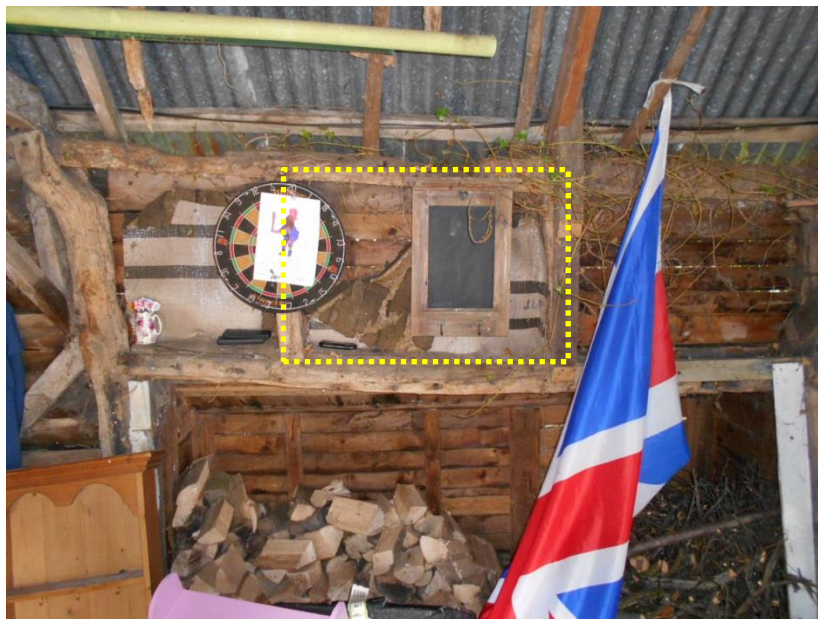
Bay 2 has at some point been lime-washed and this survived on the weatherboarded dividing partition in part, backing onto Bay 1. On the western side a low outshut has been created in recent times by taking out an upright and building outwards; this is currently used as a wood-store. Above this the framing, including a mid-rail, not present elsewhere, suggests that formerly a shuttered window lay here.

Fig 9: Possible former window; outshut below; the midrail is sagging where its supporting upright has been taken out – the empty mortise remains in the soffit

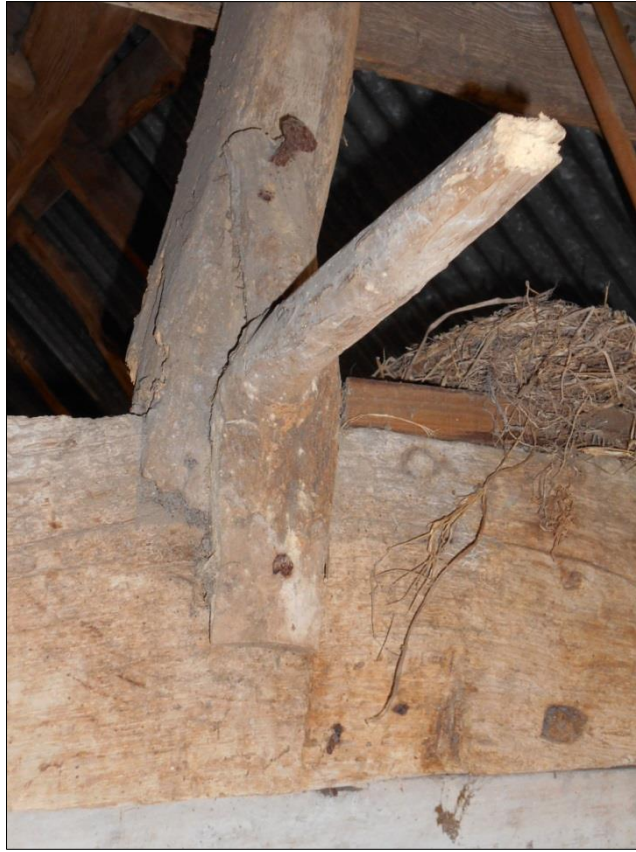
A rustic peg, nailed to the tie beam is probably for hanging a horse-collar, suggestive of a former stabling function.

Fig 11: Rustic peg, possibly for hanging a horse collar
