**An archaeological evaluation for the extension of the
churchyard of St John the Baptist Church, Thorpe
Mandeville, Northamptonshire**

Thorpe Mandeville churchyard extension

3 May 2016

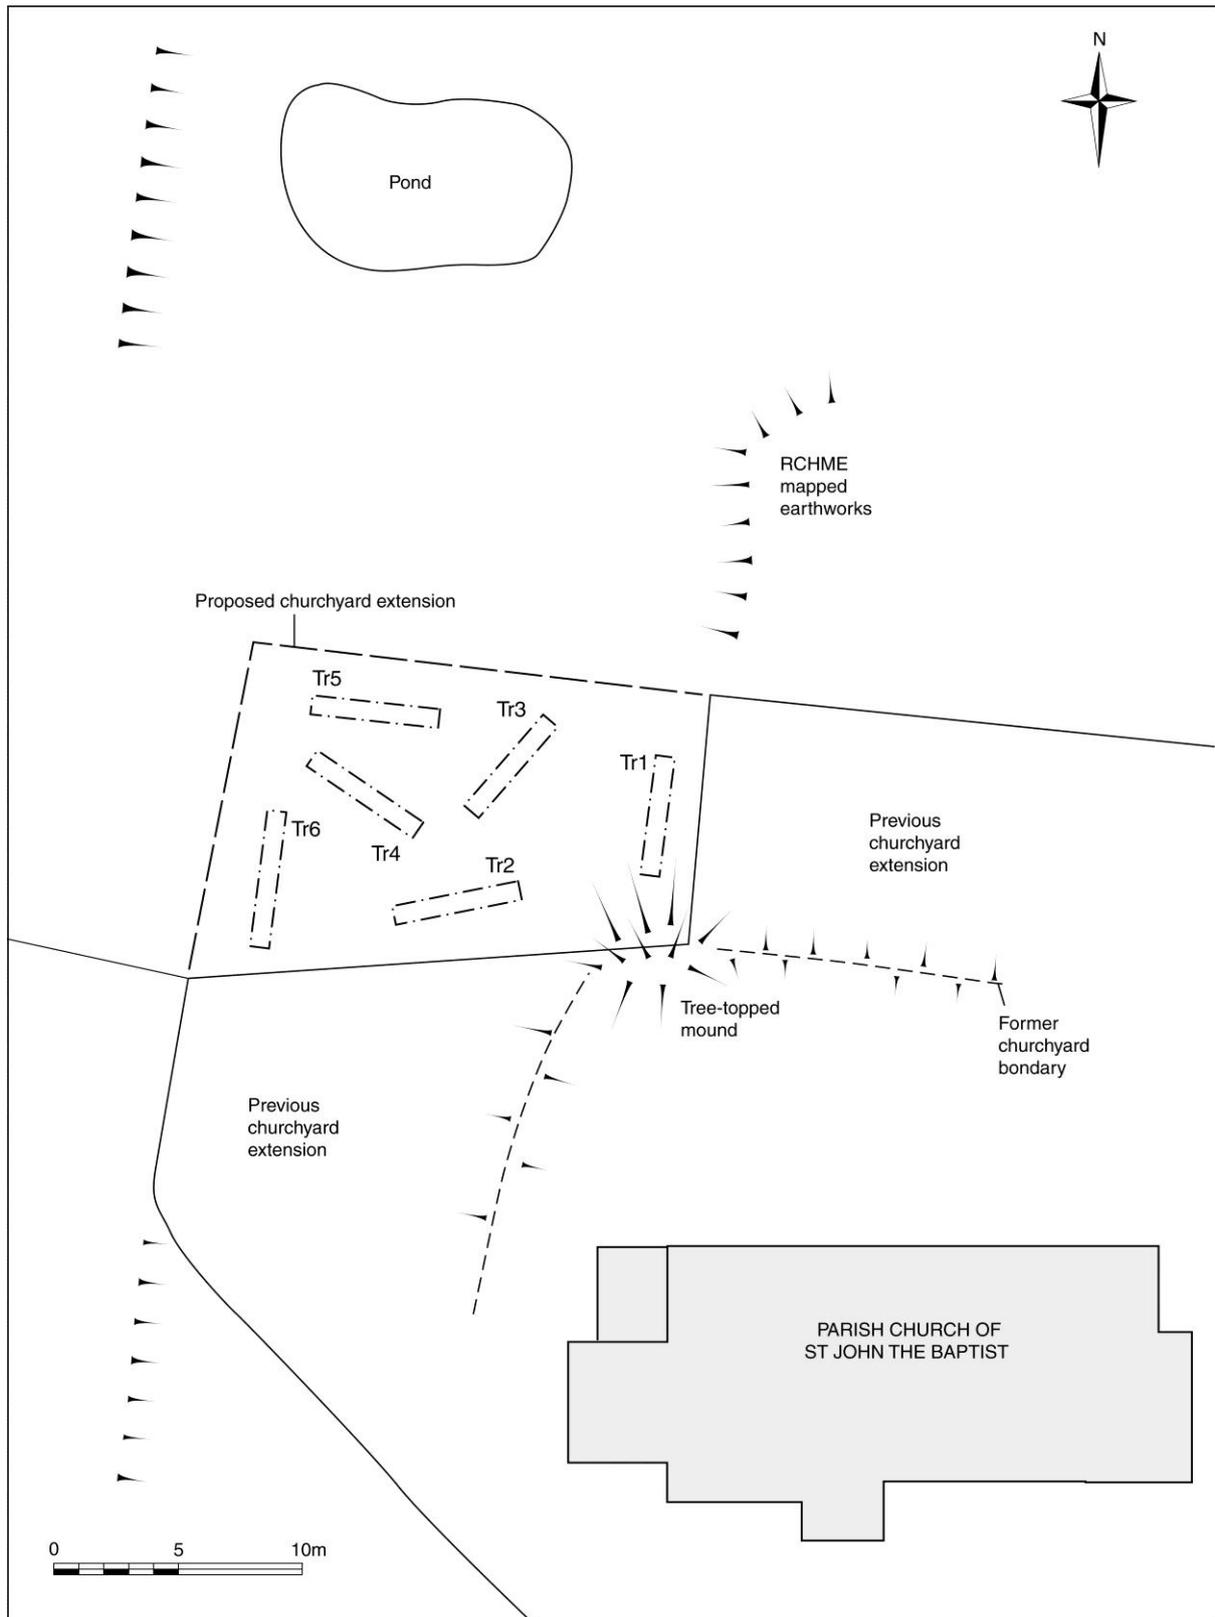
Fig 2: The trench layout (Andy Isham)

The work comprised six 5m-long trenches laid out as prescribed by the County Archaeological Advisor, and dug by a JCB-type 180-degree excavator. It was fitted with a 1.6m-wide toothless ditching bucket working under archaeological control (Fig 2).

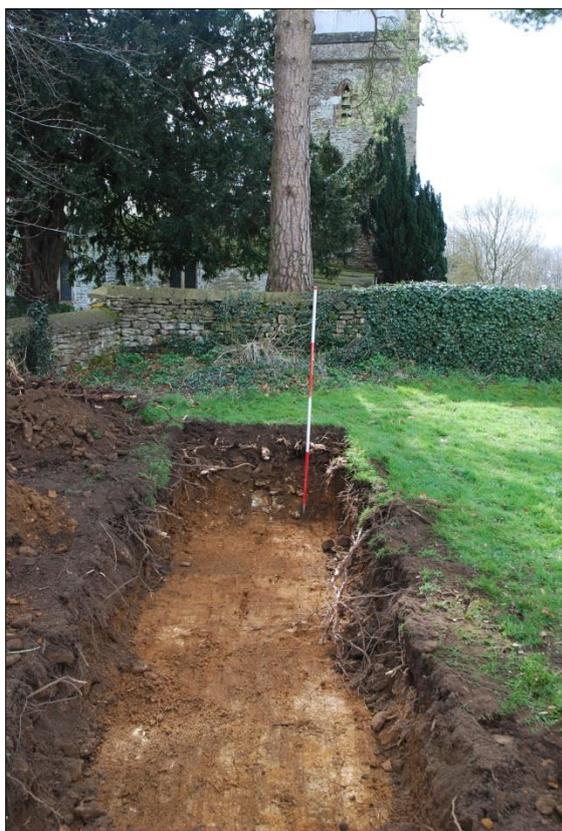
Only Trench 1 differed from the rest, and then only slightly. At its south end the limestone rubble thickened markedly to a thickness of some 400mm and formed the base and structure of the mound noted as an earthwork both inside and outside the existing churchyard (Figs 2 and 3). Tree roots had a strong hold on this deposit, over which the current topsoil had either accumulated or been deposited. Within the trench, this simple build-up of deposits amounted to 700mm in all, almost twice that in all the other trenches.

Fig 3: Trench 1, looking South, with the rubble-strewn ground rising to the tree-topped mound; scale 2m

The small mound within the churchyard appears to simply be the result of dumping of stone-rubble during works on the church or the churchyard boundaries. The self-seeding or planting of a pine tree on this mound has helped preserve it, but it is not felt to have any archaeological significance.

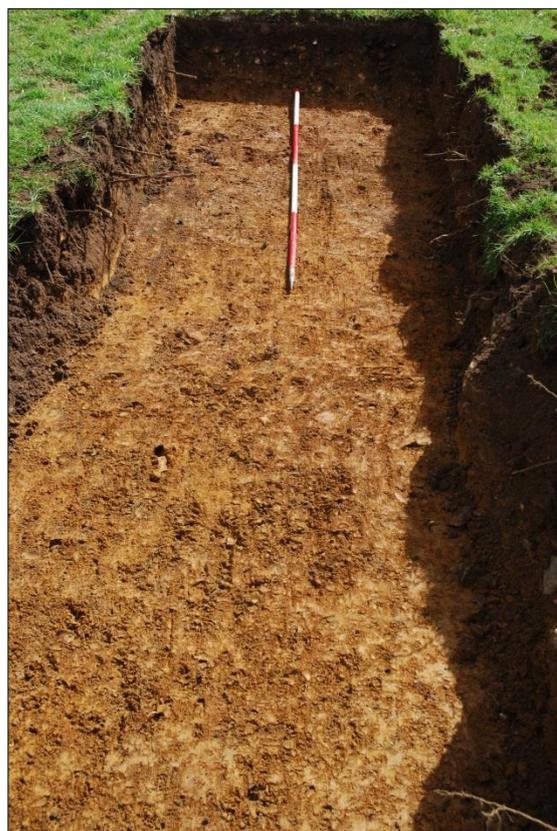
The results in all the other trenches were remarkably homogenous (Fig 4).

Fig 4: Trench 4, looking East, as representative of all the other trenches; scale 2m

None of the trenches contained significant archaeology (Figs 3, 4, 5 & 6). No dating evidence was present.

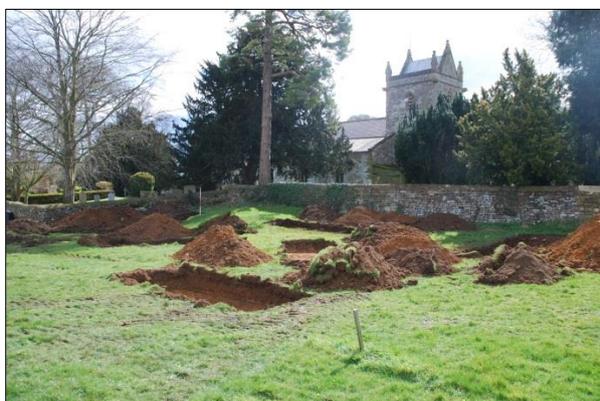
Fig 5: View south-east across open, empty trenches

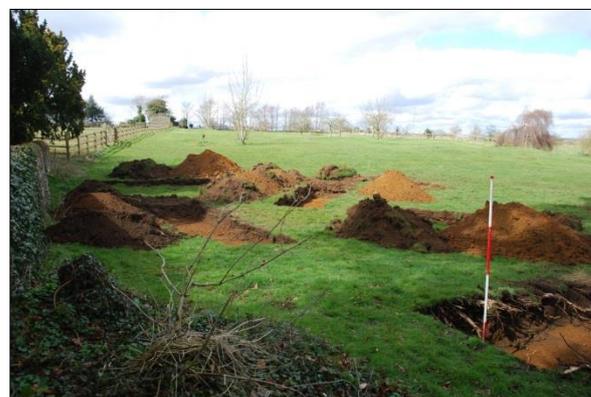
Fig 6: View west across open, empty trenches
