## Archaeological evaluation at the site of a new community centre, St Crispin's, Northampton

## An archaeological evaluation at the site of a new Community Centre, St Crispin's, Northampton

An archaeological evaluation on the site of a new community centre for the St Crispin's Area of Northampton found no evidence of pre-modern occupation, but rather one half of the site had been previously stripped and used for dumping of materials, before remediation, while the other had been substantially reduced in height before being flattened out. The site was previously open grassland.

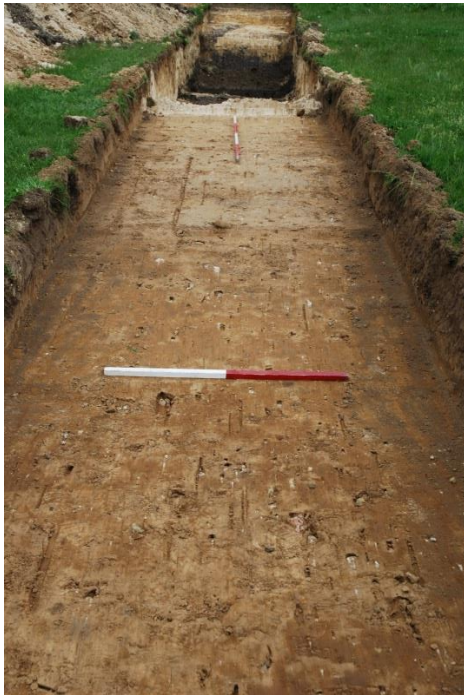
Fig 3: Trench 1, looking north from midpoint;  
scales 2m and 1m

Trench 1 measured 50m long x 1.8m wide and was aligned north-south along the long-axis of the proposed community centre building.

It cut through an average of 400mm of turf and topsoil which lay directly over natural clayey sand. There was no other stratigraphy present.

The clean, even horizon between the natural geology and the topsoil suggests that the ground has been previously stripped and re-made.

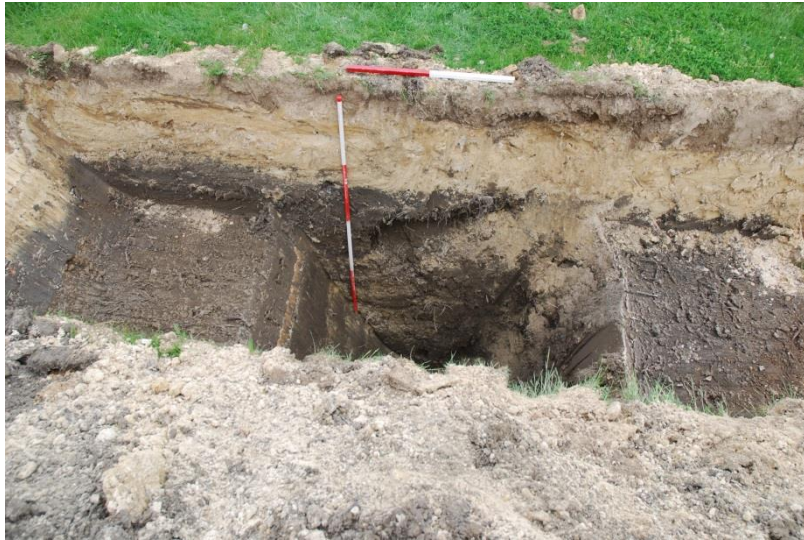
Fig 5: Massive modern disturbance at north end of Trench 1, looking east; scales 2m and 1m

However, close to the north end of the trench lay a 4m-wide swathe of deep, machine-cut modern disturbance, which had been backfilled apparently entirely with topsoil and old turf. This was not bottomed but is more than 2.85m deep (Fig 5). The fill still contained much organic material and reeked of decomposing vegetable matter as well as plastic and builder's debris. It had been sealed with a dump of sand.

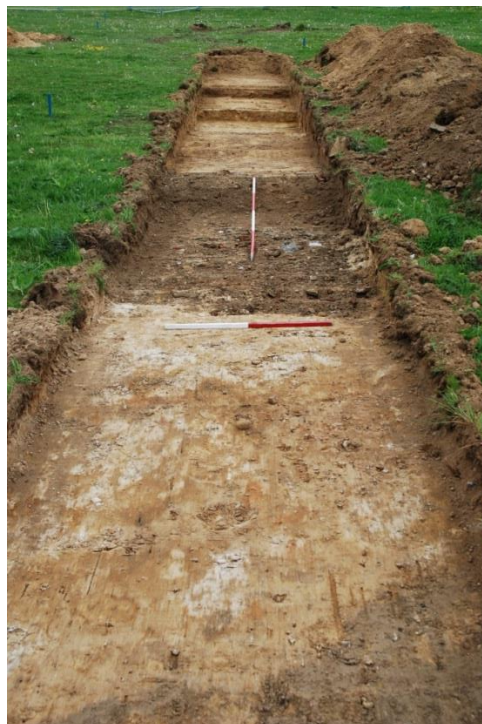
Fig 6: Trench 2, looking east, with modern disturbance; scales 2m and 1m

Trench 2 measured 20m x 1.8m and was aligned east-west across the rotunda of the new proposed community centre building. Here the topsoil and turf were as little as 200mm thick but again they directly overlay natural clayey sand. There was an area of modern disturbance across the trench, containing brick and concrete fragments (Fig 6).

There was no pre-modern archaeology present. The clean, even horizon between the natural geology and the topsoil suggests that the ground has been previously stripped and re-made.

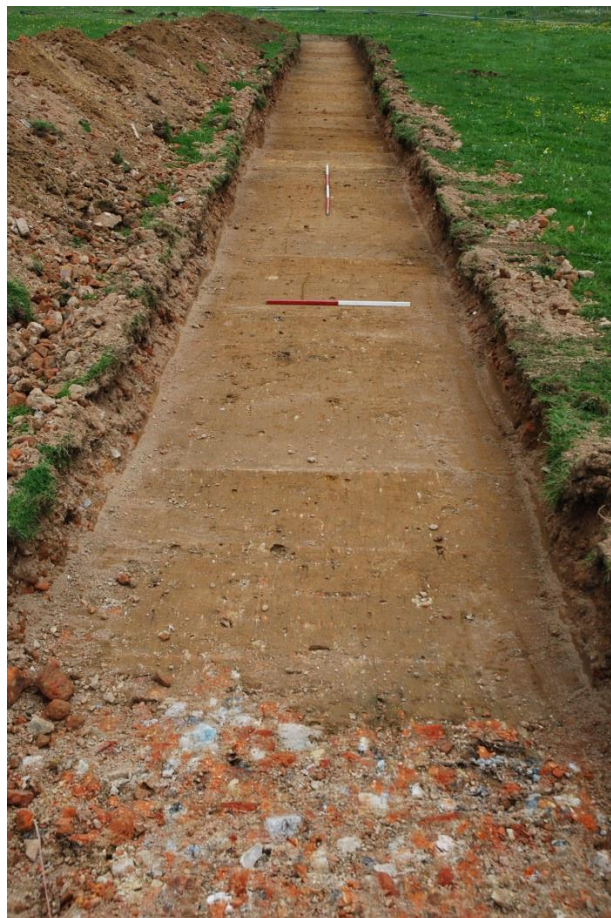
Fig 7: Trench 3, looking north-east, haul-road crush in foreground; scales 2m and 1m

Trench 3 measured 50m x 1.8m and was aligned north-east to south-west along the line of the proposed new access road on the site. Here, as in Trench 2, the topsoil and turf were very thin and for most of the south-western end there was a hard compacted layer of modern brick crush just below the turf (Fig 7). This area seems to have previously been used for storing building rubble, or may have been used as a haul road. The topsoiling and turfing/seeding seems to have constituted remediation. They and the crush directly overlay natural clayey sand, forming a flat, even, very artificial.

There was no pre-modern archaeology present. The clean, even horizon between the natural geology and the topsoil suggests that the ground has been previously stripped and re-made.

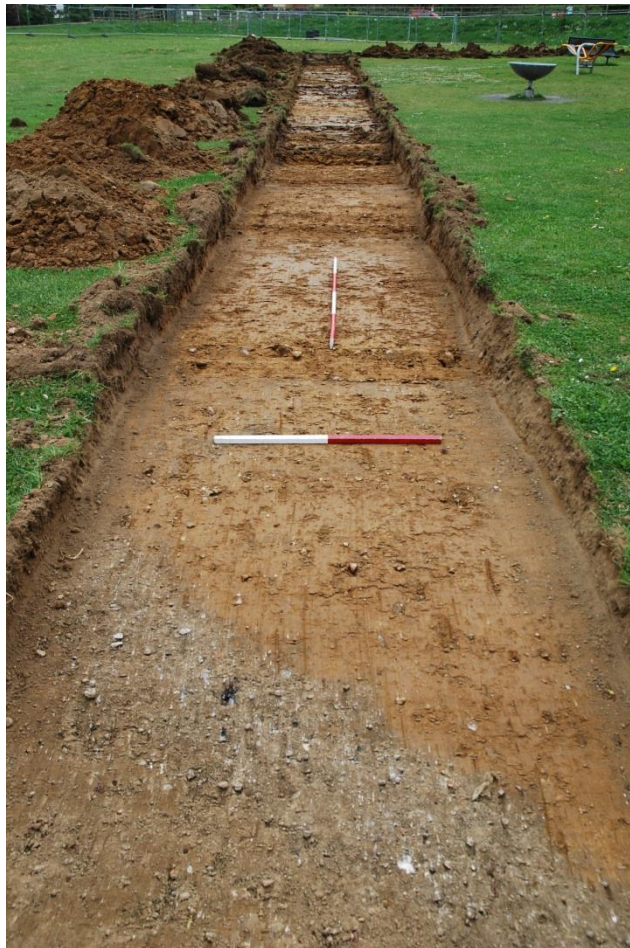
Fig 8: Trench 4, looking south, concrete crush in foreground, Trench 5 at top right; scales 2m and 1m

Here the topsoil was very thin indeed, sometimes as thin as 100mm including turf, and it overlay partly the same clayey sand encountered elsewhere, and partly lias clays which were unusually close to the surface. Within the clay was a truncated ceramic land drain of the type used in the 19<sup>th</sup> and early 20<sup>th</sup> centuries. Ordinarily such land drains lie some 750mm -1m below the ground surface and

this startlingly shallow occurrence suggests that the land has been reduced at this southern end of the site. Certainly the sweep of St Crispin's Drive, together with a nearby sewer manhole, both stand about a metre above the surrounding grass.

There was a spread of concrete crush at the northern end of the trench. The trench contained no pre-modern archaeology.

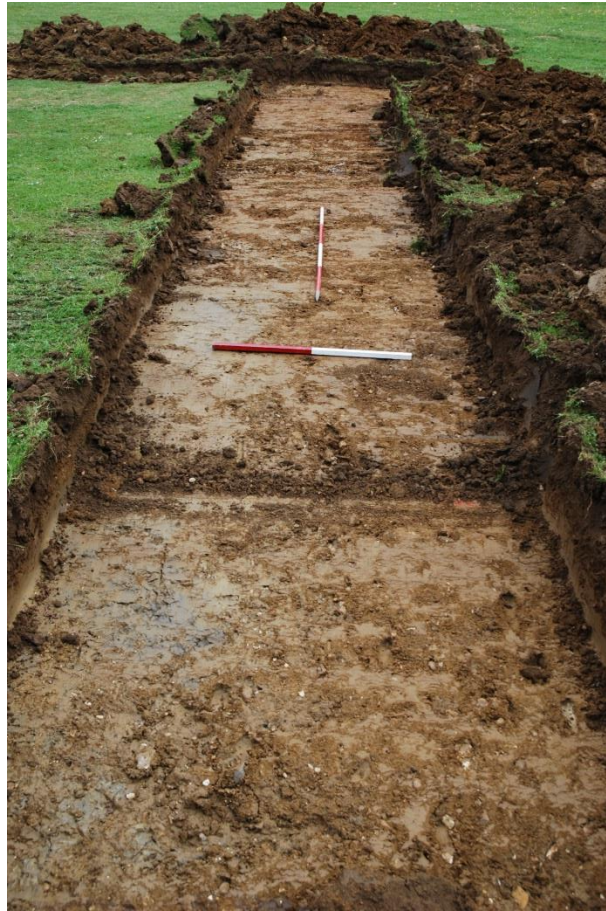
Fig 9: Trench 5, looking east; scales 2m and 1m

Trench 5 measured 20m x 1.8m and was placed at right angles to Trench 4 in order to avoid a children's playground and the large ground-anchored, rubberised plastic mesh mat on which it was constructed.

As in Trench 4 the mere scattering of turf and topsoil overlay patches of exposed lias clays, indicating that the ground hereabouts had been previously reduced before being re-made.

There was no pre-modern archaeology present.
