**Archaeological observation and monitoring for new  
greenhouse foundations at Canons Ashby House,  
Northamptonshire, August 2016**

## Archaeological observation and monitoring for new greenhouse foundations at Canons Ashby House, Northamptonshire, August 2016

### Summary

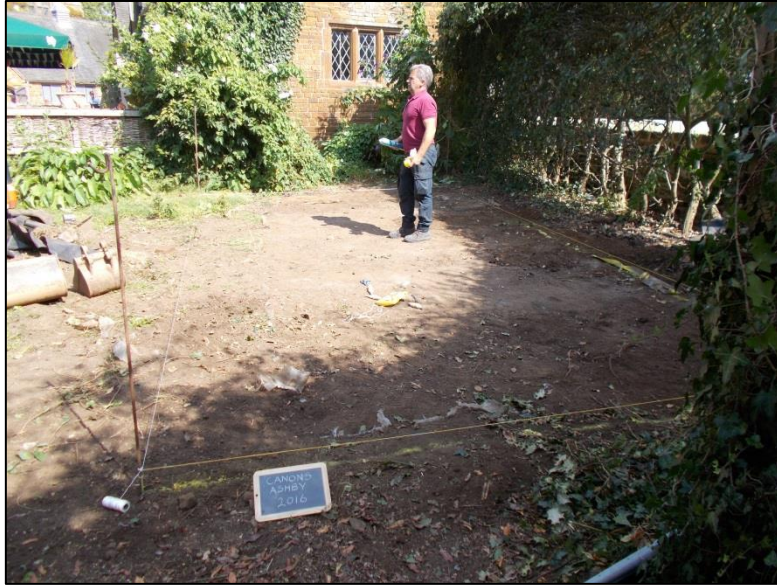
The new greenhouse was a direct replacement for a pre-existing poly-tunnel, which had been recently taken down. However, the two greenhouses did not share the same footprint. The polytunnel had lain parallel with the roadside wall, whereas the new one was set out at an angle to that wall to avoid damaging a mature holly hedge (Fig 2).

Fig 2: Setting out the building relative to the holly hedge and the roadside wall beyond (right)

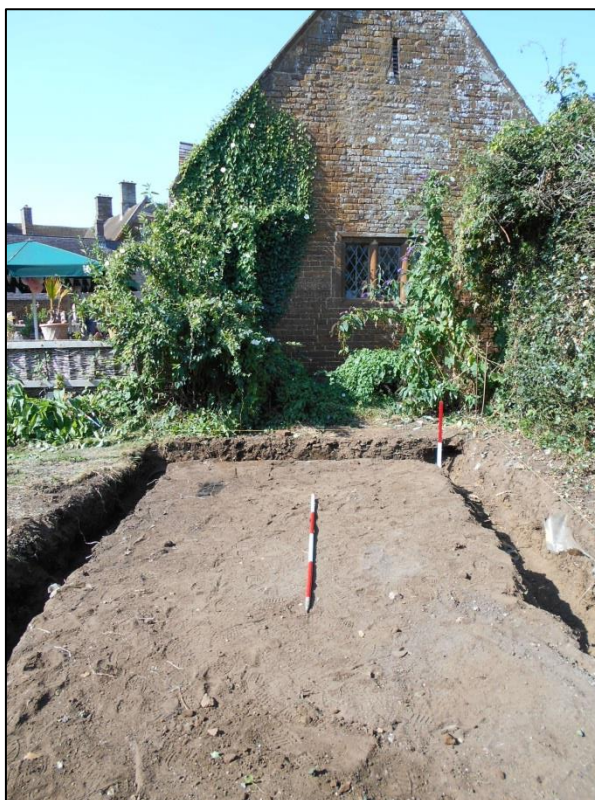
The entire depth to 500mm comprised dark brown compacted very well-drained topsoil, lightening slightly with occasional pebbles and becoming more compact to the base, where it met natural ironstone geology abruptly and evenly. There was no subsoil or intervening layers present.

Fig 4: View of the area, looking north; scales 2m (horizontal) and 1m (vertical)

There were no archaeological features visible in the trench sides or in the narrow base of the trench, but for an amorphous dump of modern brick, tile and smashed drainage pipe rubble in the north-east corner of the area, only half-buried in topsoil and clearly a recent deposit. This dump included a very damaged (and clearly residual) architectural fragment, possibly from an arch and probably medieval in origin from the nearby Augustinian Priory (Fig 5). This was set aside and labelled for retention or discard by National Trust, as appropriate. Since it has no monastic or immediately Dissolution-related context, it is of very limited value.

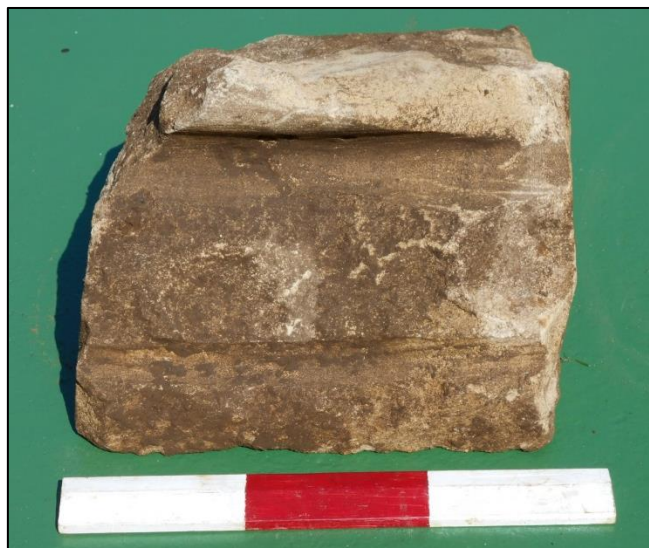
Fig 5: Un-stratified architectural fragment; scale 30cm

The single residual architectural fragment probably derives from the nearby Augustinian Priory, dissolved in 1539. It was, however, mixed in with modern brick and other building-rubble and has thus been moved more than once and has no connection with a Dissolution- or demolition-context.
