**CBA
RESEARCH
REPORT**

No 15
EXCAVATIONS
AT
ST MARY'S
CHURCH
DEERHURST
1971-73

Philip Rahtz

Excavations at
St Mary's Church,
Deerhurst,
1971-73

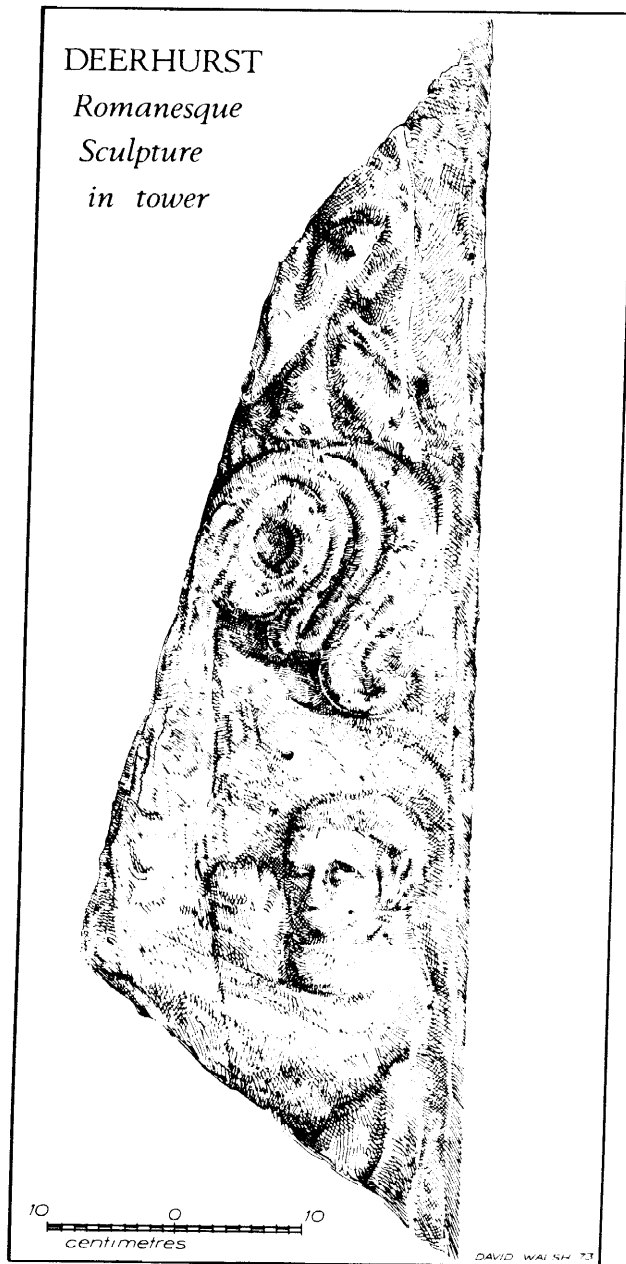
Fig. 15 Romanesque sculpture in the tower

The foliate element between the figures, as we have said, is a curling frond of a split palmette. The formal type and the method of carving of the palmette, with the curving, rounded lobes, each with depressions in the centres in the form of wide grooves with sloping sides, is of an extremely common and widespread variety. The foliage of the Deerhurst slab is a rather crude and ungraceful version of the type found on the mid-12th century tympanum of the south door at Kilpeck (Zarnecki, 1953, fig. 19). Only the upper portion of the bottom figure remains visible. The exact position of the left arm is obscured by damage done to the lower part of the slab. ²² The head is seen in three-quarter view. The features are simply blocked out and defined by a series of grooves; the chin is small and the mouth was perhaps never well articulated. The mass of the hair on the back of the head extends as low as the chin and there is a strange protuberance on the side of the head. The figure seems to be wearing a heavy collar or cowl around the neck. The figure above the palmette can only be seen below the shoulders. The articulation of what remains of the figure is rudimentary. The feet are hardly distinguishable from the amorphous lower legs. The upper part of the figure is covered with a heavy mantle.

The relief is characterized by an elemental simplicity. The projecting parts rise from the plane of the background field, the amount of relief between the background and the areas of projection being about 2 cm. The outer contours of the figures are

rounded and nearly all the projecting parts are on a single plane, so that the elements of the design read as cutouts. Articulations within the figures such as in folds of drapery are rendered as rounded V-grooves.

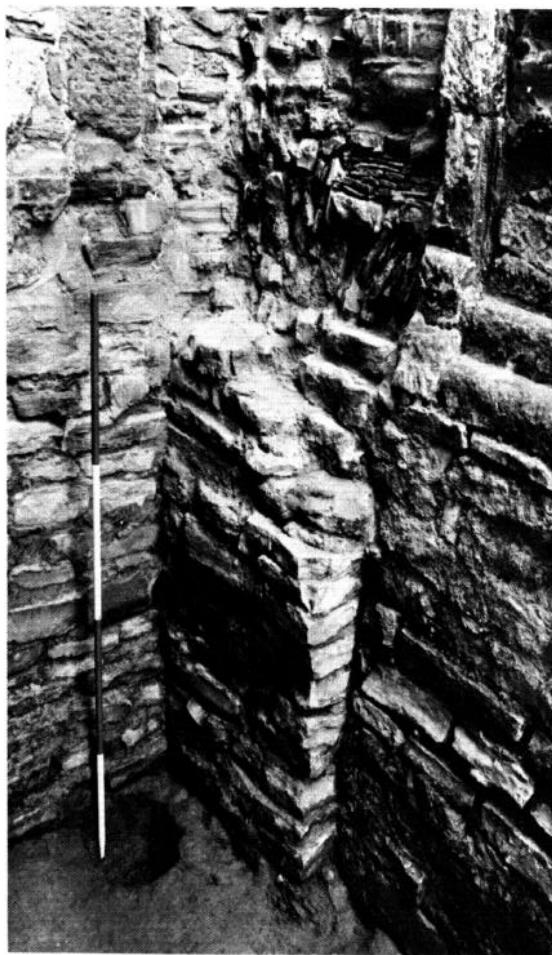
Plate II A South-east corner of first stone church, with east wall of south porticus abutting on left, and semicircular apse wall on right, with oolite plinth and pilaster strip of polygonal apse above. From south-east

B Apse : mortar of AF11 as defined in slot AF33. From north

This does not seem to have been done, however; not only are all the lower courses of the eastern quoins of the first stone church in mint condition, with very sharp angles (Plate IIa) but, as already discussed, the builders' spoil remained enveloping them down to the present day. They were buried, and there must have been a wedge-shaped bank extending round the east end or at least the quoins. Only 30 cm of this survived along the east wall (S2); this was sealed at this level by the mortar of the sub-floor level of the later apse (see below). In the north-east and

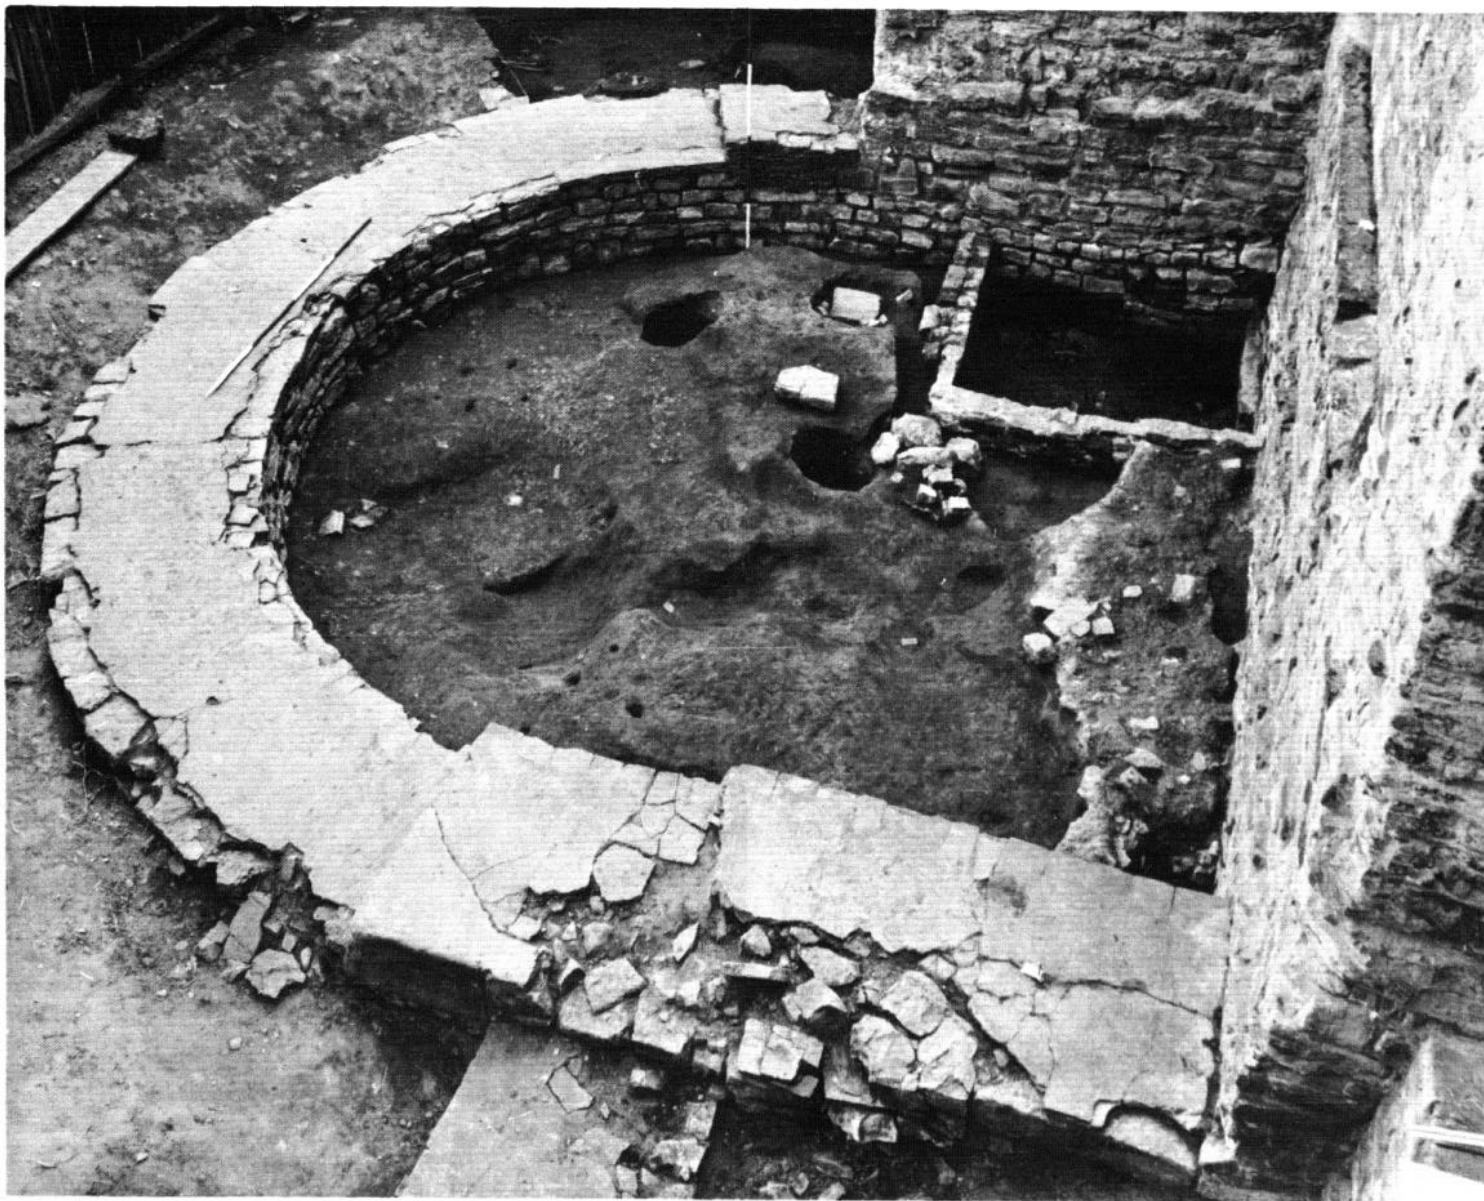
Plate IV Excavated apse from north, with remains of mortar AF11 still in position

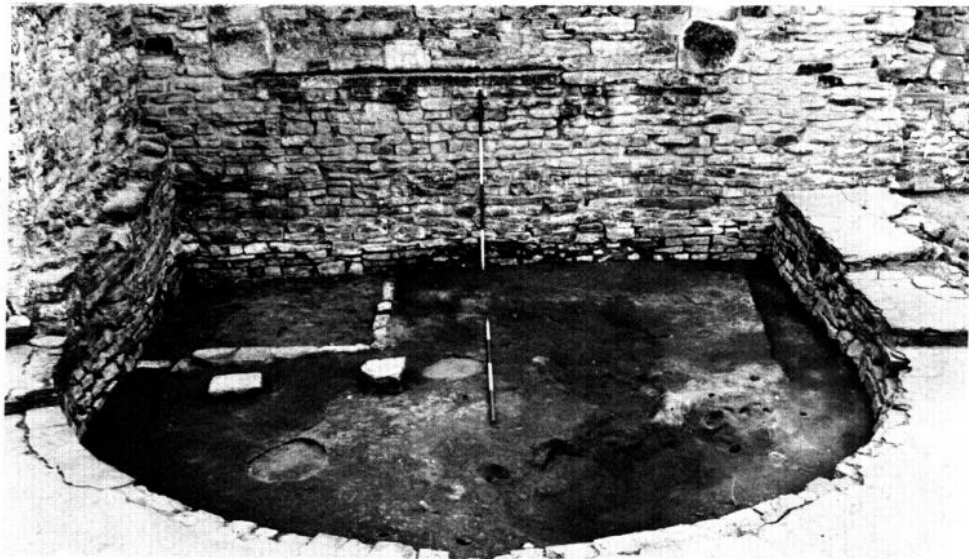
Plate V A Excavated apse from east; east wall of first stone church in background, with sill of blocked arch above

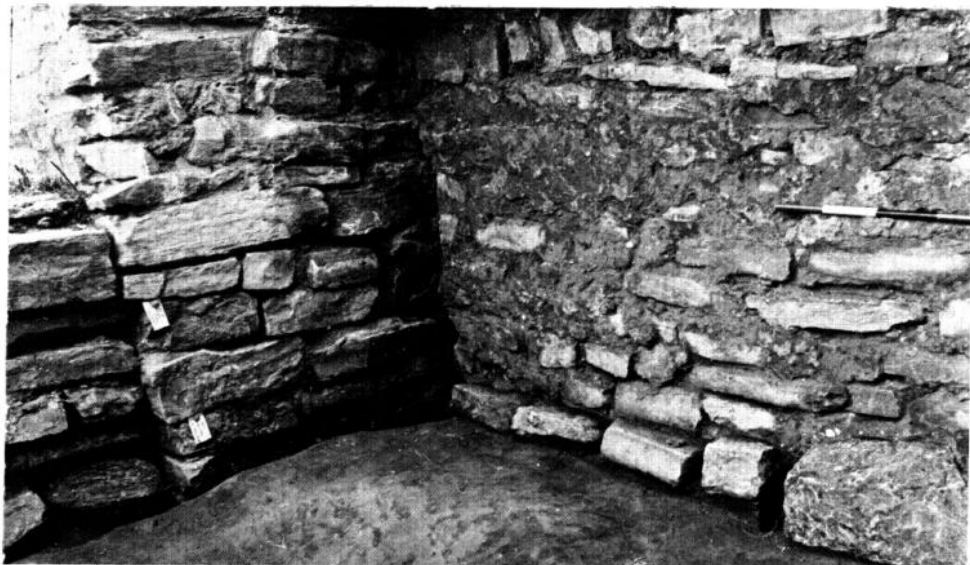
Plate V B North-east corner of first stone church, with wall of semicircular apse abutting on left and mid-wall of double north/north-east porticus on right. From north-east

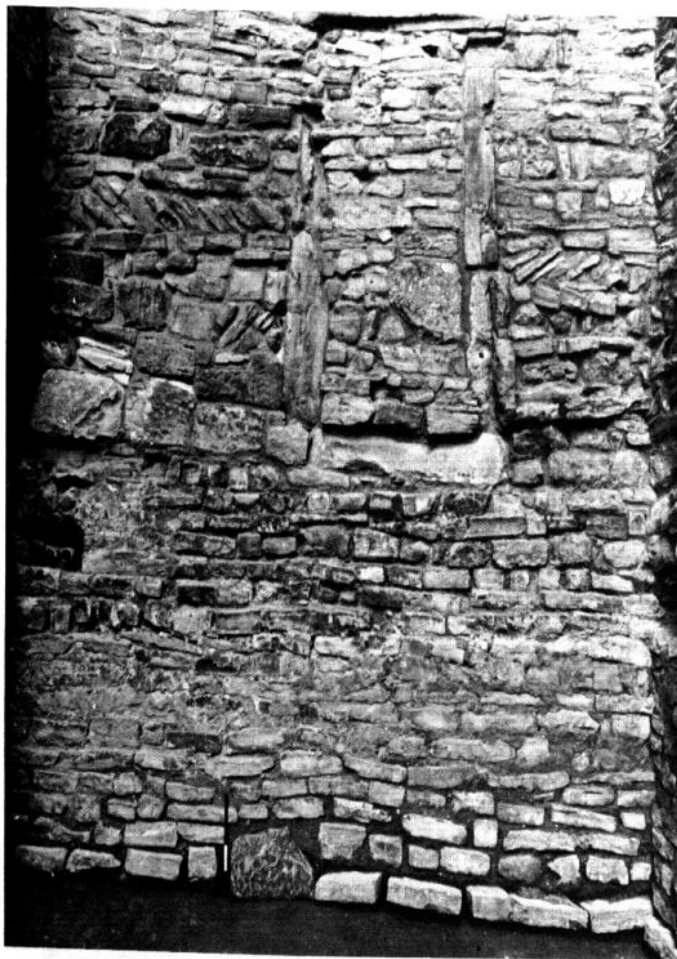
Plate VI A East face of mid-wall of double north/north-east porticus, with sill of blocked doorway. From east

The earliest features in this area associated with the first stone-church have been discussed above ; remains of a bank on the north side of this (NF9 and AF3b in S3) may have been visible to later builders. The first structure was the line of unmortared stones AF7a, numbered 1–10 from the north as in Fig. 8, which acts as an offset foundation to the midwall AF7 above. It was not, however, mortared to AF7 except for an oolite block (stone 6) in the middle which stands higher; the rest was separated from AF7 by a thin clean band of dark soil (ES, Plate VIB).

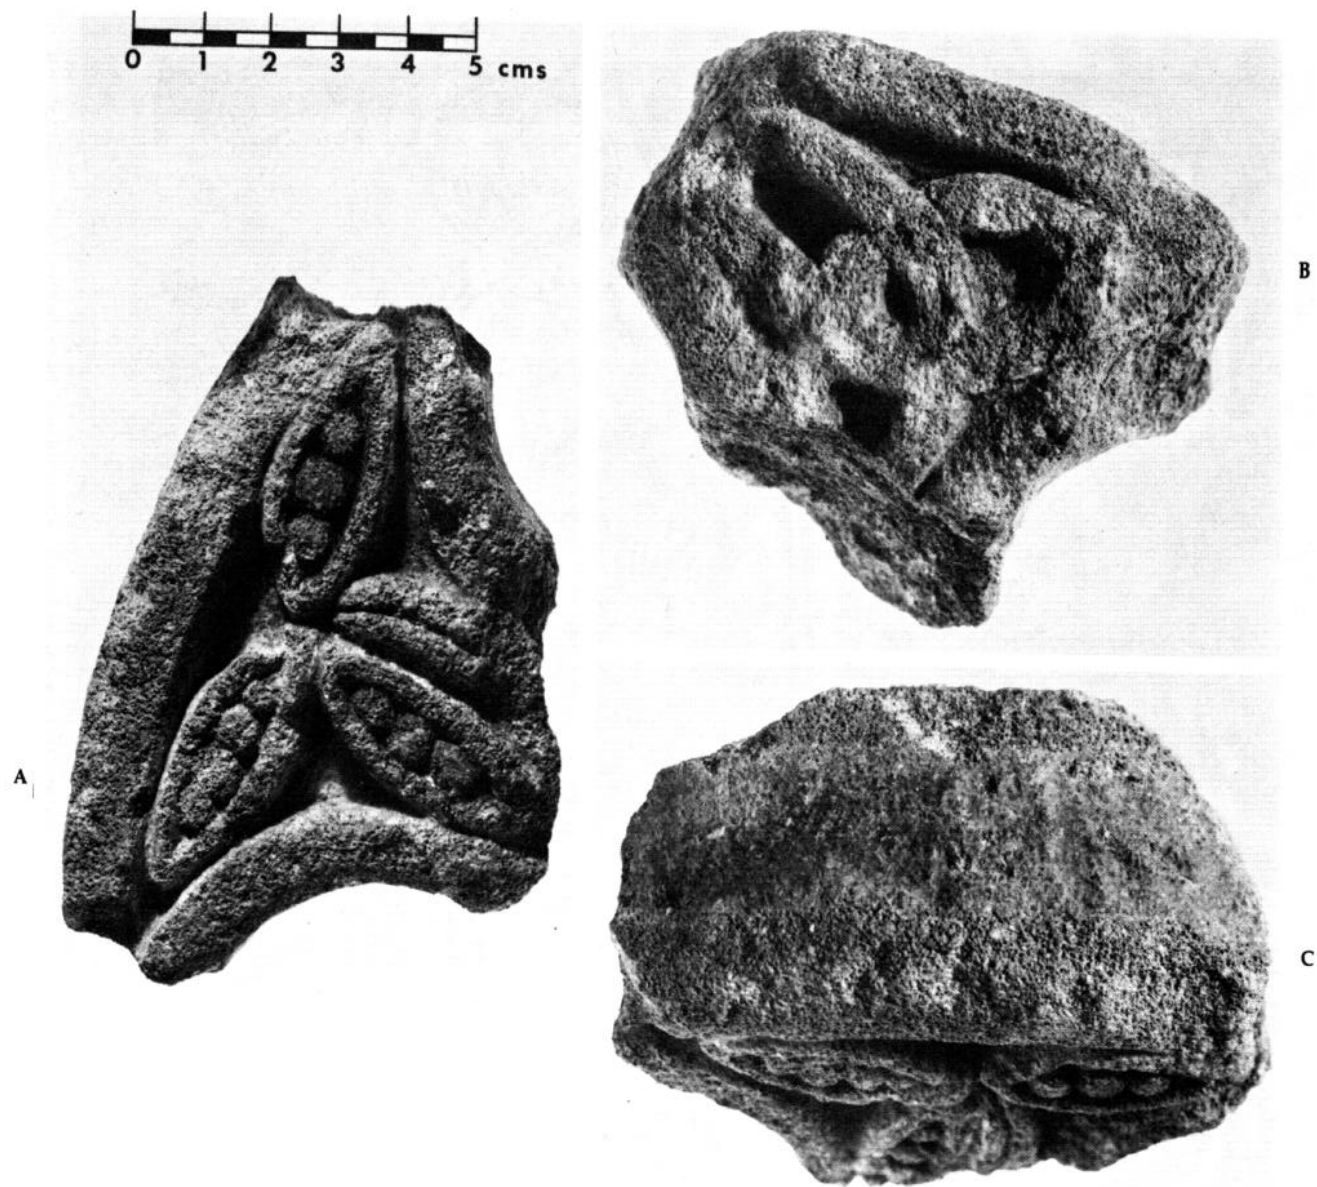
Plate XI Fragment of cross-head ST3 : A pod side, B interlace side, C edge, showing smooth band. For scale see Fig. 14

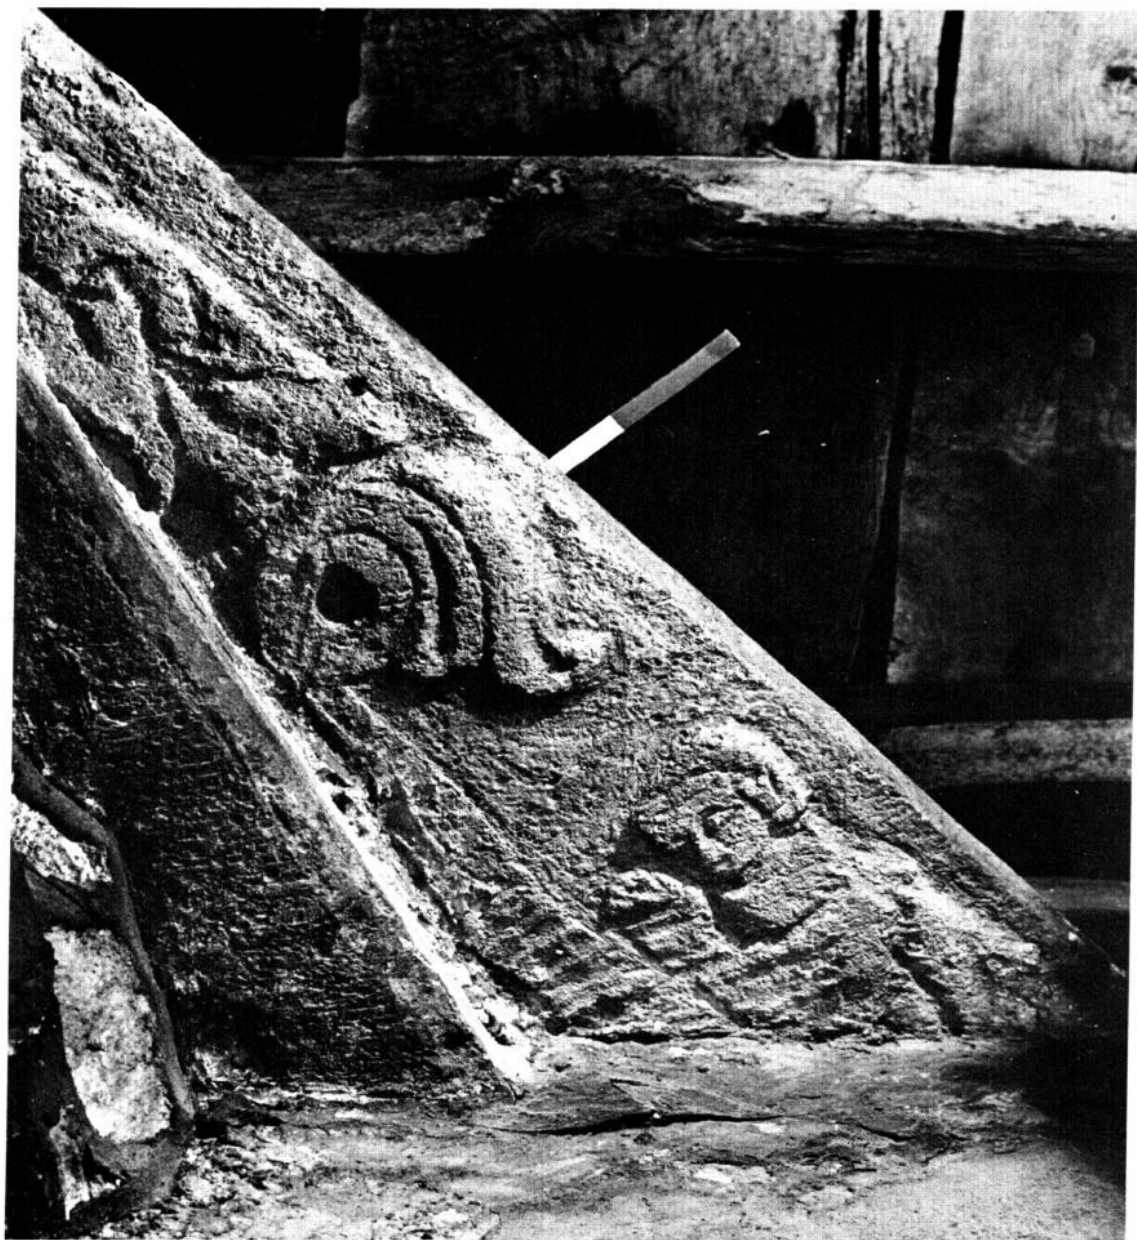
Plate XII Romanesque sculpture from tower (cf. Fig. 15)

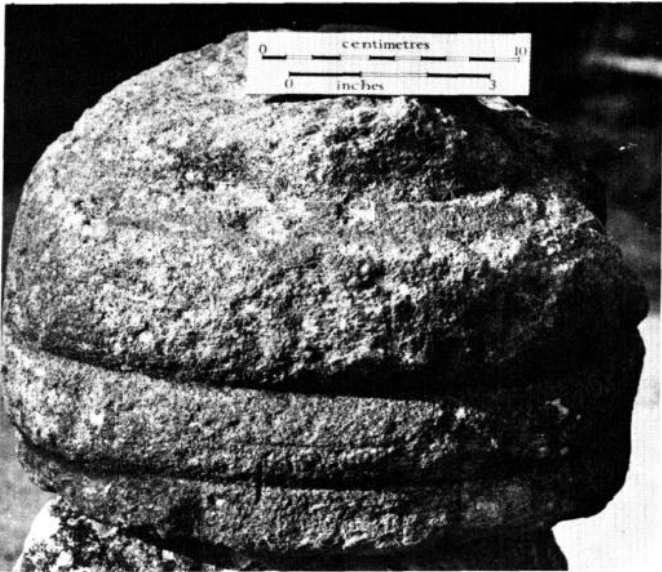
Plate XIII A Capital ST13 (inverted)

ST13	Capital or less probably base, with tenon-hole, of oolite; triple roll moulding; similar in style to stone now forming base of capital/column/base assembly in parlour of Priory Farm; the capital there is usually assigned to the 12th century (see p. 3) and the base has therefore been assumed to be of the same period, but the elements of this assembly may be derived from different places, and may be of different dates. ST13 therefore might be post-Conquest, but there is no reason why it must be; its context and associated material must be taken into account. Parallel s could be drawn from both pre- and post-Conquest contexts (SEF15b).	Fig. no. 13.1 (and Plate XIIIA) 13.2 (and Plate XIIIB)
ST14	Lintel, see illust. (NEF1) (near surface by east side of AF8).	13.5
ST15	Oolite block, see illust. (near surface by east side of AF8).	13.3
ST16	Oolite block with burnt corner (SEF15).	13.4
ST17-19	Three blocks of Lias (NEF2a and 2b and NE2).	136-8
