The Austin Friars,
Leicester

CBA Research Report 35
Leicestershire Archaeological Field Unit
Report

1981
The Leicestershire County Council and
The Council for British Archaeology

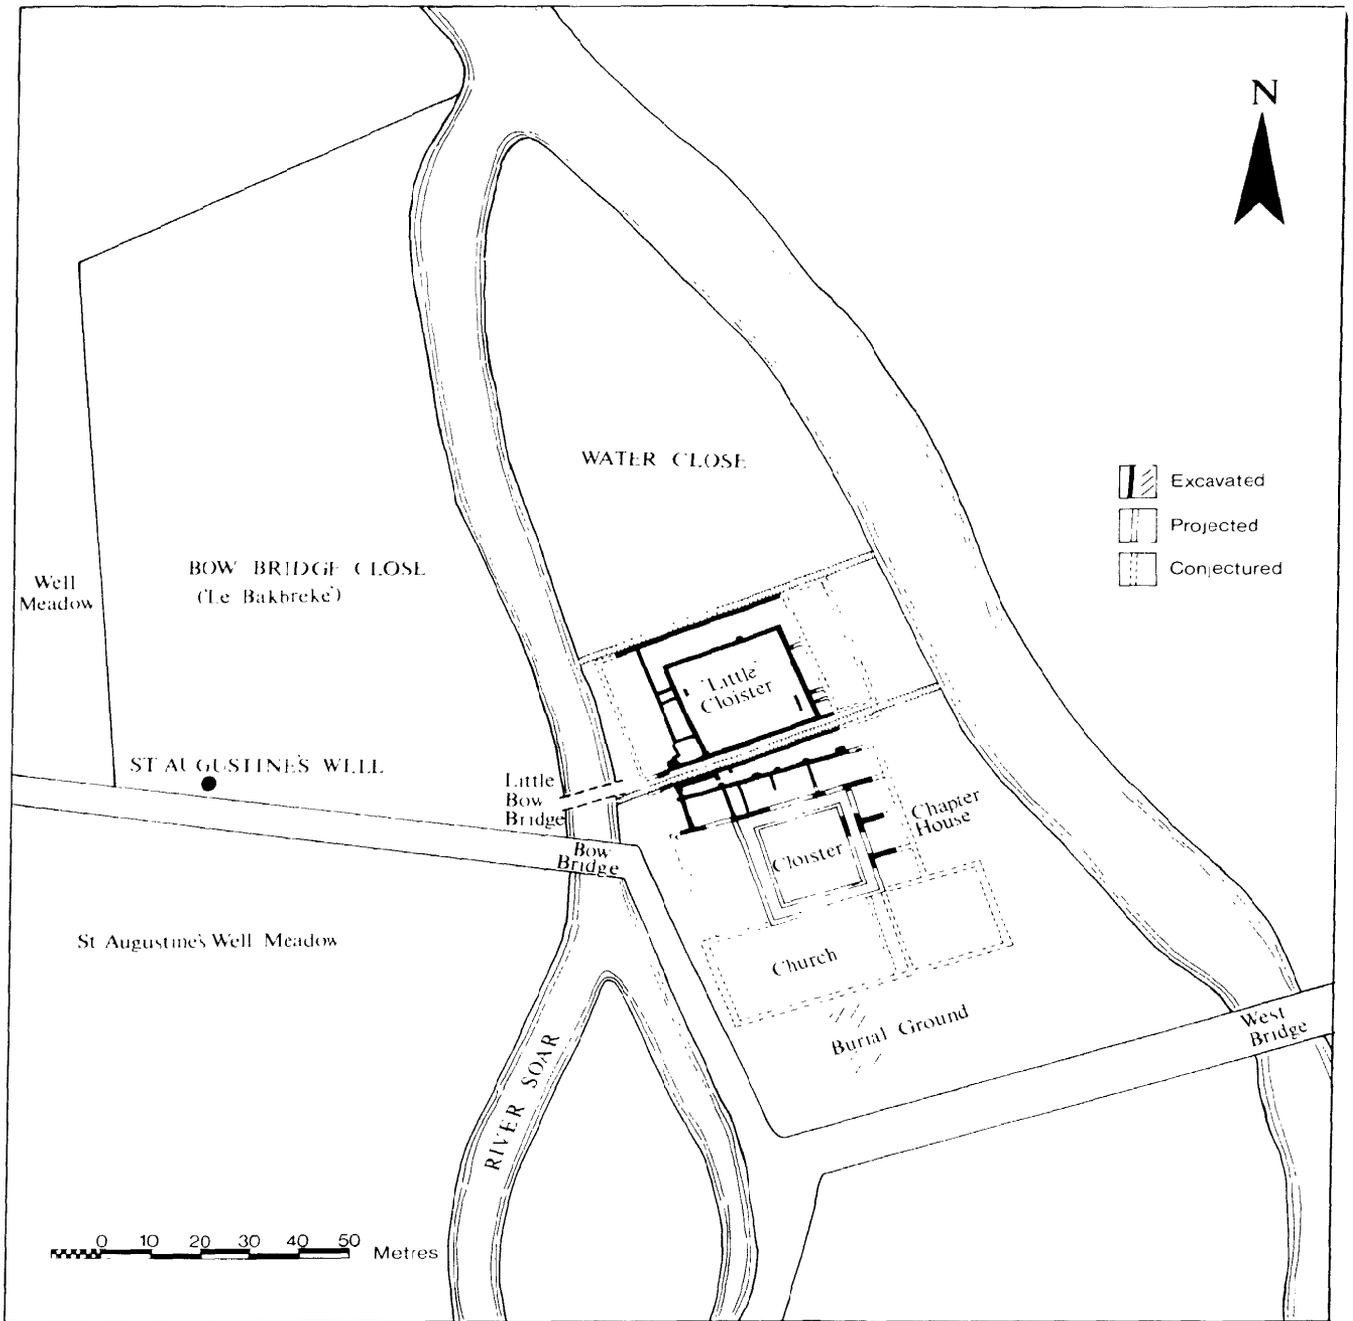
Fig 2 Augustinian Friary precinct

Between 1973 and 1978 an area of c 2400 sq m was examined and the plan of an extensive and complex series of buildings was revealed (see Fig 2). The interpretation and development of the plan will be discussed in detail below; here it is sufficient to state that the evidence from the excavation shows a series of buildings ranged round two cloisters while the Friary church lay to the south of the excavated area. In a normal monastic layout the cloistral buildings would be found to the south of the church but the friars often had to adapt to the exigencies of a cramped site often resulting in an unconventional plan. At Leicester the position of the church and consequently the layout of the rest of the buildings was determined by the relationship of the site to the road out of the town from the West Gate.

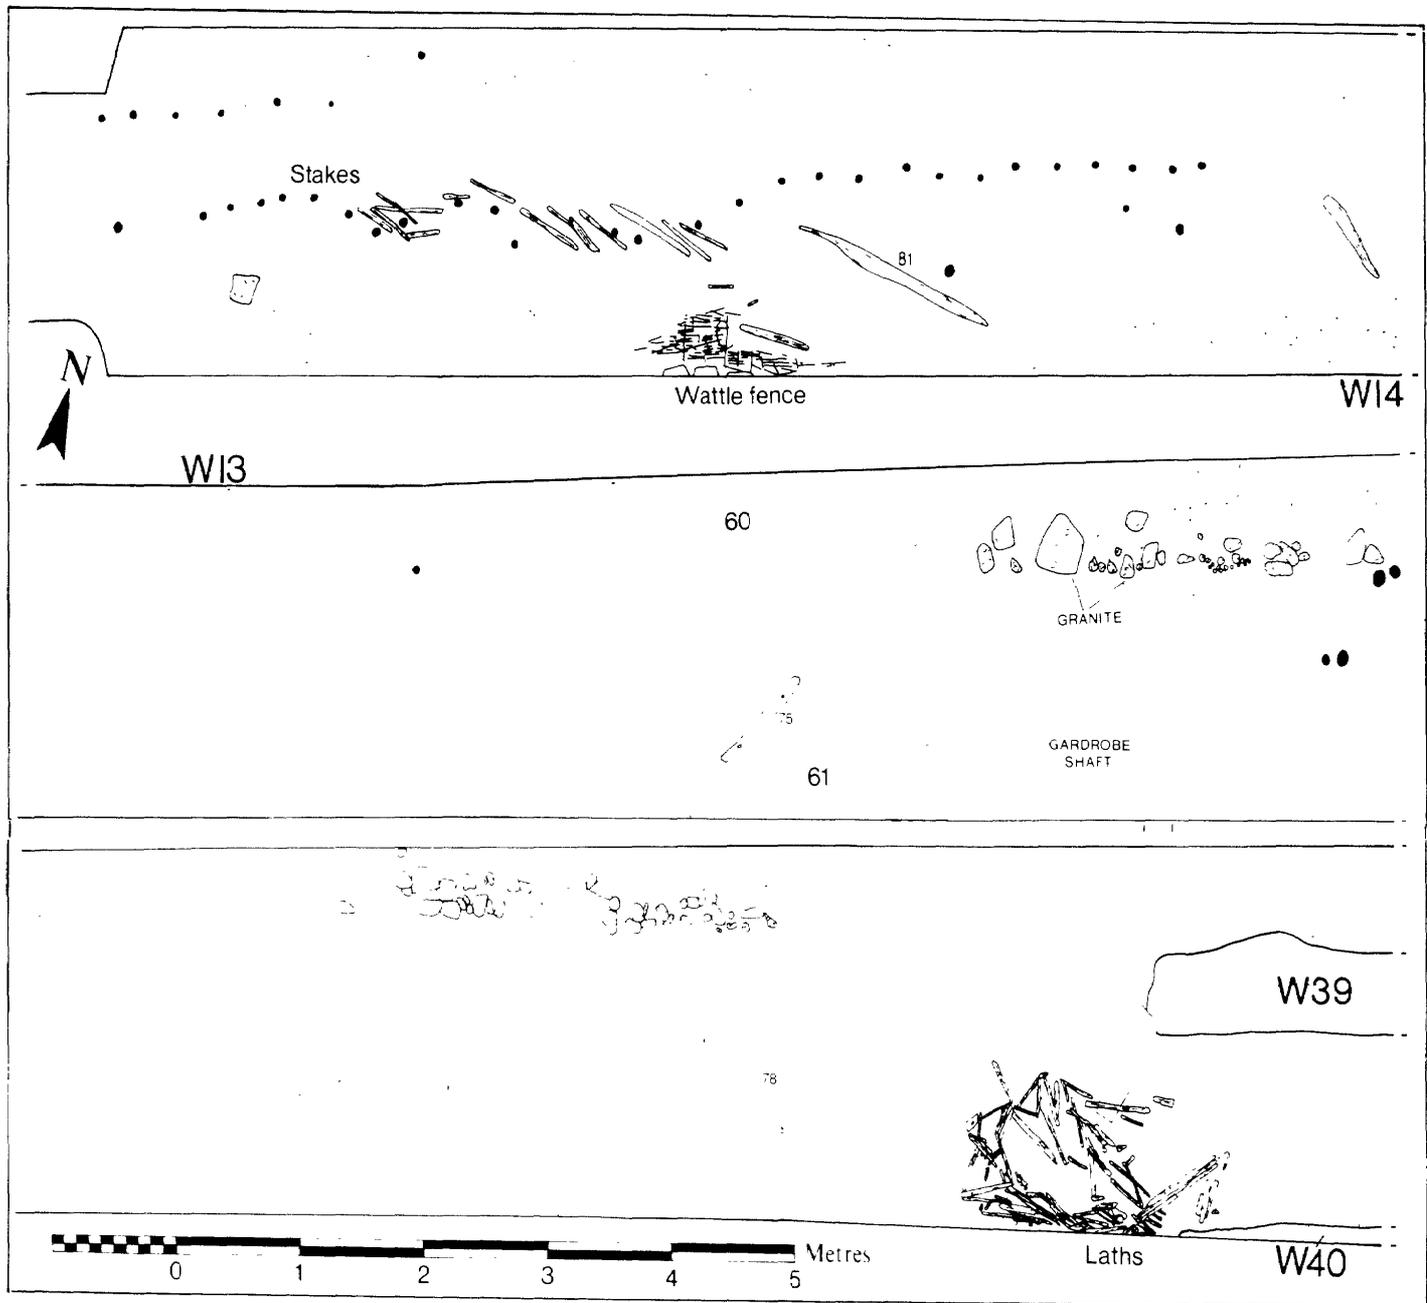
Fig 4 Plan, features within main drain

drain wall so that the base of the north culvert wall, W39, survived in the middle of the later drain. Wall W39 was 0.65m wide, faced on its south side with rough ashlar sandstone blocks and with footings of two courses of angular granite fragments. The construction of wall W40 was similar but its width could not be measured.

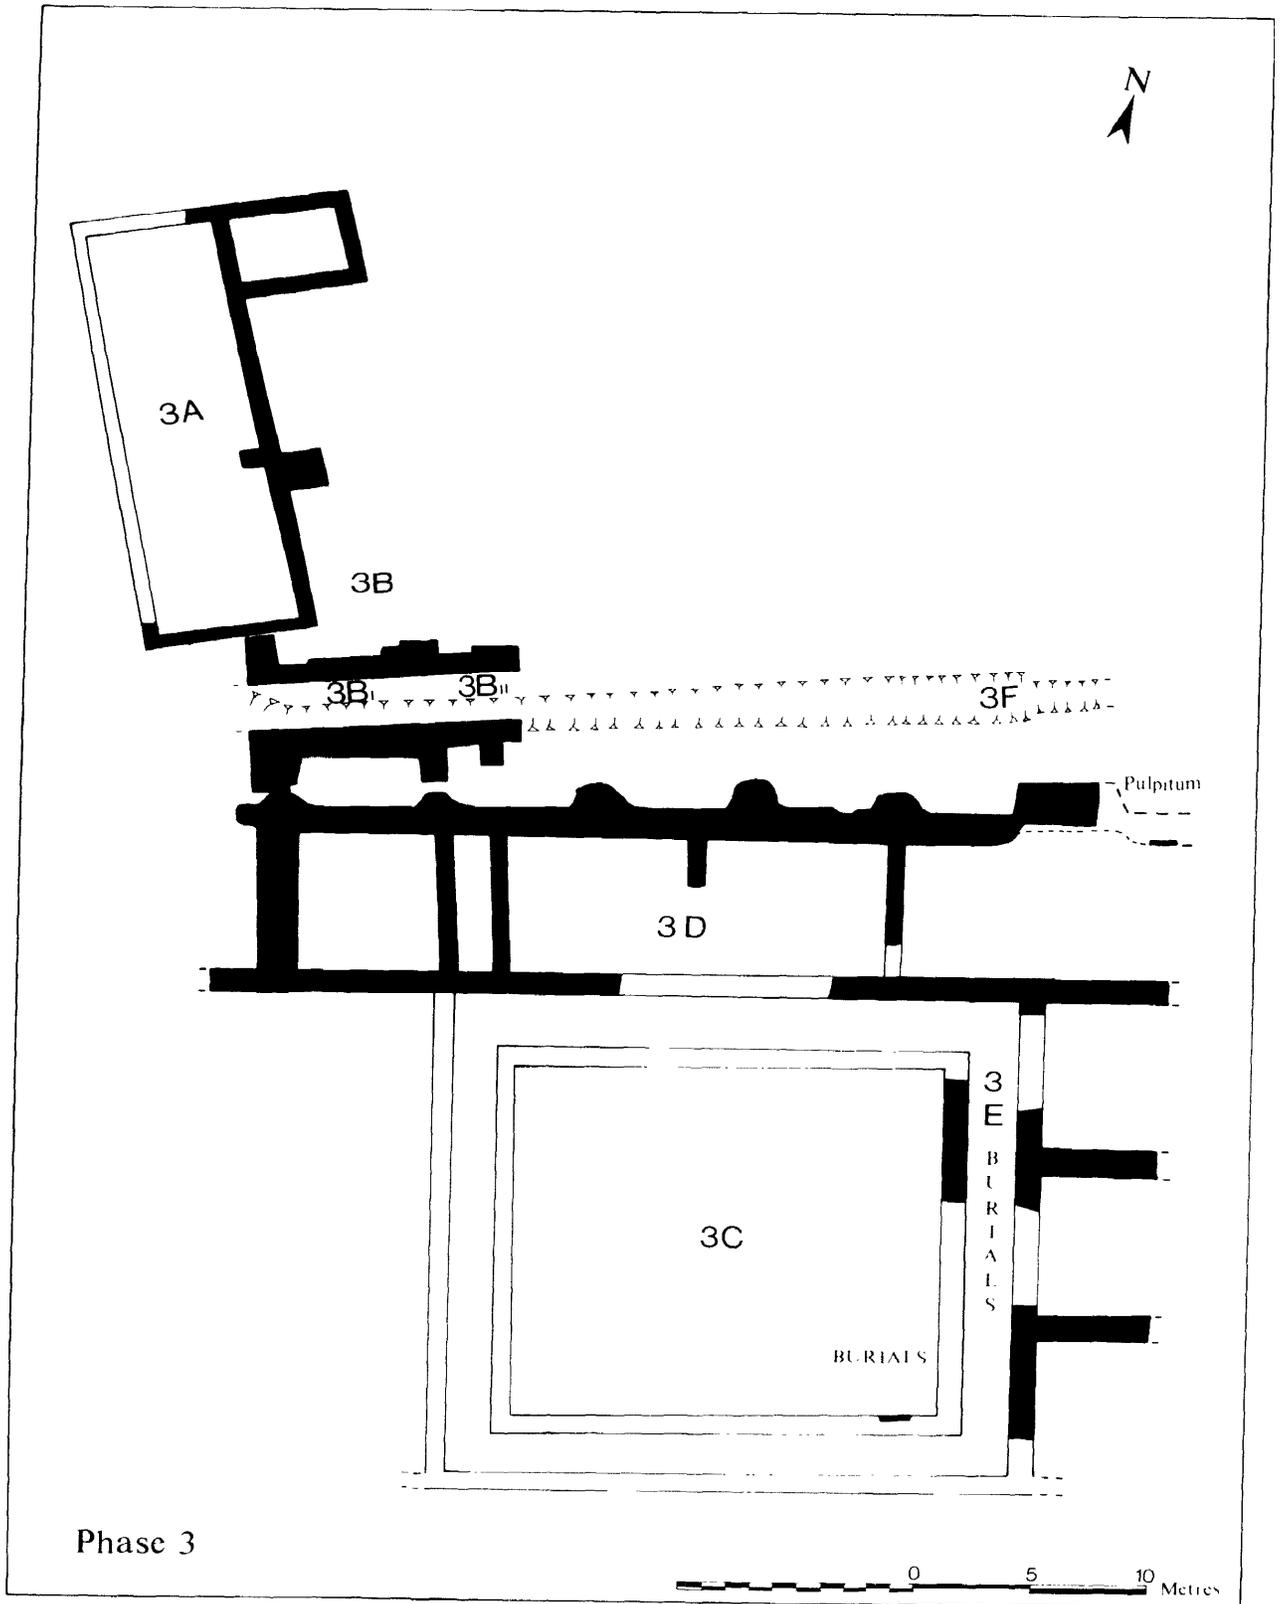
Fig 5 Plan, phase 3.

Until the end of the 13th century it would appear that the friary buildings were confined to the area south of the ditch (2D). In the early 14th century, however, a general expansion began which involved not only rebuilding on the original site but also the construction of a small stone building on the meadow land north of the ditch and a large and imposing structure which straddled the ditch at the west end. The timber and stone structures of 2A, B, and C were demolished to make way for regular cloistral buildings. The ditch continued in use throughout the 14th century although the culvert at its east end was demolished and replaced by a stone structure at the west.

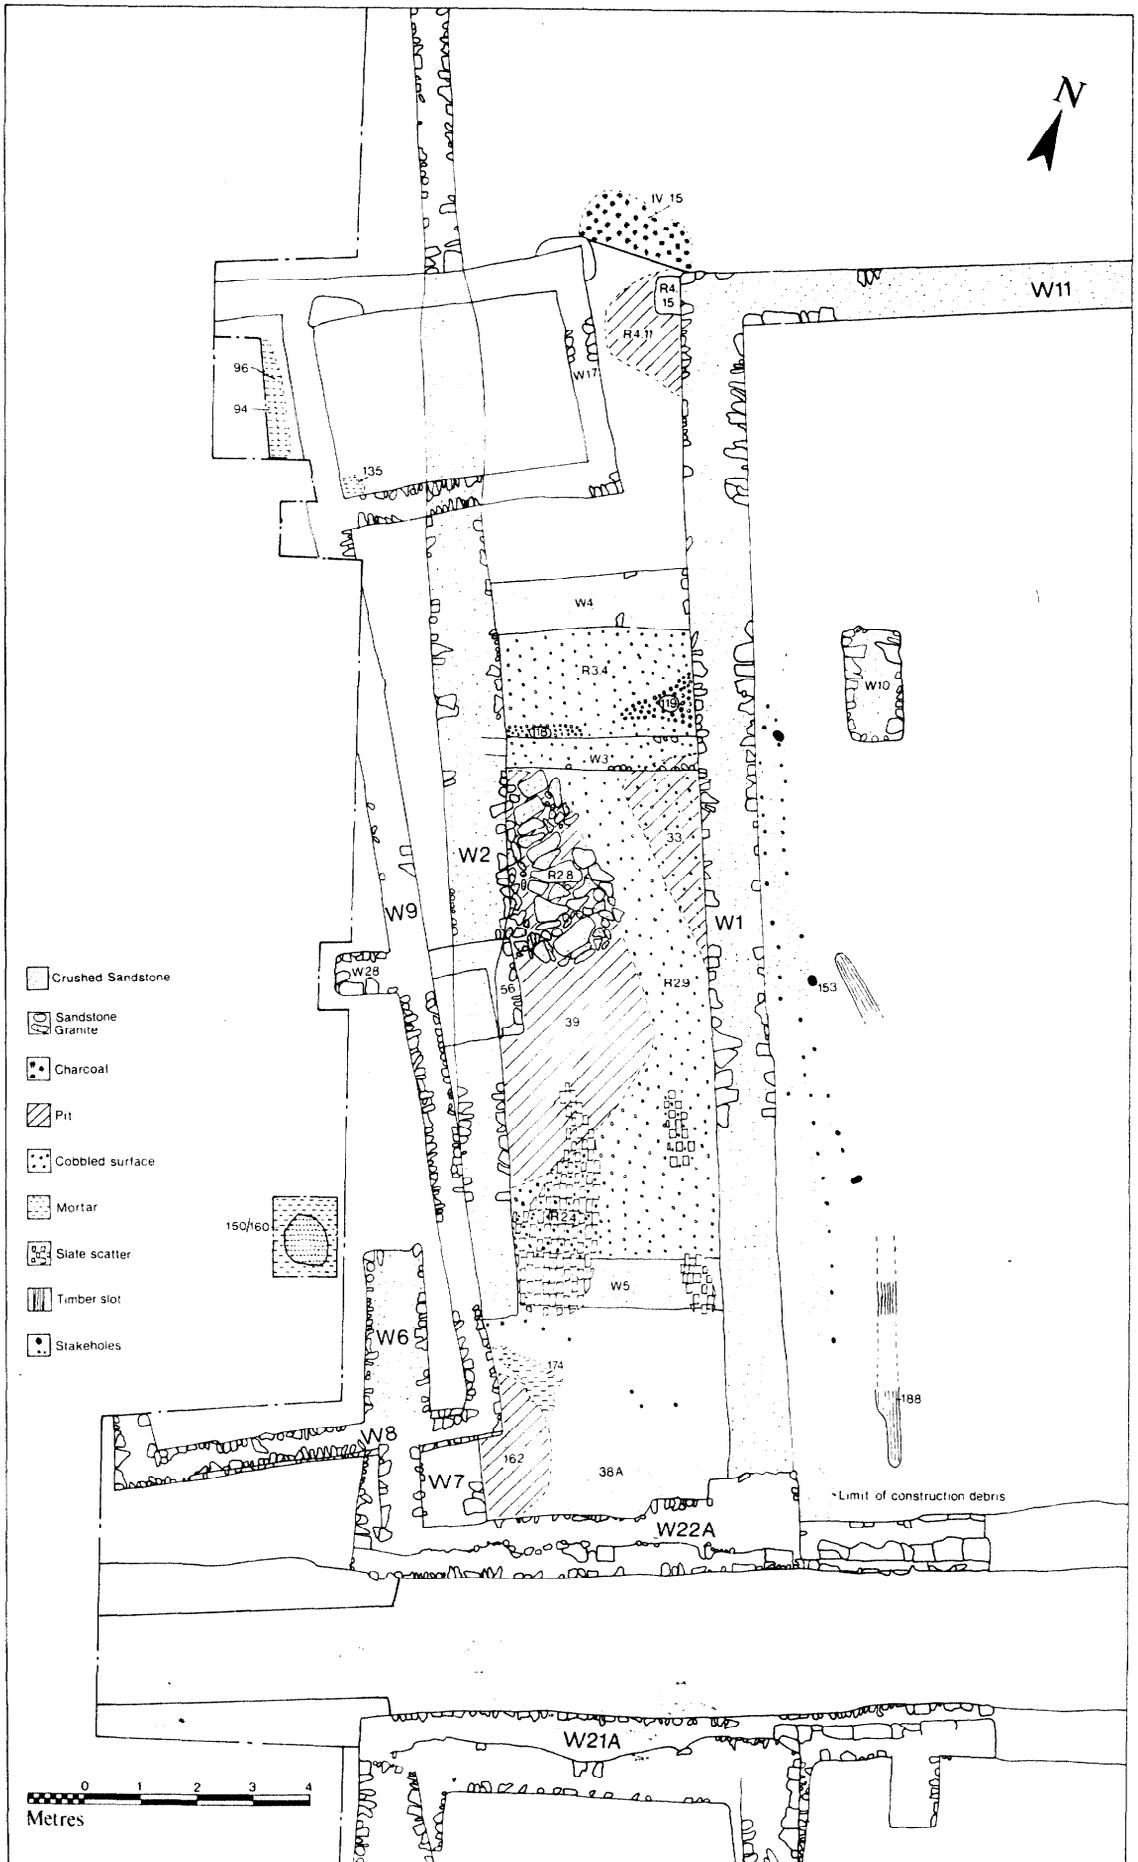
Fig 6 Plan, Area I

The walls were constructed from a less random selection of material than those of 3A, mainly granite (markfieldite and diorite), grey sandstone (Dane Hills), and Swithland slate with some quartzite pebbles, purple quartzite, hornstone, and tile (probably reused Romano-British). The north and south walls (W22A and W21A respectively) where the foundations could be seen in the sides of the ditch were set on large undressed fragments of granite up to 0.50m in size below two or three rough courses of smaller fragments (0.20m- 0.30m in size). Above this the walls were faced with at least one course of large, roughly square blocks of-dressed sandstone. These blocks had been determinedly robbed from both walls so that only traces remained with the exception of-two at the east end of wall W21A which were 0.40m wide and 0.35m high (see Pl 4). The bottom of the sandstone blocks was at a level of c 53.10m OD and the two surviving blocks in wall W21A showed that at this level the wall was reduced in width by about 0.20m. The foundations of wall W21A were 1.40m in width. The south-west buttress, W20, was 1.60m wide at foundation level and was then reduced to 1.15m, while the south-east buttress was slightly less massive being 1.30m wide reducing to 1.00m above the foundations. These buttresses projected south from the wall foundations for about 1.00m. The north wall, W22A, had foundations 1.00m wide and was reduced by about 0.15m on its south side at the level of the sandstone blocks. The buttress at the north-west corner was the most massive of all. Its foundations were 1.80m in width but on the east side there was an offset of 0.95m which was sealed by a layer of brown clay. The wall was also reduced in width on the east so that

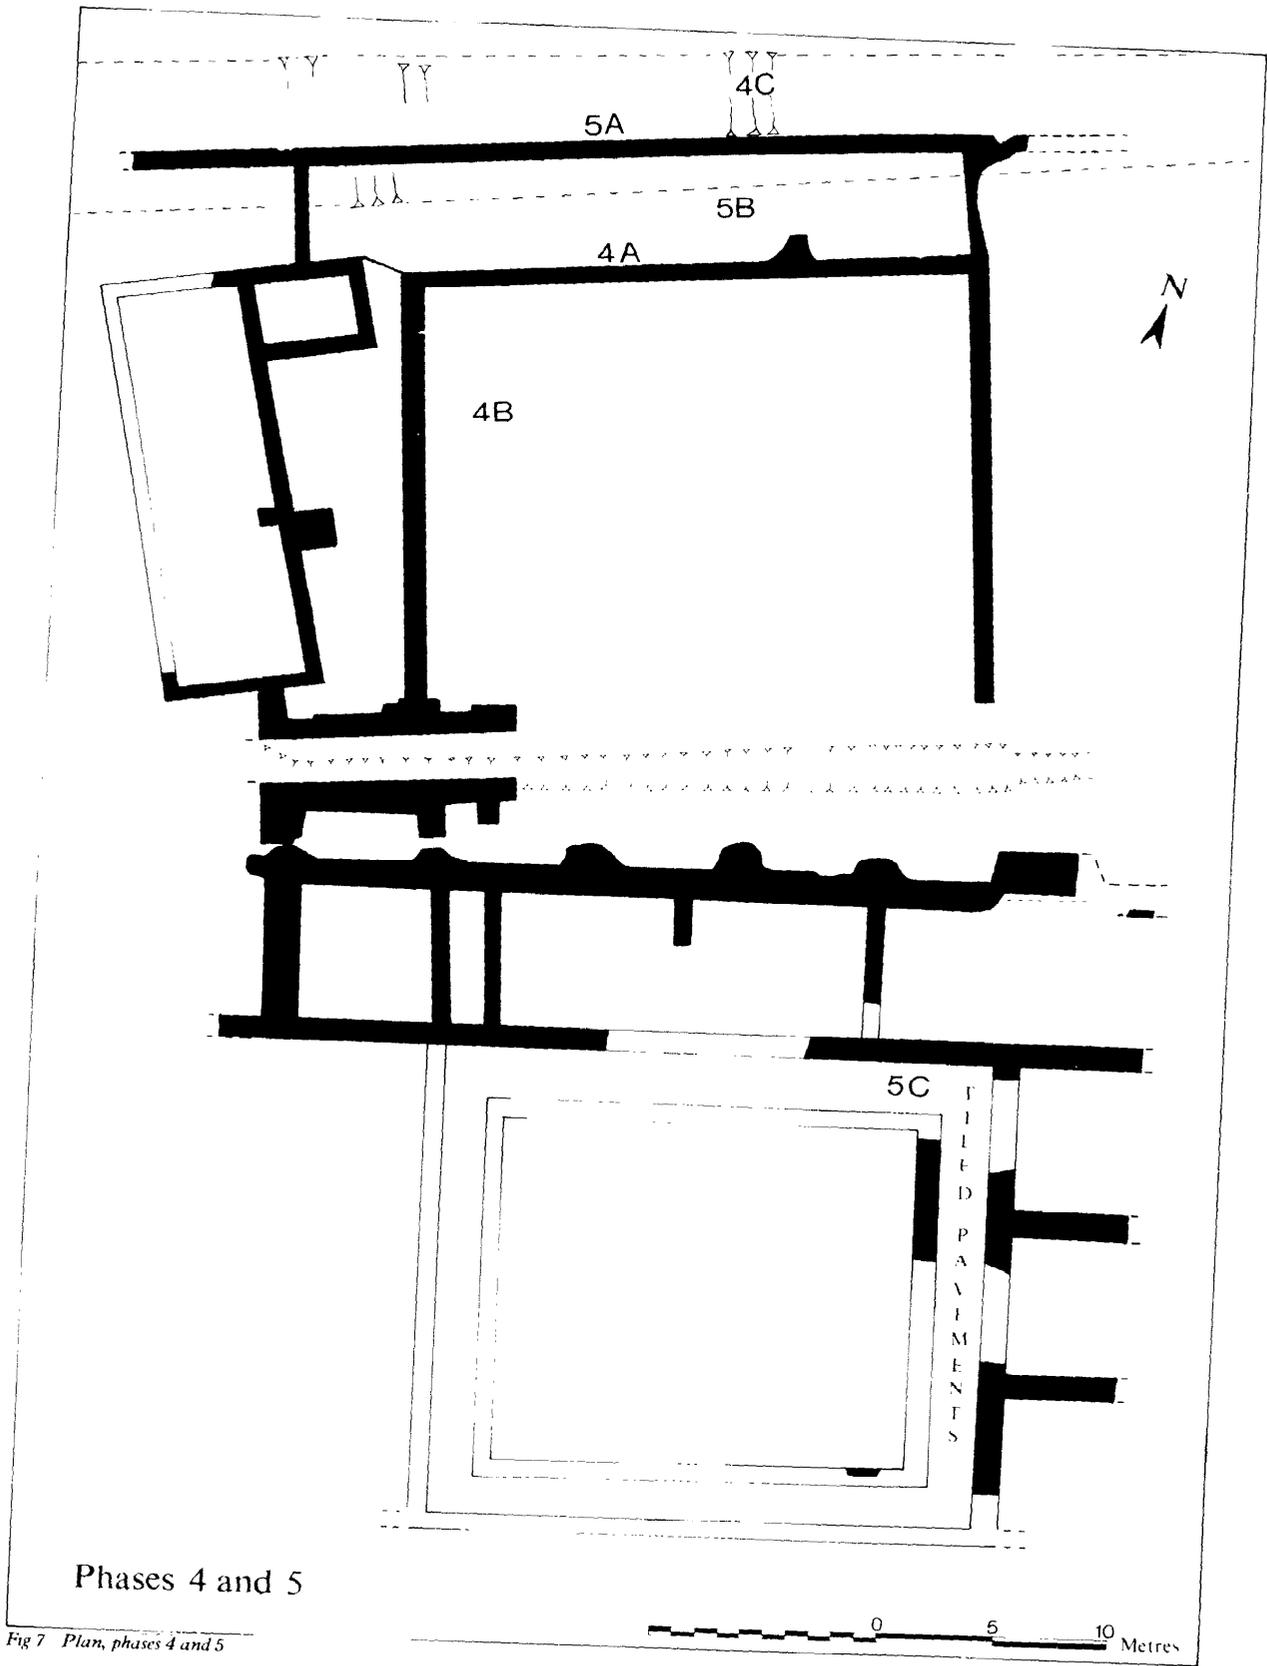
Fig 7 Plan, phases 4 and 5

The walls of the second cloister, like those of the first, were built on foundations composed of layers of gravel, clay, and crushed sandstone. The foundations were 1.00m deep and varied in width between 0.80m and 1.00m and, where it remained, the superstructure had been carried straight up without offsets on either side. The walls themselves were constructed basically of irregularly shaped pieces of Dane Hills sandstone with some diorite (Enderby), Swithland slate, and quartzite pebble. There was some tendency to use larger pieces of sandstone for the sides and

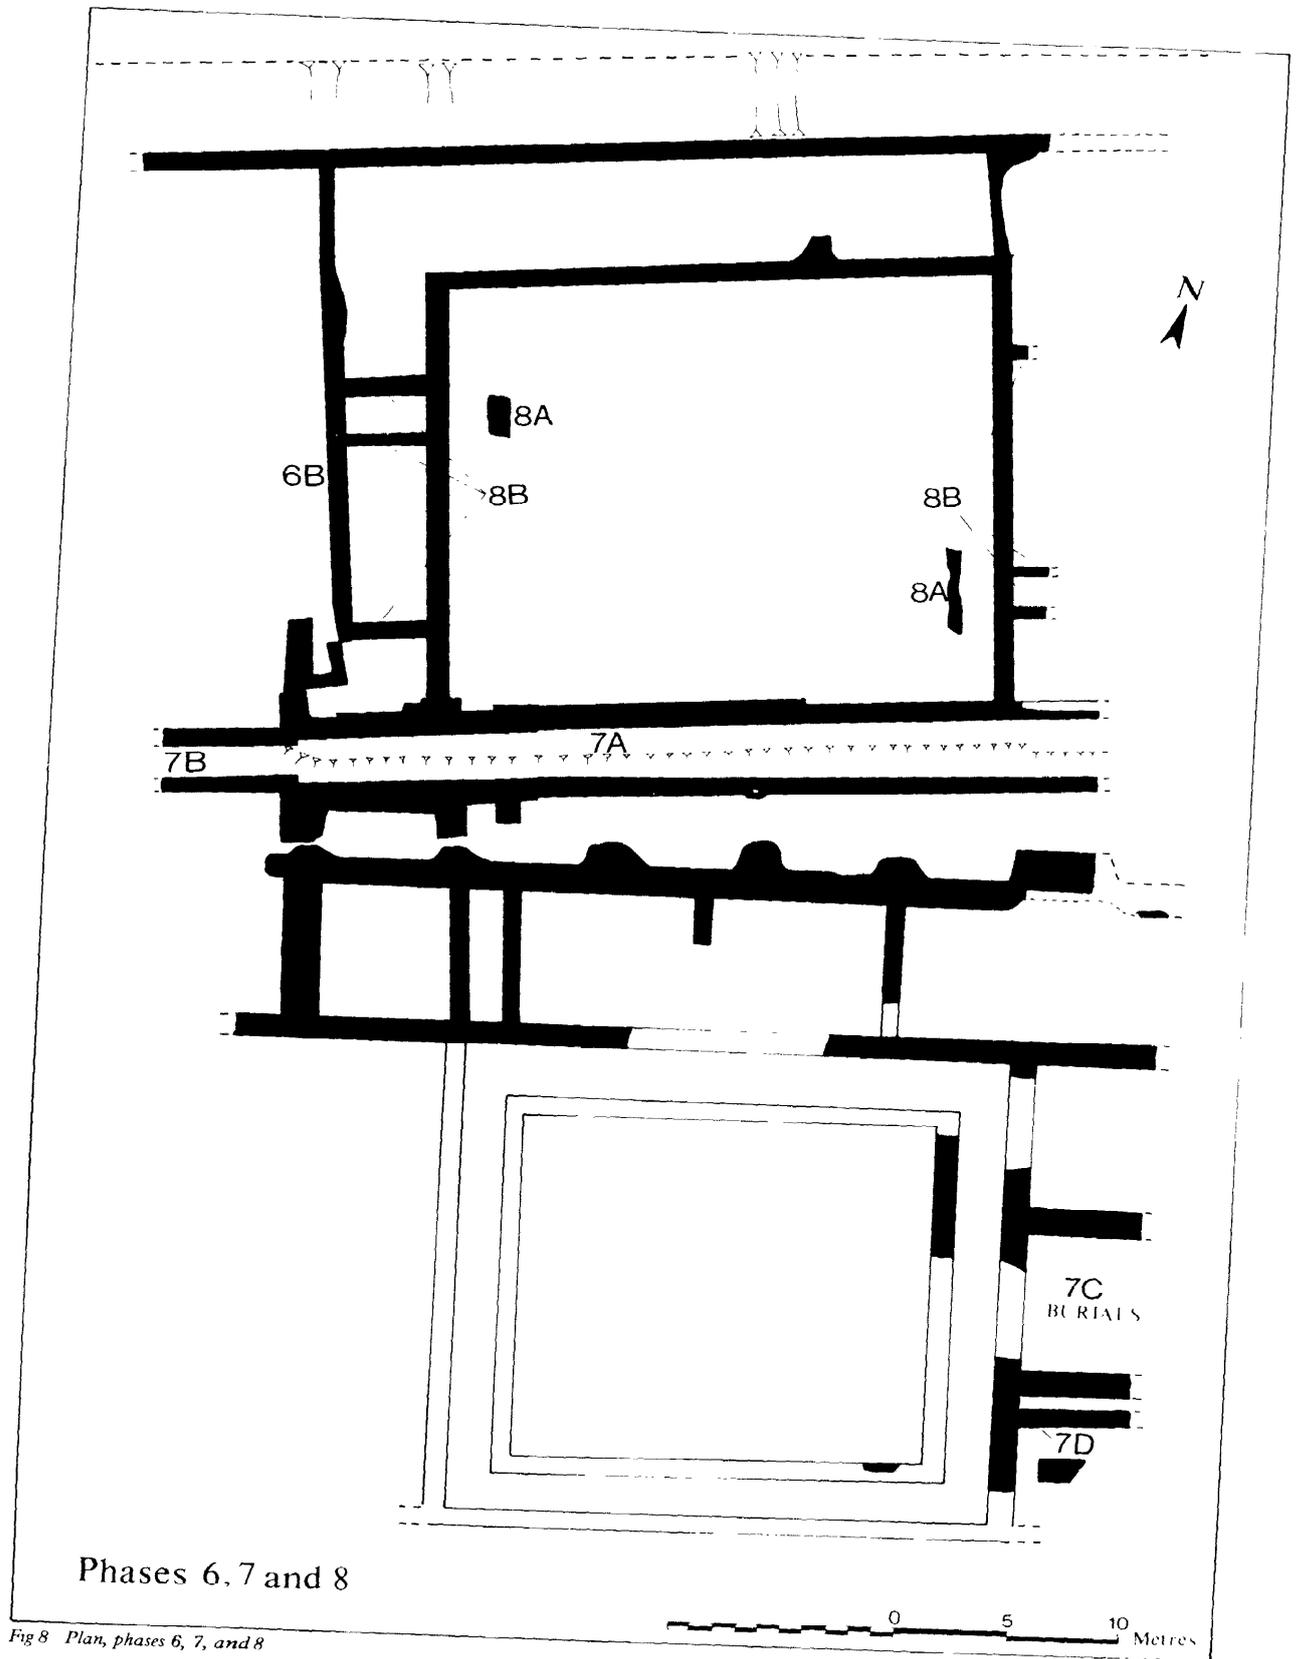
Fig 8 Plan, phases 6, 7, and 8
 Fig 8 Plan, phaser 6, 7, and 8

Wall W2 itself was not a very impressive structure. Only its foundations survived and these were insubstantial. The wall was about 1.00m wide with foundations no more than 0.50m deep, composed of rough pieces of granite and sandstone, many of which were reused as they were caked in mortar, set in a matrix of brown clay and sand. In places there were indications that the sides of the wall were composed of small, roughly shaped blocks of sandstone. At its north end the wall was cut through the make-up levels inside the eastern room of the earlier building, and a short length of the south wall of this room was incorporated in the new structure. Further south the western side of wall W2 was aligned on the west edge of the soak-away chamber which had been destroyed down to its base in phase 6A. South of the soak-away however the line of wall W2 was offset slightly to the west and here the foundation trench clearly cut pit (39) of phase 4A.

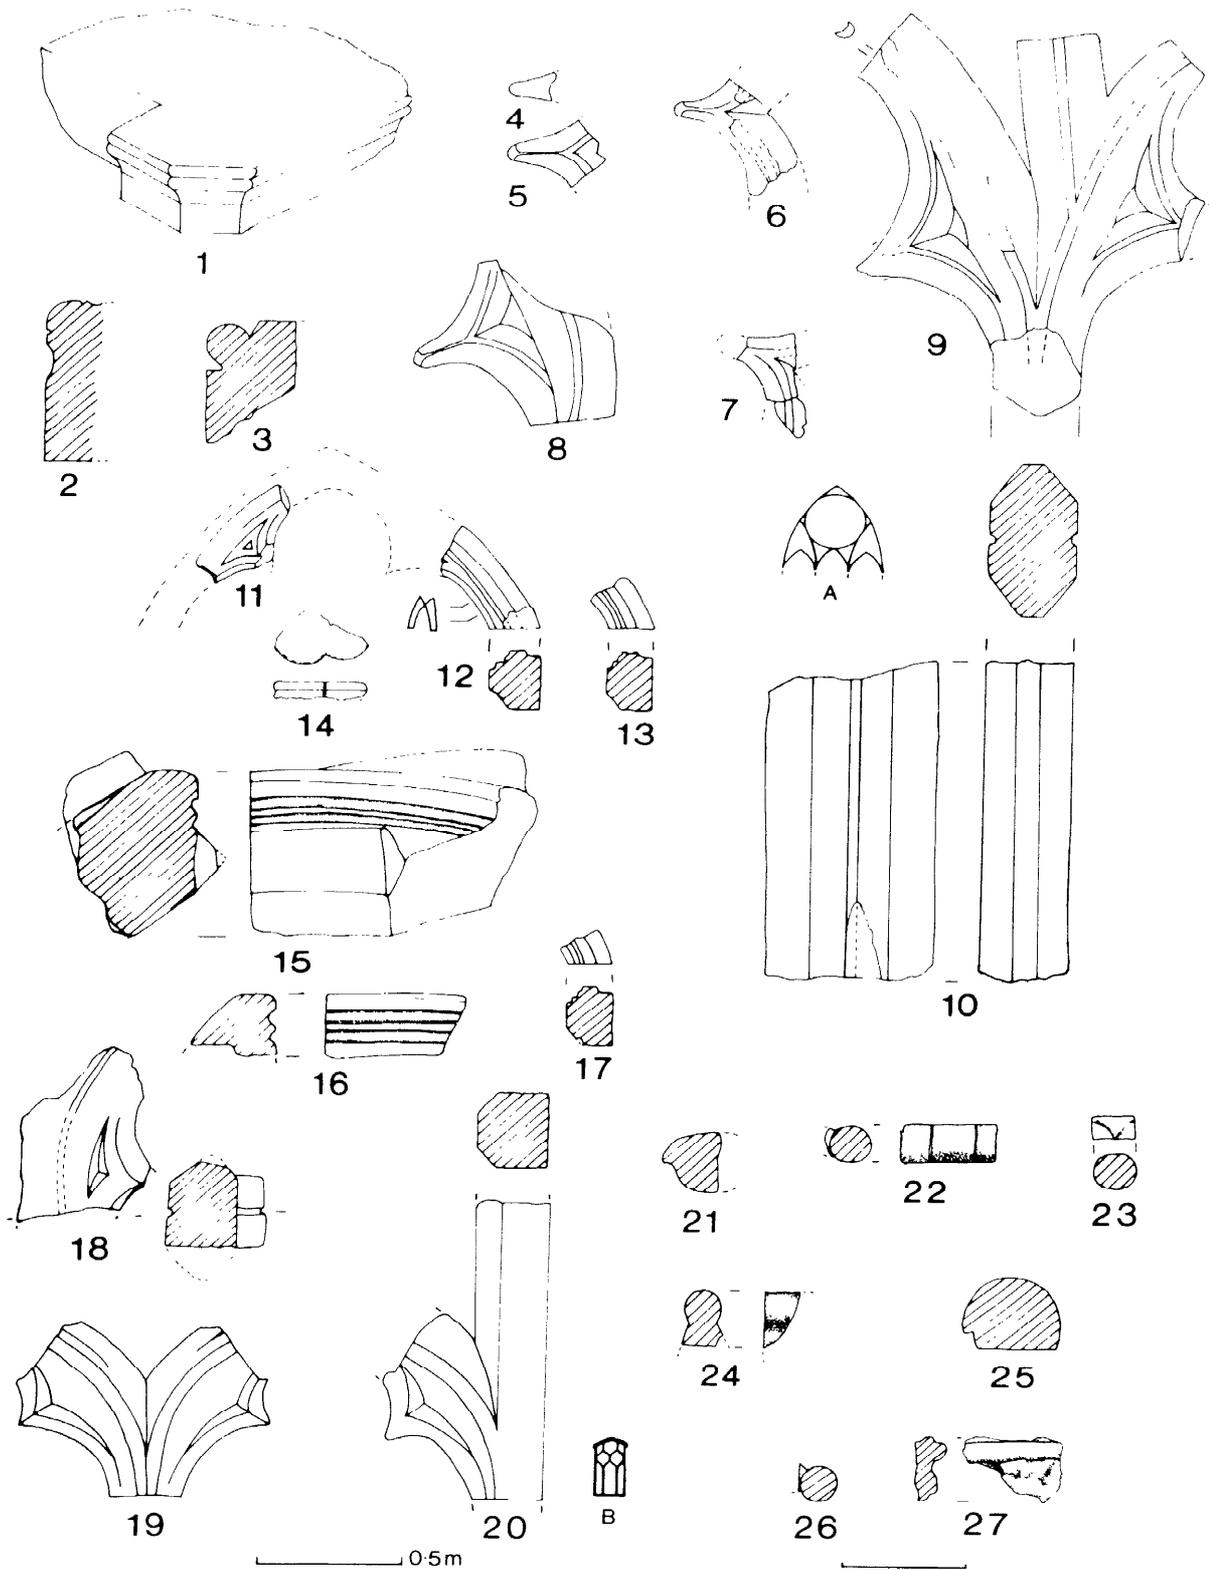
Fig 11 Architectural fragments. 1 20 scale 1:12; 21 27 scale 1:6

- 25 Phase 10A II 108
Scroll moulding with iron traces adhering. 14th century
- 26 Phase 10H VI 2
Fragment of small shaft. 14th century

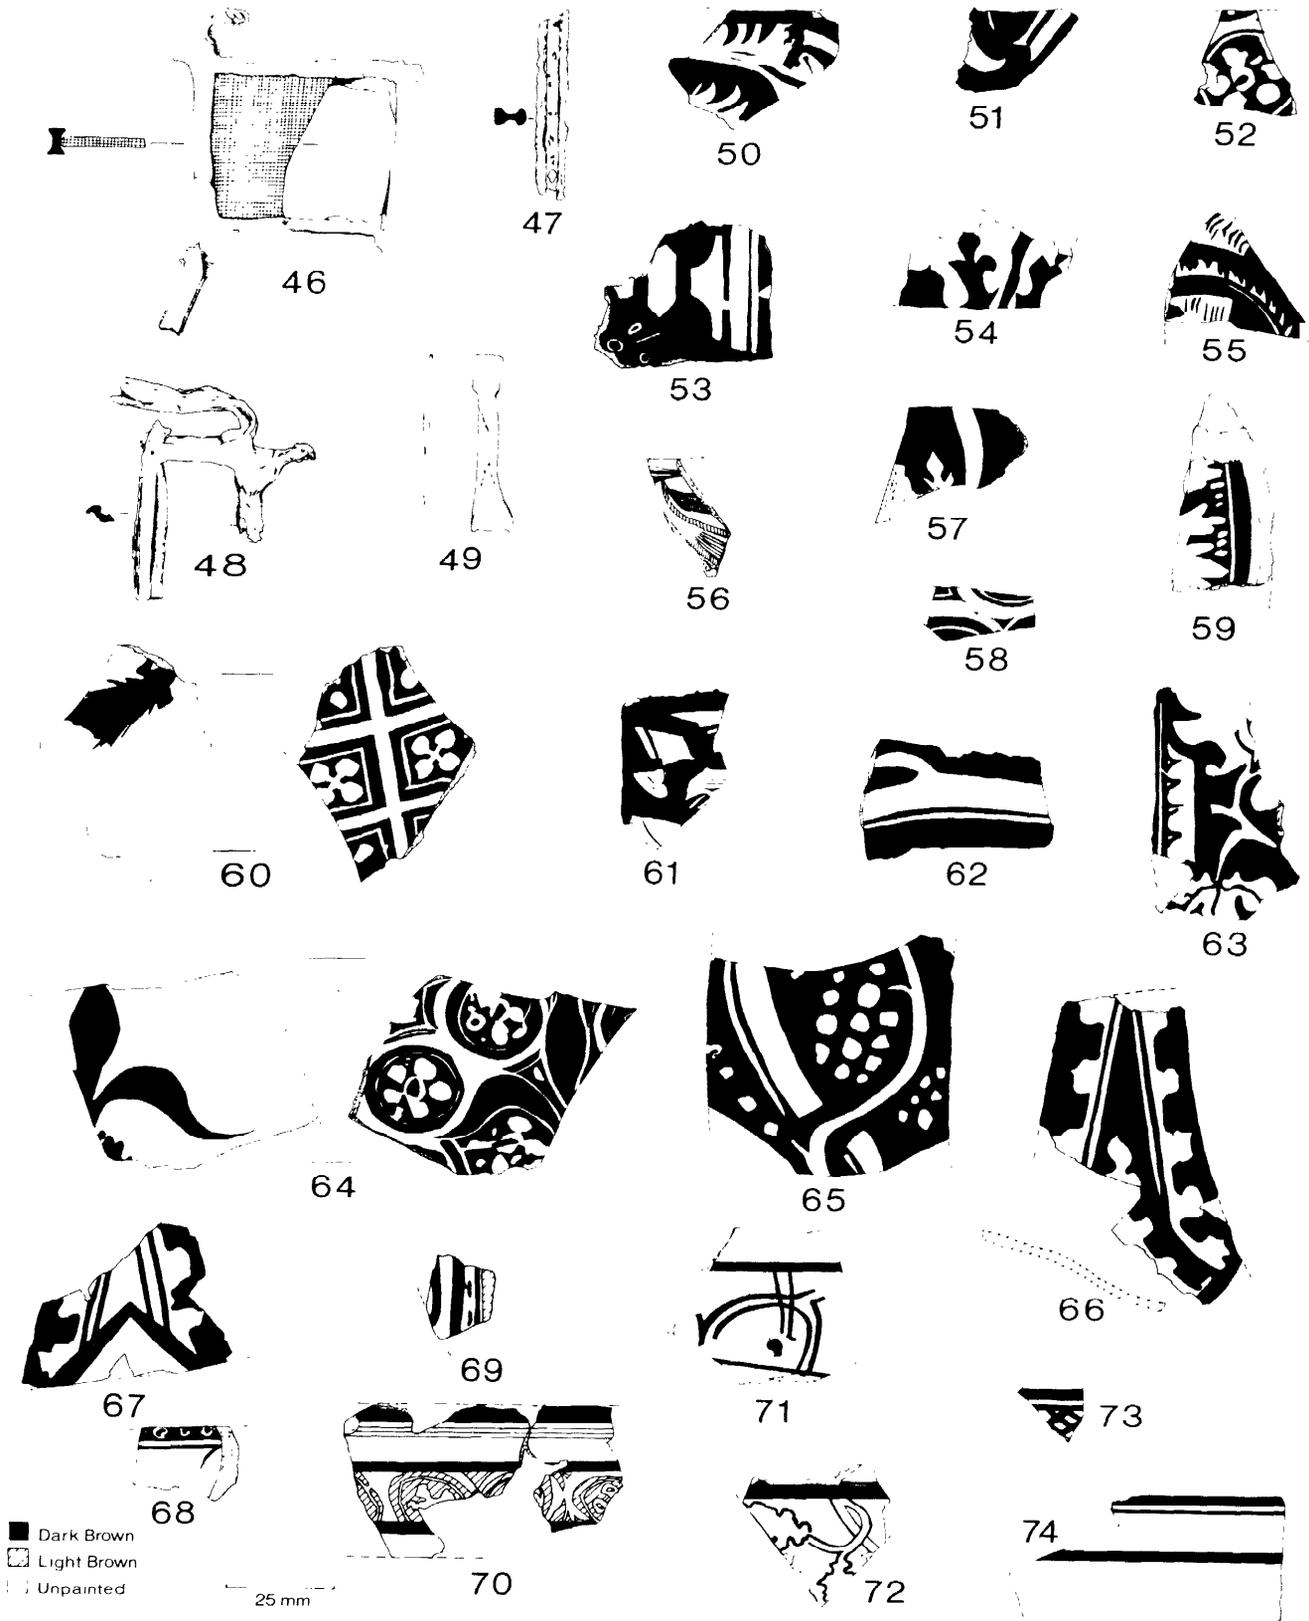
Fig 13 Window lead, 46-49, window glass, 50-74. Scale 1:2

50-58 Phase 3B(i) II 111
Fragments of border, with naturalistic foliage (50, 52) and dot and circle decoration
59 Phase 3D II 64
Border fragment
60 Phase 10A II 108
Part of the background, painted on both sides with naturalistic foliage backed by four-leafed clover motifs
61-63 Phase 10A II 108
Border fragments
64 Phase 10A II 108
Part of background with fleur-de-lys type motif on the other side
65,69 Phase 10A II 108
Border and background fragments
66,67 Phase 10A II 108
Parts of a canopy. 67 is possibly from a side shaft enclosing a central figure.
68,70 Phase 10A II 124
Two border fragments
71 Phase 10H VI 2
Border fragment with foliage (?)
72,73 Phase 10H VI 2
Border fragments with outlined oakleaf pattern (72) and diaper pattern (73)

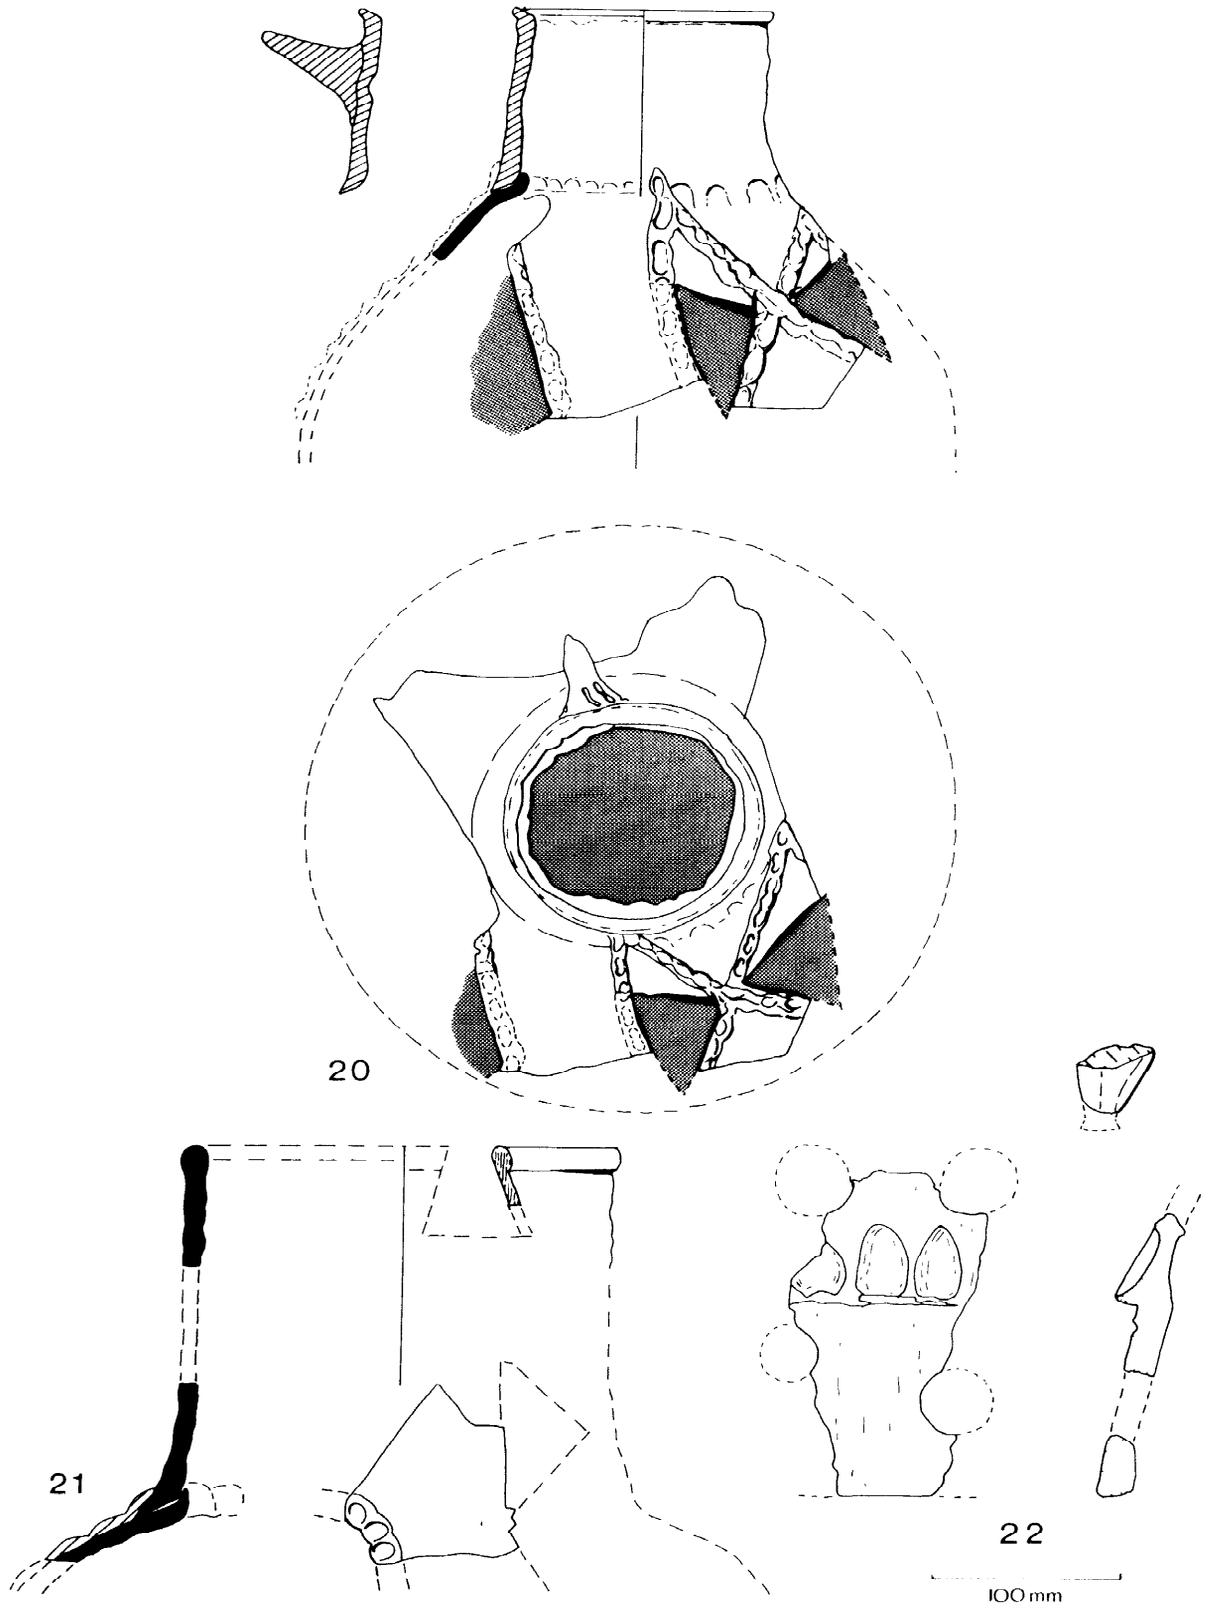
Fig 18 Louvers, 20-22. Scale 1:4

One example (Fig 18.22) from the north range is the only louver blackened by smoke and thus associated with a fire or hearth. Only a fragment has survived of what must have been a structure resembling a gabled house. There is a close parallel to this, with the same glaze and fabric, from an excavation in the heart of medieval Leicester (Leicestershire Museum Act No 302 1971, forthcoming). It consists of a house made from sanded clay slabs with a pitched roof and a cow's- or bull's-head finial at each of the gable ends and supported on legs which would have stood astride the roof ridge. Circular apertures in the roof and walls allowed the smoke to escape.
