5-7 Hanbury Street

Droitwich Spa, Worcestershire

Archaeological evaluation

January 2016

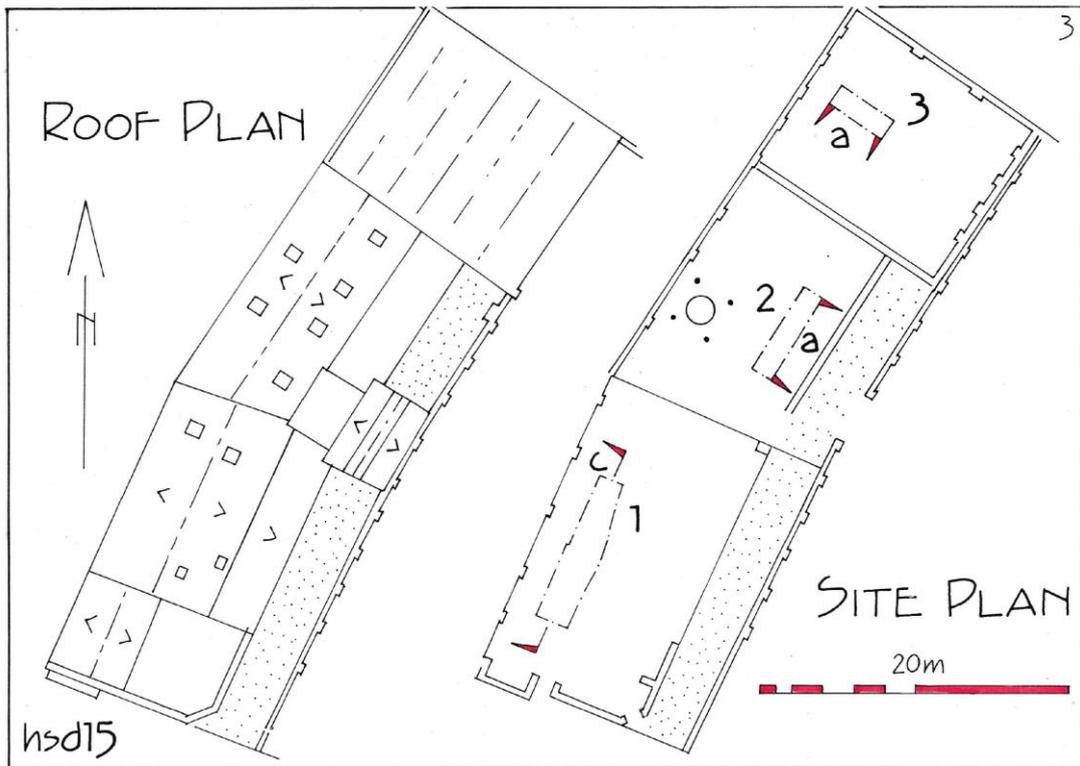
Fig. 3; site plan showing (left) period 1927-2015 & (right) trench locations

The trial trenching comprised three linear trenches approximately 1.60m wide in the location shown in the trench plan (Fig. 3). Trench 1 was 11m in length and located at the south end of the study site to investigate the area associated with planning application W/15/00730/PN. A second 10m trench, reduced to 5m in length due to the difficult ground conditions (reinforced concrete slab), was located in the northern part of the study site to investigate the area associated with planning application W/10/01566/PN. A further 5m trench was excavated in the central area of the site.

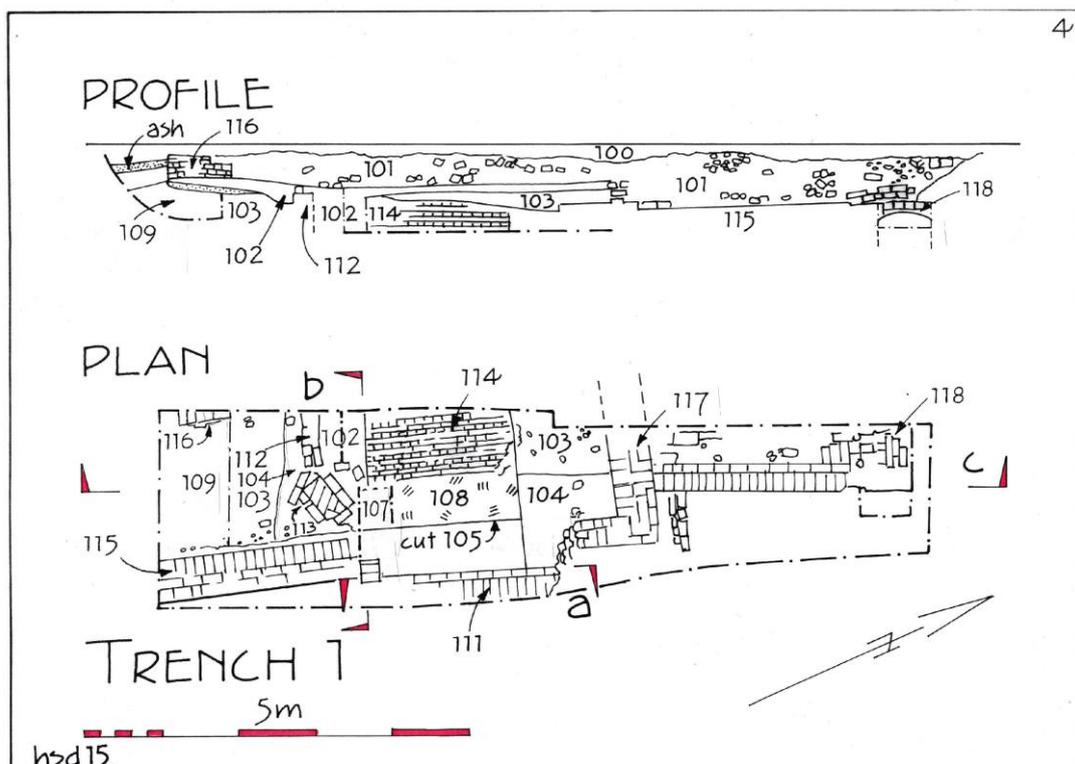
Fig. 4; trench 1 profile (top) & plan (bottom)

The surface of the natural substrate, a light brown clay, was revealed within a small area of the trench where excavation went deeper and was recorded at a height of 28.09m AOD. This clay was shown to be truncated on the east side by a

possible robber trench (context 105) and on the west side by a brick vaulted structure (context 114). The deposit appeared to continue south towards the street frontage although it was not reached at this end of the trench where excavation went 1m below ground level. The natural clay appeared to continue north below contexts 103 & 104, but it likely to be significantly truncated as a result of the construction of context (wall) 115.

The remains of the demolished salt works (OS 1885) were partially revealed within predominantly the north-west half of the trench. Context 114 comprised what appears to be the eastern side of a large vaulted brick structure, partly sunk into the clay and resting on a wall indicating a large construction trench. The south end of the vaulting, where there is an open arch, was enclosed by a rectangular brick wall (context 112) backfilled with a greyish-brown clayey-silt (context 102). Seemingly attached to this at an unusual orientation was a small rectangular shallow brick 'tank'-like structure (context 113; see plate 4). It remains an anomaly, but its position in the stratigraphic sequence, above 104, which is interpreted as associated with demolition of the saltworks suggests that it may represent a later feature.

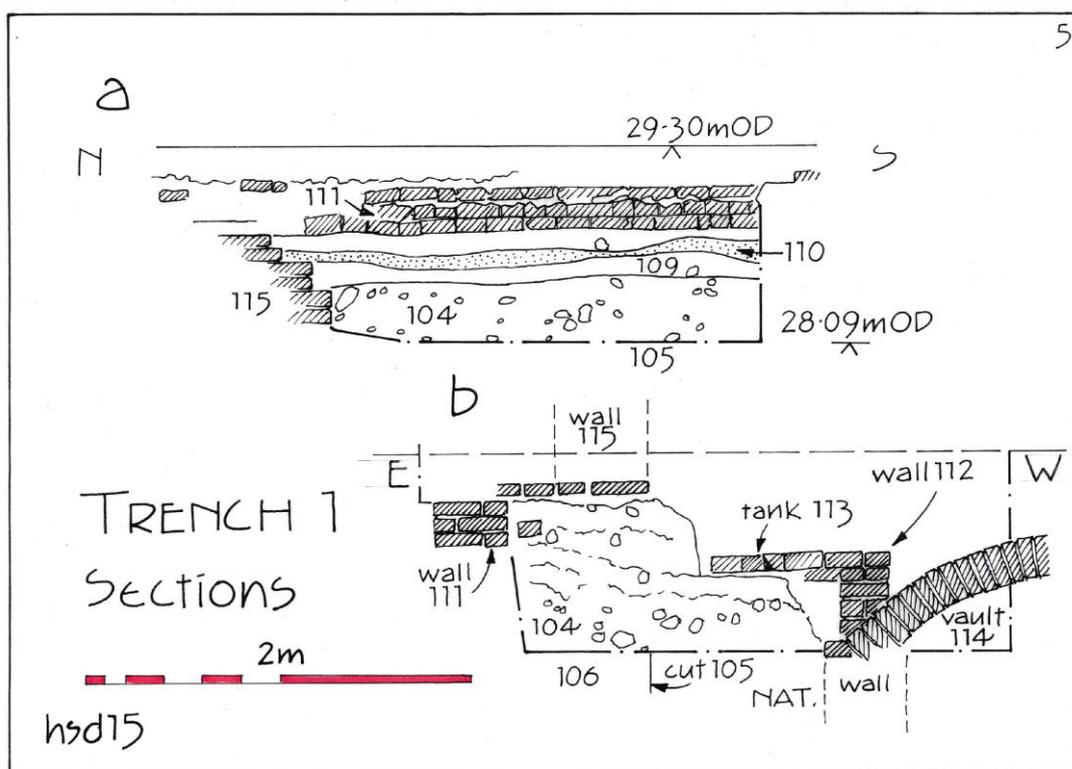
Fig.5; sections 1a & 1b

Overlying deposit 104 on the east side of the trench (section 1a) was a layer of dark greyish-brown silty-clay (context 109) about 0.20m thick which was in turn overlain by a slightly thinner and darker layer of clayey-silt and ash (context 110). Constructed over this sequence of deposits on a thin concrete foundation was a later brick wall (context 111) orientated north-east to south-west.

Situated at the south end of the trench was a brick wall (profile 1c). This was built above the deposit 102 associated with abandonment of the salt works. The wall was truncated before the evaluation and it is assumed that it originally cut across the trench.

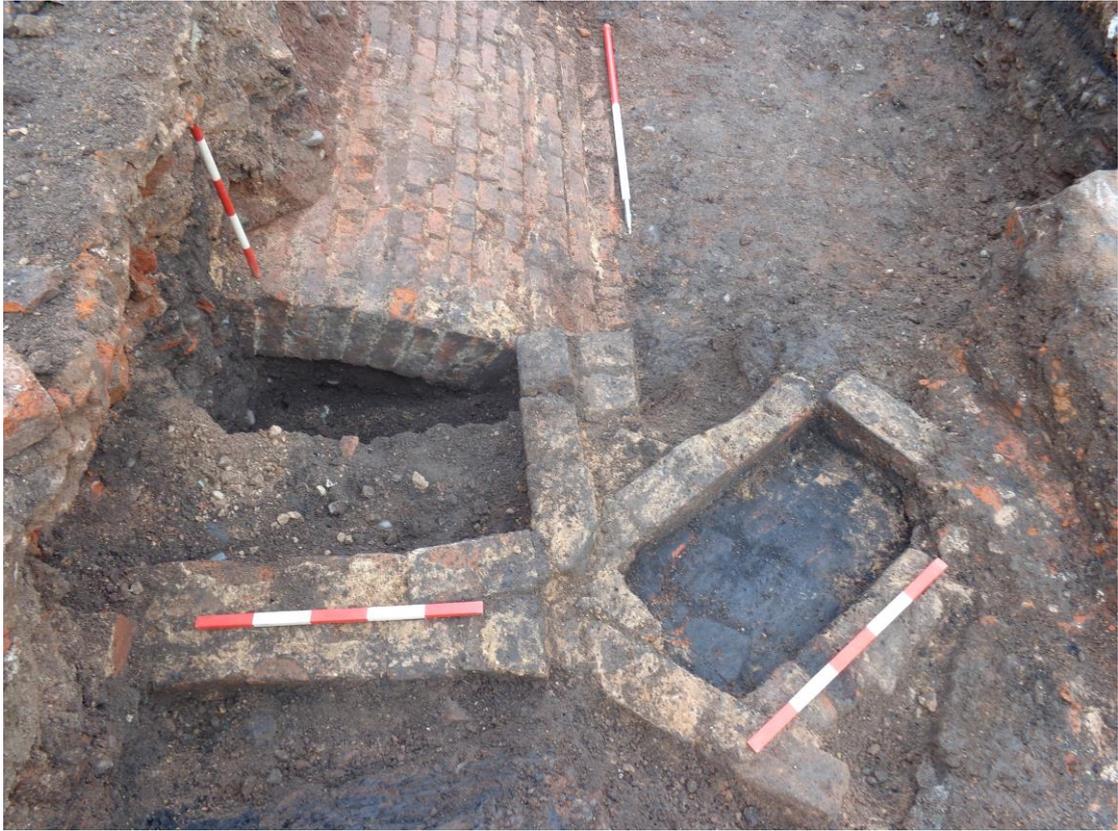
Plate 4; trench 1, showing contexts 112, 113 & 14, from the south-west

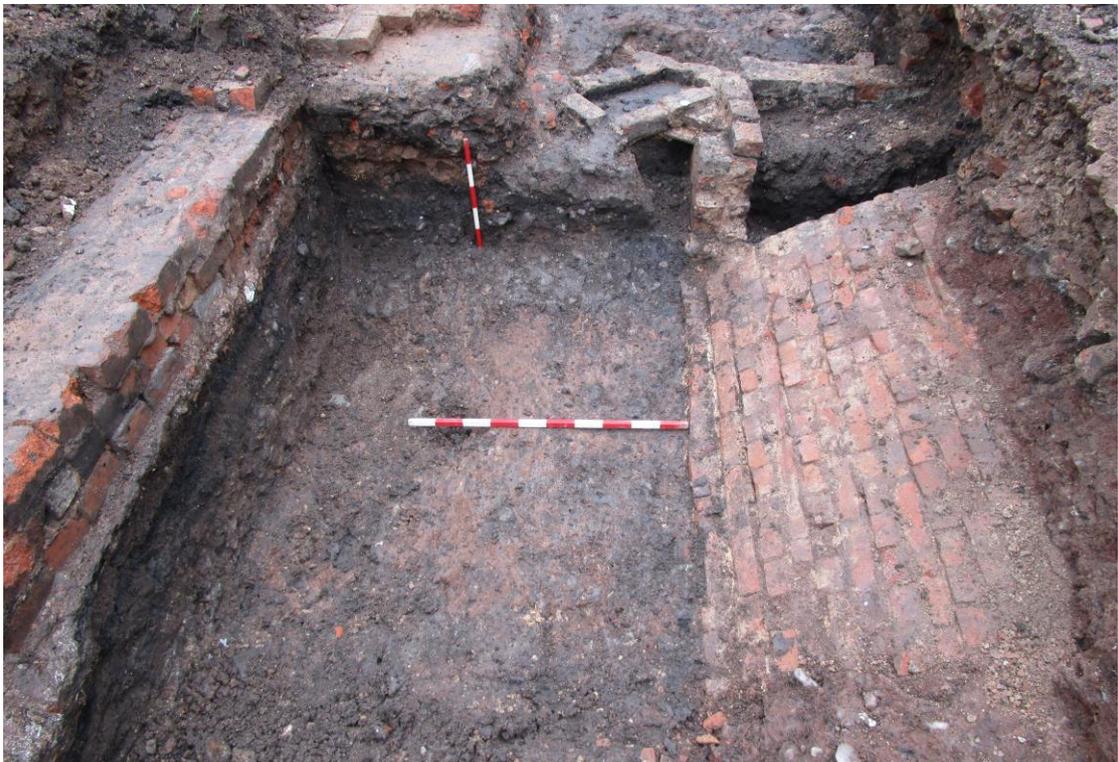
Plate 5; trench 1 (central area) detail of contexts 111 (wall to the left), 114 (brick vaulting to the right) and 108 (natural substrate) in the centre. Left of this is the robber trench and fill (contexts 105 & 106)

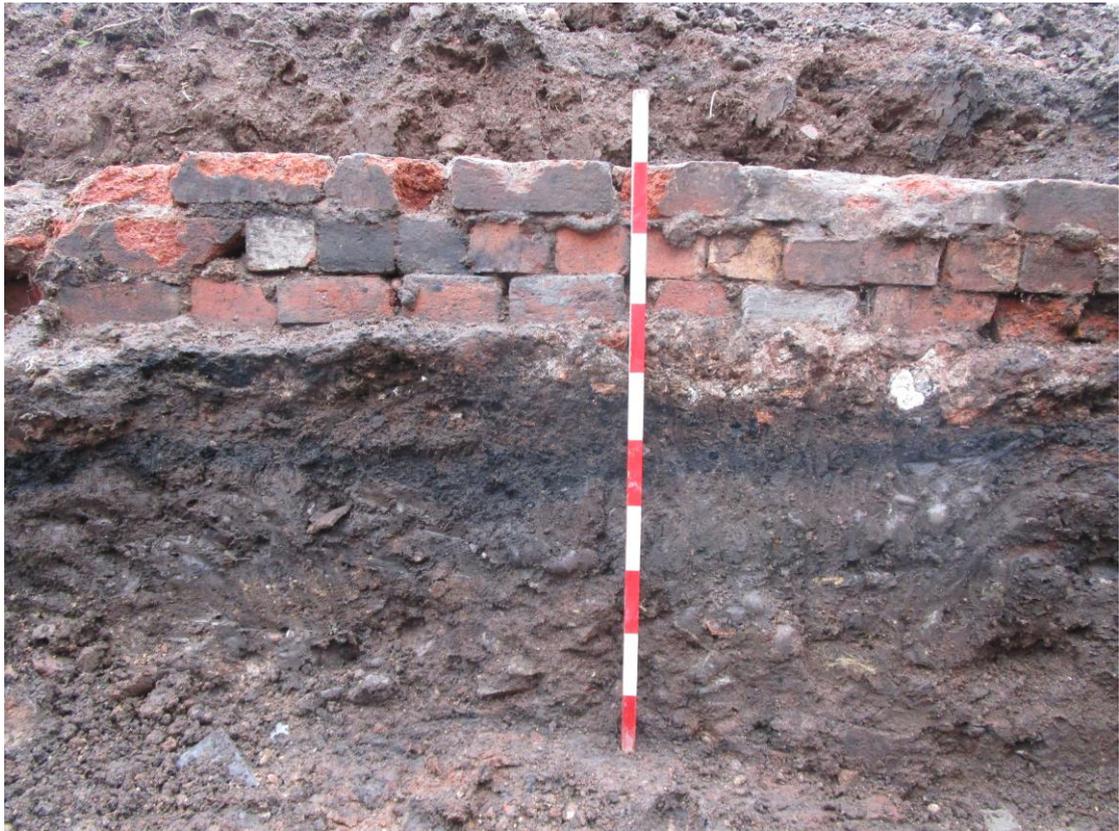
Plate 6; trench 1, section 1a, detail of contexts 104, 109, 110 & 111

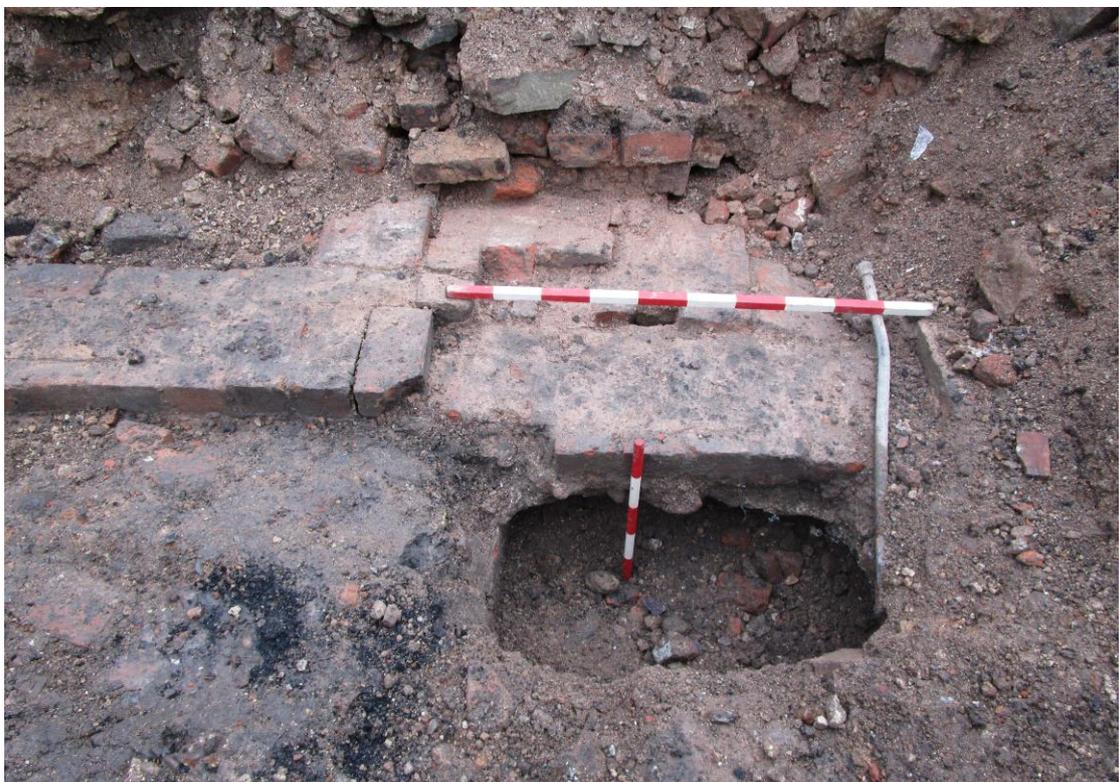
At the north end of the brick vaulting was a substantial brick wall (context 117) extending up to the north end of the trench. This wall also appears to formerly have continued south enclosing the brick vaulting, but a jagged break in the wall is probably connected with its demolition and a possible robber trench (context 105; see below) was recorded at the base of the trench. Whilst hand cleaning the west edge of the trench along wall 117, a small area of the section was further exposed revealing what appeared to be another parallel wall with a narrow gap suggesting a possible long flu-like structure. At the north end of the trench wall 117 appears to connect with another brick vaulted structure (context 118) with an arched opening facing east (see plate 7).

Plate 7; north end of trench 1 showing evidence of further brick vaulting (context 118) attached to wall 117

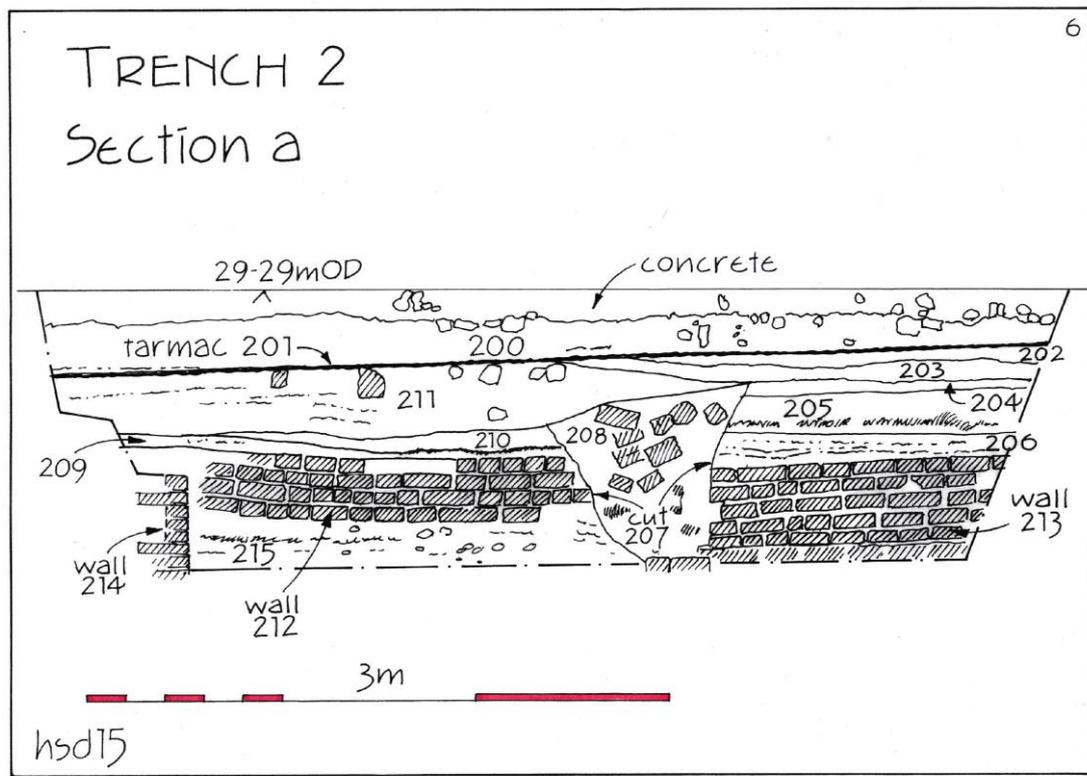
Fig. 6; trench 2, section a

The natural substrate was not reached in trench 2. Instead the base of the trench for its entire length comprised context 215, a loose sandy-clayey-silt with a large component of brick fragments and frequent large pieces of charcoal. The deposit was excavated by machine to a depth of approx. 0.40m, it was not bottomed at approx. 1.30m below existing ground level (29.29m AOD) and continued beyond the trench base.

The south-west face of a brick wall was exposed situated within context 215 across the north-east end of the trench indicating a wall or building aligned north-west to south-east (see Plate 10). This continued beyond the base of the trench.

Perpendicular to wall 214 were contexts (brick walls) 212 & 213. Wall 212 abutted wall 214 and was also constructed over the surface of layer 215

indicating that it is a later event. Wall 213 which also continues beyond the base of the trench appears to be contemporary with wall 214, suggesting that the later wall 212 represented a connection between the two structures.

Situated at the south end of the trench wall 213 is initially overlain by a thin black layer of charcoal comparable to context 209 at the north end of the trench, although here the layer is thicker and with a greater soil content. Overlying this is a sequence of alternate layers comprising, light reddish-brown crushed brick fragments with small concentrations of clinker (contexts 206 & 204), which at the north end of the trench is characterised by context 210. Within the sequence are also thicker layers of dark greyish-brown, mostly clinker (contexts 205 & 203). These were then sealed by a thin layer of crushed brick (context 202).

Both walls (contexts 212 & 213) and their stratigraphic relationship are interrupted by a trench (context 207) with back fill (context 208). This trench extended slightly north-west into the trial trench to the bottom of a small square drain-like structure which is still evident in the base of the trench.

Following the backfilling of trench 207 the ground was consolidated and levelled with a thick layer of soil clinker and brick rubble (context 211). This deposit and the remainder of the trench was then sealed by a thin layer of tarmac (context 201).

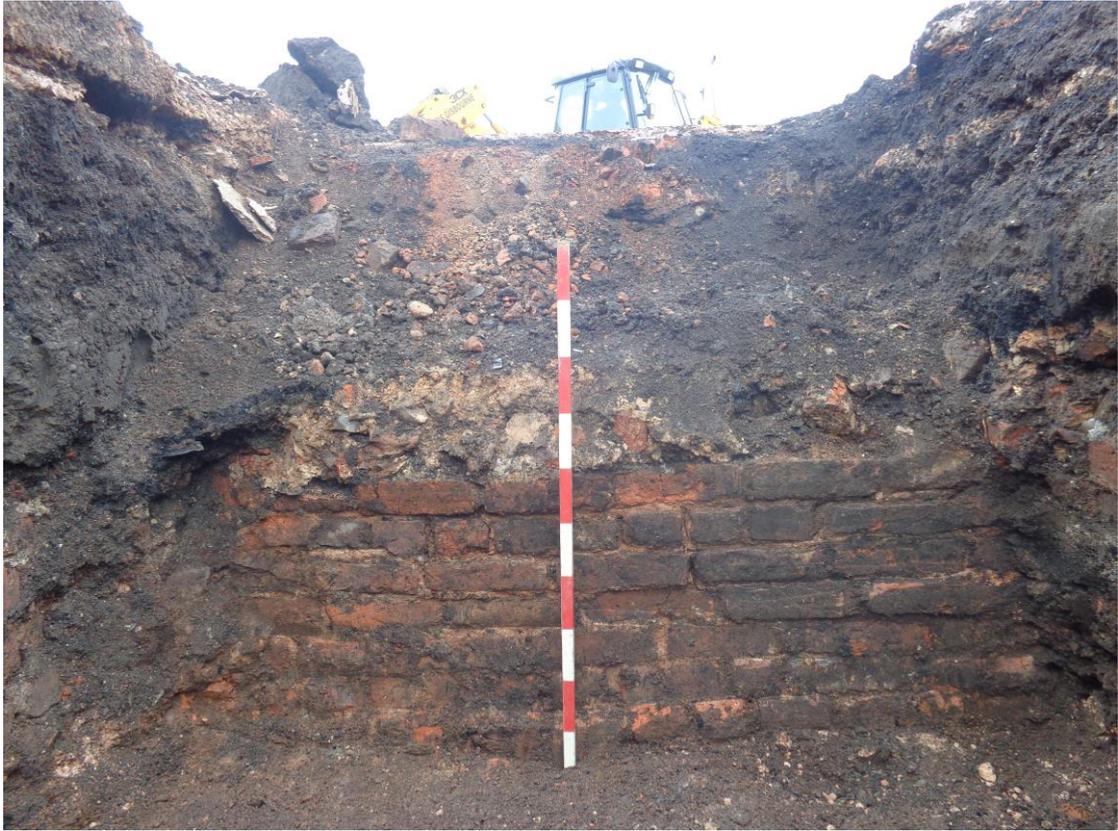
Plate 10; trench 2, north-east end showing wall (context 214)

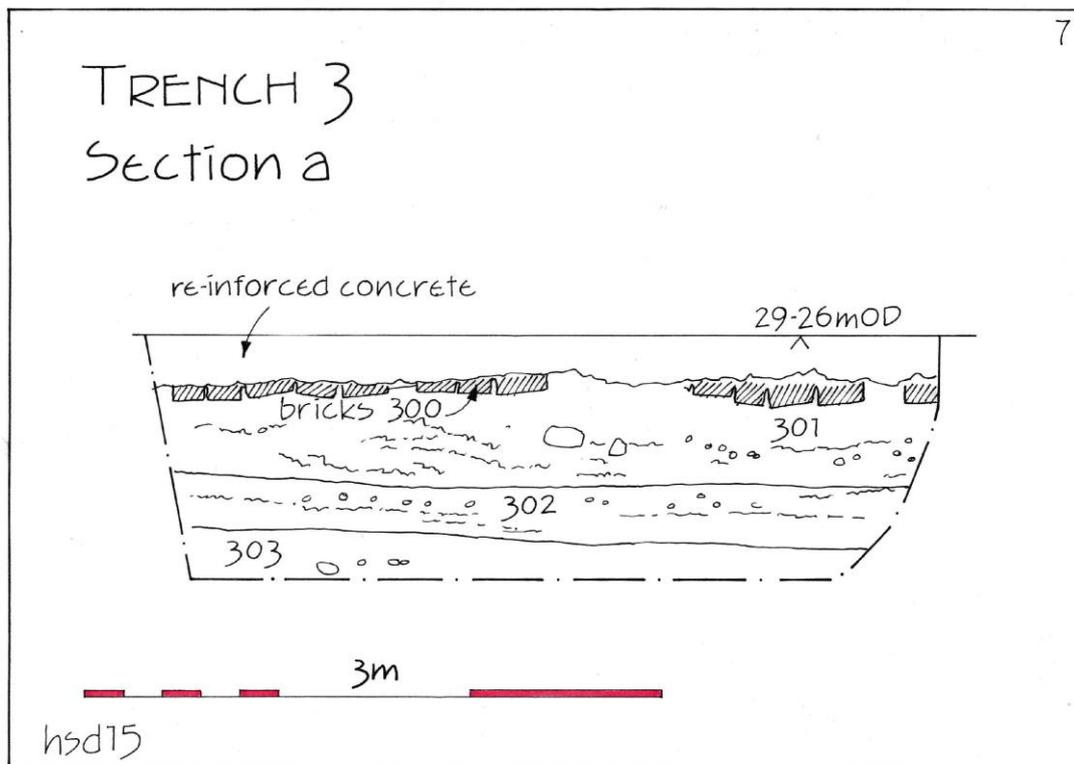
Fig. 7; trench 3, section a

The natural substrate was not reached in trench 2. Instead the base of the trench for its entire length comprised context 303, a loose dark greyish-brown deposit of mostly soil, but with a component of clinker and brick fragments. The deposit was excavated by machine to a depth of approx. 0.25m, it was not bottomed at approx. 1.30-40m below existing ground level and continued beyond the trench base.

Overlying context 303 to a depth of about 0.35m was a lighter pale reddish-brown deposit (context 302) of crushed clinker and small brick fragments mottled with darker lenses of greyish-brown soil. Overlying context 302 was a 0.45m thick dark greyish-brown deposit of clinker and soil. Brick fragments formed a small component. Stretched across the surface of this layer was a single uneven layer of bricks (context 300) which are in turn sealed by a 0.25m thick layer of reinforced concrete.

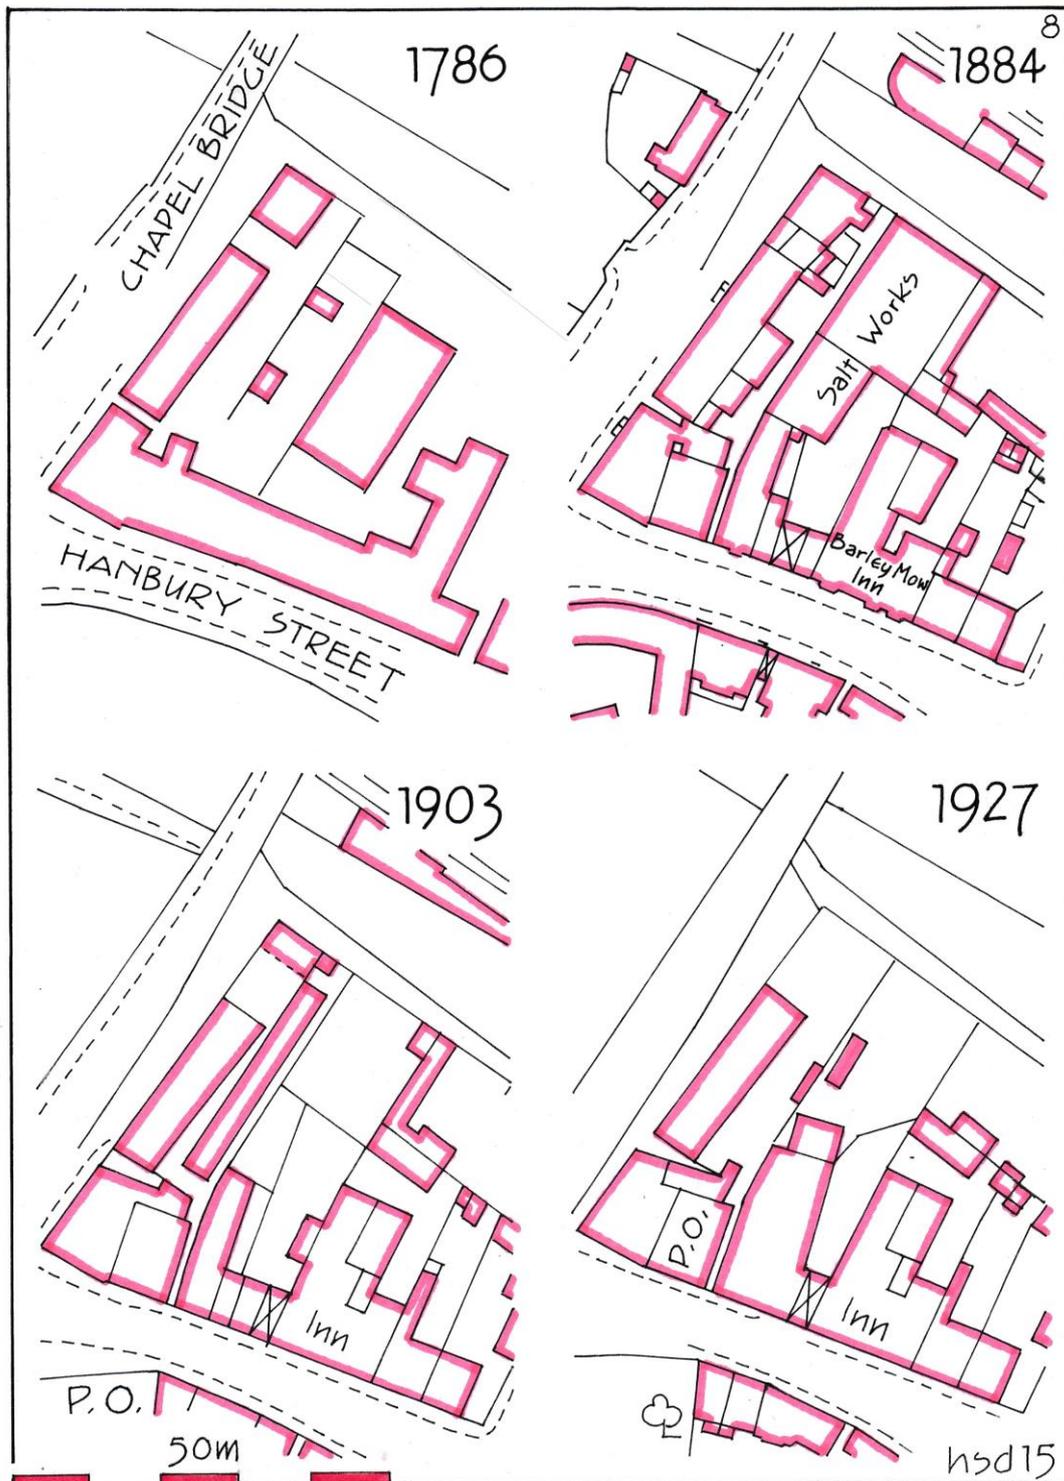
Fig. 8; topographical development 1786-1927

It can be seen from the topographical development that the study site has undergone some significant changes since it was first mapped in 1786. During this time the front of the plot appears to have formed part of a row of terraced buildings (?dwellings) along the north-east side of Hanbury Street. Two small square and rectangular structures represent the only visible features situated within the rear of the plot attached to the western boundary which has remained unchanged. However, the location of the east boundary shows that the plot was narrower in 1786 and that by 1884 (OS First Edition) the boundary had been moved to its current position.

The map configuration shows that part of the eastern half of the study site originally belonged to the adjacent Barley Mow Inn (WSM36579) when it occupied a larger plot. By 1884 when this boundary had shifted to its current alignment, which may have been directly related to construction of the saltworks, the large rectangular 18th century building had been removed. Nothing is known about the function of this building, but its size and location could indicate a former brewery. Remains of this structure including possible internal walls and floor surfaces may survive within the eastern half of the study site. The type of bricks used in the walls exposed in trench 2 (contexts 112, 113 & 114), suggest an 18th century date for their construction and the position of walls 112 & 113 would equate neatly with the alignment of the west wall of the building and boundary shown on the 1786 map.
