◆ Part 1 – the excavations

AREA A

PHASE AA: c. 5000 BC–1500 BC ■

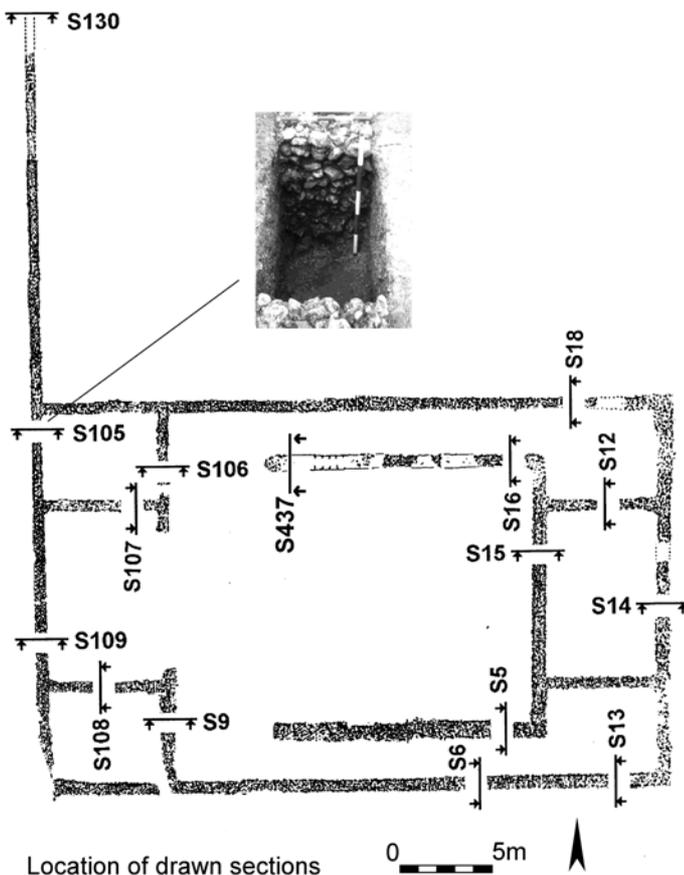
Fig. 22. Phase AB – plan of the foundations of Building 3, indicating the location of all sections excavated through the foundation walls. These sections were excavated in order to find out more about the method of construction of the walls, and to try and locate datable artefacts incorporated in the foundation walls.

Detailed descriptions of the sections through the wall foundations where they were excavated (Figs 26–39) are provided. There are 15 such sections in total and these are described by order

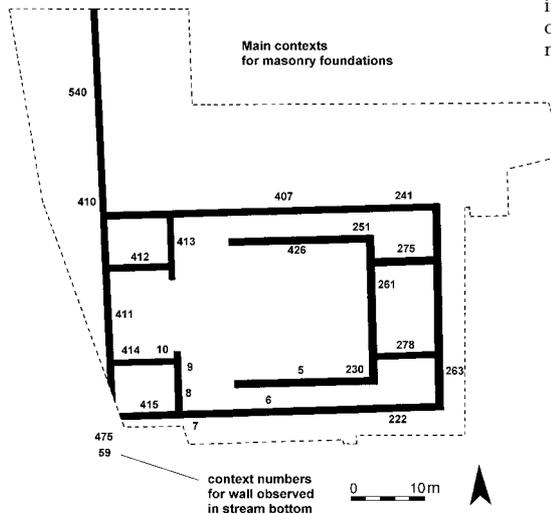
Fig. 24. Phase AB: plan of the foundations showing all masonry context numbers.

The plan of the foundations (Fig. 24) could be seen to reflect different standards of work in their formation. The quality of the work to the west range,

and most of the north and south external walls, shows much greater care in their construction than was taken elsewhere. The standard of work to the remaining areas shows a little less care in laying out the foundations, and this can be seen in the variation of width and straightness. These variations could reflect the efforts of more than one gang of workmen. Examples in the quality and nature of the work of adjacent gangs of workmen can be seen in the *principia* at South Shields (Taylor 2000, 50) and Caerhun (Kanovium Excavation Committee 1938, 71). Red clay was seen to have been rammed down the foundation trenches, particularly those to the external walls. This could represent an attempt to damp-proof the walls; a similar detail has been seen at the military bath-house at Exeter (Bidwell 1979, 28). The internal walls dividing the east and west ranges are almost equally spaced when measured from the external walls. The central spaces to the east and west ranges are almost identical in size.

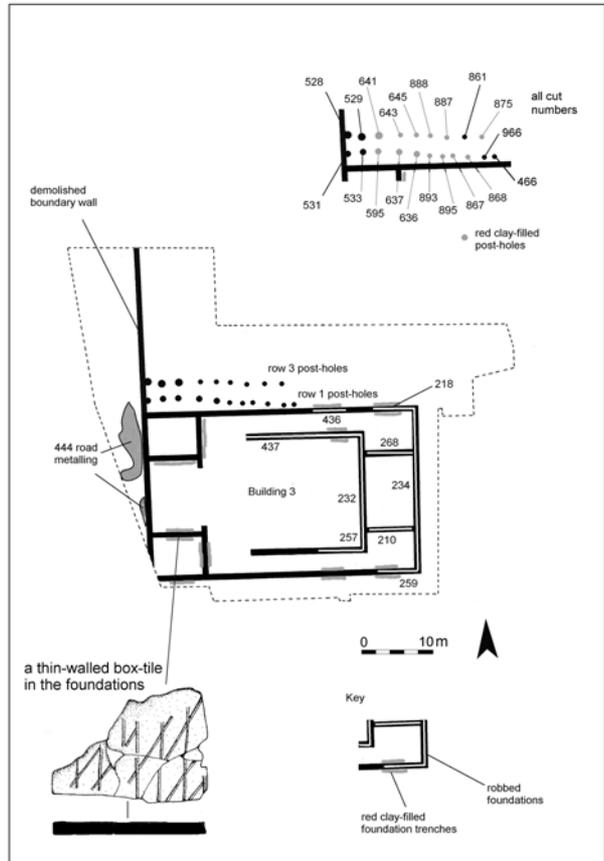
Fig. 23. Phase AB: plan of the foundations of Building 3, indicating robbed and unrobbed foundations, and the locations of 'red-clay' foundation fills; rows 1 and 3 post-holes and the north-south road.

To the immediate west of Building 3 two small irregular areas of gravel and flint metalling were discovered (Fig. 23). These appeared to be the vestigial remains of a road or path running north-south; one possible wheel rut orientated north-south was observed as an impression in the metalling.

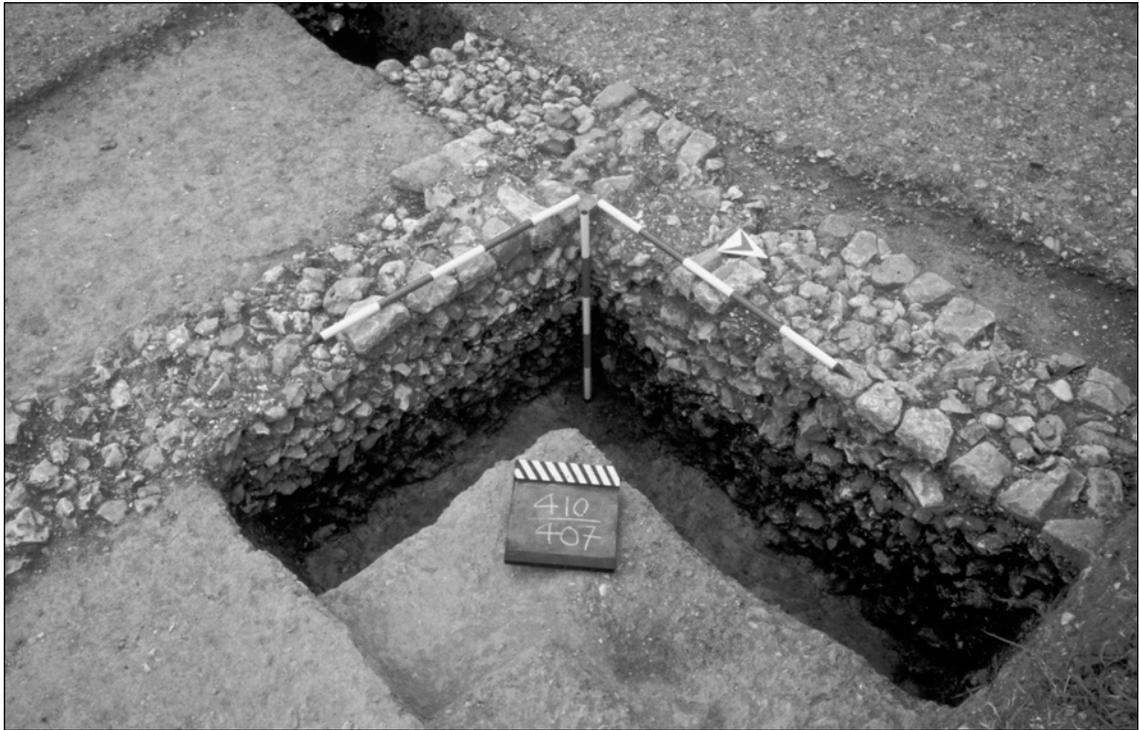
Fig. 25. The junction of foundation walls 410/407 from the north-east. The north wall of Building 3 is centre left and the boundary wall is centre right. The two foundation walls were bonded together — indicating contemporary construction. Scales are 1 m in length.

As part of the investigation into the relationship between the northern flanking wall and Building 3, a sondage was excavated in the angle formed by walls 410 and 407 (Fig. 25). The illustration produced here shows that the foundation depth of both walls was identical and that the foundations were bonded, indicating contemporary construction and a unity of design. Whatever the role of Building 3, it was designed to sit within, or as part of, a larger architectural complex.

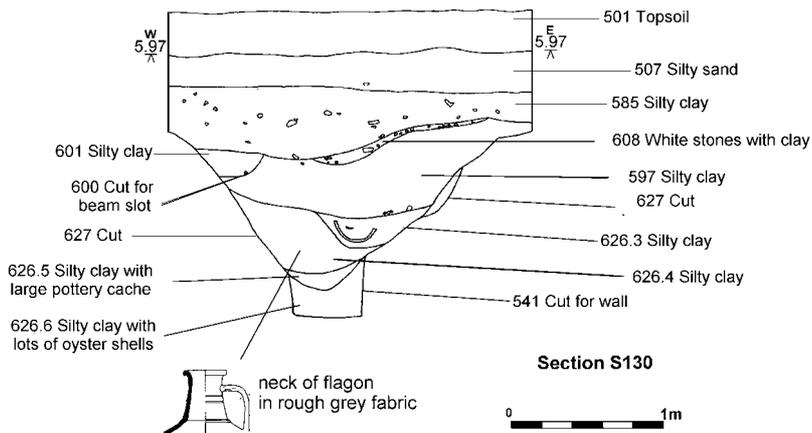
Fig. 40. Building 3: Section 130.

the robber trench (626 to 626.6); the beam slot (601) and associated chalk floor (608); the midden (585); general overburden (507) and topsoil (501). A large cache of pottery was found in 626.5). A large piece of imbrex tile was found in C626.3. These two deposits indicate that the robber trench fill comprised at least two rubbish deposits, separated by deposits of red clay which may have slumped in from the sides. The clean clay loam (626; 626.2) filling the top half of the robber trench was not consolidated. Consequently a chalk floor (608) associated with a timber building slumped into the fill of the robber trench. After the timber building went out of use the area was covered by a 500 mm of midden deposits.

It could not be ascertained from the section whether the foundation trench was wider than the foundation wall, since the robber trench had all but destroyed the original profile of the foundation trench. The foundation trench did survive at the bottom where it was 500 mm wide; overall, it was prob-

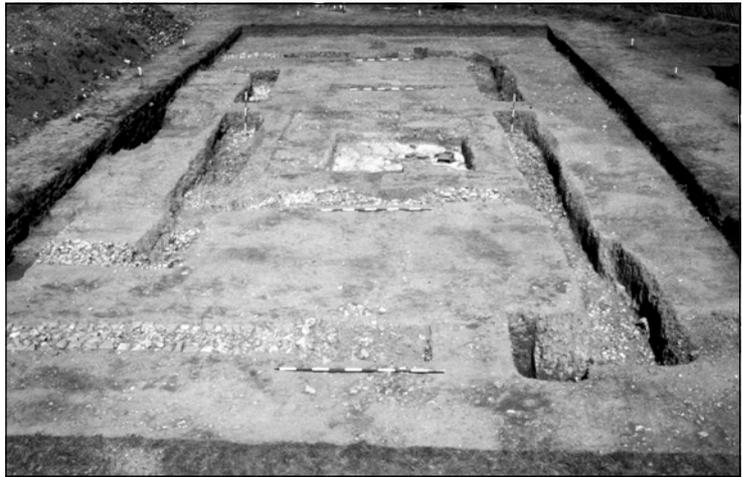
Fig. 42. 1996 dig: the eastern range of Building 3 from south; scales are 2 m; note the central pit in the middle of the range.

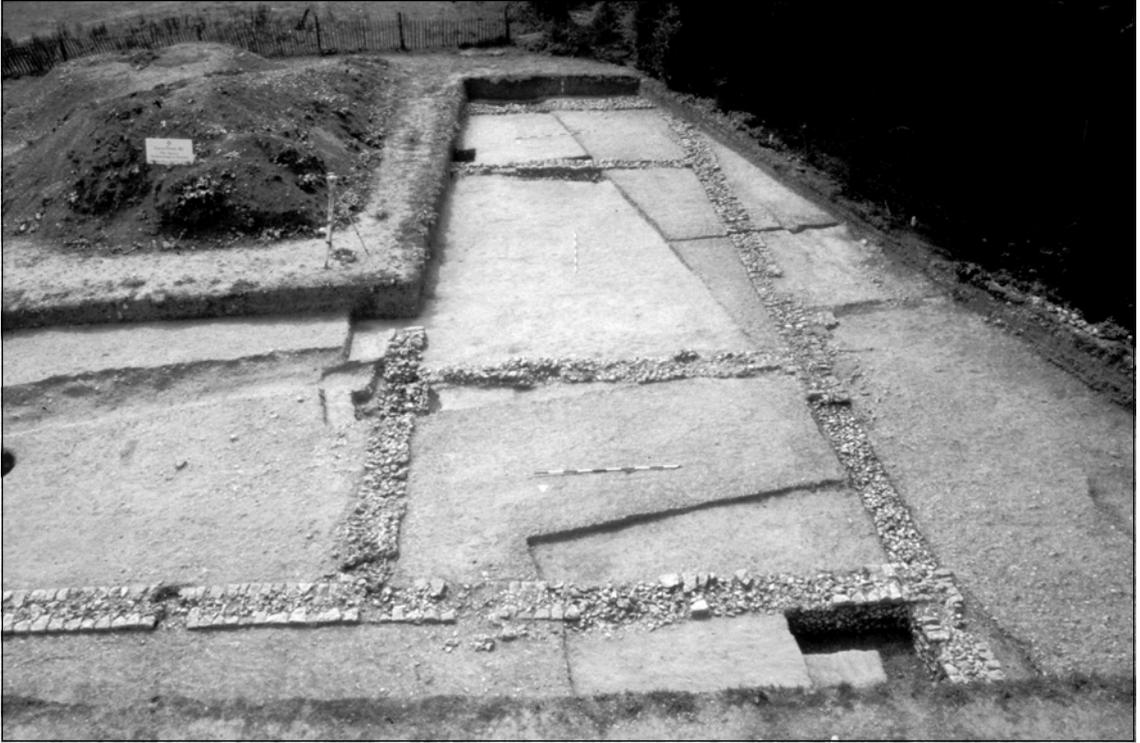
Fig. 44. 1997 dig: the western range of Building 3 from the north; scales are 2 m; the stream is to the right of the excavation.

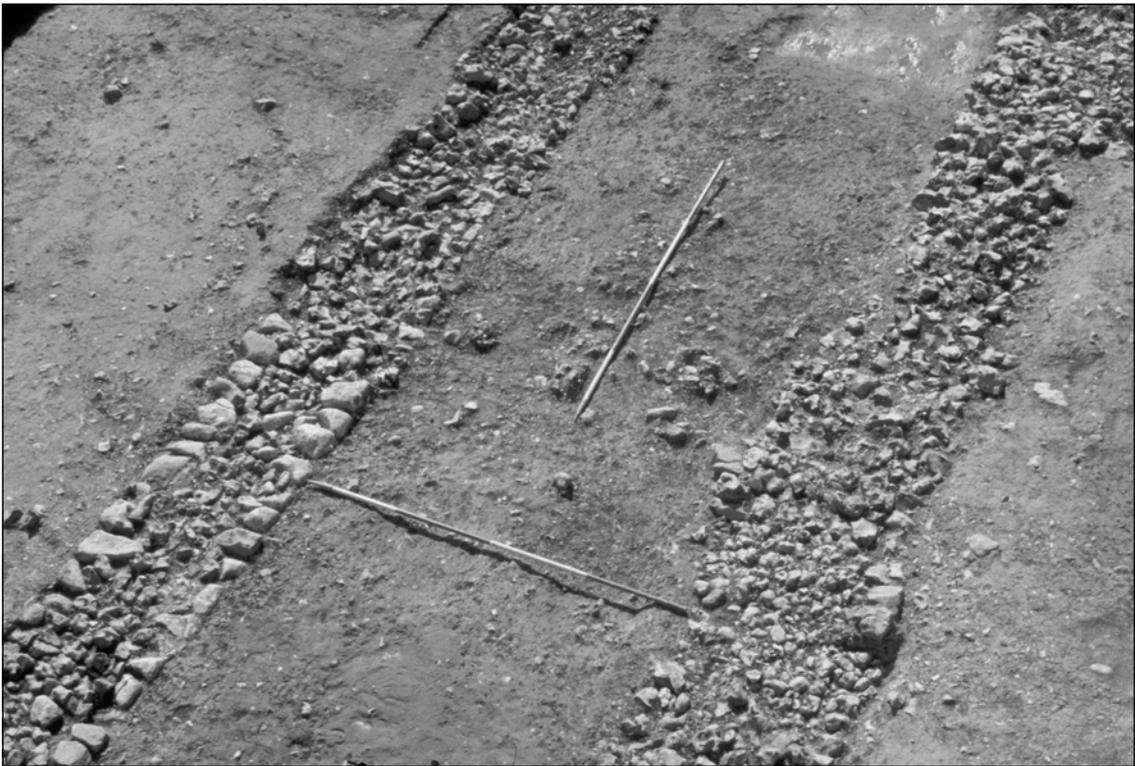
Fig. 47. The southern corridor walls of Building 3; scales are 2 m; note the greensand edging stones and the flint core of the foundations.

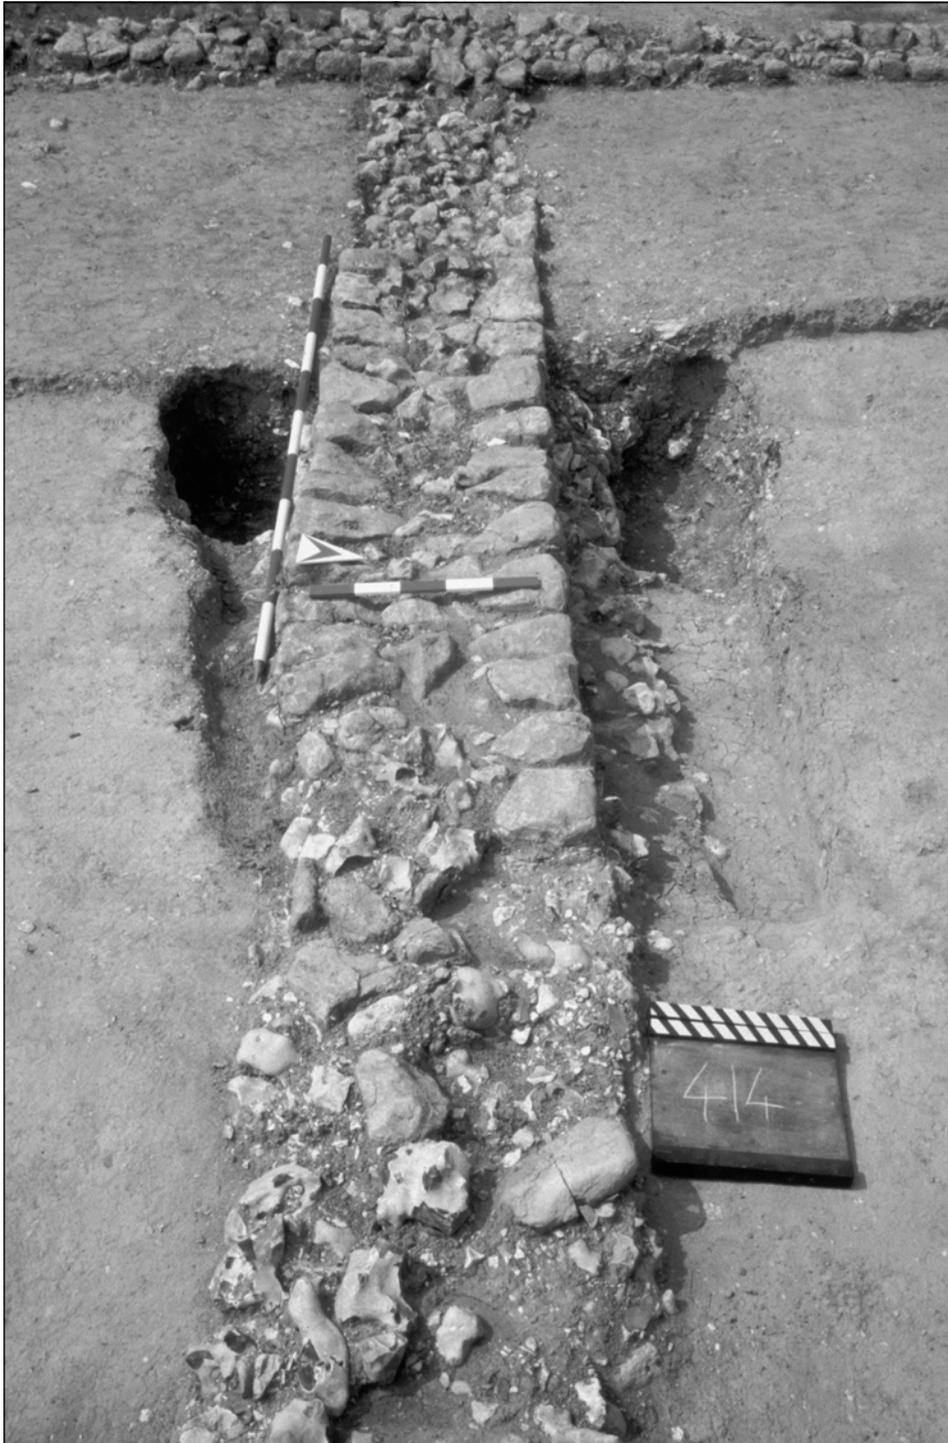
Fig. 48. The north wall (414) of the south-west room of Building 3; the scale on the top of the wall is 0.5 m; note the greensand edging stones.

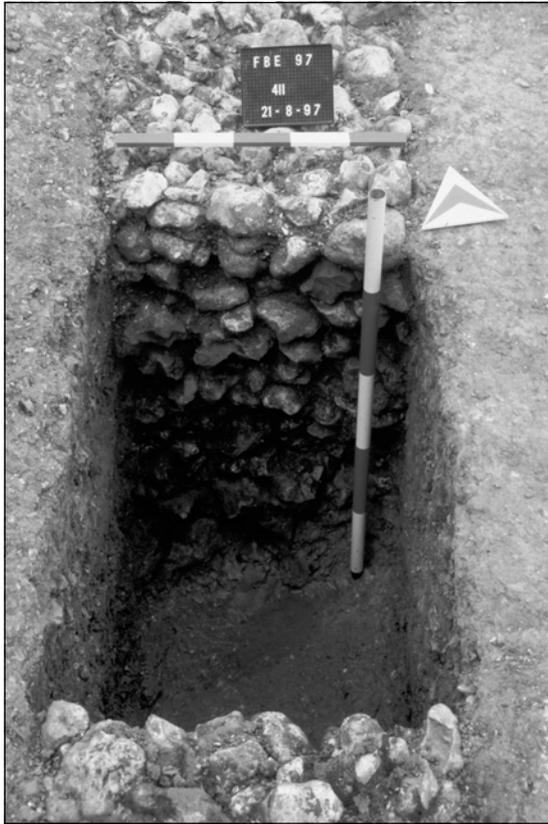
Fig. 49. An excavated section through the west wall (411) of Building 3; the vertical scale is 1 m; horizontal scale 0.5 m.

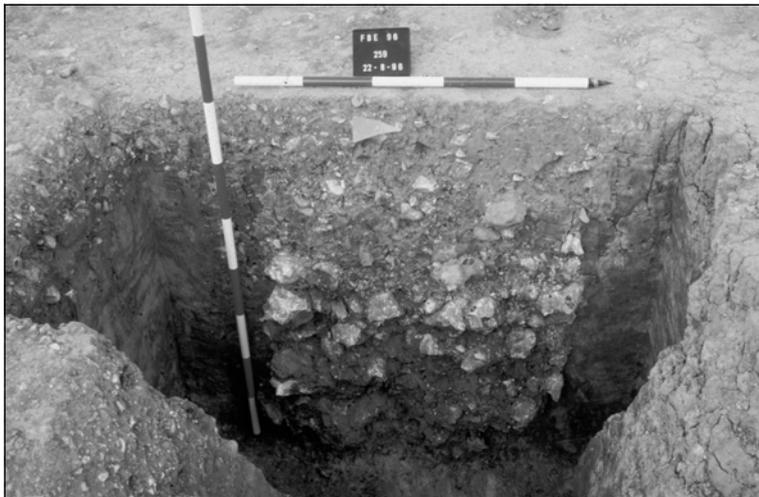
Fig. 51. South-east corner of Building 3; robber trench (259); horizontal scale is 1 m.

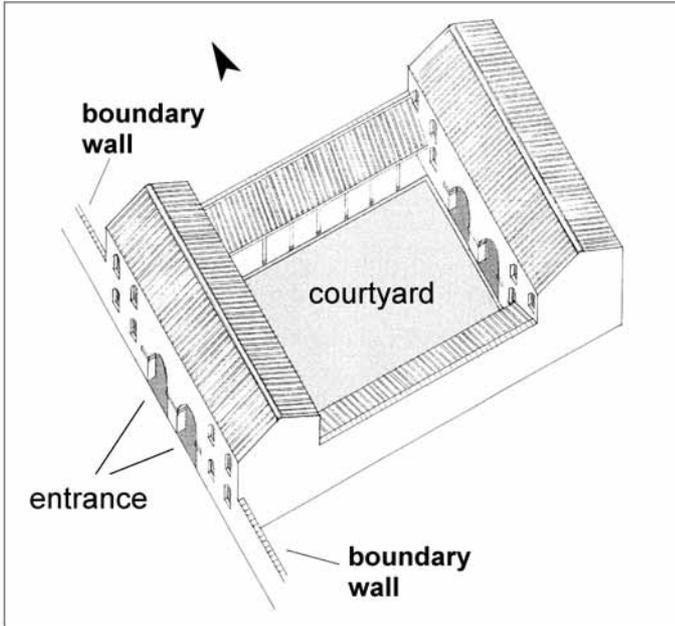
Fig. 55. Phase AB: hypothetical reconstruction of Building 3 by David J. A. Taylor.

Continuous arcades are shown to the north and south ambulatories, although as has been discussed previously, these foundations do not run up to the west range. The continuous foundation to the arcade matches that of the contemporary proto-palace, and although not always found in buildings of this type, can also be seen in the *principia* at Housesteads and Melandra. The inconsistency of the foundations to the east and west walls of the west range could raise a question over the interpretation of the openings to this range. It has been found that a great many of the buildings on Hadrian's Wall were constructed by first building the external walls, and then adding the internal walls, which were butt-jointed against the external ones (Taylor 2000, 46–7). If this was the case, in this instance, it would have been logical not to continue the foundation through the opening to the east wall of the west range. This would have enabled the opening to be formed by omitting the foundations over its width. It is suggested that there was a *spina* base in the centre of the opening with the foundation course made up of two or more stone slabs.¹²

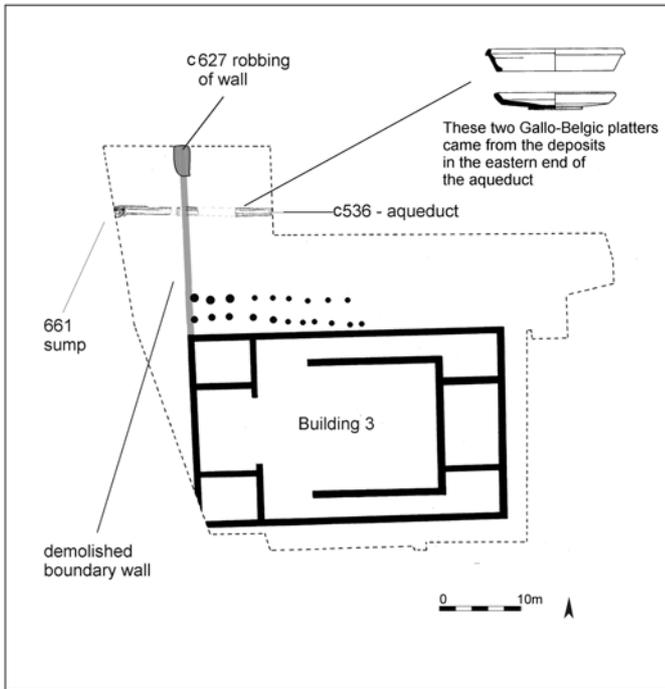
Fig. 64. Phase AC: general plan; note that the boundary wall to the north of Building 3 has been demolished, and the aqueduct cuts through the foundations of the wall.

During this period a decision was taken that whatever the function of the flanking or boundary walls that ran north and south from Building 3 had been, these walls could now be dispensed with. It is likely, therefore, that the flanking walls, but NOT Building 3 itself, were pulled down to top-of-foundation levels. At the northern end of the flanking wall the foundations were completely robbed out (Fig. 64). The posts formed by rows 1 and 3 were still in existence at this time.

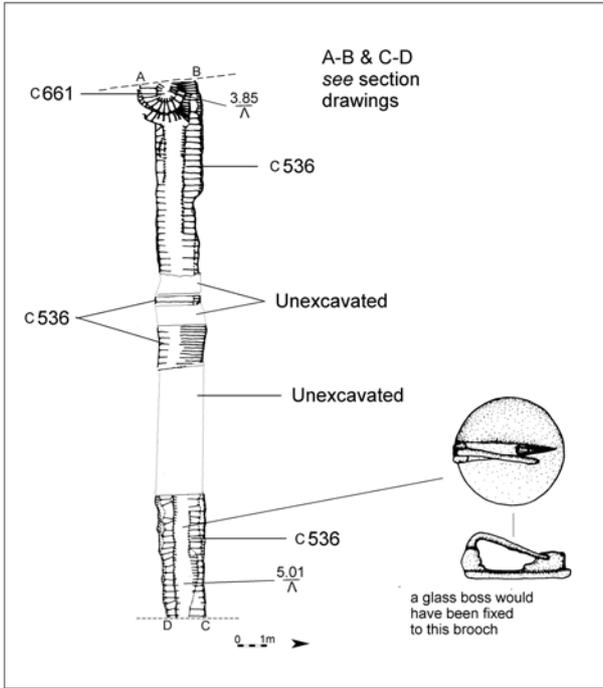
Fig. 65. Phase AC: the plan of the aqueduct, which at its western end terminated in the sump.

At its western end the upper fill of the aqueduct was very different. It was filled by a deposit of fine, well-sorted silty clay (604.1; 604.2) which contained less than 5% stony material: small, sub-rounded pieces of flint up to 40 mm in length. There was considerable evidence of iron-staining and, whereas the upper eastern fills of the aqueduct appeared to have been deliberately dumped, the western fills appeared to have been water-laid.

Across the top of the aqueduct, at its eastern end, deposits 556 and 557 could be seen in section, both containing considerable amounts of greensand. It will be argued elsewhere in this report that these two deposits relate to the demolition of Building 3. The channel for the aqueduct was excavated through the flint foundations (540: Figs 64, 74) of the demolished flanking wall of Building 3. The aqueduct therefore produced some critical stratigraphic observations: it had been constructed

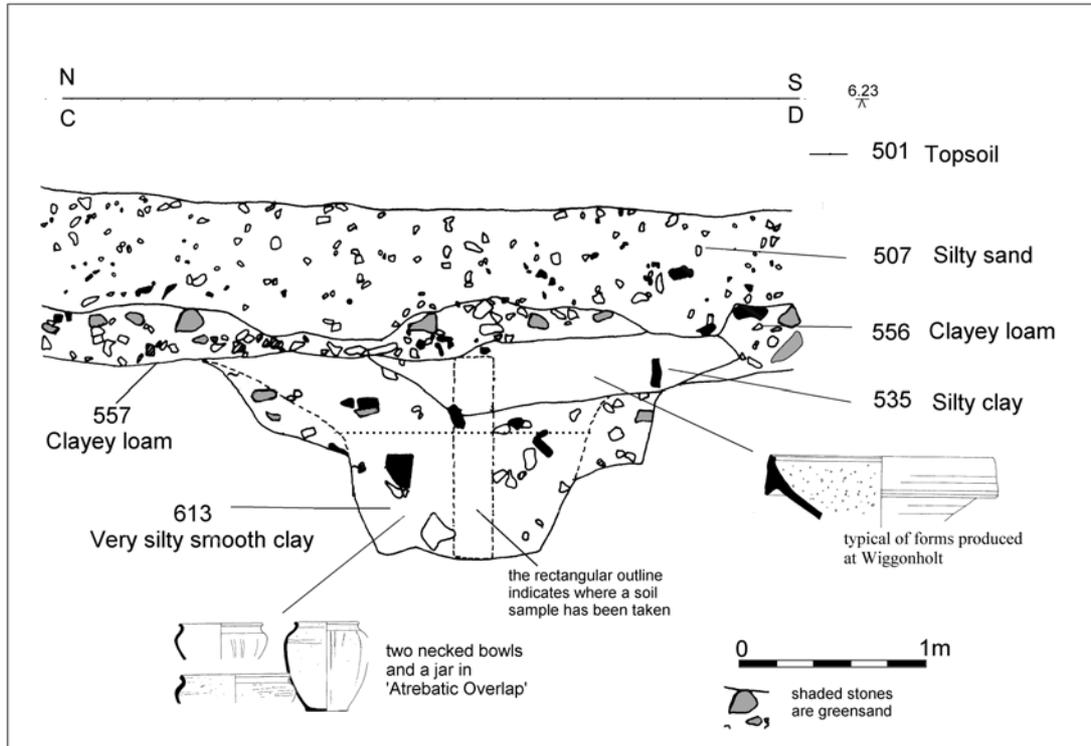
Fig. 66. Phase AC: the eastern section of the aqueduct.

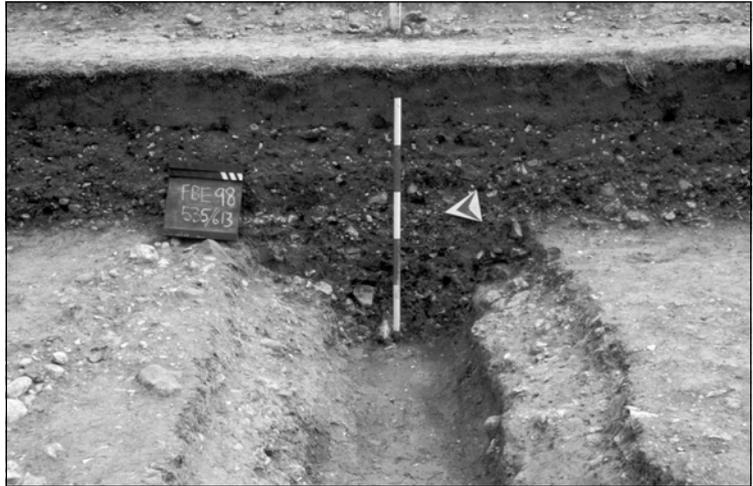
Fig. 67. Phase AC: the eastern section of the aqueduct.

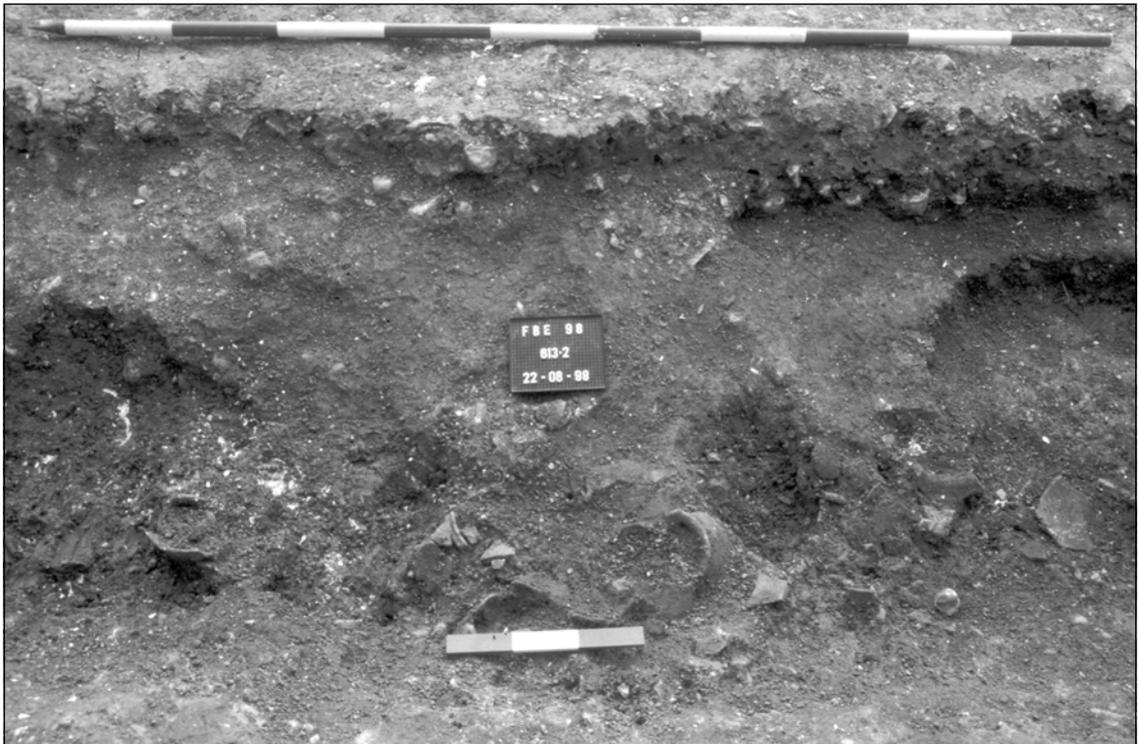
Fig. 68. Phase AC: the pottery dump in the aqueduct; this is a critical assemblage (Assemblage 7), since the boundary wall of Building 3 must be earlier than the date of deposition of this assemblage.

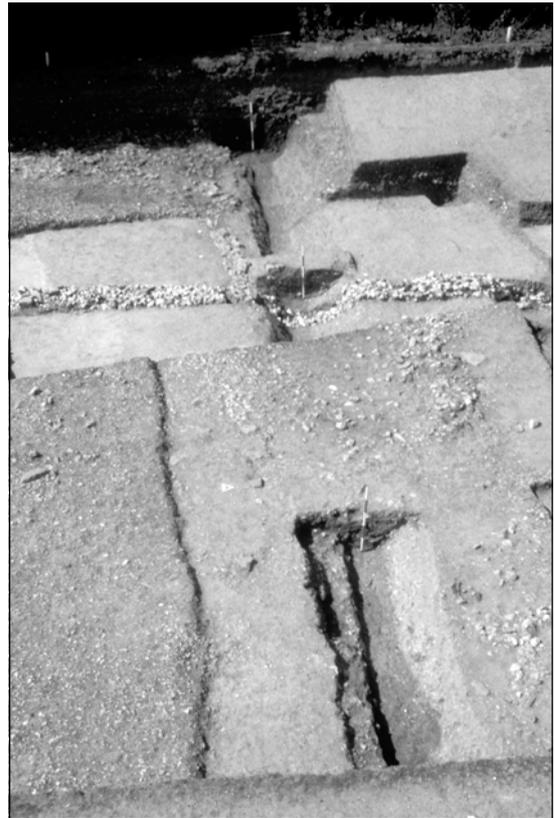
Fig. 72. Phase AC: the aqueduct cuts through the boundary wall. This was a key stratigraphic observation.

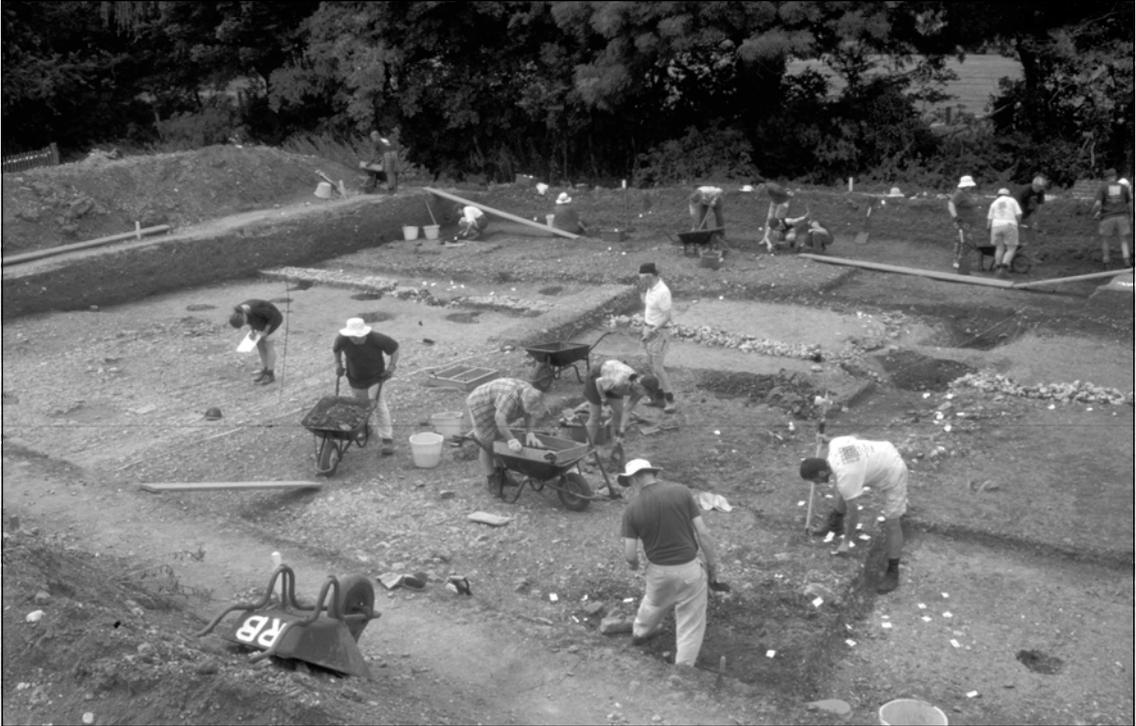
Fig. 73. 1998 dig: the eastern end of the aqueduct at lower right; the northern boundary wall runs left to right across the middle of the photograph.

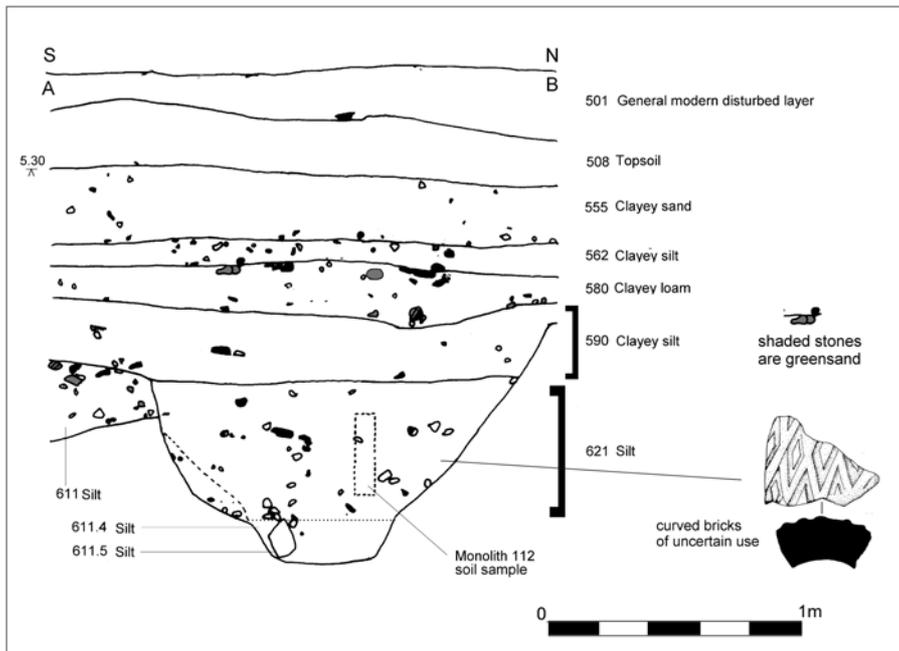
Fig. 75. Phase AC: the western section of the sump.

The sump was a semicircular depression, about 1.8 m north-south, by 1.4 m east to west and approximately 1.2 m deep (Figs 75, 76, 77). It is not known how much further to the west it would have continued. However, if it was circular, it can be anticipated that the overall diameter was about 1.8 m. The sump was sealed by C580, a context equated elsewhere in this report with the demolition of the Palace at the end of the 3rd century. The upper two context divisions (621.1 and 621.2) contained a very fine silt with iron-pan staining which also incorpo-

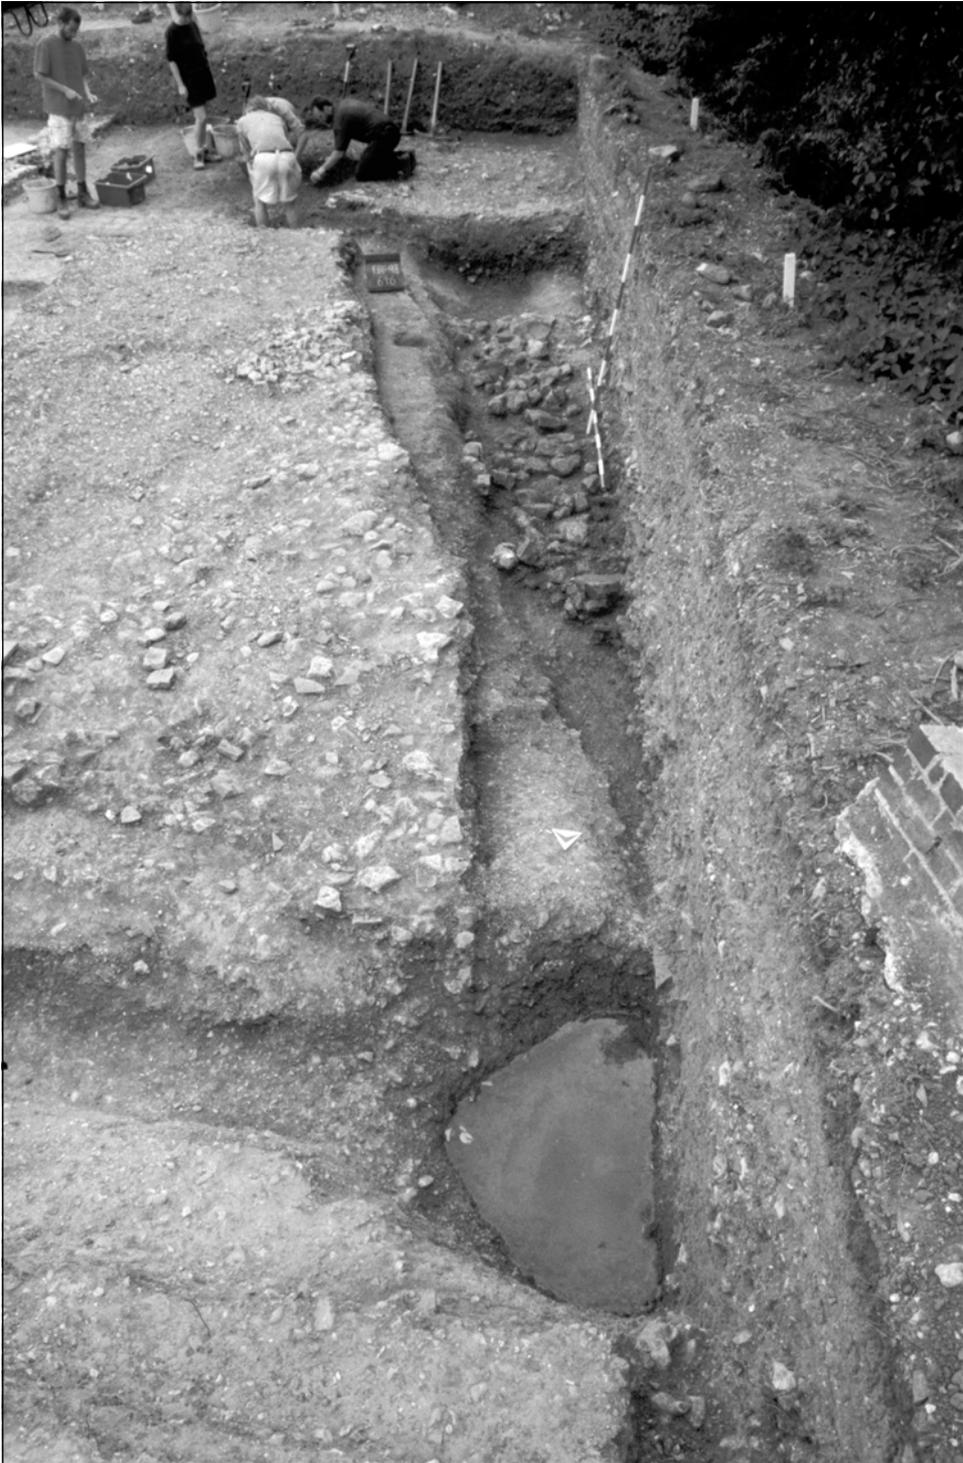
Fig. 76. Phase AC: sump, and Phase AE – greensand causeway; from the north.

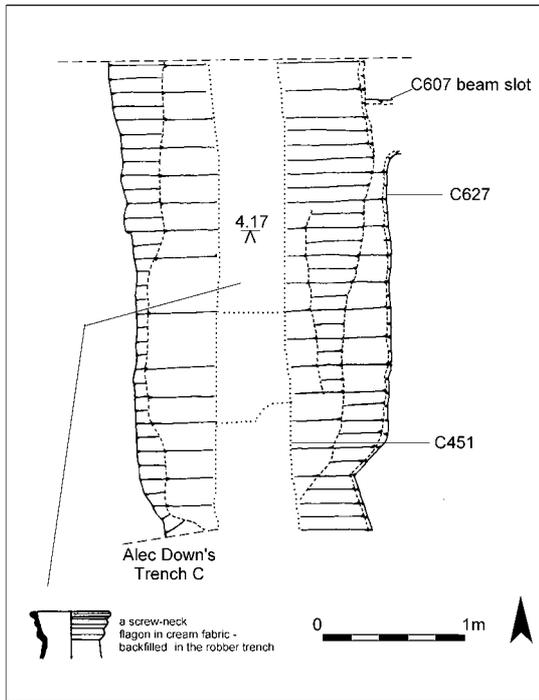
Fig. 78. Phase AC: plan of the robber trench on the north flanking/boundary wall; the beam slot cut across the top of the filled-in robber trench.

A section against the north face of the trench revealed the sequence of deposits that filled the robbed foundation trench of the northern flanking wall. The northern flanking wall had been totally robbed for a distance of 3.5 m southwards from the north section (Figs 40, 78–80). From the bottom up these deposits are: the filling of the robber trench (626 to 626.6); the beam slot (601) and associated chalk floor (608); the midden (585); general overburden (507) and topsoil (501). Deposit 626 comprised brown silty clay, with 10% of small, rounded flint pebbles; in the lower half this deposit exhibited concentrations of flecks of charcoal, tile, mortar and oyster shell. A large cache of pottery was found in C626.5. A large piece of imbrex tile was found in C626.3. These two deposits indicate that the robber trench fill comprised at least two rubbish deposits, separated by deposits of red clay, which may have slumped in from the sides. The clean clay loam (626; 626.2) filling the top half of the robber trench was not consolidated. Sealing the top of the robber-trench fill was C597, brown silty clay, relatively stone-free, but containing fragments of oyster shell, pottery, painted wall plaster, bone and nails. Consequently a chalk floor (608) associated with a timber building slumped into the fill of the robber trench.

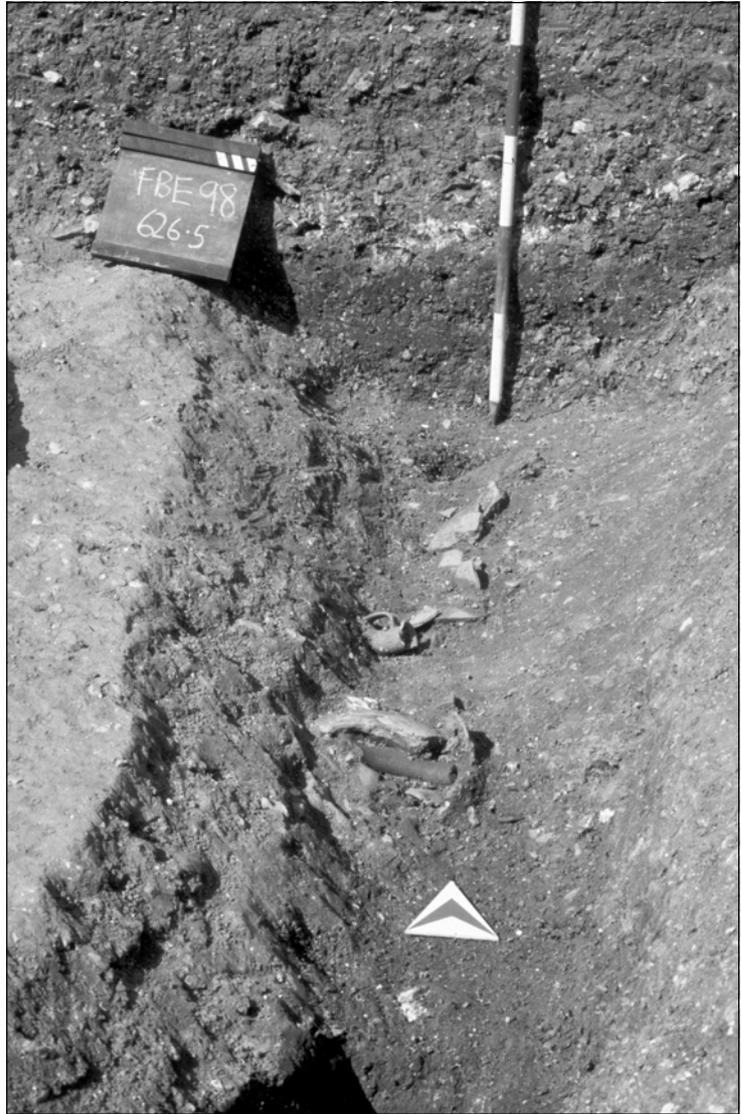
Fig. 79. Phase AC:- pottery in robber trench; this is a key assemblage (Assemblage 8).

The samian sherds included one sherd of Nero-Vespasian date and one sherd of pre-Flavian date from the lower fills of the robber trench. The other pottery finds (545 sherds) suggest that robbing of the wall took place during the period AD 55–65, followed by subsequent dumping and then more gradual rubbish accumulation. Pottery of Rowlands Castle grey wares shows a marked increase in significance and now accounts for a quarter of all the pottery. It seems likely, however, that this sudden upsurge in the supply of such wares during this period was due to a Rowlands Castle potter moving to Fishbourne to supply pots to the kitchens of the new proto-palace and associated buildings. It is possible also that the robbing of the foundations was to locate supplies of flint nodules that could be used in the construction of the proto-palace.

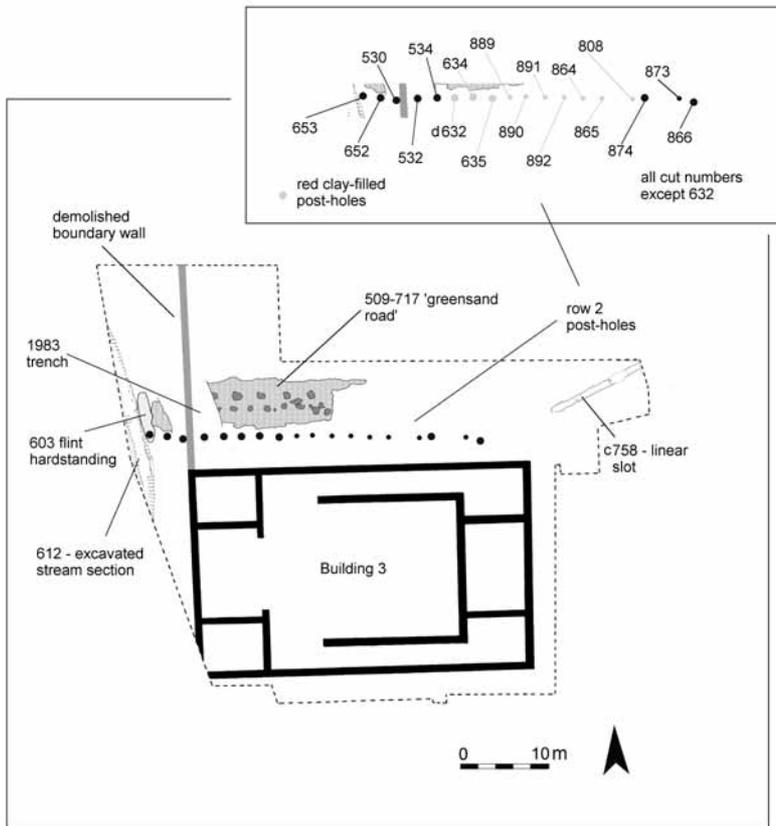
Fig. 82. Phase AD: general plan; note that the row 2 post-holes cross the line of the demolished boundary wall.

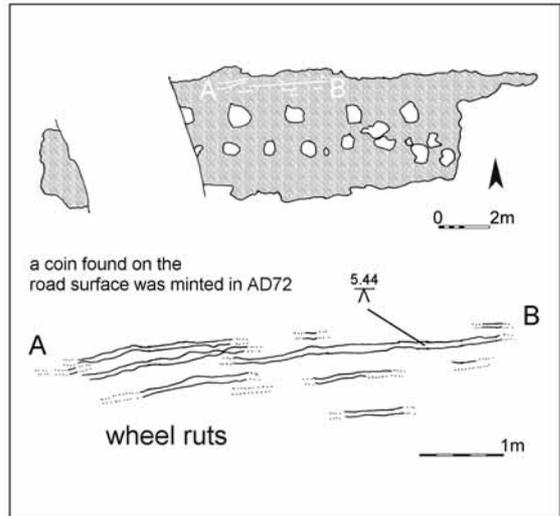
Fig. 84. Phase AD: wheel ruts in the greensand road.

Greensand itself is not a particularly hard-wearing stone and the road may have been a short-lived affair. It did serve a purpose long enough to sustain wear damage in the form of ruts (Figs 84, 85) on its northern side. These turn slightly to the south at their western end, perhaps laden carts making the last adjustment in their steering as they approach the flint hardstanding and the bridge across the stream. Part of the road is covered by a dump of pottery and tile (in 512), which appears to be part of the demolition from the main Palace. It is notable that there is an almost complete absence of flint

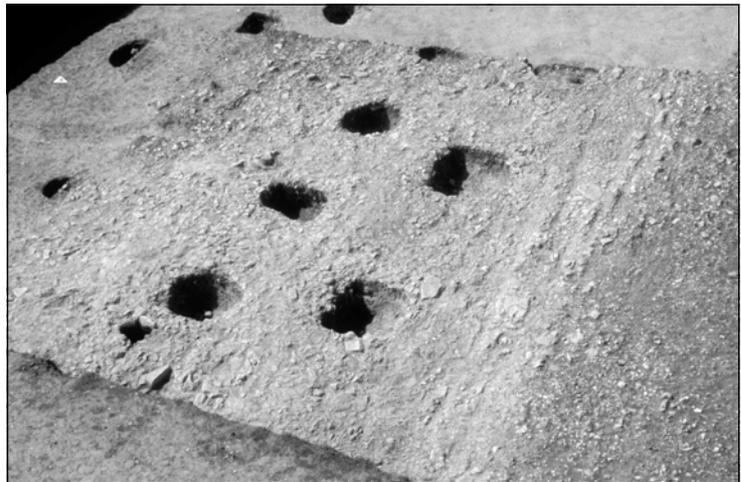
Fig. 85. Phase AD: wheel ruts and post-holes in the greensand road.

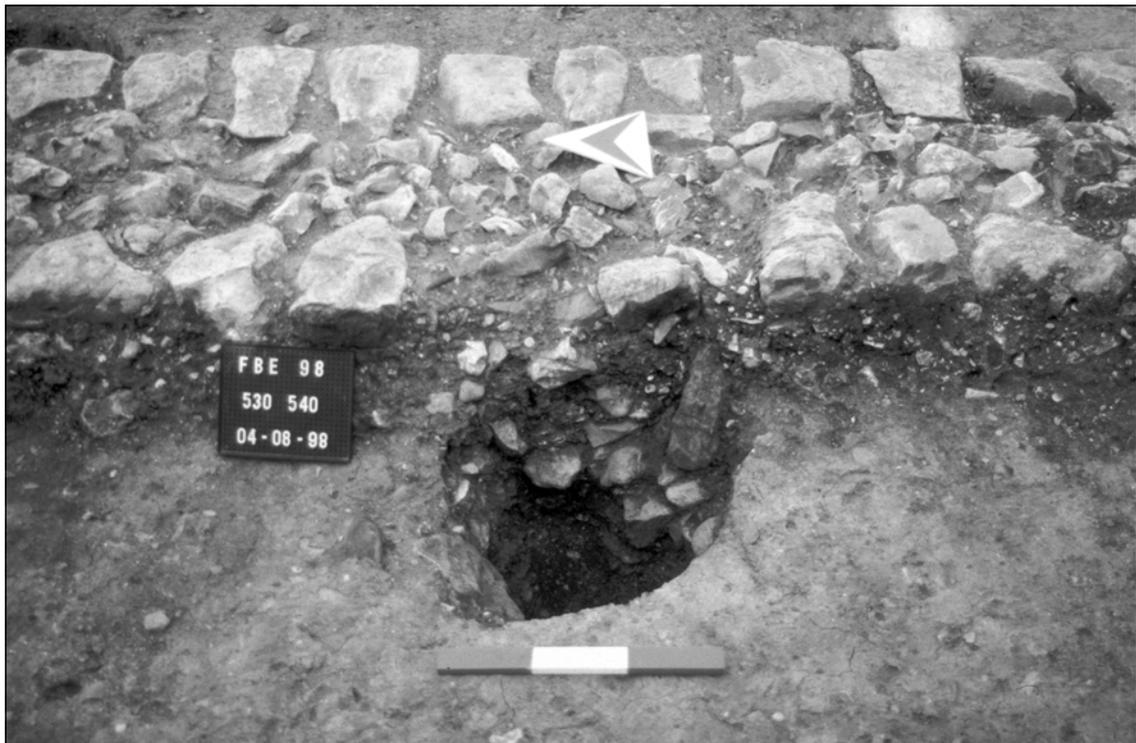
Fig. 88. Phase AD: 530, row 2 post-hole, from the west; scale is 0.3 m.

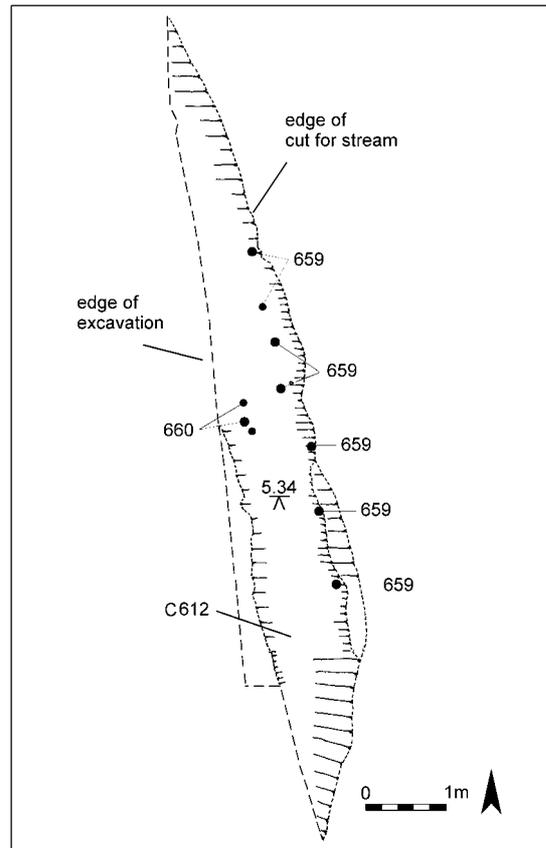
Fig. 89. Phase AD: cut for stream, showing the positions of the stake-holes at the bottom.

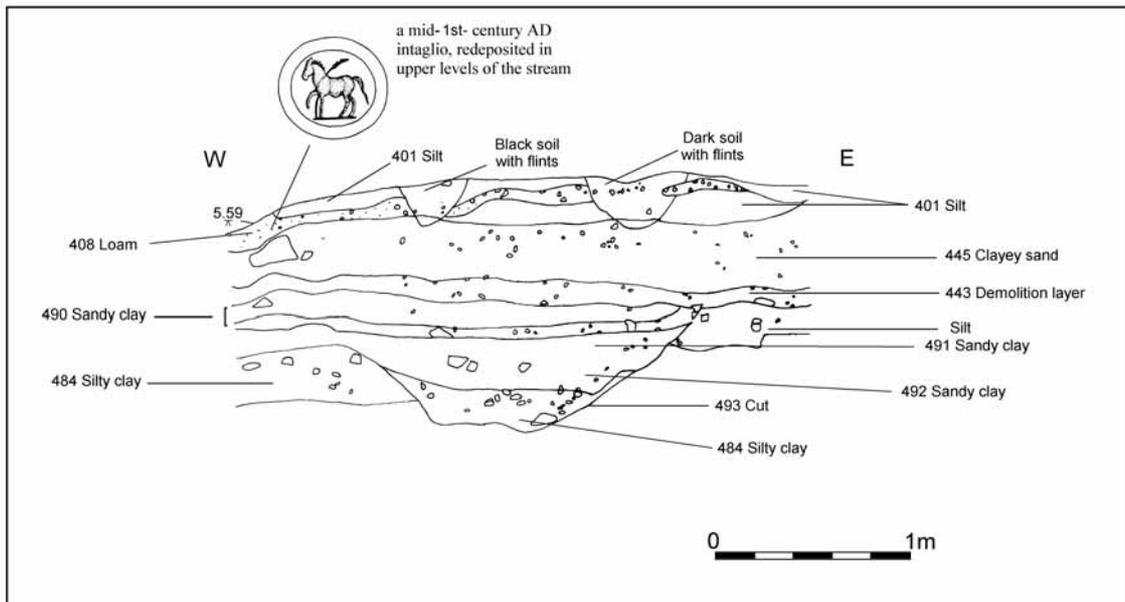
Fig. 90. Phase AD: section across the stream.

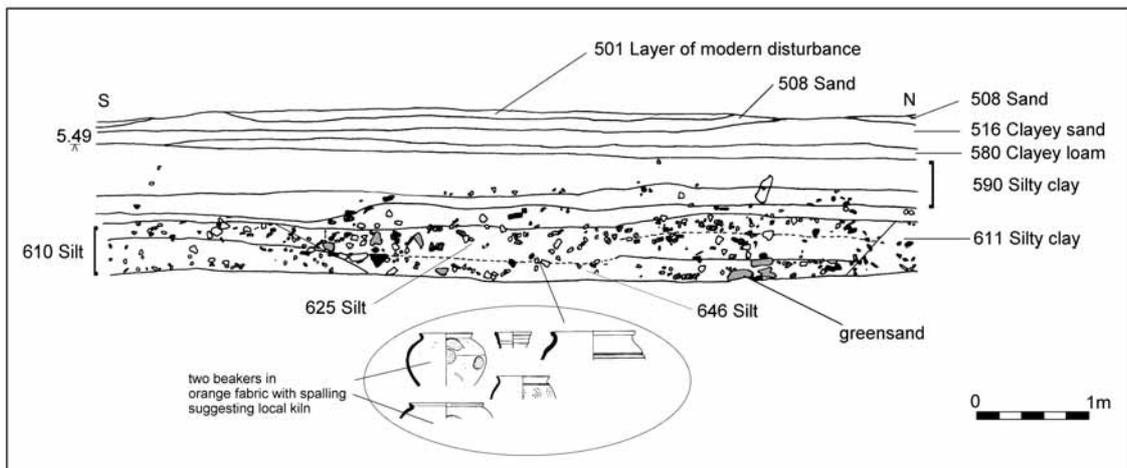
Fig. 91. Phase AD: section along the stream.

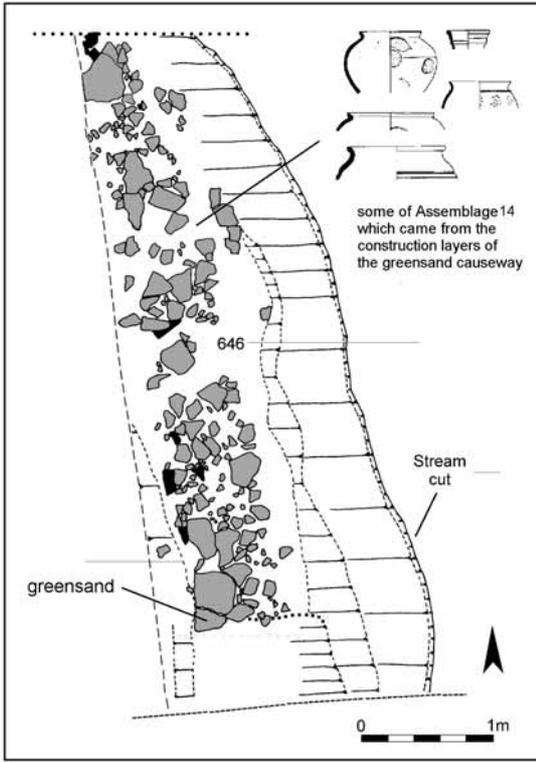
Fig. 93. Phase AE: greensand stones in the stream; Assemblage 14 came from this context.

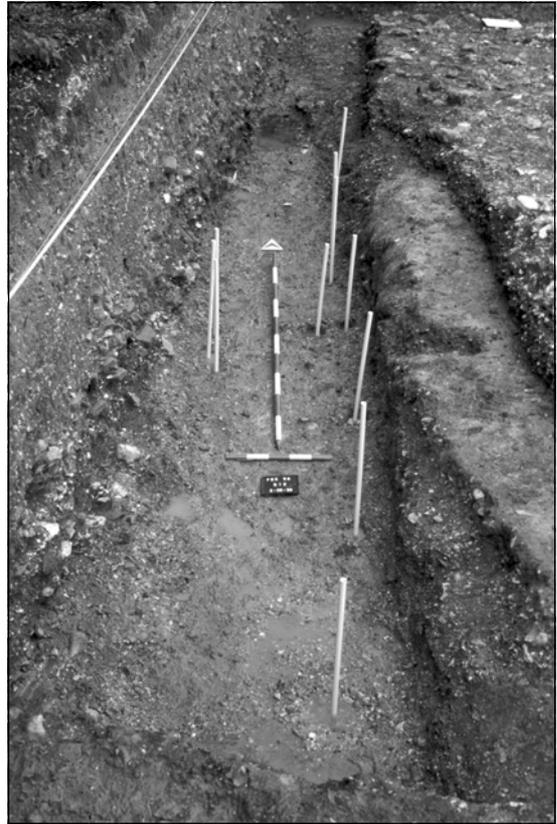
Fig. 94. Phase AD: stake-holes in the bottom of the stream; taken from the south.
