◆ Part 1 – the excavations

AREA A

PHASE AA: c. 5000 BC–1500 BC ■

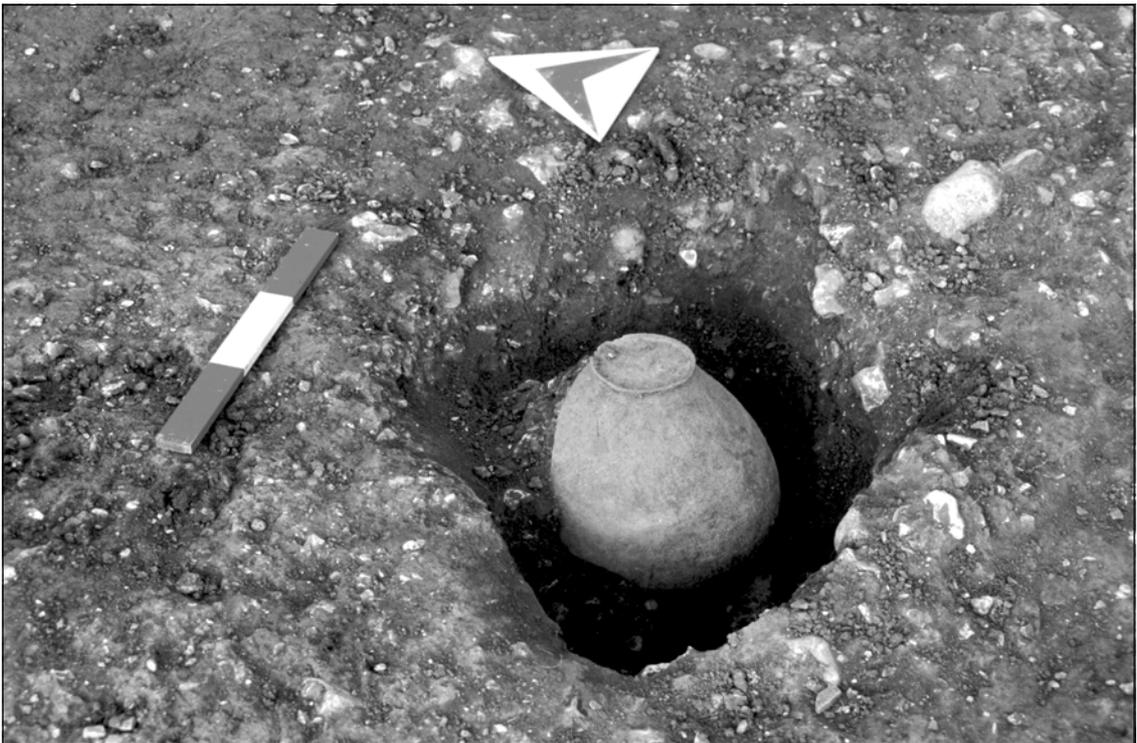
Fig. 96. Phase AD: upturned pot in the linear slot; scale is 0.3 m.

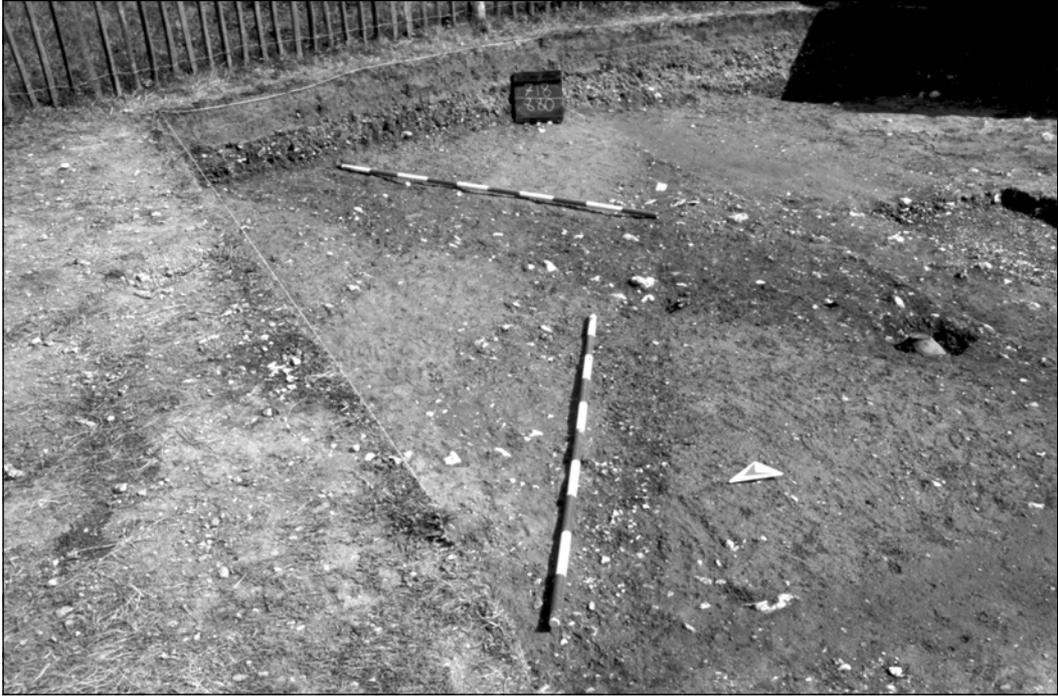
Fig. 97. Phase AD: linear slot. Phase AE: water pipe. The linear slot crosses from left to right; the water pipe runs from top to bottom.

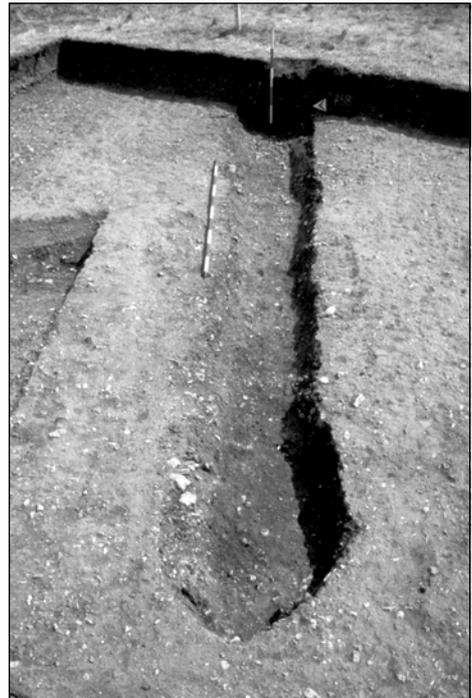
Fig. 98. Phase AD: south-west end of the linear slot.

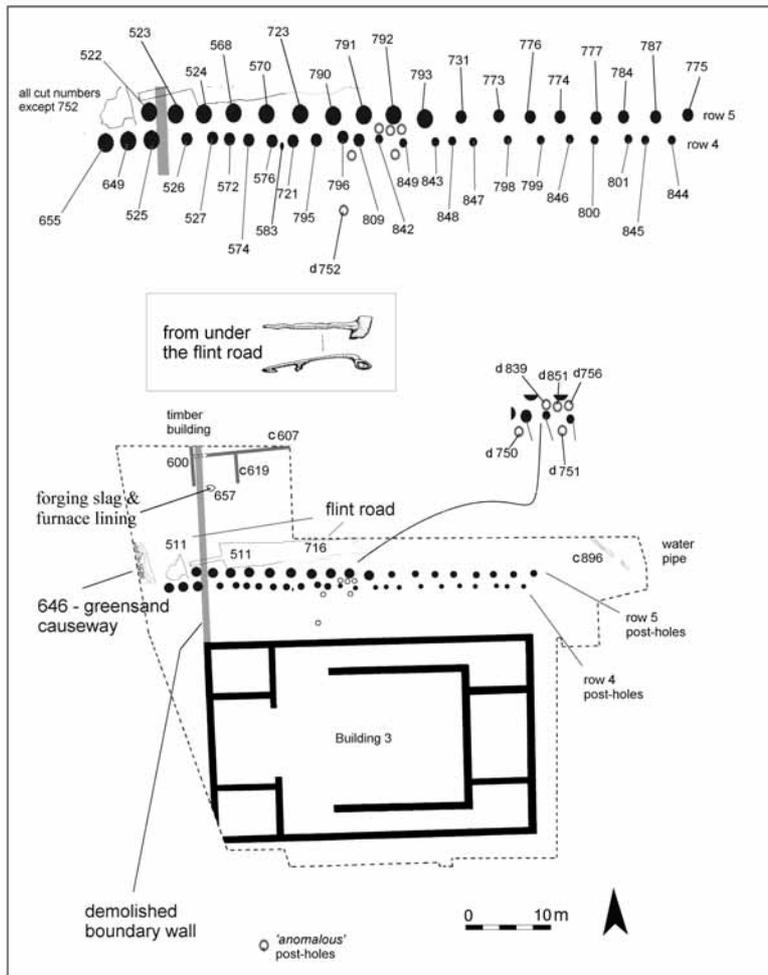
Fig. 99. Phase AE: general plan; note part of the timber building at the northern edge of the excavation.

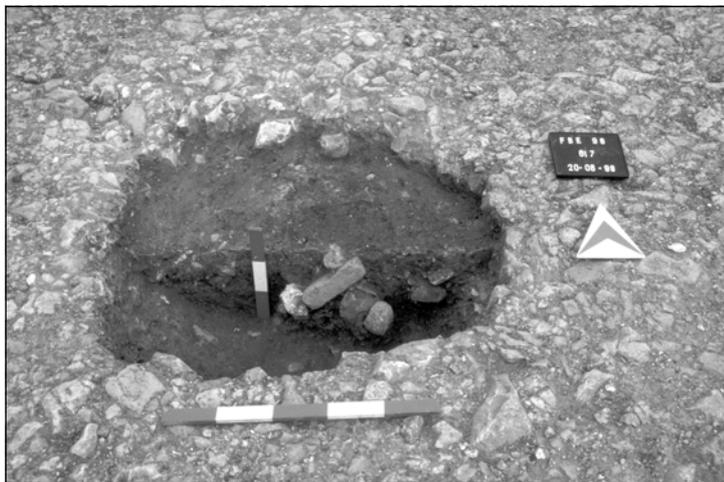
Fig. 101. Phase AE: 567: row 5; horizontal scale 0.5 m, vertical scale 0.3 m.

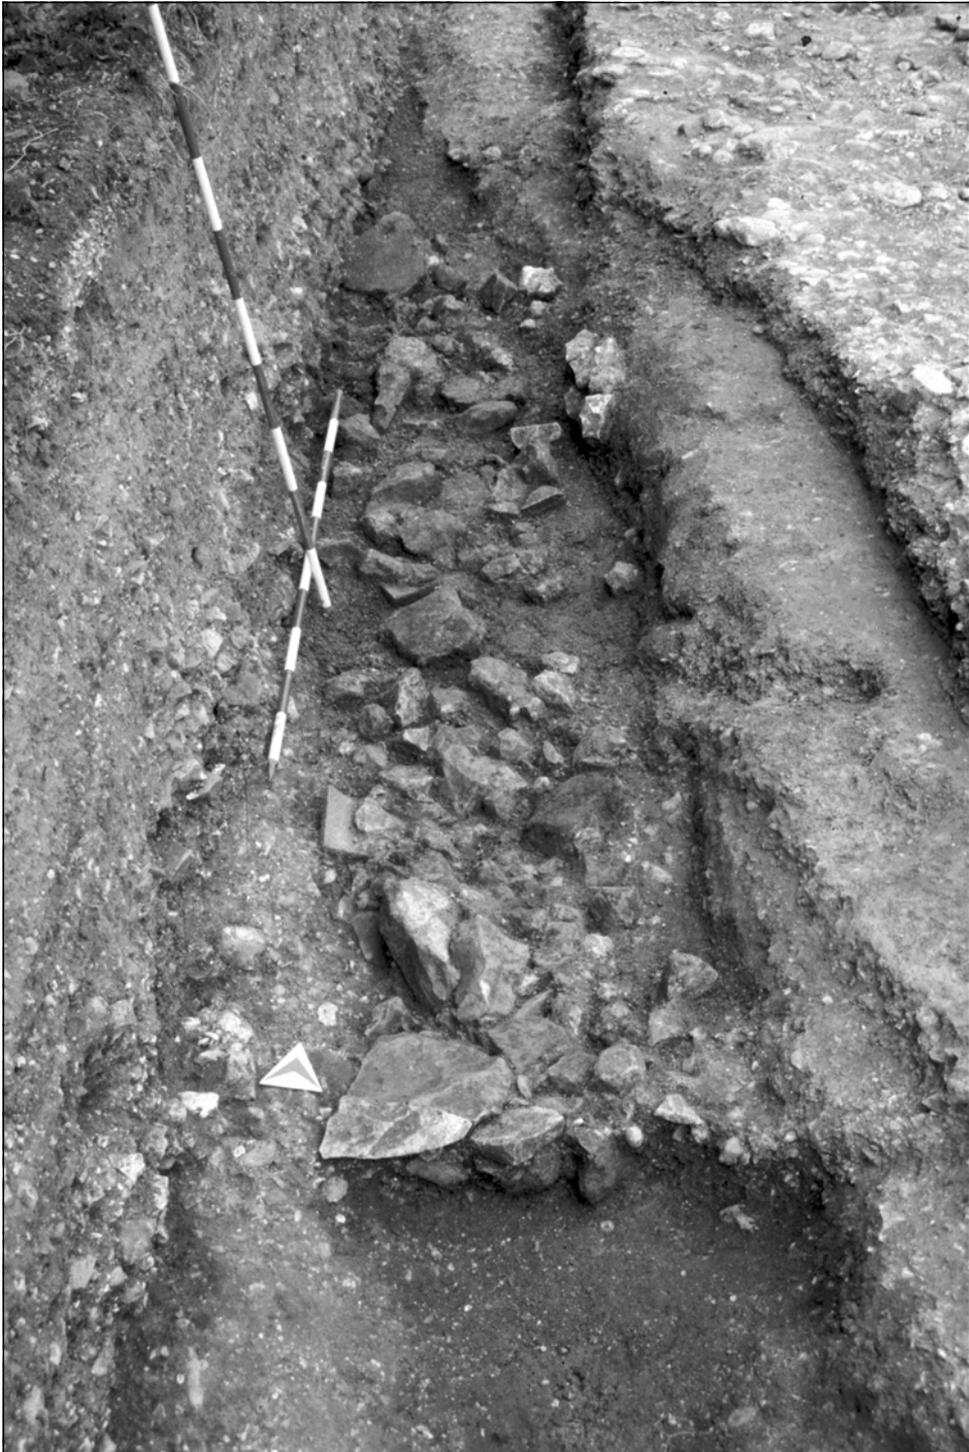
Fig. 103. Phase AE: the greensand causeway from the south.

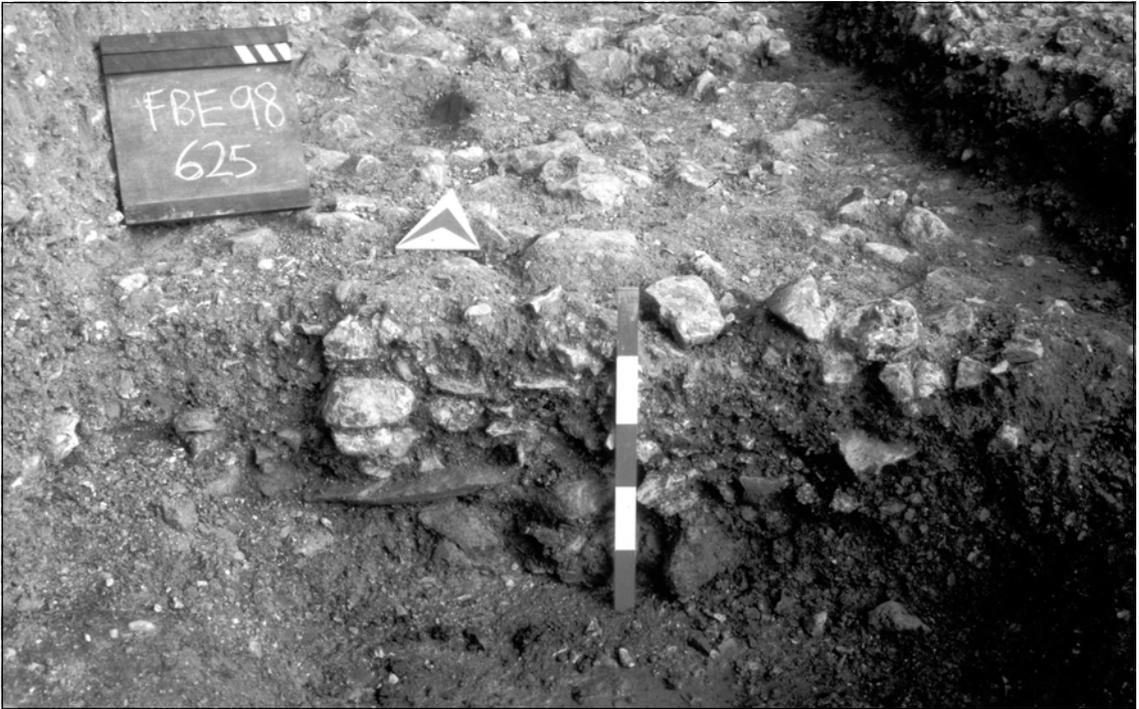
Fig. 110. Phase AE: industrial pit; scale 0.5 m.

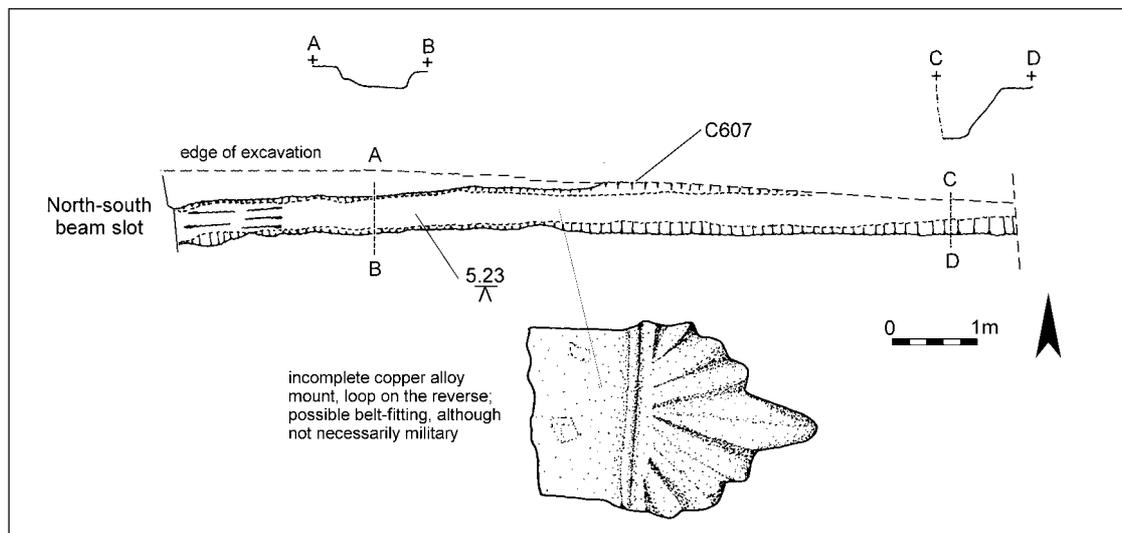
Fig. 112. Phase AE: the plan of the long east-west slot for the timber building.

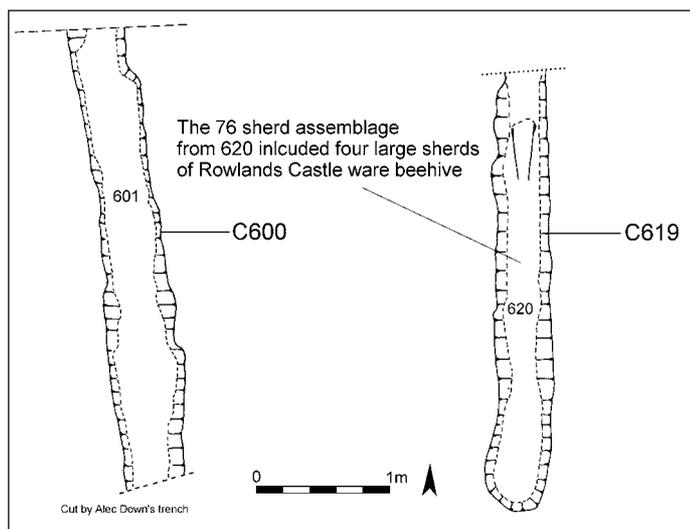
Fig. 113. Phase AE: the plan of the shorter north-south slots for the timber building.

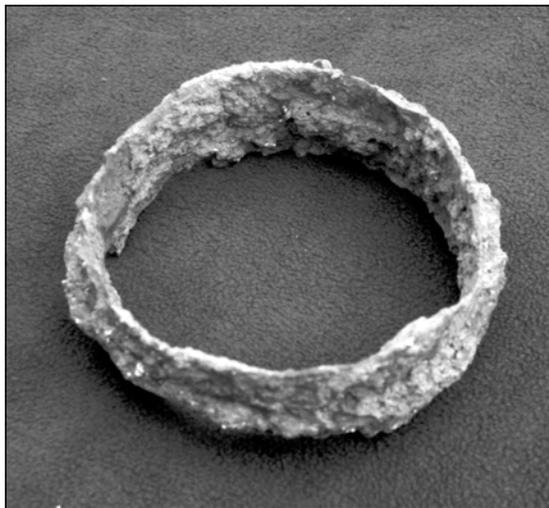
Fig. 116. One of the iron water pipe collars from Phase AE.

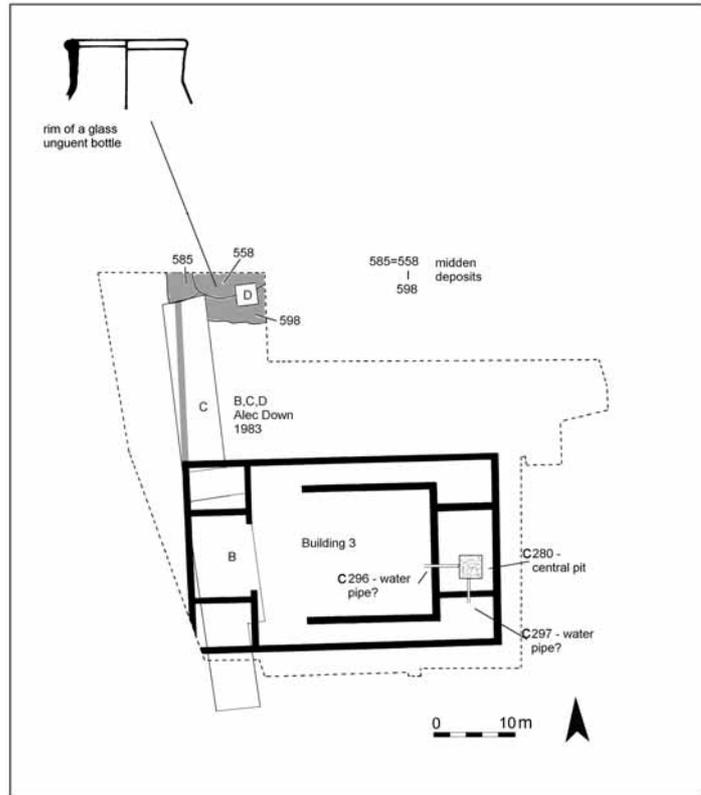
Fig. 117. Phase AF: the general plan; note the position of Alec Down's trenches B, C and D.

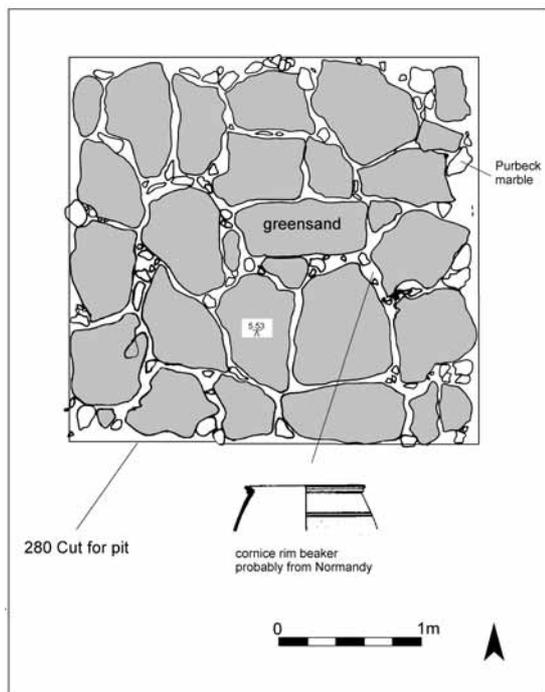
Fig. 118. Phase AF – the plan of the central pit; note how the ‘floor’ was formed by irregularly shaped pieces of greensand, with the gaps between the stones filled by small flints, and a piece of Purbeck marble.

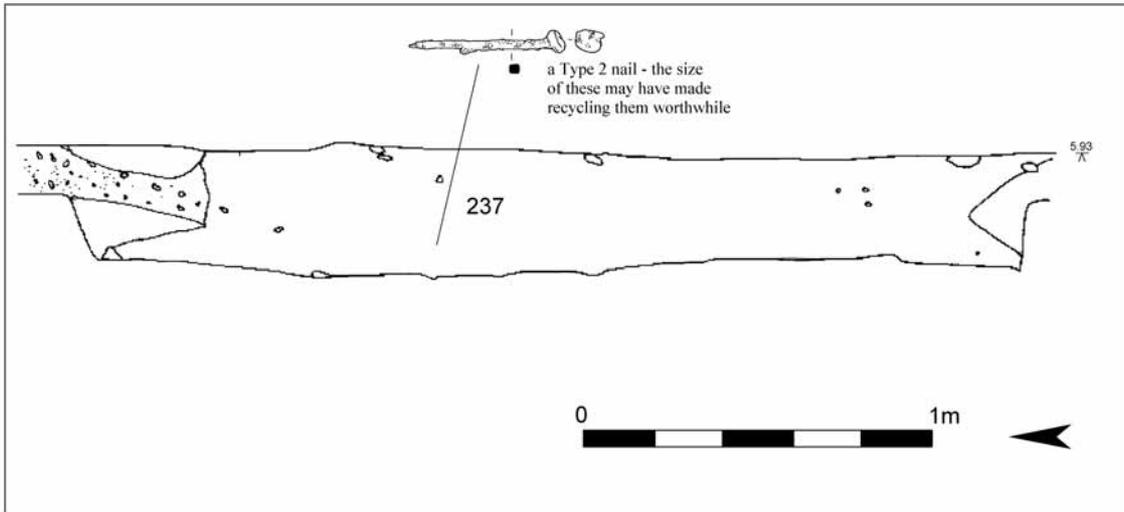
Fig. 122. Phase AF: a section of the central pit.

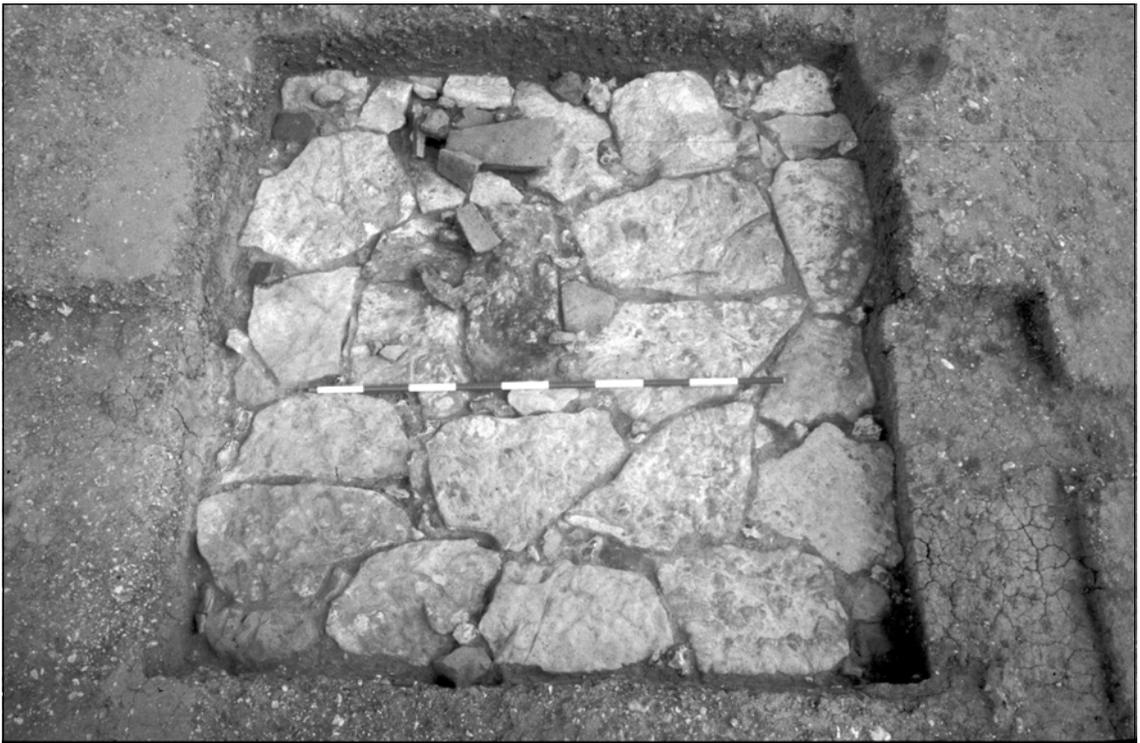
Fig. 124. Phase AF: the floor of the central pit; note the large fragment of tegula on the floor of the pit towards the top of the photograph. This is the same tegula as in Fig. 120. Note that North is to the left.

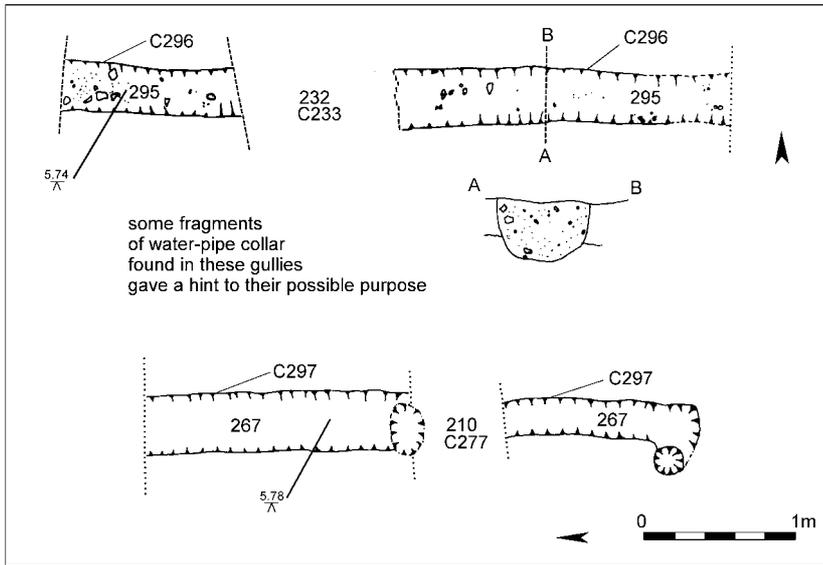
Fig. 128. Phase AF: plans of gullies from the central pit

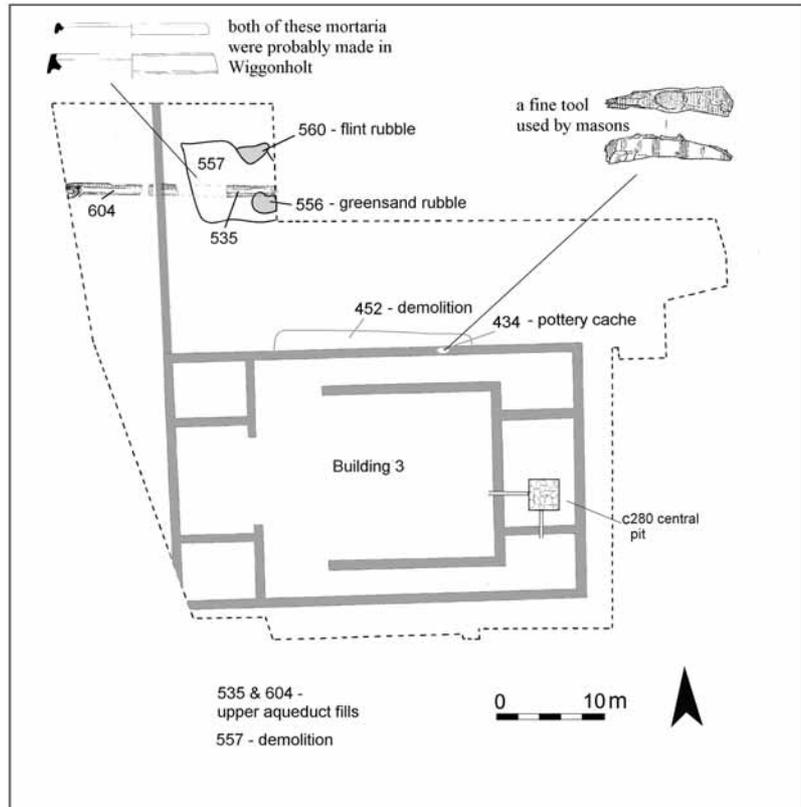
Fig. 132. Phase AG: general plan; Building 3 has been demolished.

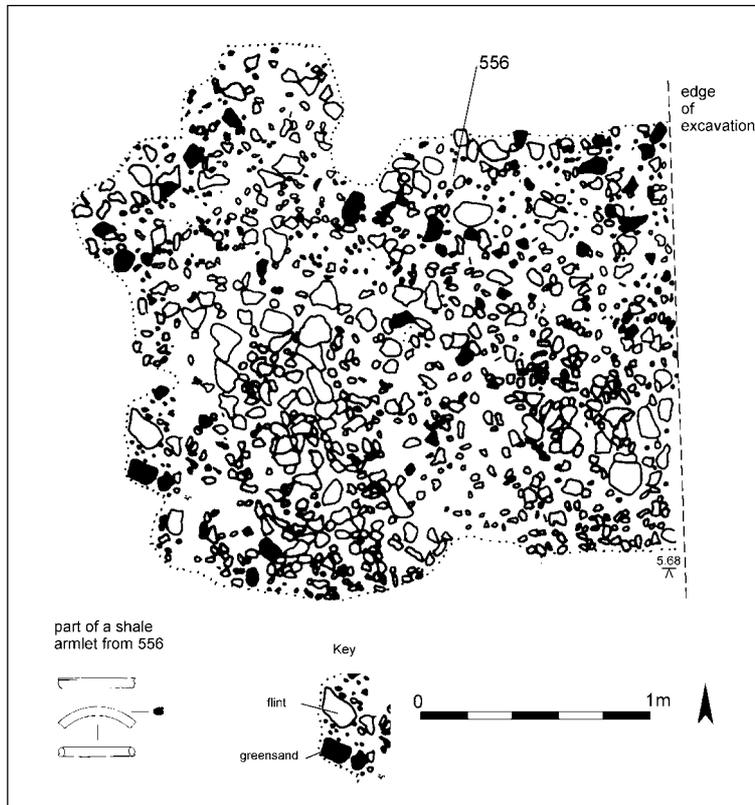
Fig. 133. Phase AG: plan of demolition deposit 556; is this an area where robbed stone was sorted, prior to being used elsewhere?

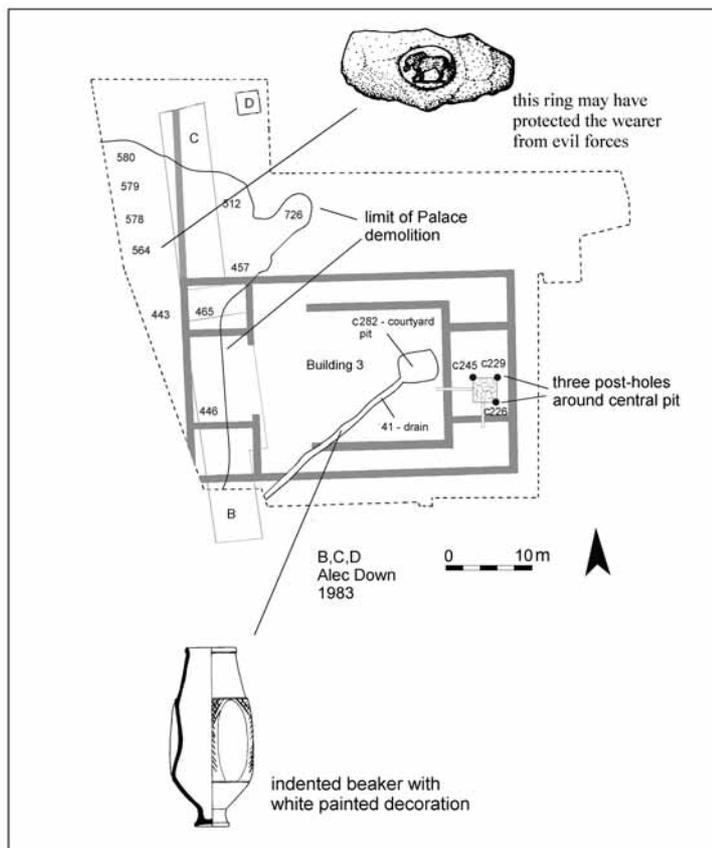
Fig. 134. Phase AH: general plan; demolition deposits probably from the Palace spread across the western end of Building 3.

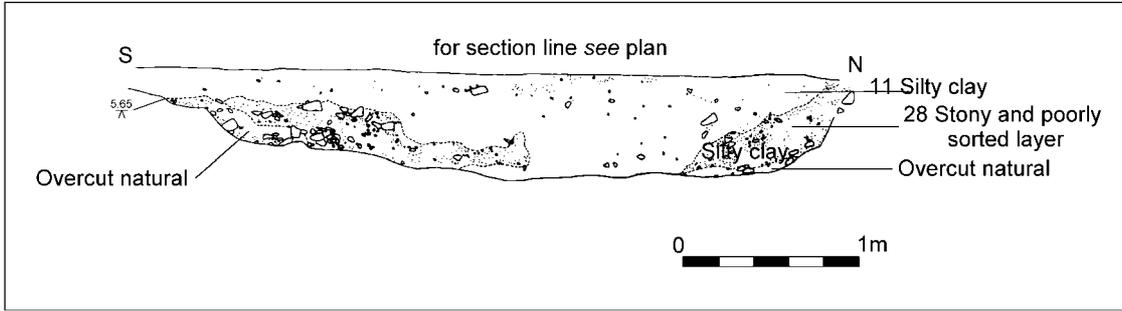
Fig. 136. Phase AH: section of the courtyard pit.

The upper fill of the pit (11) consisted of a water-lain silty clay, well-sorted and mottled by orange flecks of iron-pan staining, which incorporated several large fragments of brick and tile (especially towards the centre of the pit) and occasional large blocks of greensand. Underneath fill 11 was a 50% poorly-sorted and stony layer containing flint nodules up to 150 mm in length and occasional blocks of greensand (C28). Underlying this was the primary silt (C29) in the pit, represented by a deposit of fine, silty sand, on average about 150 mm deep, containing about 10% of small-sized flint and gravel up to 50mm in length. The cut for the pit (30) had gradually sloping sides and a flattish bottom.

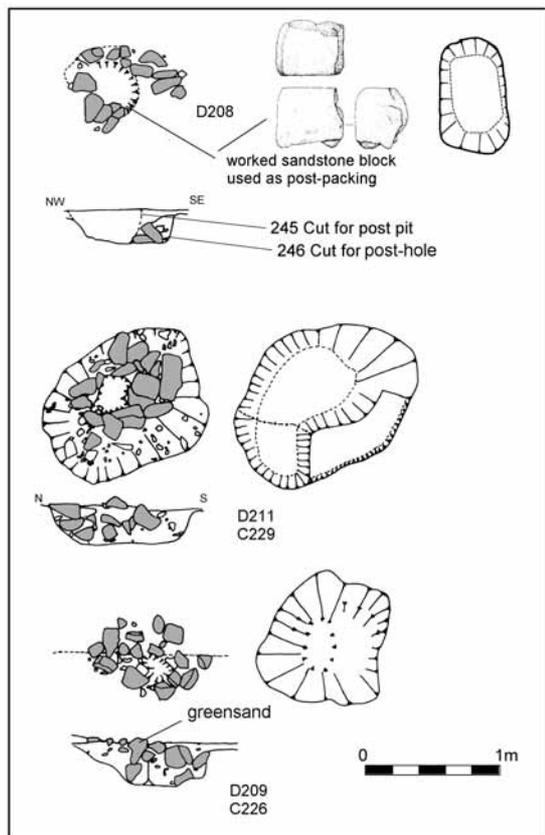
Fig. 138. Phase AH: plans and sections of three post-holes around the central pit.

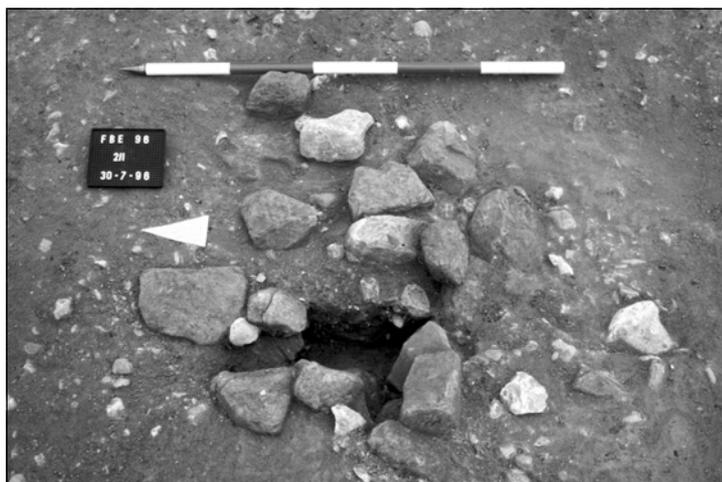
Fig. 139. Phase AH: 211 (one of three post-holes around the central pit).

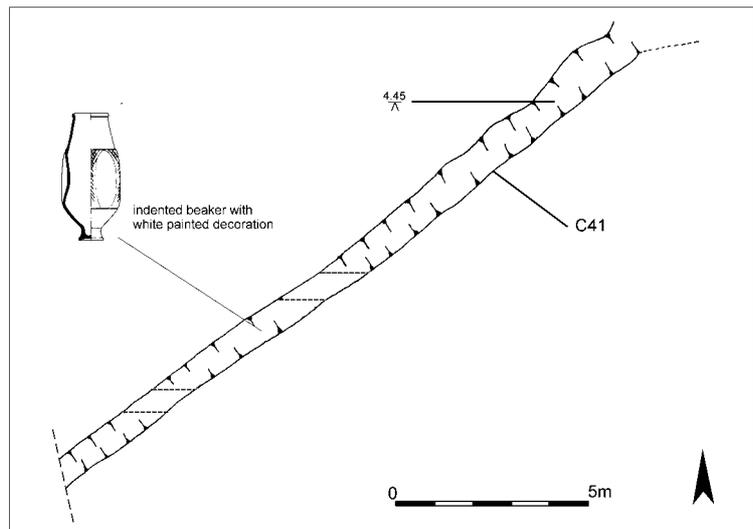
Fig. 141. Phase AH plan of the drain which cut through the foundation walls of Building 3.

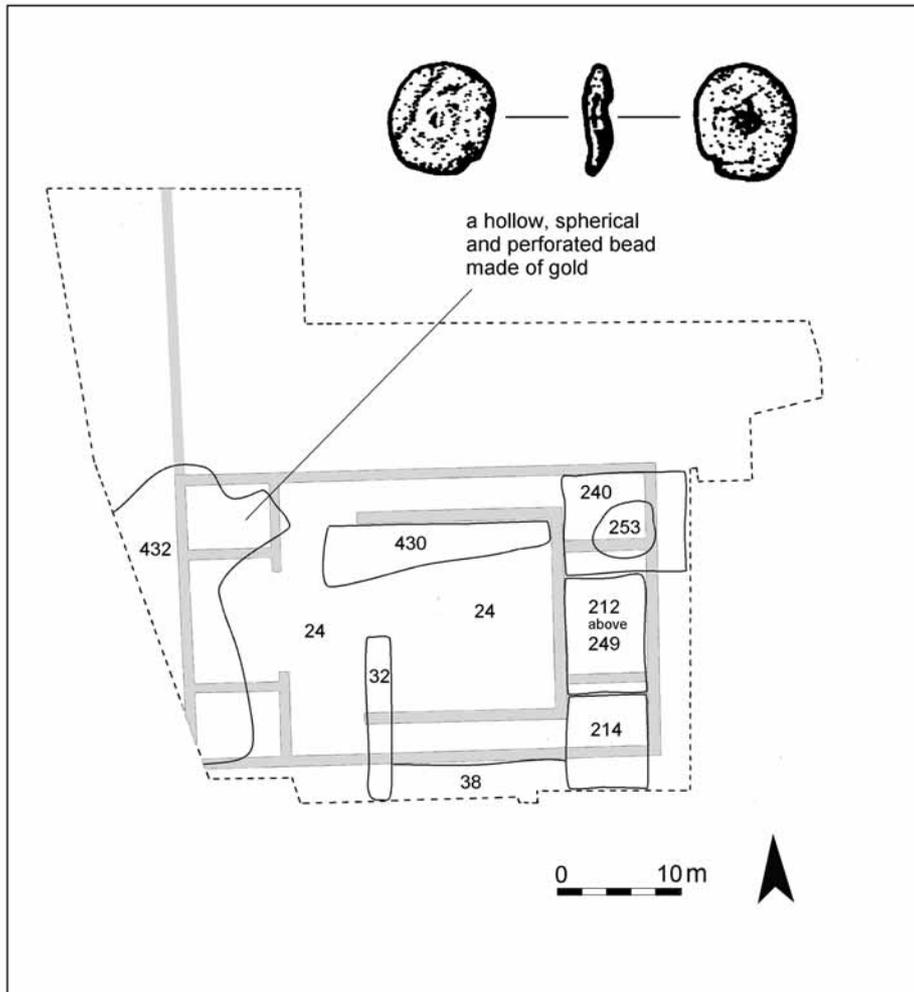
Fig. 143. Phase AI: general plan showing the extent of key deposits, some suggesting medieval activity.

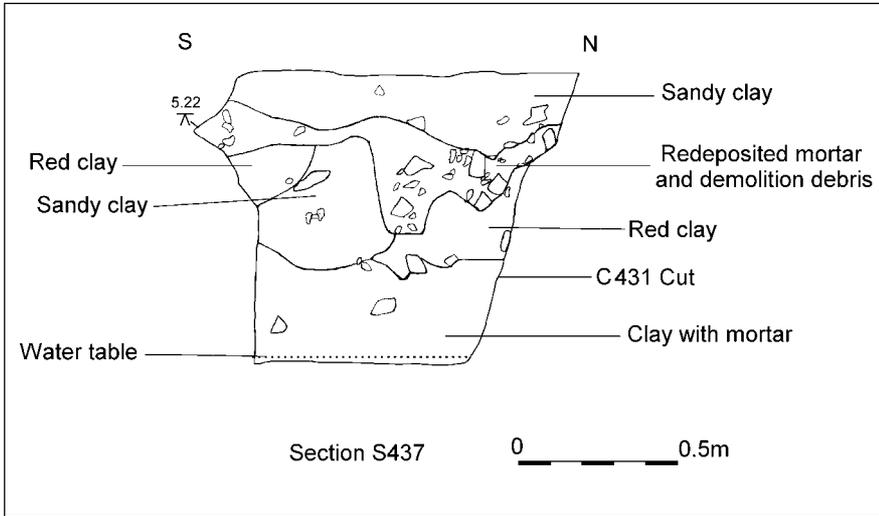
Fig. 144. Phase AJ: section across the robber trench 437.

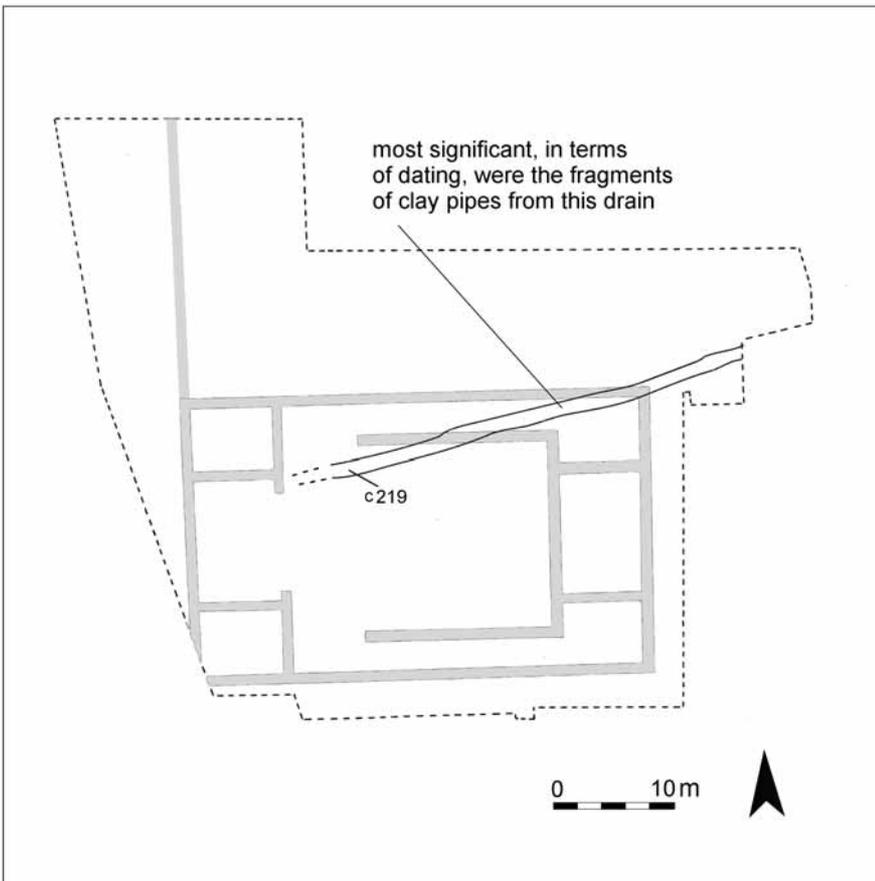
Fig. 146. Phase AK: general plan; the late medieval drain crosses the northern foundation walls of Building 3 on its way to the stream.

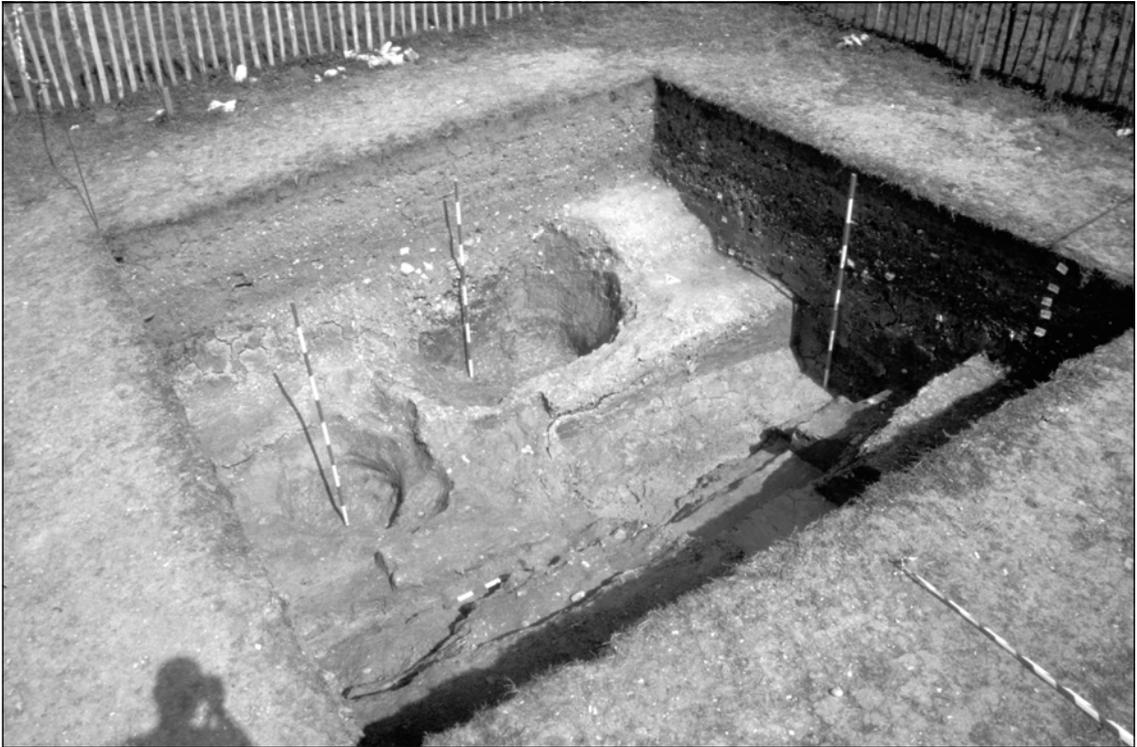
Fig. 156. Area B: from the south-west; the early ditch runs from right to left. The northern pit (Phase BF) is at the top.
