COUGHTON COURT,
WARWICKSHIRE,
AN ARCHAEOLOGICAL
WATCHING BRIEF,
2010

Project No. 2005

AN ARCHAEOLOGICAL WATCHING BRIEF

The National Trust

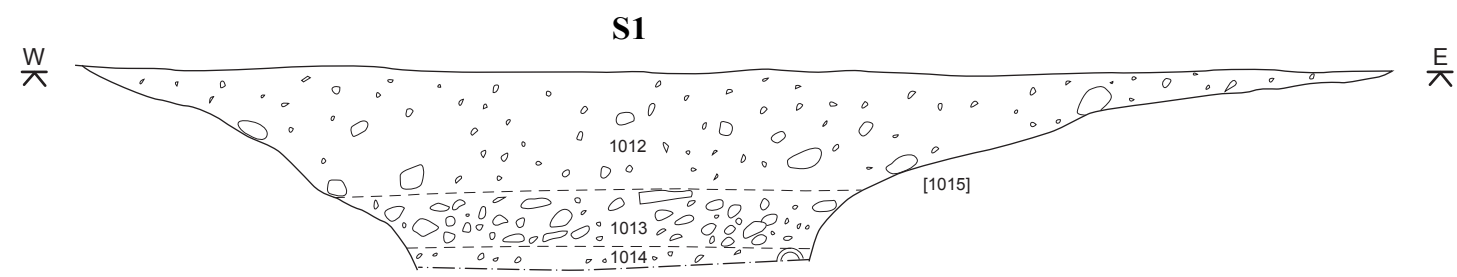
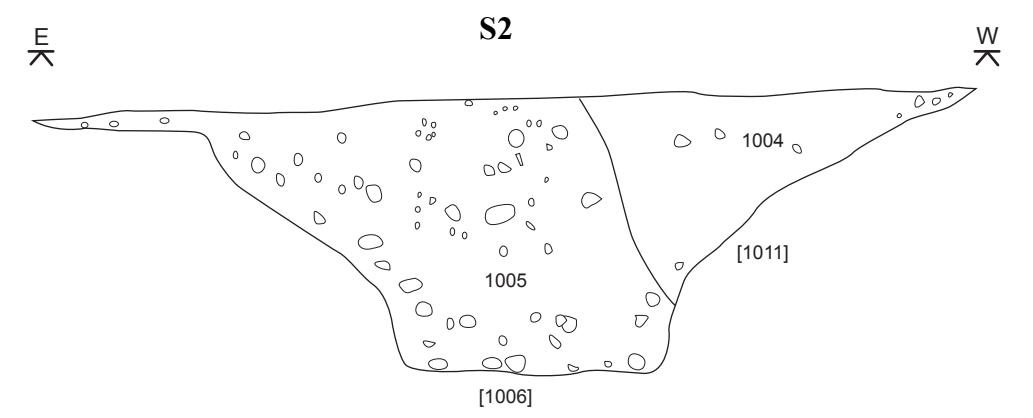
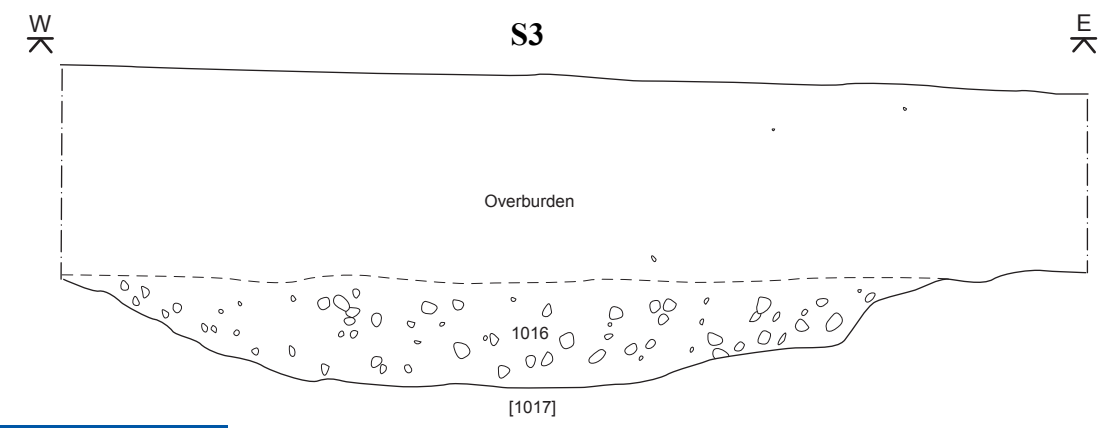
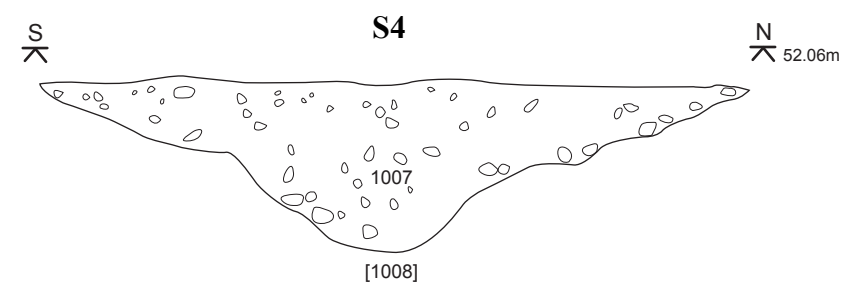
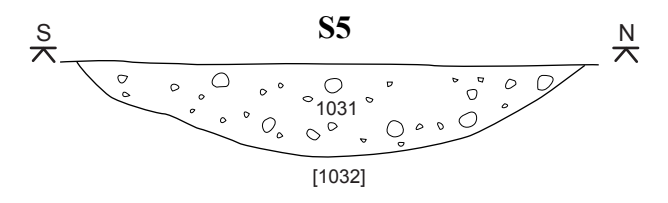
- 6.4 Ditch section 1015 (Fig. 3, S1, Plate 3) had a primary fill 1014 of pale orange-brown sandy silt 0.06m in depth and 1.30m in width, a secondary fill (1013) of mid blue-grey gravelly sandy clay, 0.20m in depth and 1.70m in width and a sealing fill (1012) of dark grey brown gravelly sandy silt with frequent small to large pebbles.

- 6.9 Ditch section 1006 (Fig. 3, S2, Plate 7), 3.10m wide and 0.92m deep and stepped, had a single fill of mid-brown pebbled silty sandy clay, 0.92m in depth by 1.84m wide. The ditch was later recut (1011) to the west by a v-shaped ditch 1.26m wide and 0.66m deep and had a single fill (1004) of mid-brown sandy silty clay with finds of building material.

- 6.10 Ditch section 1017 exposed the butt-end of the terminus of the ditch (Fig. 3, S3, Plate 6). The terminus survived to a depth of 0.38m and width of 2.96m and had a single fill (1016) of grey-brown pebbled sandy silty clay. A find of pottery was recovered from the fill. Although a ground plan of the terminus could not be obtained and a direct relationship could not be proved, it is most likely that the terminus was cut by east-west aligned connecting ditch 1008, 1035 (see below). The terminus was also truncated from above by a modern path on an east-west alignment.

- 6.12 Ditch termini 1010 and 1017 were linked in the early post-medieval period by a connecting ditch 1008, 1035 (Fig. 3, S4 Plates 4, 5), on an east-west alignment, that was exposed to a length of 10m. Ditch section 1008, bowl-shaped, 0.56m in depth and 2.34m in width, had a single fill (1007) of grey-brown pebbled sandy silty clay. One sherd of earlier post-medieval pottery was recovered. Ditch section 1035 was excavated to a length of 3m, a depth of 0.40m and width of 0.60m to find evidence of the relationship between connecting ditch 1008 and ditch terminal 1017, and a section plan of 1017 was recovered during excavation.

- 6.13 Boundary/ enclosure ditch 1010, 1015, 1022, 1025, 1028, was met by an east – west aligned ditch (1032) (Fig. 3, S5, Plate 9) towards the southern area of the site. The bowl-shaped ditch had a mid-grey sandy silty clay fill, 0.30m deep and 1.65m wide, which contained early post medieval building material and medieval pottery. No clear relationship was attained between these two features due to the high water table.

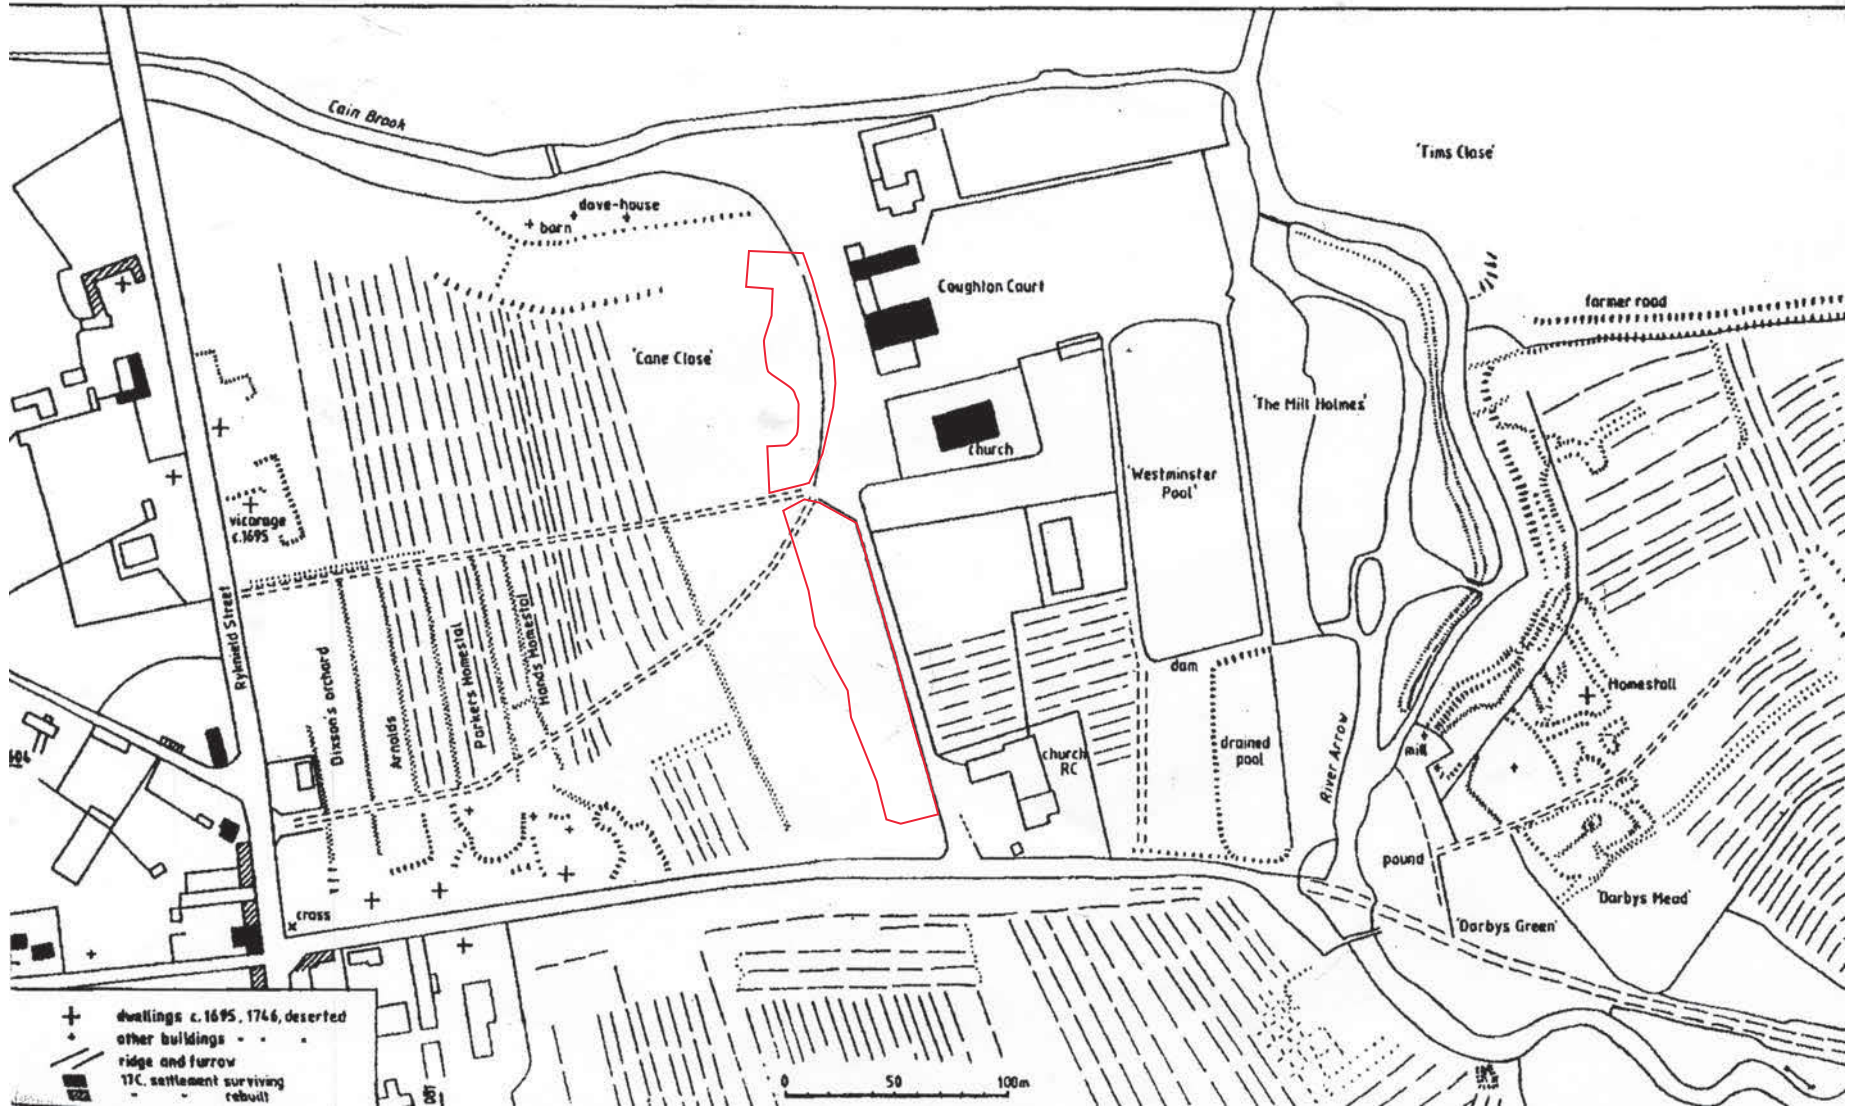
PRIMARY RECORD NO: WA
SITE: SHRUNKEN MEDIEVAL VILLAGE AND MILL S11
PARISH: COUGHTON
SCALE: 1:1000

Interpretation of the shrunken medieval village earthworks in the W
Park at Coughton. Surveyed by University of Birmingham with
Della Hooke, dated 7th March 1981
