**SHANNON'S MILL AND  
SURROUNDING AREA,  
WALSALL: POST-  
EXCAVATION  
ASSESSMENT AND  
RESEARCH DESIGN**

Project No. 1487

Norton and Proffitt Developments Ltd

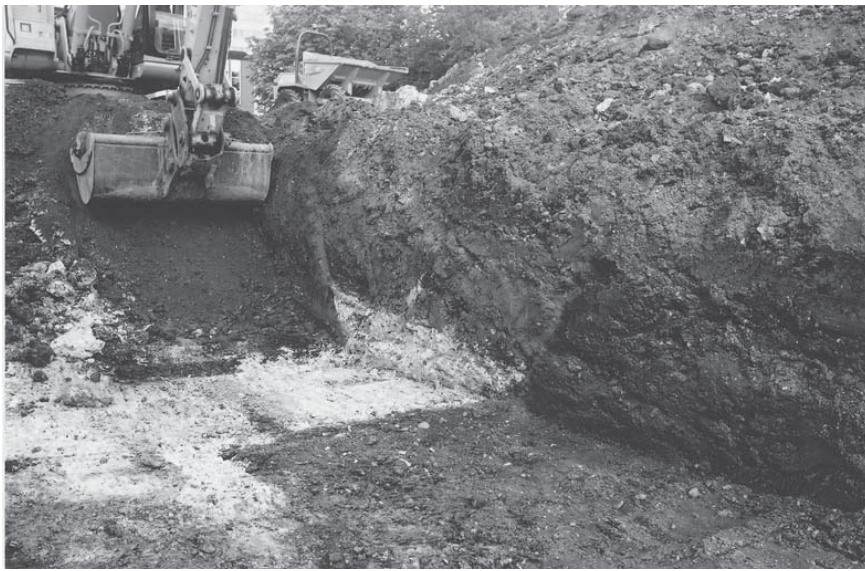
Plate 1 – Pit cut through layers of quarry backfill    Plate 2 – Layers of quarry backfill

The watching brief identified substantial depths of limestone quarry backfill. These comprised layers of red and orange sand, burnt lime, fragmented limestone and grey brown silt. Cutting these layers were large pits, which appeared to be simple lime-burning pits or clamp kilns, suggesting that the whole area was witness to ongoing industrial activity even as it was being backfilled.

The pits identified during the archaeological monitoring, cutting the layers of backfill, burnt lime and rubble, are likely to be simple lime-burning pits, or clamp kilns. These represent the simplest type of lime kiln. Up until the 19<sup>th</sup> century most lime kilns (in the county – do we need this?) were temporary structures set up to burn the lime on site. After they had served their purpose many were simply left to decay, whilst others were usually dismantled and rebuilt elsewhere. Sufficient rock (limestone or chalk) and fuel (usually charcoal) was loaded into the kiln and set alight. Broken limestone (calcium carbonate) was burned in the kiln at over 900c, which could take anything up to four days. The heating process drove off carbon dioxide from the limestone and quicklime (calcium oxide) was produced.

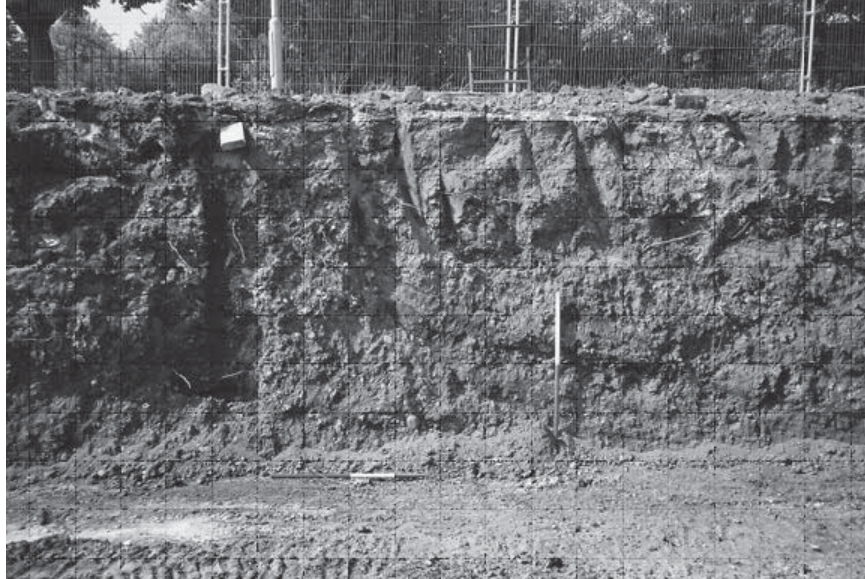
Plate 4 – Upper layers of quarry backfill

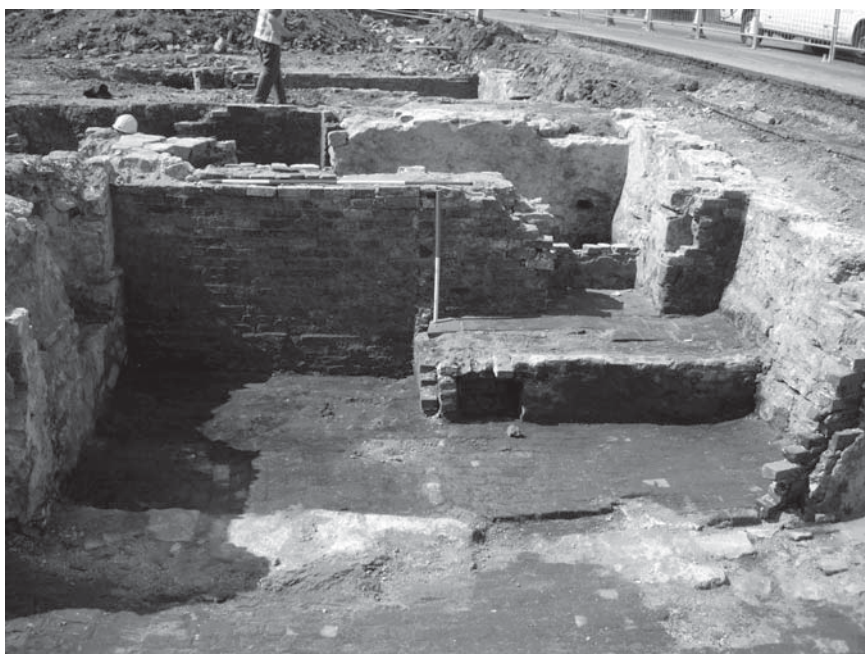
Plate 5 – Properties fronting Upper Rushall Street looking SE (**1016** in foreground)

Wall **1053** ran parallel to Upper Rushall Street and represented the front wall of the building. It appeared to be constructed in two phases, as the lower courses were wider than the upper ones. Wall **1018** to the southeast was constructed in a similar fashion and represented the back wall of the property. A recess was constructed within its build. These two walls were joined by the foundations of a third wall, **1016**. This wall represented the northern wall of the earliest cellar, and had a possible doorway within its build where the wall narrowed. Where wall 1016 narrowed, a return was present internal to the building (**1052**). A robbed out wall was present further to the south (**1046**) which may represent the continuation of this wall, and to the east of this were the remains of another possibly robbed out limestone wall **1026**.

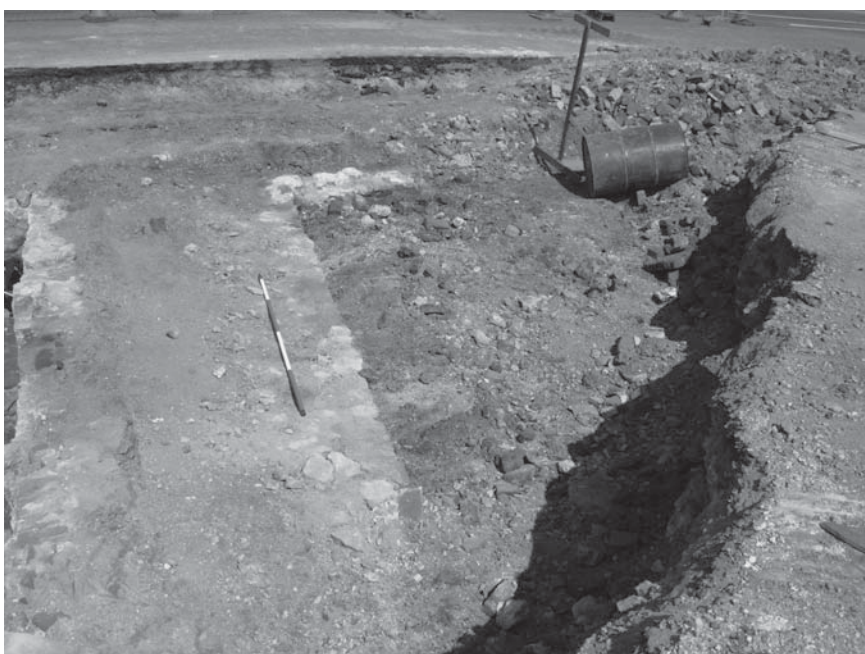
Part of another limestone wall was partially exposed further to the north, **1010**, though this was not excavated.

Plate 6 – Wall **1010** and unexcavated infill

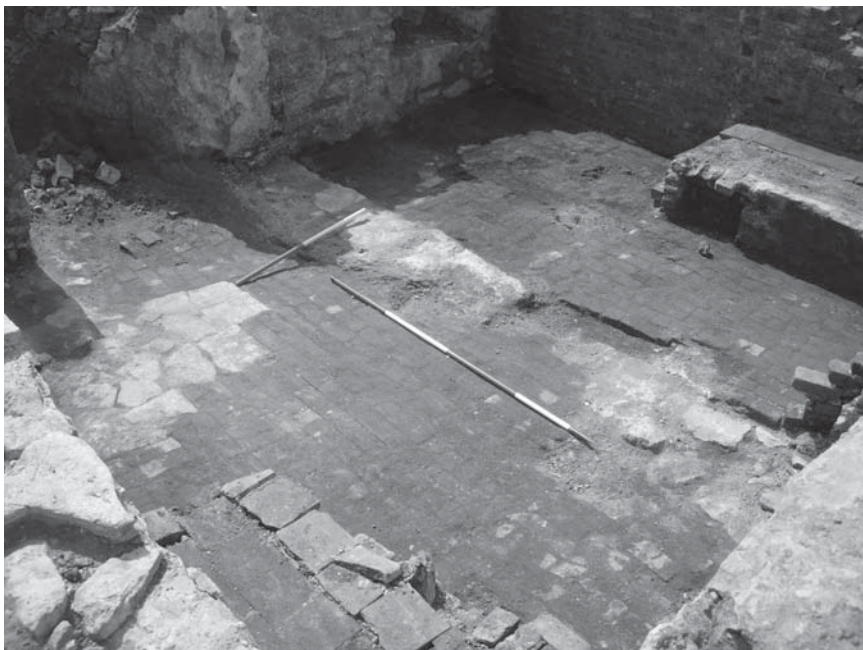
Wall **1016** was then truncated down to the ground level created by the levelling episode, and the cellar was extended to the north by the construction of wall **1011**. It is possible that internal wall **1022** relates to this phase of construction. Another limestone wall was identified to the east which also may relate to the expansion of the buildings (**1030**). At its base, **1030** was constructed by backfilled earth covered by plaster. Above the render limestone is visible, suggesting that this was possibly an original boundary wall which was reused as a cellar wall. Wall **1080** was a limestone rubble boundary wall that continued in places throughout the road corridor running to the east (**1080** Fig. 12).

Plate 7 – Wall **1016** and abutting floor surfaces

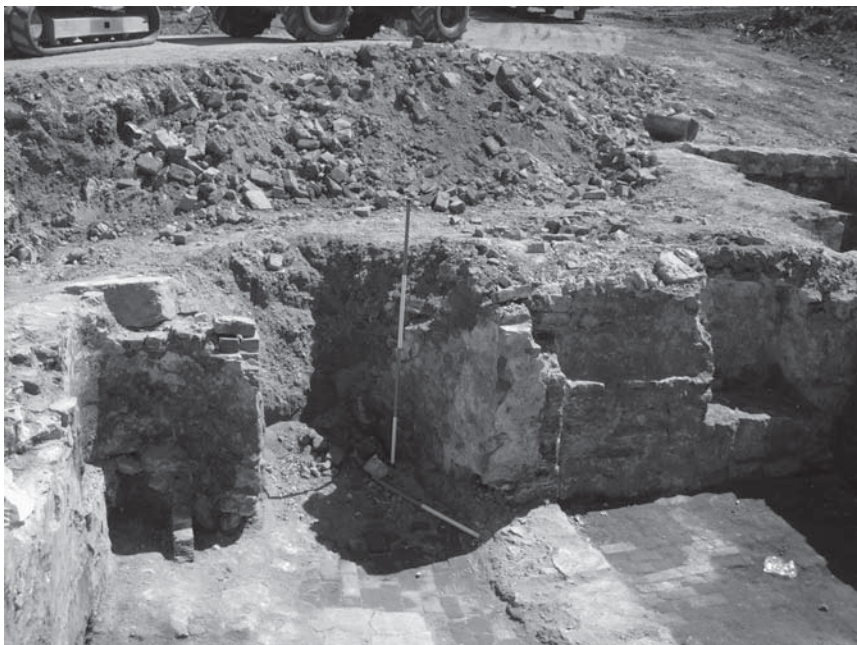
To the north of wall **1016**, a curved brick wall, **1012**, was constructed over the eastern extent of wall **1011**, and may be a holder for a boiler. A second curved brick wall **1015/1054** was built over the truncated remains of the corner of **1016** and **1018**. This wall was truncated by modern demolition to the east. The floor surface in this area overlay levelling layer **1049** and comprised a combination of brick and flagstone (**1014**). A shelf was present in the northern corner of this cellar constructed from bricks and quarry tiles (**1013**).

Plate 8 – Curving wall **1012** and **1015/1054**

1012	Wall	red brick, 9.5"x4.5"x3"	Curved wall. Possibly contained water heater
1013	Step	red bricks 6.5"x4.5"x3", red quarry tile 8.5"x8.5"x1.5"	Quarry tile and brick step 0.48m high. Filled with loose brick and mortar rubble.

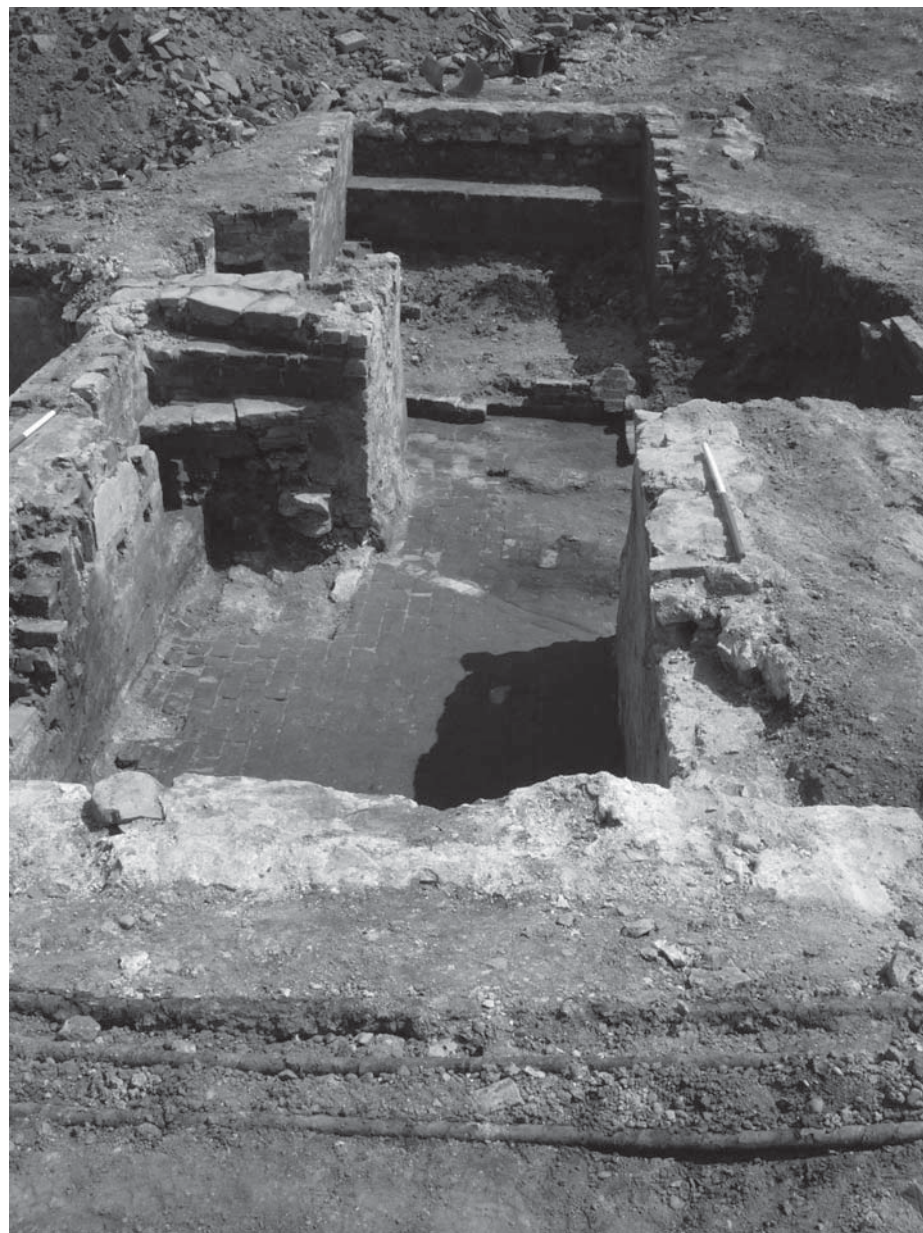
The cellaring was extended to the south by brick walls **1032**, **1029**, **1028**. A small internal wall was aligned between **1029** and **1032** (**1033**), and a large brick shelf or step

Plate 9 – Cellar extension with steps **1027**      Plate 10 – Cellar extension with steps **1027**

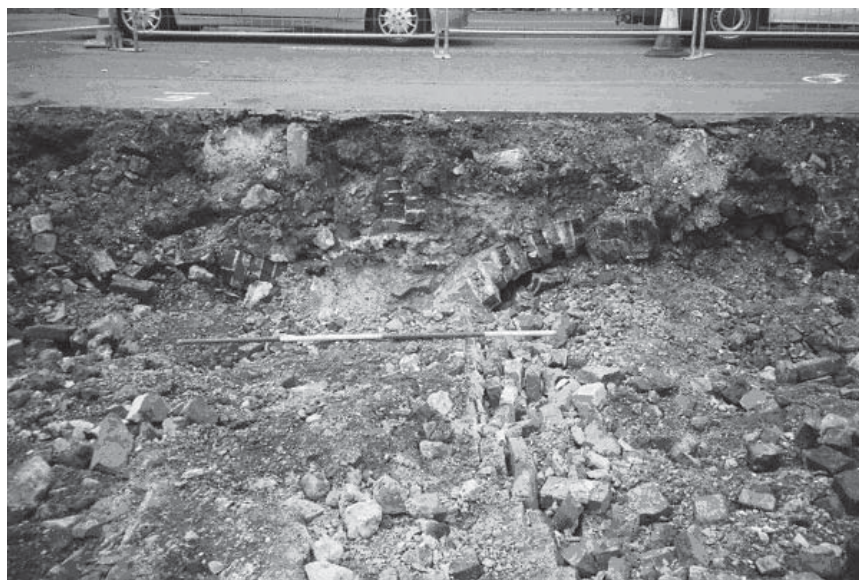
Plate 12 – Walls and part of vaulted roofs of later cellars along Upper Rushall Street

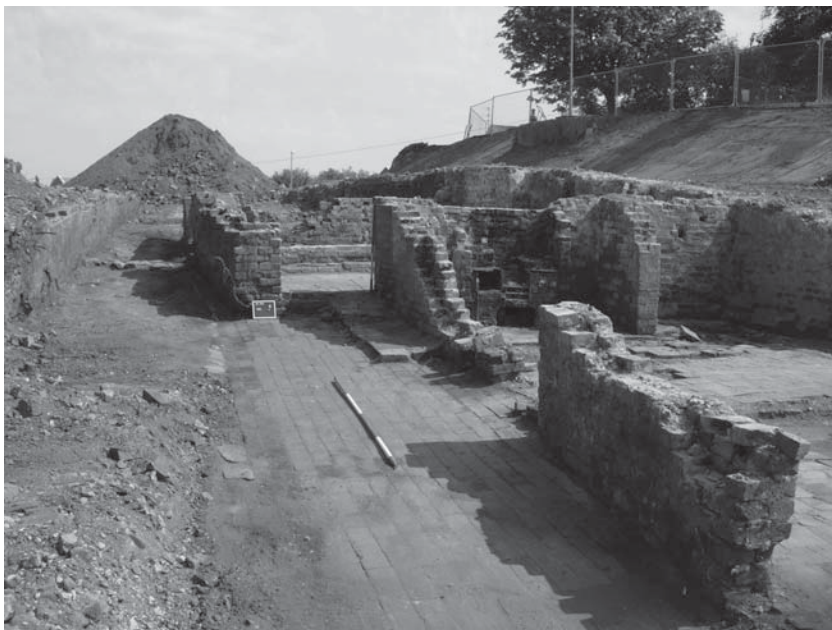
Plate 13 – Properties 2, 3 and 4 (looking S)

Property 2 was defined by walls **1076** which abutted boundary wall **1080**, wall **1079**, wall **1093**, and shared wall **1115** with Property 2. The floor comprised quarry tiles (**1077**). A partition wall, **1084**, was aligned parallel to the boundary wall, with a doorway roughly central to it. To the west of this wall, there was a brick floor **1124**. The foundations for a chimney were constructed within wall **1079**.

Property 4 was defined by walls **1127**, **1111**, **1091** and **1082**. It had a part brick, part quarry tile floor (**1089**), within which a structure constructed from bricks and quarry tiles that contained quantities of ash within it **1083**. A dividing wall **1126** contained a doorway and a burnt out fireplace, and a shelf or settle, and a brick buttress **1081** was constructed against the western wall.

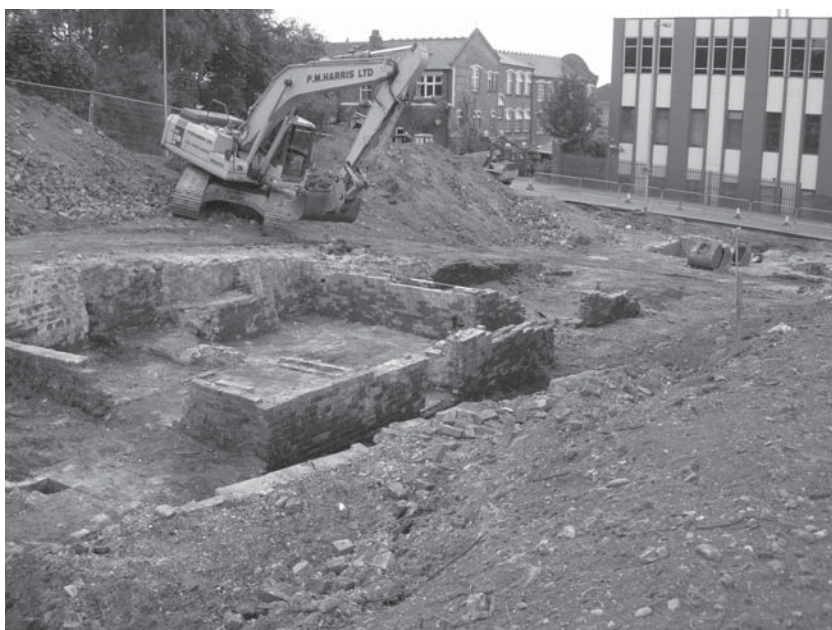
Plate 14 – Property 1 (looking E)

Property 1 (Fig. 12) was defined by brick walls **1114**, **1115** and **1116**. The northernmost wall had been demolished. The floor comprised quarry tiles (**1113**).

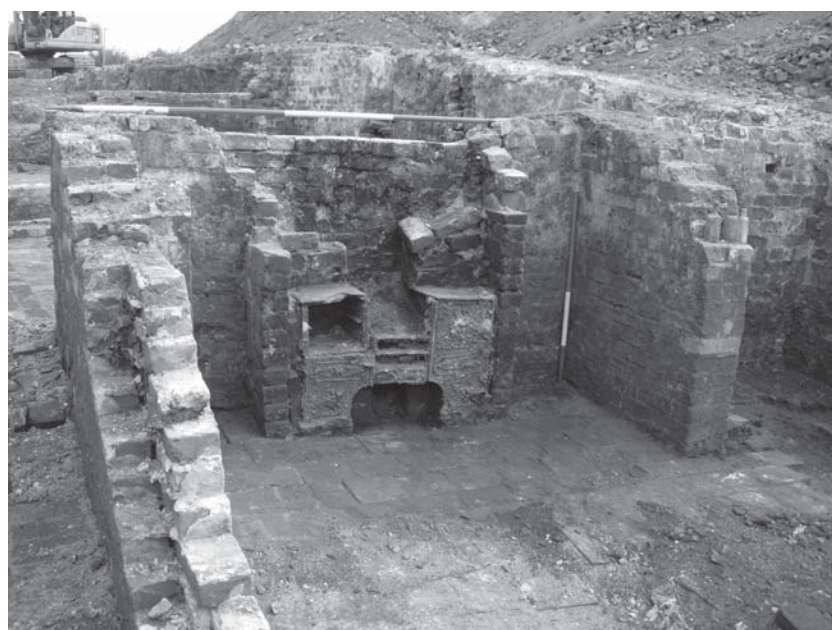
Plate 15 – Oven **1092** within wall **1088**
