31, Assembly Street, Leith

Investigation Report

*Archaeological Evaluation and Standing Building
Recording*

August 2014

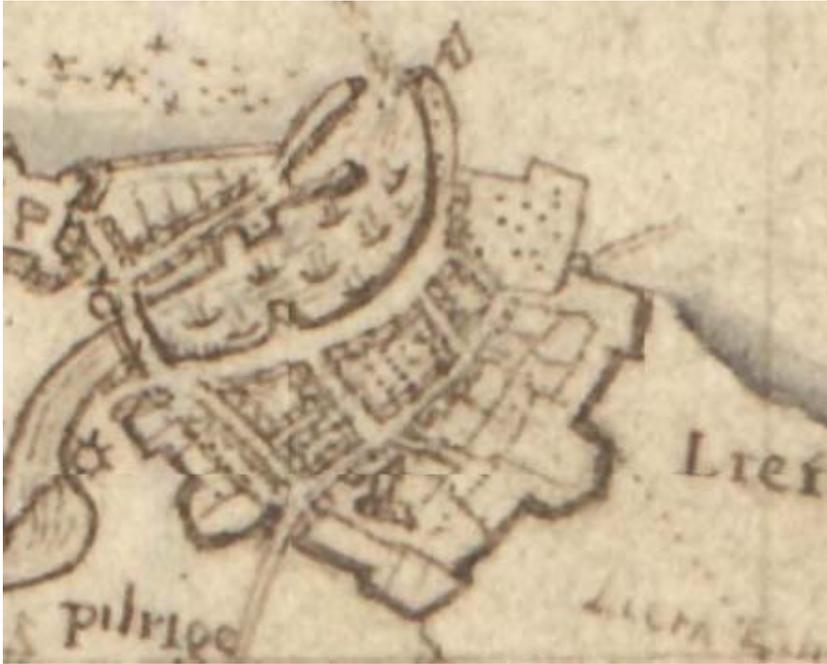
Adair, c.1682

The Adair Map of Midlothian (Manuscript 9) is the earliest map of Leith accessed online from the National Library of Scotland. It shows the town defences for the Port of Leith, and appears to show that outside the town walls there was little to no development, which was in keeping with the defensive requirements of the fortifications, with good sightlines across Leith Links being necessary for artillery.

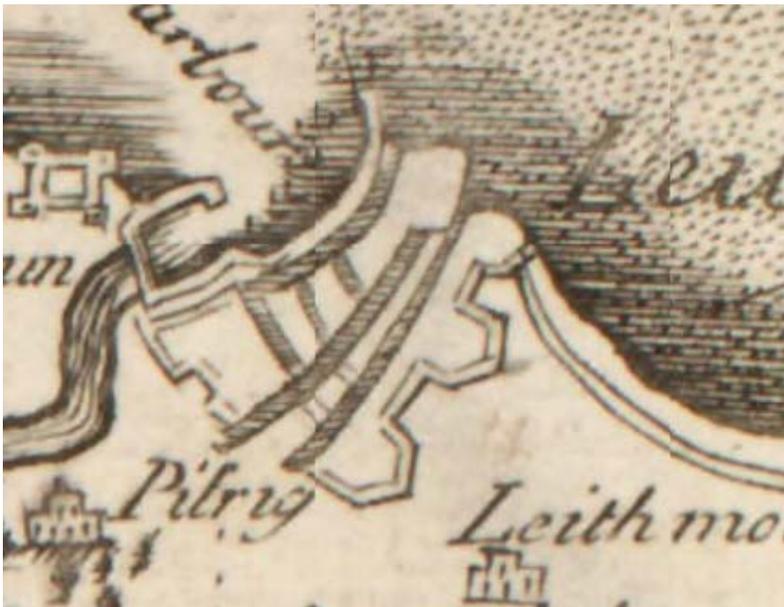
Adair (1735)

Little further is shown on the Adair map of 1735, some 50 years or so later. Development across Leith Links appears to be limited to a few grand houses, with the remaining ground of "Leith Moor" likely divided between the houses, but largely remaining as open space.

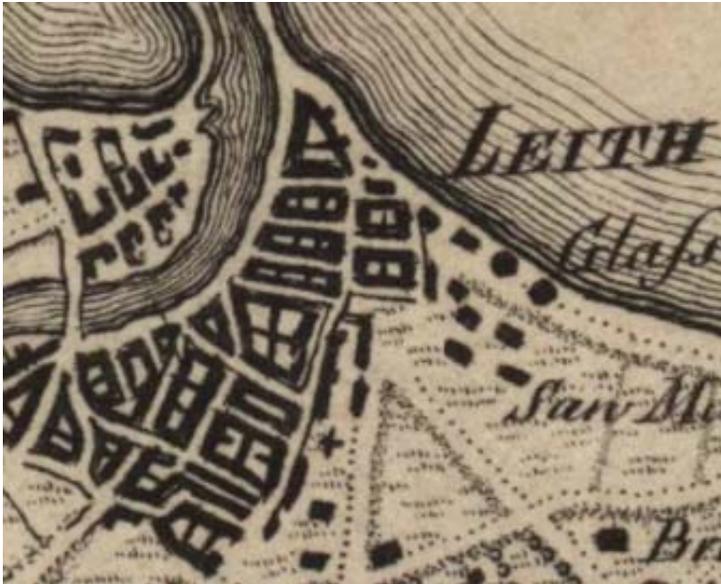
Laurie, 1766 – town walls not recorded

Laurie's 1766 map does not record the town wall, and shows development of the town to the east and south. Detail is filled in with regard to roads, as well as the main estate to the east of Leith (Hermitage) being situated within a planted landscape, accessed by roads radiating out from the town. It is likely that the defensive walls were removed preceding this map, giving a 30-year time period for their demolition. A sawmill is noted, and a glassworks; giving some indication of the increasing importance of manufacturing within an already busy port.

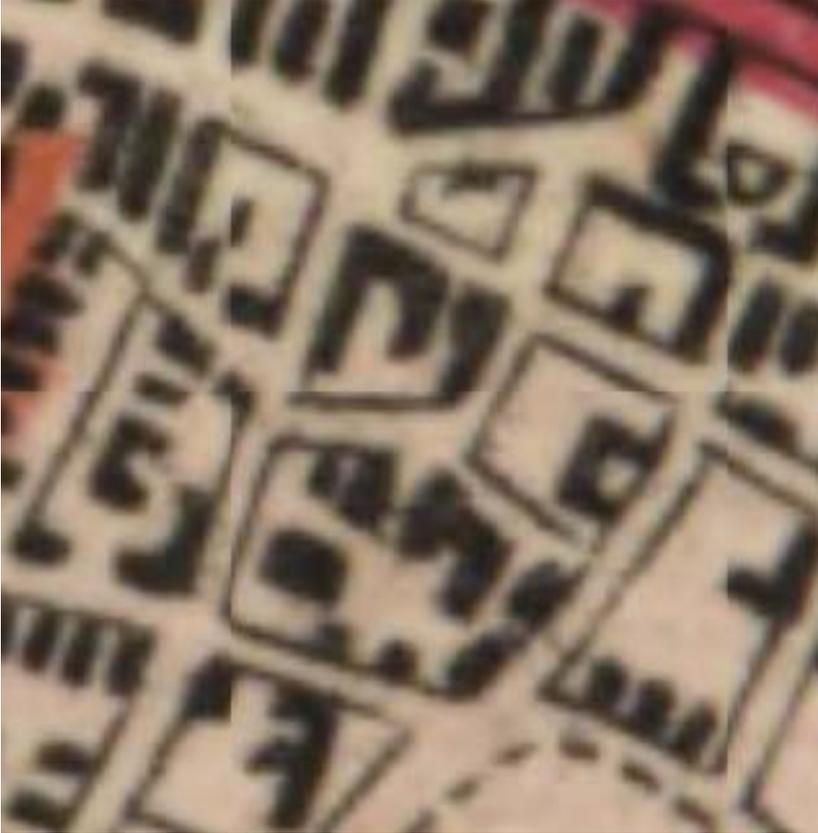
A map of the environs of Edinburgh. Kirkwood, Robert 1817, 1

The above Kirkwood map of Edinburgh, shows very poor detail for the area, due to its scale. However, it shows one significant feature, in that Assembly Street appears to curve at its south end and connect to Constitution Street. It is not clear if this was taken from an earlier survey, but does possibly show an earlier streetplan, which is significant when compared to the 1850 Robertson mapping (see below).

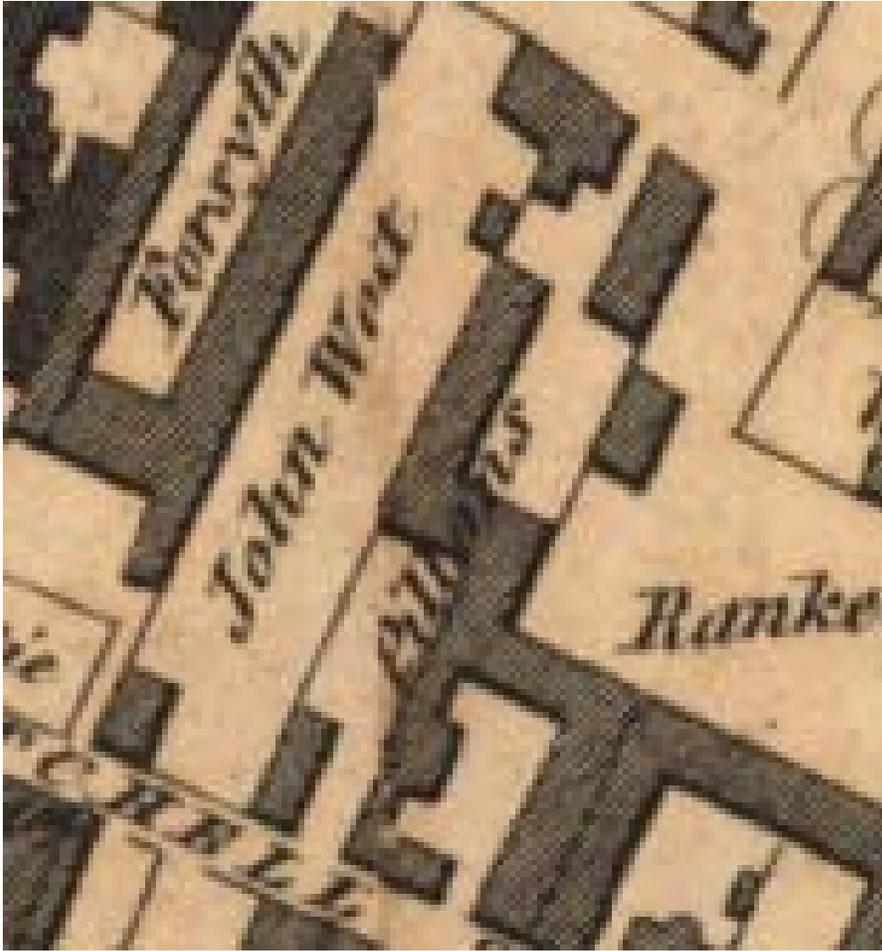
Kirkwood (1817, 2)

The more detailed 1817 Kirkwood map shows Assembly Street and the site considerably more developed than 12 years previously. Several buildings now occupy the plot, extending around the edges. In addition, ownership of the plots is also noted, although the legibility of the ownership of 31 Assembly Street is difficult to make out.

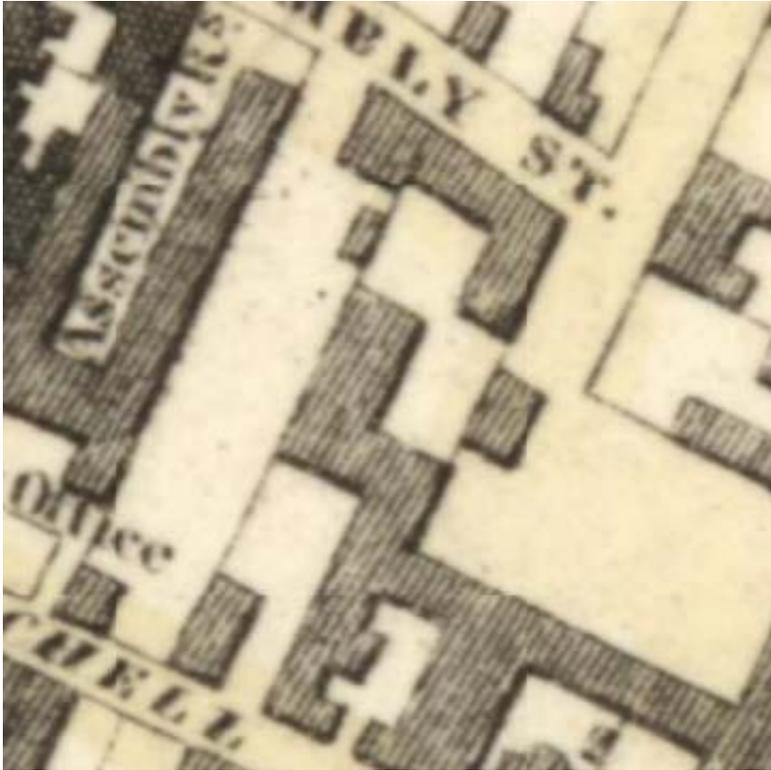
Lothian 1822

Further detail of the development of the buildings within the site is evident on the 1822 Lothian map. The frontage with Assembly Street is completely developed, and building units occupy much of the space within the plot, with only small clear areas providing access.

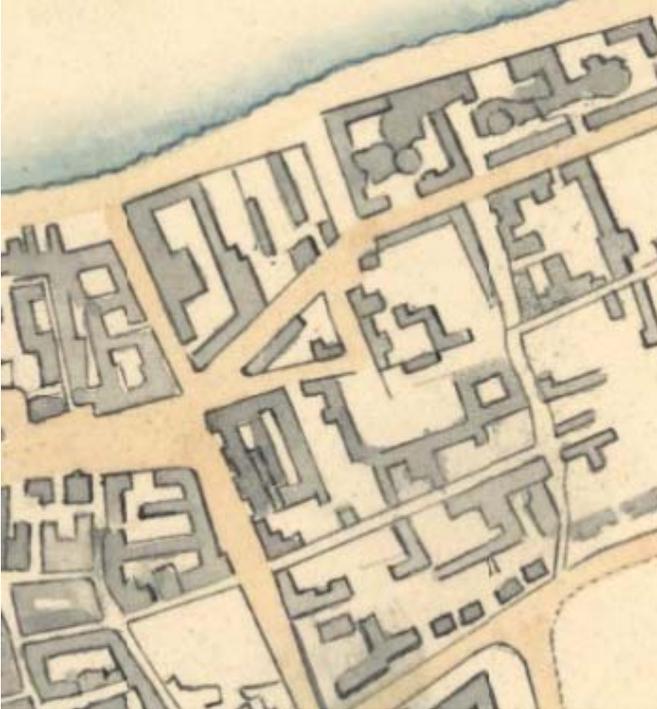
Crawford 1824

The Crawford map of 1824 is poor in definition, but shows the site as being a free-standing set of buildings with the plot to west containing no buildings. The lack of definition makes it problematic, and it is not considered to be a wholly reliable source of accurate information.

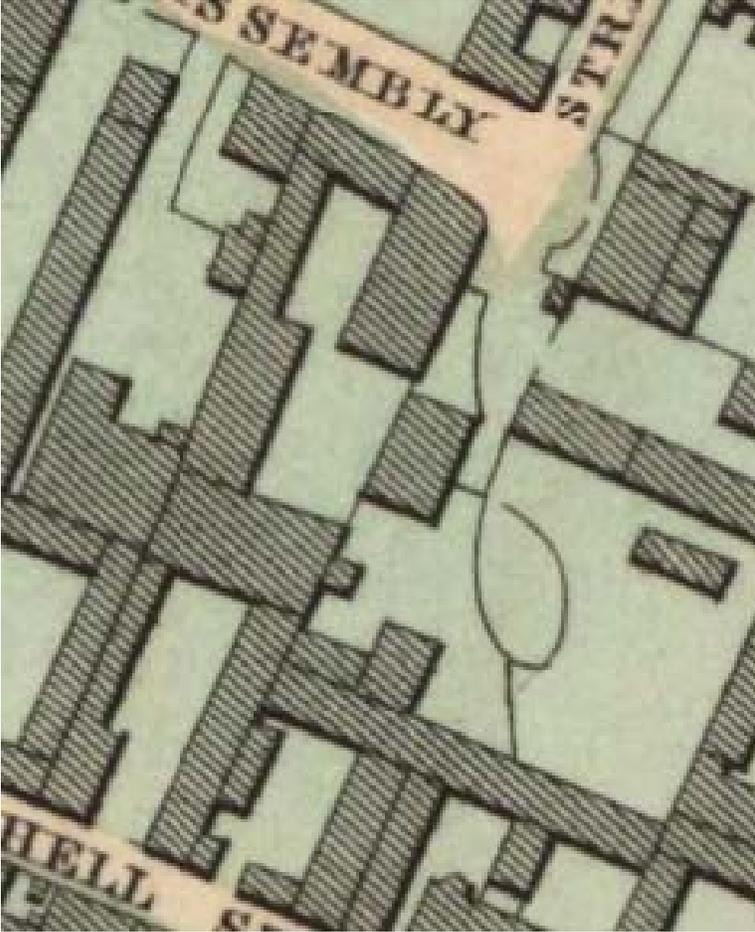
Lancefield 1851

The Lancefield map shows no further development within the site from the previous OS mapping.

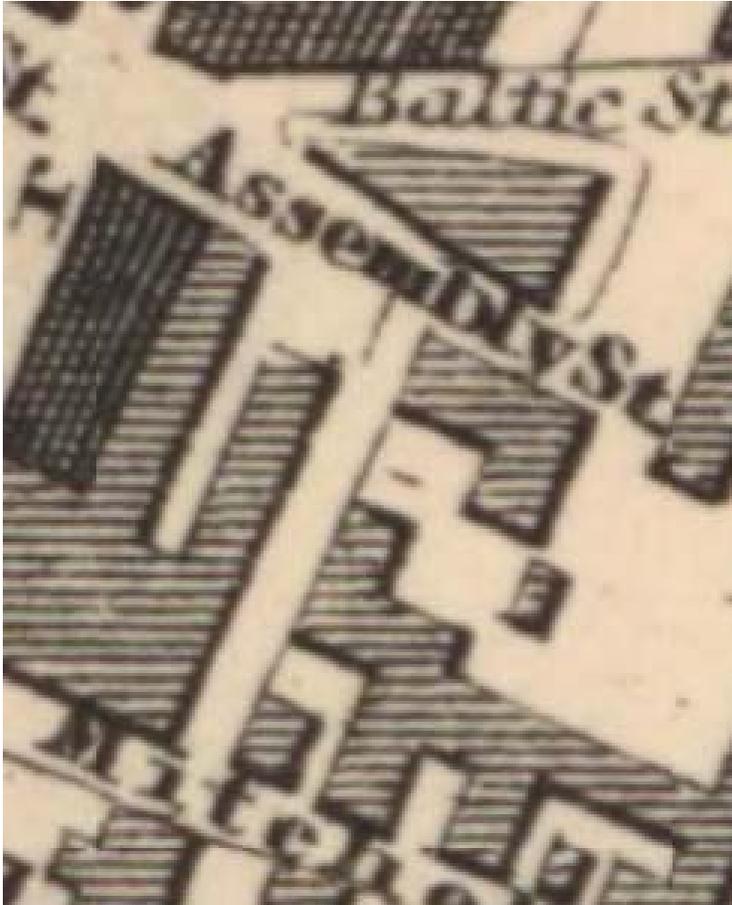
Johnson & Johnson 1856

Johnson and Johnson's 1856 map is of low definition and provides no further detail of the site.

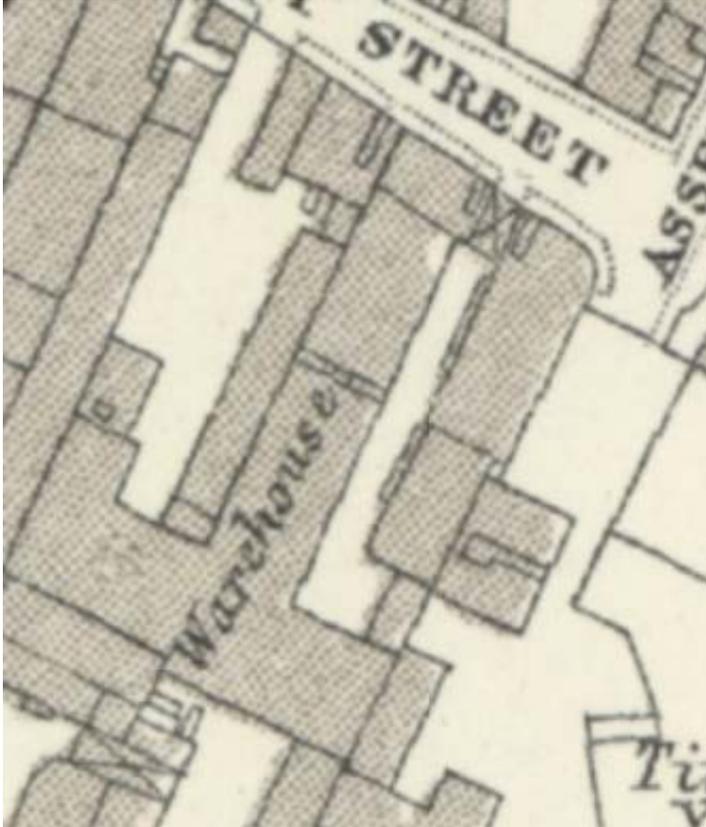
Bartolomew 1893

The Bartolomew map (1893) shows similar detail to the OS mapping of 20 years earlier, and adds the detail of the neighbouring property (to west) as a warehouse.

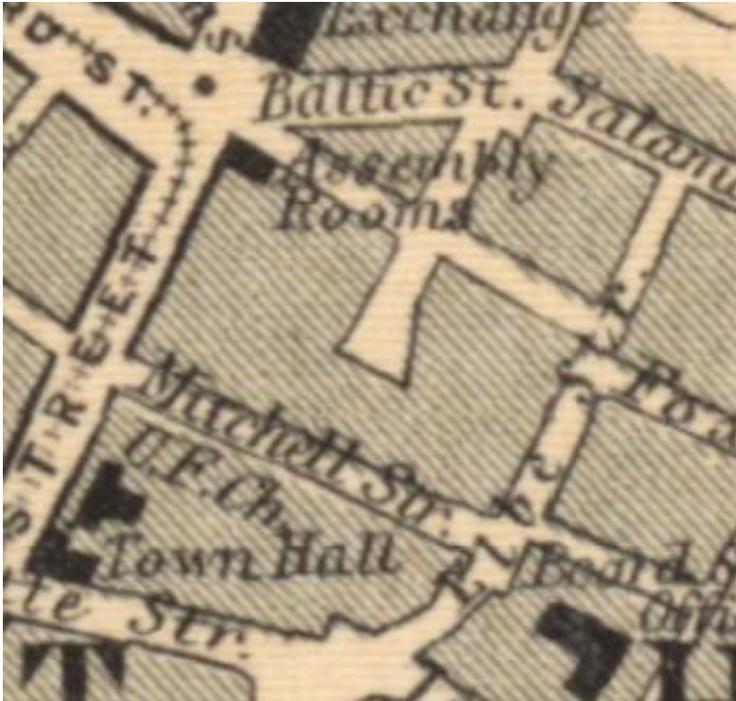
Bartolomew Survey Atlas 1912

The scale of the Bartolomew (1912) map is insufficient to show any detail of the site, showing it as completely built up. It is assumed that this is related to the scale of the mapping, rather than the level of development within the site.

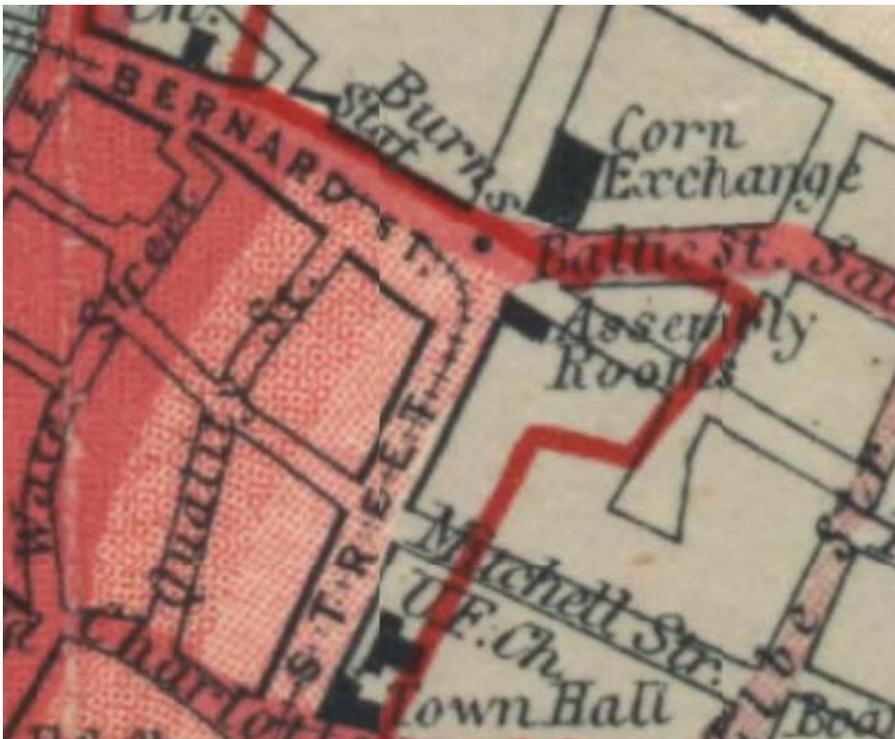
Bartolomew 1919 showing conjectural outline of old town walls

The Bartolomew 1919 appears to be a direct copy of the 1912 map, however that it overlays a conjectural plan of the town walls onto a poorly detailed map of Leith. In it, the town wall cuts through the site running almost parallel with the eastern boundary, before crossing the site westwards at about the halfway point through the plot. It is not clear from the drawing what sources are used for the information, however it does supply the only alternative layout of the town walls to Robertson's 1850 map.

There are some highly detailed maps of the site, even giving ownership information and the site's relation to the town walls. However, with regard to earlier defences, both Robertson's 1850 map and the later Bartolomew (1919) mapping, it is unclear exactly where the information came from for the town walls, or indeed how accurate it is. In the case of the Robertson mapping the relationships with roads outside the citadel do give some corroborative detail over the later Bartolomew map, which, given the poor quality and scale, is likely to be more conjectural.

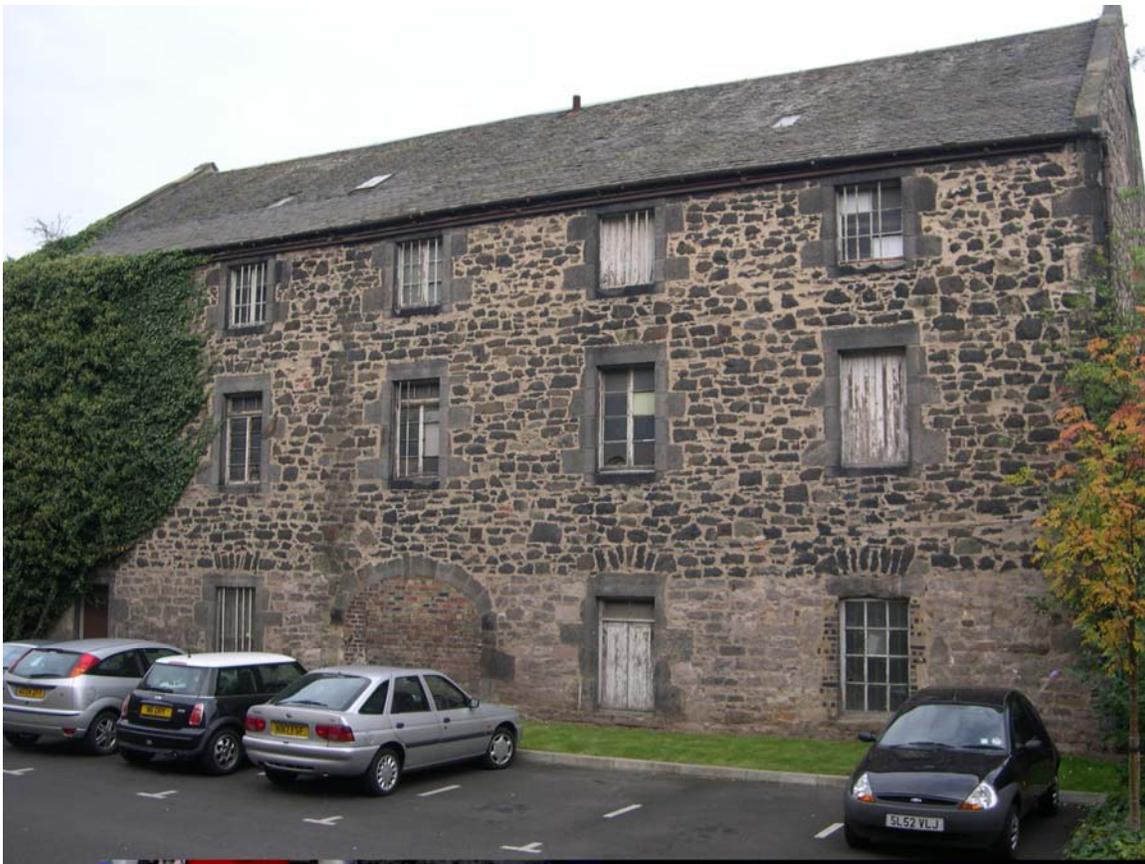
EX-16

The south elevation of the main building – likely the earliest part of the complex – was recorded. The main building was three storeys in height, with five openings on each level. The building was constructed in squared sandstone blocks to the lintels of the ground floor, and the first and second storey were constructed in whinstone rubble, built to course, below a slate roof with smooth, sandstone copes. Several tie-bars were noted on the elevation, slightly above the lintel heights of the ground and first floor openings. The ground floor windows all had tooled, quoined sandstone margins with relieving arches above, with the tooled, quoined sandstone openings also being carried through to the upper two stories. The western edge of the elevation was obscured with ivy, which covered the westernmost windows of the first and second stories.

The ground floor had a bricked-up, centrally placed arched opening, flanked by two sash-and-case windows. From east to west, the openings consisted of the following features: a 12-pane window, made to resemble sash and case, with a sandstone lintel and brick infill edging, implying modification of the original opening: possibly for widening. On the indoor side, bars were visible. The second window was also framed by tooled sandstone blocks; the lintel having relieving stonework above. The window was shuttered with a top light. The arched opening was 2.8m wide and 2.25m to apex, with sandstone blocks showing irregular quoining, radially set and tooled around the opening. The brickwork consisted of five stretcher courses to one bonding course, bonded with lime mortar. To west a sash-and-case window with external security bars was noted, and the westernmost opening contained a modern wooden door, possibly as blocking, as opposed to a functioning doorway.

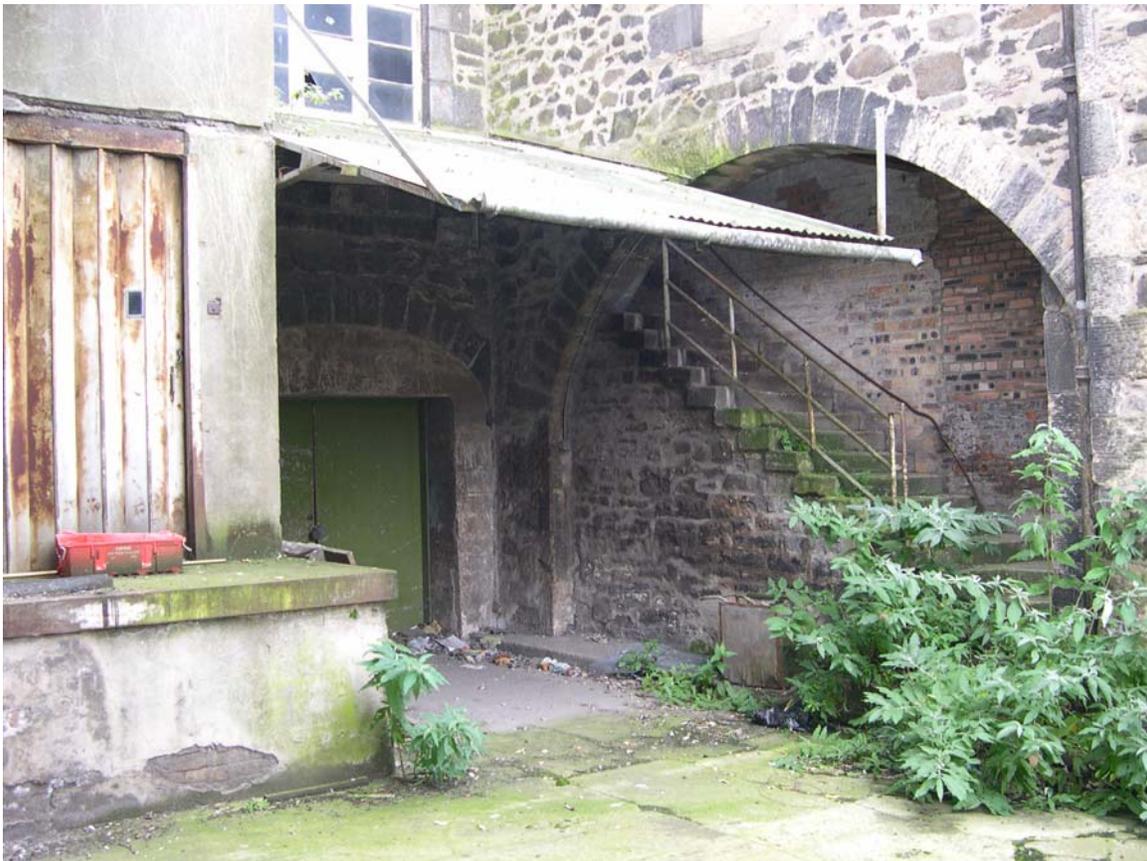
CY-06

The north elevation of the warehouse was visible from the courtyard area. This showed a raised loading bay, for access to a warehouse lift system that had been built onto the exterior of the building, to E of an arched entrance which mirrored the blocked entrance in the south elevation, and which was covered by a small suspended awning topped with corrugated iron. This entrance had been modified with brickwork around the arch, but retained the stonework of the original opening. The words "(T)homas S and Co LTD were faintly noticeable on the stonework of the arch. Above the arch at 1st and 2nd floor levels, modifications to the original windows had been carried out, with sandstone block infilling below concrete sills. To W of the entrance, a flight of stone steps afforded access to the 1st floor. This was recessed into the adjacent building and covered with an arch.

To E of the lift shaft, blocked windows were noted on the ground and 1st floor levels. The 1st floor window was partially obscured by an awning which covered the raised loading

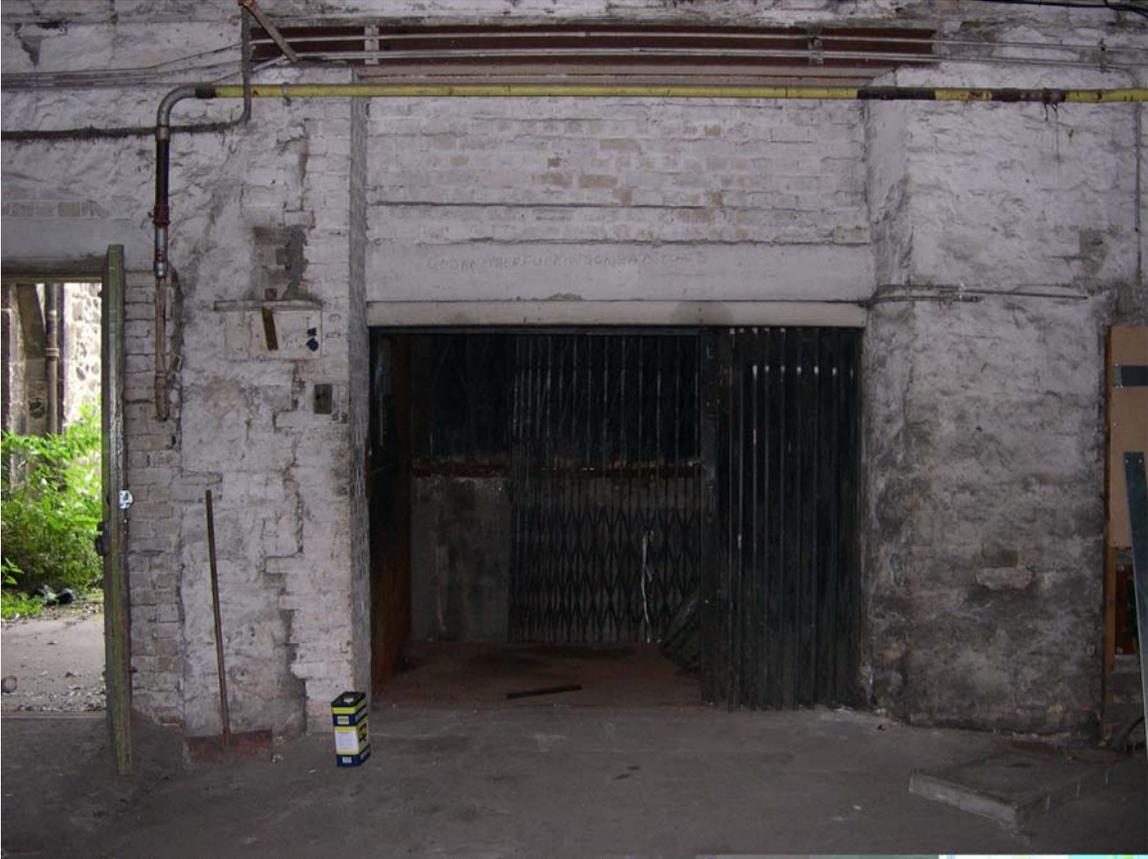
L1-01

Five openings were noted in the north internal elevation, in a similar arrangement to that noted in the south external elevation. Two windows were situated to W of a central, arched opening. The windows were blocked with a single thickness of brick and had a sill set at 0.9m high with an infill of small undressed stone below. The central arched doorway had been modified with brick blocking to infill the arch and to create a smaller, rectangular opening, 2.2m wide and 2.2m high. To E, a large service lift had been installed, presumably removing a window similar to the others on this elevation (photo L1-01). A third infilled window was noted to the east of the lift shaft. A small opening was also noted between the central doorway and the western central window. This was 0.8m wide, and 1.2m high, and was infilled with stone.

The W elevation contained no openings or alterations.

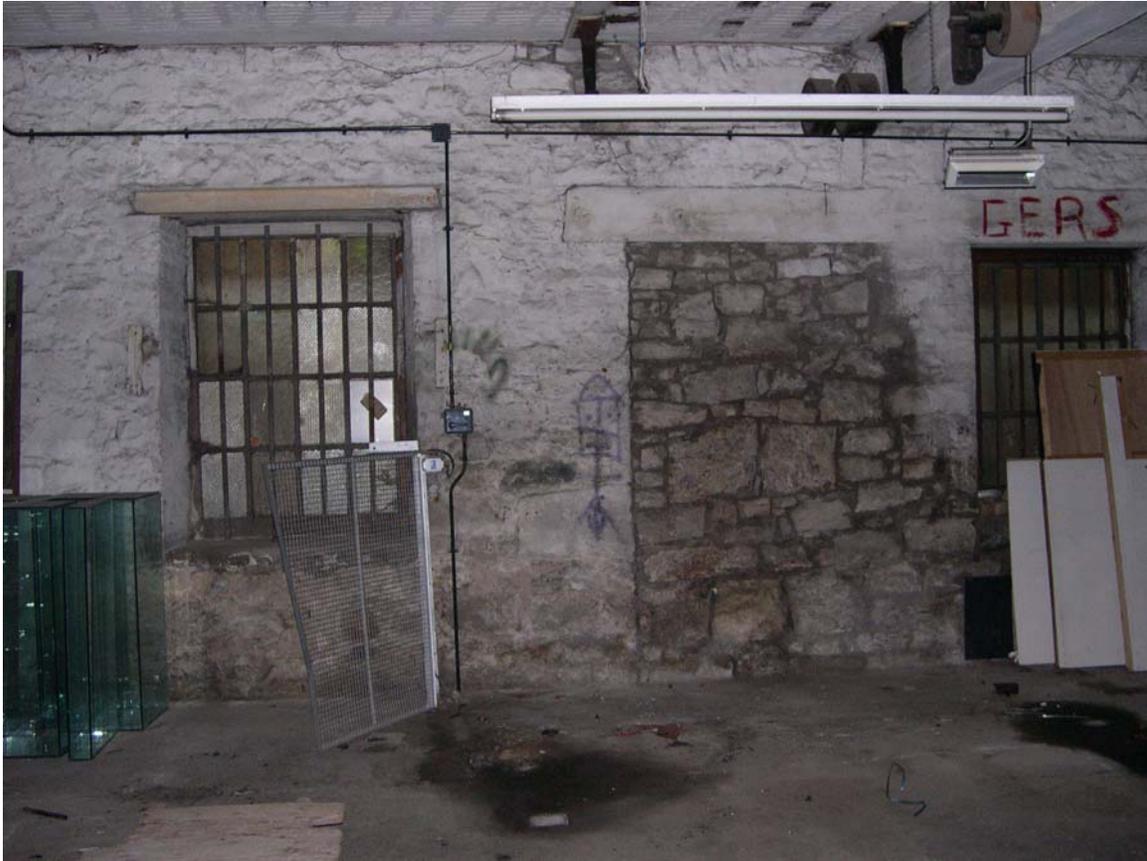
L1-03

The E elevation showed a roughly centrally positioned opening, approximately 1.5m wide, below a wooden lintel. It consisted of a doorway (blocked with squared rubble) with a barred adjoining window (photo L1-03) to S, with a further window to N. Both windows were of similar dimensions (1.0m by 0.8m), were barred vertically and horizontally, and contained frosted glass.

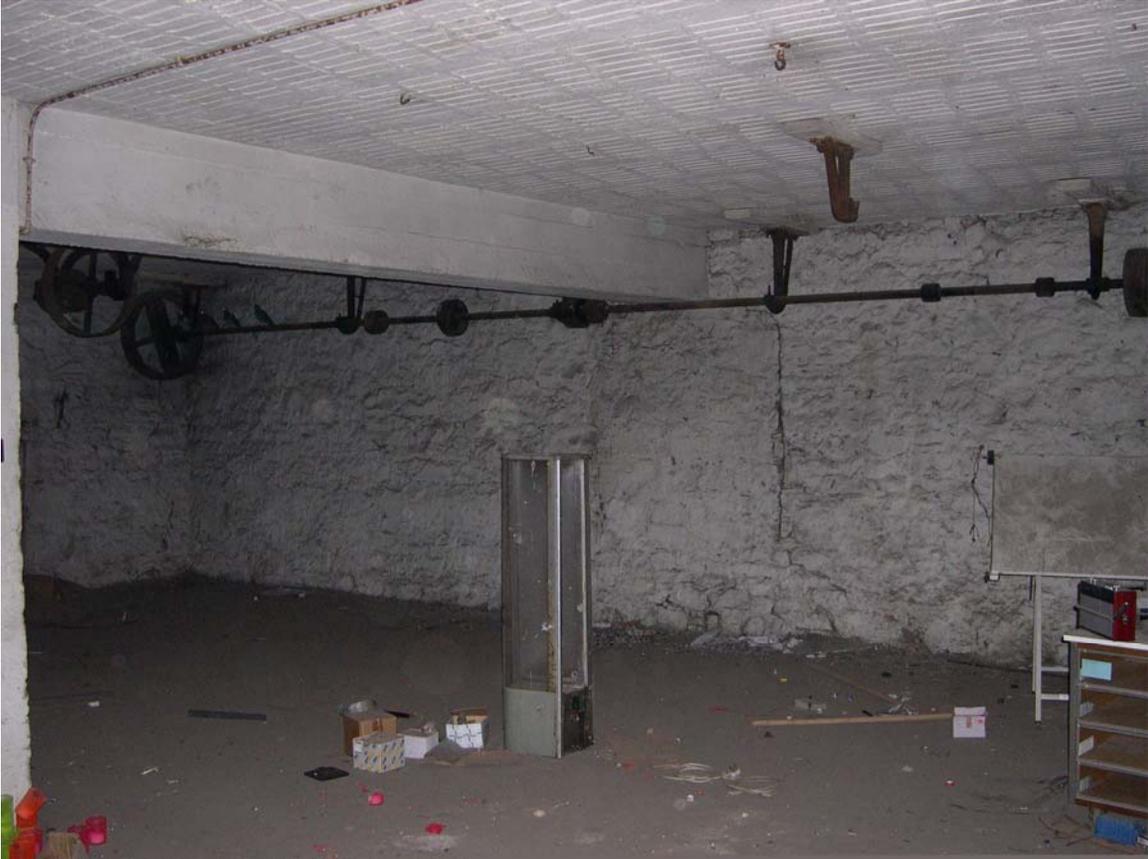
L2-07

The W elevation contained one possible blocked-in opening, covered by whitewash and splayed at the base (photo L2-07).

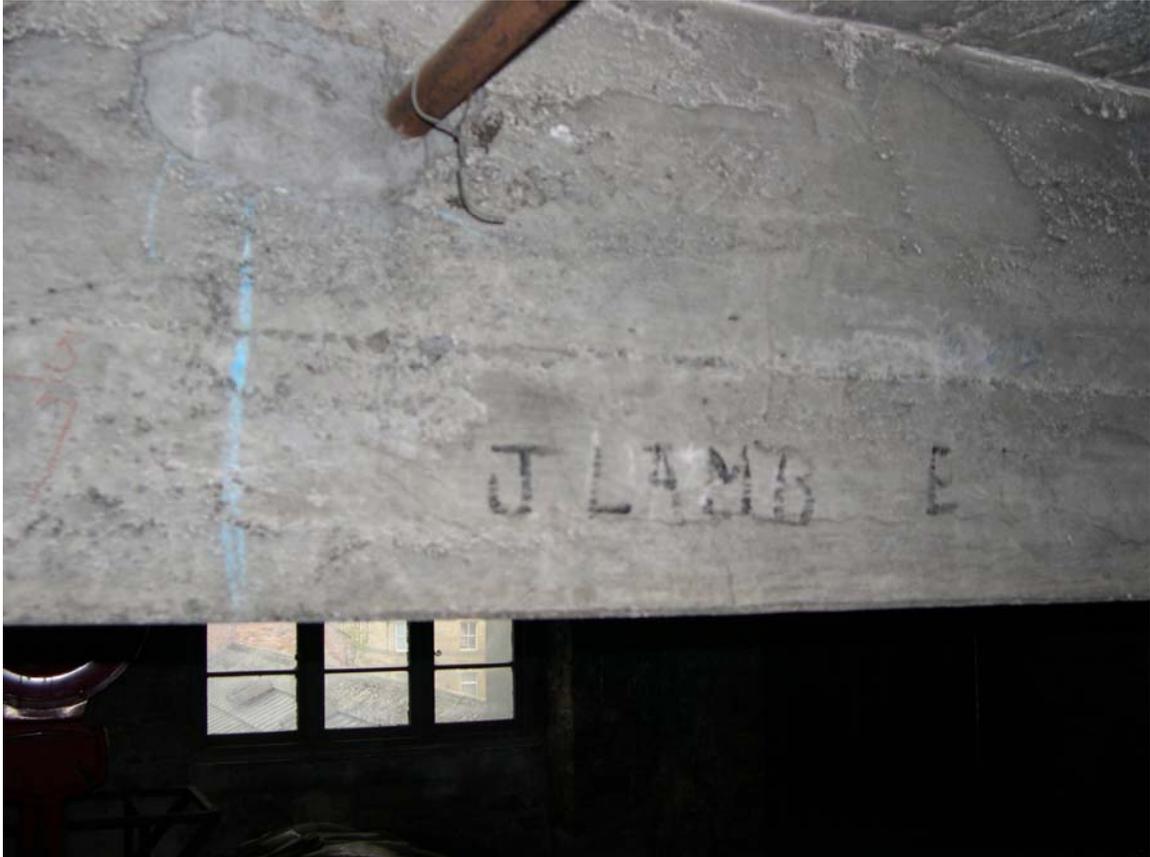
L3-03

Historic graffiti had been drawn on a central concrete spine beam, running E-W across the centre of the room (photo L3-03), which consisted of initials and names, such as J. Lamb.

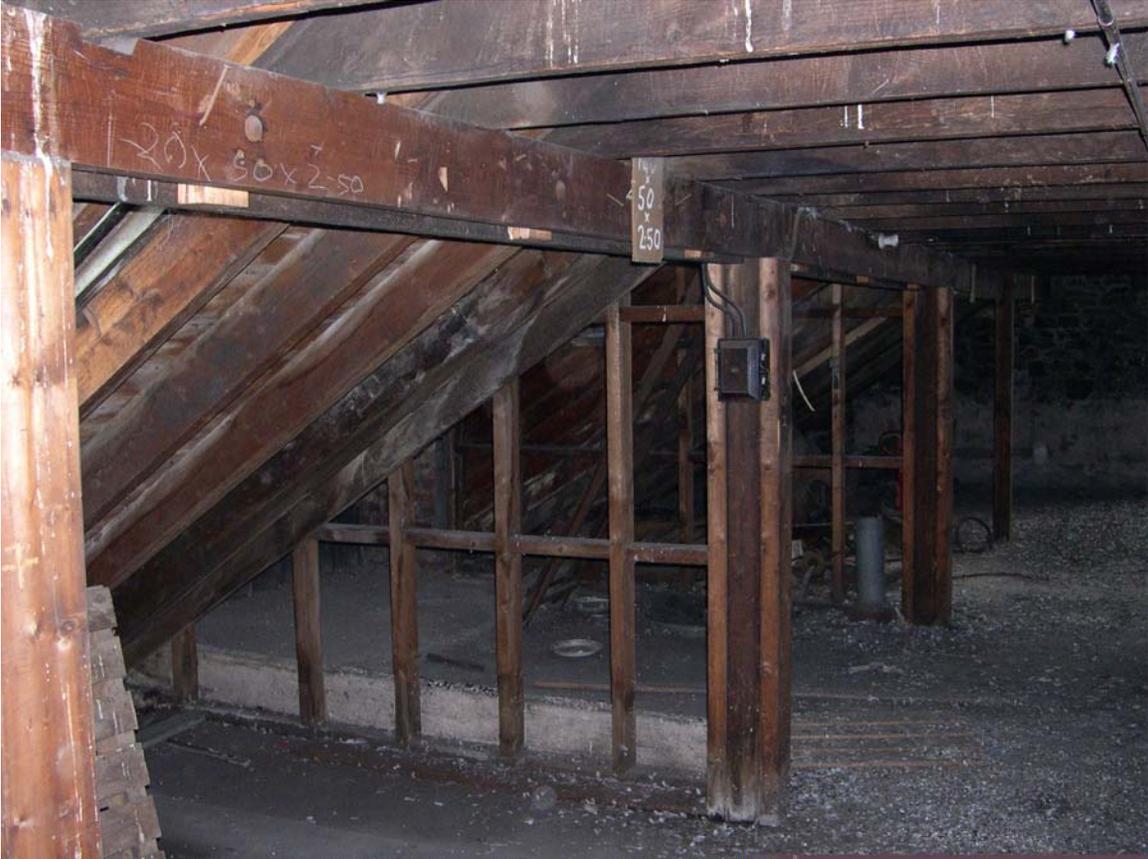
L4-10

The attic was lit by windows in the gable ends (E and W) and by rooflights. The lift rose to this level, and was accessed via a ramp constructed into the concrete floor. To incorporate the lift shaft, the roof structure had been modified (photo L4-10) to allow access.

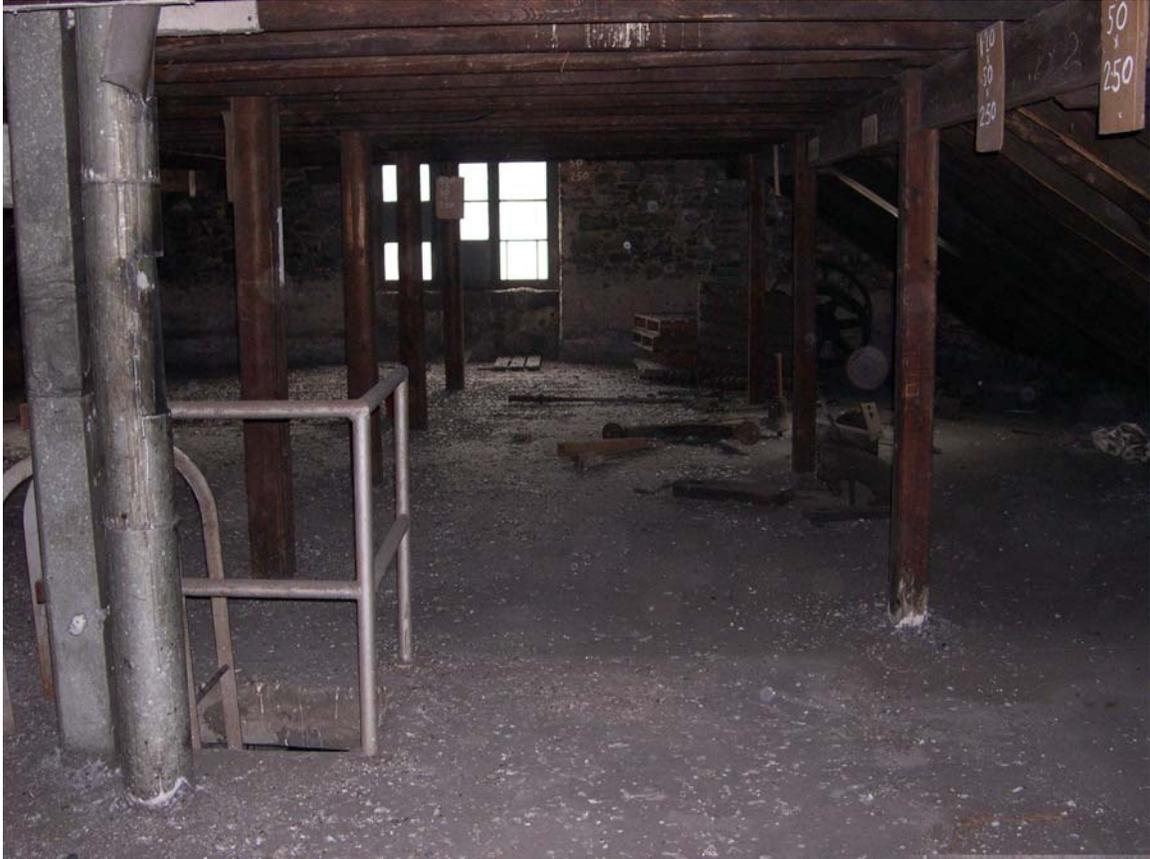
L4-03

The roof structure was simply constructed of a trussed roof with collar ties and supporting queen and king posts, with the trusses at approximately 60cm spacing (photo L4-10). The eaves were at a level with the attic floor, rising to a central, E-W running apex.

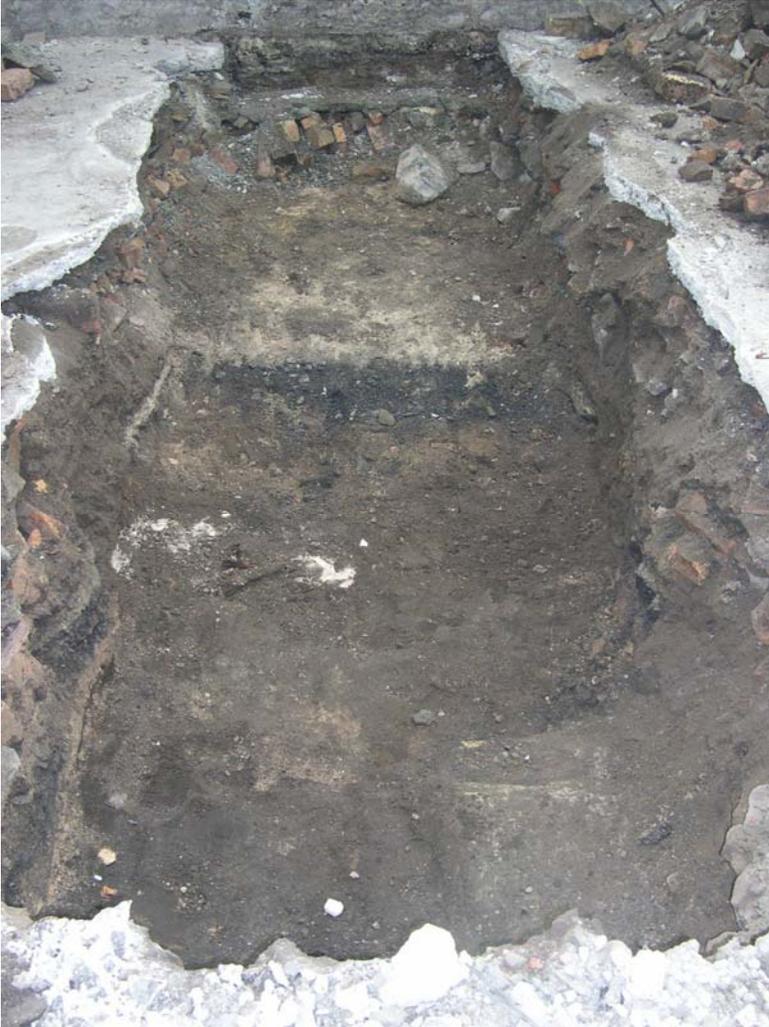
T1-1

A substantial layer of bottoming material (102) lay below the latest concrete flooring (101), which was laid directly onto an earlier concrete floor surface (103). This had been placed on a layer of brick (104), possibly laid, rather than dumped, which was approximately 300mm deep. Below this, several layers of mixed sandy, clinker and mortar rubble material (108-115) lay to either side of a longitudinal cut (107), 52cm wide, 45+cm deep, running N-S, which contained a thin timber running within the cut, which appeared to have been encased in an ashy material (106). It is possible that the timber was partially painted, however preservation was poor and it was poorly defined. Cut 107 was observed on the northern side of the trench, although it was not apparent in the southern section.

The trench was excavated on its western half to 1.2m, as space for machining was limited. At 1200mm below ground surface, a large stone pad (116) was partially exposed. This appeared to be rectangular in shape, although only two sides were visible within the trench. It was set into context 111, and was possibly a post pad.

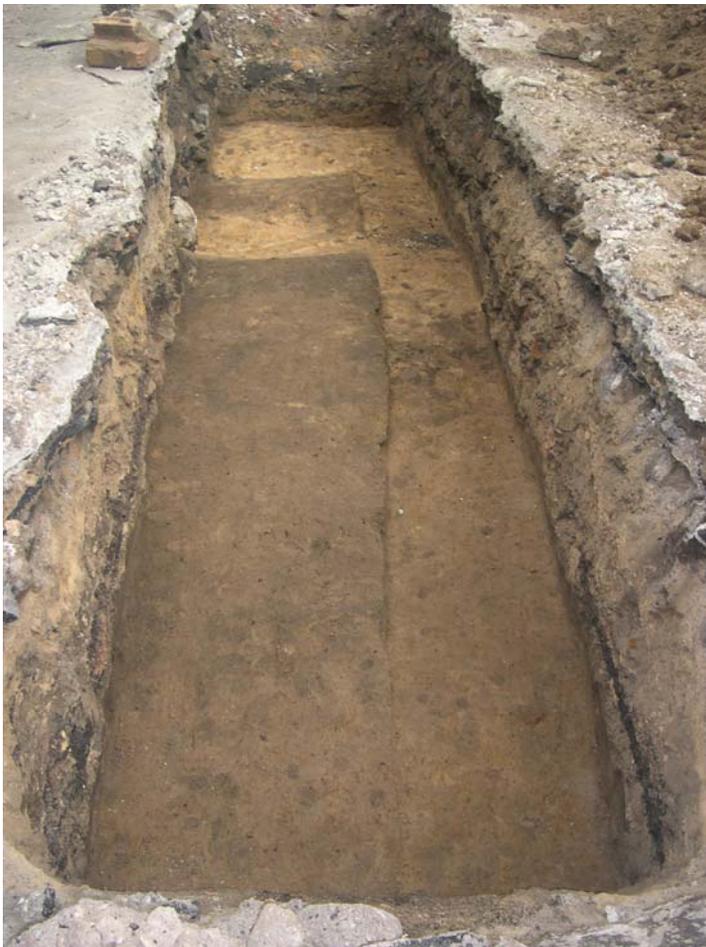
T2-7

The sequence of successive layers of deposition was broken by a wall cut (208) 4.55m from the north end of the trench, which cut 204 and earlier deposits, and contained a rubble sandstone wall (209). This was observed in the machining not to extend across the full width of the trench. To S of the wall cut, a further concrete floor (213) overlay a thick bedding layer of broken sandstone blocks (214), which in turn overlay a truncated wall (217) and further demolition deposits (215, 206, 219). Both walls 209 and 217 appeared to be bedded onto 207, although in the case of 217, this was partial.

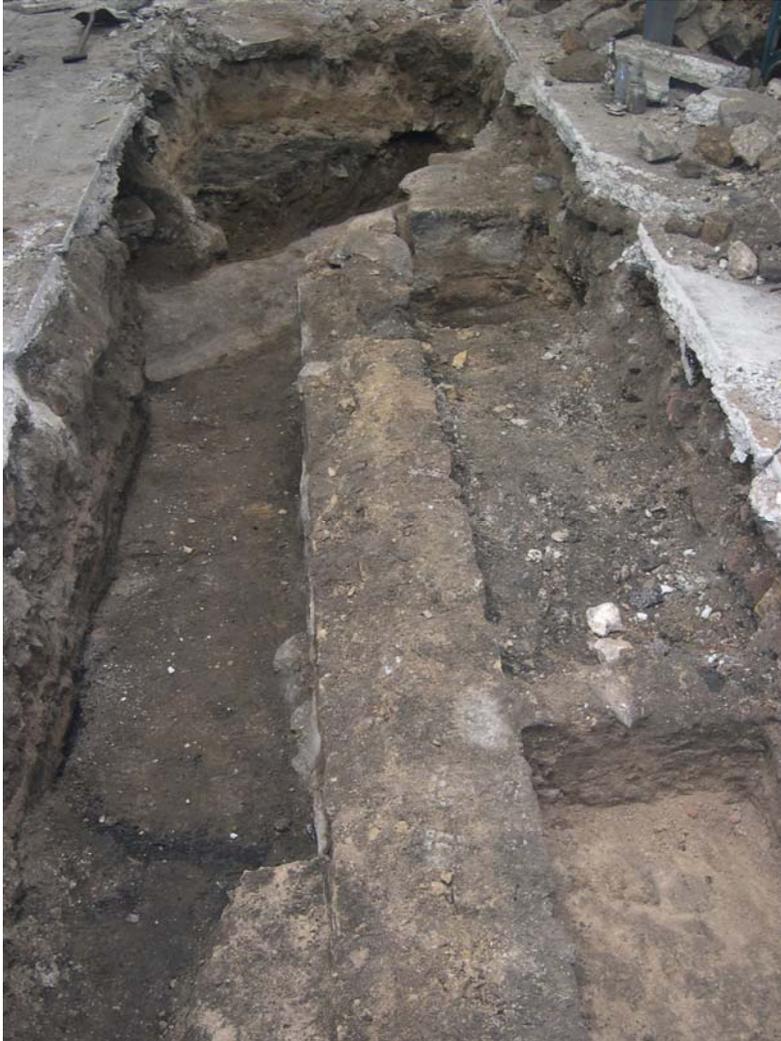
T3-9

To the west, cut 314 was not apparent, as the feature appeared to respect a low sandstone wall (316) 45cm wide and 82cm high. This wall was truncated by the modern floor level and continued below the level of excavation. To east of the wall a series of four horizontally deposited layers was noted (323-326). Layer 326 appeared to be a bedding layer comprising beach sand approximately 20cm thick, forming the base for a well-laid surface of substantial cobble sets (325). Bituminised macadam (324) sealed this surface, which was in turn sealed by a sand and rubble layer (323).

The centreline of the trench contained a 45cm wide sandstone rubble wall which separated the deposits to the north and south. The wall ran for 4.7m before being truncated by cut 305. A brick wall one course -25cm - wide (321) abutted 318, 1.5m from the east end of the trench. The two walls contained a layer of mortar (322) that was interpreted as a solum. It was not further investigated.

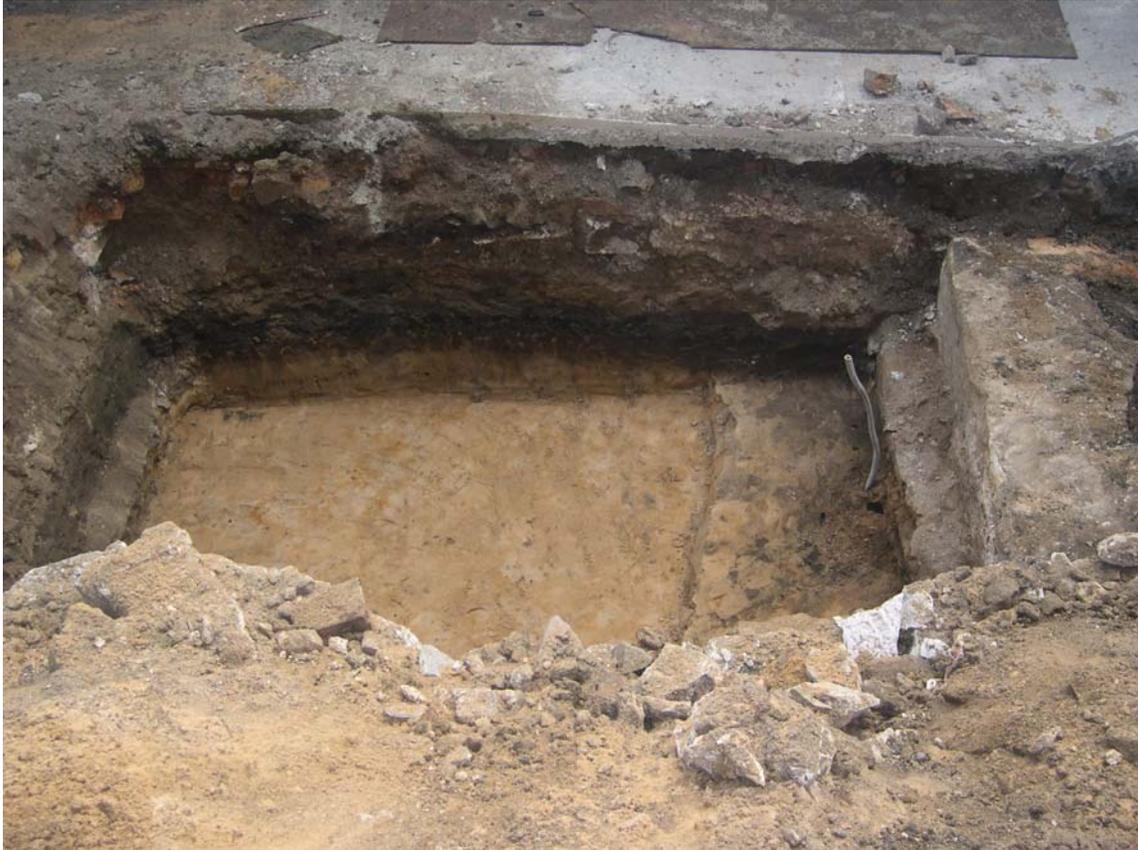
T4-6

The modern ground surface consisted of a 16mm thick layer of concrete with bitumen damp proof course (401), which was bedded onto a 200mm thick layer of mixed brick and sandy rubble (402). 402 sealed a substantial sandstone rubble wall (411), running E-W, which was 0.4m below the modern ground surface, 3.3m from the N end of the trench. On the N face, the wall widened 400mm below the top, into a possible footing, a further 120mm wider. To S, a 250mm thick layer (412) of dark brown-black humic sand with occasional broken pottery, glass and stone was noted. This was not excavated further, and continued.

A crushed limestone and rubble mix (404), 300mm thick extended 120cm N of the wall (411). Against this and to the north three successive layers of redeposited sand and sandy/ mortar mixes (403, 405, and 406) were noted. These three layers were laid down horizontally and between 50 and 120mm in thickness. 406 and 404 sealed a redeposited dark brown mixed sand (407), 200mm thick, which overlay a dark brown/black compacted sandy silt (408), 120mm thick, which in turn overlay a dark brown sand layer (409), 150mm in thickness. A sondage was excavated beneath this layer to reveal the natural substrate: a light brown sand showing slight evidence of panning (410).

Trench 4 contains one item of note: the E-W running wall 411. This appears to have been truncated by later development, and was built onto naturally occurring sands. Its foundation course was visible, and clearly defined variations in soil type were noted to N and S of the wall. It is not possible from stratigraphy alone to identify which side of the wall was the interior of the building.
