31, Assembly Street, Leith

Investigation Report

*Archaeological Evaluation and Standing Building
Recording*

August 2014

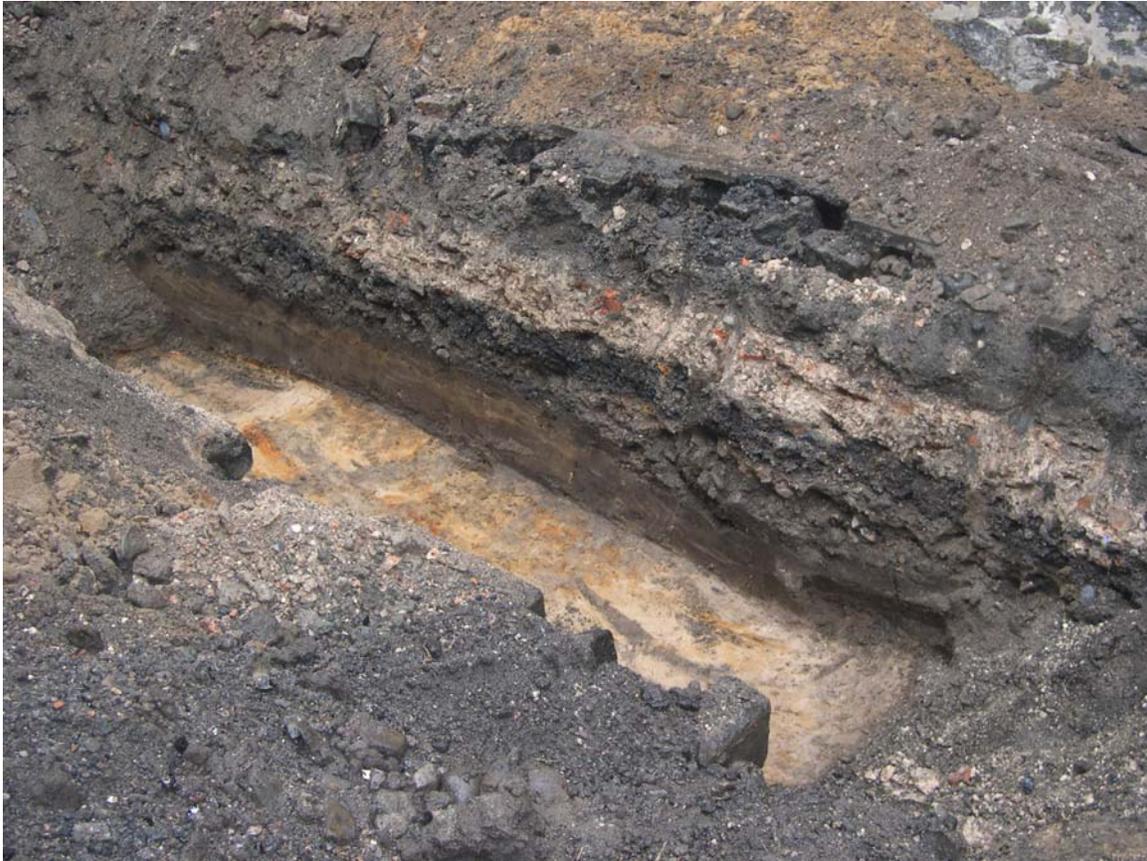
T5-5

Trench 5 was opened in the southern portion of the courtyard, and was approximately 5m in length. The loose nature of the deposits precluded a clearly defined ends to the trench, however the stratigraphy was visible, giving a clear indication of the nature of the area investigated.

An electrical service ran along the eastern edge of the trench, thereby narrowing it slightly to 1.25m, as this was left unexcavated.

A tarmac skim (501) sealed the original courtyard surface of cobble sets (502). The cobbles were bedded into a 220mm thick layer of grey-brown ashy loam (503). This in turn lay above a crushed sandstone and mortar layer, 200mm thick (504), which sealed a 100mm thick layer of black cinder and crushed brick (505). Beneath 505 a mortar, river-worn cobble and crushed sandstone layer (506), 100mm thick was noted. This lay on a dark brown sand (507), which was interpreted as naturally occurring.

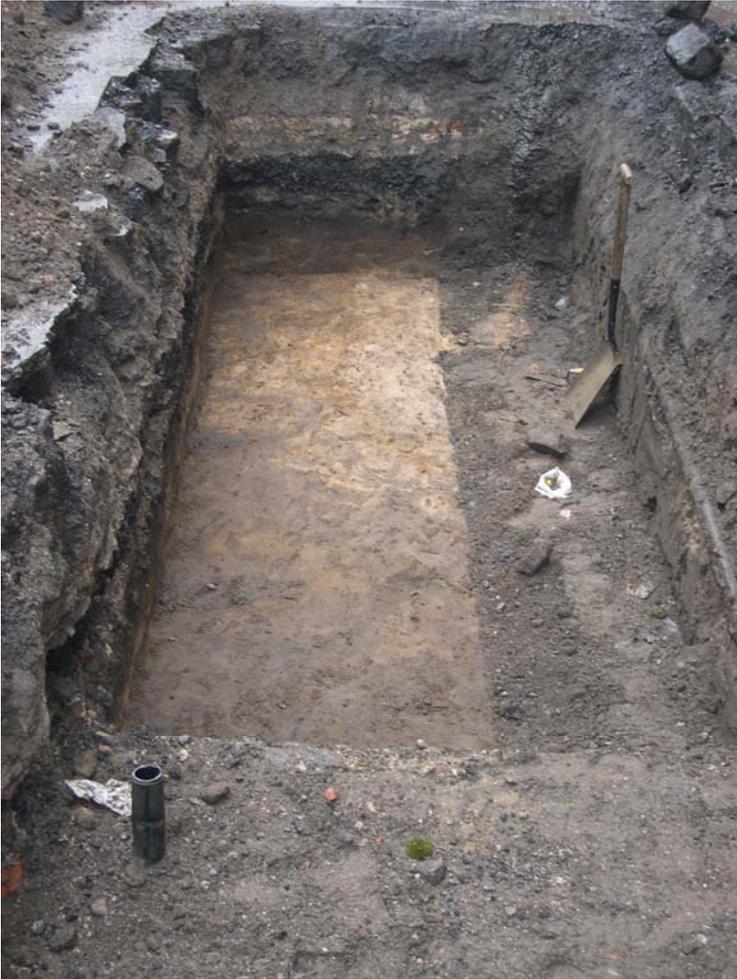
T6-3

Trench 6 was 5.7m in length, running N-S to the centre of the courtyard area. It was 1.8m in width initially, with modern services cut (609) running along the W side of the trench, reducing intact deposits to a strip 1.2m in width. An inspection tube was noted 1.6m from the N end of the trench.

A similar stratigraphic sequence was noted to trench 5 in the upper 600mm: a thin tarmac skim (601), sealing a cobble set surface (602), bedded into a mixed brown ashy loam (603), which overlay a crushed sandstone and mortar layer (604). 604 covered a black cinder and crushed brick layer (605), 100mm thick, which covered a mortar and crushed sandstone layer, also 100mm thick (606), which covered a 200mm thick layer of

dark brown sand (607). This sealed naturally occurring sands (608) which varied in colour and showed signs of leaching; becoming paler with depth.

607 was not excavated north of the inspection pipe, so as not to disturb the equipment, however it is not thought that this compromised the recording of deposits.

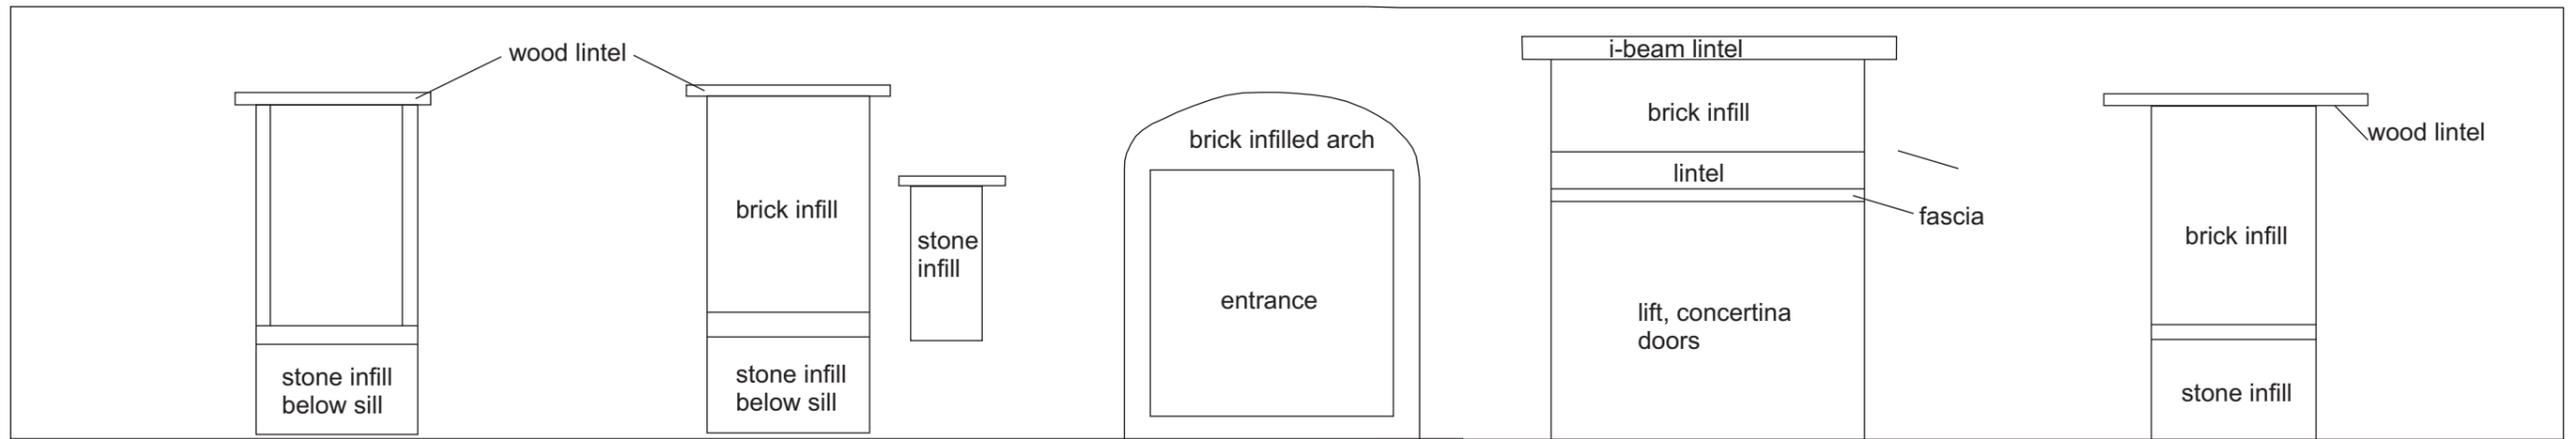
31, Assembly Street, Leith, Standing building survey
ED08
North internal elevation, ground floor

Five openings were noted in the north internal elevation, in a similar arrangement to that noted in the south external elevation. Two windows were situated to W of a central, arched opening. The windows were blocked with a single thickness of brick and had a sill set at 0.9m high with an infill of small undressed stone below. The central arched doorway had been modified with brick blocking to infill the arch and to create a smaller, rectangular opening, 2.2m wide and 2.2m high. To E, a large service lift had been installed, presumably removing a window similar to the others on this elevation (photo L1-01). A third infilled window was noted to the east of the lift shaft. A small opening was also noted between the central doorway and the western central window. This was 0.8m wide, and 1.2m high, and was infilled with stone.

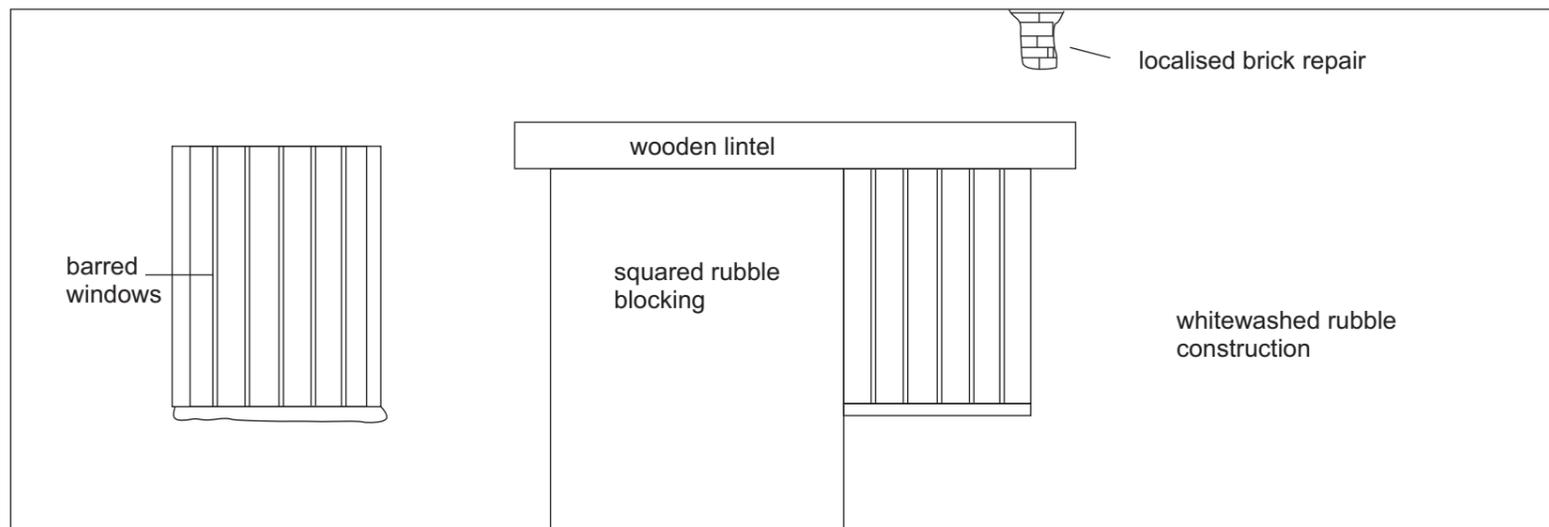
31, Assembly Street, Leith, Standing building survey
ED08
Ground floor, E internal elevation

The E elevation showed a roughly centrally positioned opening, approximately 1.5m wide, below a wooden lintel. It consisted of a doorway (blocked with squared rubble) with a barred adjoining window (photo L1-03) to S, with a further window to N. Both windows were of similar dimensions (1.0m by 0.8m), were barred vertically and horizontally, and contained frosted glass.

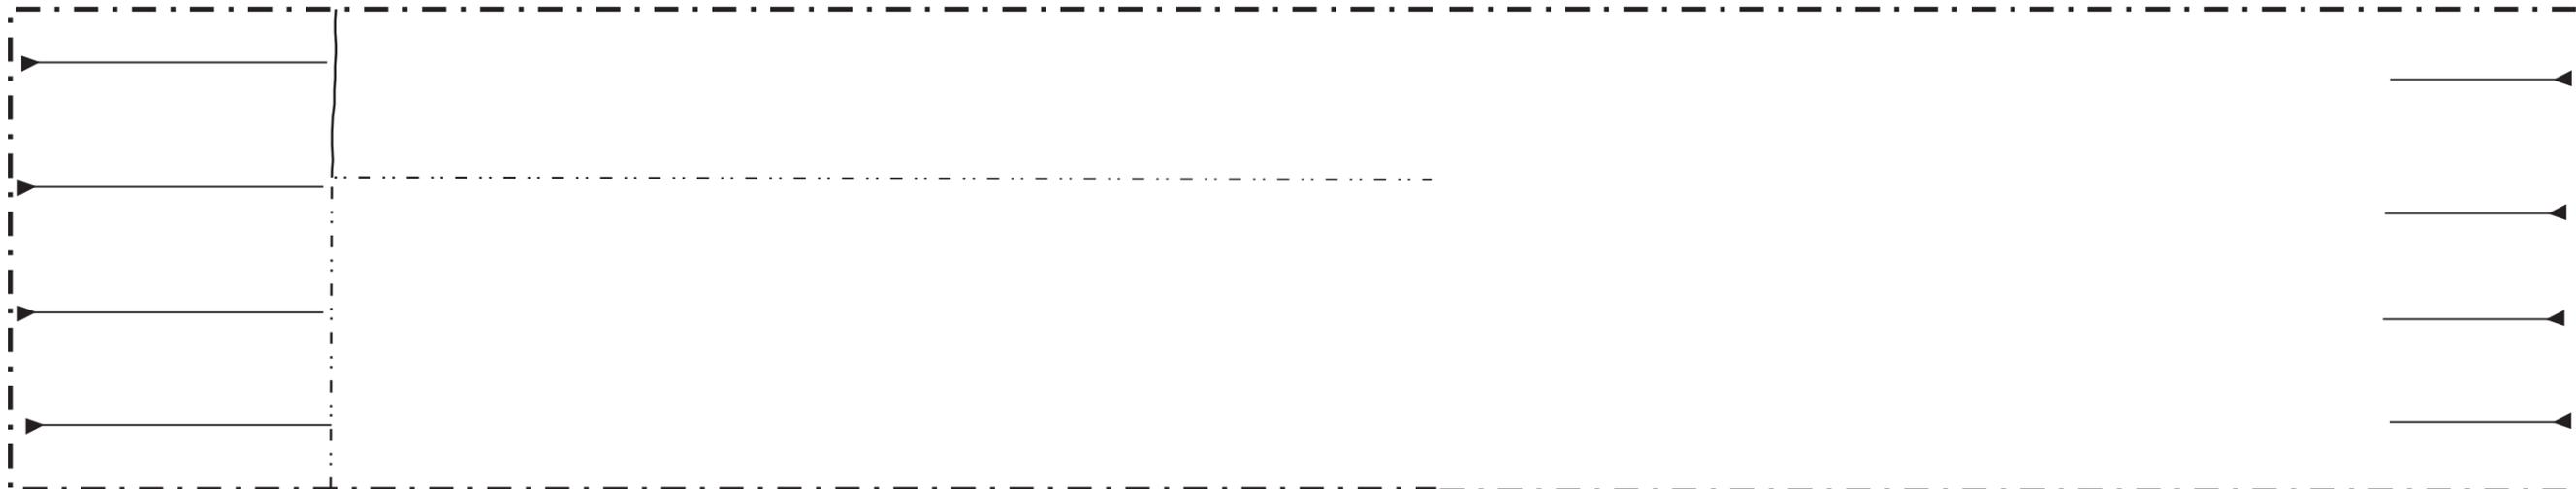
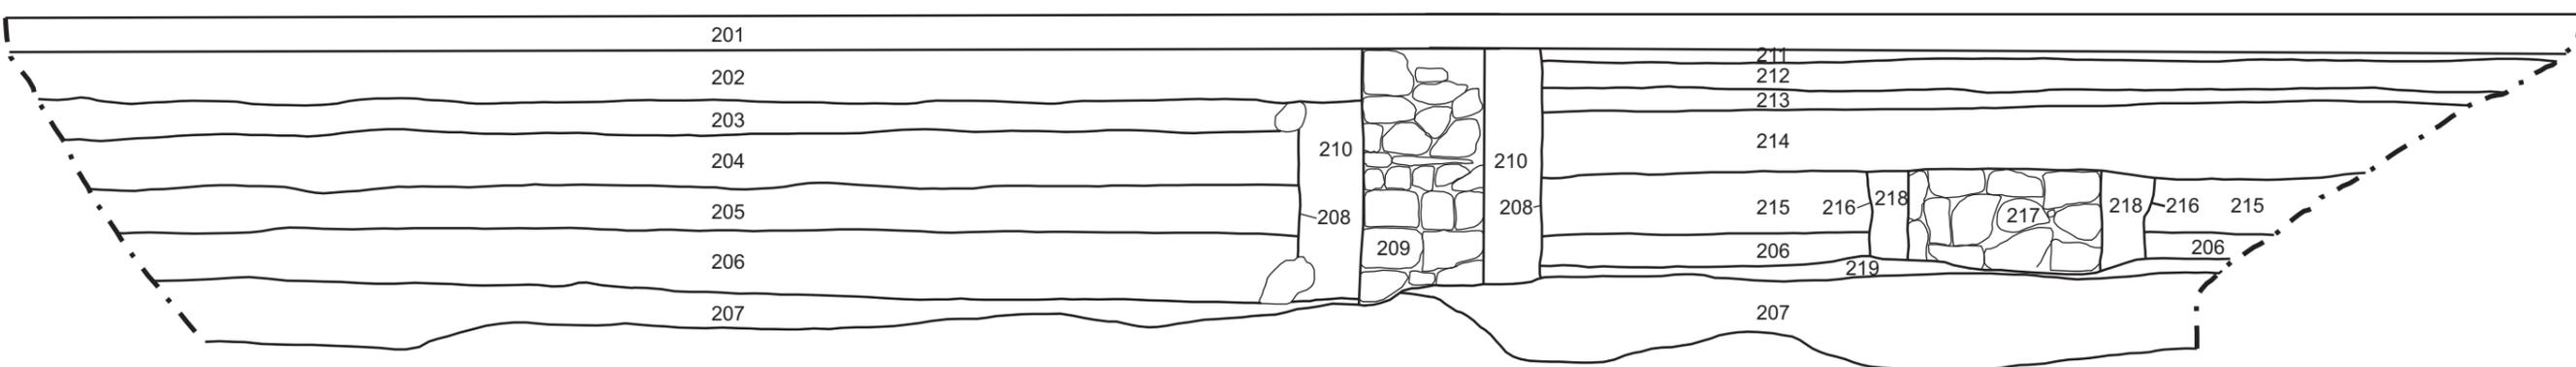
31, Assembly Street, Leith, Archaeological Evaluation
 ED08
 Trench 2: plan view and W elevation

The sequence of successive layers of deposition was broken by a wall cut (208) 4.55m from the north end of the trench, which cut 204 and earlier deposits, and contained a rubble sandstone wall (209). This was observed in the machining not to extend across the full width of the trench. To S of the wall cut, a further concrete floor (213) overlay a thick bedding layer of broken sandstone blocks (214), which in turn overlay a truncated wall (217) and further demolition deposits (215, 206, 219). Both walls 209 and 217 appeared to be bedded onto 207, although in the case of 217, this was partial.

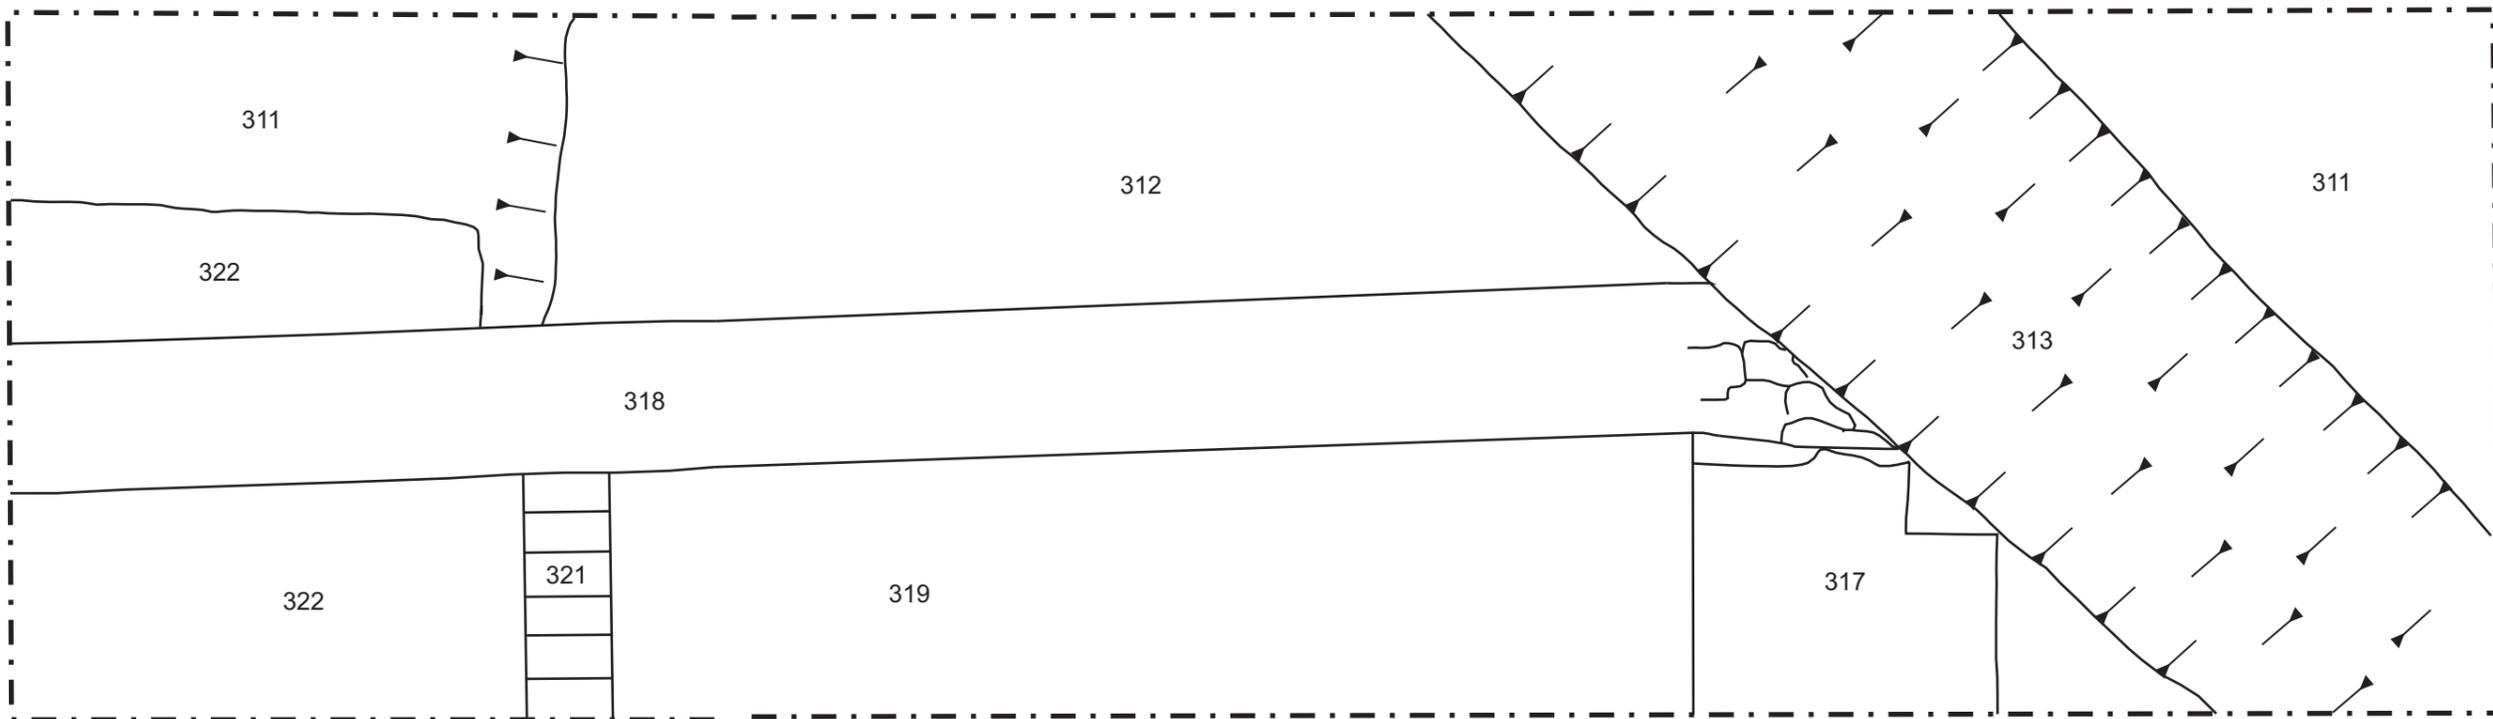
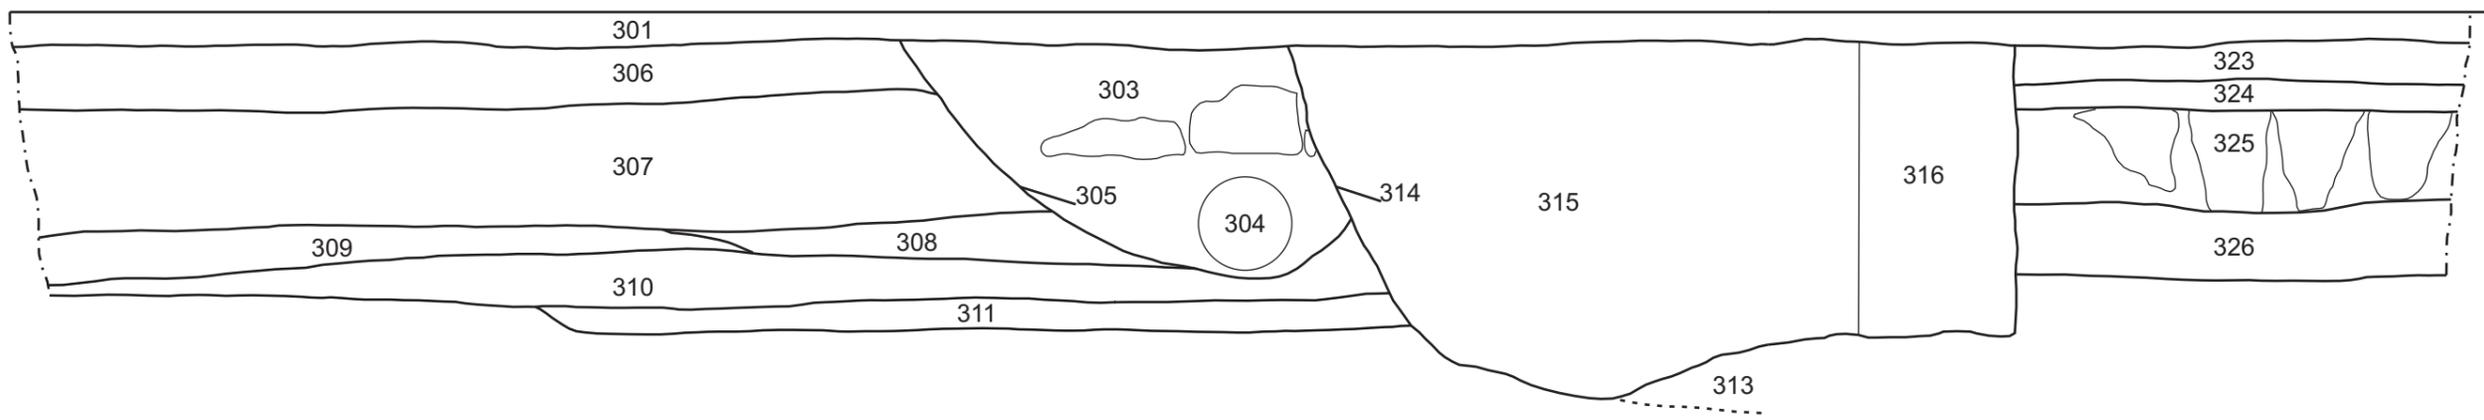
31, Assembly Street, Leith, Archaeological Evaluation
 ED08
 Trench 3: plan view and S elevation

Trench 3 was excavated within the central portion of the workshops, on the eastern side of the site. It was orientated east-west, 2.0m wide and 7.0m in length. Below the concrete floor (301) a large northwest-southeast – running cut (314) truncated many of the layers noted as being stratigraphically below. Cut 314 ran for more than 3m, continuing beyond the edges of excavation. It was filled with a 90cm deep rubble and sand deposit (315) which sealed a concrete-covered pipe, which was only partially exposed at the base of the trench. A modern vitrified ceramic drain was noted immediately to the east of 314 (304), which lay below large sandstone blocks in a sandy matrix (303), within a U-shaped cut (305) which was partially truncated by 314. The drain ran east west from the east end of the trench before turning to the southwest at the south end of the trench.

To the west, cut 314 was not apparent, as the feature appeared to respect a low sandstone wall (316) 45cm wide and 82cm high. This wall was truncated by the modern floor level and continued below the level of excavation. To east of the wall a series of four horizontally deposited layers was noted (323-326). Layer 326 appeared to be a bedding layer comprising beach sand approximately 20cm thick, forming the base for a well-laid surface of substantial cobble sets (325). Bituminised macadam (324) sealed this surface, which was in turn sealed by a sand and rubble layer (323).

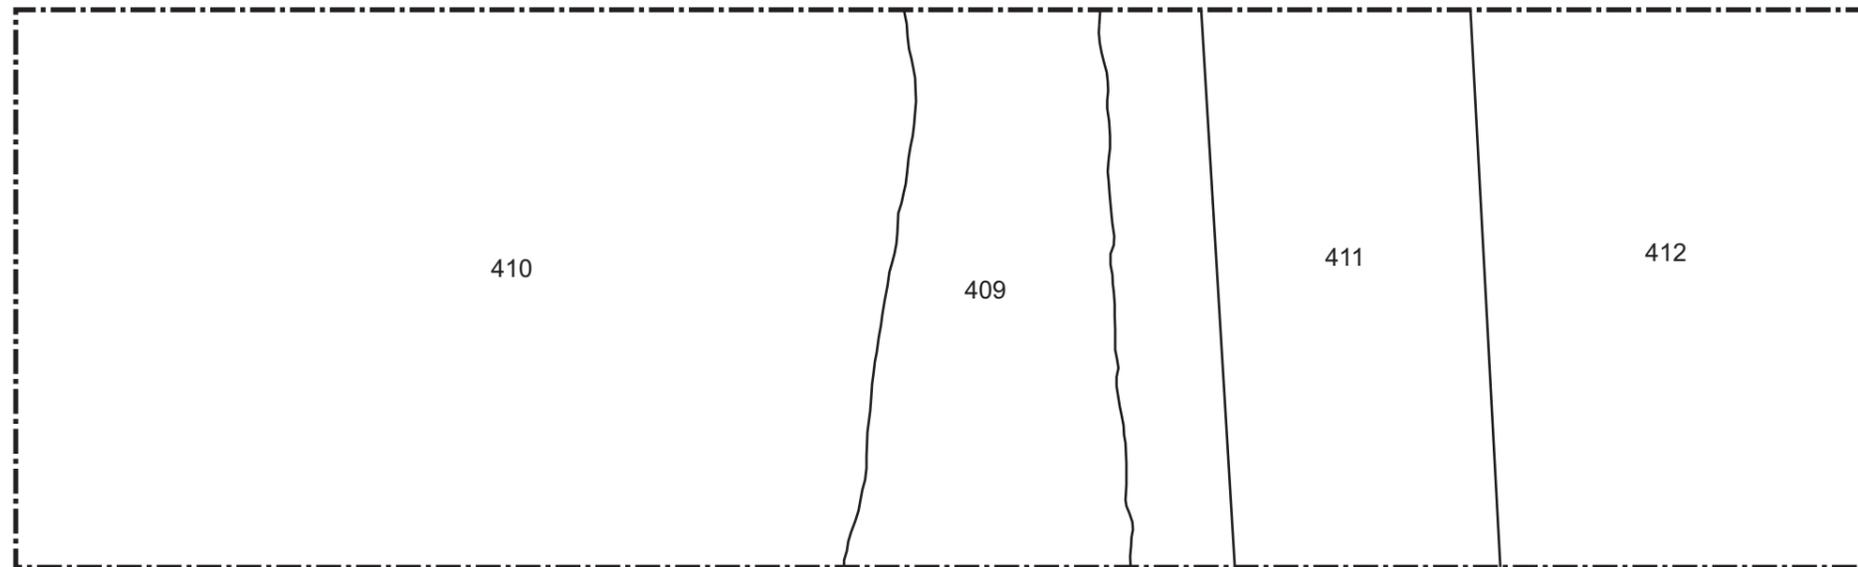
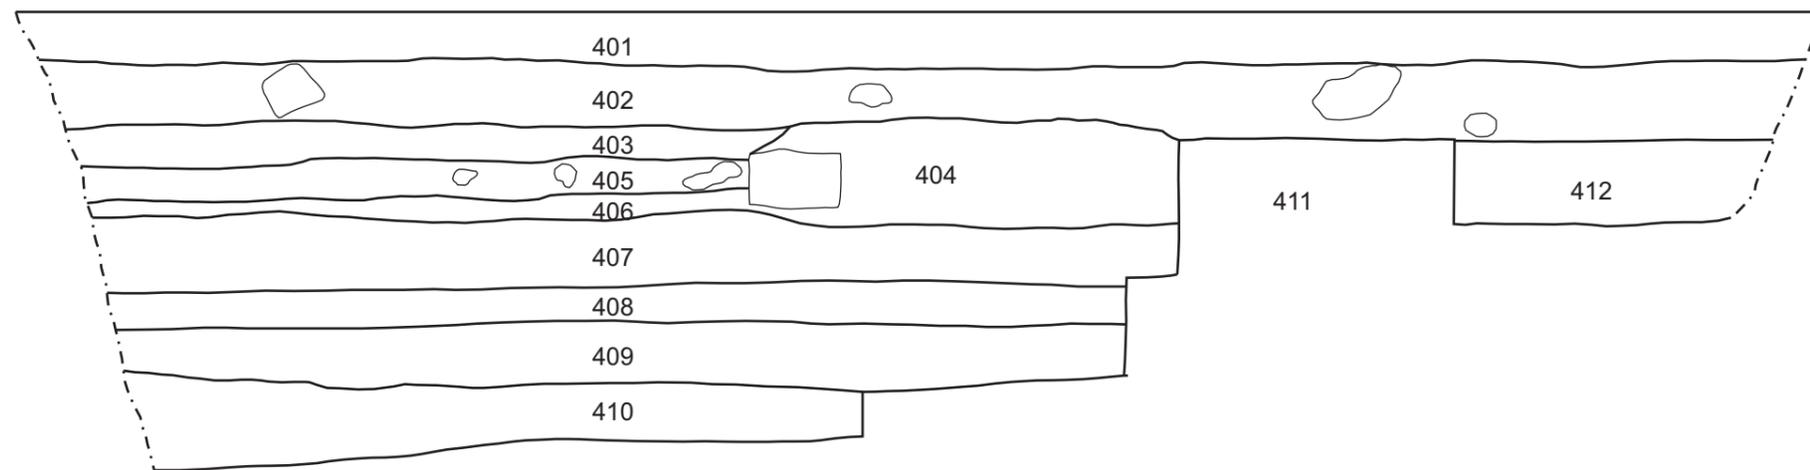
31, Assembly Street, Leith, Archaeological Evaluation
ED08
Trench 4: plan and E elevation

The modern ground surface consisted of a 16mm thick layer of concrete with bitumen damp proof course (401), which was bedded onto a 200mm thick layer of mixed brick and sandy rubble (402). 402 sealed a substantial sandstone rubble wall (411), running E-W, which was 0.4m below the modern ground surface, 3.3m from the N end of the trench. On the N face, the wall widened 400mm below the top, into a possible footing, a further 120mm wider. To S, a 250mm thick layer (412) of dark brown-black humic sand with occasional broken pottery, glass and stone was noted. This was not excavated further, and continued.

Trench 4 contains one item of note: the E-W running wall 411. This appears to have been truncated by later development, and was built onto naturally occurring sands. Its foundation course was visible, and clearly defined variations in soil type were noted to N and S of the wall. It is not possible from stratigraphy alone to identify which side of the wall was the interior of the building.

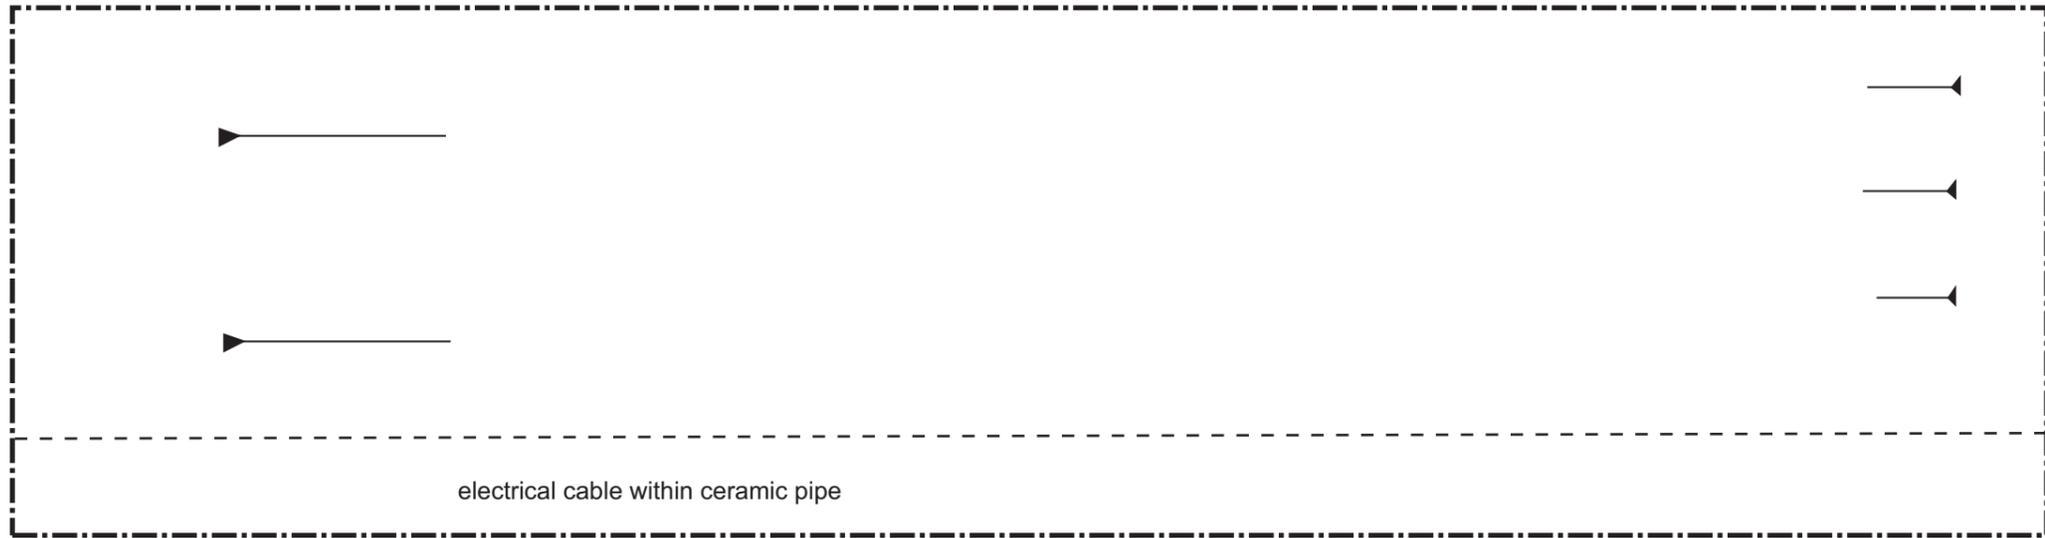
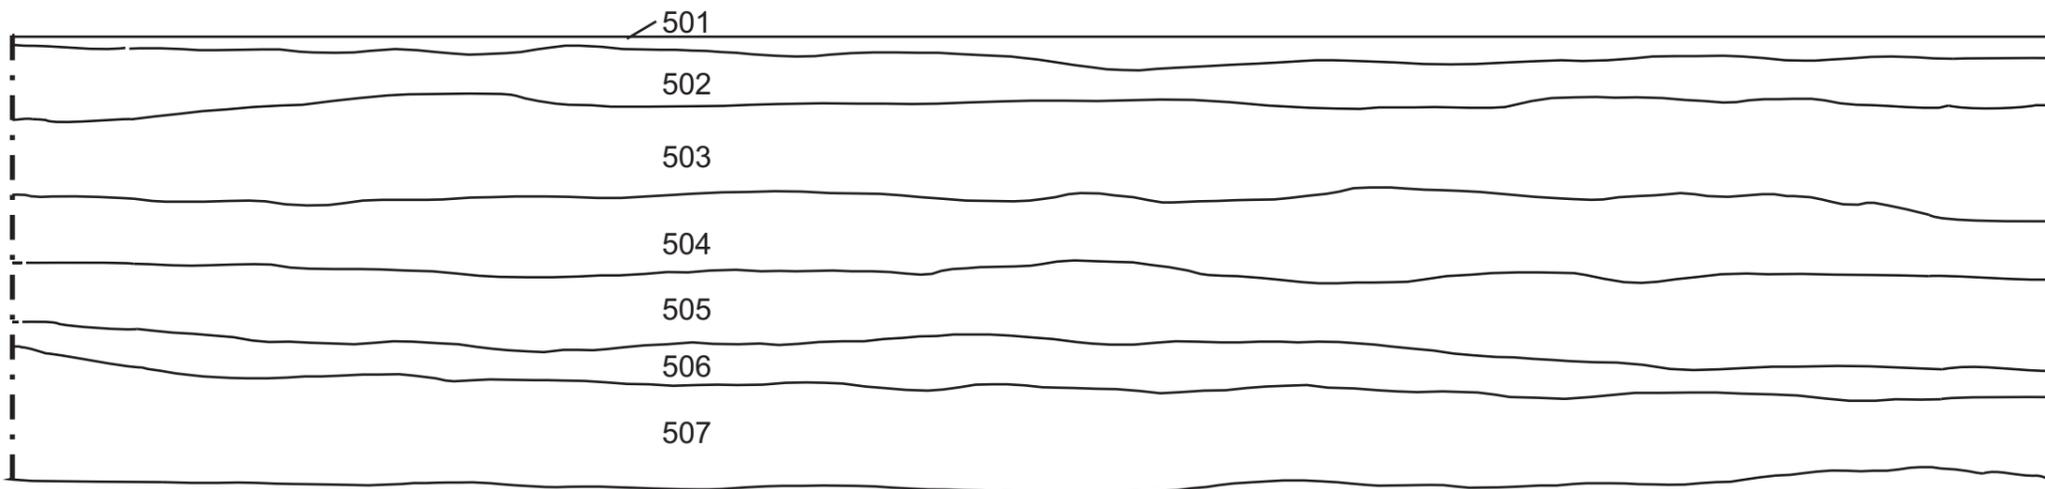
31, Assembly Street, Leith, Archaeological Evaluation
ED08
Trench 5: plan and W elevation

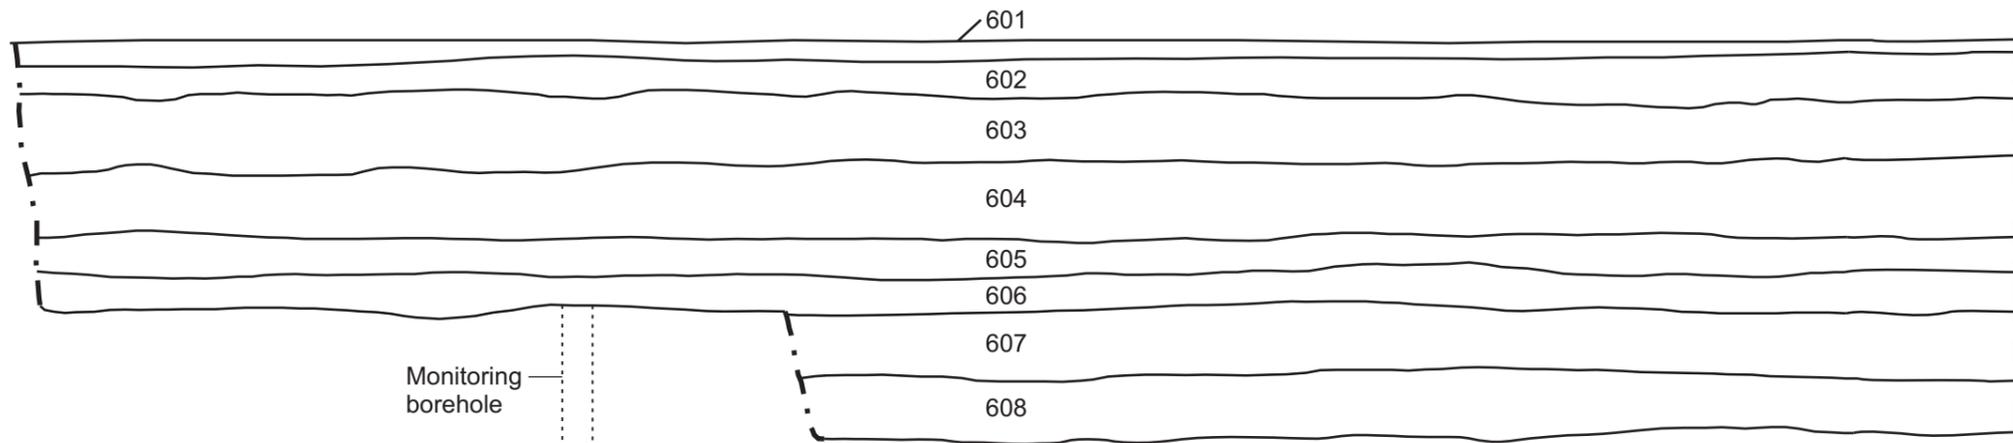
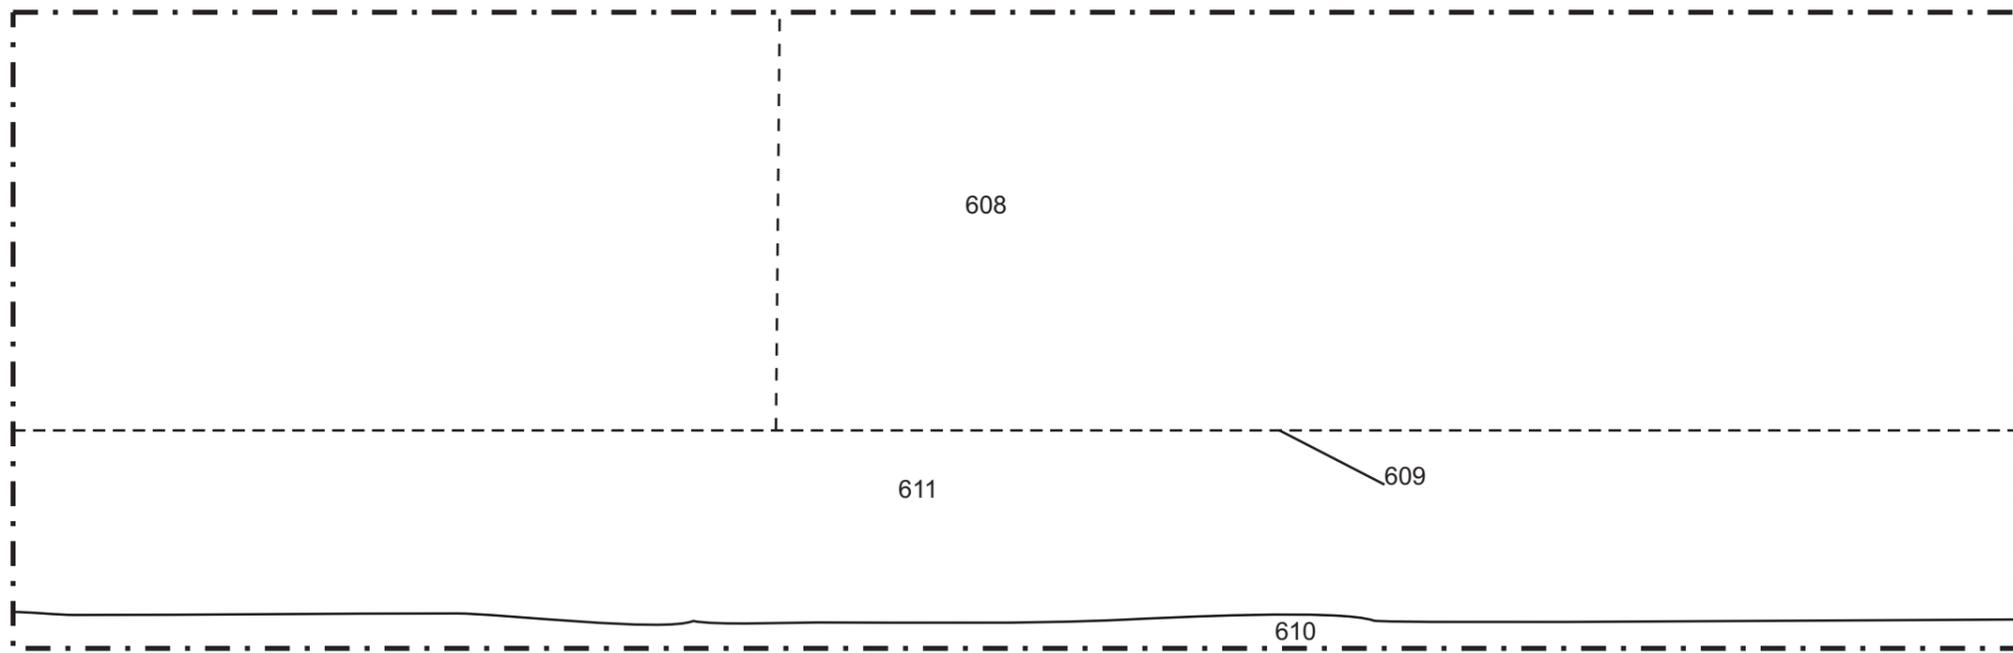
31, Assembly Street, Leith, Archaeological Evaluation
ED08
Trench 6: plan and W elevation
