**Land adjacent to  
All Saints Way,  
West Bromwich,  
Sandwell**

**ARCHAEOLOGICAL  
EVALUATION 2010**

**Project No. 2027**

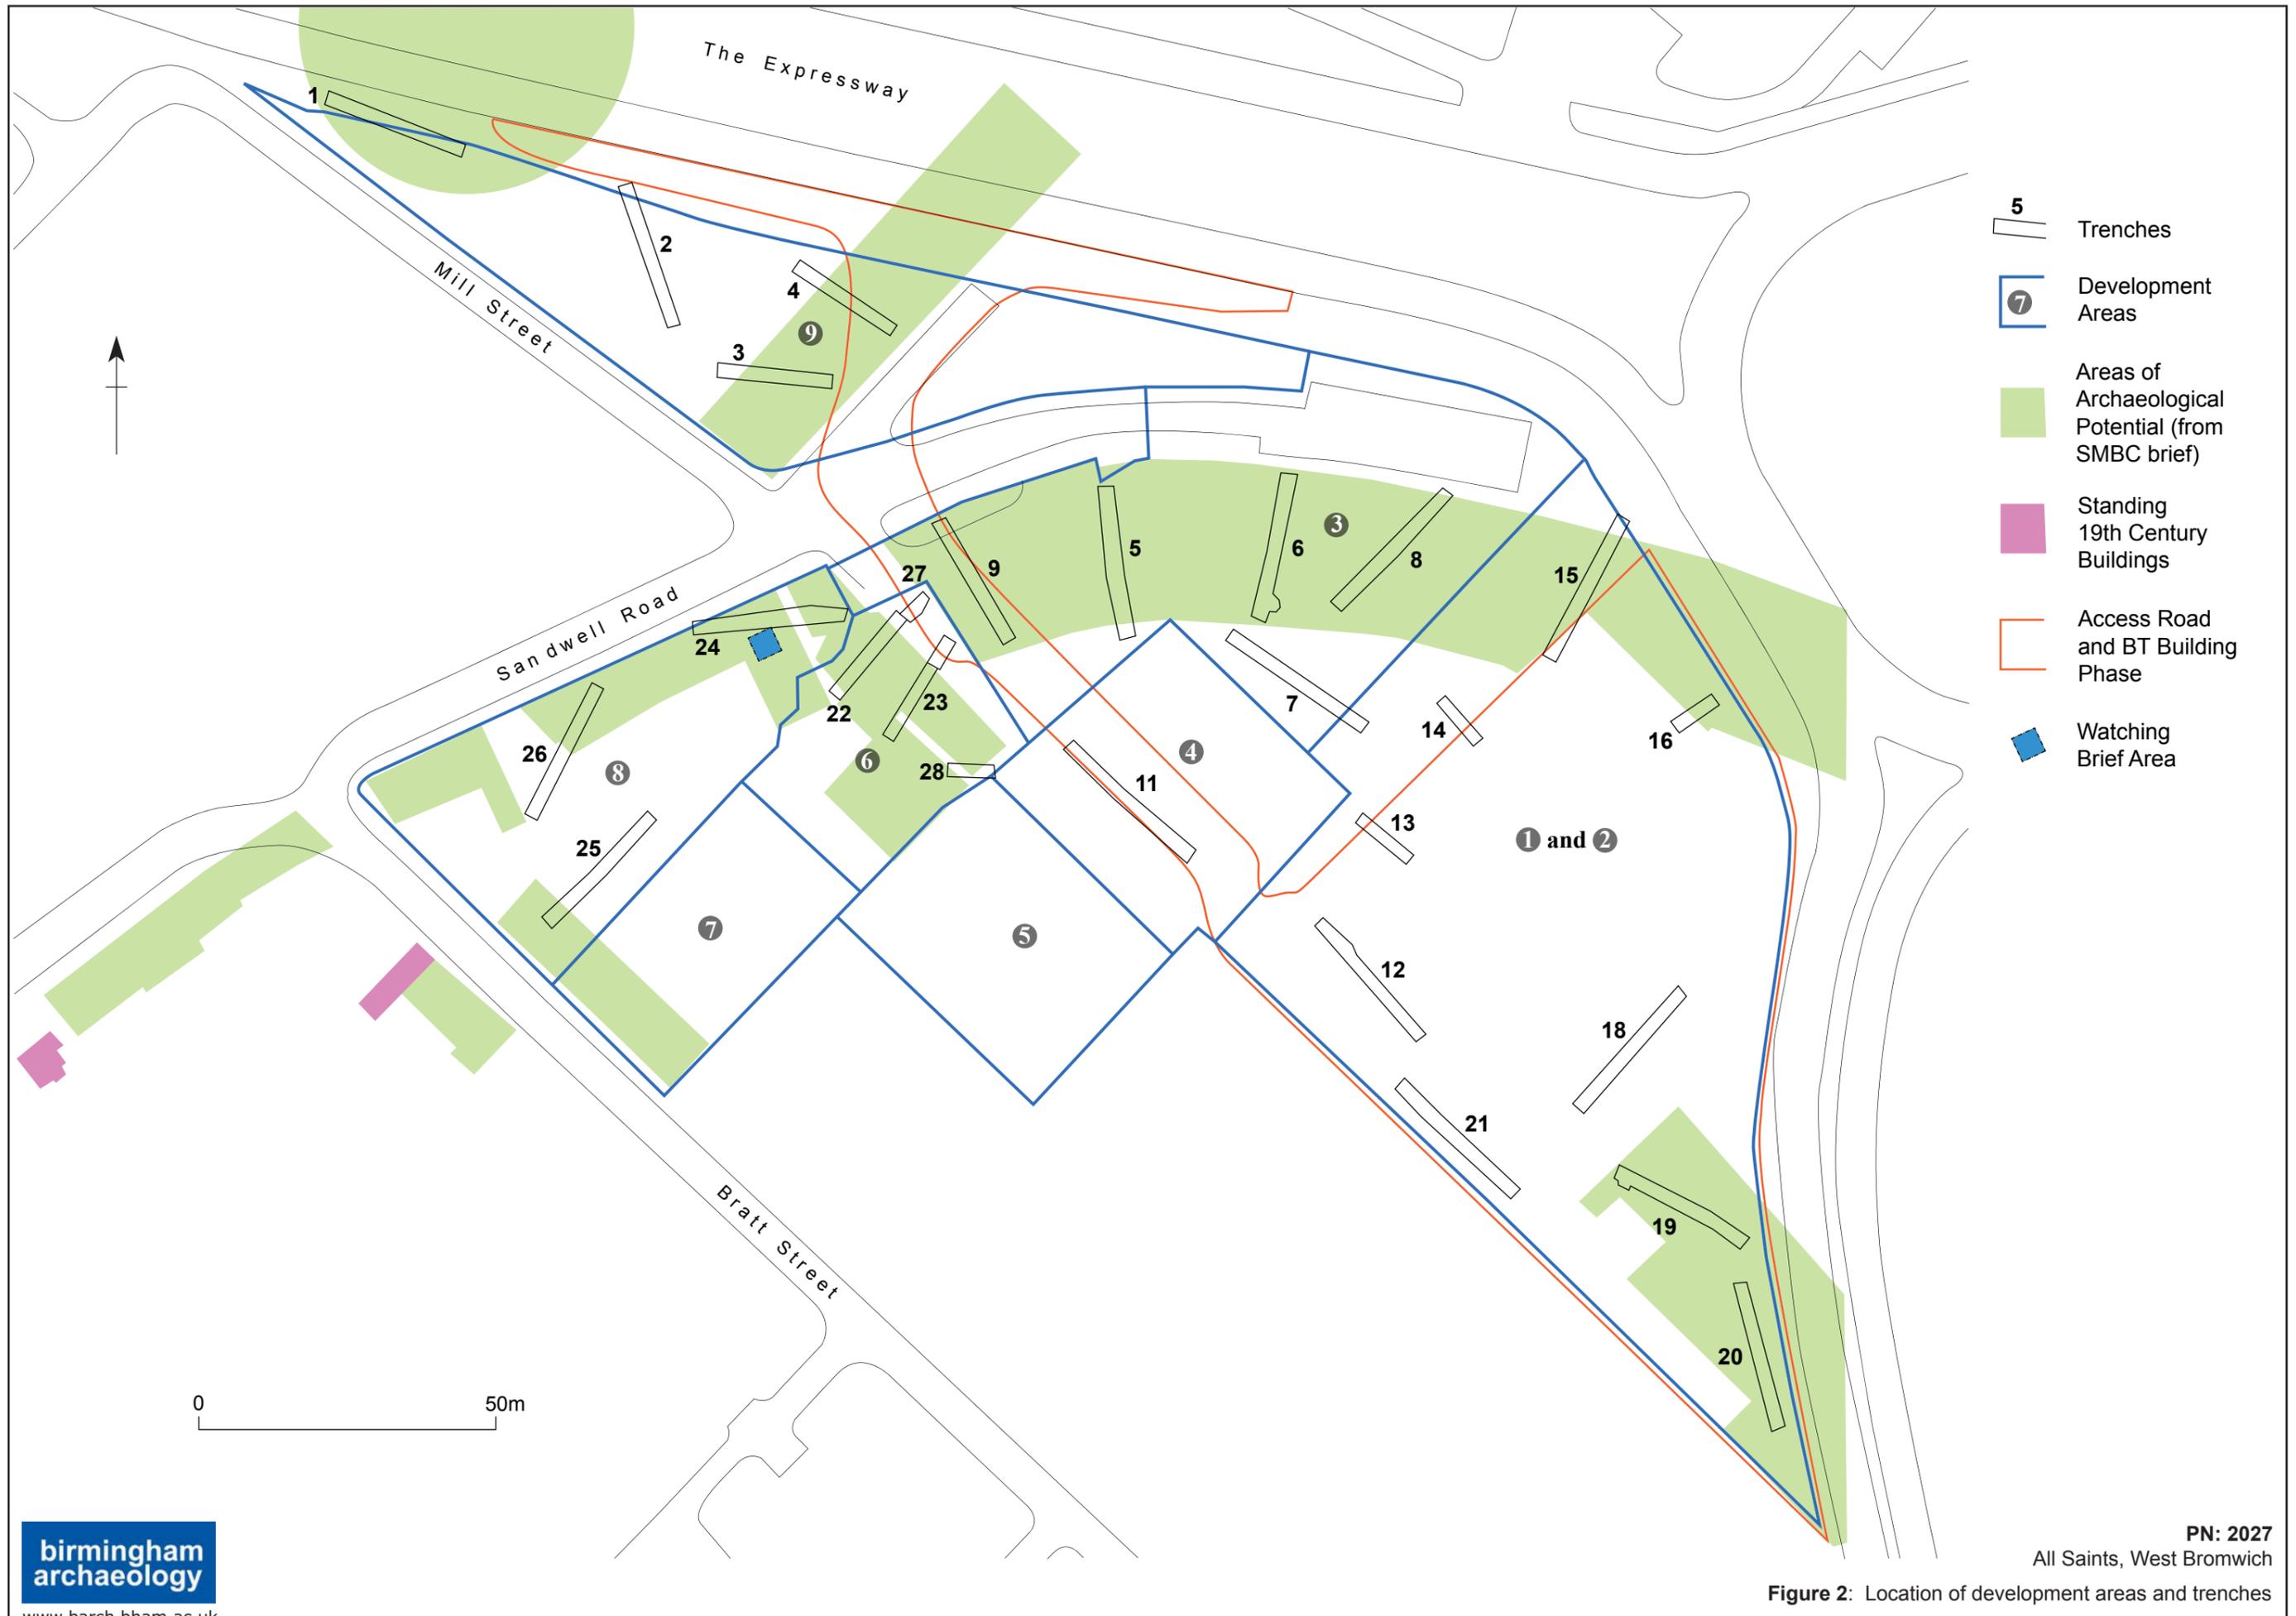
Figure 2: Location of development areas and trenches

- 5.1. Twenty-six trenches, mainly measuring 25m x 2m (unless stated otherwise in section 6, below), were excavated across the site (Fig. 2). Trenches 10 and 17 were not excavated as planned in the Written Scheme of Investigation due presence of deep modern foundations and several other trenches were shortened for the same reason. Trench 23 was extended and Trenches 27 and 28 were excavated instead, with the agreement of the Borough Archaeologist.
  - 5.2. The trench locations were agreed in advance with the Borough Archaeologist for Sandwell Metropolitan Borough Council, and surveyed-in using a Differential GPS and located on the Ordnance Survey National Grid.
-
