# Land at 29 Seymour Road, Bishopston, Bristol

## Report on Archaeological Watching Brief

Bristol: June 2016

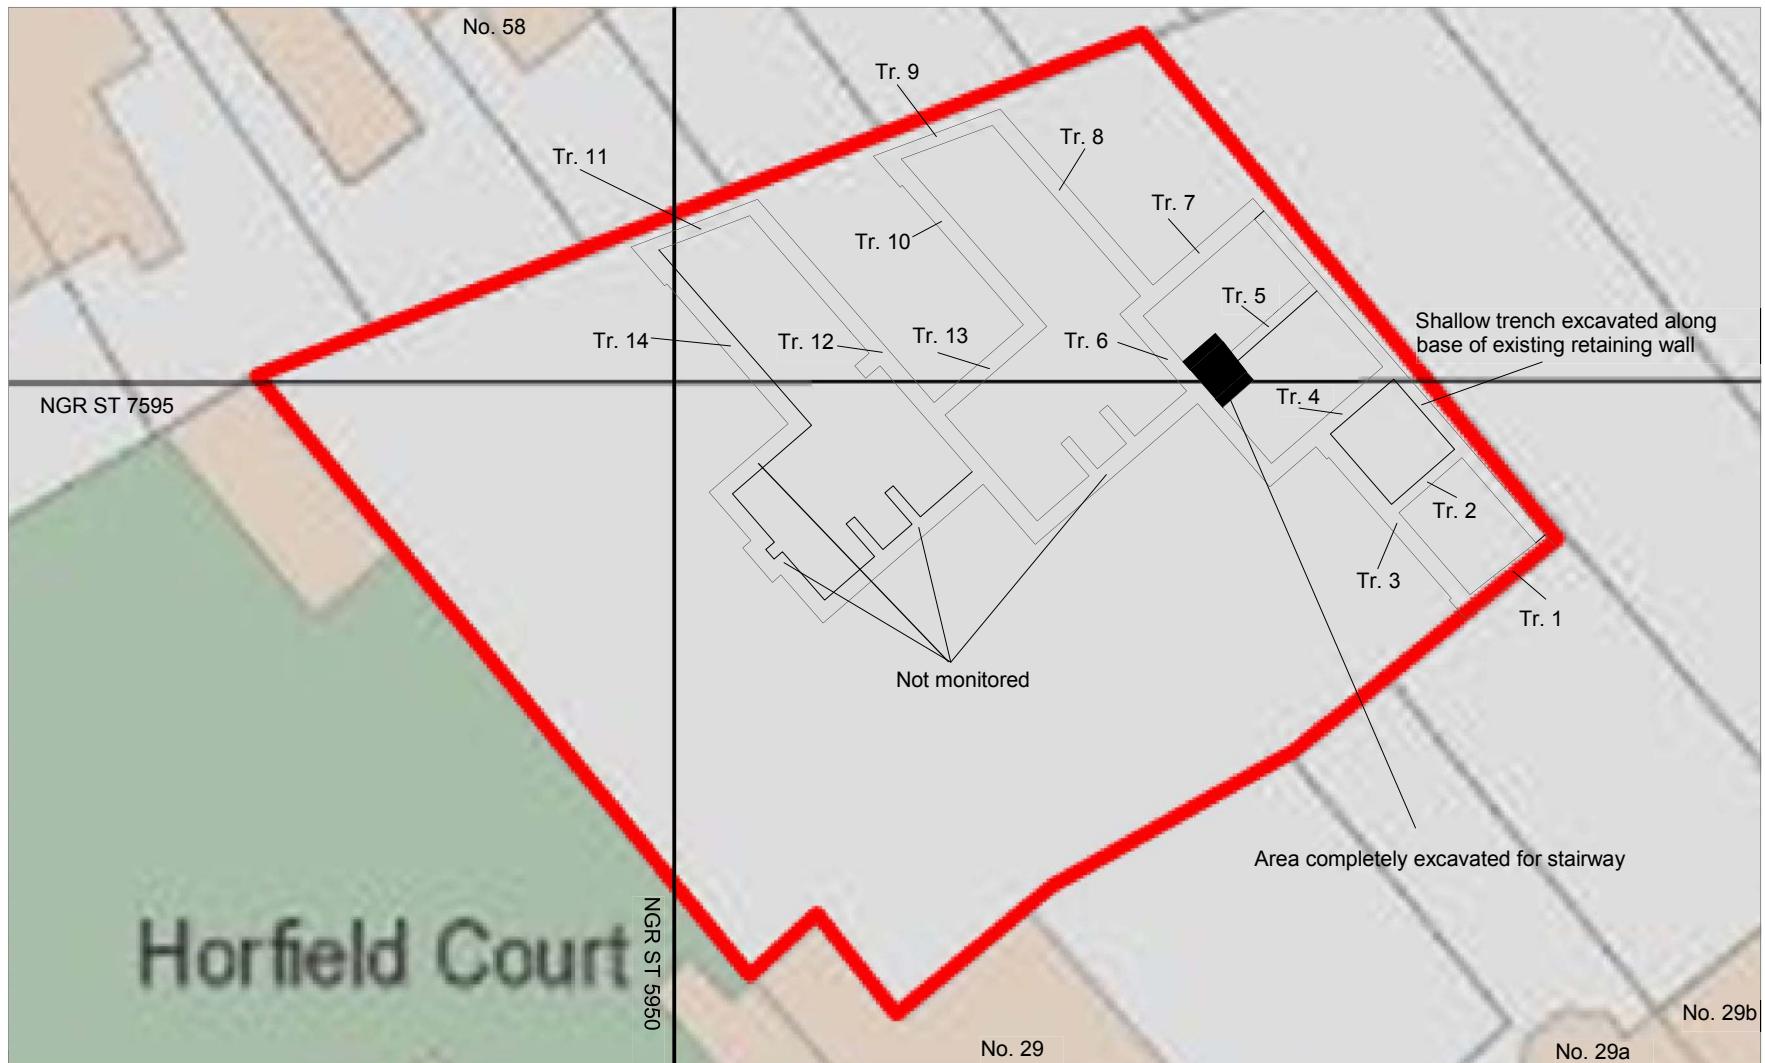
Figure 3

Trench Location Plan

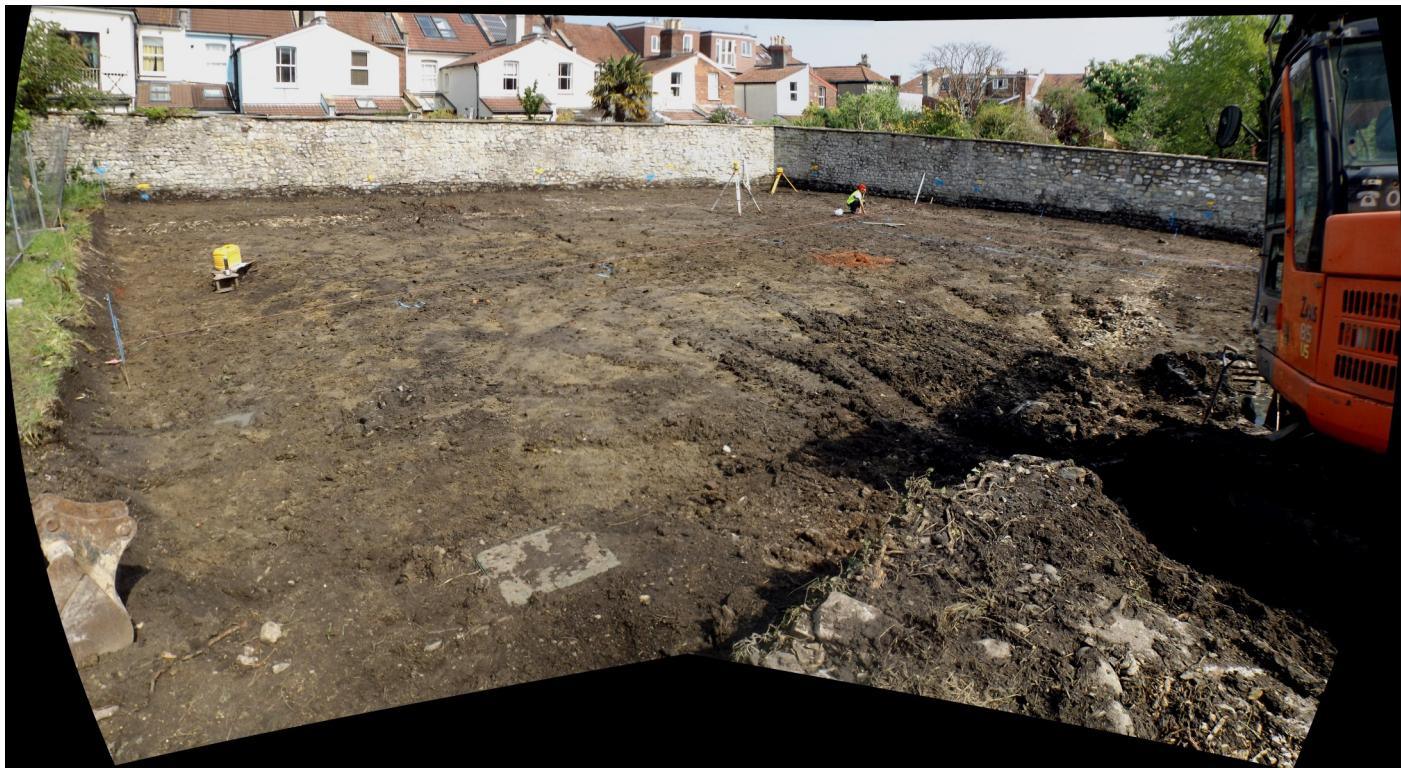
1. Composite panoramic view of the site immediately prior to the commencement of excavation. The view pans round from north-west (left-hand side of frame) to north-east (right-hand side of frame). Note that the original ground level of the topsoil on the site, prior to a slight ground reduction, is indicated by the soil mark running all the way round the base of the historic boundary wall.

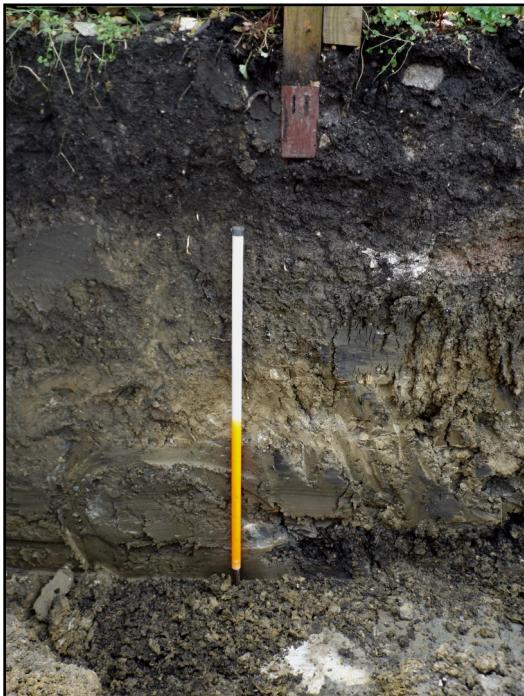
2. The typical sequence throughout the site, here seen in a north-facing section in Trench 1. Dark topsoil, mid grey-brown subsoil, and then natural clays of varying colour. Scale: 1m.

On the site these strata manifested themselves in the form of alternating bands of heavy, stiff clays, and hard, mid-grey, jointed limestones, with the latter bearing a striking resemblance to well-laid flagstone paving when exposed by excavation, and provided an extremely stable and convenient base for concrete-pouring following the digging of the foundation trenches (**Plates 2, 3, 7, 8**).

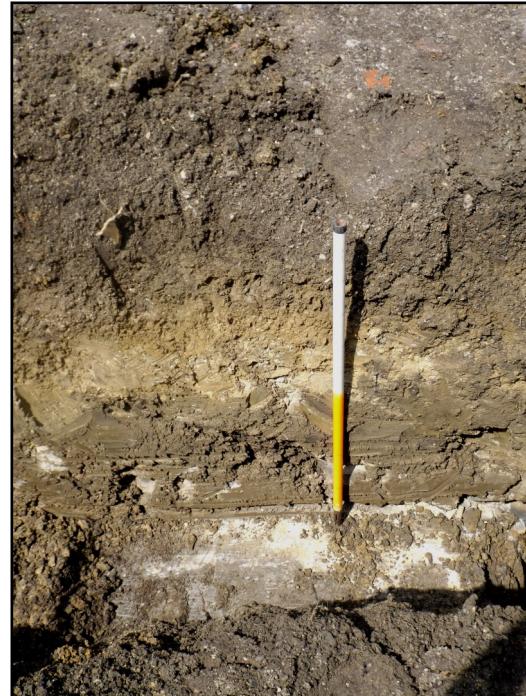
3. South-facing section in Trench 2, showing natural, level limestone 'pavement' at base of trench. Scale: 1m.

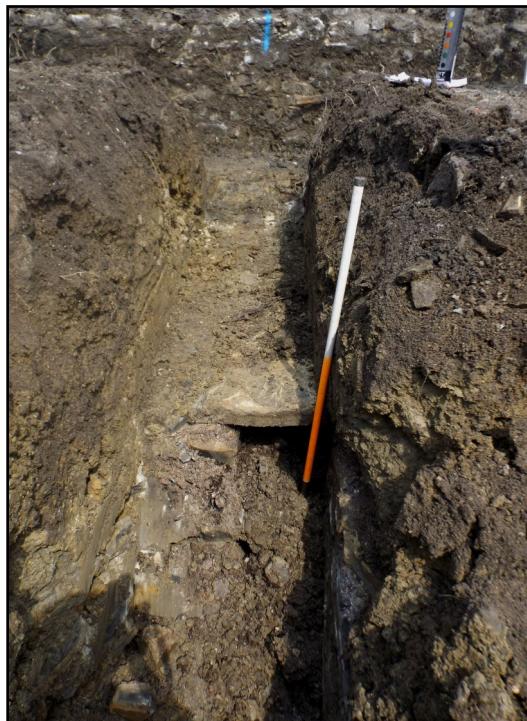
4. View of masonry culvert following exactly the line of Trench 4, running east-west. View to east, with eastern boundary wall in the background. Note capping slabs and supporting side walls, the latter with grey mortar. Scale: 1m.

From the entire monitoring work, there was a single feature of potential archaeological interest, and this was a large, masonry culvert, which by chance was found running virtually down the centre line of Trench 4 (ie east-west), on the eastern side of the site. The south wall of the culvert also formed part of the southern section of the trench itself. The culvert was a fairly large structure, with parallel supporting walls of mortared, but undressed rubble masonry, supporting capping stones made of roughly-dressed Pennant flags, of about 0.07m thickness. The *internal* width of the culvert was 0.32m, and its depth, measured from the base of the capstones, was 0.45m. The supporting walls and flags were both bonded with a dirty, grey, friable, speckly mortar, probably indicating pretty firmly a 19<sup>th</sup> century date (**Plates 4 and 5**). The top of the culvert capstones lay at about 0.50m below the stripped ground level in that part of the site. It was possible to determine that the culvert ran *underneath* the main north-south boundary wall on the eastern side of the site, the weight of the wall being taken by a massive Pennant lintel stone. It is *possible* that the culvert was punched through the pre-existing wall, but this would have entailed deconstructing part of the wall's foundation course, a difficult task, and it seems rather more likely that it was always part of the wall structure and therefore contemporary with it.

The fill of the culvert was a very friable to loose, gritty, dirty, dark brownish-grey silt, with moderate to frequent small sub-angular stones. The trench was over 1.2m in depth and so it was only possible to take basic measurements. It was impossible to see any construction cut for the culvert, but it is likely that a cut must have originally been made for it. It was also difficult to see from which level this putative cut would have been made, but it looked as though it had at least been taken through the subsoil layer. There is no indication of this culvert on either the 1840s tithe maps or the early 1880s First Edition OS map, both on the local authority's *KnowYourPlace* online heritage resource; but it is most likely that it served at least the two large, surviving pre-tithe semi-detached houses known as East and West Villas, the East Villa now being 29 Seymour Road, and the West Villa, Flats 1-4 of Horfield Court, at 27 Seymour Road. Aside from the obvious fact that it was designed to take flowing liquid, it is unclear whether it carried a fresh water supply or was a drain for sewerage and/or waste/overflow water; although that said, the fill did not have the appearance of a typical cess deposit. There is a gentle downward gradient to the east here, so presumably that was the direction of flow.

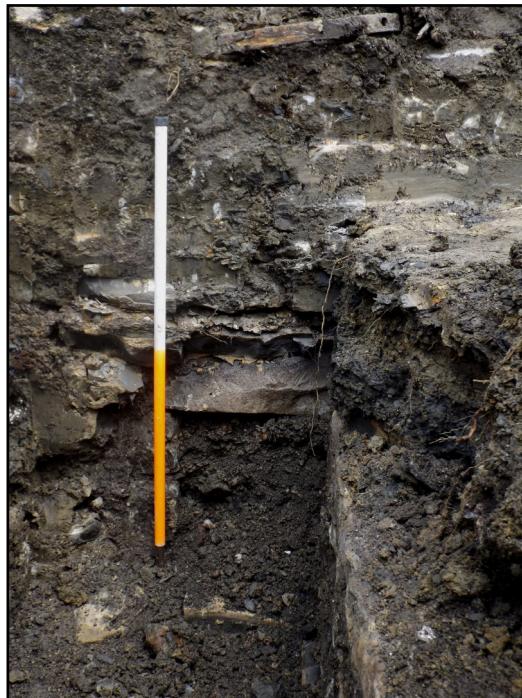
5. View to east at the eastern end of Trench 4, showing culvert passing underneath the site's eastern boundary wall. Note massive lintel slab to support the weight of the wall on top of the culvert. Scale: 1m.

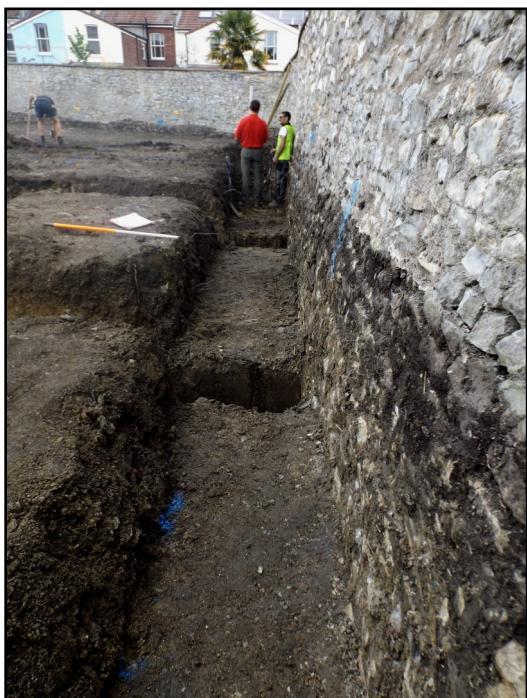
6. The shallow, unnumbered trench running parallel with the eastern boundary wall. View to north. Note the mark on the wall indicating original topsoil level on the site.

Trenches were numbered as they were excavated. Of the total of 18 trenches that were required to complete the work, 14 were monitored in full before it was decided that the entirely negative results up to that point did not justify monitoring of the remaining four trenches, all of which were, anyway, relatively short (**Figure 3**). A trench running parallel to, and at the foot of the side wall of the site (ie running north-west/south-east) was not separately numbered as it was relatively shallow, and only just clipped the top of the natural along most of its length (**Plate 6**).

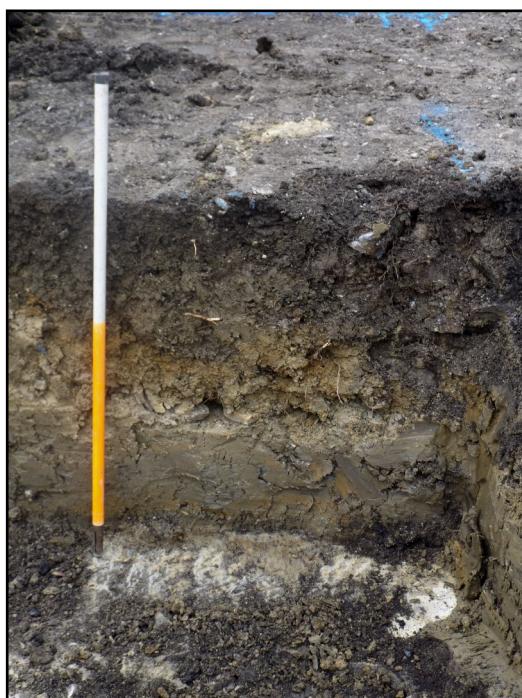
7. The sequence of deposits in the south-facing section of the stairwell trench. Scale: 1m.

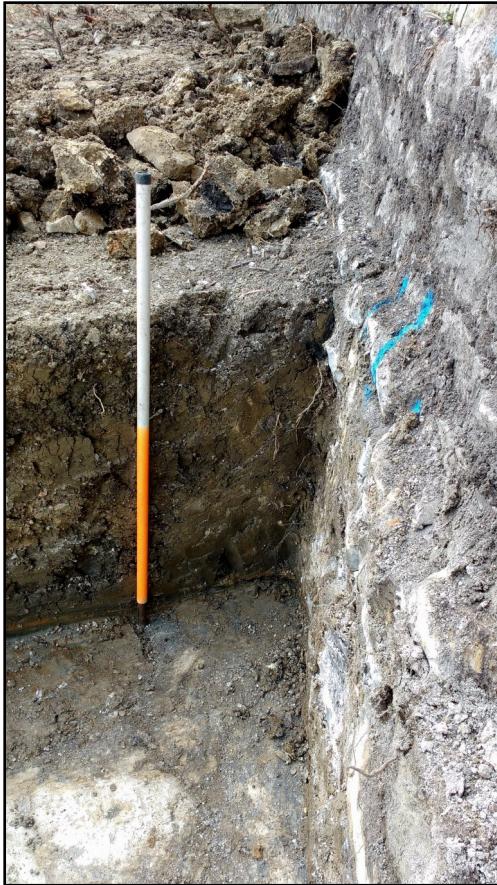
8. View to west at the north-western end of Trench 9, with the northern boundary wall on the right, resting on natural limestone 'pavement'. There does not appear to be any construction cut through the section of natural clay facing the camera. Note the 'squidged out' appearance of the mortar in the wall footing (see text).

Where possible, the opportunity was taken to examine the two historic boundary walls encompassing the site on the northern and eastern sides. The walls were constructed of uncoursed, undressed limestone rubble, with a capping of roughly dressed, flat Pennant coping stones. It was clear that, where the relationship could be seen, the wall had been built directly on top of the natural limestone pavement (eg **Plate 8**). From the top of the wall to the base of its lowest course, as far as this could be seen, was some 3.20m, of which 1.50m or thereabouts had been below the original ground level of the site, indicated by a soil mark running all around its base (**Plates 1 and 6**). Just over 2m from the top of the wall, a slight ledge or plinth stepped outwards about 0.10m, and from that point, it was just under a further 1m to the base of the wall, although it should be noted that the plinth sometimes disappeared into the body of the wall, so that in places the wall appeared to be of a single width throughout its entire height, eg at the eastern end of Trench 2. The two walls are, in any case, clearly of a single build. In the footing courses, the bonding used was a hard, speckly, dirty grey mortar, slightly different to that in the culvert in Trench 4, but again, most likely to be of 19<sup>th</sup> century date. Where it was possible to see the relationship between the natural and the wall, there was no clear construction cut, and the mortar in the lower courses appeared 'squidged out' into the natural. This may suggest that the wall foundation was constructed by making a vertical cut into the natural clay, and then 'backing' one side of the wall into it. The main body of the wall was then constructed on top of the footing. The mortar used in the above-ground part of the wall was very different to that used in the footing, being hard, coarse, light creamy-grey in colour, quite friable, and with moderate flecks of charcoal. The reason for the difference is unclear, but it may well suggest building phases which although technically separate, were in fact differentiated by only weeks or even days. It may, though, also be that a different mortar was used in the below ground section of the walls simply for technical reasons. It is also unclear whether it was these actual walls which were depicted as the property boundaries here on the tithe maps of the 1840s. It is also worth noting that the current ground level on the eastern side of the north/south stretch of the boundary wall, ie that relating to what is now no. 31 Seymour Road, is considerably lower than the *original* ground level on the site – on the eastern side from the top of the wall to ground level was a height of 3.30m; on the site, the same height was 1.90m, a difference of some 1.40m. The reason for this was unclear, and of course, unfortunately, the eastern side of the wall could not be examined. In theory this would mean that the very base of the wall footing on the eastern

side would have been not much, if at all, below the modern ground level, with implications for the overall stability of the wall, but this is speculation, and could not be confirmed.

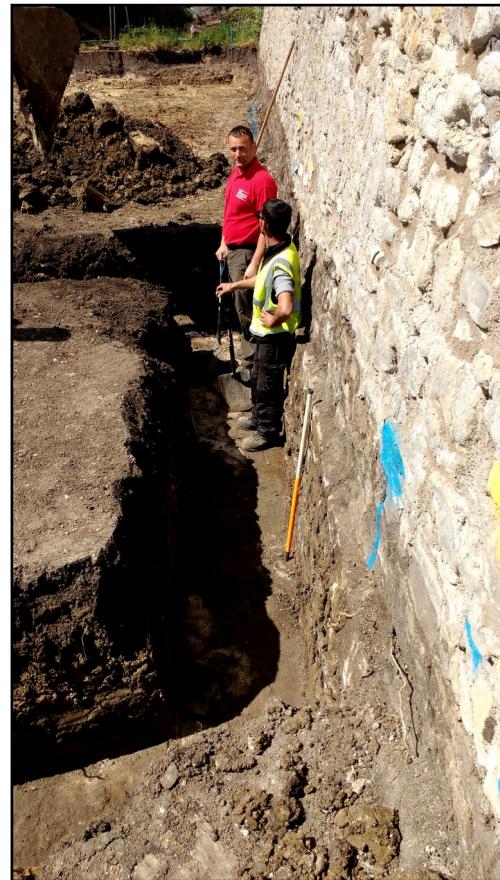
9. View to west along Trench 9, showing slightly stepped out footing of northern boundary wall, on right.

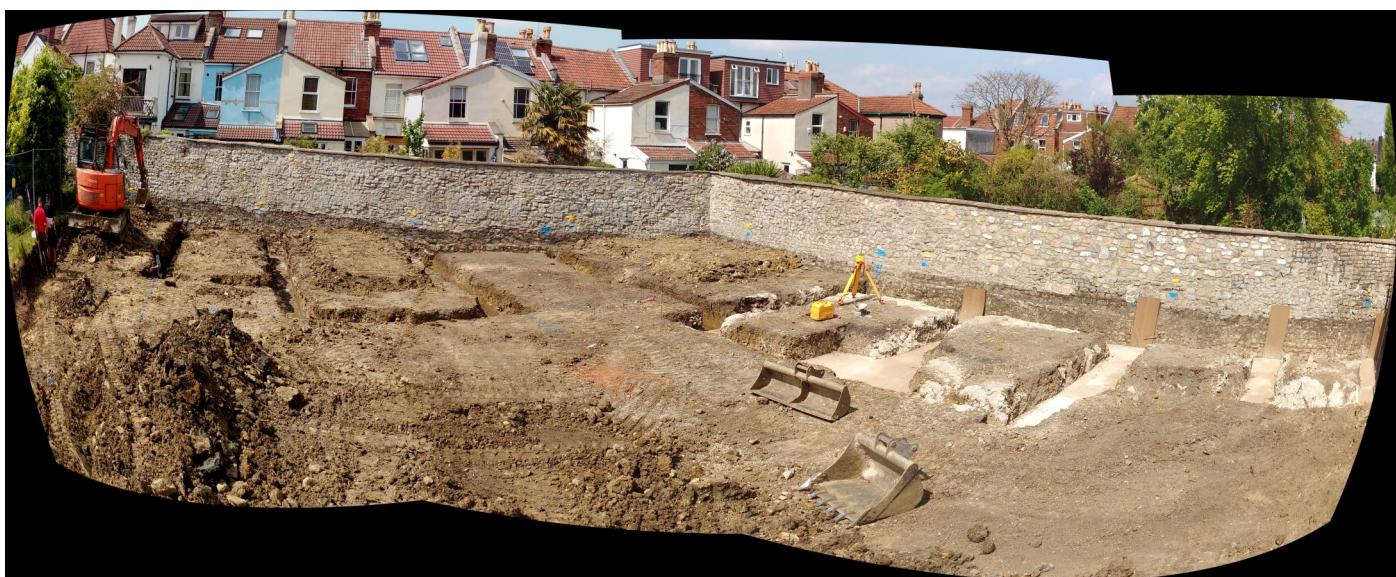
10. Composite panoramic view of site with Trenches 1-14 completed, and concrete already poured in Trenches 1-7. Same viewpoint as for Plate 1.
