**Paradise Cottage, Paradise Lane, Newton Longville,
Buckinghamshire**

Site Code: NWL-C

The Medieval Peasant House in Midland England

NWL-C: PARADISE COTTAGE, PARADISE LANE, NEWTON LONGVILLE,
BUCKINGHAMSHIRE

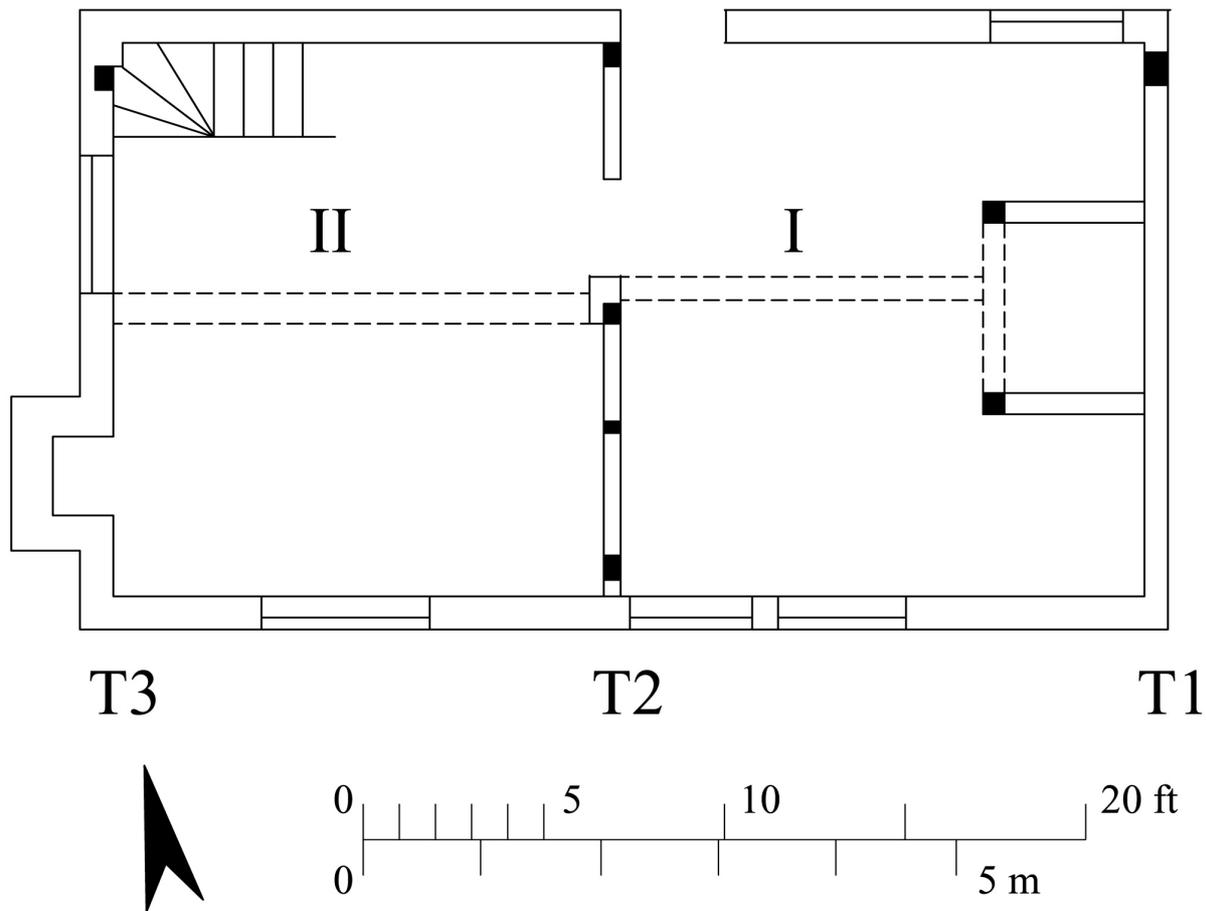
Fig. 2. Plan, showing truss and bay numbering.

PHASE 1: Paradise Cottage stands at the corner of Church End and Paradise Lane, facing slightly west of south. It is a two-bayed cruck house with three trusses with truncated blades (types V and W apices). Built of small scantling timbers, and probably originally of only two bays (Fig. 2), this house represents the lowest level of surviving peasant housing, and as such is of considerable interest. The eastern bay (I) was certainly open to the rafters originally, but it is possible that the western bay (II) was floored over with a loft above. Some slight smoke blackening is evident on both sides of the central truss, suggesting that the loft and the hall were not completely separated. A largely intact timber-framed fireplace and smoke hood in bay I is either original or an early insertion

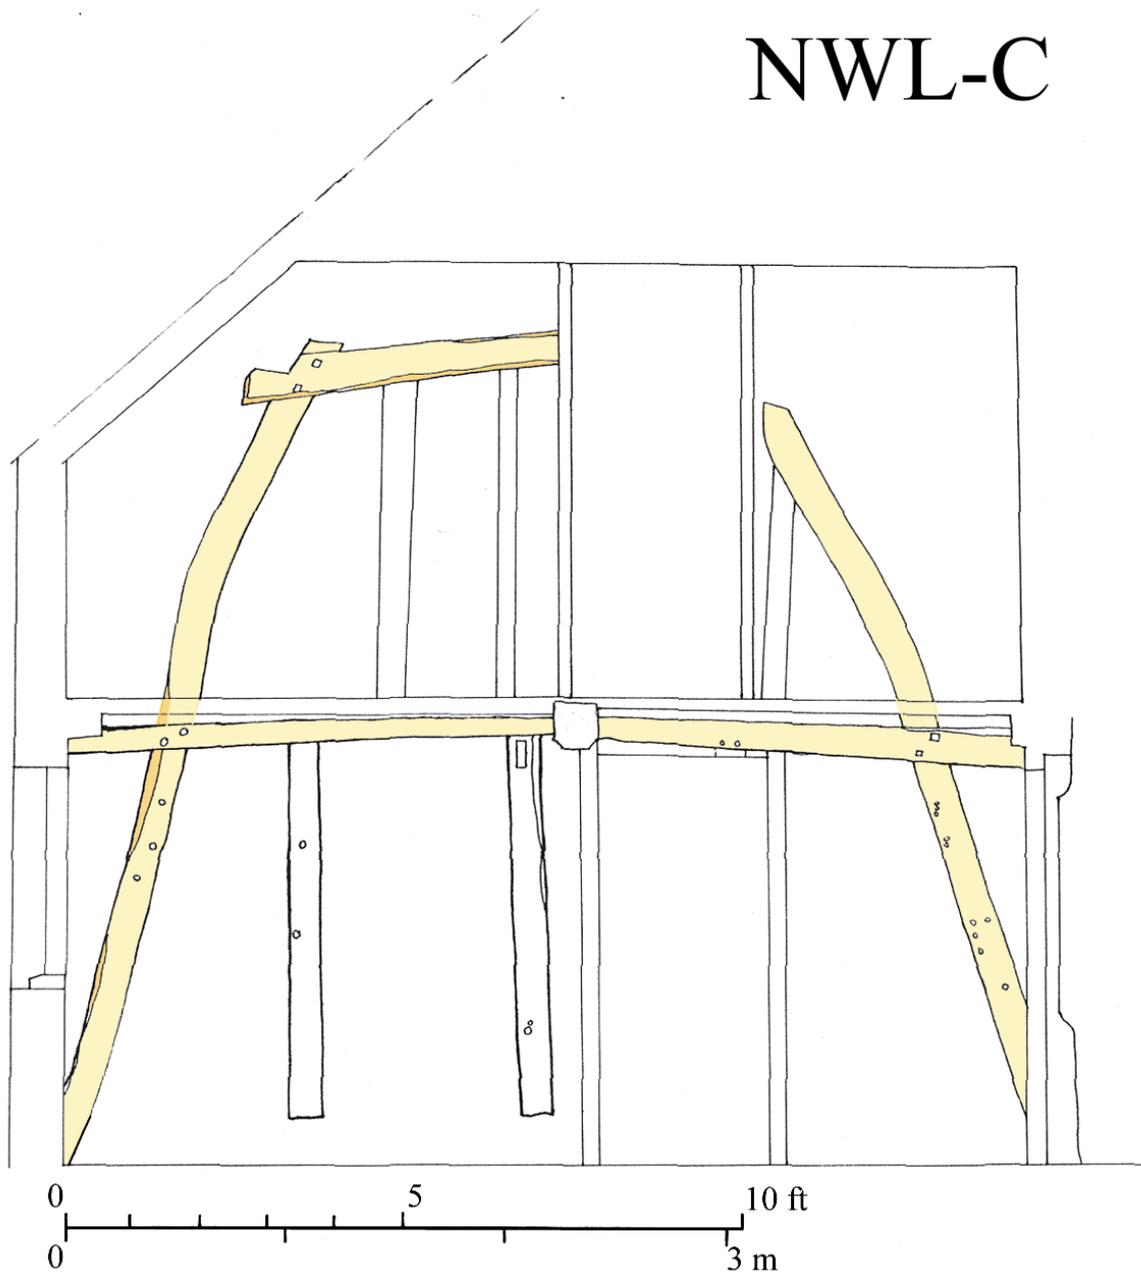
Fig. 3. Section of truss T2

PHASE 1: The central cruck truss (T2, Fig. 3) has a type W apex, in which the cruck blades terminate just above the collar, and the half-hipped end trusses are of the same form (type V apices). The boxed heart cruck blades are of small section, averaging just 6-7in square. In truss T2 the elm collar is 6in high. The tiebeam of T3 appears to be a reused cruck blade as a halving joint is visible. The 6in high tiebeam to T2 extends to support the wall-plates which are just about 6ft 6in above

ground level. The north wall plate has a bridled scarf just to the east of T2. The floor in bay II is carried on a 10½in axial beam with 1½in unstopped chamfers. The joists to the southern side of the beam range from 3½ to 7in wide with ¾in chamfers with runout stops. This floor is not obviously early, but does not match that in bay I, and so may be original.

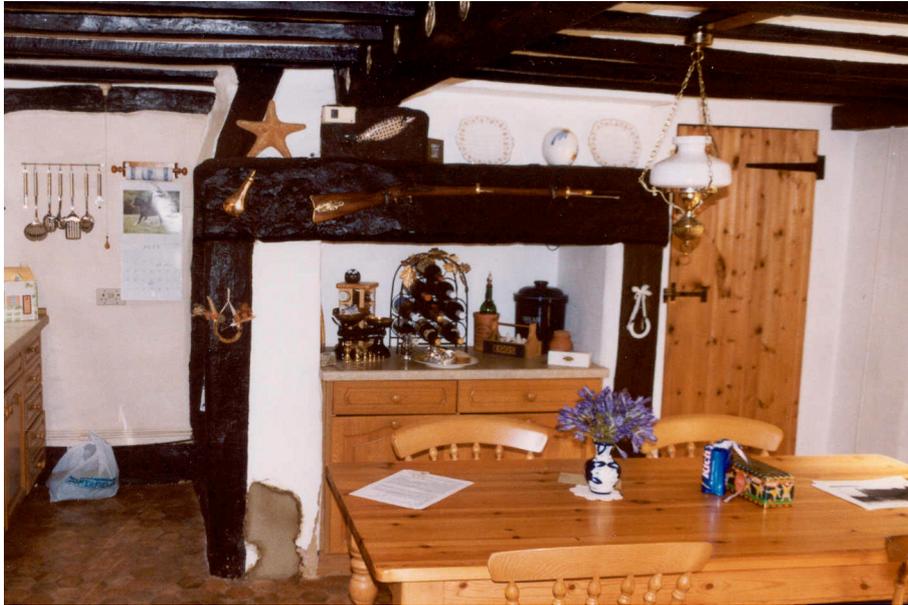
Fig. 4. Timber-framed hall fireplace: ground floor.

The mantel beam of the smoke hood (Figs. 4-5) is supported by two front corner posts, 6½ by 8in, the left hand one being in its original position, but at the right-hand end, the mantel-beam has been cut back to the edge of the raking principal post. These posts rake back from the front of the mantel beam. Originally two ‘hip’ posts slanting from the front corners of the mantel-beam were pegged to the sides of the front raking principals. Three morticed and tenoned cross pieces (5-6 by 3½in) survive on the left hand side, with two more between the front principals. The hood is infilled with hazel staves with cleft laths for wattles to receive the lime-rich daub. A large timber sill beam

runs across the back of the fireplace, with a side sill carrying the front corner post. The mantel-beam measures 13in high by 11in deep and is heavily bevelled internally. A chamfer runs up the inside of the left hand jamb and is carried around the lintel. A later brick fireplace has been built within the narrowed opening.

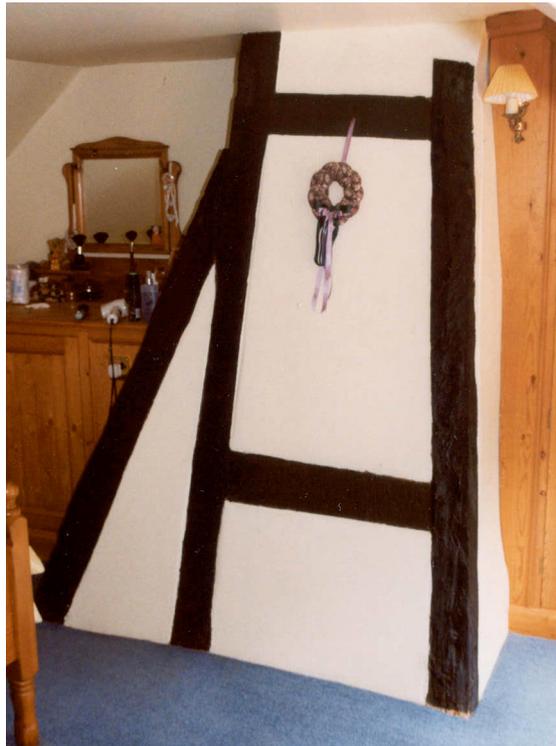
Fig. 5. Timber-framed hall fireplace/smoke hood: first floor.
