Report for  
**Green Farm, Bradgate Road, Anstey,  
Leicestershire**

The Medieval Peasant House in Midland England

ANS-A: GREEN FARM, BRADGATE ROAD, ANSTEY, LEICESTERSHIRE

Survey Date: 24 July 1991

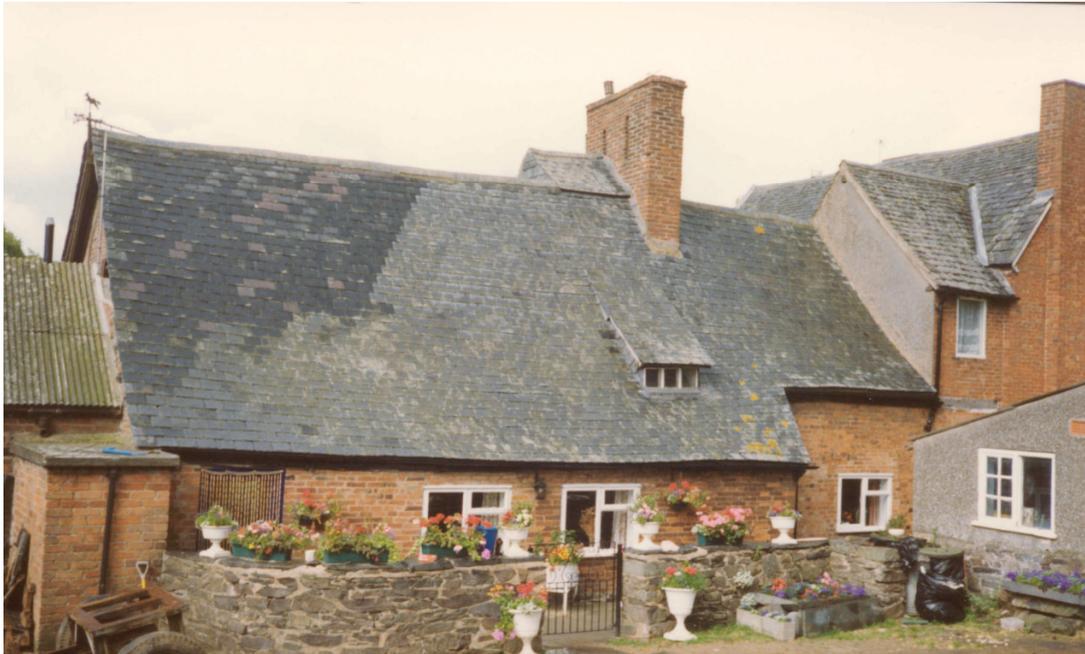
Fig. 2. View from the south. (The brickwork date is not visible.)

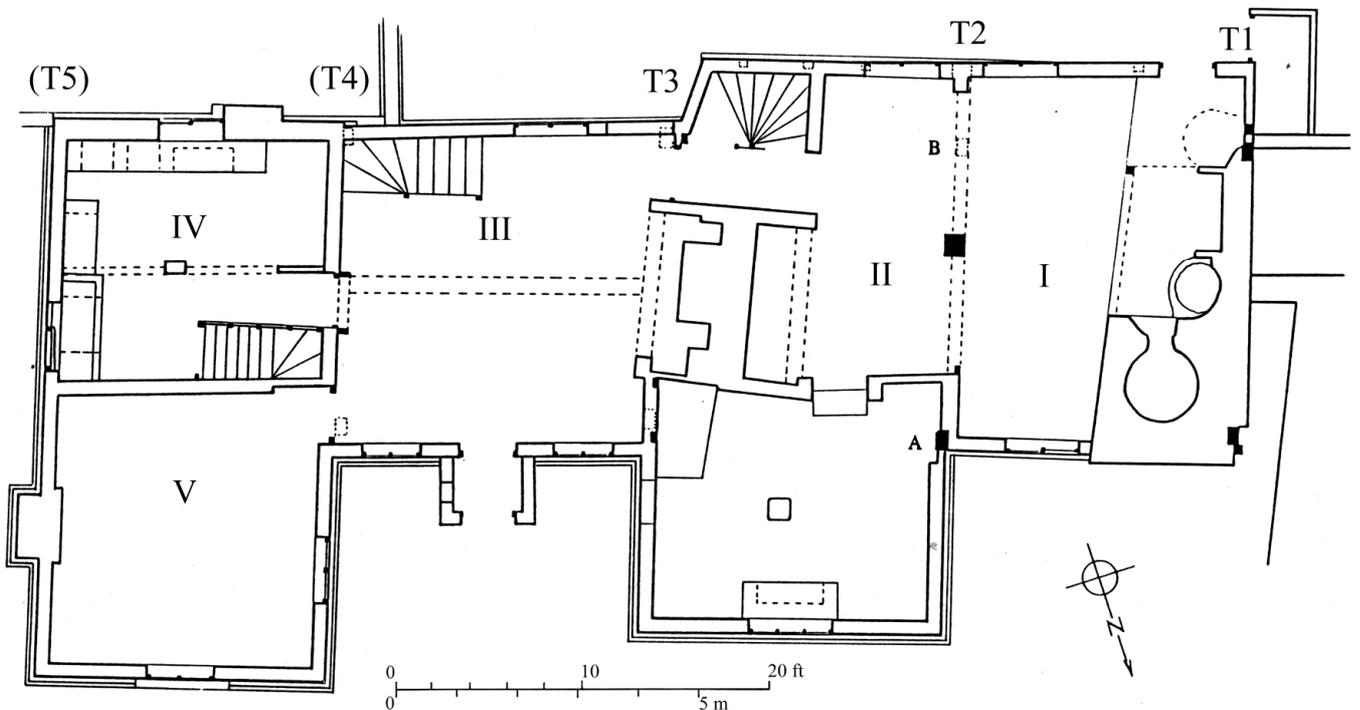
Fig. 3. Plan, showing truss and bay numbering.

PHASE 1: Green Farm is a substantial cruck house running roughly east to west, of three bays and with strong evidence for the existence of a fourth bay. It has been dated by dendrochronology to 1449/50. The cruck trusses have type 'C' apexes and the purlins, crucks, and collars are exceptionally heavy in section. Three bays of the original cruck range are intact, Bays II and III were the hall, with bay I at the western end probably for service. Bay IV was probably the chamber end but has been replaced by the 1715 cross-wing. The heaviest smoke blackening in bays I to III is near the western end of bay III. The open hearth may have been here, or possibly under the existing chimney stack on the other side of truss T3.

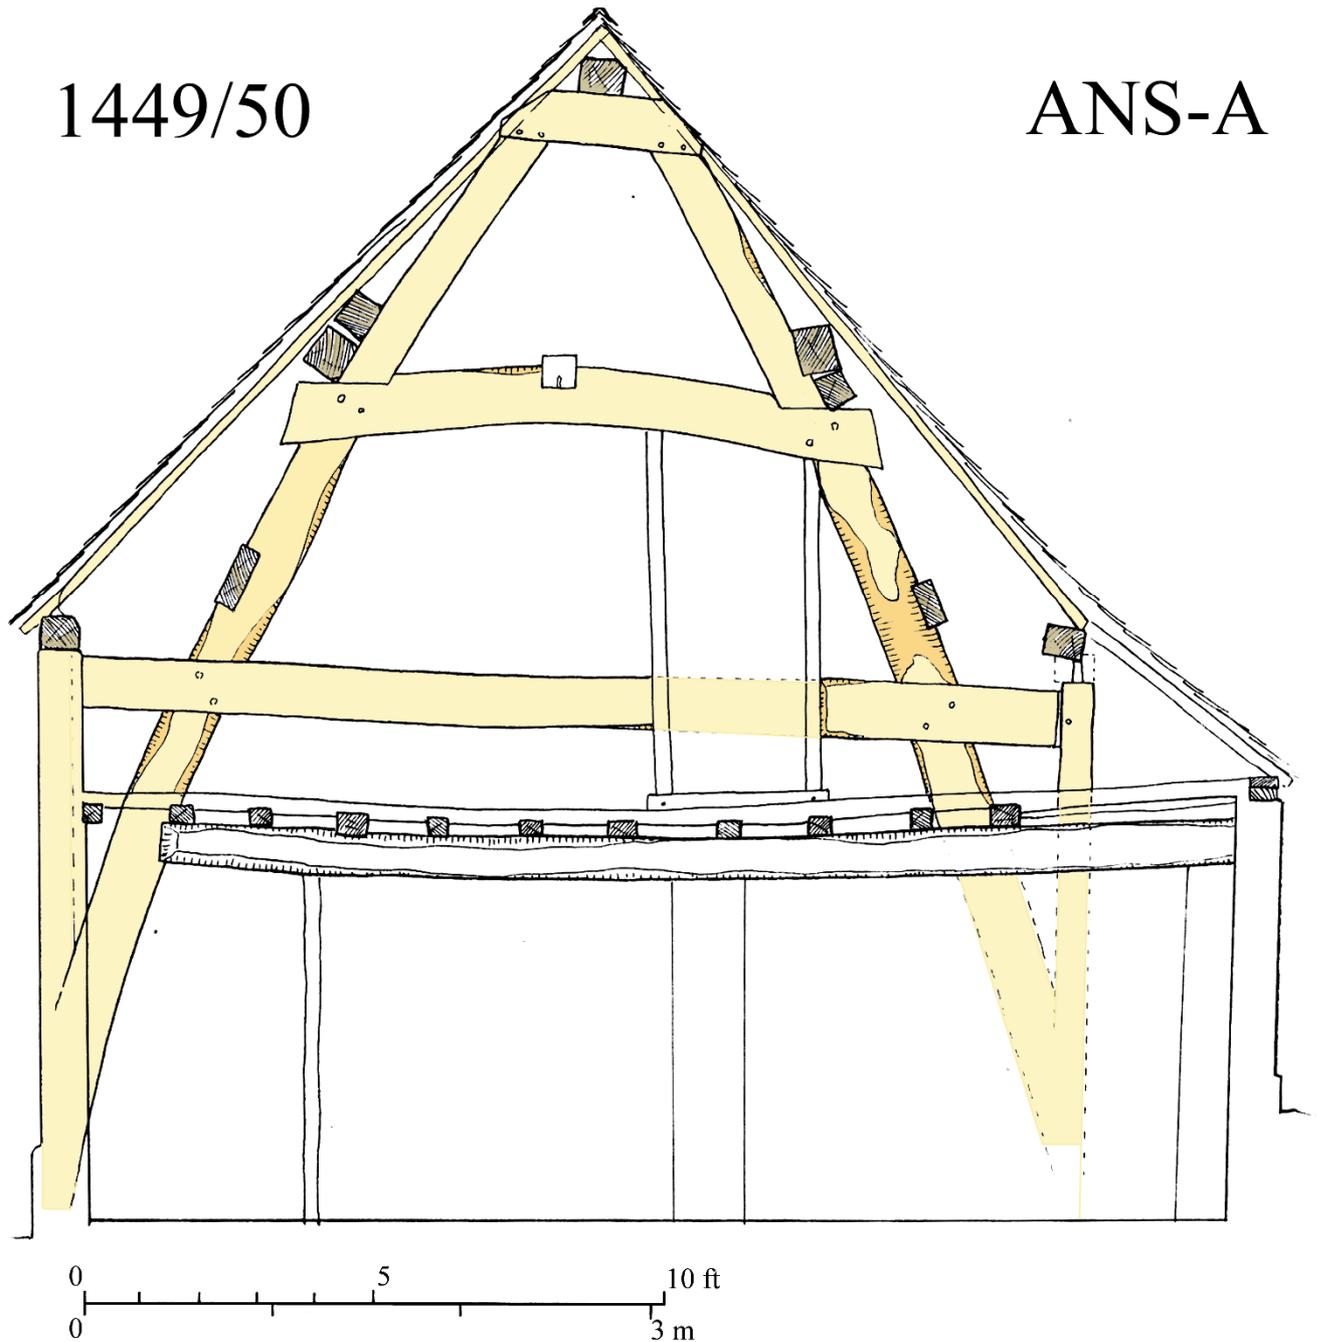
Fig. 4. Section of Truss T2.

On truss T1, most of the tiebeam was removed to insert the 18th century kitchen chimney stack, and the front cruck stud has been recently replaced. All of the original wattle and daub panels have been replaced in brick, probably also in the 18th century. Truss T2 (Fig. 4) is reasonably intact with the exception of the rear cruck blade which is cut off below first floor level with a beam inserted to transfer the load to the outside of the rear lean-to. The tiebeam has also been severed for a doorway, probably in phase II, and the front cruck stud was removed during the 19th century refronting of bay I. Between the tiebeam and collar, much wattle and daub still remains. For truss T3 the blades are only visible on the first floor. At the position of the removed truss T4, the rear purlin is trenched with a peg hole, and the end of the ridge beam has one half of a splayed and pegged scarf at the same point, confirming the presence of a further bay. The rear wall-plate has a similar splayed scarf, half way along bay III.

PHASE 1: *Cruck range*: Of the first phase construction, three cruck trusses remain, along with some of the rear wall framing. All three trusses have type 'C' apexes which consist of cruck blades joined by a saddle (10 x 9in) on which rests the ridge (9½ by 9in). The purlins (9 by 8in) are supported on the back of the cruck blades (11in wide x 10in thick), resting on the extended ends of the collar (12 by 7in); they carry substantial wind-braces (4½ by 9in) which are trenched into the backs of the cruck blades and the purlins. The tiebeams (12 by 5in) continue past the crucks to tenon into the cruck studs (6 by 5in) which rise another inch above the top of the tiebeams to tenon into the underside of the wall-plate (6 by 8in). It was not possible to inspect the junction between the bottom of the cruck stud and the cruck blade. All the component members are among the most massive that have been recorded during the project.
